MARTINDALE HALL

CONSERVATION MANAGEMENT PLAN

REV. A / NOV 2021

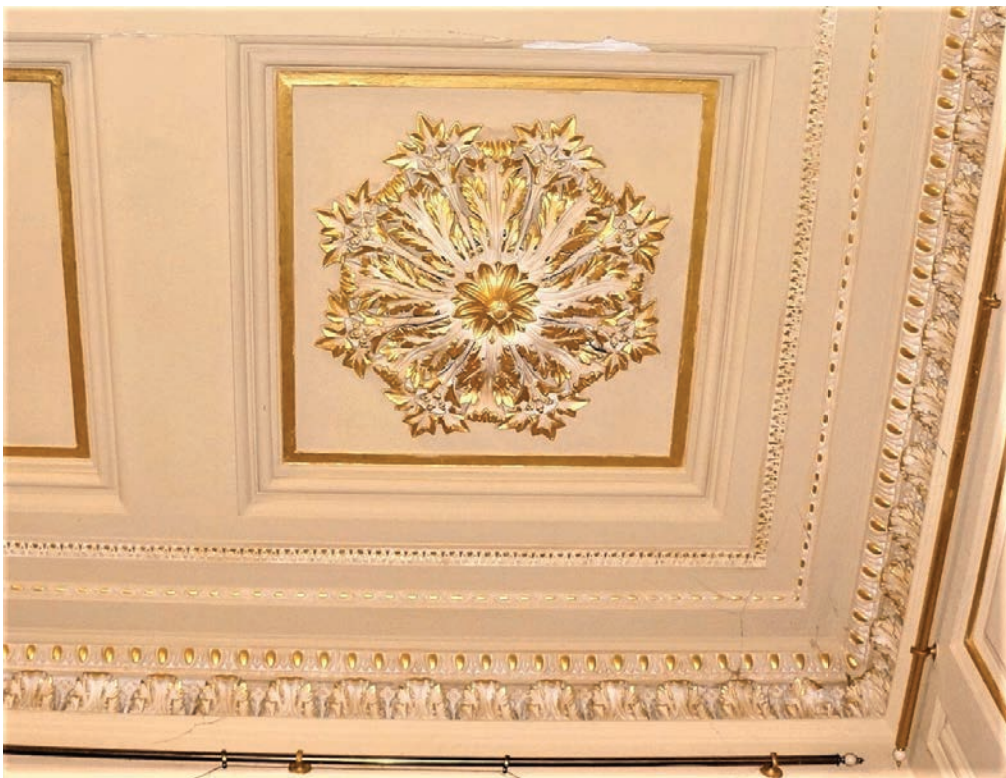
Figure 23: Decorative acanthus leaf pattern corner rose. Note the chipped moulding and general movement cracks.

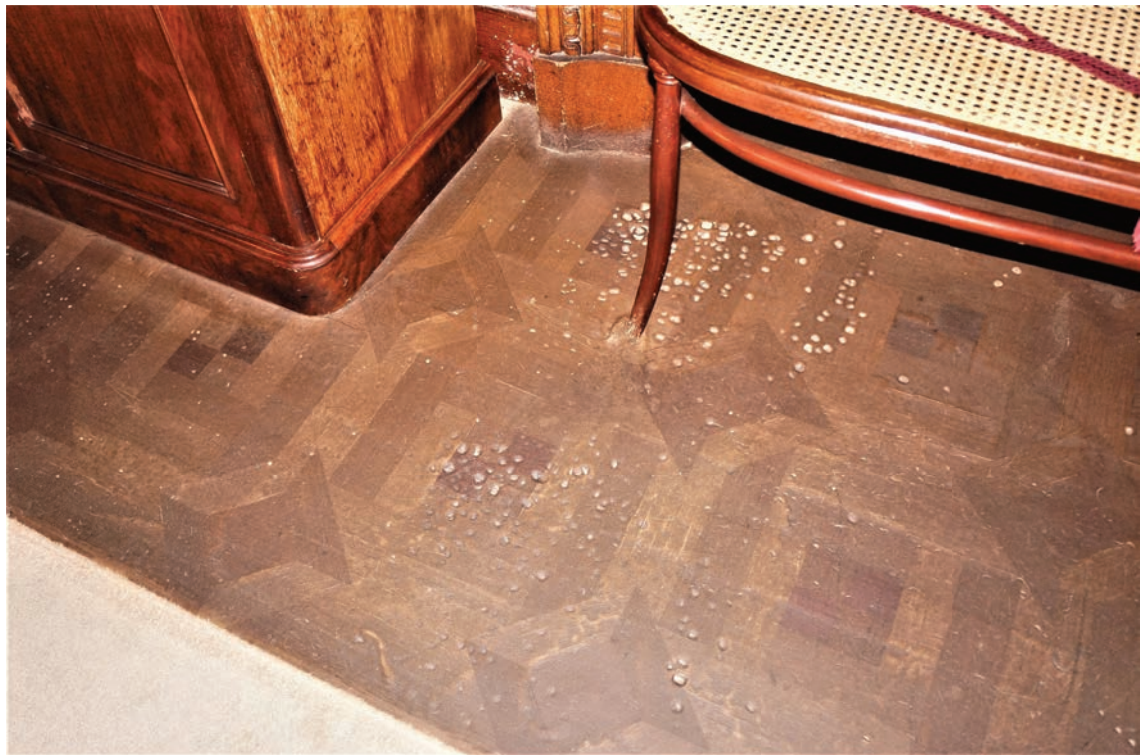
Figure 55: Patterned lino floor covering pockmarked with damage from billiard cues.

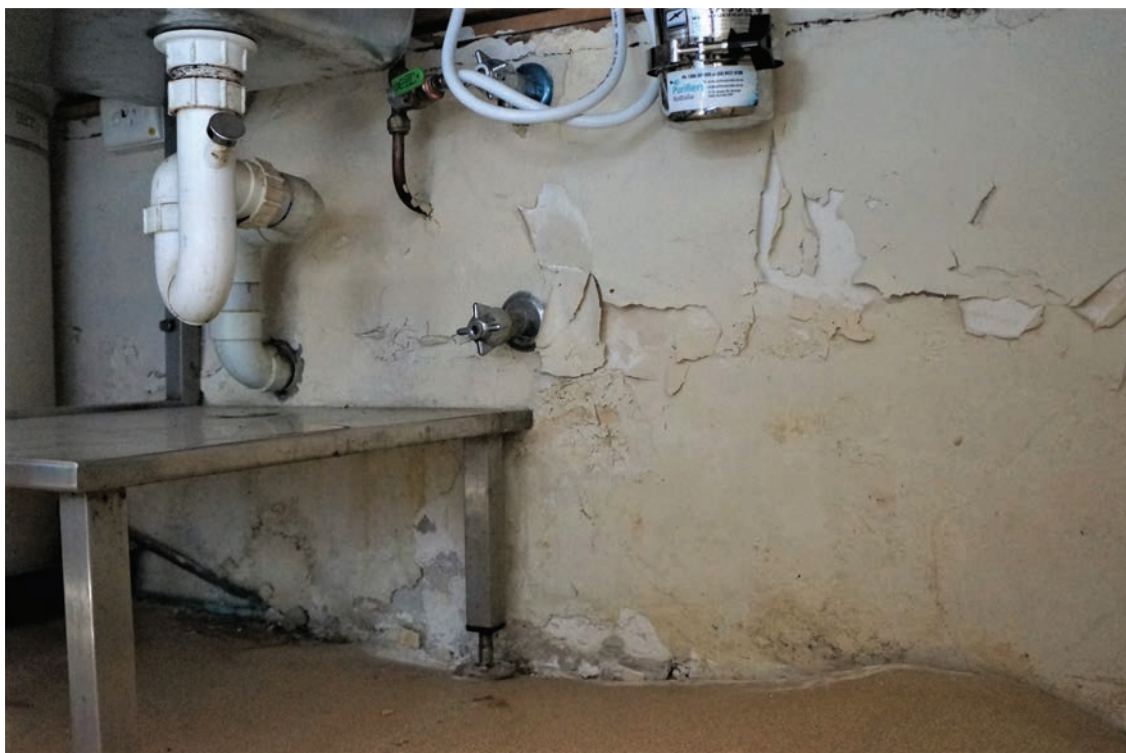
Figure 79: Peeling paint and friable plaster under the sink. Note the floor vinyl that is lifting against the wall.

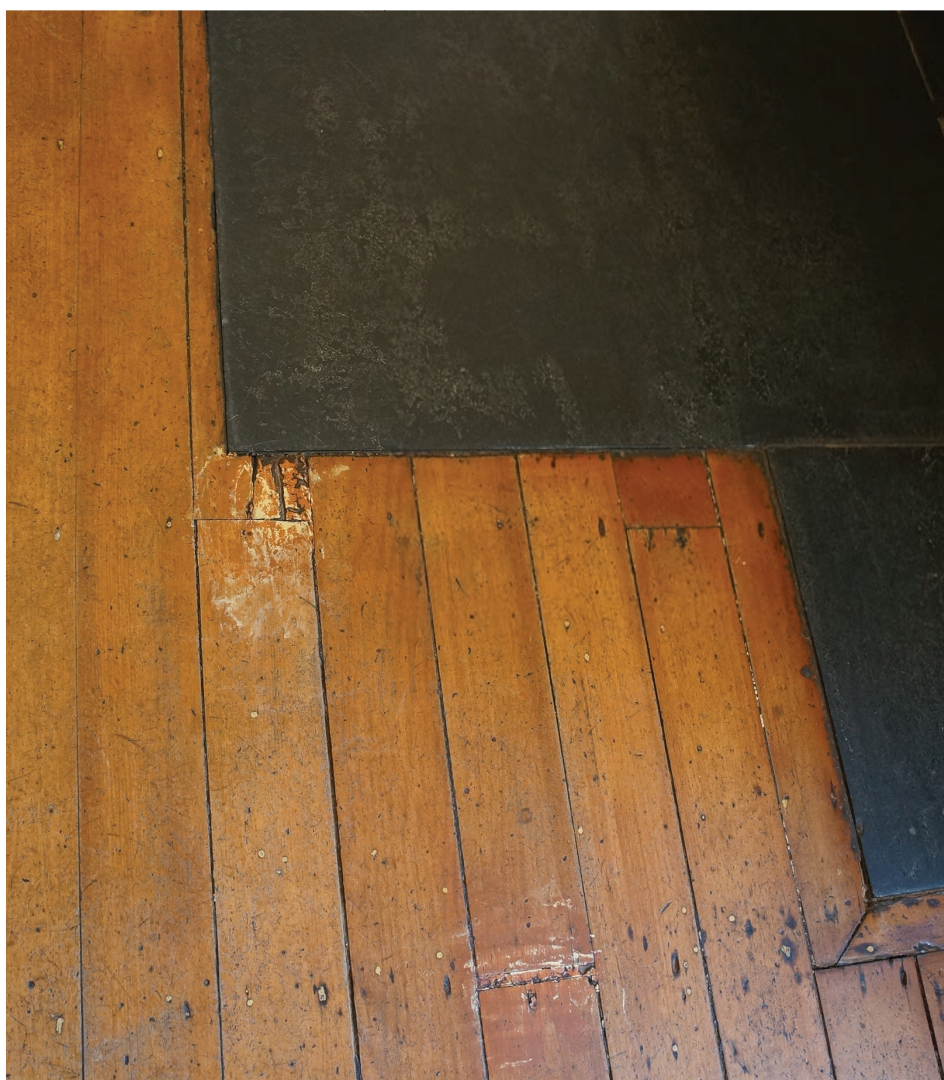
Figure 82:
Wear and tear
to the floor
near the slate
hearth.

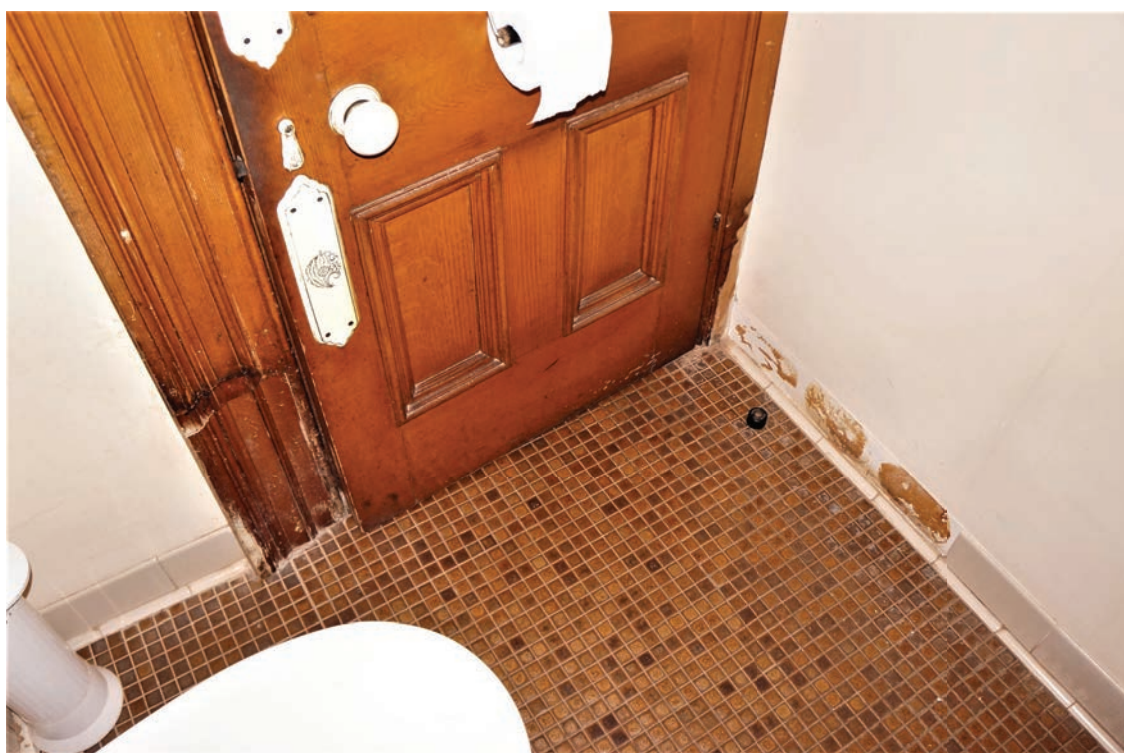
Figure 97: There are missing skirting tiles within the WC.

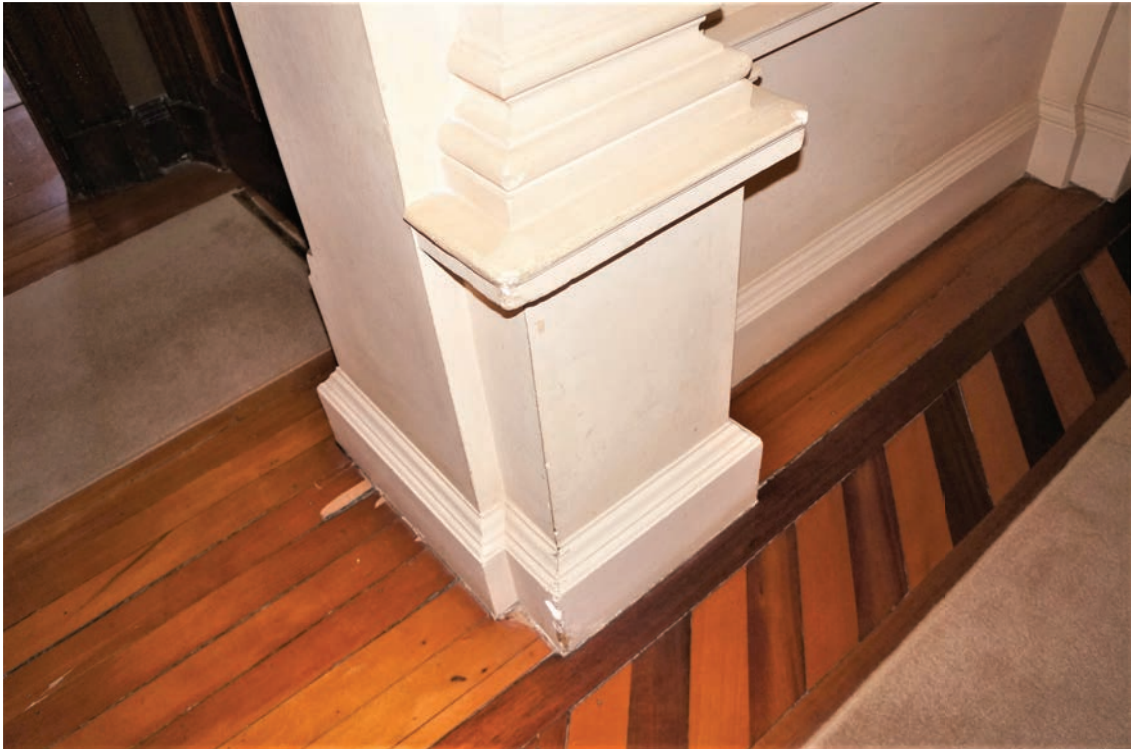
Figure 105: The walls around the Central Gallery are ornately detailed with recessed panels and pilasters with Corinthian capitals all on moulded bases. The finishes display wear and tear and require refurbishment.

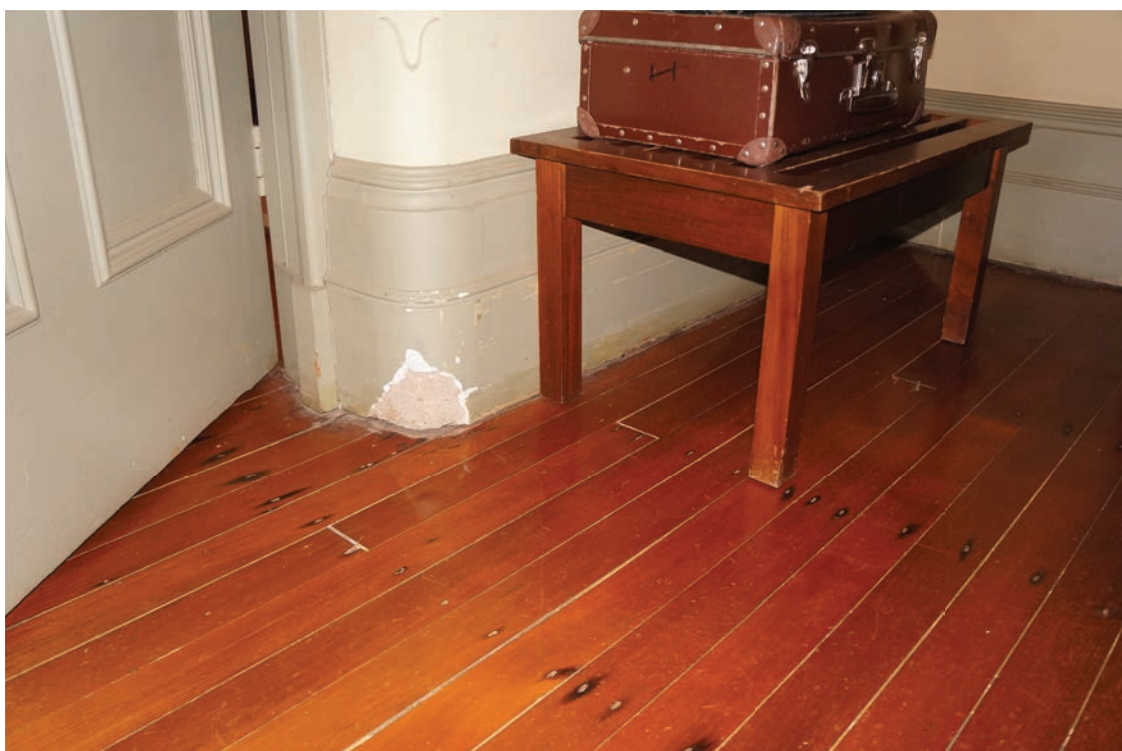
Figure 123: Damage to the rounded cement skirting adjacent to the entrance door.

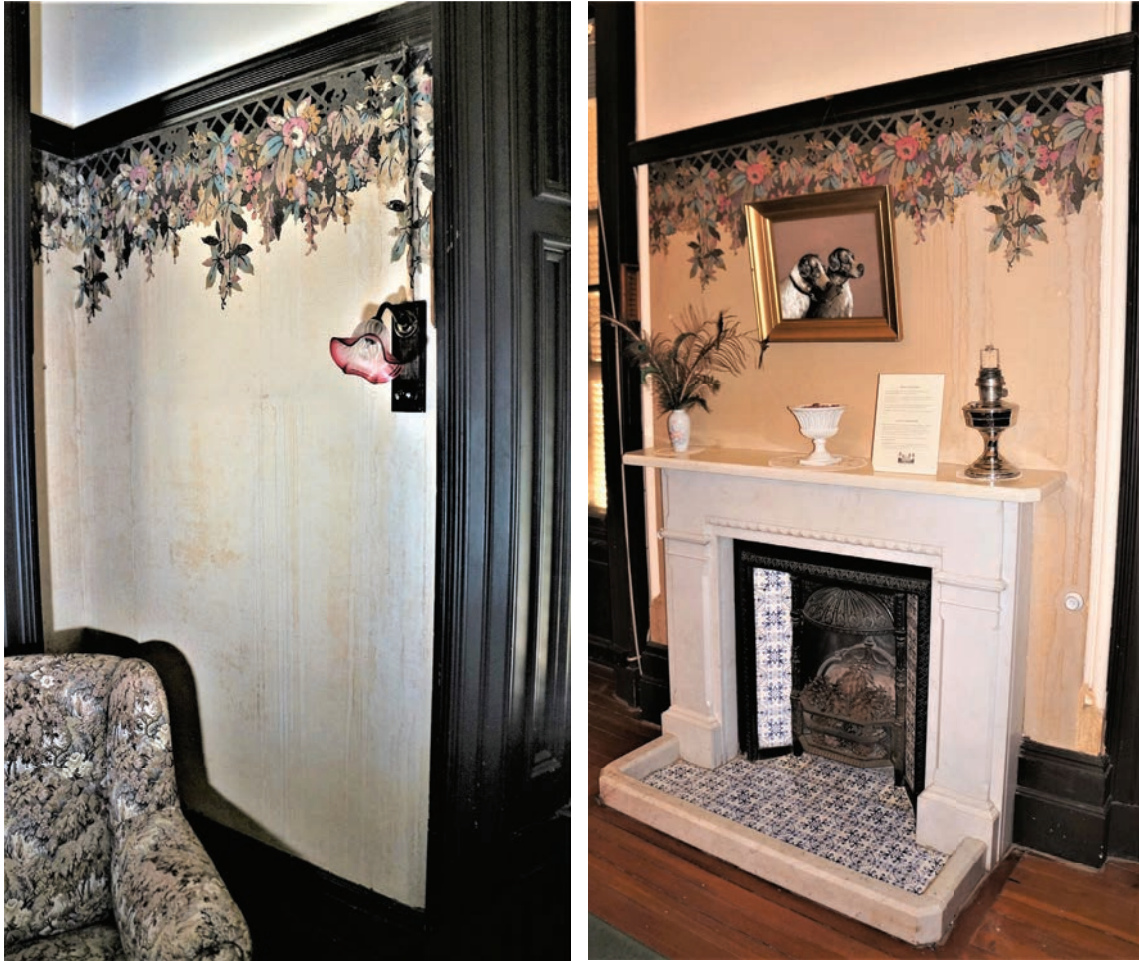
Figure 133: Above left: North east corner of room. Note the water staining on the wall paper. There is an embedded rainwater pipe in this section of external wall.

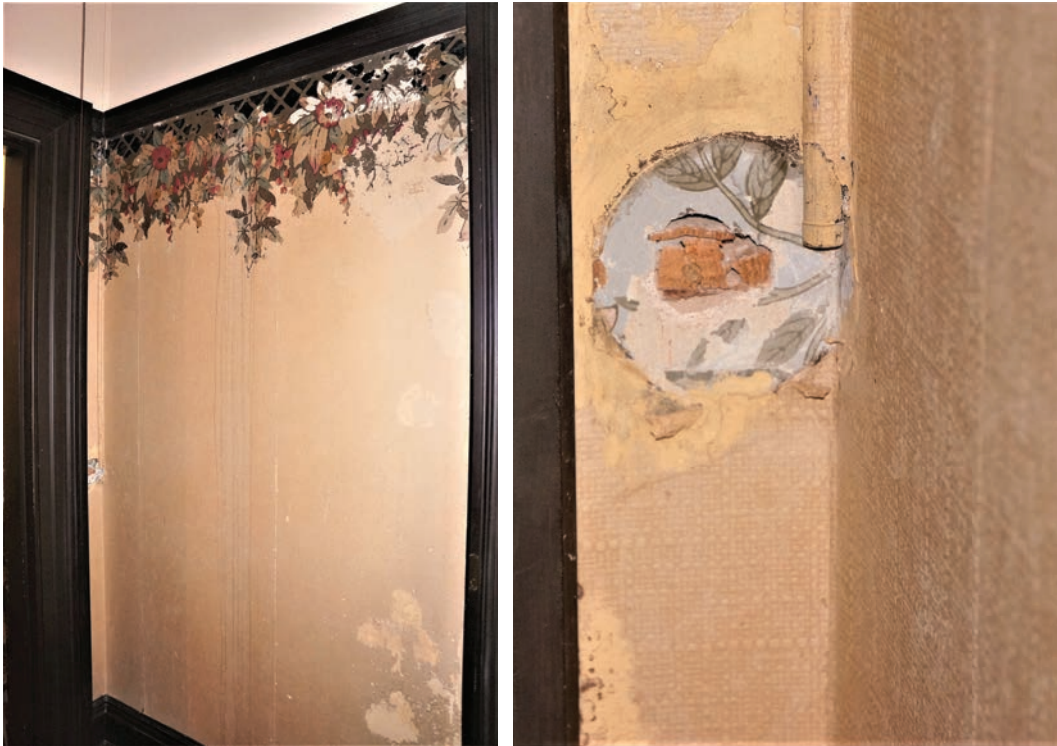
Figure 137: Above left: External wall to the bathroom. Note the water staining similar to that in the bedroom. There is an embedded rainwater pipe in this section of external wall.

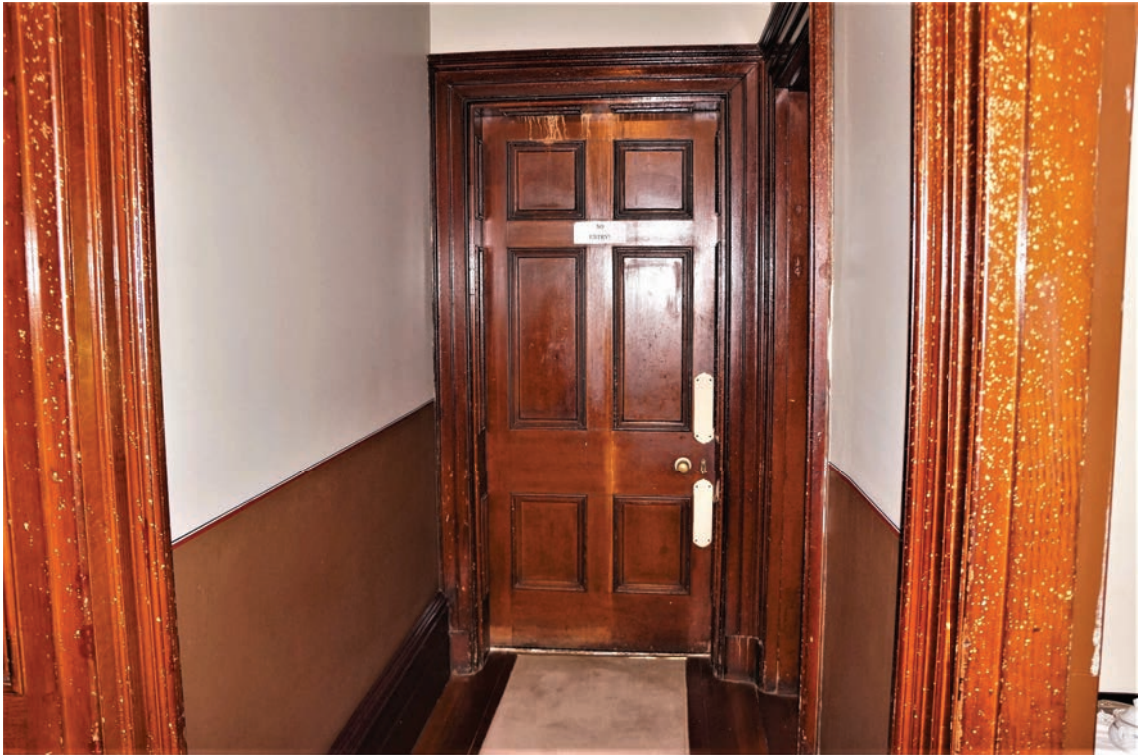
Figure 142: Corridor leading to Servants' WC. Note the damage to the grained door facings on either side.p.

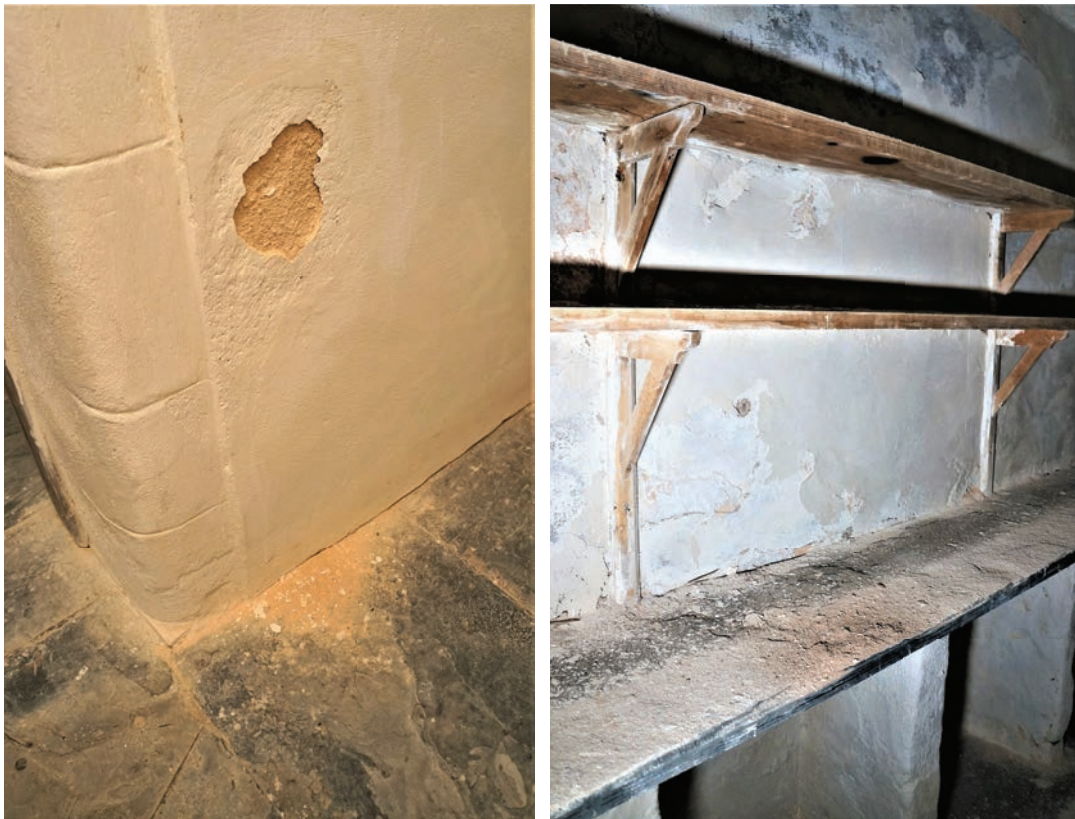
Figure 162: Above left: spalling lime render in main passage.

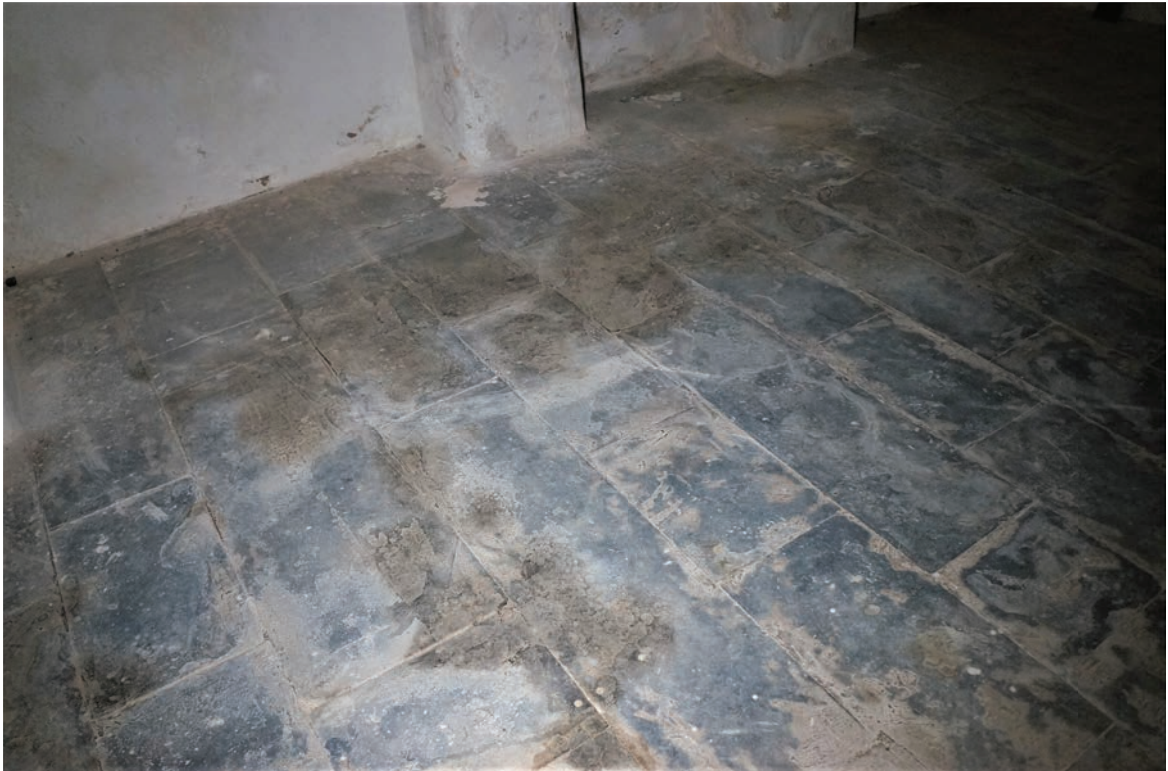
Figure 166: Damp patches on the slate flagstones of the General Store floor.

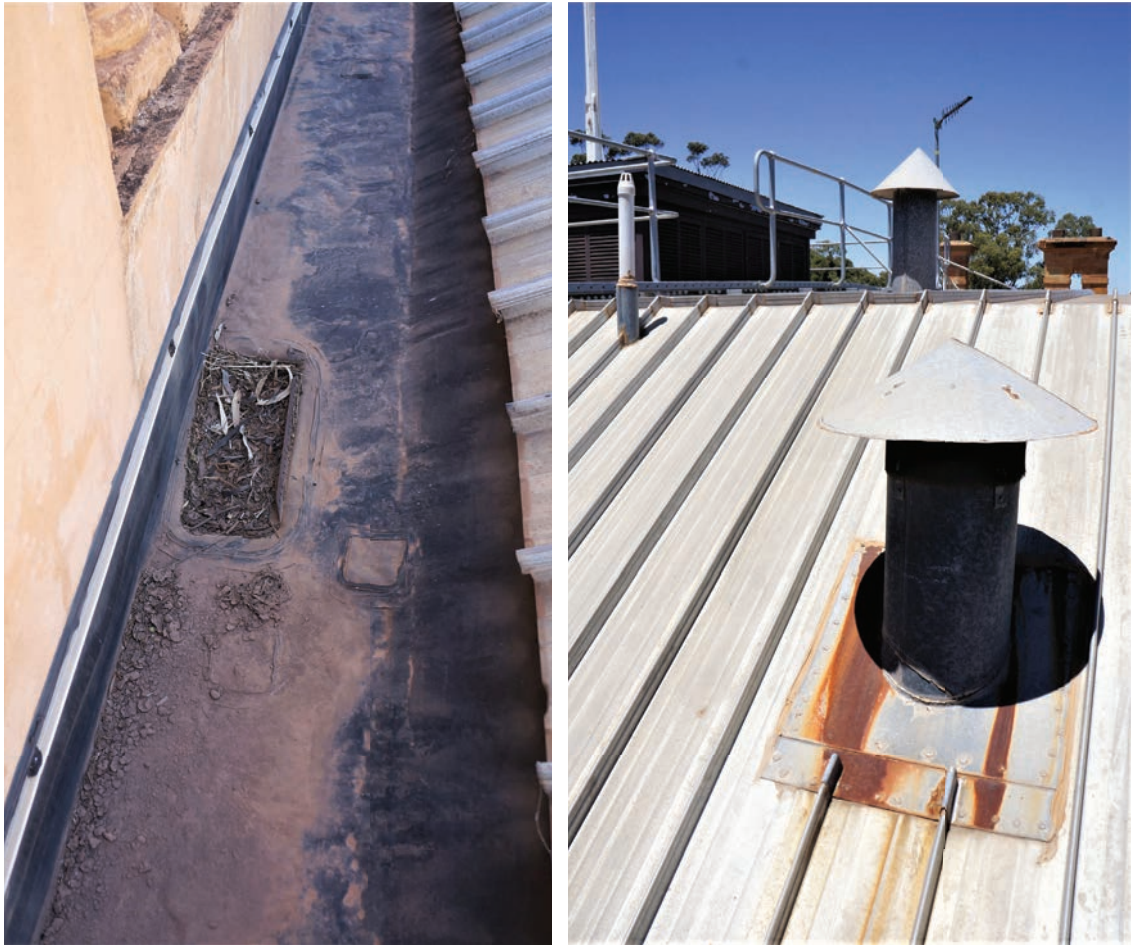
Figure 208: Above left: View of membrane-lined box gutter. Note the blocked roof outlet.

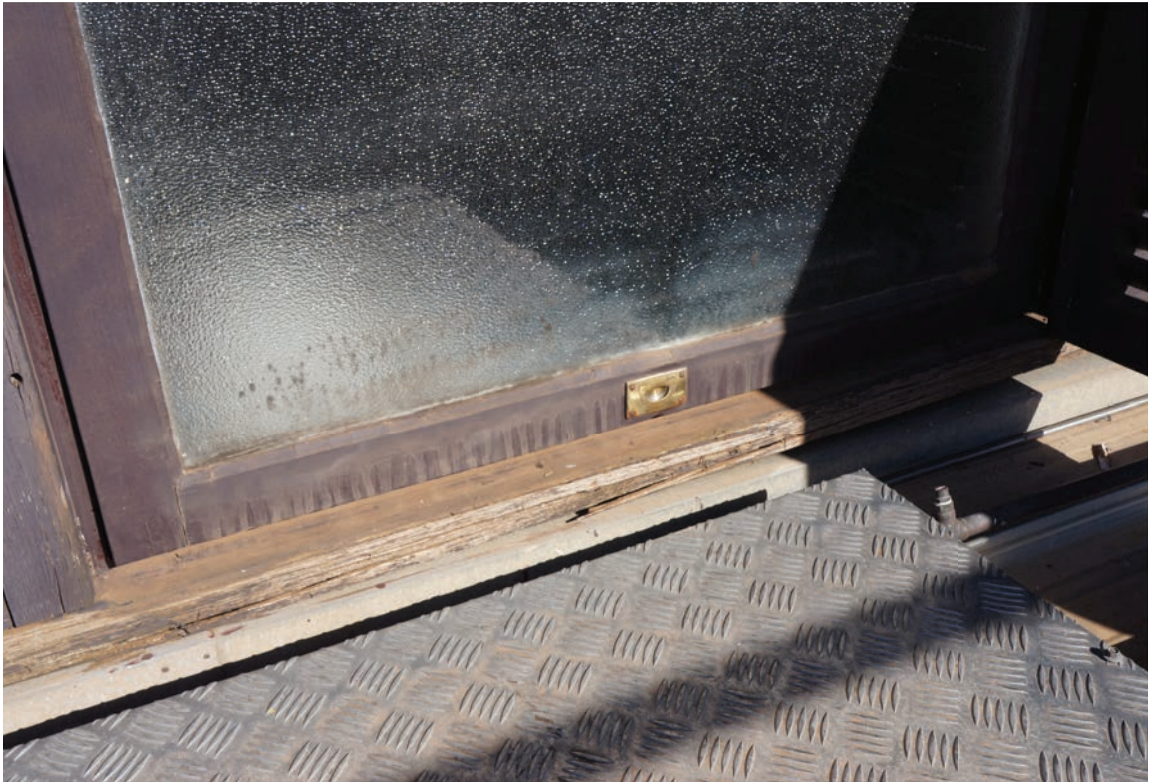
Figure 212: The timber sill on which the lantern sits is rotten.

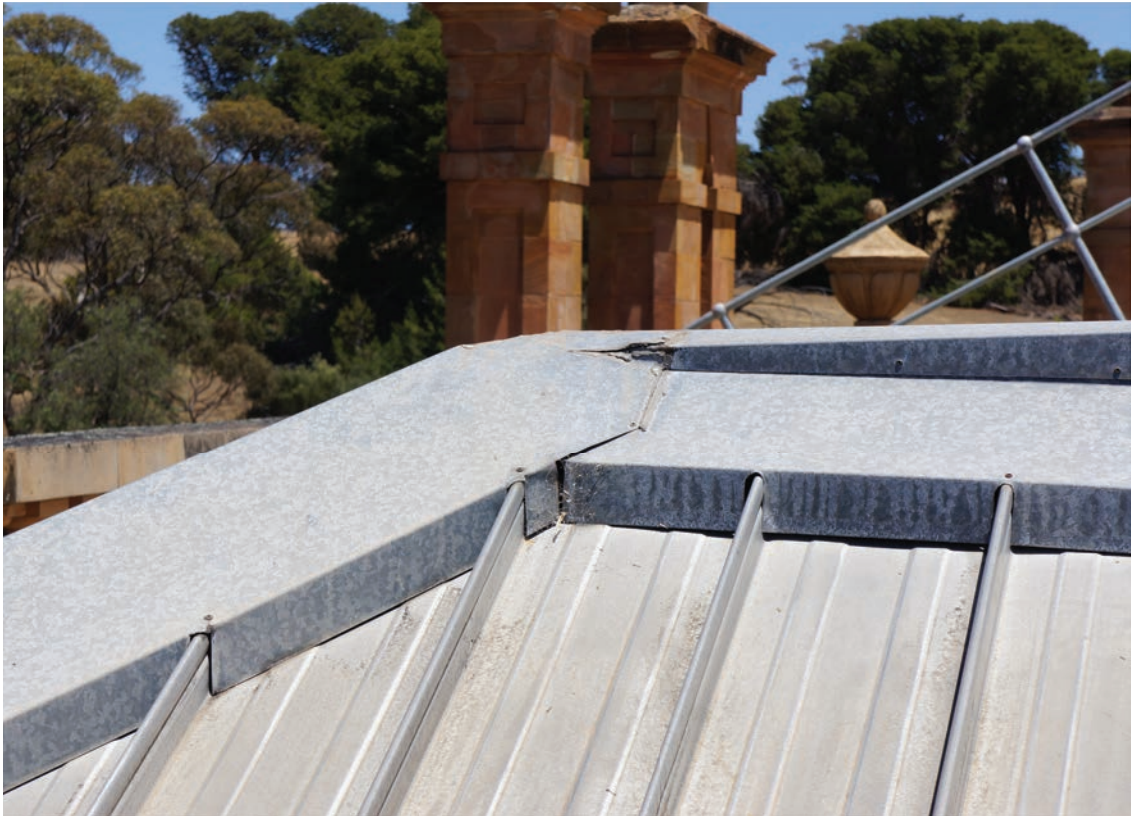
Figure 214: Past attempts to seal failing junction by means of welding and mastic. This occurs on all four corners of the mansard roof and is likely to be one source of current leaks.

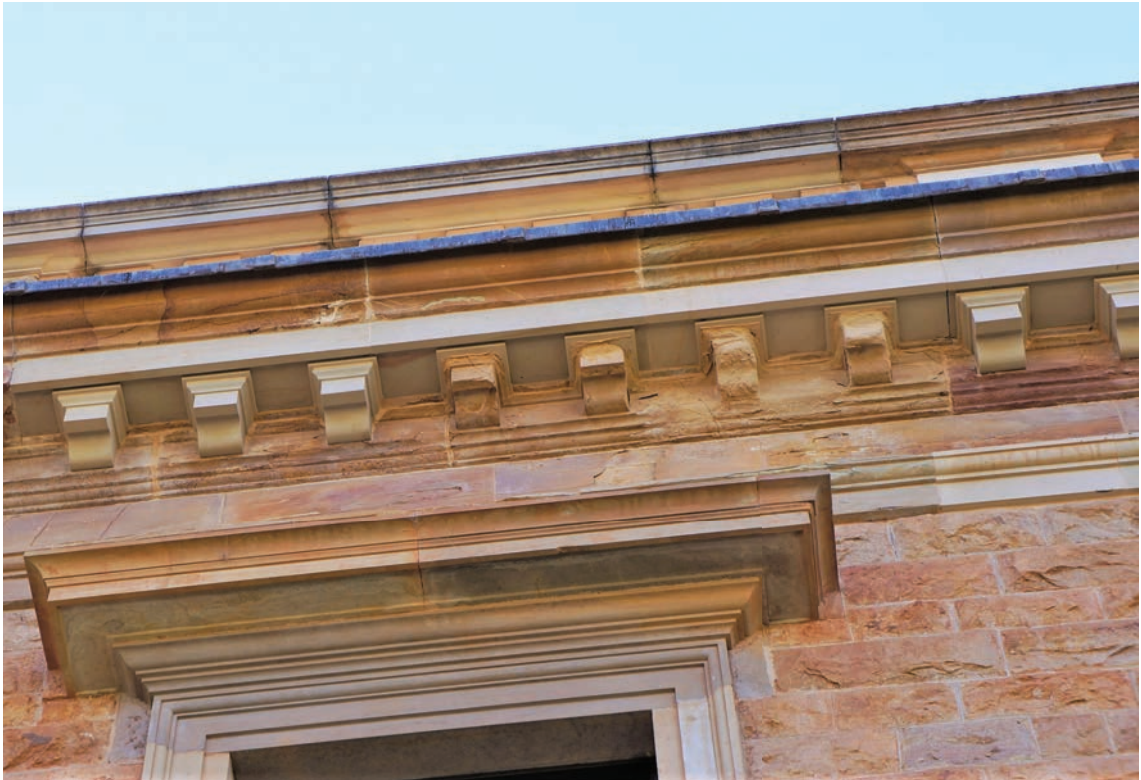
Figure 217: Deterioration of dentils. Note the fresh stone all around which, if harder, will be accelerating the decay of the original stone. Also, there appears to be a plastic repair on the stones directly underneath that is peeling off.

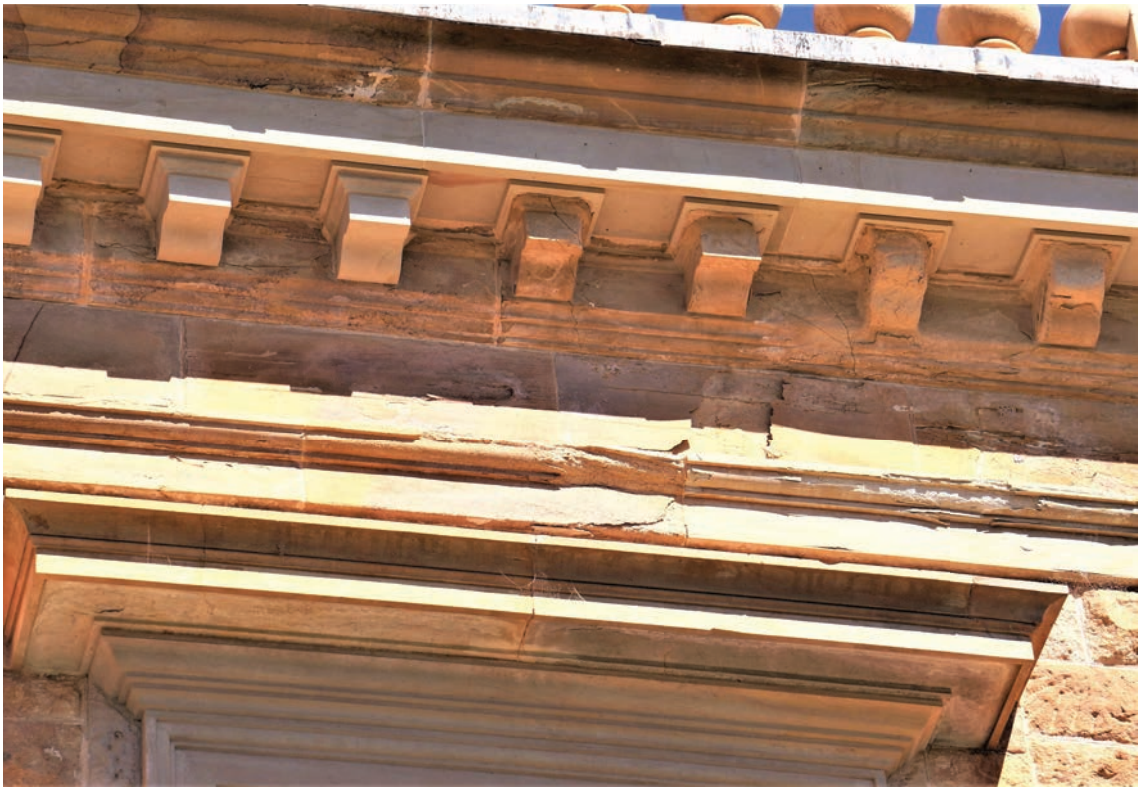
Figure 218: There appears to be a plastic repair/ cementitious coating on the stones directly underneath the dentils that is peeling off.

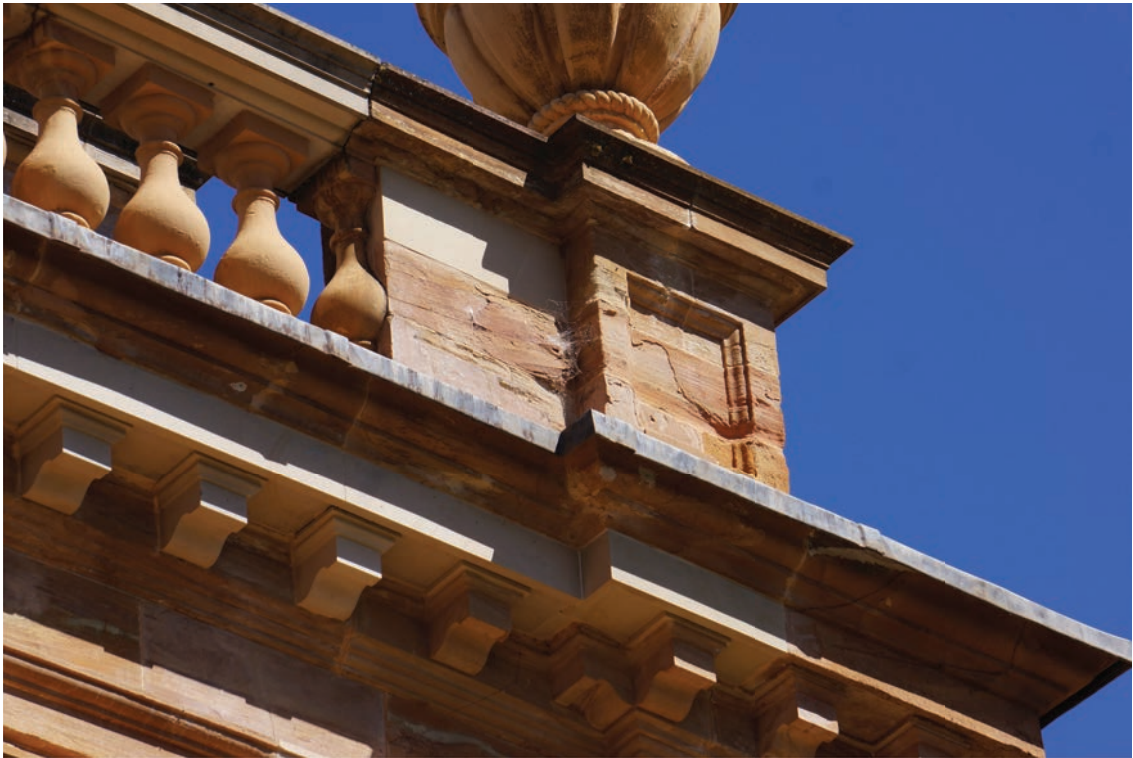
Figure 219: Deterioration of the dressed panel to the north corner of the east elevation parapet. Note the area of new stone. Many of the stone balusters have been renewed in concrete and coated to match adjacent stonework.

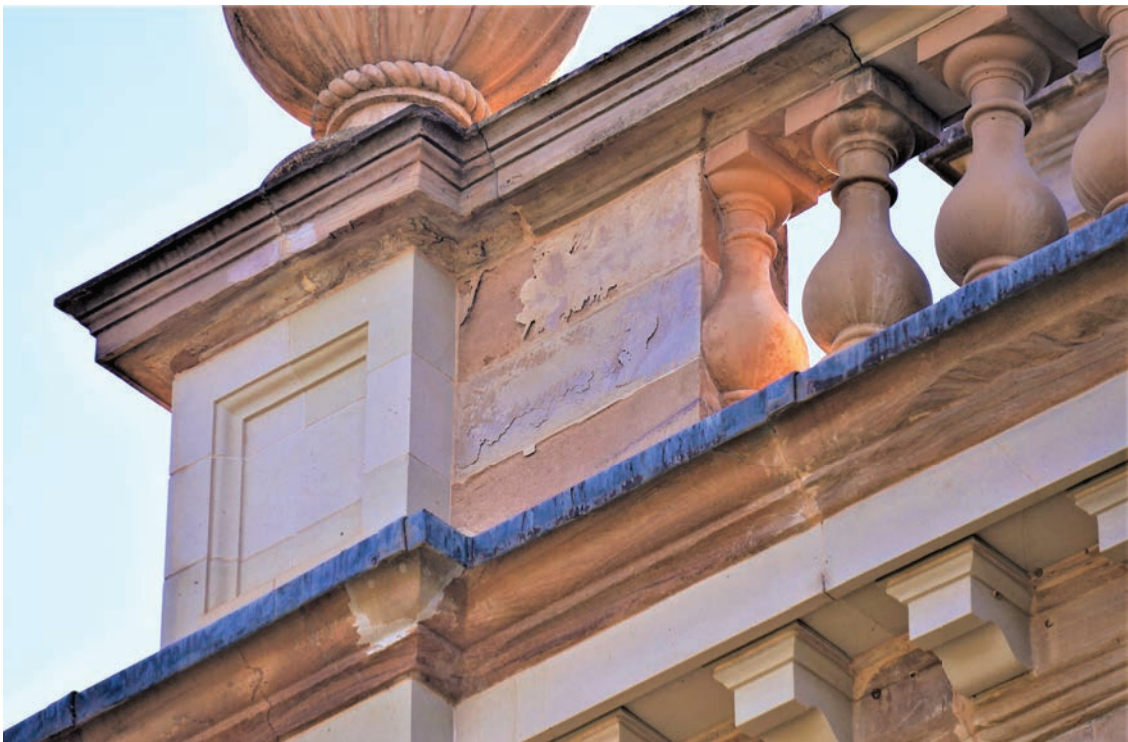
Figure 220: Exfoliation of a plain area of dressed to the south corner of the east elevation parapet. It looks like a coating that is peeling off. Note areas of new stone, and the plastic repair to the corner under the lead over-cloak.

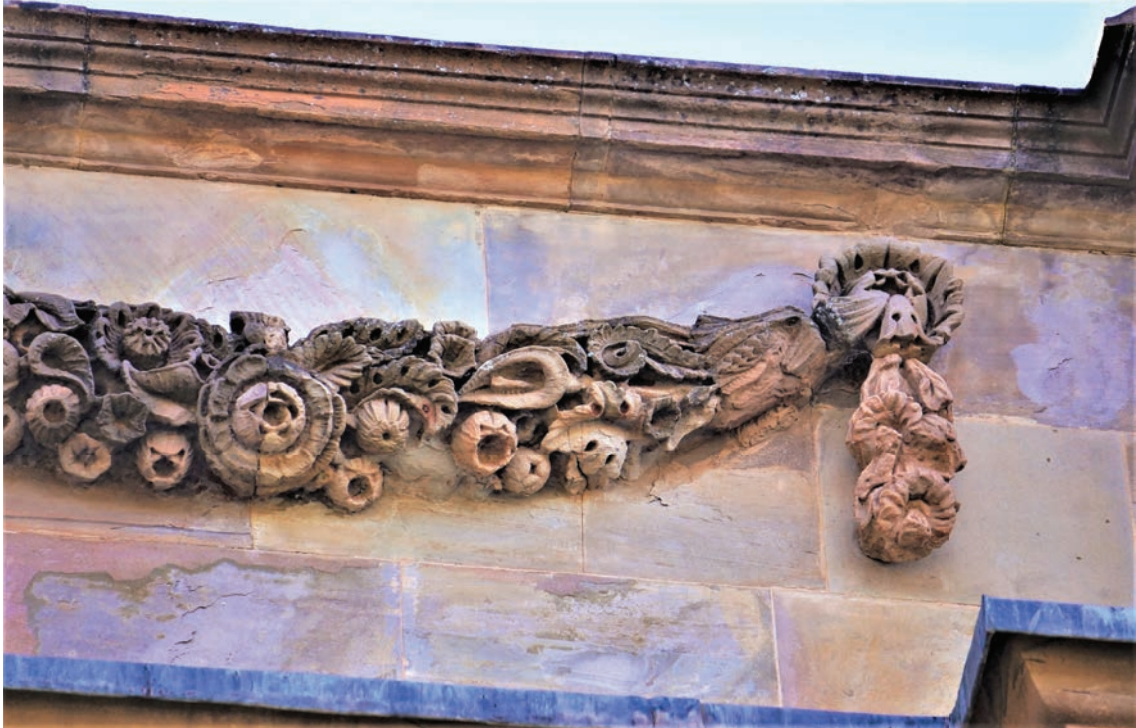
Figure 221: Garlanded decoration at parapet level directly above the main entrance. There are a variety of different repairs in this area, mostly plastic repairs.

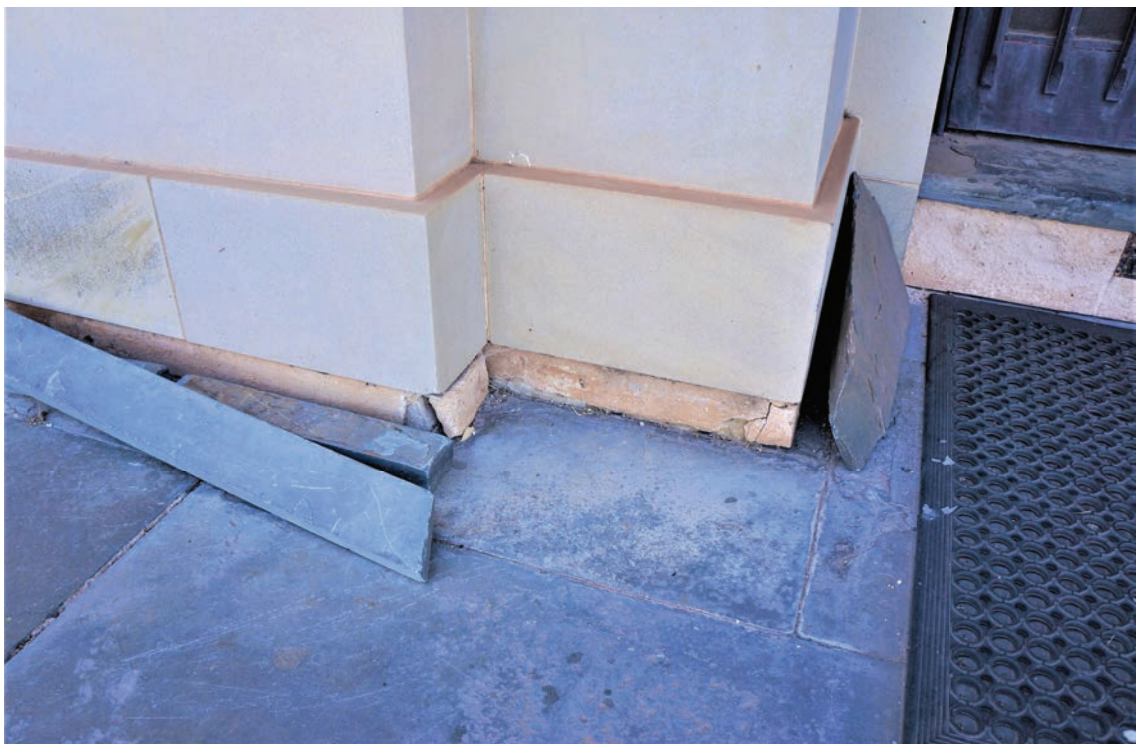
Figure 222: Picture taken to the left of the main entrance. A past render repair, just above slate paving, that is breaking away. The render continues on the face of the threshold step, seen to the right, and around the whole perimeter of the house. Note the new stone plinth above with what appears to be a protective coating applied to its top edge.

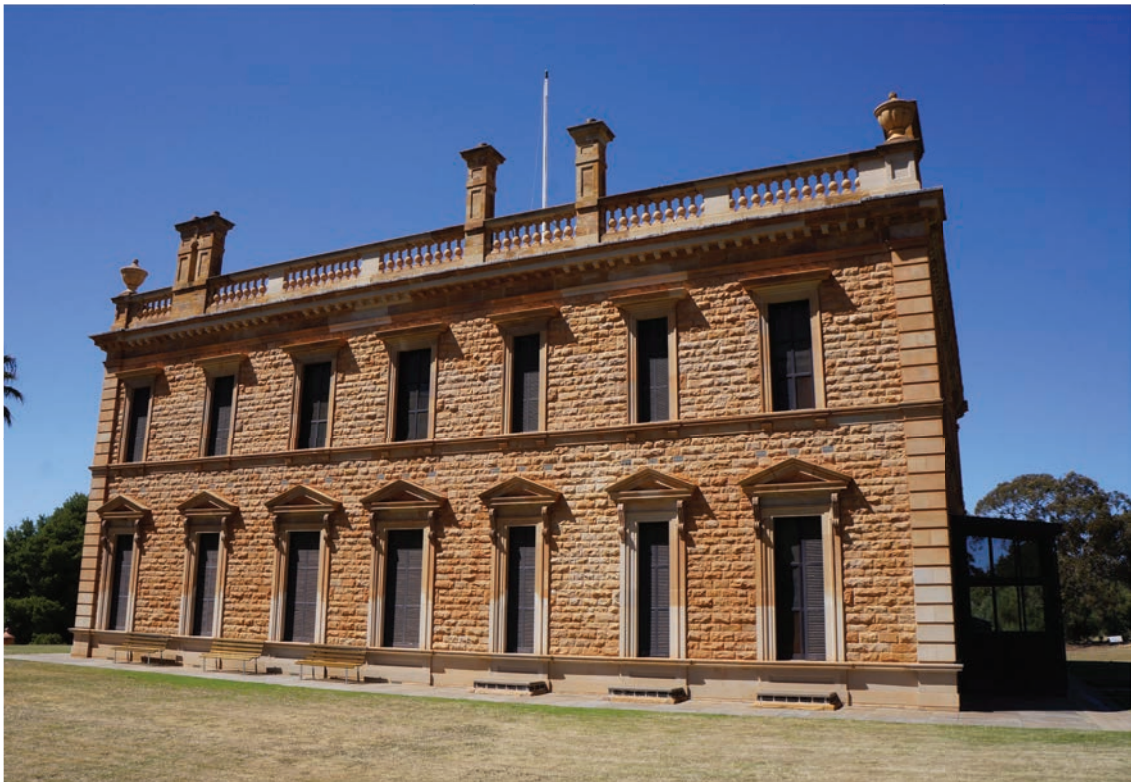
Figure 223: North elevation. Note the variation in stone colouring. Areas of original stonework that were artificially coloured have faded. Note: The parapet features should be structurally strengthened against earthquakes.

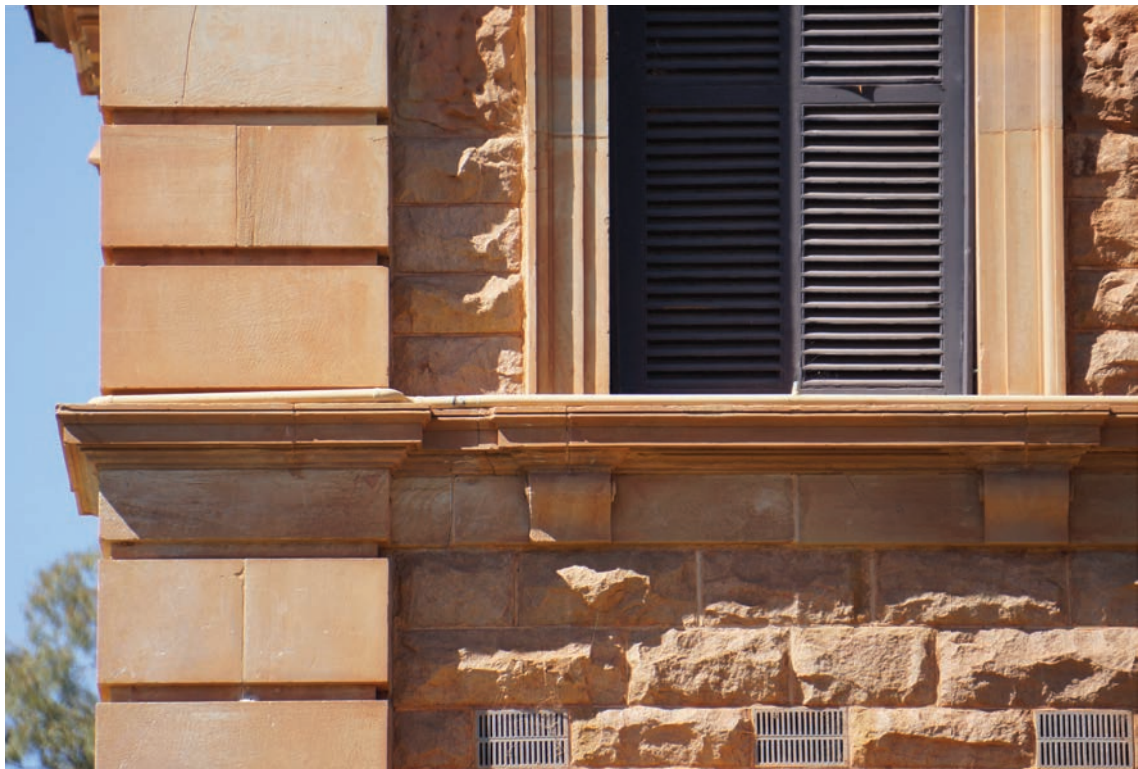
Figure 229: Sprinkler pipe visible on the string course at the level of the first floor window sills.

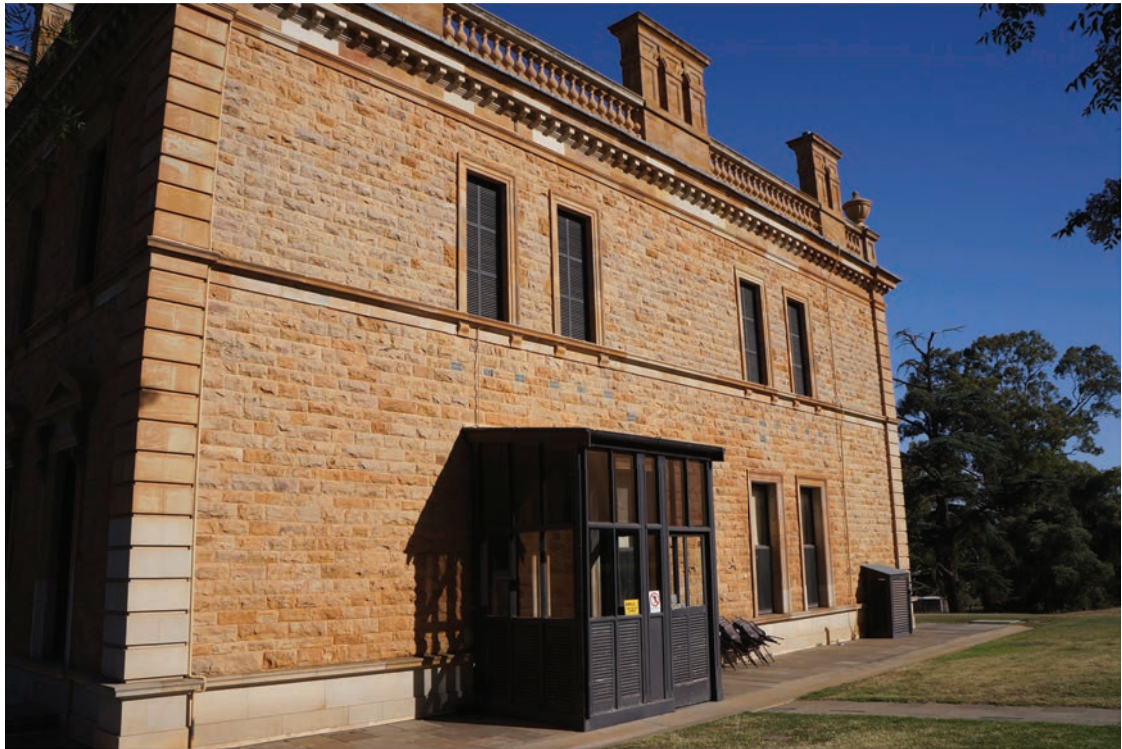
Figure 230: West elevation. The chimneys should be structurally strengthened against earthquakes.

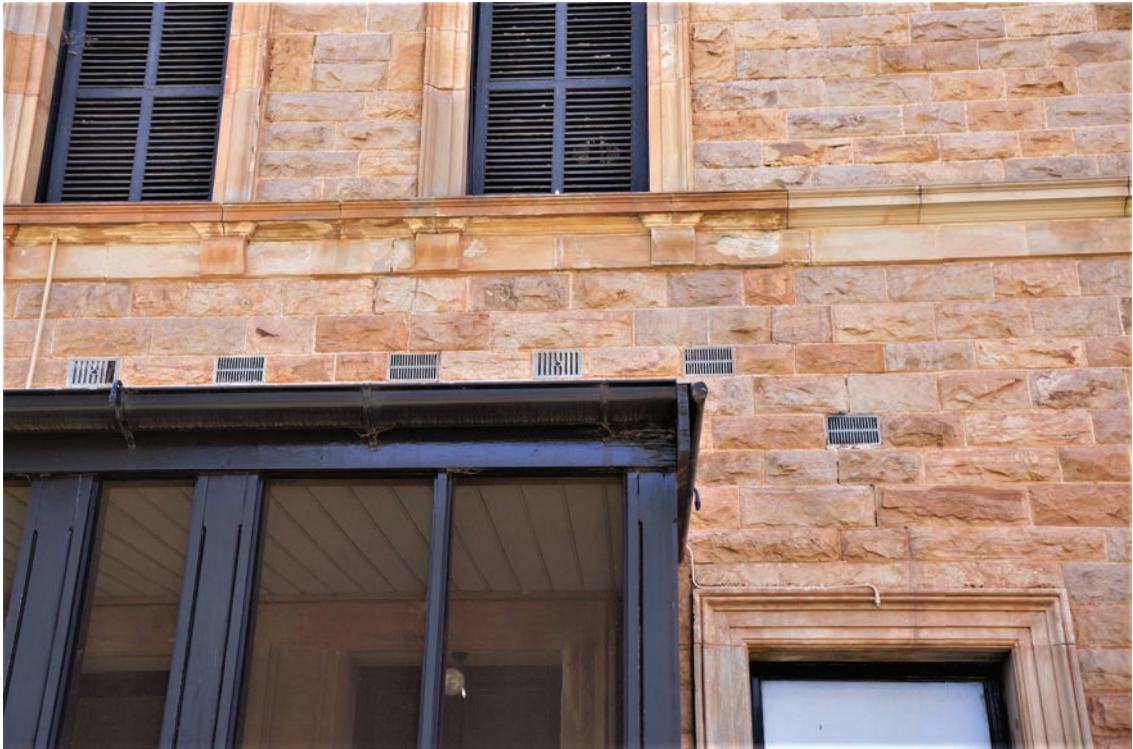
Figure 231: There are a number of movement cracks throughout the west elevation.
