MARTINDALE HALL

CONSERVATION MANAGEMENT PLAN

REV. A / NOV 2021

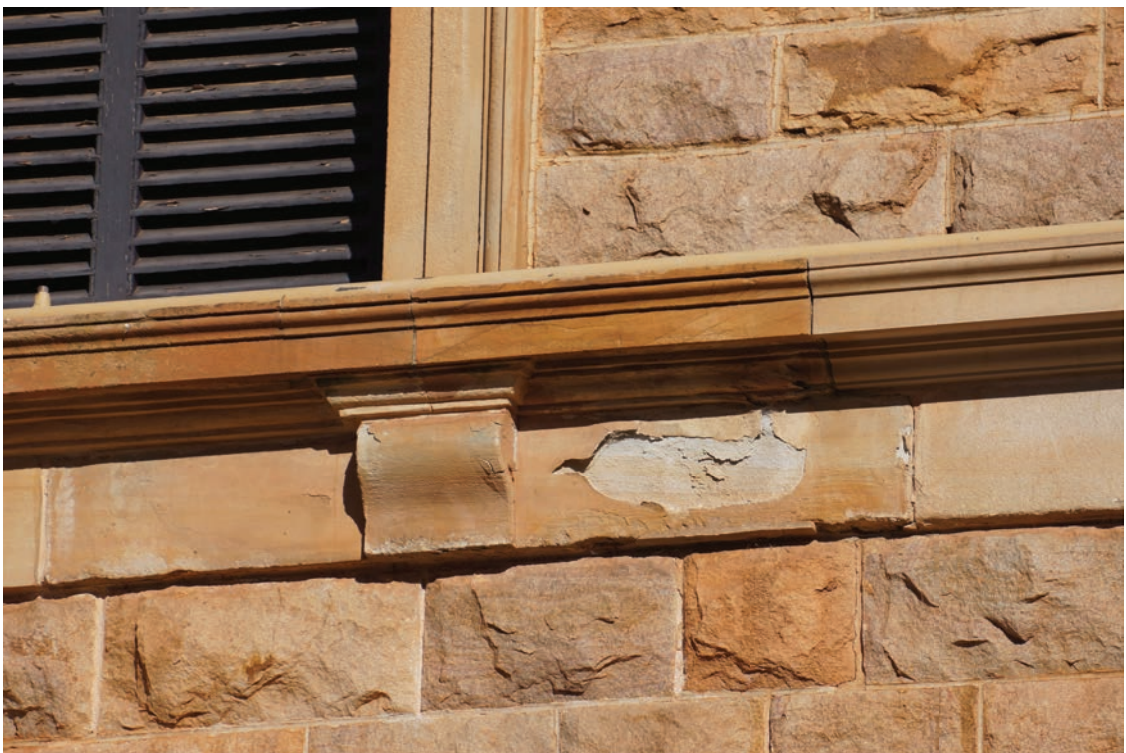
Figure 232: Exfoliation of a stone that appears to have an applied coating, which covers the bracket to the left also. Directly beneath the exfoliating area is a plastic repair.

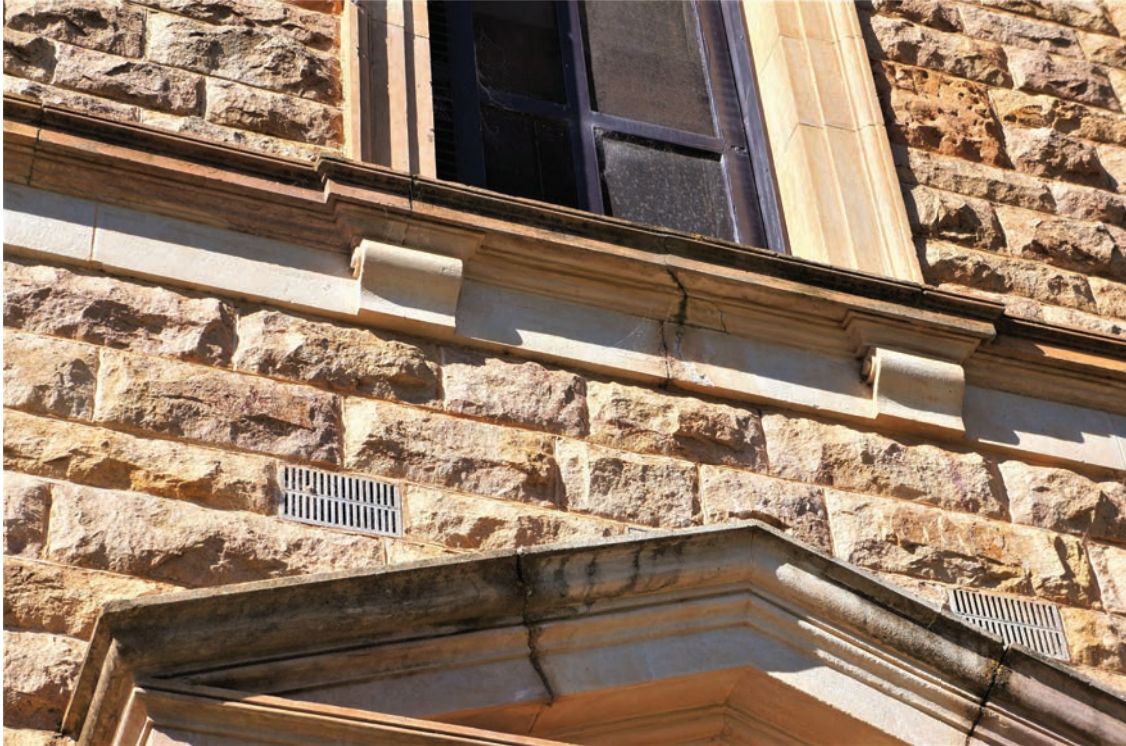
Figure 235: A crack in the string course/ sill of the first-floor window. Note the staining and water runs on the pedimented hood moulding below. All projecting mouldings would benefit from the protection of being capped with lead.

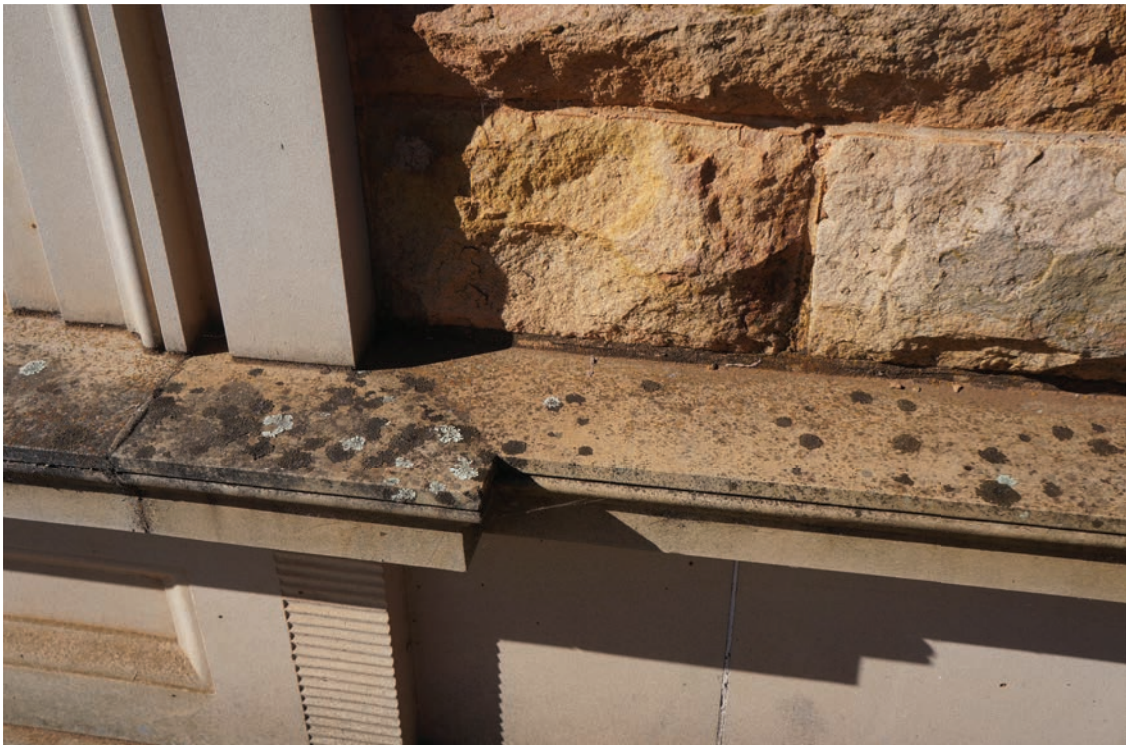
Figure 236: Lichens growing on the string course/ sill of a ground floor window. These need to be cleaned off periodically otherwise they can etch the surface of the stone.

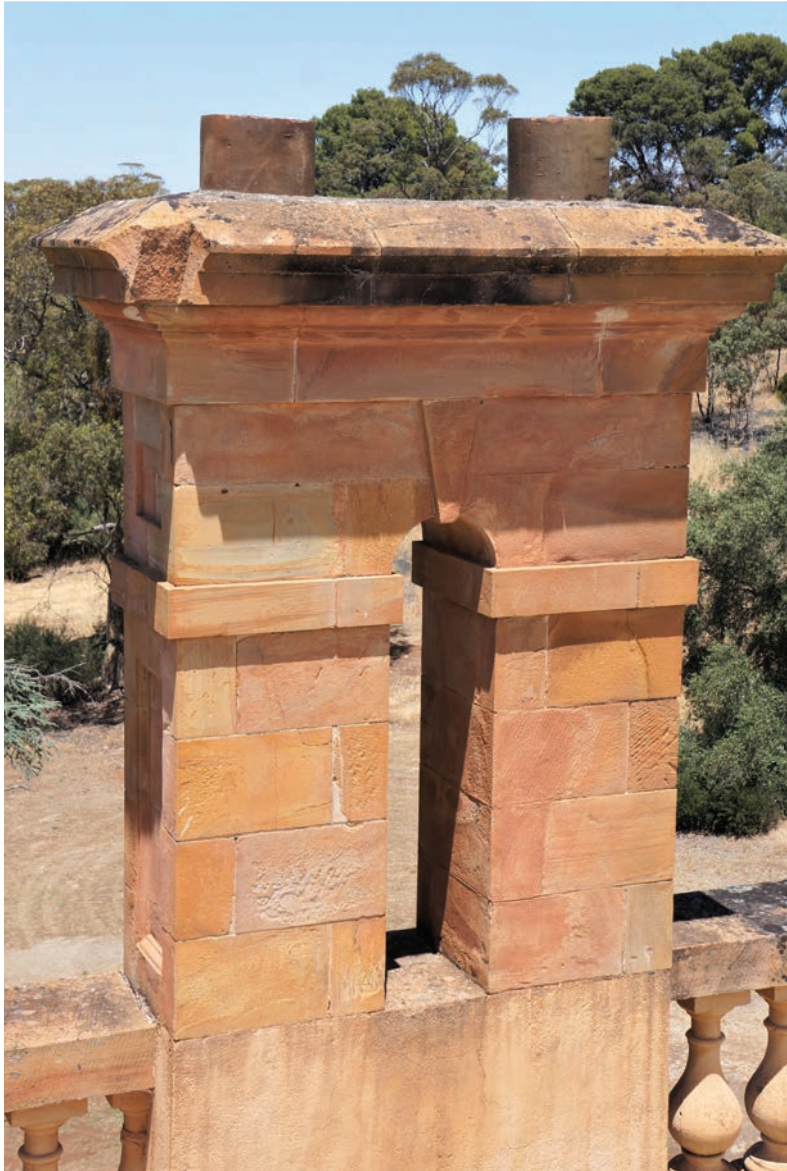
Figure 237: Chimney above the Housekeeper's Bedroom on the west elevation. Note the missing corner to the capping. There are a range of plastic repairs and different coatings. Note also the render below parapet level that has cracks in its surface. This chimney is in better condition than most.

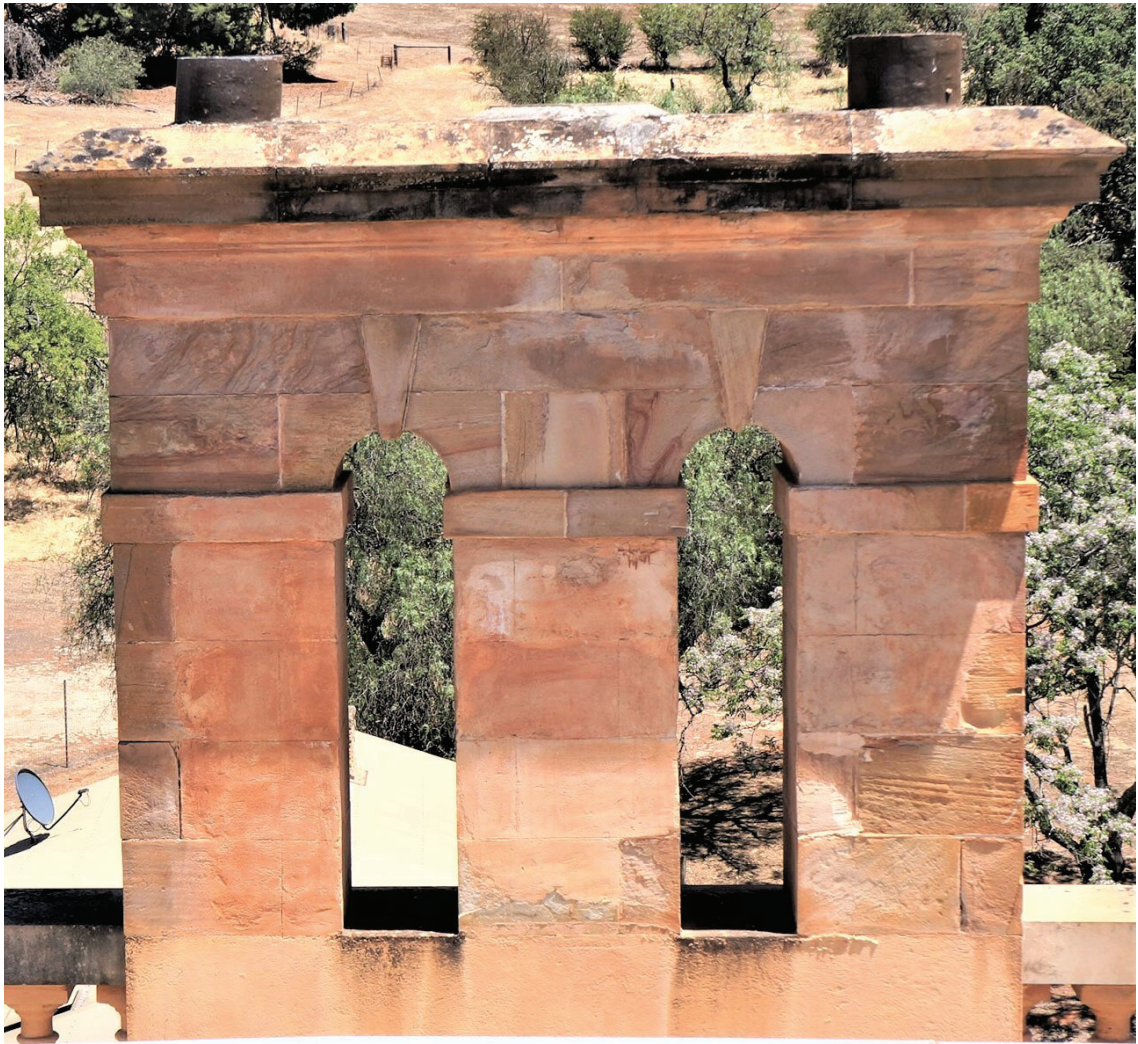
Figure 238: Chimney above the Boardroom and Guest Lounge on the west elevation. Again, this has a range of plastic repairs and different coatings, especially above the central arched slots and to the upper righthand side. Note the build-up of lichens on top of the chimney capping.

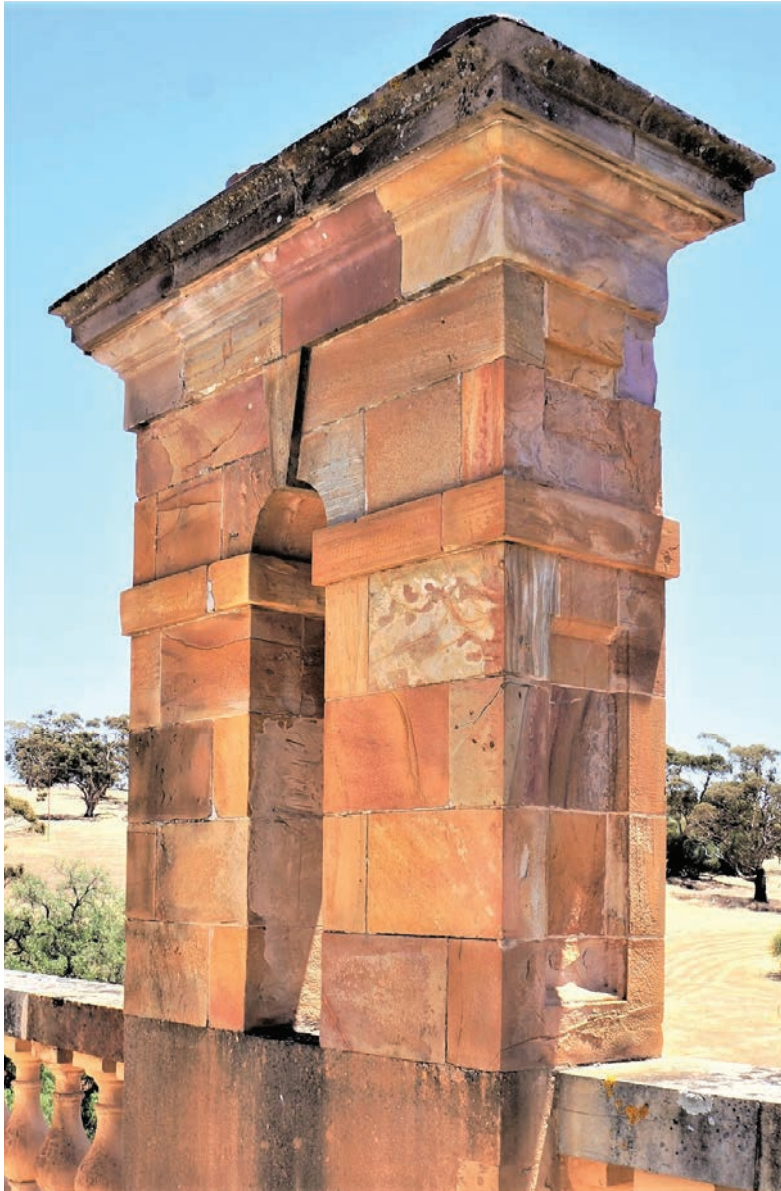
Figure 239: Chimney above the main bedroom on the north east corner of the house. This is probably in the worst condition as around 25% of the surface area has plastic repairs. Note also the heavy soiling of the chimney capping. Exfoliation is also ongoing.

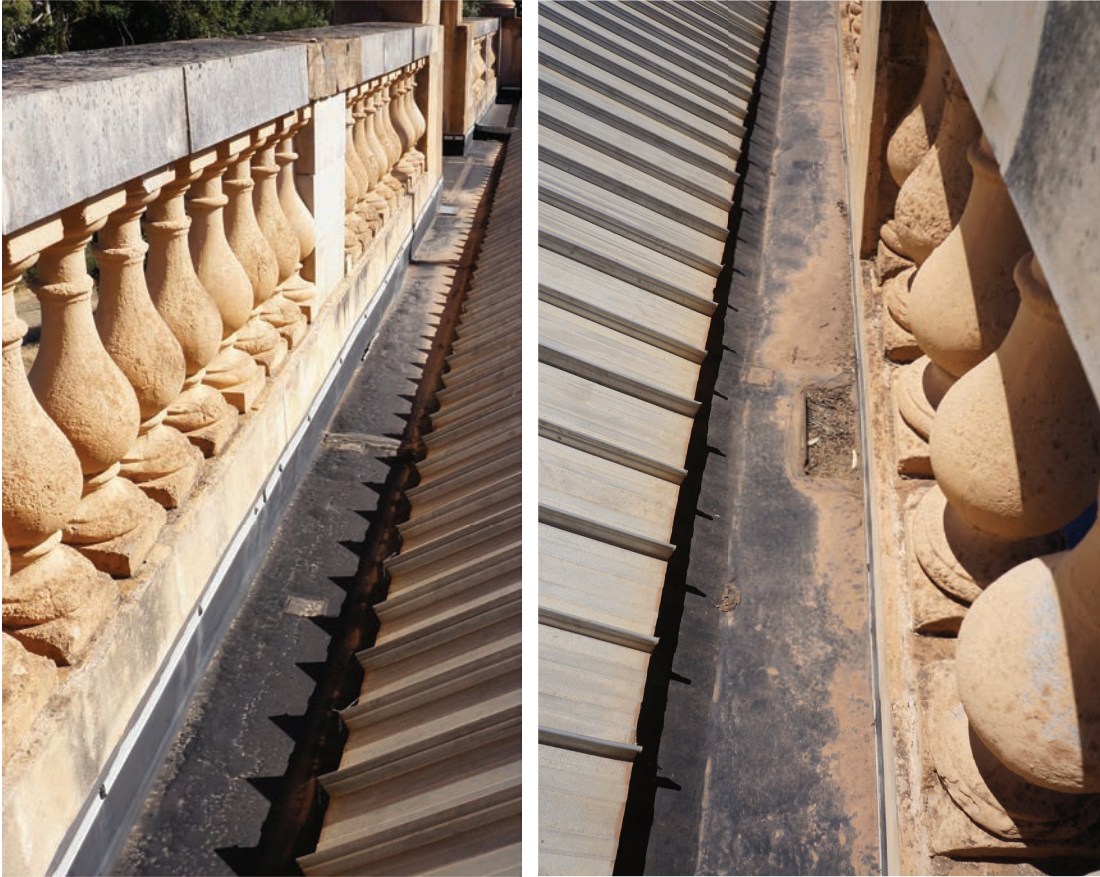
Figure 240: Above left: Concrete balusters. Note their friable surfaces and the thin necks just below where they support the heavy coping stones. The cement render base above the gutter compression flashing is cracked all along its top edge and has de-bonded from the substrate allowing water to penetrate.

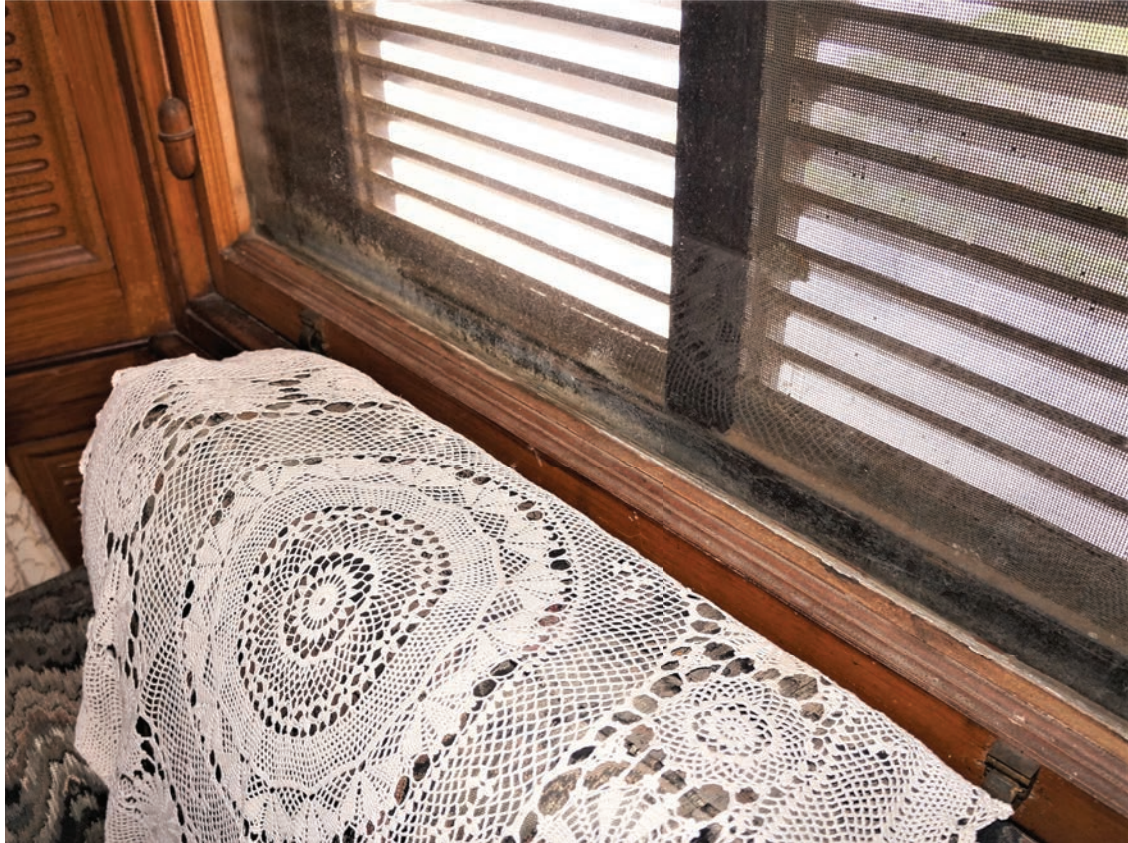
Figure 247: Inside view of Drawing Room bottom window sash and outside timber louvred sash containing fly mesh. Note the etching on the bottom edge of the glass where the bore water from the lawn sprinklers has corroded the surface.

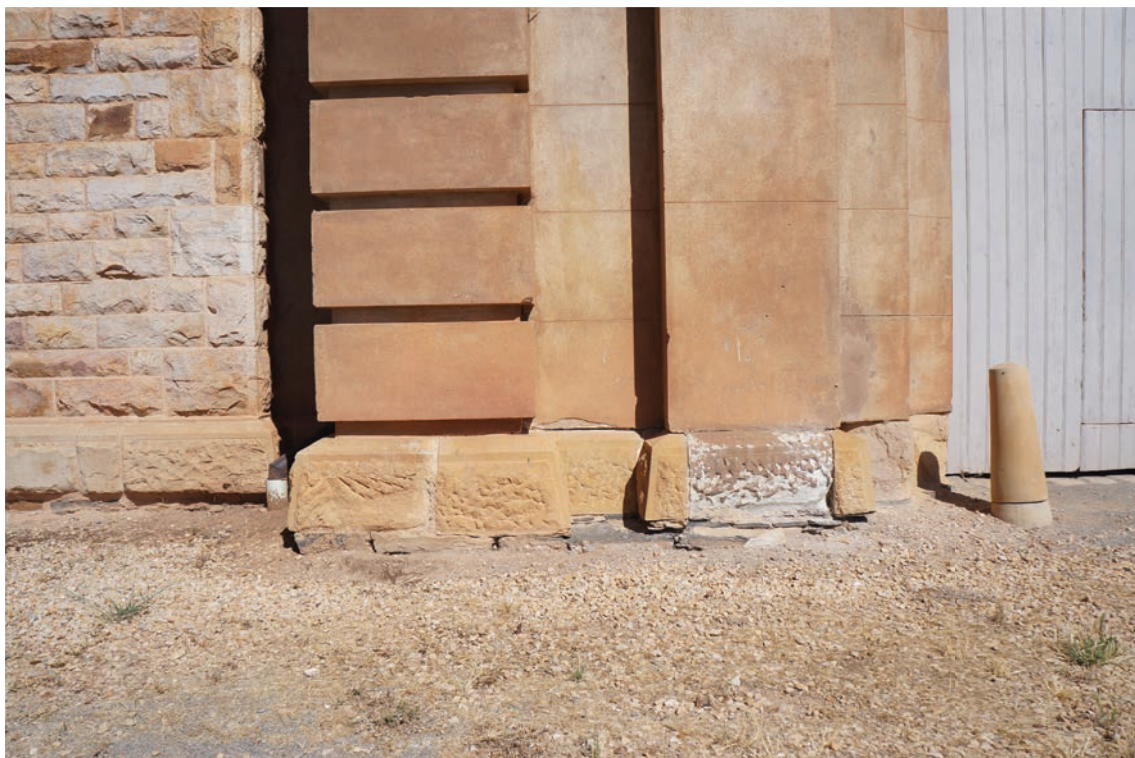
Figure 269: Base of east elevation at junction between main and side pavilion. Note the mixture of walling treatments that include some replacement stonework.

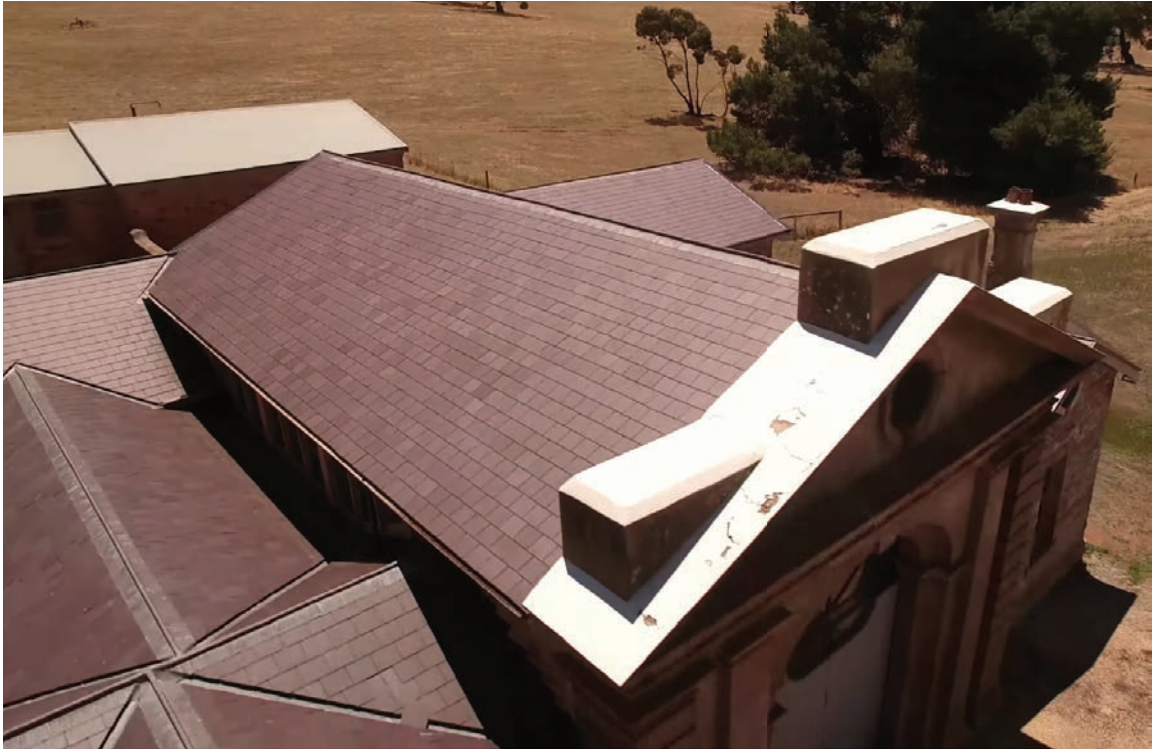
Figure 270: View from 2 years ago looking north over the roofs looking. Note the loose slate sitting in the valley gutter (bottom left) and the spalling paint to the top of the pedimented gable. (Photograph credit: Definitive Aerials/YouTube. January 2017)

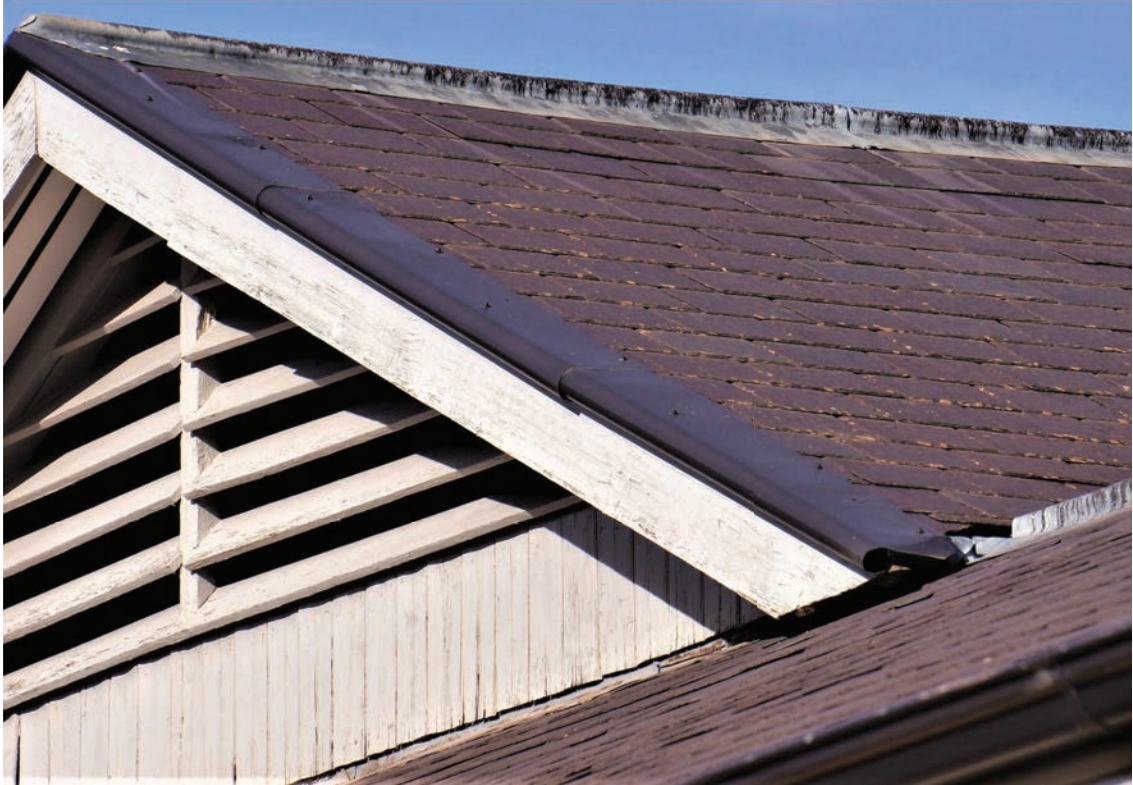
Figure 271: View of gable louvres on the west elevation. Note the lead roll ridge flashings and newer, dark grey painted galvanised steel barge flashing. The woodwork to the louvre panel and barge boards badly needs painting. The vertical timber cladding boards need to be renewed, and the rusting galvanised flashing to the base of the cladding should be replaced at the same time.

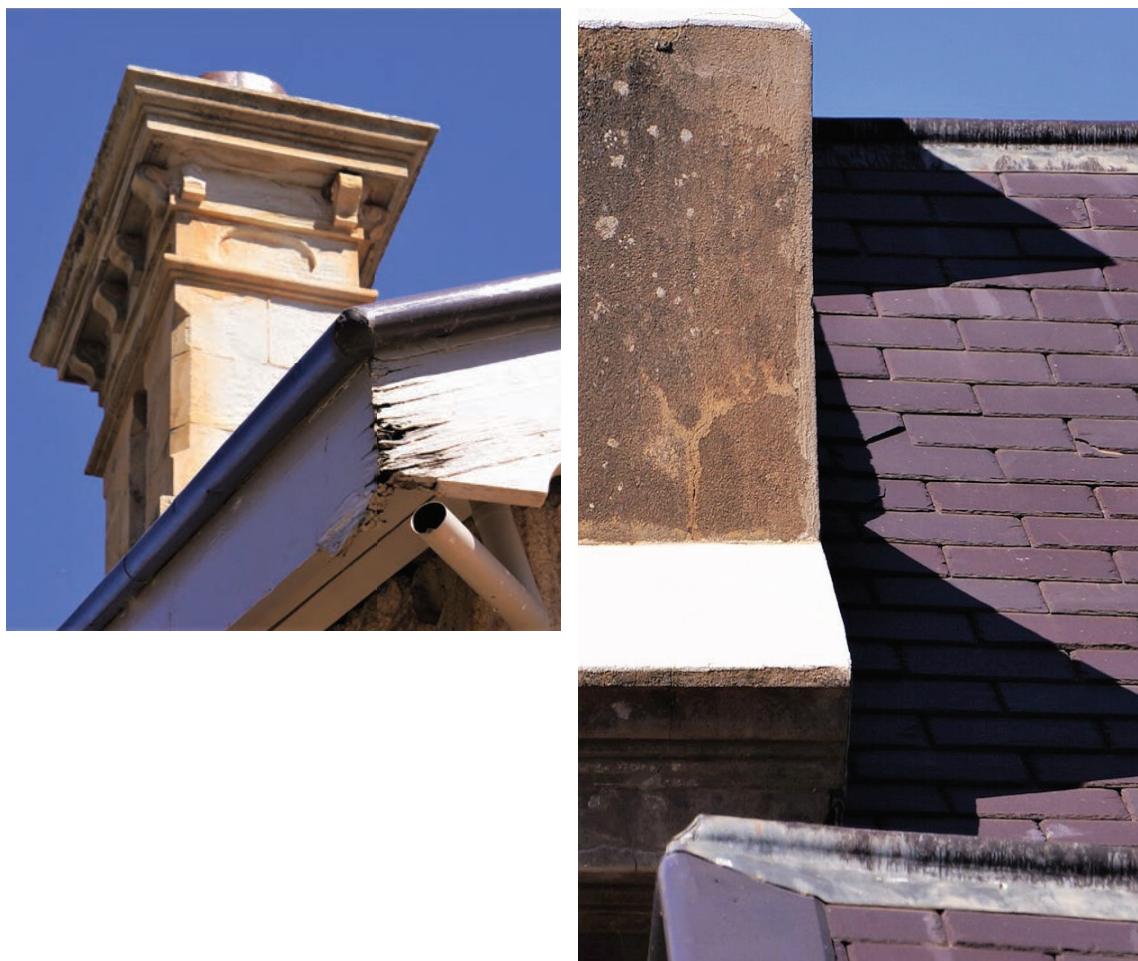
Figure 273: Above left: View of south east corner of smaller pavilion. Note the grey painted galvanised steel barge flashings and the poor condition of the woodwork. The spout discharges water collected from the valley gutter pitching down to this corner. This is a poor detail as rainwater missing the small outlet is running over the woodwork leading the timber rot.

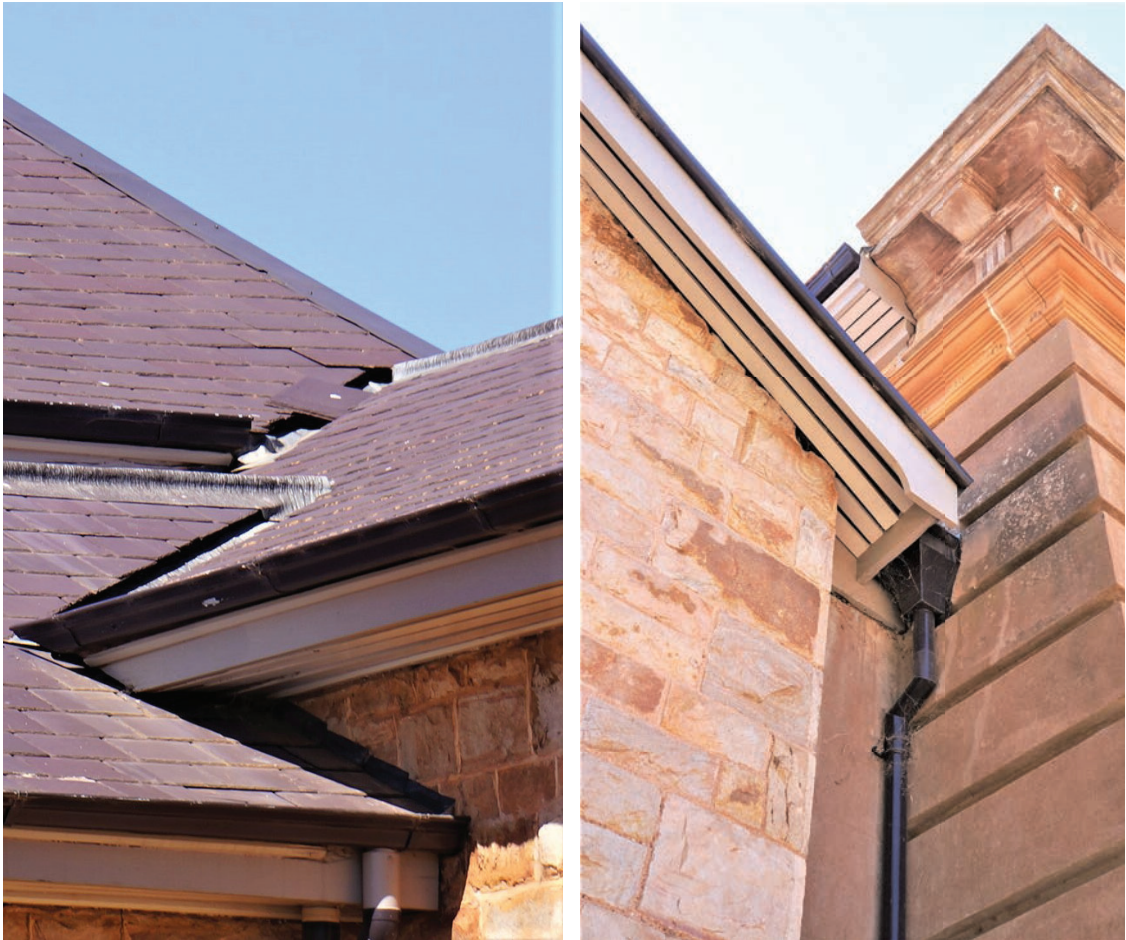
Figure 275: Above left: View of junction between main roof and side and rear pavilion roofs. Note the loose slate in the valley gutter centre right in the picture.

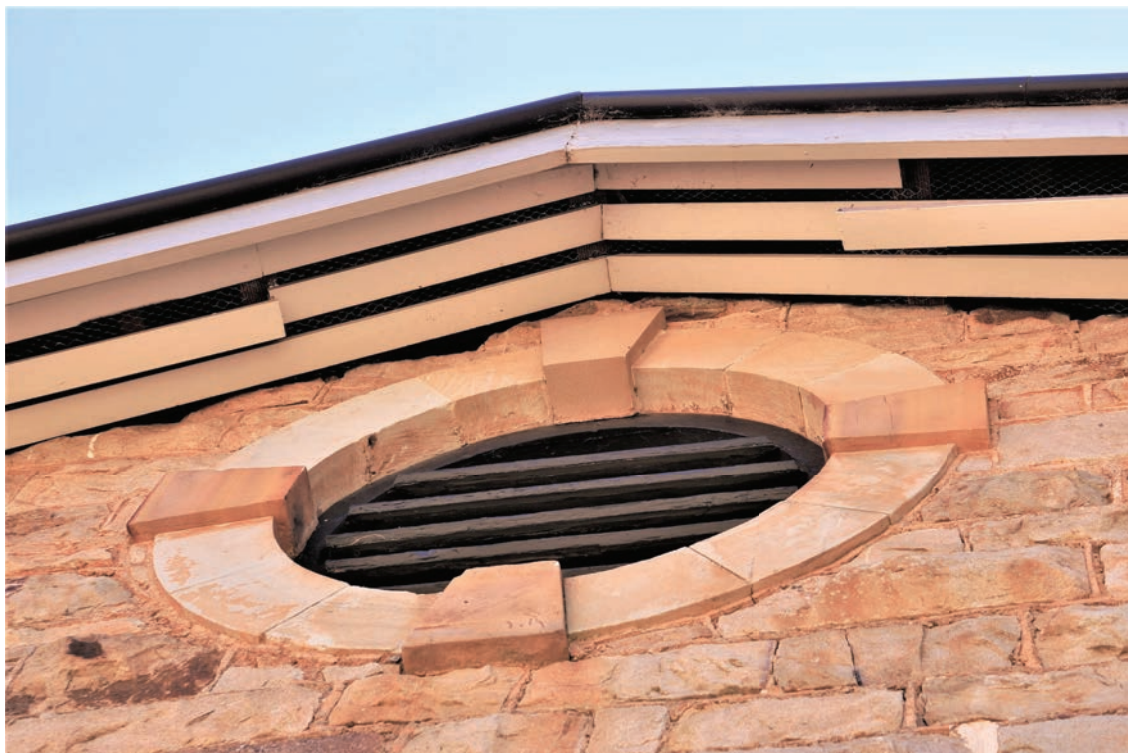
Figure 279: Barge boards hanging loose on the south elevation west gable of the rear pavilion.

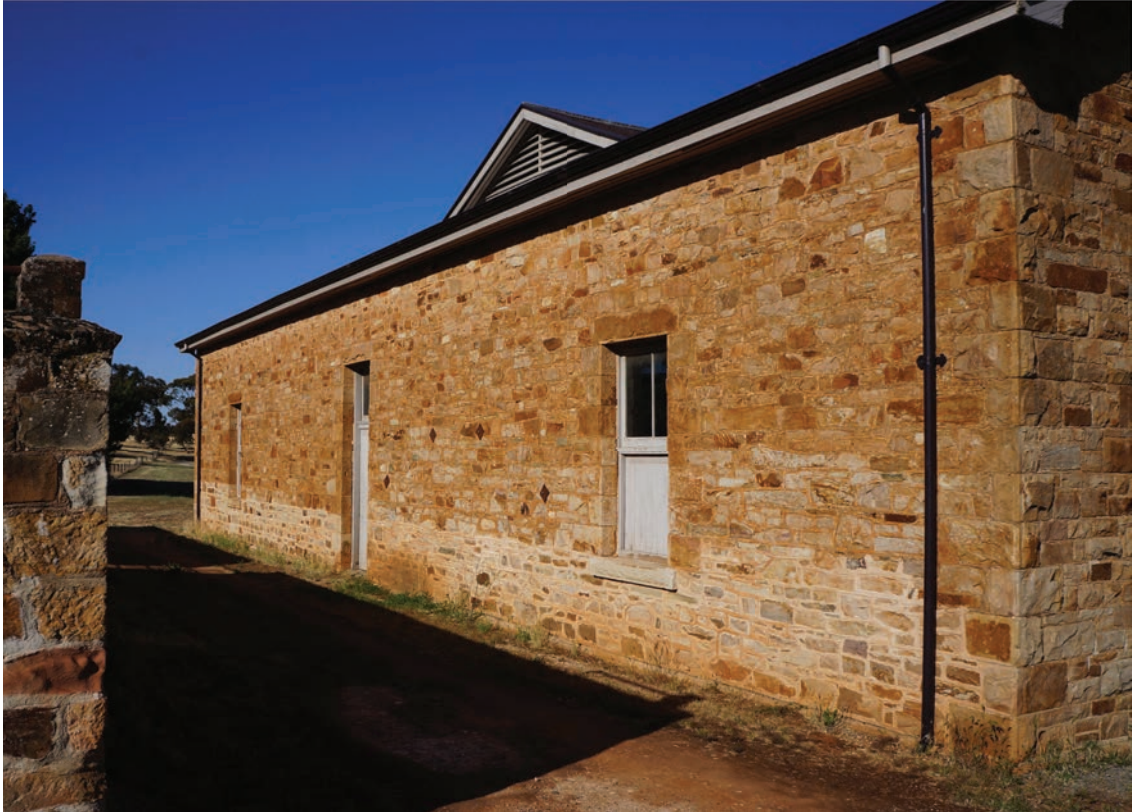
Figure 280: Reasonably recent stone repointing in a hard mortar mix up to 800mm above ground level along the base of the west elevation.

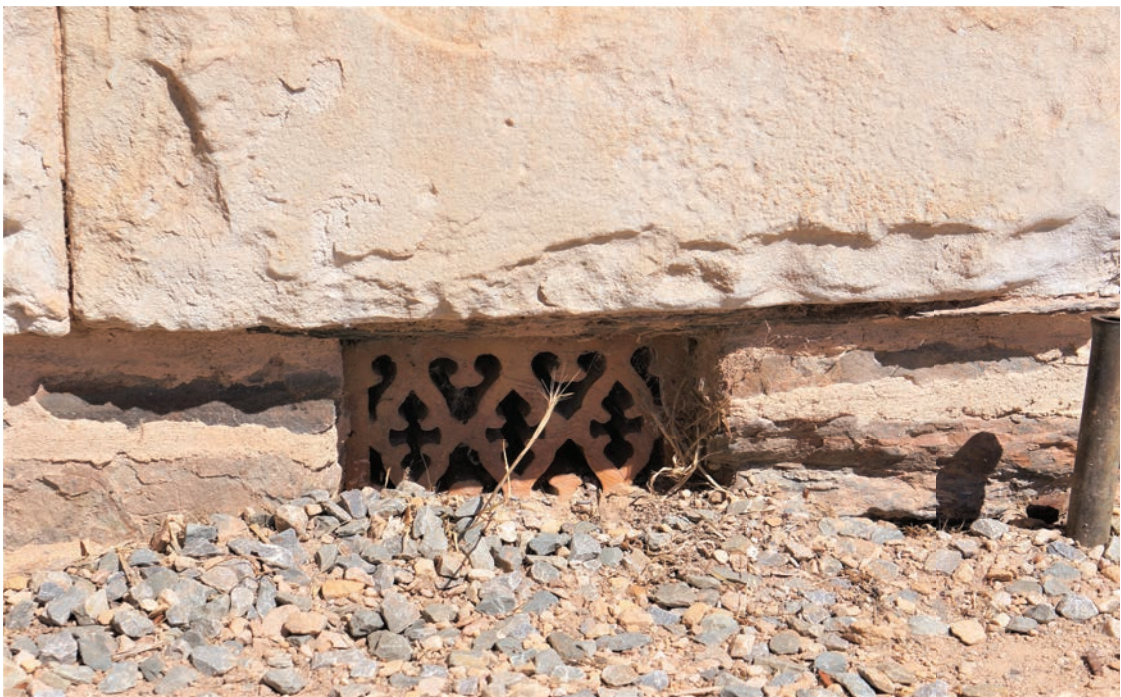
Figure 283: Underfloor vents partially buried.

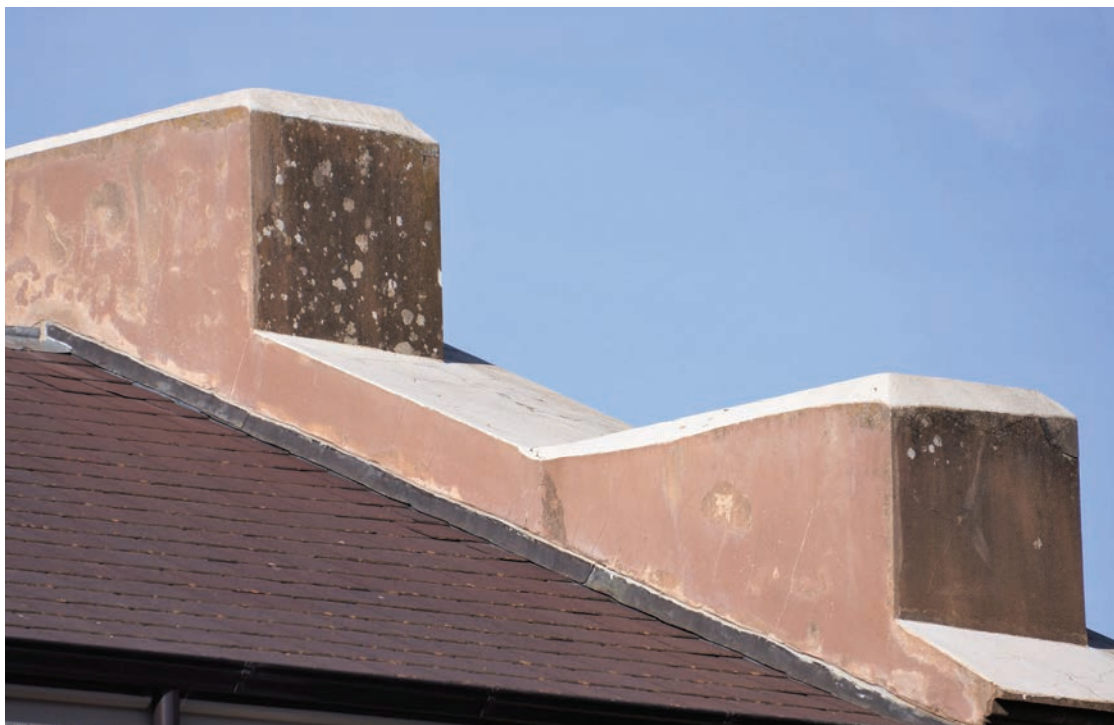
Figure 289: Past repairs to the render on the back of the front entrance pediment. New cracks have started at right angles to the line of the lead flashing and are extending up to meet the cracks on the top surface of the pediment/parapet.

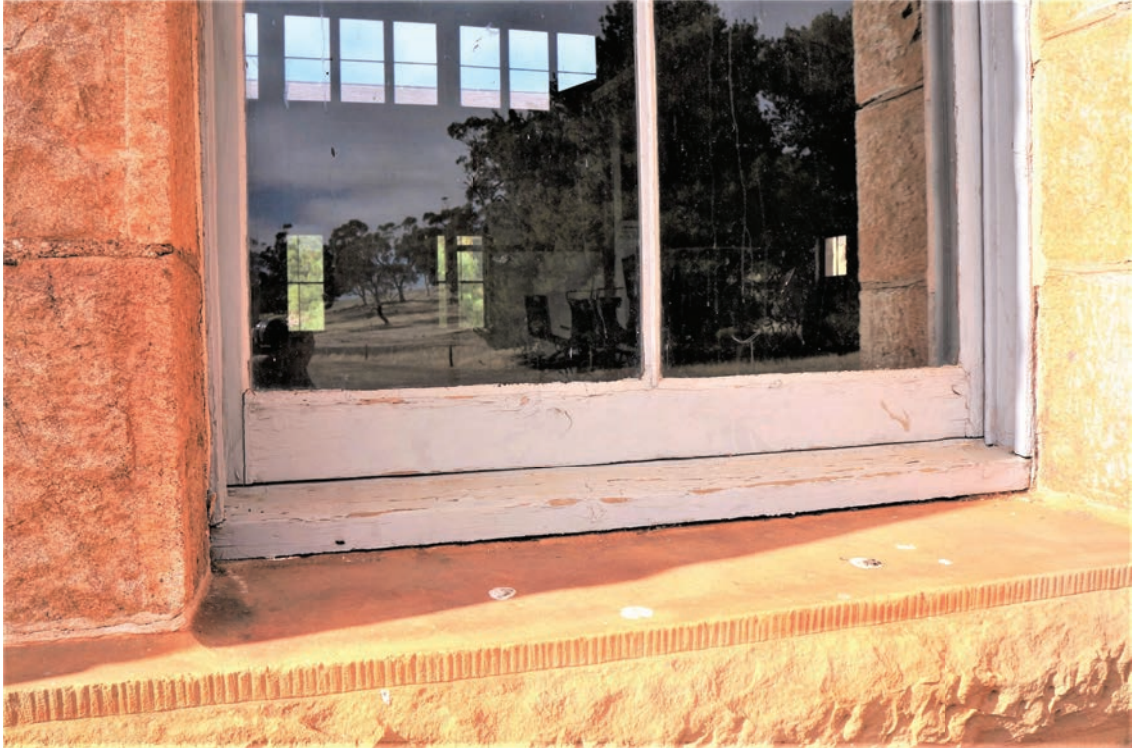
Figure 290: Sill detail of glazed sash and case window. The paintwork is thin and peeling off and the pointing to the stonework is poor. There are signs of timber rot in the bottom rail of the lower sash.

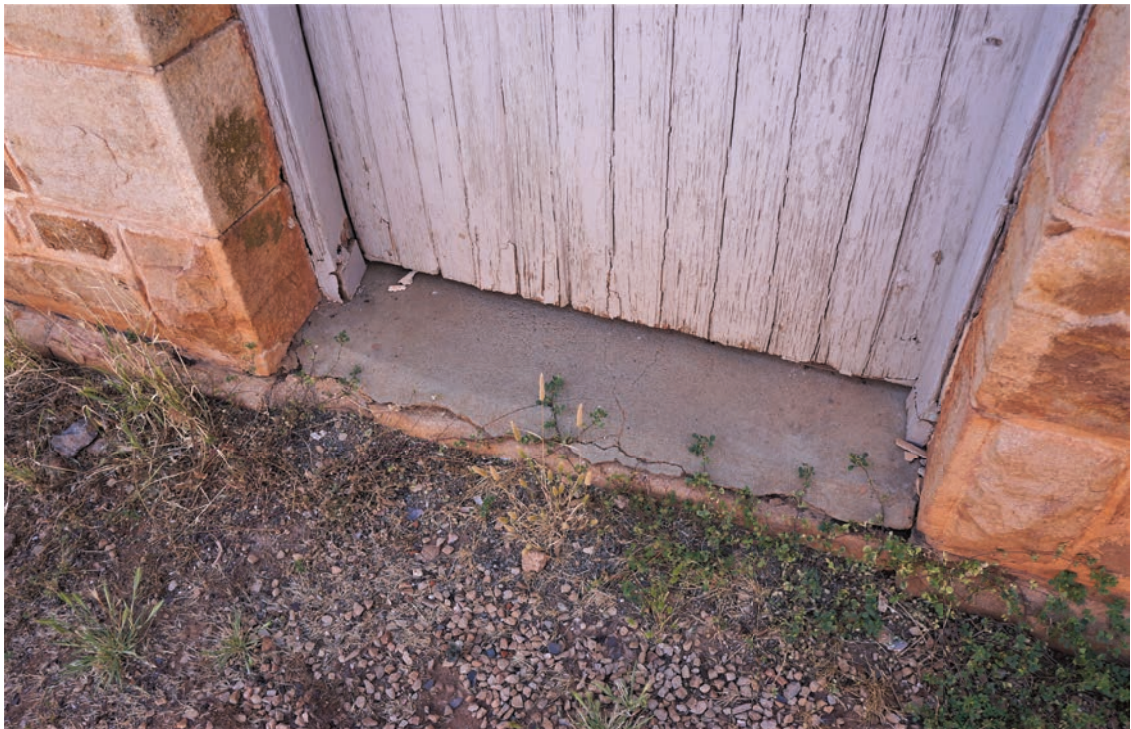
Figure 291: Threshold of door to west elevation. The bottom of the boarding and jambs have timber rot.

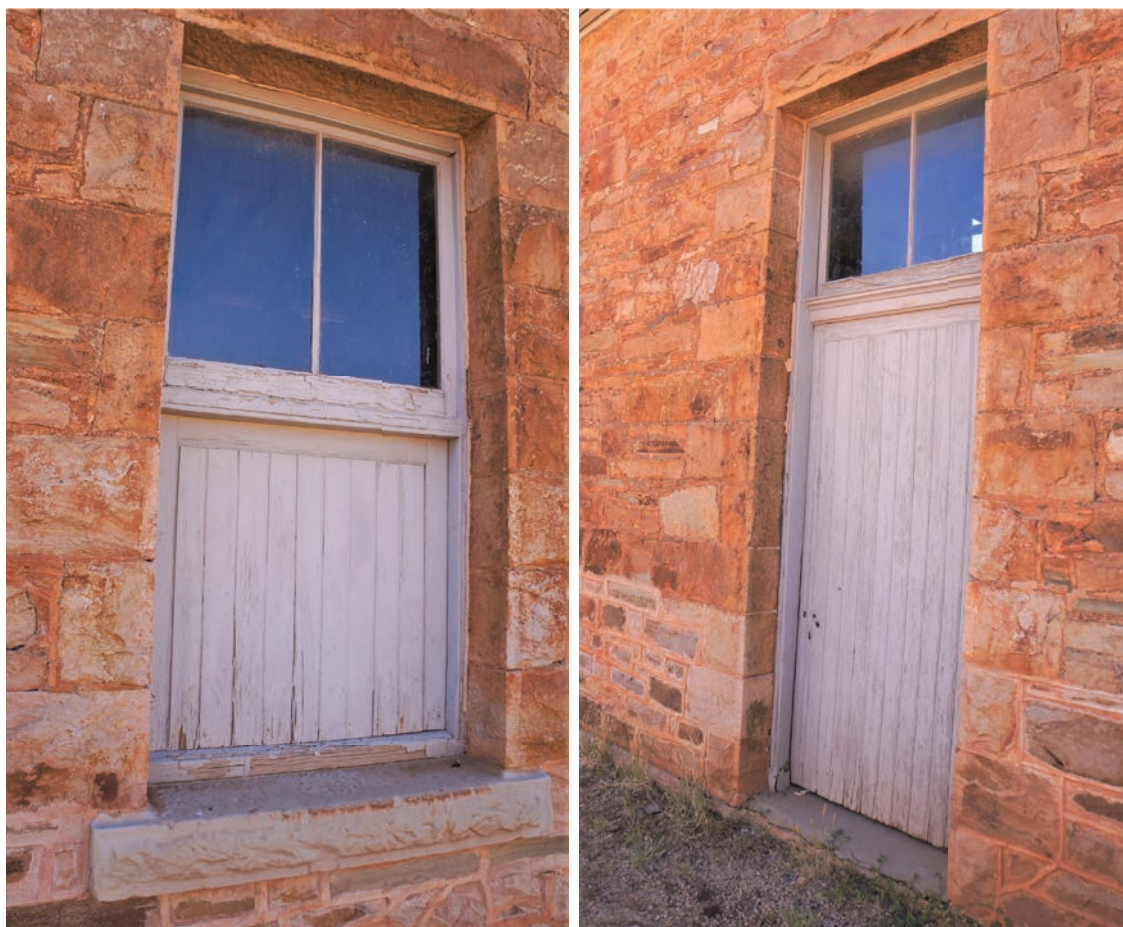
Figure 292: Above left: Window along west elevation. The paint is cracking and peeling off and there are signs of timber rot throughout.

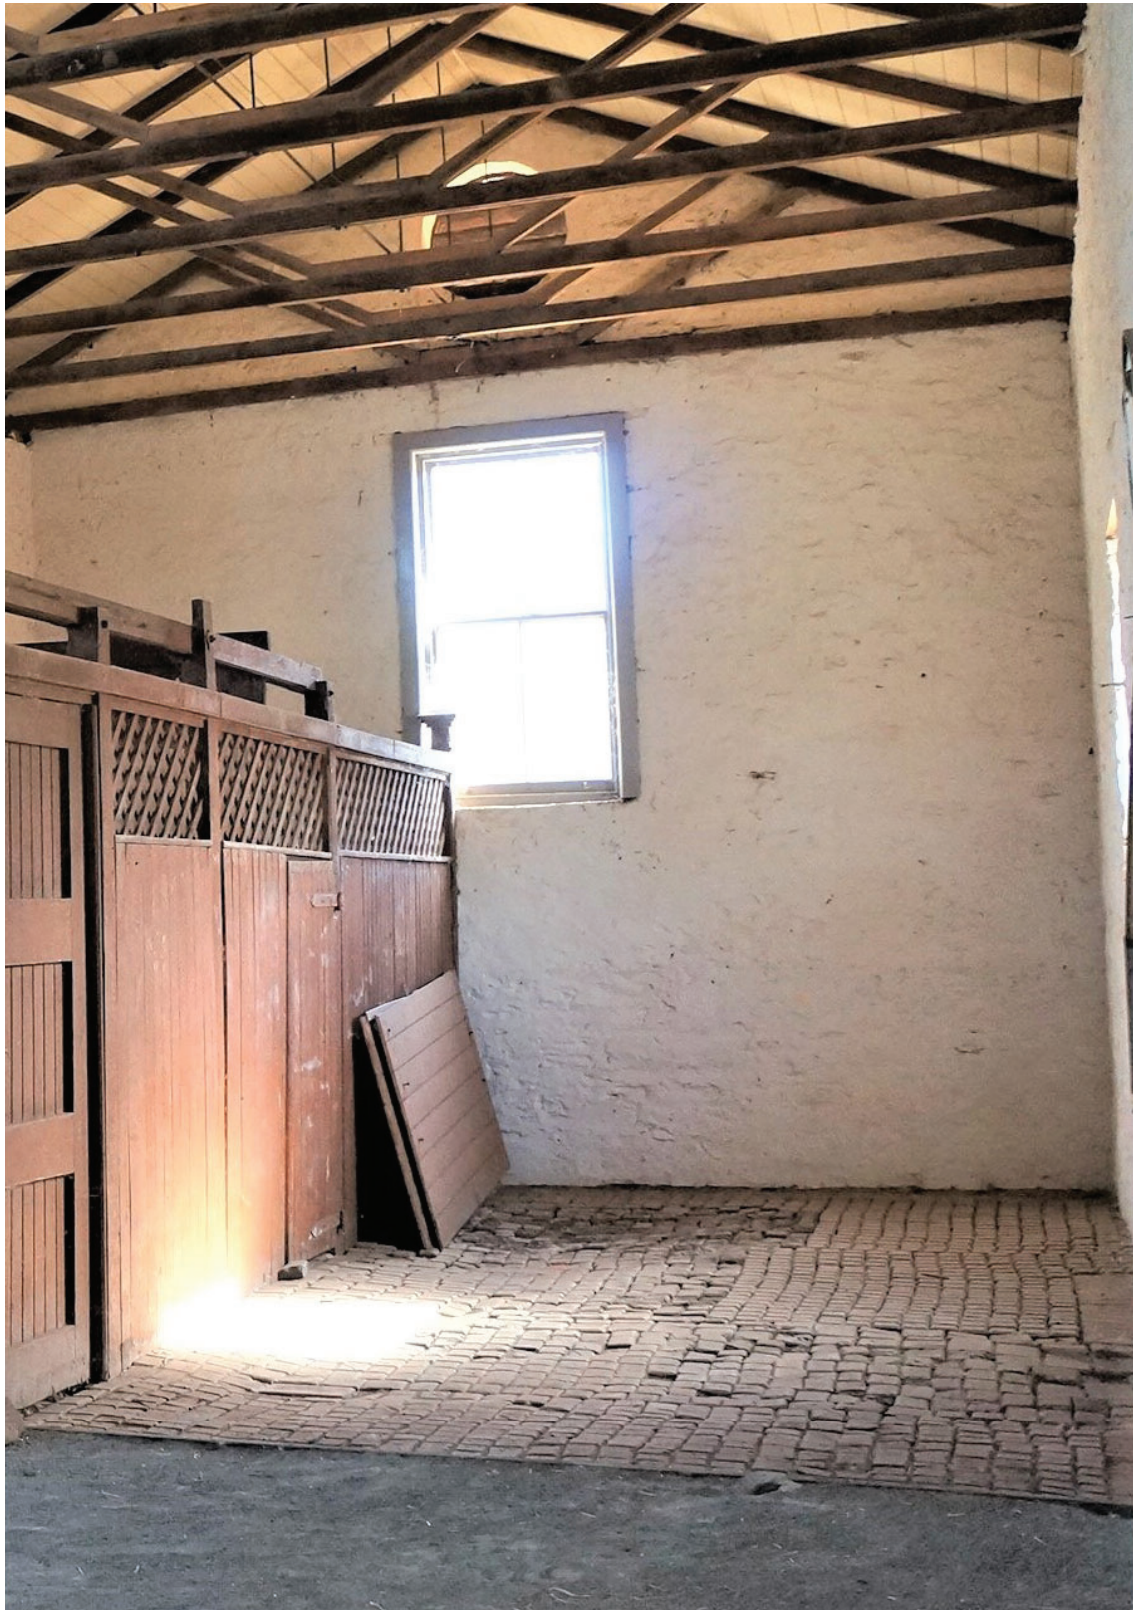
Figure 304: Missing vertical timber cladding to south carriage service area. Signs of timber rot to top rail above cladding may indicate past problems with roof above where the valley gutter meets the box gutter.

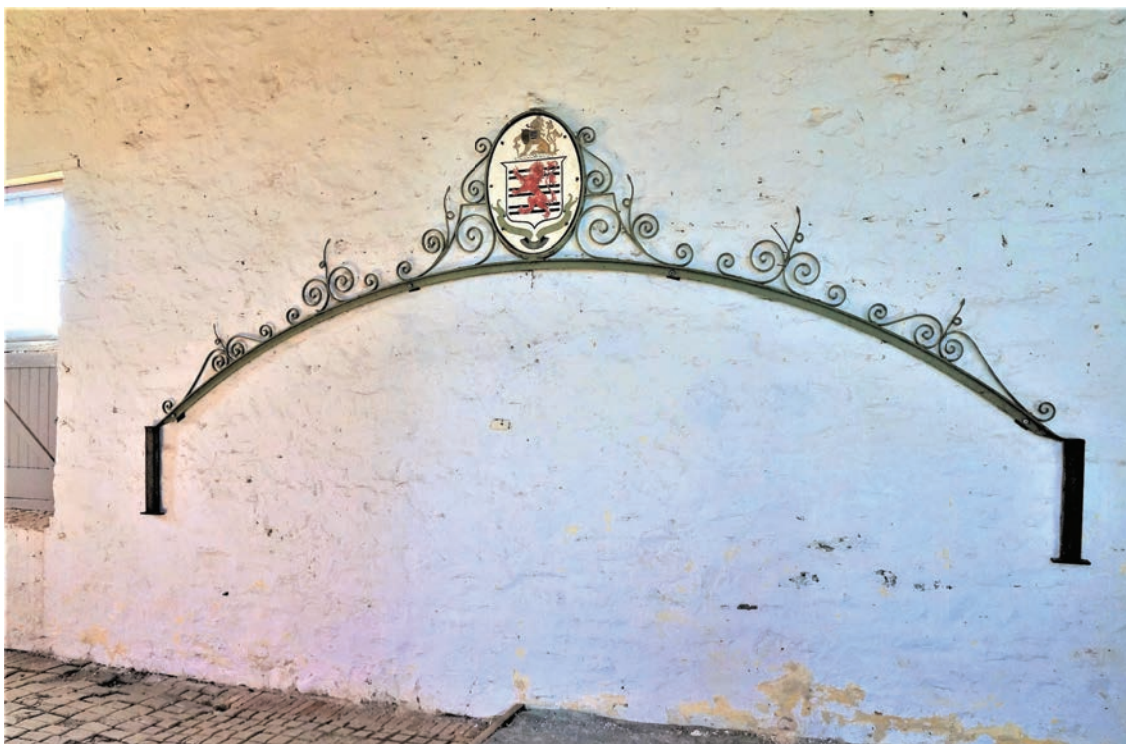
Figure 305: Inside of west elevation with signs of damp at low level where paint is spalling off. Note the arched ironwork feature above that originally spanned above the gates to the main entrance.

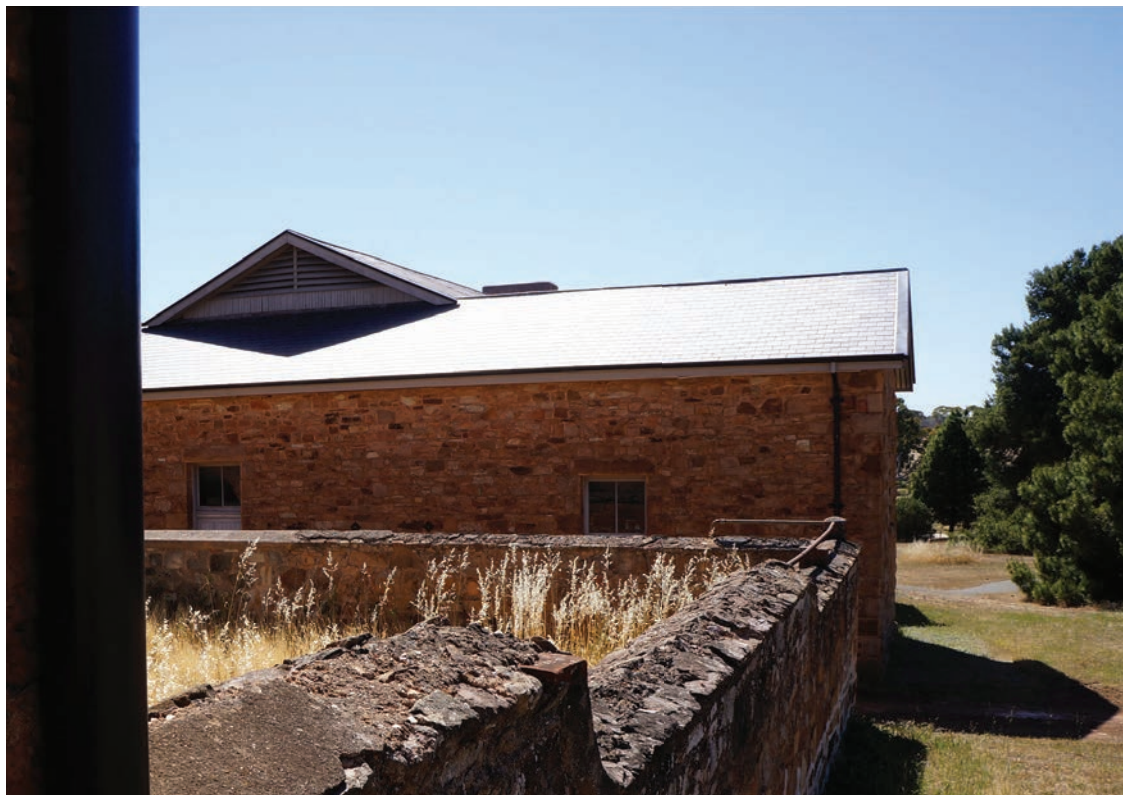
Figure 316: View along top of yard wall. The cement capping has spalled off. Note also the ground cover in the yard that requires to be cut back.
