MARTINDALE HALL

CONSERVATION MANAGEMENT PLAN

REV. A / NOV 2021

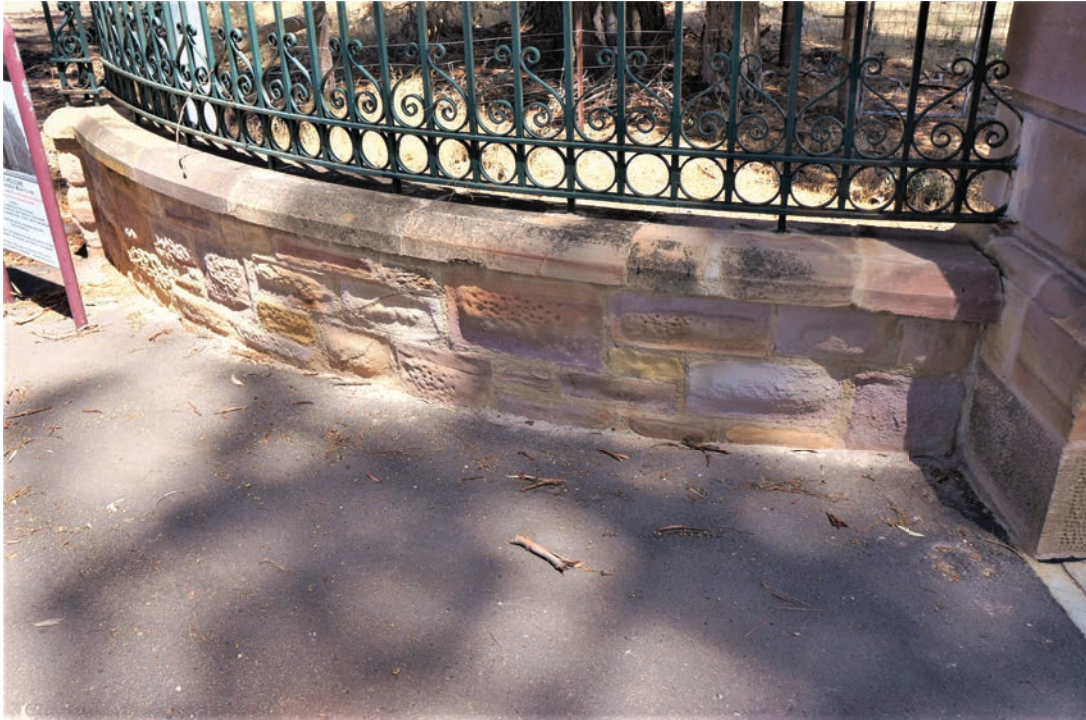
Figure 321: Walls facing the road. Stonework is exfoliating.
