# Native Vegetation Clearance

## Dry Plains Road

### Data Report

Clearance under the *Native Vegetation Regulations 2017*

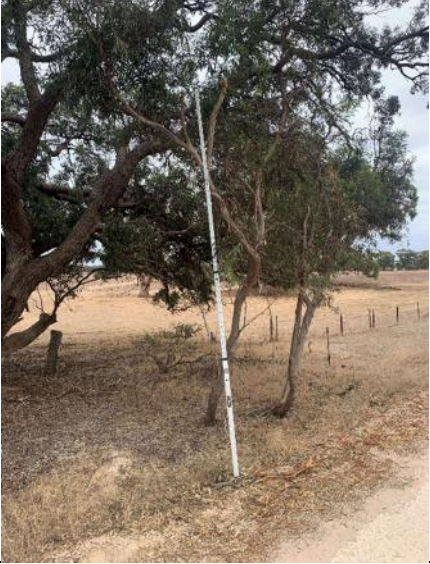
Photo direction - West Waypoint - 157
Number of trees – 1		
Height (m) –4		
Hollows –0		
Diameter (cm) – 9 cm		
Canopy dieback (%) –10%		
Total Biodiversity Score –0.25		
Two very small trees with a low habitat value

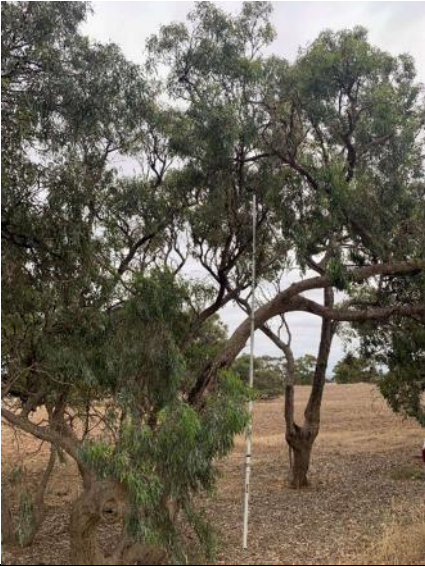
Photo direction - West
Number of trees – 1		Waypoint 160
Height (m) –5		
Hollows –1		
Diameter (cm) –35cm		
Canopy dieback (%) –10%		
Total Biodiversity Score –0.96		
Damaged tree very close to the road Hollows present which may provide habitat for numerous species including NP&W Act species.

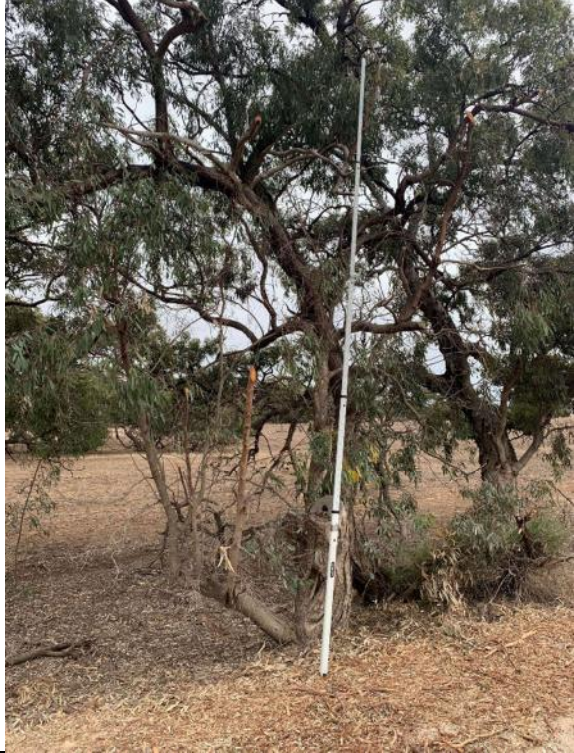
Photo direction - West Waypoint 161
Number of trees – 1		
Height (m) –5		
Hollows –0		
Diameter (cm) –28cm		
Canopy dieback (%) –80%		
Total Biodiversity Score –0.11		
Damaged tree, pruned many times as very close to road edge. No hollows.

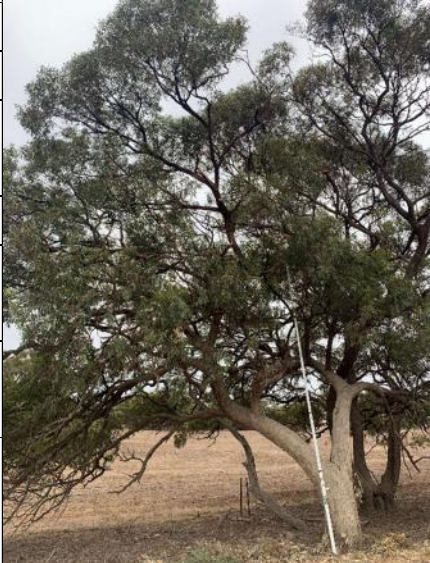
Photo direction - West Waypoint 162
Number of trees – 1		
Height (m) – 8		
Hollows –1		
Diameter (cm) –60cm		
Canopy dieback (%) –10%		
Total Biodiversity Score –2.51		
Excellent solid tree as part of a clump of the same species. Hollows present which may provide habitat for numerous species including NP&W Act species.

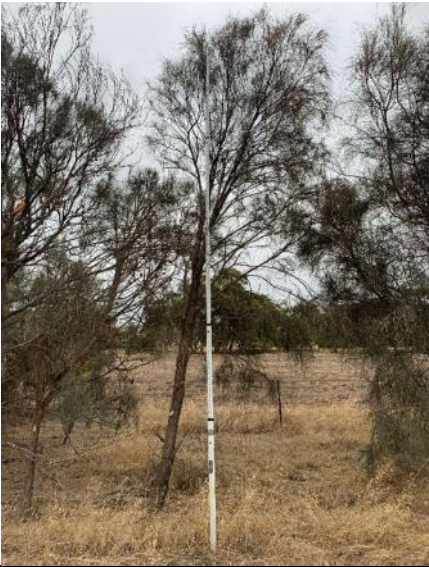
Photo direction - West Waypoint 169
Number of trees – 1		
Height (m) –5		
Hollows –0		
Diameter (cm) –10cm		
Canopy dieback (%) –30%		
Total Biodiversity Score –0.18		
This is a small tree with a low habitat value

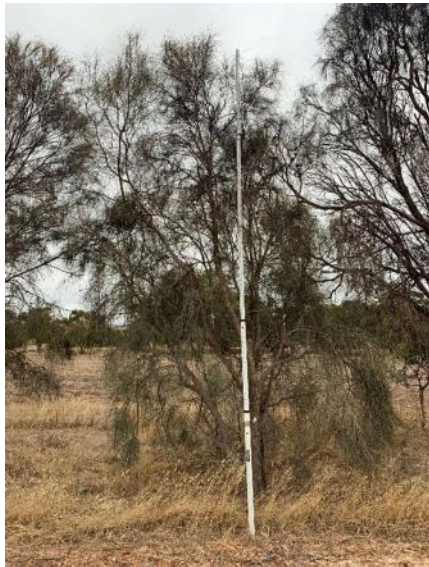
Photo direction - West Waypoint 170
Number of trees – 1		
Height (m) –4.5		
Hollows –0		
Diameter (cm) –27cm		
Canopy dieback (%) –5%		
Total Biodiversity Score –0.4		
This is a small tree with a low habitat value

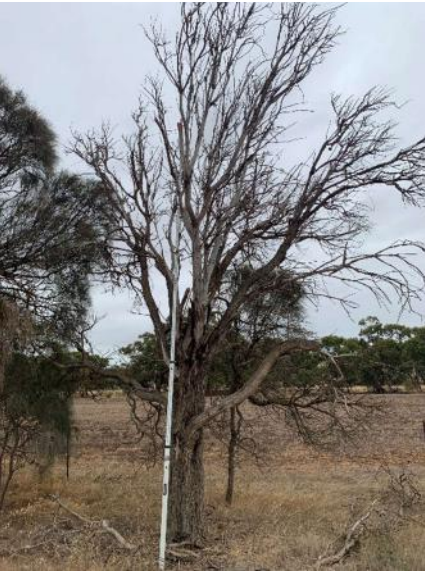
Photo direction - West Waypoint 171
Number of trees – 1		
Height (m) –6		
Hollows –0		
Diameter (cm) –36cm		
Canopy dieback (%) –100%		
Total Biodiversity Score –0.22		
Tree is dead

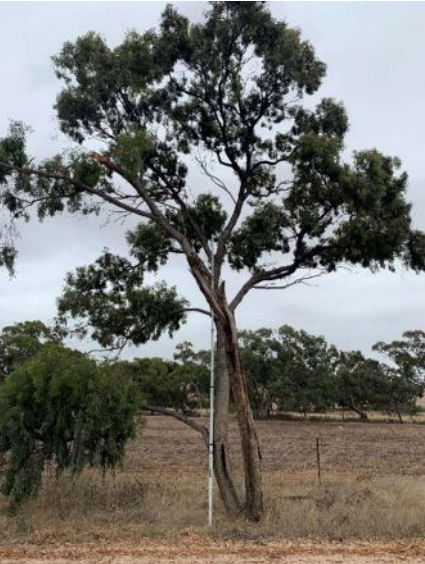
Photo direction - West Waypoint 172
Number of trees – 1		
Height (m) –8		
Hollows –0		
Diameter (cm) –54cm		
Canopy dieback (%) –20%		
Total Biodiversity Score –0.5		
Multi trunk tree in fair condition

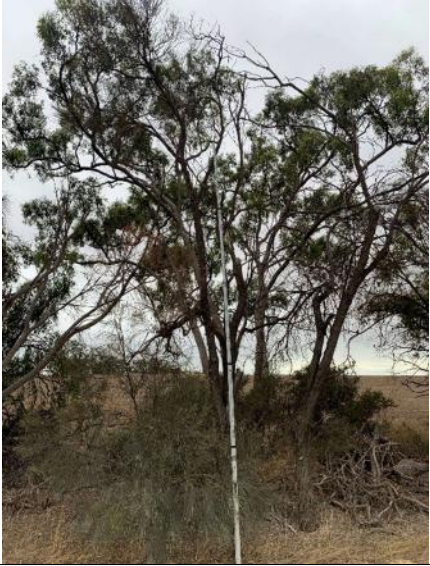
<p>Photo Direction East Waypoint 173</p>
Tree spp. <i>Allocasuarina verticillata</i>	
Number of trees – 1	
Height (m) –6	
Hollows –0	
Diameter (cm) –20cm	
Canopy dieback (%) –70%	
Total Biodiversity Score –0.18	
<p>This is a small tree with a low habitat value. Top of tree is dead with low shoots showing.</p>

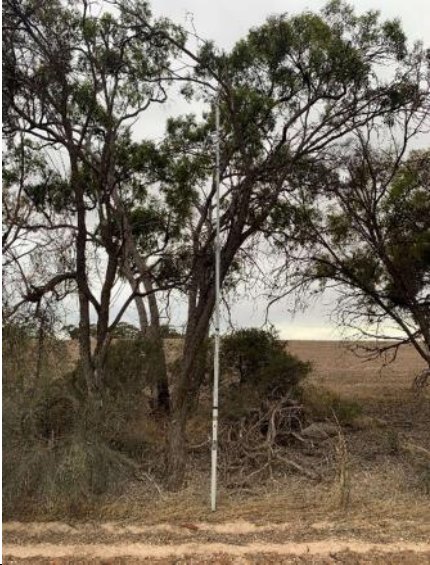
<p>Photo Direction East Waypoint 174</p>
Tree spp. <i>Allocasuarina verticillata</i>	
Number of trees – 1	
Height (m) –4	
Hollows –0	
Diameter (cm) –19cm	
Canopy dieback (%) –100%	
Total Biodiversity Score –0.7	
<p>Tree is dead</p>

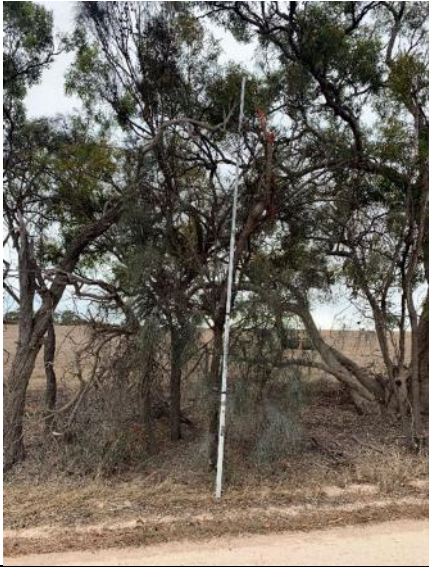
Photo Direction East Waypoint 175
Number of trees – 1		
Height (m) –6		
Hollows –0		
Diameter (cm) –14cm		
Canopy dieback (%) –40%		
Total Biodiversity Score –0.15		
This is a small tree with a low habitat value. Significant dieback.

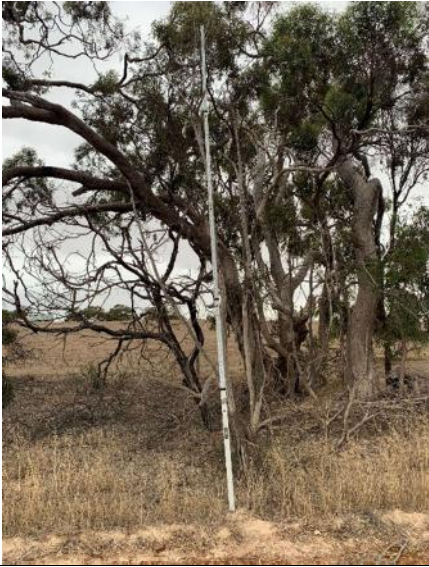
Photo Direction East Waypoint 176
Number of trees – 1		
Height (m) –4		
Hollows –0		
Diameter (cm) –20cm		
Canopy dieback (%) –100%		
Total Biodiversity Score –0.7		
Tree is dead

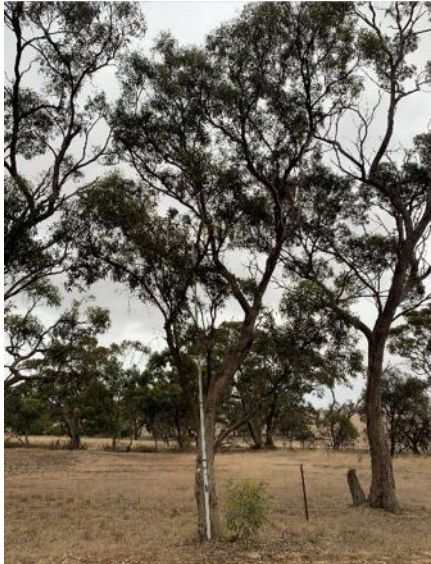
Photo Direction East
Number of trees – 1		Waypoint 177
Height (m) –8		
Hollows –1		
Diameter (cm) –31cm		
Canopy dieback (%) –40%		
Total Biodiversity Score –0.57		
<p>Canopy dieback. Hollows present which may provide habitat for numerous species including NP&amp;W Act species. Leans back into the roadside vegetation.</p>

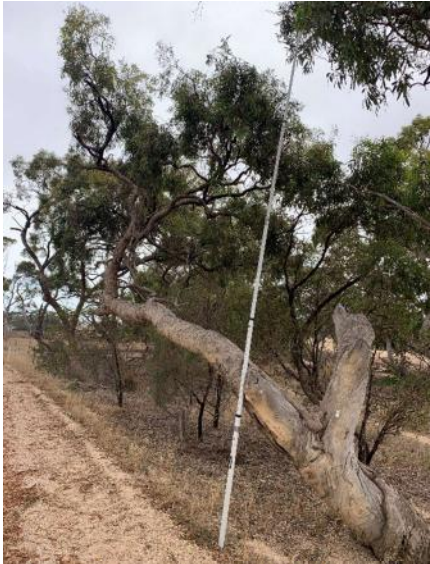
Photo Direction South West
Number of trees – 1		Waypoint 178
Height (m) –6		
Hollows –0		
Diameter (cm) –29cm		
Canopy dieback (%) –50%		
Total Biodiversity Score –0.41		
<p>Older tree that has been damaged in the past. Near an intersection. Hollows present which may provide habitat for numerous species including NP&amp;W Act species</p>

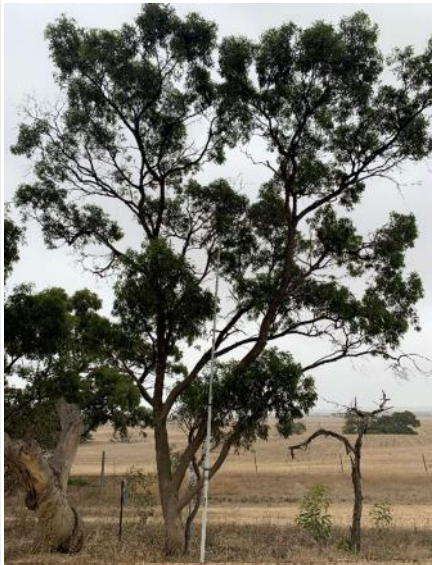
Photo Direction South West
Number of trees – 1		Waypoint 179
Height (m) –9		
Hollows –1		
Diameter (cm) –31cm		
Canopy dieback (%) –20%		
Total Biodiversity Score –0.39		
Smaller tree near the intersection and on a corner

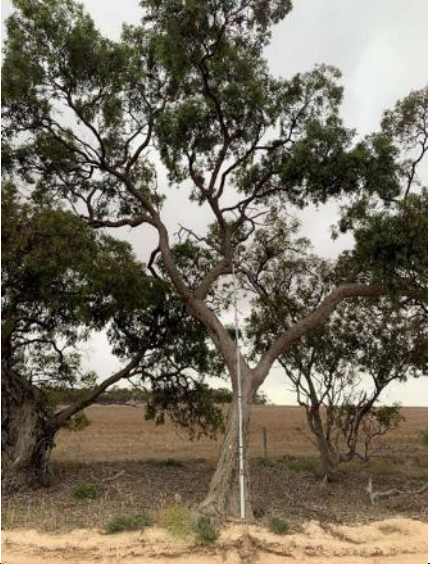
Photo direction East
Number of trees – 1		Waypoint 180
Height (m) –9		
Hollows –0		
Diameter (cm) –65cm		
Canopy dieback (%) –30%		
Total Biodiversity Score –2.11		
Larger tree for the region, found on very edge of gravel road. Hollows present which may provide habitat for numerous species including NP&W Act species.

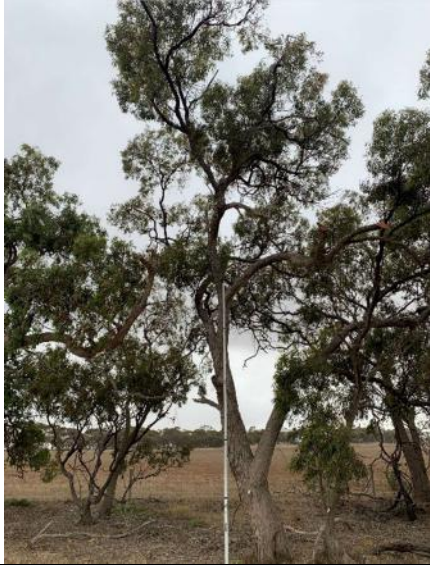
Photo direction East
Number of trees – 1		Waypoint 181
Height (m) –9		
Hollows –2		
Diameter (cm) –55cm		
Canopy dieback (%) –25%		
Total Biodiversity Score –1.98		
Larger tree for the region. Hollows present which may provide habitat for numerous species including NP&W Act species.

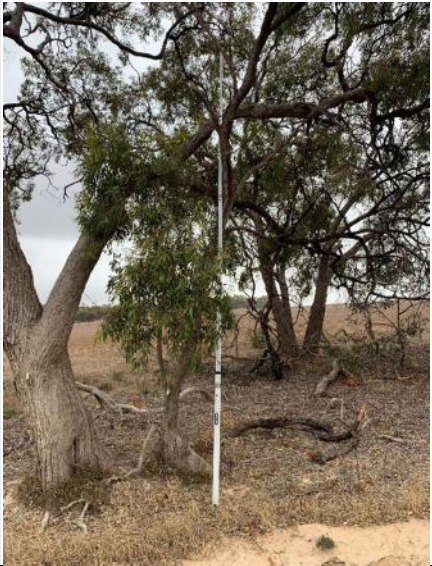
Photo direction East
Number of trees – 1		Waypoint 182
Height (m) –6		
Hollows –0		
Diameter (cm) –12cm		
Canopy dieback (%) –60%		
Total Biodiversity Score –0.09		
This is a small tree with a low habitat value.

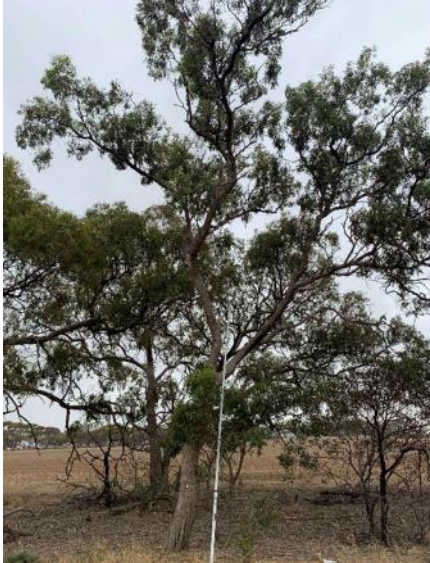
Photo direction East
Number of trees – 1		Waypoint 183
Height (m) –11		
Hollows –0		
Diameter (cm) –39cm		
Canopy dieback (%) –30%		
Total Biodiversity Score –0.52		
Tree close to edge of road way on a corner. Not a significant tree in good condition.

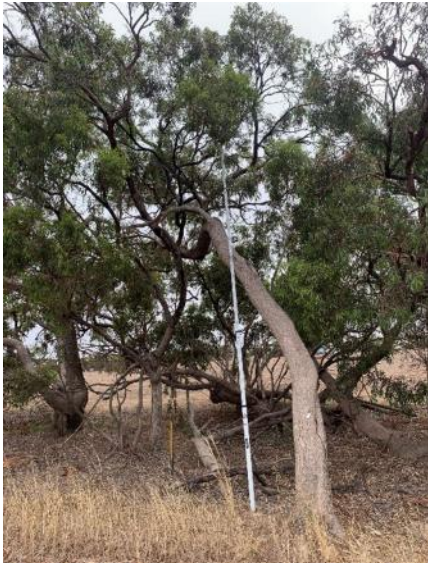
Photo direction East
Number of trees – 1		Waypoint 184
Height (m) –7		
Hollows –0		
Diameter (cm) –30cm		
Canopy dieback (%) –20%		
Total Biodiversity Score –0.32		
Tree close to edge of road way on a corner. Not a significant tree in good condition.

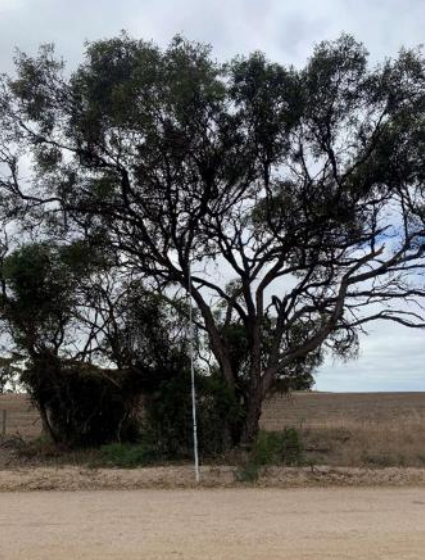
Photo direction East
Number of trees – 1		Waypoint 185
Height (m) –10		
Hollows –0		
Diameter (cm) –67cm		
Canopy dieback (%) –40%		
Total Biodiversity Score –3.63		
<p>On the edge of the road. Multiple stems, excellent solid tree as part of a clump of the same species. NO hollows present however may provide habitat for numerous species including NP&amp;W Act species.</p>

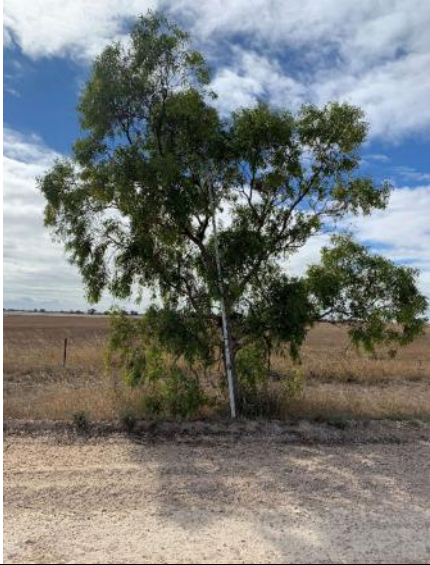
Photo direction East
Number of trees – 1		Waypoint 189
Height (m) –5		
Hollows –0		
Diameter (cm) –20cm		
Canopy dieback (%) –5%		
Total Biodiversity Score –0.22		
This is a small tree with a low habitat value on roadside verge

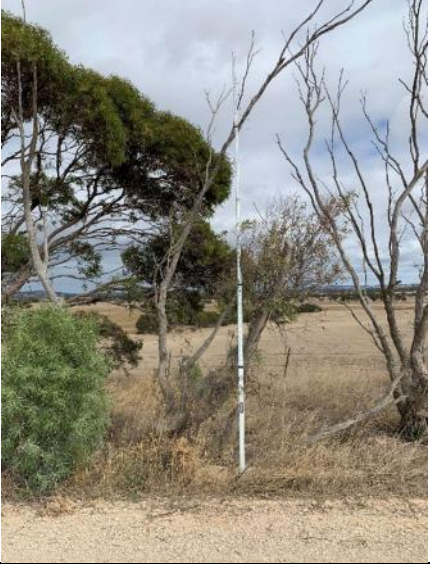
Photo direction West
Number of trees – 1		Waypoint 197
Height (m) –2		
Hollows –0		
Diameter (cm) –21cm		
Canopy dieback (%) –95%		
Total Biodiversity Score –0.04		
This is a small tree is nearly dead.

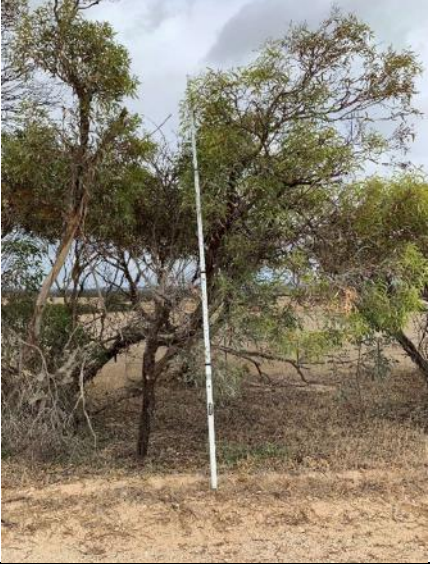
Photo direction West
Number of trees – 1		Waypoint 198
Height (m) –4		
Hollows –0		
Diameter (cm) –13cm		
Canopy dieback (%) –60%		
Total Biodiversity Score –0.17		
This is a small tree in decline with a low habitat value

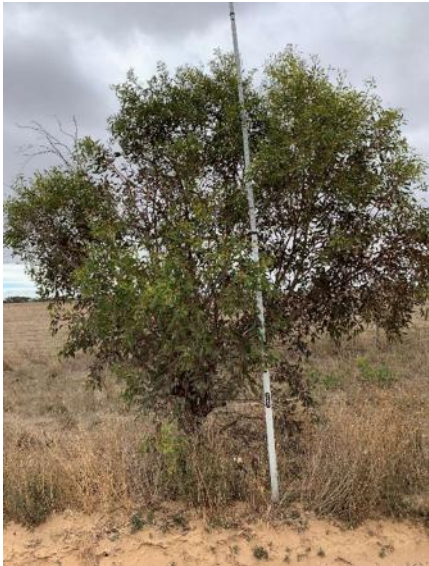
Photo direction East
Number of trees – 1		Waypoint 202
Height (m) –3		
Hollows –0		
Diameter (cm) –22cm		
Canopy dieback (%) –40%		
Total Biodiversity Score –0.27		
This is a small tree with a low habitat value surrounded by introduced weeds

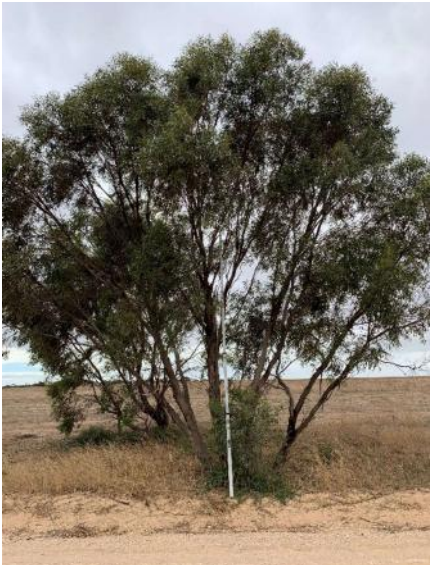
<p>Photo direction East Waypoint 203</p>
Tree spp. <i>Eucalyptus largiflorens</i>	
Number of trees – 1	
Height (m) –7	
Hollows –0	
Diameter (cm) –21cm	
Canopy dieback (%) –5%	
Total Biodiversity Score –0.28	
<p>This is a tree is on the edge of the alignment surrounded by introduced grasses.</p>

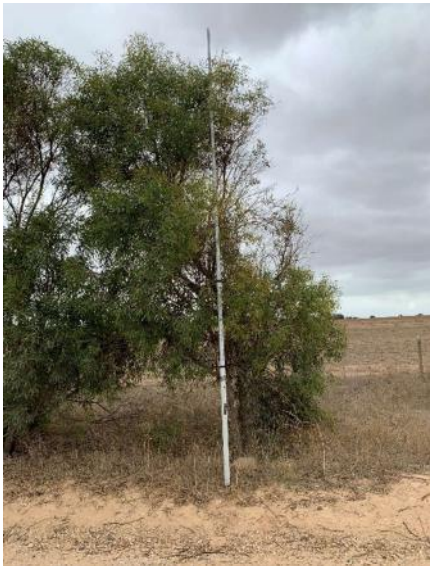
<p>Photo direction East Waypoint 204</p>
Tree spp. <i>Eucalyptus odorata</i>	
Number of trees – 1	
Height (m) –4	
Hollows –0	
Diameter (cm) –16cm	
Canopy dieback (%) –25%	
Total Biodiversity Score –0.16	
<p>This is a small tree with a low habitat value</p>

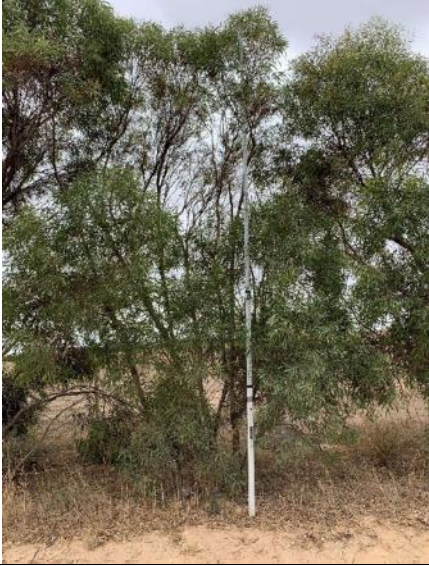
Photo direction East
Number of trees – 1		Waypoint 205
Height (m) –5		
Hollows –0		
Diameter (cm) –16cm		
Canopy dieback (%) –10%		
Total Biodiversity Score –0.26		
This is a small tree with a low habitat value which has been cut back numerous times.

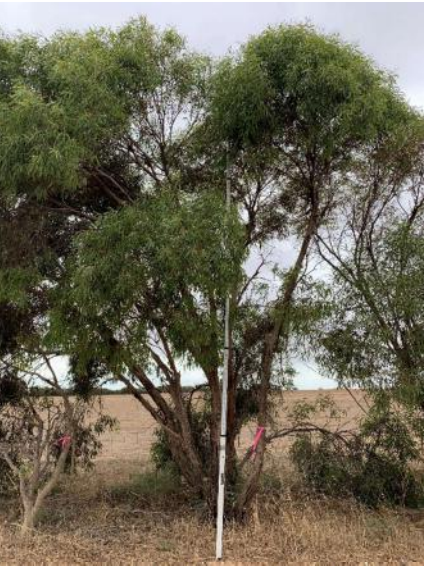
Photo direction East
Number of trees – 1		Waypoint 206
Height (m) –5.5		
Hollows –0		
Diameter (cm) –25cm		
Canopy dieback (%) –0%		
Total Biodiversity Score –0.37		
Multi trunk small tree with a low habitat value which has numerous stems

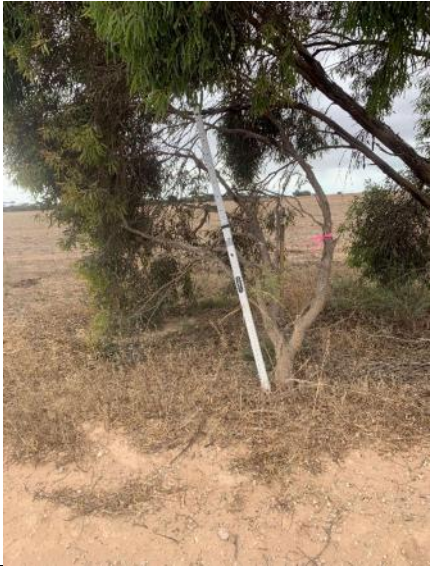
Photo direction East
Number of trees – 1		Waypoint 207
Height (m) –1		
Hollows –0		
Diameter (cm) –10cm		
Canopy dieback (%) –0%		
Total Biodiversity Score –0.10		
This is a small tree with a low habitat value which has been cut back numerous times.

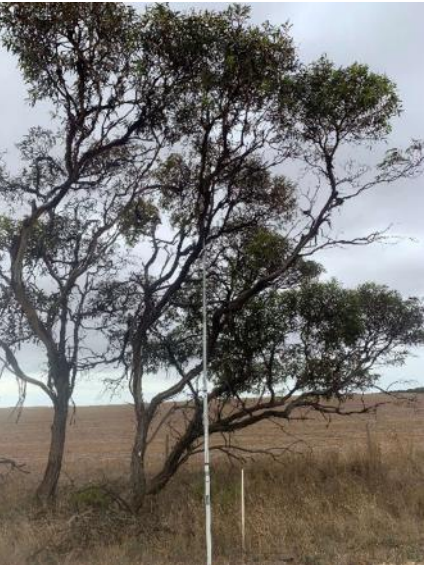
Photo direction East
Number of trees – 1		Waypoint 208
Height (m) –7		
Hollows –0		
Diameter (cm) –33cm		
Canopy dieback (%) –25%		
Total Biodiversity Score –1.25		
This is a small multi trunk mallee tree surrounded by introduced grasses

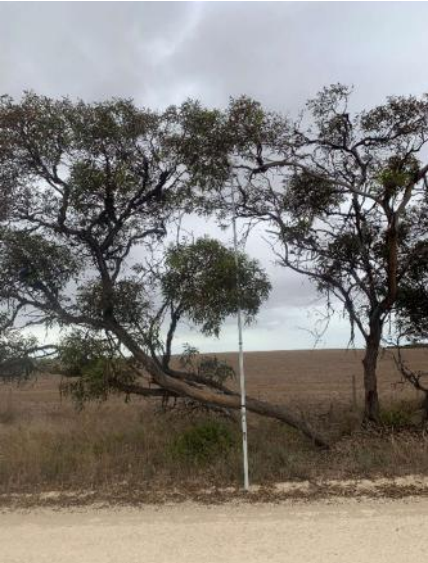
Photo direction East
Number of trees – 1		Way Point 209
Height (m) –6		
Hollows –0		
Diameter (cm) –20m		
Canopy dieback (%) –30%		
Total Biodiversity Score –0.60		
Multi stemmed tree with broken branch, surrounded by introduced grasses

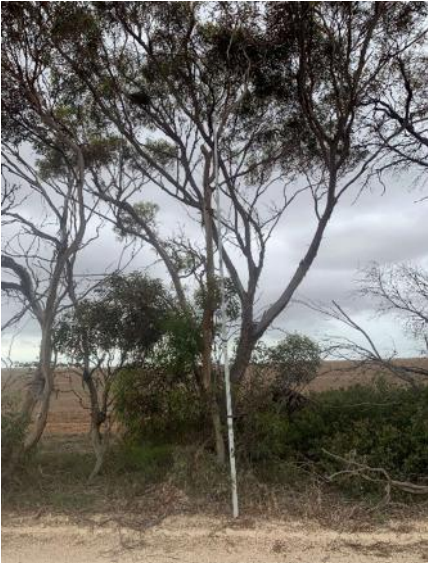
Photo direction East
Number of trees – 1		Waypoint 210
Height (m) –6		
Hollows –0		
Diameter (cm) – 21cm		
Canopy dieback (%) –25%		
Total Biodiversity Score –0.44		
This is a small tree as part of a group of trees close to the roadside verg

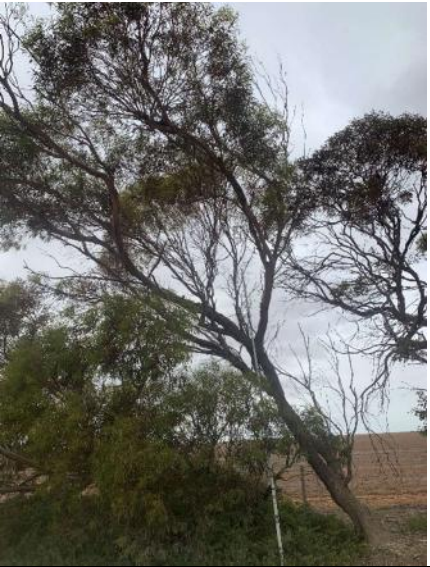
Photo direction East
Number of trees – 1		Waypoint 213
Height (m) – 8		
Hollows –0		
Diameter (cm) –30cm		
Canopy dieback (%) –50%		
Total Biodiversity Score –0.63		
Multi stemmed tree as part of a group of trees close to the roadside verg. Leaning over road.

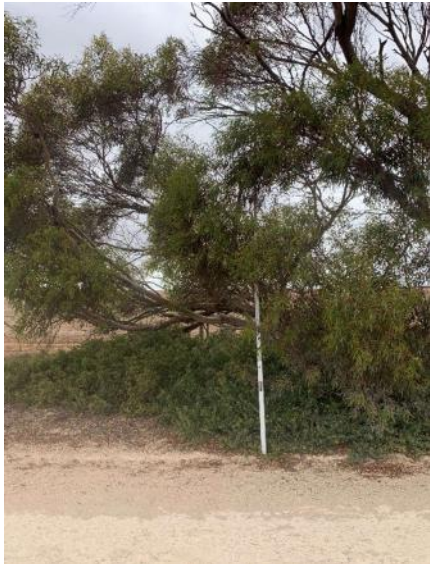
Photo direction East
Number of trees – 1		Waypoint 214
Height (m) –4		
Hollows –0		
Diameter (cm) –29cm		
Canopy dieback (%) –20%		
Total Biodiversity Score –0.37		
This is a multi-stem small tree close to road verg

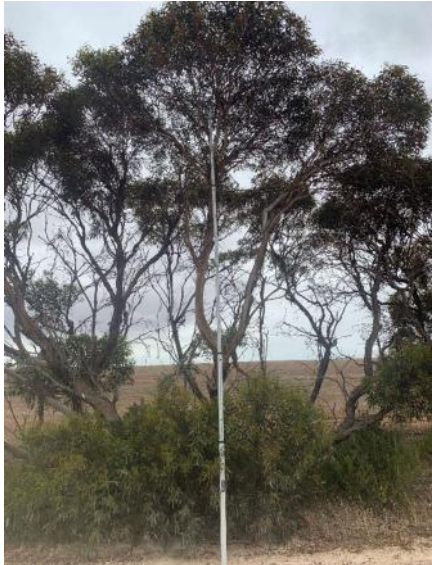
Photo direction East Waypoint 215
Number of trees – 1		
Height (m) – 6		
Hollows –0		
Diameter (cm) –28cm		
Canopy dieback (%) –20%		
Total Biodiversity Score –0.54		
This is a small tree close to road verg which is damaged by grader during maintenance

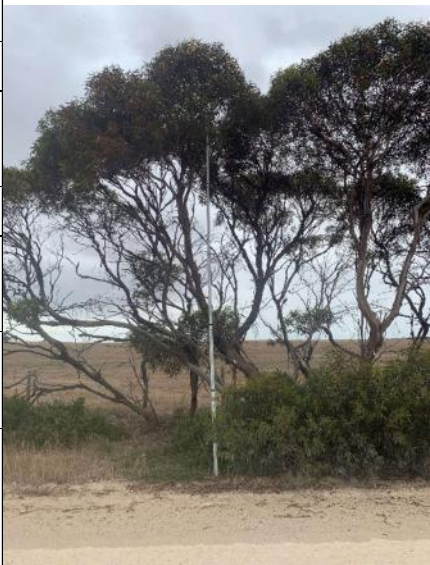
Photo direction East Waypoint 216
Number of trees – 1		
Height (m) – 6		
Hollows –0		
Diameter (cm) –18cm		
Canopy dieback (%) –20%		
Total Biodiversity Score –0.42		
Multi stemmed tree

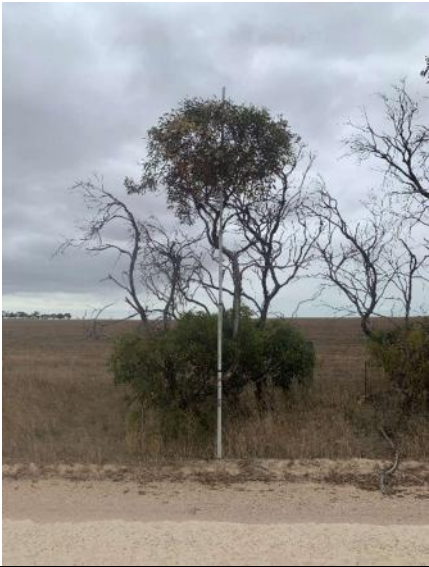
Photo direction East
Number of trees – 1		Waypoint217
Height (m) –5		
Hollows –0		
Diameter (cm) –18cm		
Canopy dieback (%) –80%		
Total Biodiversity Score –0.16		
This is a small tree with significant dieback

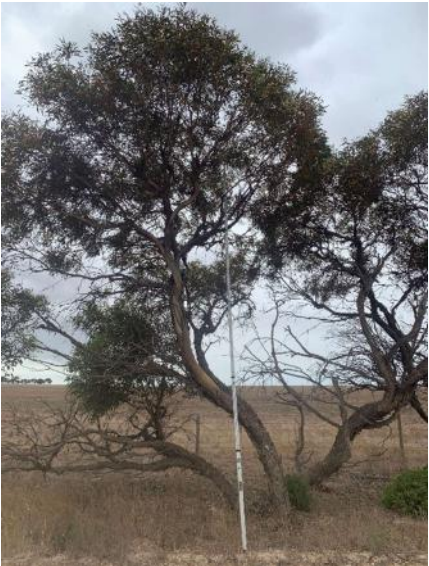
Photo direction East
Number of trees – 1		Waypoint 218
Height (m) –7		
Hollows –0		
Diameter (cm) –20cm		
Canopy dieback (%) –20%		
Total Biodiversity Score –0.32		
Multi stemmed small tree in good condition however close to graded road

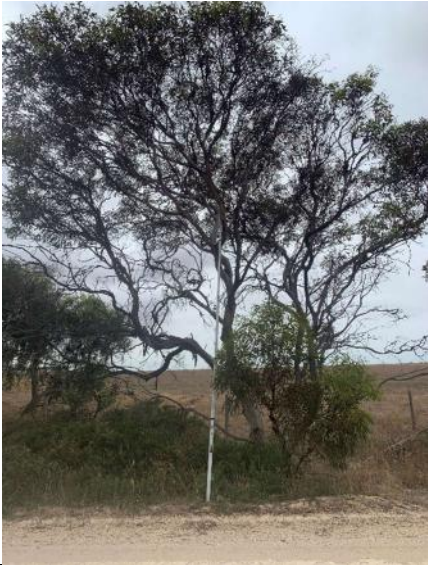
Photo direction East
Number of trees – 1		Waypoint 219
Height (m) –7		
Hollows –0		
Diameter (cm) –33cm		
Canopy dieback (%) –30%		
Total Biodiversity Score –1.2		
Multi stemmed small tree in good condition however close to graded road

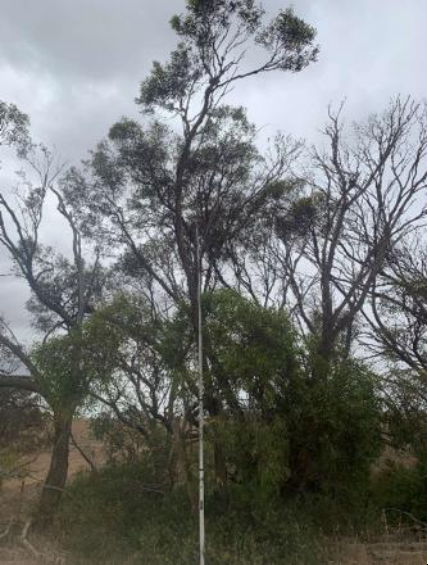
Photo direction East
Number of trees – 1		Waypoint 220
Height (m) –8		
Hollows –0		
Diameter (cm) –18cm		
Canopy dieback (%) –50%		
Total Biodiversity Score –0.16		
Multi stemmed tree as part of a group of trees close to the roadside verg in poor health

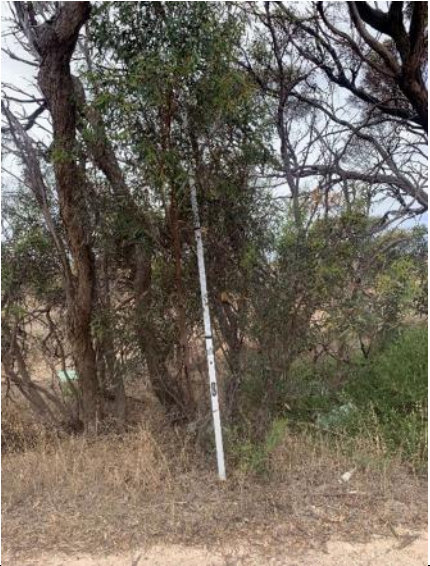
Photo direction East
Number of trees – 1		Waypoint 225
Height (m) –2.5		
Hollows –0		
Diameter (cm) –8cm		
Canopy dieback (%) –20%		
Total Biodiversity Score –0.08		
This is a small tree damaged by grader

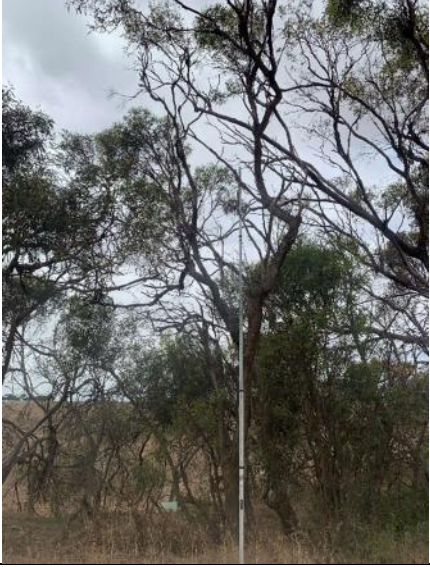
Photo direction East
Number of trees – 1		Waypoint 226
Height (m) –8		
Hollows –0		
Diameter (cm) –42cm		
Canopy dieback (%) –50%		
Total Biodiversity Score –0.34		
Multi stemmed tree as part of a group of trees close to the roadside verg

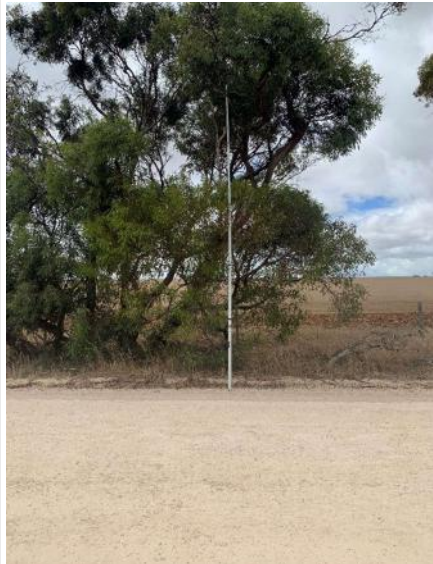
Photo direction East
Number of trees – 1		Waypoint 232
Height (m) –3		
Hollows –0		
Diameter (cm) – 8cm		
Canopy dieback (%) – 0%		
Total Biodiversity Score –0.23		
This is a small tree under mallee

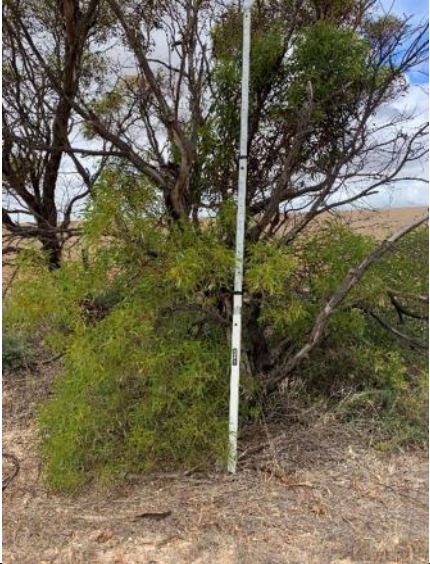
Photo direction East
Number of trees – 1		Waypoint 236
Height (m) – 2		
Hollows –0		
Diameter (cm) – 24 cm		
Canopy dieback (%) – 90%		
Total Biodiversity Score –0.08		
This is a small tree with significant dieback

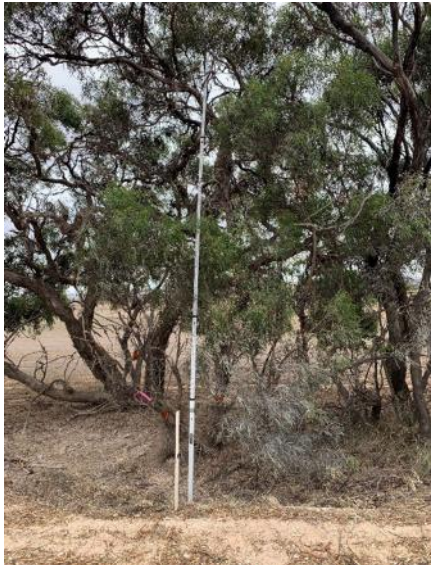
Photo direction West
Number of trees – 1		Waypoint 238
Height (m) – 4		
Hollows –0		
Diameter (cm) –28cm		
Canopy dieback (%) –50%		
Total Biodiversity Score –0.14		
Multi stemmed tree as part of a group of trees close to the roadside verg and culvert

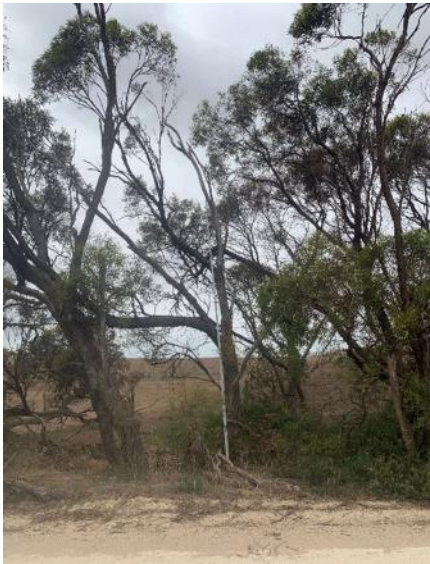
Photo direction East
Number of trees – 1		Waypoint 240
Height (m) –5		
Hollows –0		
Diameter (cm) –26cm		
Canopy dieback (%) –30%		
Total Biodiversity Score –0.19		
Multi stemmed tree as part of a group of trees close to the roadside verg and culvert

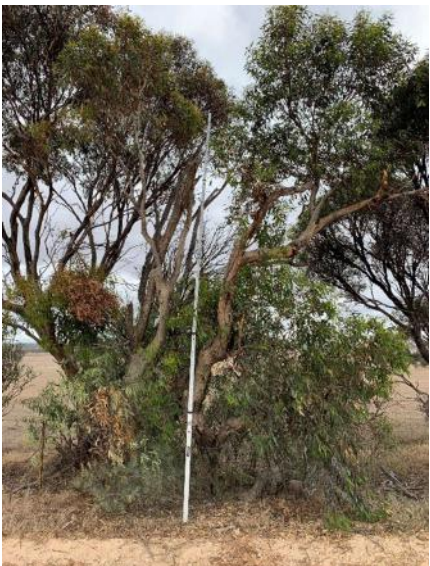
Photo direction West
Number of trees – 1		Waypoint 241
Height (m) –6		
Hollows –0		
Diameter (cm) –38cm		
Canopy dieback (%) –50%		
Total Biodiversity Score –1.24		
Small tree on edge of road in poor health

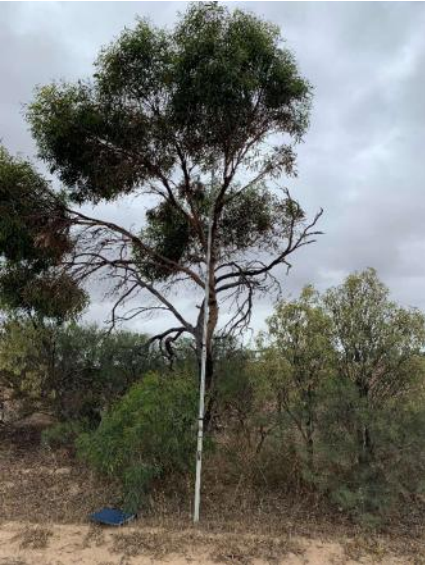
Representative photo
Tree spp. <i>Eucalyptus largiflorens</i>		Photo direction East
Number of trees – 1		Waypoint 242
Height (m) –6		
Hollows –0		
Diameter (cm) –23cm		
Canopy dieback (%) –10%		
Total Biodiversity Score –0.25		
Damaged by grader close to the roadside verg

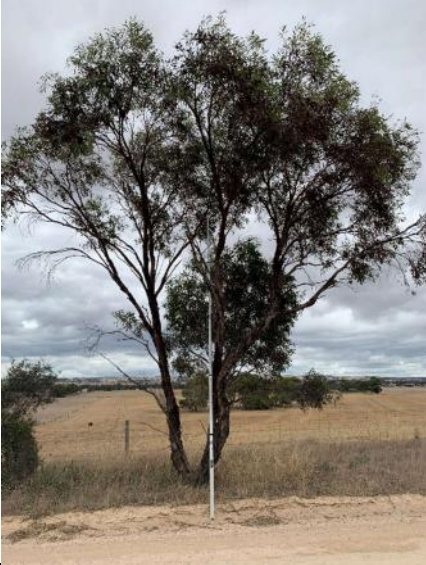
Representative photo
Tree spp. <i>Eucalyptus largiflorens</i>		Photo direction West
Number of trees – 1		Waypoint 243
Height (m) – 7		
Hollows –0		
Diameter (cm) – 36cm		
Canopy dieback (%) –10%		
Total Biodiversity Score –0.40		
Multi stemmed tree close to the roadside verg

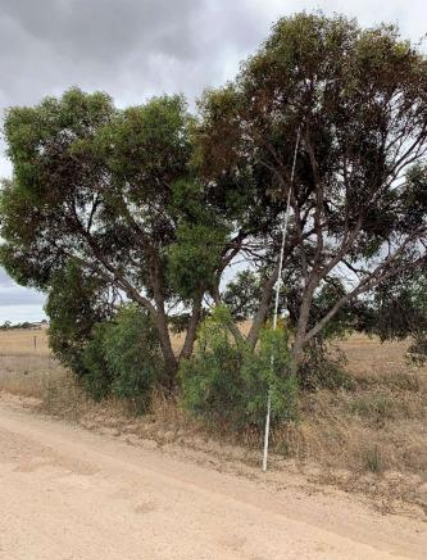
Photo direction East
Number of trees – 3		Waypoints 244, 245,246
Height (m) – 7		
Hollows –0		
Diameter (cm) – 48cm		
Canopy dieback (%) –5%		
Total Biodiversity Score –1.56		
A group of trees in good condition

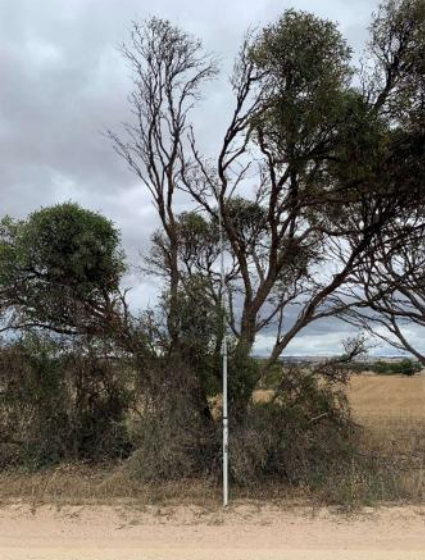
Photo direction West
Number of trees – 1		Waypoint 247
Height (m) – 7		
Hollows –0		
Diameter (cm) – 32cm		
Canopy dieback (%) –70%		
Total Biodiversity Score –0.18		
Multi stemmed tree which is in poor condition

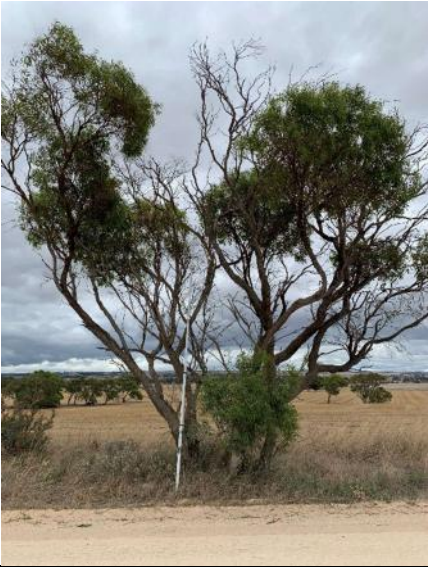
Photo direction West
Number of trees – 1		Waypoint 248
Height (m) – 7		
Hollows –0		
Diameter (cm) – 41cm		
Canopy dieback (%) – 50%		
Total Biodiversity Score –0.30		
Multi stemmed tree close to the roadside verg in poor condition

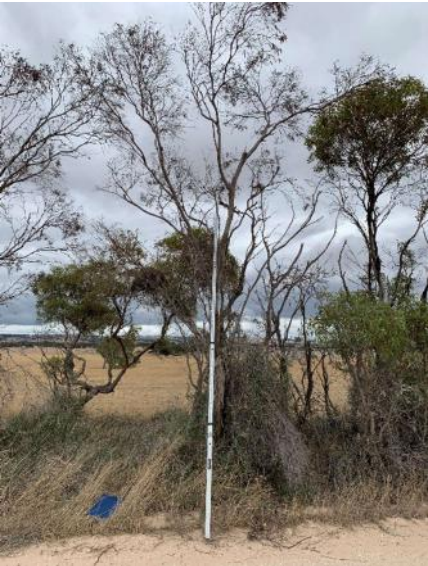
Photo direction West
Number of trees – 1		Waypoint 249
Height (m) – 6		
Hollows –0		
Diameter (cm) – 27cm		
Canopy dieback (%) –100%		
Total Biodiversity Score –0.23		
Tree is dead

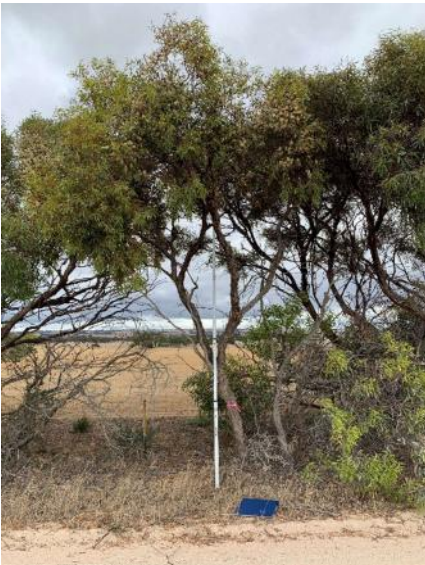
Photo direction West
Number of trees – 1		Waypoint 250
Height (m) – 6		
Hollows –0		
Diameter (cm) – 18cm		
Canopy dieback (%) –0%		
Total Biodiversity Score –0.51		
Smaller mallee in good condition

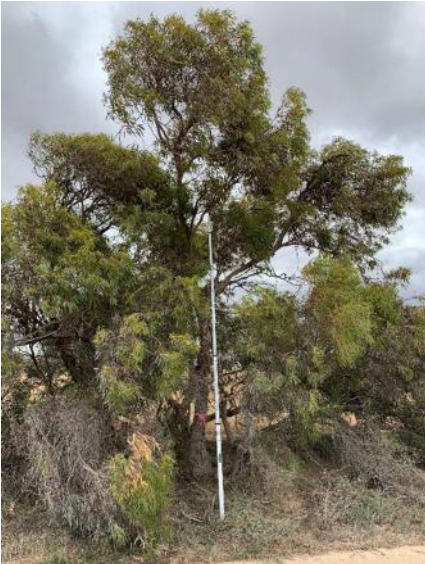
Photo direction West
Number of trees – 1		Waypoint 251
Height (m) – 7		
Hollows –0		
Diameter (cm) – 23cm		
Canopy dieback (%) –10%		
Total Biodiversity Score –0.64		
Smaller mallee in good condition no hollows
