Mallee Seep NDVI imagery Report October 2019

Rob Jericho's property

Andrew Baldock property Site 1

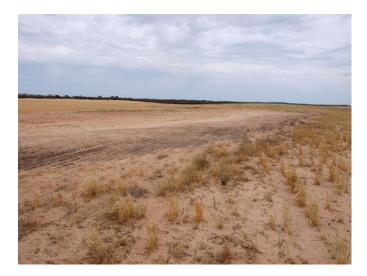
Photo 1. Seep 1.

Paddock 1 Site 1. A. In unproductive low lying dark coloured area of paddock. 61cm deep hole dug to clay. Sand soon 'melted' with the water saturating the sand sitting above the clay. . pH on soil samples taken with a soil spike sample pH 10.

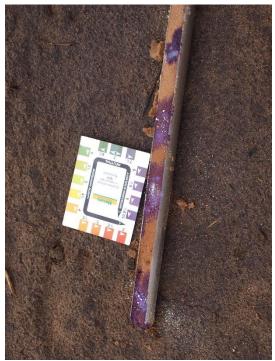
Photo 2. Shows the hard back crust and soil pH

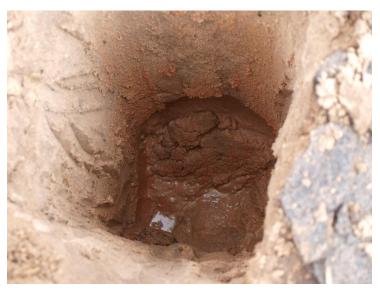
Photo 3. As soon as the pressure was released soil and water oozed into the hole.

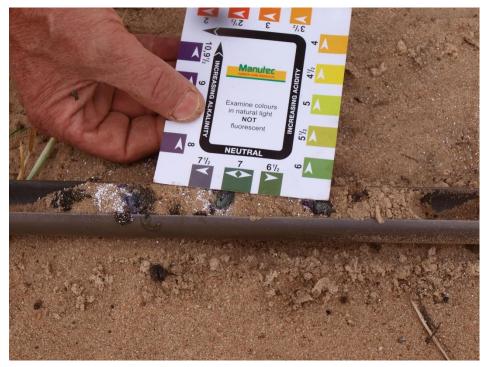
Paddock 1 Site 1 C. Sample taken on the sandy rise approx. 2m up- hill North East from low lying dark coloured area of paddock. Soil spike sample to 60cm deep. Clay at 55cm, rest is sand. Dry to 38cm deep. Non-wetting sand pH 7. Clay pH 8 – 9. GPS point saved 53H 0619336 6325745

Photo 6. Slope above the seep where crop was established has natural soil pH

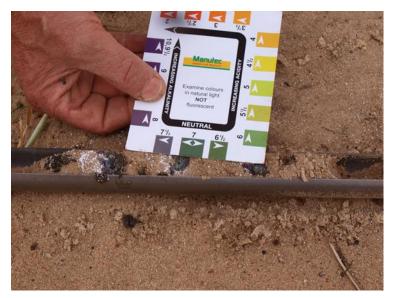
Second paddock 'seep 2 north' soil samples showed that the top 15cm was non wetting sands with a pH 5.5 in 0- 6cm. At 14 cm the pH lowered to pH 5 and then increased to pH 8.5 to 10 from 16cm –to 38cm.

Photo 9 soil sample tested for pH

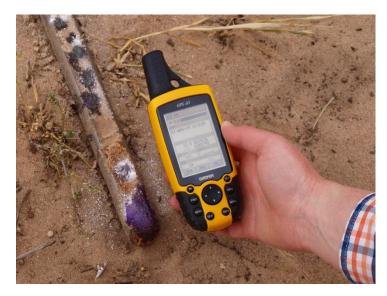
Photo 10 Soil sample showing variation in pH levels.

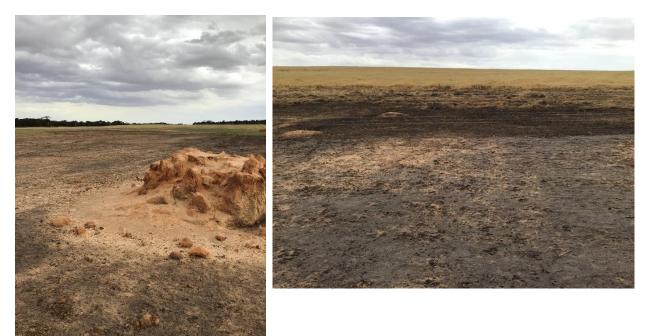
Two flights were undertaken on November 1st 2019 covering 278 ha over three seep and prospective seep areas. Site plans 2 and 3 were combined when the site was flown. The first site is a large unproductive area with a hard black crust covering the majority of the site. A number of samples including water were taken from the site.

Photos 11 and 12 shows a severally degraded mallee seep which is having significant impact on the crop as it has moved uphill.

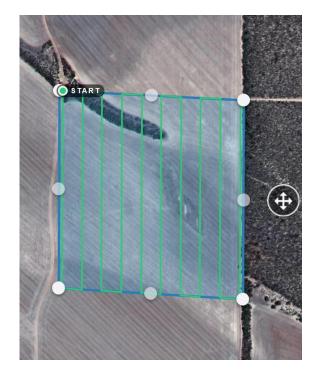
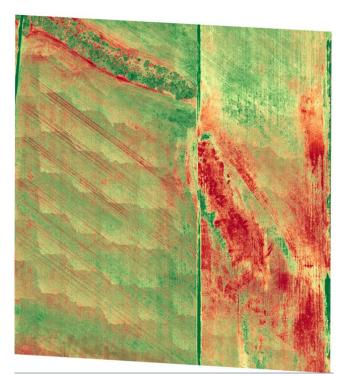
The NDVI map show the extent of the seep (red) and the potential to spread into the neighbouring paddock as shown in Photo 12.

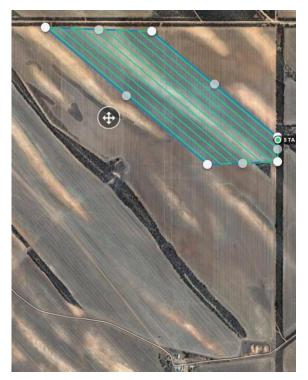
Site 2a

There was complete crop failure on the swale at site 2. There was no evidence of scaling and the soil profile was very dry. pH levels were pH 6 at the surface and pH 9.5 at depth
