SA Seep Site 1: Kevin and Geoff Bonds, Mannum

“Repairing a recently formed seep scald area back into crop production.”

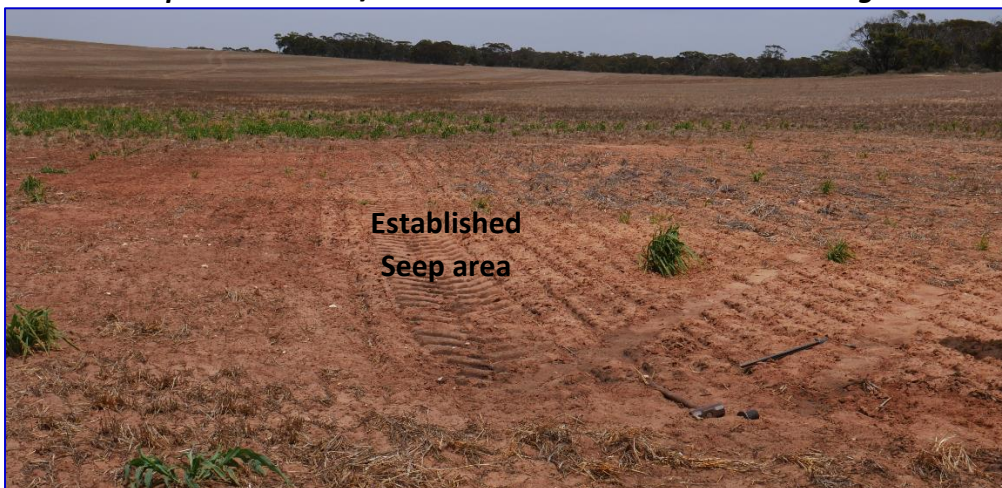
A seep area that has quickly developed over the few years, becoming initially waterlogged after the 2016 wet year, forming into a rapidly growing bare scalded area, not highly saline yet, but too saline in the surface to support wheat and summer crop growth. This is at the base of a deep sandhill and has the potential to spread into a much larger saline scald (Figures 1-2).

Photo 1. Seep scald in 2018/19 summer with some millet and sorghum surrounding

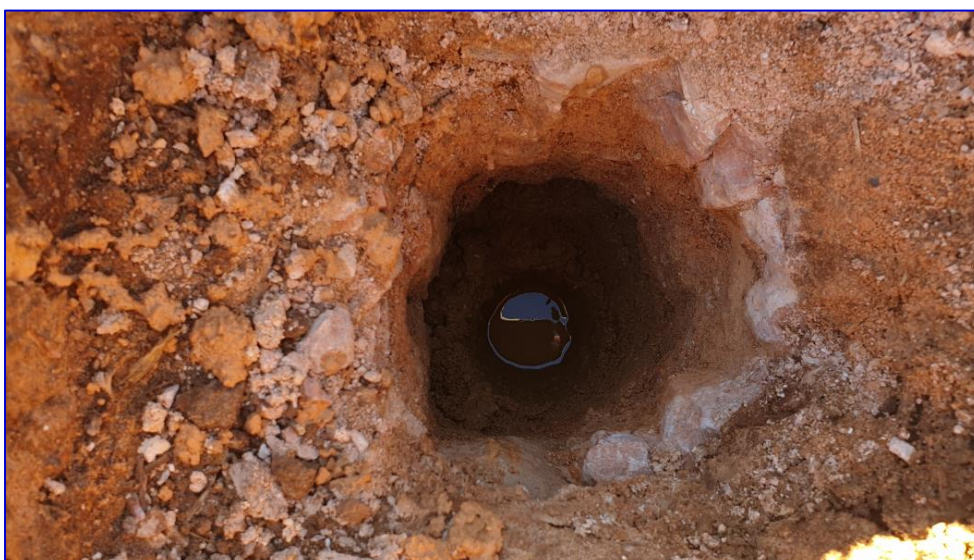
Photo 2. Shallow water table below the stone at the site

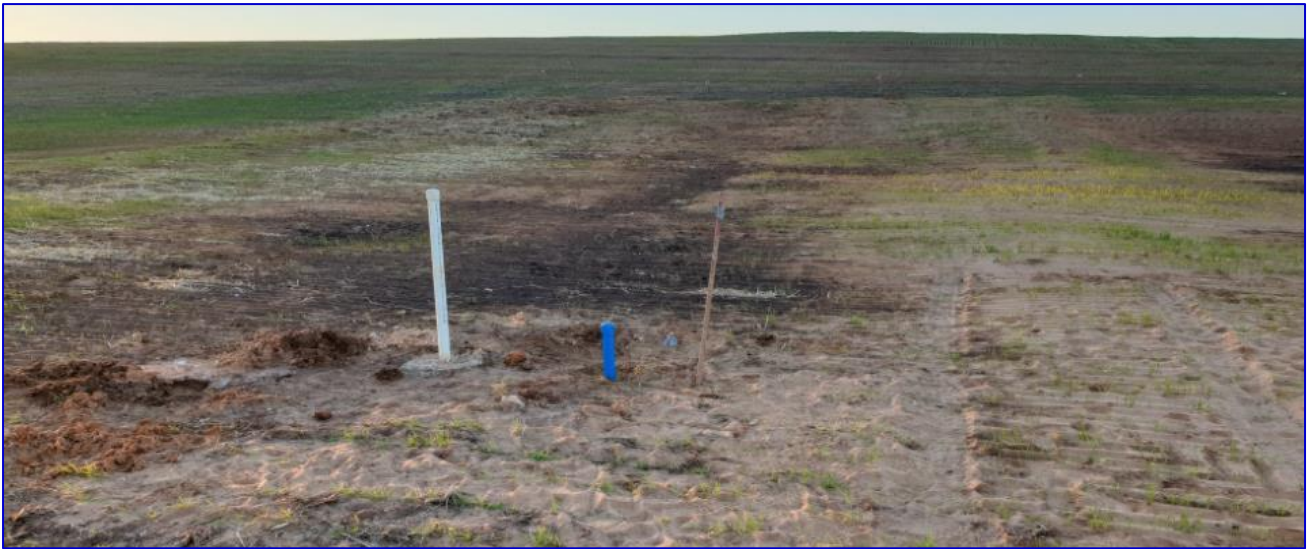
Photo 3. Piezometer placed within the trial measuring water table at 50cm

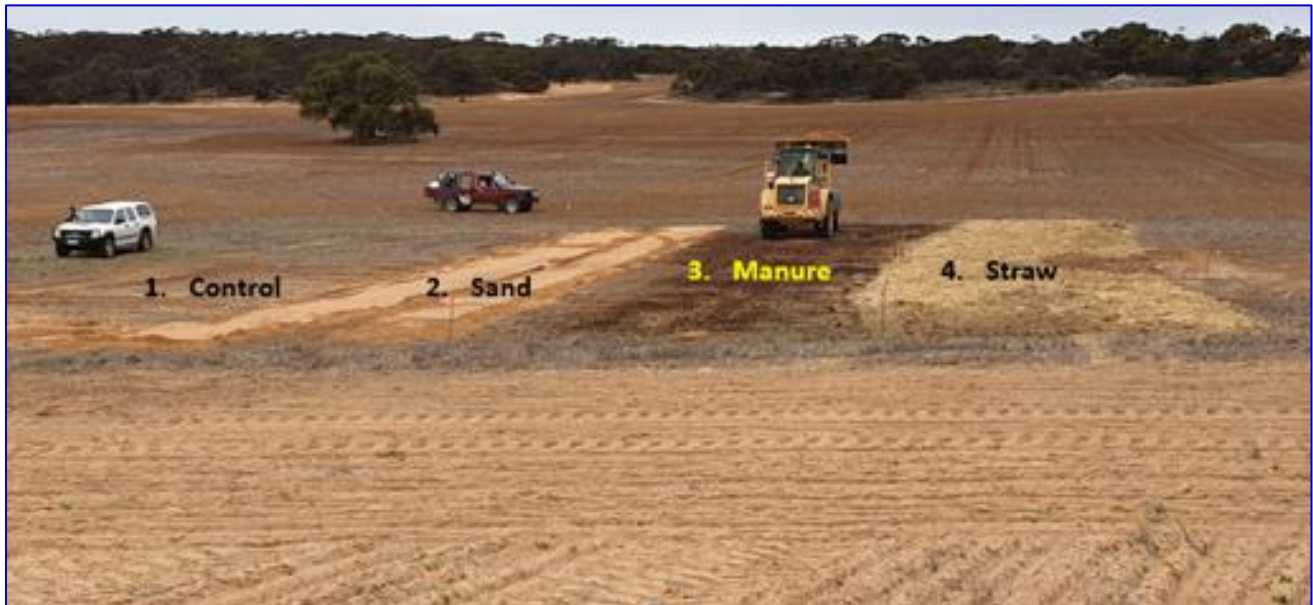
Photo 4. Construction of site treatments by the farmers

The seep scald area was divided in to 4 areas (Photos 4-5), 8m wide and 50m long, being:

1. Control,
2. Sand alone (depth 15cm),
3. Sand (ave depth about 10cm) with composted chicken manure (approx. 20t/ha) and
4. Sand (10cm) & straw (approx. 30t/ha) with composted chicken manure (approx. 20t/ha).

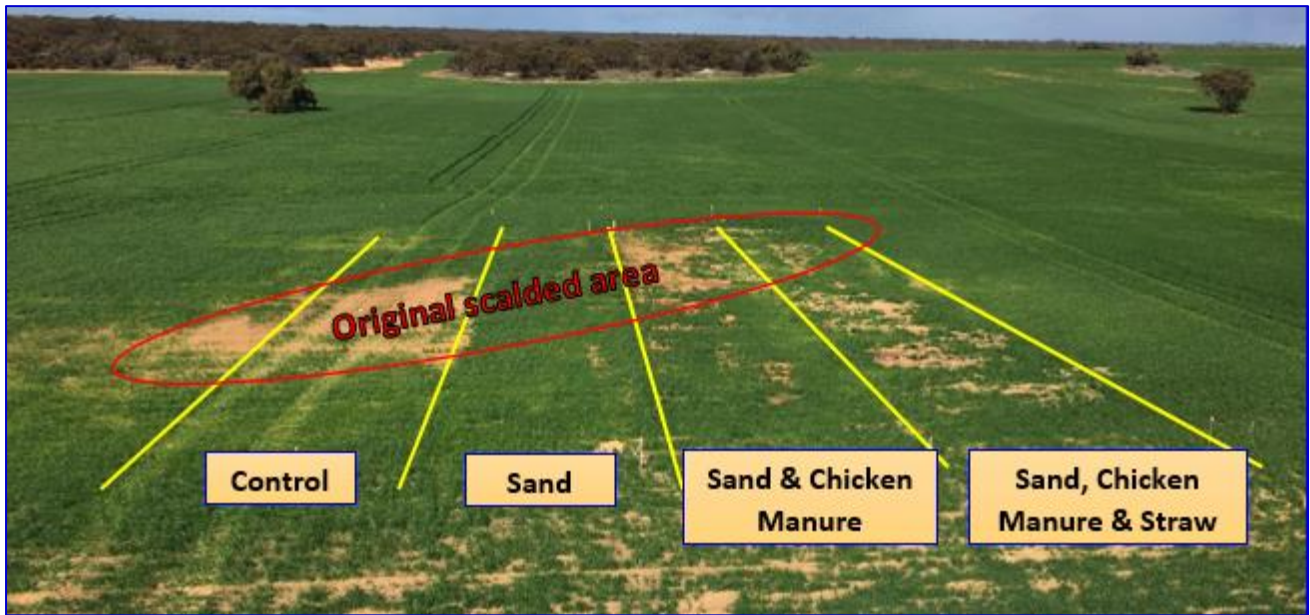
Photo 5. Mid-season results with promising crop establishment achieved

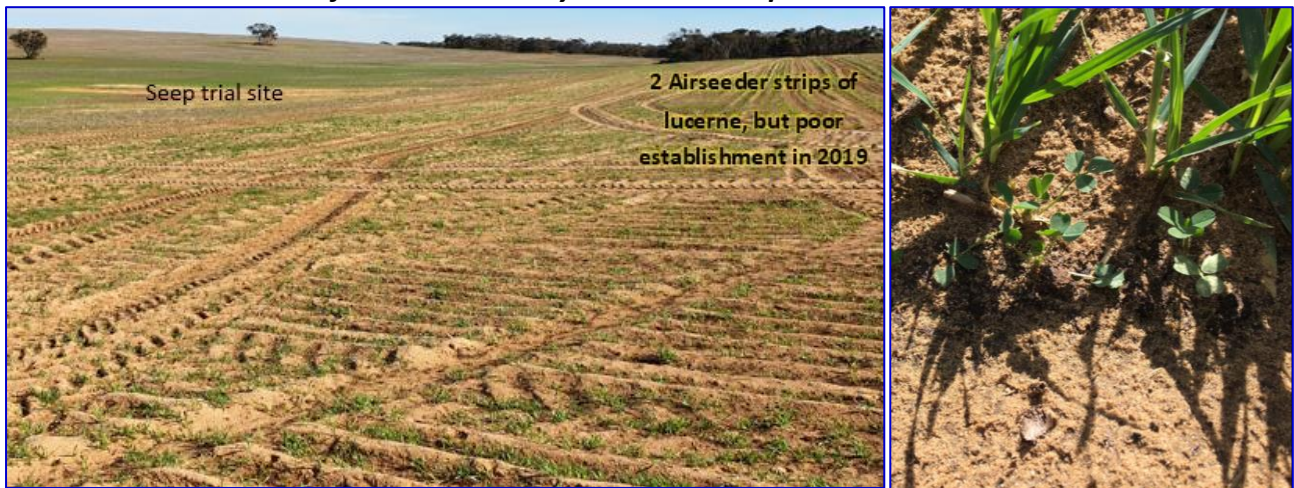
Photo 6. Establishment of lucerne on sandy rise above seep area

Unfortunately the lucerne strip for the lower section of the sandhill was sown fairly late into an already established barley crop, which was less than ideal given the very poor season.

Consequently, establishment was very poor. It is hoped that this water interception strip will be better established in 2020.

- i. **Recharge Zone:** To intercept the excess recharge water coming from the deep sandhill above the seep, 2 seeder widths of lucerne were sown (35m width) at the base end of the sandhill above the seep (Photos 6-7). This was sown into an establishing cereal crop in early June 2019. The timing and seasonal conditions were not ideal for lucerne establishment, but it was thought that this could be done safely, given that it was a relatively small area. Re-establishment of this lucerne strip will be attempted in 2020.

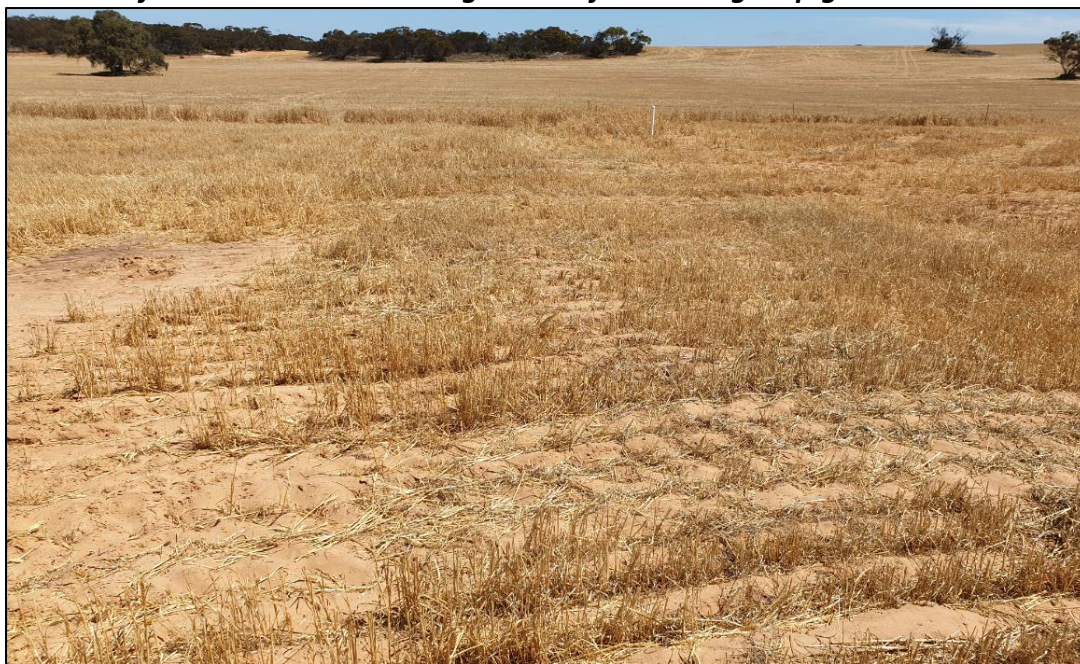
It was not the intention to try and obtain accurate yield results from each treatment strip, as there were too many variables associated with the size and shape of the scald areas in each plot. However, it was clear that each plot of rehabilitated soil did achieve the desired aim of greatly improving crop establishment and growth on areas that would have otherwise been bare scalds, as evidenced in photos 7 & 8.

Photo 7. After harvest shot showing stubble from strong crop growth on raised Sand strip.

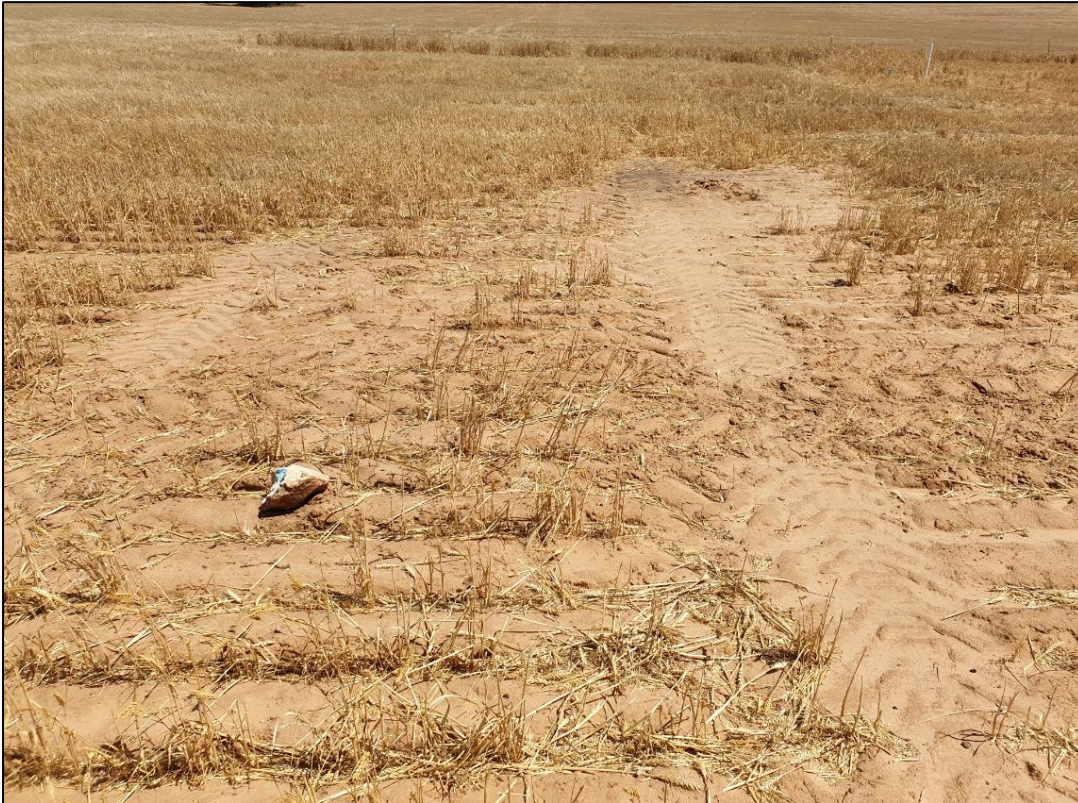
Photo 8. After harvest shot showing poor crop growth from scalded Control area

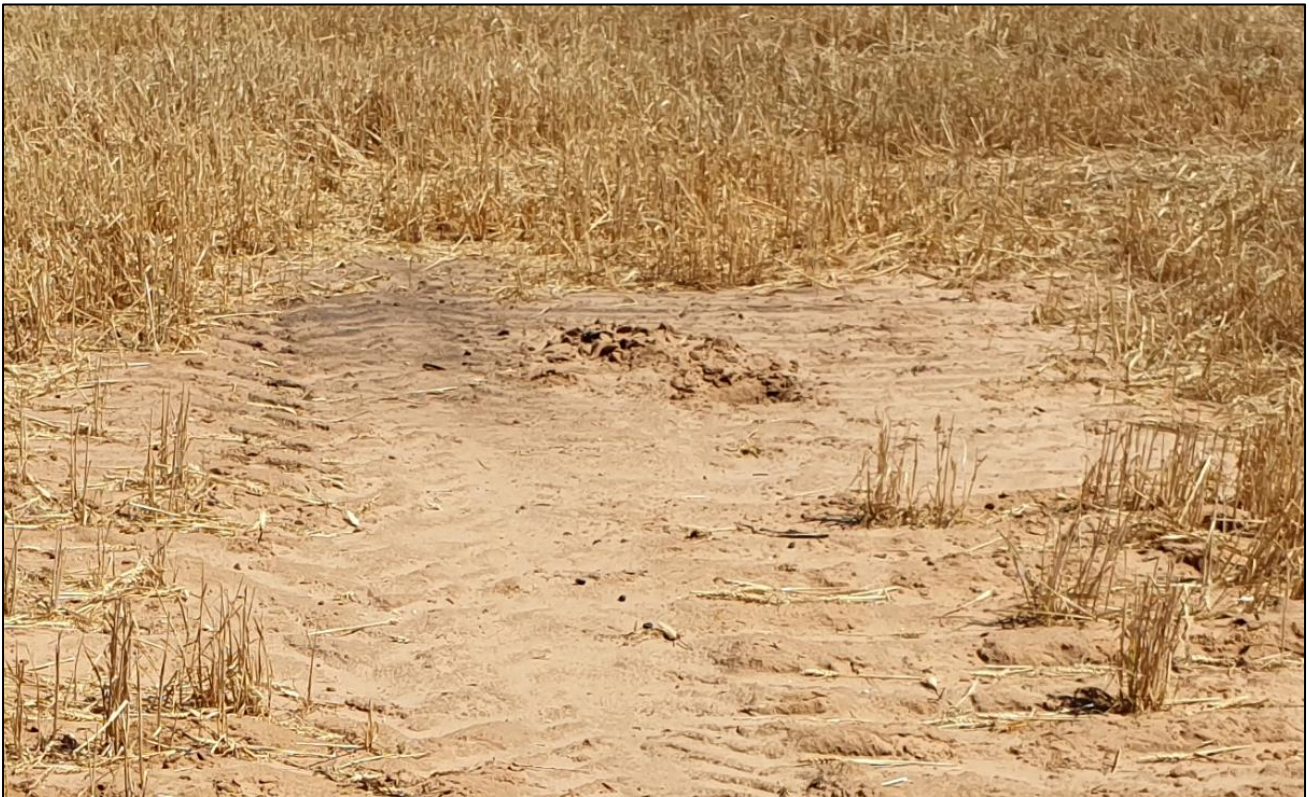
6. Crust and Topsoil salinity levels greatly increased in the bare Control 1 treatment area, with only slight variations occurring at all other sample sites. Some crust samples had become quite black and hard.

Photo 9. Blackened crusty areas forming in bare scald areas

This area was sown to summer crop after summer, as is the farmers practice on all developing seep areas, in an effort to maintain soil cover and prevent surface salt accumulation.

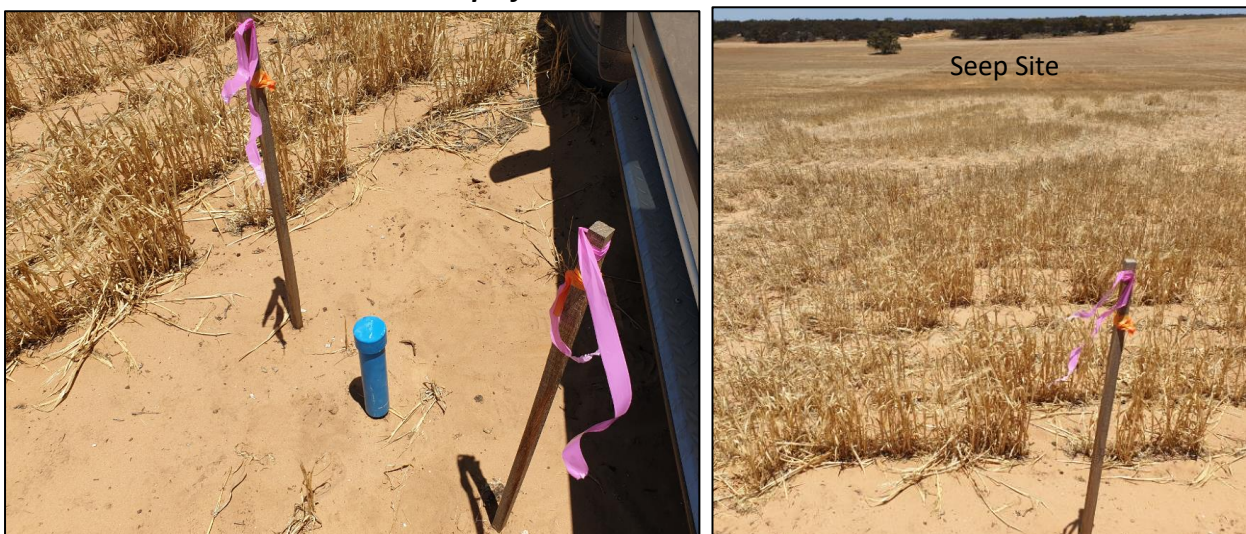
The deep sandhill above the seep scald was sown to barley in 2019 and grew relatively well, despite the late break and poor season. A soil moisture probe was established on top of this hill to measure the soil's ability to retain rainfall for crop use or to contribute to recharge after rain events. The seed passed around this probe meaning there was little crop growing in its immediate vicinity (Photo 10).

Figure 6 shows a slight rise in soil moisture at all levels due to the lack of crop growth at the probe site. There were major rainfall events recorded that would lead to a clear spike in the 100cm moisture sensor that would be indicative of water passing through the rootzone. Next season crop plants will be transplanted next to the probe.

Photo 10. Soil Moisture Probe on top of Sandhill
