# Riparian Habitat Values Assessment of the Diamantina River Catchment; Lake Eyre Basin, South Australia

Henry Mancini  
June 2017

Report to the South Australian Arid Lands  
Natural Resources Management Board

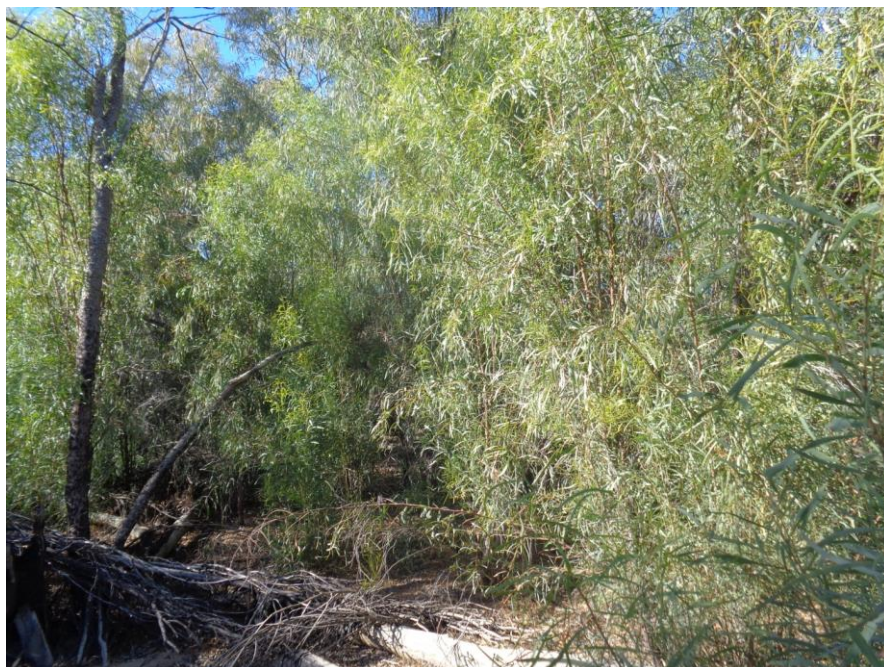
A site that offered a 'best on offer' 'reference' type condition was at Diamantina-split (D-split). This site has had minimal recent cattle grazing, in contrast to the adjoining paddock, and with low rabbit activity demonstrates obvious signs of recovery. The recovery is probably over a timeframe of 40-50 years with previous tree removal for fence posts a significant disturbance. Plant species richness was not high, however, the site was stable and provided a good example of structural vegetation integrity with high percentage leaf litter and woody debris; and high mid-stratum vegetation and tree canopy cover. Consequently, this rich habitat supported a rare bird with identification of a spotted bowerbird that was thought to be extinct in SA. The site was located on an inner meander bend with expected higher productivity due to higher deposition and deeper soil profiles found on these deposition zones and consequently a wider riparian corridor supporting greater lateral vegetation extent.

**Figure 4 High value riparian habitat showing good structural vegetation and high percentage woody debris and leaf litter cover at D-split waterhole, Diamantina River**

**It is recommended this site is nominated as a 'reference site', fenced from grazing, grazing strategies implemented and monitoring continued to provide valuable baseline data on plant, bird, and terrestrial species presence and absence and use this site as a benchmark for riparian habitat recovery projects.**

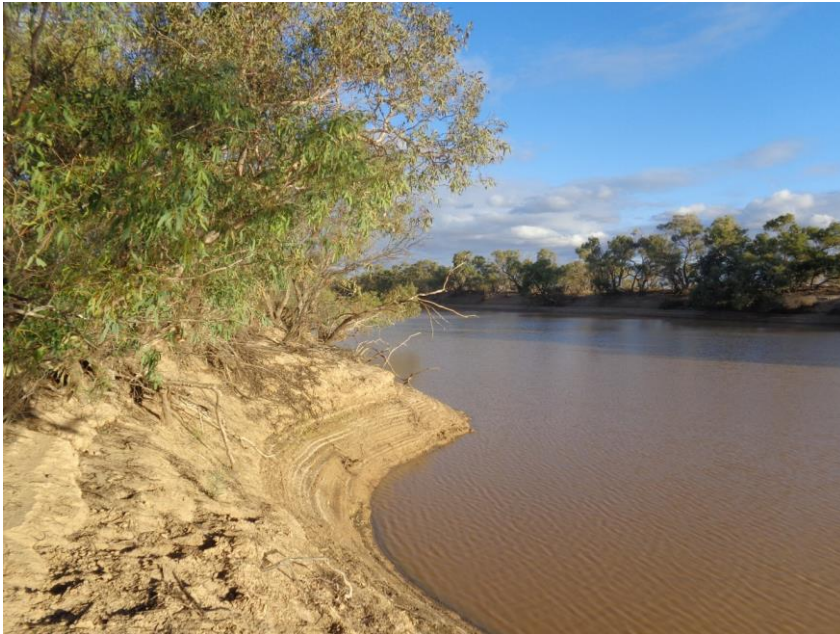
**Figure 5 Riparian vegetation and streambank shear zone exposing banks to natural flow events**

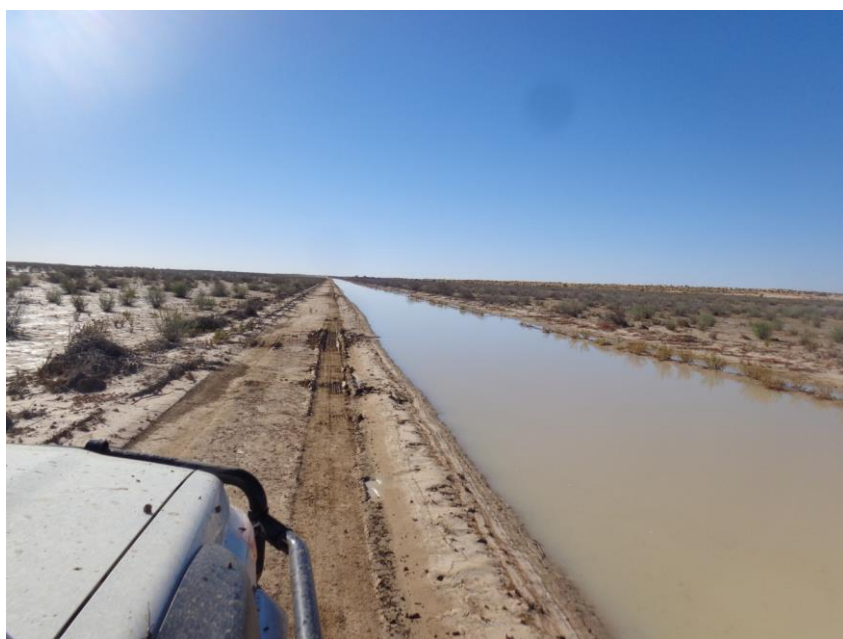
**Figure 6 Inside Track – a surface water flow diversion forming a depression channel dewatering the surrounding landscape**

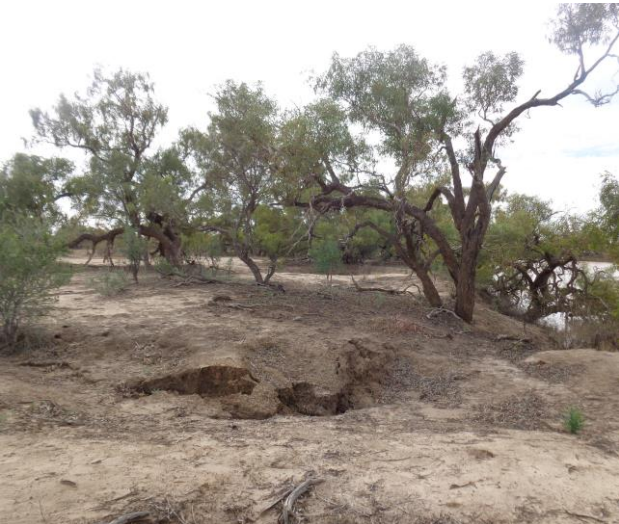
**Reduced riparian shrub layer and groundcover**

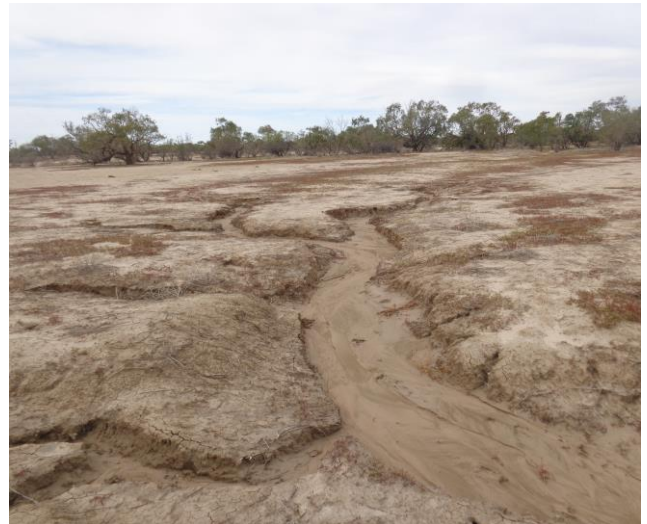
**Scalding on clay flats adjacent to waterhole**

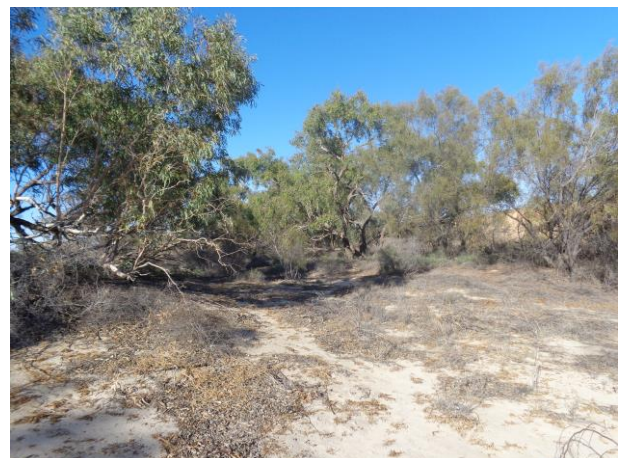
**Sparse riparian vegetation - low species richness**

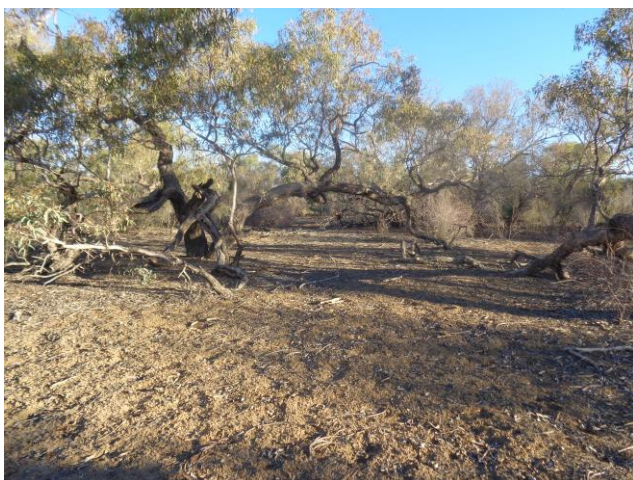
**Grazed area on other side of fenced 'reference' area**

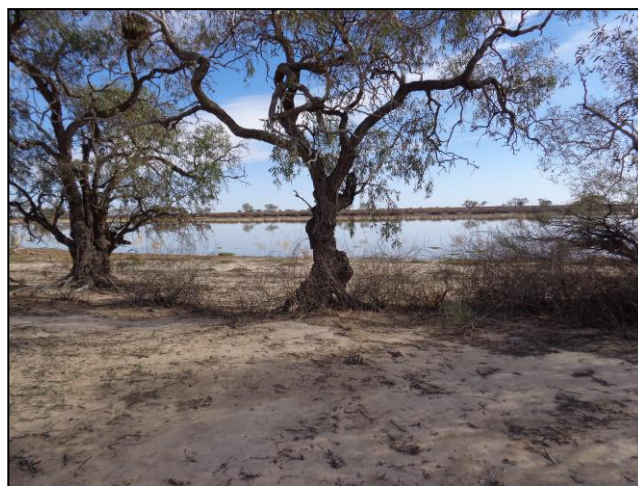
**Low gradient waterhole receives runoff from nearby gibber** **Reduced groundcover and shrublayer along riparian edge**

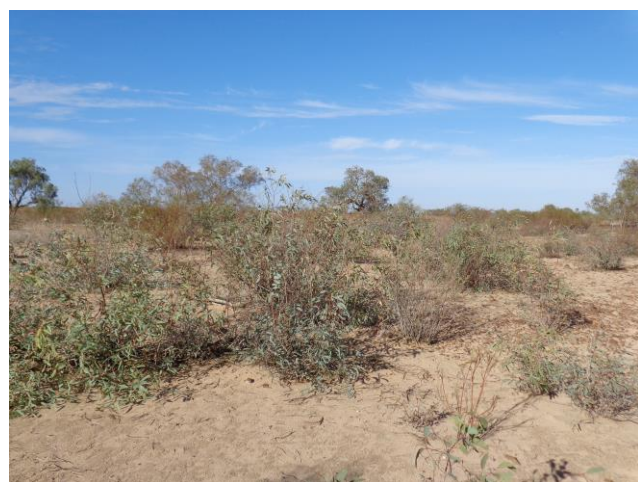
**Stunted grazed mature coolibah on the outer riparian zone**

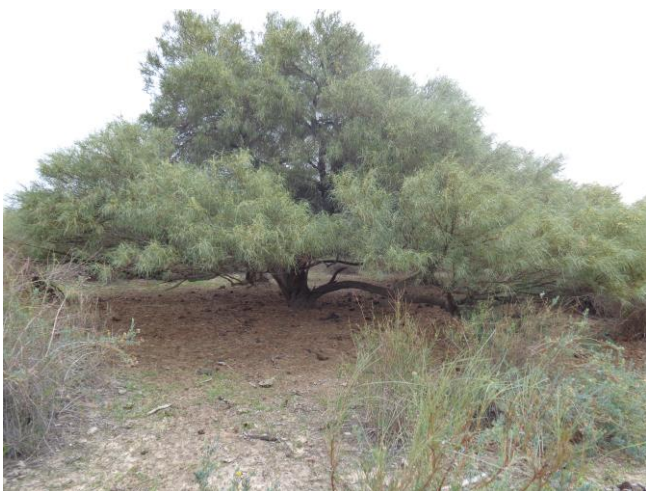
**Browse line on large Broughton willow**

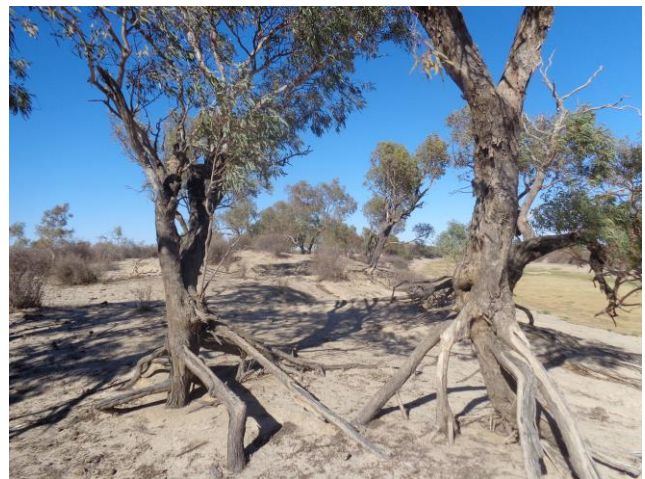
**Exposed coolibah tree roots on riparian edge**

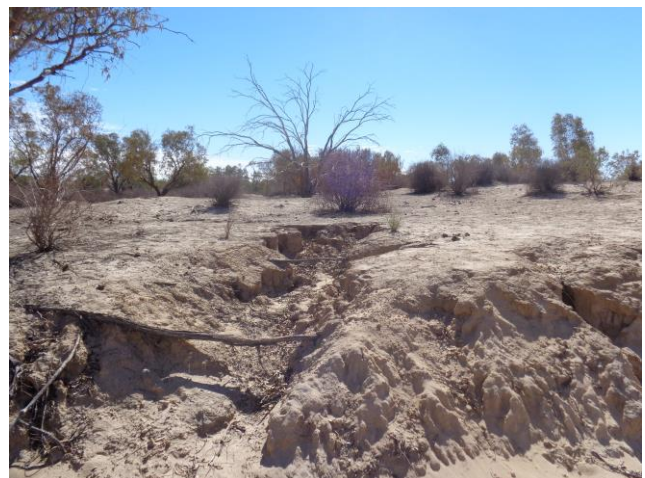
**Erosion areas on floodplain adjacent waterhole**

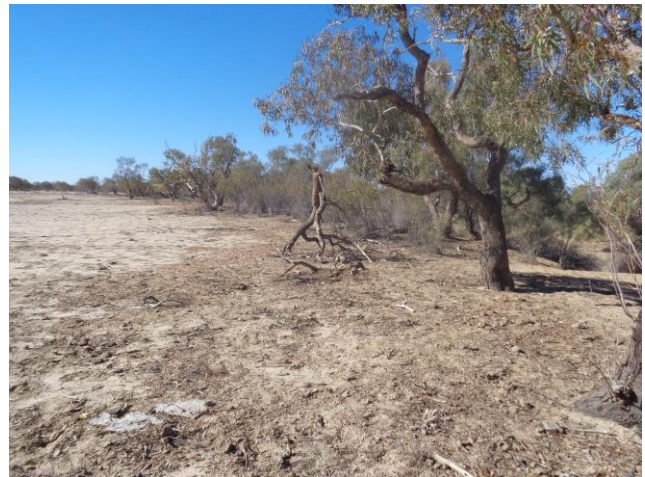
**Heavy grazing pressure along riparian edge**

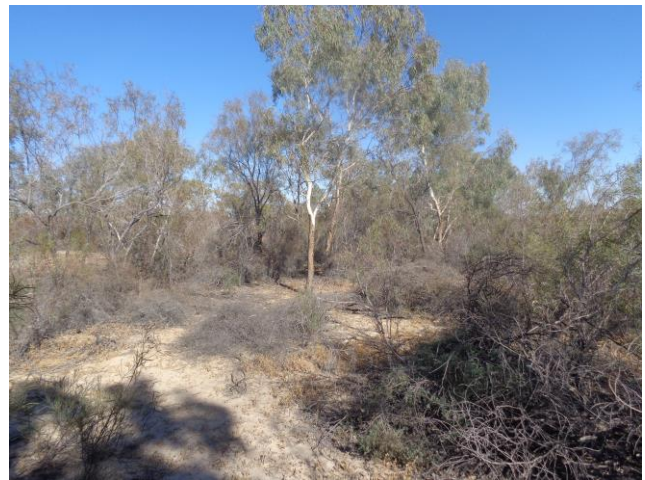
**Riparian zone - moderate grazing impacts – conditions dry**

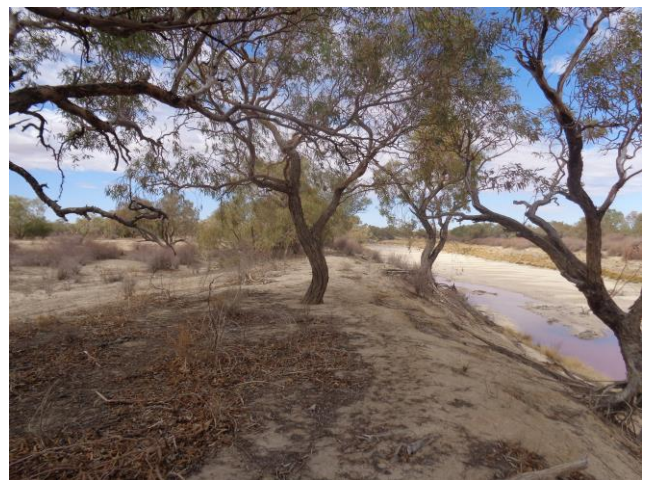
**Groundcover and shrub layer reduced along riparian zone**

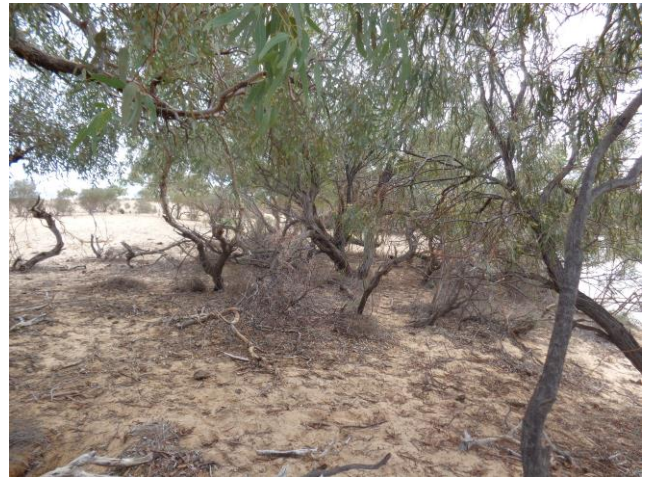
**Heavy grazing pressure due to permanent water**

**It is recommended the bore drain at Tepamimi is decommissioned preventing flow into the waterhole and water use is restricted and maintained as a water-tight delivery system.**

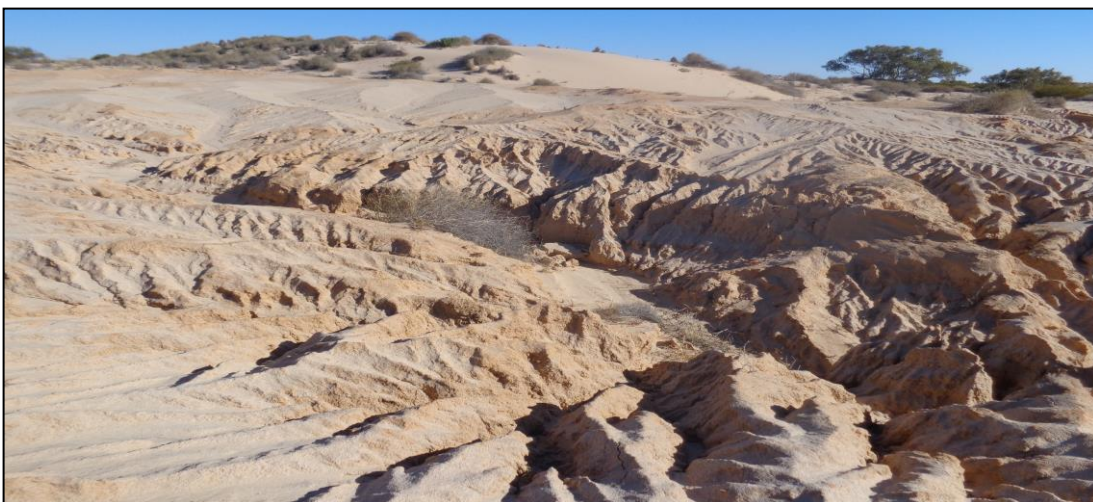
**Example of severe scalding and erosion – a legacy of vegetation removal**

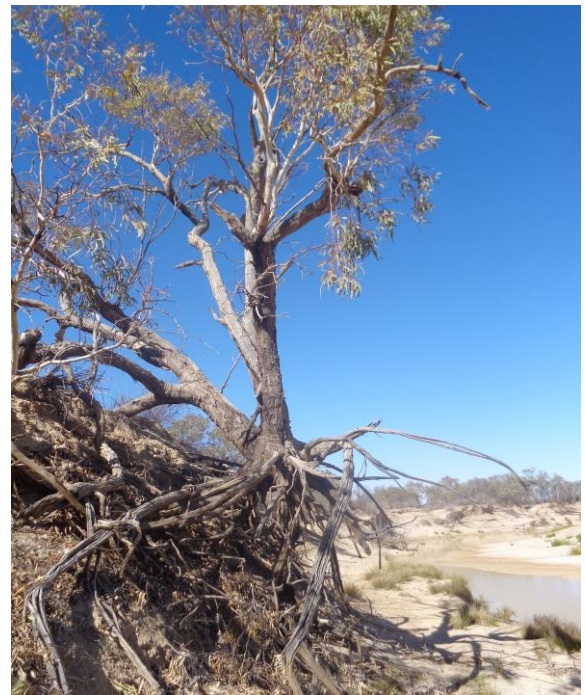
**Exposed roots of mature Coolibah**

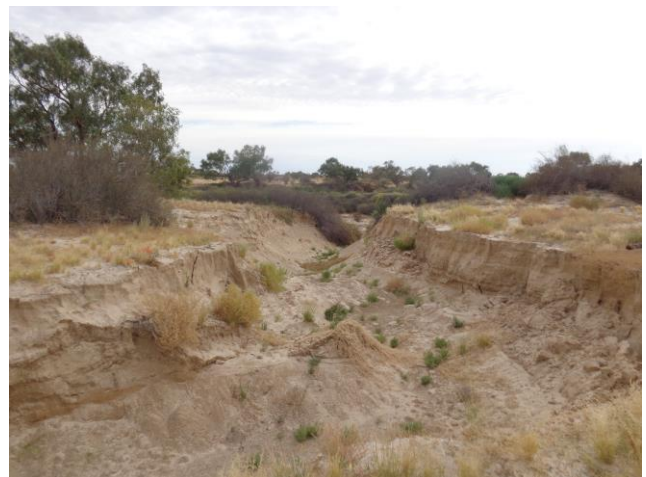
**Increased erosion gullying 2016**

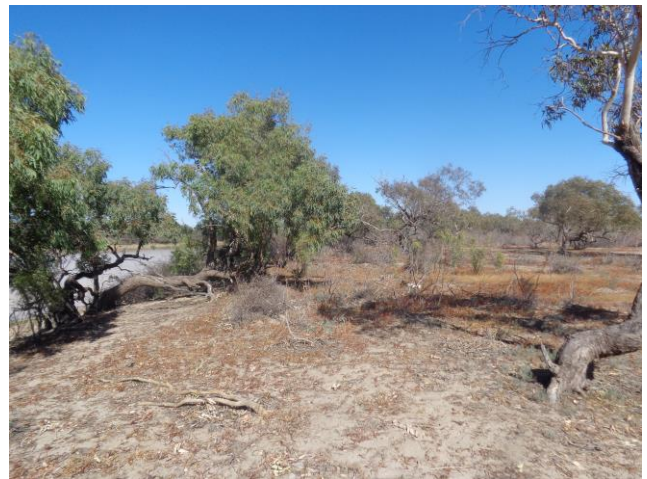
**Riparian vegetation reduced**
