EARLY ROOFING AND ROOF MATERIALS IN SOUTH AUSTRALIA

June 1999

Prepared by Heritage South Australia
Text and photographs Mark Butcher Architects
Design by Lofty Designs

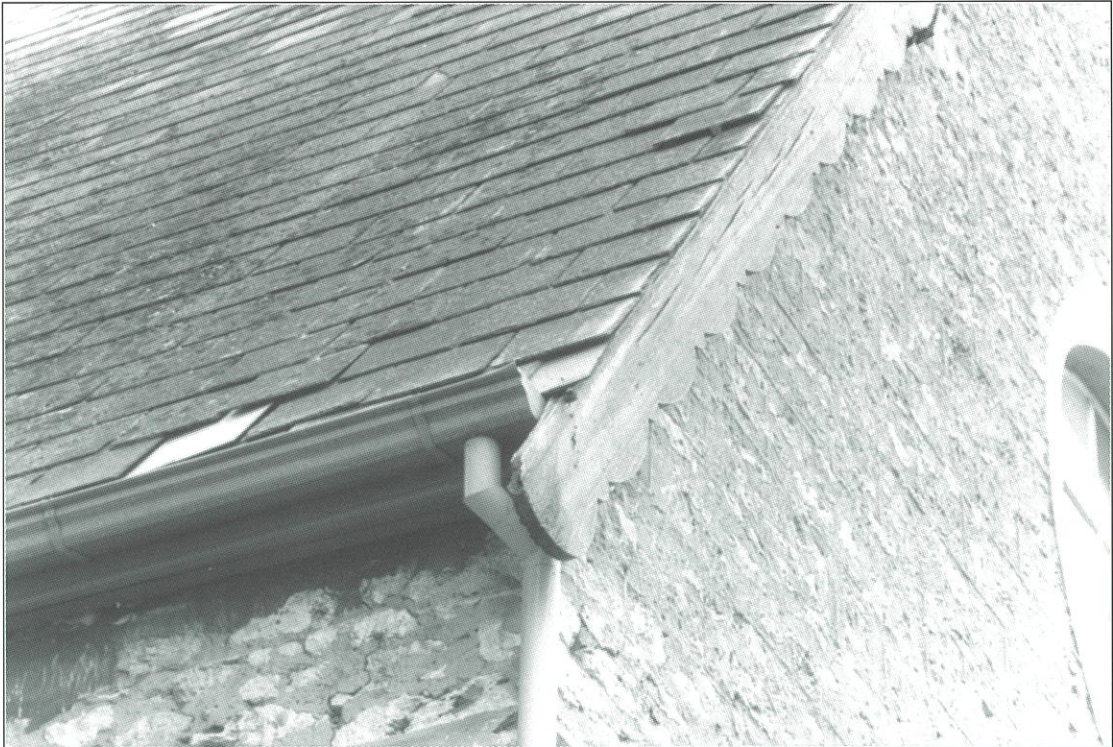
*Detail of a slate roof gable end
Note verge detail and loose slates*

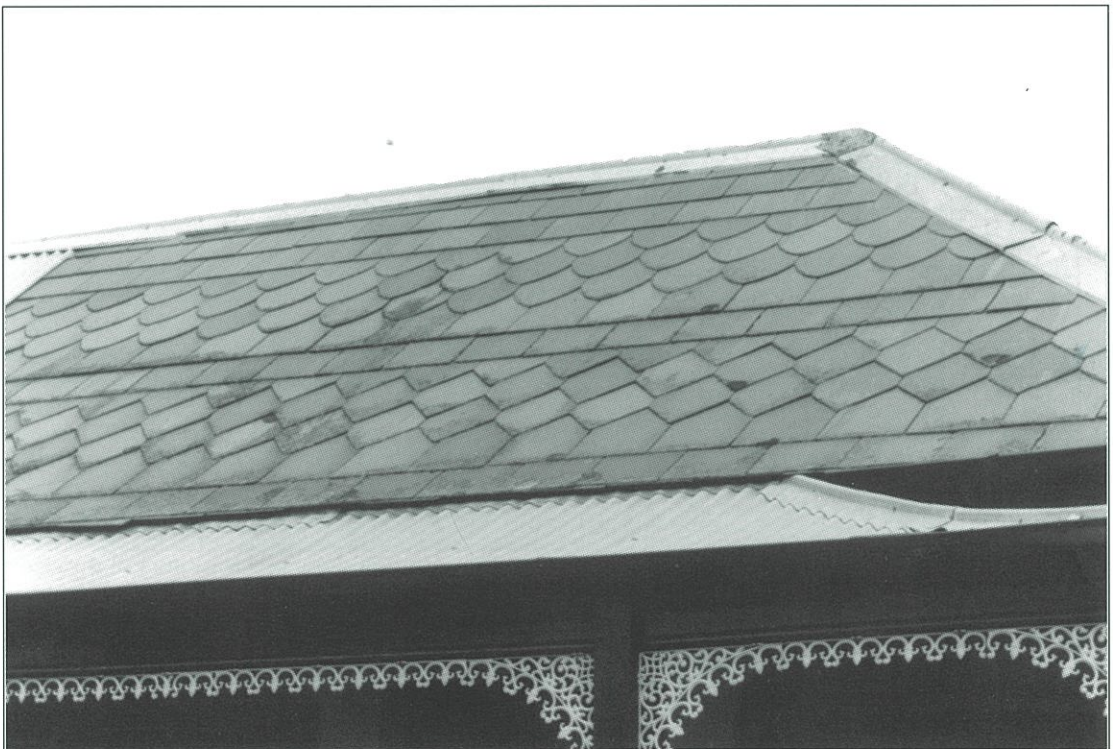
*Detail of patterning of roofing slate
Note use of three different slates*

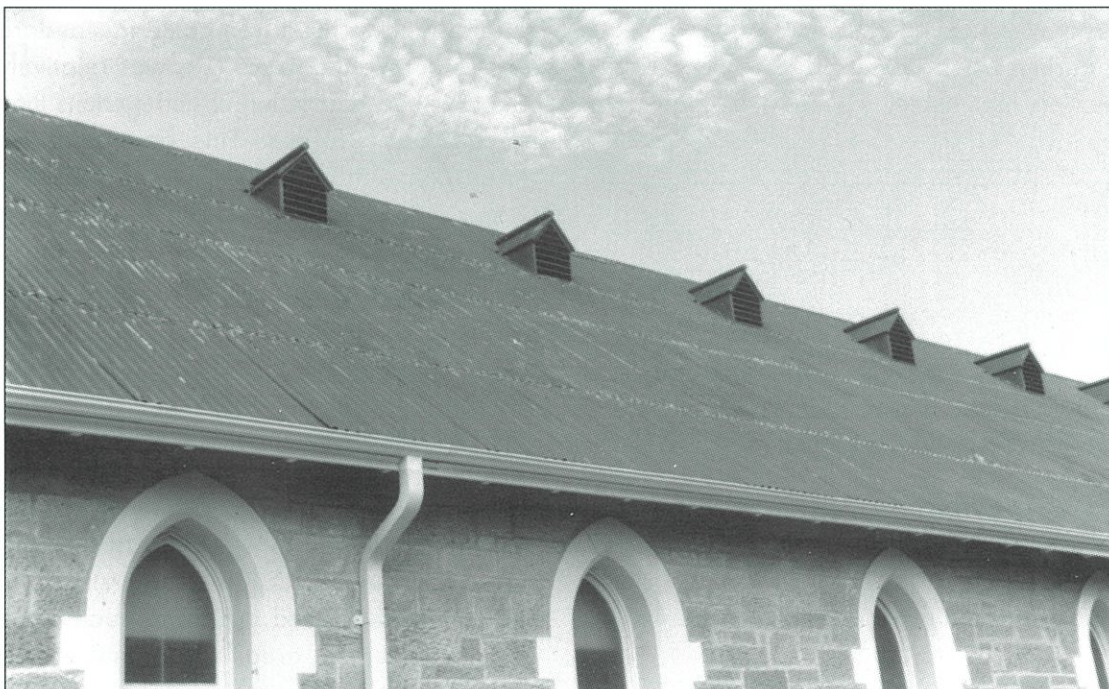
Church hall roofed with original 6'0" long sheets of corrugated iron. Note the pattern or texture the small sheets make.

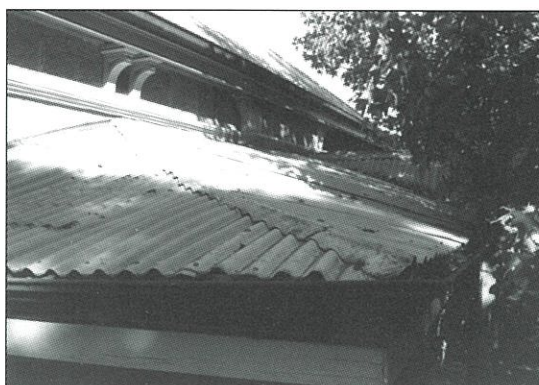
Lead hip capping on a verandah

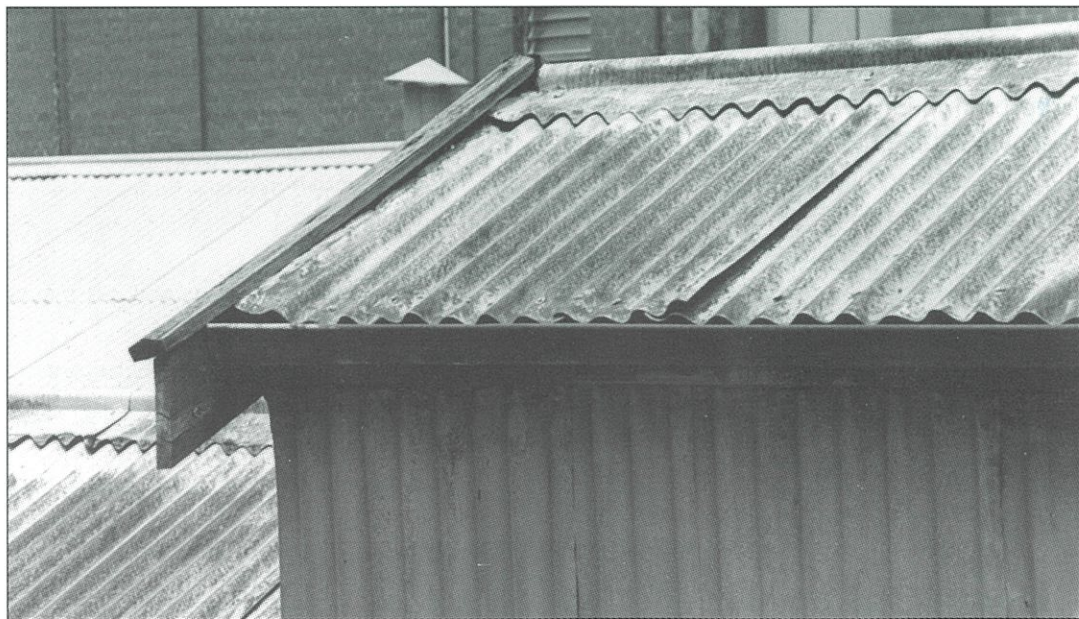
Timber barge capping detail

Timber barge capping. Note weathered profile. Also note scribing of galvanised iron capping into flutes.

The first barge cappings for corrugated iron roofs were made from timber. These consisted of a weathered 'cricket bat' piece of timber, typically 140 x 45mm, fixed to the top of the barge board and supported on the outside by a timber scotia. The corrugated roofing slipped in under this on the roof side and was thus effectively 'flushed'. These were used for many years, well into the Twentieth Century. The problem with timber however was that it had a limited life and generally deteriorated within a few decades, depending upon the timber used and the degree of exposure.

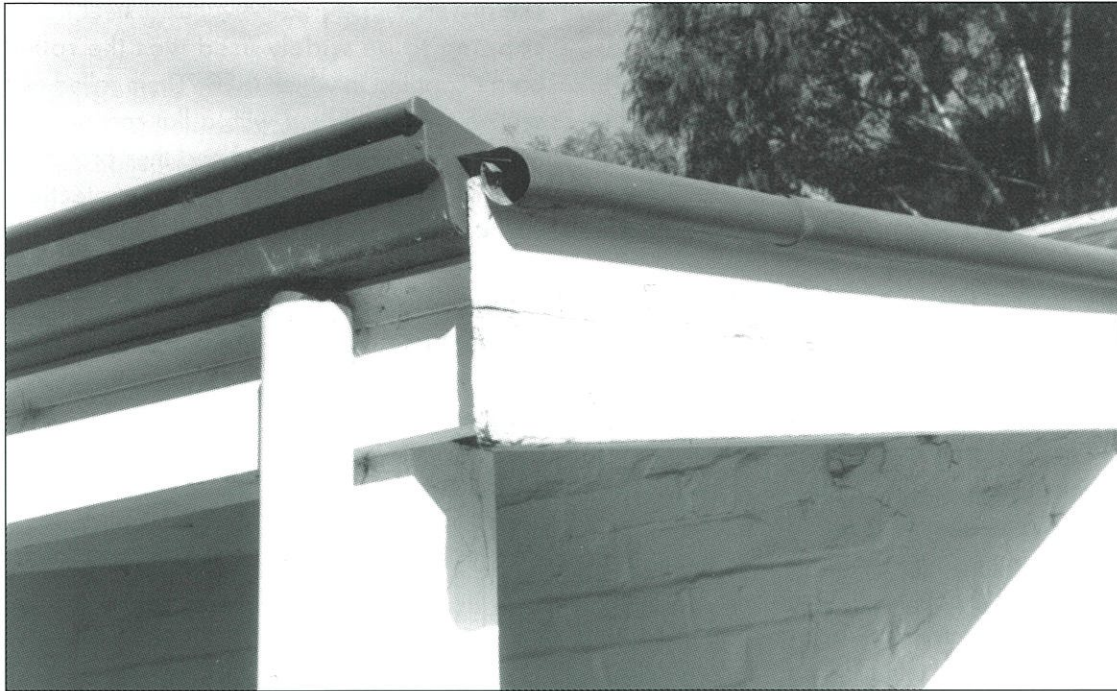
Rolled barge capping on lean-to

The first manufactured galvanised steel barge capping to be widely used was the rolled barge capping in which a 50-70mm rolled end section was combined with a flat section to fit neatly over a barge board and thus provide a considerable degree of weather protection. This came into wide spread use in the early Twentieth Century and quickly superseded timber barge cappings. It became the new industry standard and is still available.

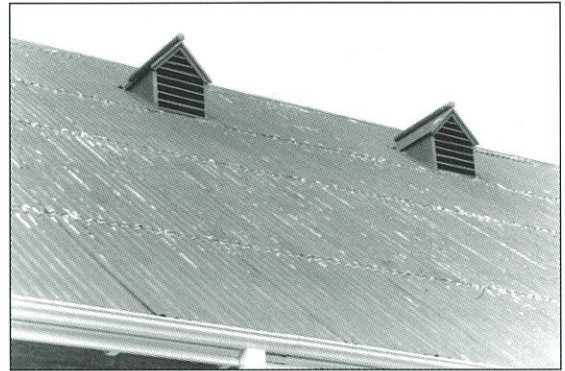
Roof vents in corrugated steel roofing. Note pattern created by roof cladding.

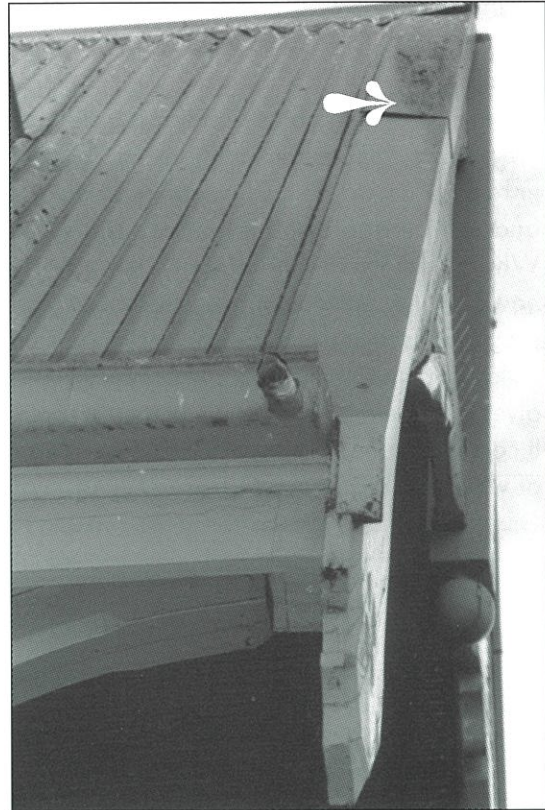
Historic gable design compromised by replacing original timber capping with new folded metal capping

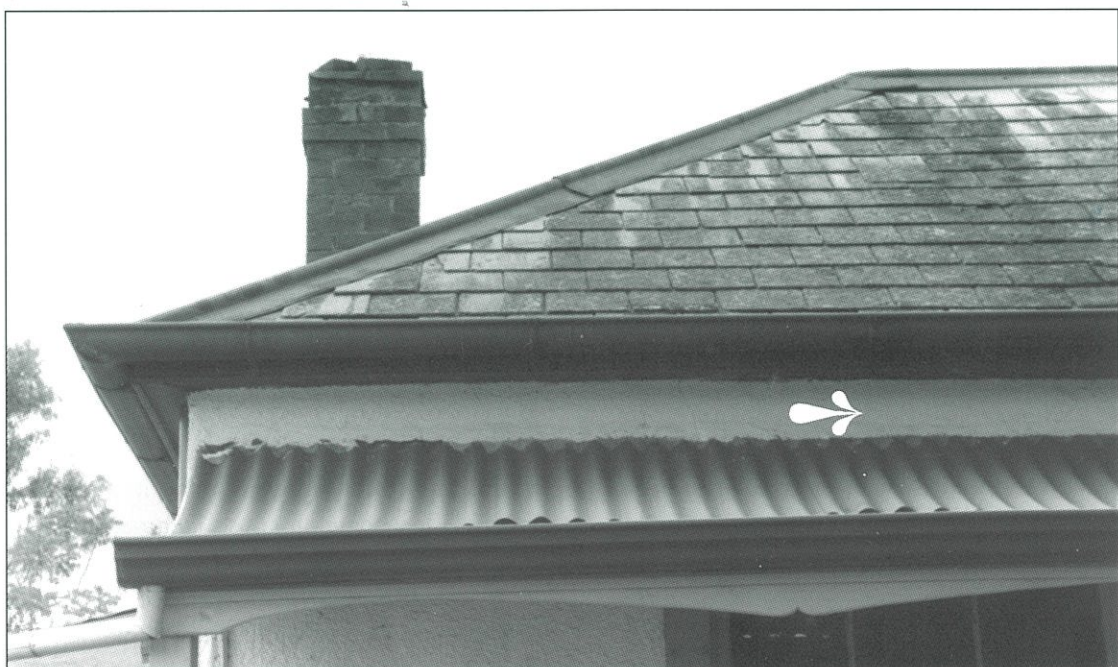
Verandah roof with rendered flashing

When re-cladding a verandah roof, do not use a standard modern metal flashing to seal the roof to the main building. These are too large and can significantly change the appearance of a building. If there is no traditional brick string course, try to locate a small minimum size zinc or lead flashing into a horizontal brick joint. If this is not possible, pin the vertical part of the flashing to the wall face and seal it to the wall using a band of render. Try to avoid cutting into the stonework. The hips of curved hipped verandahs should ideally be sealed with a rolled lead capping as they were traditionally, not with a modern folded galvanised steel capping.

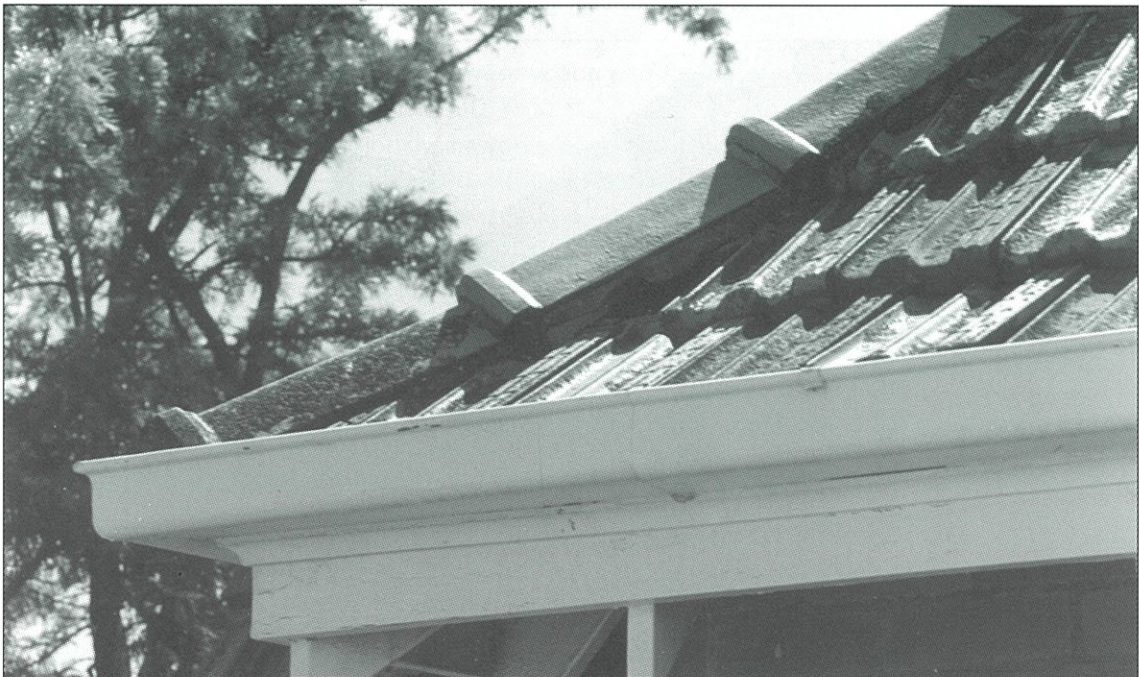
Original Ogee gutter replaced by D gutter
