# Native Vegetation Clearance Data Report

## Hart Lagoon Stormwater Retention Basin

Clearance under the *Native Vegetation Regulations 2017*

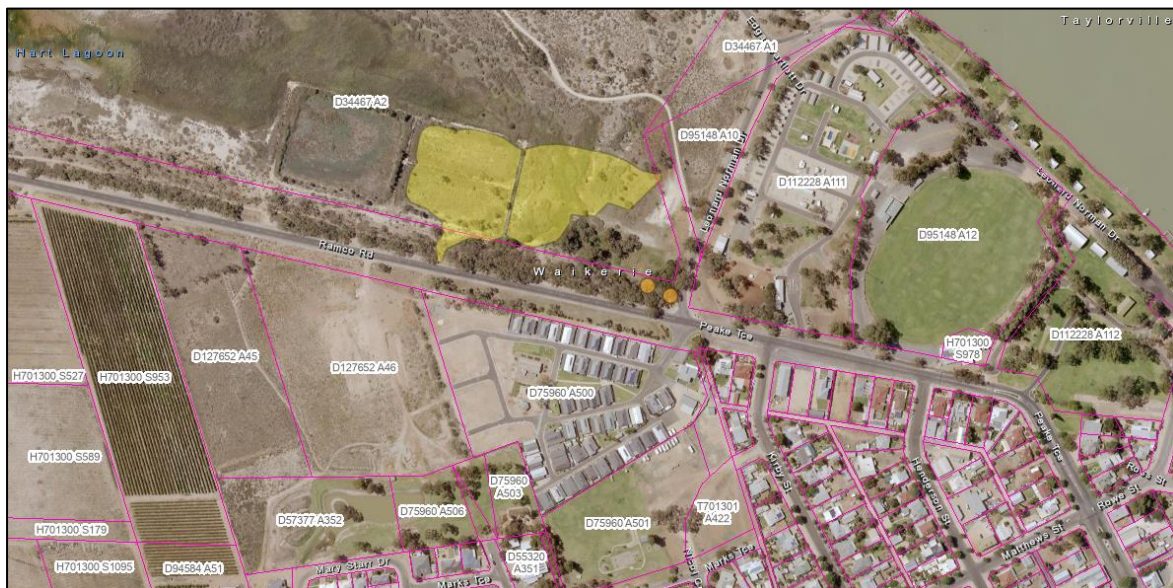
## Map of proposed clearance area

| Total proposed clearance - area (ha) and number of trees | 1.99 ha of native vegetation and 2 scattered trees are proposed to be cleared. |

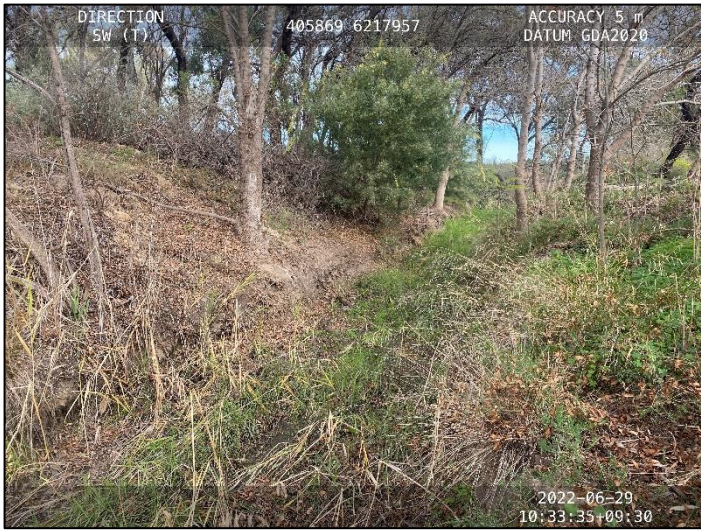
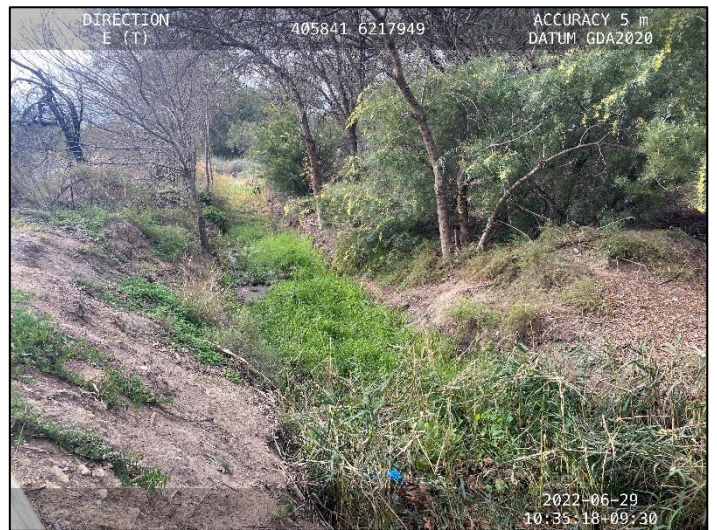
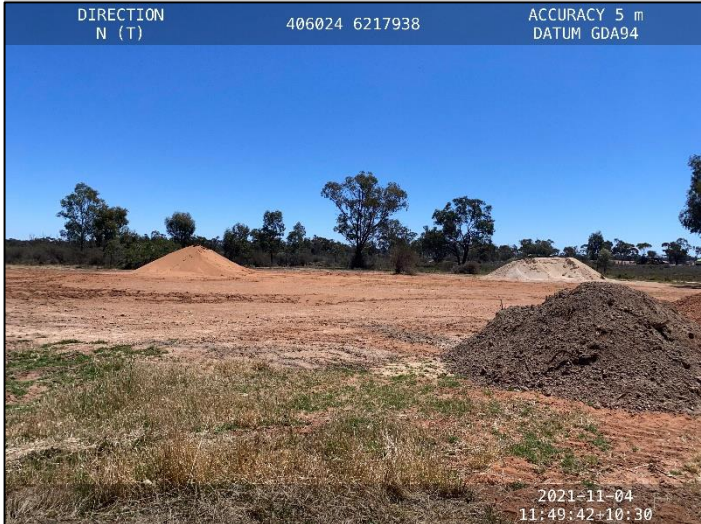
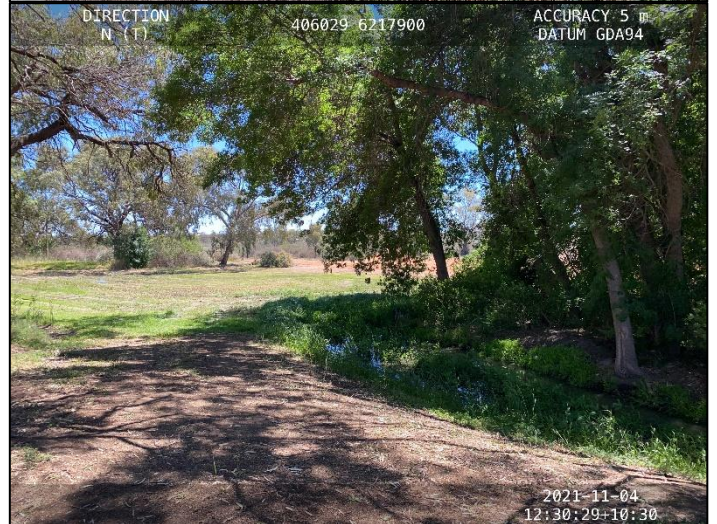
There are two main areas which do not have native vegetation (protected under the Act) present, which are indicated on Map 2. Please refer to photographs below.

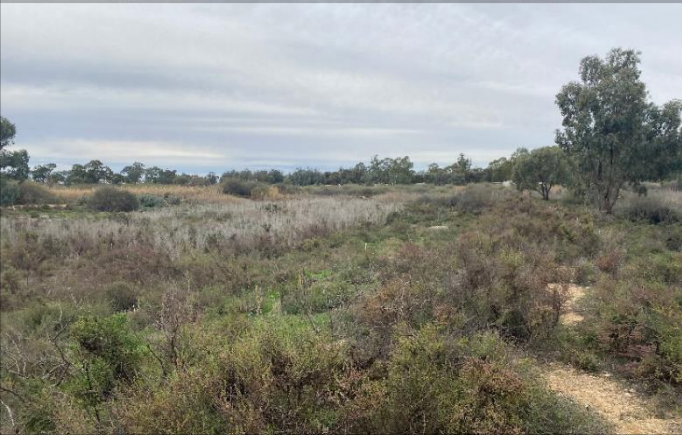
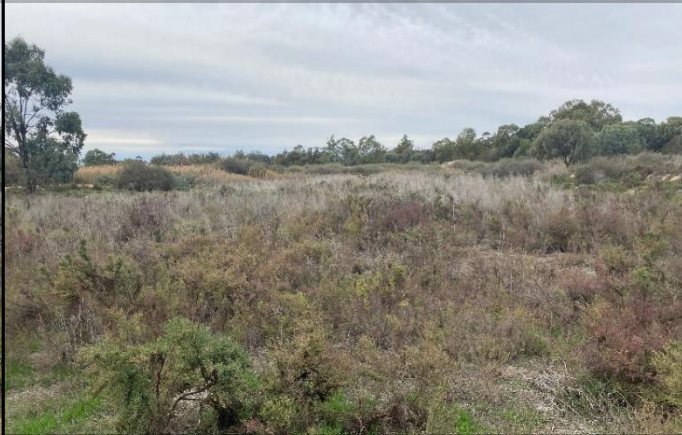
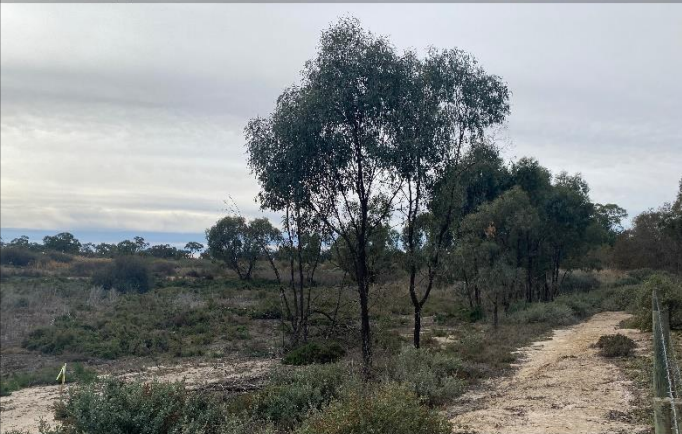
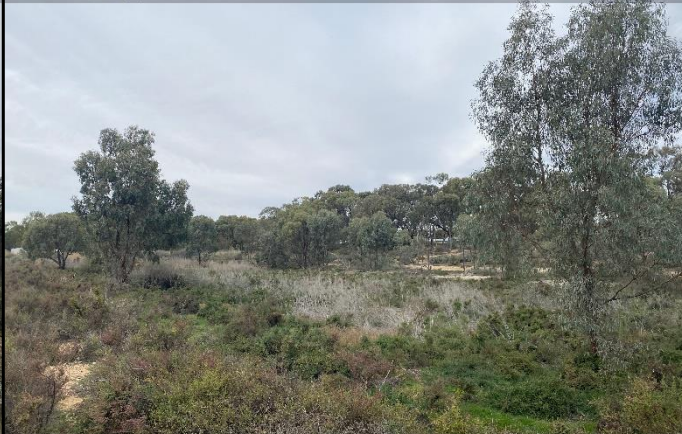
| General description | | The site is disturbed and dominated by colonizing plants. The site has been historically used as a sewage pond and the soil is in very poor condition. There are planted <i>Eucalyptus largiflorens</i> present on the site, as well as emergent <i>Eucalyptus largiflorens</i> trees. | | | |

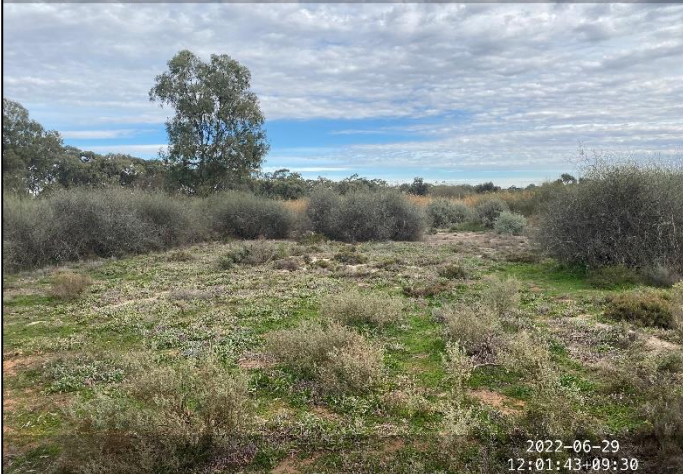
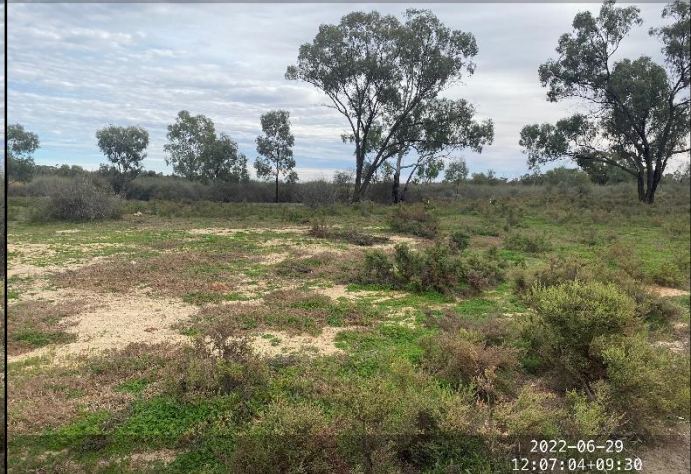
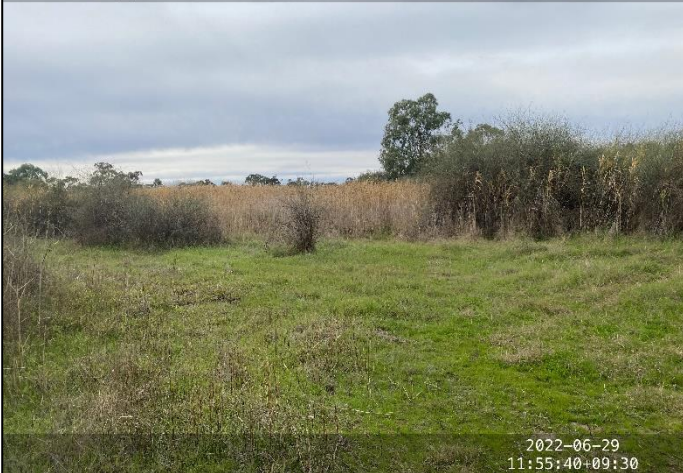
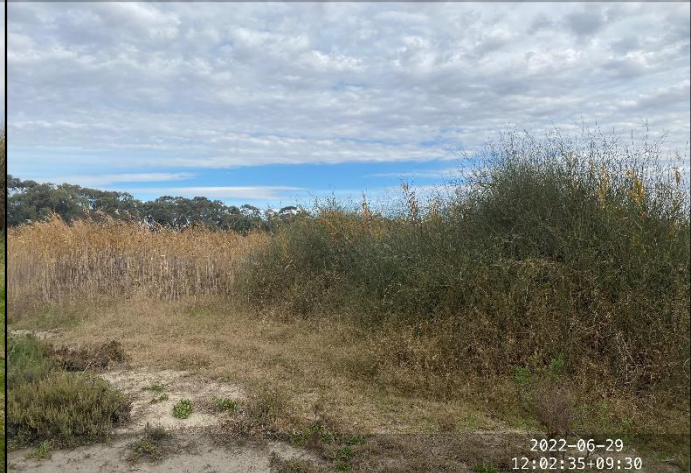
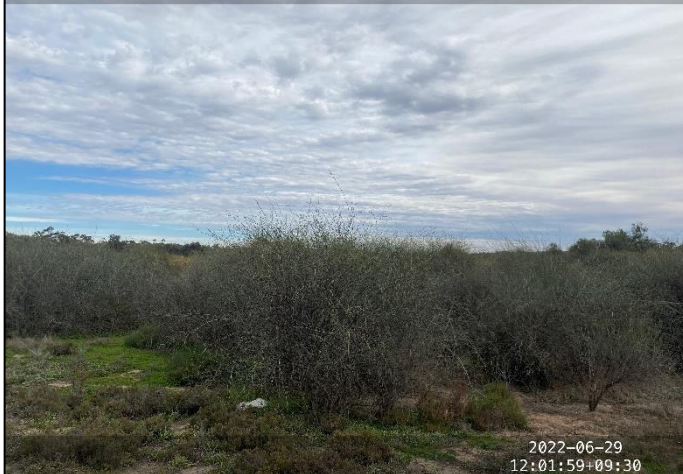
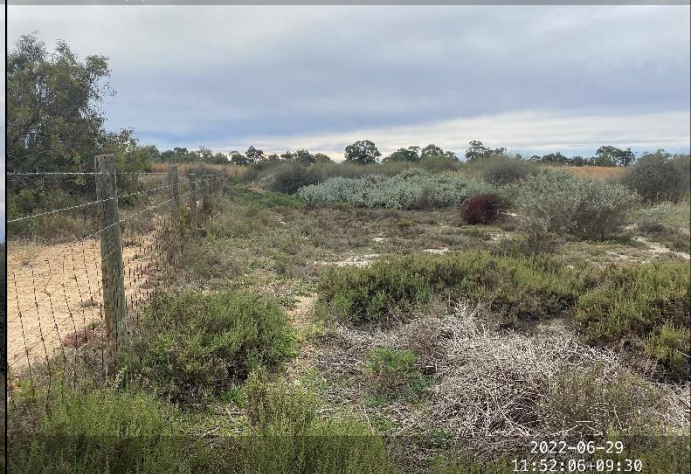
| General description | The vegetation is B1 is patchy across the site, dominated by <i>Duma florulenta</i> , with emergent <i>Eucalyptus camaldulensis</i> and <i>Eucalyptus largiflorens</i> . The understorey is degraded and interspersed with planted vegetation i.e., <i>Atriplex nummularia</i> . | | | | |

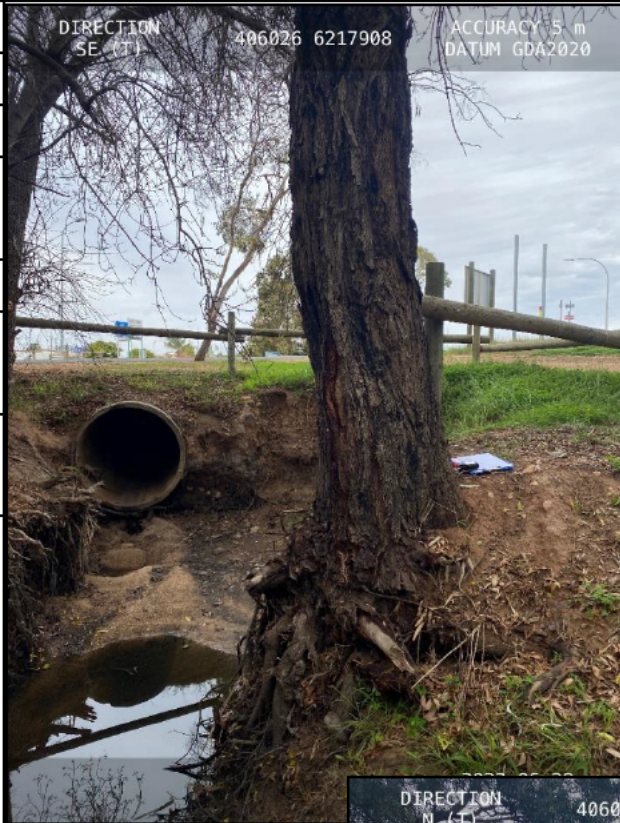
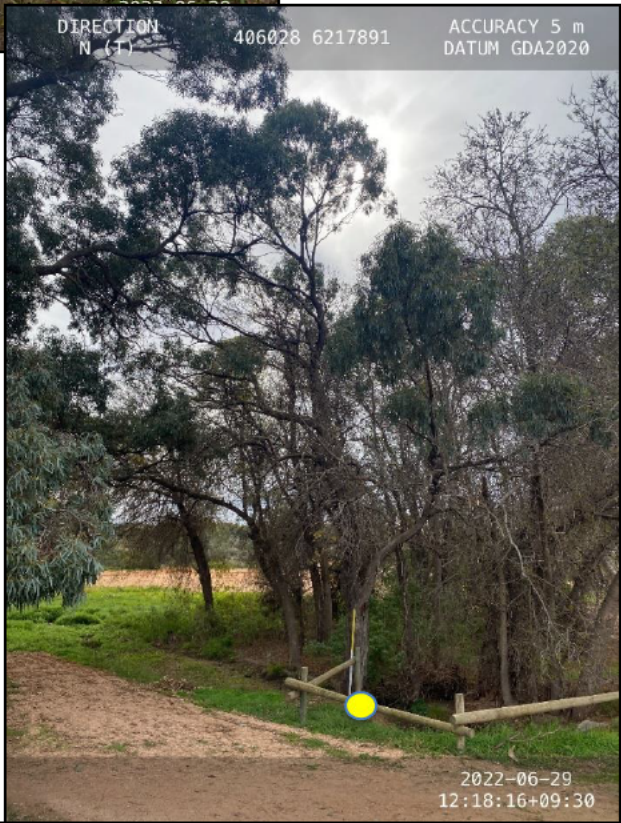
| Height (m) – 12.2 | | |
| Diameter (cm) – 55 | | |
| Canopy dieback (%) – 5 | | |
| Tree 1 and 2 are in good condition with valuable habitat for common species in the area. Limited habitat for threatened species known to inhabit the local area i.e., Regent Parrots. Refer to the threatened species assessment for further information. Tree 1 is occurring in a stormwater outfall which is dominated by Ash trees. | | |

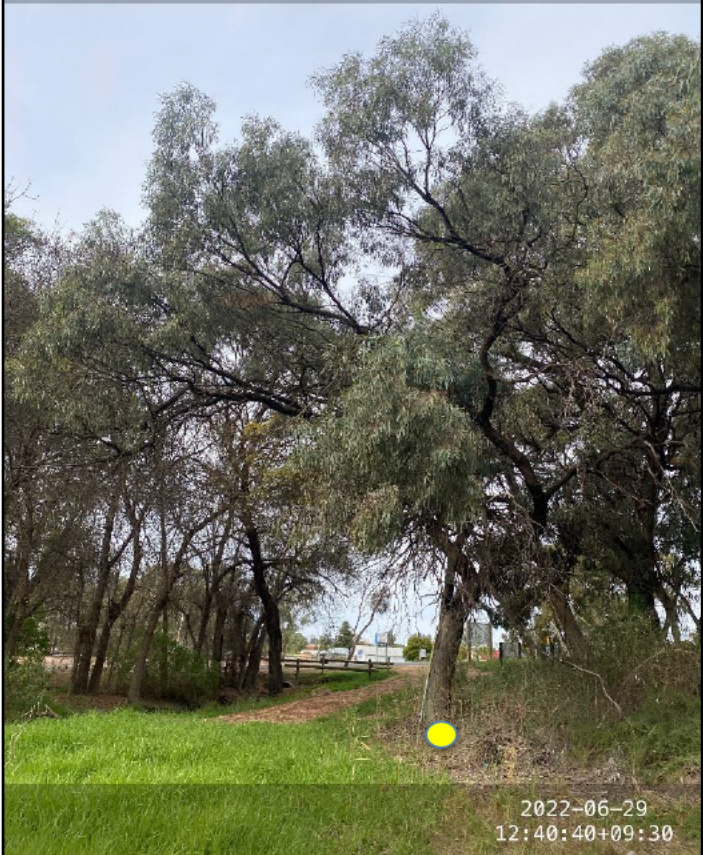
| Height (m) – 13.1 | |
| Diameter (cm) – 52 | |
| Canopy dieback (%) – 5 | |
| <p>Trees 1 and 2 are in good condition with valuable habitat for common species in the area. Limited habitat for threatened species known to inhabit the local area i.e., Regent Parrots. Refer to the threatened species assessment for further information.</p> | |

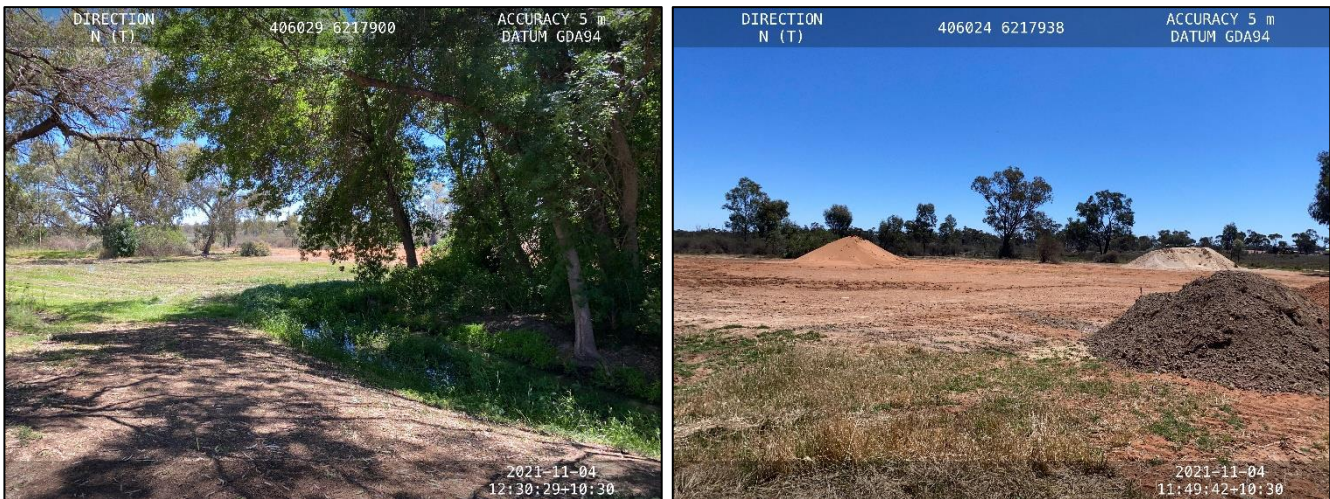
Figure 2: Reference photographs showing potential areas for the carpark location.

Proposed carpark location: During the field assessment, the proposed carpark site was inspected (Photo 1). Much of this site is native vegetation protected under the Native Vegetation Act 1991. There is planted vegetation present – consisting of scattered plants and close to the existing track. To avoid and minimize native vegetation clearance, an alternative location could be considered with appropriate engineering considerations (refer photos below):

- Utilise the area immediately to the South which has been previously cleared and is likely to be a set down area for the construction of the project. Some minor clearance of exotic vegetation could be undertaken to increase the area available.
- Utilise parking areas on the adjoining roadside area on Leonard Norman Drive, which is devoid of native vegetation.

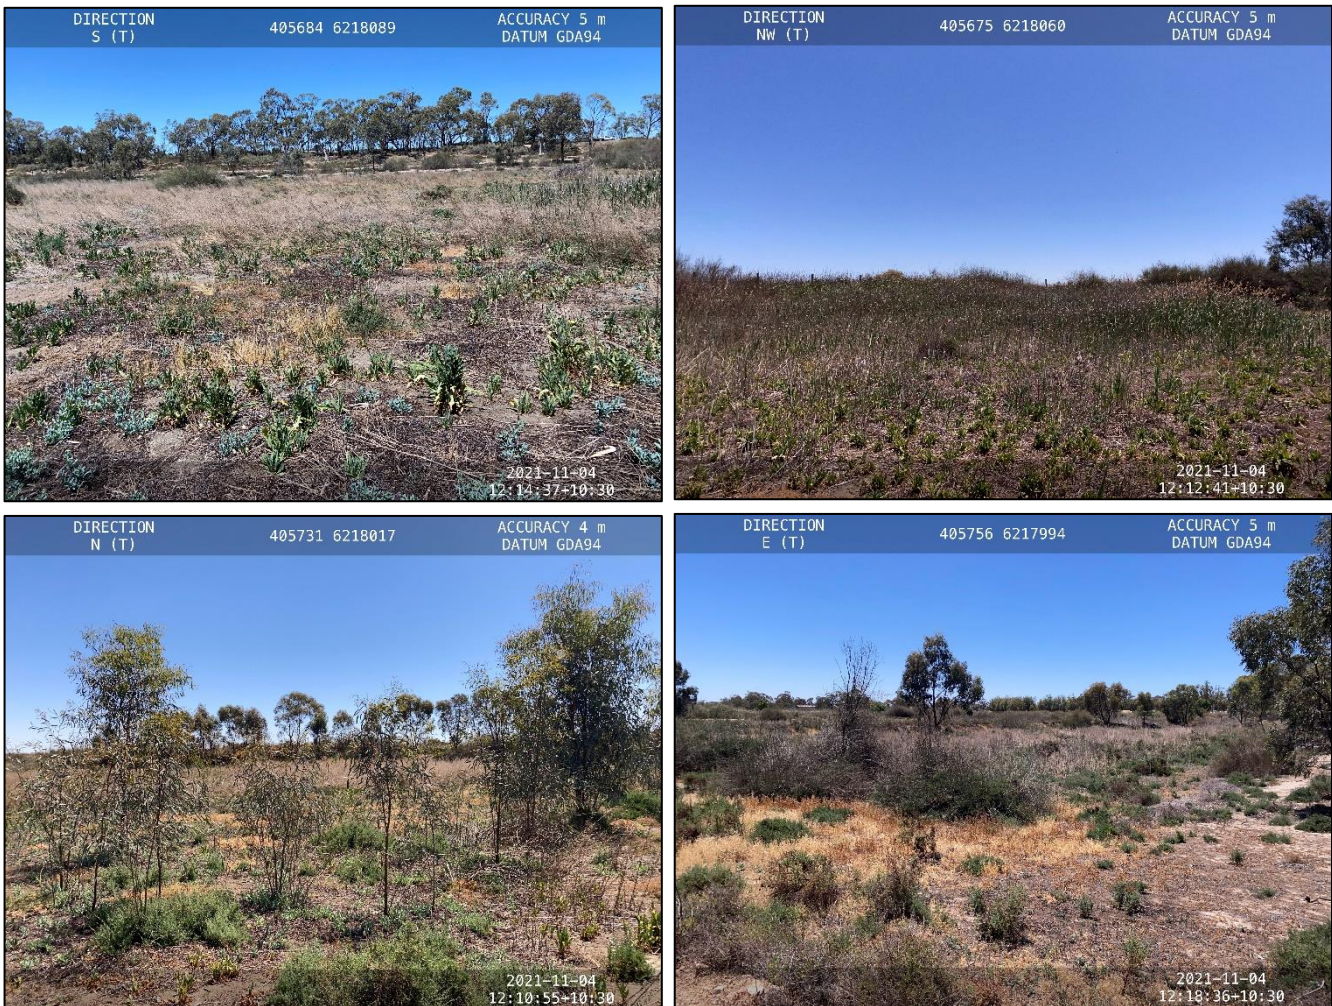
Figure: Photographs showing effluent ponds.

Placement of 'Fill': An option being considered by council, is to place the fill in the areas that were previously utilized as effluent ponds. Native vegetation has since regenerated in these areas. Some areas are devoid of native vegetation and subsequently dominated by weeds in patches. (Particularly referring to the western pond). The vegetation in the effluent ponds is in poor condition with much growth of introduced plants, but with significant regeneration on the edges and in patches throughout, including *Eucalyptus largiflorens* and chenopod understorey.

It is possible that soil movement (from the other vegetated areas) into these areas may lead to an overall improvement of the site and could be rehabilitated as such. Native vegetation impacted by the fill and would be subsequently impacted would need to be included in the native vegetation clearance proposal. However, advice should be sought from the EPA about appropriate rehabilitation of this area, following its use as an effluent refuse area.
