Ecological Monitoring of Lake Hawdon North and South Spring 2025

Nature
GlenelgTrust

Report to the South Australian Government Department for Environment and Water

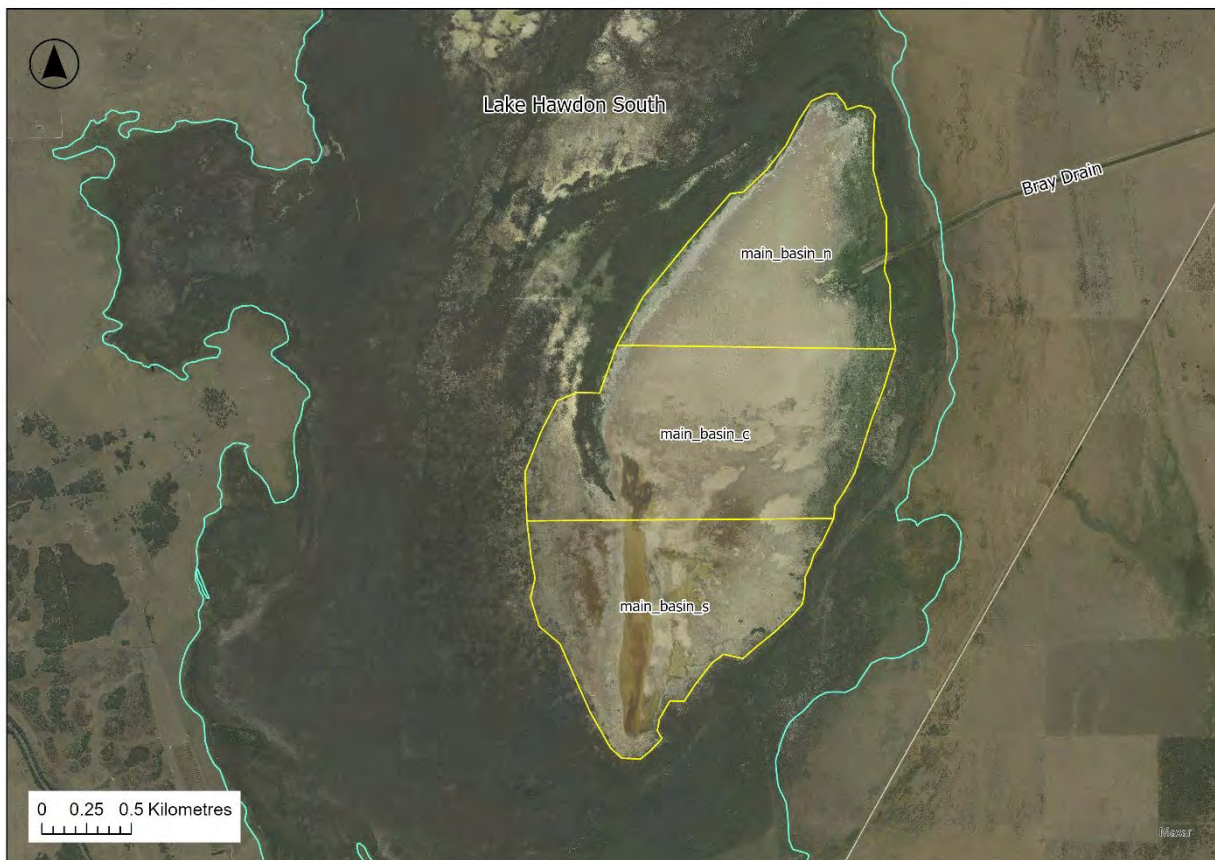
Figure 2. Lake Hawdon South survey area (yellow polygons).

The survey area for LHS covers 440 ha and is the area of open water/mudflat that initially receives inflows from the Bray Drain (Figure 2). The survey area was divided into three sub-areas, north, central and south, with teams counting different sub-areas. Sub-area boundaries were identifiable to surveyors on the ground using the AvenzaMaps® application on mobile phones. All other aspects of the methodology were as per Lake Hawdon North.

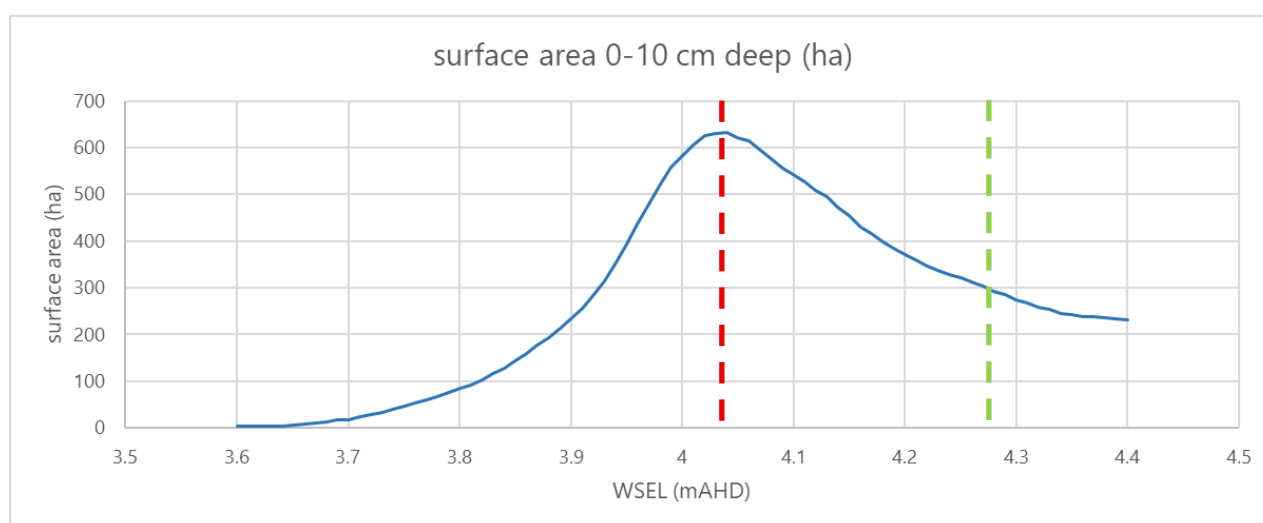
The monitoring results were affected by two factors that likely contributed to lower abundances of HCHB target species than would be anticipated under optimal conditions. Firstly, habitat modification works in LHN (i.e. clearance of *Melaleuca halmaturorum* shrubland from the lakebed) were approximately 58% complete at the time of the census, with approximately 343 ha of approved mechanical clearance yet to be undertaken. Therefore, the extent of open pan, the target shorebird habitat within LHN, was considerably less at the time of the census than it will be when habitat modification works are completed. Secondly, water levels in LHN were considerably higher than anticipated. Modelling undertaken by DEW (2021) predicted a WSEL of around 4.0 mAHD in LHN by mid-November under average conditions post-restoration. During the census on 10-11 November 2025, LHN had a WSEL of 4.25 – 4.31 mAHD. Maximum foraging habitat availability for HCHB target species is understood to be provided at a WSEL of 4.03 mAHD (Figure 10). When the census was undertaken, foraging habitat availability for HCHB target species was approximately 50% of its maximum, with much of the lakebed too deeply inundated for shorebird foraging. These factors likely contributed to counts of HCHB target shorebirds, and wading species broadly, that were generally lower than baseline (pre-restoration) counts. However, the effectiveness of the regulator at retaining water in the lake provides a positive indication of what can be anticipated in LHN once habitat modification is complete, as discussed below.

informs management, such as the volume-depth relationship and the extent of HCHB target species habitat across the range of WSELs. It is recommended that a more accurate DEM be obtained for Lake Hawdon, covering both LHN and LHS (for which the existing DEM also has identified inaccuracies (Taylor et al. 2014)).

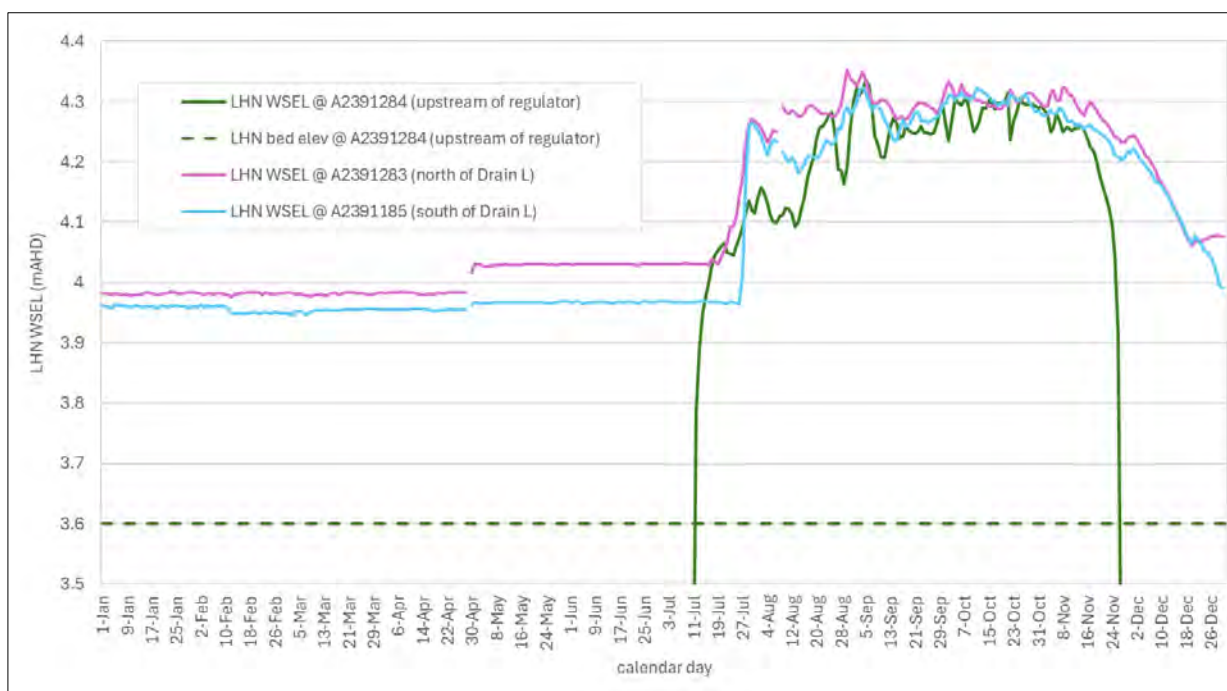
Figure 13. WSEL in LHN (mAHD) in 2025 at each of the three monitoring stations within the lake.

In 2025 the newly completed Lake Hawdon North regulator performed better than anticipated, with a WSEL in LHN in mid-November that was 25 – 30 cm higher than predicted by modelling (DEW 2021). This suggests that either the modelling was overly conservative, that conditions were wetter than average or a combination of both contributed to the outcome.

In summary, the rainfall, flow rate and water level data do not indicate above average water availability in the Drain L catchment in 2025. Therefore, the better than anticipated water retention in LHN in spring 2025 is likely to be indicative of the restored hydrology henceforth.

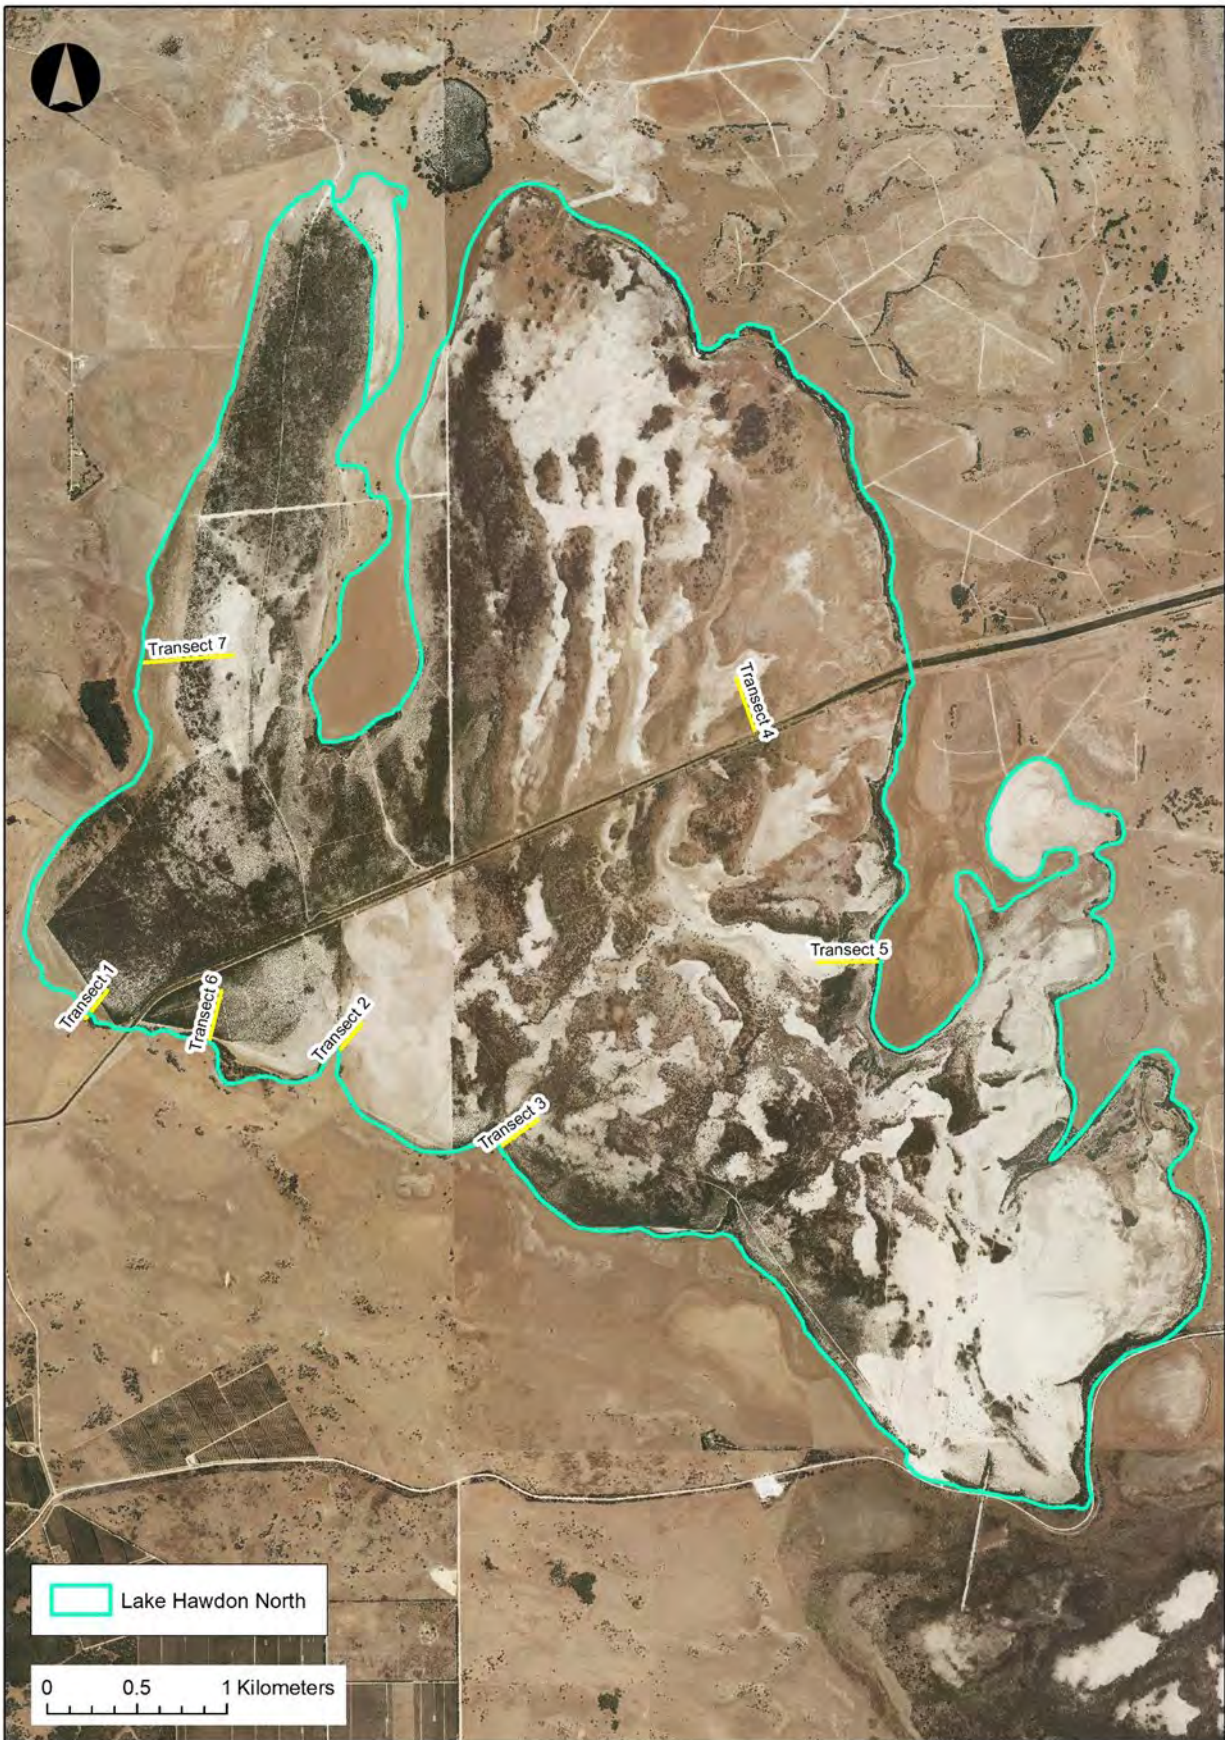
Figure 14. Vegetation transect locations (yellow lines) in Lake Hawdon North.

GPS coordinates (AMG, GDA 1994, Zone 54) are known for both ends of each transect and the compass bearing taken from the start point. A photograph was taken at each end, looking along the transect. A general site description was recorded noting forms of disturbance (e.g. stock impacts, native herbivores, fire, fences and tracks), along with measurements of weediness, vegetation health and evidence of change.

The vegetation composition and density was recorded along each transect. Where possible a tape measure was placed along the transect beginning at the terrestrial end. For transects longer than 200 m a handheld GPS was used to record the locations of changes to vegetation. For longer transects, particularly across structurally diverse vegetation, GPS approximation is considered to have a similar margin of error to tape measurement.

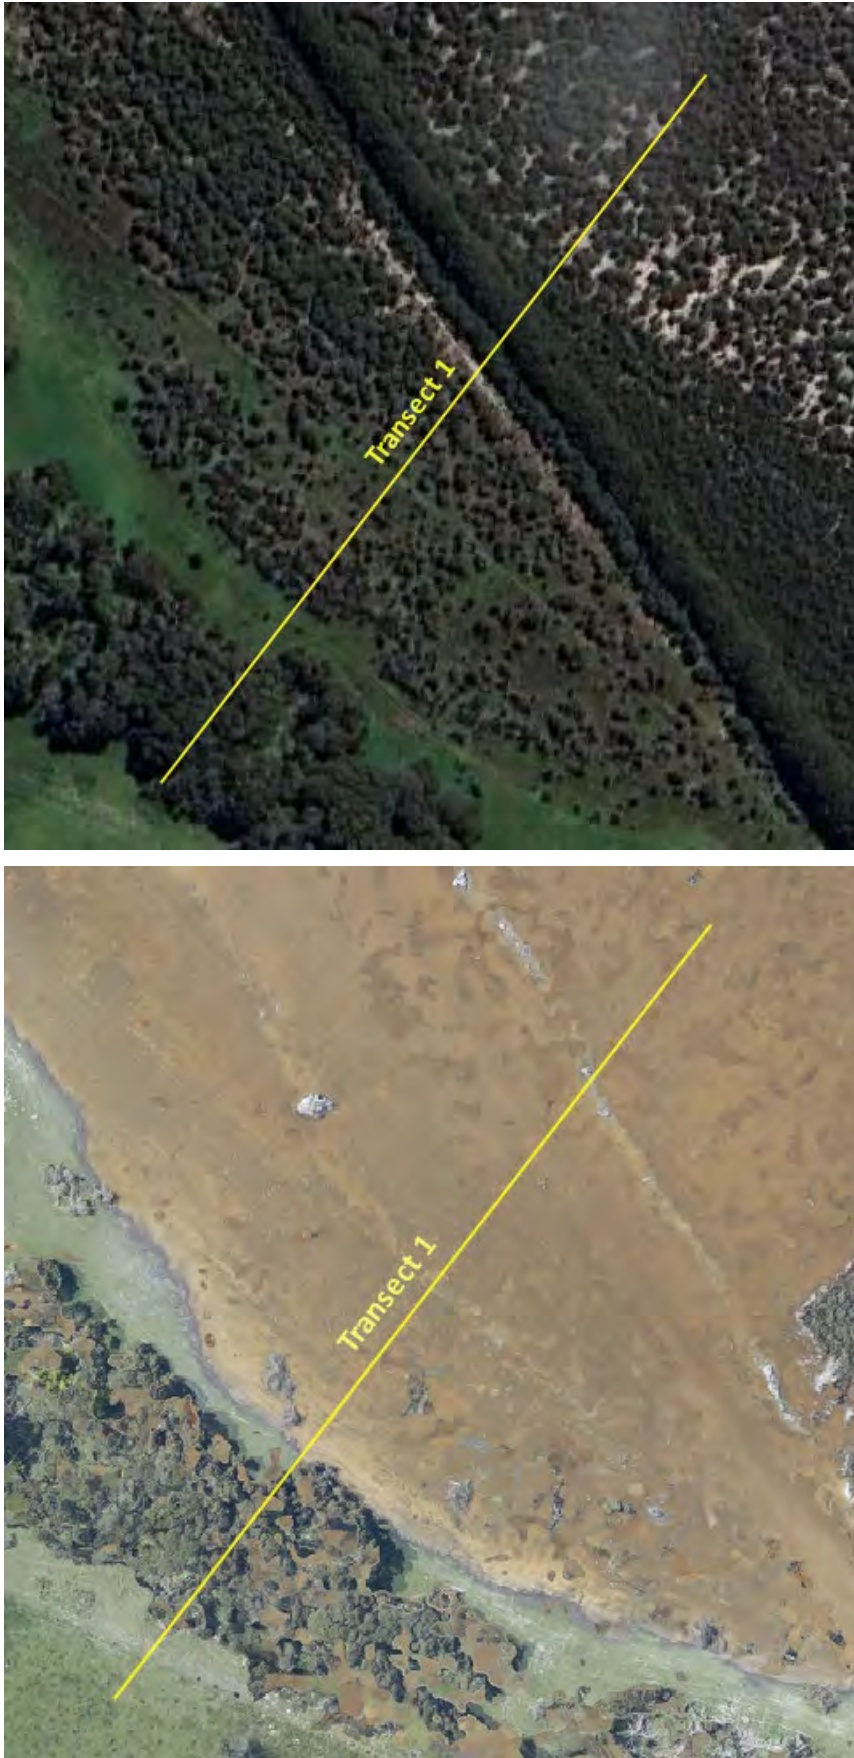
Figure 16. Aerial images of Transect 1 prior to restoration (above) and in mid-October 2025 after restoration works (below).

Start Easting: 400495	End Easting: 400616
Start Northing: 5887535	End Northing: 5887693
Bearing (from start): 38°	
Length: 199 m	
Start photo	End photo
  <p>Oct 2021</p>	  <p>Oct 2021</p>
  <p>Oct 2025</p>	  <p>Oct 2025</p>

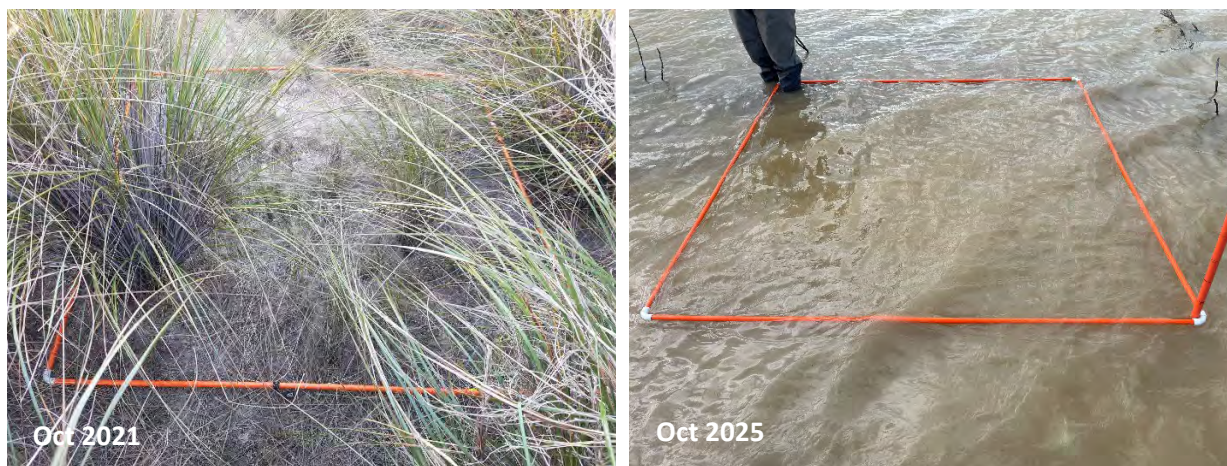
Figure 18. Transect 1, Quadrat 1.

Transect End Stake Easting	400616					
Transect End Stake Northing	5887693					
Survey date	11/10/2021			22/10/2025		
Quadrat number	1	2	3	1	2	3
Water quality and quantity						
EC (μ S/cm)	No water			4808		
Temperature ($^{\circ}$ C)				15.23		
pH				8.35		
DO (mg/L)				0.55*		
depth (cm)	0	0	0	27	27	27
Species	Braun Blanquet Cover					
<i>Gahnia filum</i>	2	3	3	F	F	F
<i>Schoenus nitens</i>	1	1	1	F	F	F
<i>Drosera pygmaea</i>	R		R			
Gramineae sp.	R					
<i>Melaleuca halmaturorum</i> 0 - 0.3m	R					
<i>Melaleuca halmaturorum</i> 1 -2m	1	3	3			
Charophytic algae				F		F

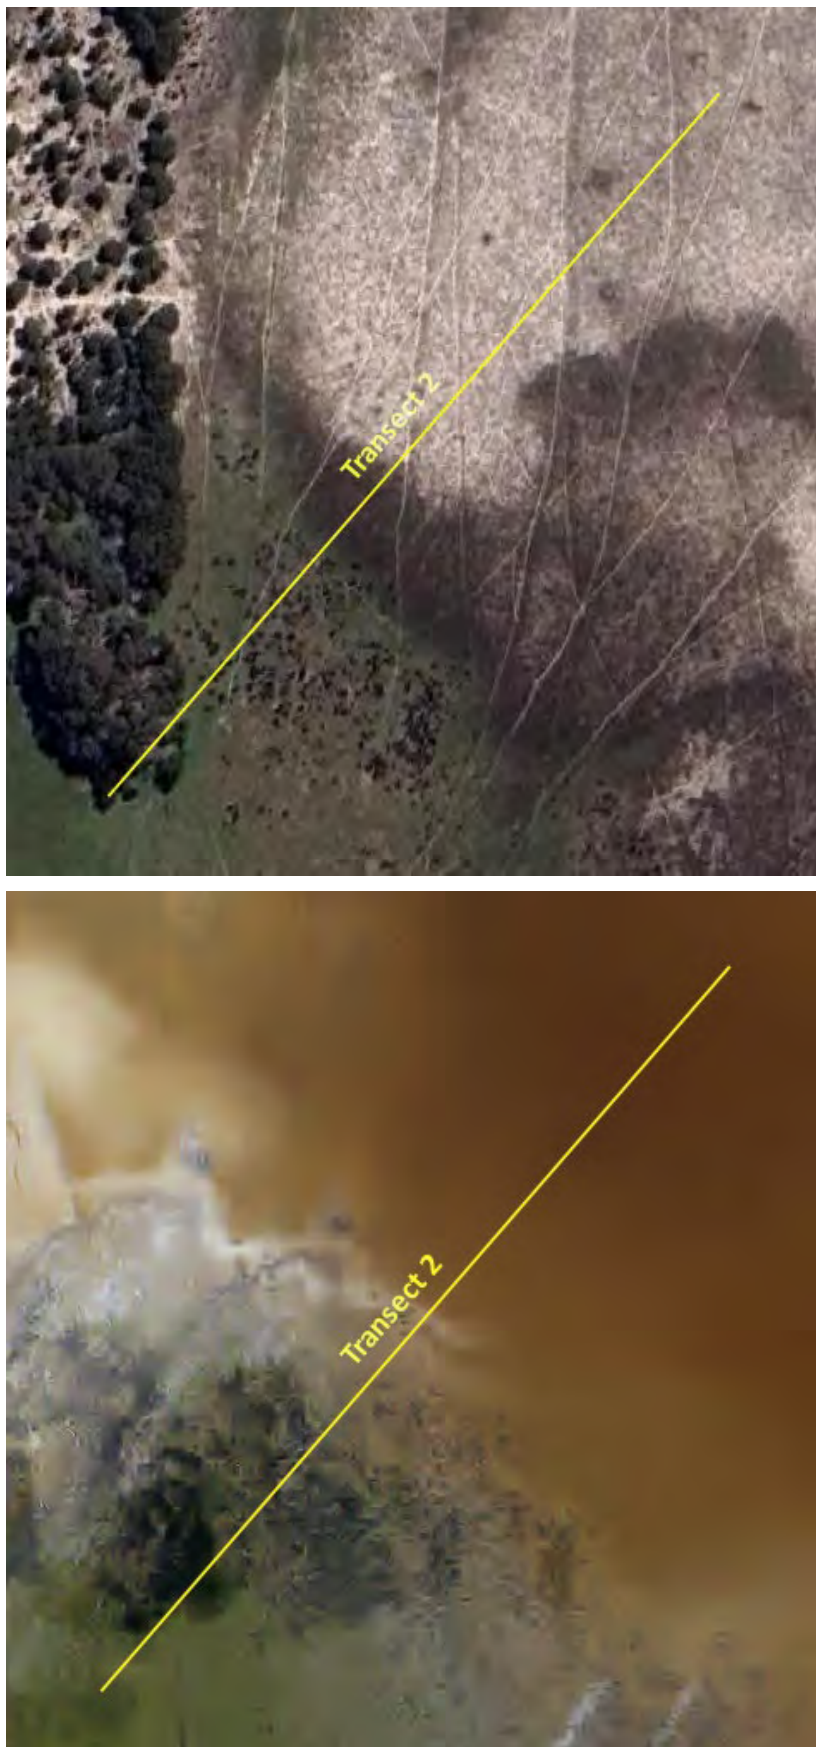
Figure 19. Aerial images of Transect 2 prior to restoration (above) and in mid-October 2025 after restoration works (below).

Start Easting: 401902	End Easting: 402033
Start Northing: 5887354	End Northing: 5887505
Bearing (from start): 25°	
Length: 199.9 m	
Start photo	End photo

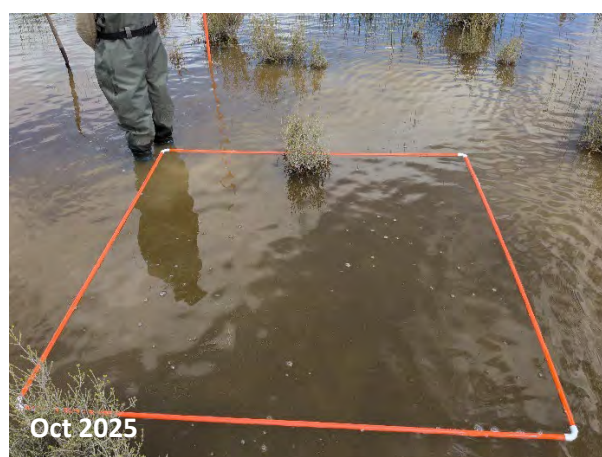
Figure 24. Transect 3, Quadrat 1.

Transect End Stake Easting	403012					
Transect End Stake Northing	5886971					
Survey Date	11/10/2021			23/10/2025		
Quadrat number	1	2	3	1	2	3
Water quality and quantity						
EC (µS/cm)	4022			4870		
Temperature (°C)	17.5			19.01		
pH	8.37			8.25		
DO (mg/L)	22.58			0.33*		
depth (cm)	16.5	16.5	18	24.5	24.5	24.5
Species	Braun Blanquet Cover					
<i>Schoenus nitens</i>	1	1	F			
<i>Melaleuca halmaturorum</i> 0 - 0.3m	1	1	1	F		F
<i>Melaleuca halmaturorum</i> 0.3 - 1m			2	R	R	
<i>Lachnagrostis filiformis</i>	2	2	3			
<i>Isolepis fluitans</i>	1	1	1	2	2	2
<i>Charophytic algae</i>	2	2	1	F	F	F
<i>Myriophyllum muelleri</i>	R	R	R		F	F
<i>Triglochin striata</i>	R			1	1	1
<i>Samolus repens</i>					F	
<i>Selliera radicans</i>	R	1	F			
<i>Macherina arthrophylla</i>						F

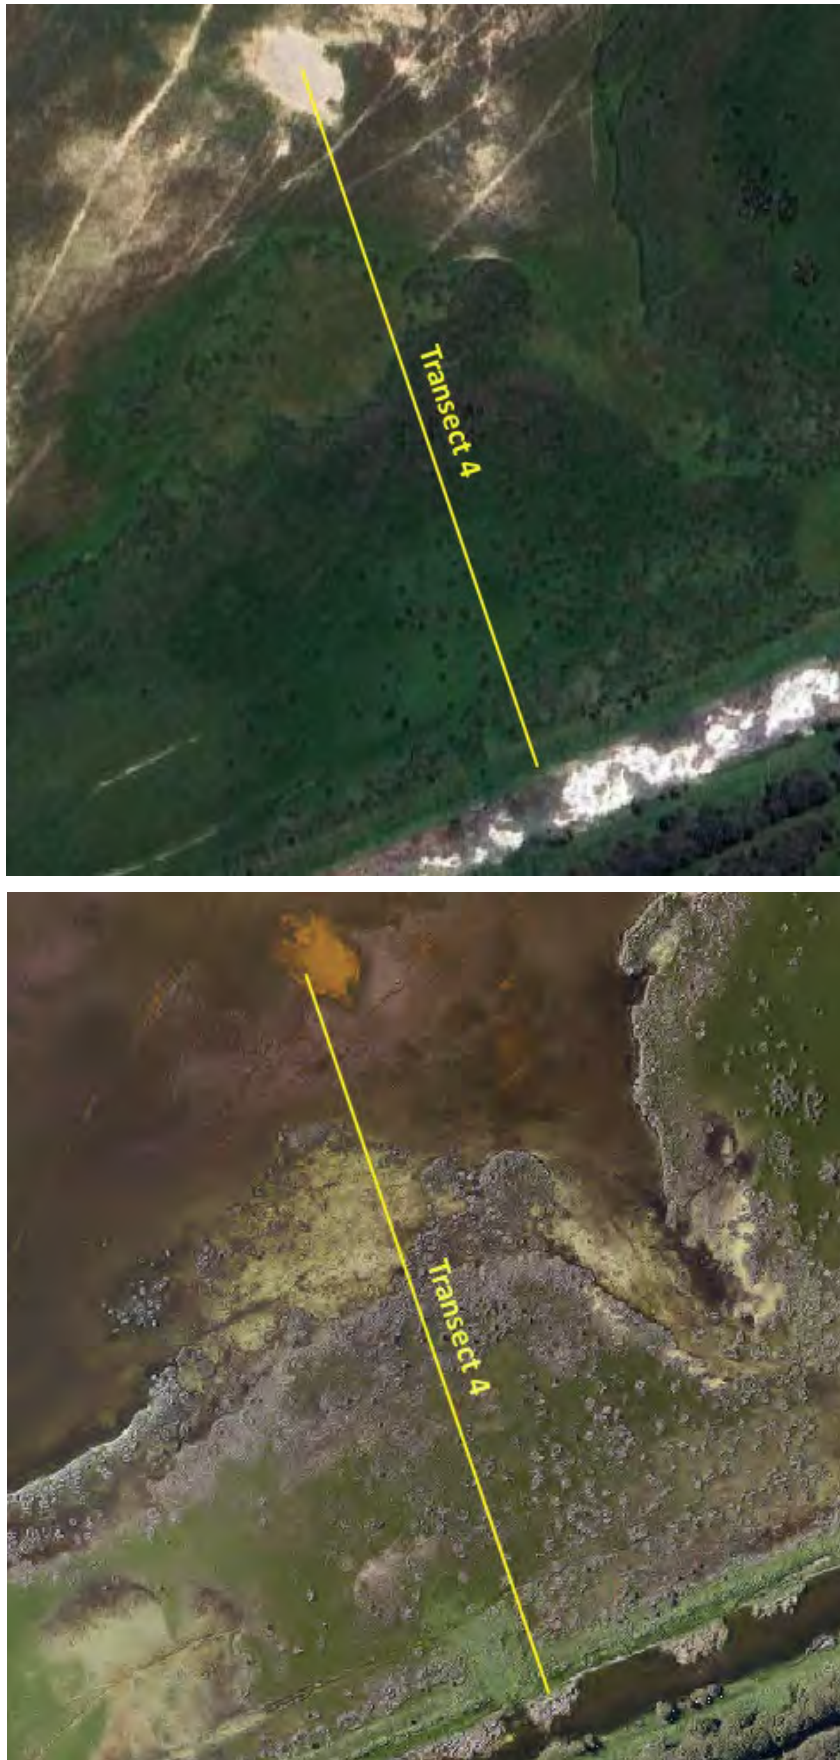
Figure 25. Aerial images of Transect 4 prior to restoration (above) and in mid-October 2025 (below). Habitat modification is not proposed in this area of the lake.

Start Easting: 404147	End Easting: 403997
Start Northing: 5889111	End Northing: 5889335
Bearing (from start): 325°	
Length: 305.8 m	
Start photo	End photo

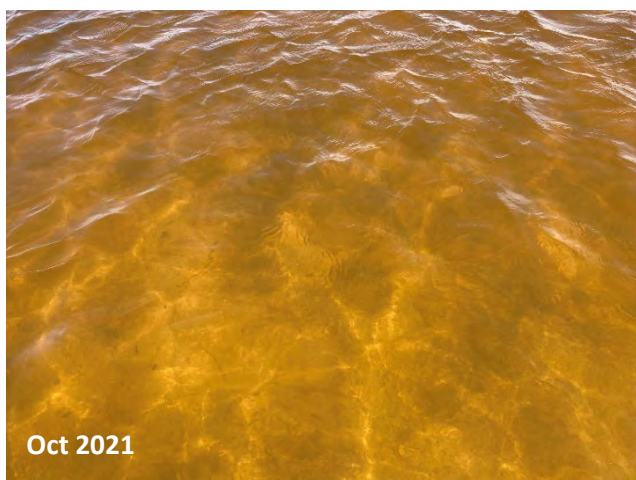
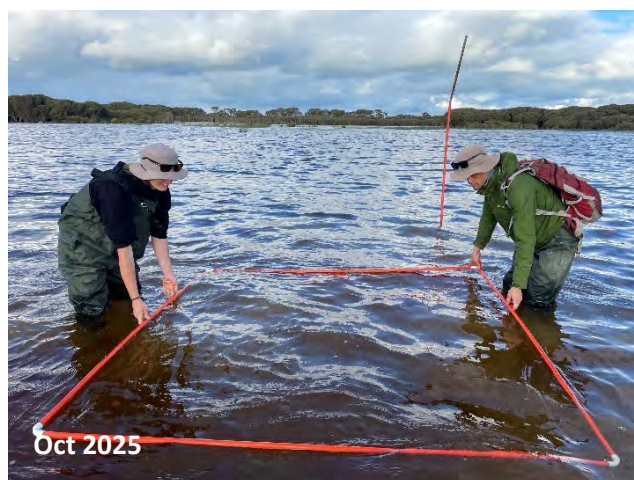
Figure 30. Transect 5, indicative view of quadrat location (2021, left) and Quadrat 1 (2025, right).

Transect End Stake Easting	404569					
Transect End Stake Northing	5887848					
Survey date	12/10/2021			23/10/2025		
Quadrat number	1	2	3	1	2	3
Water quality and quantity						
EC ($\mu\text{S}/\text{cm}$)	5024			4294		
Temperature ($^{\circ}\text{C}$)	15.3			19.8		
pH	8.44			8.71		
DO (mg/L)	17.21			0.34*		
depth (cm)	44	44	45	55	55	55
Species	Braun Blanquet Cover					
Charophytic algae	2	2	2	4	3	4
<i>Myriophyllum muelleri</i>		R			1	1
<i>Montia australasica</i>						1

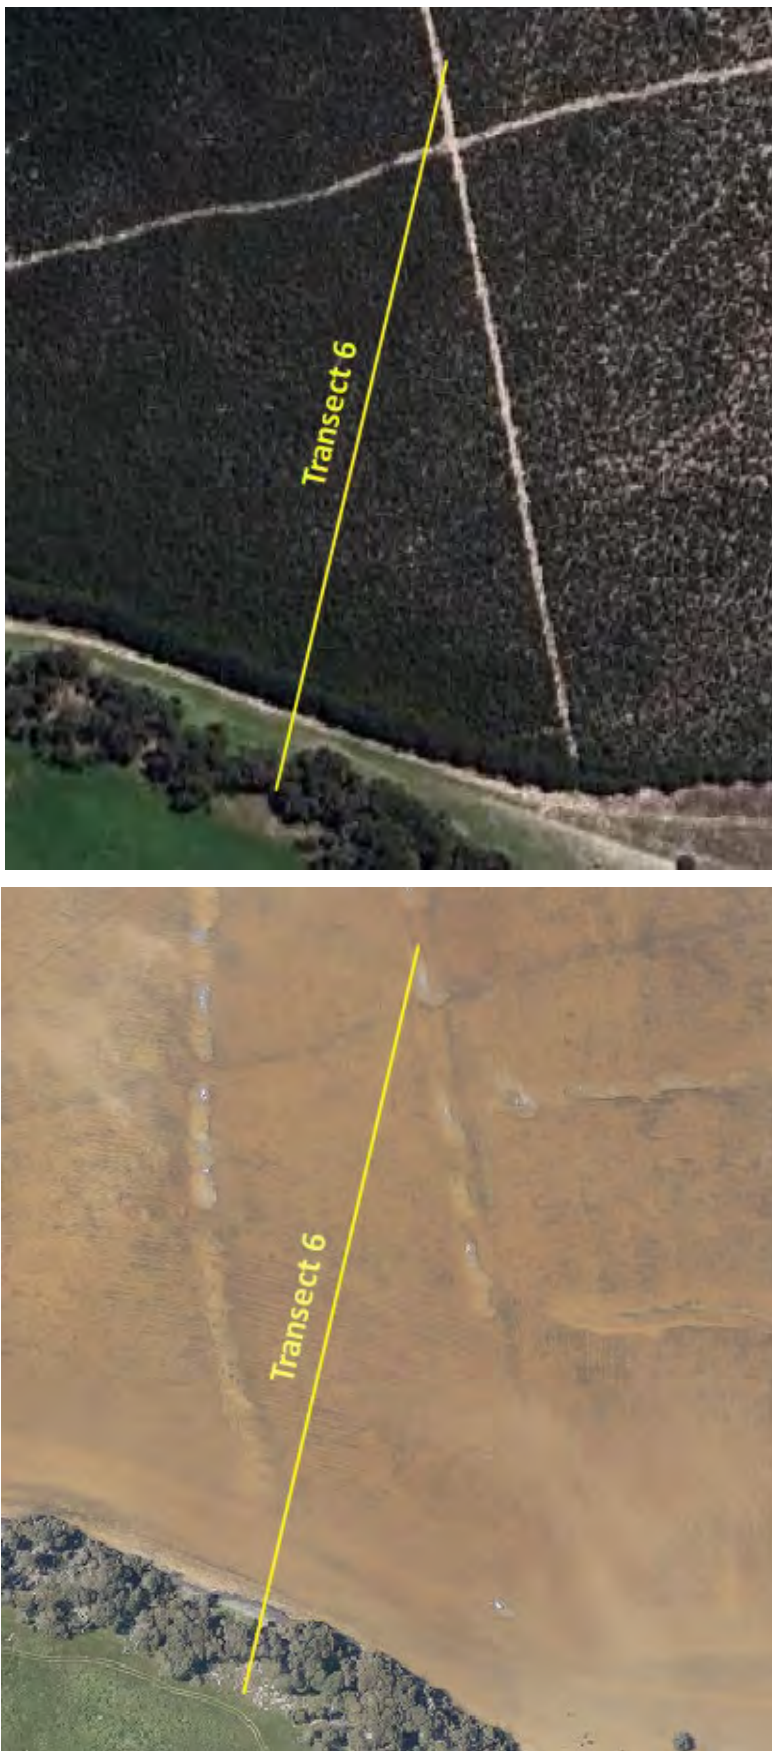
Figure 31. Aerial images of Transect 6 prior to restoration (above) and in mid-October 2025 after restoration works (below).

Start Easting: 401185	End Easting: 401250
Start Northing: 5887412	End Northing: 5887690
Bearing (from start): 15°	
Length: 285.5 m	
Start photo	End photo

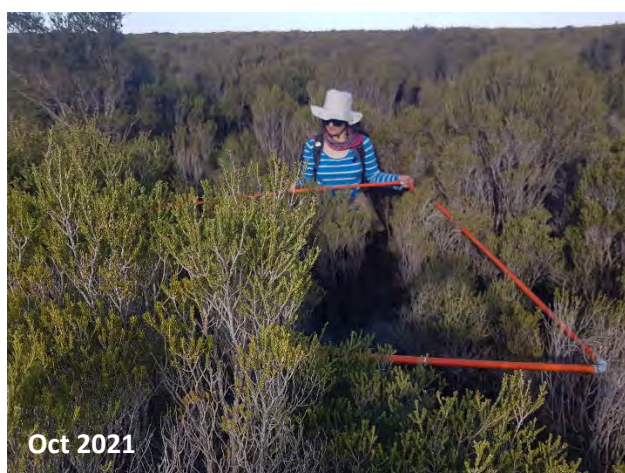
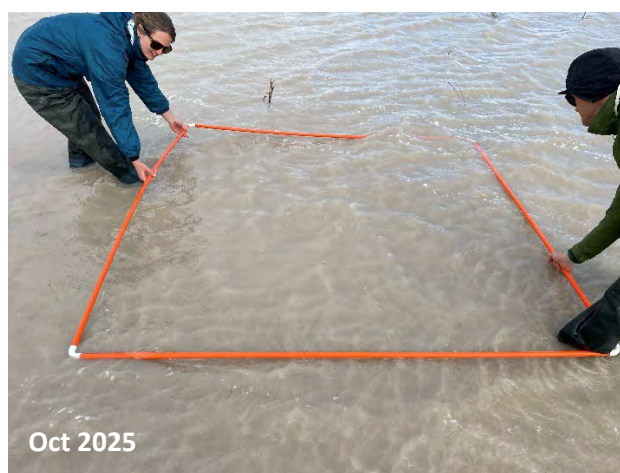
Figure 33. Transect 6, Quadrat 1.

Transect End Stake Easting	401250					
Transect End Stake Northing	5887690					
Survey date	12/10/2021			23/10/2025		
Quadrat number	1	2	3	1	2	3
Water quality and quantity						
EC (µS/cm)	No water			4825		
Temperature (°C)				16.3		
pH				8.32		
DO (mg/L)				2.25*		
depth (cm)	0	0	0	21	21	21
Species	Braun Blanquet Cover					
<i>Gahnia filum</i>	R					
<i>Schoenus nitens</i>	2	2	2	2	1	1
<i>Drosera pygmaea</i>	R	R	R			
<i>Melaleuca halmaturorum</i> 0.3 -1m		R				
<i>Melaleuca halmaturorum</i> 1 - 2m	2	2	3			
Charophytic algae				1	1	
<i>Triglochin striata</i>	F	R			R	
<i>Samolus repens</i>	F		R			
<i>Selliera radicans</i>	F	F	R

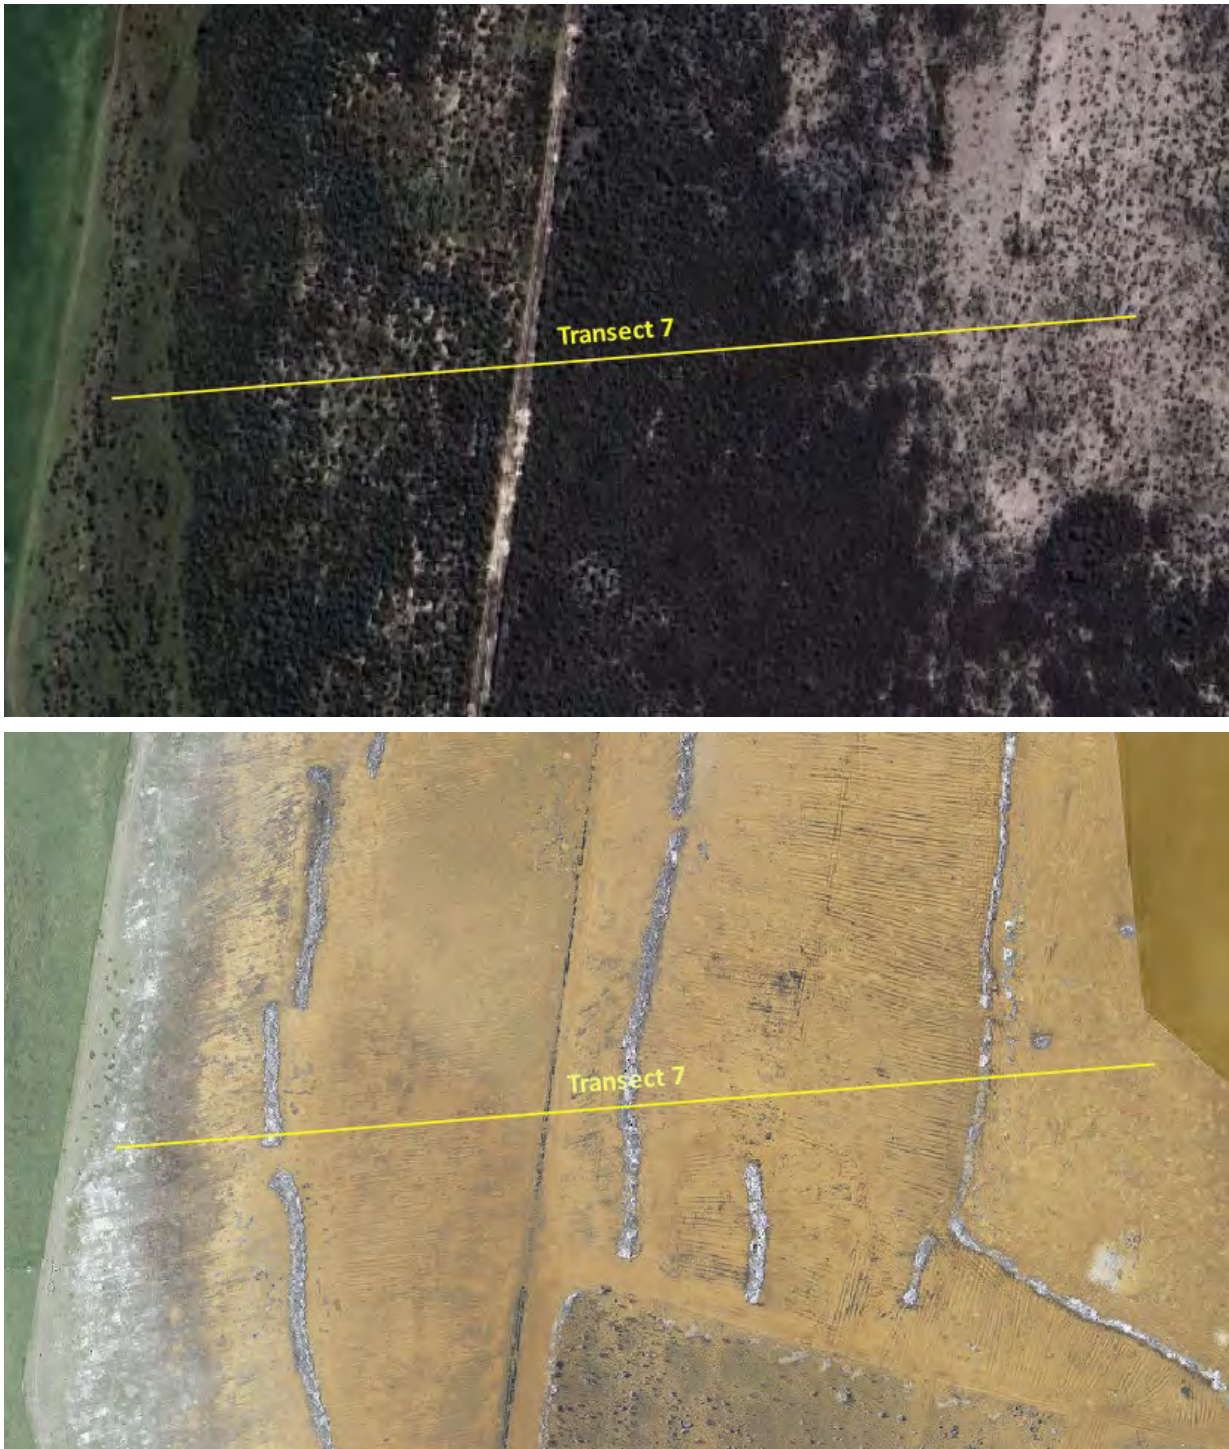
Figure 34. Aerial images of Transect 7 prior to restoration (above) and in mid-October 2025 after restoration works (below).

Start Easting: 400818	End Easting: 401316
Start Northing: 5889520	End Northing: 5889560
Bearing (from start): 85°	
Length: 500.2 m	
Start photo	End photo

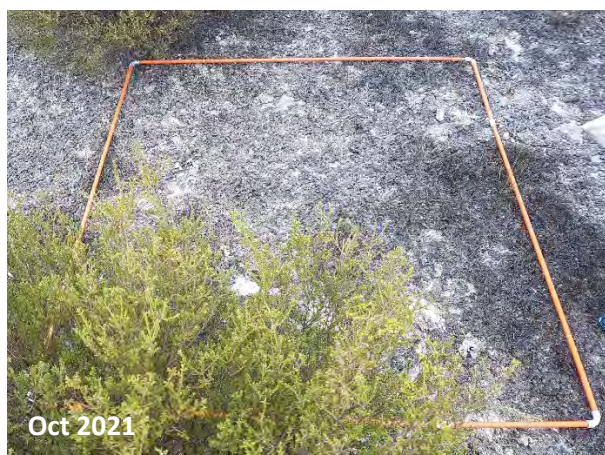
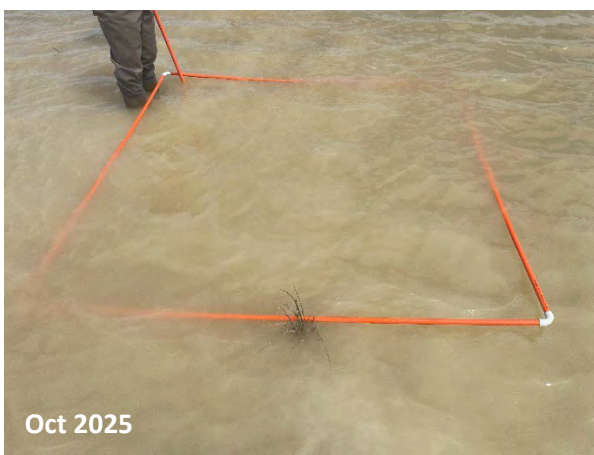
Figure 36. Transect 7, Quadrat 1.

Transect End Stake Easting	401316					
Transect End Stake Northing	5889560					
Survey date	13/10/2021			23/10/2025		
Quadrat number	1	2	3	1	2	3
Water quality and quantity						
EC ($\mu\text{S}/\text{cm}$)	No water			5140		
Temperature ($^{\circ}\text{C}$)				17.38		
pH				8.56		
DO (mg/L)				0.36*		
depth (cm)	0	0	0	20	17	18
Species	Braun Blanquet Cover					
<i>Gahnia filum</i>	R	1	1	R		
<i>Schoenus nitens</i>	1	1	1	1	1	1
<i>Melaleuca halmaturorum</i> 0 - 0.3m			1			
<i>Melaleuca halmaturorum</i> 0.3 -1m		1	2			
Charophytic algae				2	2	2
<i>Wilsonia backhousei</i>	1	1	1			
<i>Samolus repens</i>	R		1			
<i>Ruppia sp.</i>				F

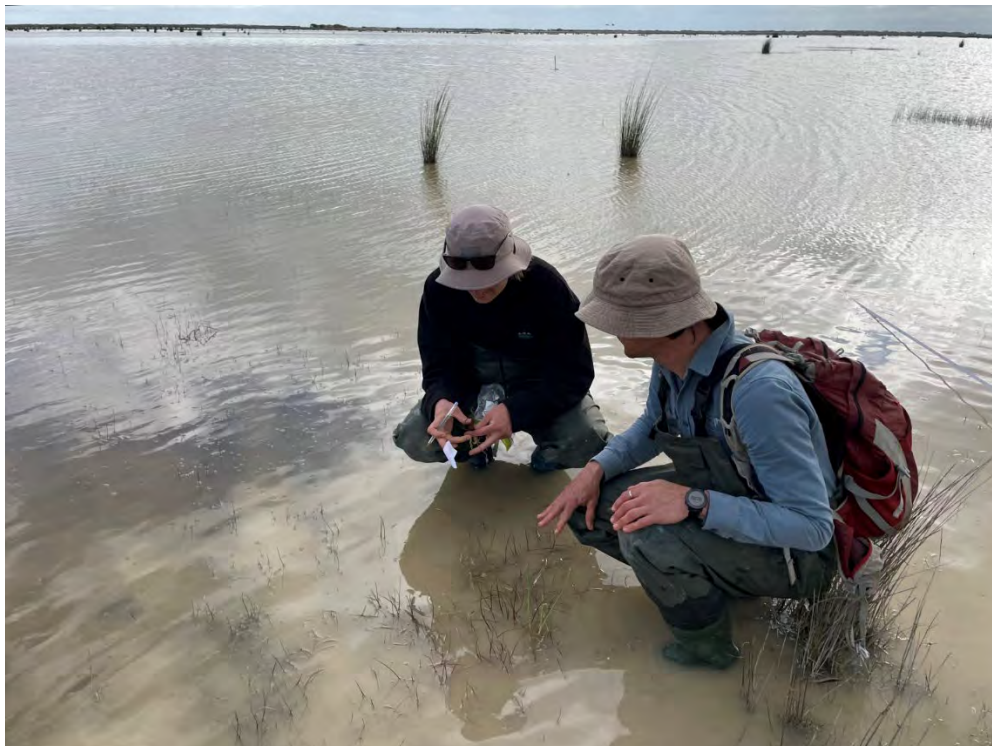
Figure 37. Highly turbid water, Transect 2, 22/10/2025.

Although turbidity was not measured, we observed very high turbidity at transects located where extensive habitat modification works had occurred (Transects 1, 2, 6 and 7; see Figure 37) compared to the turbidity that is typical in Lake Hawdon North in spring (see 2021 quadrat photos). It is likely that disturbance of the lakebed by machinery in autumn 2025, combined with very high winds immediately prior to monitoring, caused elevated turbidity.

Habitat modification works will continue in autumn 2026 and have the potential to cause elevated turbidity in spring 2026. However, the effect is anticipated to be temporary, with lakebed sediments likely to consolidate through time as the cover of submerged aquatic vegetation increases following restoration.

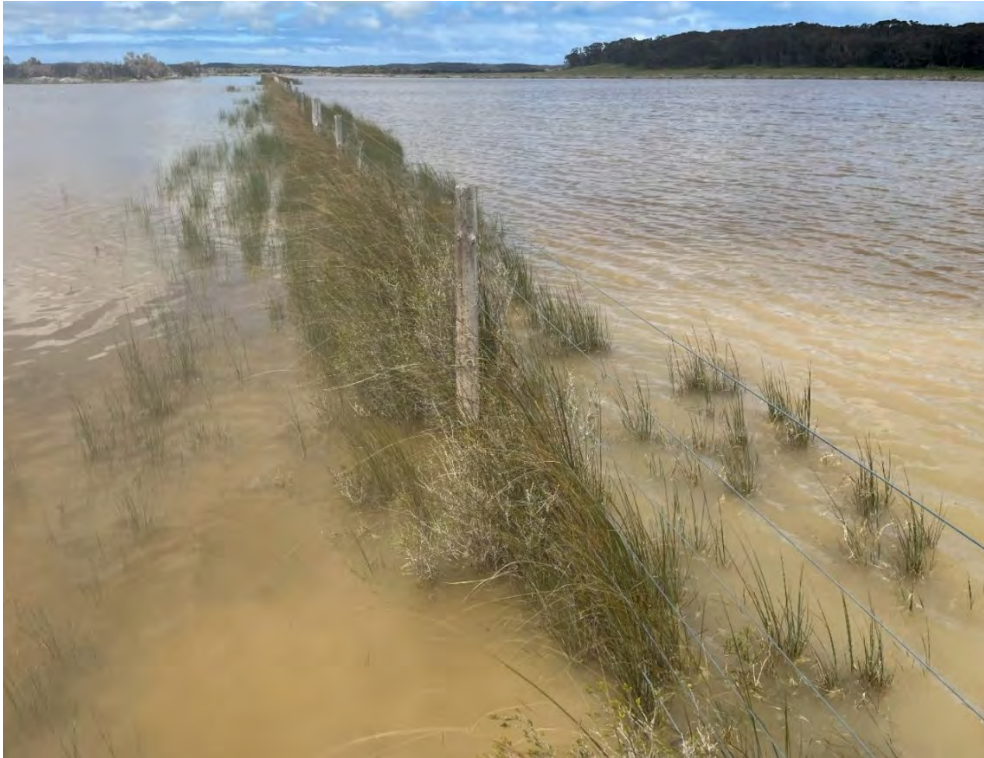
Figure 38. Uncleared *Gahnia filum* and *Melaleuca halmaturorum* along a fenceline bisecting Transect 7.

To avoid damage to a fenceline bisecting Transect 7, a narrow strip of vegetation had not been mechanically cleared (Figure 38). The vegetation includes *M. halmaturorum* shrubs, currently lower than 1.5 m, that will provide an ongoing source of seed and likely contribute to the re-establishment of shrubland on the surrounding mudflats from which it was recently cleared. The removal of this linear strip of *M. halmaturorum*, e.g. via spraying, is recommended. There are other fencelines within the habitat restoration footprint that may require similar treatment.

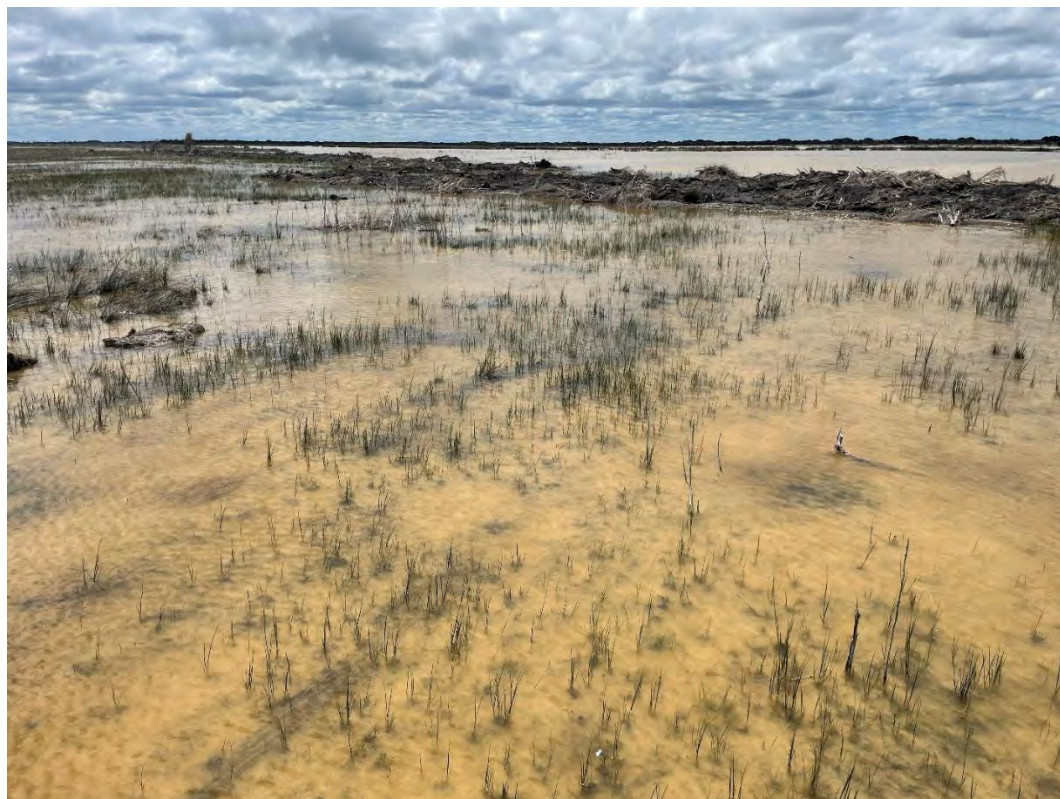
Figure 39. Dense recruitment of *G. filum* within mechanical clearance footprint the near the start of Transect 7.

Dense recruitment of *Gahnia filum* was evident in some areas within the more elevated zone (c.4.20 mAHD) of the mechanical (loader) clearance footprint, which were shallowly inundated (c.5 cm deep) on the date of survey (Figure 39). Given the elevation, hydrology alone is unlikely to maintain open pan habitat in such areas, and dense *G. filum* sedgeland will likely return without additional, ongoing management. Grazing may play a role, but regular burning will likely be required to maintain, or temporarily create, open pan in such areas over the longer term. Relatively high numbers of migratory shorebirds were observed in this habitat (e.g. cells G9, G10, F10, F11) during the waterbird census.

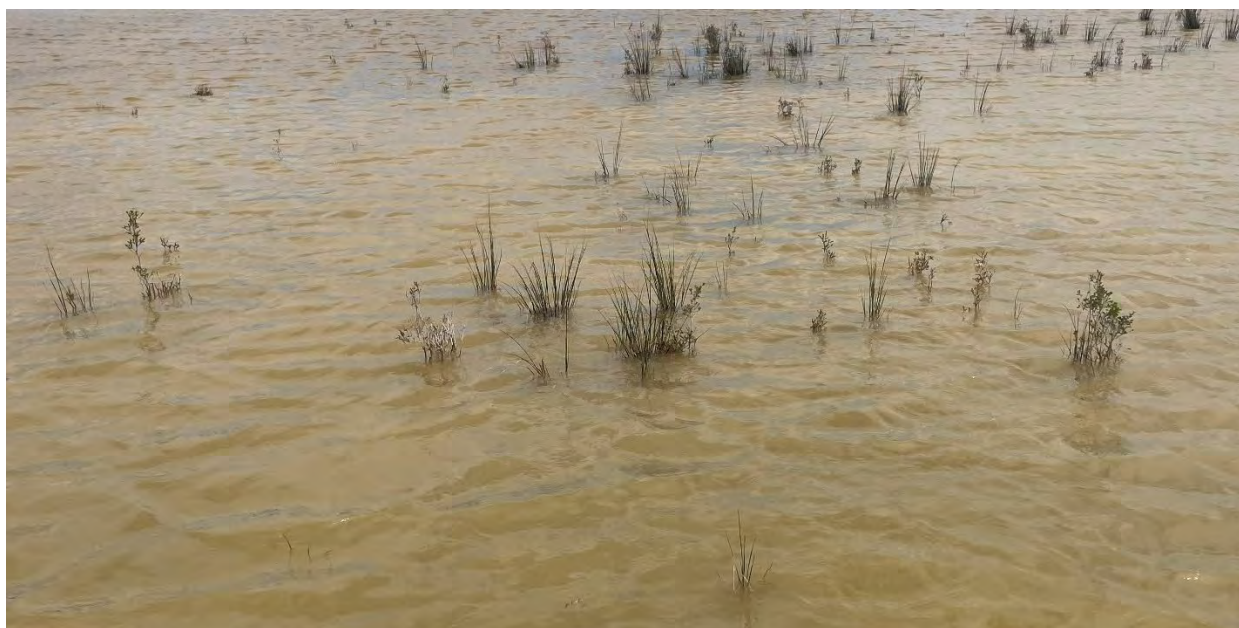
Figure 40. Resprouting *Gahnia filum* and small *Melaleuca halmaturorum* not removed by mechanical clearance, Transect 7.

Another observation throughout the mechanical (loader) clearance footprint (outside of the May 2025 prescribed burn footprint) was, in some locations, sparse, low (<0.5 m) *Melaleuca halmaturorum* shrubs that were alive and had not been removed by the loader (Figure 40). These shrubs were not completely submerged and therefore will likely survive inundation and continue to grow, providing an ongoing source of seed. Spot spraying (when dry) or hand-pulling (when inundated) is effective for individual plants, but the widespread yet sparse distribution of these shrubs presents a challenge for management.

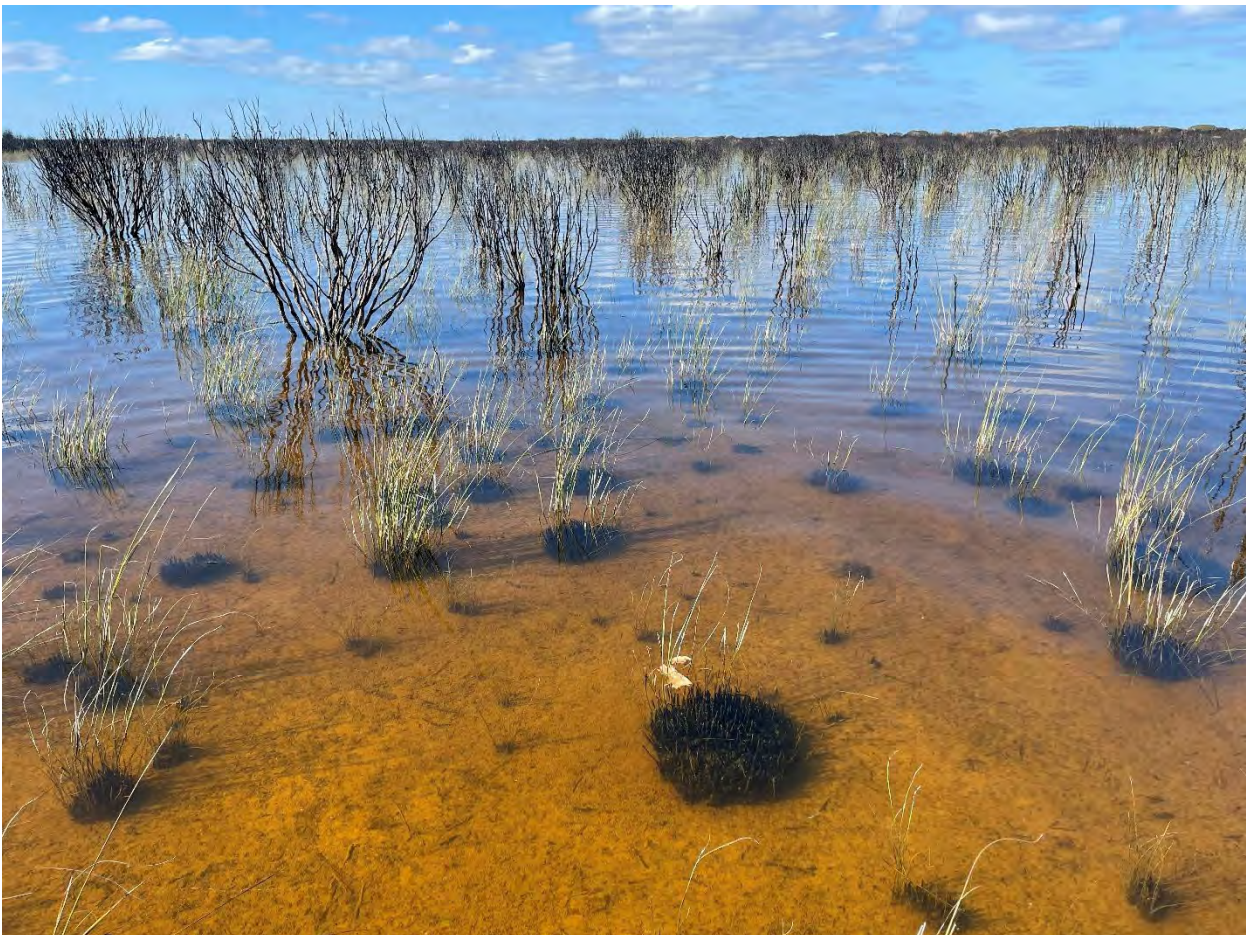
Figure 41. Within the footprint of the May 2025 prescribed burn, area yet to be mechanically cleared, showing resprouting *G. filum* and standing dead *M. halmaturorum* (10/11/2025).

Figure 41 shows vegetation within the footprint of the May 2025 prescribed burn, proposed for mechanical (dozer) clearance in autumn 2026. The burn had effectively killed the *Melaleuca halmaturorum* shrubs but the *Gahnia filum* sedges had resprouted and extended new leaves above the water surface (c.35 cm deep), ensuring their survival of inundation.
