Ecological Monitoring of Lake Hawdon North and South Spring 2025

Nature
GlenelgTrust

Report to the South Australian Government Department for Environment and Water

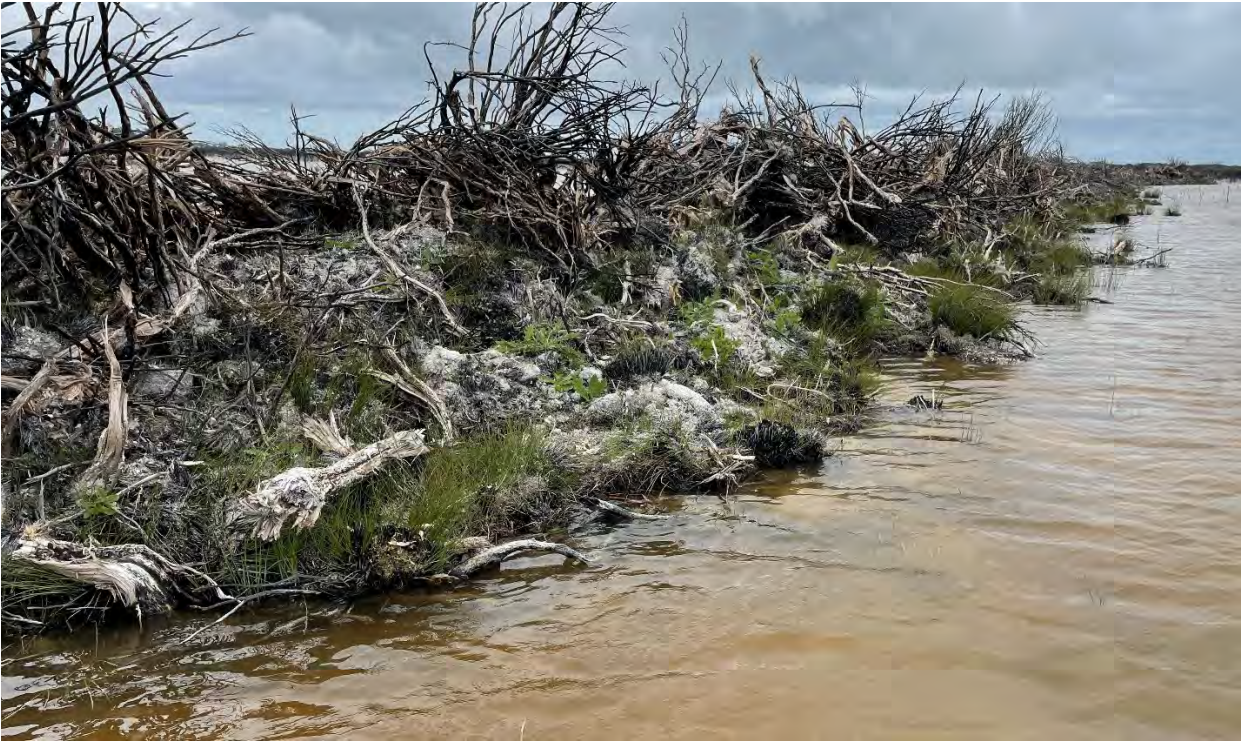
Figure 42. Windrow created during mechanical (dozer) clearance within the footprint of the May 2025 prescribed burn, showing uprooted but resprouting *G. filum* and pasture weeds (9/11/2025).

Both forms of mechanical clearance employed at LHN in 2025, loader and dozer, created windrows of cleared vegetation and sediment that are elevated well above the maximum water level of the lake (Figure 42). In the approximately five months since their creation, plants had established on the windrows, including various pasture weeds and the resprouting bases of uprooted *Gahnia filum*. If the windrows remain in place they are likely to be colonised by *Melaleuca halmaturorum* that will provide an ongoing source of seed and compromise the ability to maintain open pan habitat on surrounding areas of the lakebed. Removal of windrows by further burning of dead vegetation (if possible) followed by spreading of sediment (if necessary) is recommended to ensure that linear islands of shrubland do not develop within the lake.
