# Native Vegetation Clearance

## Morgan Whyalla Pipeline Stage 3

### Data Report

Clearance under the *Native Vegetation Regulations 2017*

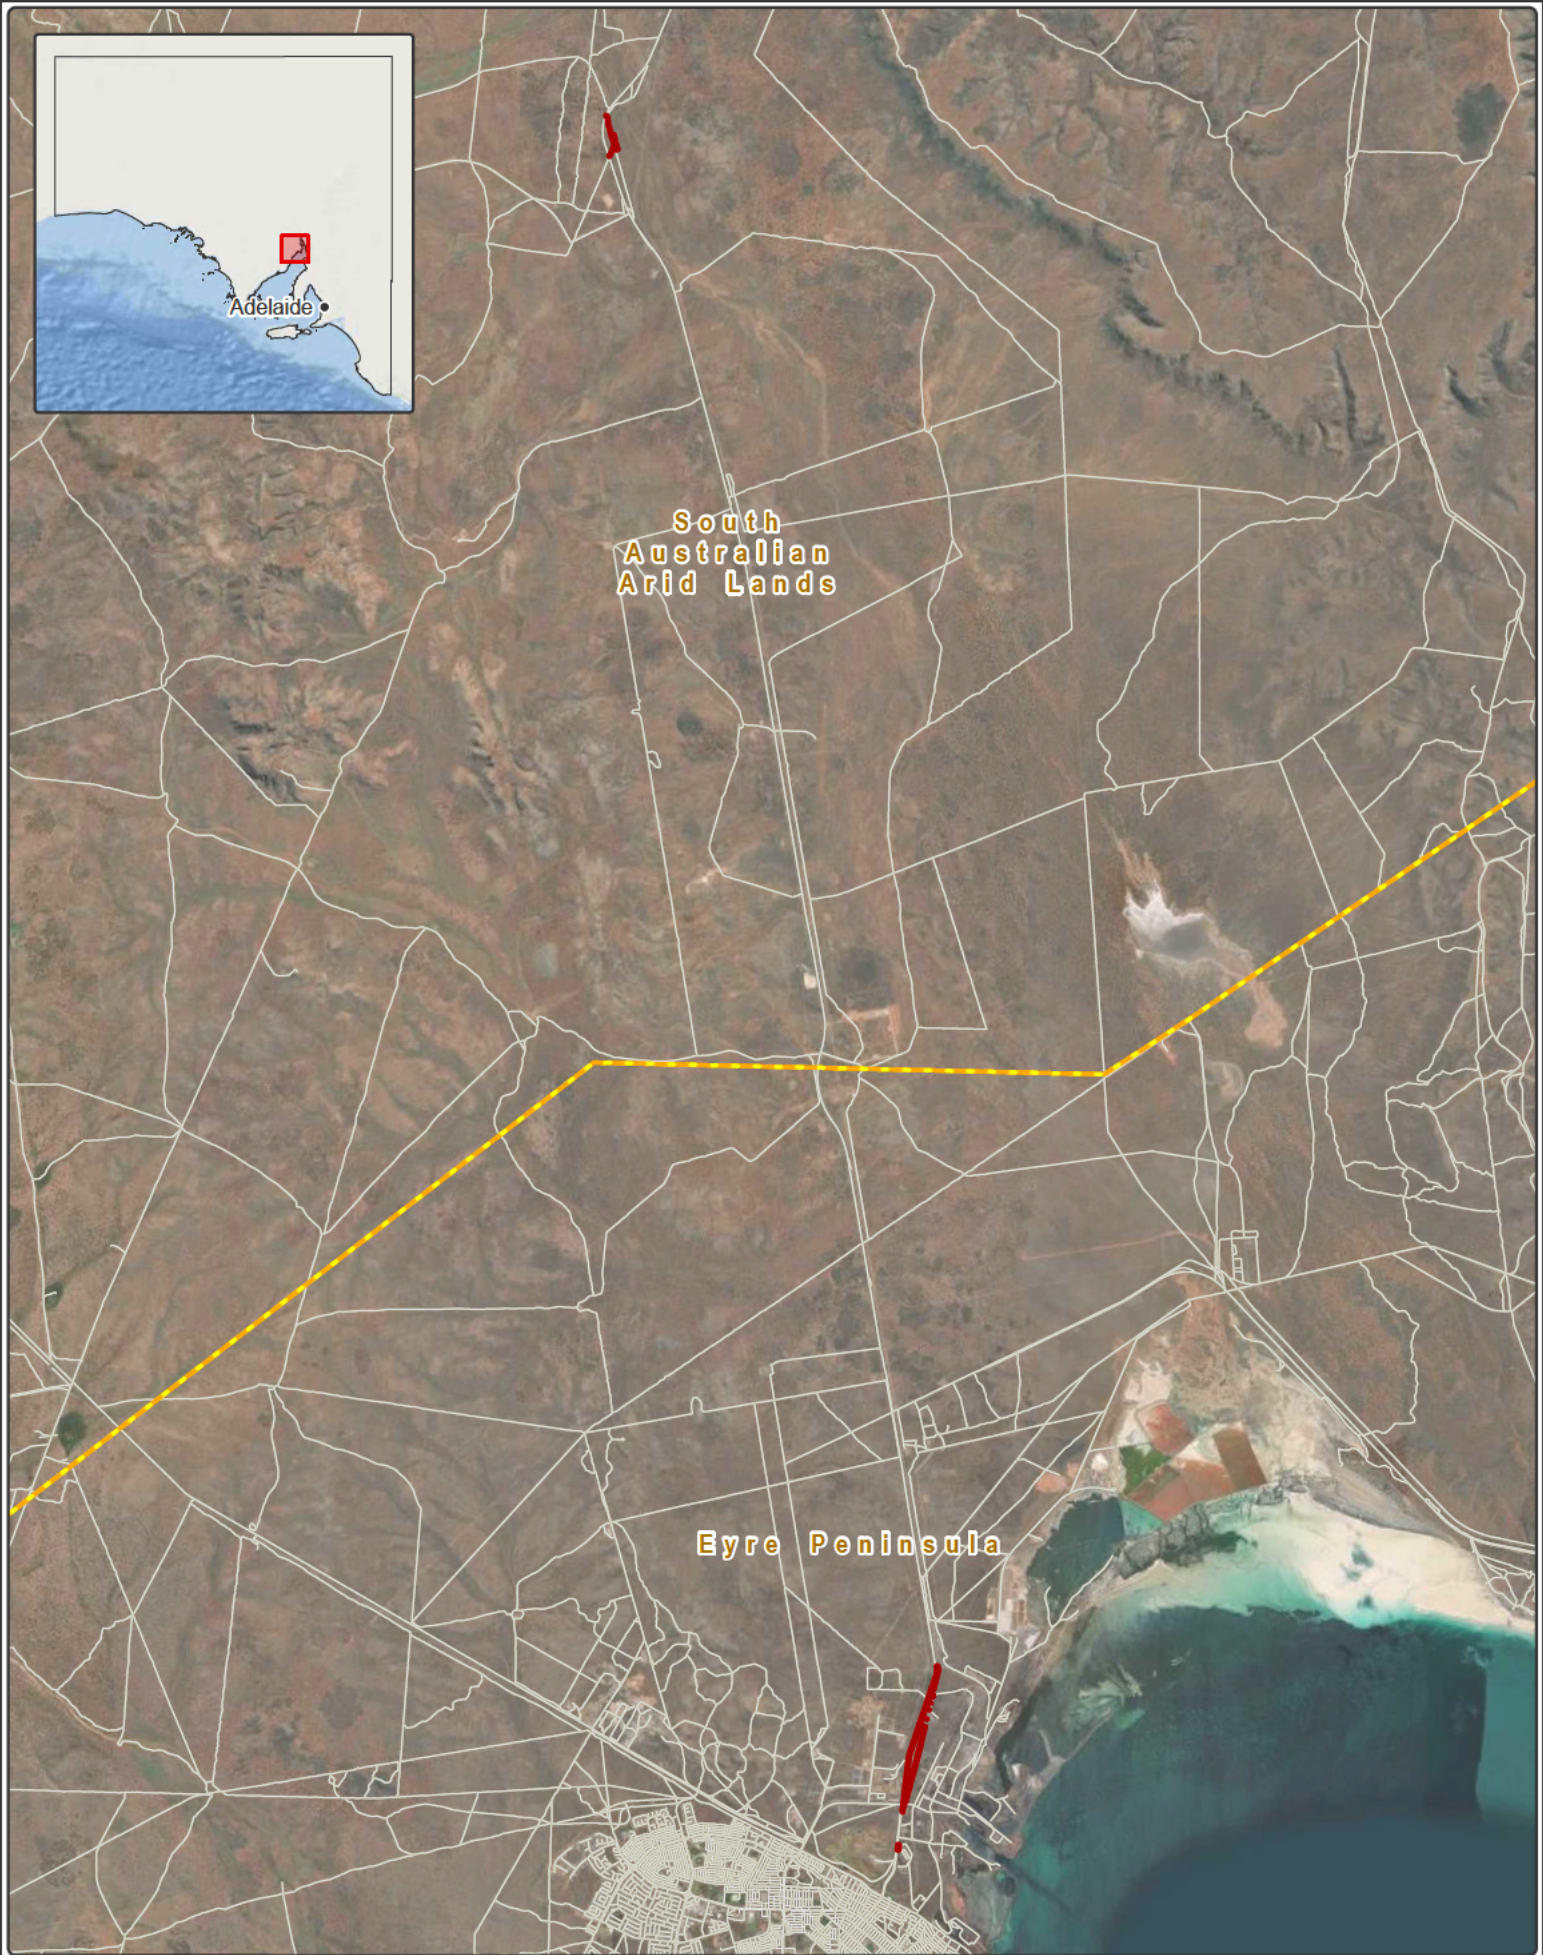
**Figure 1: Location of the study area**

This application is for work needed to renew sections of the Morgan Whyalla Pipeline (MWPL) in a roughly 3 km section parallel to the Lincoln Highway heading north from Whyalla. Figure 1 shows the general location of the study area while Figure 2 shows the clearance area in more detail including the ecological features of the study area. The work may require an up to 25m wide corridor, but all effort will be made to minimize the vegetation disturbance during the renewal of this pipeline. This application also includes clearance required to extract and remove sections of the old pipeline once the renewal has been completed.

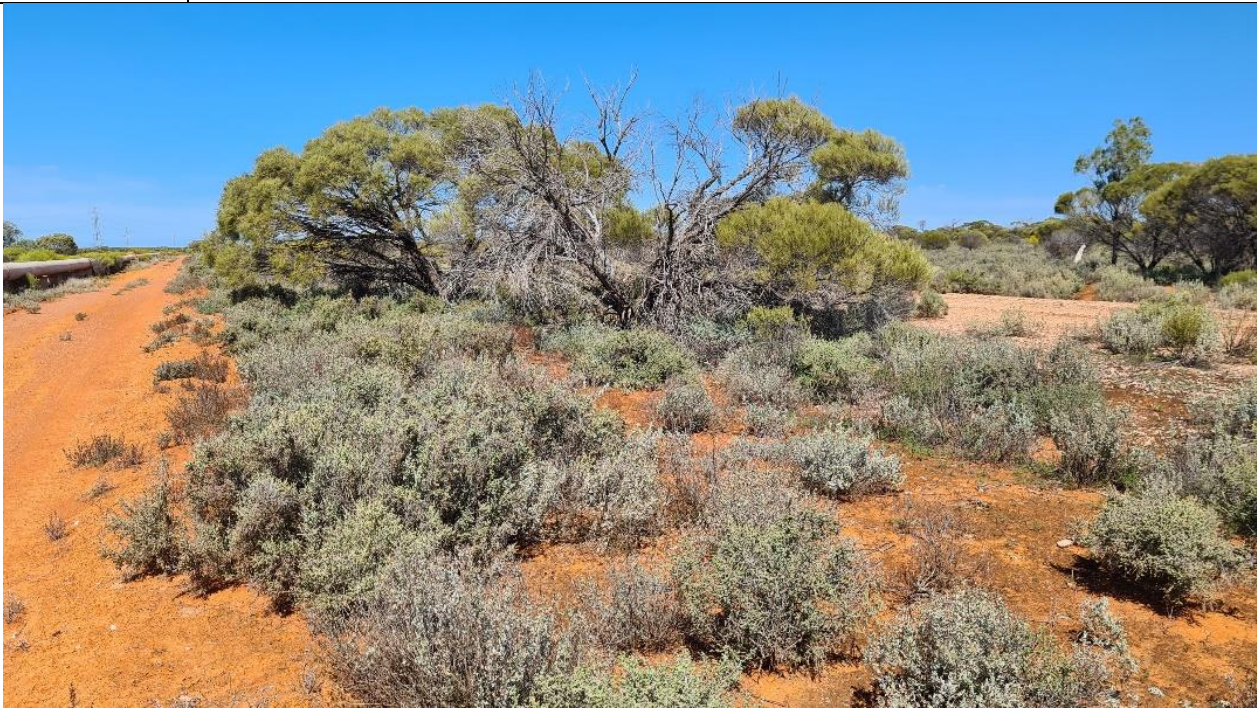
Photo 1 taken facing S at easting: 735283, Northing: 6376423					
General description	Native vegetation within VA1 occurred between the roads and a rail lines. The native vegetation within VA1 contained 12 native species with <i>Acacia papyrocarpa</i> (Western Myall), <i>Acacia oswaldii</i> (Umbrella Wattle) and <i>Atriplex vesicaria</i> (Bladder Saltbush) being the dominant species. Weedy species include <i>Carrichtera annua</i> (Ward's Weed) and <i>Lycium ferocissimum</i> (African Boxthorn).				
Threatened species or community	Threatened species with current occurrence records nearby which may use this as habitat include: White-winged Chough, Grey Falcon, Scarlet Chested Parrot, Major Mitchell's Cockatoo and Carpet Python. Refer to the likelihood of occurrence table (Table 8) for the full assessment.

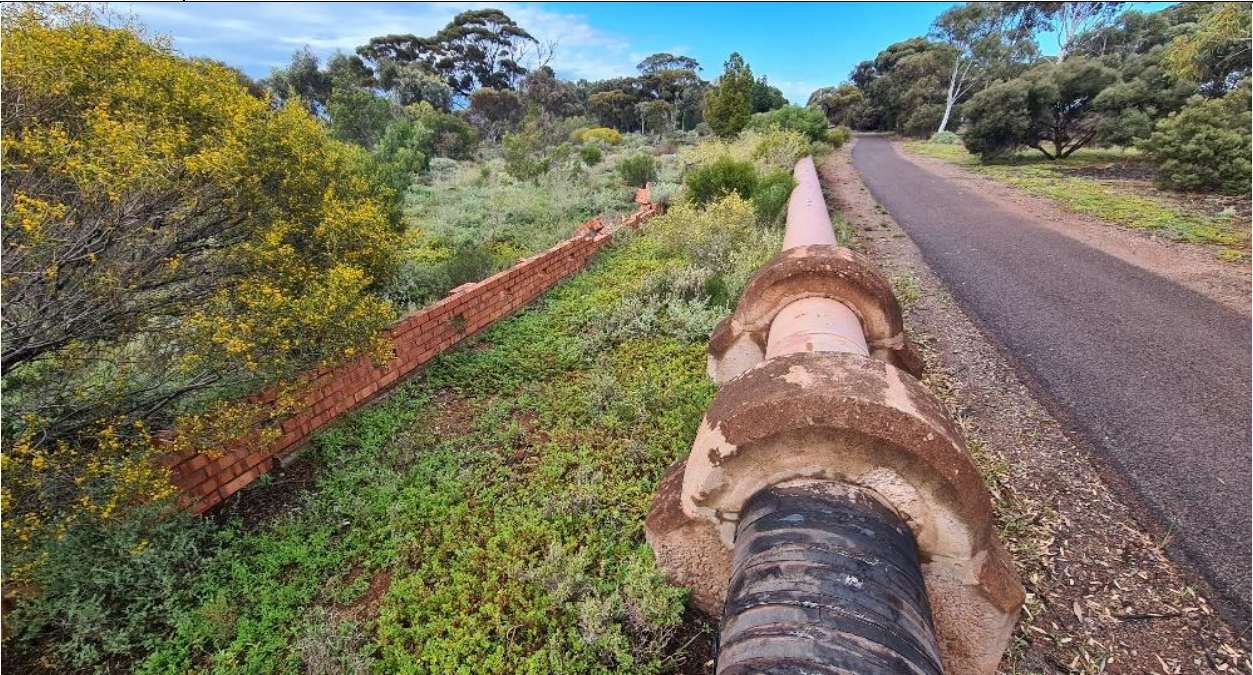
Photo 2 taken facing S at easting: 740558, Northing: 6343903					
General description	<p>Native vegetation within VA4 occurred between the roads and a rail line (see Figure 2). The native vegetation within VA4 contained 28 native species with <i>Marieana brevifolia</i> (Short-leaf Bluebush), <i>Maireana sedifolia</i> (Pearly bluebush) and <i>Atriplex stipitata</i> (Bitter saltbush) being the dominant species.</p> <p>Declared weeds present: There were 15 species of declared weeds present in VA4, among these were <i>Avena barbata</i> (Bearded Oat), <i>Carrichtera annua</i> (Ward's Weed) and <i>Lycium ferocissimum</i> (African Boxthorn)</p>				
Threatened species or community	Threatened species with current occurrence records nearby which may use this as habitat including: Slender-billed Thornbill, Western Grasswren, and Southern Whiteface . Refer to the likelihood of occurrence table (Table 8) for the full assessment.

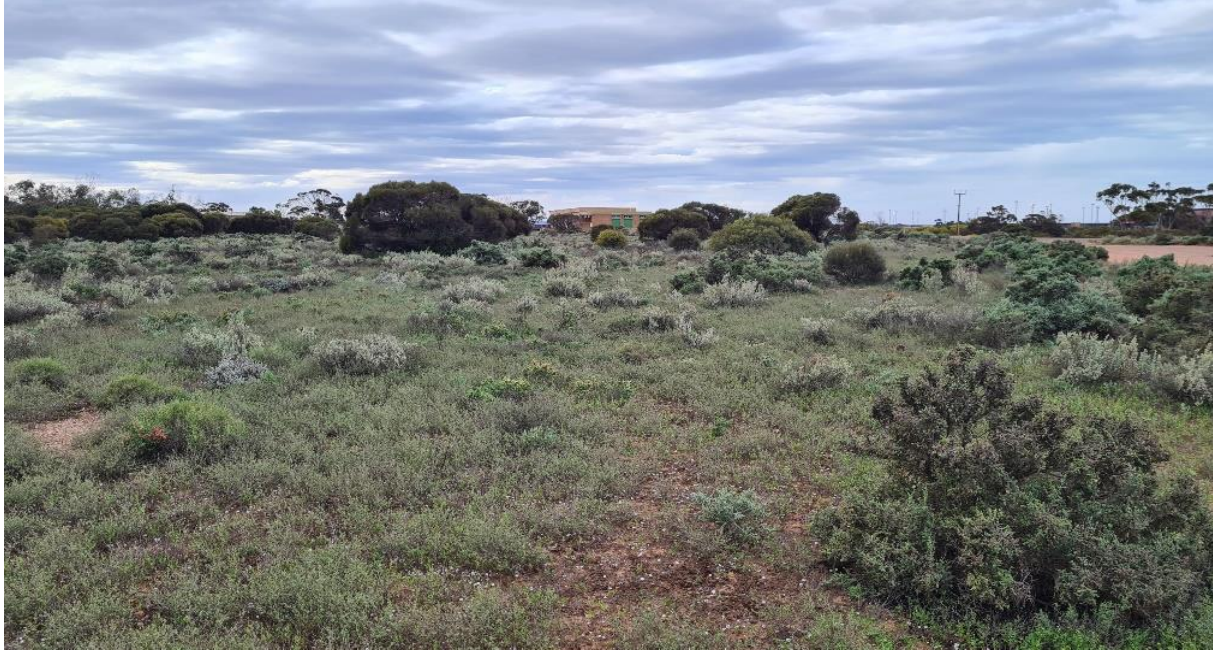
Photo 3 taken facing N at easting: 740780, Northing: 6345505					
General description	Native vegetation within VA6 occurred between the roads and a rail line (see Figure 2). The native vegetation within VA6 contained 26 native species with <i>Acacia papyrocarpa</i> (Western myall) <i>Maireana brevifolia</i> (Short-leaf Bluebush) and <i>Atriplex stipitata</i> (Bitter Saltbush) being the dominant species. Declared weeds present: There were 6 species of declared weeds present in VA4, among these were <i>Avena barbata</i> (Bearded Oat), <i>Carrichtera annua</i> (Ward’s Weed) and <i>Asphodelus fistulosus</i> (Onion Weed )				
Threatened species or community	Threatened species with current occurrence records nearby which may use this as habitat including: Slender-billed Thornbill, Western Grasswren, and Southern Whiteface. Refer to the likelihood of occurrence table (Table 8) for the full assessment.

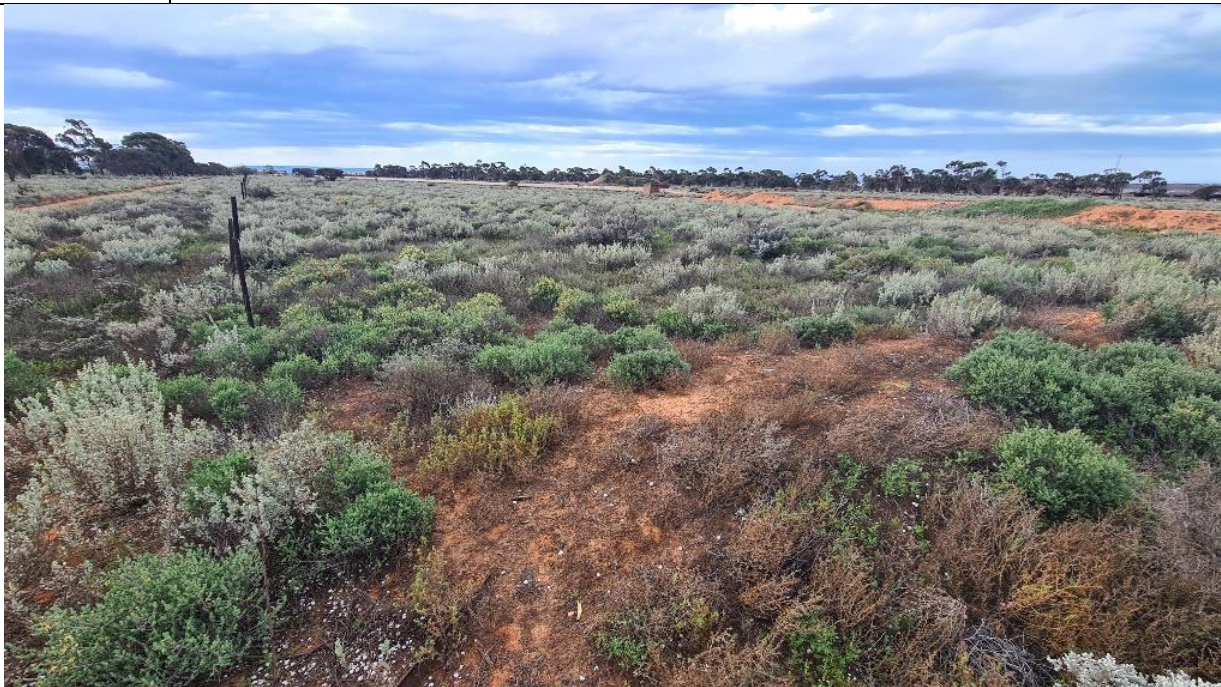
Photo 4 taken facing NE at easting: 741123, Northing: 6347056					
General description	Native vegetation within VA7 occurred between the roads and a rail line (see Figure 2). The native vegetation within VA7 contained 9 native species with <i>Atriplex vesicaria</i> (Bladder Saltbush) being the dominant species. Declared weeds present: <i>Carrichtera annua</i> (Ward's Weed)				
Threatened species or community	Threatened species with current occurrence records nearby which may use this as habitat including: Slender-billed thornbill, Western Grasswren, and Southern Whiteface. Refer to the likelihood of occurrence table (Table 8) ) for the full assessment.				
Landscape context score	1.03	Vegetation Condition Score	30.19	Conservation significance score	1.10
Unit biodiversity Score	34.20	Area (ha)	1.67	Total biodiversity Score	57.11
