Native Vegetation Clearance

Billy Lights Point: Eyre Peninsula Desalination Plant Project Data Report

Clearance under the *Native Vegetation Regulations 2017*

October 2024

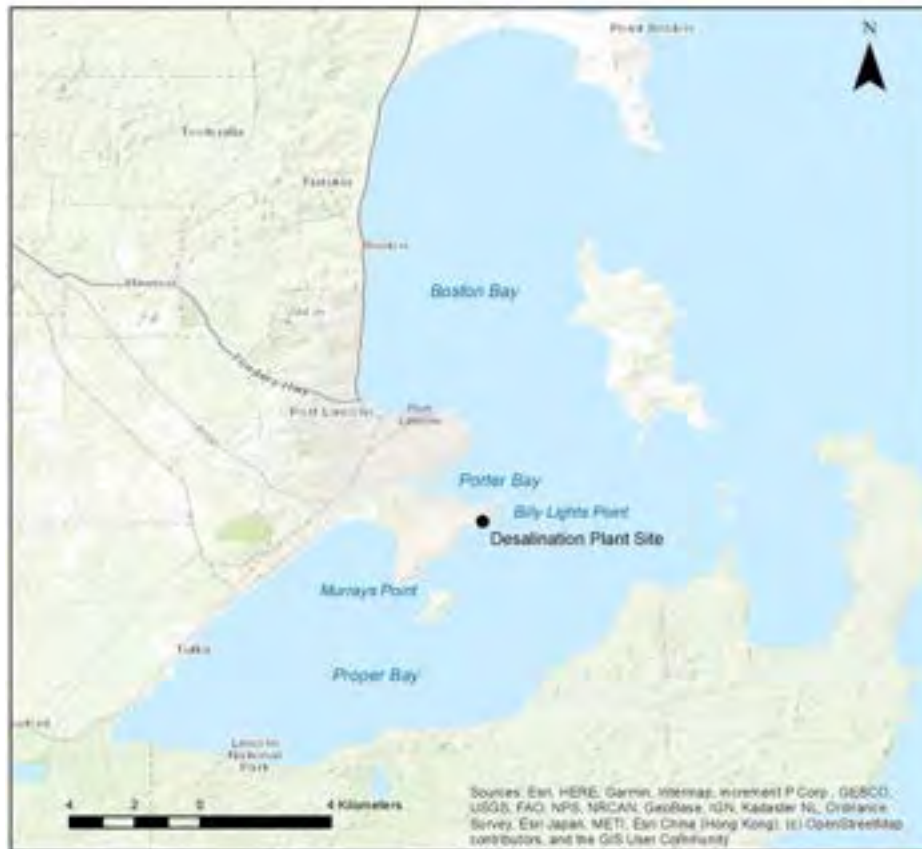
Figure 1. Site Location.

Clearance of native vegetation is required to construct a desalination plant and associated infrastructure at Billy Lights Point at Port Lincoln, South Australia (Figure 1).

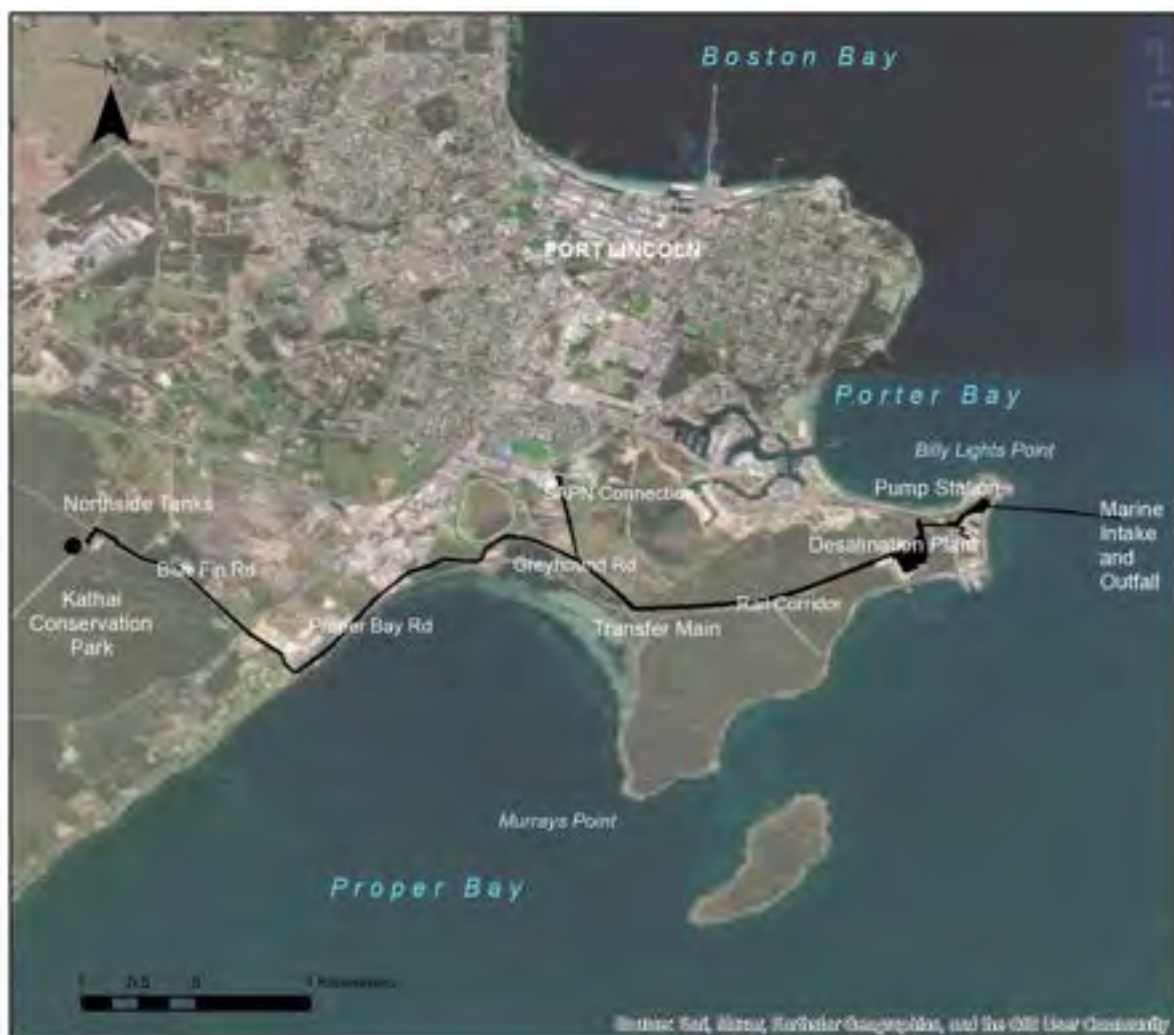
Figure 2. General location map

The desalination plant will be constructed at the former BHP sand depot at Billy Lights Point (Figure 2). A new pipeline will be constructed to transfer drinking water from the plant to existing storage tanks at Northside Hill 4 km south-west of Port Lincoln. Marine transfer pipelines will be constructed from the desalination plant into Proper Bay to provide seawater to the desalination plant and dispose of brine. A pump station will be constructed on the marine intake pipeline within the Port Lincoln Wastewater Treatment Plant. A new electricity connection will be required to supply the plant and will connect to the grid in Port Lincoln.

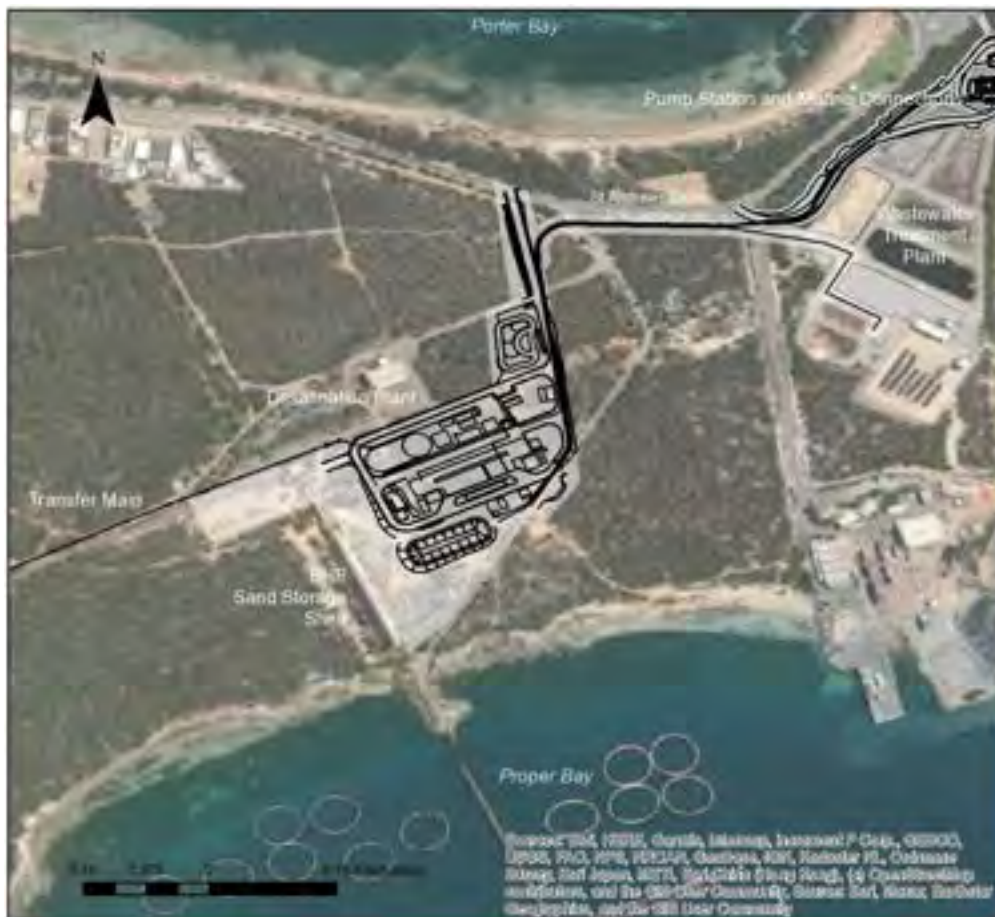
Figure 3. RO Desalination Plant

- RO desalination plant building and associated infrastructure
- Entrance way to join St Andrews Drive to the north
- Treated water pump station
- Site office, shed, chemical storage and dosing areas
- Treated water tank
- Temporary (back up) and two permanent diesel generators (duty), in case of power outage
- Concrete water tank for drinking water
- Electrical switchrooms and high voltage transformers
- Brine tank and brine pit
- Stormwater basin and process lagoon.

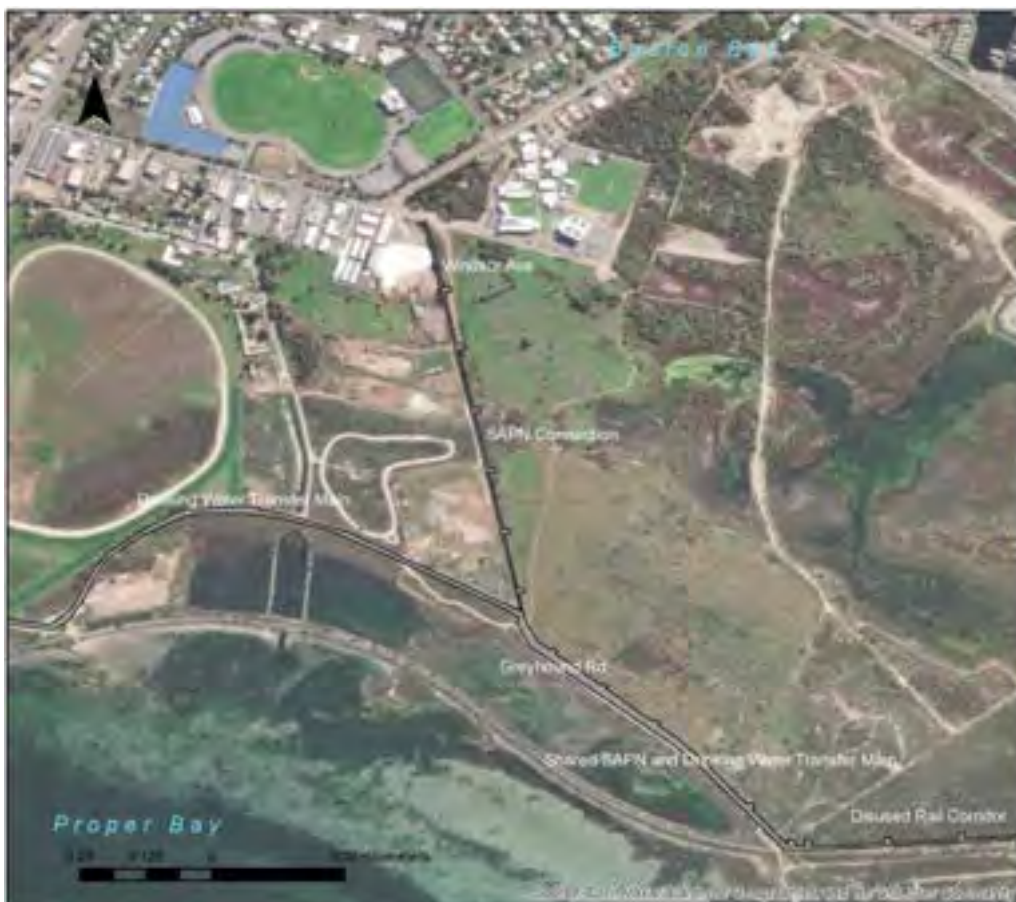
Figure 4. SAPN Connection at Windsor Avenue

The overhead SAPN transmission line would be approximately 3.5 km in length and supported by 32 monopoles up to 13 m high.

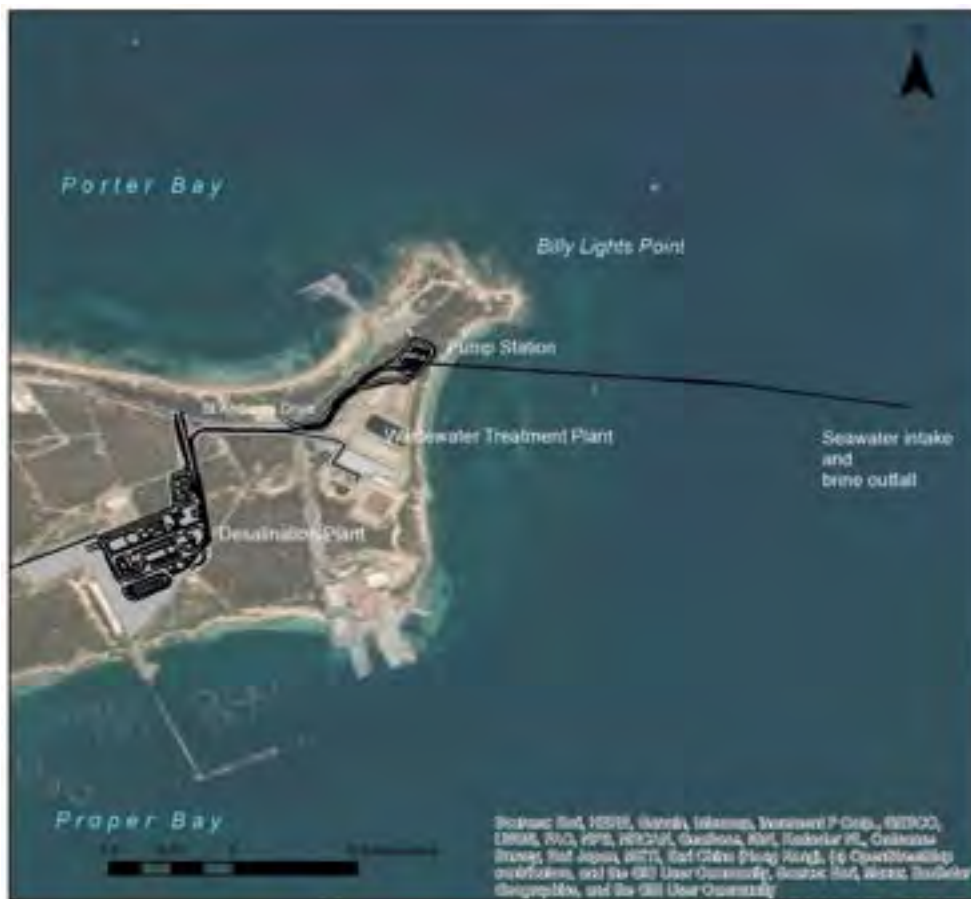
Figure 5. Marine transfer pipelines and pump station

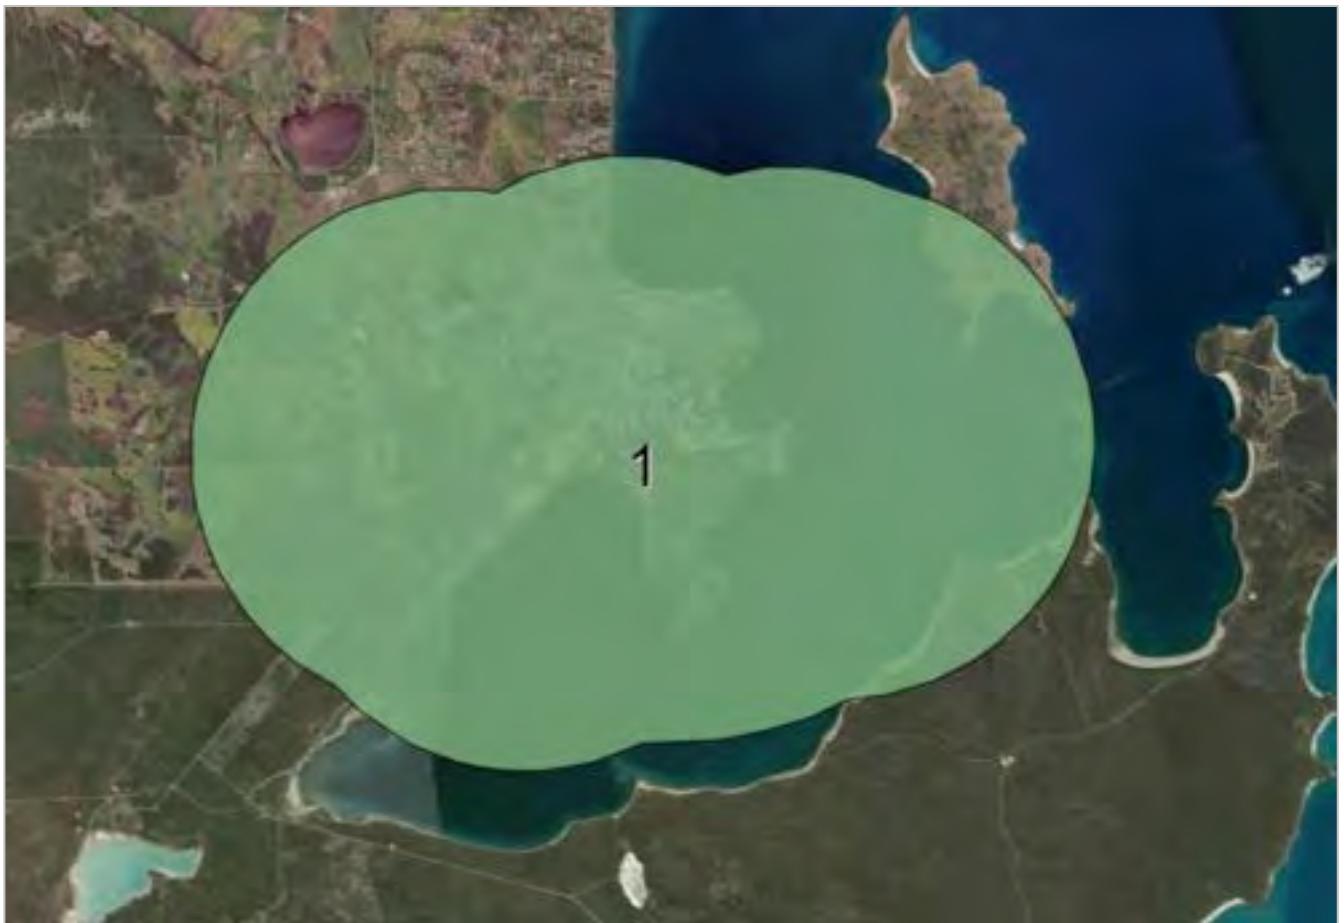
Figure 6. Protected Matters search area following route from Northside tanks near Kathai Conservation Park to the Billy Lights Point Wastewater Treatment Plant, with 5 km buffer.

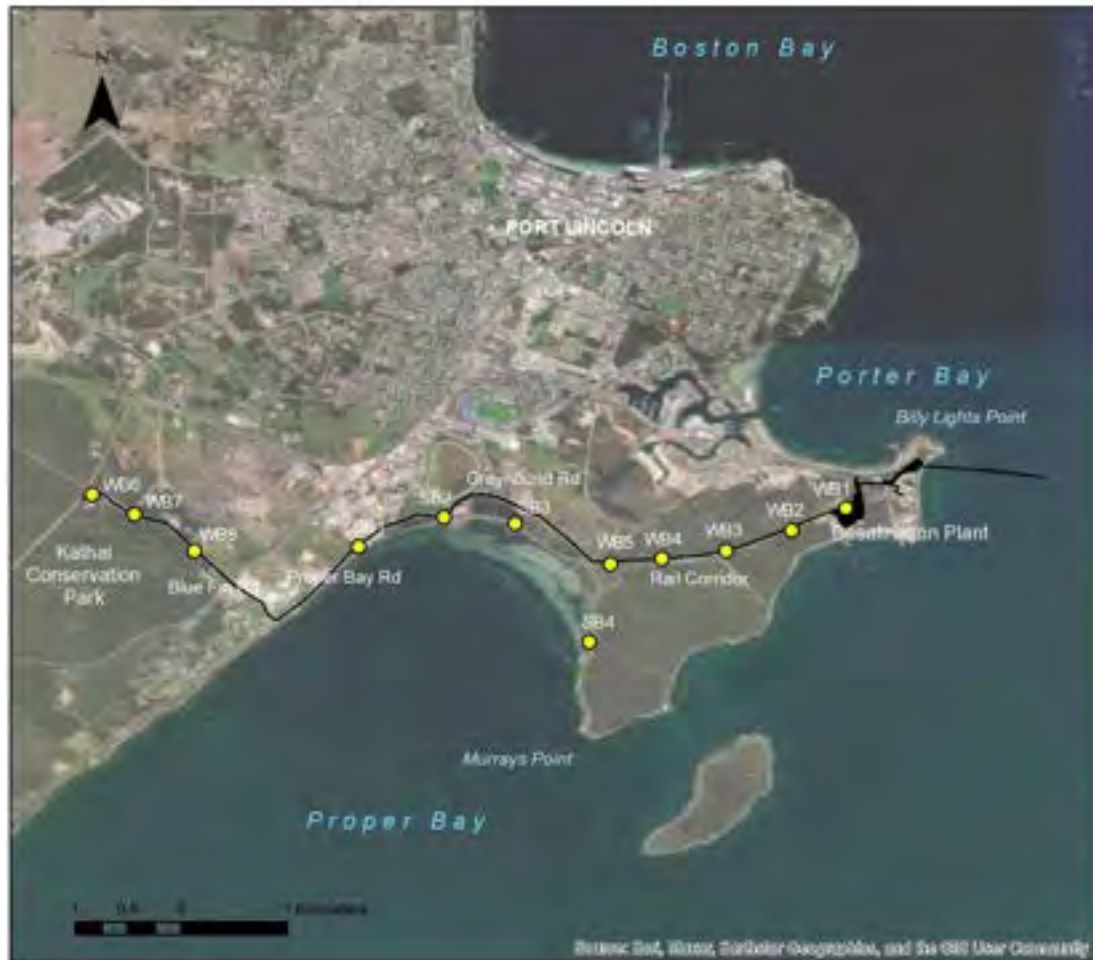
Figure 7. Location of fauna survey sites conducted in December 2023 at 8 woodland (WB) sites and 4 shoreline (SB) sites along the proposed works alignment.

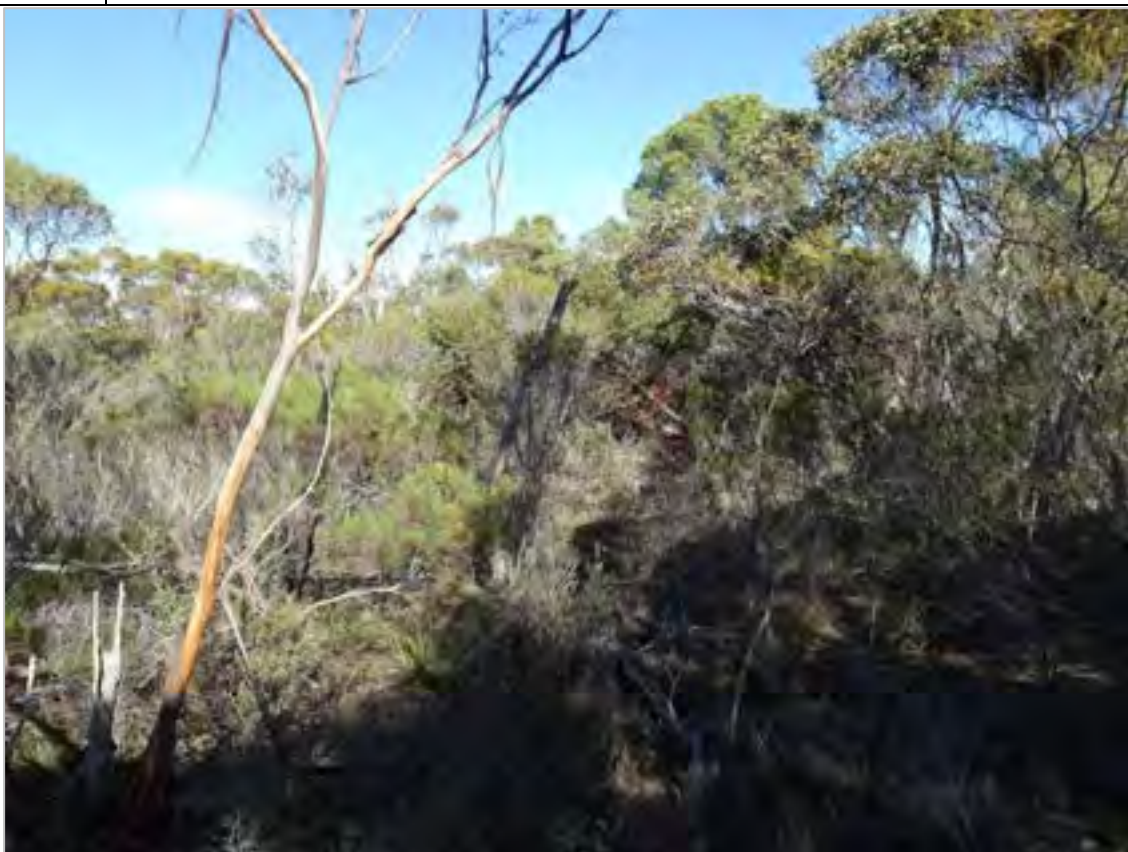
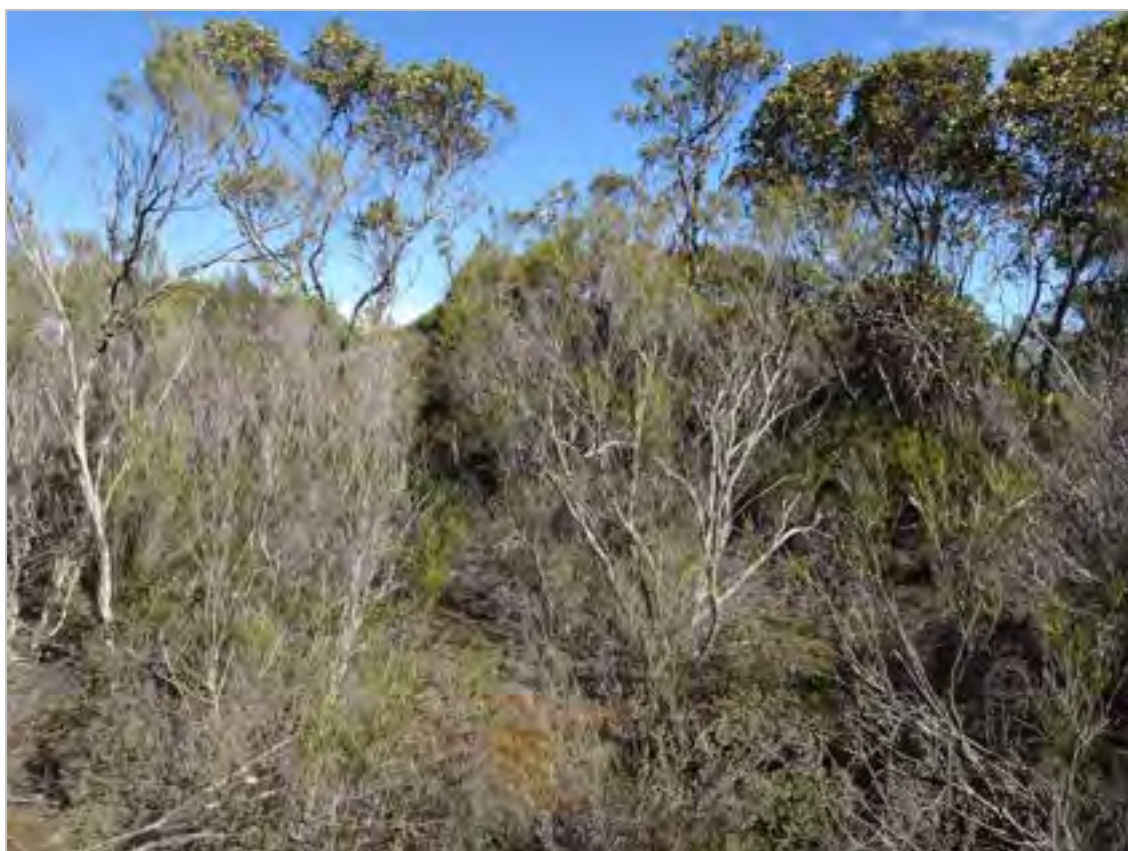
Photo Site 3.1 facing south at 581091, 6154439 (WGS 84 Zone 53).

General description	<p>This vegetation association occurs in lower lying areas in the north-western section of the proposed desalination plant site.</p> <p><i>Melaleuca uncinata</i> (Broombush) and <i>M. lanceolata</i> (Dryland Teatree) become dominant understory species beneath a canopy of <i>Eucalyptus angulosa</i>, <i>E. diversifolia</i> and <i>E. globata</i>. Other common understory species include <i>Gonocarpus mezianus</i> (Broad-leaf Raspwort), <i>Lepidosperma viscidum</i> (Sticky Sword-sedge), <i>Templetonia retusa</i> and <i>Pomaderris flabellaris</i> (Fan Pomaderris). The groundlayer supports a variety of orchid species, including Greenhoods, Mosquitos orchids, Gnat-orchids, Onion orchids, Donkey orchids and Sun-orchids.</p> <p><i>Freesia</i> sp. was the most encountered weed species, with Bridal Creeper, Aleppo Pine, <i>Acacia cyclops</i> (Western Coastal Wattle) and <i>Moraea setifolia</i> (Thread Iris) being minor components of the association.</p> <p>The plant community has a very high diversity of native species, good structural diversity, deep leaf litter and provides good habitat value.</p> <p>The vegetation community is in very good condition.</p>

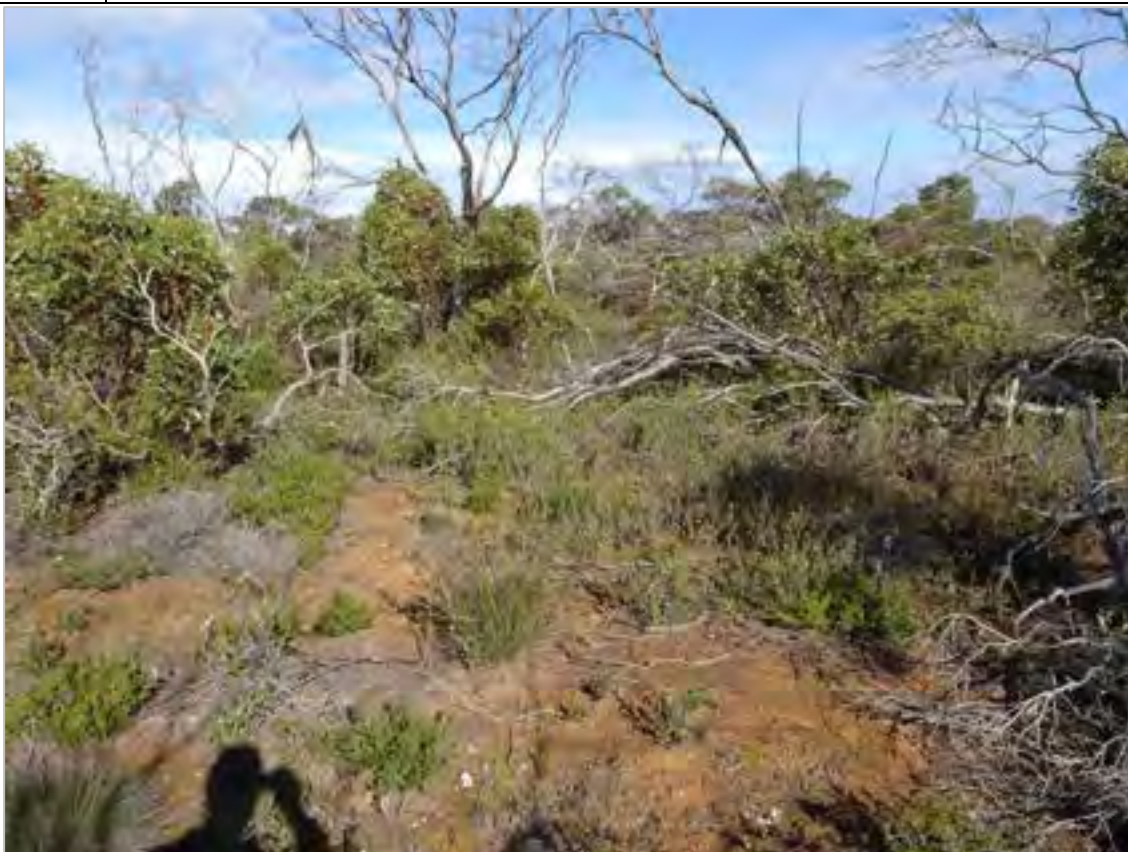
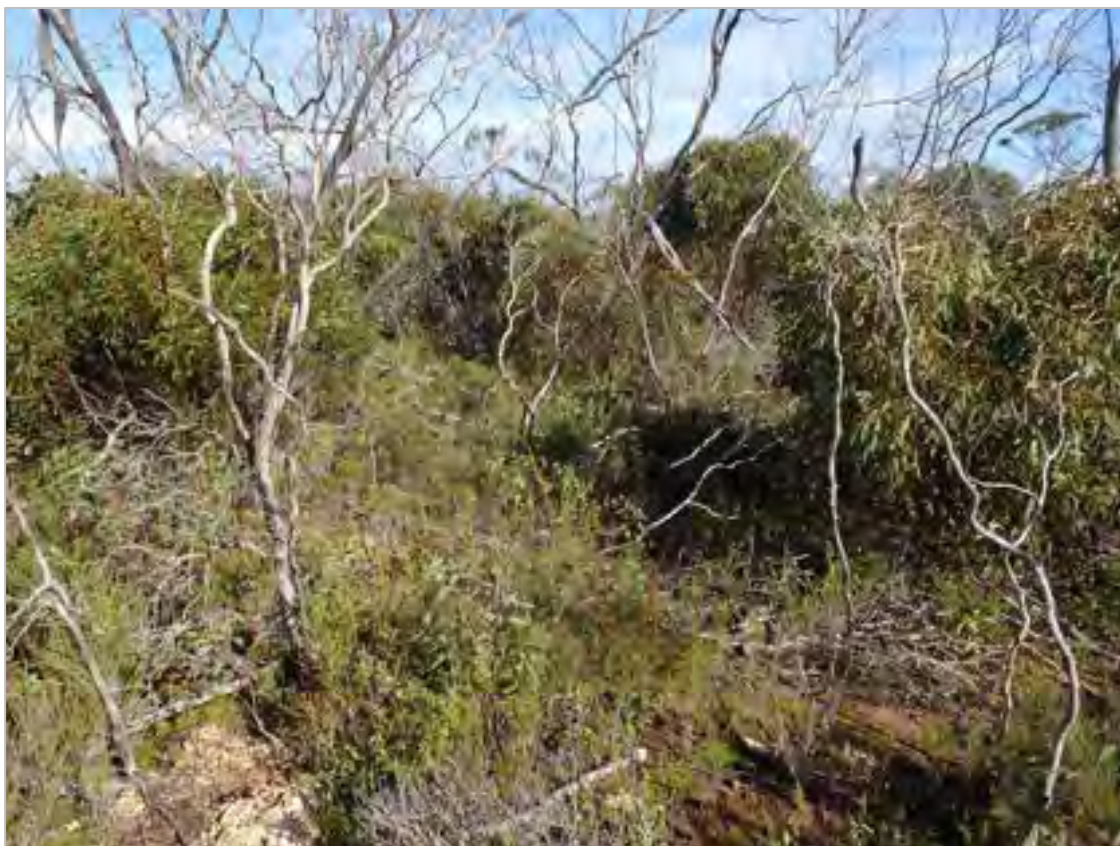
Photo Site 4.1 facing south at 581105, 6154511 (WGS 84 Zone 53).

Photo Site 4.2 facing south at 581118, 6154577 (WGS 84 Zone 53).

General description	<p>Vegetation association 4 occurs along the proposed access route to the north of the desalination plant. <i>Eucalyptus angulosa</i> and <i>E. diversifolia</i> provide the main canopy cover, with <i>E. conglobata</i> and <i>Eucalyptus oleosa ssp. ampliata</i> (Red Mallee) also present. Velvet-bushes (<i>Lasiopetalum</i> spp.), <i>Eutaxia microphylla</i> (Common Eutaxia), <i>Templetonia retusa</i> and <i>Acacia spinescens</i> (Spiny Wattle) are common in the understory. Several species of spring-flowering orchids were observed in the groundlayer.</p> <p>Weed cover is low but includes scattered plants of Bridal Creeper, Myrtle-leaf Milkwort and Western Coastal Wattle.</p> <p>The community has a high diversity of native plant species and is regenerating well after a fire approximately 11 years ago. It is of high habitat value with good structural diversity and fallen timber and debris.</p> <p>The vegetation community is in very good condition.</p>

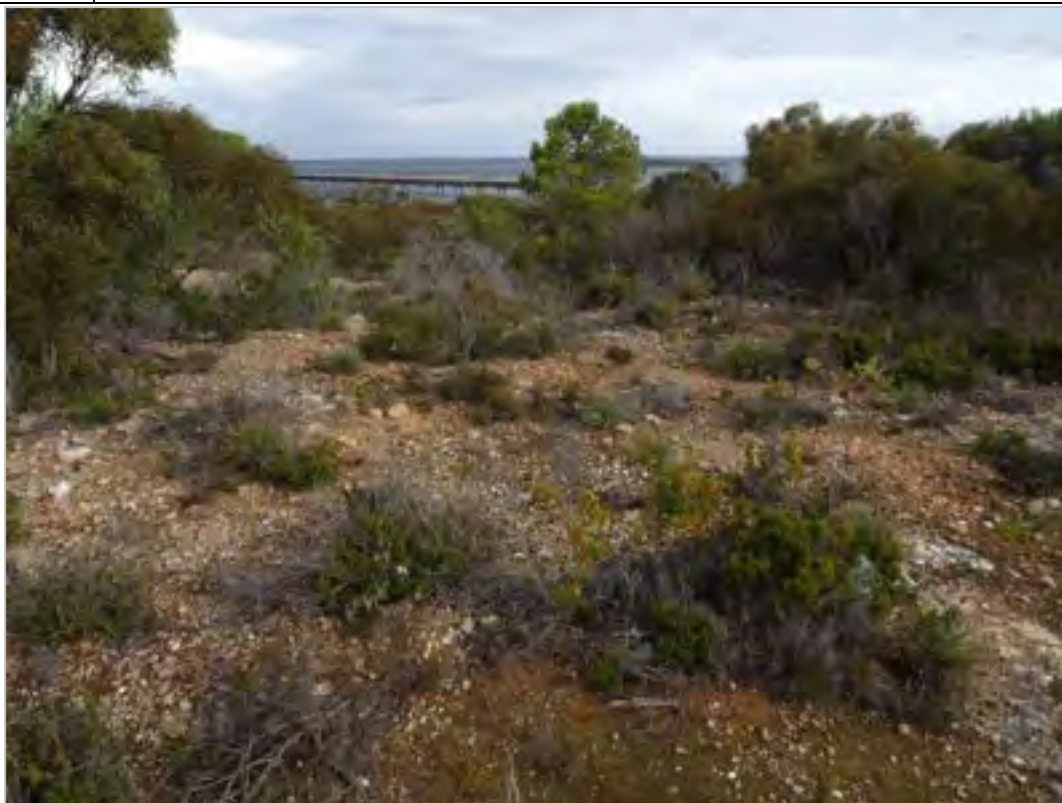
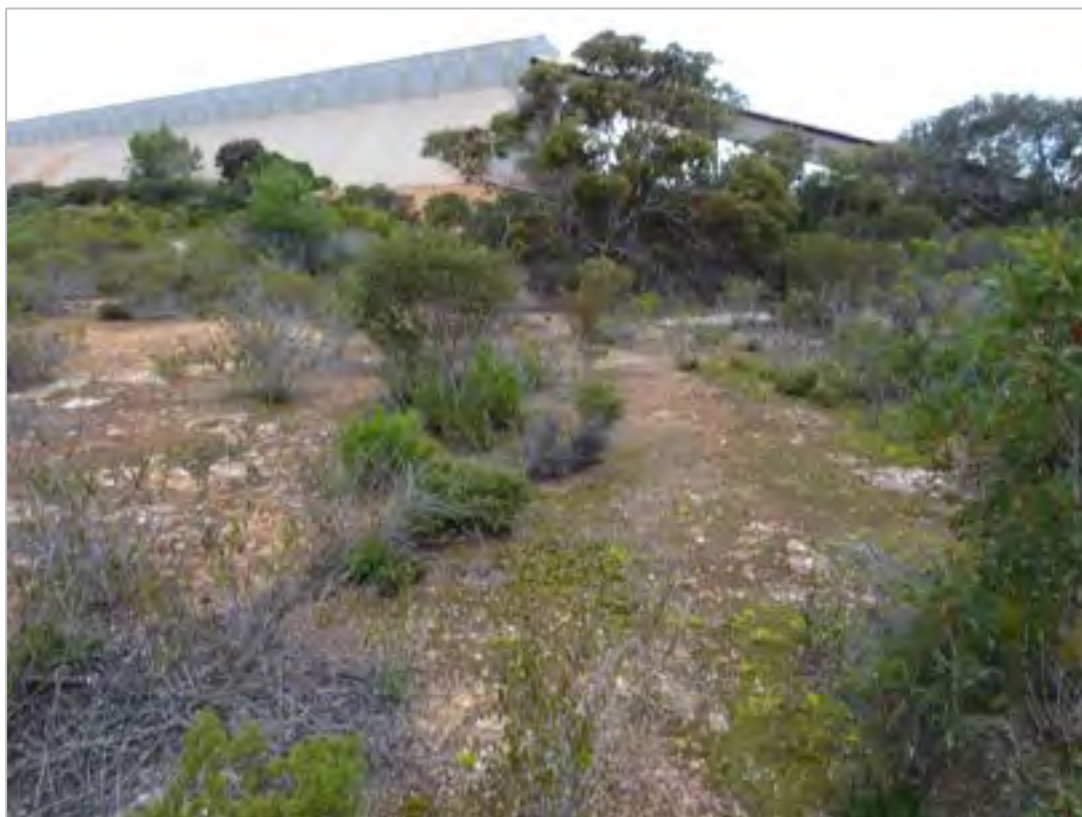
Photo 6.1 facing south at 581133, 6154152 (WGS 84 Zone 53).

Photo Site 6.2 facing south at 580979, 6154257 (WGS 84 Zone 53).

General description	<p>Vegetation association 6 comprises areas where areas where previous clearance has occurred but natural regeneration of the mallee community is occurring.</p> <p>The canopy layer is sparse and dominated by <i>Eucalyptus diversifolia</i> and <i>E. rugosa</i> and the understory supports regenerating shrub species such as <i>Alyxia buxifolia</i> (Sea Box), <i>Templetonia retusa</i> and several species of wattles. Two species of spring-flowering orchids were observed (<i>Caladenia</i> sp. and <i>Microtis</i> sp.).</p> <p>The community has a moderate diversity of native species, represented by shrubs, sedges, vines and grasses.</p> <p>Exotic species include Bridal Creeper, Aleppo Pine, Swamp Oak, Onion Weed and Western Coastal Wattle, each being a minor component of the community.</p> <p>The vegetation community is in moderate condition.</p>				
Threatened species or community	<p><u>State-listed vegetation community:</u> Not considered a threatened ecosystem</p> <p><u>State-threatened flora observed:</u></p> <ul style="list-style-type: none"> State Rare Alcock's Wattle (<i>Acacia alcockii</i>) <p><u>Nationally- and State-threatened fauna that might utilise this vegetation community:</u></p> <ul style="list-style-type: none"> Nationally Vulnerable: Diamond Firetail State Vulnerable: Yellow-tailed Black Cockatoo State Rare: Purple-gaped Honeyeater, Elegant Parrot, Western Gerygone, Shy Heathwren, Peregrine Falcon and Rock Parrot. <p>The Rock Parrot was observed within this vegetation association. The State Endangered Eastern Osprey and White-bellied Sea Eagle occur nearby, but vegetation at the site is not their preferred nesting habitat.</p> <p>The State Rare Bush Stone-curlew, White-winged Chough and Painted Buttonquail have been recorded within 5 km of the site but are unlikely to use degraded habitats with little leaf litter.</p>

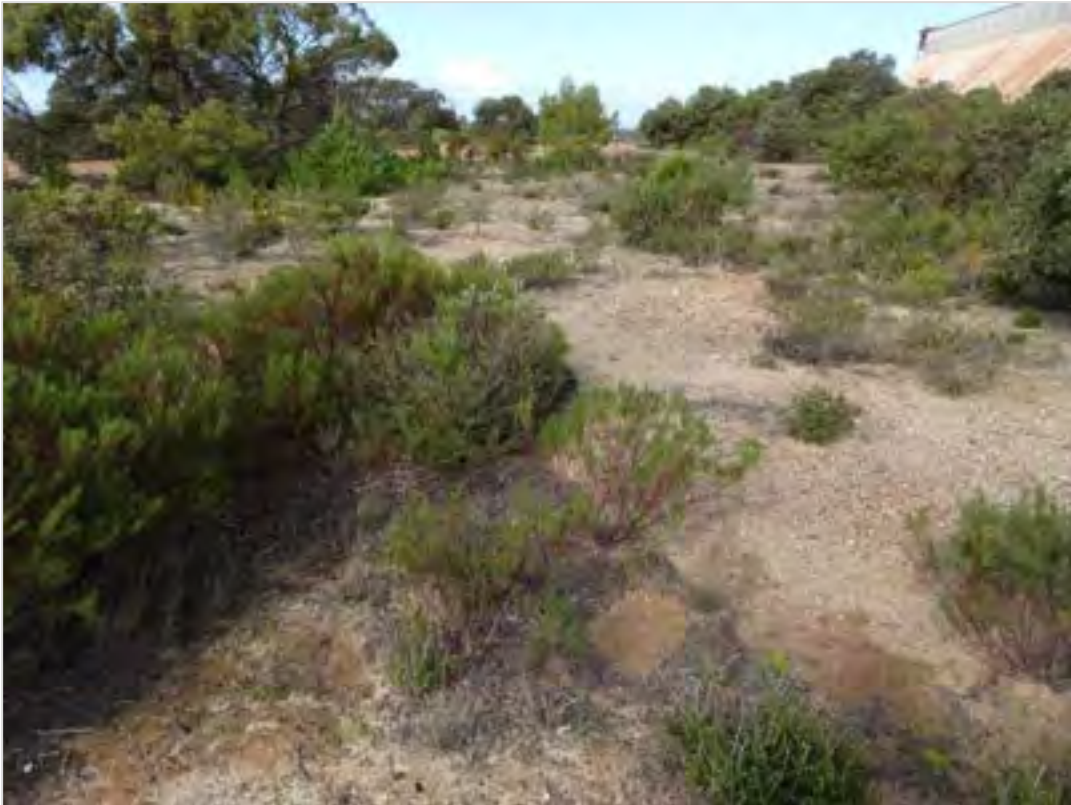
Photo Site 6a facing south at 580988, 6154224 (WGS 84 Zone 53).				
General description	<p>This plant community is a more degraded version of vegetation association 6, occurring in the vicinity of the existing infrastructure at the site and along the southern road verge of St Andrews Drive.</p> <p>Both the canopy and shrub layers are sparser due to previous clearance and disturbance, but several species are naturally regenerating.</p> <p>The vegetation community is in poor to moderate condition.</p>				
Threatened species or community	<p>State-listed vegetation community: Not considered a threatened ecosystem</p> <p>State-threatened flora observed:</p> <ul style="list-style-type: none">State Rare Alcock's Wattle (<i>Acacia alcockii</i>) <p>Nationally- and State-threatened fauna that might utilise this vegetation community:</p> <ul style="list-style-type: none">Nationally Vulnerable: Diamond FiretailState Vulnerable: Yellow-tailed Black CockatooState Rare: Purple-gaped Honeyeater, Elegant Parrot, Western Gerygone, Rock Parrot, Peregrine Falcon <p>The State Endangered Eastern Osprey and White-bellied Sea Eagle occur nearby, but vegetation at the site is not their preferred nesting habitat.</p> <p>The State Rare Bush Stone-curlew, White-winged Chough and Painted Buttonquail have been recorded within 5 km of the site but are unlikely to rely on this plant community.</p>

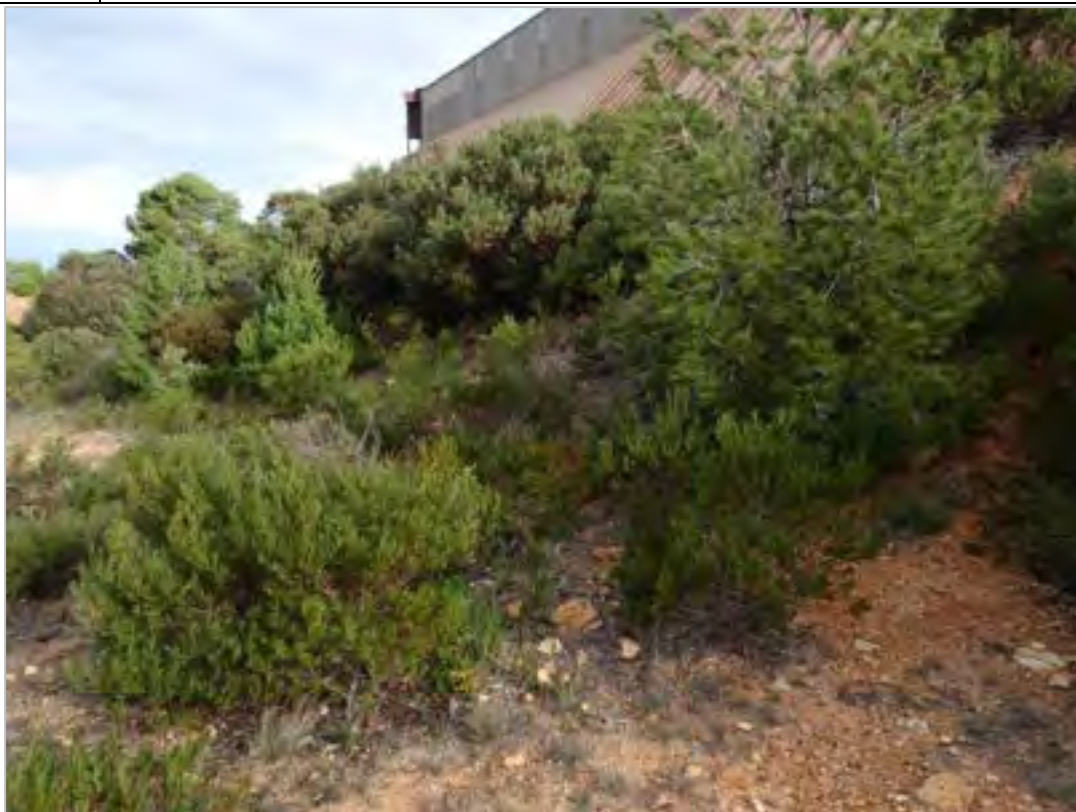
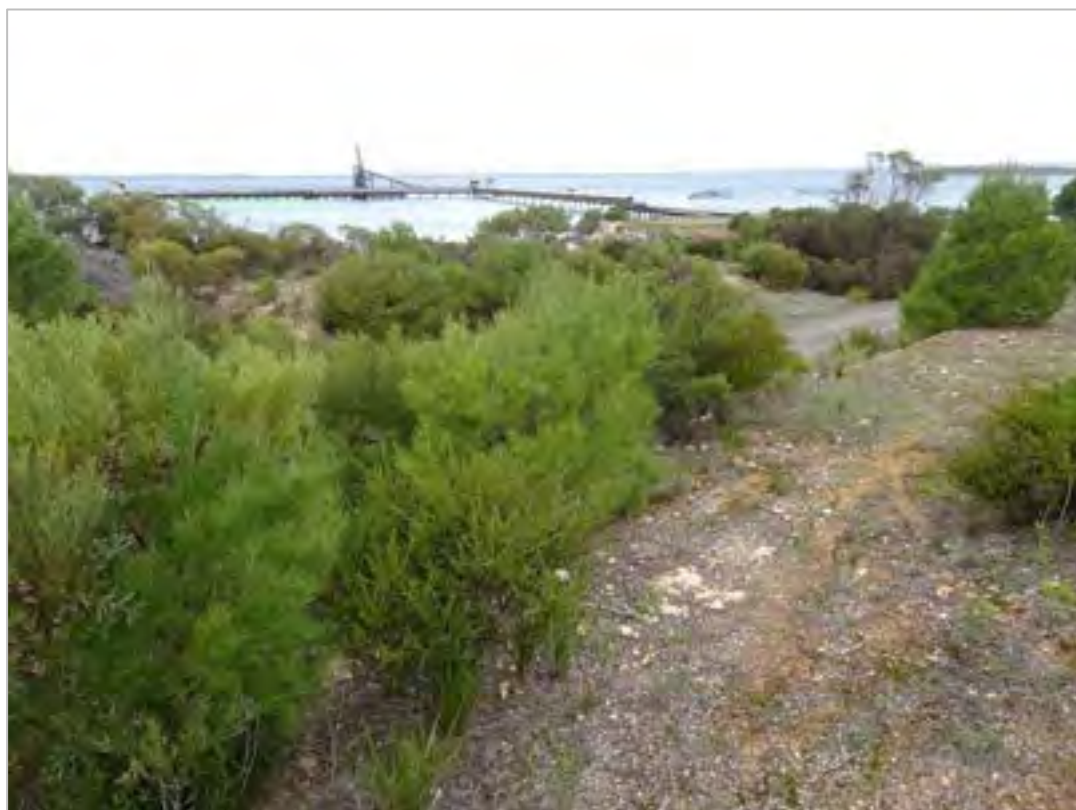
Photo Site 7.1, facing south at 581000, 6154136 (WGS 84 Zone 53).

General description	<p>This plant community occurs in highly disturbed areas adjacent to the disused BHP shed and associated tracks and infrastructure. It has been cleared in the past and is now dominated by exotic trees and shrubs (Western Coastal Wattle, Aleppo Pine, <i>Rhamnus alaternus</i> (Blowfly Bush) and <i>Lycium ferocissimum</i> (African Boxthorn)).</p> <p>Although sparse, the understory supports a medium diversity of regenerating native species including <i>Eucalyptus diversifolia</i> (Coastal White Mallee), several <i>Acacia</i> species, <i>Pomaderris obcordata</i> (Wedge-leaf Pomaderris), <i>Templetonia retusa</i> (Cockies Tongue), <i>Carpobrotus rossii</i> (Native Pigface), and a variety of small shrubs, forbs and grasses.</p> <p>The vegetation community is in poor to moderate condition.</p>				
Threatened species or community	<p><u>State-listed vegetation community:</u> Not considered a threatened ecosystem</p> <p><u>State-threatened flora observed:</u></p> <ul style="list-style-type: none"> State Rare Port Lincoln Mallee (<i>Eucalyptus globata</i>) <p><u>Nationally- and State-threatened fauna that might utilise this vegetation community:</u></p> <ul style="list-style-type: none"> Nationally Vulnerable: Diamond Firetail State Vulnerable: Yellow-tailed Black Cockatoo State Rare: Purple-gaped Honeyeater, Elegant Parrot, Western Gerygone, Rock Parrot, Peregrine Falcon. <p>Given the poor condition of the vegetation and limited structural diversity it is unlikely to provide important habitat for most of these species.</p> <p>The State Endangered Eastern Osprey and White-bellied Sea Eagle occur nearby, but vegetation at the site is not their preferred nesting habitat.</p> <p>The State Rare Bush Stone-curlew, White-winged Chough and Painted Buttonquail have been recorded within 5 km of the site but are unlikely to rely on this plant community.</p>

Landscape context score	1.12	Vegetation Condition Score	34.25	Conservation significance score	1.12
Unit biodiversity Score	42.97	Area (ha)	Permanent: 0.0317 Rehabilitate: 0.1275	Total biodiversity Score	Permanent: 1.36 Rehabilitate: 5.48

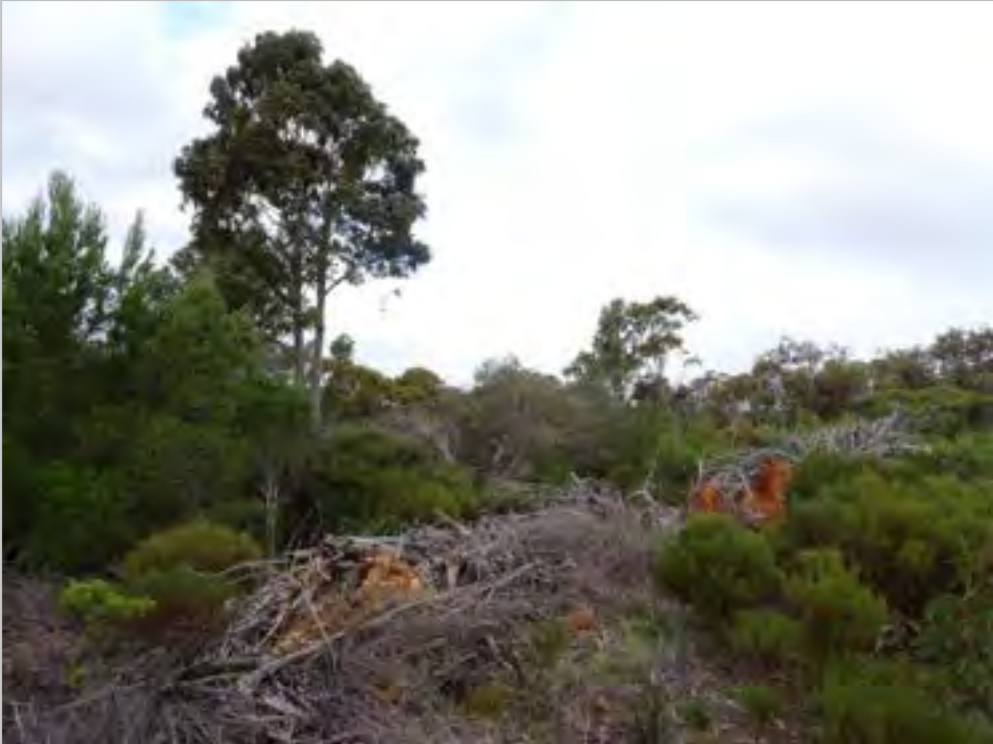
<p><i>Photo Site 8, facing south-east at 581036, 6154416 (WGS 84 Zone 53).</i></p>				
General description	<p>Plant association 8 occurs adjacent to an old shed and a section of the southern road verge along St Andrews Drive. It compromises areas where some planting has been undertaken with non-indigenous <i>Eucalyptus</i> species but there is natural regeneration occurring underneath.</p> <p>The community supports a medium diversity of native species including regenerating <i>Eucalyptus diversifolia</i> (Coastal White Mallee) and <i>E. conglobata</i> (Port Lincoln Mallee), as well as several species of <i>Acacia</i>. The understory comprises a variety of shrubs (e.g. <i>Lasiopetalum</i> spp. (Velvet-bushes), <i>Acrotriche</i> spp. (Ground-berries)), vines, daisies and native grasses.</p> <p>Exotic species are a significant component and include <i>Aleppo Pine</i>, Bridal Creeper, Myrtle-leaf Milkwort, <i>Scabiosa atropurpurea</i> (Pincushion) and <i>Piptatherum miliaceum</i> (Rice Millet).</p> <p>The vegetation community is in poor to moderate condition.</p>

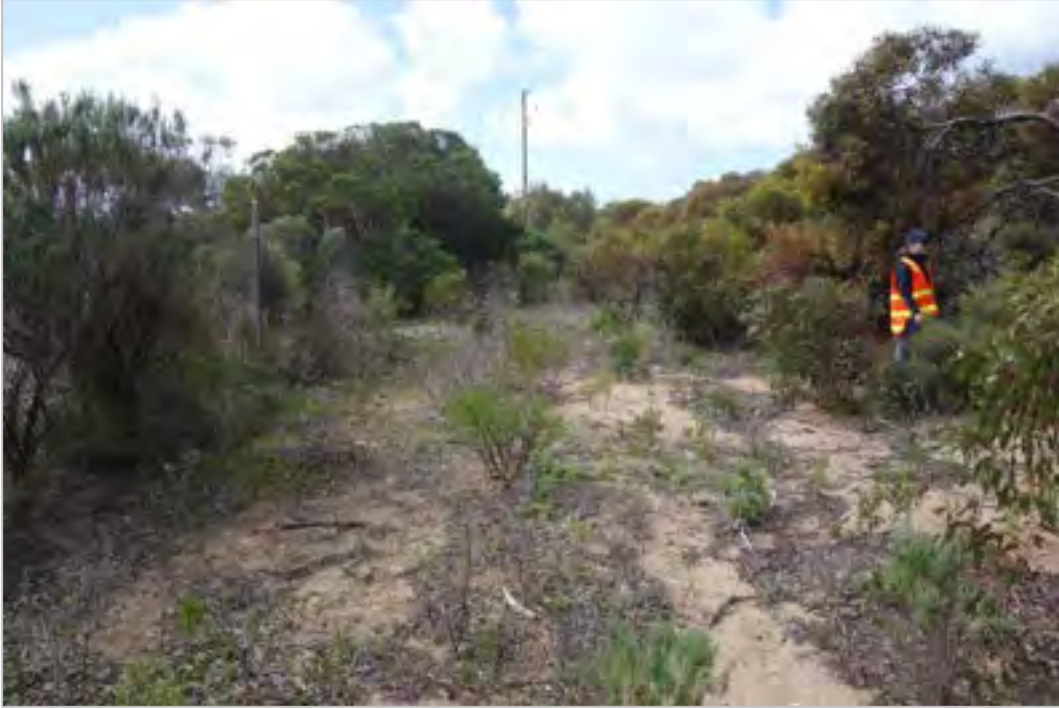
Photo 457, facing east along fenceline at waypoint 1053, Latitude -34.74772/ Longitude 135.888694					
General description	<p>Plant association 9a occurs on an SA Water easement on the southern side of St. Andrews Drive linking the desalination plant with the marine pump station.</p> <p>An ~8 m strip of vegetation inside the boundary fence has been cleared and/or slashed, and comprises a regenerating <i>Eucalyptus rugosa</i> mallee over a sclerophyllous shrublayer dominated by <i>Acacia nematophylla</i> (Coast Wallowa), <i>Pimelea serpyllifolia</i> (Thyme Riceflower), <i>Lasiopetalum discolor</i> and <i>Templetonia retusa</i>. The community lacks a tall canopy and shrub layer, and the understory is often sparse, however the diversity of native plant species is relatively high with many regenerating. Other lifeforms present include vines (<i>Cassytha melantha</i>), mat plants (<i>Carpobrotus rossii</i>, <i>Tetragonia implexicoma</i>), sedge-like plants (<i>Dianella brevicaulis</i>), and grasses (<i>Austrostipa elegantissima</i>).</p> <p>The introduced Western Coastal Wattle and Soursob occur throughout the community. Other high-risk weeds such as Bridal Creeper, African Boxthorn and Aleppo Pine are mostly present near the western and eastern boundary fences.</p> <p>Plant association 9a is in moderate condition.</p>

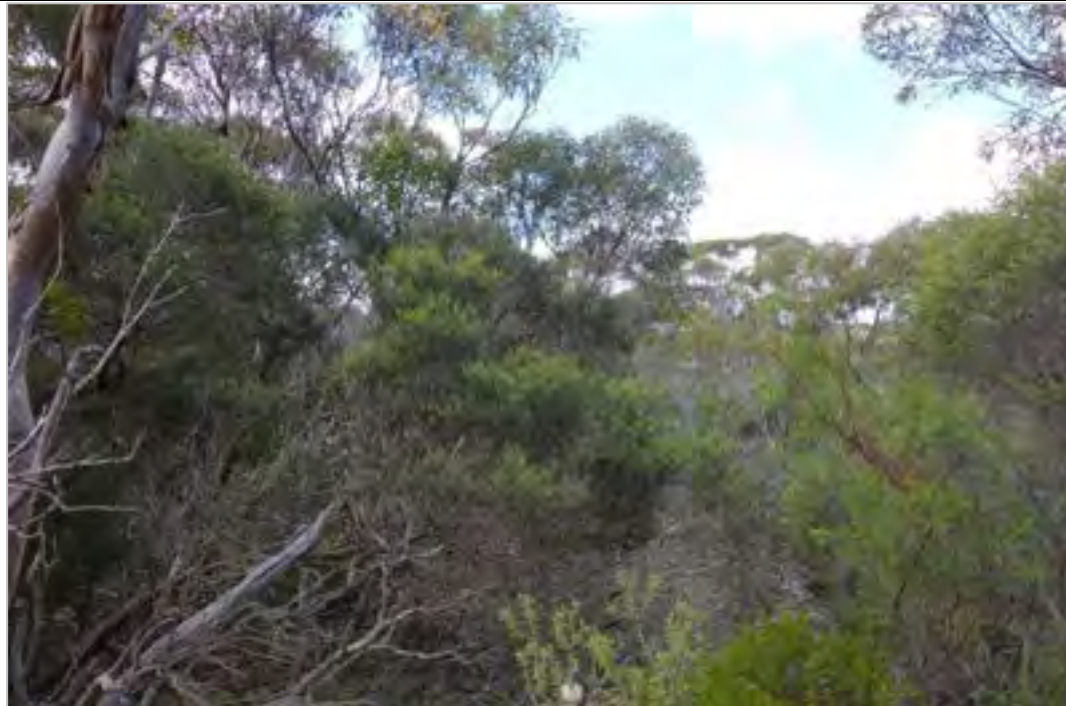
Photo 467, facing east at waypoint 1055, Latitude -34.747875/ Longitude 135.887828					
General description	<p>Plant association 9b extends south of association 9a where dense overstory and shrub layers have been retained. <i>Eucalyptus rugosa</i> is the dominant canopy species over tall shrubs of <i>Melaleuca lanceolata</i> and <i>M. acuminata</i>.</p> <p>The community supports a similar suite of understory flora, but includes additional species and lifeforms such as <i>Pomaderris obcordata</i>, <i>Comesperma calymega</i> (Blue-spike Milkwort), <i>Pittosporum angustifolium</i> (Native Apricot), <i>Amyema melaleucae</i> (Tea-tree Mistletoe) and <i>Cyrtostylis</i> spp. (Gnat Orchid). Habitat features such as fallen logs and deep leaf litter provide additional structural diversity.</p> <p>The introduced Western Coastal Wattle, Soursob, Bridal Creeper and Rice Millet occur throughout the community, with scattered individuals of Aleppo Pine also present.</p> <p>Plant association 9b is in moderate to good condition.</p>

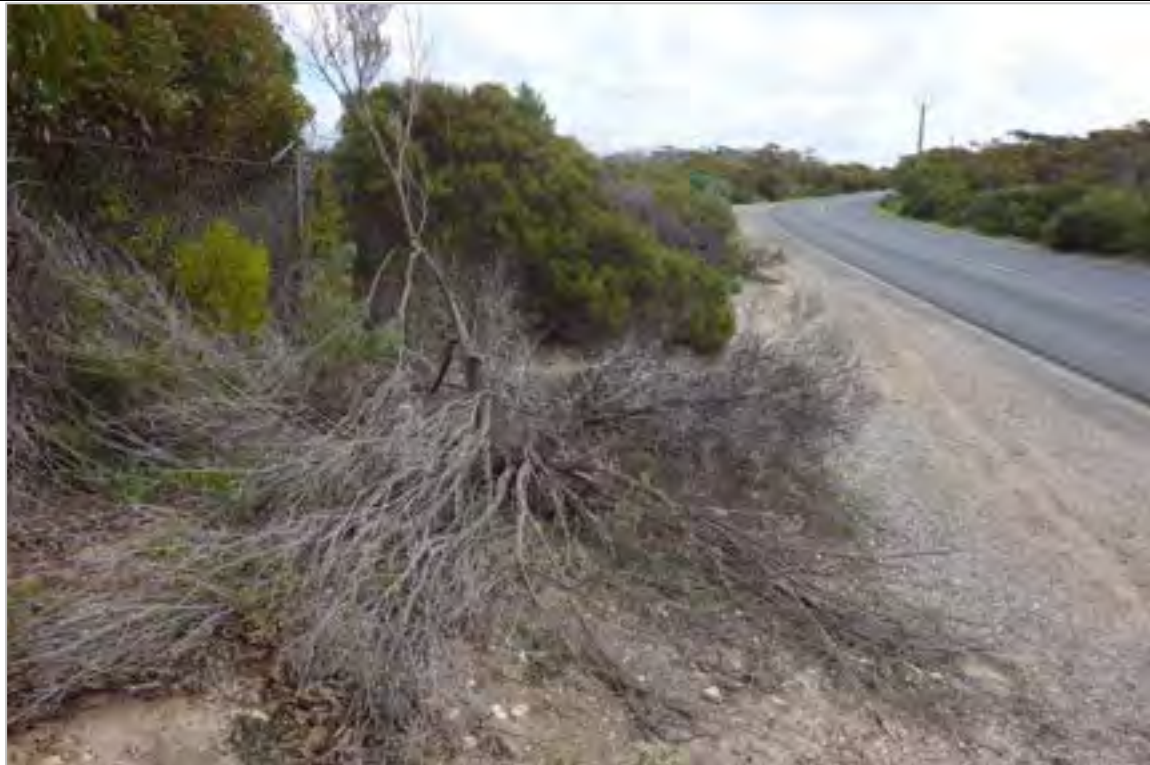
Photo 469, facing west at waypoint 1057, Latitude -34.747673/ Longitude 135.887378					
General description	<p>Plant association 9c is a highly degraded mallee community growing within the roadside reserve on the southern side of St Andrews Drive.</p> <p><i>Eucalyptus rugosa</i> is present as highly scattered individuals, with the predominant canopy structure provided by the introduced Western Coastal Wattle.</p> <p>The ground layer is highly disturbed and sparse and dominated by <i>Acacia nematophylla</i> and <i>Olearia axillaris</i>. Other native species include <i>Myoporum insulare</i> (Common Boobiella), <i>Correa pulchella</i> (Salmon Correa), <i>Rhagodia candolleana</i>, <i>Alyxia buxifolia</i>, <i>Pimeala serpyllifolia</i> and <i>Cassytha melantha</i>, many of which are regenerating.</p> <p>High-risk weeds present in the community include Bridal Creeper, <i>Juncus acutus</i> (Spiny Rush), Onion Weed, Soursob, African Daisy and Rice Millet.</p> <p>Plant association 9c is in poor condition.</p>
