Native Vegetation Clearance

Billy Lights Point: Eyre Peninsula Desalination Plant Project Data Report

Clearance under the *Native Vegetation Regulations 2017*

October 2024

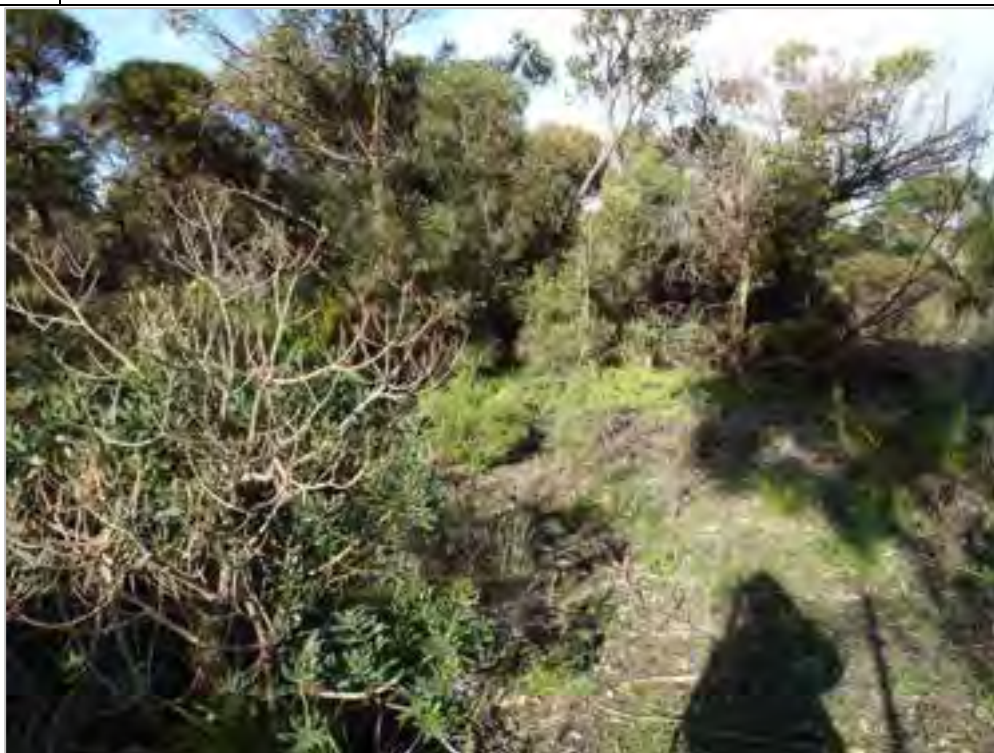
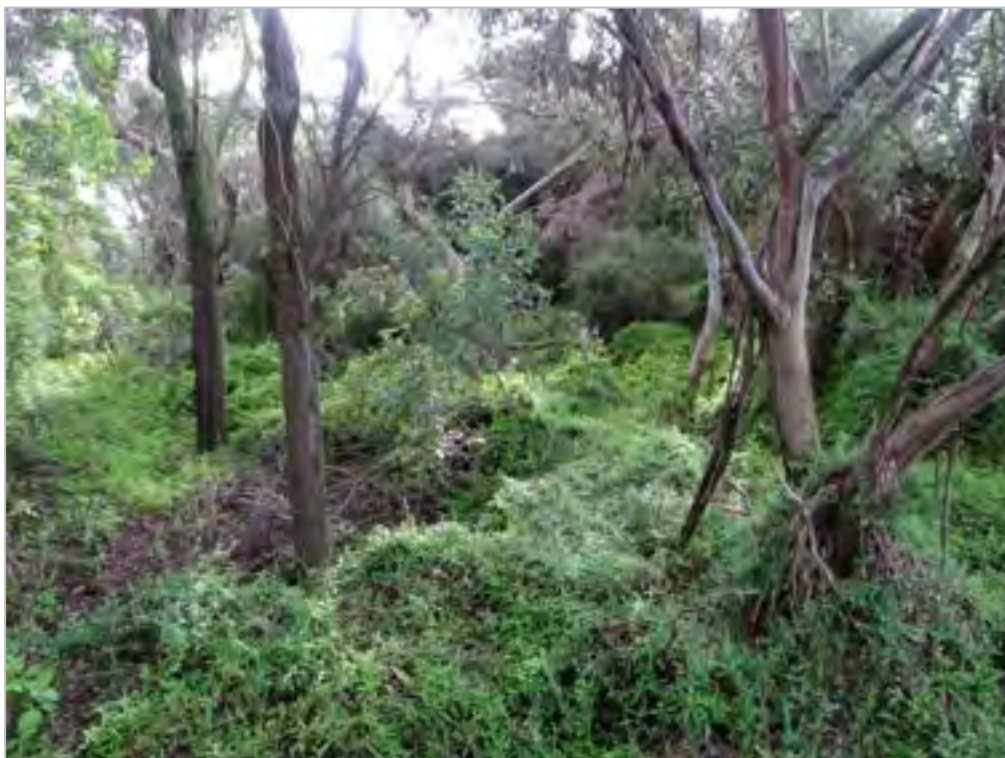
Photo Site WW1.1, facing south at 581384, 6154601 (WGS 84 Zone 53).

General description	<p>This plant community occurs along the northern, western and southern edges of the Wastewater Treatment Plant. The overstorey is principally <i>Eucalyptus diversifolia</i> (Coastal White Mallee) and <i>E. rugosa</i> (White Mallee), with scattered patches of <i>E. albopurpurea</i> (Purple-flowered Mallee Box) and scattered emergent planted Eucalypt species. The principal dominants in the understory are <i>Melaleuca lanceolata</i> (Dryland Tea-tree) and <i>Myoporum insulare</i> (Common Boobialla). There are small, lower lying sections where water accumulates during winter, and moisture-loving species such as <i>Melaleuca brevifolia</i> (Short-leaf Honey-myrtle) and <i>Atriplex paludosa ssp. cordata</i> (Marsh Saltbush) occur. Vine lifeforms, such as <i>Tetragonia implexicoma</i> (Bower Spinach), <i>Cassytha melantha</i> (Coarse Dodder-laurel), <i>Clematis microphylla</i> (Old Man's Beard) and <i>Comesperma volubile</i> (Love Creeper) are prominent features of this vegetation.</p> <p>The most abundant weed species are African Boxthorn and <i>Oxalis pes-caprae</i> (Soursob), with <i>Juncus acutus</i> (Spiny Rush) and <i>Watsonia</i> sp. present as minor components.</p> <p>The vegetation community is in moderate to good condition.</p>

Threatened species or community	<p><u>State-listed vegetation community:</u> No</p> <p><u>State-threatened flora observed:</u></p> <ul style="list-style-type: none"> State Rare Alcock's Wattle (<i>Acacia alcockii</i>) <p><u>Nationally- and State-threatened fauna that might utilise this vegetation community:</u></p> <ul style="list-style-type: none"> State Endangered: White-bellied Sea Eagle State Vulnerable: Yellow-tailed Black Cockatoo, Brown Quail State Rare: Purple-gaped Honeyeater, Elegant Parrot, White-winged Chough, Western Gerygone, Shy Heathwren, Rock Parrot, Peregrine Falcon and Painted Buttonquail. <p>The State Endangered Eastern Osprey has been recorded nearby, but vegetation at the site is not preferred habitat.</p> <p>The Nationally Vulnerable Diamond Firetail and State Rare Bush Stone-curlew have been recorded within 5 km of the site but prefer more open habitats and are unlikely to use this plant community.</p>

Landscape context score	1.12	Vegetation Condition Score	46.71	Conservation significance score	1.12
Unit biodiversity Score	58.59	Area (ha)	Permanent: 0.7269 Rehabilitate: 0.2036	Total biodiversity Score	Permanent: 42.59 Rehabilitate: 11.93

Infrastructure and paved areas occupy most of the Wastewater Treatment Plant site and remnant vegetation is mostly limited to the edges of the site. Along the northern, western and southern perimeter (Site WW1), the overstorey is principally *E. diversifolia* and *E. rugosa* with scattered patches of *E. albopurpurea* and scattered emergent planted eucalypt species. The principal dominants in the understorey are *M. lanceolata* and *Myoporum insulare*. There are small, lower lying sections where water accumulates during winter, and moisture-loving species such as *Melaleuca brevifolia* and *Atriplex paludosa* occur. Vine lifeforms, such as *Tetragonia implexicoma*, *Cassytha melantha*, *Clematis microphylla* and *Comesperma volubile* are prominent features of this vegetation.

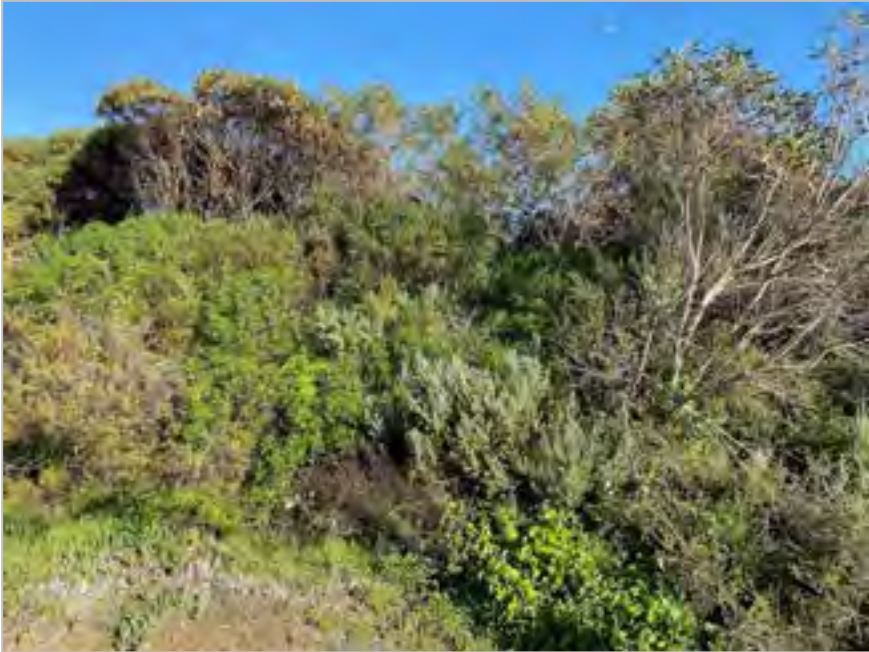
<p><i>Photo Site WW4.1 7146 facing west at Latitude -34.78552 / Longitude 135.891395</i></p>				
General description	<p>Vegetation association WW4 occurs along the coast east of the Wastewater Treatment Plant sedimentation ponds. The overstorey becomes dominated by <i>Eucalyptus diversifolia</i> and <i>E. conglobata</i> with scattered <i>E. oleosa</i>, <i>E. angulosa</i> and emergent <i>E. leptophylla</i>. <i>Myoporum insulare</i>, <i>Olearia axillaris</i>, <i>Templetonia retusa</i> and <i>Leocopogon parviflorus</i> shrubs along with <i>Tetragonia implexicoma</i> and <i>Threlkeldia diffusa</i> (Coast Bonefruit) are prominent features of the dense understory and groundlayer. The mallee thins out along the coastal frontage where sedges such as <i>Gahnia deusta</i>, <i>Lepidospermum viscidum</i> and <i>Ficinia nodosa</i>, and tussocks of <i>Austrostipa stipoides</i> grow amongst the shrublayer.</p> <p>Bridal Creeper occurs throughout the understory, but other weed species are a minor component and include very sparse individuals of African Boxthorn and African Daisy. Soursob grows mostly along the edges of the walkway.</p> <p>The plant association has a medium to high diversity of native species including many regenerating species, very high structural diversity, and moderate weed cover.</p> <p>The vegetation community is in good condition.</p>

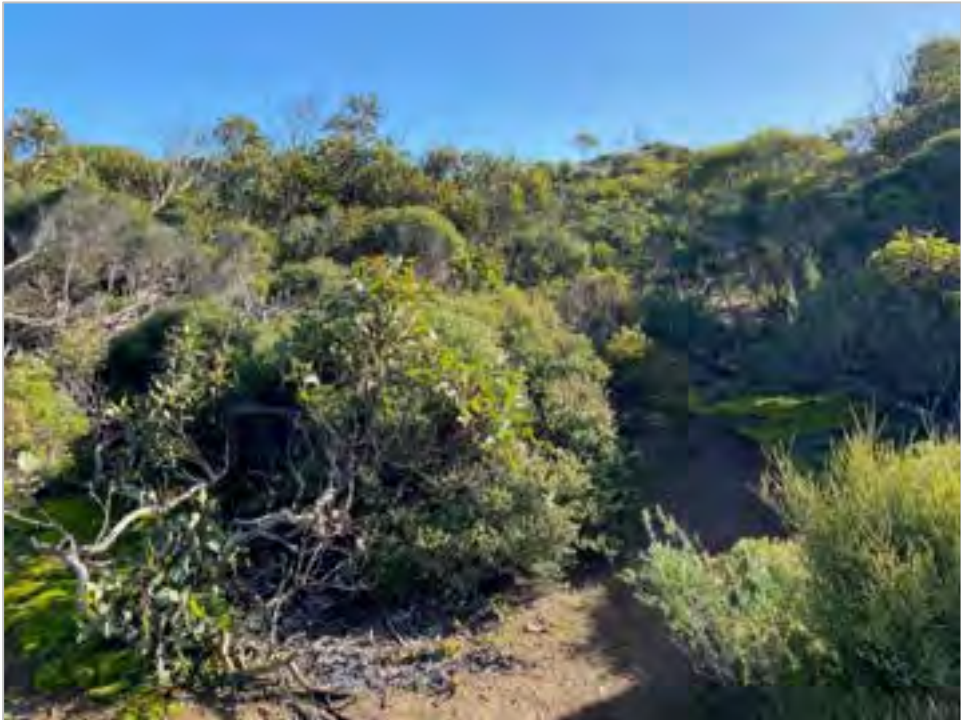
<p><i>Photo 7257, facing west at Latitude -34.76006 / Longitude 135.892051</i></p>				
General description	<p>Vegetation association WW5 occurs between the coast and the decommissioned ponds of the Wastewater Treatment Plant. The overstorey is similar to that of WW4, being dominated by <i>Eucalyptus diversifolia</i> and <i>E. conglobata</i>, but the groundlayer becomes more open, and the predominant shrubs are <i>Pomaderris paniculosa</i>, <i>Alyxia buxifolia</i>, <i>Exocarpos aphyllus</i> and <i>Melaleuca lanceolata</i>. Moss covers the ground beneath the mallee, and two species of winter-flowering orchids (<i>Cyrtostylis robusta</i> and <i>Pterostylis erythroconcha</i>) were observed.</p> <p>The most abundant weed is Bridal Creeper which occurs scattered throughout the mallee understory. Other exotic species such as African Daisy and Box Thorn are present as minor components and Soursob grows mostly along the edges of the walking track.</p> <p>The plant association has a medium to high diversity of native species including many regenerating species, very high structural diversity, and moderate weed cover.</p> <p>The vegetation community is in good condition.</p>

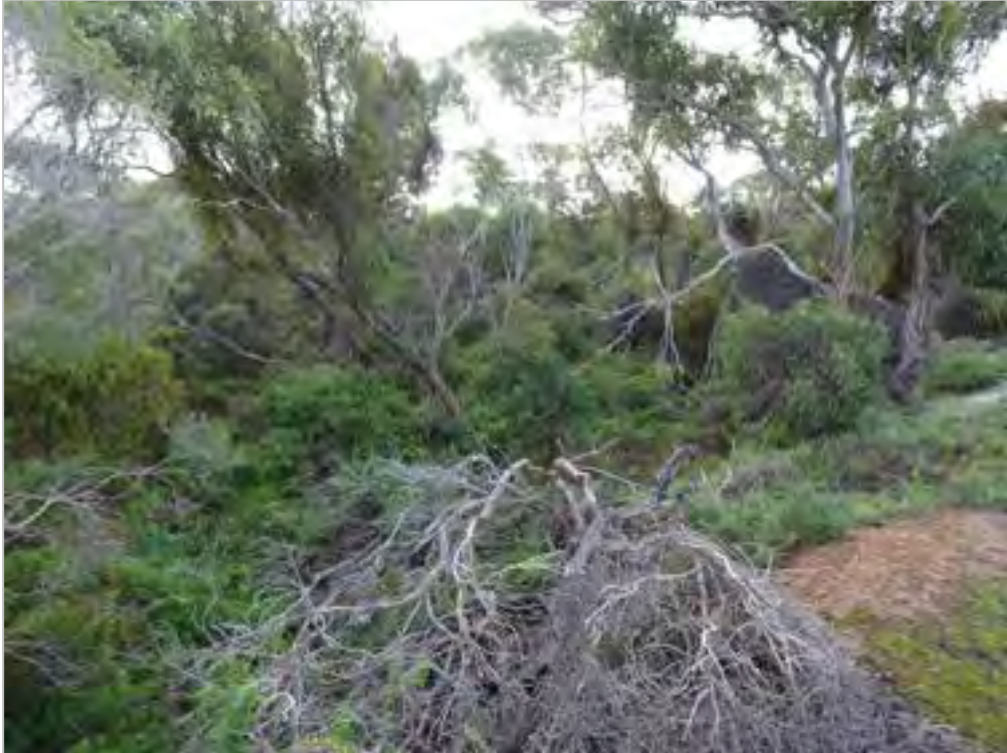
<p><i>Photo RC1, facing NE at 579139, 6153850 (WGS 84 Zone 53).</i></p>				
General description	<p>Vegetation association RC1 occurs at the western end of a large expanse of mallee between the proposed desalination plant and Greyhound Rd. The canopy is dominated by <i>Eucalyptus albopurpurea</i> over <i>Rhagodia crassifolia</i>, <i>Melaleuca lanceolata</i> and a dense cover of <i>Tetragonia implexicoma</i>. There are some dense patches of <i>Austrostipa elegantissima</i> in more open areas, but the remaining groundlayer is highly disturbed and invaded by exotic annual grasses. Bridal Creeper and African Daisy are also present.</p> <p>The plant association has a moderate diversity of native plant species and good structural diversity but the groundlayer is disturbed by rubbish dumping and weed invasion.</p> <p>The vegetation community is in moderate condition.</p>

The drinking water transfer pipeline and power line extend west from the desalination plant through a large area of mallee. The route follows a cleared track, approximately 3 m wide, which runs adjacent to the disused rail corridor on the northern side. The vegetation includes areas in good to excellent condition. Vegetation includes areas dominated by *E. conglobata* and *E. diversifolia* with low shrubs prominent in the understorey (Sites RC2, RC3 and RC4), and areas dominated by *E. gracilis*, *E. oleosa* and *E. rugosa* with a dense mid-shrub understorey of *Melaleuca* spp. over a thick layer of leaf litter layer (Site RC6). Towards the western end, *E. albopurpurea* makes up the dominant overstorey although these sections have been disturbed by rubbish dumping and track clearances (Site RC1).

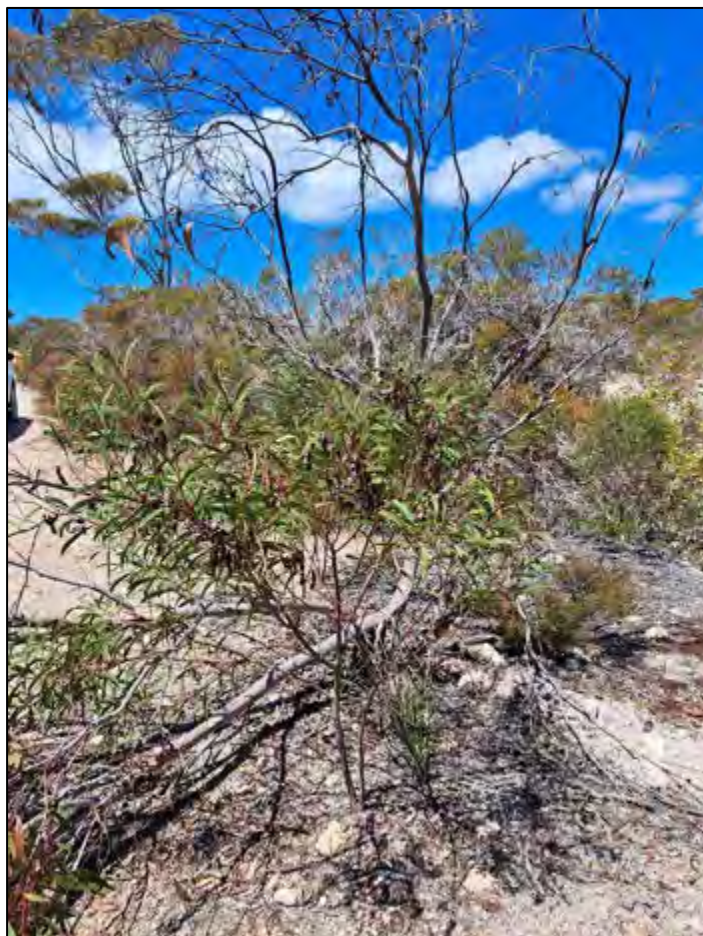
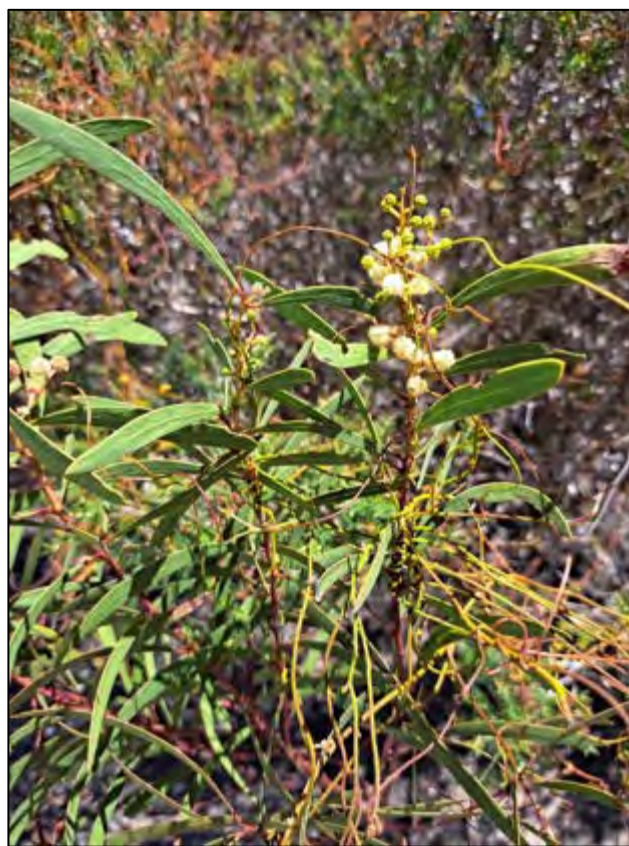
Acacia alcockii stand growing on the southern side of the existing track

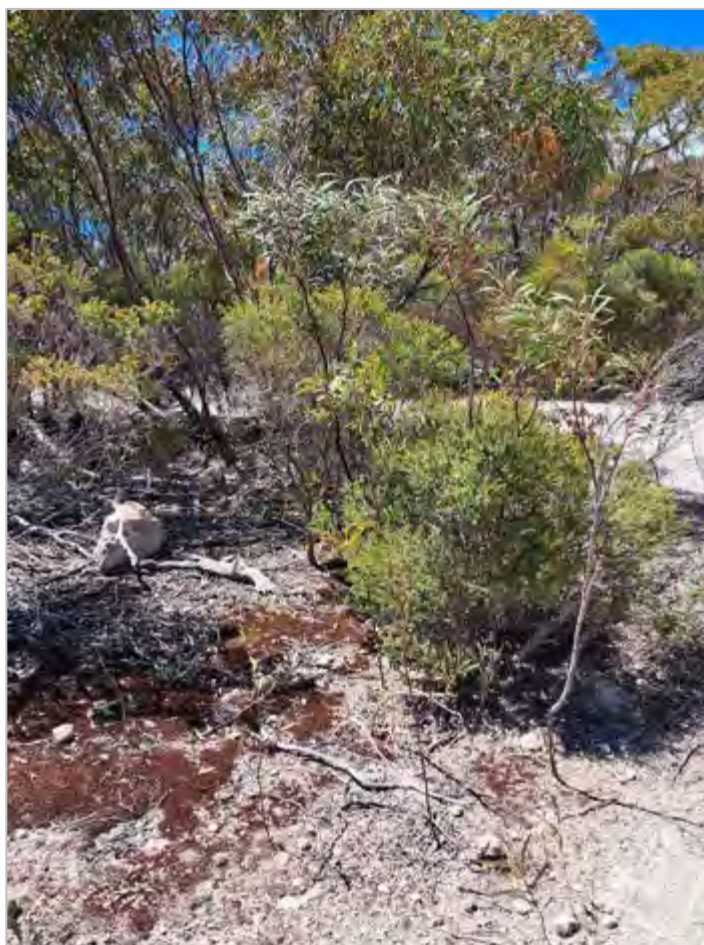
Photo RC3.2 Stand of Acacia alcockii along the northern side of the track

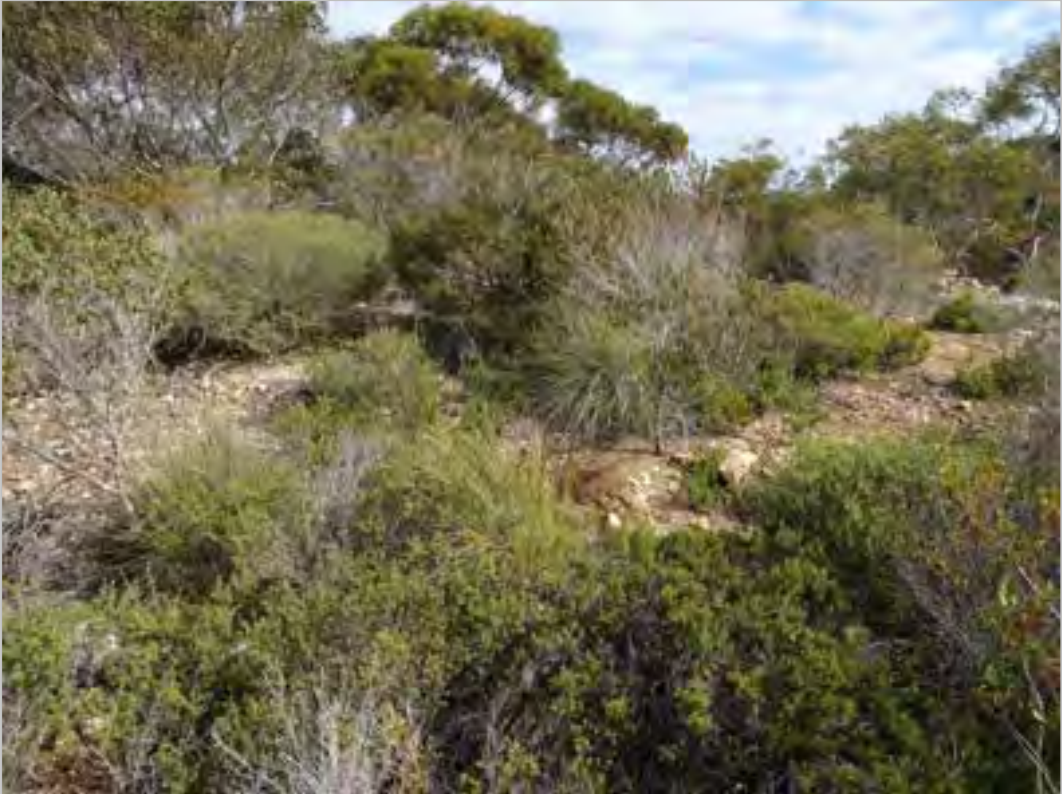
<p><i>Photo RC4, facing SW at 580801, 6154218 (WGS 84 Zone 53).</i></p>				
General description	<p>Vegetation association RC4 occurs within a small patch on the northern side of the track, where <i>Eucalyptus diversifolia</i> dominates over a dense cover of low and medium shrubs and sedges. <i>Eucalyptus conglobata</i> is present as a minor overstory component. <i>Acrotriche</i> spp., <i>Melaleuca lanceolata</i>, <i>Gahnia deusta</i>, <i>Pomaderris obcordata</i> and <i>Templetonia retusa</i> are common understory species.</p> <p>The plant association has a moderate-high diversity of native plant species, with several regenerating species. Weed cover is low and includes sparse plants of Bridal Creeper, Aleppo Pine and Western Coastal Wattle.</p> <p>The vegetation community is in good condition.</p>

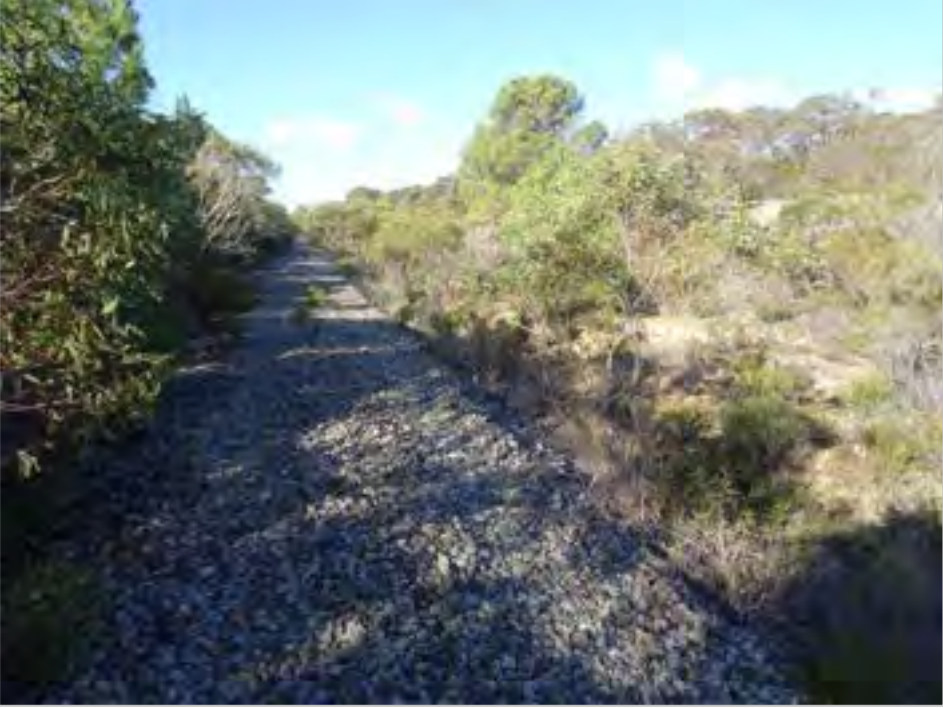
<p><i>Photo RC6, facing East at 579506, 6153858 (WGS 84 Zone 53).</i></p>				
General description	<p>Vegetation association RC6 occurs between the track and the rail corridor, where mallee vegetation is recovering well after past disturbances, but still contains open bare areas and has a greater incursion of weeds. <i>Eucalyptus diversifolia</i>, <i>E. conglobata</i>, <i>E. gracilis</i> and <i>E. rugosa</i> are the main native canopy species, with several species of <i>Acacia</i>, <i>Dodonaea</i> and <i>Melaleuca</i> regenerating in the understory.</p> <p>Dominant weed species include Aleppo Pine and Pincushion, with Bridal Creeper, Western Coastal Wattle and <i>Phalaris</i> sp. (Canary Grass) present as minor components.</p> <p>The plant association has a moderate-high diversity of native plant species, and very good regeneration, but lower structural diversity compared to adjacent mature mallee communities.</p> <p>The vegetation community is in moderate condition.</p>

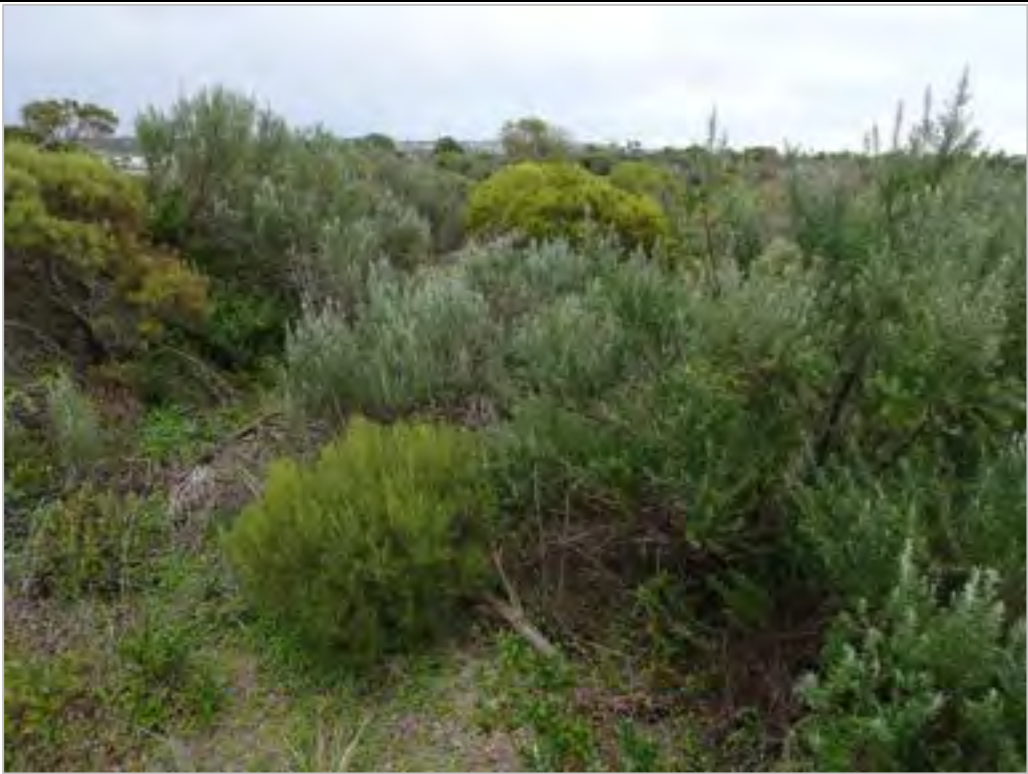
<p><i>Photo RC7, facing NW at 579041, 6153877 (WGS 84 Zone 53).</i></p>				
General description	<p>Vegetation association RC7 occurs west of the mallee communities, along either side of Greyhound Rd. It is a coastal shrubland community with an overstorey principally composed of <i>Acacia nematophylla</i>, <i>Leucopogon parviflorus</i> and <i>Olearia axillaris</i>. <i>Rhagodia spp.</i> and <i>Pomaderris paniculosa</i> are prevalent in the understorey.</p> <p>Sour-sob is the most dominant weed with Bridal Creeper, Western Coastal Wattle and <i>Euphorbia terracina</i> (False Caper) present as minor components.</p> <p>The plant association has a high diversity of native plant species.</p> <p>The vegetation community is in moderate to good condition.</p>				
Threatened species or community	<p><u>State-listed vegetation community:</u> No</p> <p><u>State-threatened flora observed:</u> None</p> <p><u>Nationally- and State-threatened fauna that may use this community:</u></p> <ul style="list-style-type: none"> • State Endangered Eastern Osprey, White-bellied Sea Eagle • State Vulnerable: Yellow-tailed Black Cockatoo, Brown Quail • State Rare: Elegant Parrot, Rock Parrot, Painted Buttonquail, Cape Barren Goose and Peregrine Falcon. <p>The Rock Parrot was recorded in nearby coastal habitat during bird surveys conducted in December 2023.</p> <p>Coastal shrubland is not preferred habitat for the Nationally Vulnerable Diamond Firetail or the State Rare Purple-gaped Honeyeater, Western Gerygone, Shy Heathwren, White-winged Chough and Bush Stone-curlew.</p>

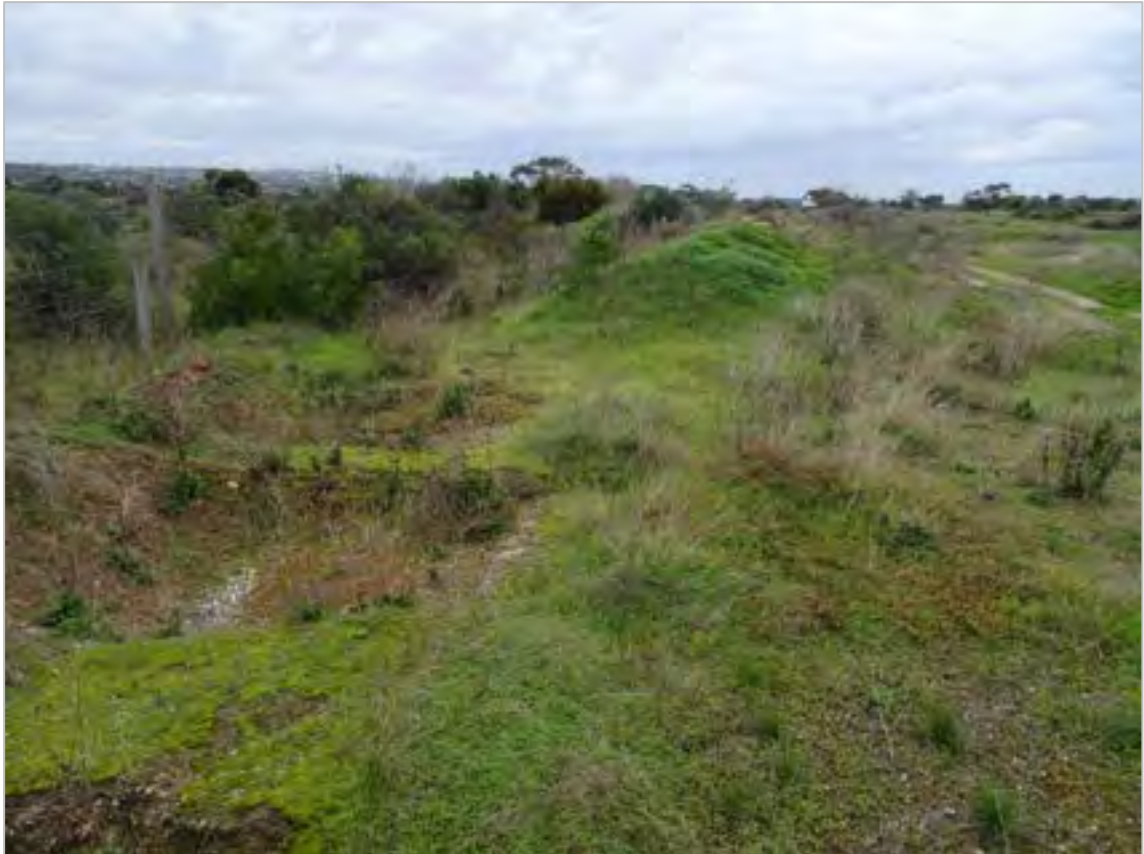
Photo RC10 facing NW at 578654, 6154278 (WGS 84 Zone 53).					
General description	<p>This degraded coastal shrubland occurs north of Greyhound Road where there has been past clearance. The overstory is quite sparse and comprised mostly of <i>Olearia axillaris</i>, <i>Acacia nematophylla</i> with regenerating <i>Leucopogon parviflorus</i>, <i>Adriana quadripartita</i> and various chenopod shrubs. Native plant species diversity is moderate to high.</p> <p>The ground layer is heavily invaded by grassy and herbaceous weeds such as Coastal Galenia, Bridal Creeper and Soursob.</p> <p>The vegetation community is in moderate condition.</p>				
Threatened species or community	<p><u>State-listed vegetation community:</u> No</p> <p><u>State-threatened flora observed:</u> None</p> <p><u>Nationally- and State-threatened fauna that may use this community:</u></p> <ul style="list-style-type: none">State Rare: Elegant Parrot, Rock Parrot and Peregrine Falcon. <p>This disturbed coastal shrubland is not preferred habitat for the Nationally Vulnerable Diamond Firetail, State Endangered Eastern Osprey and White-bellied Sea Eagle, State Vulnerable Yellow-tailed Black Cockatoo and Brown Quail, or the State Rare Purple-gaped Honeyeater, White-winged Chough, Western Gerygone, Shy Heathwren, Painted Buttonquail and Bush Stone-curlew.</p>

The SAPN power line route extends north from Greyhound Road to join Windsor Avenue. The route initially passes through a coastal shrubland degraded by invasive grassy and herbaceous weeds (Site RC10). The route follows the Windsor Avenue road reserve where clearance is required of degraded coastal vegetation (RC8 and RC11), degraded mallee (RC15) and degraded *Melaleuca halmaturorum* shrubland (RC13).

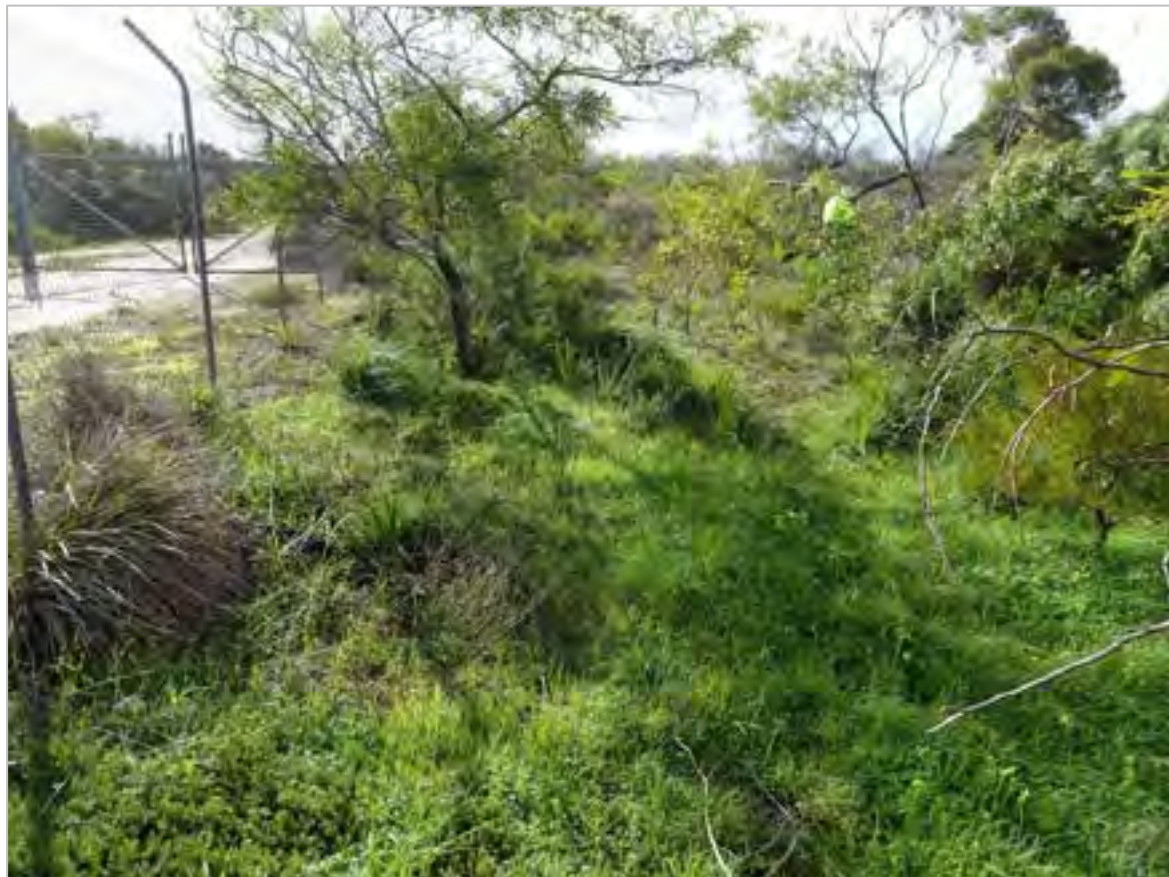
Photo RC11, facing NW at 578593, 6154568 (WGS 84 Zone 53).					
General description	<p>Plant community RC11 is present along the powerline alignment on the spur heading north from the transfer pipe.</p> <p>It occurs on a very disturbed low dune considered likely to have once been a coastal mallee community. It is now dominated by <i>Acacia paradoxa</i> (Kangaroo Thorn), with the introduced <i>Acacia saligna</i> (Golden Wreath Wattle) and <i>Pinus halepensis</i> also significant in the overstorey. The understorey supports native shrub and sedge lifeforms including several <i>Acacia</i> species, <i>Adriana quadripartita</i>, <i>Rhagodia crassifolia</i> and <i>Dianella brevicaulis</i>, but also with a heavy load of grassy and herbaceous weeds.</p> <p>The plant association has a moderate diversity of native plant species, with a high burden of high-threat weeds (e.g. Bridal Creeper, Myrtle-leaf Milkwort, Blowfly Bush, Sour-sob, African Boxthorn and <i>Asparagus declinatus</i> (Bridal Veil).</p> <p>The vegetation community is in poor condition.</p>

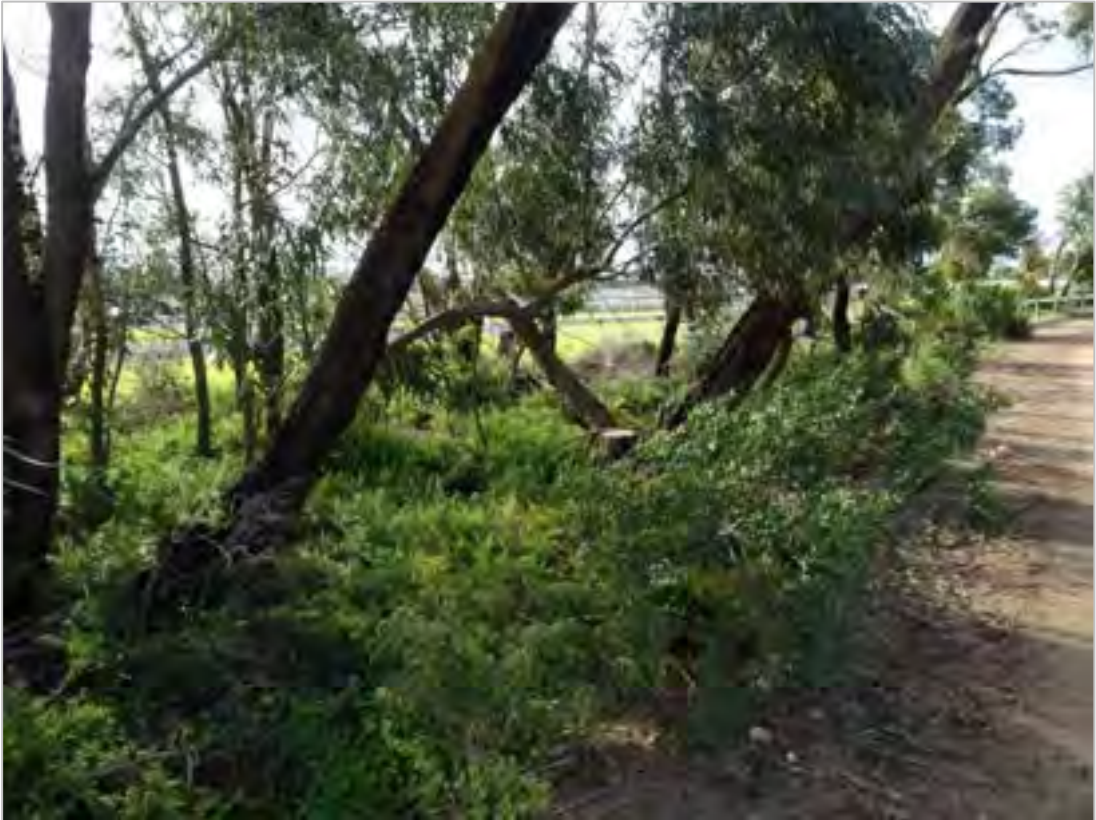
<p><i>Photo RC12 facing N at 577990, 6154382 (WGS 84 Zone 53).</i></p>				
General description	<p>This plant association occurs to the south-east of the racecourse and near the intersection of Greyhound and Proper Bay roads. It is a degraded version of the coastal shrubland (RC7), where the disturbed remnant community persists beneath overstorey plantings of non-indigenous <i>Eucalyptus</i> and <i>Casuarina</i> species, and exotic Aleppo Pine and Western Coast Wattle.</p> <p><i>Enchylaena tomentosa</i> and <i>Rhagodia candolleana</i> are the most common native shrubs, and there are several regenerating species including <i>Leucopogon parviflorus</i>, <i>Melaleuca halmaturorum</i>, <i>Acacia nematophylla</i> and <i>A. paradoxa</i>, Sour-sob is dominant in the groundlayer, and Bridal Creeper is also present.</p> <p>The vegetation community is in moderate condition.</p>

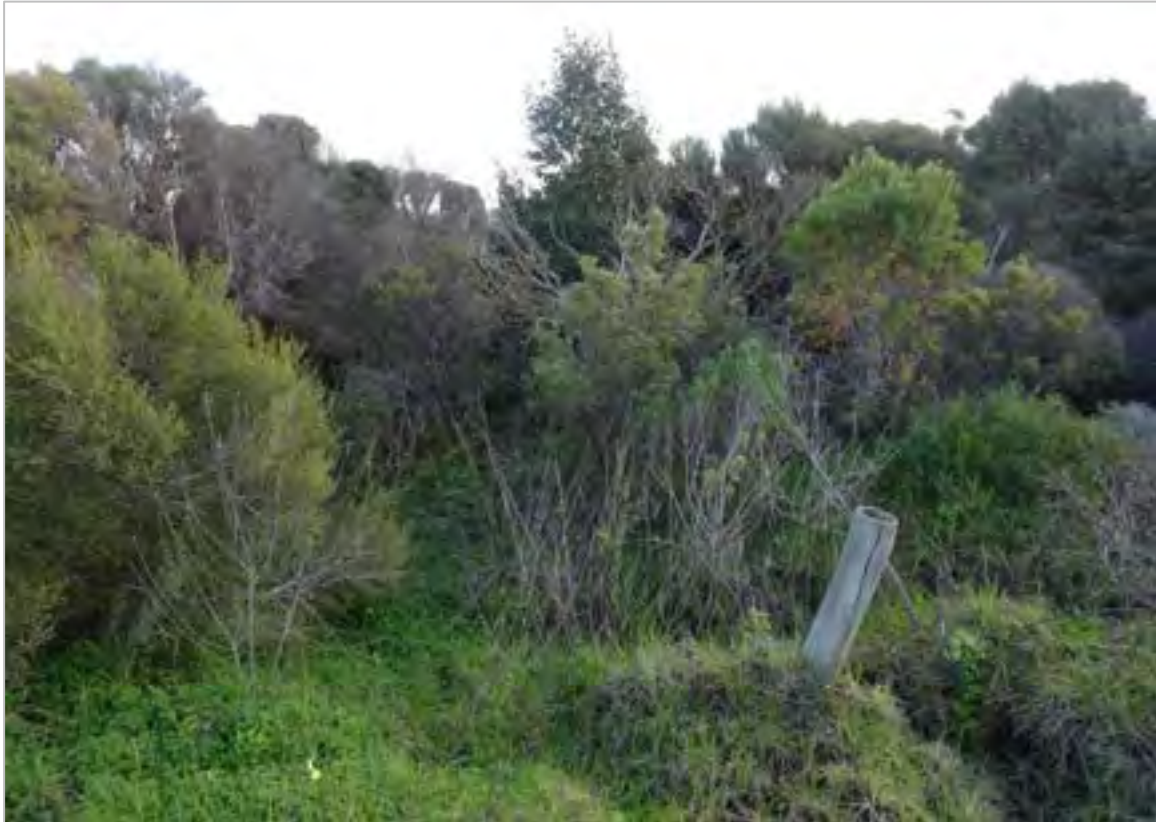
<p><i>Photo RC13, facing W at 577948, 6154311 (WGS 84 Zone 53).</i></p>				
General description	<p>This saline wetland system occurs south of the racecourse on the northern side of Greyhound Road, and along the powerline spur heading north from the transfer pipe.</p> <p>It consists of an overstorey of <i>Melaleuca halmaturorum</i> (Swamp Paper-bark) over <i>Distichlis distichophylla</i> (Emu-grass) and the small/medium chenopod shrubs <i>Rhagodia candolleana</i> and <i>Threlkeldia diffusa</i> (Coast Bonefruit), with several highly threatening weeds, including <i>Juncus acutus</i> (Spiny Rush), Bridal Creeper, Olive and African Boxthorn.</p> <p>Native species diversity and the community has a medium-high level of structural diversity, with good canopy cover.</p> <p>The vegetation community is in moderate condition.</p>

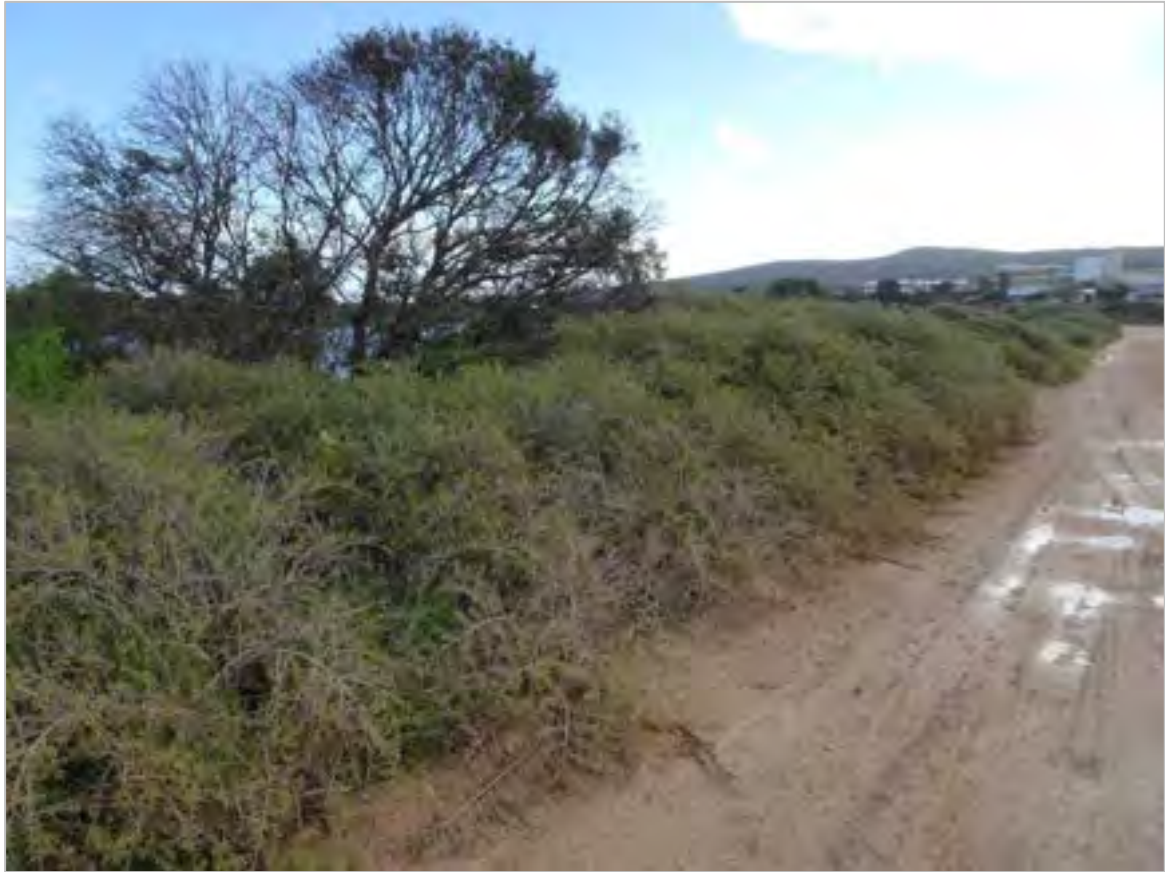
Photo RC14, facing W at 577790, 6154287 (WGS 84 Zone 53).					
General description	<p>Plant community RC14 occurs as a narrow strip on the southern side of Greyhound Rd, south of the racecourse.</p> <p>The coastal shrubland has a moderate diversity of native species with an overstorey dominated by <i>Nitraria billardieri</i> (Nitre Bush) over <i>Suaeda australis</i> (Austral Seablite). Three SA Declared weeds Spiny Rush, Bridal Creeper and African Boxthorn occur in the association.</p> <p>The vegetation community is in moderate condition.</p>				
Threatened species or community	<p><u>State-listed vegetation community:</u> No</p> <p><u>State-threatened flora observed:</u> None</p> <p><u>Nationally- and State-threatened fauna that may use this community:</u></p> <ul style="list-style-type: none">State Rare: Elegant Parrot, Rock Parrot, Painted Buttonquail and Peregrine Falcon. <p>Coastal shrubland is not preferred habitat for the Nationally Vulnerable Diamond Firetail, the State Vulnerable Yellow-tailed Black Cockatoo or Brown Quail, or the State Rare Purple-gaped Honeyeater, Western Gerygone, Shy Heathwren, White-winged Chough and Bush Stone-curlew. Given the site's proximity to busy roads, it is highly unlikely to support the State Endangered Eastern Osprey and White-bellied Sea Eagle.</p>

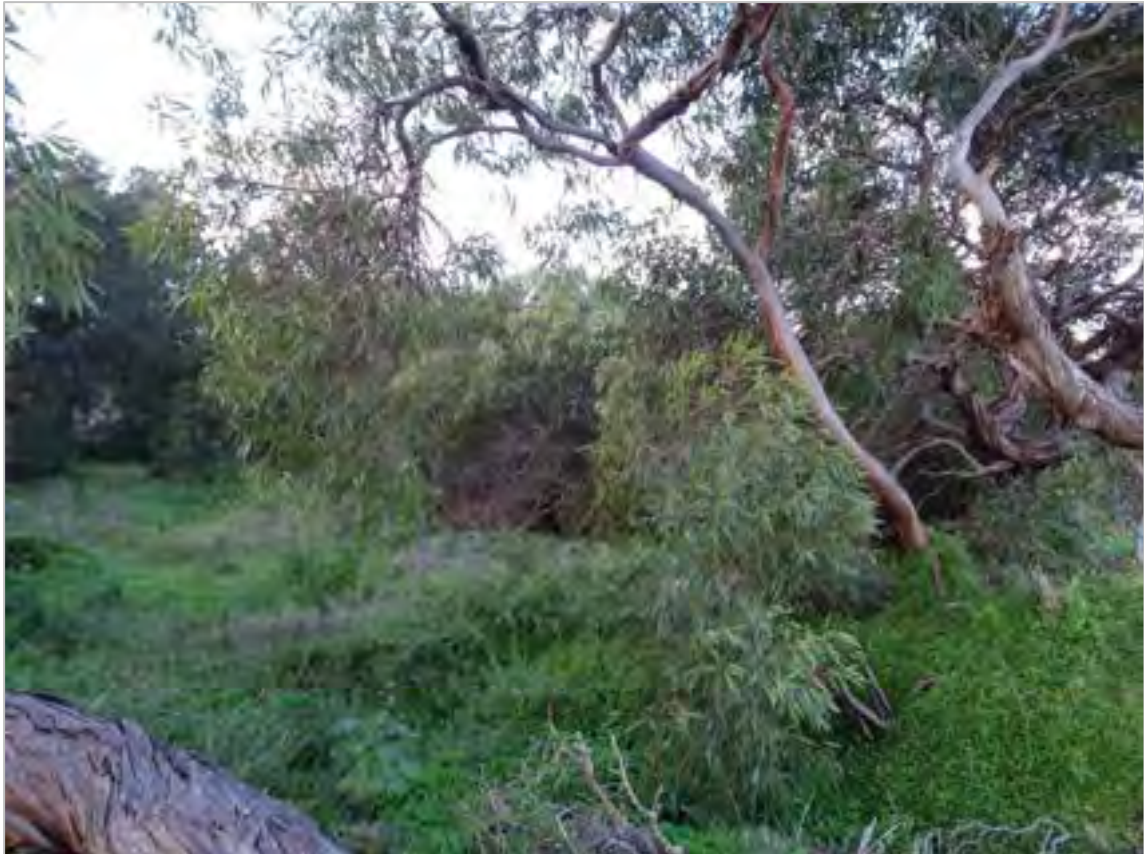
Photo RC15, facing North at 578481, 6155053 (WGS 84 Zone 53).					
General description	<p>This highly disturbed <i>Eucalyptus albopurpurea</i> and <i>Eucalyptus diversifolia</i> mallee community occurs at the northernmost end of the powerline alignment on the spur heading north from the transfer pipe.</p> <p>Whilst the overstorey trees are generally in good condition, the understorey is highly degraded and generally dominated by introduced grass, herb and climber weeds.</p> <p>Native species diversity is low and includes some understorey shrubs and groundcovers such as <i>Rhagodia crassifolia</i>, <i>Pimelea serpyllifolia</i>, <i>Exocarpos aphyllus</i> and <i>Tetragonia implexicoma</i>.</p> <p>The community contains several high threat weeds (Bridal Creeper, Aleppo Pine, African Box Thorn, Sour Sob and Swamp Oak).</p> <p>The vegetation community is in poor condition.</p>

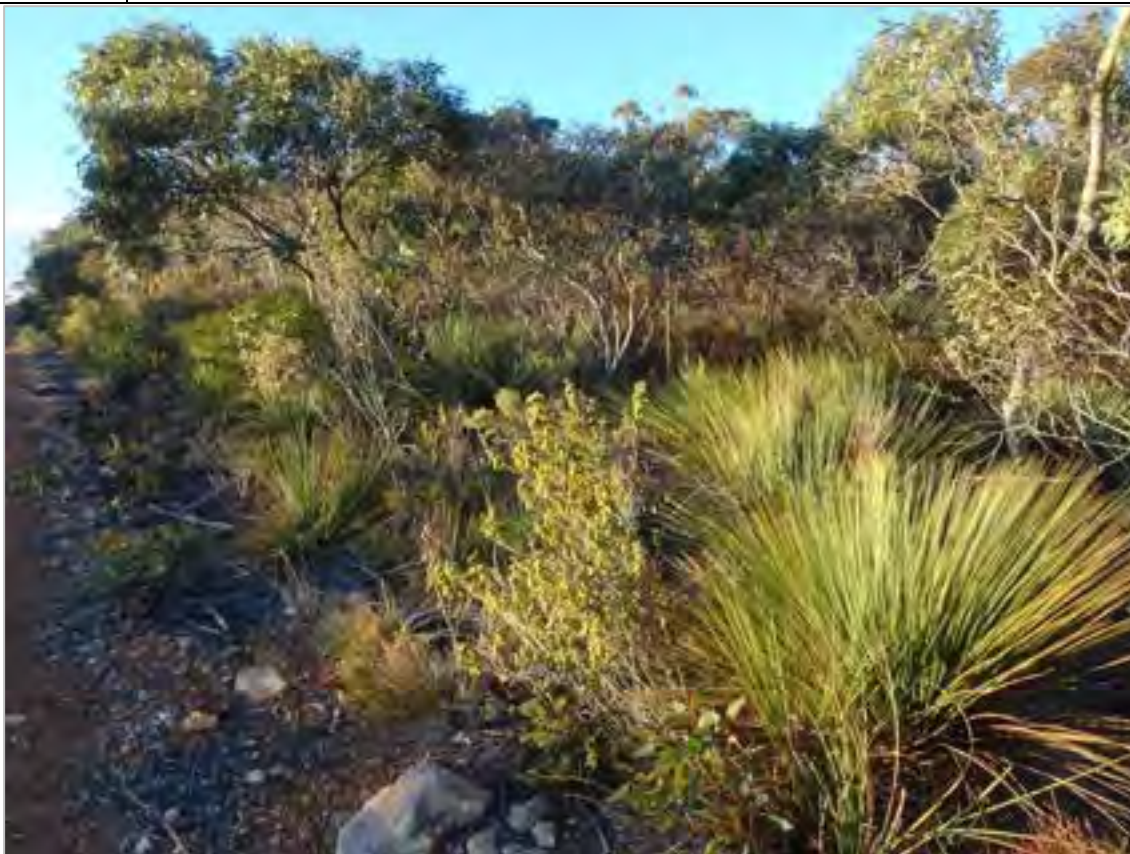
Photo TR1, facing SE at 575172, 6154560 (WGS 84 Zone 53).

General description	<p>Vegetation Association TR1 is present around the existing North Side Hill tank site at the western end of Blue Fin Rd. <i>Eucalyptus diversifolia</i> and <i>Eucalyptus albopurpurea</i> are co-dominant canopy species with some emergent <i>Allocasuarina verticillata</i>. The vegetation has a highly diverse heathy shrub layer comprising <i>Pomaderris obcoradta</i>, <i>Xanthorrhoea semiplana</i>, <i>Acrotriche cordata</i>, <i>Acacia myrtoifolia</i>, <i>A. paradoxa</i>, <i>Hibbertia devitata</i>, <i>Lepidospermum viscidum</i> and <i>Lasiopetalum</i> species. Two species of orchids (<i>Diuris</i> sp. and <i>Microtis</i> sp.) were detected in spring surveys.</p> <p>Weed incursions are minor and include scattered plants of Bridal Creeper, Freesias, Sour-sob, African Daisy and Aleppo Pine.</p> <p>The plant community has very high structural and native plant species diversity, with many regenerating species, and offers good fauna habitat.</p> <p>The vegetation community is in excellent condition.</p>

Threatened species or community	<p><u>State-listed vegetation community:</u> No</p> <p><u>State-threatened flora observed:</u></p> <ul style="list-style-type: none"> • State Rare Tate's Grass-tree (<i>Xanthorrhoea semiplana</i> ssp. <i>tateana</i>) • State Rare Spoon-leaved Spyridium (<i>Spyridium daphnoides</i>) • State Rare Snowdrop Spurge (<i>Lysiandra calycina</i>) • State Rare Yellow Sour-bush (<i>Choretrum chrysanthum</i>) <p><i>Xanthorrhoea semiplana</i> ssp. <i>tateana</i> (SA Rare) occurs interspersed with <i>X. semiplana</i> ssp. <i>semiplana</i>. <i>Xanthorrhoea semiplana</i> are a dominant component of the understory, however it is not possible to estimate numbers of Tate's Grass-tree plants as the subspecies is only distinguishable when flowering or in mature individuals that have a distinct trunk. Flowering individuals of Tate's Grass-tree were identified along the roadside of Bluefin Road, and at waypoint 408 north-west of the tanks. Note, many <i>Xanthorrhoea</i> are showing signs of yellowing, possibly indicating the presence of <i>Phytophthora cinnamomi</i> at the site.</p> <p>Numerous individuals of <i>Spyridium daphnoides</i> are present along the north-eastern roadside of Blue Fin Rd, and a few to the north-west of the tanks outside the fence (waypoints 406, 408, 409 to 427).</p> <p>Two plants of <i>Lysiandra calycina</i> were recorded on the northern side of Blue Fin Rd at waypoints 407 and 420.</p> <p>Two plants of <i>Choretrum chrysanthum</i> were noted within the road reserve on the northeastern side of Blue Fin Rd at waypoints 1062.1 and 1062.2.</p> <p><u>Nationally- and State-threatened fauna that may use this community:</u></p> <ul style="list-style-type: none"> • Nationally Endangered: Mallee Whipbird, EP Southern Emu-wren • Nationally Vulnerable: Diamond Firetail • State Vulnerable: Yellow-tailed Black Cockatoo and Little Eagle • State Rare: Purple-gaped Honeyeater, Western Gerygone, Shy Heathwren, White-winged Chough, Painted Buttonquail and Peregrine Falcon. <p>The Diamond Firetail was recorded during fauna surveys in December 2023 and White-winged choughs were observed at the site in October 2023.</p> <p>Although not recorded within 5km of the site, it is considered likely that the Mallee Whipbird may occur at the site, as the mallee provides suitable habitat and is part of an extensive and continuous tract of mallee to the south and west.</p>

Landscape context score	1.09	Vegetation Condition Score	69.35	Conservation significance score	1.18
Unit biodiversity Score	89.20	Area (ha)	Permanent: 0.0316 Rehabilitate: 0.0327	Total biodiversity Score	Permanent: 2.82 Rehabilitate: 2.92

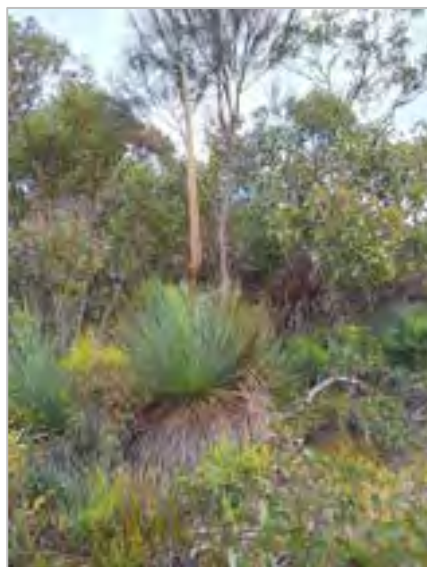
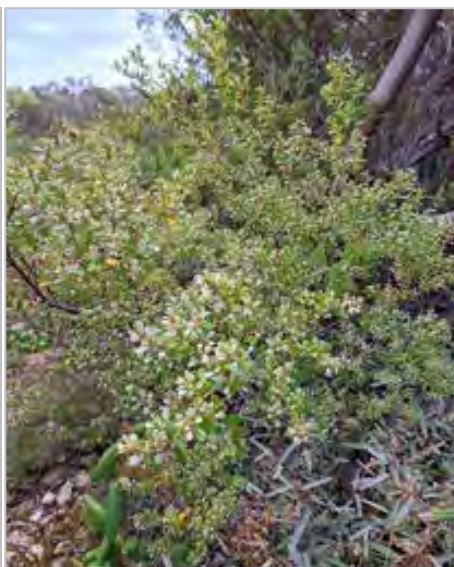
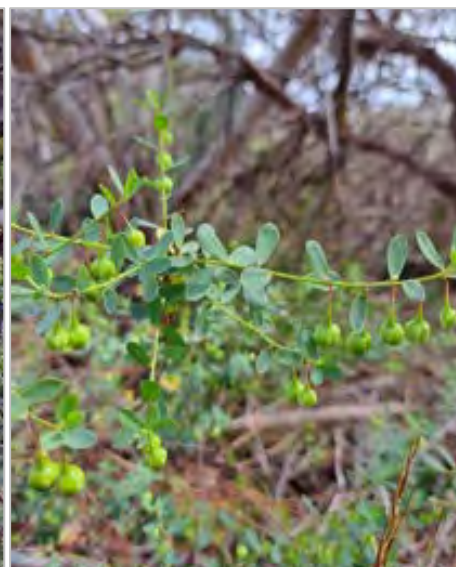
Threatened flora recorded in TR1: Tate's Grass Tree (left), Spoon-leaved Spyridium (centre) and Snowdrop Spurge (right)

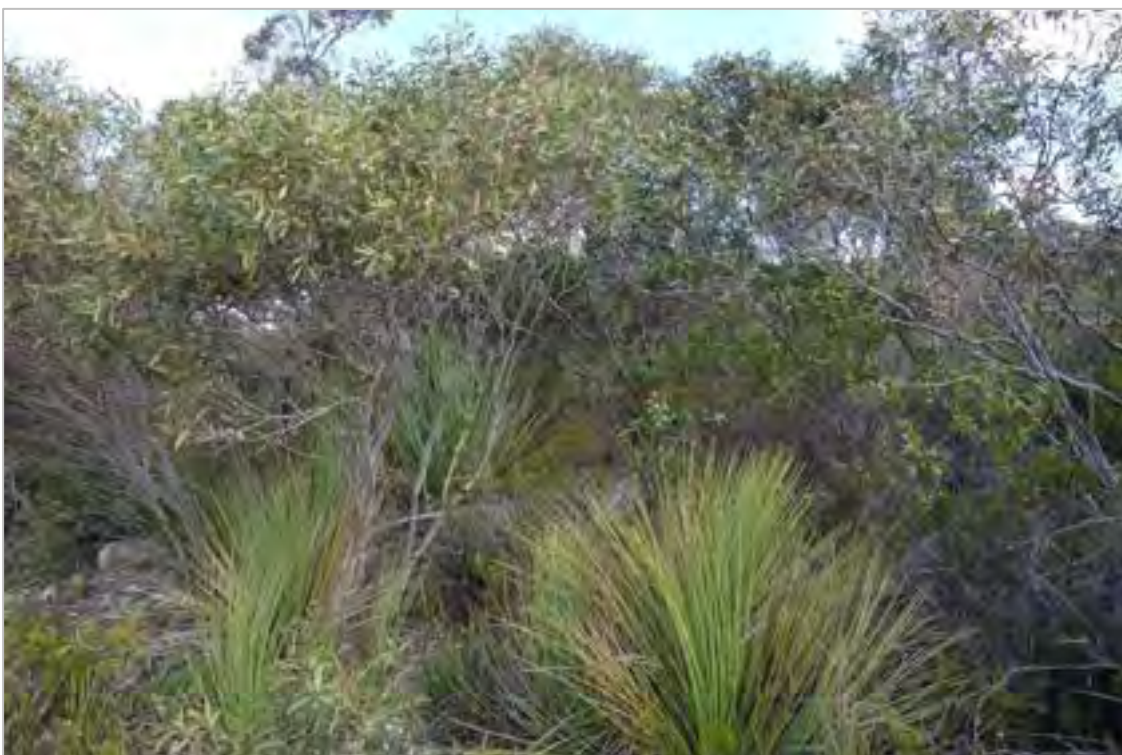
Photo TR2.2 facing South-east at waypoint 1061 (575285, 6154503 (WGS 84 Zone 53), showing vegetation structure of adjacent non-slashed mallee community
