Native Vegetation Clearance

Billy Lights Point: Eyre Peninsula Desalination Plant Project Data Report

Clearance under the *Native Vegetation Regulations 2017*

October 2024

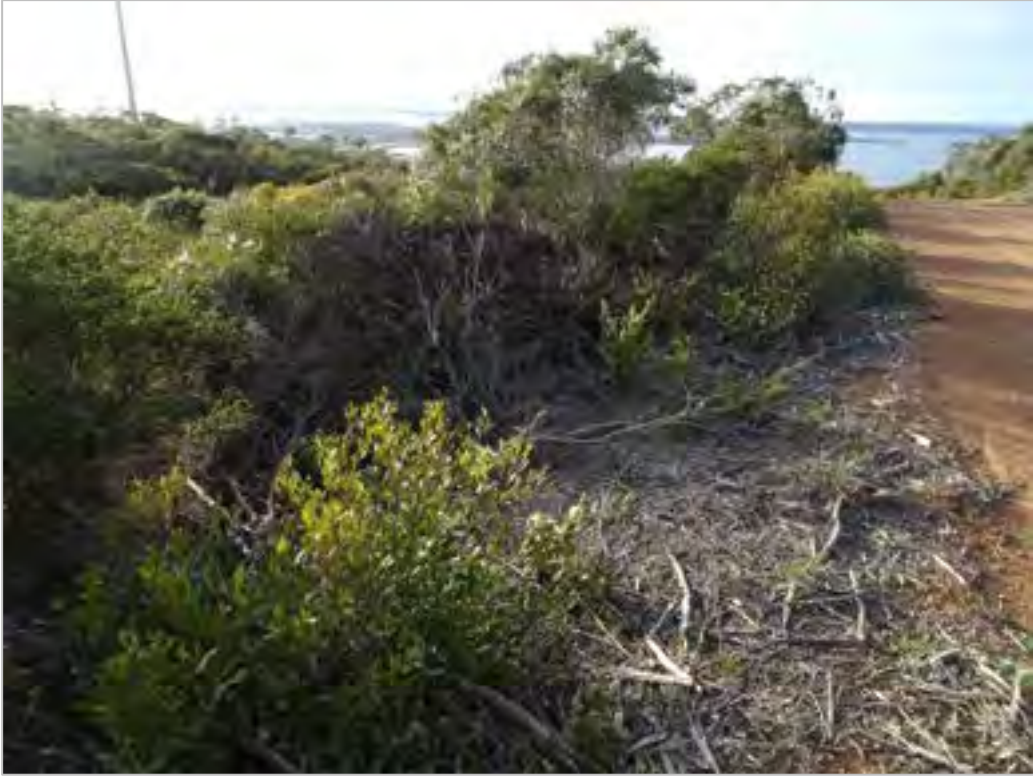
<p><i>Photo TR3, facing E at 575404, 6154372 (WGS 84 Zone 53).</i></p>				
General description	<p>Association TR3 occurs along the roadsides of Blue Fin Rd, east of the intersection with Kathai Drive. The mallee overstorey becomes more open, but is still principally <i>Eucalyptus diversifolia</i> and <i>E. albopurpurea</i>. There is a dense mid-shrub layer of <i>Acacia paradoxa</i> with a lower diversity and cover of native heath species, likely as a result of previous disturbance, including clearance and fire.</p> <p>Vegetation in close proximity to the road verge is often highly disturbed by grading activities and invaded by weeds such as Rice Millet, Soursob and Pincushion. Bridal Creeper, Boxthorn and Myrtle-leaf Milkwort are present in the understory.</p> <p>The vegetation community is in moderate condition.</p>

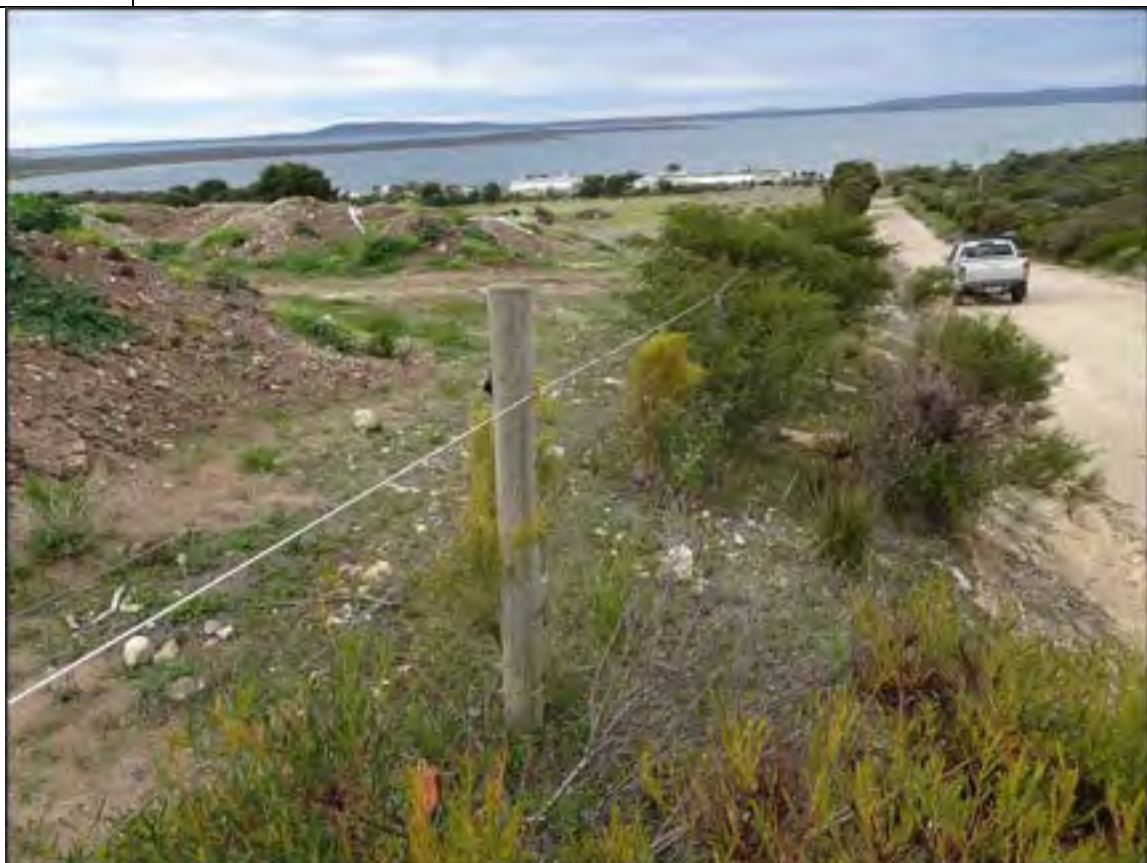
<p><i>Photo TR4, facing E at 575952, 6154031 (WGS 84 Zone 53).</i></p>				
General description	<p>Association TR4 represents sections of recovering roadside vegetation along the eastern end of Blue Fin Rd.</p> <p>Native shrub species are regenerating, with a moderate diversity, but generally very low cover. These areas would formerly have been mallee, and so are considered to be highly disturbed. Weeds are dominated by Pincushion, but also include Bridal Creeper, African Daisy, False Caper and Onion Weed.</p> <p>The vegetation community is in poor condition.</p>				
Threatened species or community	<p><u>State-listed vegetation community:</u> No</p> <p><u>State-threatened flora observed:</u></p> <ul style="list-style-type: none">State Rare Snowdrop Spurge (<i>Lysiandra calycina</i>) <p><i>Lysiandra calycina</i> was recorded in this plant association during surveys in July 2021. A subsequent survey in October 2023 found no plants within the proposed impact area along the northern side of Blue Fin Rd.</p> <p><u>Nationally- and State-threatened fauna that may use this community:</u></p> <p>This highly disturbed community is unlikely to provide significant habitat for threatened fauna.</p>

At the eastern end roadside vegetation has been degraded by clearance and ongoing mowing and comprises *Acacia paradoxa* and *A. cupularis* shrubland (TR4).

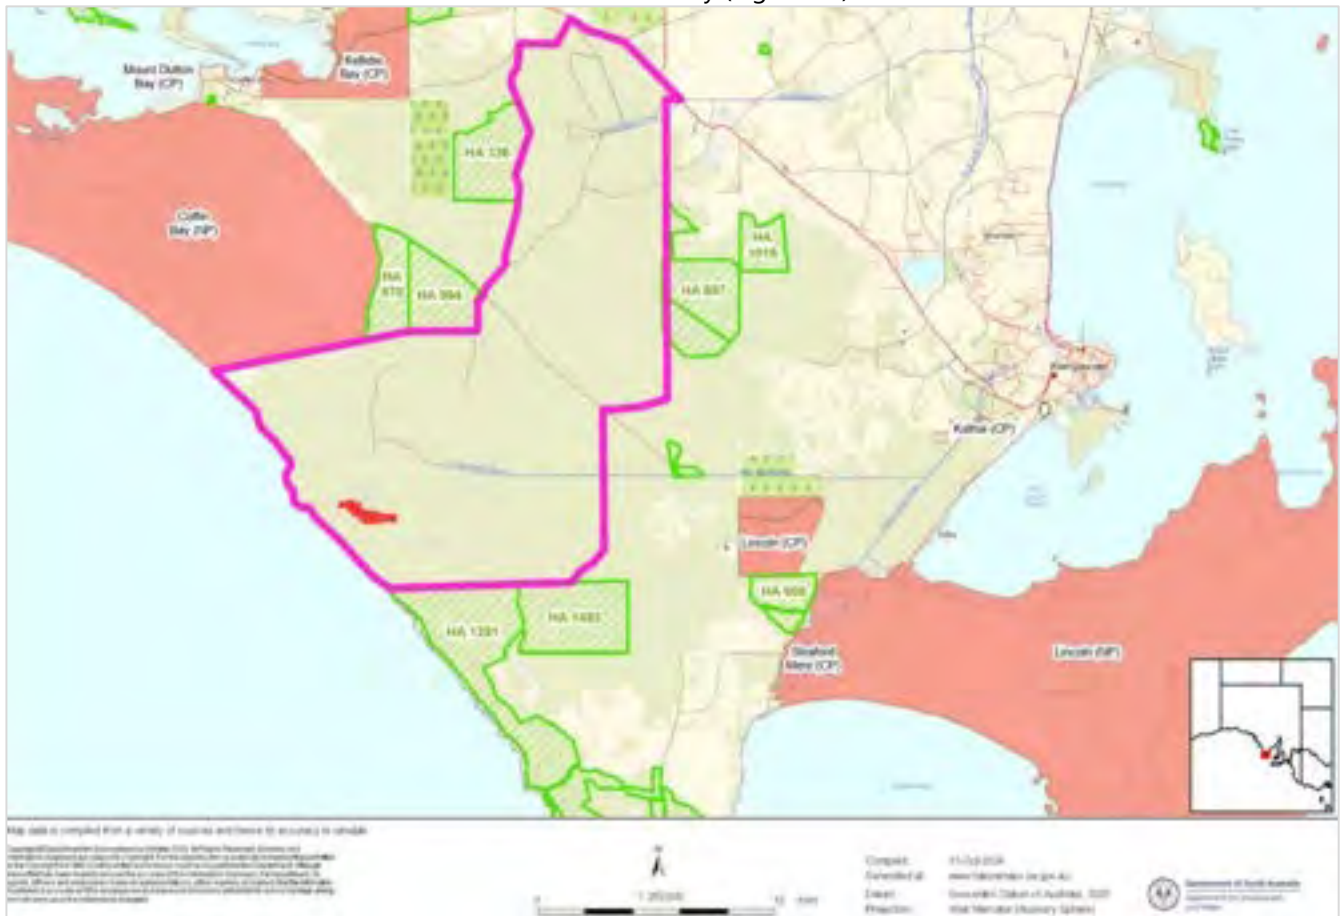
Figure 17. Site Location (in red), showing boundary of Uley South Basin (pink outline) and proximity to Heritage Agreement properties (green hatching) and protected reserves

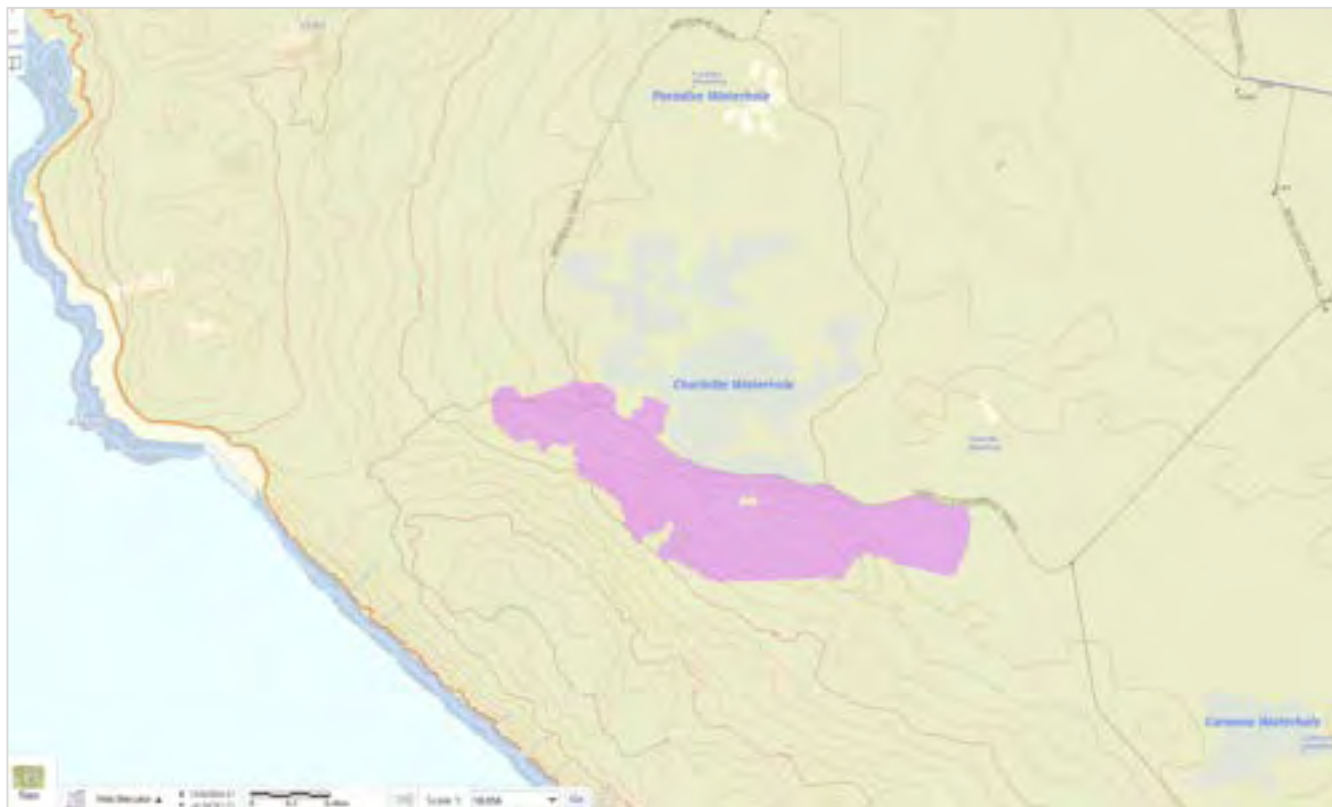
Figure 18. Topographical setting of proposed SEB offset area (in pink)

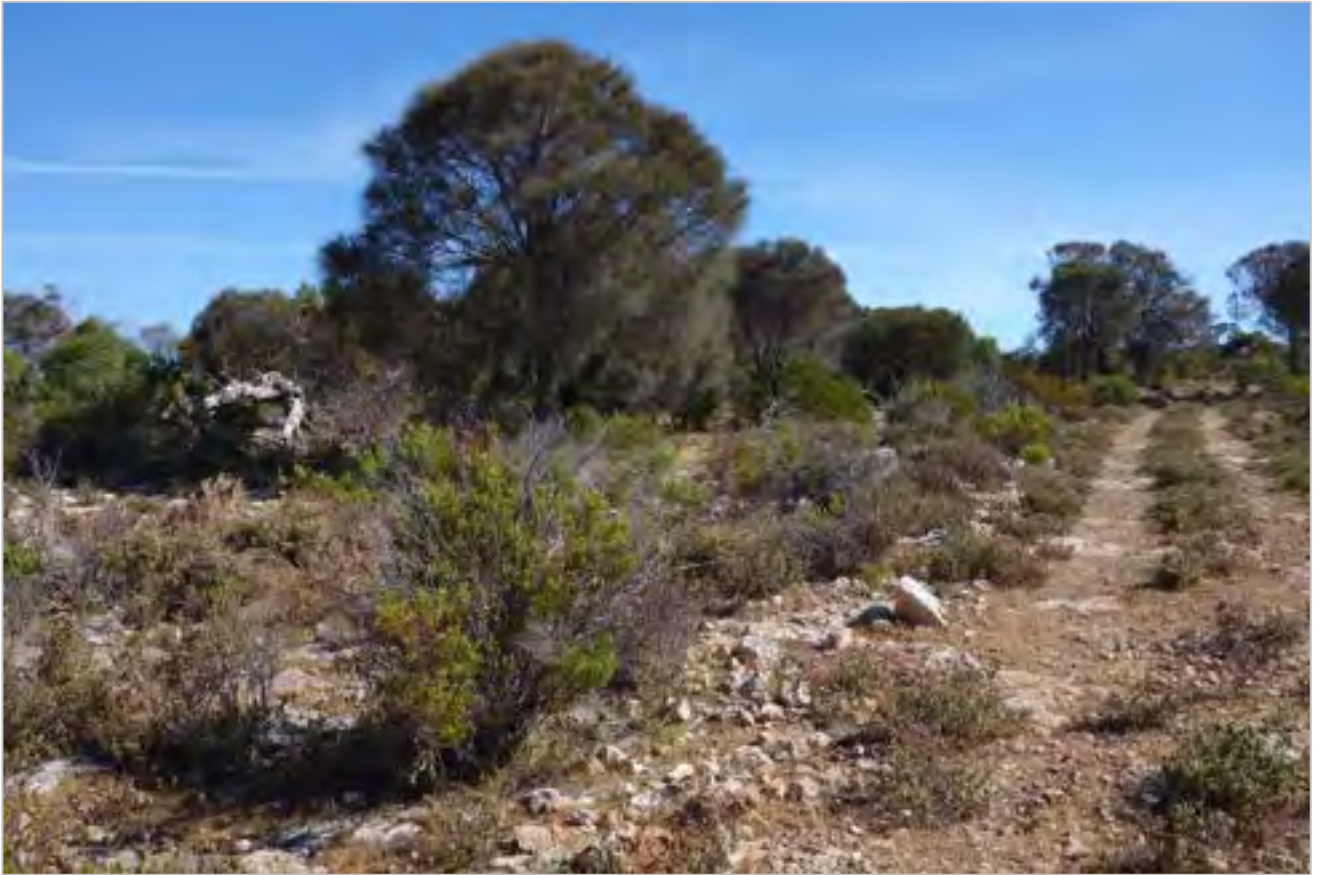
Figure 19. Potential benchmark community for Drooping Sheoak Grassy Woodland. Photo 9288 facing south at waypoint 433.

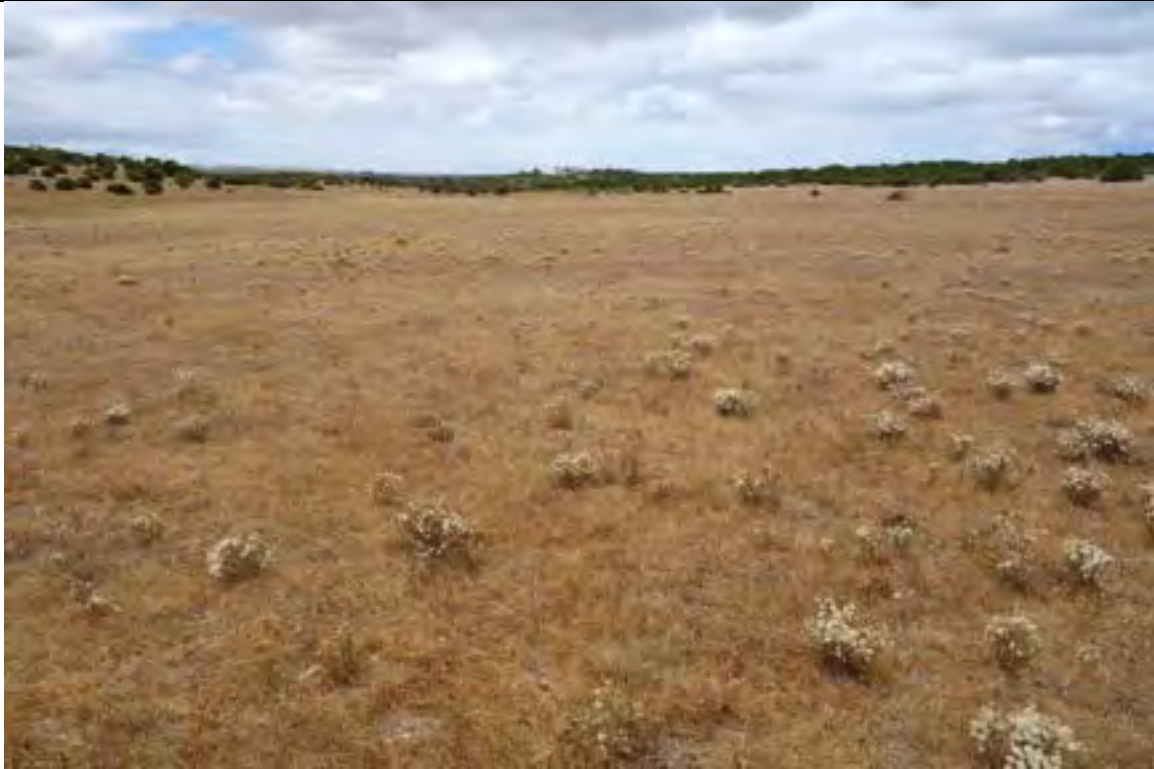
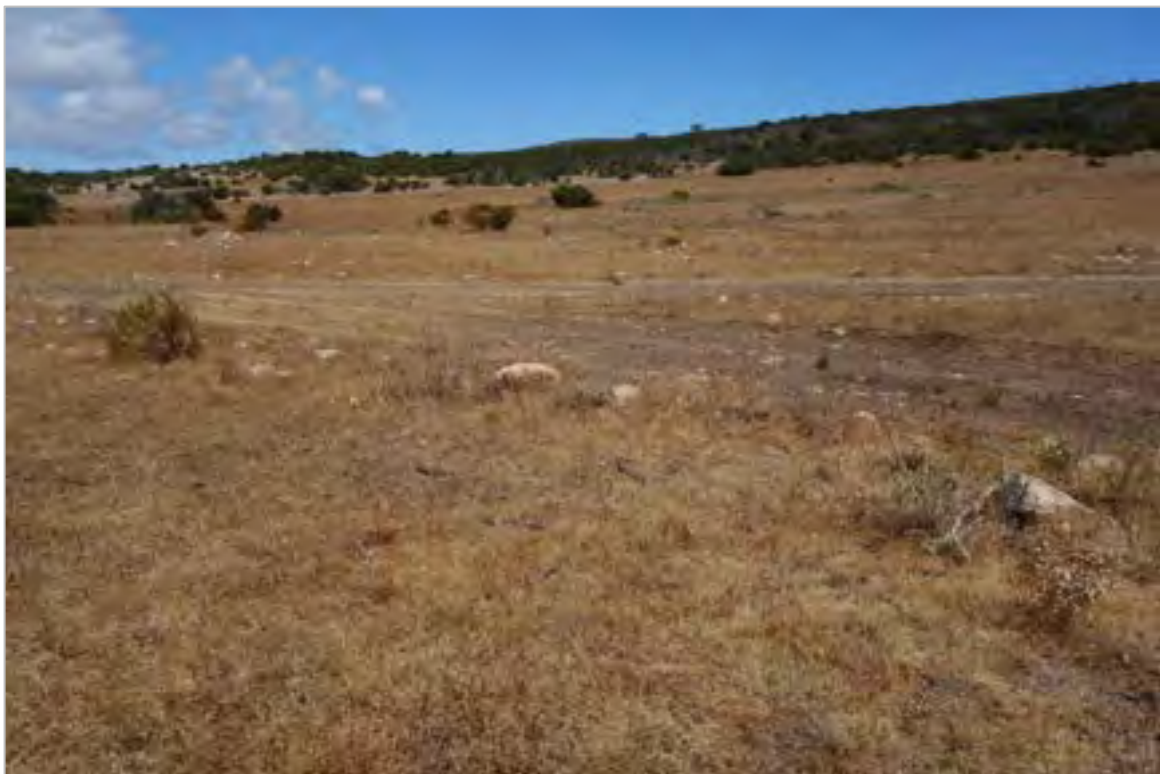
Photo 9304 facing east at waypoint 437 (Latitude -34.787035, Longitude 135.532098)

General description	<p>Plant community US2 covers an area of approximately 12 ha on a raised plain in the central part of the offset area (waypoint 437). The soil substrate comprises unusually deep sandy loam with little exposed limestone and holds water during the wetter months. Piles of scattered rocks near the edges indicate that the land was cleared of rocks and taller vegetation. A previous landholder has confirmed that the area was historically used for cropping.</p> <p>The vegetation association is a native herbland/grassland dominated by native grasses (<i>Austrostipa exilis</i> (Heath Spear-grass), <i>Austrostipa scabra ssp. falcata</i> (Rough Spear-grass), <i>Rytidosperma caespitosum</i> (Common Wallaby-grass) and daisies (<i>Asteridea athrixioides</i> (Wirewort), <i>Vittadinia megacephala</i> (Giant New Holland Daisy) and <i>V. australasica</i> (Sticky New Holland Daisy)). It supports a medium diversity of native species including <i>Pimelea serpyllifolia</i> (Thyme Riceflower), <i>Wahlenbergia gracilentia</i> (Annual Bluebell) and <i>Acaena echinata</i> (Sheep's Burr), with patches of <i>Selliera radicans</i> (Tongue Plant), <i>Schoenus nitens</i> (Shiny Bog-rush) and mosses in areas that retain moisture. Many of the groundlayer species are characteristic of a Drooping Sheoak Grassy woodland community (highlighted in bold). Shrubs such as <i>Leucopogon parviflorus</i> (Coast Beard-heath), <i>Olearia axillaris</i> (Coast Daisy-bush) and <i>Exocarpos syrticola</i> (Coast Cherry) are very sparse and often heavily grazed.</p> <p>Exotic grasses and herbs such as <i>Vulpia</i> spp. (Fescue), <i>Rostraria cristata</i> (Annual Cat's-tail), <i>Lysimachia arvensis</i> (Pimpernel), <i>Trifolium campestre</i> (Hop Clover), <i>Bellardia trixago</i> (Mediterranean Linseed), <i>Asphodelus fistulosus</i> (Onion Weed) and <i>Carthamus lanatus</i> (Saffron Thistle) are prominent. A small stand of <i>Eucalyptus gomphocephala</i> (Tuart Gums) planted as shade trees north of waypoint 437 has been excluded from the association. The SA Declared weeds <i>Echium plantagineum</i> (Salvation Jane) and <i>Marrubium vulgare</i> (Horehound) are present as minor components of the association.</p> <p>Grazing pressure is high with large numbers of kangaroos seen nearby, and there are areas of significant soil disturbance caused by rabbits. The introduced White Italian Snail (<i>Theba pisana</i>) is abundant and known to inhibit the recruitment of native plants by feeding on germinating seedlings.</p> <p>The plant association is in poor condition with a low to medium diversity of native species, no canopy cover, very high grazing pressure and moderate levels of weed invasion.</p>

Threatened species or community	<p><u>Threatened Ecological Communities</u> None</p> <p><u>Threatened Flora</u> No threatened flora were recorded in the vegetation association.</p> <p><u>Threatened Fauna</u> The plant community may provide resources for three threatened fauna species:</p> <ul style="list-style-type: none"> - Diamond Firetail (EPBC Vulnerable) - Heath Goanna (SA Vulnerable) - Peregrine Falcon (SA Rare) 				
Landscape context score	1.03	Vegetation Condition Score	16.96	Conservation significance score	1.08
Gain Score	4.91	Area (ha)	11.3	SEB Points of Gain	55.5

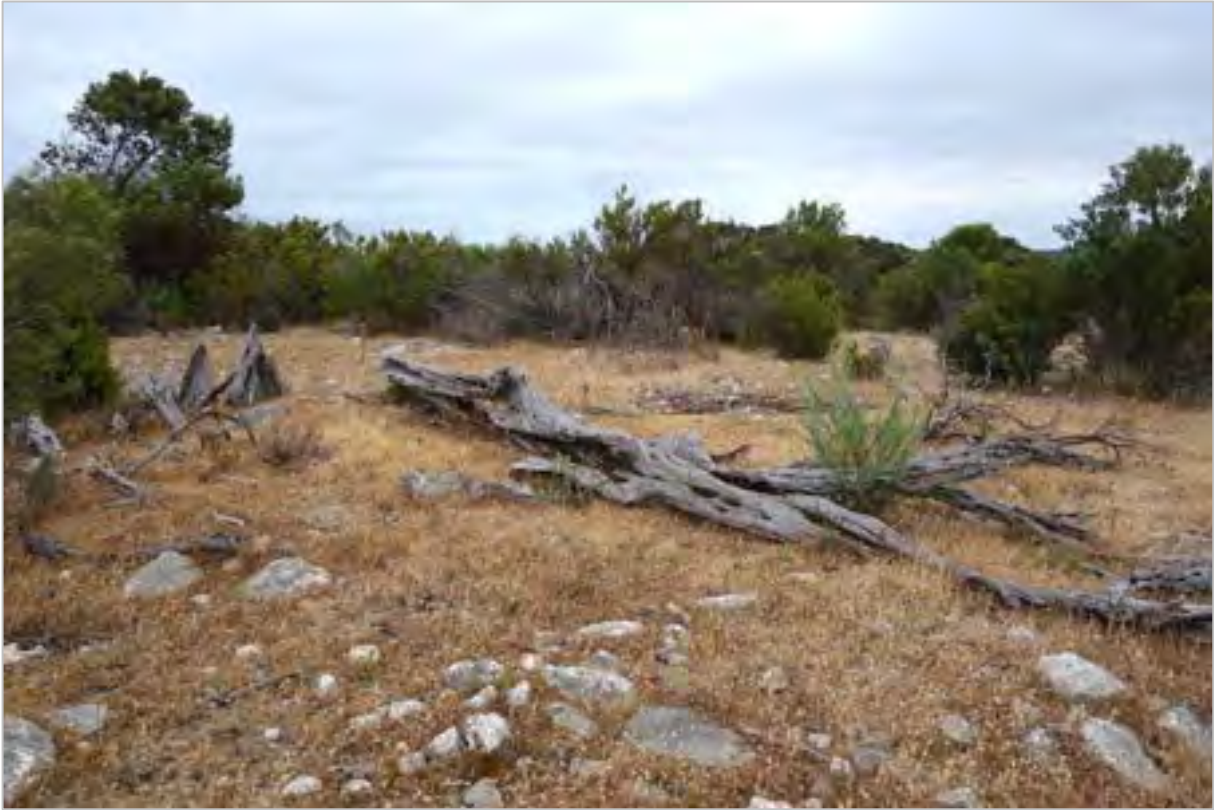
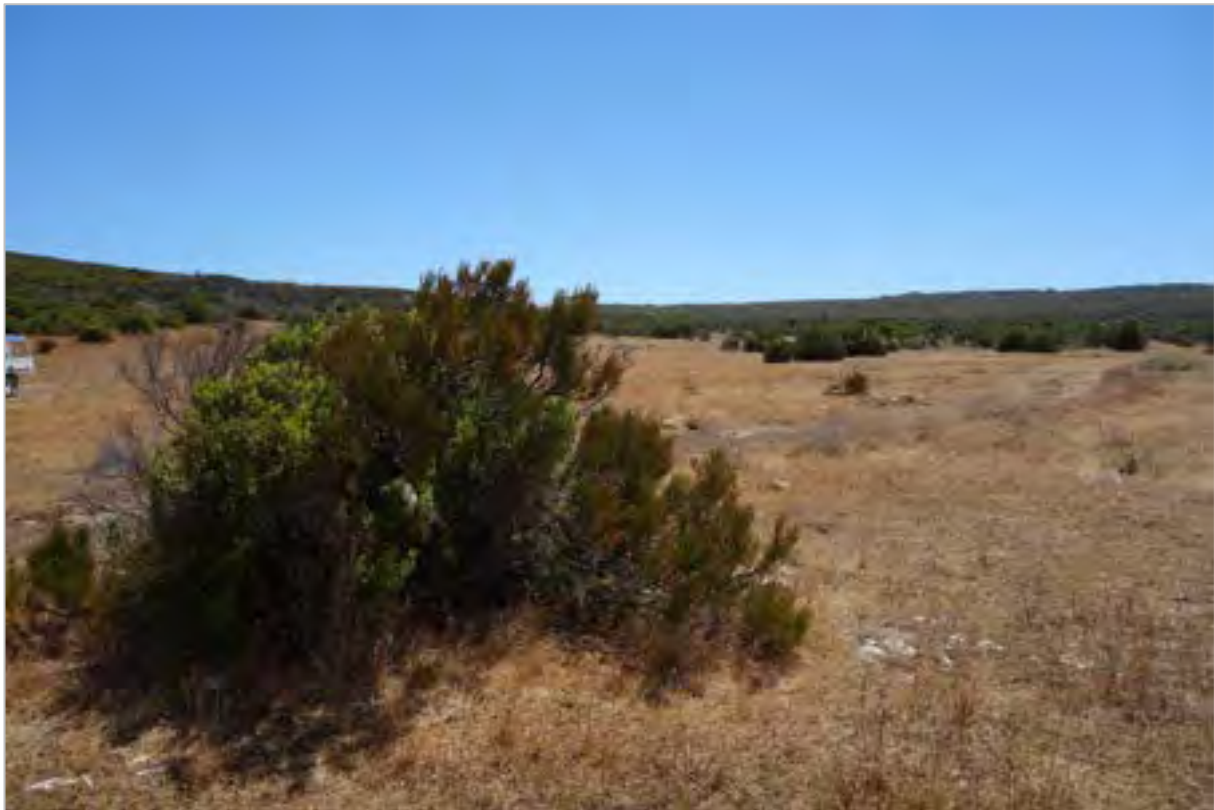
Photo 9323 facing west at waypoint 442 (Latitude -34.786964, Longitude 135.540067)

General description	<p>Plant community US3 is a regenerating shrubland growing on calcrete areas with extensive areas of exposed limestone. The association is characterised by a very open to mid-open shrublayer dominated by <i>Leucopogon parviflorus</i>, <i>Acacia longifolia</i> var. <i>sophorae</i> and <i>Exocarpos syrticola</i> over a herbland of native daisies, native grasses and mosses, with exotic annual grasses and herbs. Sheoak stumps and fallen trunks are widespread, indicating that the community was once an <i>Allocasuarina verticillata</i> woodland. Exposed limestone outcrops are prominent. Shrub cover varies from quite sparse in the north-western parts to moderately dense in the south-east.</p> <p>The vegetation association has a medium diversity of native species which includes several regenerating shrub species (<i>Pittosporum angustifolium</i> (Native Apricot), <i>Olearia axillaris</i>, <i>Melaleuca lanceolata</i> (Dryland Tea-tree), <i>Pimelea serpyllifolia</i>, <i>Rhagodia candolleana</i> (Sea-berry Saltbush), <i>Acrotriche patula</i> (Prickly Ground-berry), <i>Lasiopetalum discolor</i> (Coast Velvet-bush) and <i>Dodonaea viscosa</i> subsp. <i>spatulata</i> (Sticky Hop-bush). The community also supports a variety of other native lifeforms such as vines (<i>Clematis microphylla</i>), lilies (<i>Bulbine semibarbata</i> (Small Leek-lily)), sedges (<i>Gahnia deusta</i> (Limestone Saw-sedge), <i>Gahnia lanigera</i> (Black Grass Saw-sedge), forbs (<i>Asteridea athrixoides</i>, <i>Vittadinia australasica</i>, <i>Dichondra repens</i> (Kidney Weed)), grasses (<i>Austrostipa exilis</i>, <i>Rytidosperma caespitosum</i>) and mosses.</p> <p>Prominent introduced species include <i>Lagurus ovatus</i> (Hair's Tail Grass), Fescue, Onion Weed, Mediterranean Linseed, Hop Clover and <i>Melilotus indicus</i> (King Island Melilot). High risk weeds present in parts of the community include <i>*Acacia cyclops</i> (Western Coastal Wattle), Horehound, Salvation Jane, <i>Senecio pterophorus</i> (African Daisy) and <i>Asparagus asparagoides</i> (Bridal Creeper).</p> <p>Grazing pressure is high with large numbers of kangaroos observed in the area and there is significant soil disturbance by rabbits. The introduced White Snail is abundant throughout the community.</p> <p>The plant association is in moderate condition with a medium diversity of native species, little tree canopy, very high grazing pressure and moderate levels of weed invasion.</p>

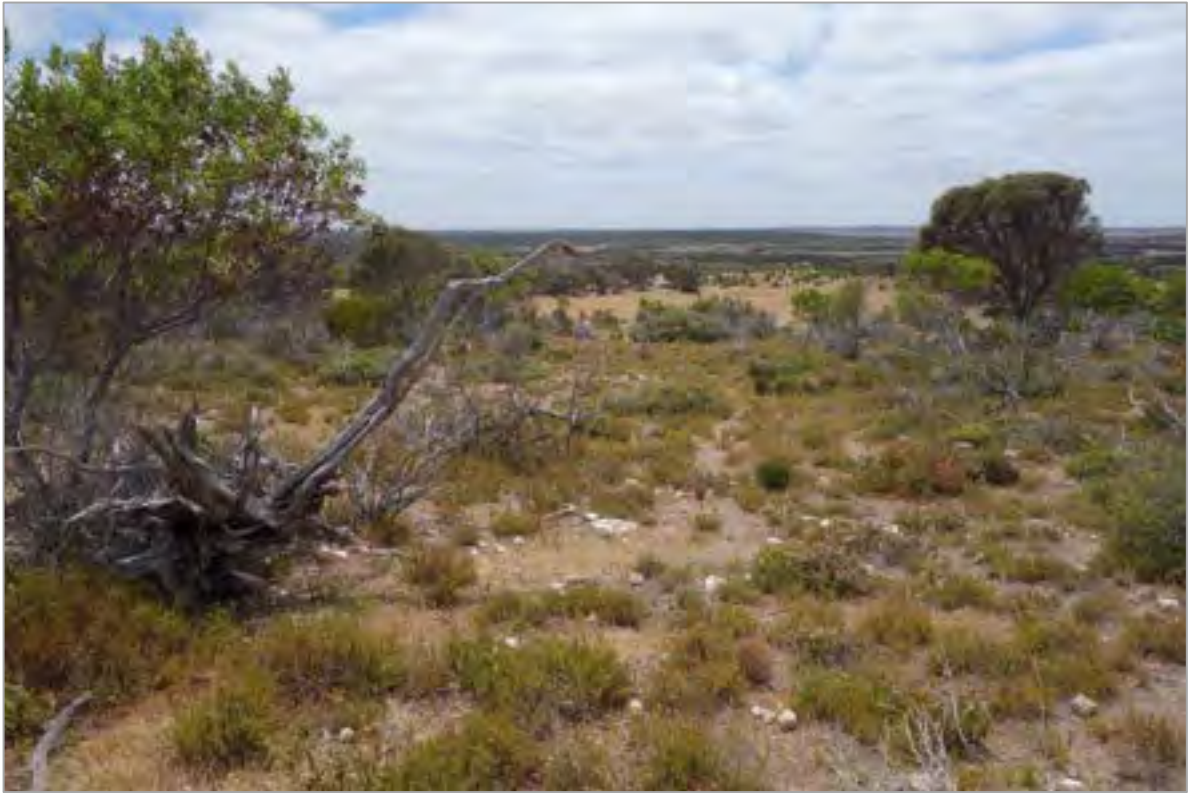
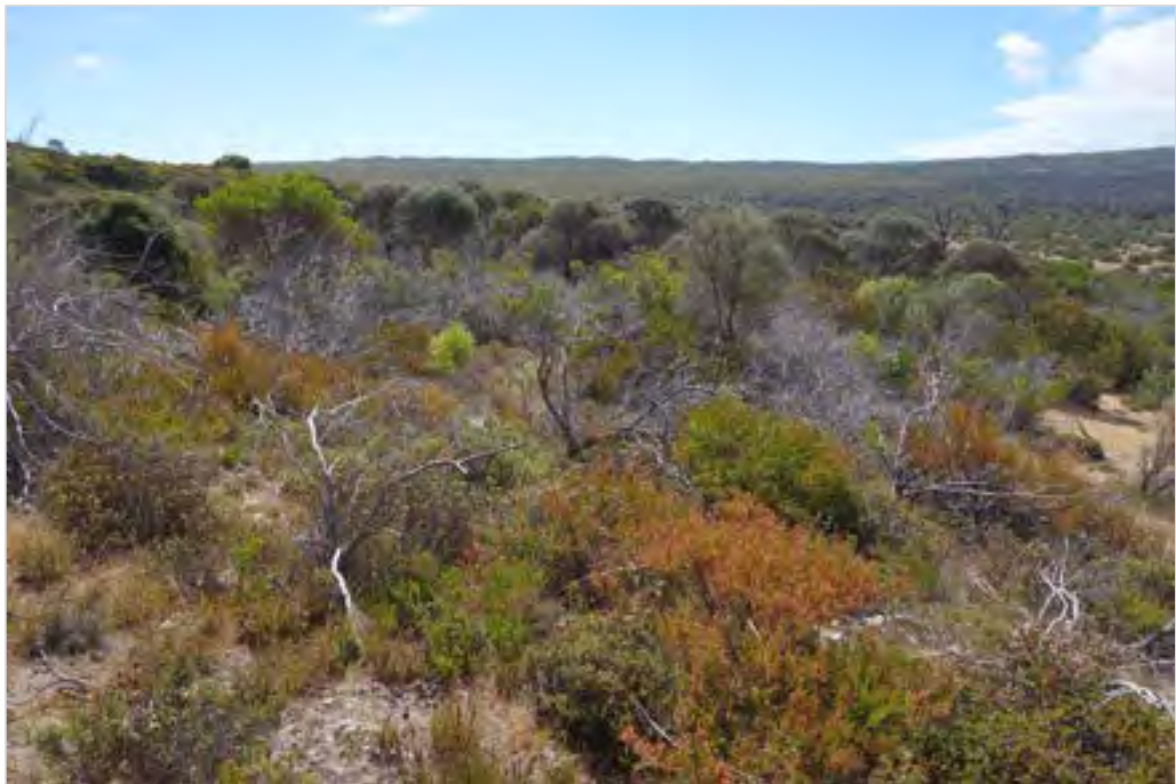
Photo 9333 facing north at waypoint 445 (Latitude -34.789431, Longitude 135.530189)

General description	<p>Plant community US4 occurs on calcareous soils of the east-facing mid-slopes above the derived shrubland and herbland communities.</p> <p>Varying age classes of <i>Allocasuarina verticillata</i> occur mostly as sparsely scattered trees, although there are some small stands where the species becomes more dense, particularly in the north-western parts. Large fallen trunks and logs indicate that the canopy layer was once dominated by <i>Allocasuarina verticillata</i>. The introduced <i>Acacia cyclops</i> (listed as <i>Acacia longifolia</i> ssp. <i>longifolia</i> in the BAM scoresheet) now forms the dominant canopy layer in some areas.</p> <p>The low shrub layer comprises <i>Lasiopetalum discolor</i>, <i>Olearia axillaris</i>, <i>Hibbertia devitata</i> (Smooth Guinea-flower), <i>Leucopogon parviflorus</i> and <i>Acrotriche patula</i> with dense patches of <i>Gahnia lanigera</i>. Calcrete rocks are present on the soil surface and interspersed with the vegetation.</p> <p>Native species diversity is high and comprises a suite of other species that are characteristic of the EPBC-listed <i>Drooping Sheoak Grassy Woodland on calcrete of the Eyre Yorke Block Bioregion</i> community (e.g. <i>Pittosporum angustifolium</i>, <i>E. diversifolia</i>, <i>Pimelea serpyllifolia</i>, <i>Acacia cupularis</i> (Cup Wattle), <i>A. triquetra</i> (Mallee Wreath Wattle), <i>A. spinescens</i> (Spiny Wattle), <i>Pomaderris paniculosa</i> (Coast Pomaderris), <i>Clematis microphylla</i>, <i>Dianella brevicaulis</i>, <i>Asteridea athrixioides</i>, <i>Austrostipa</i> spp. and <i>Rytidosperma</i> spp.). Several species of orchids were noted during a spring site visit (September 2024).</p> <p>The SA Declared Bridal Creeper is present as very sparsely scattered small plants. Non-native grasses and herbs are a minor component of the ground layer.</p> <p>Grazing pressure is generally less than on the lower slopes but remains high in more open areas.</p> <p>The vegetation association is generally in good condition with a high diversity of native species, low to moderate cover of canopy and fallen timber and low levels of weed invasion outside of <i>*A. cyclops</i> patches.</p>

Threatened species or community	<p><u>Threatened Ecological Communities</u></p> <p>While there are some denser stands of <i>Allocasuarina verticillata</i>, much of the community does not currently meet the minimum threshold criteria for the nationally-listed <i>Drooping Sheoak Grassy Woodland on calcrete of the Eyre Yorke Block Bioregion</i> (at least 2 mature Drooping Sheoak trees and/or 10 seedlings and/or saplings present per 30 x 30 m sample plot). However, the highly diverse understory supports numerous flora species characteristic of the threatened ecological community (indicated in bold above), and the community (in particular the canopy layer) could be restored through the management of pest plants and grazing pressure.</p> <p><u>Threatened Flora</u></p> <p>One threatened flora species was recorded:</p> <ul style="list-style-type: none"> - <i>Thysanotus nudicaulis</i> (a Fringe-lily), (SA Endangered) <p><u>Threatened Fauna</u></p> <p>The plant community may provide resources for seven threatened fauna species:</p> <ul style="list-style-type: none"> - EP Southern Emuwren (EPBC Endangered) - White-bellied Whiplbird (EPBC Endangered) - Diamond Firetail (EPBC Vulnerable) - Heath Goanna (SA Vulnerable) - Yellow-tailed Black Cockatoo (SA Vulnerable) - Peregrine Falcon (SA Rare) - Rock Parrot (SA Rare)

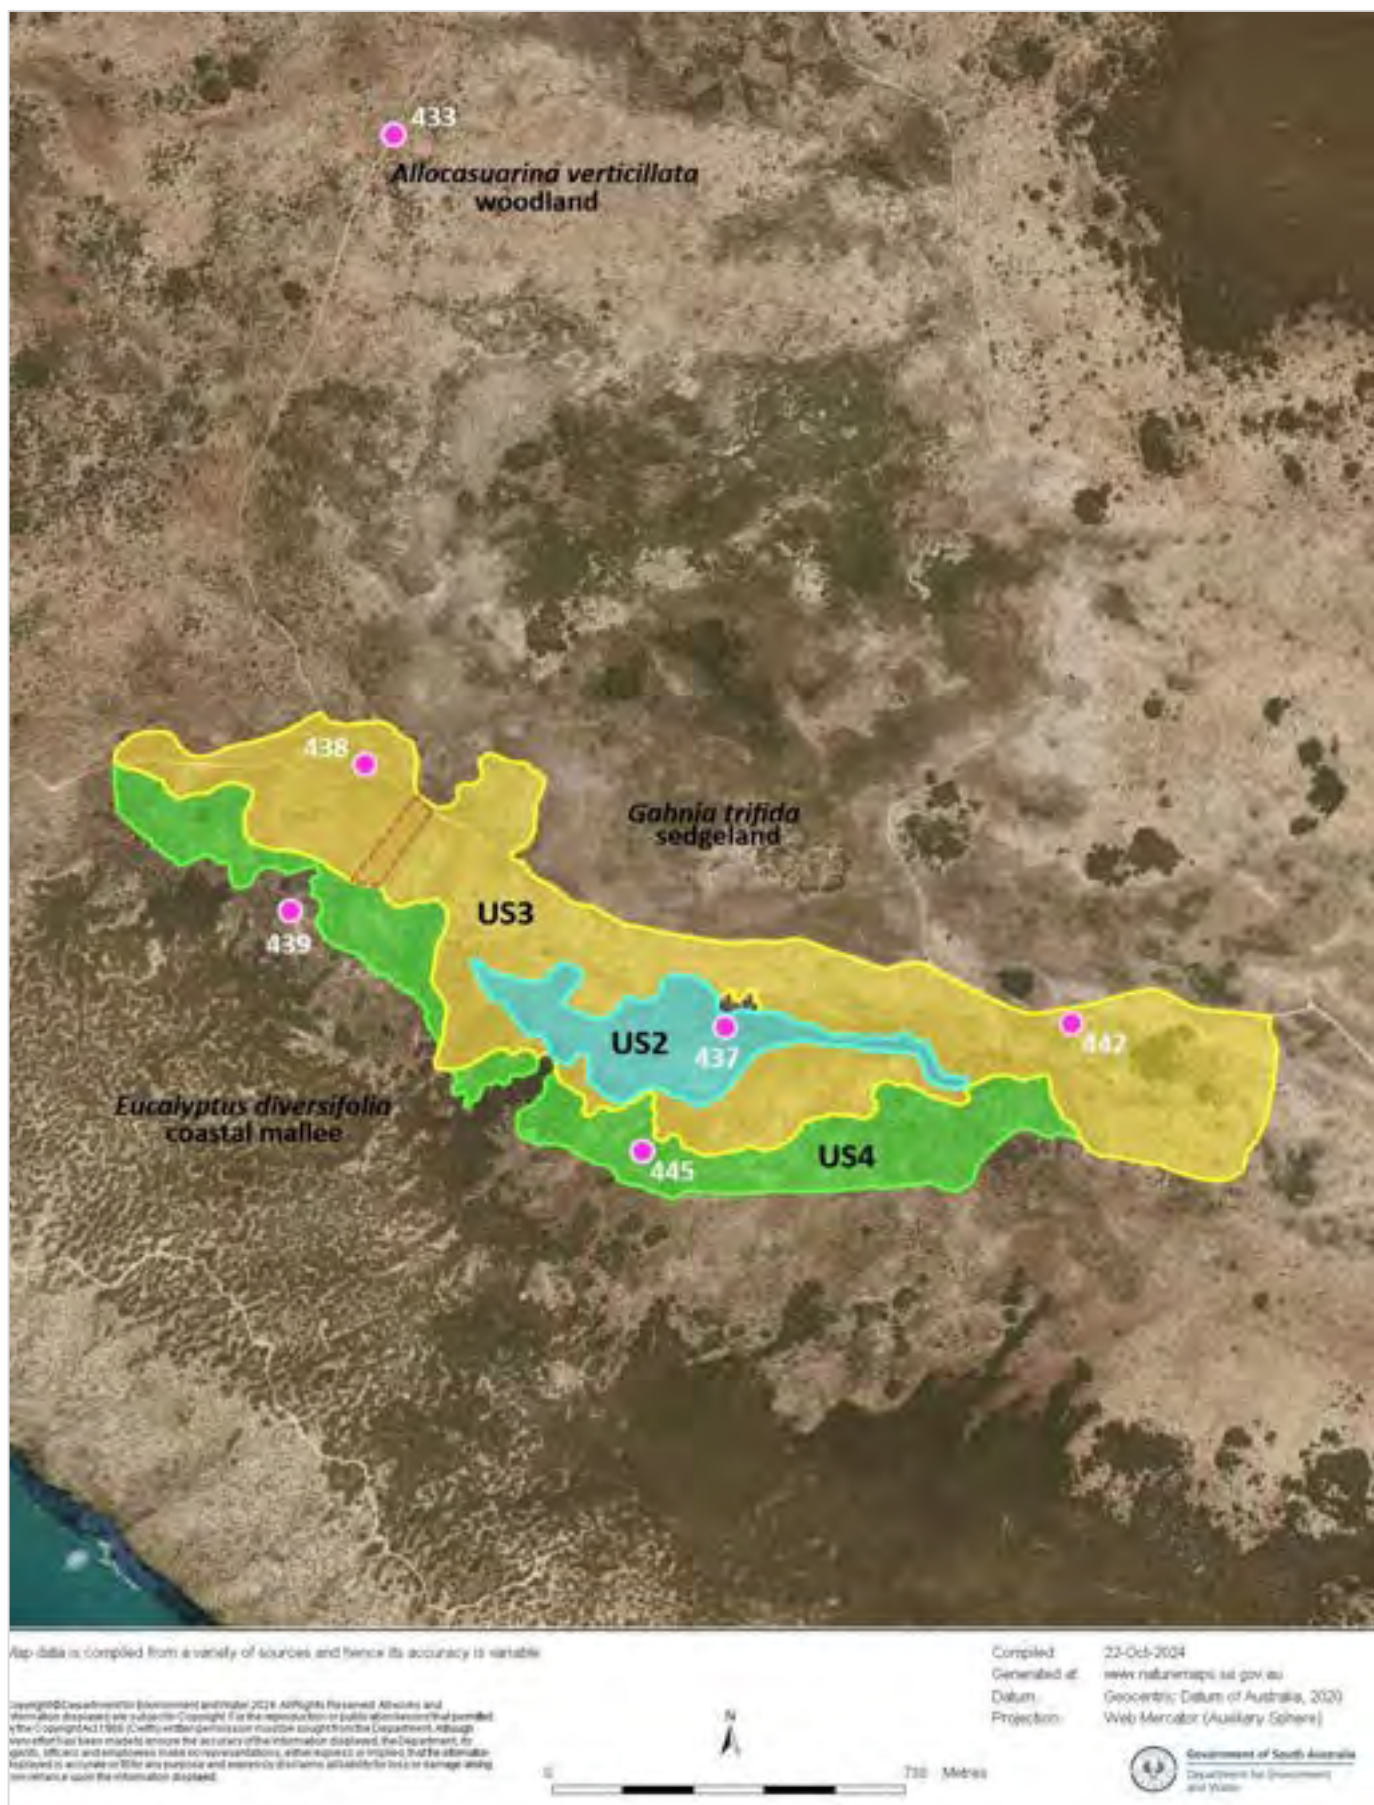
Figure 20. Site map showing vegetation associations within proposed SEB offset area, waypoints (pink circles) and proposed faunal linkage habitat (brown dashed line).

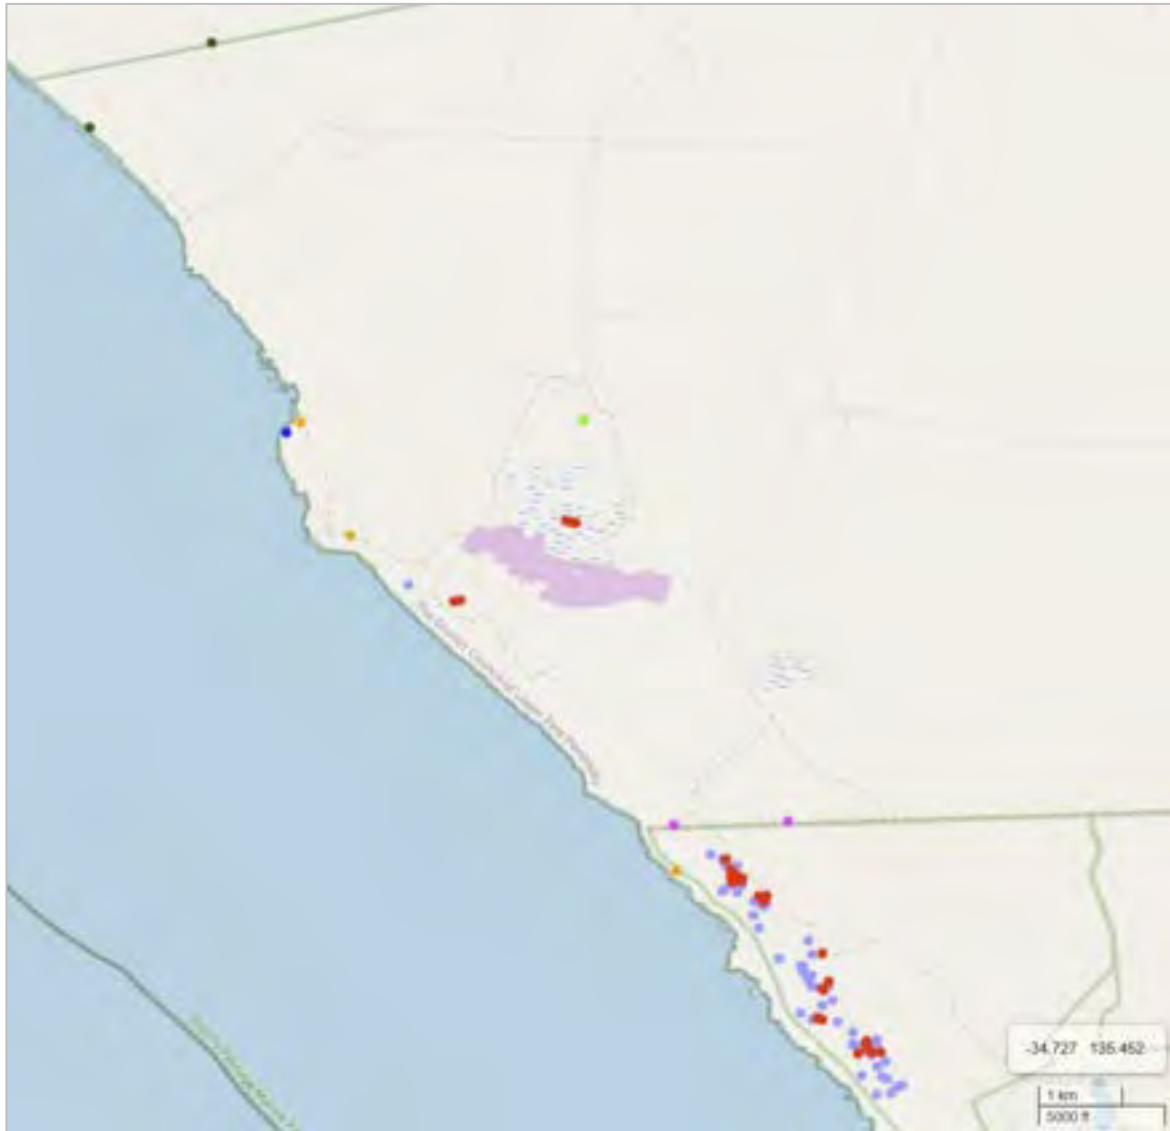
Figure 21. Map of threatened fauna species recorded since 1995 within 5 km of the proposed SEB offset area (shaded in pink). EP Southern Emuwaren (red dots), Mallee Whipbird (purple), Diamond Firetail (bright pink), Rock Parrot (orange), Peregrine Falcon (dark blue), Yellow-tailed Black Cockatoo (light green) and Heath Monitor (dark green). Note that the higher density of records in private land south of the SA Water Reserve most likely reflects a greater survey effort rather than differences in habitat use.

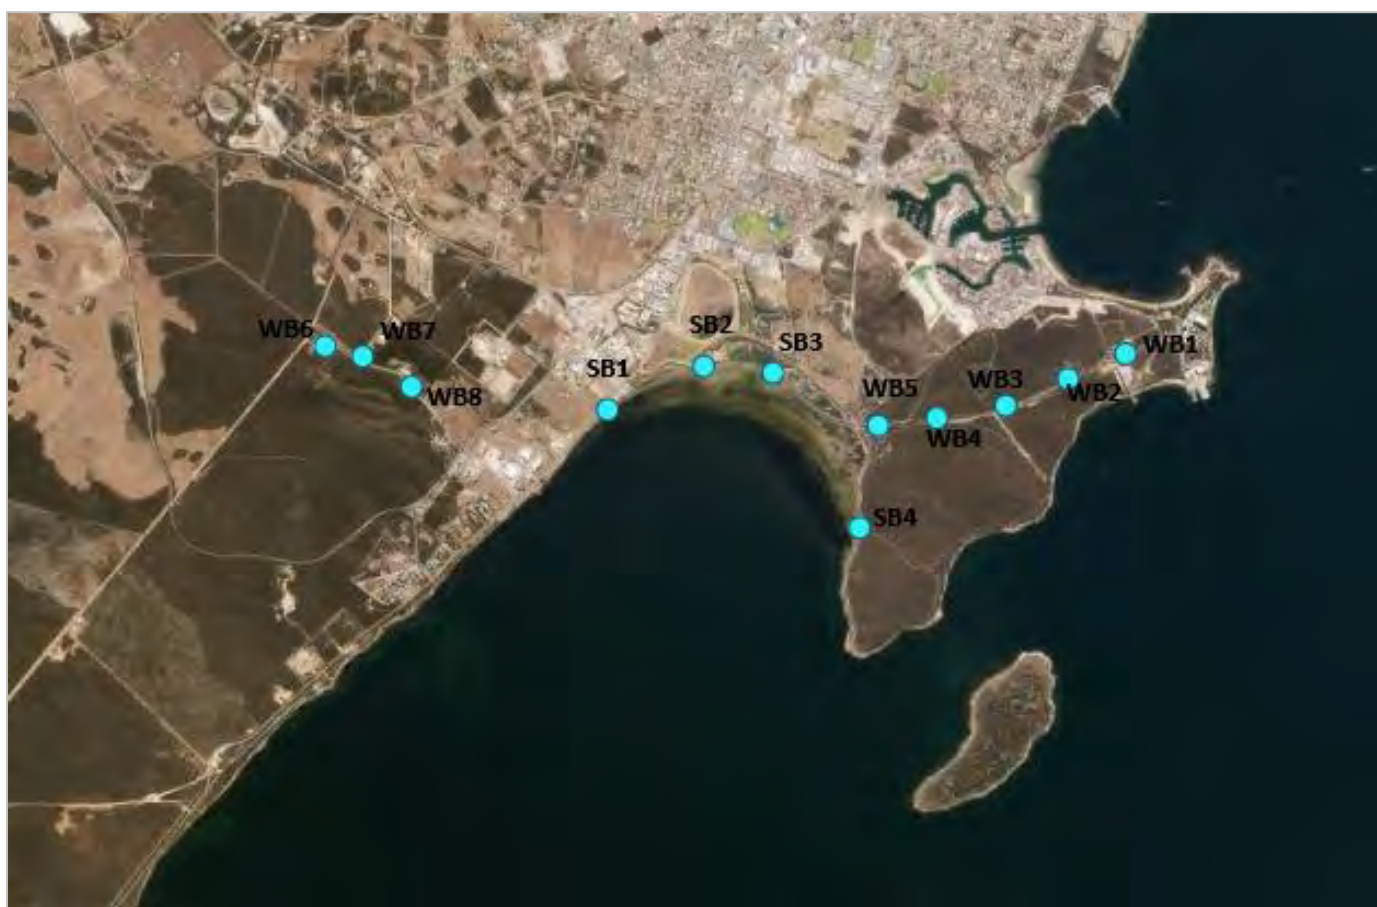
Figure A1: locations of systematic survey sites for woodland (WB) and shore birds (SB).
