Native Vegetation Clearance

Yoorndoo Ilga Solar Project – BDAC

Data Report

Clearance under the *Native Vegetation Regulations 2017*

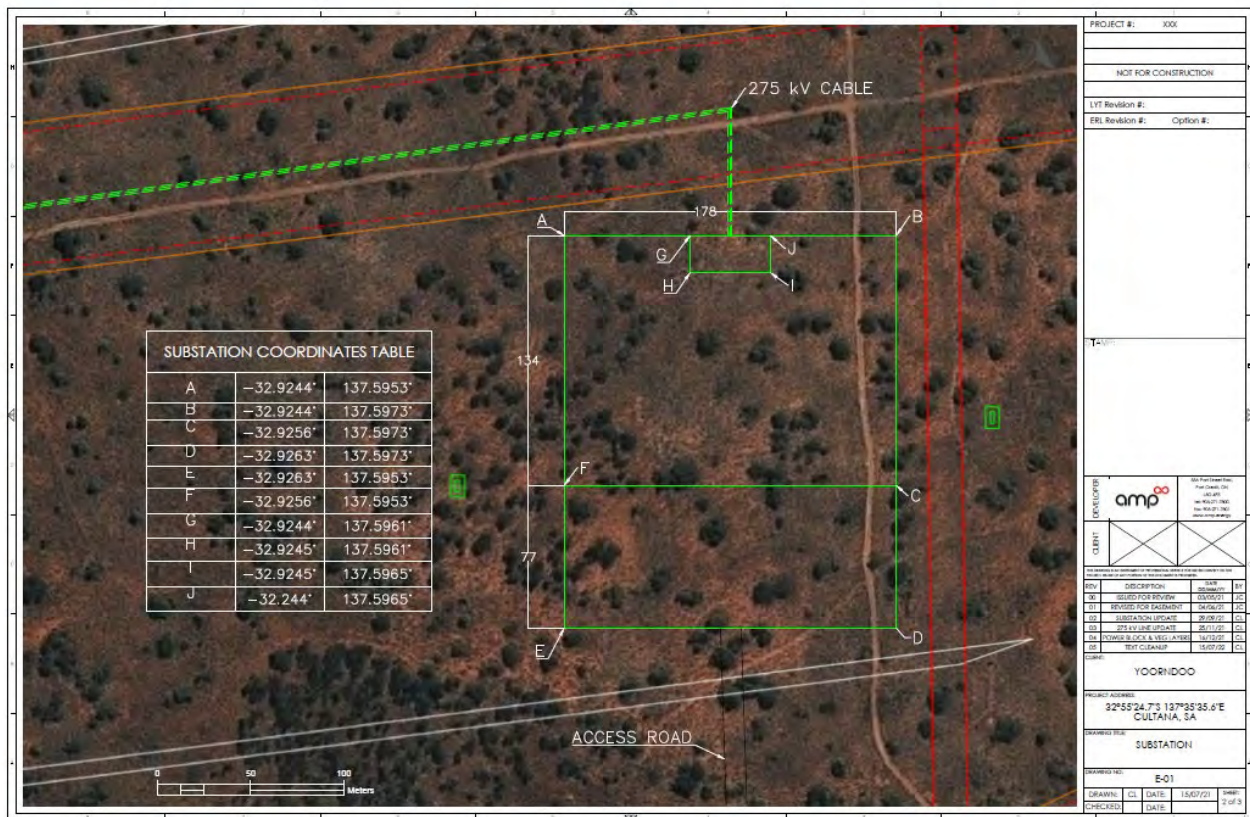
Figure 3: Design for BESS on BDAC property.

The project design is provided in Figures 3 and 4.

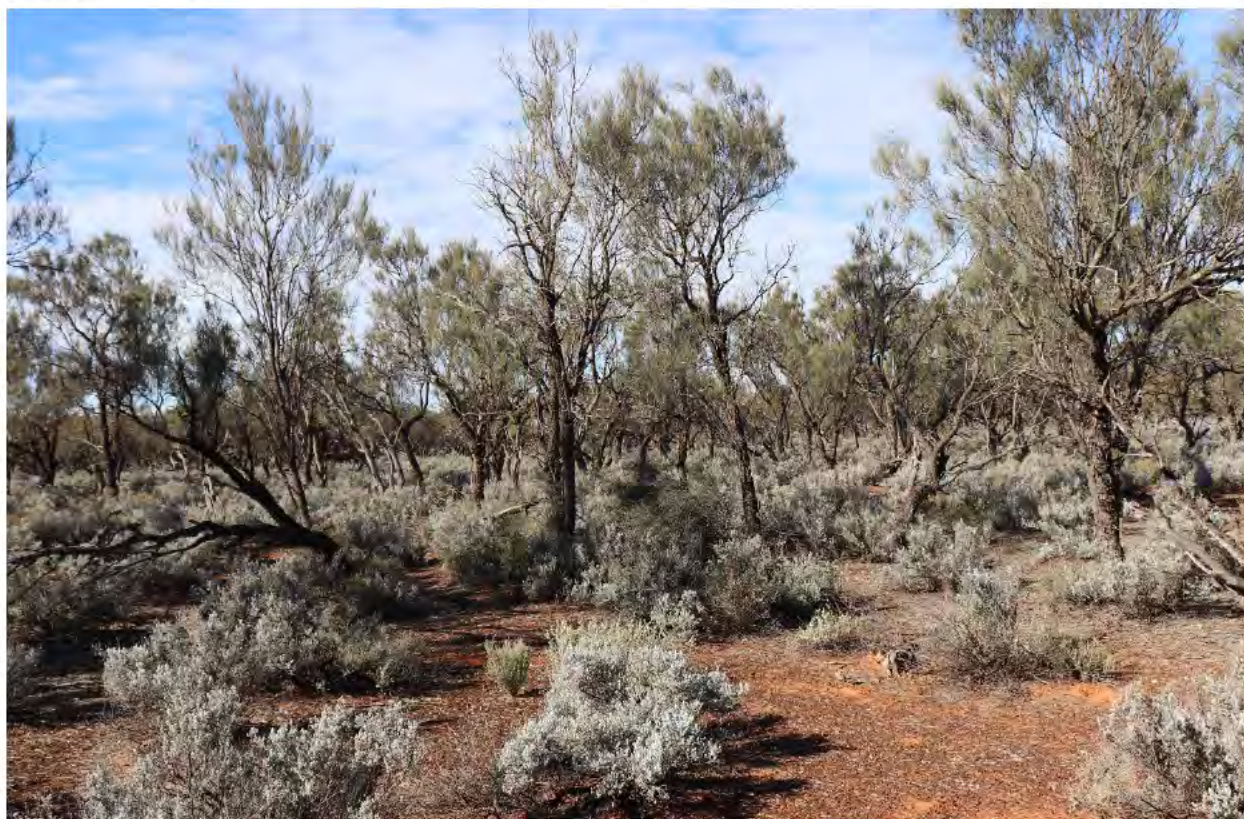
Figure 10: *Casuarina pauper* Woodland with *Chenopod* Understorey

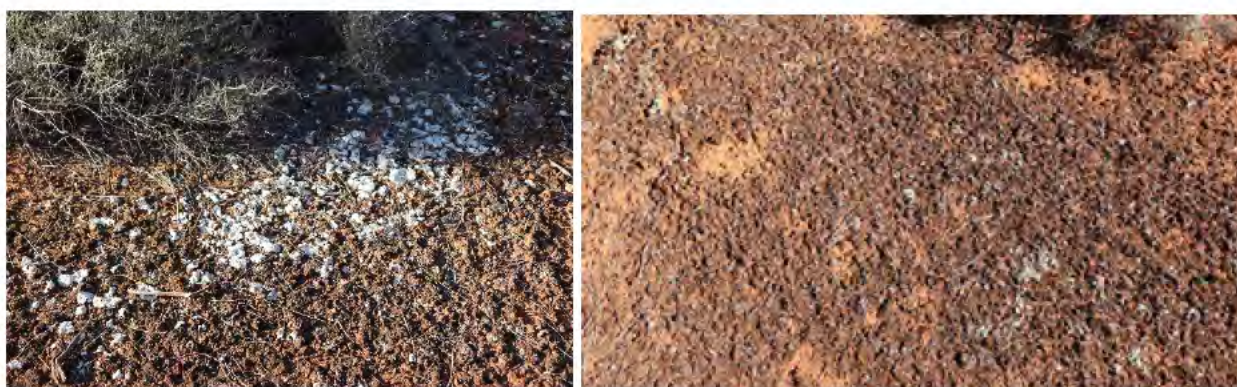
Figure 11: Areas with no leaf litter were covered in biological soil crust. Very little bare ground was present

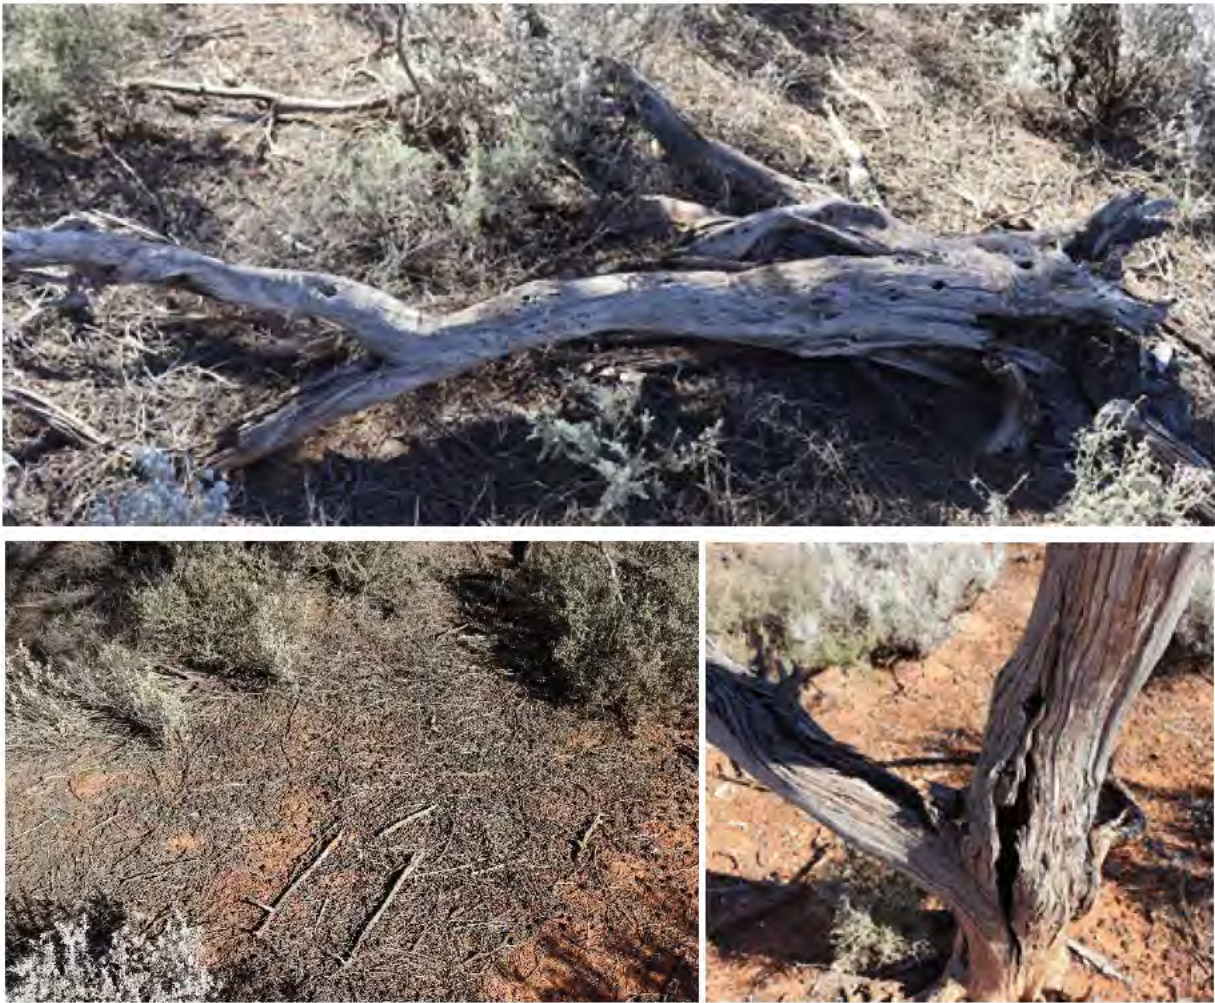
<p data-bbox="276 1216 1300 1245">Figure 12: Structural habitat features present within VA2 (fallen logs, hollows, and dense leaf litter)</p>	
General description	<p>This vegetation association is in good condition (Figure 10); some disturbance was present in the form of vehicle tracks and dumping although this association was less impacted than VA1. The tracks create an edge effect allowing public access, weed incursion, vertebrate pest access and soil crust disturbance. Unfortunately, public access via the multiple tracks covering the site has led to a lot of illegal dumping although this is not as prolific in this VA as it is in VA1.</p> <p>This vegetation association is dominated by of which <i>Casuarina pauper</i>, with a tall shrub layer of <i>Maireana sedifolia</i> and <i>Scaevola spinescens</i>. The upperstorey was predominantly densely spaced, with scattered patches of open space. Diversity was limited, with <i>C. pauper</i> only occasionally interspersed with <i>Acacia papyrocarpa</i>, <i>Eremophila scoparia</i> and <i>Myoporum platycarpum</i>. The understorey was sparse interspersed with extensive patches of biological soil crust and leaf litter. Ground cover species included <i>Sclerolaena obliquicuspis</i>, <i>Roepera angustifolia</i>, <i>Calandrinia eremaea</i> and <i>Eriochiton sclerolaenoides</i>. The biological soil crust provided effective cover over 80-90% of the bare ground and was represented by a broad range of lichens and mosses (Figure 11).</p> <p>A total of 25 native and three weed species were recorded within this vegetation association (Appendix 3). No threatened species were present. While regeneration was present, it was from a limited number of species (six) and a low number of individuals. Habitat features such as small and medium hollows and large fallen logs, and branches were present throughout the community (Figure 12).</p>

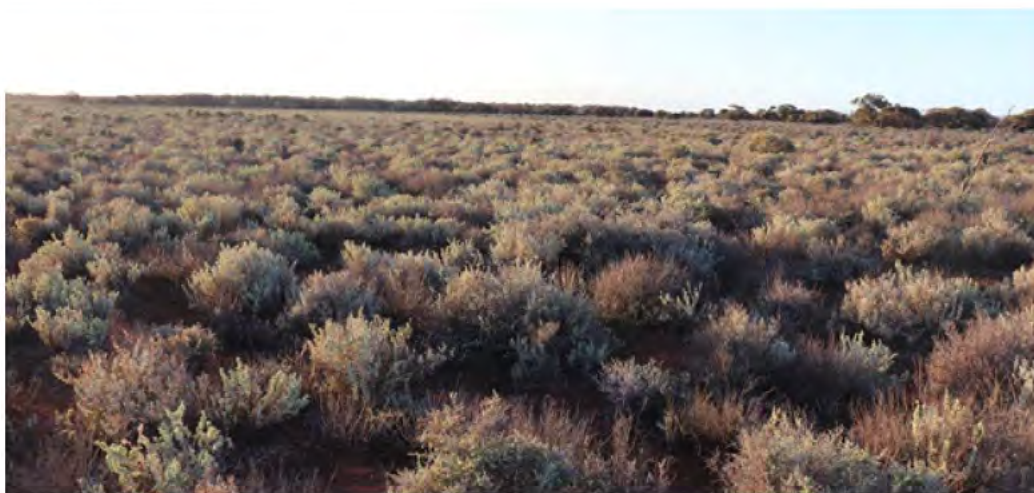
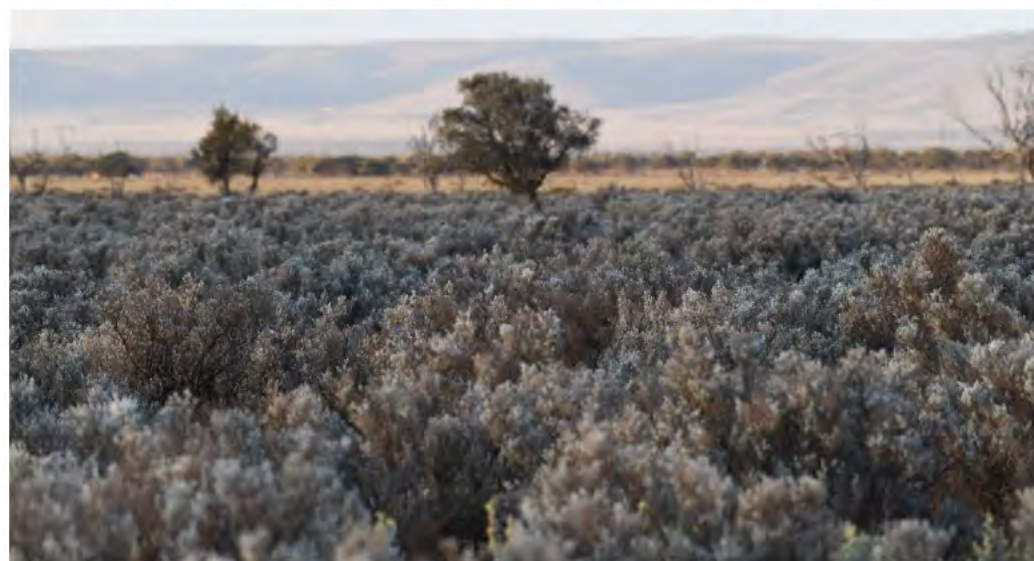
Figure 13: Inland Chenopod Shrubland with *Atriplex vesicaria* (top) and *Maireana sedifolia* (bottom).

Vegetation Association	VA3: Inland Chenopod Shrubland with emergent <i>Acacia papyrocarpa</i>				
General description	<p>This vegetation association is in good condition (Figure 13); however, disturbance was present in the form of vehicle tracks, power lines, fencing and dumping. The tracks create an edge effect allowing public access, weed incursion, vertebrate pest access and soil crust disturbance.</p> <p>This vegetation occurs between the <i>A. papyrocarpa</i> and <i>C. pauper</i> woodlands. It is a low shrubland dominated by <i>Maireana sedifolia</i> and <i>Atriplex vesicaria</i>. These two species display a clear distribution pattern suggesting that soil type or soil moisture drive distribution. <i>Scaevola spinescens</i> is also present, usually in the crossover between <i>Maireana sedifolia</i> and <i>Atriplex vesicaria</i>. Scattered <i>Acacia papyrocarpa</i> are present in the overstorey. Emergent <i>Exocarpus aphyllus</i>, <i>Myoporum platycarpum</i> and <i>Eremophila scoparia</i> were also present. Native ground cover included <i>Sclerolaena obliquicuspis</i>, <i>Maireana turbinata</i> and <i>Enchylaena tomentosa</i>. Hotspots of diversity and high-density plant cover were observed underneath emergent trees and shrubs.</p> <p>A total of 23 native and two weed species were recorded within this vegetation association (Appendix 3). Recruitment was poor with only six species showing signs of regeneration (Figure 14). Due to the lack of over storey, no hollows and very little fallen timber were present. Some leaf litter was present, but ground cover consisted mostly of biological soil crust. Where this soil crust was not present, weed species were prolific.</p>

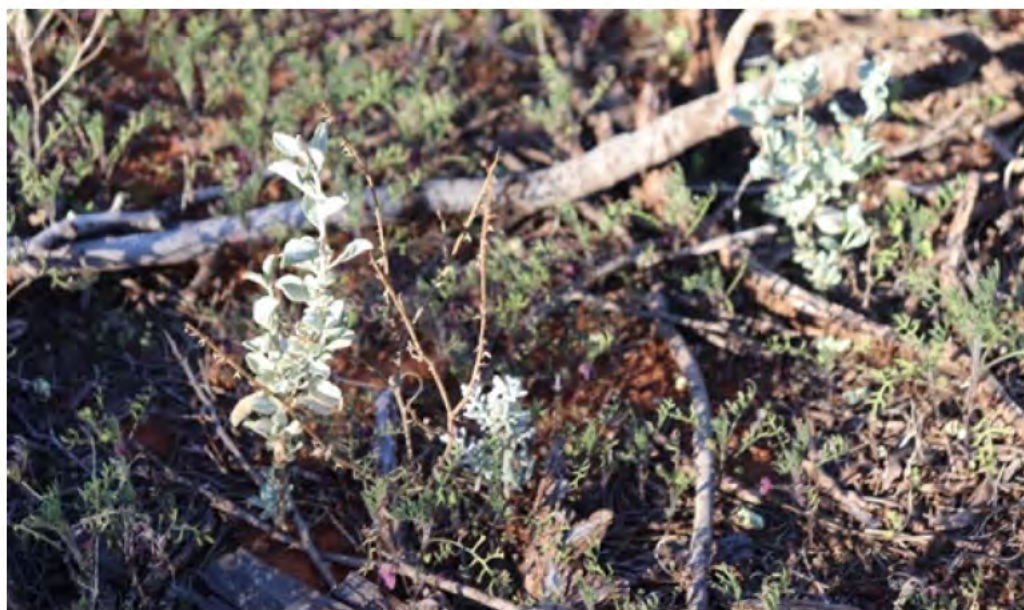
Figure 14: Recruitment of *Atriplex vesicaria* and *Maireana sedifolia* amongst Wards Weed.

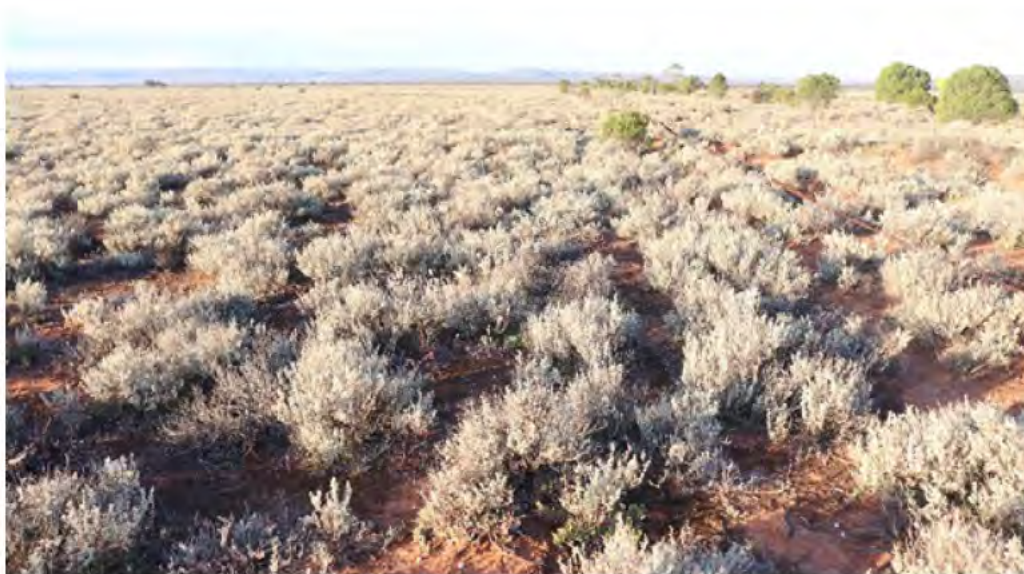
Figure 15: Coastal low chenopod shrubland.

This coastal shrubland is found at the eastern end of the BDAC site (Figure 15). It is in good condition with the same impacts as the other vegetation associations; tracks, fencing, dumping and retired dams (Figure 16). The western portion of this vegetation association is dominated by *Atriplex vesicaria*, *Maireana pyramidata* and *Scaevola spinescens*, shifting to *Tecticornia halocnemoides* saltmarsh flats to the east as elevation decreases and salinity increases. Emergent shrubs of *Eremophila scoparia*, *E. longifolia* and *Myoporum insulare* were present, increasing towards the west and south (Figure 17). Native understorey biomass and diversity was also high, with species such as *Disphyma crassifolium*, *Osteocarpum* spp., *Sarcocolla praecox*, *Sclerolaena* spp. and *Frankenia pauciflora* (Figure 18).

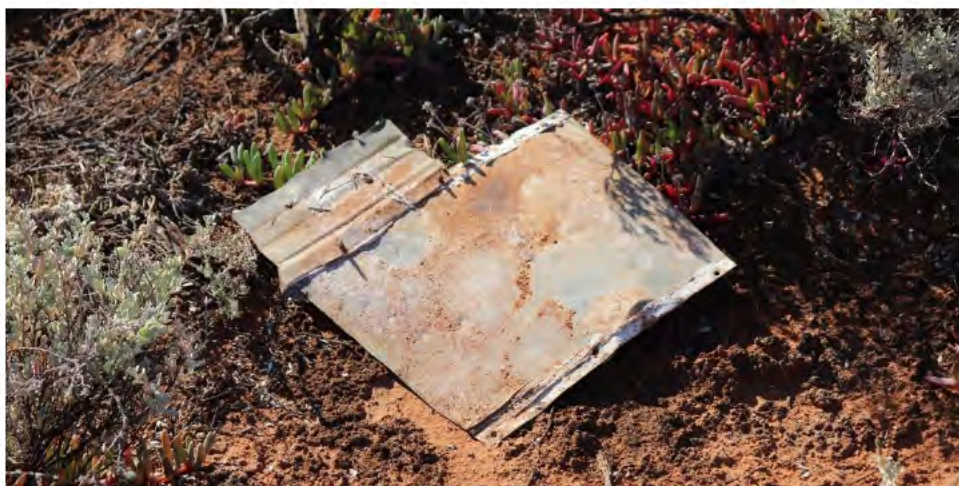
Figure 16: Illegal dumping in areas along access tracks.

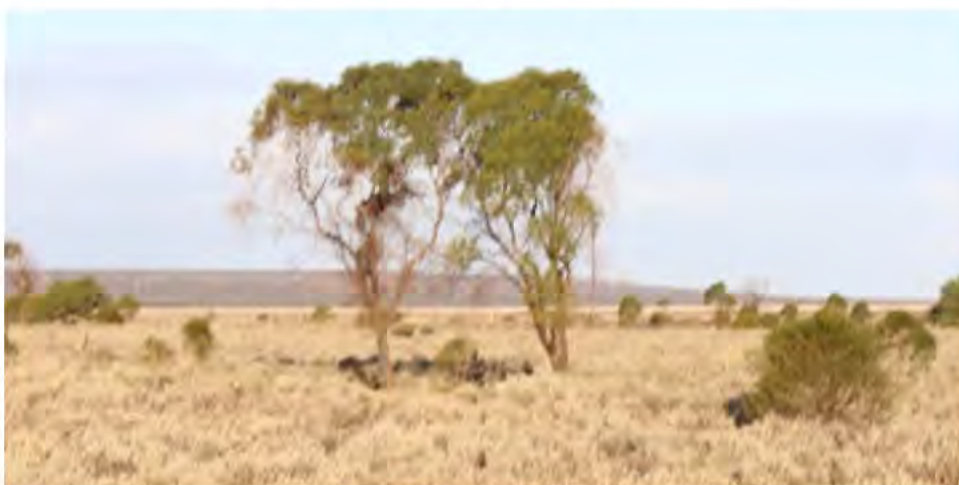
Figure 17: Emergent Myoporum platycarpum over low chenopod shrubland.

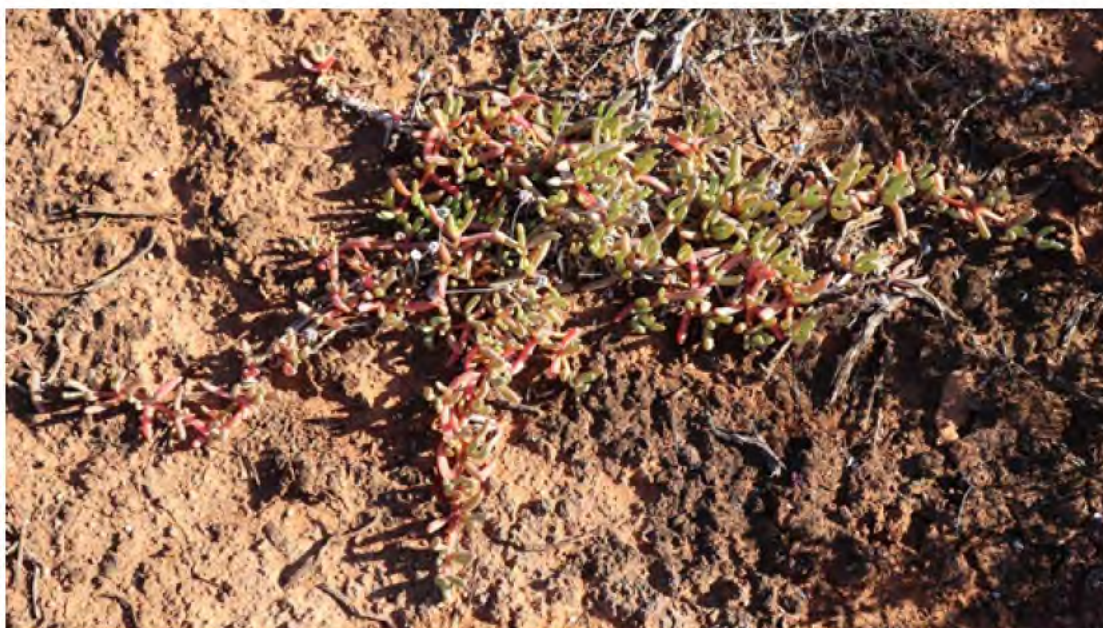
Figure 18: Common groundcover species *Disphyma crassifolium* (Rounded Pigface)

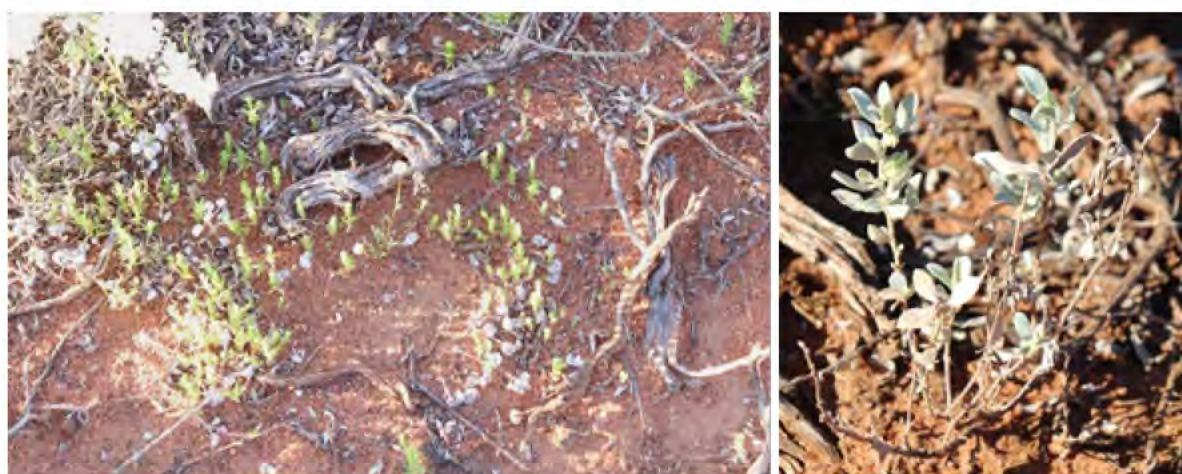
Figure 19: Recruitment of native flora species

This vegetation association had the highest plant diversity, with 37 native and seven weed species. No threatened species were recorded in this vegetation association. Good recruitment was observed, with juvenile plants from over ten species present and multiple age classes observed (Figure 19). Some leaf litter, and small fallen branches and logs were present, and biological soil crust was present across the site.
