Native Vegetation Clearance

Upper Yorke Road

Port Broughton to Bute

Data Report

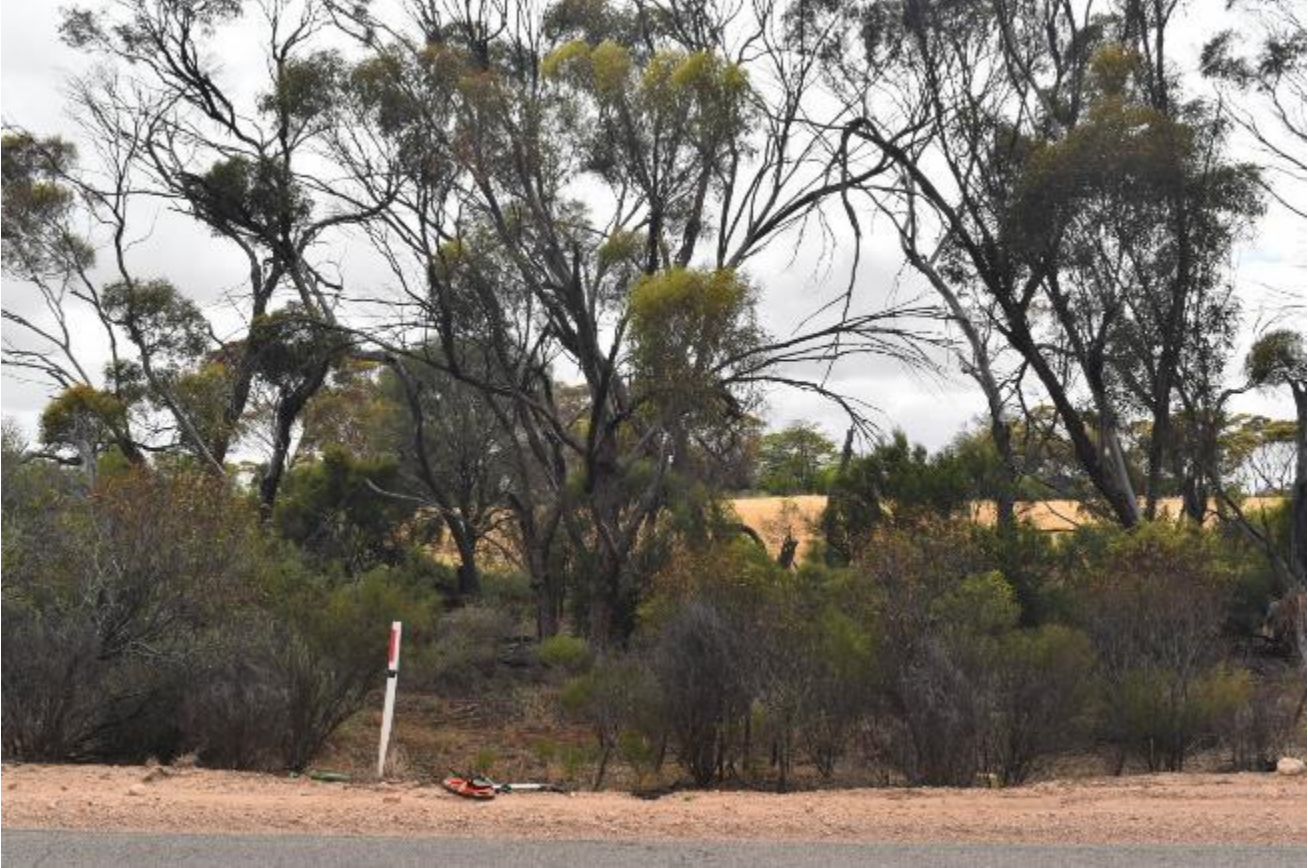
<p>Photo 1. Indicative impact - culvert site A. Taken facing east, MM 4.885 LHS</p>	
  <p>Photo 2. Indicative impact, curve extension, MM 8.893 – 9.238 LHS facing north</p>

General description	This association covers the majority of the impacted vegetation, including most of the shoulder sealing sites, all impacted culvert extension, curve and side road sites. The complexity, diversity and condition changes moderately across the length of the association, however it can be broadly described as a mid-mallee woodland with a sclerophyll shrub understorey, consistent with the BCM YP4 community. The dominant species are <i>Eucalyptus gracilis</i> , <i>E. oleosa</i> , <i>E. brachycalyx</i> , over <i>Acacia</i> , <i>Senna</i> and <i>Rhagodia</i> spp. Disturbed with weed invasion and litter close to the road shoulder, grading to more diverse and less degraded closer to property boundaries. Dead Bridal Creeper was present, sometimes in large patches, otherwise small occurrences.				
Threatened species or community	The State Rare listed <i>Geijera parviflora</i> was present in the road verge vegetation but not within the impact site, which was limited to less than 1m from the shoulder.

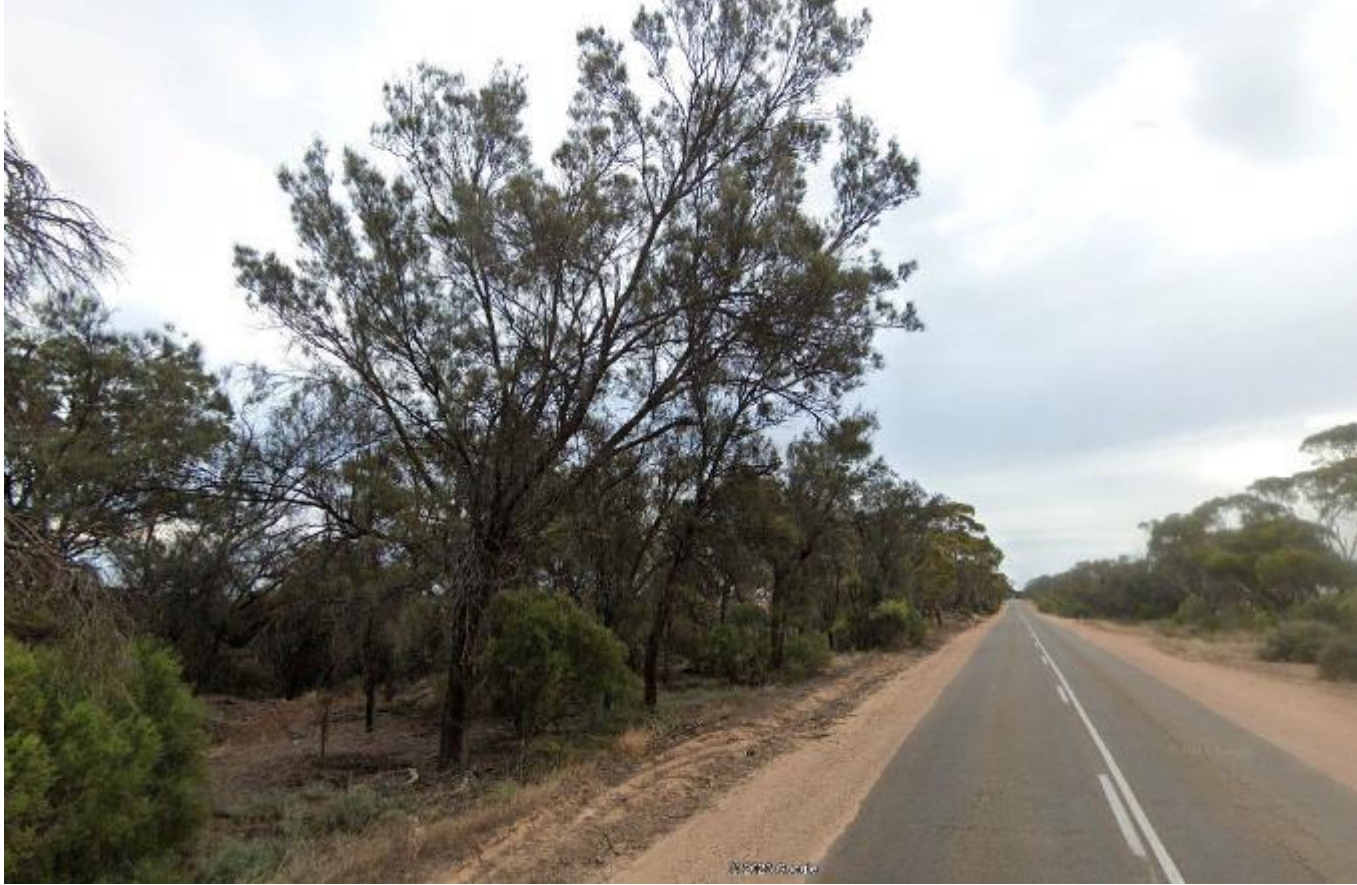
Photo 4. Indicative shoulder sealing impact, MM 5.0 – 5.5 LHS facing south					
General description	A small patch existing within the more common mallee woodland, this association is dominated by <i>Casuarina pauper</i> in fair condition overall. Disturbance is as at VA1 and other sites, with weeds and litter present close to the road. There were environmental but no declared weeds noted in this patch. Shoulder sealing impact site 2a lies within this association.				
Threatened species or community	No threatened flora or fauna under the NP&W Act or EPBC Act listed species or community were noted within this association.				
Landscape context score	1.12	Vegetation Condition Score	30.19	Conservation significance score	1.04
Unit biodiversity Score	35.16	Area (ha)	0.0185	Total biodiversity Score	0.65

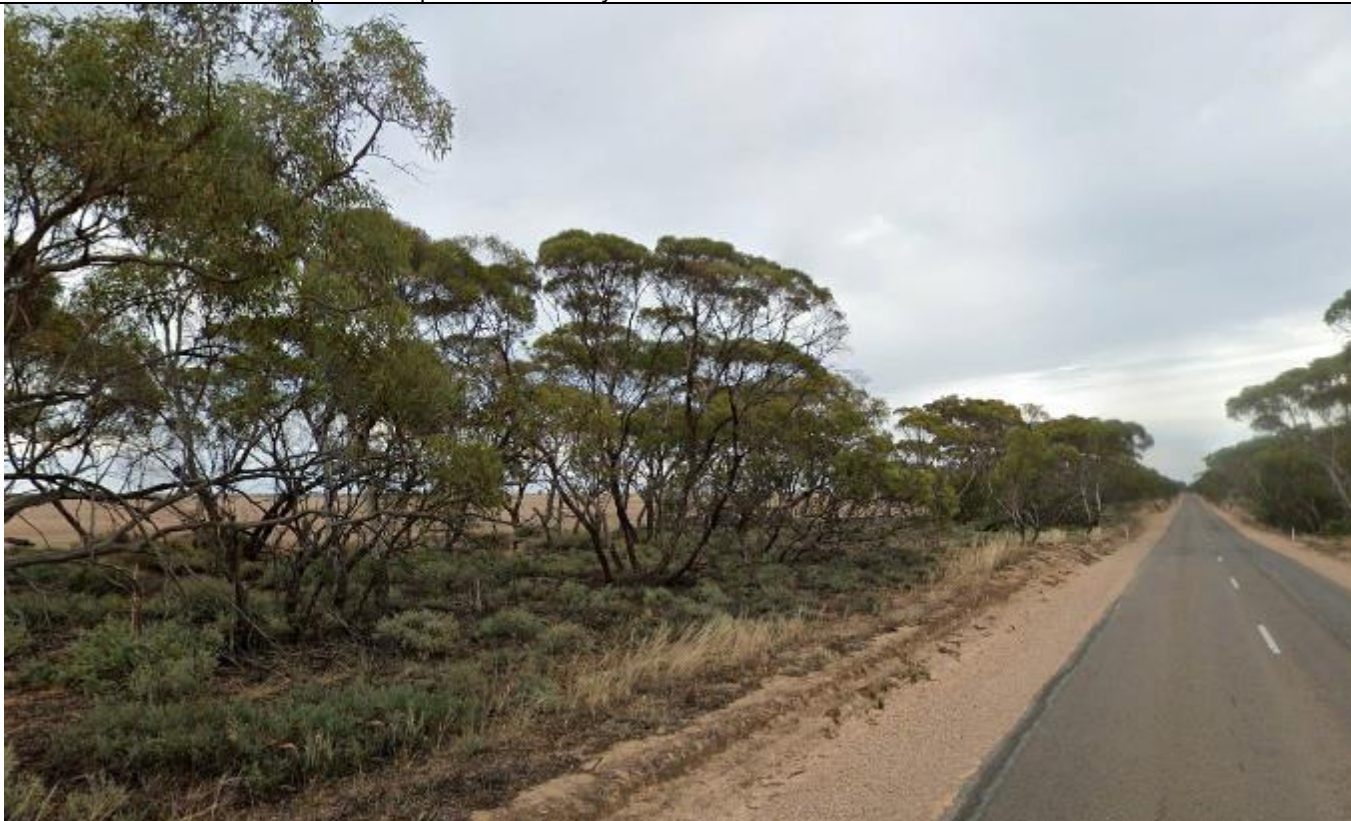
Photo 5, Indicative shoulder sealing impact, approximate MM 13.5 LHS facing south					
General description	<i>Eucalyptus gracilis</i> , <i>E. oleosa</i> , <i>E. socialis</i> dominate the upper storey with mainly chenopods including <i>Marieana</i> , <i>Rhagodia</i> , <i>Atriplex spp.</i> in the understorey. At times <i>Santalum acuminatum</i> is present also. Shoulder sealing impact sites 4a, 5a, and 16a have been aggregated within this association. Disturbed with weed invasion and litter close to the road shoulder, grading to more diverse and less degraded closer to property boundaries. The association is consistent with the BCM YP5 community.				
Threatened species or community	No threatened flora or fauna under the NP&W Act or EPBC Act listed species or community were noted within this association.

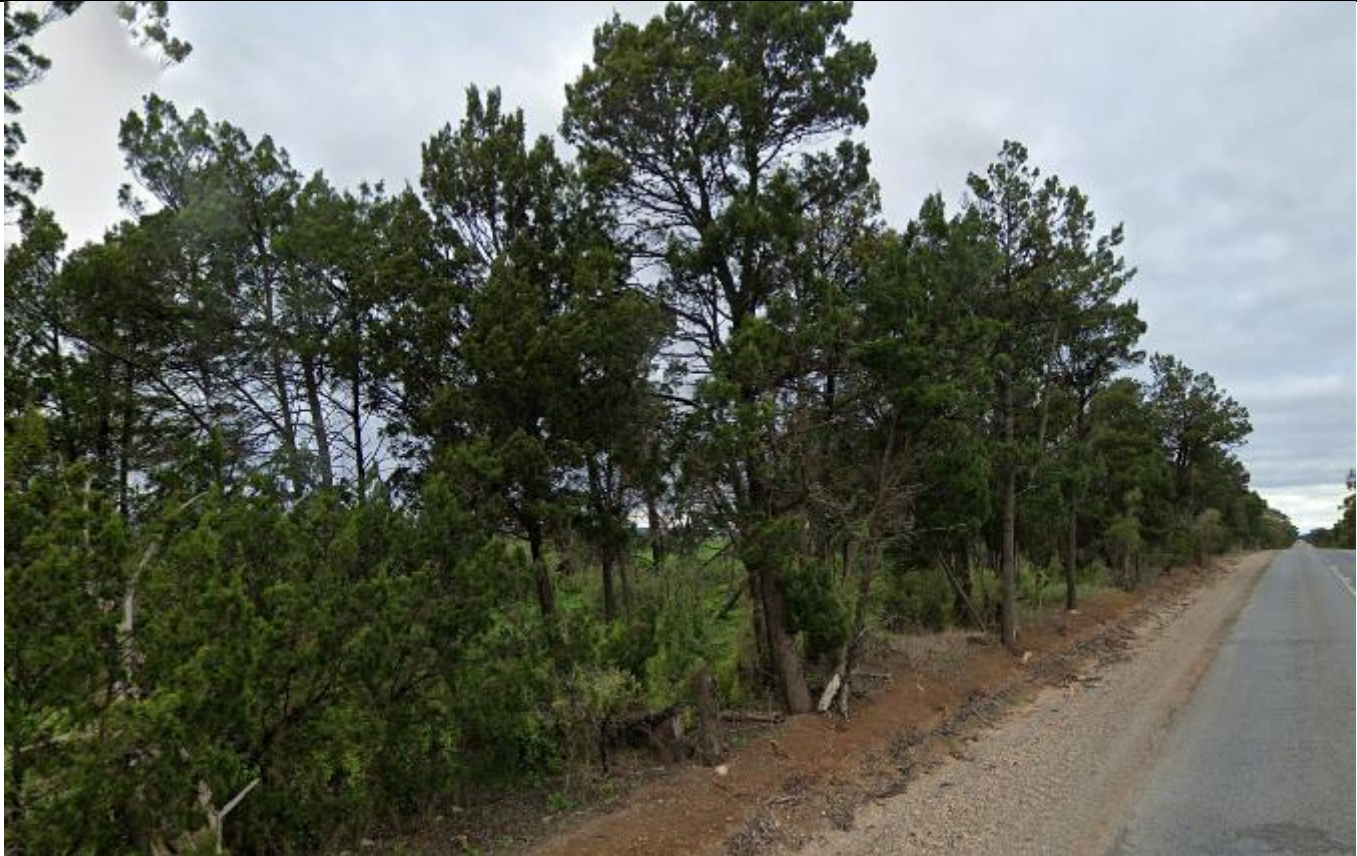
Photo 6. Indicative shoulder sealing impact, approximate MM 25.5 LHS, facing south					
General description	<i>Callitris gracilis</i> dominates the overstorey, with closely spaced trees reducing diversity in the understorey. The odd Eucalypt appears, and chenopod and sclerophyllous shrubs occur with scattered sparse grasses on the edges of the patch. Dead Bridal Creeper residue is present, Google Earth shows a significant infestation at the time of the imagery (7/23). Shoulder sealing sites 17a, 18 and 19 are aggregated here.				
Threatened species or community	No threatened flora or fauna under the NP&W Act or EPBC Act listed species or community were observed.				
Landscape context score	1.12	Vegetation Condition Score	29.53	Conservation significance score	1.04
Unit biodiversity Score	34.40	Area (ha)	0.05	Total biodiversity Score	1.72

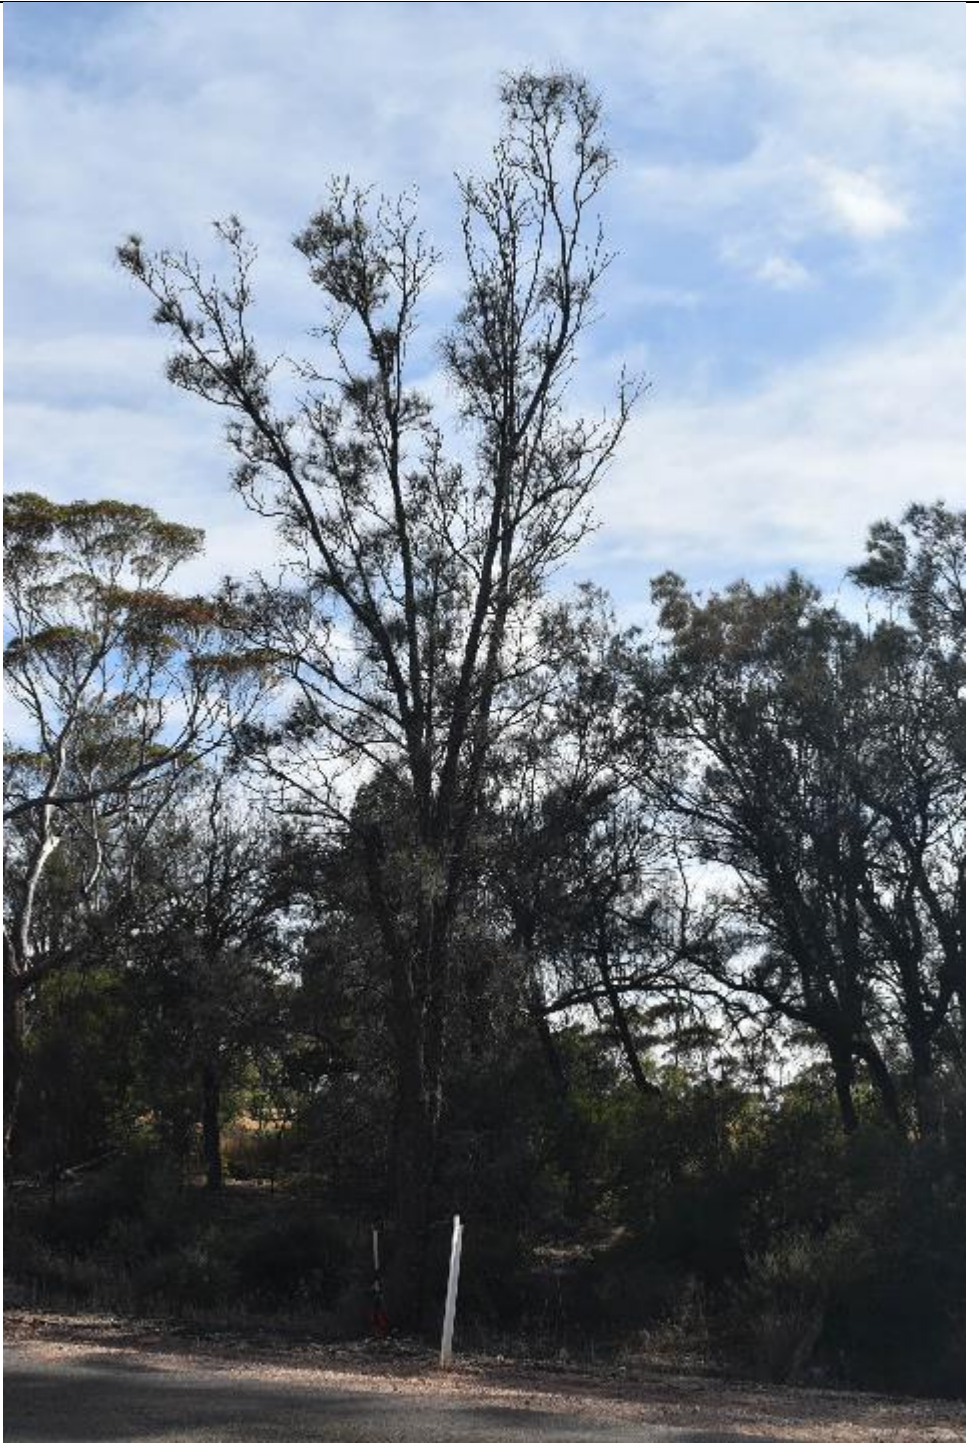
Tree ID – Tree 1
Tree spp: <i>Casuarina pauper</i>
Number of trees: 1
Height (m): 12
Hollows: nil
Diameter (cm): 30
Canopy dieback (%): 70
Total Biodiversity Score: 0.52

Photo 7. A Mature Black Oak in poor condition, within 7m of the road CL, roots potentially impacted by shoulder sealing. Potential value for threatened species but appears in decline. Loss factor 1.0.

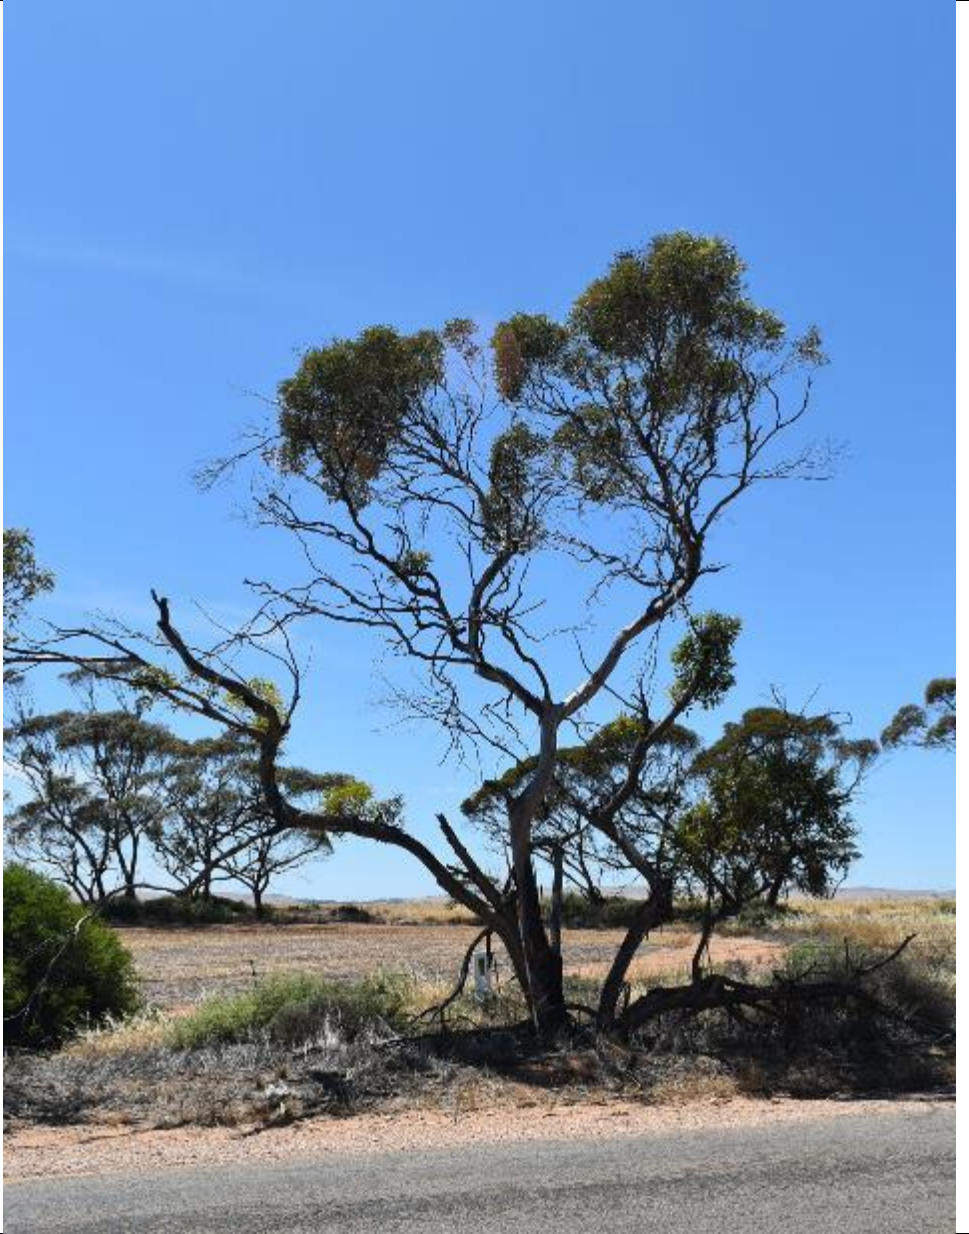
Tree ID – Tree 2

Tree spp: <i>Eucalyptus phenax</i>	
Number of trees: 1	
Height (m): 8	
Hollows: nil	
Diameter (cm): 25	
Canopy dieback (%): 70	
Total Biodiversity Score: 1.23	
<p>Photo 8. A White Mallee in poor condition, within 7m of the road CL, roots potentially impacted by shoulder sealing. Potential value for threatened species but is in decline with no evident hollows. Loss factor 1.0.</p>

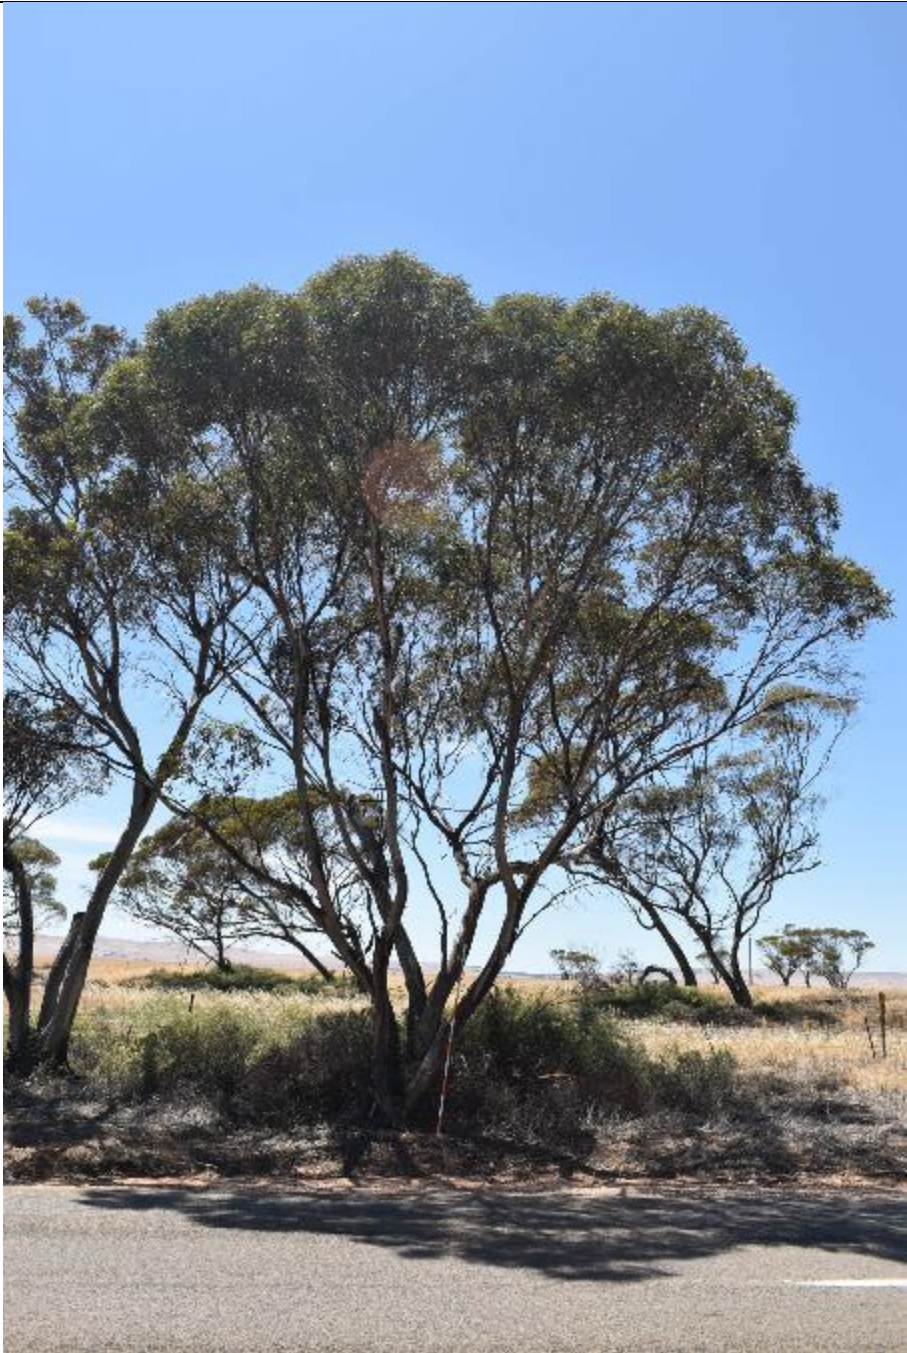
Tree ID – Tree 3

Tree spp: <i>Eucalyptus phenax</i>	
Number of trees: 1	
Height (m): 8	
Hollows: nil	
Diameter (cm): 20	
Canopy dieback (%): 20	
Total Biodiversity Score: 2.17	
Photo 9. A White Mallee in good condition, within 7m of the road CL, roots potentially impacted by shoulder sealing. Potential value for threatened species. Loss factor 1.0.

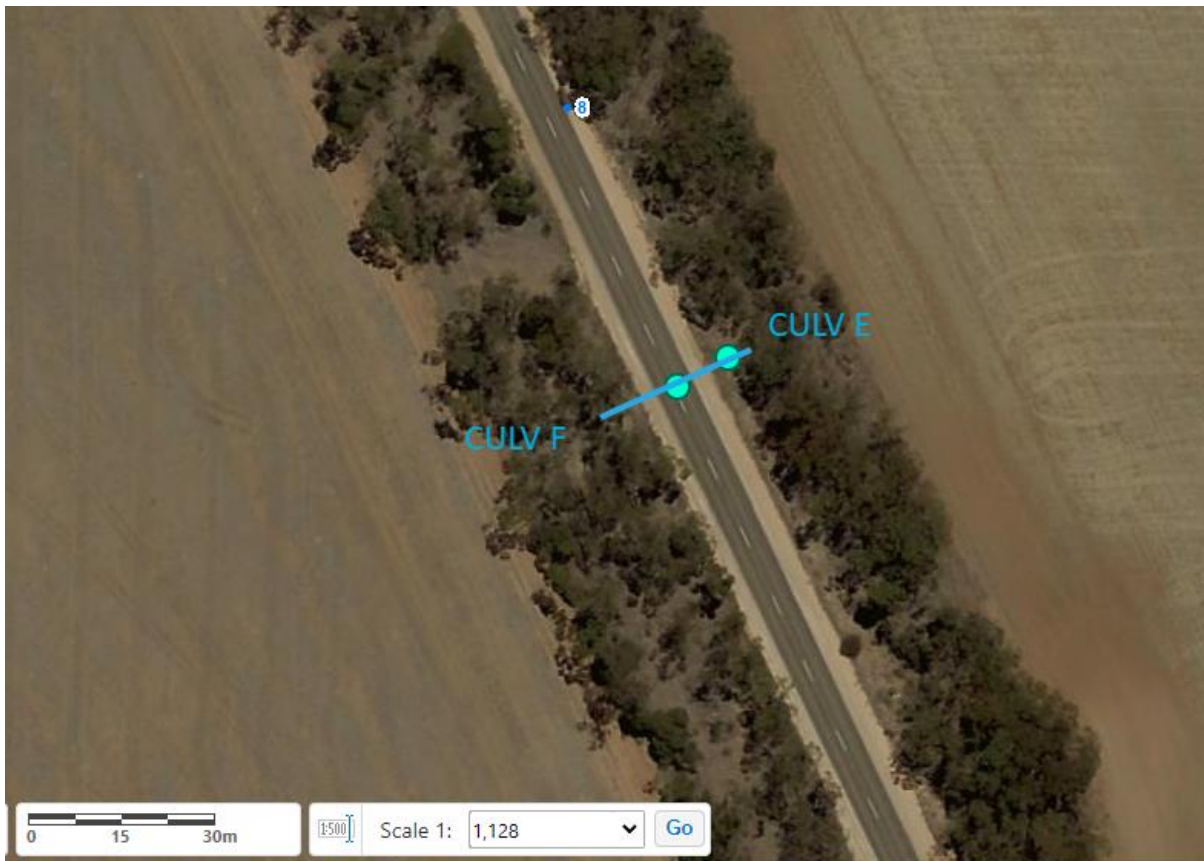
Figure 7. Culvert extension sites E, F (Culvert site E not impacted)
