Native Vegetation Clearance

Upper Yorke Road

Kulpara to Arthurton

Data Report

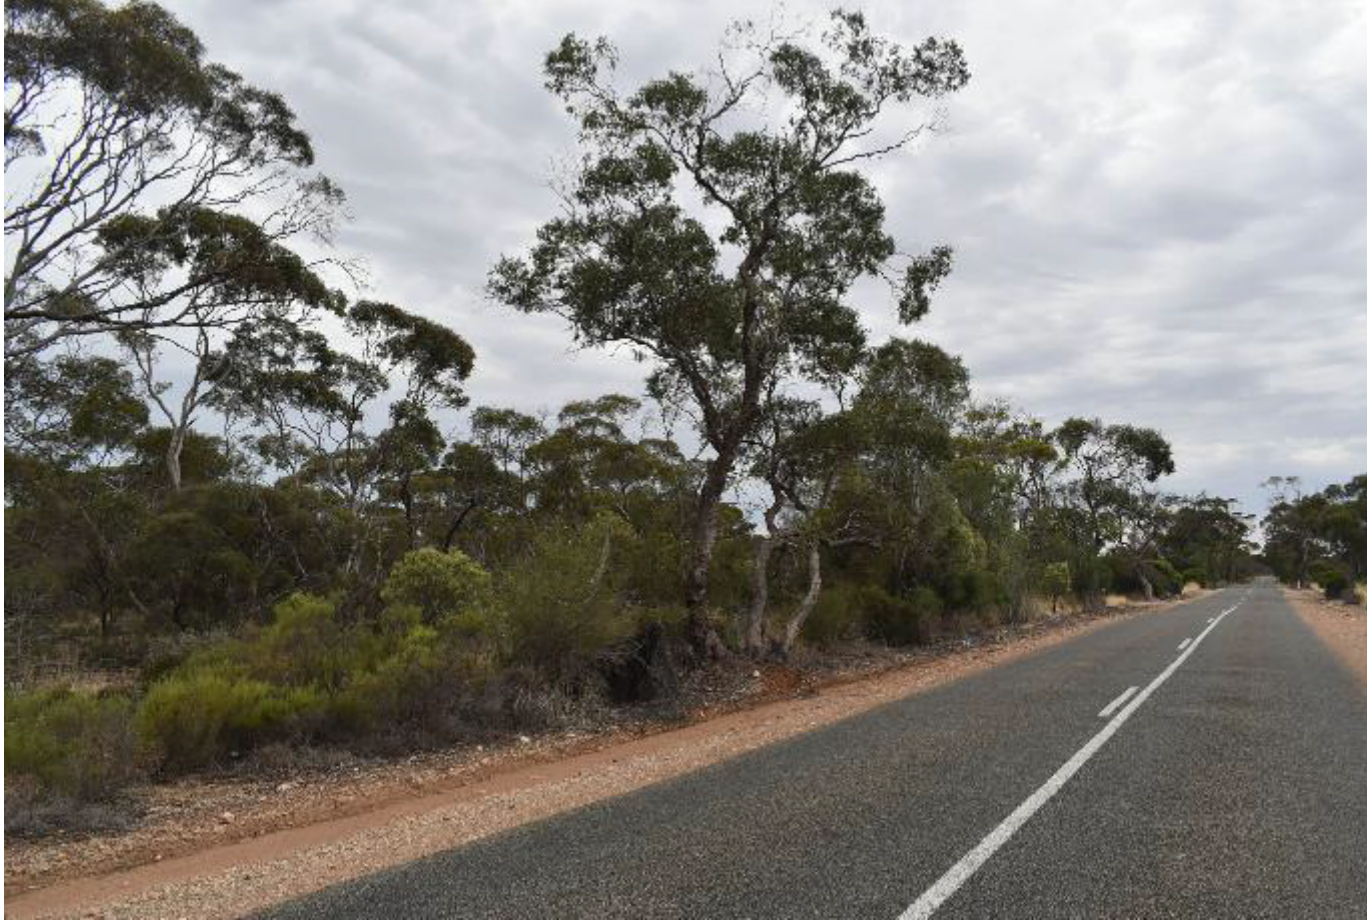
Photo 1. Looking south between MM 6.7 – 7.2, LHS					
General description	Dominance is shared by <i>E. porosa</i> and mallee species including (more or less equally) <i>E. brachycalyx</i> , <i>E. leptophylla</i> , <i>E. gracilis</i> and <i>E. socialis</i> . Patch condition varied across multiple sites - the photograph shows one of the better condition sites adjacent a small patch of remnant vegetation on private property. Weeds were present in varying densities.				
Threatened species or community	No threatened flora or fauna species were noted on site. No listed communities were recorded.				
Landscape context score	1.14	Vegetation Condition Score	43.20	Conservation significance score	1.10
Unit biodiversity Score	54.17	Area (ha)	0.205	Total biodiversity Score	11.11

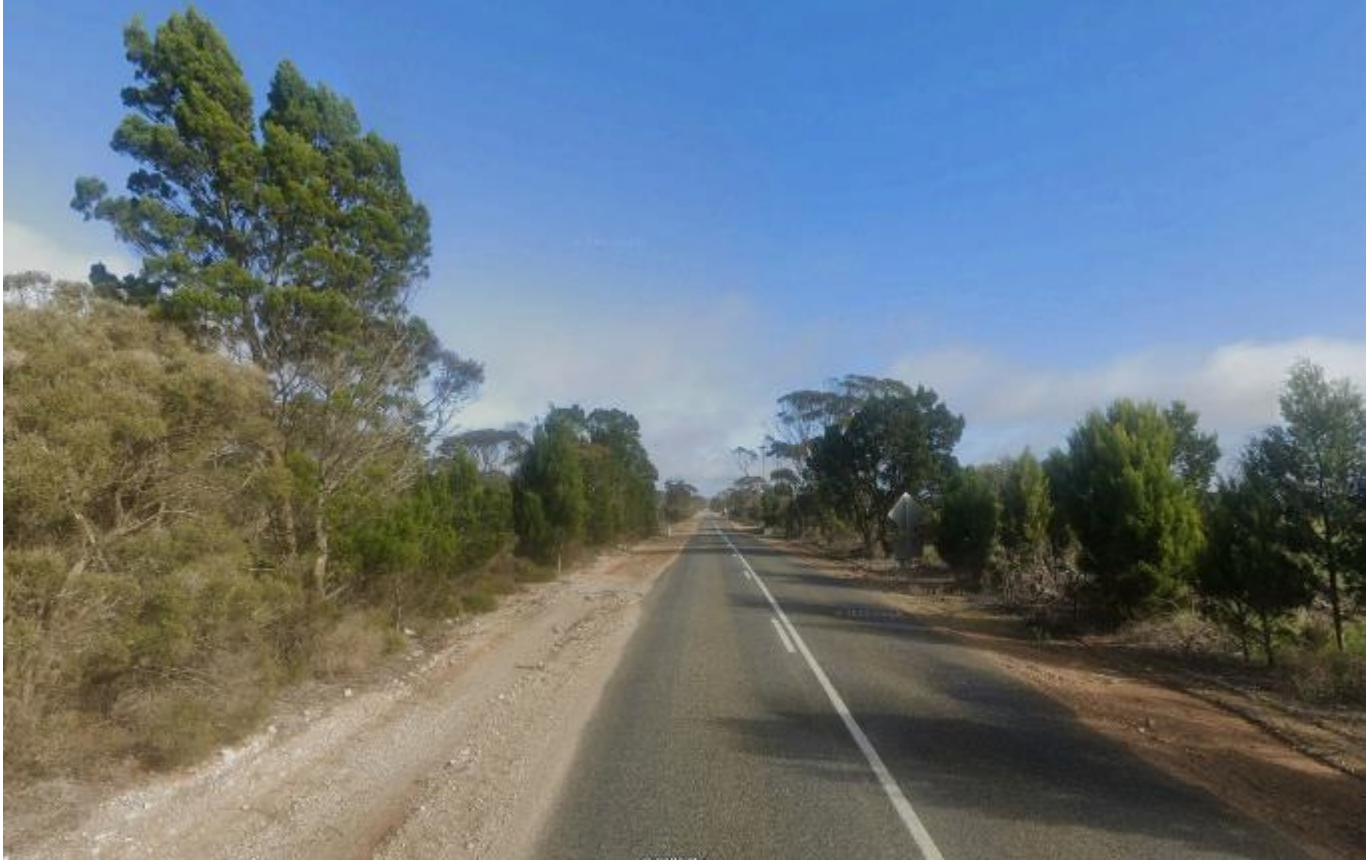
Photo 2. Looking west between MM 7.4 – 7.55 both sides					
General description	<i>Callitris gracilis</i> dominates this small patch of woodland, with mallee Eucalypts emerging before the association reverts to a Mallee Woodland/Mallee community. Patch condition was fair, with more species diversity in the adjacent patch on private property. Environmental weeds were present.				
Threatened species or community	No threatened flora or fauna species were noted on site. No listed communities were recorded.				
Landscape context score	1.16	Vegetation Condition Score	28.03	Conservation significance score	1.10
Unit biodiversity Score	35.77	Area (ha)	0.040	Total biodiversity Score	1.43

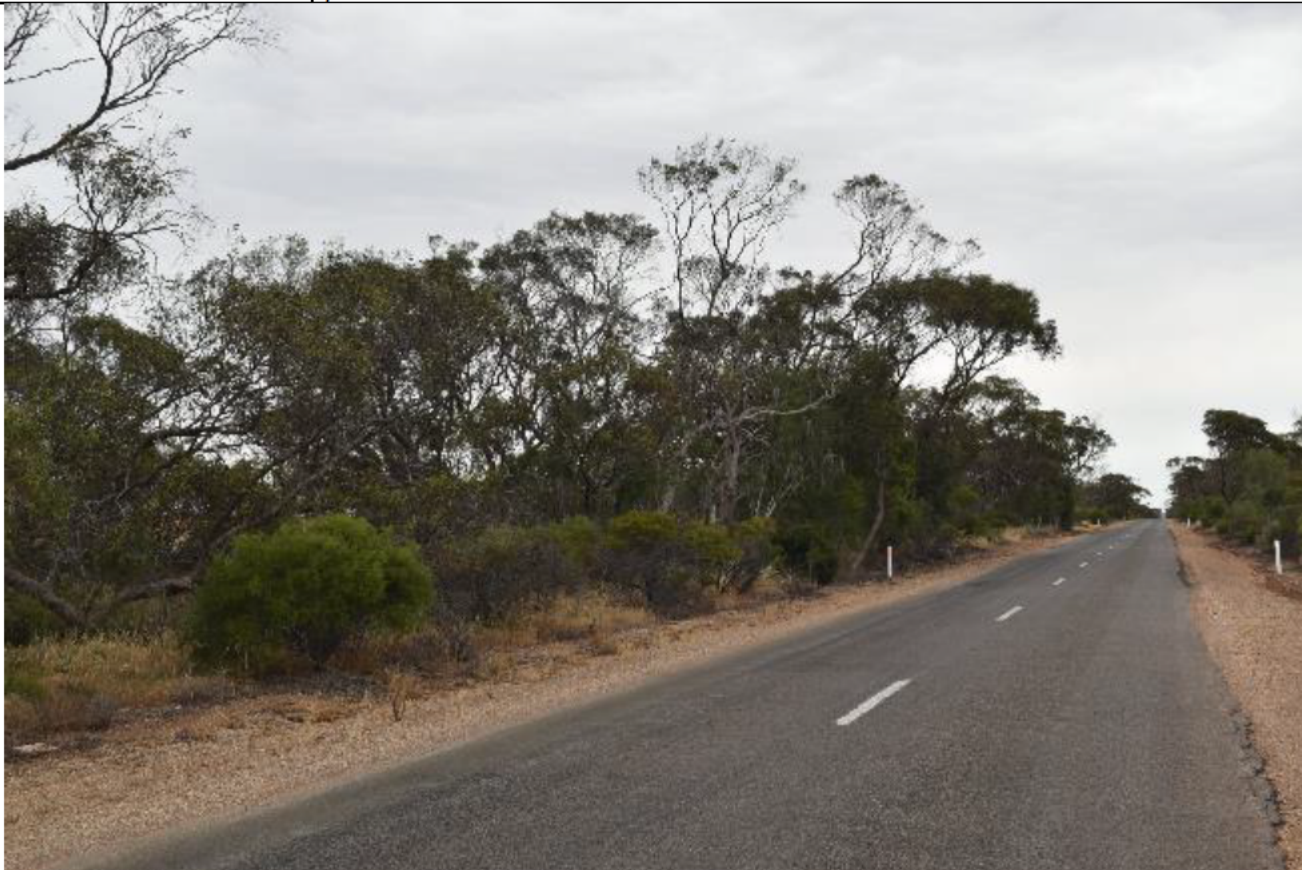
Photo 3. Looking south between MM 22.1- 23.45 LHS with a mostly sclerophyll shrub understorey					
General description	<p>This association was the most common across the site. It straddles the Boor Plain and Arthurton IBRA associations thus is presented in two scoresheets.</p> <p>Given the distance covered by this association, the following mallee eucalypts occur with varying dominance: <i>E. brachycalyx</i>, <i>E. leptophylla</i>, <i>E. gracilis</i>, <i>E. socialis</i>, <i>E. phenax</i>. Understorey included both sclerophyll shrub species and chenopods, often one type was more dominant than other. Small occurrences of suckering <i>Eremophila longifolia</i> were aggregated into this association as they were too small to constitute a separate association. Patch condition varied across multiple sites. Weeds were present in varying densities including Bridal Creeper and Boxthorn (few).</p>

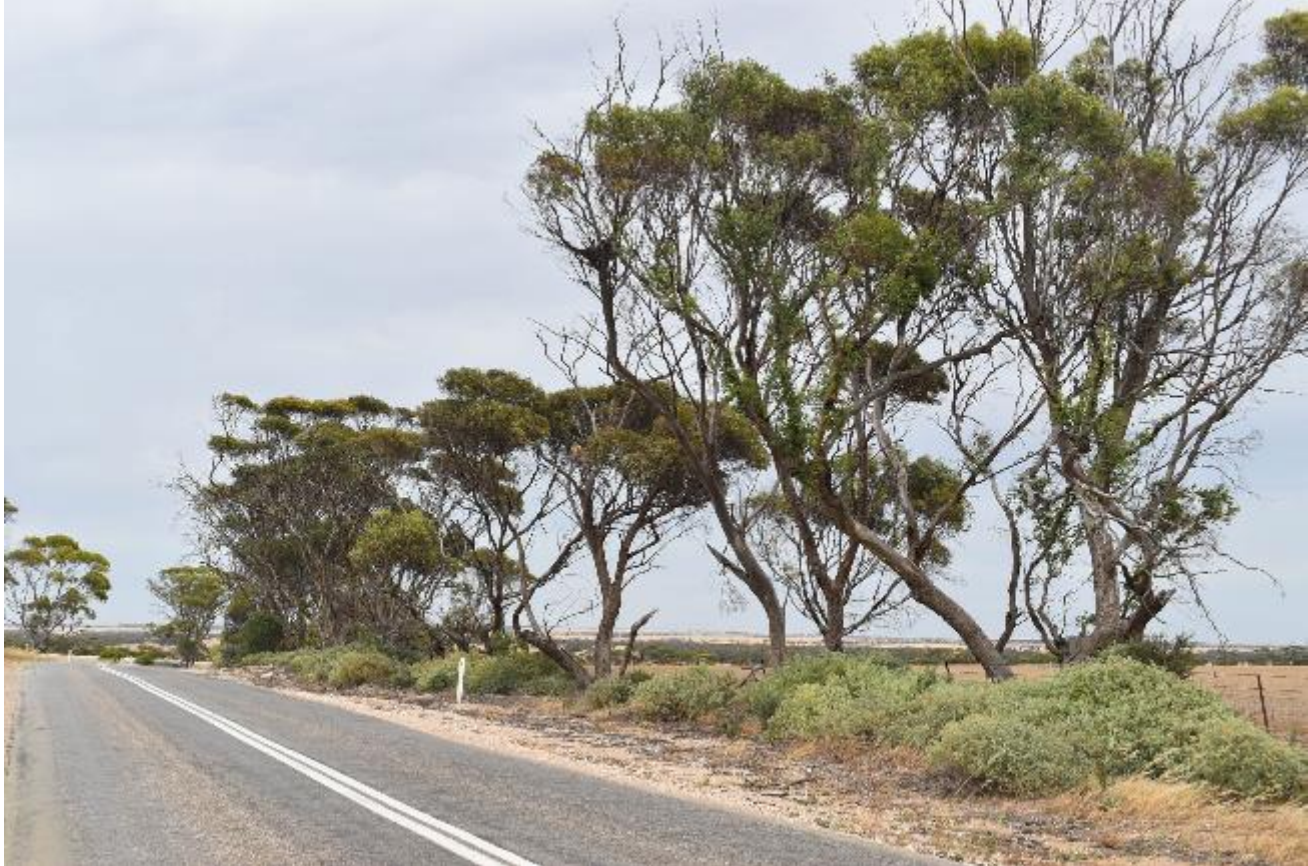
Photo 4. Looking south between MM 15.9-16.55, RHS, showing chenopod understorey					
General description	<i>E. brachycalyx</i> is dominant with <i>E. leptophylla</i> , <i>E. oleosa</i> and <i>E. socialis</i> also occurring. Patch condition varied across multiple sites. Weeds were present in varying densities.				
Threatened species or community	No threatened flora or fauna species were noted on site. No listed communities were recorded.				
Landscape context score	1.13	Vegetation Condition Score	43.20	Conservation significance score	1.10
Unit biodiversity Score	53.70	Area (ha)	0.1375	Total biodiversity Score	7.38

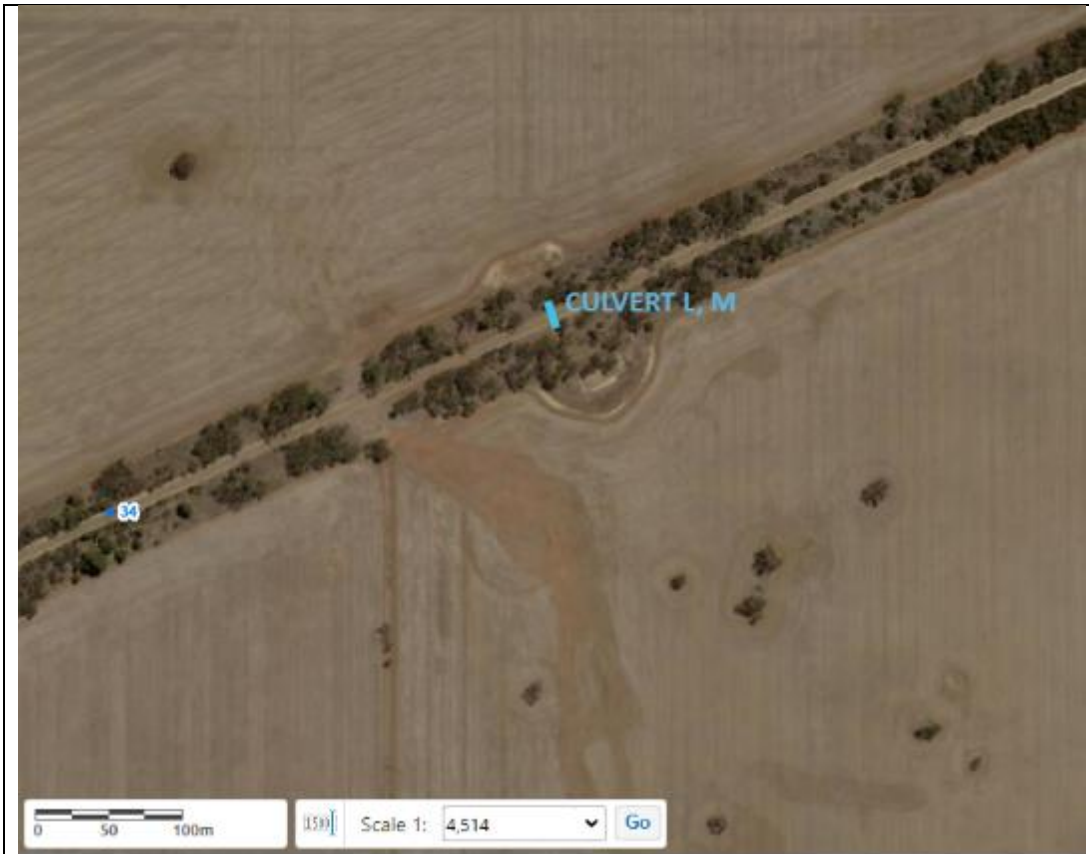
Figure 7 Culvert extension sites L, M (no impact at M)

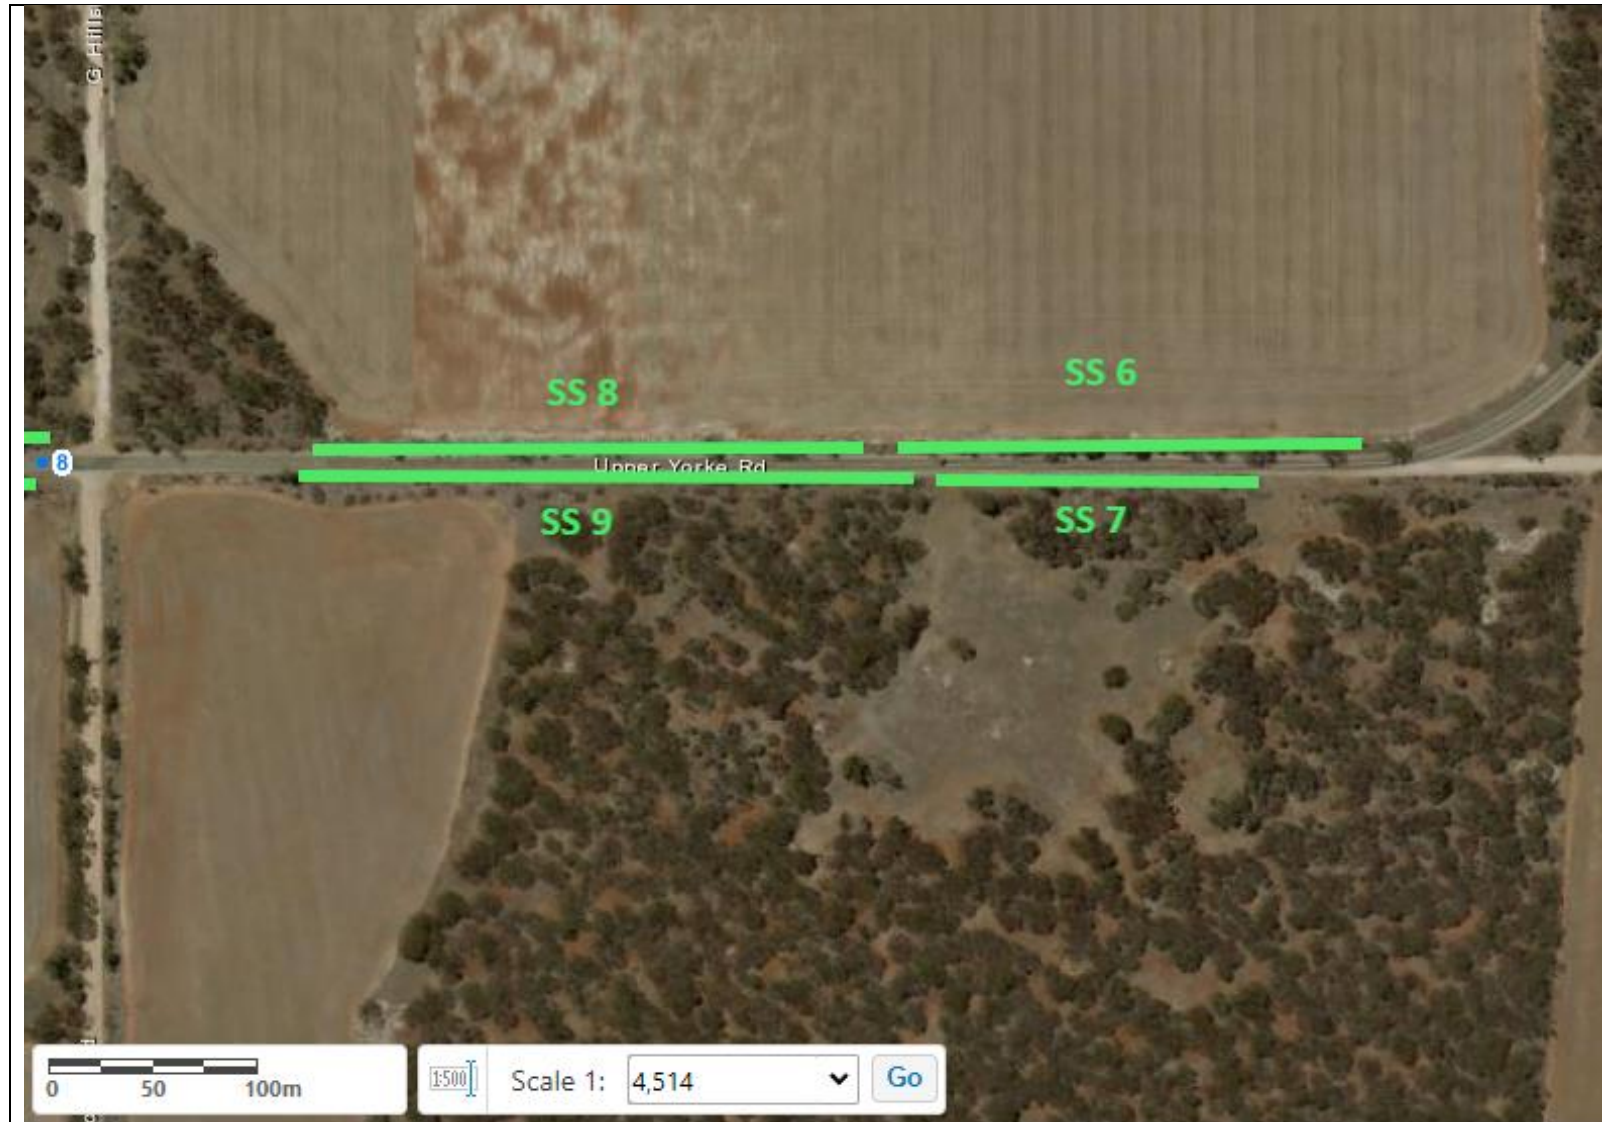
Figure 17 Shoulder sealing sites 6, 7, 8 and 9 (no impact at 9)

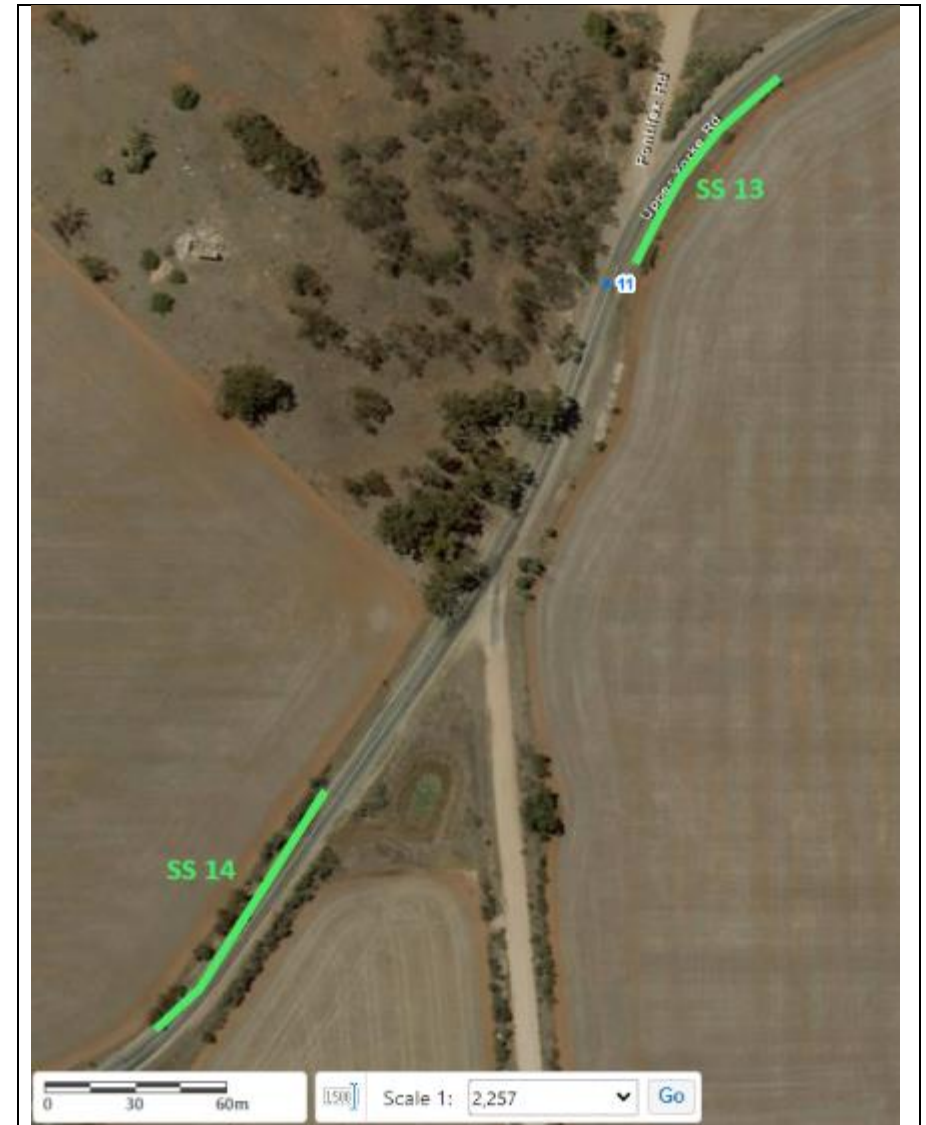
Figure 20 Shoulder sealing sites 13 and 14 (no impact at these sites)

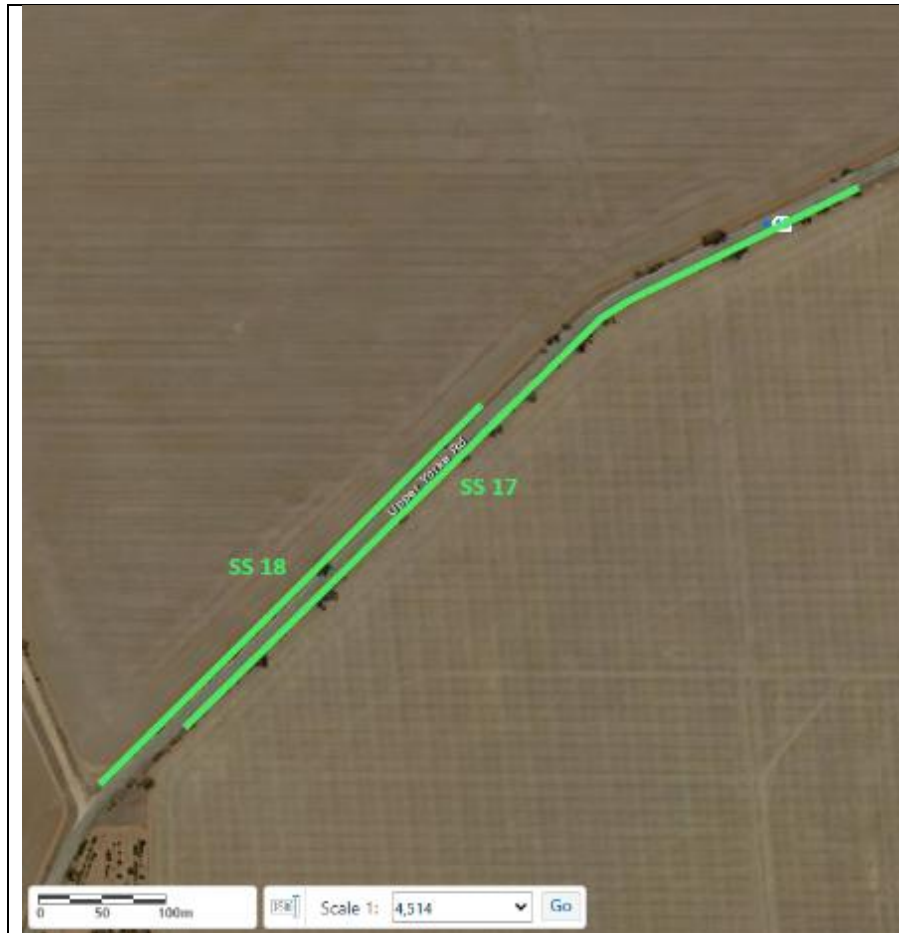
Figure 22 Shoulder sealing sites 17 (no impact) and 18

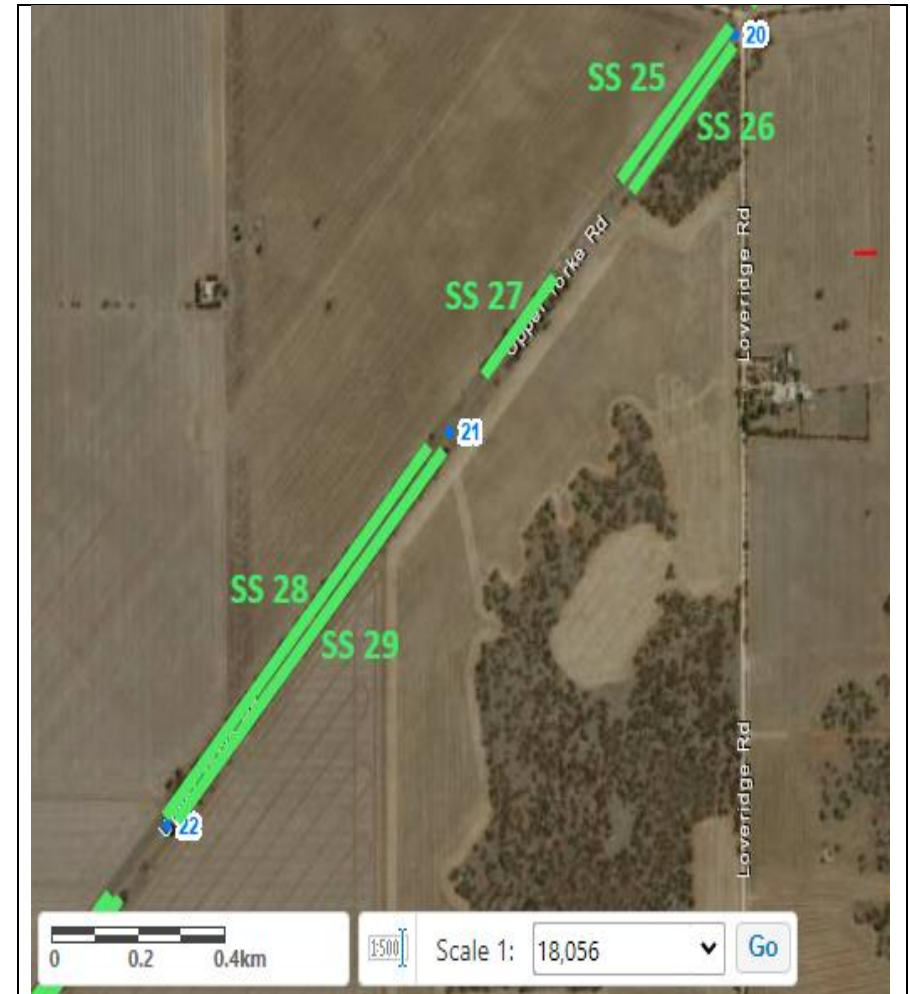
Figure 27 Shoulder sealing sites 25, 26, 27 (no impact), 28 and 29
