Torrens Drill Hall and Parade Ground

[Conservation Management Plan]

Update to 1992 Conservation Plan

*Prepared by Danvers Schulz Holland Architects
Prepared for The Dept for Administrative and Information Services*

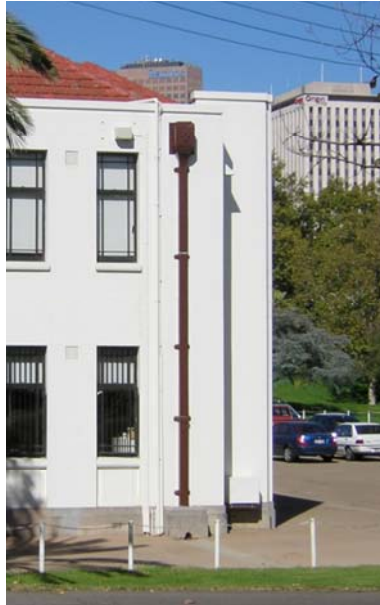
Figure 32
Cast iron rainwater goods

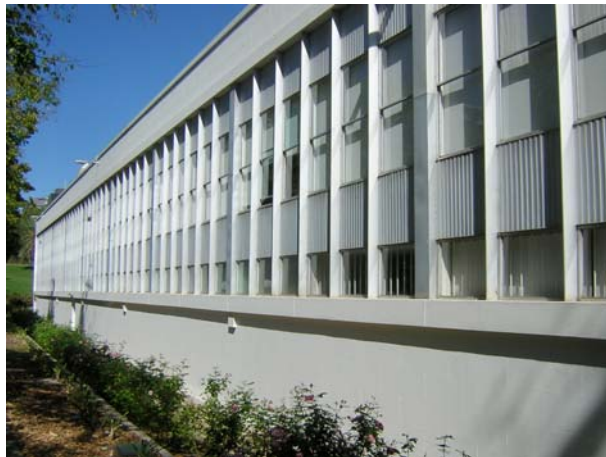
Substantial additions to the Drill Hall in 1955 included the removal of the dividing wall in the main hall, and the replacement and infilling of the open eastern verandah. This infill was undertaken in a Post War International style, and dominates the eastern facade. Despite this, it sits comfortably with the overall building proportions and style, and does not detract from the remaining 3 elevations, including the predominant Western facade facing the Parade Grounds.

Figure 33
Torrens drill hall, eastern facade additions, 2005

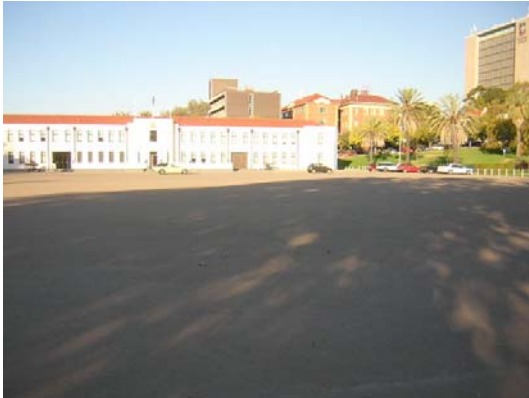
Parade Grounds – new coloured bitumen to grounds

PARADE GROUNDS				
Physical Assessment				Conservation Policy
Significance	Area	Significant Fabric	Alterations / Adaptation of original fabric	Specific Conservation Policy and recommendations
Very High		Significance of the Parade Grounds is in the retention of the flat open space as both a formal parade ground and setting for the building,	New coloured bitumen	The open expanse of ground is very important to the setting of the building and the cultural significance of the site generally. The significance lies within the openness of the space, rather than the fabric, which has been generally replaced over time (most recently the bitumen). The siting of the cannons at the ground predated the drill hall building, and are an important element to the cultural significance of the space, and should be retained on the grounds accordingly.
			Chain fence	
			Lighting to perimeter	
			Boom gate	
		Specific fabric that constitutes this Parade Ground is secondary to the retention of its form	Flag pole to western end

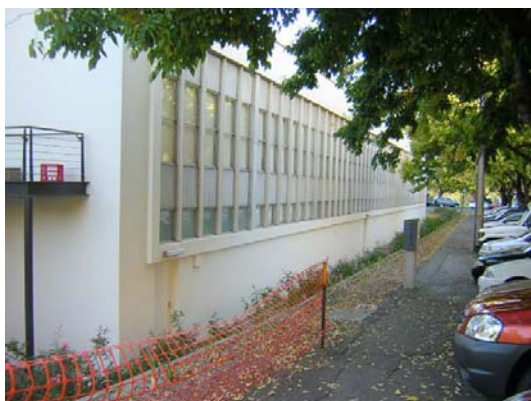
Eastern Façade - 1955 addition to the rear of the Torrens Drill Hall

EXTERIOR SPACES: EASTERN FACADE						
Physical Assessment				Conservation Policy		
Significance	Area	Significant Fabric	Alterations / Adaptation of original fabric	Specific recommendations	Conservation Policy	Policy and
Moderate		<ul style="list-style-type: none"> All remaining fabric significant unless noted otherwise Significant fabric includes rendered masonry walls, windows and terracotta tile roof 	<ul style="list-style-type: none"> Lighting and electrical services Doors to staircase and ground floor areas 	<ul style="list-style-type: none"> While eastern facade dates from later period, and therefore is of only moderate significance, it nonetheless sits compatibly with the remainder of the building facades. While a higher degree of adaptation is permissible, and changes should not adversely impact in the interpretation of the remaining facades, or building setting

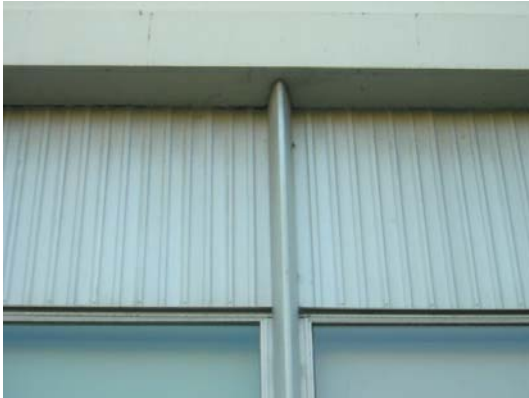
Eastern Façade – 1955 addition window treatment

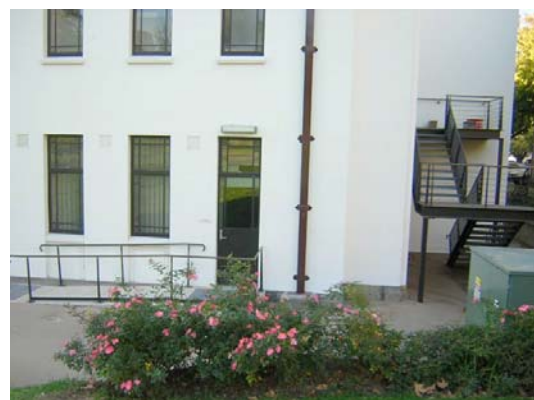
South Façade - Ramp and stair to eastern end

EXTERIOR SPACES: SOUTHERN FACADE						
Physical Assessment				Conservation Policy		
Significance	Area	Significant Fabric	Alterations / Adaptation of original fabric	Specific recommendations	Conservation Policy	and
High		<ul style="list-style-type: none"> All remaining fabric significant unless noted otherwise Significant fabric includes rendered masonry walls and detailing, rainwater goods, windows, doors, terracotta tiled roof 	<ul style="list-style-type: none"> Ramp and staircase to eastern end Sub-basement vent hoods Window opening modified to accommodate new ramp 	<ul style="list-style-type: none"> The significance of the southern facade lies in the context and setting and setting it provides to the western facade and parade grounds. Recent fire egress doorway and staircase have been appropriately set back from the western facade so as to minimise and adverse impact. Any future modifications should be kept to a minimum, and again undertaken in a manner so as not to adversely impact on the setting of the western facade or parade grounds.

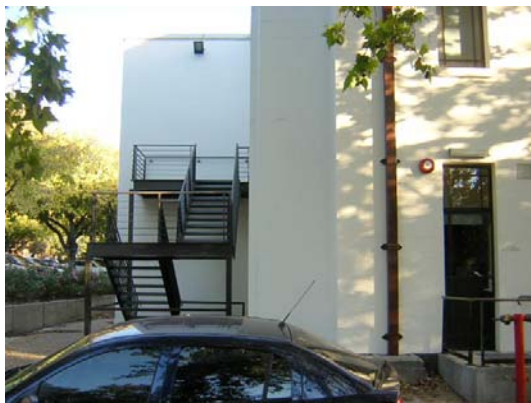
North Façade - ramp and stair to eastern end

EXTERIOR SPACES: NORTHERN FACADE						
Physical Assessment				Conservation Policy		
Significance	Area	Significant Fabric	Alterations / Adaptation of original fabric	Specific recommendations	Conservation Policy	and
High		<ul style="list-style-type: none"> All remaining fabric significant unless noted otherwise Significant fabric includes rendered masonry walls and detailing, rainwater goods, windows, doors, terracotta tiled roof 	<ul style="list-style-type: none"> Ramp and staircase to eastern end Window opening modified to accommodate new ramp 	<ul style="list-style-type: none"> The significance of the northern facade lies in the context and setting and setting it provides to the western facade and parade grounds. Recent fire egress doorway and staircase have been appropriately set back from the western facade so as to minimise and adverse impact. Any future modifications should be kept to a minimum, and again undertaken in a manner so as not to adversely impact on the setting of the western facade or parade grounds.

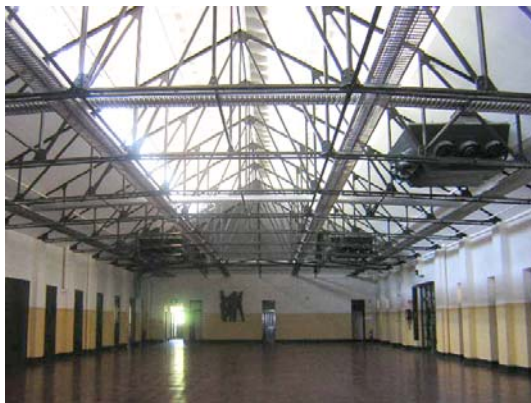
Drill Hall – exposed steel truss with air conditioning services

INTERIOR SPACES: Drill Hall (G02)						
Physical Assessment				Conservation Policy		
Significance	Area	Significant Fabric	Alterations / Adaptation of original fabric	Specific recommendations	Conservation Policy	and
High	Ceiling	Exposed steel truss roof modified in 1955 to include clerestory roof section with timber boarded upper section	<ul style="list-style-type: none"> Services including air conditioning, lighting, cable trays and fire sprinklers Clerestory windows Acoustic ceiling lining 	<ul style="list-style-type: none"> Exposed trusses should be maintained. Exposed services integration appropriate 		
	Walls	<ul style="list-style-type: none"> Door joinery unless noted otherwise Plastered masonry wall with plaster moulding details at mid height and plaster skirting Early door hardware unless noted otherwise Wall safe to western facade 	<ul style="list-style-type: none"> Eastern wall – circa 1936 windows removed and new infills/doors installed Eastern wall – recent double doors to G34 modified to single leaf Later door hardware to G30 and G23 All later key locks Timber door leaf, joinery and hardware to G23, G26, G27 and G39 Glazed doors/windows to G04 and G10 Four panel doors appear to date from a later period, however this should be confirmed Second door from south of G05 dates from 1955 Original opening to G06 and G07 infilled New door hardware to G09a, G09, G09c, G17, G18 Emergency lighting Surface mounted services

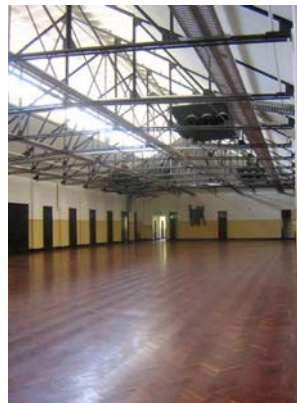
Drill Hall – timber parquetry flooring

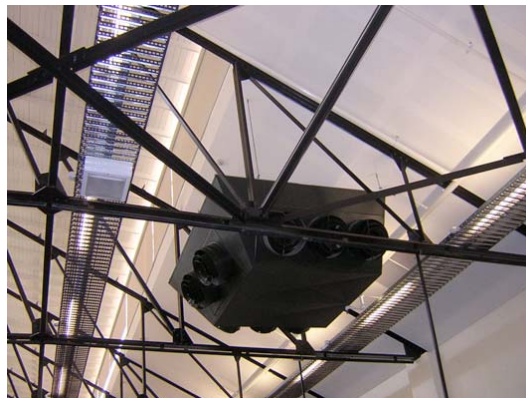
Drill Hall – air conditioning services

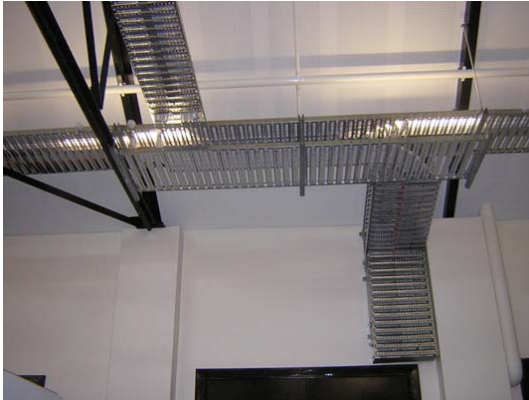
Drill Hall – cable trays

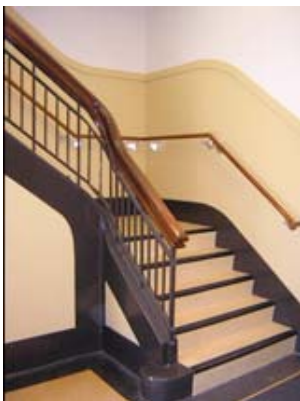
Staircase with significant handrail and Balustrade. Later vinyl to treads

INTERIOR SPACES: G00, G00a, G00b, G01, G06, G07 and G08 (inclusive)						
Physical Assessment				Conservation Policy		
Significance	Area	Significant Fabric	Alterations / Adaptation of original fabric	Specific recommendations	Conservation Policy	Policy and
High	General			Location of staircase is integral to the circulation configuration of the building and should be retained. Emphasis should be made where possible to retain this space as a main entry to the building.		
	Ceiling		<ul style="list-style-type: none"> • Later lighting and electrical services • Later replica ceiling and cornice with suspended panel sections 	While ceiling is reproduction, it provides suitable setting for this high significance space, and should be retained or replaced with similar if affected by future works

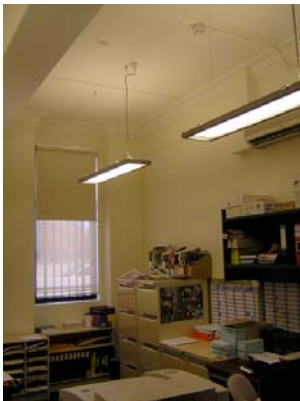
G09 – windows with security grills and later blinds

INTERIOR SPACES: G09a, G09, G09b, G09c				
Physical Assessment				Conservation Policy
Significance	Area	Significant Fabric	Alterations / Adaptation of original fabric	Specific Conservation Policy and recommendations
Moderate	General		Internal walls reconfigured as part of recent development	
	Ceiling	Batten ceiling with cornice	<ul style="list-style-type: none"> • Later electrical services 	Original battened ceiling to remain exposed where possible, with later suspended ceiling avoided where possible
	Walls	<ul style="list-style-type: none"> • Western and eastern masonry walls • Windows to western and eastern walls with security bars • Door joinery to Drill Hall (G02) • Wall/door interface with Drill Hall (G02) 	<ul style="list-style-type: none"> • Window blinds • Internal walls with associated services • Wall vent to store (G09c) 	
	Floors	<ul style="list-style-type: none"> • Probable early timber floor under later carpet finishes 	<ul style="list-style-type: none"> • Lightweight partition walls

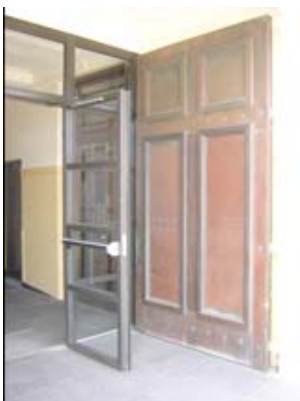
Early doors to G10 and later
Glazed door/wall system

INTERIOR SPACES: G10				
Physical Assessment				Conservation Policy
Significance	Area	Significant Fabric	Alterations / Adaptation of original fabric	Specific Conservation Policy and recommendations
Moderate	General			Space to remain as key entrance point to drill hall
	Ceiling	Batten ceiling with cornices	<ul style="list-style-type: none"> Later lighting and electrical services 	
	Walls	<ul style="list-style-type: none"> Early external doors to G11 and G09c and surrounding masonry walls 	<ul style="list-style-type: none"> New entry glazed door/wall system to G10 Internal glazed door/wall system to Drill Hall (G02) 	Existing external doors to remain unpainted
	Floors		<ul style="list-style-type: none"> Later paving and floor matt recesses 	
	Fitments

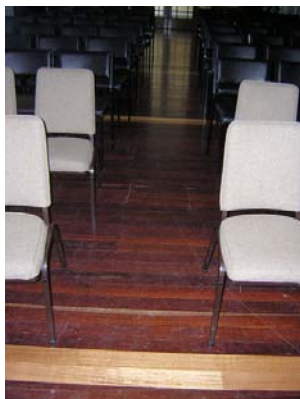
G11 - Early jarrah timber floor with Lighter infill indicating location of early dividing wall

INTERIOR SPACES: G11 (continued)						
Physical Assessment				Conservation Policy		
Significance	Area	Significant Fabric	Alterations / Adaptation of original fabric	Specific recommendations	Conservation Policy	and
High	Fitments	Various honour boards, memorial plaques, certificates, photographs, WW1 poster		Various memorabilia are in themselves significant, however do not necessarily have to be located in current area

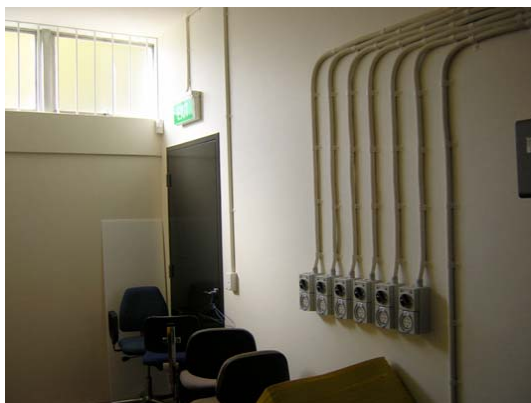
G28 – later surface mounted electrical services

INTERIOR SPACES: G23-29 (inclusive) (continued)						
Physical Assessment				Conservation Policy		
Significance	Area	Significant Fabric	Alterations / Adaptation of original fabric	Specific recommendations	Conservation Policy	and
Moderate	Walls	<ul style="list-style-type: none"> High level external windows to eastern wall with security bars Wall/door interface with Drill Hall (G02) significant 	<ul style="list-style-type: none"> New external door to G24 and G30 Surface mounted services (electrical and mechanical services) 			
	Floors		<ul style="list-style-type: none"> Concrete floor dating from 1955 with later carpet finish Later compactus Later main switch board to G23 	•		
	Fitments			\

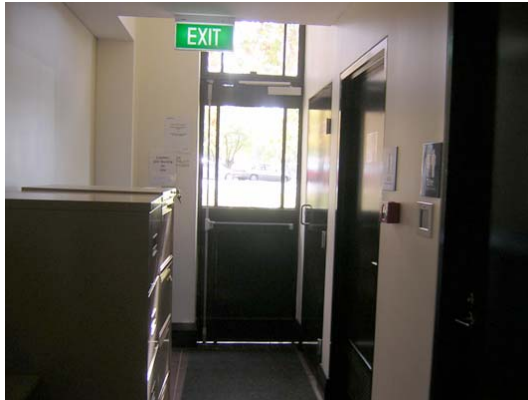
New fire exit to northern facade

INTERIOR SPACES: G41, G42, G43 and G44 (continued)						
Physical Assessment				Conservation Policy		
Significance	Area	Significant Fabric	Alterations / Adaptation of original fabric	Specific recommendations	Conservation Policy	and
Low	Ceiling		<ul style="list-style-type: none"> • Later electrical services • Later suspended ceiling 			
	Walls	<ul style="list-style-type: none"> • Windows with security grills to G42 	<ul style="list-style-type: none"> • New fire exit to northern facade 			
	Floors	<ul style="list-style-type: none"> • Section of original staircase to G41 	<ul style="list-style-type: none"> • Later tiling and adjustment of floor levels • Later wet area fitout 	Section of remaining original staircase can be removed if required as part of future adaptation of space.		
	Fitments

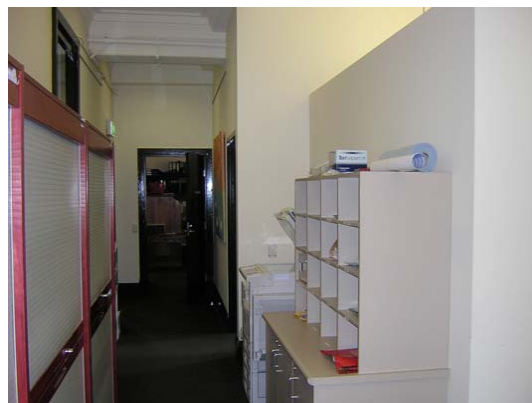
Later joinery and partition wall fitout

INTERIOR SPACES: G40, G45 and G47				
Physical Assessment				Conservation Policy
Significance	Area	Significant Fabric	Alterations / Adaptation of original fabric	Specific Conservation Policy and recommendations
Moderate	General			
	Ceiling	Batten ceiling with cornices	<ul style="list-style-type: none"> • Later lighting and electrical services 	Original battened ceiling to remain exposed where possible, with later suspended ceiling avoided where possible
	Walls	<ul style="list-style-type: none"> • Masonry northern walls with windows and security bars • Southern wall interface with Drill Hall (G02) 	<ul style="list-style-type: none"> • All internal walls, joinery and associated services • Window blinds 	
	Floors	<ul style="list-style-type: none"> • Later carpet finish conceals potential early timber floor 	<ul style="list-style-type: none"> • Later carpet • compactus 	
	Fitments

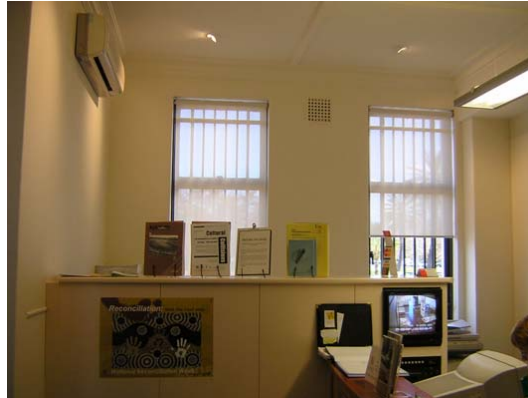
G03 – windows with security bars and window blinds

INTERIOR SPACES: G03 and G48					
Physical Assessment				Conservation Policy	
Significance	Area	Significant Fabric	Alterations / Adaptation of original fabric	Specific Conservation Policy	and recommendations
Moderate	General	Refer to development sequence plans for reconfiguration of some sections of internal spaces, but generally configuration maintains original form.	Internal space reconfigured to a minor degree, but generally maintains original form (refer to development sequence plans for details)	A high degree of adaptation or reconfiguration of internal spaces is acceptable provided it does not adversely impact on the setting of the Drill Hall internal elevation and external eastern façade/	
	Ceiling	Batten ceiling with cornices	• Later lighting and electrical services	Original battened ceiling to remain exposed where possible, with later suspended ceiling avoided where possible	
	Walls	<ul style="list-style-type: none"> • Masonry perimeter walls with windows and security bars to western façade • Interface of doors with Drill Hall (G02) remains significant • Door opening to G45 	<ul style="list-style-type: none"> • New opening with glazed sliding doors to G46 • Lighting and electrical services • Air conditioning unit • Later door hardware to door G45 • Later door opening and glazed doors to G04 • Internal walls and timber door joinery

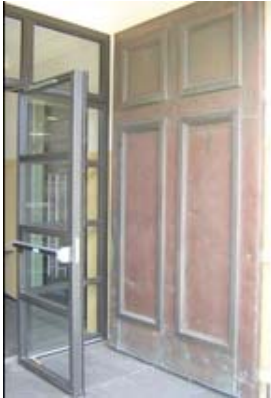
Early external doors and later
Glazed door/wall system to G04

INTERIOR SPACES: G04				
Physical Assessment				Conservation Policy
Significance	Area	Significant Fabric	Alterations / Adaptation of original fabric	Specific Conservation Policy and recommendations
Moderate	General			Space to remain as key entrance point to drill hall
	Ceiling	Batten ceiling with cornices	<ul style="list-style-type: none"> • Later lighting and electrical services 	
	Walls	<ul style="list-style-type: none"> • Early external doors and surrounding masonry walls 	<ul style="list-style-type: none"> • New door opening and glazed door/wall system to G05 and G03 • New entry glazed door/wall system to G04 • Internal glazed door/wall system to Drill Hall (G02) 	Existing external doors to remain unpainted
	Floors		<ul style="list-style-type: none"> • Later paving and floor matt recesses 	
	Fitments

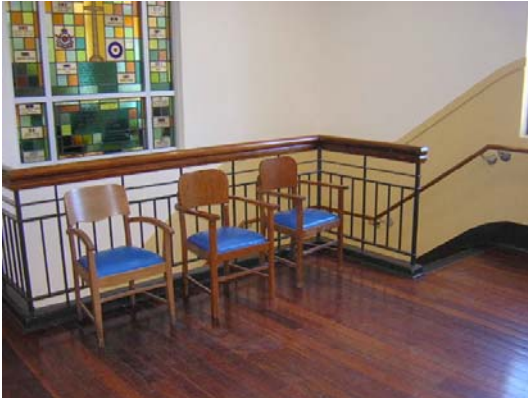
Area F01 – balustrade and handrail to stair, jarrah timber floors

INTERIOR SPACES: F01						
Physical Assessment				Conservation Policy		
Significance	Area	Significant Fabric	Alterations / Adaptation of original fabric	Specific recommendations	Conservation Policy	and
High	Ceiling	Reproduction batten ceiling and cornices date from recent (2004) works, however ceilings are typical of the era of construction and as such should be treated as significant accordingly	Lighting and electrical services	<ul style="list-style-type: none"> While ceiling is reproduction, it provides suitable setting for this high significance space, and should be retained or replaced with similar if affected by future works 		
	Walls	<ul style="list-style-type: none"> Masonry walls with plaster detail to staircase Stained glass window to southern wall Although not original the Air Force Association window (sourced from North Adelaide) does add to the significance of the space Location of window hatch in southern wall 	<ul style="list-style-type: none"> Central door in northern wall Original door locations in southern and northern walls widened, door joinery removed and replaced with new wider doors (original doors stored on site) Window hatch in southern wall Door hardware generally Recent handrails to staircase wall Electrical services Window hatch joinery in southern wall 	<ul style="list-style-type: none"> Stain glass window has been relocated from other site. While the window is significant in its own right, and its present location is appropriate, it may be relocated to other appropriate locations if required.

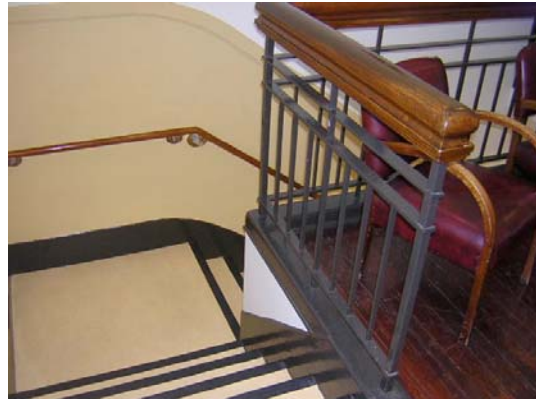
Area F01 – Reconfigured stairs and new vinyl and copings to stair

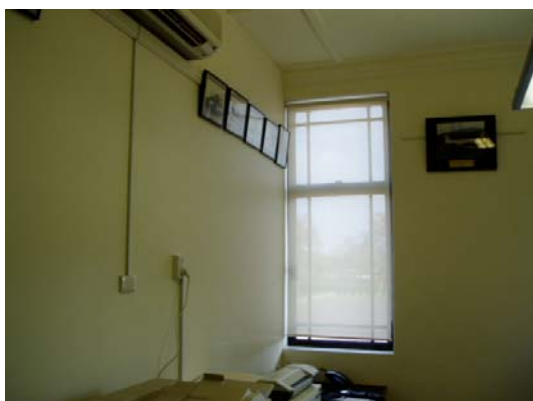
Area F05 – windows with later blinds and non-significant masonry dividing wall

INTERIOR SPACES: F05						
Physical Assessment				Conservation Policy		
Significance	Area	Significant Fabric	Alterations / Adaptation of original fabric	Specific recommendations	Conservation Policy	and
Moderate - High	Ceiling	Batten ceiling with cornice and vents	<ul style="list-style-type: none"> Lighting and electrical services 	<ul style="list-style-type: none"> Original battened ceiling to remain exposed where possible, with later suspended ceiling avoided where possible 		
	Walls	<ul style="list-style-type: none"> Masonry walls, unless noted otherwise Location of door Windows 	<ul style="list-style-type: none"> New hardware/locks/handles to doors/windows Door joinery appears to date from a later period Southern masonry wall Window blinds 			
	Floors		<ul style="list-style-type: none"> Floor appears to be raised. Extent of original floor finishes concealed by later carpet unknown. 			
	Fitments		<ul style="list-style-type: none"> Picture rails

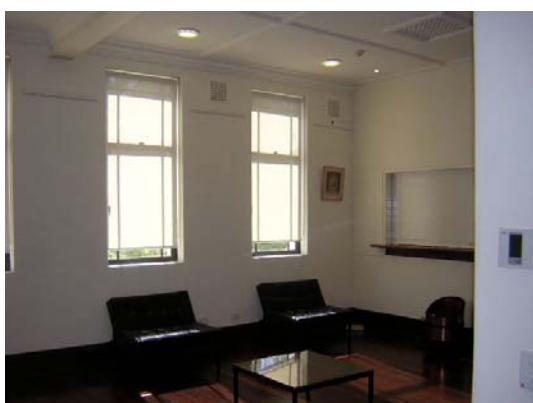
Area F34 – windows with new window blinds, lightweight eastern wall with access hatch

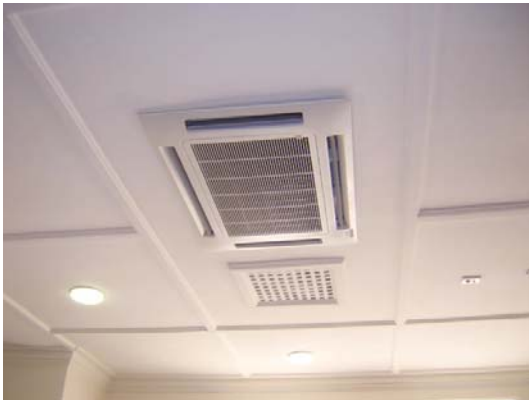
Area F34 – Cassette A/C unit to ceiling, later down light fitments

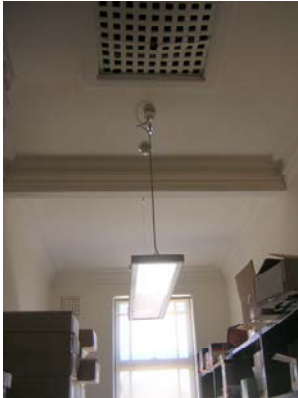
Area F35 – ceiling vent and cornices, window and wall vent to western wall, later light fitting

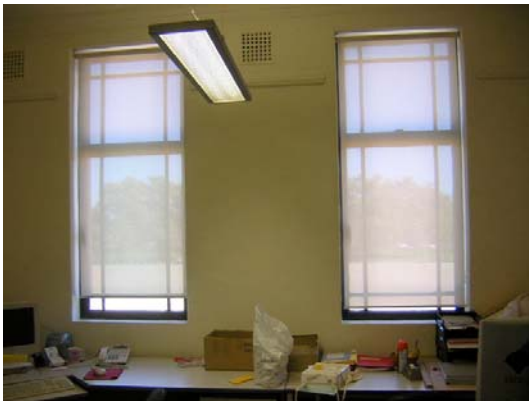
Area F39 – Windows to southern wall with later window blinds

INTERIOR SPACES: F39						
Physical Assessment				Conservation Policy		
Significance	Area	Significant Fabric	Alterations / Adaptation of original fabric	Specific recommendations	Conservation Policy	and
Moderate	Ceiling	Ceiling vent and cornices	Lighting and electrical services	<ul style="list-style-type: none"> Original battened ceiling to remain exposed where possible, with later suspended ceiling avoided where possible 		
	Walls	<ul style="list-style-type: none"> Masonry walls Windows and wall vents to western wall Skirtings 	<ul style="list-style-type: none"> Door to corridor Electrical skirting ducts New hardware/locks/handles to doors/windows Electrical services 			
	Floors	<ul style="list-style-type: none"> Probable original floor boards concealed by later carpet 	<ul style="list-style-type: none"> Carpet finish 			
	Fitments		<ul style="list-style-type: none"> Fixed joinery A/C system to northern wall Blinds to windows

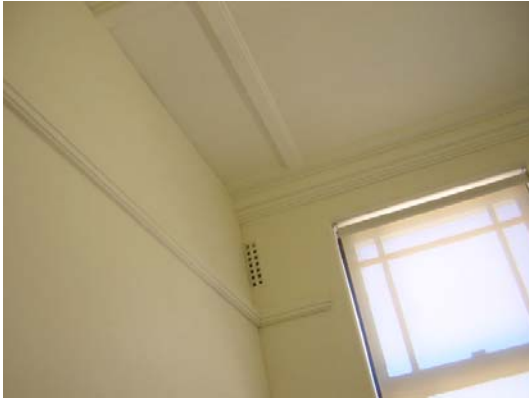
Area F40 – Later wall dividing areas F40 and F39. Note partially concealed wall vent

INTERIOR SPACES: F40						
Physical Assessment				Conservation Policy		
Significance	Area	Significant Fabric	Alterations / Adaptation of original fabric	Specific recommendations	Conservation Policy	and
Moderate	Ceiling	Batten ceiling with ceiling vents and cornices	Lighting and electrical services	• Original battened ceiling to remain exposed where possible, with later suspended ceiling avoided where possible		
	Walls	<ul style="list-style-type: none"> • Masonry walls • Windows and wall vents to western wall • Door in southern wall • Skirtings • Access hatch to southern wall 	<ul style="list-style-type: none"> • Risers to N/E and S/E corners • Door to corridor • Electrical skirting ducts • New hardware/locks/handles to doors/windows • Electrical services 			
	Floors	• Probable original floor boards concealed by later carpet	• Carpet finish			
	Fitments		<ul style="list-style-type: none"> • Fixed joinery • A/C system to northern wall • Blinds to windows • Picture rails to masonry wall

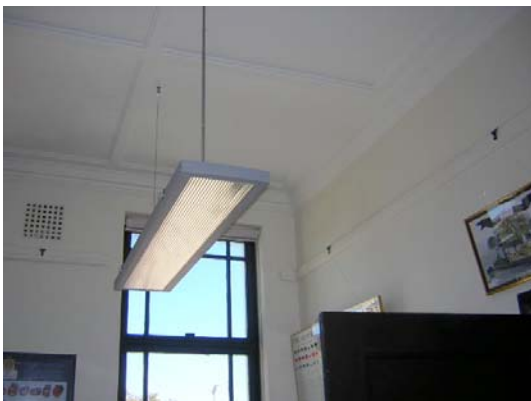
Area F41 – Significant batten ceiling, window and wall vents to western wall, later light fitting

INTERIOR SPACES: F41 (continued)						
Physical Assessment				Conservation Policy		
Significance	Area	Significant Fabric	Alterations / Adaptation of original fabric	Specific recommendations	Conservation Policy	and
Moderate	Walls	<ul style="list-style-type: none"> • Masonry walls • Windows and wall vents to western wall • Door in northern wall • Fire reel enclosure door • Skirtings 	<ul style="list-style-type: none"> • Risers to N/E and S/E corners • Fire hose reel enclosure • Door to corridor • Electrical skirting ducts • New hardware/locks/handles to doors/windows • Electrical services 			
	Floors	<ul style="list-style-type: none"> • Probable original floor boards concealed by later carpet 	<ul style="list-style-type: none"> • Carpet finish 			
	Fitments	<ul style="list-style-type: none"> • Some picture rails 	<ul style="list-style-type: none"> • Picture rails to risers • Fixed joinery • A/C system to southern wall • Blinds to windows
