# Native Vegetation Data Report - Barossa Bikeway

Prepared by Sheree Edwards, Terra Gana Pty Ltd  
14<sup>th</sup> September 2026  
FOR: Barossa Council

Terra Gana Pty Ltd have been engaged by the Barossa Council to undertake a native vegetation clearance assessment of the proposed alignment of a 3km multi-use trail (Barossa Bike Path) to be constructed along the dis-used railway corridor, between Randall Road, Mount Torrens and Torrens Valley Road, Mount Pleasant.

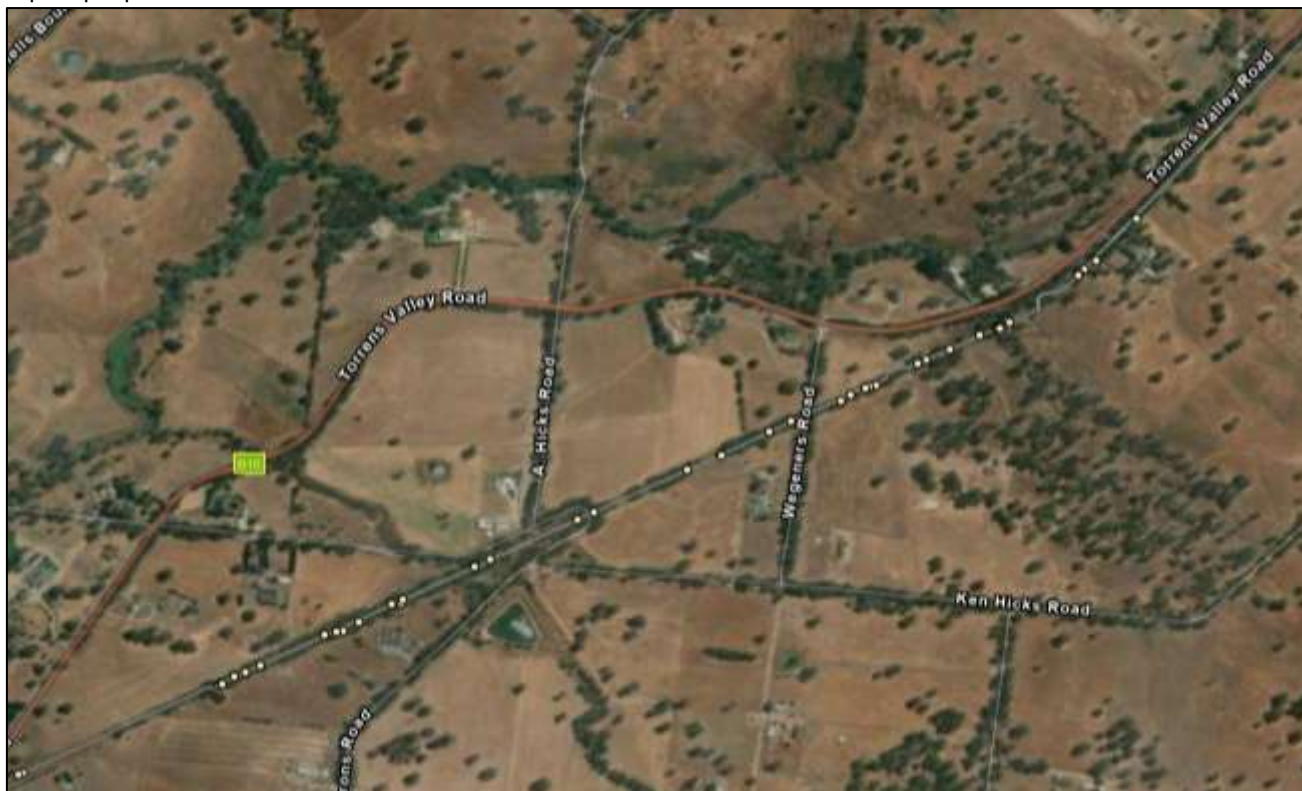
Map of proposed clearance area

| Total proposed clearance - area (ha) and number of trees | 66 Scattered Trees proposed to be impacted (inclusive trees which require pruning) AND 0.08 Ha of bushland. |

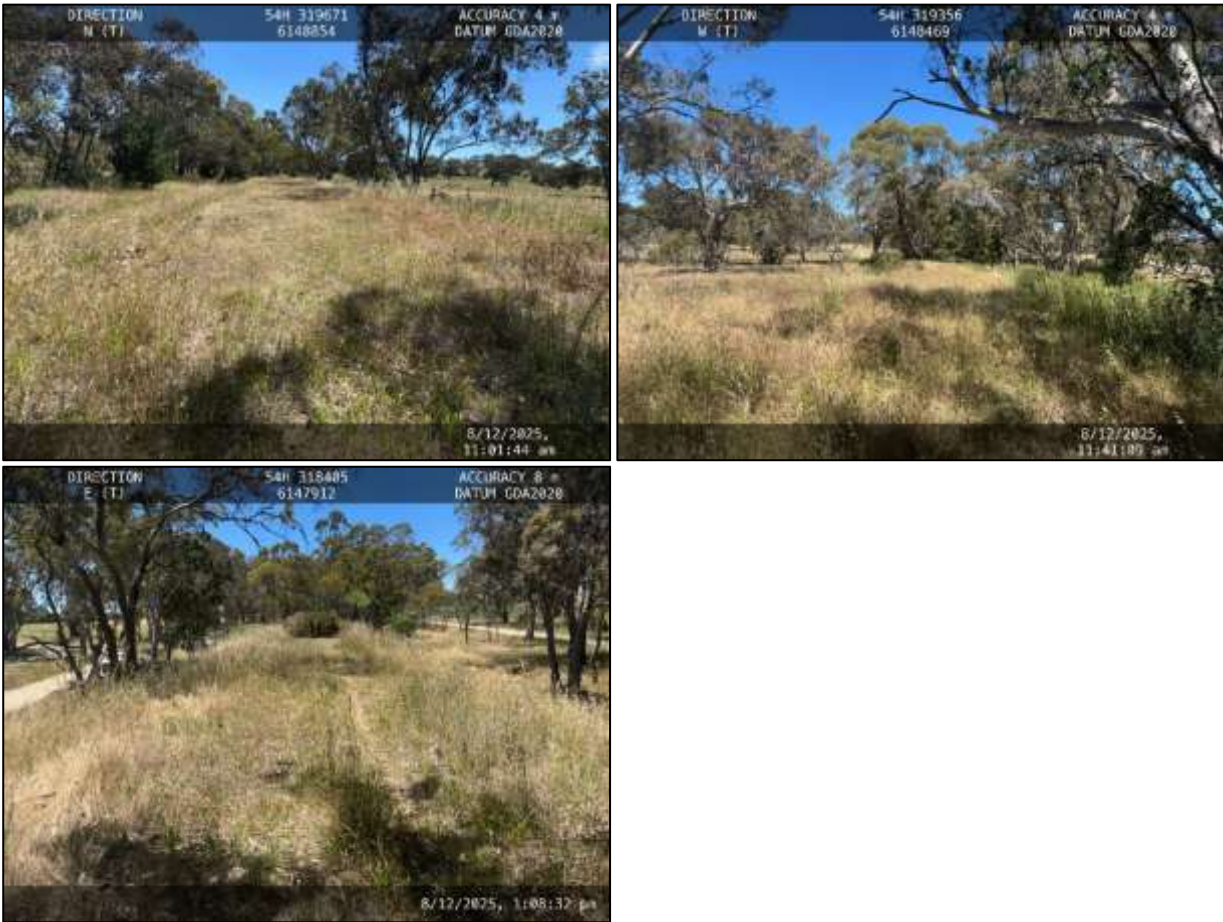
| Vegetation Association A1: <i>Themeda triandra</i> , <i>Austrostipa</i> sp degraded grassland | | | | | |

| Vegetation Association A1: <i>Themeda triandra</i> , <i>Austrostipa</i> sp degraded grassland | | | | | |
|---|---|---|---|---|---|
| Threatened species or community | No threatened flora or fauna under the NP&W Act or EPBC Act listed species or community recorded. | | | | |
| Landscape context score | 1.14 | Vegetation Condition Score | 11.28 | Conservation significance score | 1.08 |
| Unit biodiversity Score | 13.89 | Area (ha) | 0.06 | Total biodiversity Score | 0.83 |

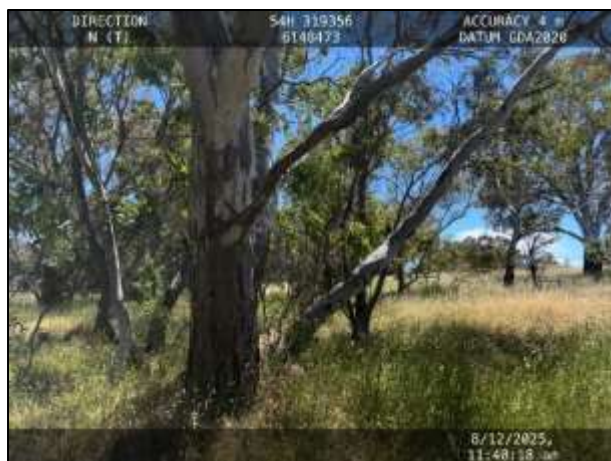
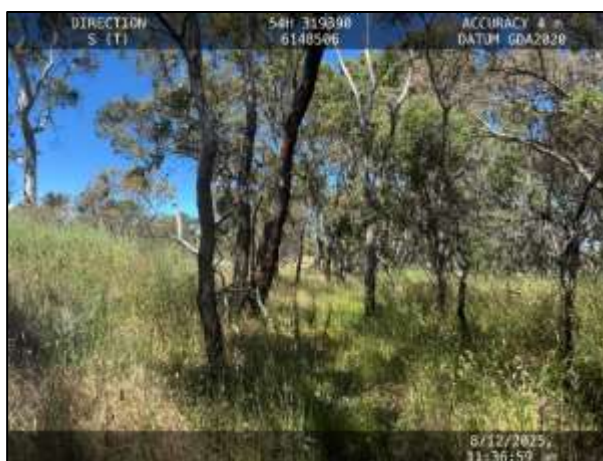
Vegetation Association B1 – *Eucalyptus camaldulensis* ssp *camaldulensis* open woodland with sparse degraded understorey

| Threatened species or community | No threatened flora or fauna under the NP&W Act or EPBC Act listed species or community recorded. | | | | |
| Landscape context score | 1.17 | Vegetation Condition Score | 30.06 | Conservation significance score | 1.08 |
| Unit biodiversity Score | 37.98 | Area (ha) | 0.02 | Total biodiversity Score | 0.76 |
