# Native Vegetation Clearance Data Report

## Mount Compass to Goolwa Road

### Department for Infrastructure and Transport

SLR Project No.: 655.010559.00006

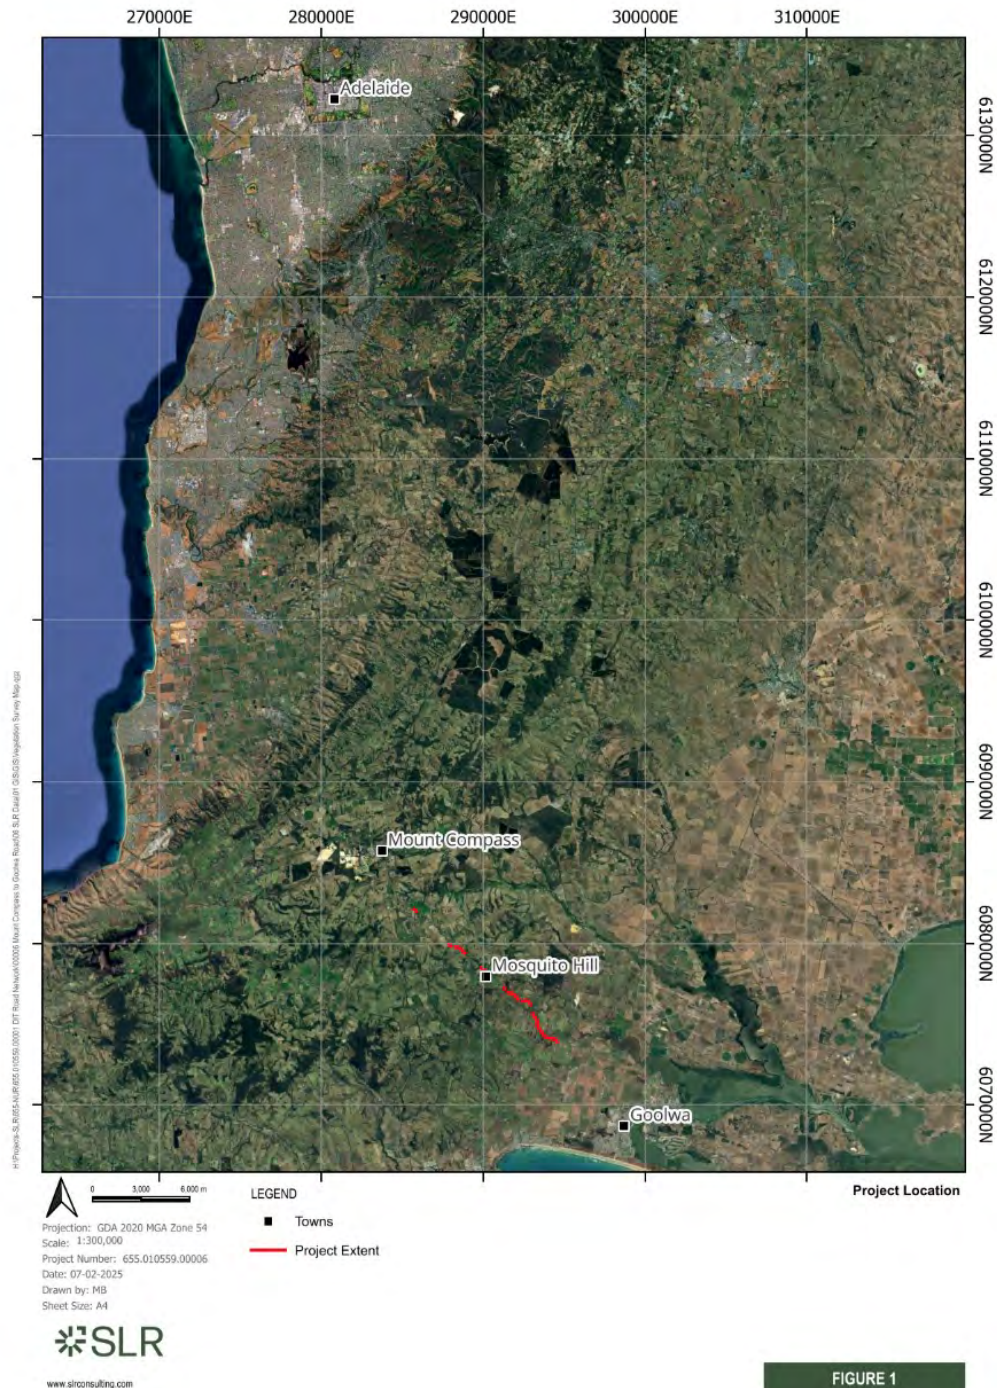
**Figure 1 Project Location**

The proposed works are located approximately 65 km south of Adelaide, South Australia. Refer to Figure 1 for a visual representation of the Project Area.

SLR Consulting Australia (SLR) have been engaged by DIT to undertake Native Vegetation Assessments for sections along Goolwa Road (ID: 17816), near Mount Compass, South Australia, refer to Figure 1 for a visual representation of the project footprint. Several work sites, defined as “Project Sites” are proposed between maintenance marker (MM) 1.6 – MM 14.2 (Defined as the overall “Project Area”), across the suburbs of Mount Compass, Mosquito Hill and Currency Creek.

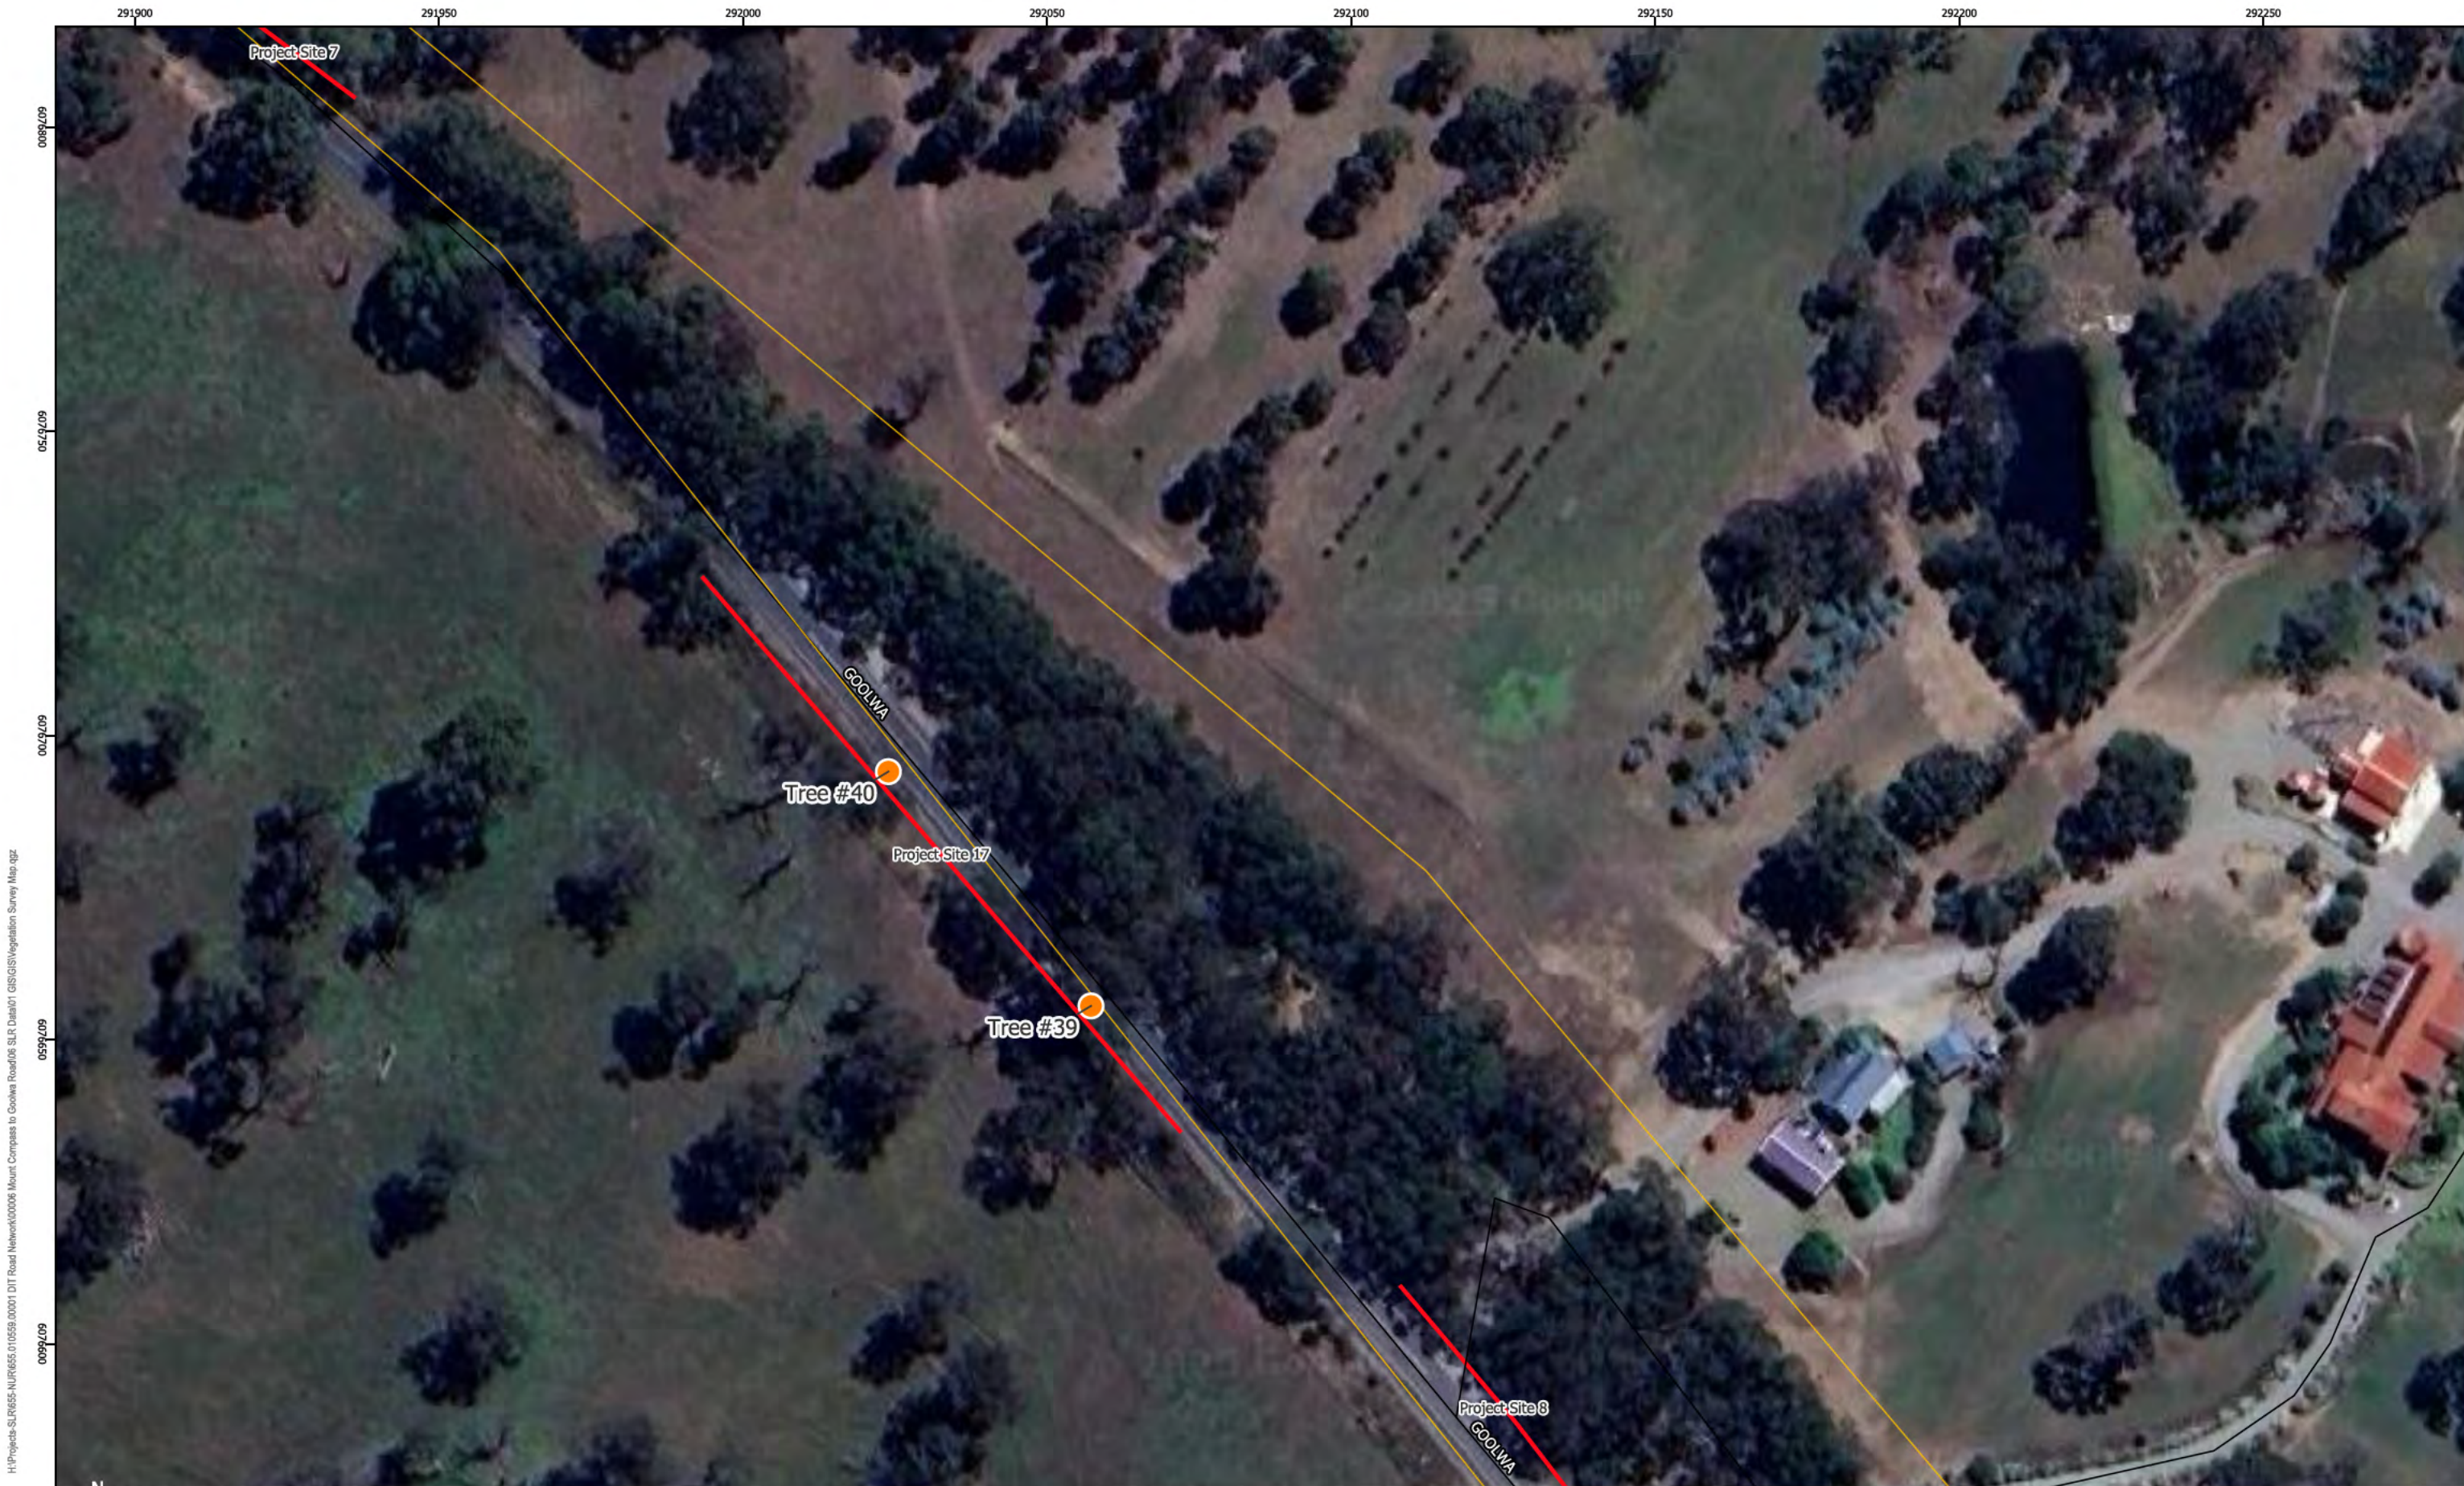
FIGURE 4

NVC Map - Project Sites 5, 7 & 16

| Project Site | Vegetation Summary | Approval Required | Figure Reference | IBRA Association |
|---|---|---|---|---|
| 5 & 7 | A total of 11 trees (ID 23,25,26,27,28,29,30,31,32,33,34) to be impacted through root zone encroachment. | Yes | Figure 4 | Sandergrove |

| Project Site | Vegetation Summary | Approval Required | Figure Reference | IBRA Association |
|---|---|---|---|---|
| 16 | No vegetation impacts. | None required | Figure 4 | Kerby Hill |

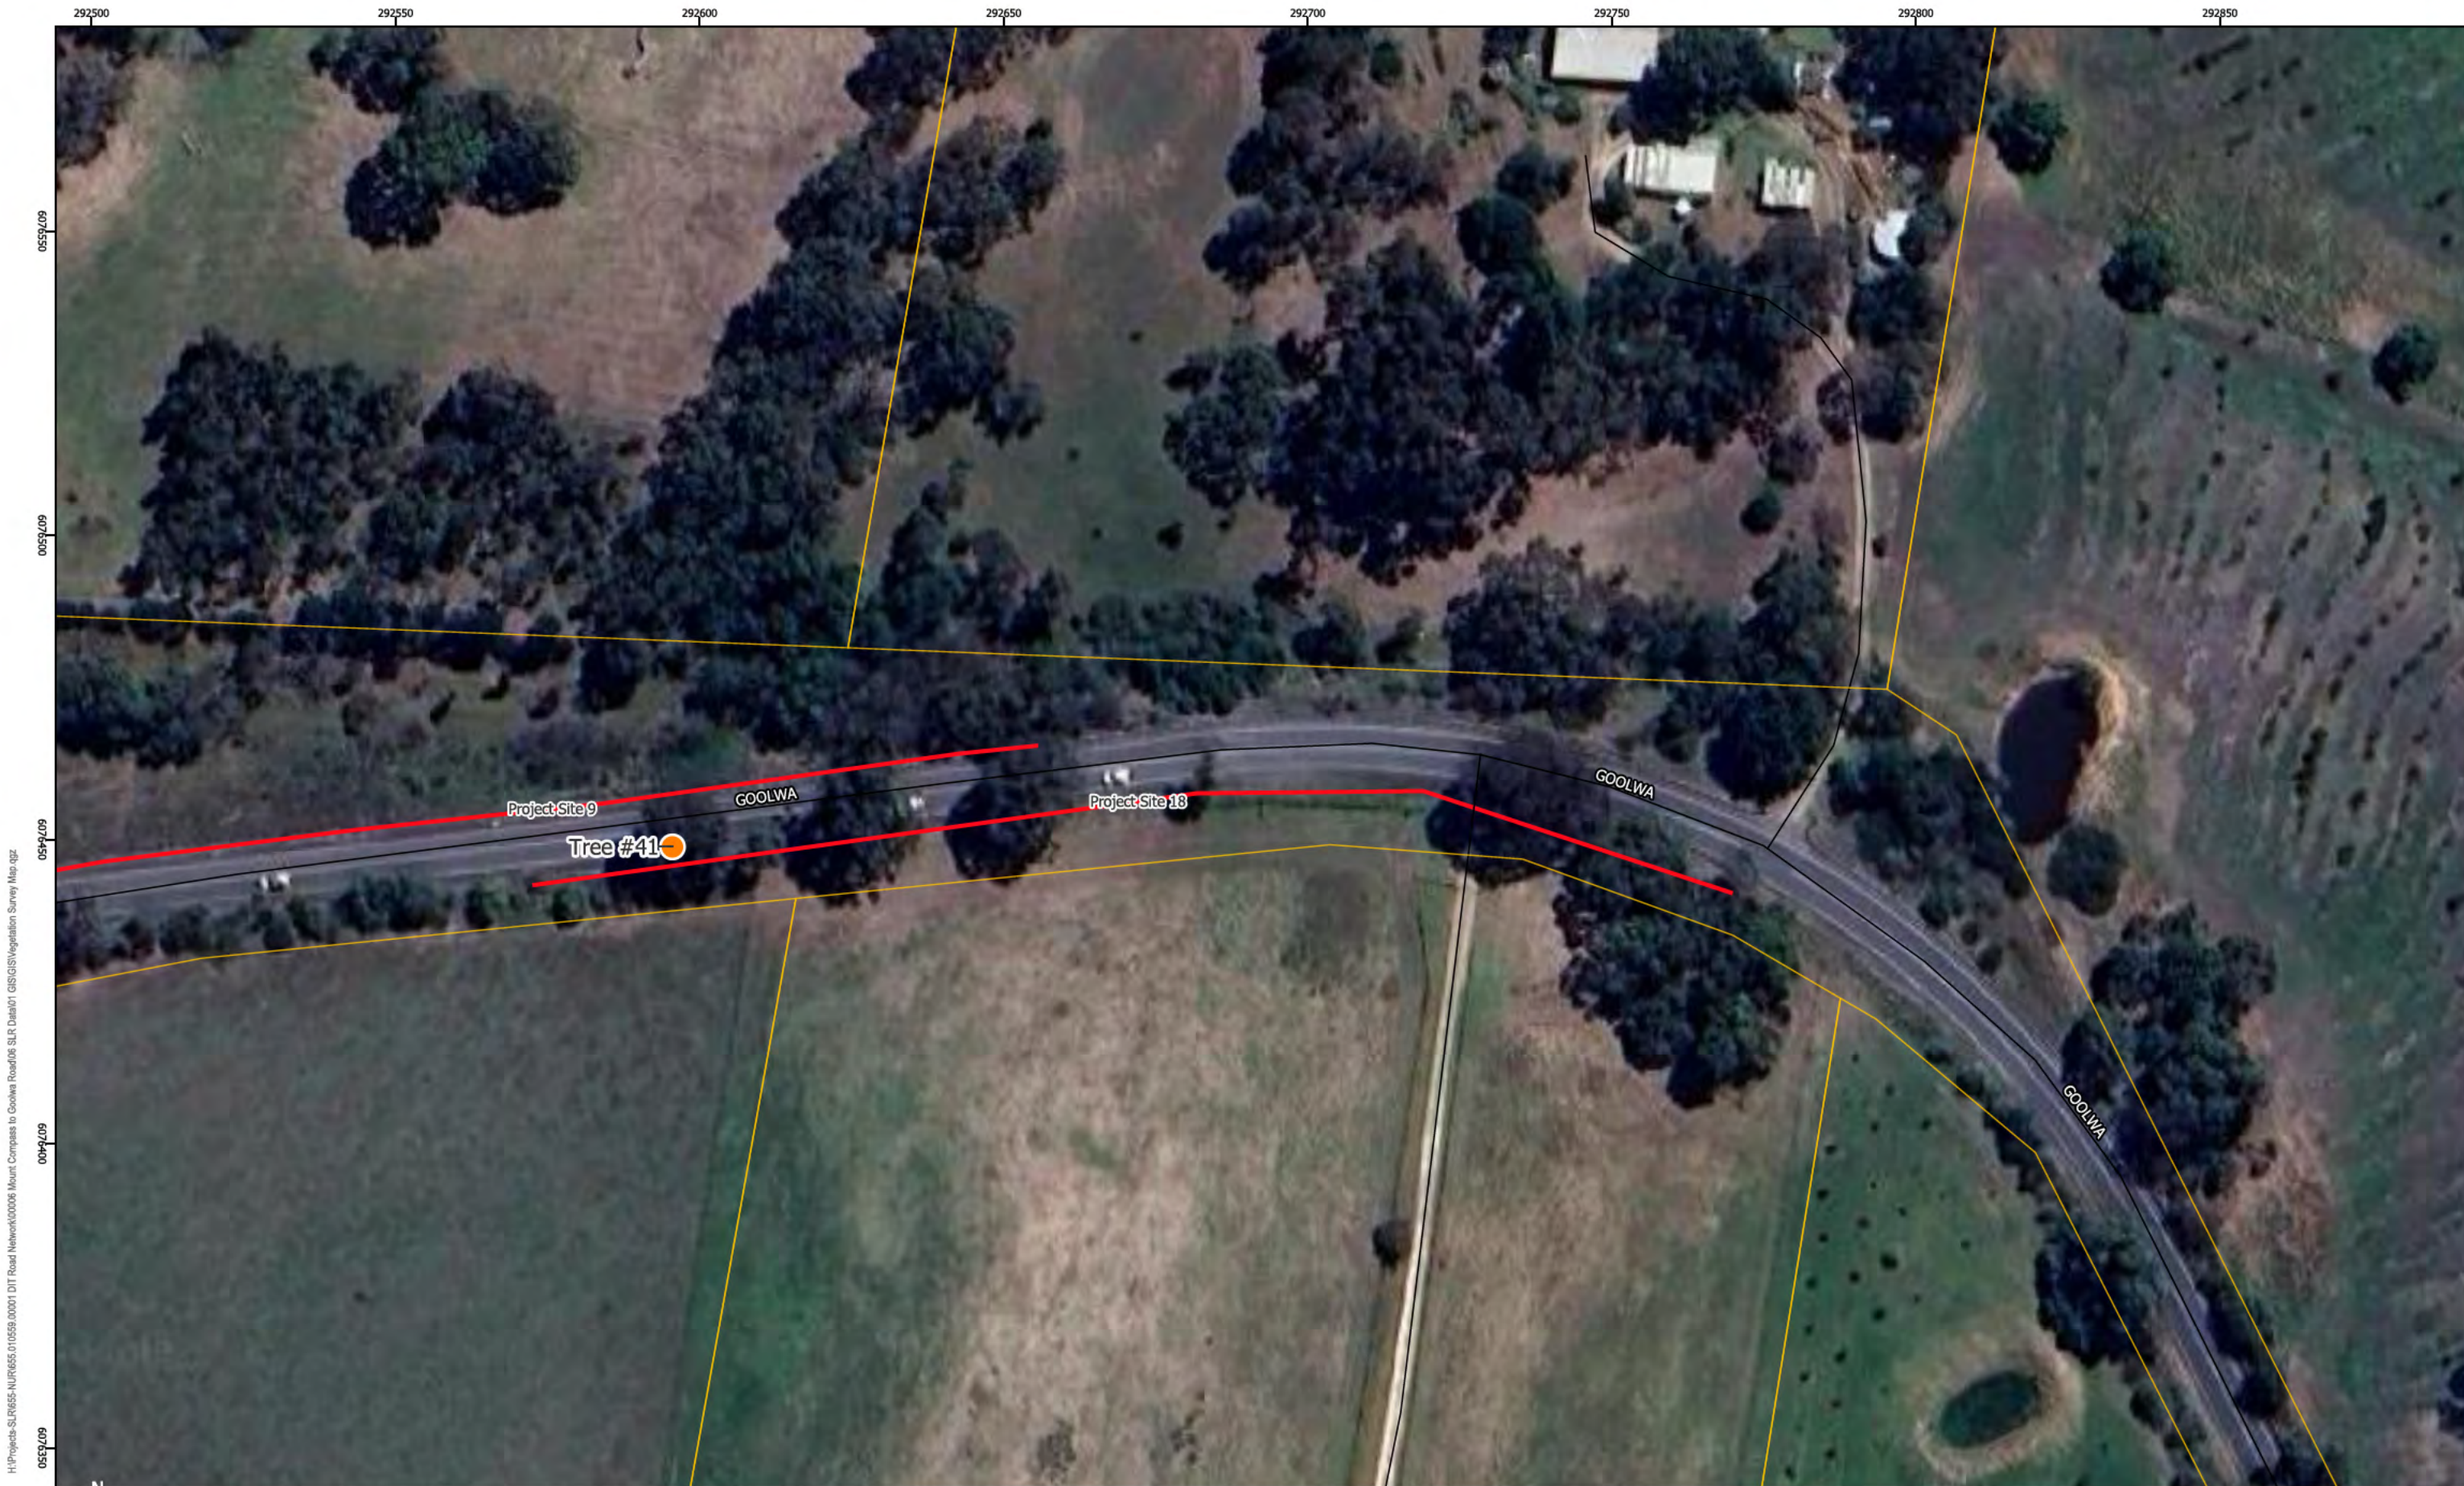
FIGURE 5

NVC Map - Project Site 17

| Project Site | Vegetation Summary | Approval Required | Figure Reference | IBRA Association |
|---|---|---|---|---|
| 17 | A total of two trees (ID 39, 40) to be impacted through root zone encroachment. Further vegetation located down embankment and at a greater distance. Understorey a mixture of introduced herbaceous species. | Yes | Figure 5 | Sandergrove |

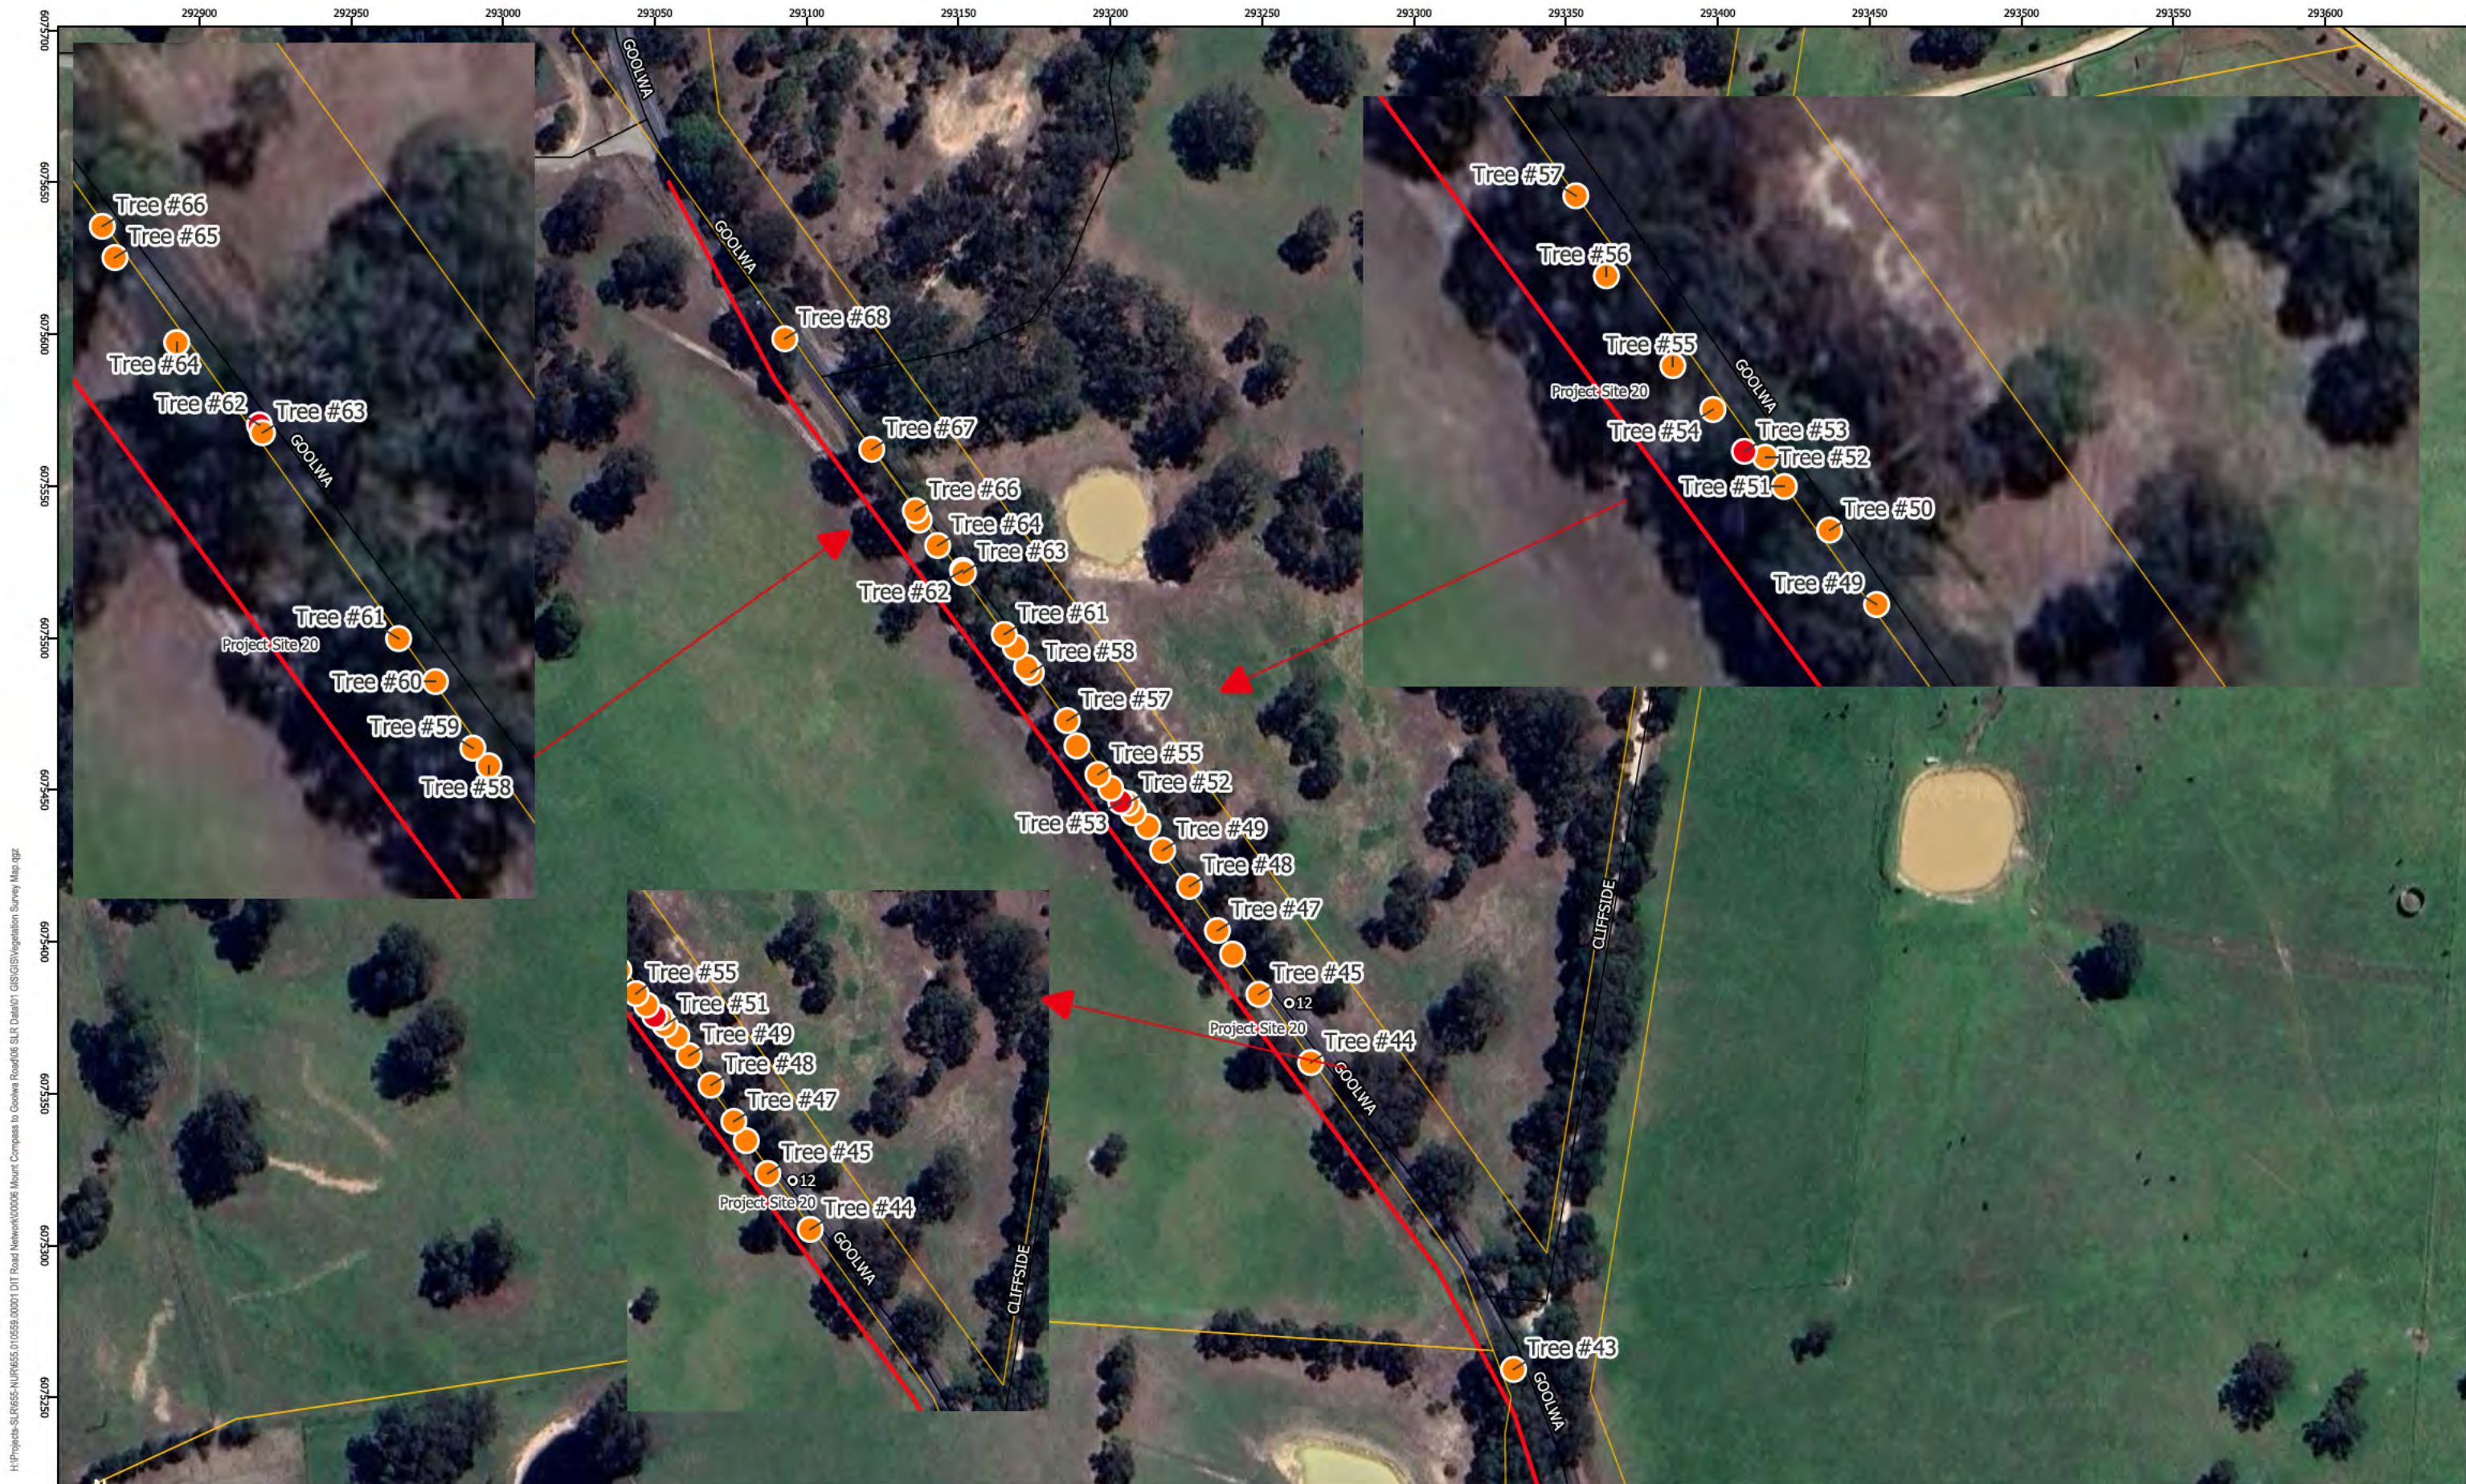
FIGURE 7

| Project Site | Vegetation Summary | Approval Required | Figure Reference | IBRA Association |
|---|---|---|---|---|
| 19 | One native tree (ID 42) to be impacted through root zone encroachment. Prolific Dog Rose, <i>Olea europaea ssp. Europaea</i> (Olive), and Bridal Creeper noted. | Yes | Figure 7 | Sandergrove |

NVC Map - Project Site 19

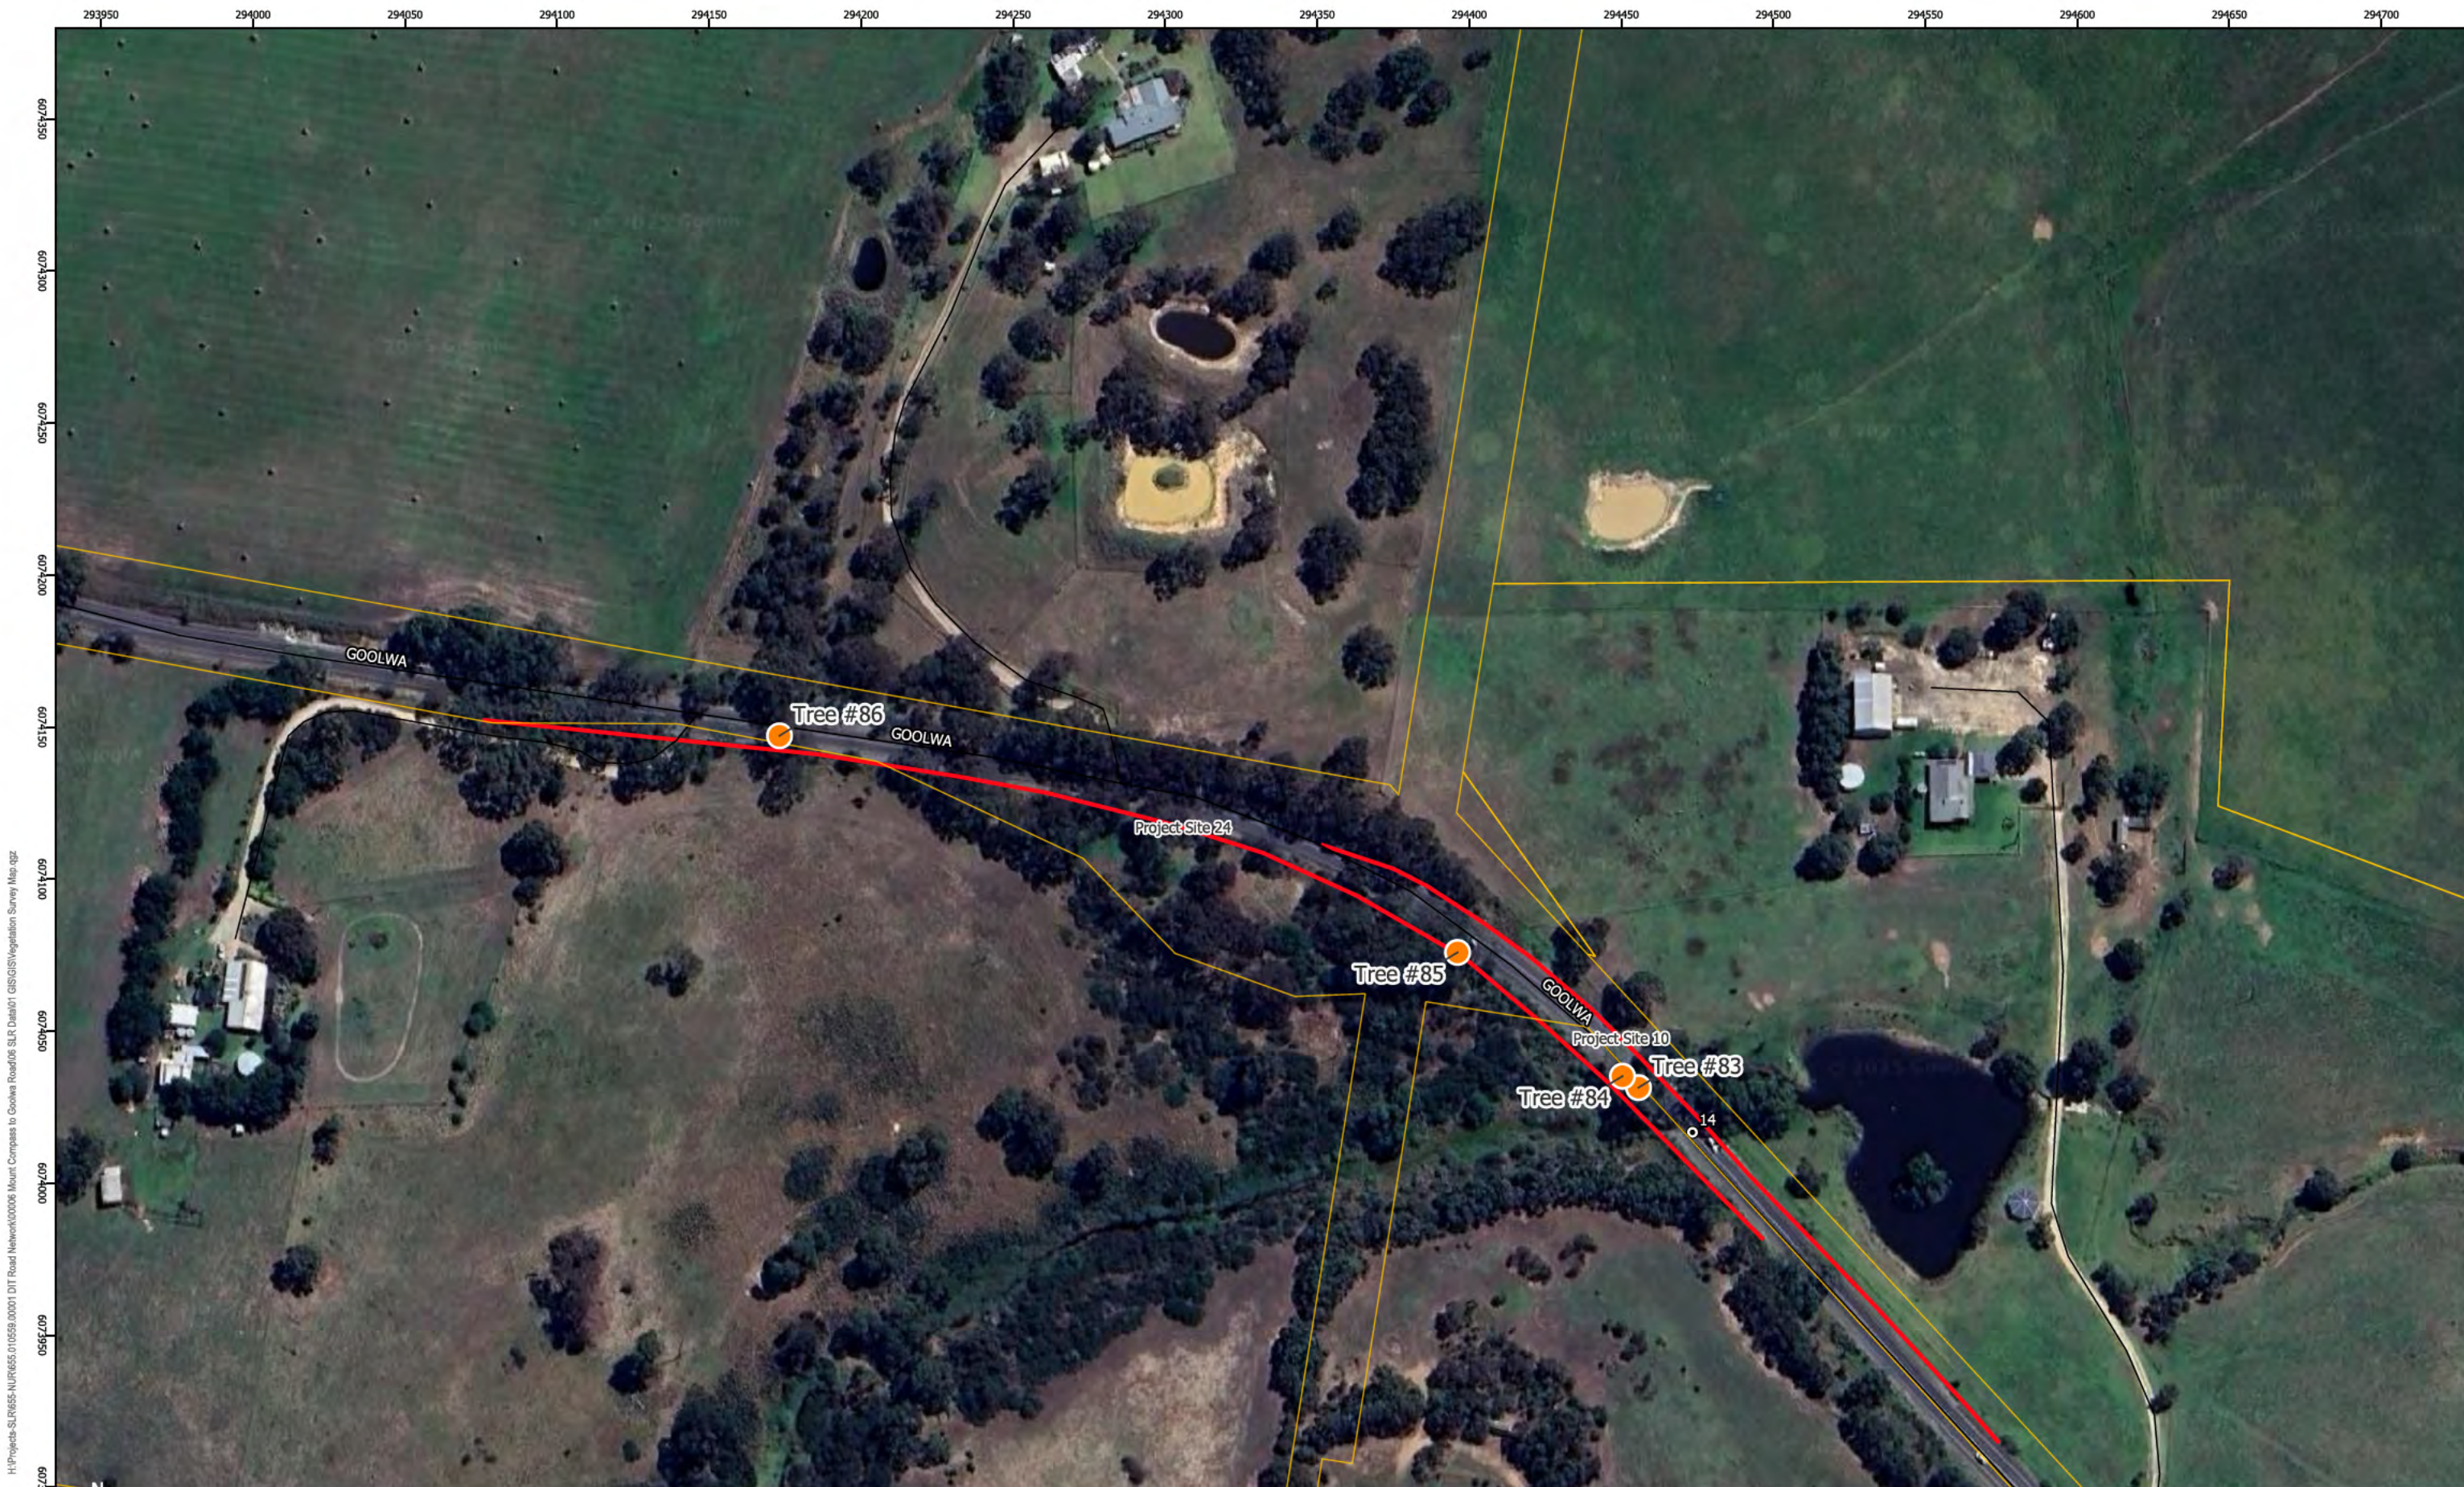
| Project Site | Vegetation Summary | Approval Required | Figure Reference | IBRA Association |
|---|---|---|---|---|
| 23 | Roadside Significant Site (ID75). A total of eight trees (ID 81,80,79,77,76,75,74,82) to be impacted through root zone encroachment, one tree (ID 78) to be removed. Blackberry noted. | Yes | Figure 10 | Kerby Hill |

NVC Map - Project Site 23
