# Native Vegetation Clearance

## Piggott Range Road Upgrade

### Data Report

Clearance under the *Native Vegetation Regulations 2017*

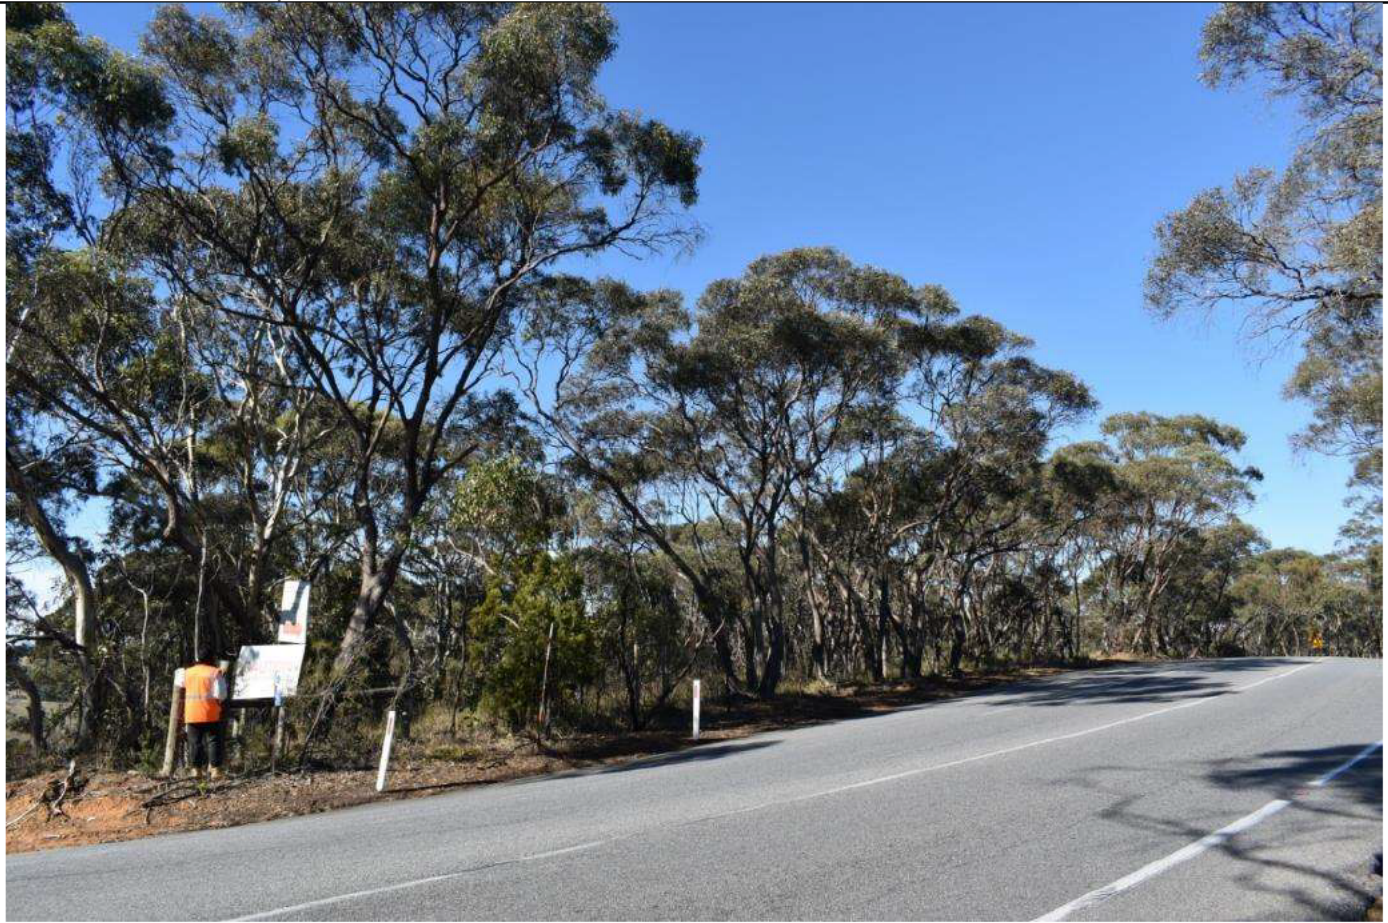
Photo 1. Looking SE, an area of approximately 440m<sup>2</sup> of roadside vegetation across two small sites (aggregated), may be impacted by works.

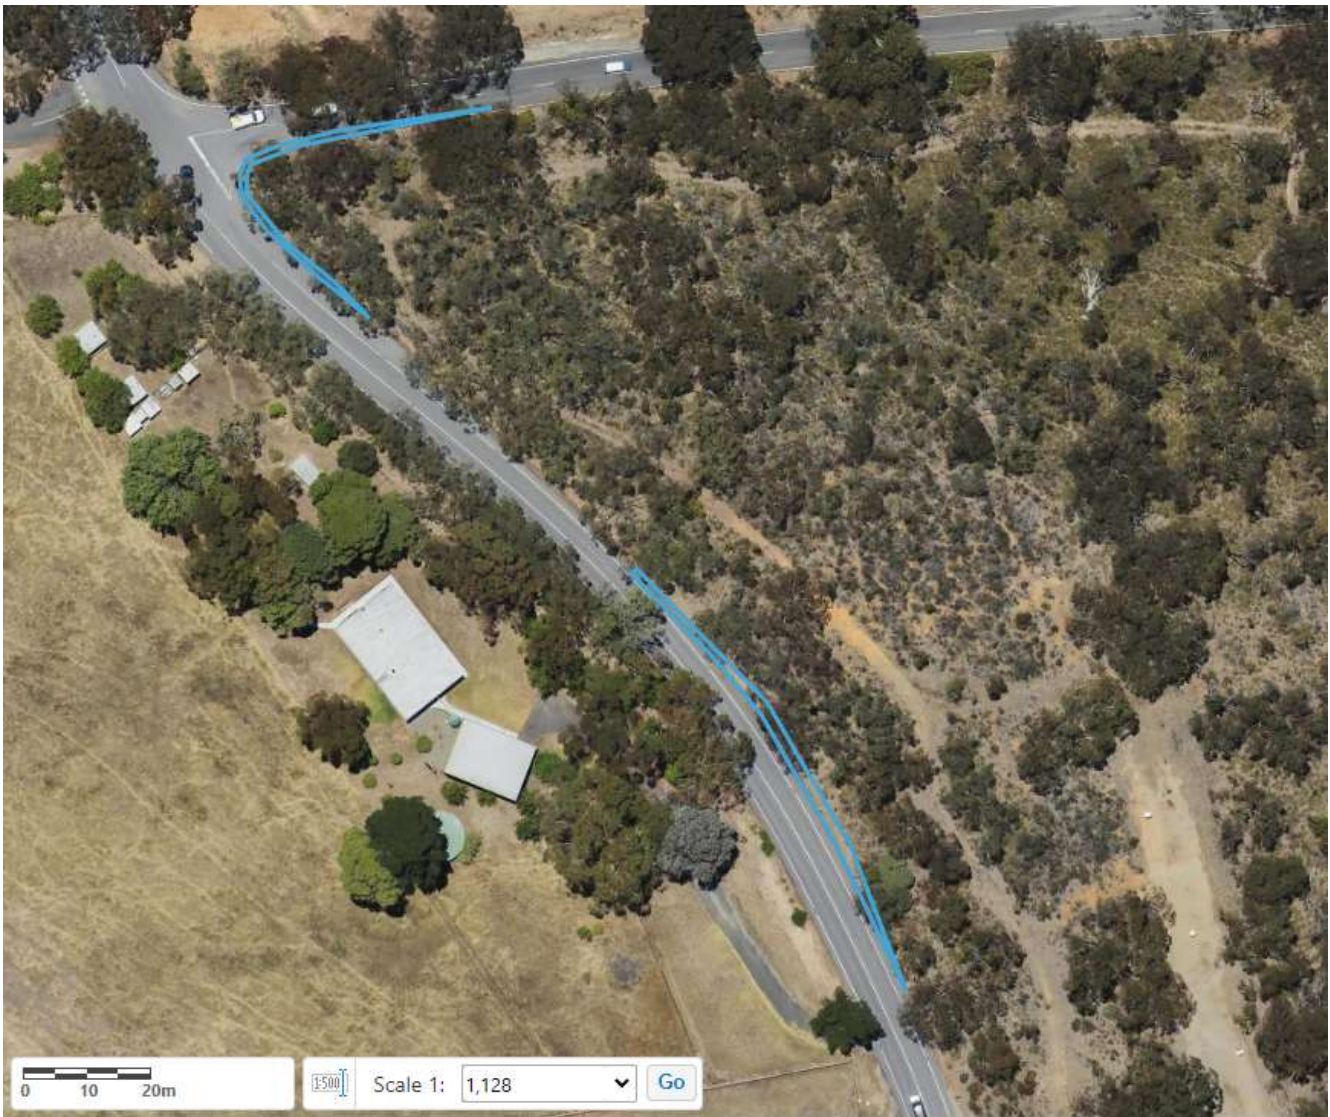
**Figure 3.** Bushland area impacted (two small sites, aggregated)

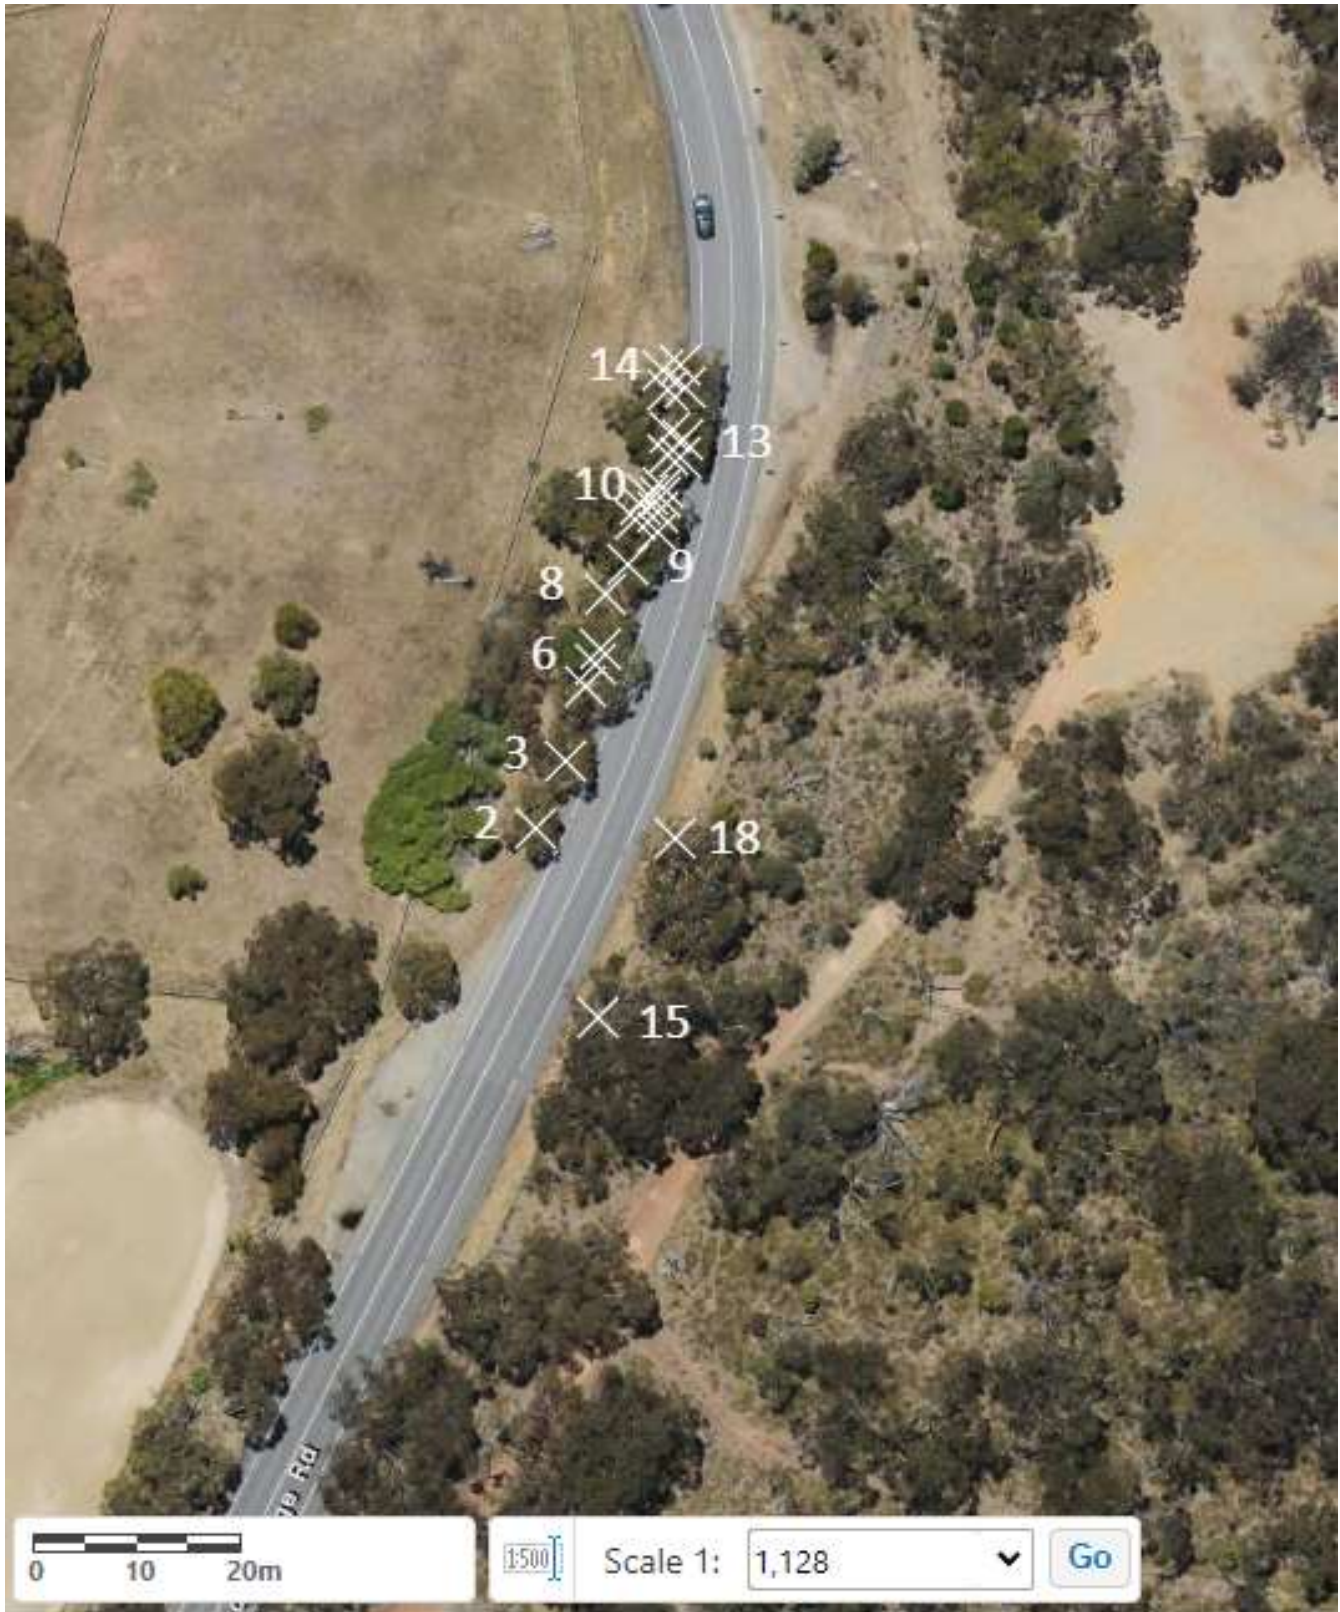
**Figure 4.** Scattered trees impacted

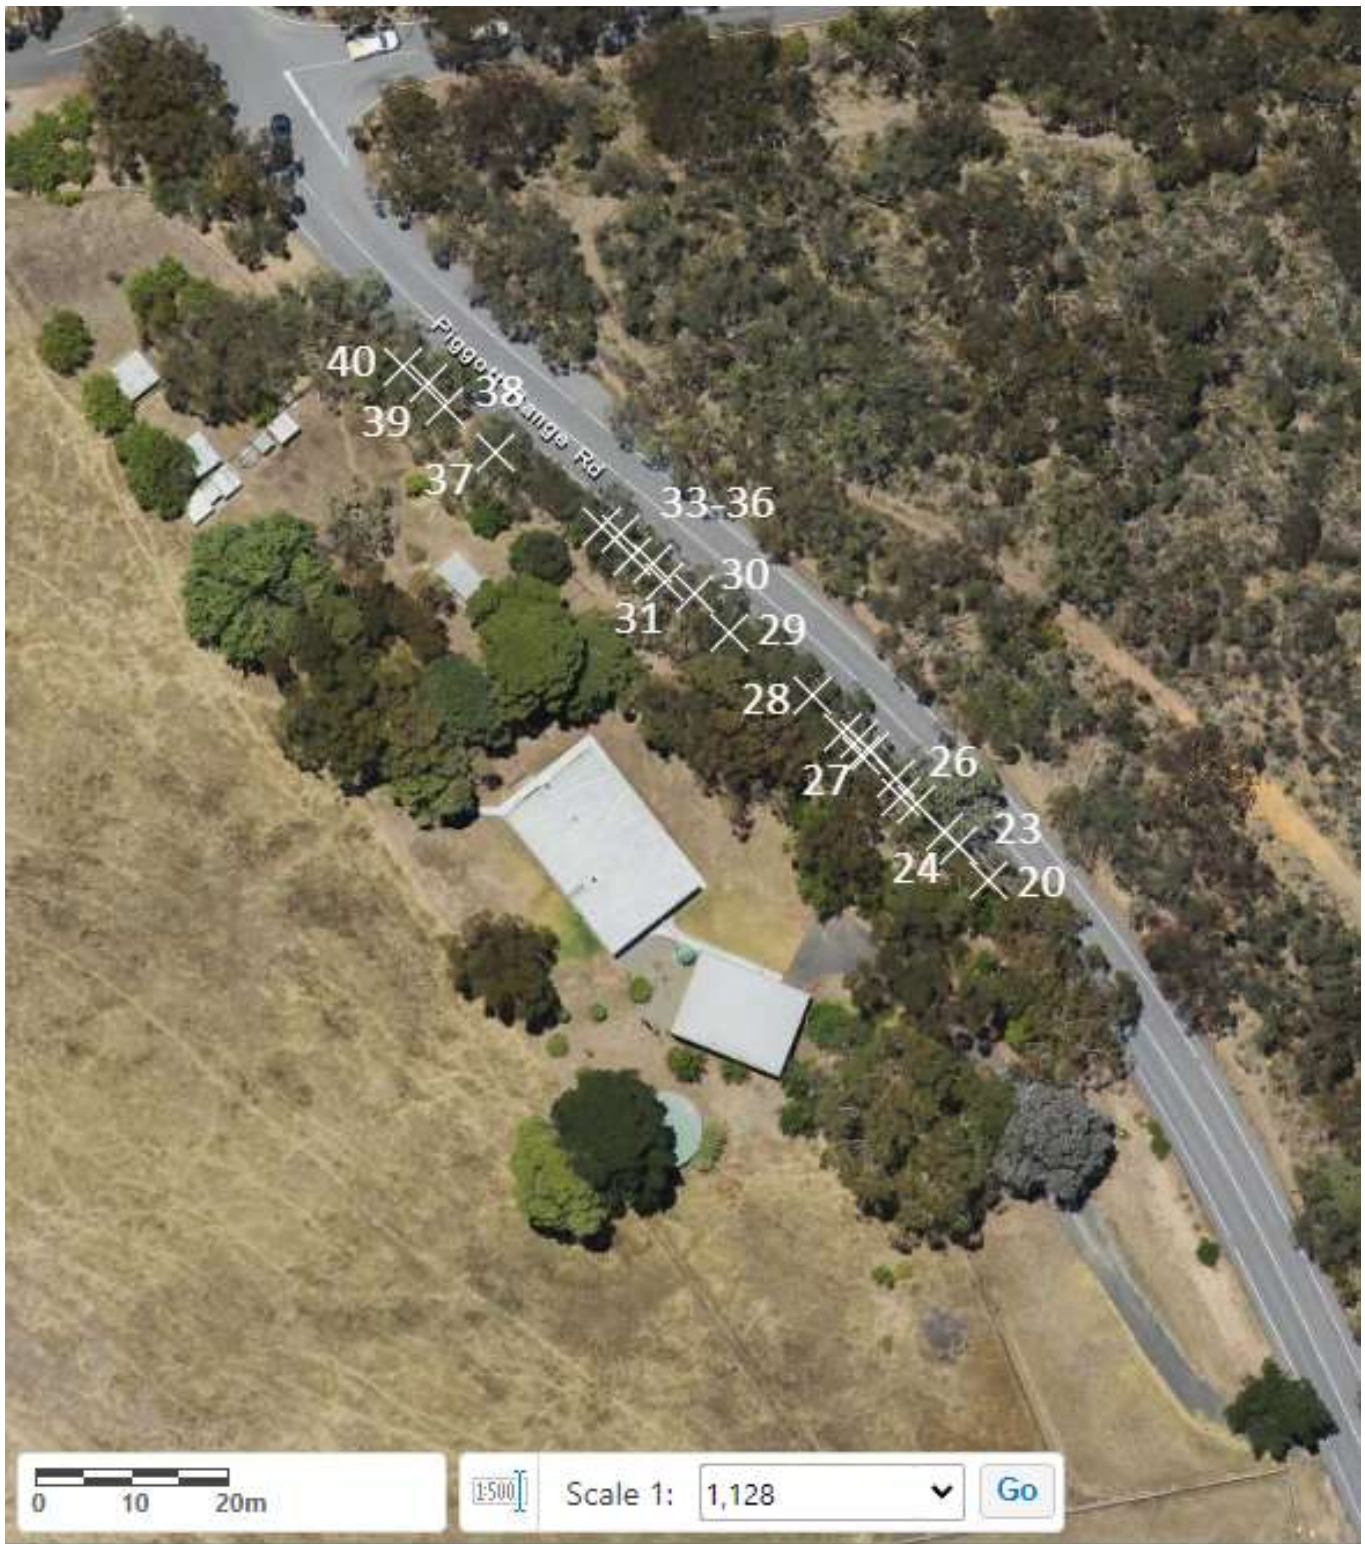
**Figure 5.** Scattered trees impacted

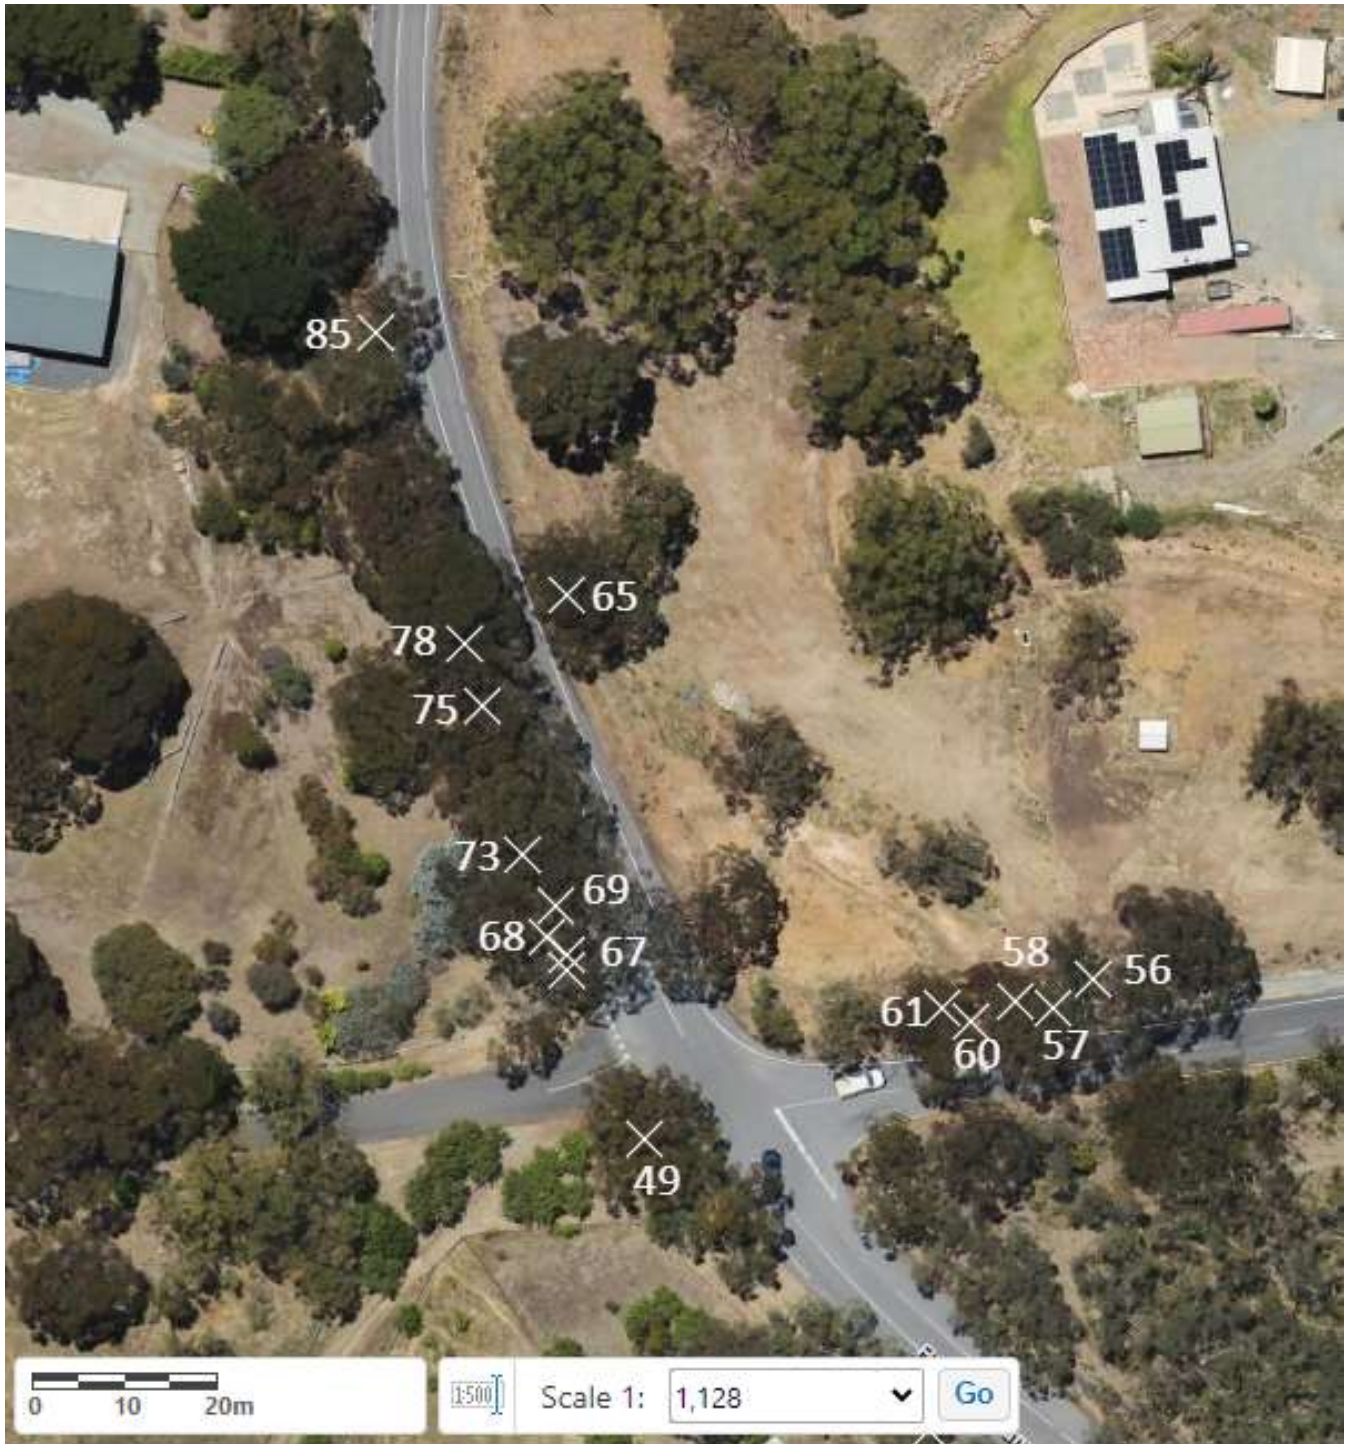
**Figure 6.** Scattered trees impacted

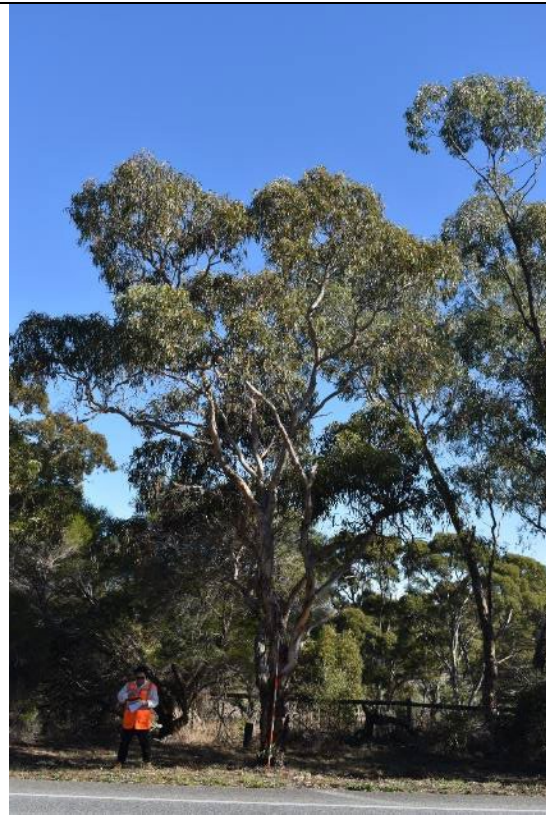
Photo 2 Tree 3

| Tree # | Tree spp. | No. of trees | Height (m) | Hollows | Diameter (cm) | Canopy dieback (%) | Biodiversity Score | General comments | Photo # |
|---|---|---|---|---|---|---|---|---|---|
| 3 | <i>Eucalyptus fasciculosa</i> | 1 | 8.0 | 0 | 60 | 5 | 1.41 | Small tree in good condition providing habitat for a number of threatened species | 2 |

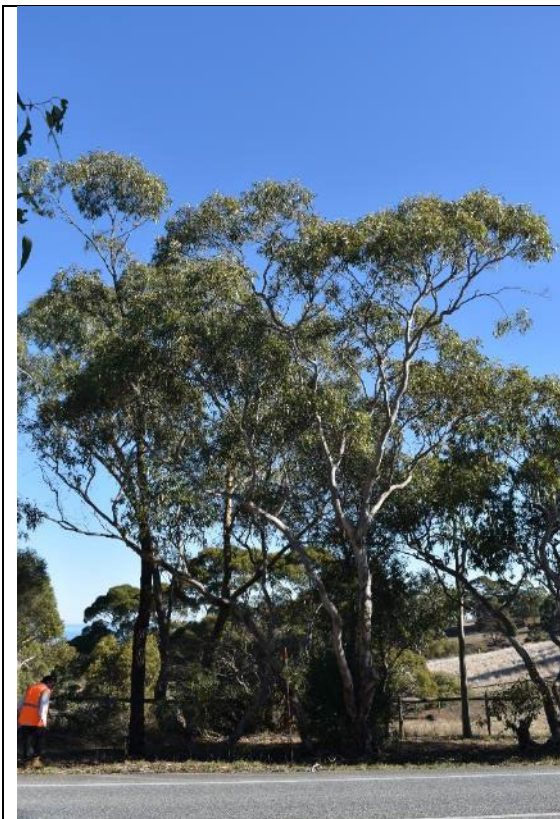
Photo 3 Tree 6

| Tree # | Tree spp. | No. of trees | Height (m) | Hollows | Diameter (cm) | Canopy dieback (%) | Biodiversity Score | General comments | Photo # |
|---|---|---|---|---|---|---|---|---|---|
| 6 | <i>Eucalyptus fasciculosa</i> | 3 | 10.0 | 0 | 20 | 10 | 1.56 | Medium tree in good condition providing habitat for a number of threatened species | 3 |

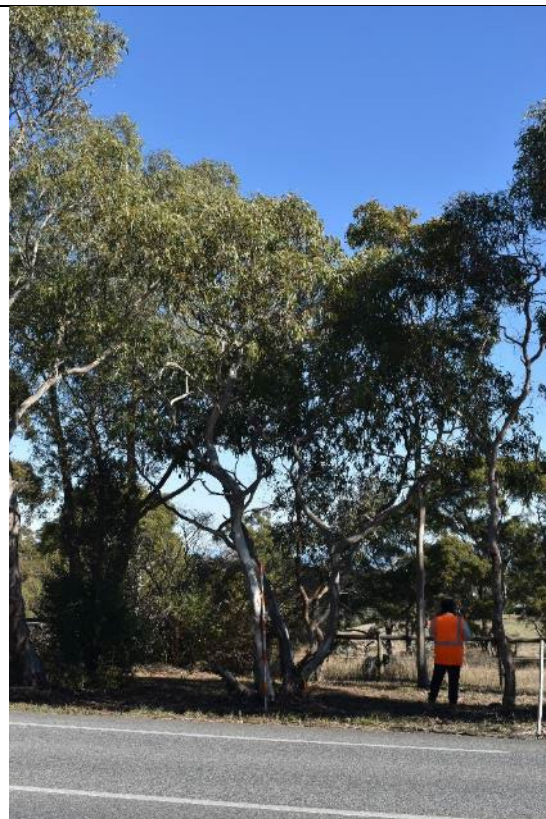
Photo 4 Tree 8

| Tree # | Tree spp. | No. of trees | Height (m) | Hollows | Diameter (cm) | Canopy dieback (%) | Biodiversity Score | General comments | Photo # |
|---|---|---|---|---|---|---|---|---|---|
| 8 | <i>Eucalyptus fasciculosa</i> | 1 | 6.0 | 0 | 25 | 10 | 0.45 | Small tree in good condition providing habitat for a number of threatened species | 4 |

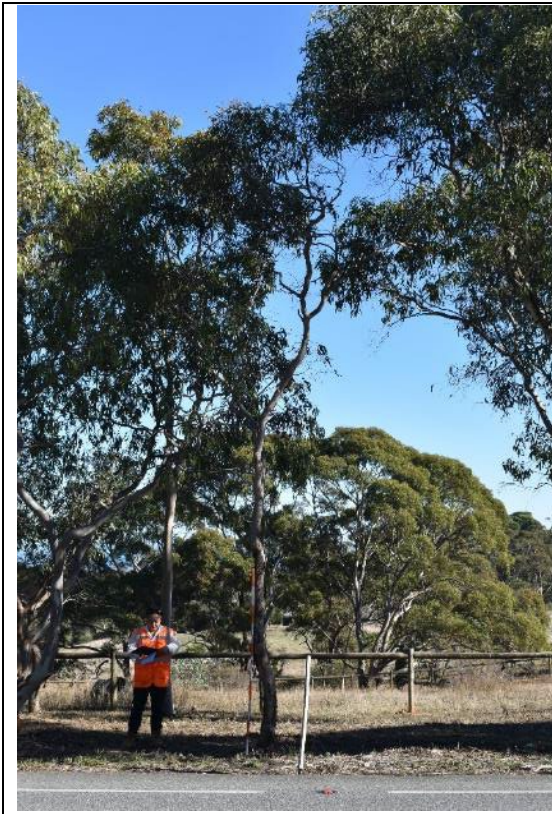
Photo 5 Tree 9

| Tree # | Tree spp. | No. of trees | Height (m) | Hollows | Diameter (cm) | Canopy dieback (%) | Biodiversity Score | General comments | Photo # |
|---|---|---|---|---|---|---|---|---|---|
| 9 | <i>Eucalyptus fasciculosa</i> | 1 | 6.0 | 0 | 20 | 15 | 0.37 | Small tree in good condition providing habitat for a number of threatened species | 5 |

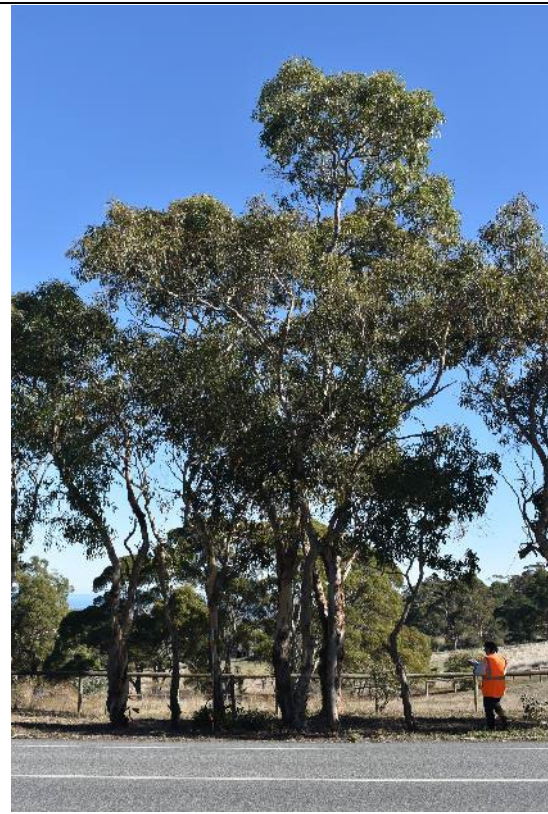
Photo 6 Tree 10

| Tree # | Tree spp. | No. of trees | Height (m) | Hollows | Diameter (cm) | Canopy dieback (%) | Biodiversity Score | General comments | Photo # |
|---|---|---|---|---|---|---|---|---|---|
| 10 | <i>Eucalyptus fasciculosa</i> | 7 | 14.0 | 0 | 40 | 5 | 15.00 | Medium tree in good condition providing habitat for a number of threatened species | 6 |

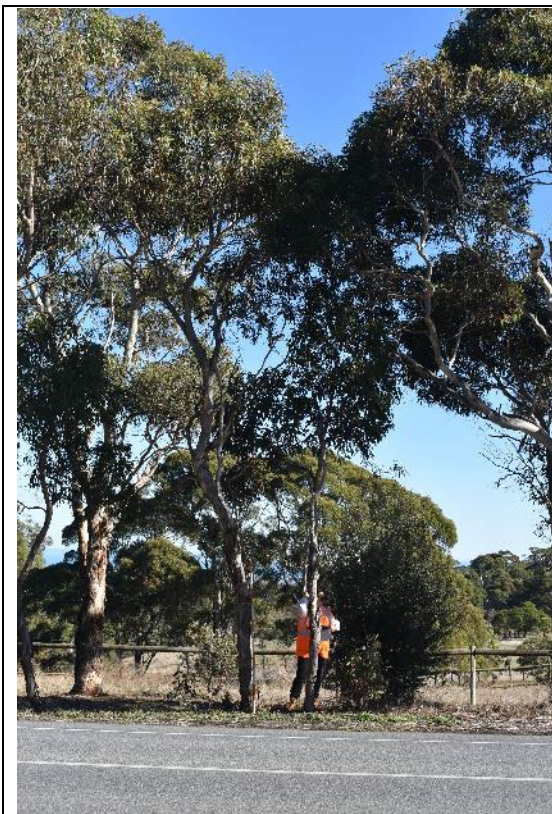
Photo 7 Tree 13

| Tree # | Tree spp. | No. of trees | Height (m) | Hollows | Diameter (cm) | Canopy dieback (%) | Biodiversity Score | General comments | Photo # |
|---|---|---|---|---|---|---|---|---|---|
| 13 | <i>Eucalyptus fasciculosa</i> | 4 | 8.0 | 0 | 25 | 10 | 2.05 | Small tree in good condition providing habitat for a number of threatened species | 7 |

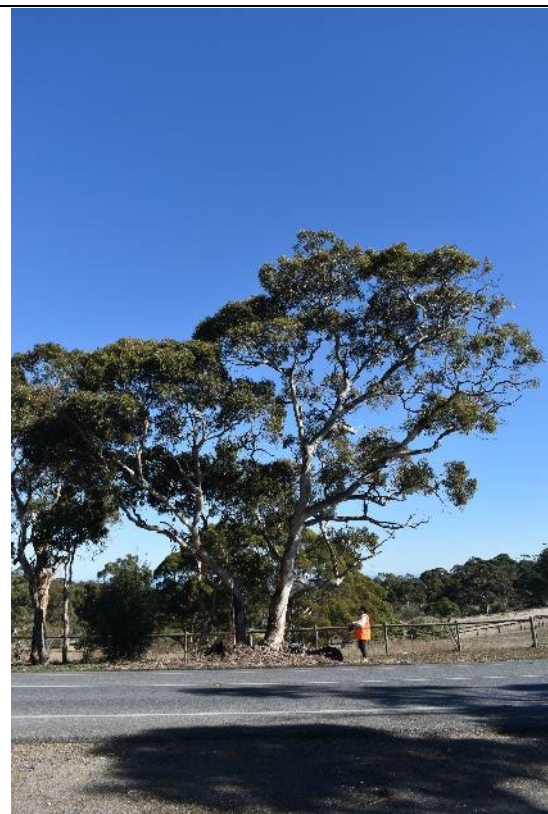
Photo 8 Tree 14

| Tree # | Tree spp. | No. of trees | Height (m) | Hollows | Diameter (cm) | Canopy dieback (%) | Biodiversity Score | General comments | Photo # |
|---|---|---|---|---|---|---|---|---|---|
| 14 | <i>Eucalyptus fasciculosa</i> | 4 | 14.0 | 0 | 70 | 20 | 10.24 | Medium tree in fair condition providing habitat for a number of threatened species | 8 |

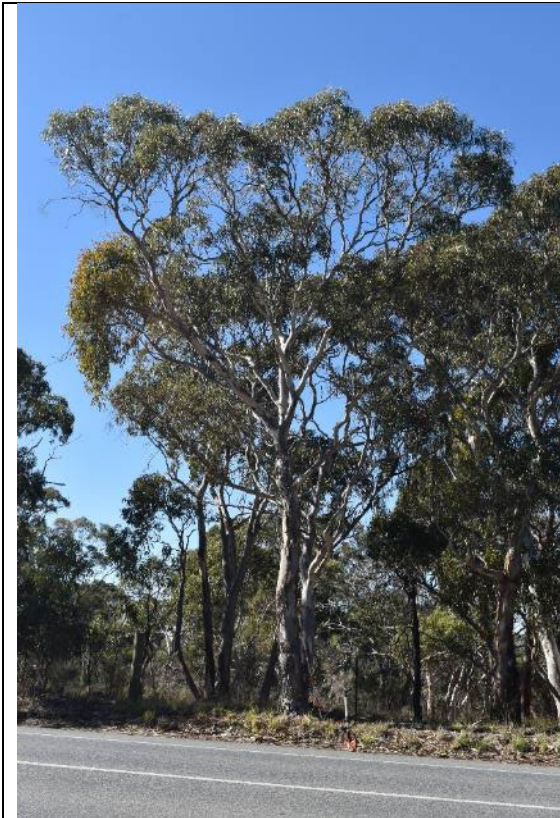
Photo 9 Tree 15

| Tree # | Tree spp. | No. of trees | Height (m) | Hollows | Diameter (cm) | Canopy dieback (%) | Biodiversity Score | General comments | Photo # |
|---|---|---|---|---|---|---|---|---|---|
| 15 | <i>Eucalyptus fasciculosa</i> | 1 | 14.0 | 0 | 45 | 20 | 2.01 | Medium tree in fair condition providing habitat for a number of threatened species | 9 |

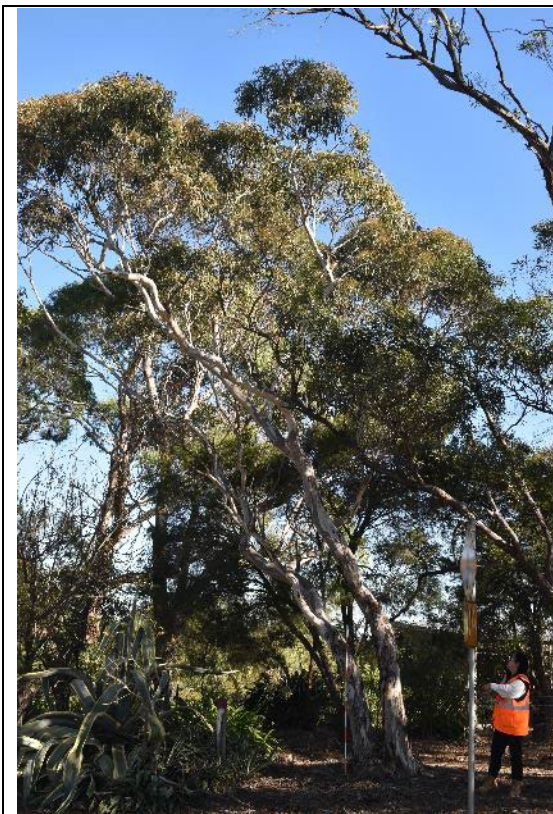
Photo 11 Tree 20

| Tree # | Tree spp. | No. of trees | Height (m) | Hollows | Diameter (cm) | Canopy dieback (%) | Biodiversity Score | General comments | Photo # |
|---|---|---|---|---|---|---|---|---|---|
| 20 | <i>Eucalyptus fasciculosa</i> | 1 | 12.0 | 0 | 40 | 20 | 1.28 | Medium tree in fair condition providing habitat for a number of threatened species | 11 |

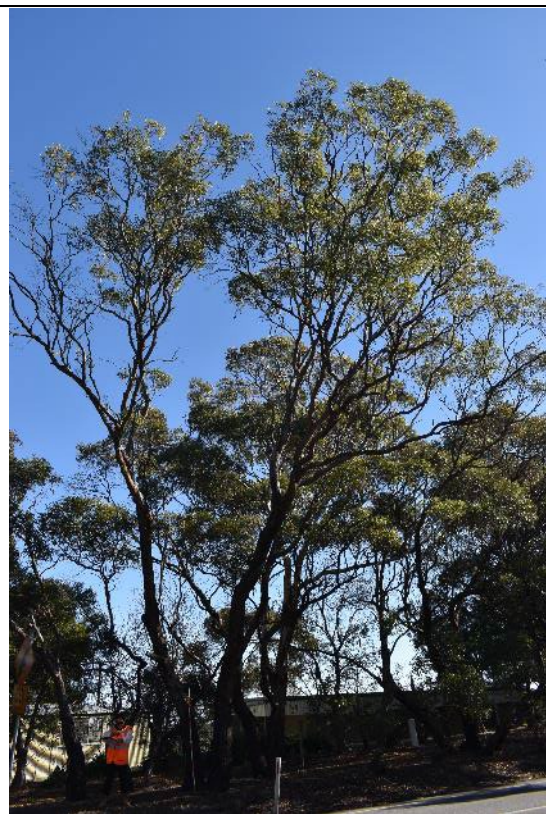
Photo 12 Tree 23

| Tree # | Tree spp. | No. of trees | Height (m) | Hollows | Diameter (cm) | Canopy dieback (%) | Biodiversity Score | General comments | Photo # |
|---|---|---|---|---|---|---|---|---|---|
| 23 | <i>Eucalyptus porosa</i> | 1 | 16.0 | 1s | 45 | 40 | 3.67 | Large tree in poor condition providing habitat for a number of threatened species | 12 |

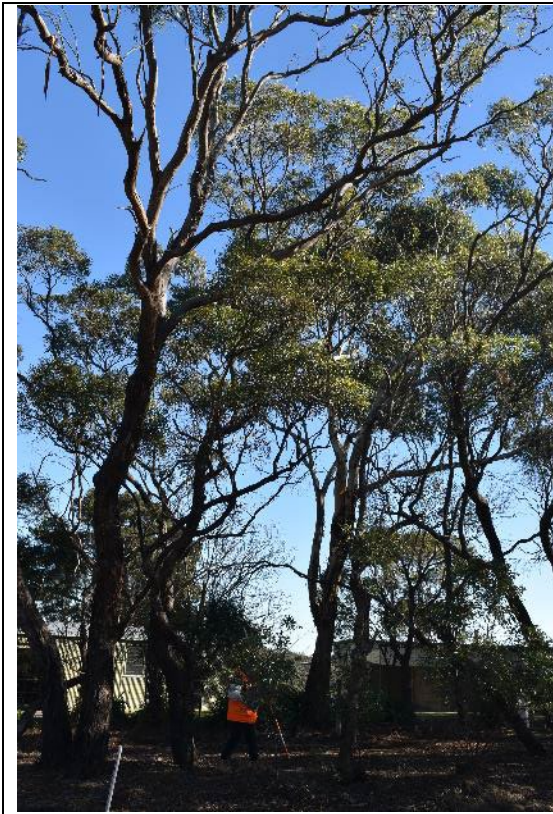
Photo 13 Tree 24

| Tree # | Tree spp. | No. of trees | Height (m) | Hollows | Diameter (cm) | Canopy dieback (%) | Biodiversity Score | General comments | Photo # |
|---|---|---|---|---|---|---|---|---|---|
| 24 | <i>Eucalyptus porosa</i> | 1 | 10.0 | 0 | 40 | 30 | 3.28 | Medium tree in fair condition providing habitat for a number of threatened species | 13 |

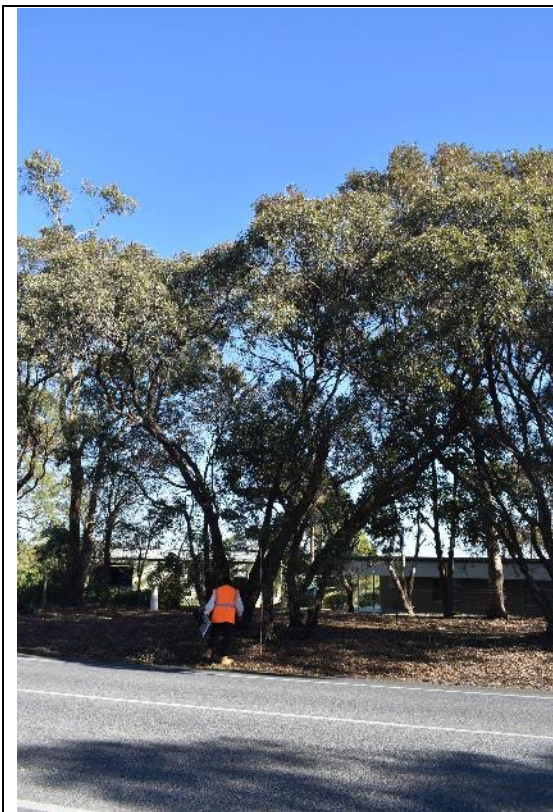
Photo 15 Tree 27

| Tree # | Tree spp. | No. of trees | Height (m) | Hollows | Diameter (cm) | Canopy dieback (%) | Biodiversity Score | General comments | Photo # |
|---|---|---|---|---|---|---|---|---|---|
| 27 | <i>Eucalyptus porosa</i> | 4 | 10.0 | 1m | 25 | 10 | 13.13 | Medium tree in good condition providing habitat for a number of threatened species | 15 |

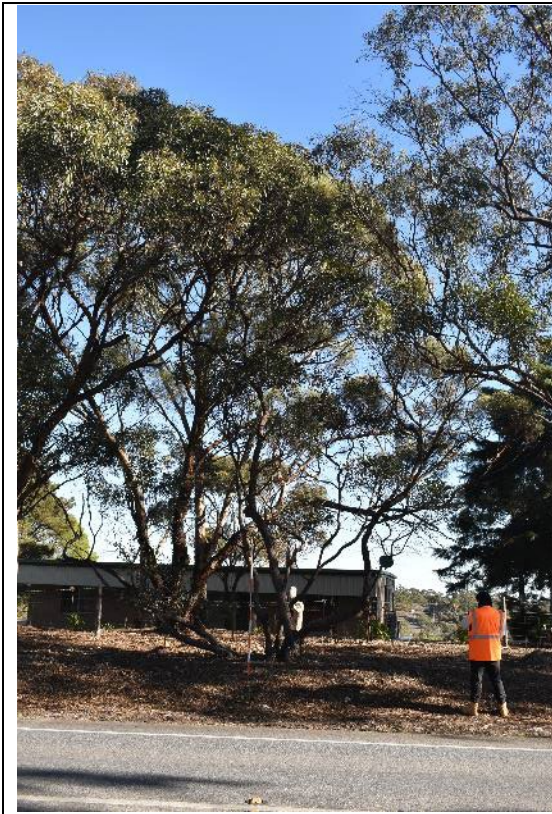
Photo 17 Tree 29

| Tree # | Tree spp. | No. of trees | Height (m) | Hollows | Diameter (cm) | Canopy dieback (%) | Biodiversity Score | General comments | Photo # |
|---|---|---|---|---|---|---|---|---|---|
| 29 | <i>Eucalyptus porosa</i> | 1 | 9.0 | 0 | 15 | 30 | 1.19 | Small tree in fair condition providing habitat for a number of threatened species | 17 |

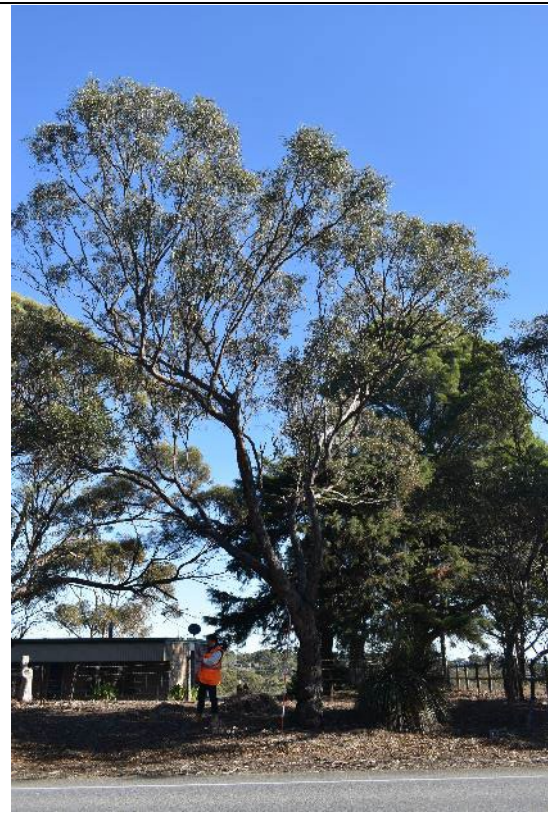
Photo 18 Tree 30

| Tree # | Tree spp. | No. of trees | Height (m) | Hollows | Diameter (cm) | Canopy dieback (%) | Biodiversity Score | General comments | Photo # |
|---|---|---|---|---|---|---|---|---|---|
| 30 | <i>Eucalyptus porosa</i> | 1 | 14.0 | 1s | 50 | 20 | 4.35 | Medium tree in fair condition providing habitat for a number of threatened species | 18 |

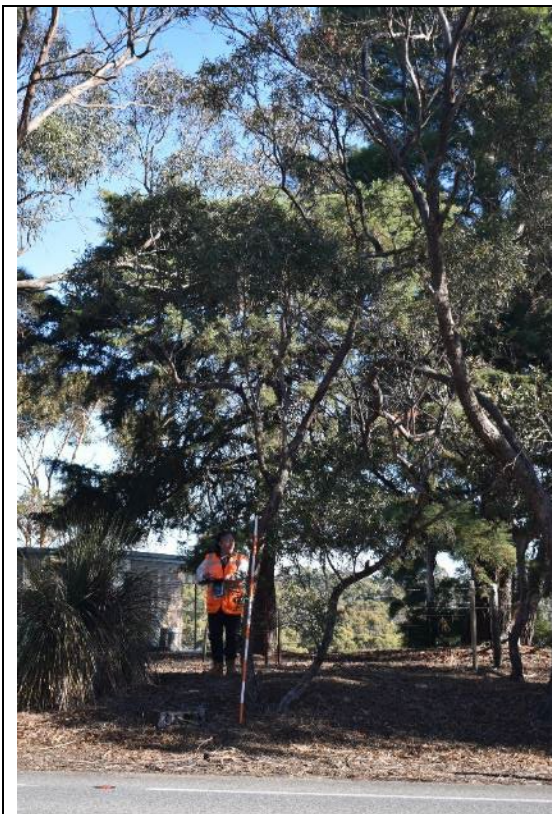
Photo 19 Tree 31

| Tree # | Tree spp. | No. of trees | Height (m) | Hollows | Diameter (cm) | Canopy dieback (%) | Biodiversity Score | General comments | Photo # |
|---|---|---|---|---|---|---|---|---|---|
| 31 | <i>Eucalyptus microcarpa</i> | 1 | 5.0 | 0 | 20 | 40 | 0.25 | Small tree in poor condition providing habitat for a number of threatened species | 19 |

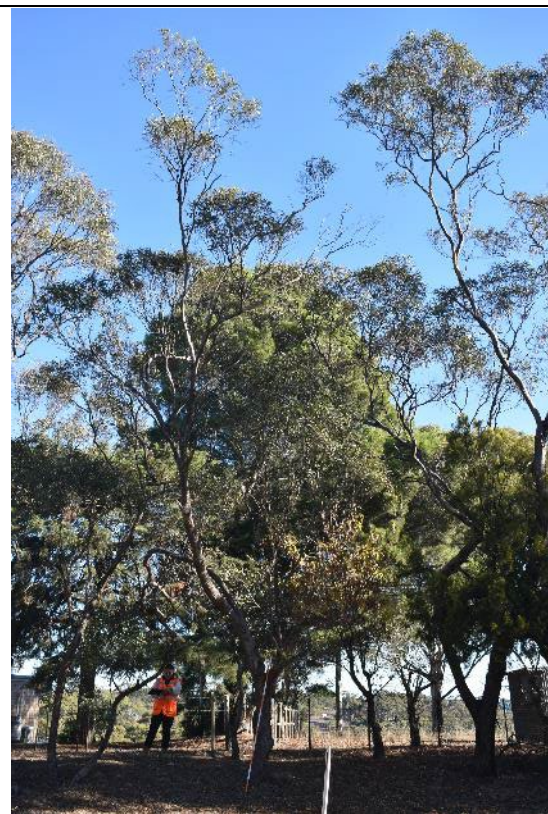
Photo 20 Tree 33

| Tree # | Tree spp. | No. of trees | Height (m) | Hollows | Diameter (cm) | Canopy dieback (%) | Biodiversity Score | General comments | Photo # |
|---|---|---|---|---|---|---|---|---|---|
| 33 | <i>Eucalyptus microcarpa</i> | 1 | 13.0 | 0 | 30 | 30 | 1.05 | Medium tree in fair condition providing habitat for a number of threatened species | 20 |

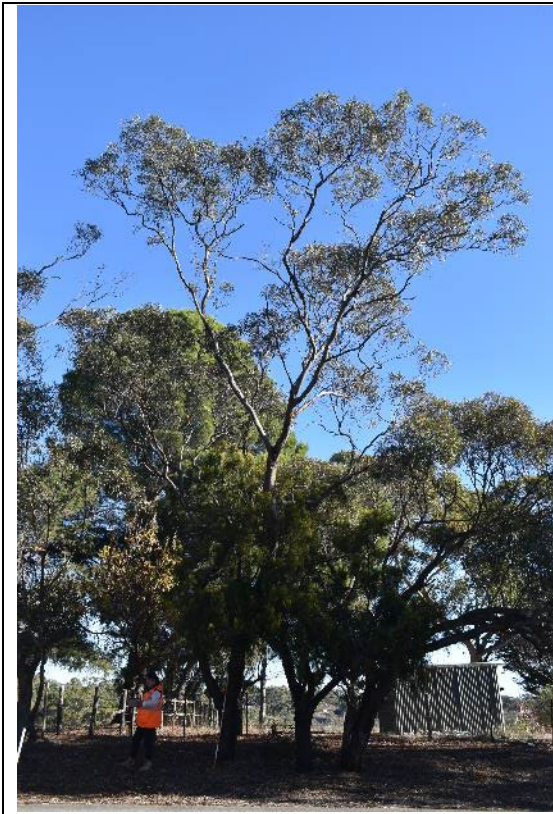
Photo 21 Tree 34

| Tree # | Tree spp. | No. of trees | Height (m) | Hollows | Diameter (cm) | Canopy dieback (%) | Biodiversity Score | General comments | Photo # |
|---|---|---|---|---|---|---|---|---|---|
| 34 | <i>Eucalyptus porosa</i> | 1 | 16.0 | 0 | 40 | 20 | 3.51 | Large tree in fair condition providing habitat for a number of threatened species | 21 |

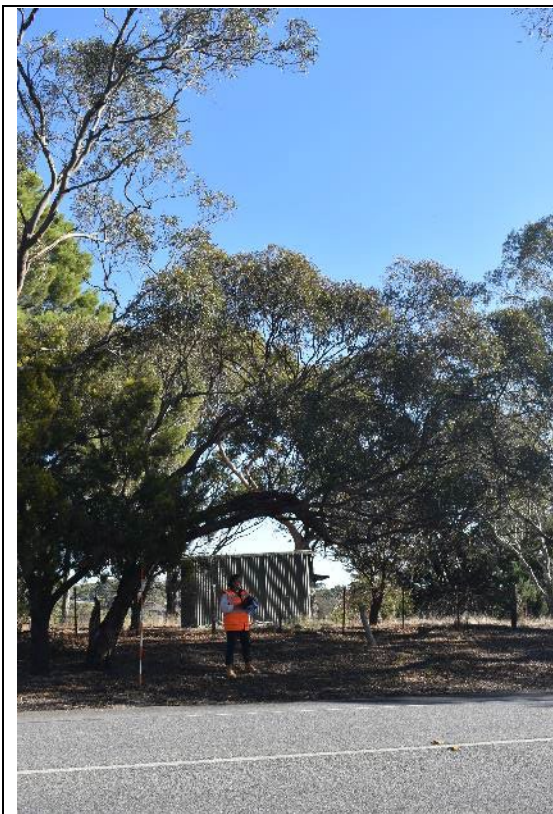
Photo 23 Tree 36

| Tree # | Tree spp. | No. of trees | Height (m) | Hollows | Diameter (cm) | Canopy dieback (%) | Biodiversity Score | General comments | Photo # |
|---|---|---|---|---|---|---|---|---|---|
| 36 | <i>Eucalyptus porosa</i> | 1 | 7.0 | 1s | 50 | 10 | 3.64 | Small tree in good condition providing habitat for a number of threatened species | 23 |

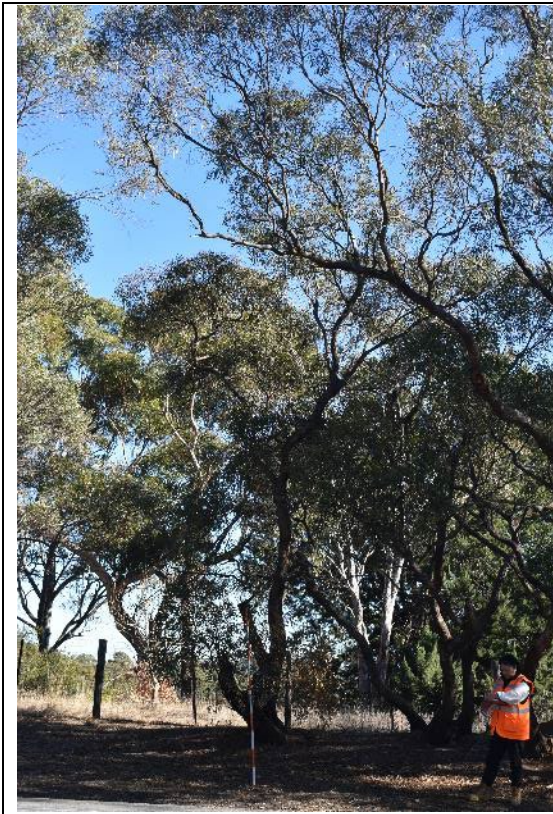
Photo 25 Tree 38

| Tree # | Tree spp. | No. of trees | Height (m) | Hollows | Diameter (cm) | Canopy dieback (%) | Biodiversity Score | General comments | Photo # |
|---|---|---|---|---|---|---|---|---|---|
| 38 | <i>Eucalyptus microcarpa</i> | 1 | 10.0 | 0 | 40 | 20 | 1.15 | Medium tree in fair condition providing habitat for a number of threatened species | 25 |

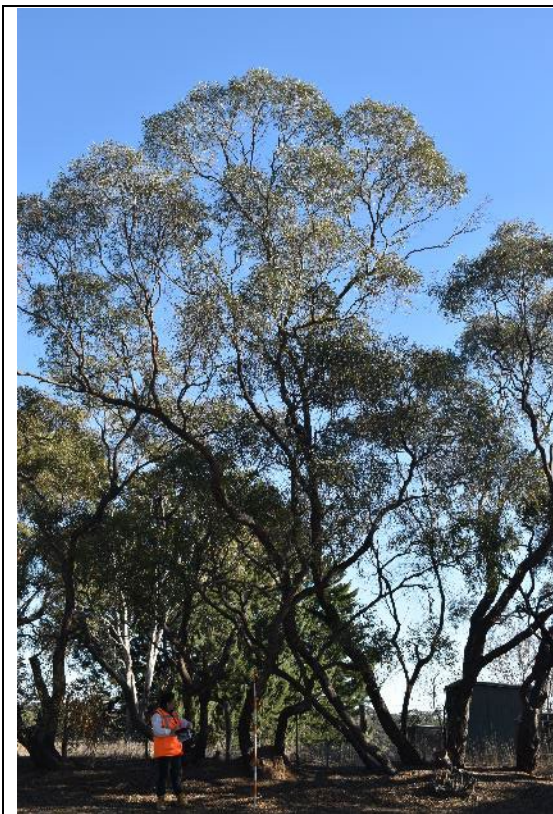
Photo 27 Tree 40

| Tree # | Tree spp. | No. of trees | Height (m) | Hollows | Diameter (cm) | Canopy dieback (%) | Biodiversity Score | General comments | Photo # |
|---|---|---|---|---|---|---|---|---|---|
| 40 | <i>Eucalyptus microcarpa</i> | 1 | 12.0 | 0 | 20 | 15 | 0.59 | Medium tree in good condition providing habitat for a number of threatened species | 27 |

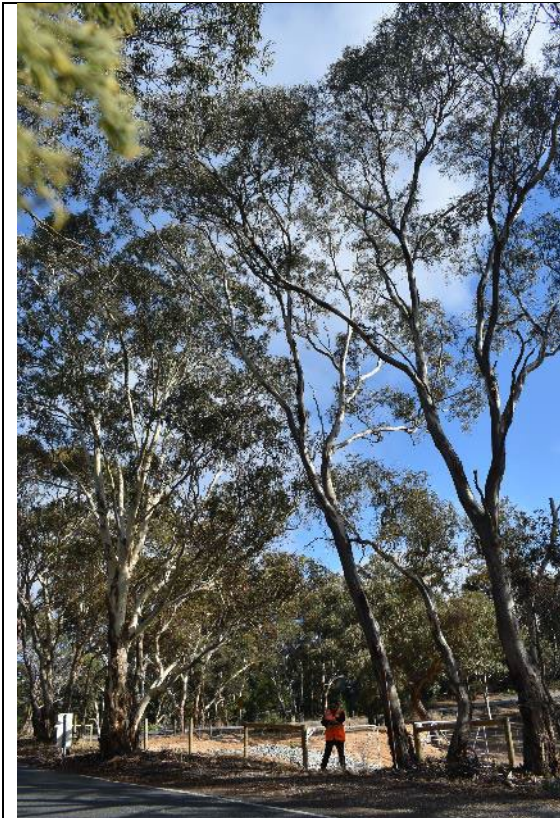
Photo 29 Tree 56

| Tree # | Tree spp. | No. of trees | Height (m) | Hollows | Diameter (cm) | Canopy dieback (%) | Biodiversity Score | General comments | Photo # |
|---|---|---|---|---|---|---|---|---|---|
| 56 | <i>Eucalyptus leucoxylon ssp leucoxylon</i> | 1 | 16.0 | 0 | 45 | 20 | 2.11 | Large tree in good condition providing habitat for a number of threatened species | 29 |

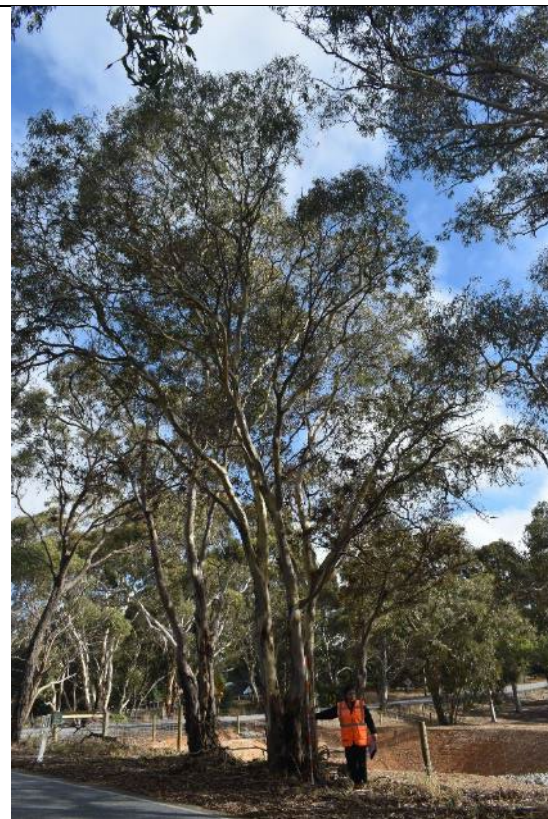
Photo 32 Tree 60

| Tree # | Tree spp. | No. of trees | Height (m) | Hollows | Diameter (cm) | Canopy dieback (%) | Biodiversity Score | General comments | Photo # |
|---|---|---|---|---|---|---|---|---|---|
| 60 | <i>Eucalyptus leucoxylon ssp leucoxylon</i> | 1 | 14.0 | 0 | 40 | 20 | 1.27 | Medium tree in good condition providing habitat for a number of threatened species | 32 |

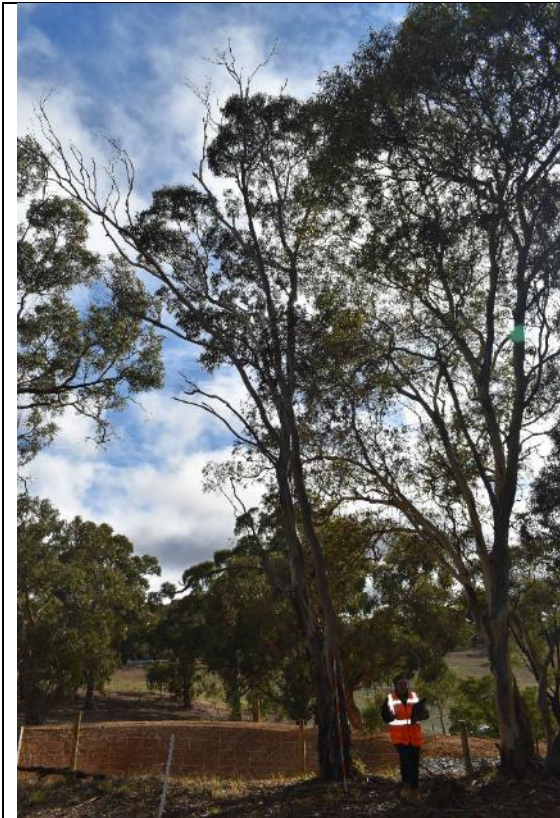
Photo 33 Tree 61

| Tree # | Tree spp. | No. of trees | Height (m) | Hollows | Diameter (cm) | Canopy dieback (%) | Biodiversity Score | General comments | Photo # |
|---|---|---|---|---|---|---|---|---|---|
| 61 | <i>Eucalyptus leucoxylon ssp leucoxylon</i> | 1 | 17.0 | 0 | 40 | 50 | 1.18 | Large tree in poor condition providing habitat for a number of threatened species | 33 |

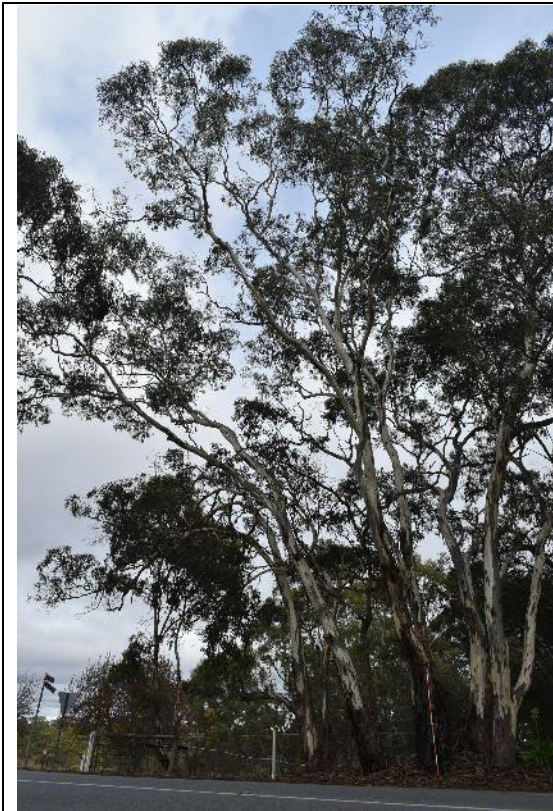
Photo 35 Tree 67

| Tree # | Tree spp. | No. of trees | Height (m) | Hollows | Diameter (cm) | Canopy dieback (%) | Biodiversity Score | General comments | Photo # |
|---|---|---|---|---|---|---|---|---|---|
| 67 | <i>Eucalyptus leucoxylon ssp leucoxylon</i> | 2 | 20.0 | 1s | 70 | 20 | 8.65 | Large tree in good condition providing habitat for a number of threatened species | 35 |

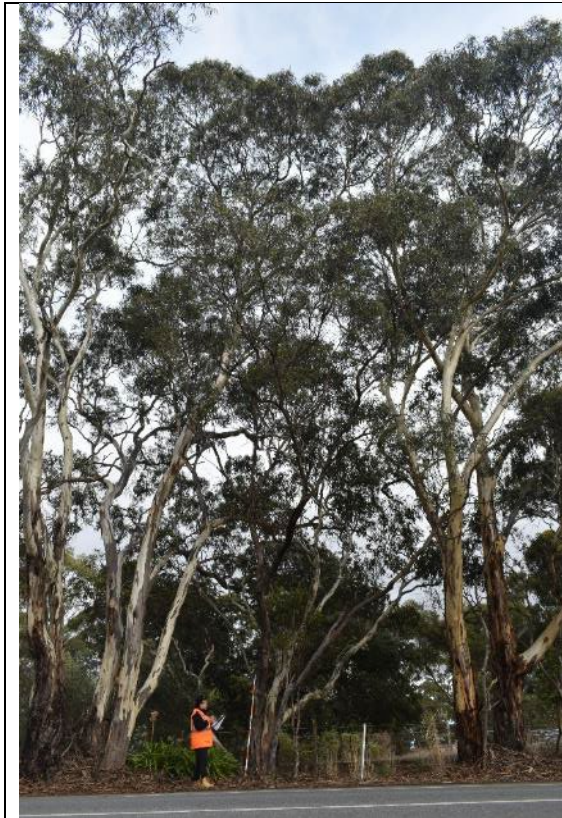
Photo 37 Tree 69

| Tree # | Tree spp. | No. of trees | Height (m) | Hollows | Diameter (cm) | Canopy dieback (%) | Biodiversity Score | General comments | Photo # |
|---|---|---|---|---|---|---|---|---|---|
| 69 | <i>Eucalyptus microcarpa</i> | 1 | 14.0 | 0 | 30 | 30 | 1.13 | Medium tree in fair condition providing habitat for a number of threatened species | 37 |
