# Native Vegetation Clearance

## Piggott Range Road Upgrade

### Data Report

Clearance under the *Native Vegetation Regulations 2017*

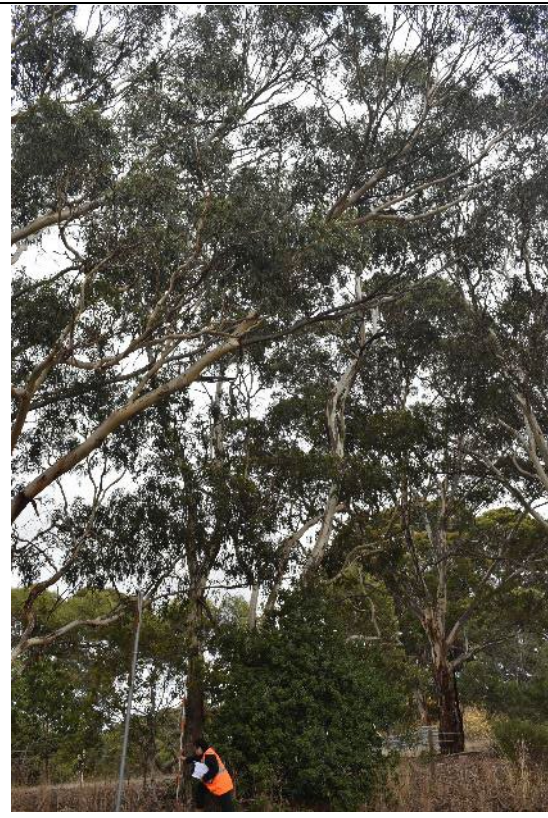
Photo 38 Tree 73

| Tree # | Tree spp. | No. of trees | Height (m) | Hollows | Diameter (cm) | Canopy dieback (%) | Biodiversity Score | General comments | Photo # |
|---|---|---|---|---|---|---|---|---|---|
| 73 | <i>Eucalyptus leucoxylon ssp leucoxylon</i> | 1 | 16.0 | 0 | 50 | 10 | 2.25 | Large tree in good condition providing habitat for a number of threatened species | 38 |

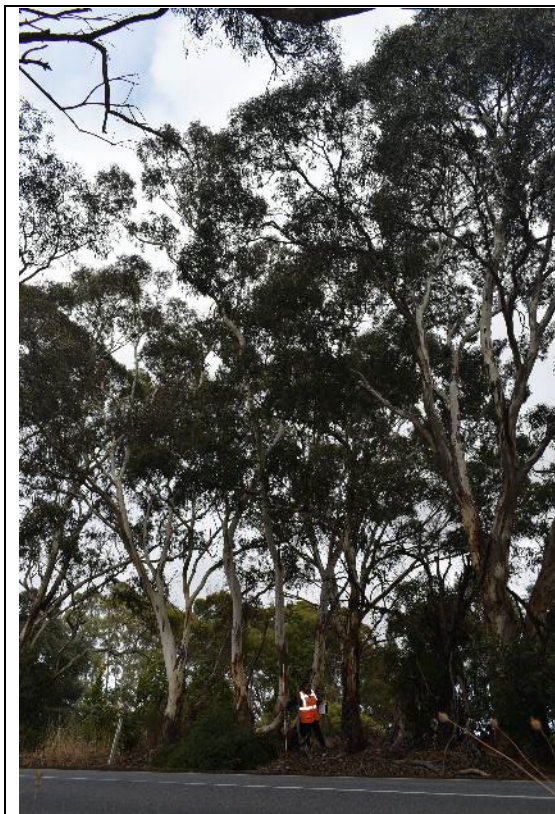
Photo 39 Tree 75

| Tree # | Tree spp. | No. of trees | Height (m) | Hollows | Diameter (cm) | Canopy dieback (%) | Biodiversity Score | General comments | Photo # |
|---|---|---|---|---|---|---|---|---|---|
| 75 | <i>Eucalyptus leucoxylon ssp leucoxylon</i> | 1 | 18.0 | 0 | 40 | 10 | 2.26 | Large tree in good condition providing habitat for a number of threatened species | 39 |

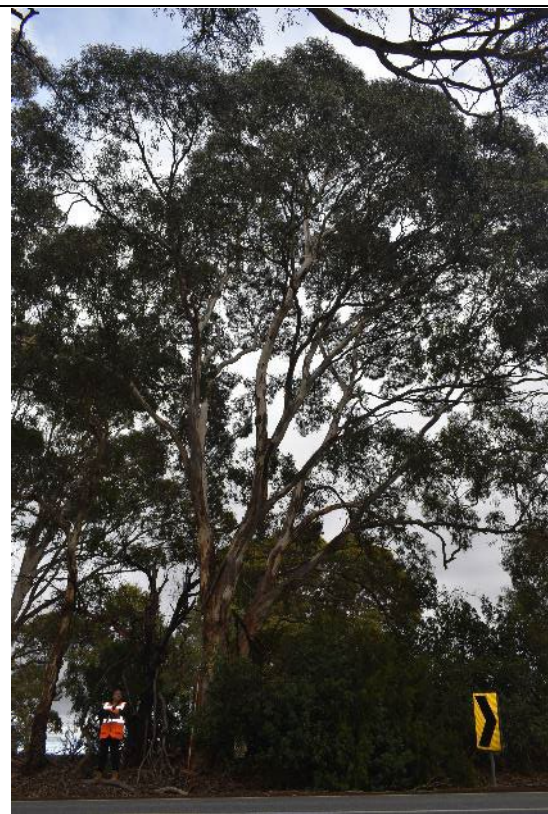
Photo 40 Tree 78

| Tree # | Tree spp. | No. of trees | Height (m) | Hollows | Diameter (cm) | Canopy dieback (%) | Biodiversity Score | General comments | Photo # |
|---|---|---|---|---|---|---|---|---|---|
| 78 | <i>Eucalyptus leucoxylon ssp leucoxylon</i> | 1 | 18.0 | 1s | 120 | 5 | 6.64 | Large tree in good condition providing habitat for a number of threatened species | 40 |

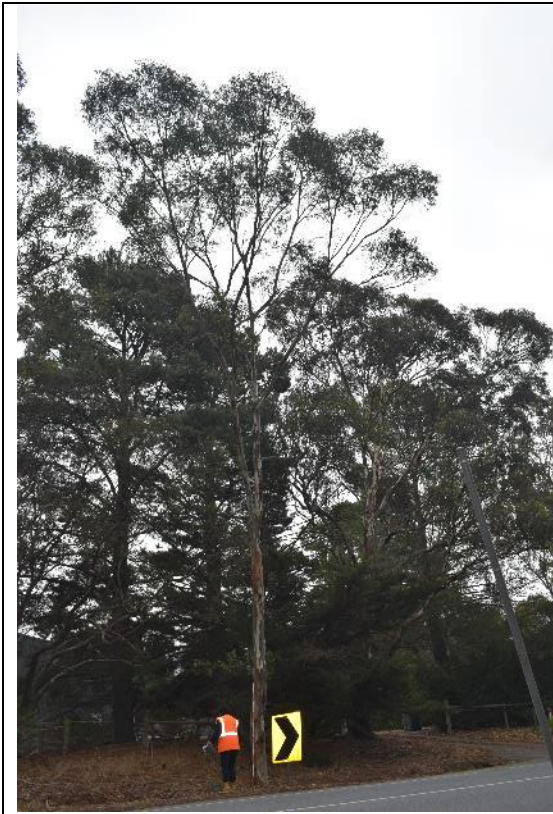
Photo 41 Tree 85

| Tree # | Tree spp. | No. of trees | Height (m) | Hollows | Diameter (cm) | Canopy dieback (%) | Biodiversity Score | General comments | Photo # |
|---|---|---|---|---|---|---|---|---|---|
| 85 | <i>Eucalyptus leucoxylon ssp leucoxylon</i> | 1 | 16.0 | 0 | 30 | 30 | 1.06 | Large tree in fair condition providing habitat for a number of threatened species | 41 |

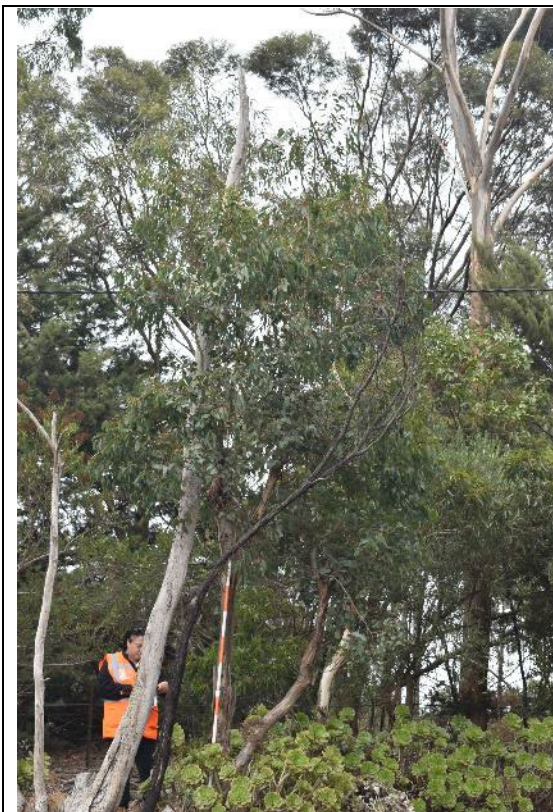
Photo 43 Tree 93

| Tree # | Tree spp. | No. of trees | Height (m) | Hollows | Diameter (cm) | Canopy dieback (%) | Biodiversity Score | General comments | Photo # |
|---|---|---|---|---|---|---|---|---|---|
| 93 | <i>Eucalyptus leucoxylon ssp leucoxylon</i> | 1 | 14.0 | 0 | 40 | 10 | 1.38 | Medium tree in good condition providing habitat for a number of threatened species | 43 |

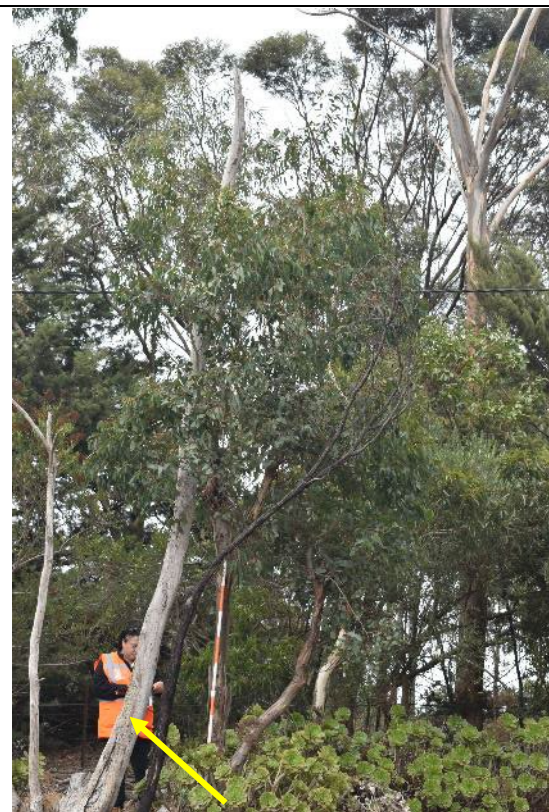
Photo 44 Tree 95

| Tree # | Tree spp. | No. of trees | Height (m) | Hollows | Diameter (cm) | Canopy dieback (%) | Biodiversity Score | General comments | Photo # |
|---|---|---|---|---|---|---|---|---|---|
| 95 | <i>Eucalyptus leucoxylon ssp leucoxylon</i> | 1 | 5.0 | 0 | 20 | 20 | 0.28 | Small tree in good condition providing habitat for a number of threatened species | 44 |

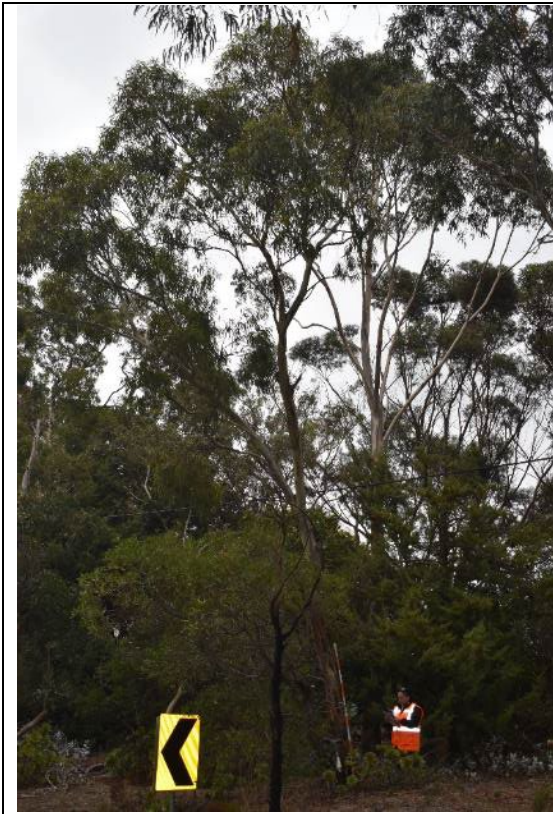
Photo 45 Tree 97

| Tree # | Tree spp. | No. of trees | Height (m) | Hollows | Diameter (cm) | Canopy dieback (%) | Biodiversity Score | General comments | Photo # |
|---|---|---|---|---|---|---|---|---|---|
| 97 | <i>Eucalyptus leucoxylon ssp leucoxylon</i> | 1 | 10.0 | 0 | 30 | 10 | 0.58 | Medium tree in good condition providing habitat for a number of threatened species | 45 |

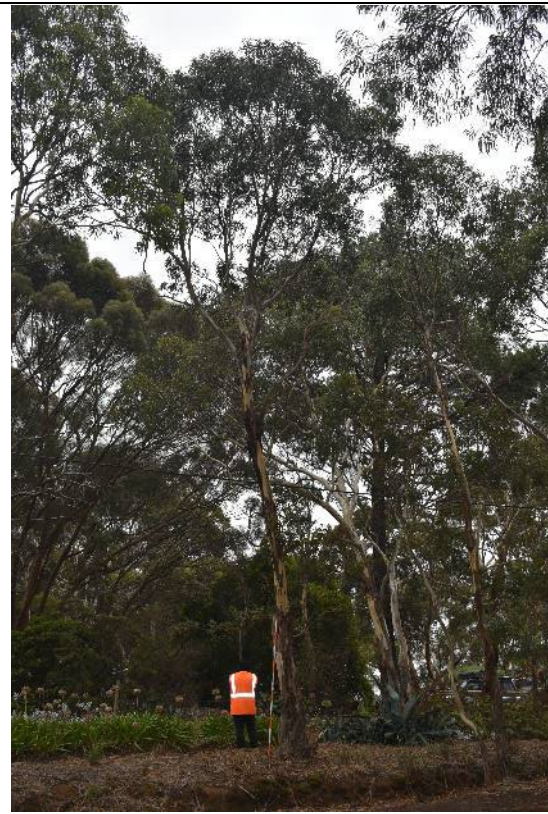
Photo 46 Tree 98

| Tree # | Tree spp. | No. of trees | Height (m) | Hollows | Diameter (cm) | Canopy dieback (%) | Biodiversity Score | General comments | Photo # |
|---|---|---|---|---|---|---|---|---|---|
| 98 | <i>Eucalyptus leucoxylon ssp leucoxylon</i> | 1 | 12.0 | 0 | 30 | 5 | 1.03 | Medium tree in good condition providing habitat for a number of threatened species | 46 |

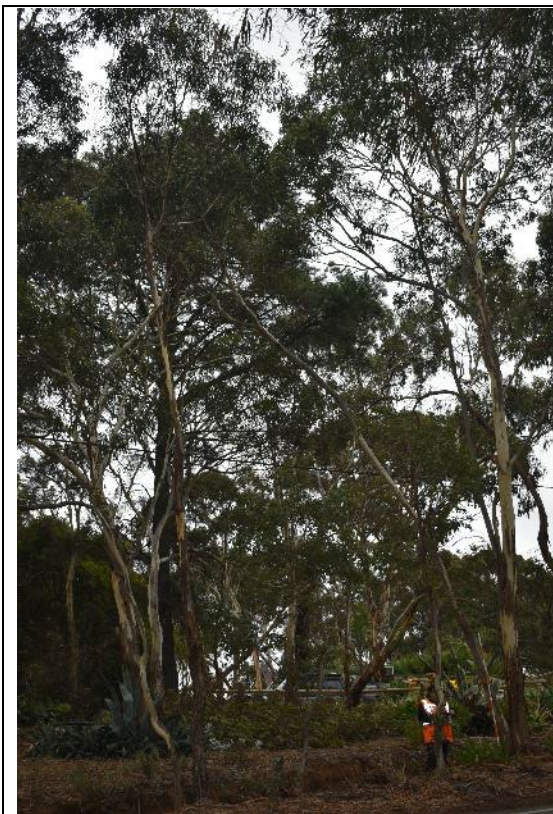
Photo 47 Tree 99

| Tree # | Tree spp. | No. of trees | Height (m) | Hollows | Diameter (cm) | Canopy dieback (%) | Biodiversity Score | General comments | Photo # |
|---|---|---|---|---|---|---|---|---|---|
| 99 | <i>Eucalyptus leucoxylon ssp leucoxylon</i> | 4 | 11.0 | 1m | 20 | 20 | 2.14 | Medium tree in good condition providing habitat for a number of threatened species | 47 |

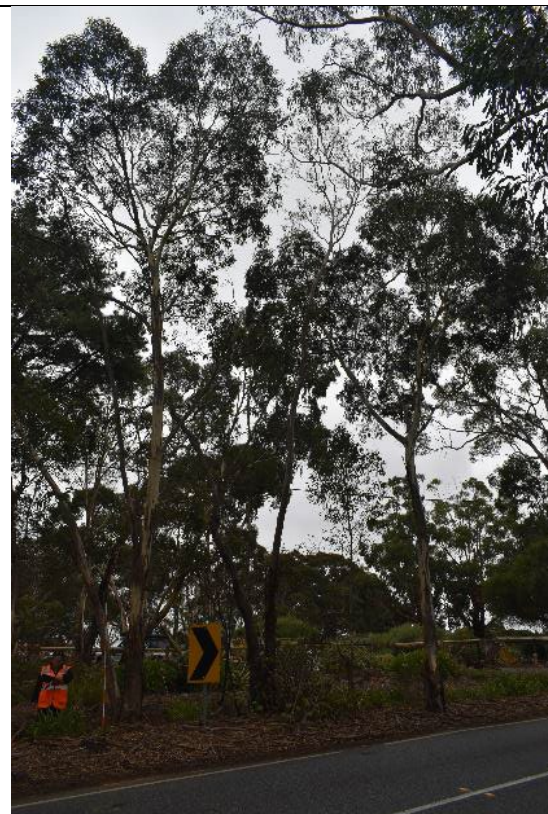
Photo 48 Tree 100

| Tree # | Tree spp. | No. of trees | Height (m) | Hollows | Diameter (cm) | Canopy dieback (%) | Biodiversity Score | General comments | Photo # |
|---|---|---|---|---|---|---|---|---|---|
| 100 | <i>Eucalyptus leucoxylon ssp leucoxylon</i> | 4 | 14.0 | 0 | 20 | 20 | 2.15 | Medium tree in good condition providing habitat for a number of threatened species | 48 |

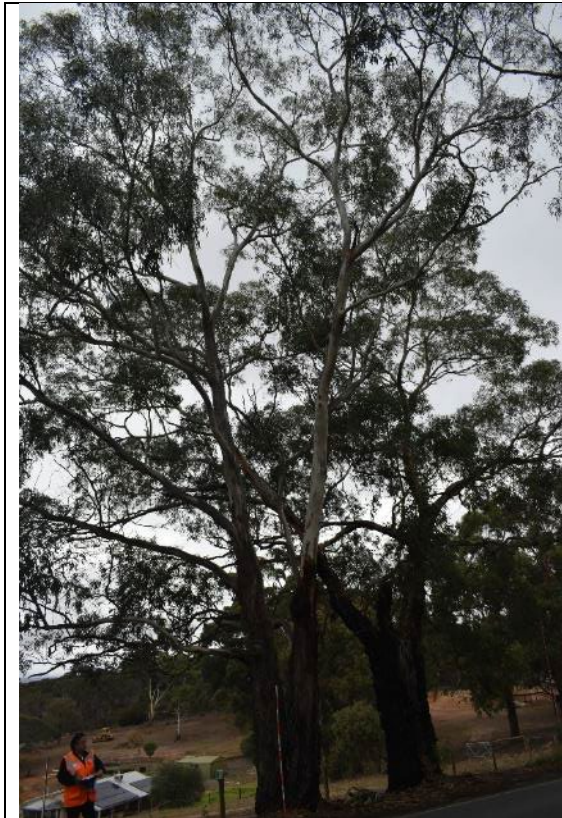
Photo 49 Tree 104

| Tree # | Tree spp. | No. of trees | Height (m) | Hollows | Diameter (cm) | Canopy dieback (%) | Biodiversity Score | General comments | Photo # |
|---|---|---|---|---|---|---|---|---|---|
| 104 | <i>Eucalyptus viminalis ssp cygnetensis</i> | 1 | 16.0 | 0 | 80 | 25 | 3.94 | Large tree in good condition providing habitat for a number of threatened species | 49 |

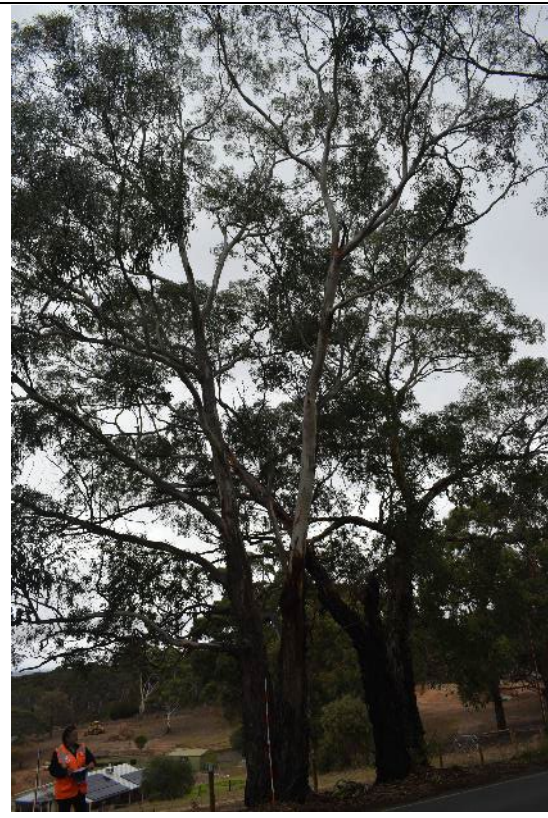
Photo 50 Tree 106

| Tree # | Tree spp. | No. of trees | Height (m) | Hollows | Diameter (cm) | Canopy dieback (%) | Biodiversity Score | General comments | Photo # |
|---|---|---|---|---|---|---|---|---|---|
| 106 | <i>Eucalyptus viminalis ssp cygnetensis</i> | 1 | 17.0 | 0 | 130 | 20 | 6.31 | Large tree in good condition providing habitat for a number of threatened species | 50 |

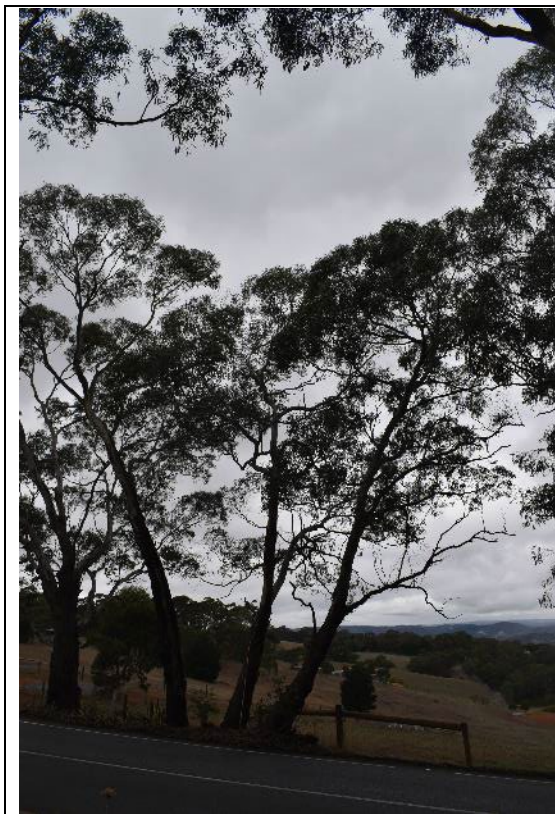
Photo 51 Tree 107

| Tree # | Tree spp. | No. of trees | Height (m) | Hollows | Diameter (cm) | Canopy dieback (%) | Biodiversity Score | General comments | Photo # |
|---|---|---|---|---|---|---|---|---|---|
| 107 | <i>Eucalyptus viminalis ssp cygnetensis</i> | 3 | 17.0 | 0 | 60 | 15 | 11.22 | Large tree in good condition providing habitat for a number of threatened species | 51 |

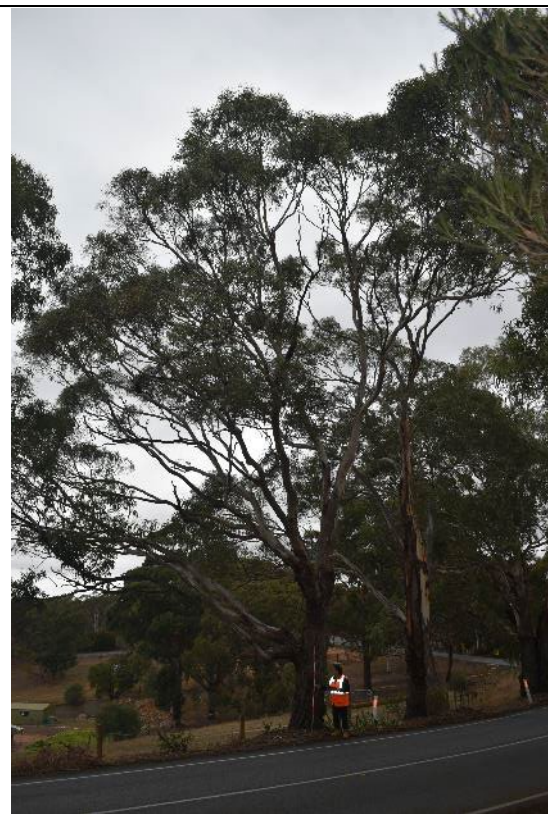
Photo 52 Tree 108

| Tree # | Tree spp. | No. of trees | Height (m) | Hollows | Diameter (cm) | Canopy dieback (%) | Biodiversity Score | General comments | Photo # |
|---|---|---|---|---|---|---|---|---|---|
| 108 | <i>Eucalyptus viminalis ssp cygnetensis</i> | 1 | 17.0 | 0 | 90 | 10 | 4.76 | Large tree in good condition providing habitat for a number of threatened species | 52 |

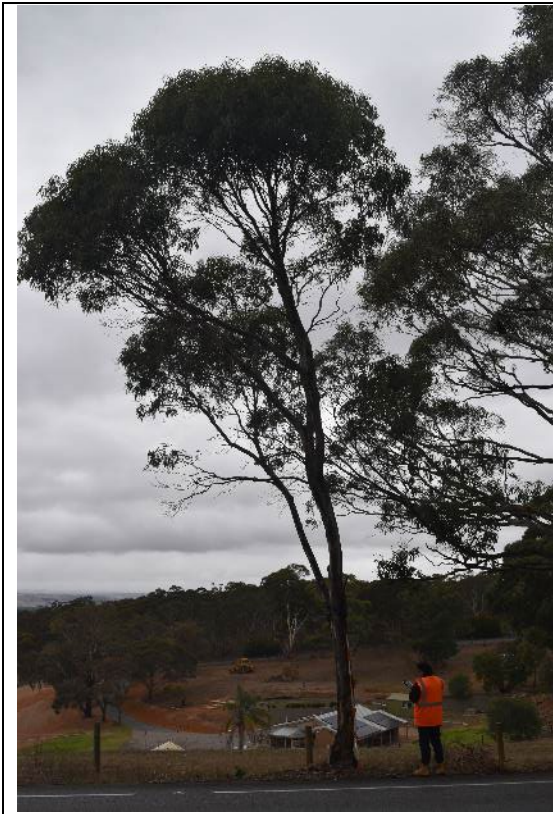
Photo 53 Tree 109

| Tree # | Tree spp. | No. of trees | Height (m) | Hollows | Diameter (cm) | Canopy dieback (%) | Biodiversity Score | General comments | Photo # |
|---|---|---|---|---|---|---|---|---|---|
| 109 | <i>Eucalyptus leucoxylon ssp leucoxylon</i> | 1 | 10.0 | 0 | 30 | 20 | 0.53 | Medium tree in good condition providing habitat for a number of threatened species | 53 |

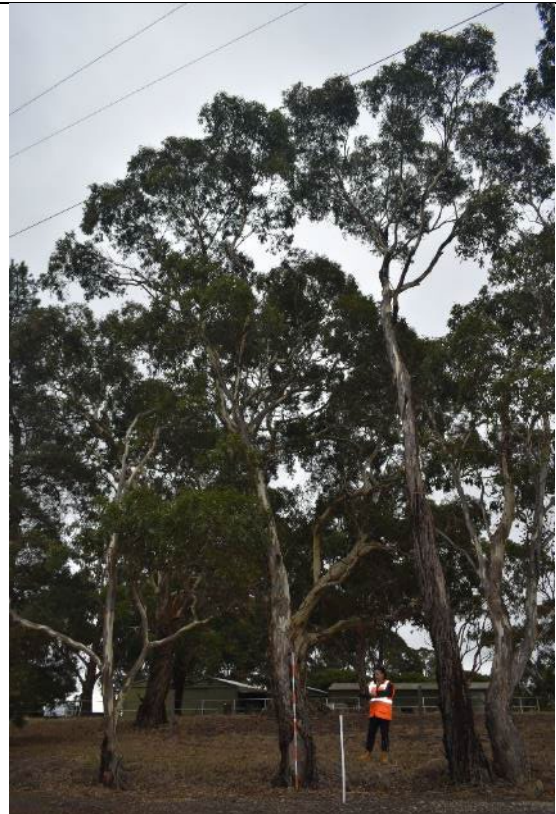
Photo 54 Tree 112

| Tree # | Tree spp. | No. of trees | Height (m) | Hollows | Diameter (cm) | Canopy dieback (%) | Biodiversity Score | General comments | Photo # |
|---|---|---|---|---|---|---|---|---|---|
| 112 | <i>Eucalyptus leucoxylon ssp leucoxylon</i> | 1 | 15.0 | 0 | 60 | 10 | 2.35 | Large tree in good condition providing habitat for a number of threatened species | 54 |

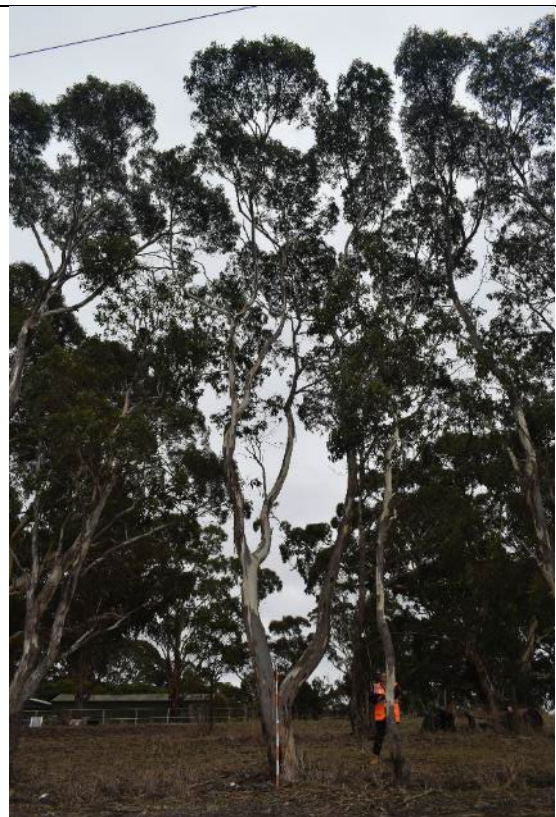
Photo 56 Tree 114

| Tree # | Tree spp. | No. of trees | Height (m) | Hollows | Diameter (cm) | Canopy dieback (%) | Biodiversity Score | General comments | Photo # |
|---|---|---|---|---|---|---|---|---|---|
| 114 | <i>Eucalyptus leucoxylon ssp leucoxylon</i> | 1 | 16.0 | 0 | 70 | 10 | 3.38 | Large tree in good condition providing habitat for a number of threatened species | 56 |

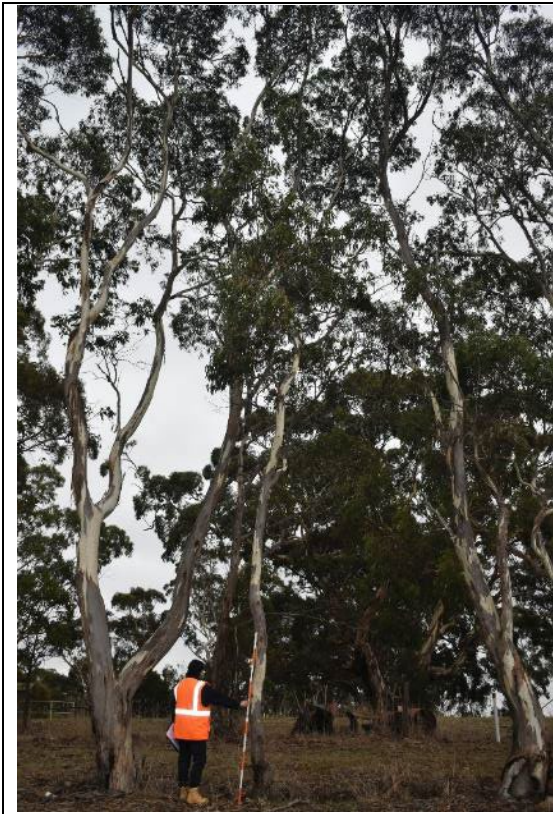
Photo 57 Tree 115

| Tree # | Tree spp. | No. of trees | Height (m) | Hollows | Diameter (cm) | Canopy dieback (%) | Biodiversity Score | General comments | Photo # |
|---|---|---|---|---|---|---|---|---|---|
| 115 | <i>Eucalyptus leucoxylon ssp leucoxylon</i> | 1 | 11.0 | 0 | 25 | 20 | 0.50 | Medium tree in good condition providing habitat for a number of threatened species | 57 |

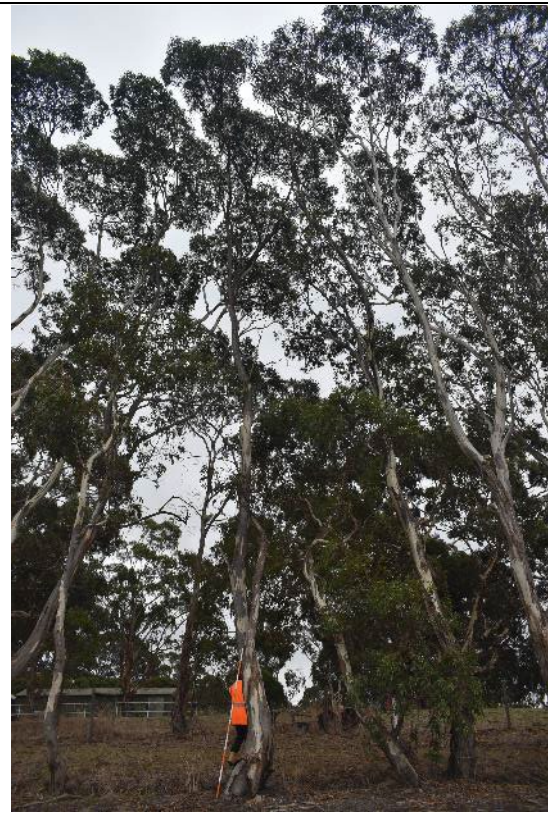
Photo 58 Tree 116

| Tree # | Tree spp. | No. of trees | Height (m) | Hollows | Diameter (cm) | Canopy dieback (%) | Biodiversity Score | General comments | Photo # |
|---|---|---|---|---|---|---|---|---|---|
| 116 | <i>Eucalyptus leucoxylon ssp leucoxylon</i> | 1 | 16.0 | 0 | 30 | 20 | 1.15 | Large tree in good condition providing habitat for a number of threatened species | 58 |

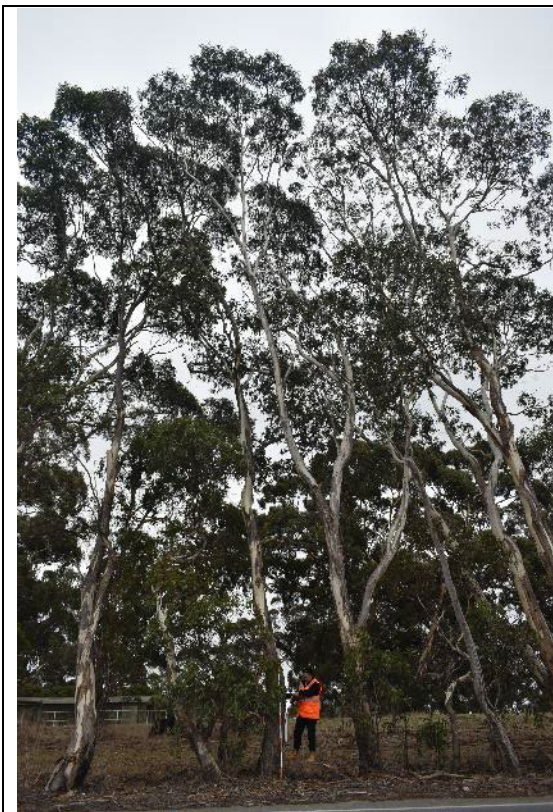
Photo 59 Tree 118

| Tree # | Tree spp. | No. of trees | Height (m) | Hollows | Diameter (cm) | Canopy dieback (%) | Biodiversity Score | General comments | Photo # |
|---|---|---|---|---|---|---|---|---|---|
| 118 | <i>Eucalyptus leucoxylon ssp leucoxylon</i> | 1 | 16.0 | 0 | 30 | 30 | 1.06 | Large tree in fair condition providing habitat for a number of threatened species | 59 |

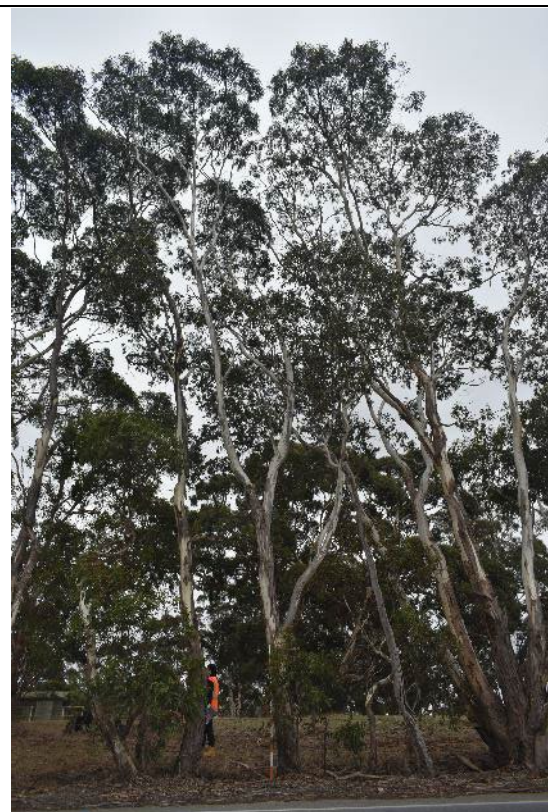
Photo 60 Tree 119

| Tree # | Tree spp. | No. of trees | Height (m) | Hollows | Diameter (cm) | Canopy dieback (%) | Biodiversity Score | General comments | Photo # |
|---|---|---|---|---|---|---|---|---|---|
| 119 | <i>Eucalyptus leucoxylon ssp leucoxylon</i> | 1 | 16.0 | 0 | 40 | 10 | 2.04 | Large tree in good condition providing habitat for a number of threatened species | 60 |

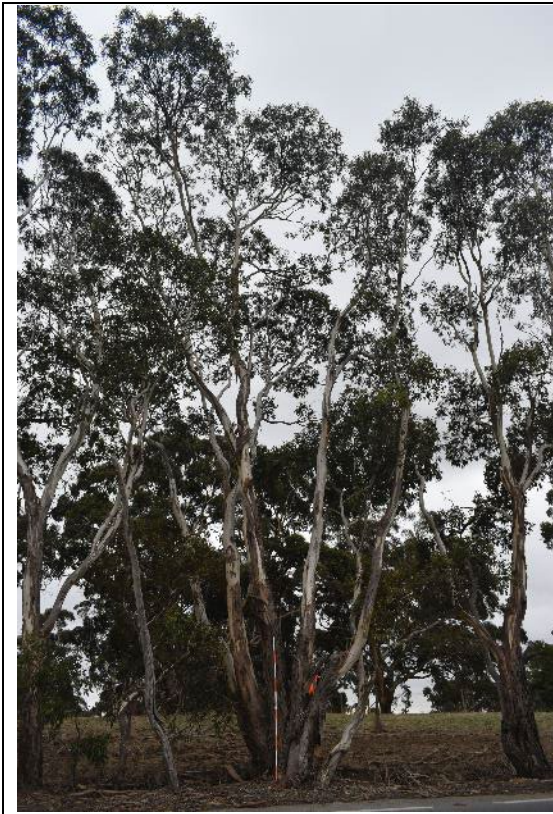
Photo 61 Tree 121

| Tree # | Tree spp. | No. of trees | Height (m) | Hollows | Diameter (cm) | Canopy dieback (%) | Biodiversity Score | General comments | Photo # |
|---|---|---|---|---|---|---|---|---|---|
| 121 | <i>Eucalyptus leucoxylon ssp leucoxylon</i> | 1 | 16.0 | 0 | 40 | 10 | 2.04 | Large tree in good condition providing habitat for a number of threatened species | 61 |

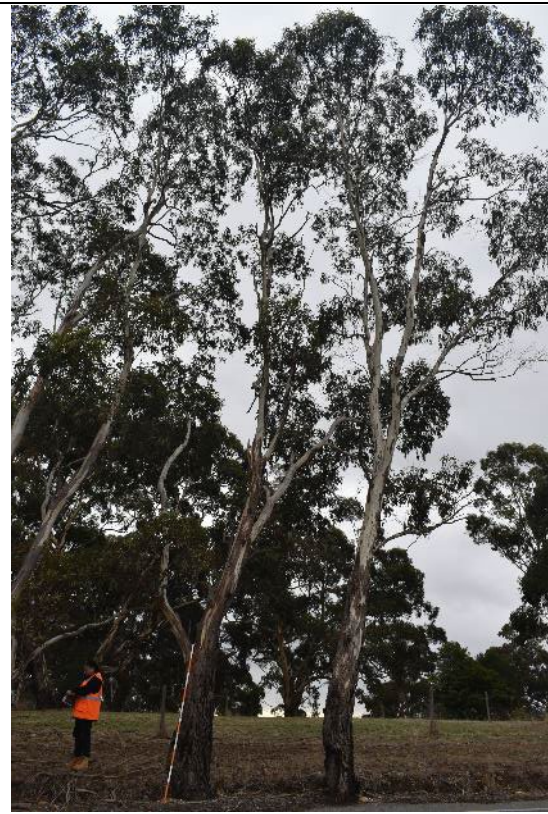
Photo 62 Tree 122

| Tree # | Tree spp. | No. of trees | Height (m) | Hollows | Diameter (cm) | Canopy dieback (%) | Biodiversity Score | General comments | Photo # |
|---|---|---|---|---|---|---|---|---|---|
| 122 | <i>Eucalyptus leucoxylon ssp leucoxylon</i> | 1 | 16.0 | 0 | 40 | 30 | 1.31 | Large tree in fair condition providing habitat for a number of threatened species | 62 |

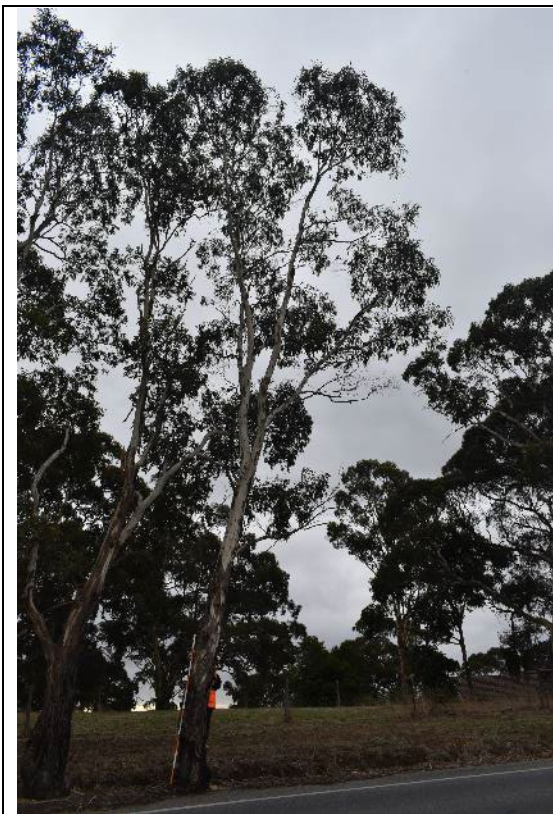
Photo 63 Tree 123

| Tree # | Tree spp. | No. of trees | Height (m) | Hollows | Diameter (cm) | Canopy dieback (%) | Biodiversity Score | General comments | Photo # |
|---|---|---|---|---|---|---|---|---|---|
| 123 | <i>Eucalyptus leucoxylon ssp leucoxylon</i> | 1 | 16.0 | 0 | 40 | 20 | 1.42 | Large tree in good condition providing habitat for a number of threatened species | 63 |
