# Restoration Feasibility Assessment of Lake Hawdon North

Report to the South Australian Government Department for Environment and Water

Taylor, B., (2020). *Restoration Feasibility Assessment of Lake Hawdon North*. Nature Glenelg Trust, Mount Gambier, South Australia.

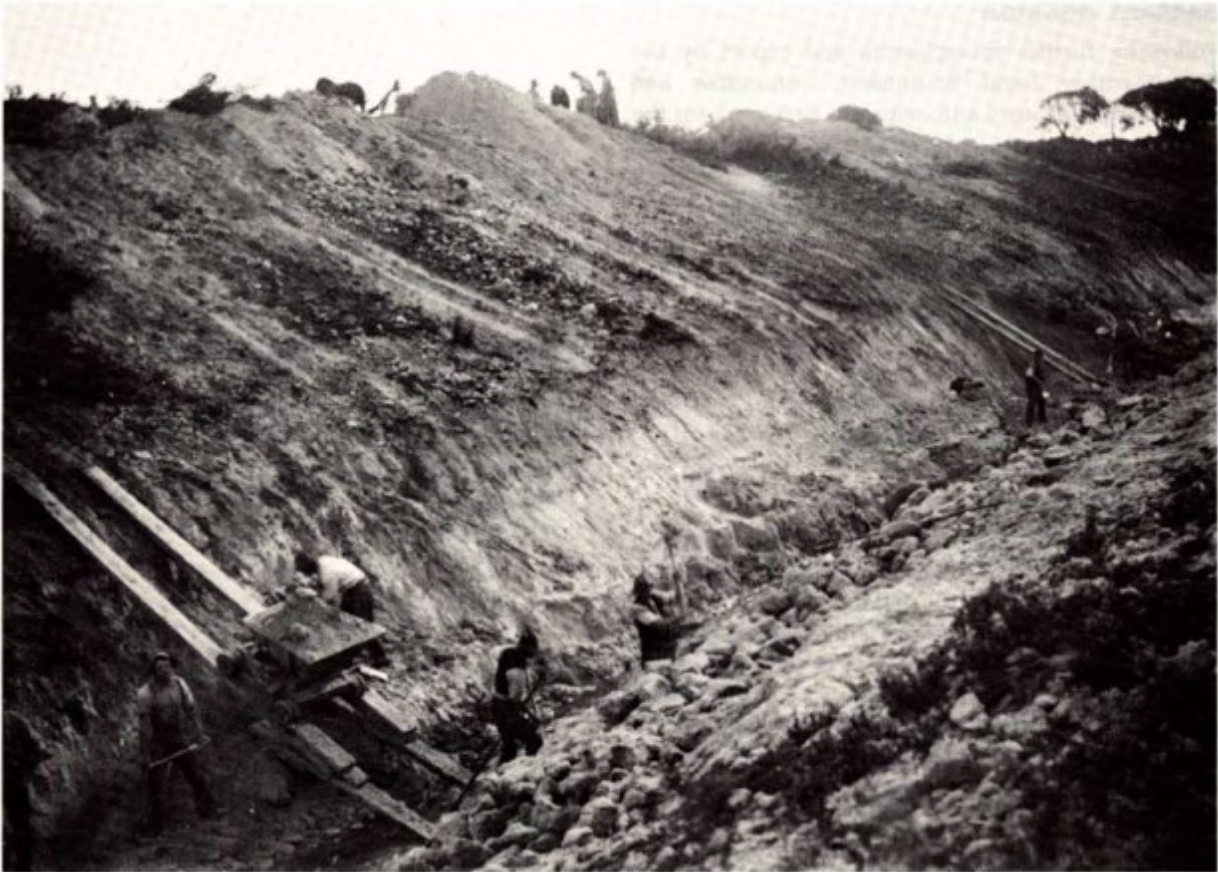
*Figure 4. Construction of Drain L cutting through the Woakwine Range, c.1915 (source: SEDB 1980).*

The absence of an obvious natural outlet is underscored by the effort that was required to drain the Lake Hawdon system. Drain L was constructed in 1915-18 and involved massive excavation through the Woakwine Range (Figure 4). The capacity of Drain L was further enlarged in 1957-58 during the Anderson Scheme period of drain construction in the South East region (SEDB 1980).

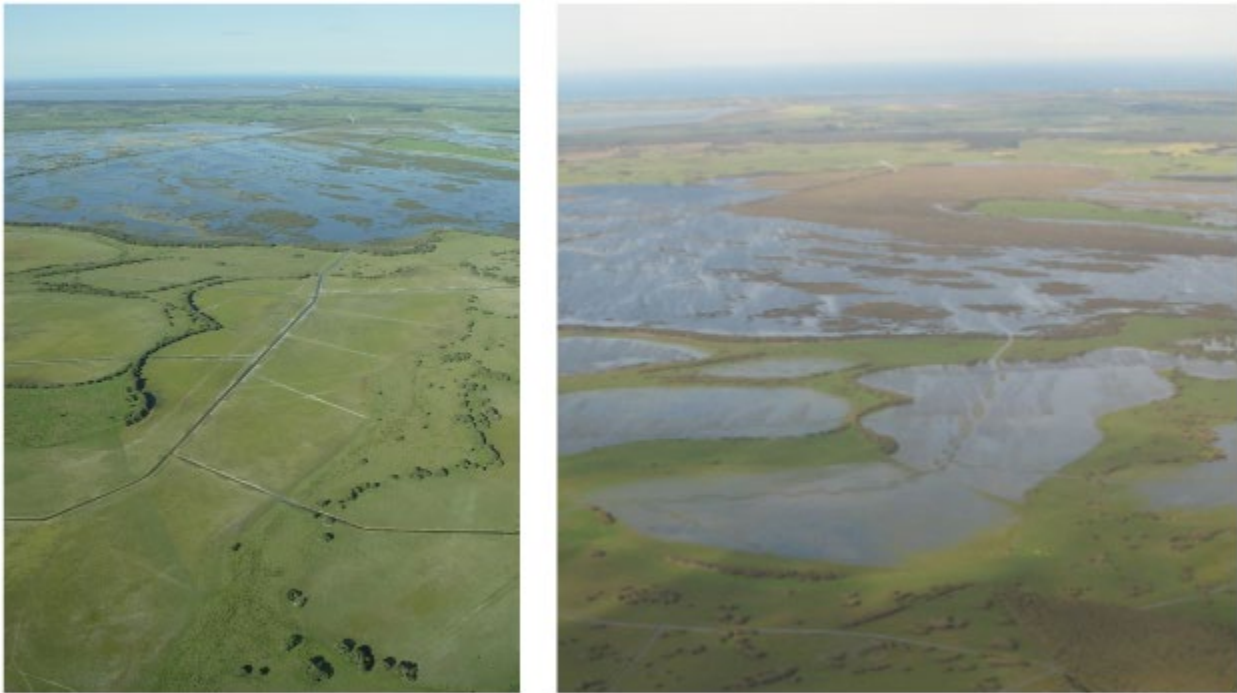
Figure 9. Left: Lake Hawdon North (middle ground) completely inundated but with water levels still permitting effective drainage of adjoining properties to the east (foreground), 1st October 2004. Right: similar view on 23 September 2016 with high water levels causing inundation of adjoining properties (photos: Ben Taylor).

Lake Hawdon North acts as an equalisation basin that has importance in the provision of a drainage service to agricultural properties in the surrounding area. The ‘as constructed’ plans for Drain L indicate that its capacity immediately upstream of Lake Hawdon North is 44.457 m<sup>3</sup>/sec, while immediately downstream of the wetland its capacity is 39.558 m<sup>3</sup>/sec. The downstream capacity of Drain L is 4.899 m<sup>3</sup>/sec, or 423 ML/day, less than upstream capacity. In addition to Drain L, inflows to Lake Hawdon North also include flows from the Bray Drain catchment, entering via Lake Hawdon South and the Lake Hawdon Connecting Drain, and flows from adjoining agricultural properties in minor drains. Thus at times, inflows to Lake Hawdon North greatly exceed the capacity of Drain L downstream. When this occurs, Lake Hawdon North acts as an equalisation basin, temporarily storing up to c.8,000 ML without compromising drainage of surrounding properties (Figure 9). At times, persistently high inflows cause the volume of water in Lake Hawdon North to exceed this, and drainage of adjoining properties is compromised (Figure 9).

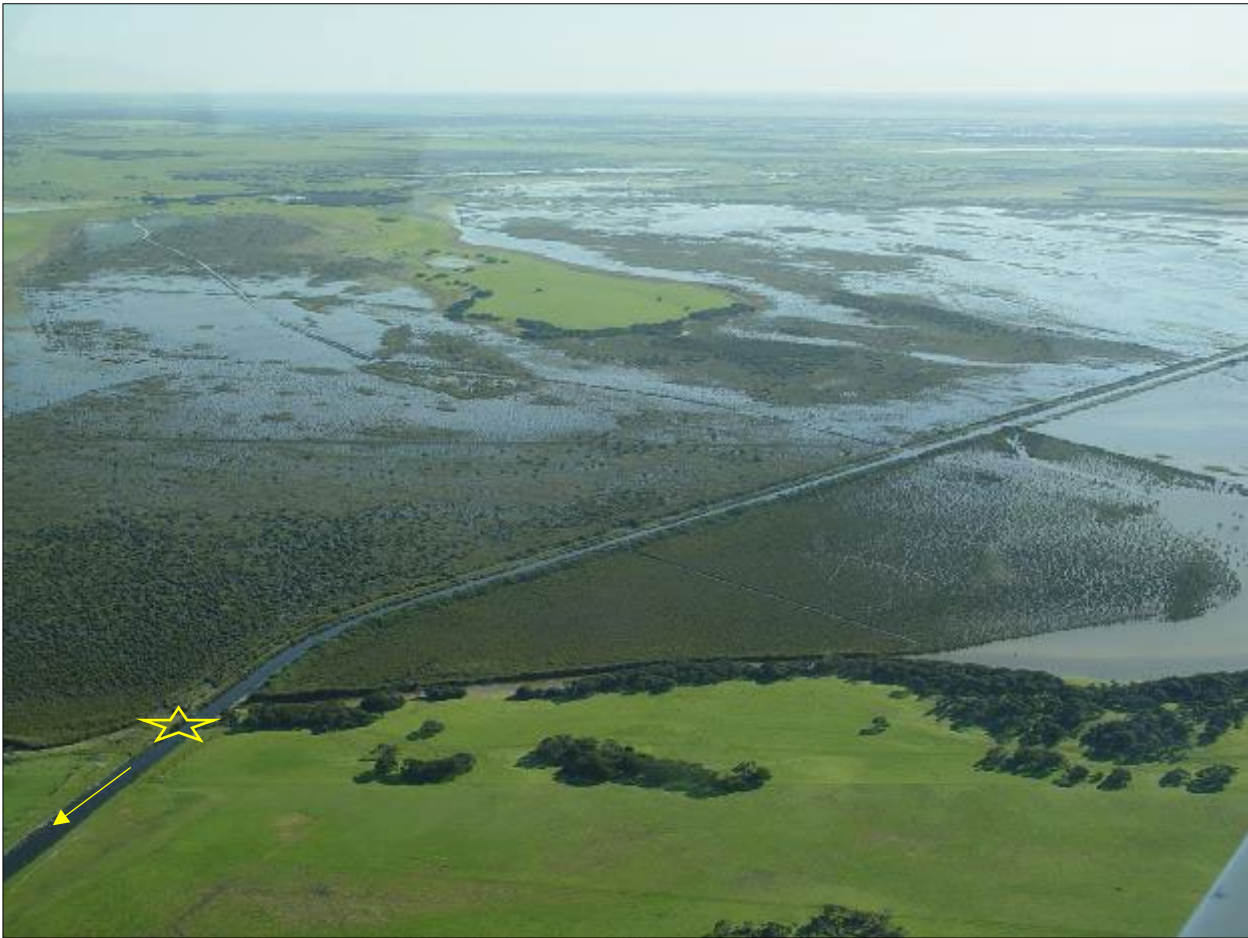
Figure 12. Proposed location of a regulator on Drain L (yellow star) to manage water levels in Lake Hawdon North. The direction of flow in the drain is also shown (yellow arrow) (photo: Ben Taylor).

To restore a more natural hydrology to Lake Hawdon North, with inundation persisting well into summer to align more closely with the presence of migratory shorebirds in the region, it is proposed that a regulator be constructed on Drain L at the outlet of Lake Hawdon North. This is the highest priority restoration action. The proposed location is on the western side of the wetland, at approximately E400757, N5887499, and is shown in Figure 12.

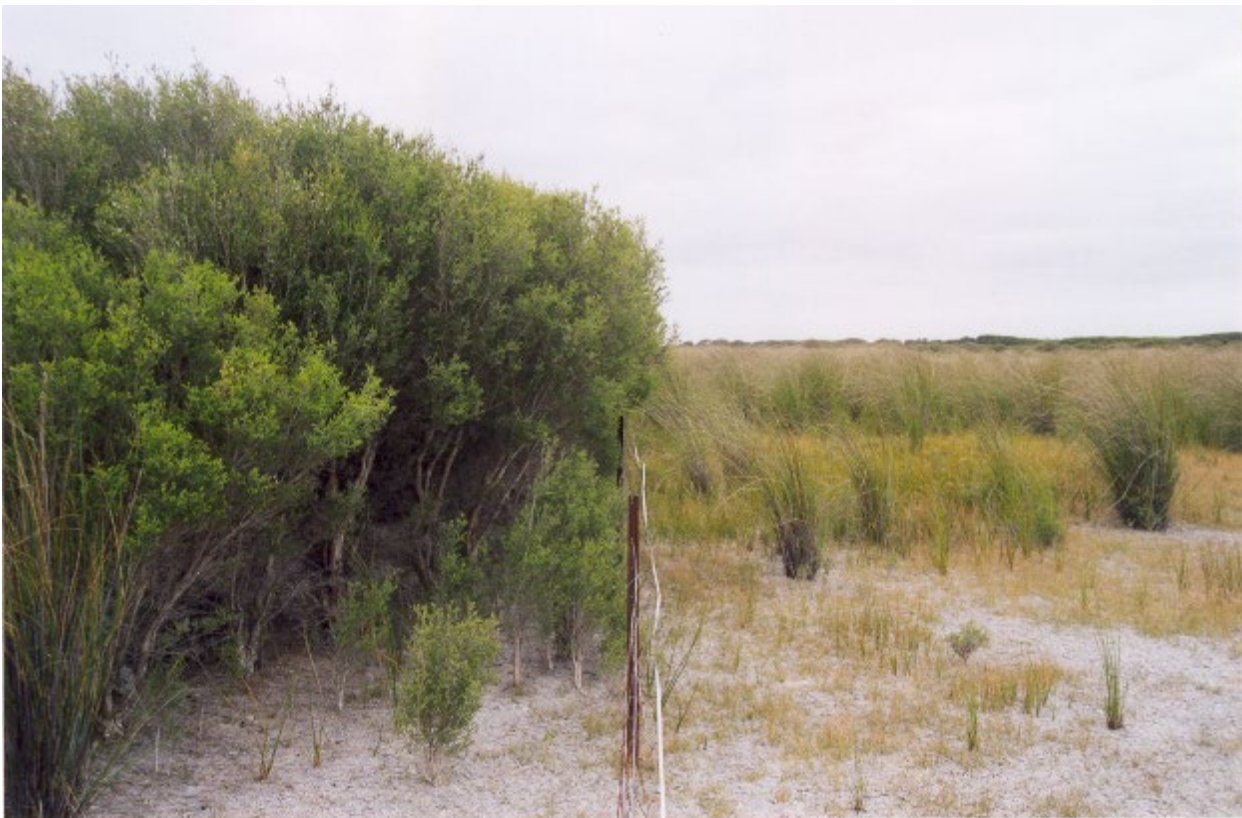
Figure 14. Grazing exclosure (left of fence) and adjoining control (grazed) site (right), Lake Hawdon North, 27<sup>th</sup> February 2002 (photographer unknown).

The effects of grazing upon the vegetation of the Lake Hawdon complex have been under consideration for several decades. Sheep exclosures were established at four locations in the Lake Hawdon complex in 1984 for this purpose. Monitoring of vegetation within the exclosures and in adjacent control (grazed) quadrats was undertaken but these data have not been obtained for the current assessment. However, a photograph of one of the exclosures taken 18 years after establishment (Figure 14) is informative. Eighteen years of grazing exclusion led to the establishment of dense *Melaleuca halmaturorum* shrubland within the exclosure, while the adjoining control area, subject to ongoing grazing, had little to no *M. halmaturorum* and a much more open structure featuring sparse *Gahnia filum* tussocks. This suggests that grazing has played an important role in suppressing, or at least delaying, the establishment of *M. halmaturorum* shrubland and maintaining an open vegetation structure at Lake Hawdon North and the current hydrology.

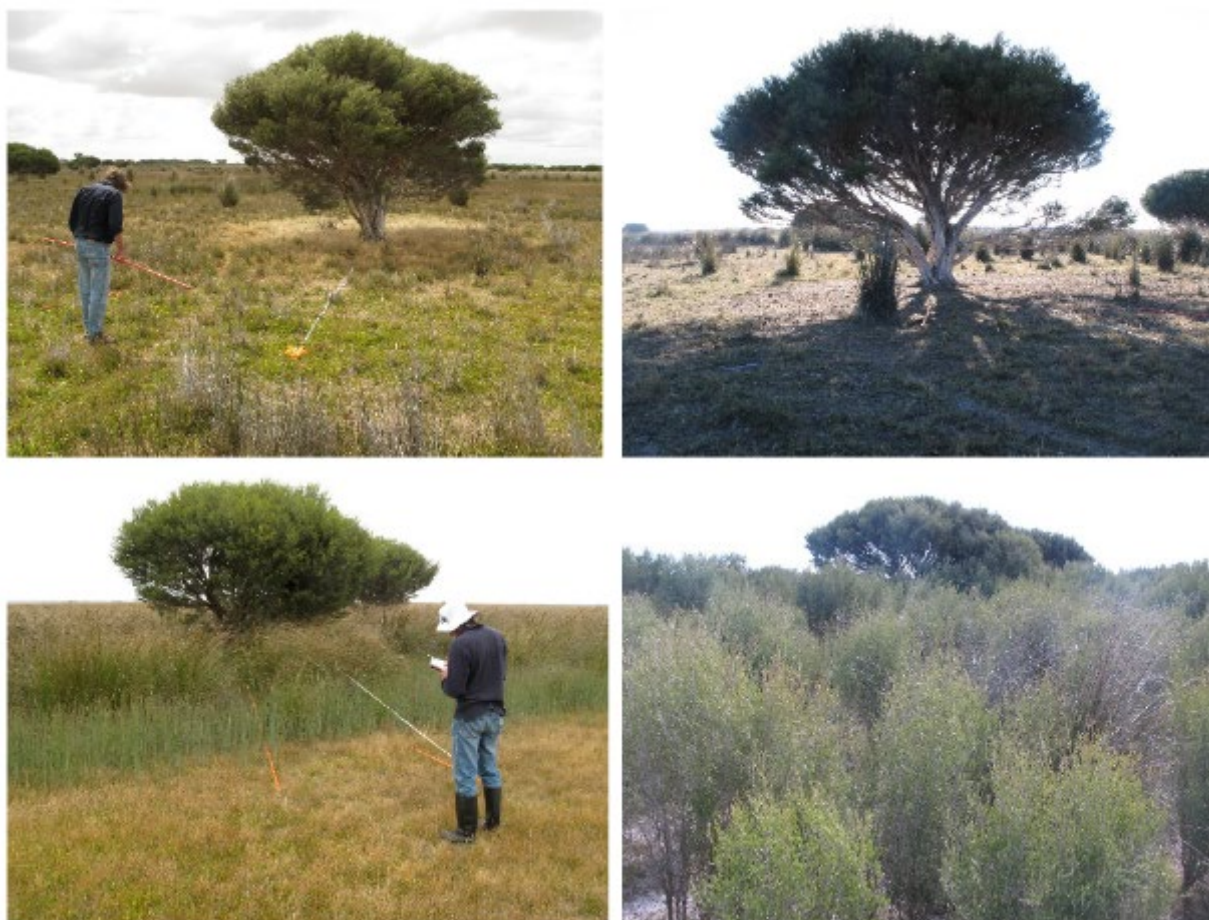
Figure 15. Top row: *Melaleuca halmaturorum* recruitment monitoring site in Lake Hawdon North (grazed control) in 2013 (left) and 2019 (right). Bottom row: *M. halmaturorum* recruitment monitoring site in Lake Hawdon South (sheep permanently removed May 2009) in February 2010 (left) and April 2019 (right). (photos: Ben Taylor).

Another vegetation monitoring program within the Lake Hawdon complex, which commenced in 2008 (Ecological Associates 2008) and is ongoing, has made similar findings. Monitoring has revealed mass establishment of *M. halmaturorum* in Lake Hawdon South following the permanent removal of sheep in 2009, while control sites in Lake Hawdon North, where grazing has continued, have shown no change in the abundance of *M. halmaturorum* over the same time period (Taylor and Brown 2019) (Figure 15).

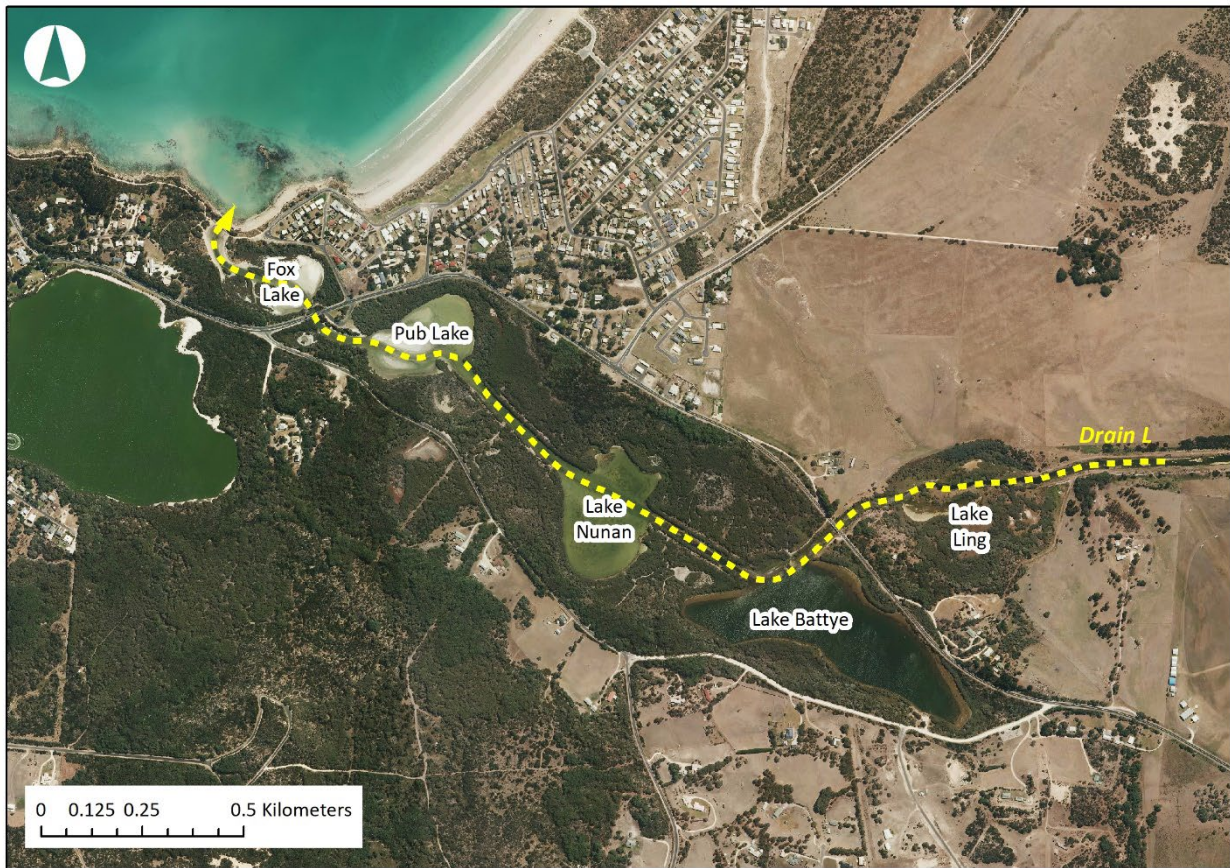
Figure 25. The Robe Lakes comprise a chain of connected lakes receiving water from Drain L to the east and water flowing north-west to exit to the ocean north of Fox Lake.
