# Chowilla Creek Environmental Regulator and Ancillary Structures - *Summary of 2014 testing*

*Successful testing of the new environmental water management infrastructure on the Chowilla Floodplain took place in 2014. It was the culmination of many years of work by many people within DEWNR, SA Water, the MDBA, a range of scientific organisations and the community. The testing has provided opportunities for further learning and adaptive management over the coming years.*

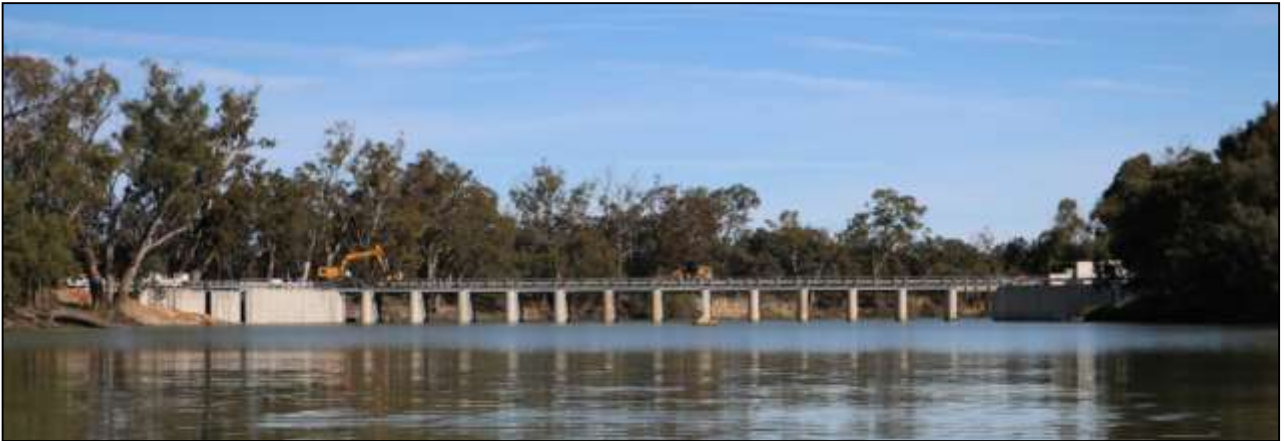
Chowilla Creek environmental regulator

The testing involved the progressive positioning of stop logs between the concrete piers at the Chowilla Regulator to raise water levels in Chowilla Creek and the anabranch by up to approximately 2.75 metres, which corresponds to a 'medium level' operational height of 19.1 metres with respect to Australian Height Datum (mAHD). Flow was maintained over the regulator throughout the testing as will occur through any operation.

Engineering checks and monitoring were undertaken throughout the testing to ensure that the regulator was operating as it was designed to. All of the structures operated to design specifications.

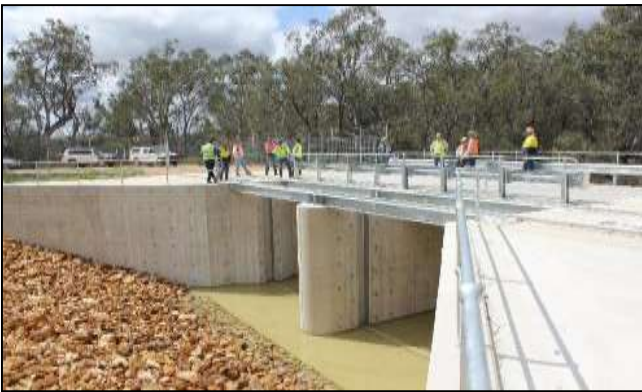
Woolshed Creek South regulator.

As water levels were raised, flows also passed through structures on the Chowilla Island Loop and through the Woolshed Creek South and East regulators, enabling these structures to be tested. Testing also involved the operation of the vertical slot fishway at the Chowilla Regulator.

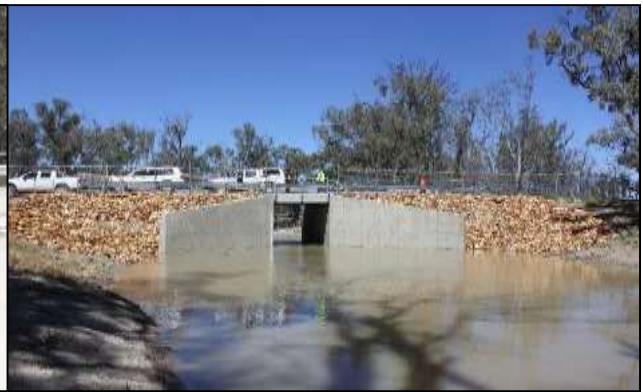
Woolshed Creek East regulator.

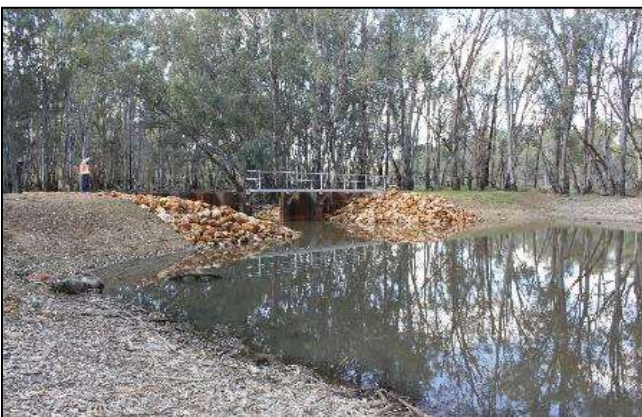
Chowilla Island Loop Ancillary Regulator.

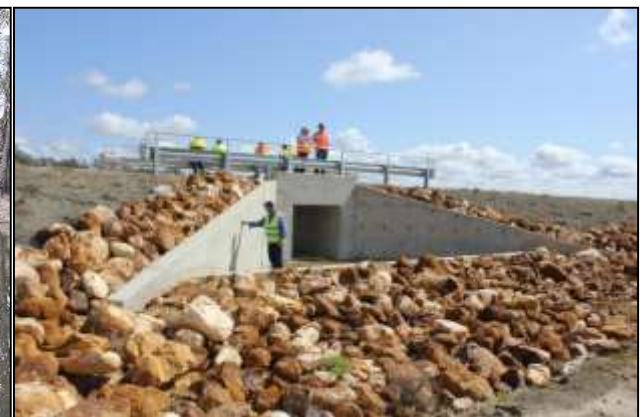
Chowilla Island Loop Channel regulator.

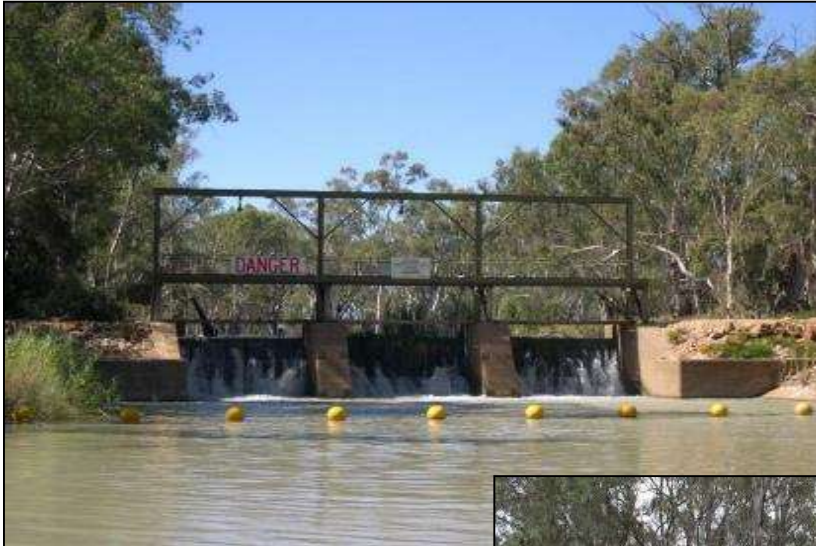
Pipeclay Creek Weir prior to upgrade.

The testing also involved the simultaneous operation of Locks 5 and 6 and the Pipeclay and Slaney Creek weirs. These weirs were built around 1930, at the same time as Lock 6, and have been significantly upgraded, as part of the Chowilla project, to improve flow management in the Chowilla anabranch. Fishways have also been installed in the upgraded Pipeclay and Slaney weirs to allow the movement of fish of all sizes through the structures.

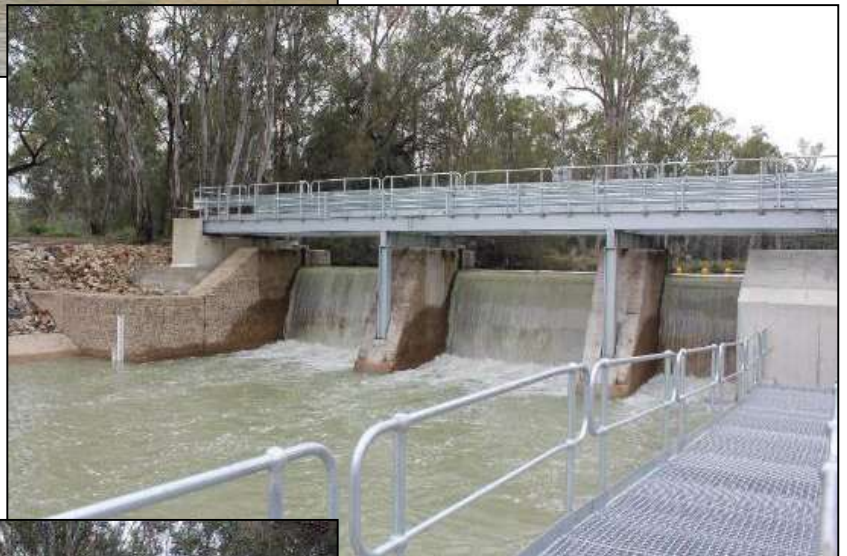
Pipeclay Creek Weir after the upgrade and installation of fish passage.

The gates on the recently upgraded weirs on Pipeclay and Slaney creeks were fully opened during the testing. This allowed sufficient flows to pass through the Chowilla anabranch, to manage water quality and maintain areas of high flow velocity (which provide important fish habitat). Fishways recently installed at these weirs were operated throughout the testing.

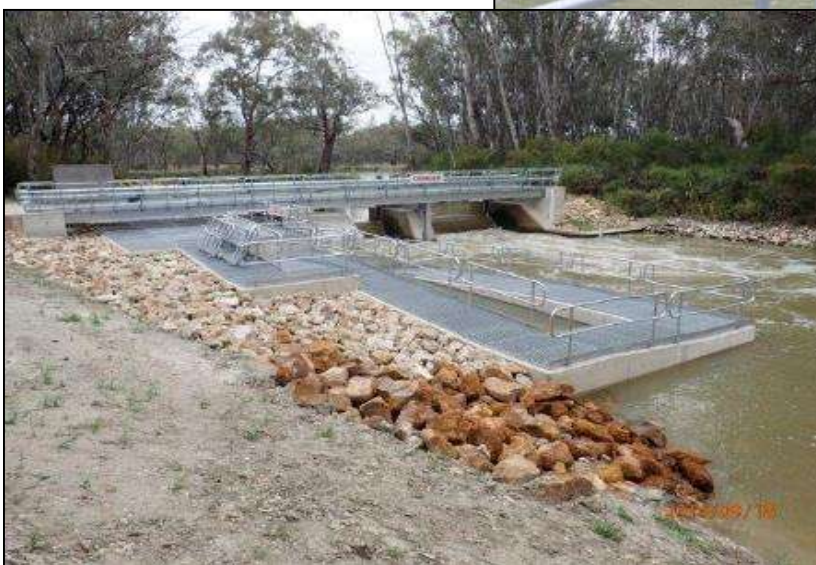
Slaney Creek Weir after upgrade and installation of fish passage.

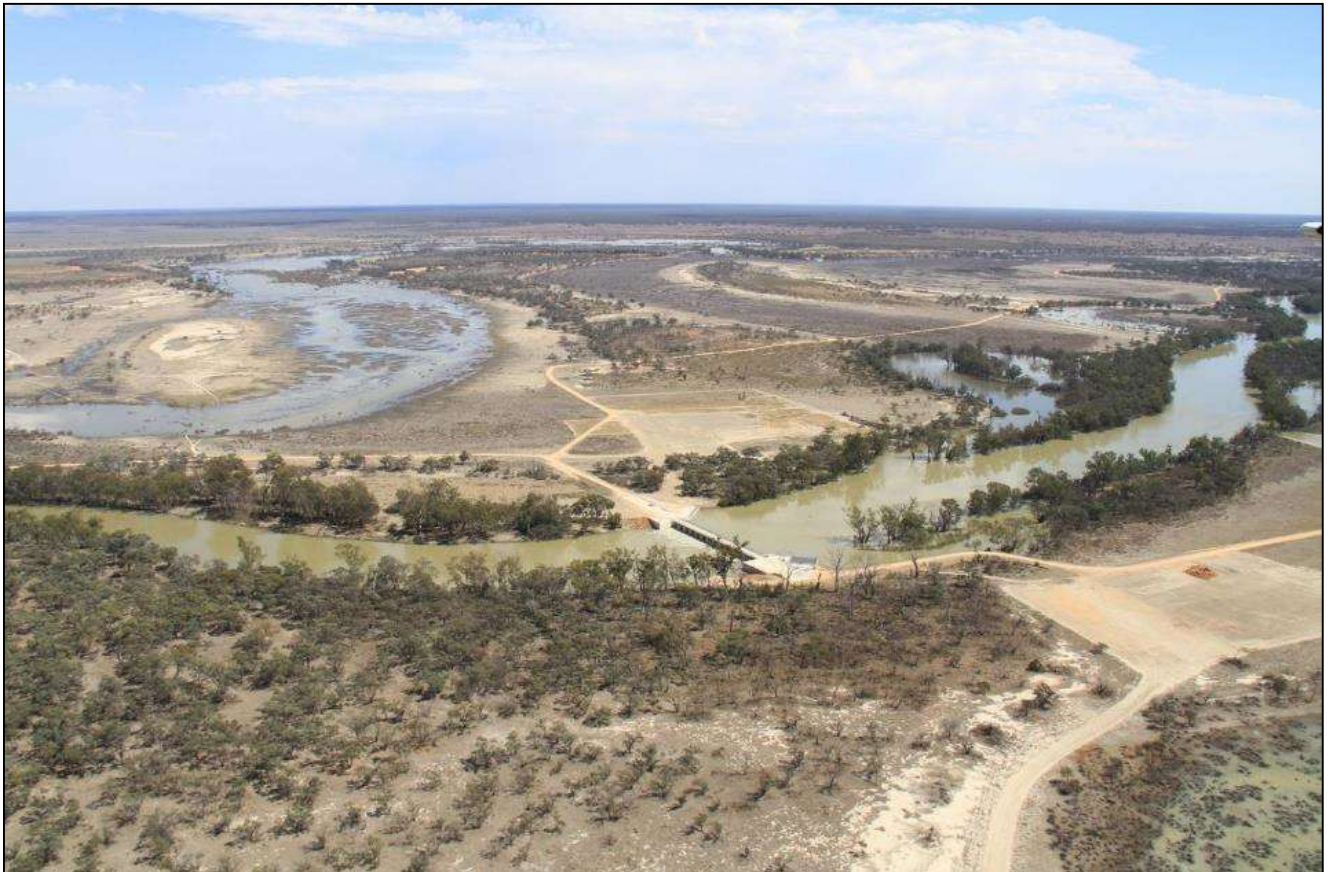
Looking over the Chowilla Regulator in operation, with the Coppermine wetland complex in background.  
Photo: Callie Nickolai.
