Native Vegetation Clearance

Jock Barrett Road Pipeline River Murray to 3km south Cadell/Sunlands Data Report

Clearance under the *Native Vegetation Regulations 2017*

11 August 2020

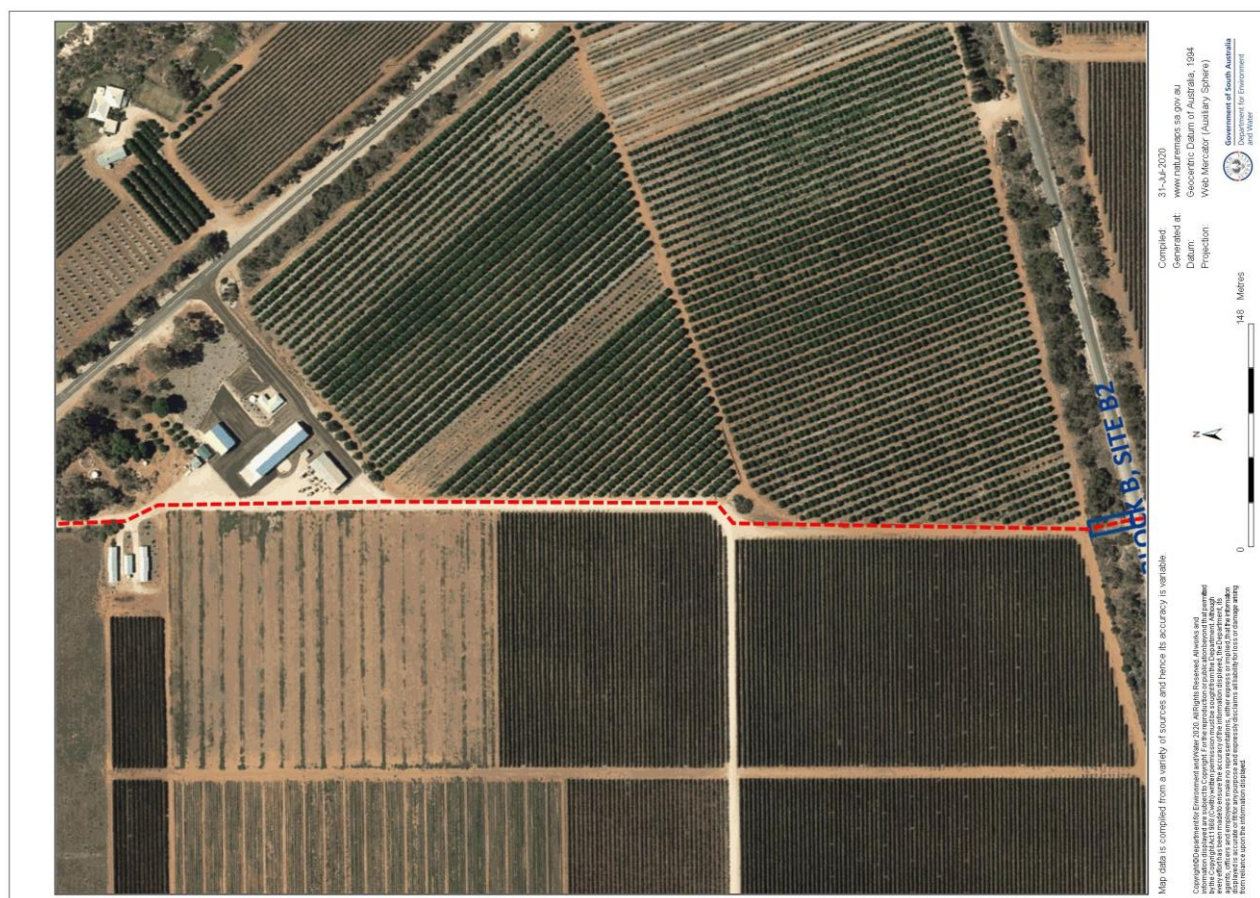
Figure 4. Route map showing attempts to avoid native vegetation, Yalumba Estates to Oxford Landing Road

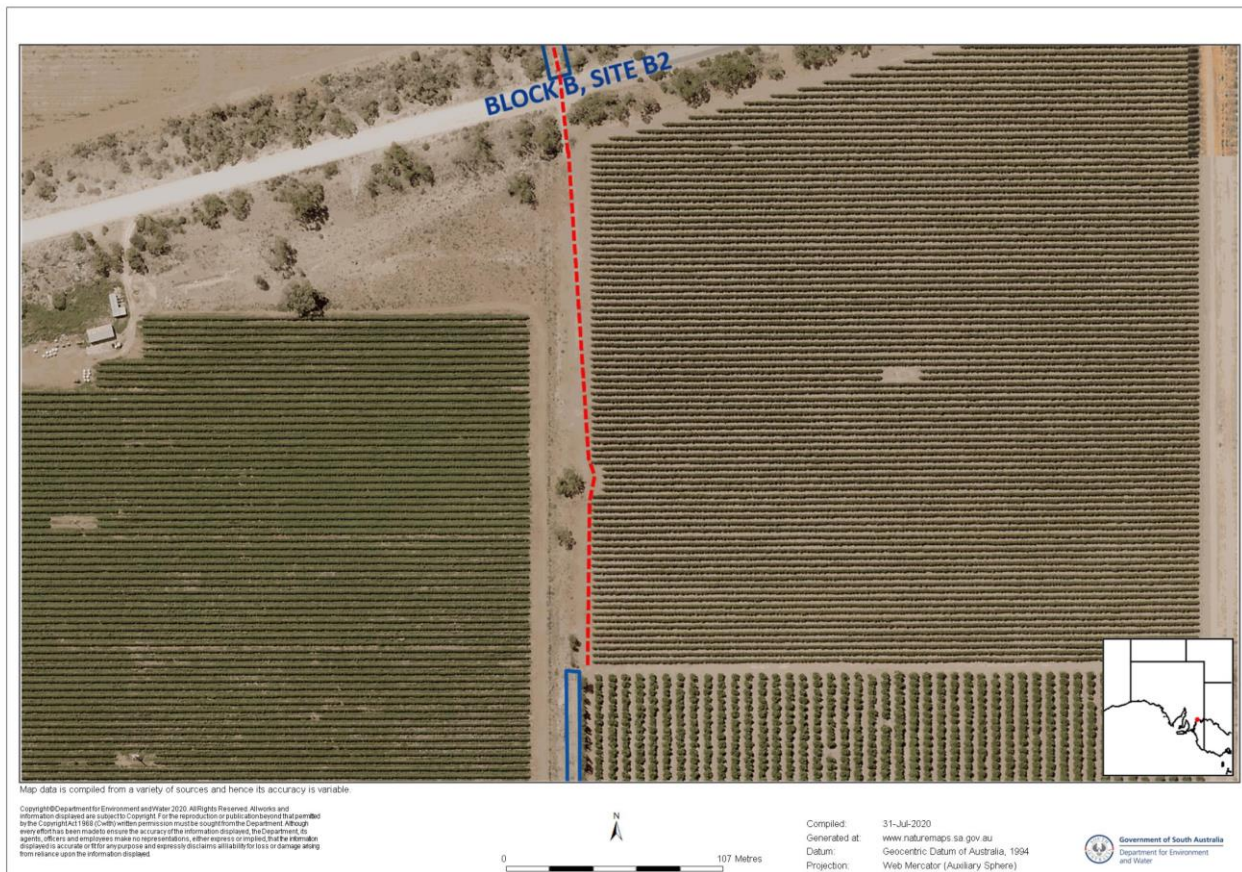
Figure 5. Route map showing attempts to avoid native vegetation, Oxford Landing Road to orange orchard. Maireana shrubland to west of route.

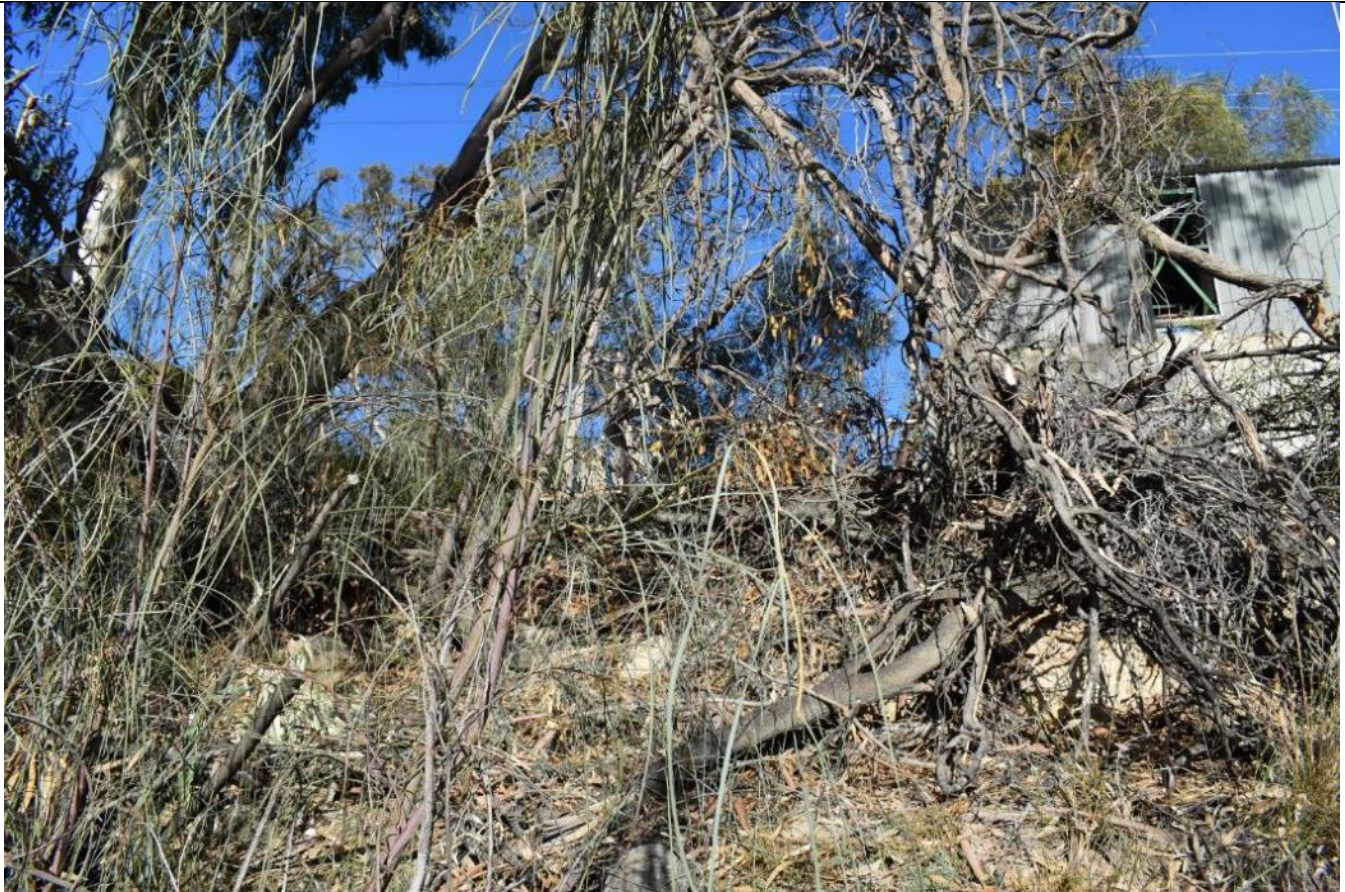
Photo 2. Looking south west from the riverbank, up toward the site of the pump shed and pipeline. Some of the vegetation on the bank is dead (no hollows)

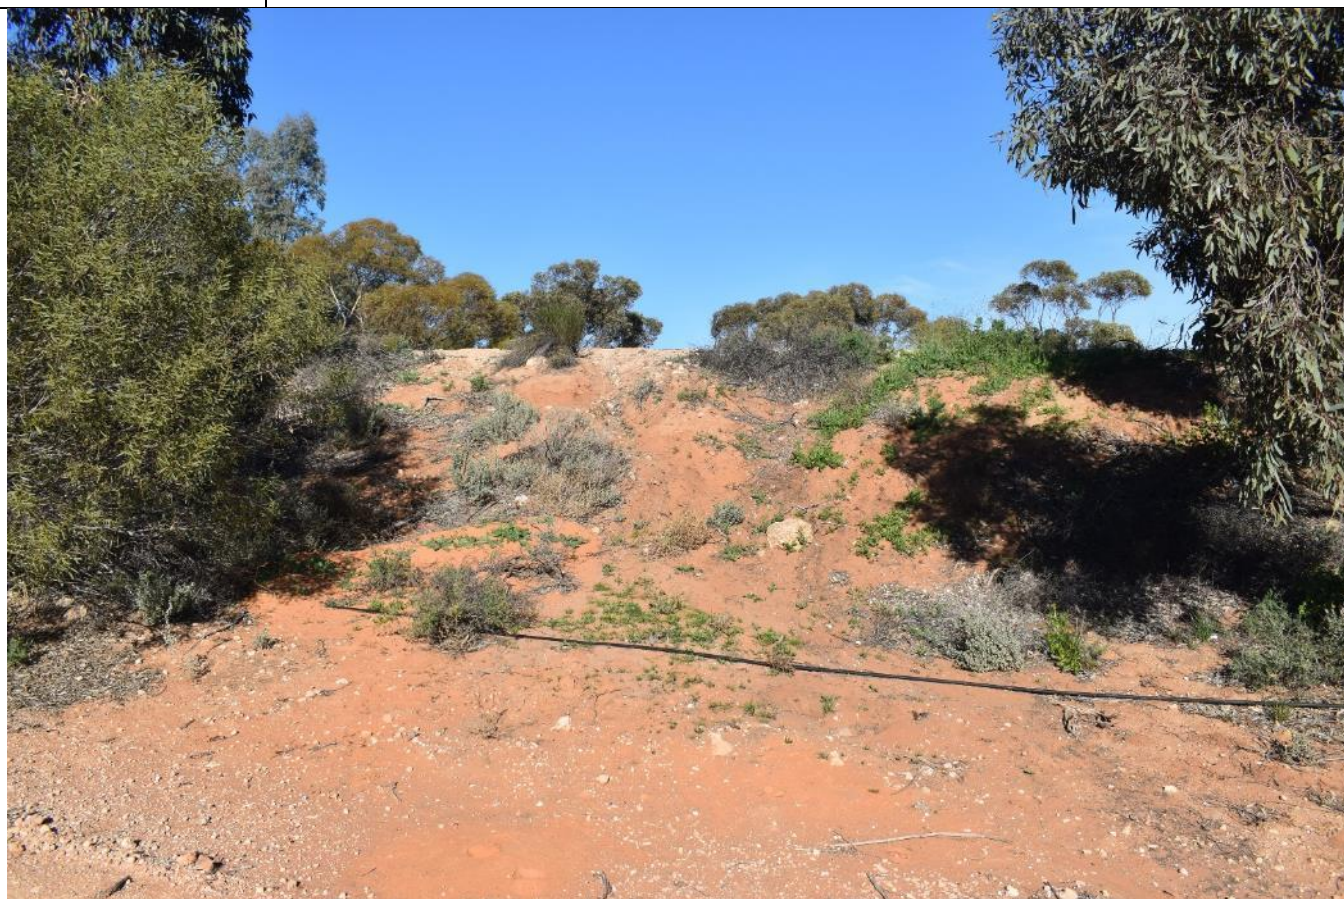
Photo 3. Site B1 - Looking south west, from the access track toward Cadell Valley Road (at the top of the bank). Excavation through the centre of this degraded area is required to install the pipeline. Much of the impact is confined to weed species and a few low chenopod shrubs. There is unlikely to be any root impact to the trees visible in the photo.

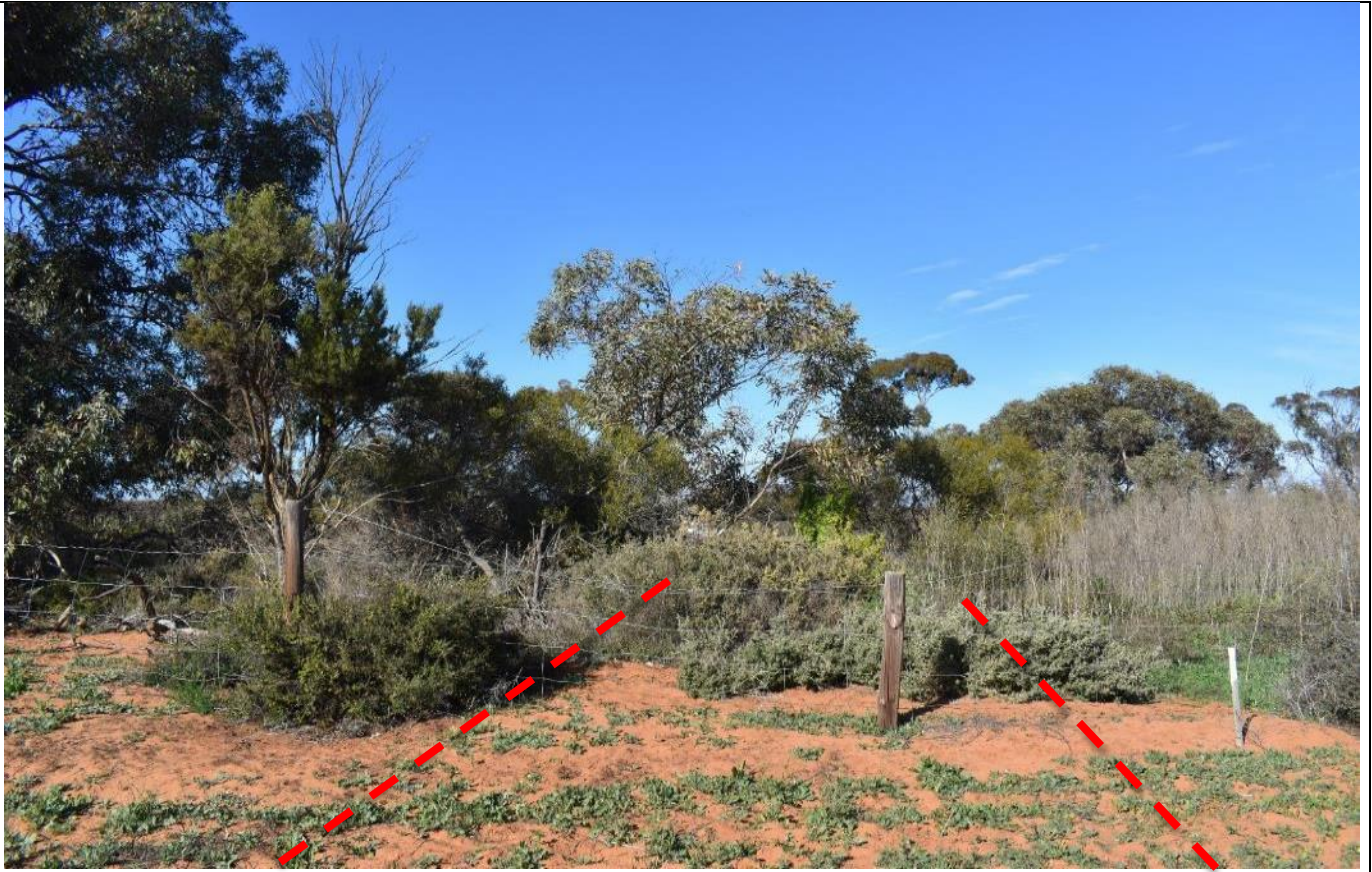
Photo 4. Site B2 - Looking south toward Oxford Landing Road from farmland/Jock Barrett road reserve. The pipeline will require 3m width for machinery access. Dashed line shows indicative route width.

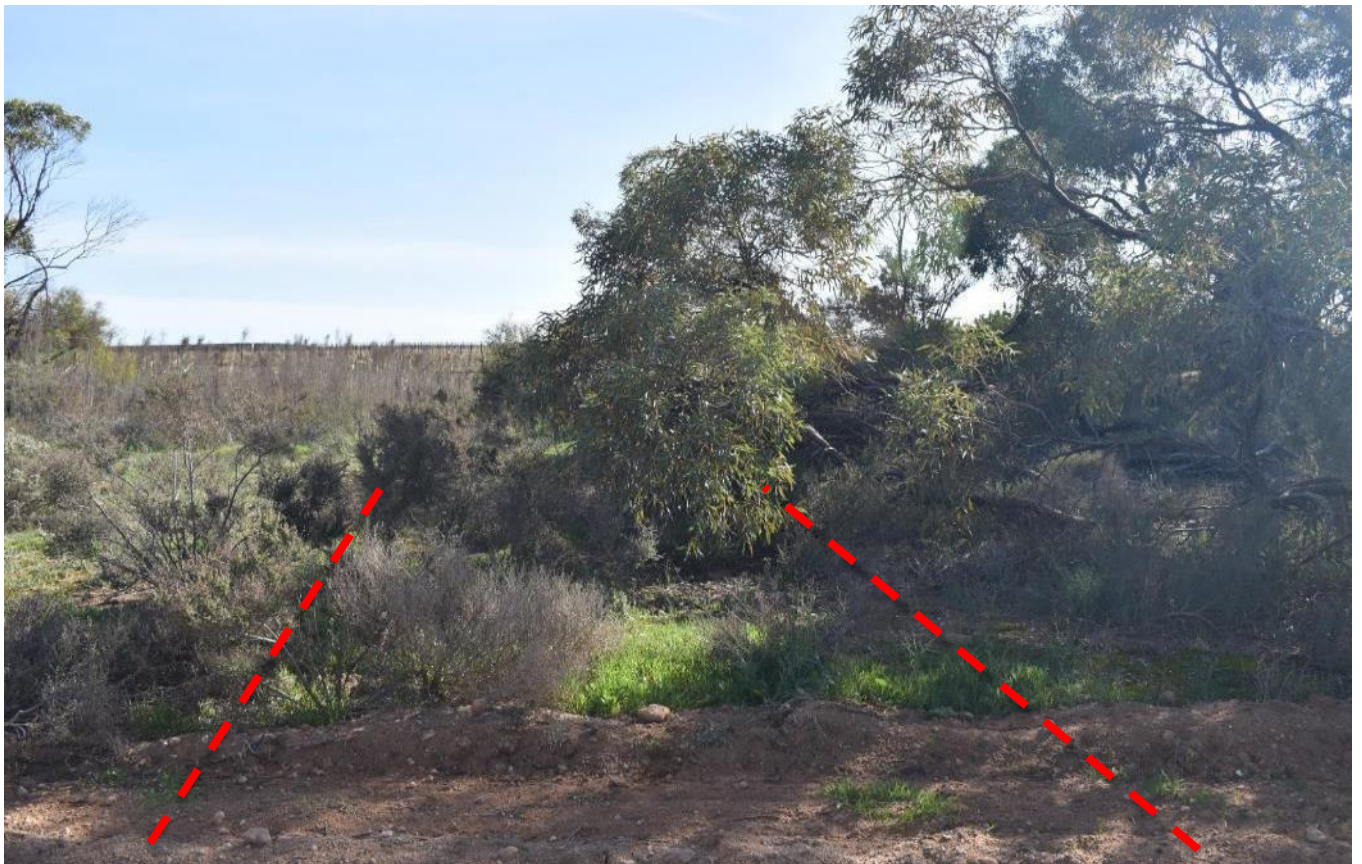
Photo 5. Site B2 - Looking north from Oxford Landing Road. The pipeline will require 3m width for machinery access. Dashed line shows indicative route width.

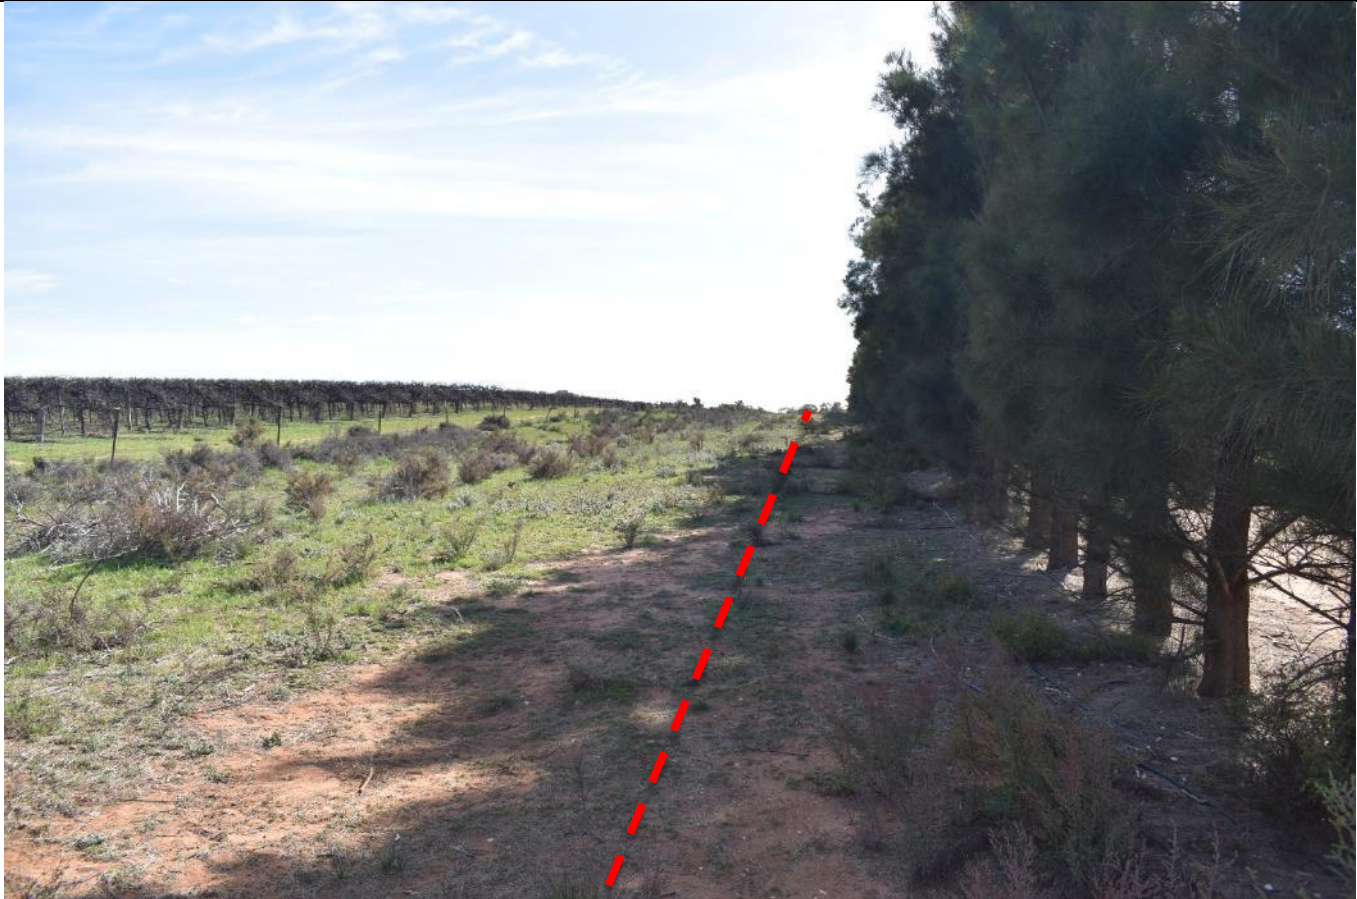
<p>Photo 6. Looking north, from the southern end of the association impacted. The impact zone is between 2m and 5m west of the (planted) <i>Casuarina</i> trees (approximate pipeline location indicated by dashed line). Very little impact to the remnant vegetation, which is in very poor condition with a significant weed burden, is anticipated.</p>					
General description	<i>Maireana brevifolia</i> and <i>Enchylaena tomentosa</i> are co-dominant. Horehound is present on the site, and rabbit scratchings evident. This patch is highly disturbed and of limited habitat value. The route has been selected to avoid impact and the area chosen contains less than 25% native vegetation. In order to minimise root disturbance and potential structural instability, the route will keep 2m away from the trees (planted <i>Casuarina</i> sp.)

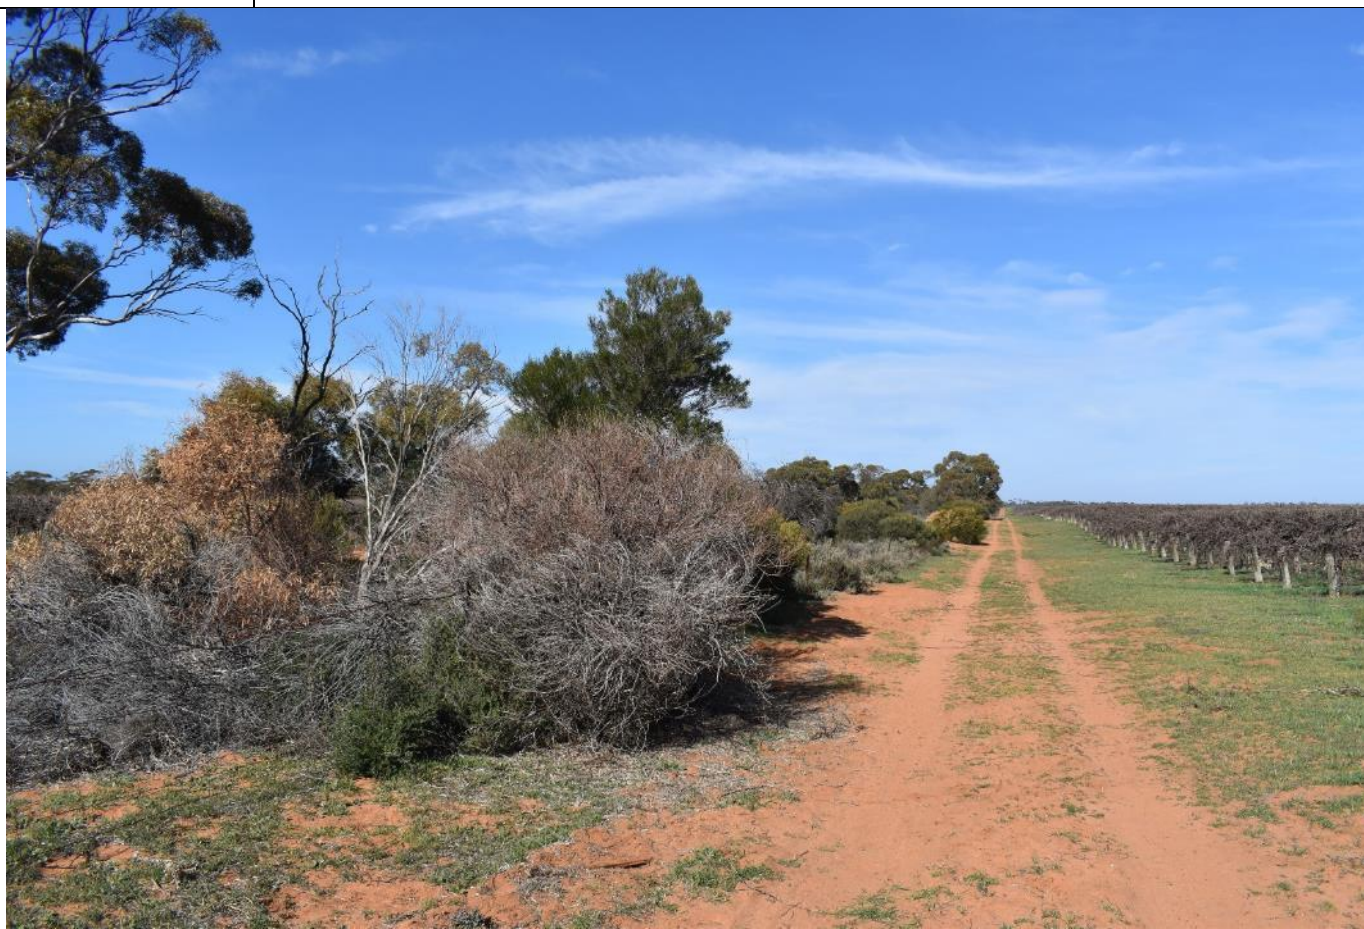
Photo 7. Looking south, from the start of the Site. Impacts are restricted to the western side of the remnant patch, and removal of up to 3m from the western fence is required. The road reserve is approximately 20m wide, and remnant vegetation extends to that width for the northern part of this Site, reducing to around 12m wide on parts of the southern section.

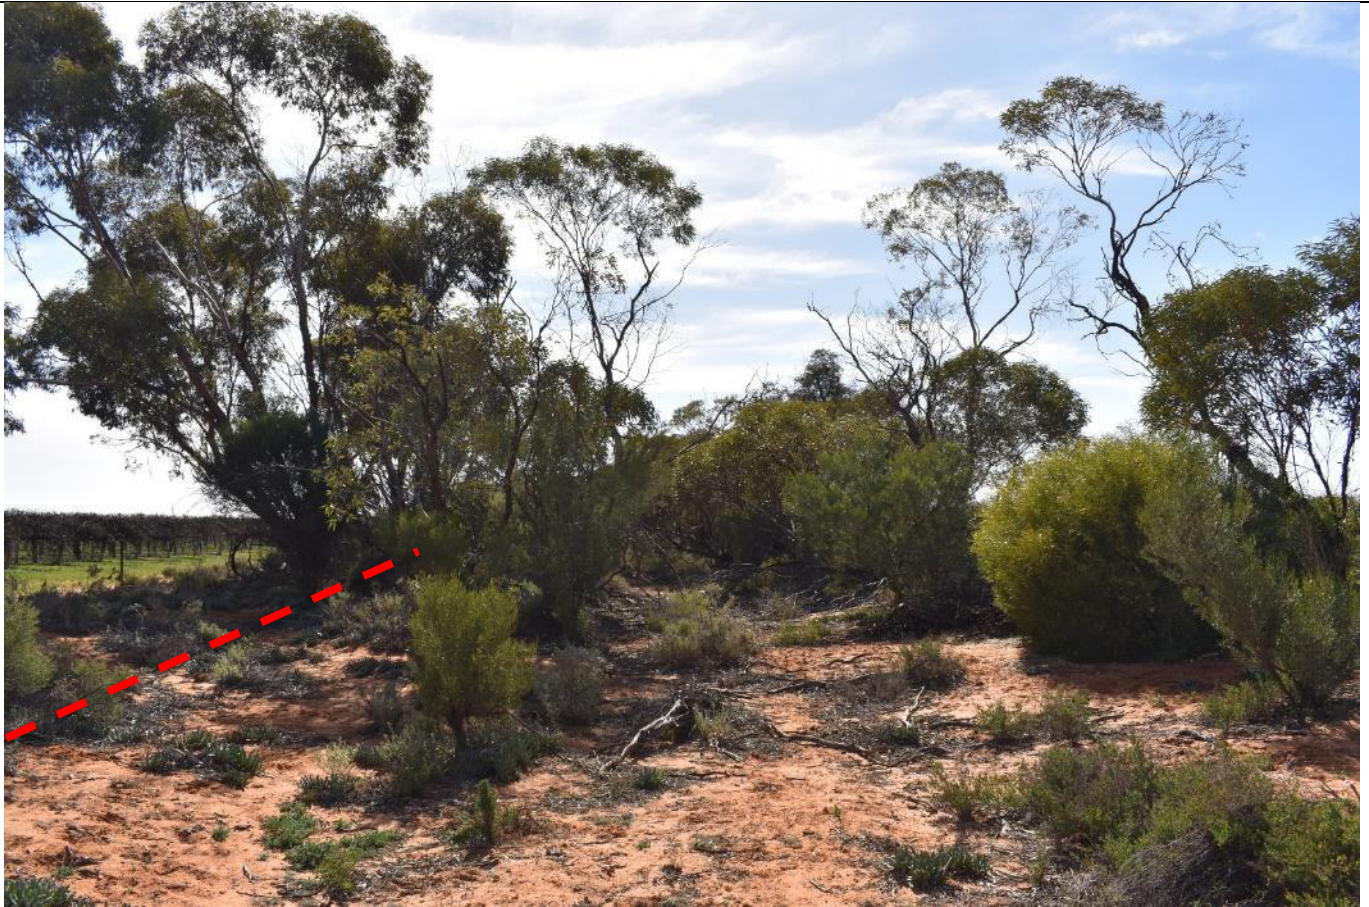
Photo 8. Looking north, from midway through the Site. Impact is restricted to the western side of the patch; removal of 3m from the western fence is anticipated. The road reserve is approximately 20m wide. The vegetation extends to that width for the northern part of this Site, reducing to c.12m wide on parts of the southern section.

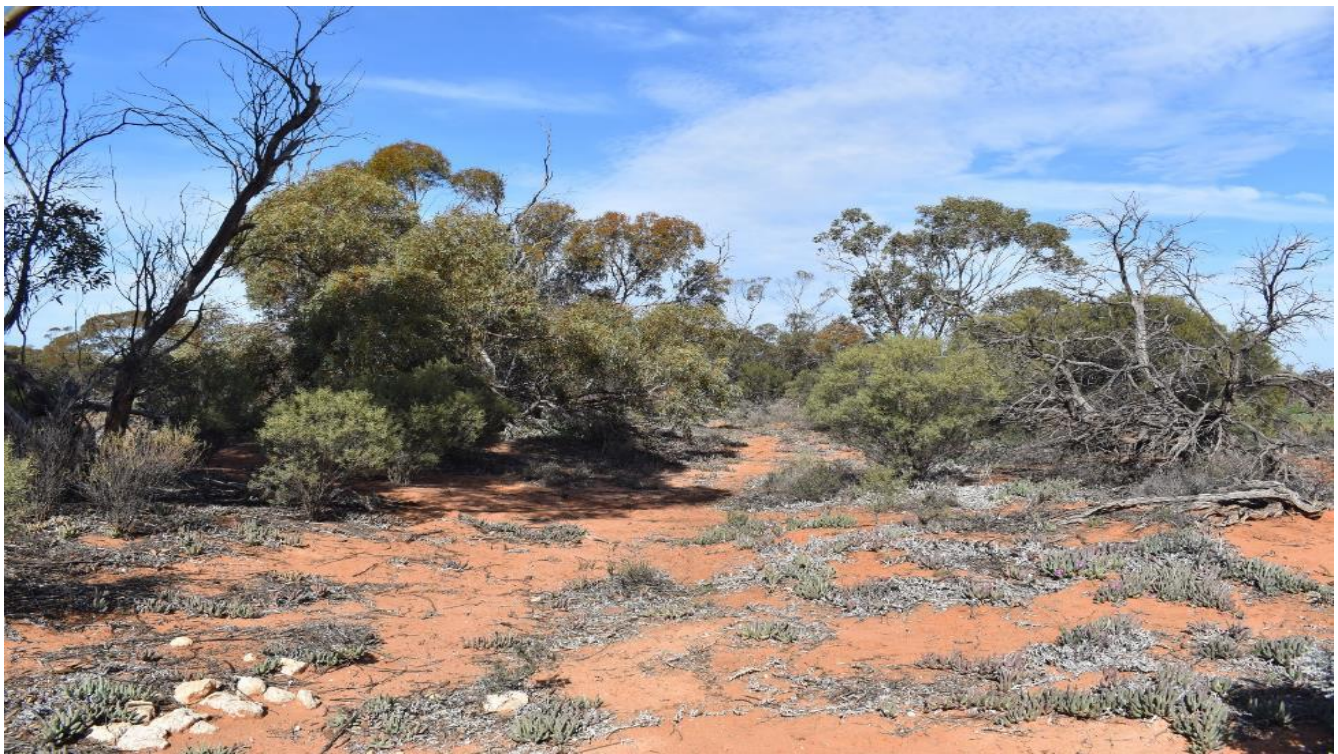
Photo 9. Looking south from midway through the Site. The impacts are restricted to the western side of the remnant patch, covering 3m from the western fence. Ground layer is predominantly *Carpobrotus* and *Roepera* sp. Limited weed invasion is evident.

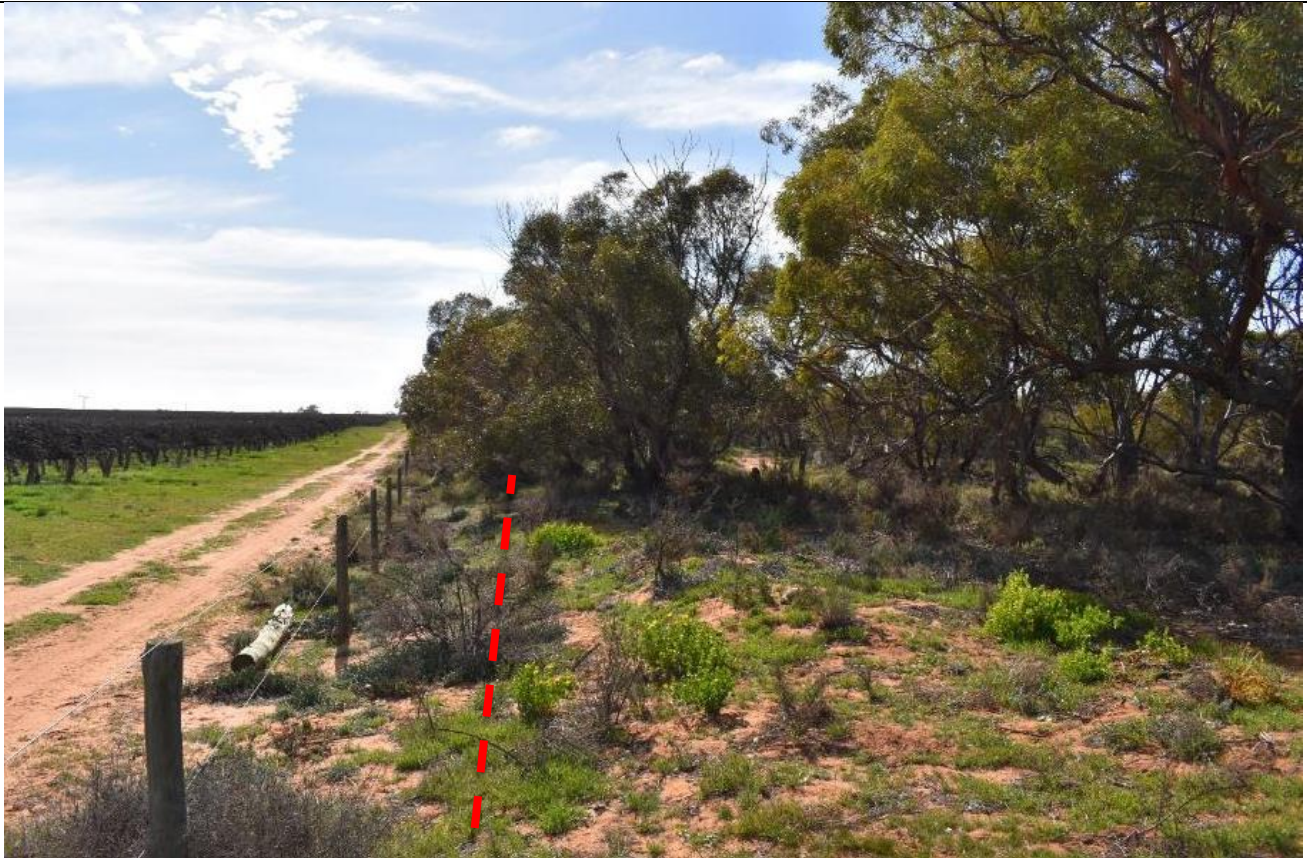
Photo 10. Looking north from the southern section of the Site. The vegetation patch reduces in width to approximately 12m and is more degraded as a result of edge effects. The first 3m from the western fenceline will be impacted.

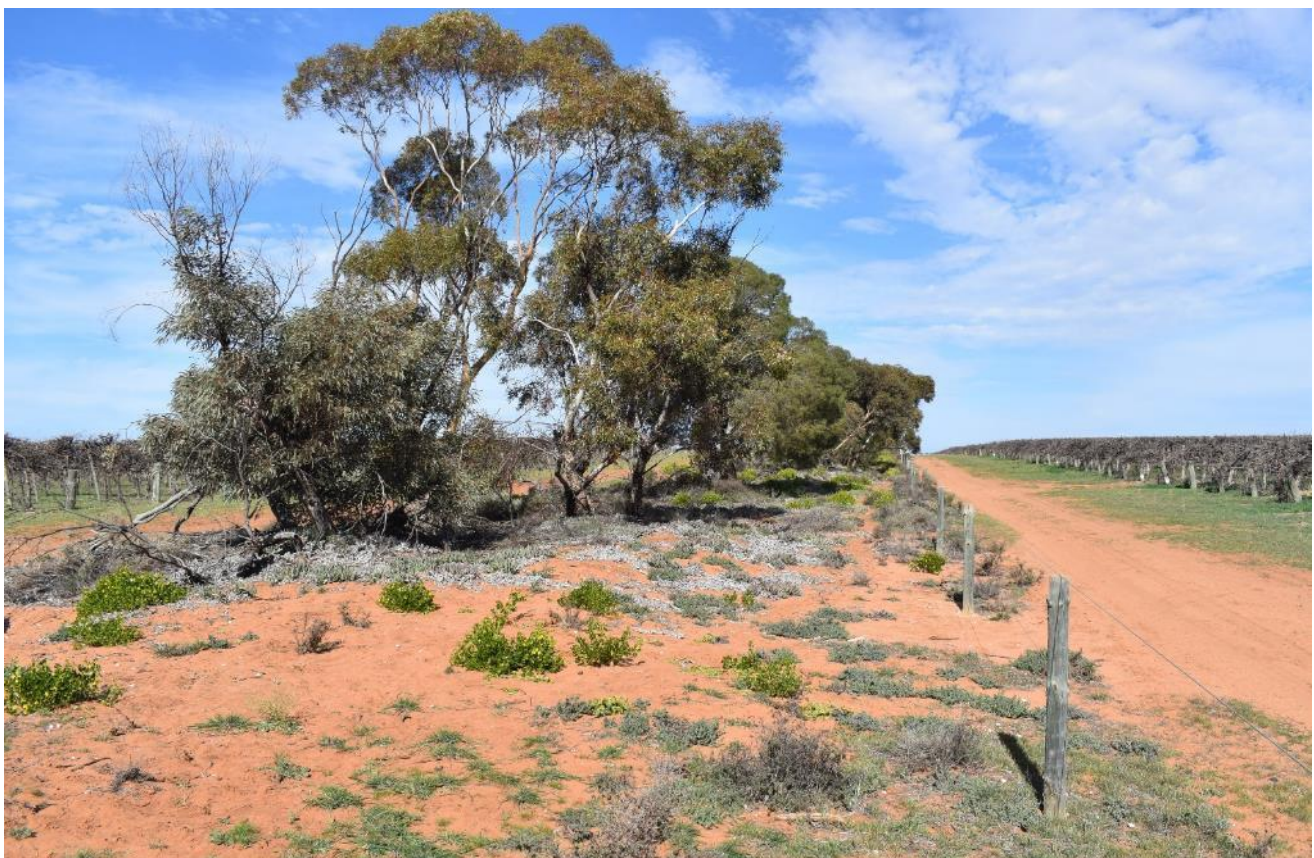
Photo 11. Looking south toward the southern section of the Site. The vegetation patch is more degraded as a result of edge effects, with weed infiltration evident. The first 3m from the western fenceline will be impacted.

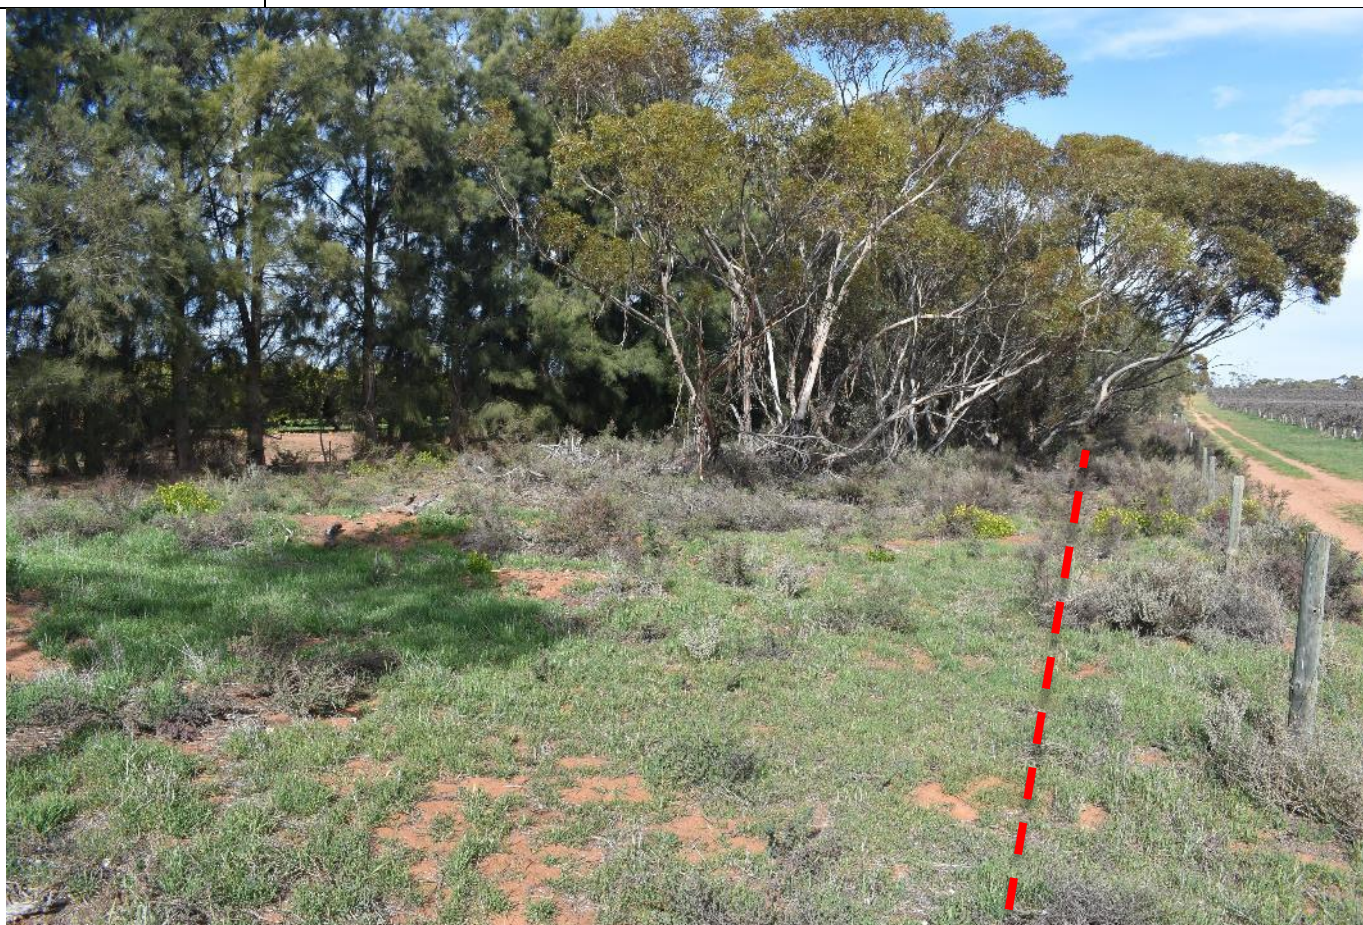
Photo 12. Looking south from the northern end of the Site. Significant weed disturbance and rabbit scratchings were evident. The impact is confined to 3m from the western fenceline. The patch is subject to edge effects at the northern portion, with several open areas as shown in the image. A row of planted *Casuarina* sp. occurs along the eastern flank for about half the length of the Site.

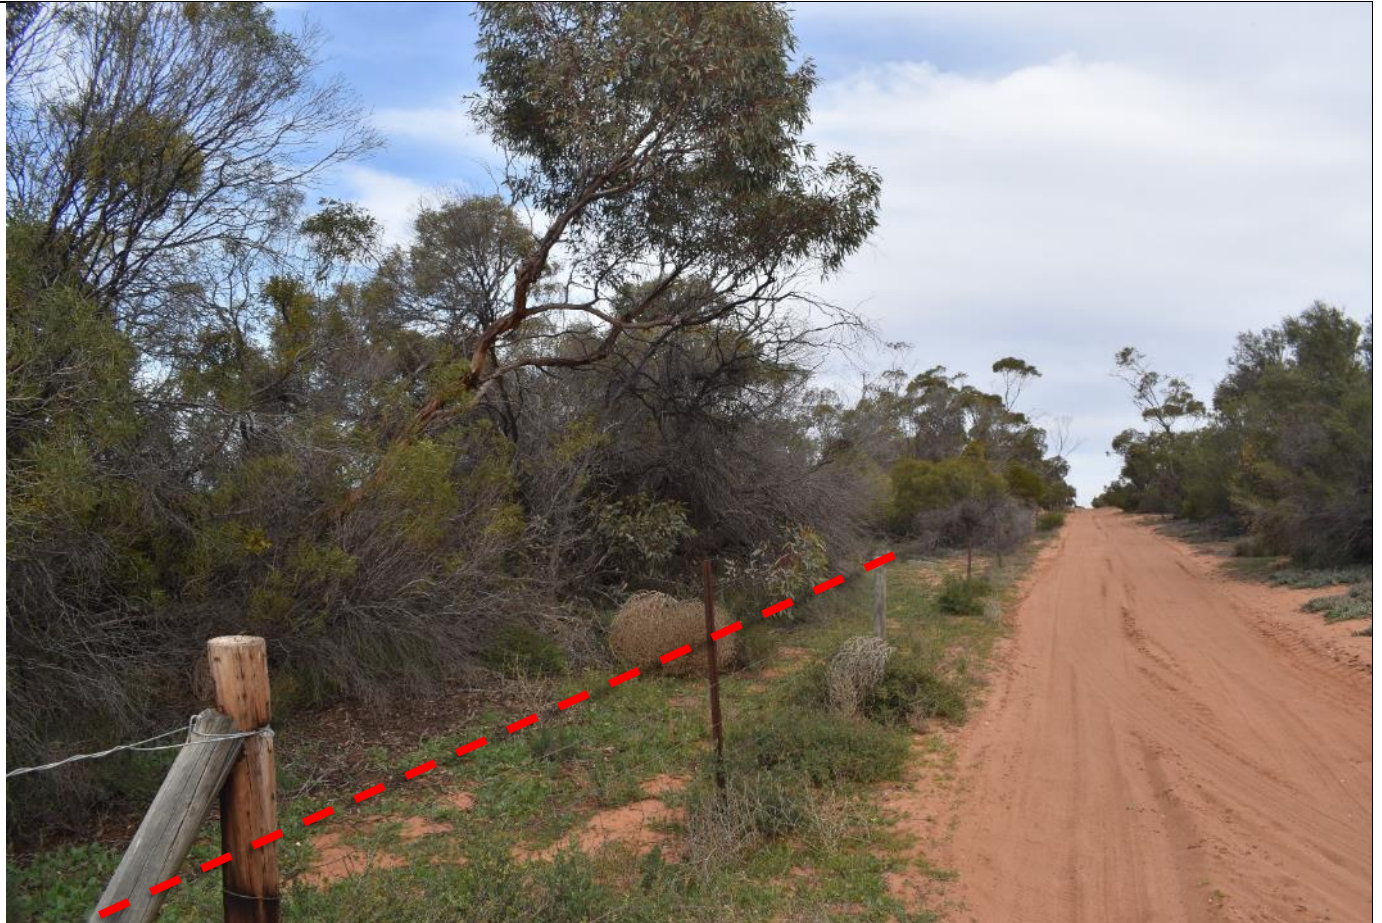
Photo 13. Looking south from the centre of the Site. A patch of remnant bushland can be seen to the right of the photo. The impact is confined to 3m to the east of the fenceline. The patch is subject to edge effects and weed invasion at the northern end but this reduces further south as a result of buffering from the larger remnant.

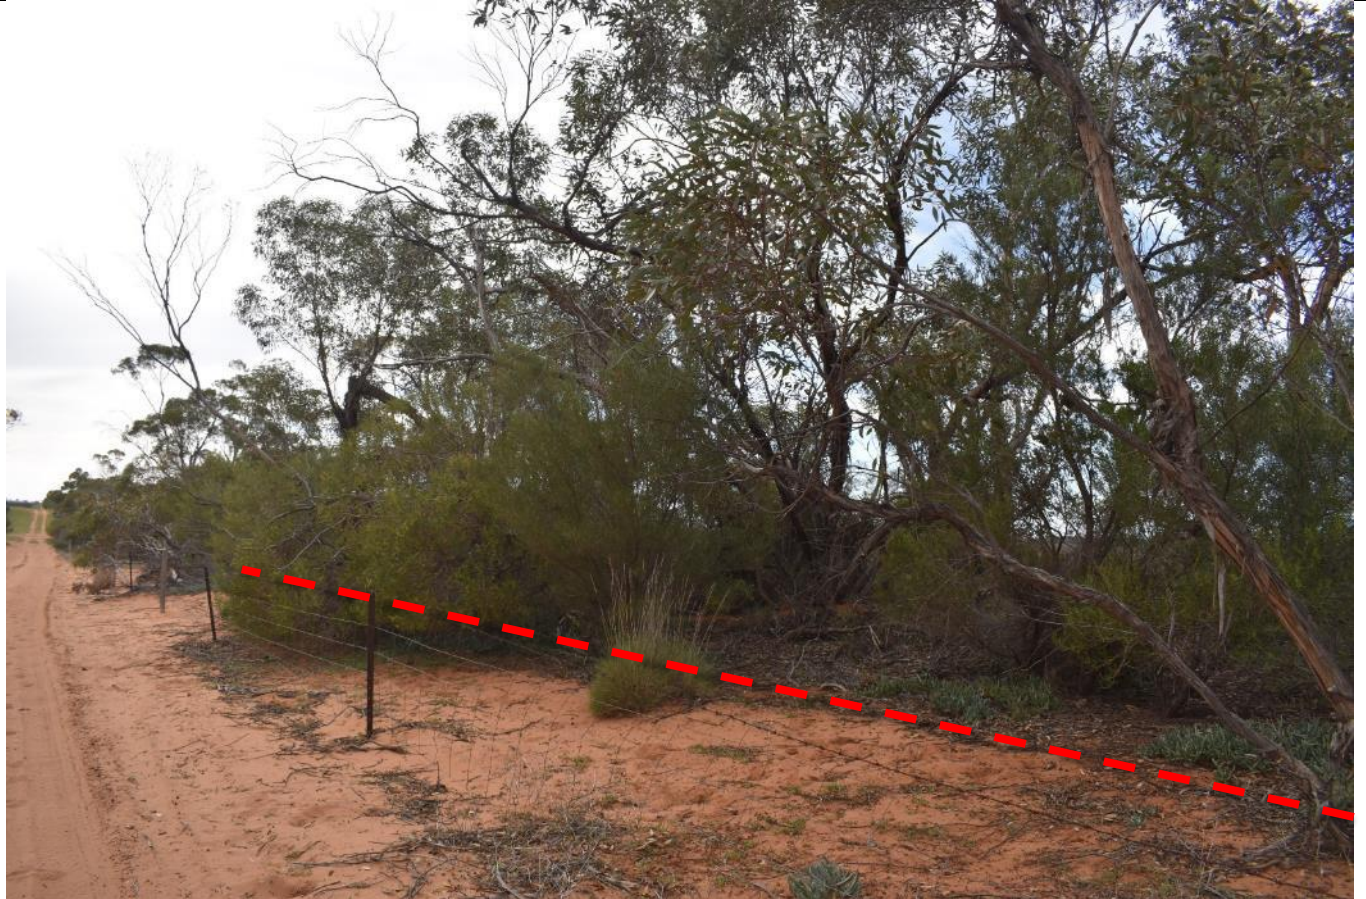
Photo 14. Looking north from the southern end of the patch where works finish. 3m from the western fenceline is impacted by excavation and pipe installation. Immediately south of where this photo was taken, the works divert in a south westerly direction into a bare paddock.
