## Native Vegetation Clearance

## Berri Solar Farm

## Data Report

# Clearance under the *Native Vegetation Regulations 2017* 22/04/2021

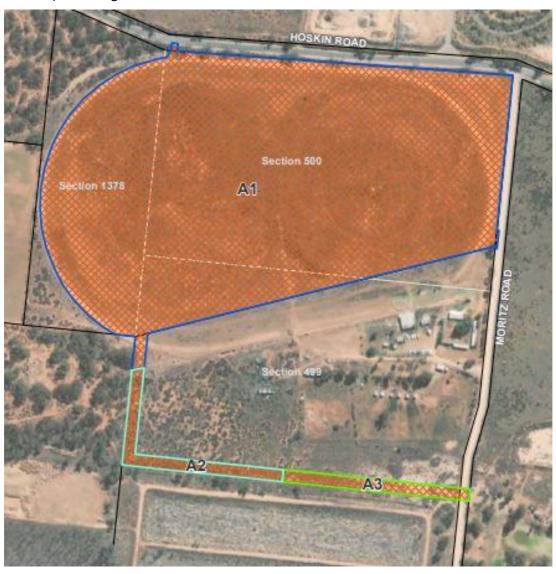
Site Map showing the three areas A, B and C

Area A is proposed for the solar array while areas b and C are to facilitate the transmission line to connect to the grid.

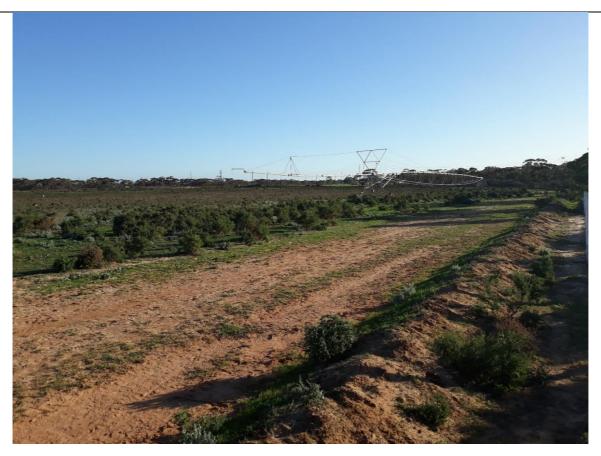
Location 463212 6209218 Northern side of Site A1 looking South West

General description	Regenerating low open shrub land of <i>Maireana pyramidata, Dissocarpus paradfoxus</i> and assorted chenopods and scattered annuals						
Threatened species or community	There were no threatened flora, fauna or communities located in the A1 site						
Landscape context score	1.14 Vegetation 19.25 Conservation 1 significance score						
Unit biodiversity Score	21.95	Area (ha)	16.24	Total biodiversity Score	356.39

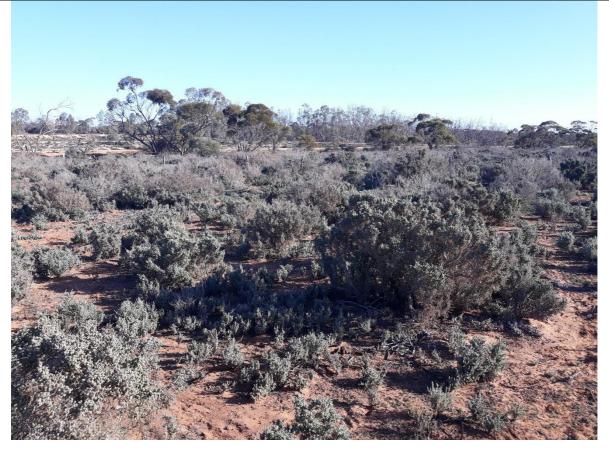
Location 463162 6208873 Northern side of Site A2 looking South

General description		Open shrub land of <i>Maireana pyramidata</i> with scattered <i>Eucalyptus dumosa</i> and <i>Dodonaea viscosa</i>						
Threatened species or community	There were no	There were no threatened flora, fauna or communities located in the A2 site						
Landscape context score	1.13	1.13 Vegetation 26.71 Conservation 1 significance score						
Unit biodiversity Score	30.18	Area (ha)	0.46	Total biodiversity Score	13.88

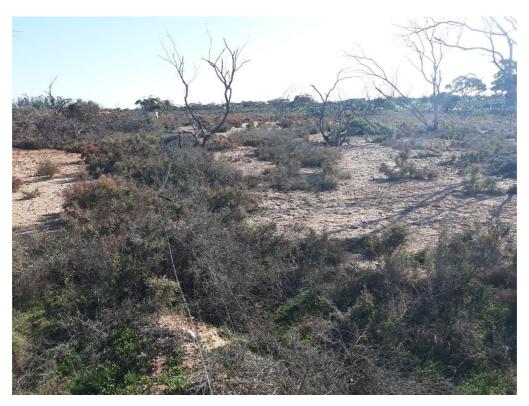
Location 463444 6208756 Eastern Side of Site A3 looking West

General description	Salt affected degraded Mallee with <i>Maireana pyramidata, Dissocarpus paradfoxus</i> and <i>Atriplex lindleyi</i> amongst scattered annuals							
Threatened species or community	There were no threatened flora, fauna or communities located in the A3 site							
Landscape context score	1.13 Vegetation 20.40 Conservation 1 Significance score							
Unit biodiversity Score	23.05	3

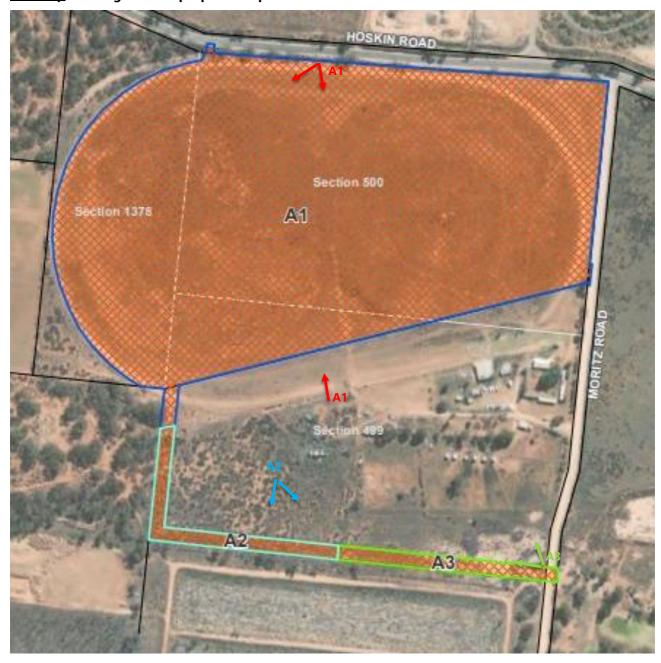
#### Site map showing areas of proposed impact

See the map above for photo locations according to each assessment site.
