Native Vegetation Clearance

Stage 2, VS 2020/025 Part 1G Horrocks Highway Upgrade Undalya to Giles Corner, MM 206 to MM 225.170 Shoulder Sealing, Culvert Extensions and Guard Fence Installation Data Report

Clearance under the *Native Vegetation Regulations 2017*

8 March 2021

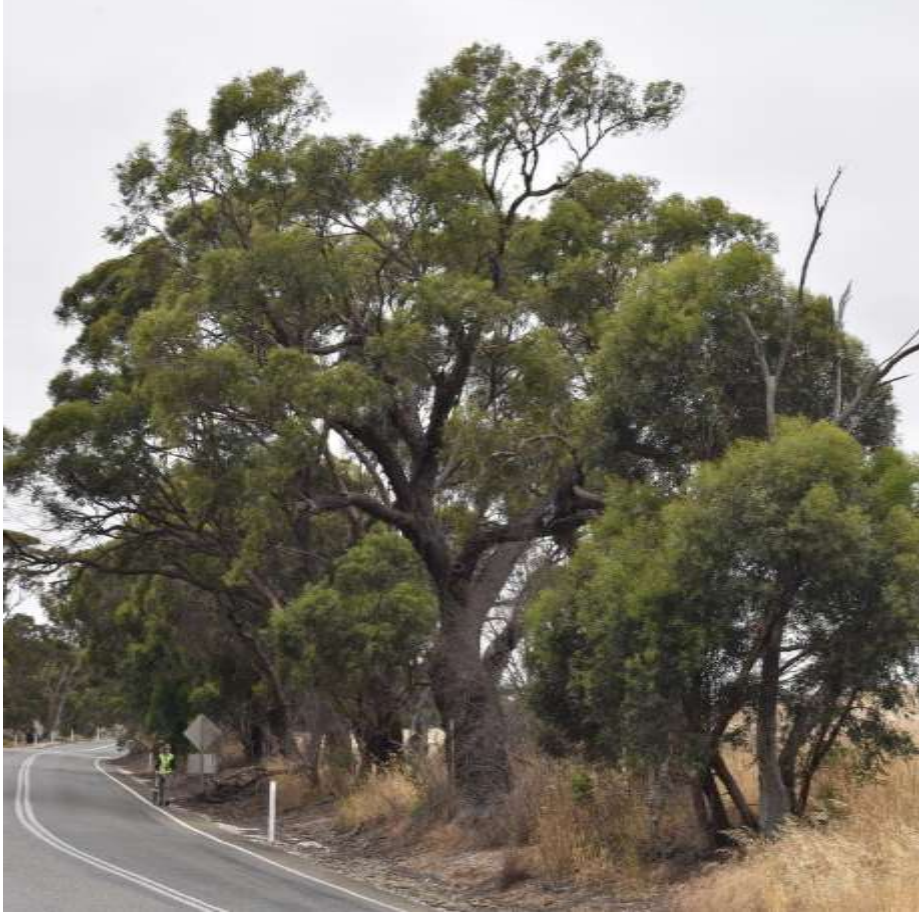
Photo 1. Looking south from approximate MM215.9, GPS 287621/6217858. Understorey is mainly exotic herbaceous and woody species dominated by *Avena barbata/fatua* (Wild Oats). *Olea europaea* and *Rosa canina* were present across much of the association as scattered individuals or groups. A few scattered patches of native grasses/herbs exist closer to the wider remnant patch around MM 215.5 – MM 217.2, but elsewhere the understorey is almost exclusively exotic.

Vegetation Condition Score	██████████	██████████	██████████																																												
		South																																													
		GPS Reference																																													
		Datum WGS84																																													
		Zone (52, 53 or 54) 54																																													
		Easting (6 digits) 287621																																													
		Northing (7 digits) 6217858																																													
		Description

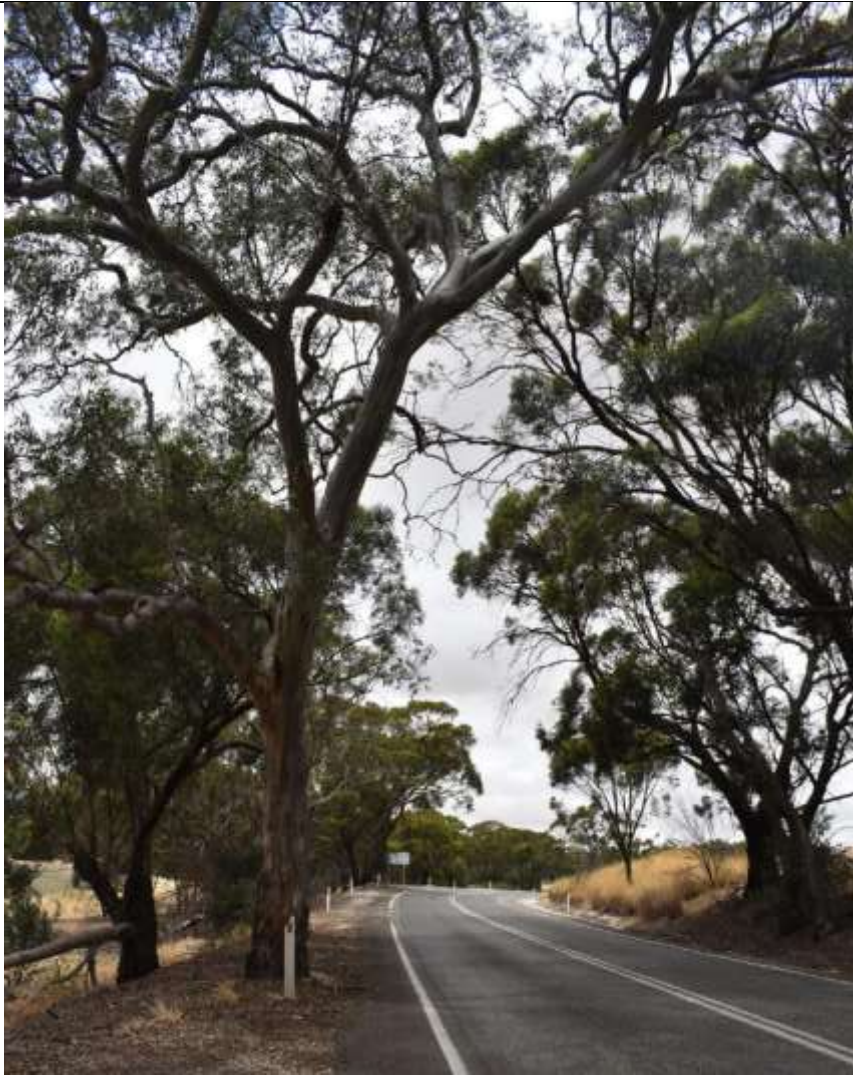
Photo 2. Looking south from approx. MM 216.3, GPS 287730/6217495. In the middle distance the larger remnant is visible. Associated roadside vegetation is subject to impact. Mid storey, where present, is dominated by *Olea europaea* and understorey is dominated by *Avena barbata/fatua* (Wild Oats). Aleppo Pine occurs amongst the remnant, quite densely around MM 217.

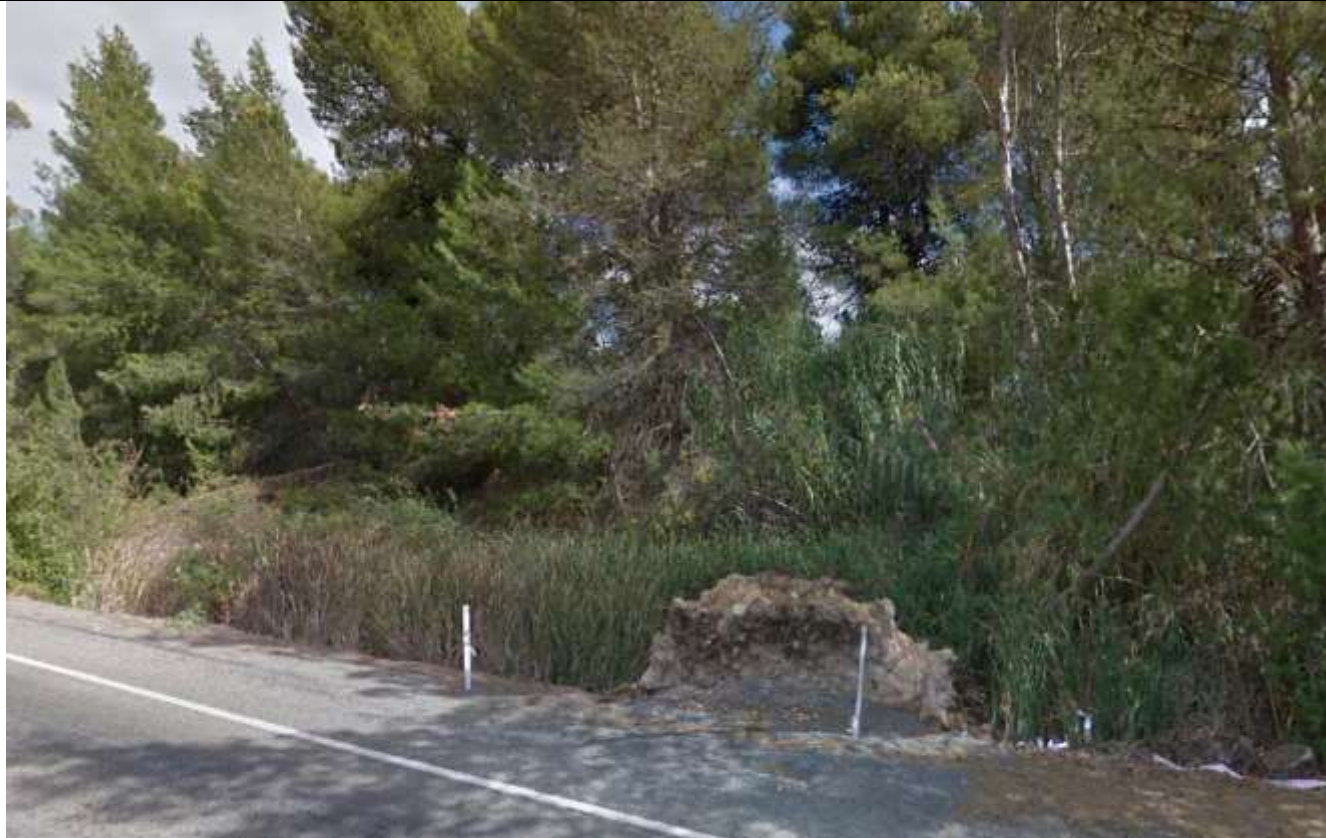
Photo 3. Looking south west from approx. MM 206.05, GPS 287252/6227266. The reeds occur in the deeper part of the creek which is fringed by exotic species including declared weeds. Drainage infrastructure is to be cleaned out, headwalls replaced, and scour protection provided.

General description	Phragmites and Typha dominate the vegetation in the watercourse at this site. The remnant was observed to be in poor condition with proliferation of the two native species. An estimated that 0.027ha of this association will be impacted by drainage upgrade works.				
Threatened species or community	Not applicable. No threatened flora or fauna species were observed. Threatened fauna species recorded as occurring in the area include the (State listed) White-winged Chough, Black Falcon, Jacky Winter, Diamond Firetail and Common Brushtail Possum. No EPBC species were listed under the search criteria.				
Landscape context score	1.2	Vegetation Condition Score	19.37	Conservation significance score	1.06
Unit biodiversity Score	24.64	Area (ha)	0.027	Total biodiversity Score	0.67
