Natural Resources SA Murray-Darling Basin Wetland and Floodplain Program

Environmental Water Review 2014-15

**Government
of South Australia**

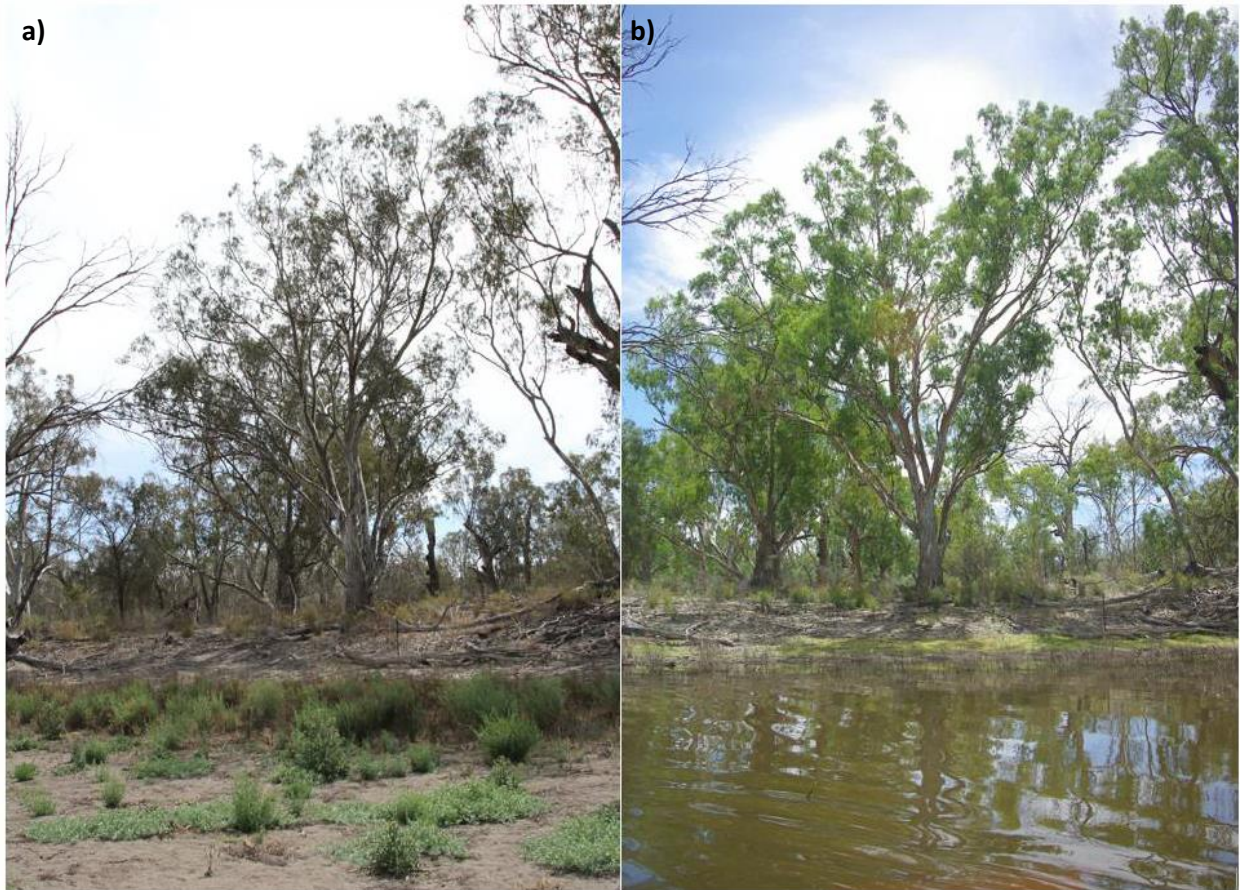
Figure 1. a) pre-watering photo, b) post watering photo, Wiela Wetland, 2014-15.

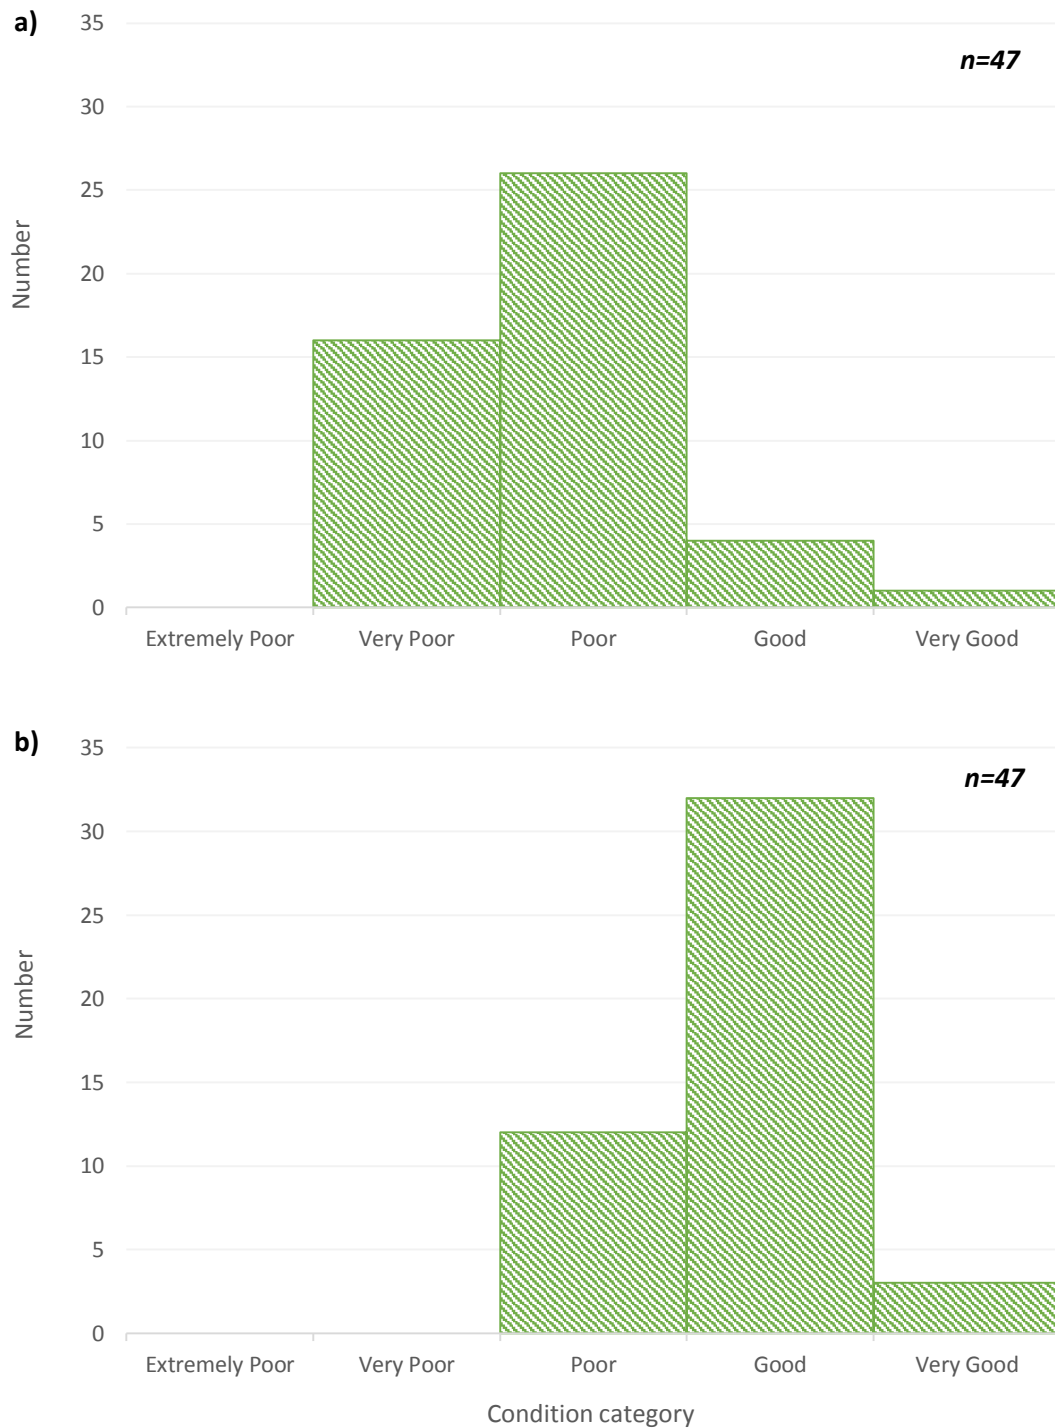
The majority of trees monitored prior to the site receiving water were scored as in 'Very poor' ($n=16$) to 'Poor' ($n=26$) condition, with few trees in the 'Good' ($n=4$) and one tree in 'Very good' condition (Figure 2). Six weeks following watering, the majority of trees were recorded to be in 'Good' ($n=32$) condition, with three in 'Very good' condition and twelve in 'Poor' condition.

Figure 2. Tree condition before and six weeks following water delivery, Markaranka Flat Wetland Complex, a) November 2014 b) February 2015.

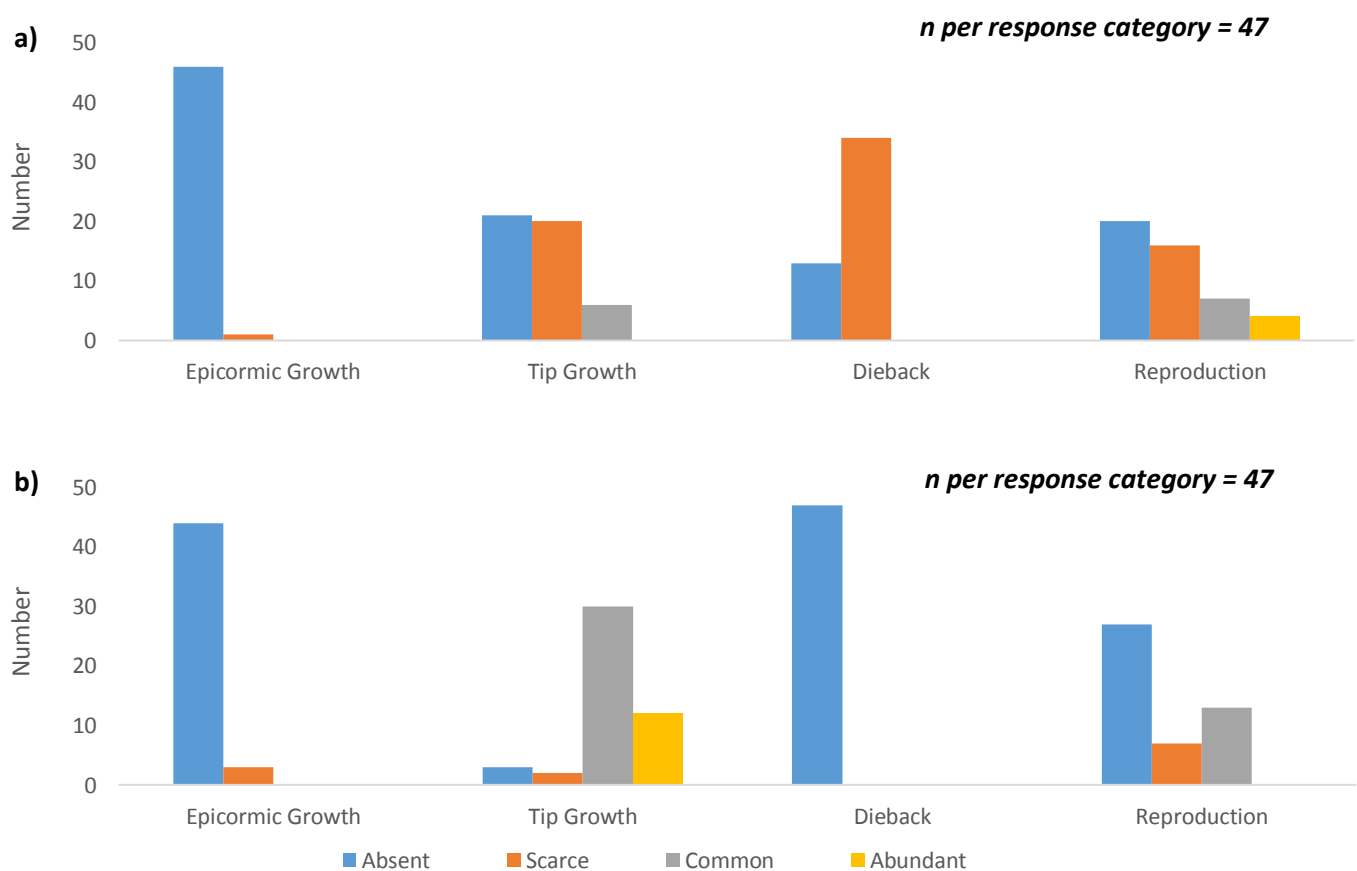
There was no clear change in reproduction scores over time with similar numbers recorded showing no sign of reproduction before ($n=20$) and after watering ($n=26$). Most other trees were scored as having scarce or common signs of reproduction both before and after watering.

Figure 3. Tree response (epicormic growth, tip growth, dieback and reproduction), Markaranka Flat Wetland Complex, a) November 2014 b) February 2015.

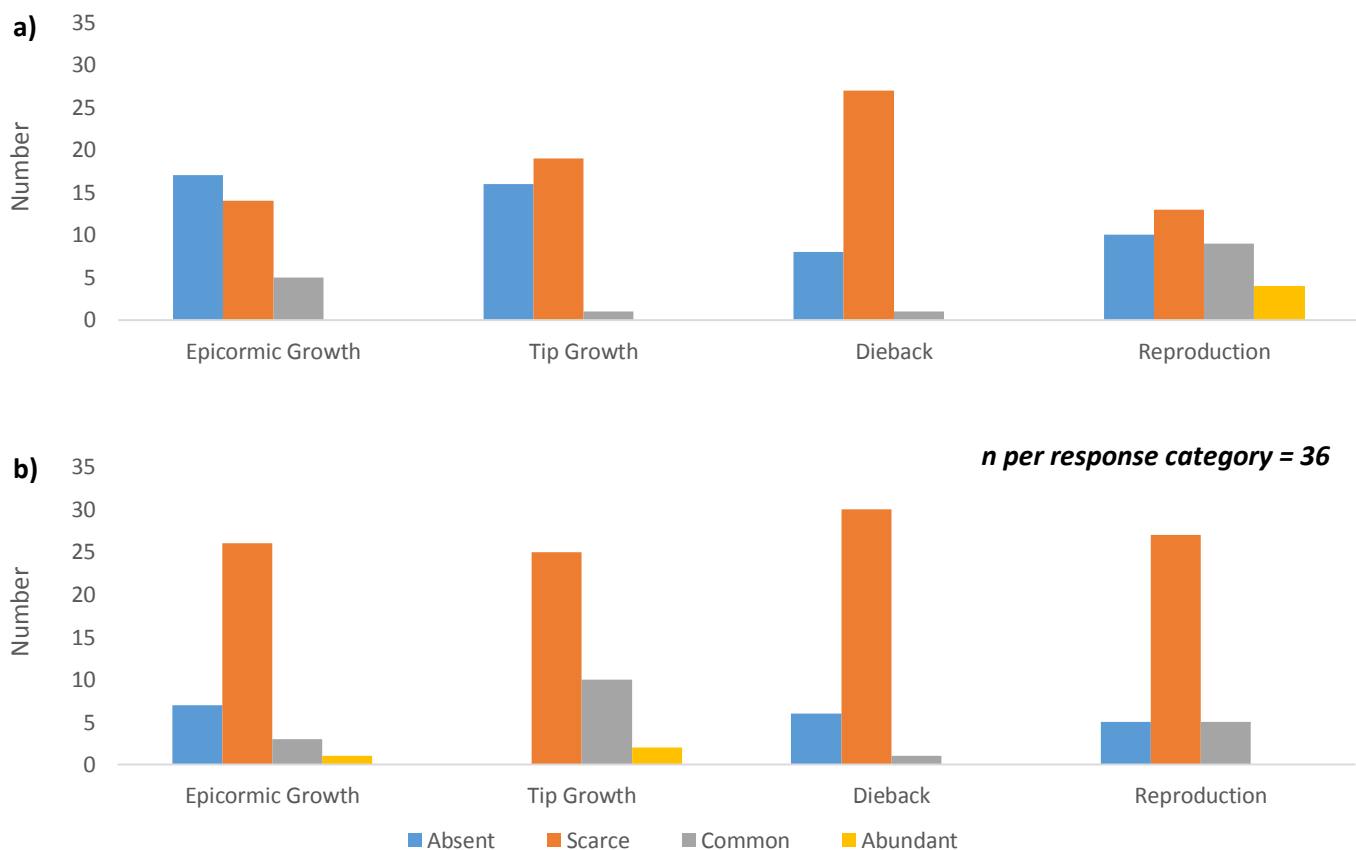
Figure 5. Tree response (epicormic growth, tip growth, dieback and reproduction) Molo Flat Wetland Complex, a) November 2014 b) February 2015.

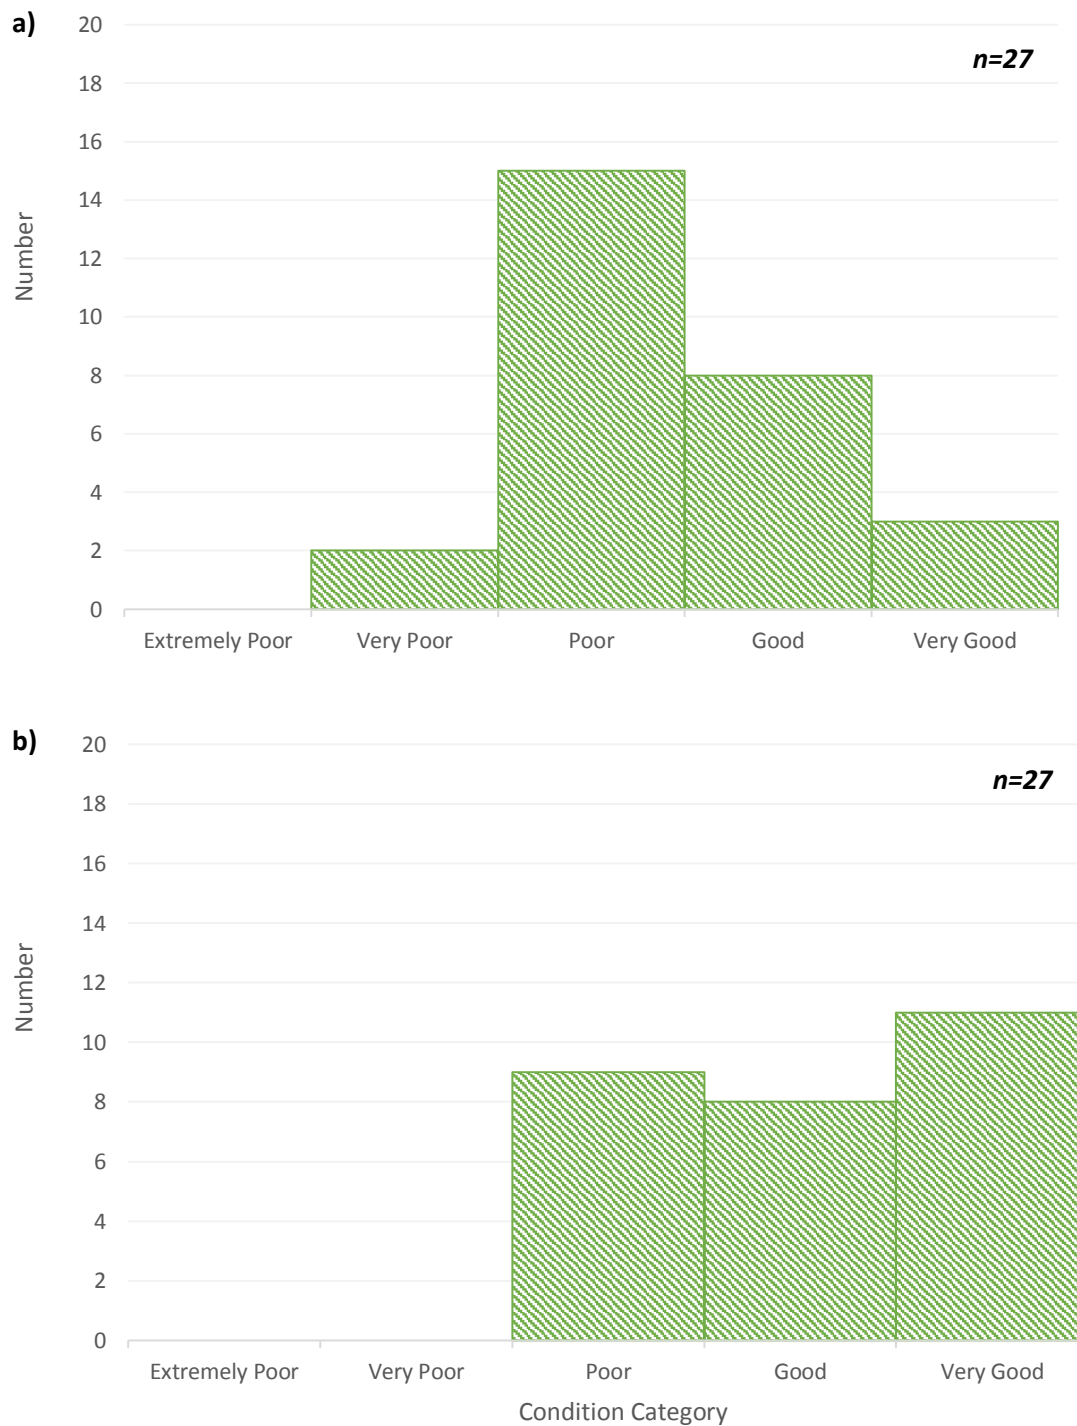
At Wiela Wetland, the most frequent tree condition class prior to watering was 'poor' (n=15), whereas after watering, more trees were classed in 'good' and 'Very good' condition (n=19) and no trees were classed as 'Very poor' (Figure 6).

Figure 6. Tree condition before and six weeks following water delivery, Wiela Wetland, a) November 2014 b) January 2015.

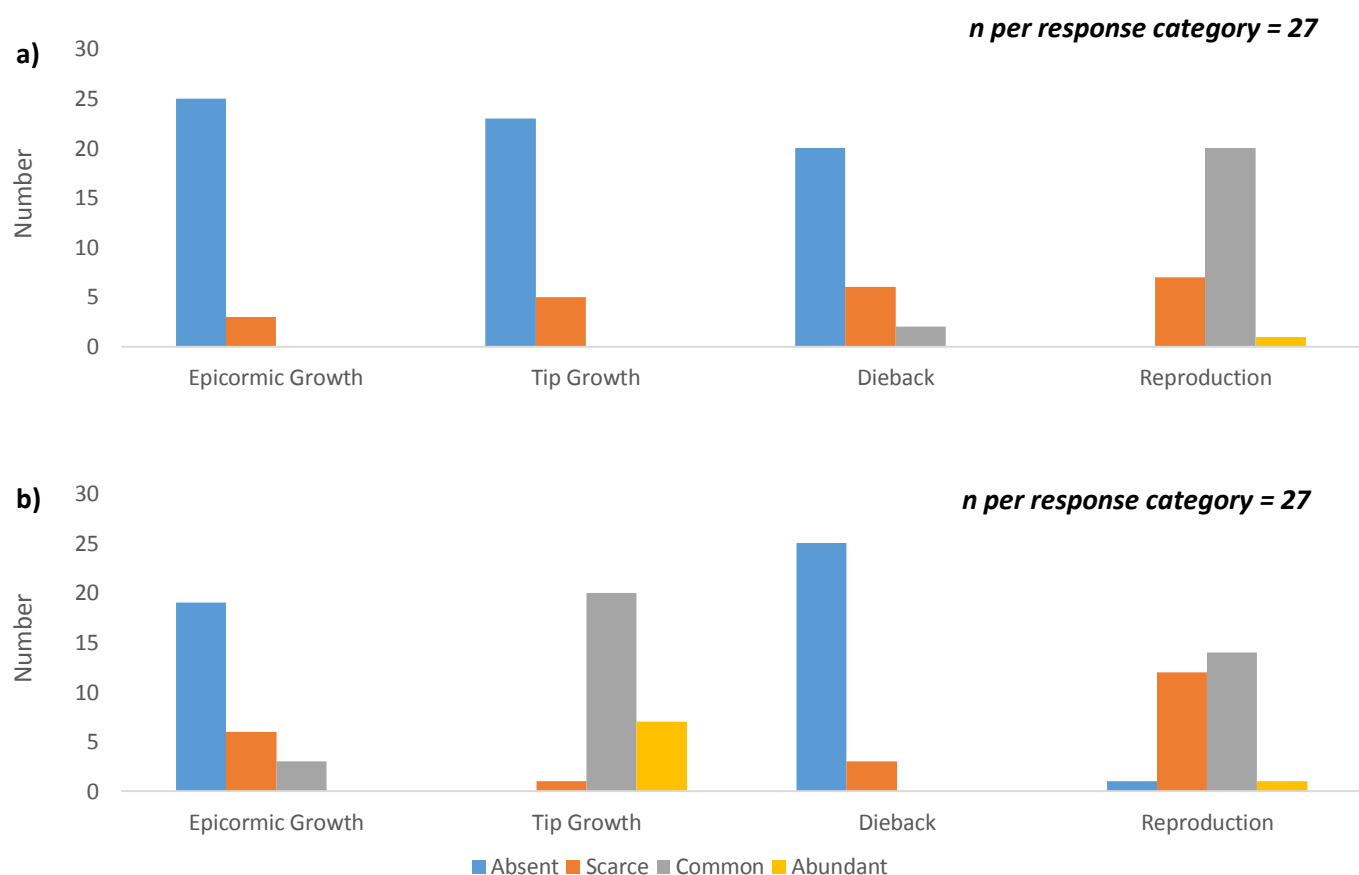
Scores of the extent of reproduction was similar before and after watering. Prior to watering commencing, reproduction was observed in all trees (*scarce=7; common=20; abundant=1*). Following watering, reproduction was observed in all but one tree (*scarce=12; common=14; abundant=1*).

Figure 7. Tree response (epicormic growth, tip growth, dieback and reproduction), Weila Wetland, a) November 2014 b) January 2015.

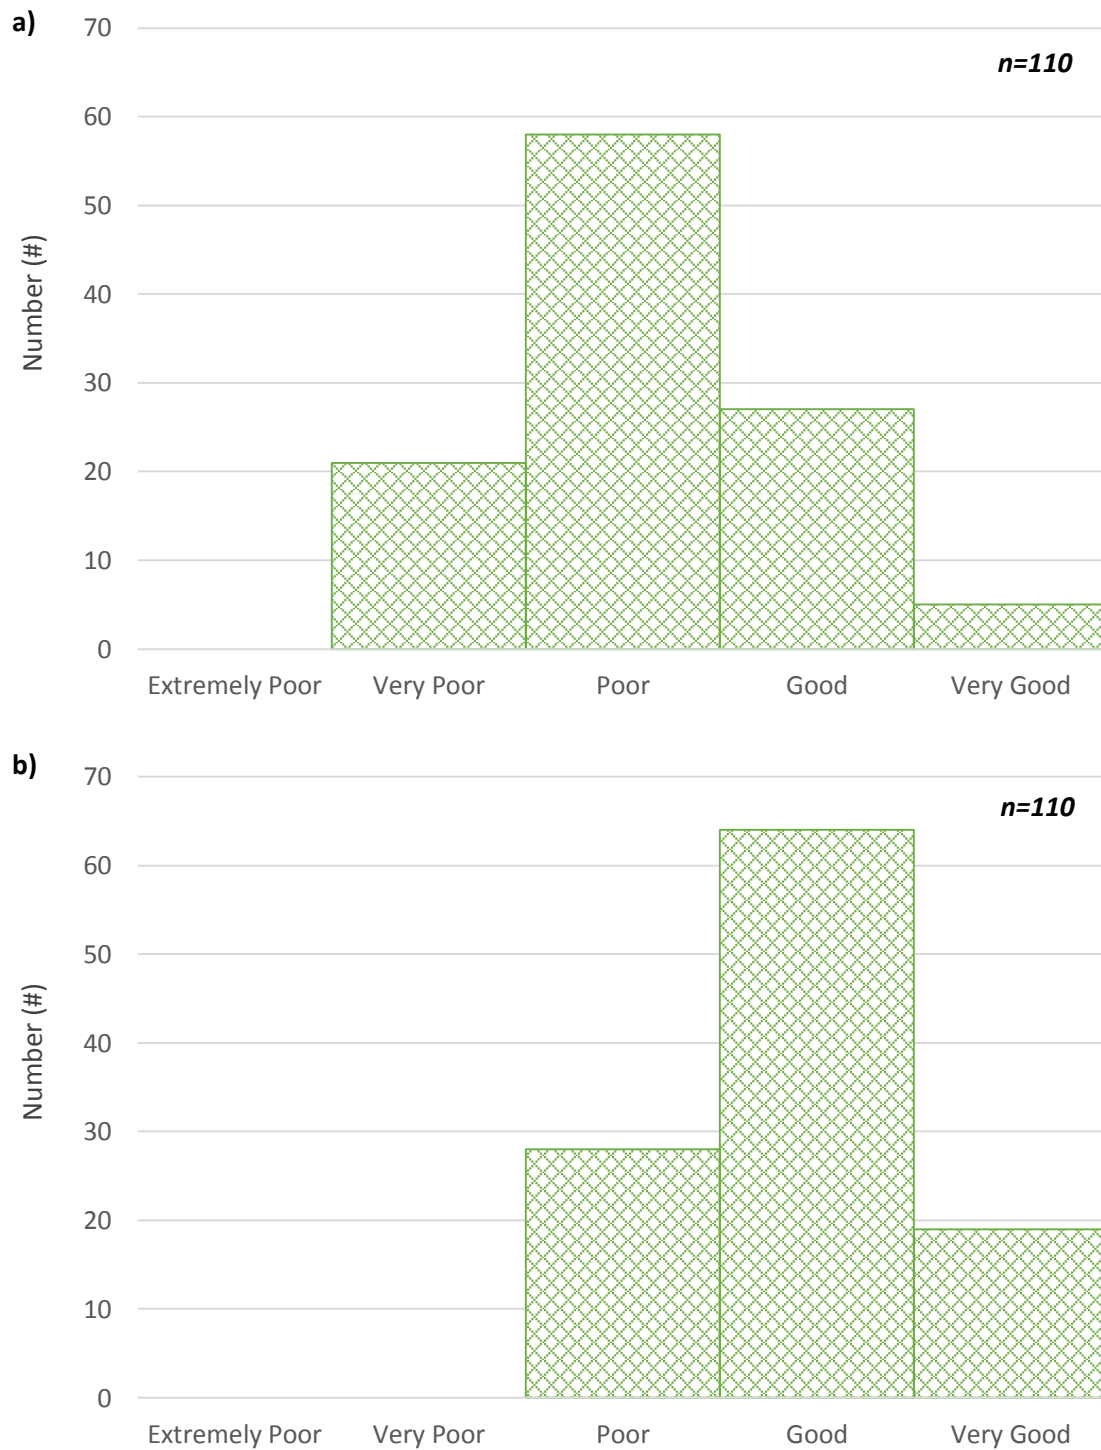
All monitored trees were grouped together to evaluate trends across sites. Overall, across all three wetlands, trees showed a clear positive improvement in condition over time, with a decrease in the number of trees scored in 'Poor' condition and an increase in the number of trees scored as 'Good' or 'Very good' during the six weeks post-inundation surveys (Figure 8).

Figure 8. All tree condition before and six weeks following water delivery across all sites, a) November 2014 b) January 2015.

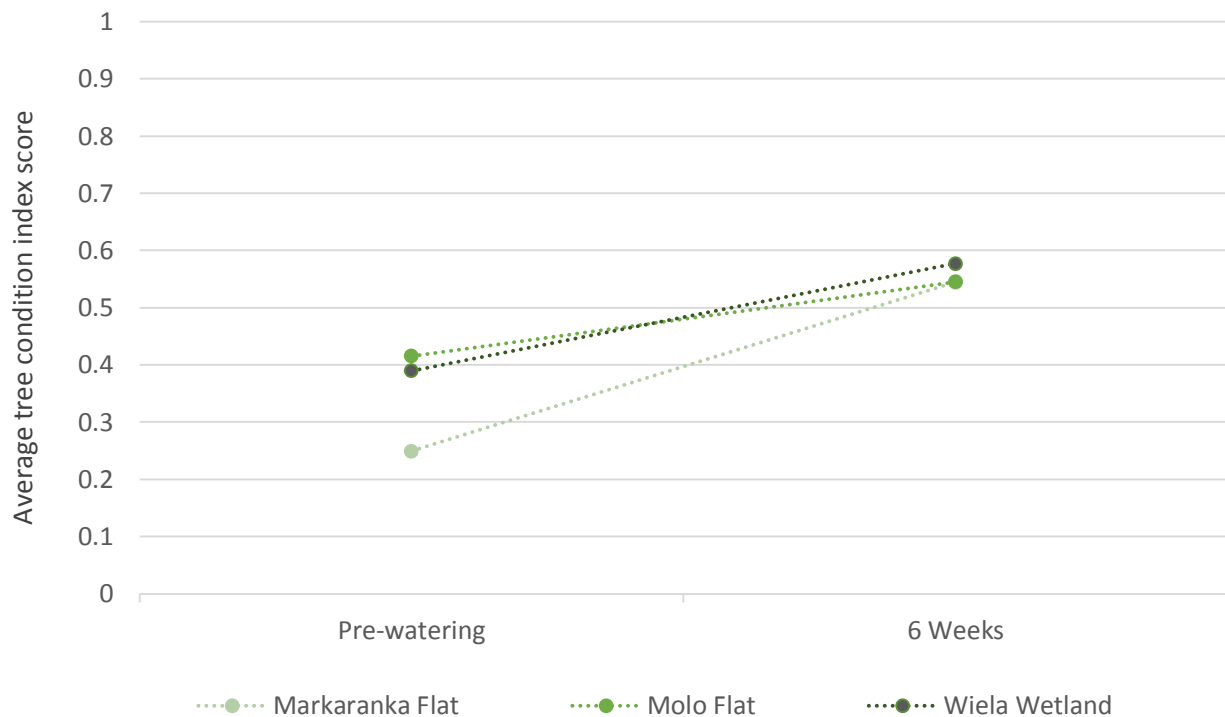
The average tree condition score showed a clear increase following environmental water delivery across all three monitored wetland sites (Figure 9). The greatest change in average condition was observed in tree condition at Markaranka. Initially average tree condition across trees at the site was 'Very poor', however six weeks following watering, average tree index score increased with average tree condition in the 'Good' condition category. Similar trends were observed at Molo Flat and Wiela Wetland as demonstrated below.

Figure 9. Average tree condition index score across monitored sites (Markaranka Flat Wetland Complex, Molo Flat Wetland Complex and Wiela Wetland), pre-watering and six weeks following watering commencement.

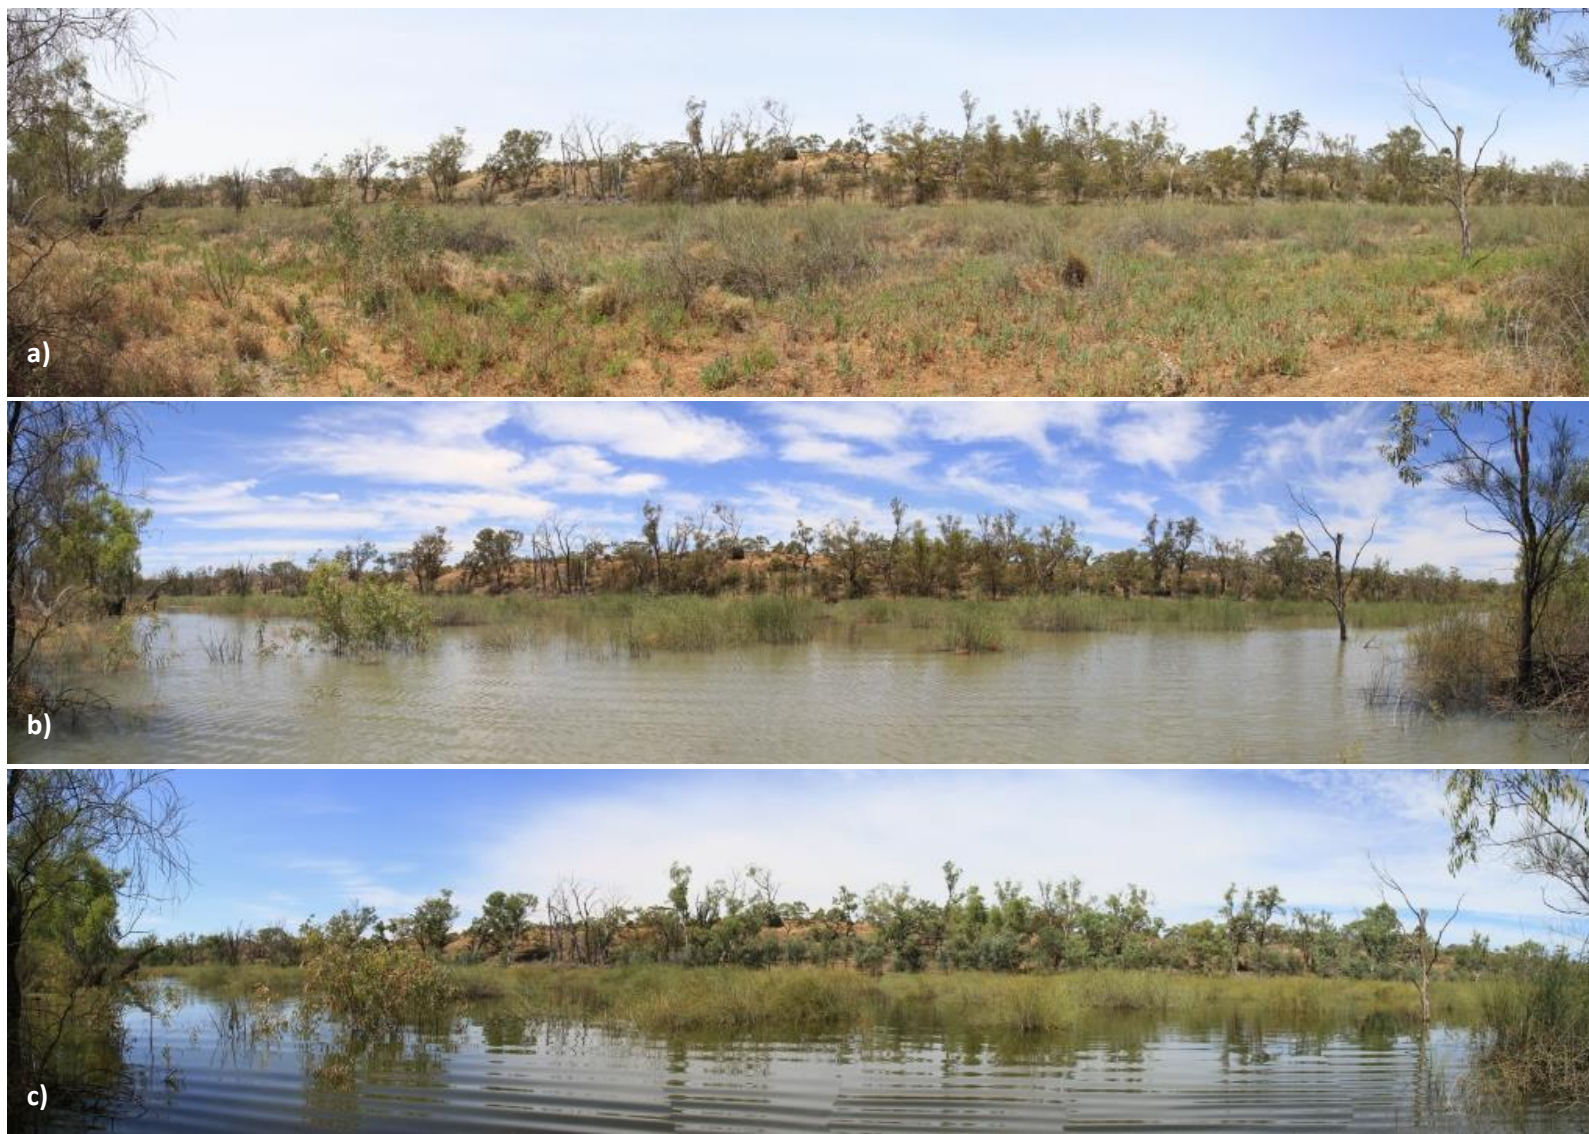
Figure 14 shows a clear response by the vegetation surrounding and within the wetland basin to the delivery of environmental water at Molo Flat in December 2014. Initially in November 2014 (Figure 14 a), the wetland basin was dry and the bed was dominated by terrestrial vegetation and the large river red gums at the base of the cliff displayed poor crown extent and density. Figure 14 (b) shows the wetland basin approximately four weeks following the delivery of environmental water. The lignum within the wetland basin displayed new tip growth while a slight increase in crown density in the trees on the far-side of the wetland basin was observed. Figure 14 (c) was taken in March 2015, four months following the commencement of watering at the site. The lignum in the foreground showed increased greening and growth while the river red gums in the background exhibited a notable greening and increase in both crown extent and density.

Figure 14. Molo Flat wetland basin MFPP04 a) November 2014; b) December 2014; c) March 2015.

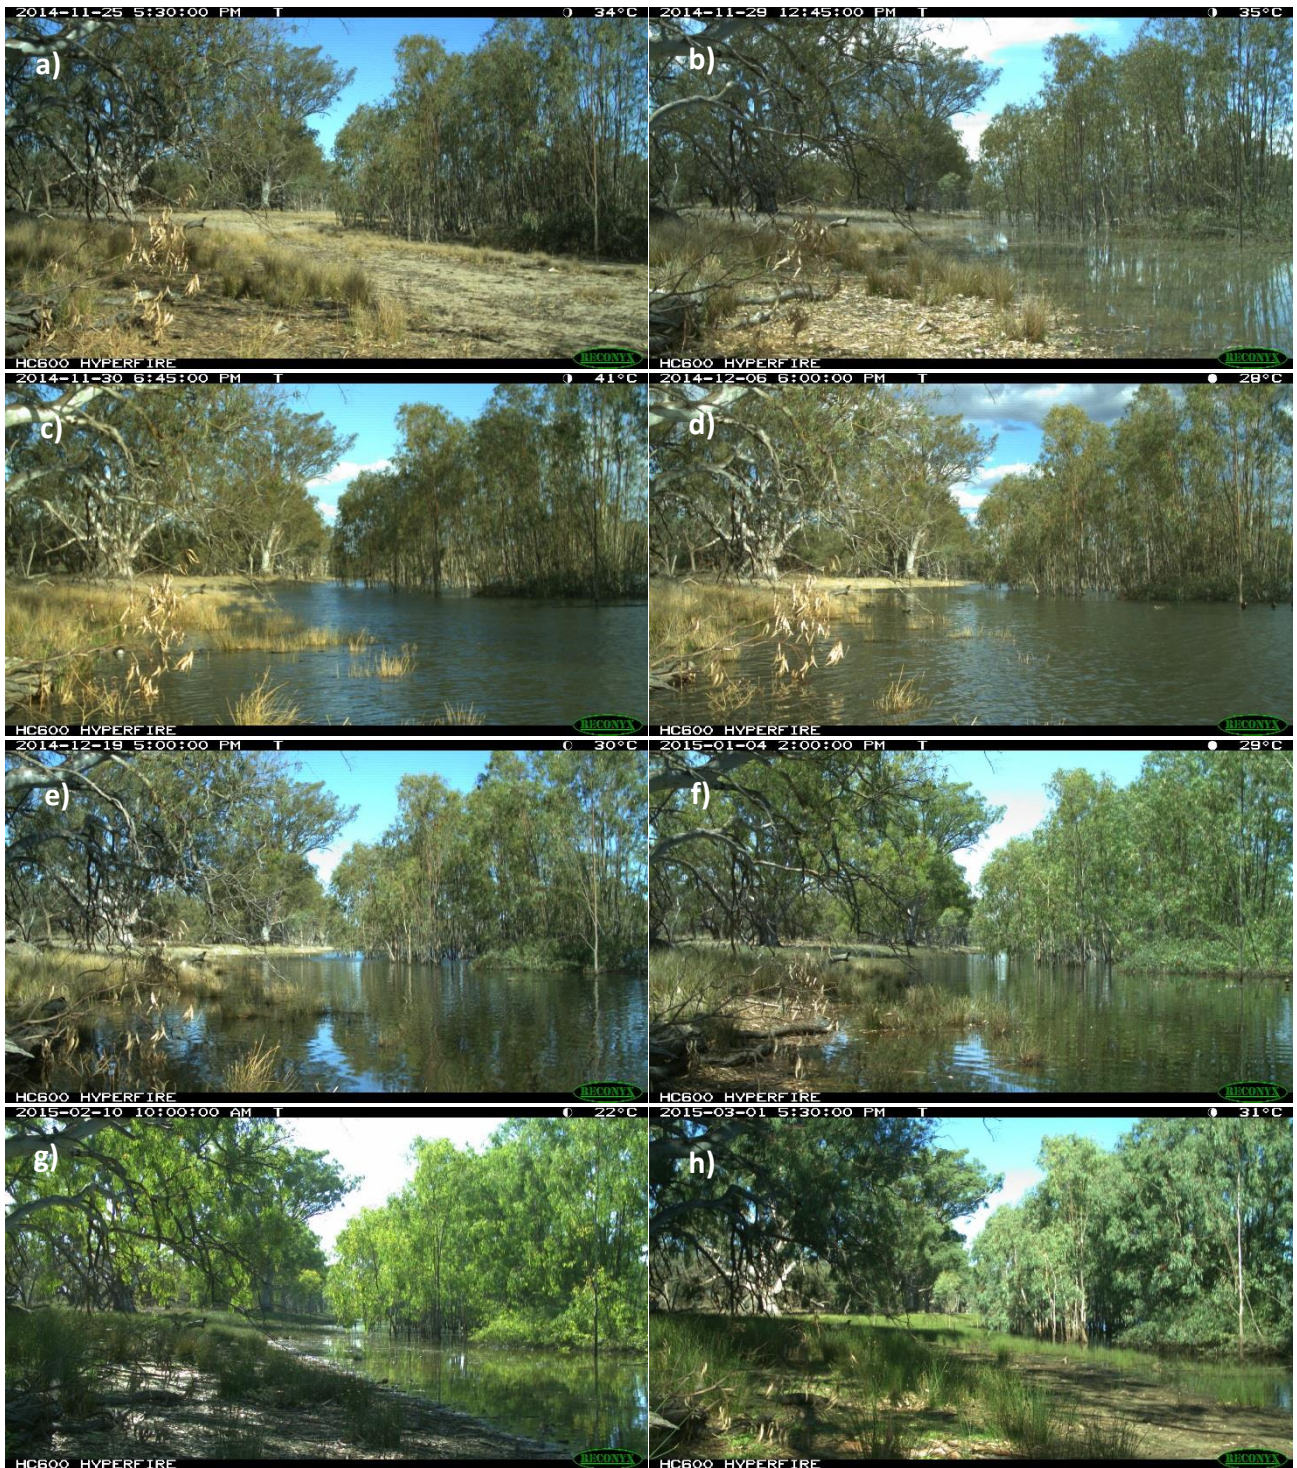
The following figure (Figure 15) demonstrates the vegetation response to environmental water delivery at Akuna Wetland. A large increase in tip growth and consequently the crown extent and density of the river red gums was observed over time, and an increase in the growth and cover of sedges fringing the wetland basin as water levels drew down at the site.

Figure 15. Time lapse photos at Akuna Wetland. a) 25 Nov 2014, b) 29 Nov 2014, c) 11 Nov 2014, d) 6 Dec 2014, e) 19 Dec 2014, f) 4 Jan 2015, g) 10 Feb 2015, and h) 1 Mar 2015.

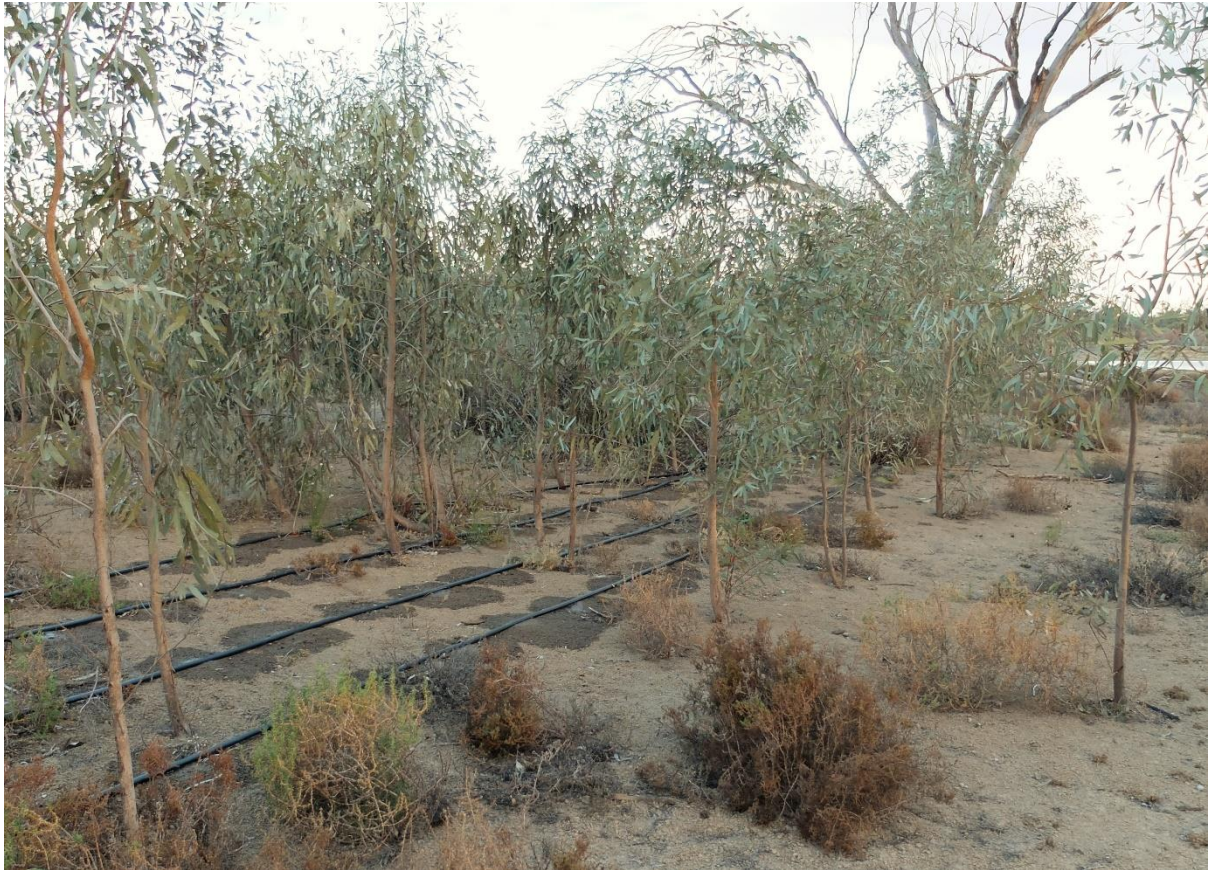
Figure 22. Dripper irrigation infrastructure delivering water to natural strandlines of river red gum saplings at Wiela Shedding Basin.

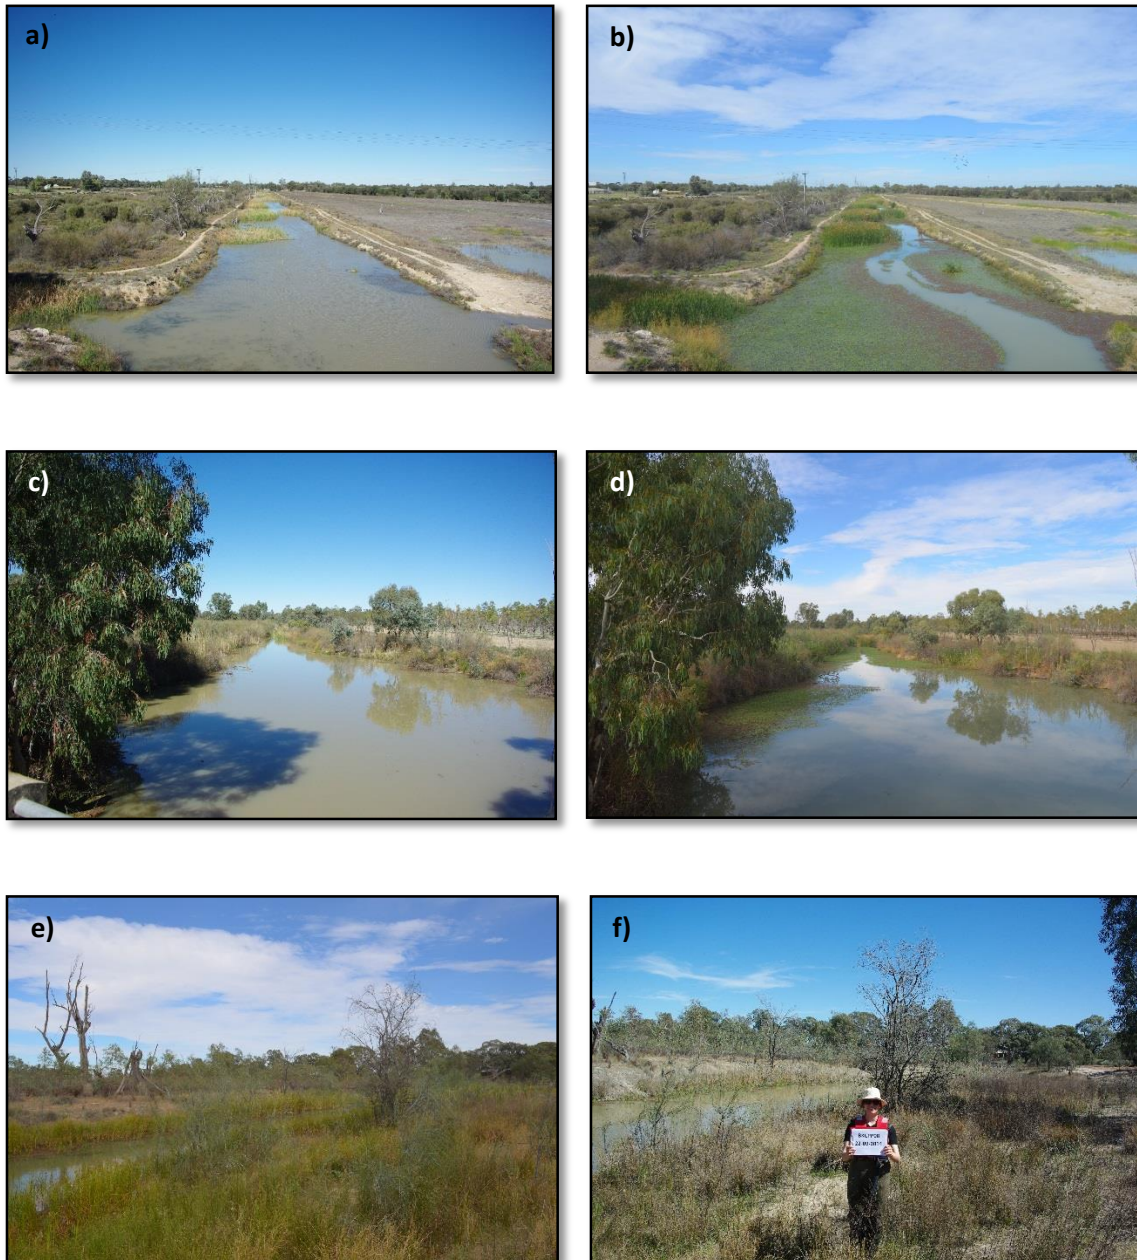
Figure 37. Bookmark Creek photopoint BCKPP03 D/S a) September 2014 b) March 2015; Bookmark Creek photopoint BCKPP04 D/S c) September 2014 d) March 2015; BCKPP07 e) September 2014 f) March 2015.

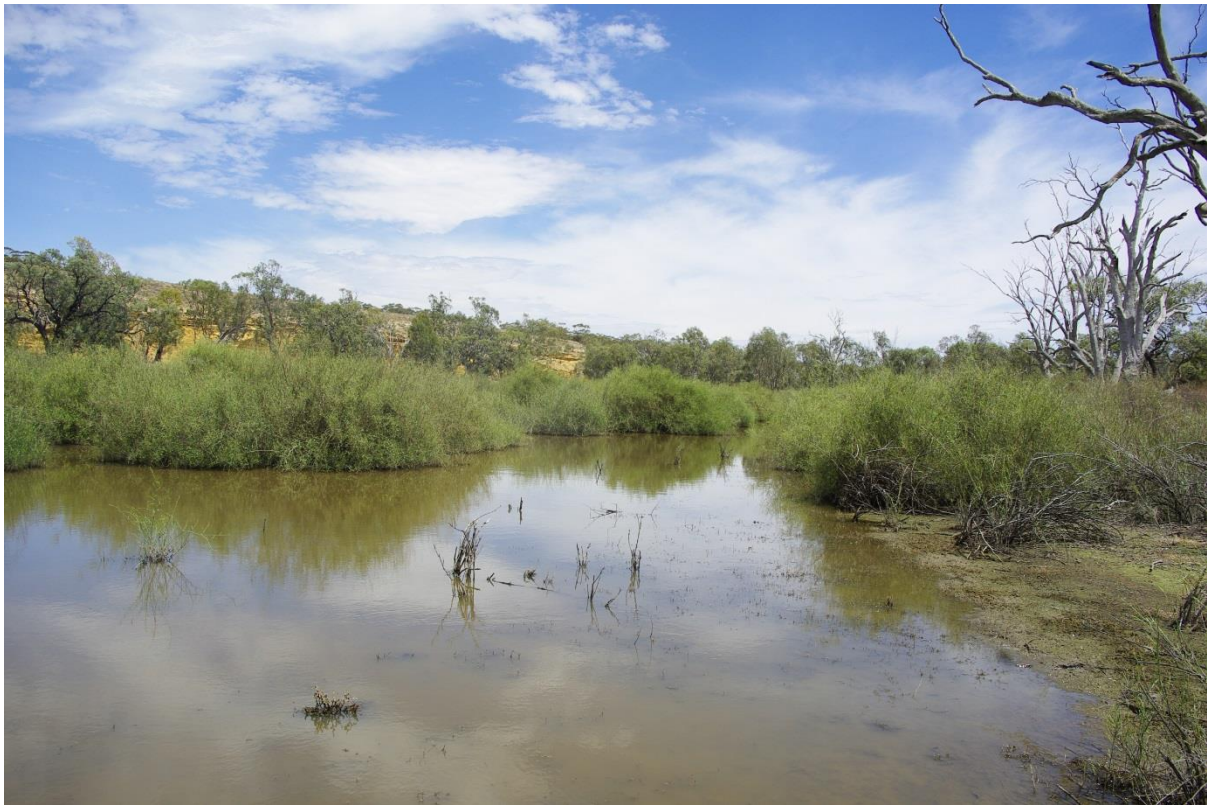
Figure 45. Lush lignum growth at Sugar Shack Wetland 6 following environmental watering, December 2014.
