Native Vegetation Clearance

Stage 2, VS 2020/025
Horrocks Highway Upgrade
Isolated High Risk Sites
MM 151.5 to MM 248.3
Undulation and Drainage Issues
and High Risk Curve

Data Report

2 September 2021

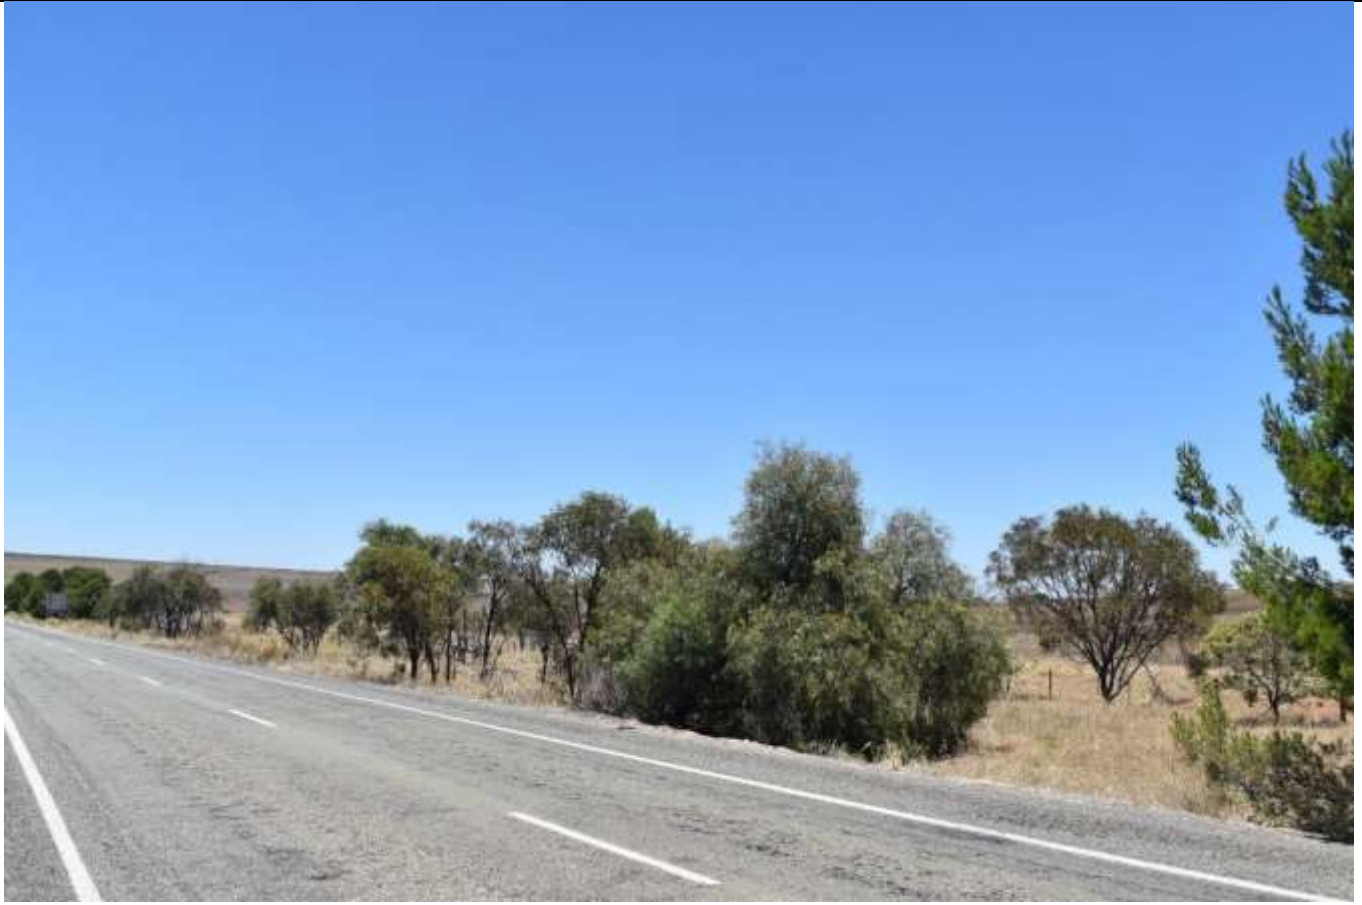
Photo 1. Looking southwest across the road reserve from approximate MM 151.0, RHS. GPS 264210/6269511. Impacted by hazard reduction and widening including fill batters.

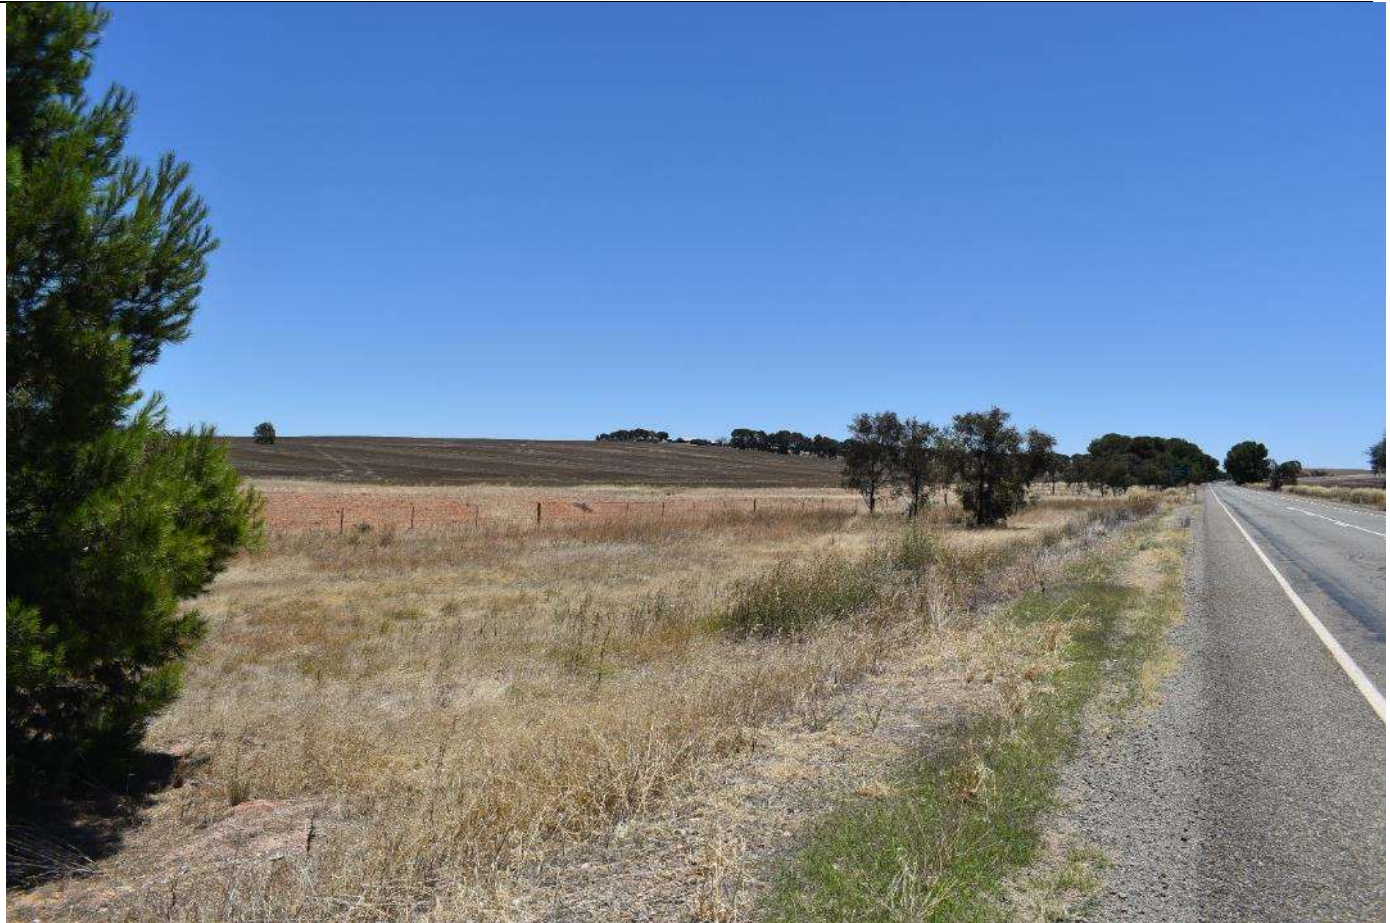
Photo 2. Looking northwest at the road reserve vegetation from approximate MM 151.3, RHS. GPS 264282/6269338. The ground layer consisted of patches of *Themedia triandra* and *Rytidosperma caespitosum*. in good condition, although patchy. Impacted by hazard reduction and widening including fill batters.

General description	<i>Accia pycnantha</i> dominated the overstorey with few scattered <i>Bursaria spinosa</i> , <i>Accia ligulata</i> , <i>Senna artemisioides ssp. filifolia</i> , and a single <i>Santalum acuminatum</i> . The ground layer included <i>Themeda triandra</i> , <i>Rytidosperma caespitosum</i> and very few scattered <i>Dianella revoluta</i> , <i>Lomandra effusa</i> and <i>Enchylaena tomentosa</i> amongst dense Wild Oats and other grassy weeds. Also present were <i>Pinus halepensis</i> , <i>Schinus molle</i> , <i>Olea europaea</i> , <i>Rosa canina</i> and <i>Marrubium vulgare</i> .				
Threatened species or community	The association is not considered threatened under the NP&W Act or EPBC Act				
Landscape context score	1.13	Vegetation Condition Score	14.00	Conservation significance score	1.04
Unit biodiversity Score	16.45	Area (ha)	0.478	Total biodiversity Score	7.86

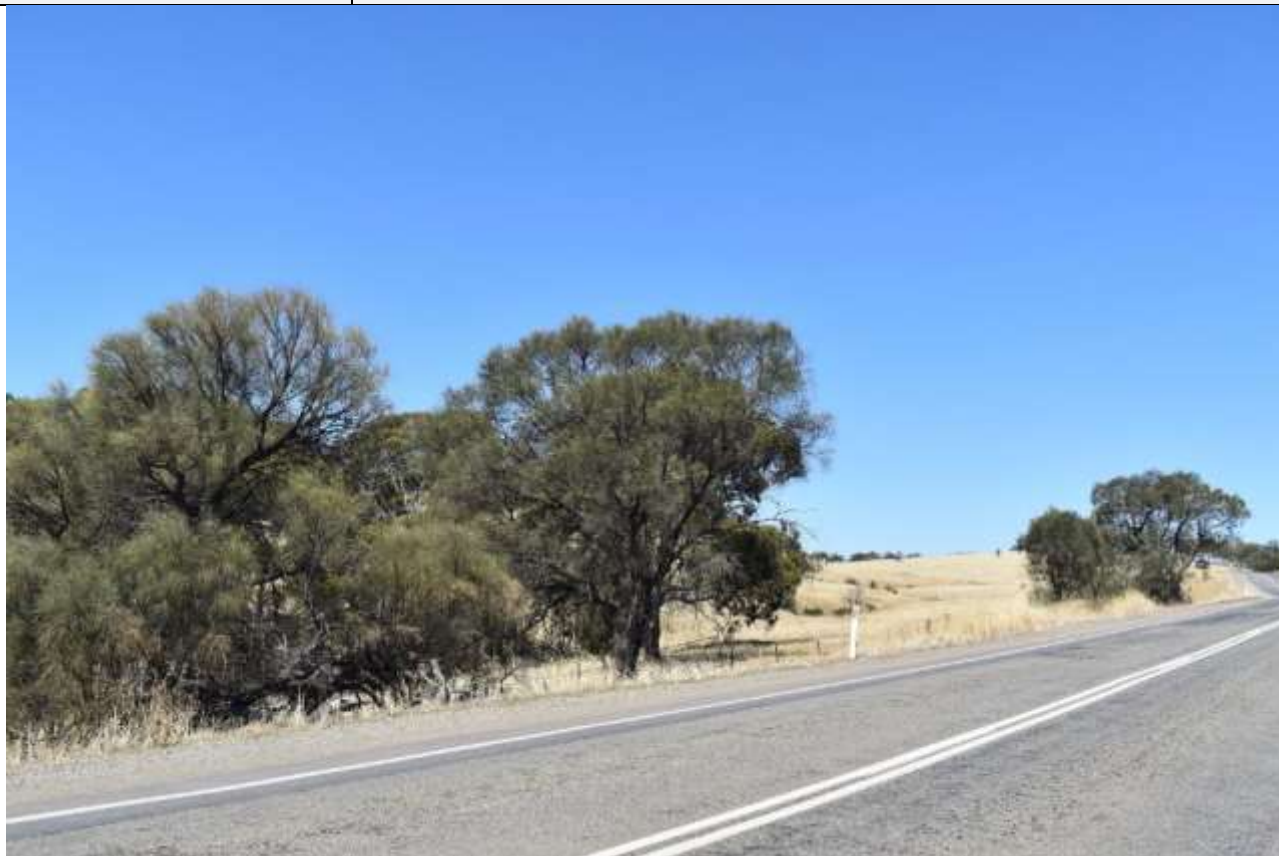
Photo 3. Looking northeast from approximate MM 159.5 GPS 271712/6267237, LHS. Impact is due to hazard reduction (proximity to road) and/or drainage upgrade.

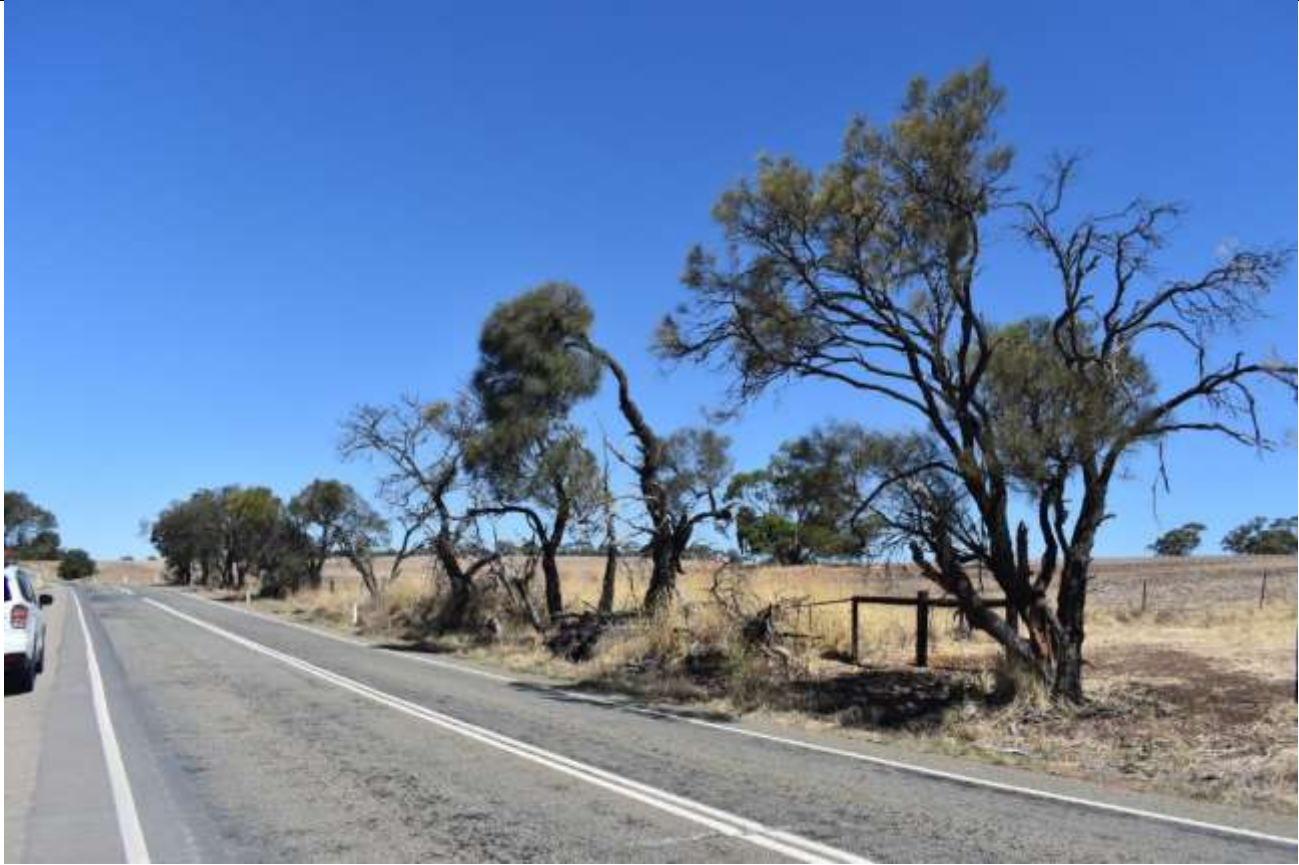
Photo 4. Looking southeast from approximate MM 159.5 GPS 271672/6267235, RHS. Impact is due to hazard reduction (proximity to road) and/or drainage upgrade.

General description	<i>Allocasuarina verticillata</i> dominated the overstorey with few <i>Acacia pycnantha</i> , five scattered <i>Xanthorrhoea quadrangulata</i> and a few <i>Senna artemisioides ssp.</i> , one or two <i>Dianella revoluta</i> and <i>Lomandra effusa</i> across the individual sites making up this association. Wild Oats and other grassy weeds dominated the ground layer. Also present was <i>Rosa canina</i> .				
Threatened species or community	The association is not considered threatened under the NP&W Act or EPBC Act				
Landscape context score	1.16	Vegetation Condition Score	11.96	Conservation significance score	1.04
Unit biodiversity Score	14.43	Area (ha)	0.2	Total biodiversity Score	3.75

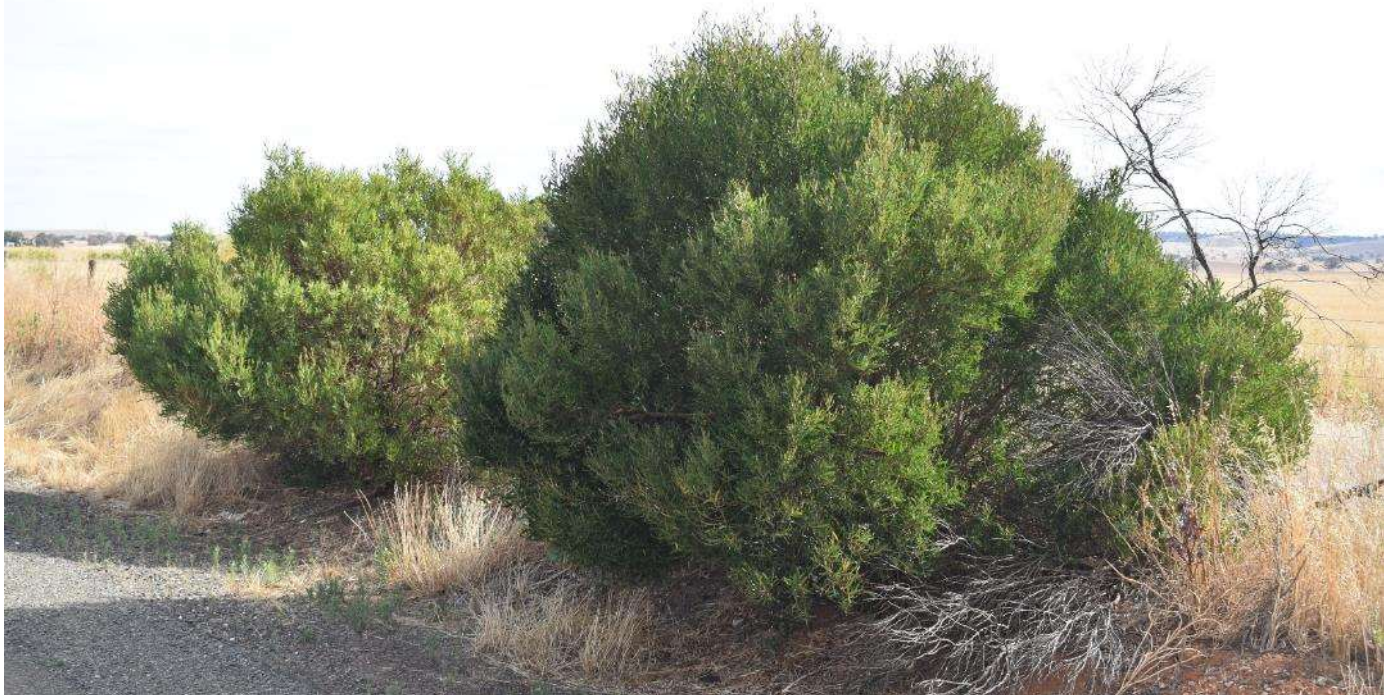
Photo 5. Looking northeast from approximate MM 235.0, LHS. GPS 295716/5202324. The ground layer consisted of Wild Oats and other grassy weeds.

General description	<i>Acacia ligulata</i> was represented by very few scattered individual shrubs isolated from other vegetation. Dense Wild Oats and other grassy weeds represented the ground layer.				
Threatened species or community	The association is not considered threatened under the NP&W Act or EPBC Act				
Landscape context score	1.12	Vegetation Condition Score	8.77	Conservation significance score	1.00
Unit biodiversity Score	9.82	Area (ha)	0.0067	Total biodiversity Score	0.07

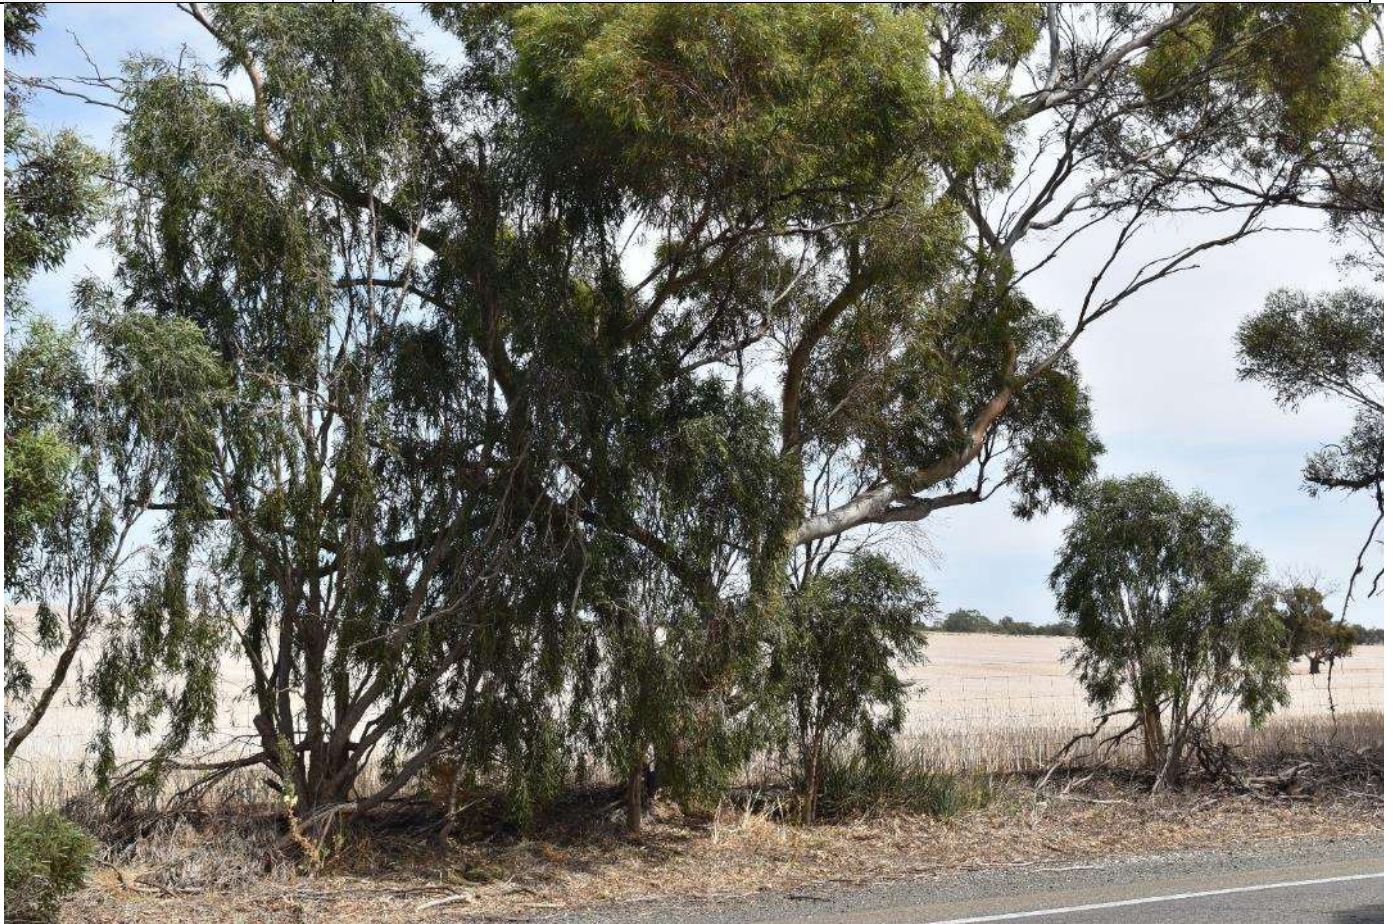
Photo 6. Looking northwest from approximate MM 237.5. GPS 296426/6198819, RHS. The understorey consisted of a very small patch of *Dianella revoluta*, and here, and at sites elsewhere within this association occurred *Acacia ligulata* and *Senna artemisioides*. Wild Oats and other grassy weeds dominated the ground layer.

General description	<i>Pittosporum angustifolium</i> was represented by these five or six young plants amongst planted amenity Eucalypts. <i>Acacia ligulata</i> and <i>Senna</i> presented as scattered individual shrubs isolated from other vegetation. Dense Wild Oats and other grassy weeds represented the ground layer. Overall impact is likely to be less than LF 1.0 but given some of the Acacias and Sennas will be removed, the higher LF is considered appropriate. Removal will only occur where essential for works or safety reasons.				
Threatened species or community	The association is not considered threatened under the NP&W Act or EPBC Act				
Landscape context score	1.13	Vegetation Condition Score	6.39	Conservation significance score	1.00
Unit biodiversity Score	7.22	Area (ha)	0.002	Total biodiversity Score	0.01

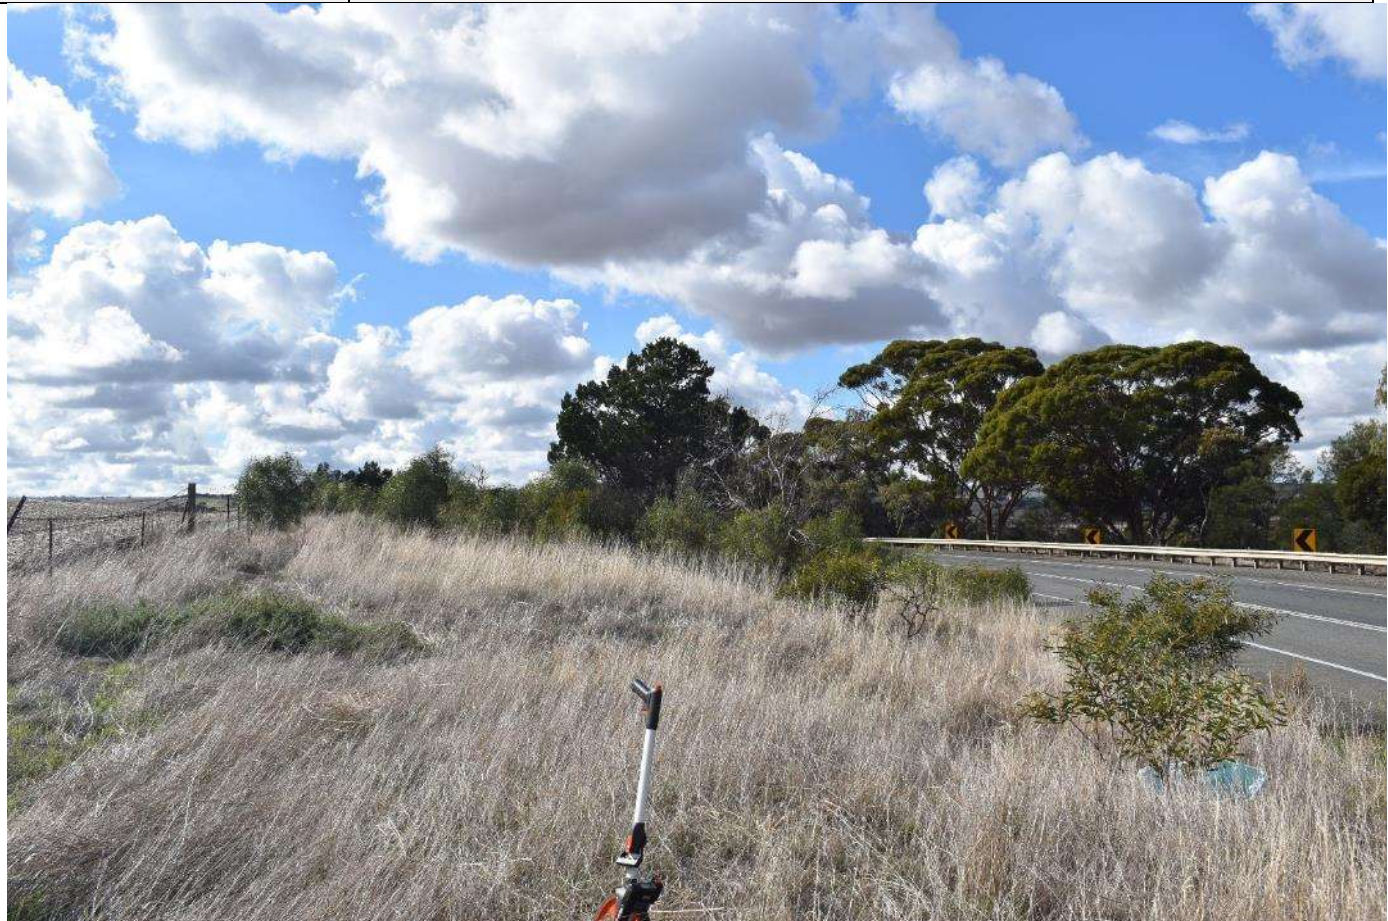
Photo 7. Looking northeast from approximate MM 238.88, GPS 296130/6197667. The ground layer consisted of Wild Oats and other grassy weeds. RHS

General description	<i>Acacia notabilis</i> was present as mainly juveniles in small patches closer to the road verge. <i>A. ligulata</i> and <i>Pittosporum angustifolium</i> were represented by very few scattered individuals. A single <i>Callitris gracilis</i> and one <i>Eucalyptus</i> species (juvenile) was noted. Three <i>Acacia paradoxa</i> occur on the eastern side of the road and are included in this block. Dense Wild Oats and other grassy weeds represented the ground layer.				
Threatened species or community	The association is not considered threatened under the NP&W Act or EPBC Act				
Landscape context score	1.13	Vegetation Condition Score	7.78	Conservation significance score	1.00
Unit biodiversity Score	8.80	Area (ha)	0.3	Total biodiversity Score	2.64

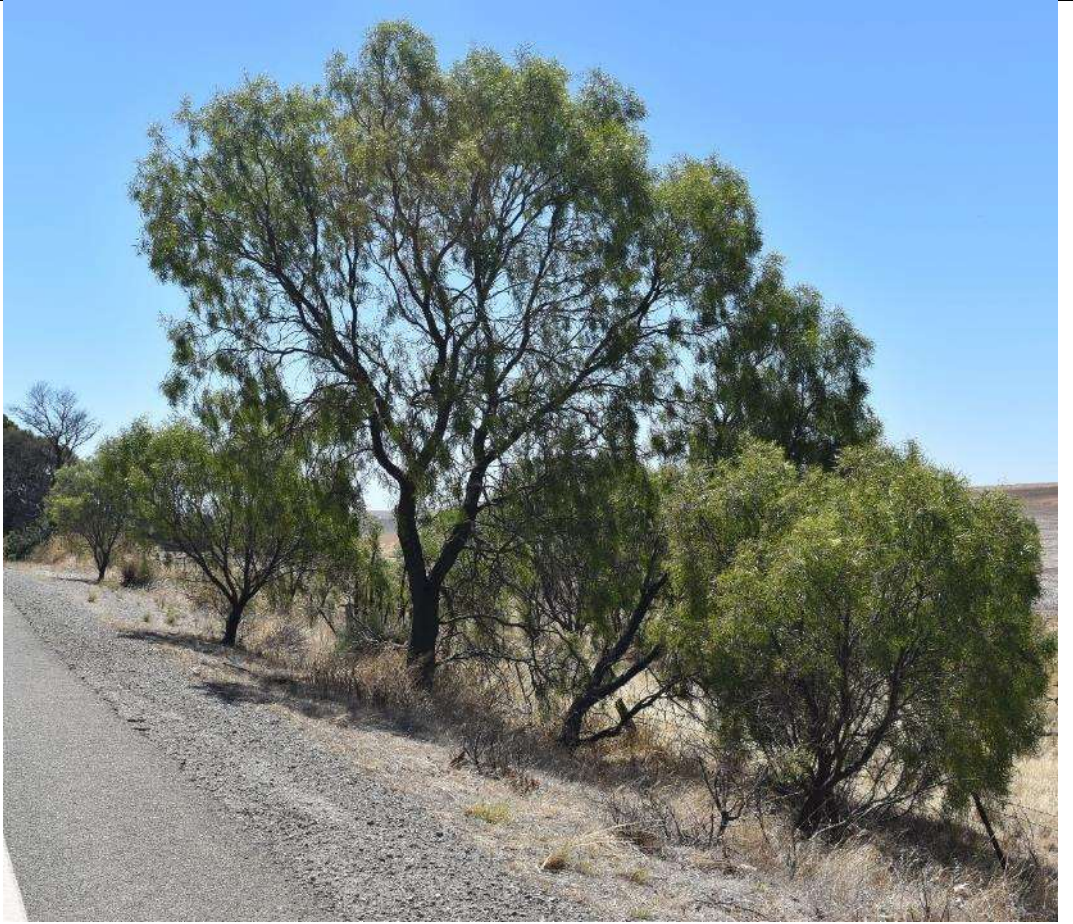
Tree spp. <i>Acacia salicina</i>	
Number of trees – 5	
Height (m) – 6	
Hollows – 0	
Diameter (cm) –15	
Canopy dieback (%) – 0	
Total Biodiversity Score –10.35	
<p>Photo 8. SITE 2 taken facing northwest from near MM 158.8 GPS 271028/6267402, LHS</p>	
<p>A group of immature and semi-mature Broughton Willow occurring on the edge of shoulder. Limited habitat value for threatened species. Impacted by hazard reduction requirements (proximity to road).</p>

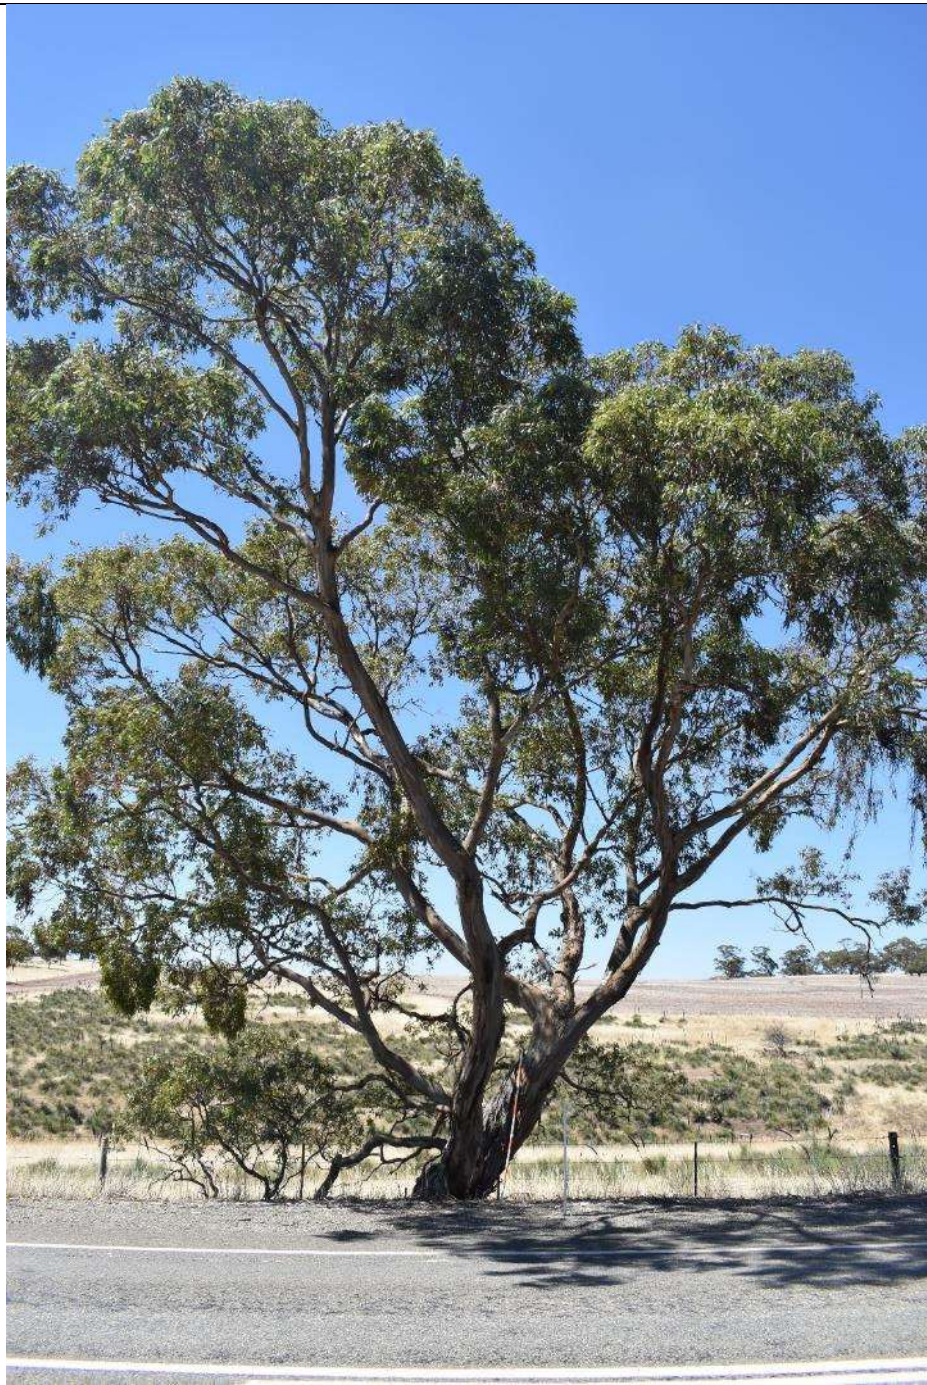
Tree ID – Tree 3
Tree spp. – <i>Eucalyptus leucoxylon ssp. pruinosa</i>
Number of trees – 1
Height (m) –12
Hollows – 0
Diameter (cm) – 60
Canopy dieback (%) –10
Total Biodiversity Score –2.52

Photo 9. SITE 2 taken facing north from near MM 159.1 GPS 271274/6267320, LHS

A single Blue Gum at approximately 8m from centreline (CL). No habitat hollows; roosting, perching and foraging value for threatened species. Impacted by hazard protection (guard fence installation). Loss factor 0.6, pruning of canopy for clearance, and potential root pruning from guardrail post installation.

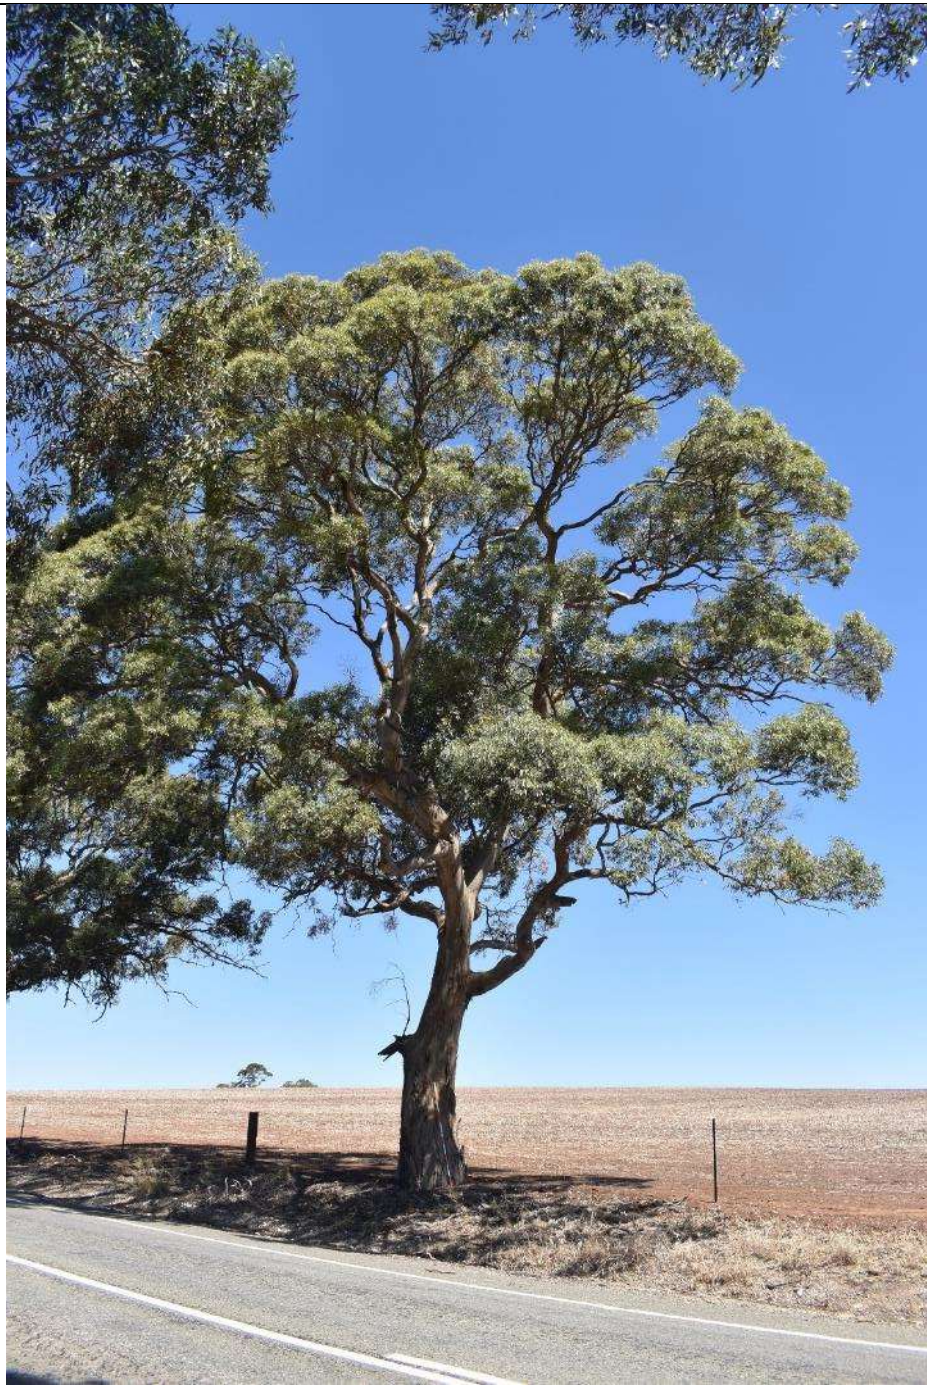
Tree ID – Tree 4
Tree spp. – <i>Eucalyptus leucoxylon ssp. pruinosa</i>
Number of trees – 1
Height (m) –16
Hollows – 6 small, 2 medium
Diameter (cm) –140
Canopy dieback (%) –5
Total Biodiversity Score –9.19

Photo 10. SITE 2 taken facing southeast from near MM 159.1 GPS 271376/6267295, RHS

A single Blue Gum at approximately 8m from centreline (CL). Several habitat hollows, providing potential nesting, roosting, perching and foraging habitat for threatened species. Impacted by hazard protection (guard fence installation) and drainage upgrade (subsoil drain). Loss factor 0.6, potential root pruning from guardrail post and drain installation.

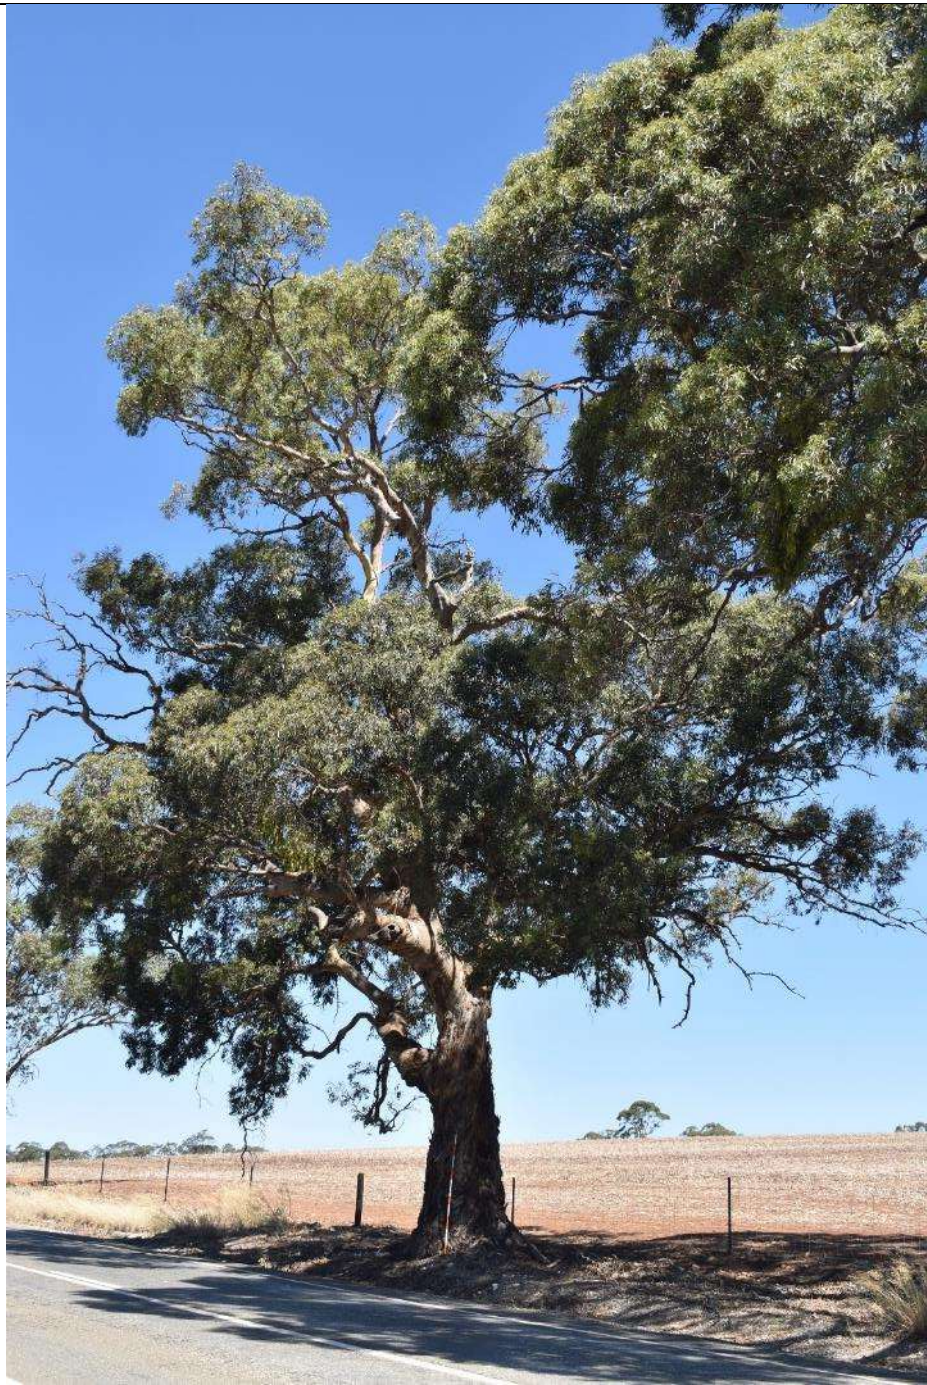
Tree ID – Tree 5
Tree spp. <i>Eucalyptus leucoxylon</i> <i>ssp. pruinosa</i>
Number of trees – 1
Height (m) –18
Hollows – 3 small 2 medium
Diameter (cm) – 130
Canopy dieback (%) – 15
Total Biodiversity Score – 9.27

Photo 11. SITE 2 taken facing southeast from near MM 159.1 GPS 271400/6267295, RHS

A single Blue Gum at approximately 7m from centreline (CL). Several habitat hollows, including 2 large ones, providing potential nesting, roosting, perching and foraging habitat for threatened species. Impacted by hazard protection (guard fence installation) and drainage upgrade (subsoil drain). Loss factor 0.6, potential root pruning from guardrail post and drain installation.

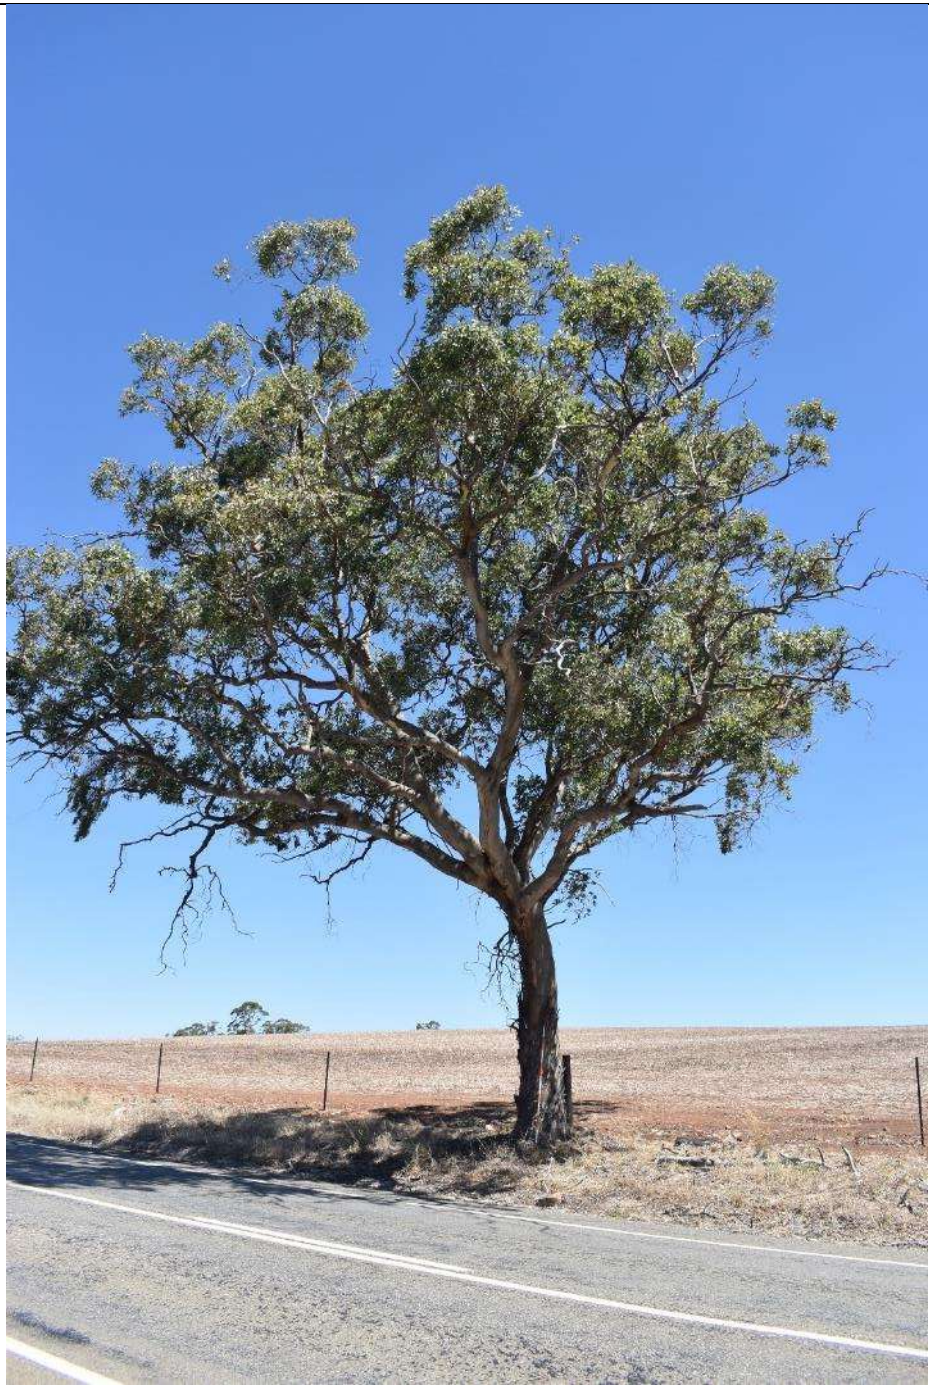
Tree ID – Tree 6
Tree spp. <i>Eucalyptus leucoxylon</i> <i>ssp. pruinosa</i>
Number of trees – 1
Height (m) –16
Hollows – 0
Diameter (cm) – 80
Canopy dieback (%) –10
Total Biodiversity Score – 4.76

Photo 12. SITE 2 taken facing southeast from near MM 159.1 GPS 271427/6267288, RHS

A single Blue Gum at approximately 8m from centreline (CL). No habitat hollows, providing limited roosting, perching and foraging habitat for threatened species. Impacted by hazard protection (guard fence installation) and drainage upgrade (subsoil drain). Loss factor 0.6, potential root pruning from guardrail post and drain installation.

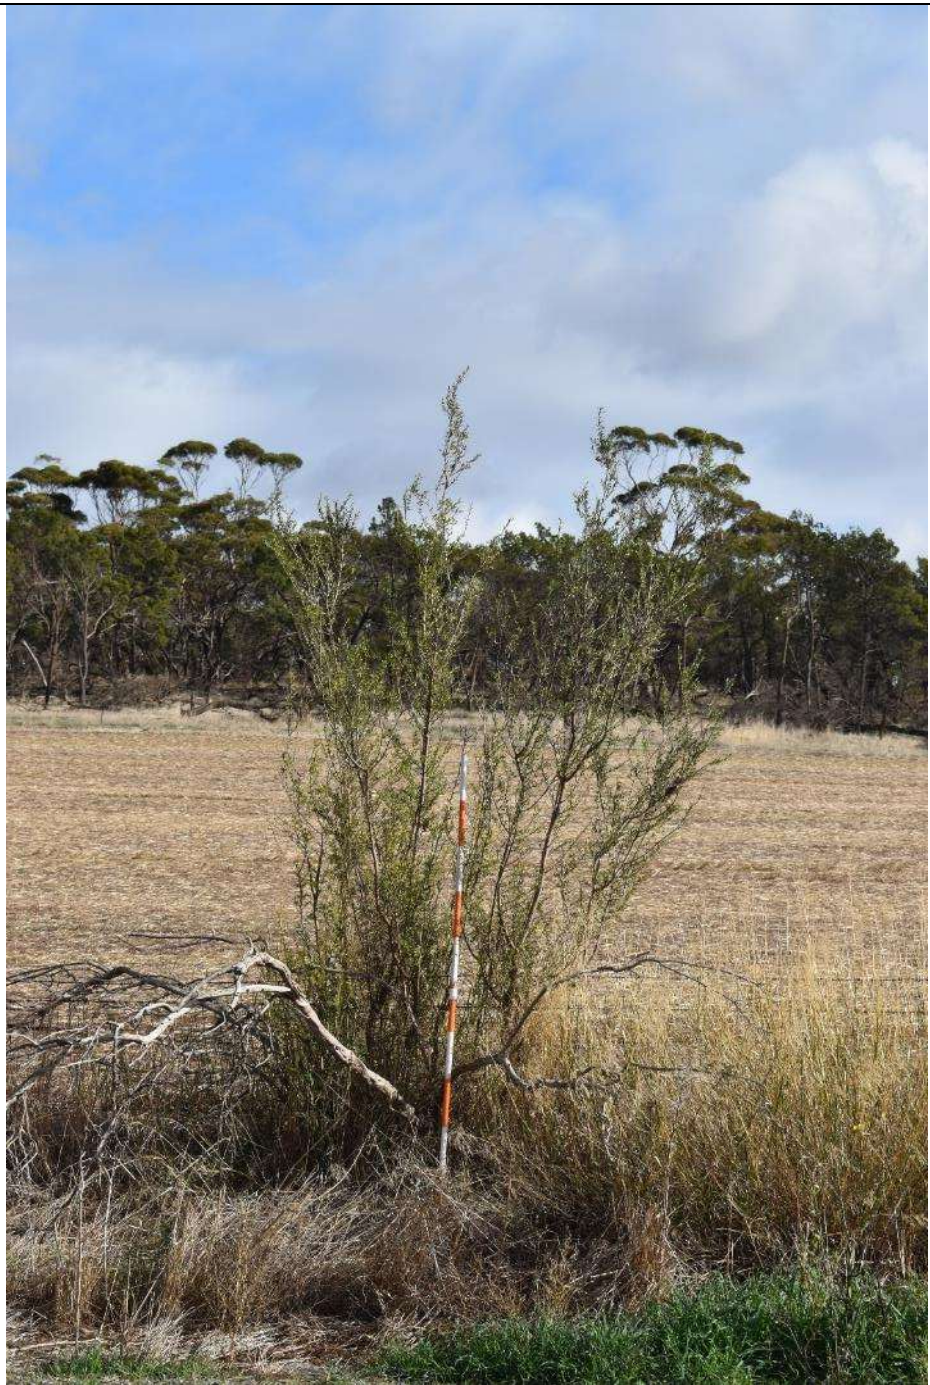
Tree ID – Tree 7
Tree spp. <i>Bursaria spinosa</i>
Number of trees – 1
Height (m) – 3
Hollows – 0
Diameter (cm) – 6
Canopy dieback (%) –30
Total Biodiversity Score – 0.44

Photo 13. SITE 4 taken facing west from near MM 238.65, GPS 296239/6197850, RHS

A small *Bursaria* in poor condition, having shed one stem. Limited habitat value for threatened species. Impacted by curve upgrade works and hazard reduction.

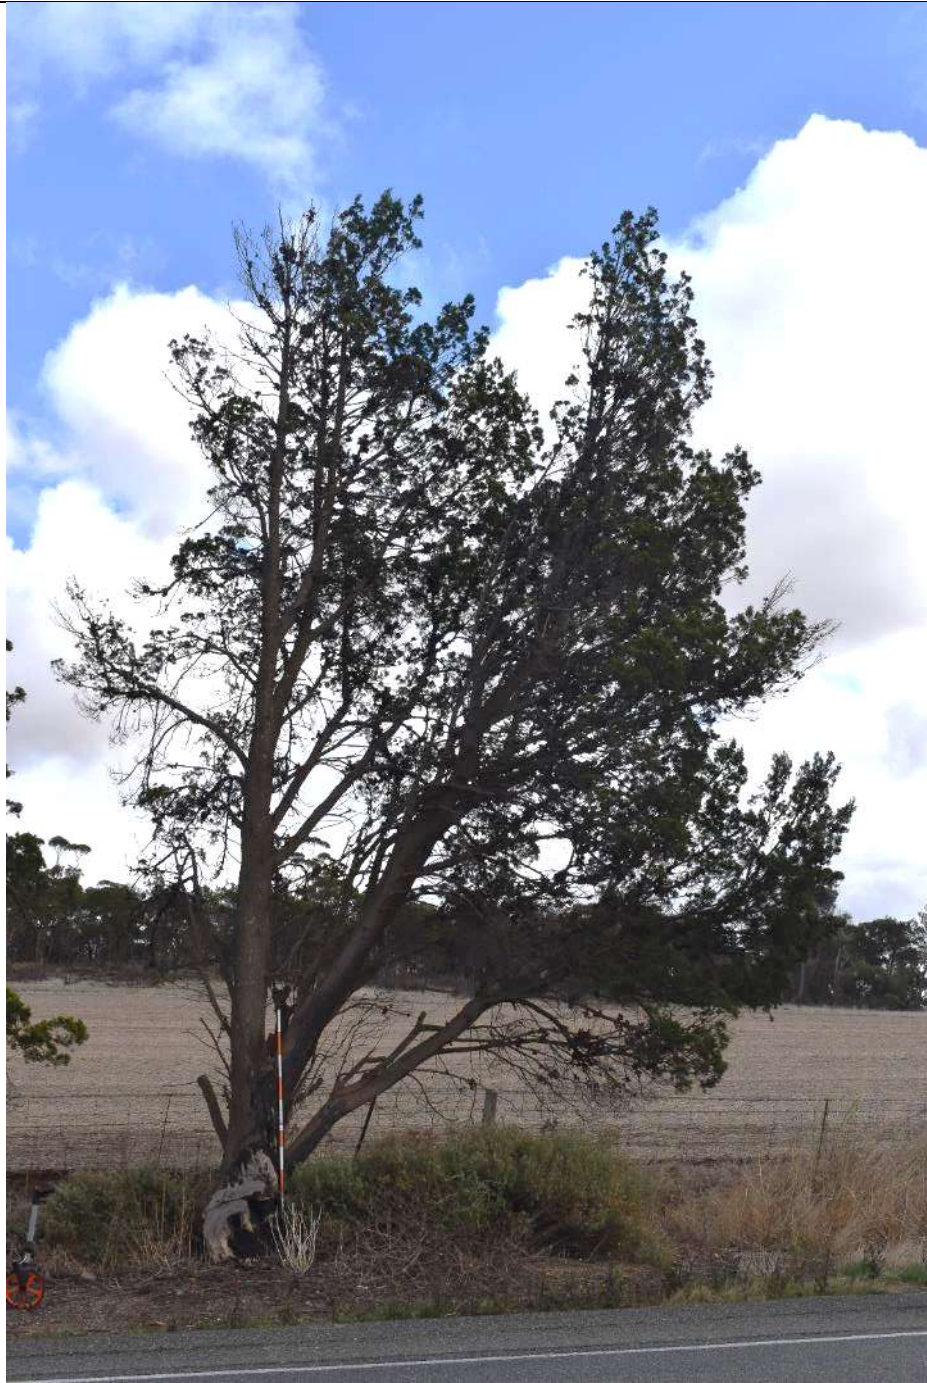
Tree ID – Tree 8
Tree spp. <i>Callitris gracilis</i>
Number of trees – 1
Height (m) – 10
Hollows – 0
Diameter (cm) – 60
Canopy dieback (%) – 40
Total Biodiversity Score – 1.18

Photo 14. SITE 4 taken facing west from near MM 238.65, GPS 296236/6197839, RHS

A single mature White Cypress Pine in poor condition with dieback and the loss two main stems. Limited habitat value for threatened species. Impacted by curve upgrade works and hazard reduction.

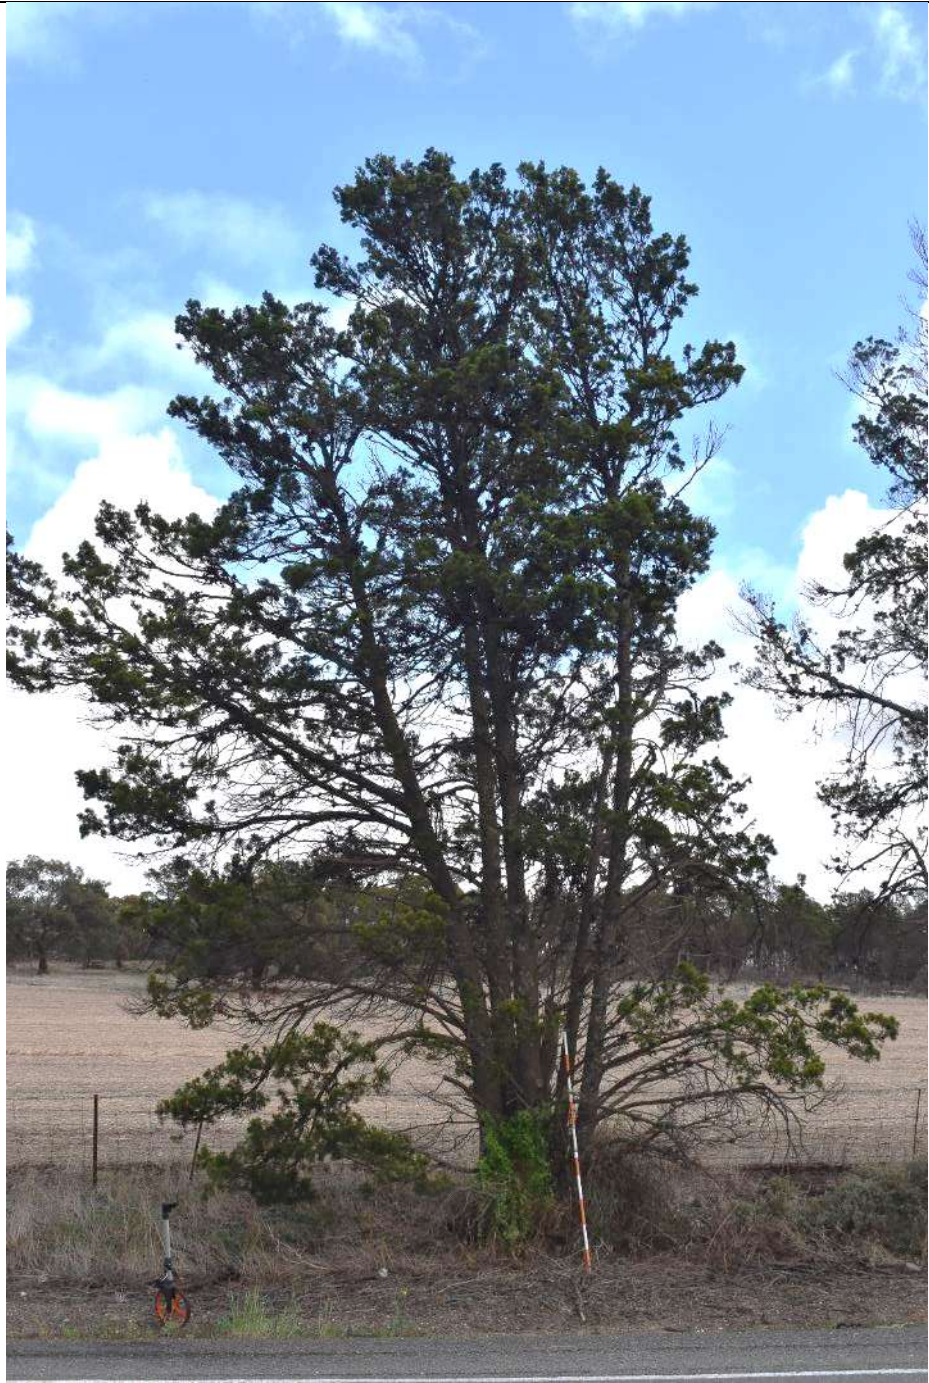
Tree ID – Tree 9
Tree spp. <i>Callitris gracilis</i>
Number of trees – 1
Height (m) – 9
Hollows – 0
Diameter (cm) – 40
Canopy dieback (%) –20
Total Biodiversity Score – 1.00

Photo 15. SITE 4 taken facing west from near MM 238.65, GPS 296234/6197833, RHS

A mature White Cypress Pine in fair condition with some dieback, offering potential habitat value for threatened species. Impacted by curve upgrade works and hazard reduction.

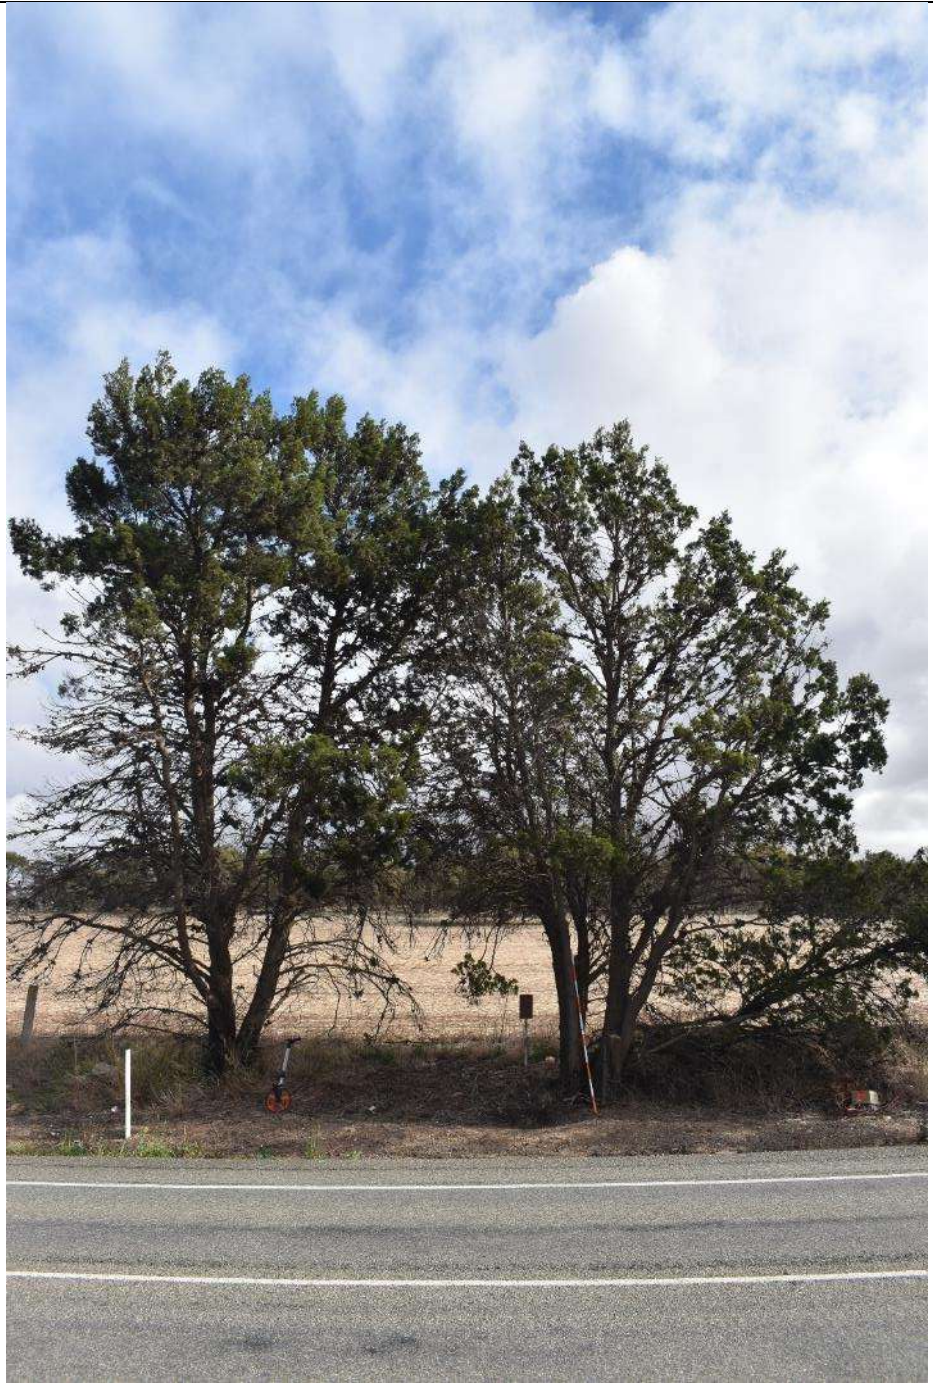
Photo 16. SITE 4 taken facing west from near MM 238.65, GPS 296230/6197820, RHS

Two White Cypress Pines in fair-poor condition with some dieback, providing potential habitat value for threatened species. Impacted by curve upgrade works and hazard reduction.
