Native Vegetation Clearance

Stage 2, VS 2020/025
Horrocks Highway Upgrade
Isolated High Risk Sites
MM 151.5 to MM 248.3
Undulation and Drainage Issues
and High Risk Curve

Data Report

2 September 2021

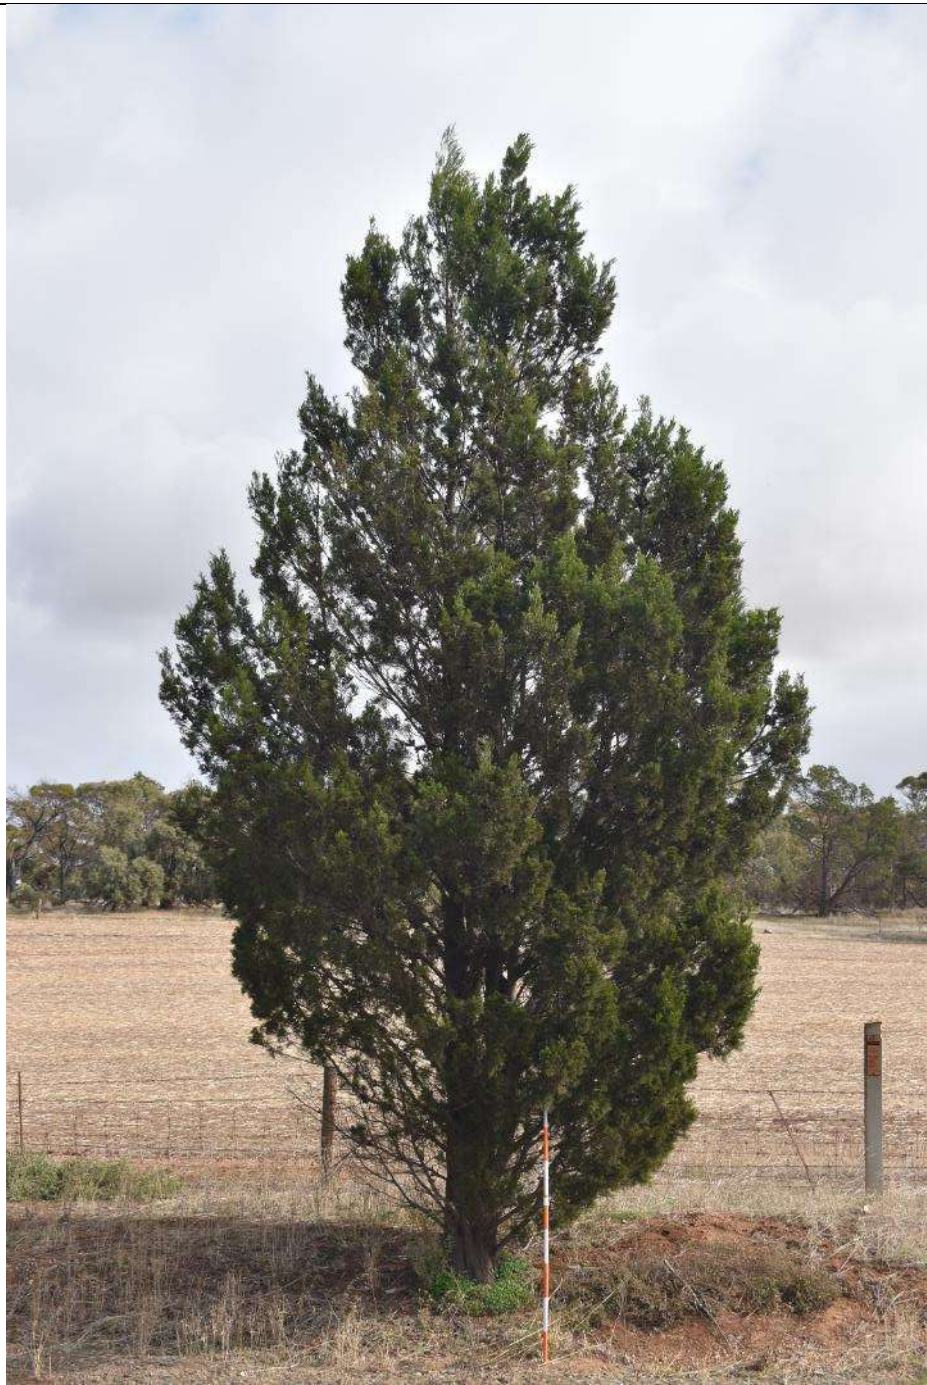
Tree ID – Tree 11
Tree spp. <i>Callitris gracilis</i>
Number of trees – 1
Height (m) – 8
Hollows – 0
Diameter (cm) – 40
Canopy dieback (%) – 0
Total Biodiversity Score – 1.07

Photo 17. SITE 4 taken facing west from near MM 238.65, GPS 296226/6197805, RHS

A single young White Cypress Pine in good condition. Potential habitat value for threatened species. Impacted by curve upgrade works and hazard reduction.

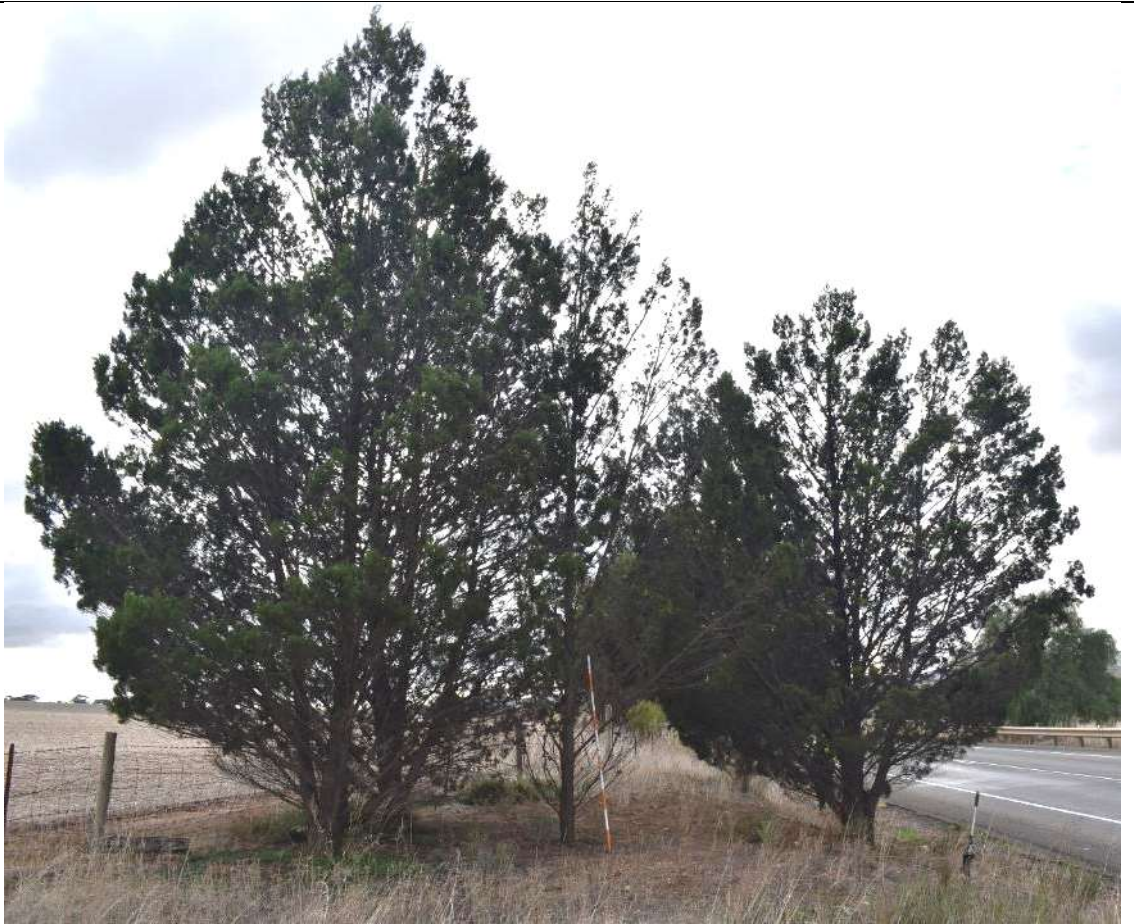
Tree ID – Tree 12
Tree spp. <i>Callitris gracilis</i>
Number of trees – 4
Height (m) – 8
Hollows – 0
Diameter (cm) – 20
Canopy dieback (%) – 10
Total Biodiversity Score – 1.59

Photo 18. SITE 4 taken facing north from near MM 238.7, GPS 296216/6197786, RHS

A small group of four young to mature White Cypress Pines in poor - good condition, some with significant dieback. Potential habitat value for threatened species. Impacted by curve upgrade works and hazard reduction.

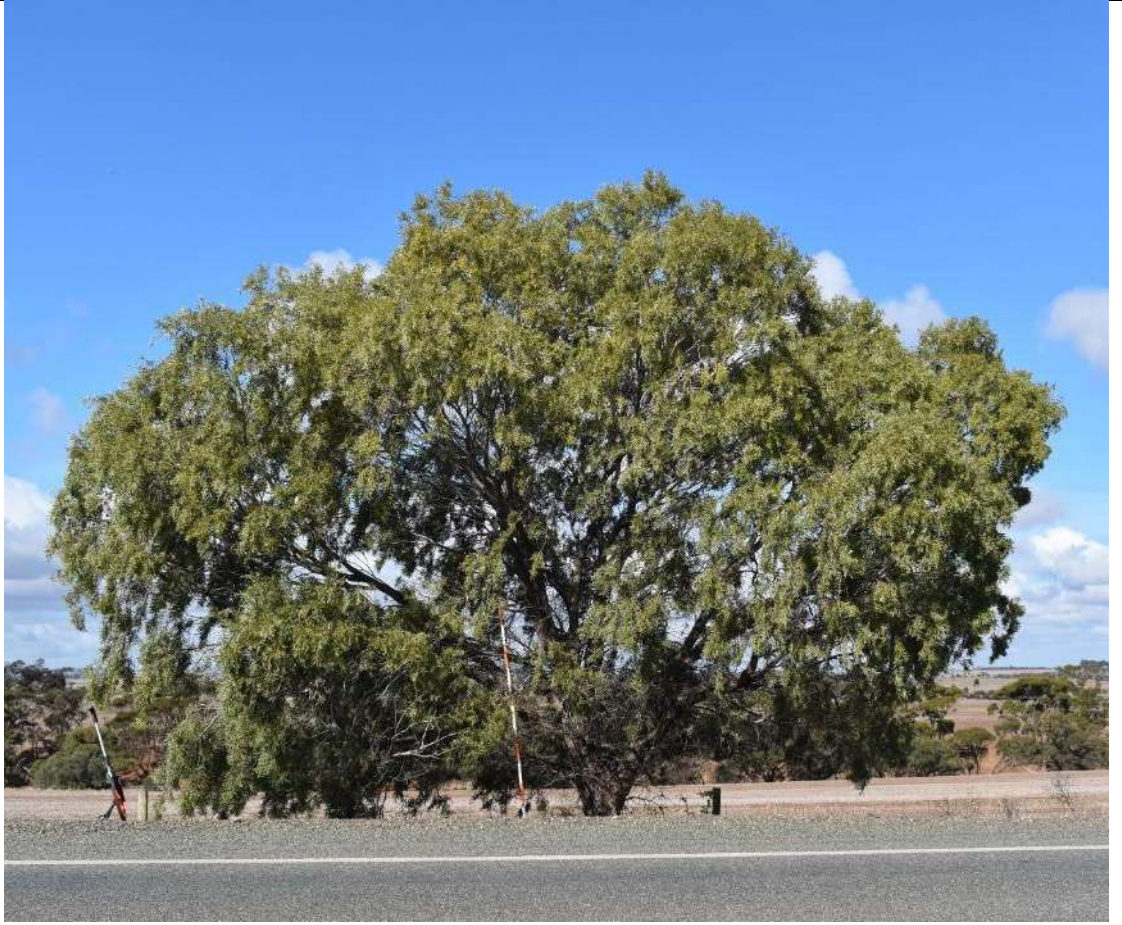
Tree ID – Tree 13

Tree spp. <i>Acacia salicina</i>	
Number of trees – 1	
Height (m) – 6	
Hollows – 0	
Diameter (cm) – 15	
Canopy dieback (%) – 0	
Total Biodiversity Score – 1.07	
<p>Photo 19. SITE 4 taken facing east from near MM 238.88, GPS 296120/6197633, LHS</p>	
<p>A single Broughton Wattle in good condition with no dieback. Potential habitat value for threatened species. Impacted by curve upgrade works and hazard reduction.</p>
