INVESTIGATOR STRAIT

State Heritage Branch

Department of Environment and Natural Resources

Investigator Strait Maritime Heritage Trail.

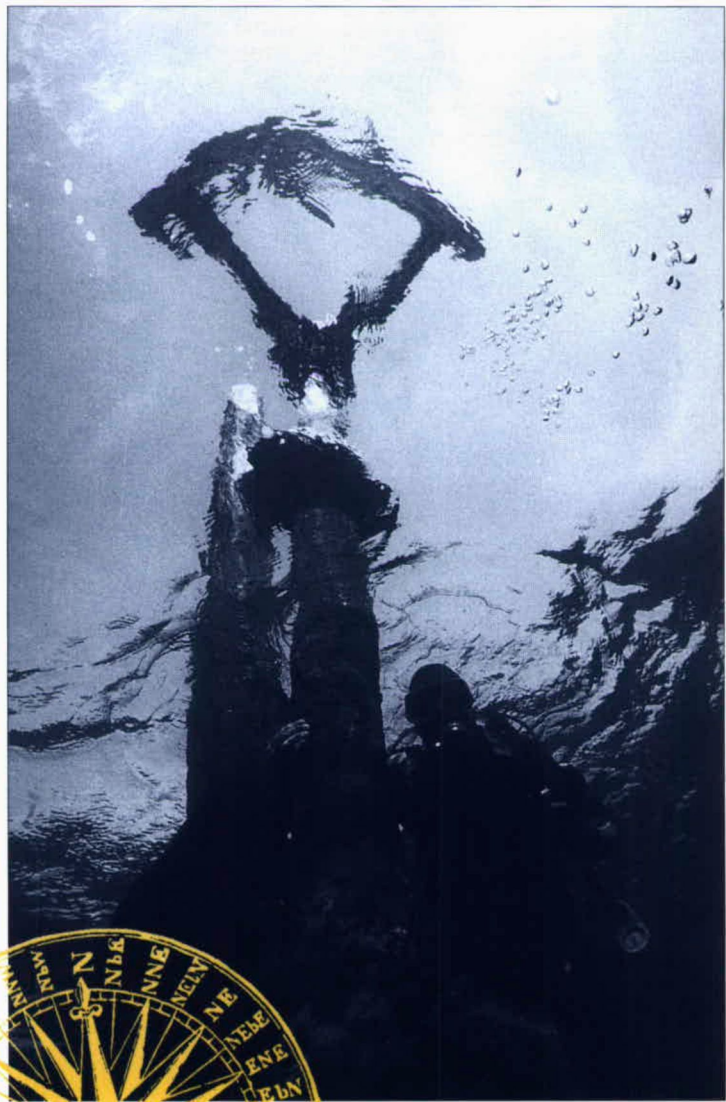
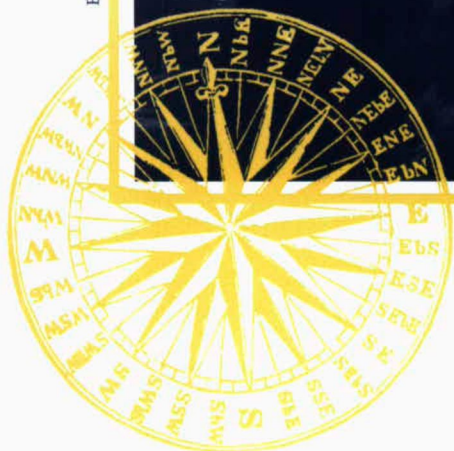
▲ The steering quadrant is visible above water as a diver examines the *Wilyama's* sternpost.

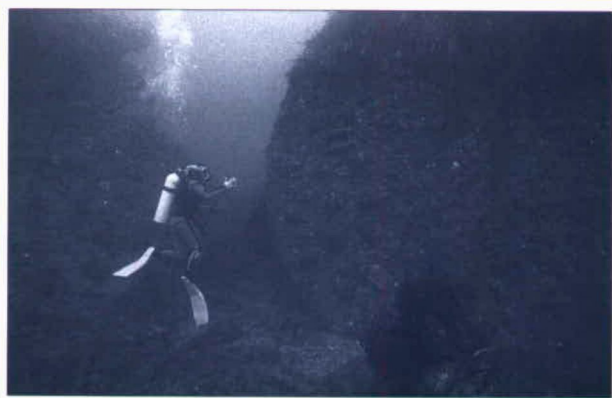
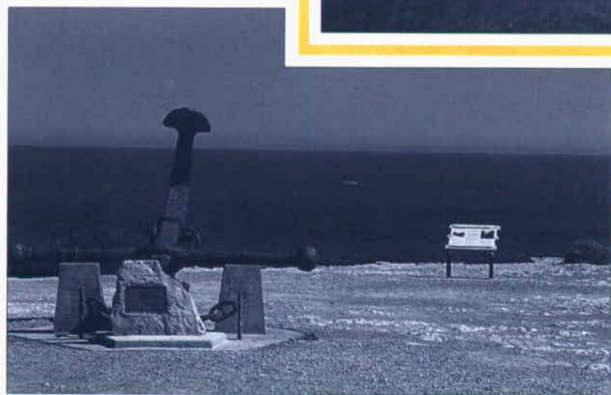
Diver swimming between the *Clan Ranald's* hull and boiler.

Clan Ranald anchor and Maritime Heritage Trail sign, with a dive boat at centre anchored over the wreck

The wreck of the S.S. *Clan Ranald* rests on its starboard side almost upside down on a sandy seabed at a depth of 18-20 metres. The bow section has collapsed forwards and downwards. The double hull bottom of the bow stands vertical, and the port bow plating has deteriorated leaving the bow stem laying horizontal on the seabed.

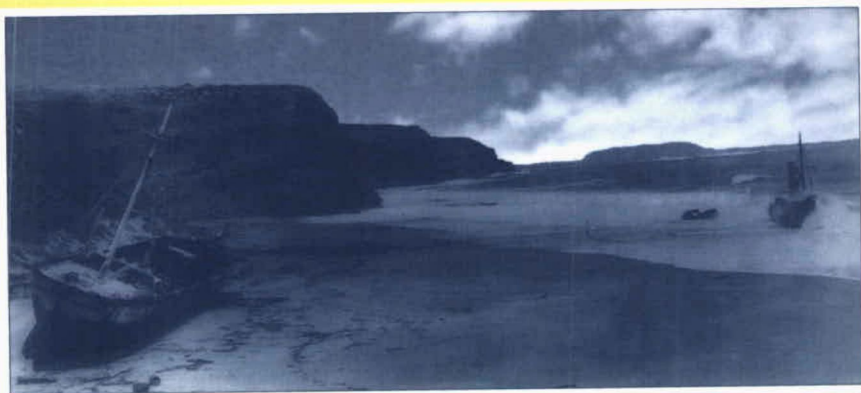
▲ *Ethel* and *Ferret* on the beach. *Ethel* ashore under the cliffs and S.S. *Ferret* lying in the surf zone.

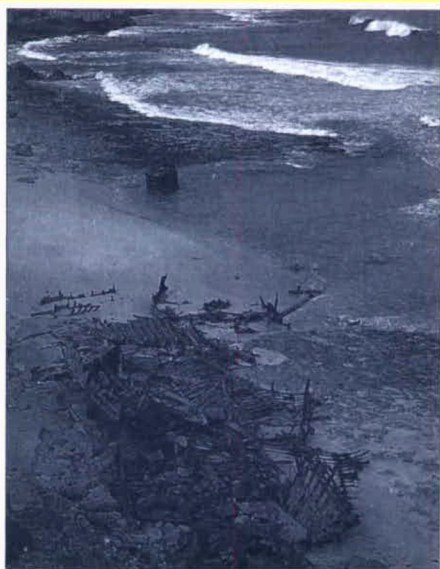
▶ Collapsed hull of the *Ethel* in the foreground and exposed boiler of the *Ferret* centre left, after a storm in 1988.

The remains of the *Ethel* lie parallel to the shore with the bow heading south-east. For many years the hull was largely intact deteriorating gradually with every storm. A severe gale in 1988 caused the hull to completely collapse leaving the iron frames as the most identifiable feature of the site.

The remains are broken up and mostly buried, although a section of the bow is often visible in the waves at low tide. Ship's fittings and parts of the engine, drive shaft and propeller are also present on the site. A partially buried scotch boiler, 12 feet (3.66m) in diameter and about 10 feet (3.05m) in length, can sometimes be seen at low tide inshore of the main site and about 100 metres to the east of the *Ethel* wreck. The full length of the boiler can be seen on occasions when the sand is washed off the beach.

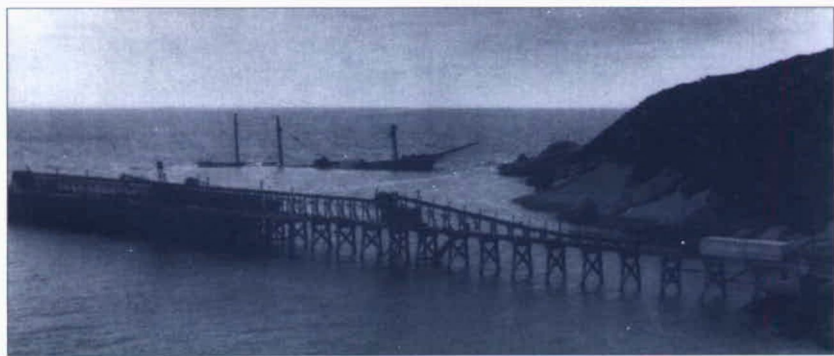
▲ *Hougomont* shortly after being scuttled as a breakwater for the jetty at Stenhouse Bay.

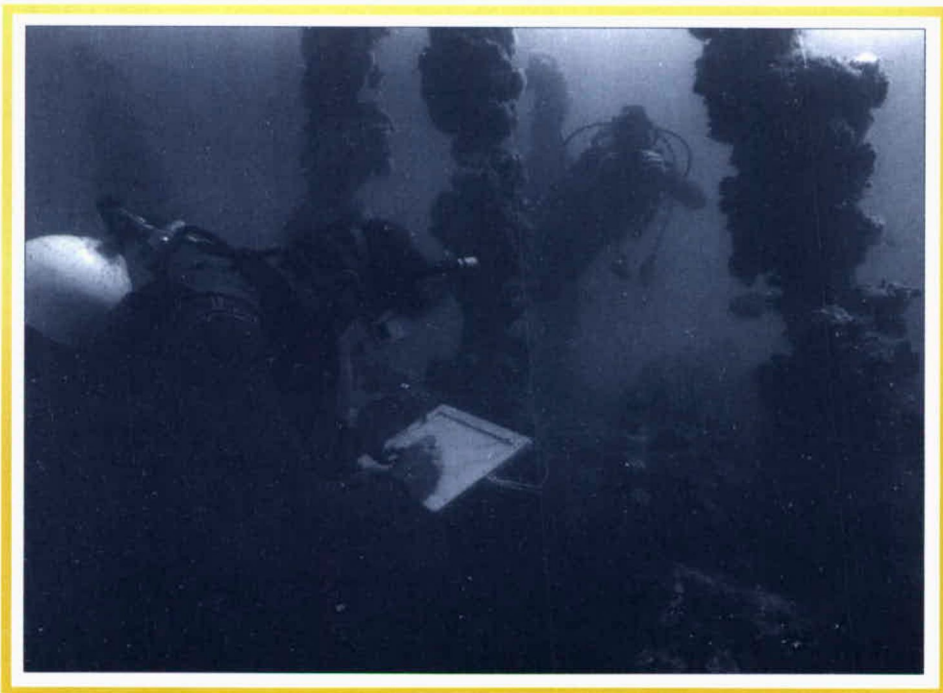
Divers recording the stanchions amidships on the *Hougomont*.

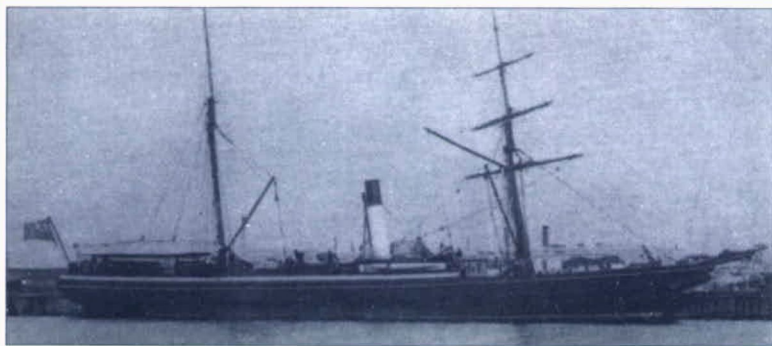
▲ Vessel of similar age and rig to the S.S. *Marion*.

The schooner rigged, single screw steamer *Marion* was built in 1854 at Glasgow, Scotland and imported for the Hobart - Melbourne passenger trade. In 1857 it was sold to South Australian interests for the Port Adelaide - Port Lincoln trade. The *Marion* was the first vessel to operate a regular steam shipping service from Port Adelaide to the Spencer Gulf ports. The iron hulled vessel of 197 gross tons measured 114.2 feet (34.8m) in length, 19.6 feet (6.0m) breadth and 10 feet (3.0m) depth.

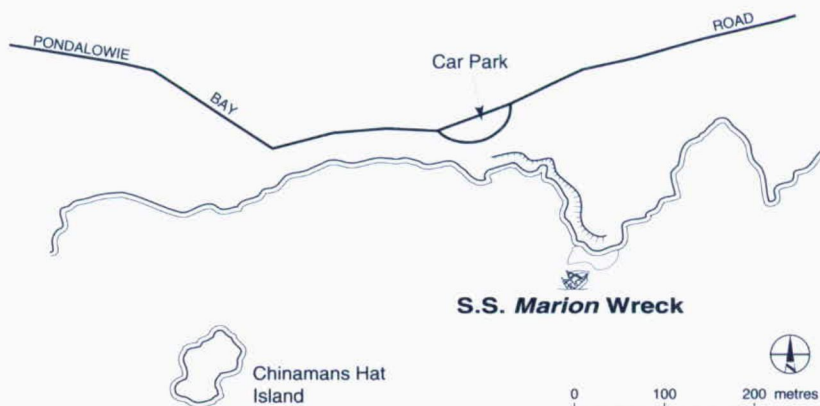
▲ Map showing the approximate location of the S.S. *Marion* wreck

The wreck of the S.S. *Marion* lies at the base of a cliff, in 2-7 metres of water, east of Chinamans Hat Island, and to the south-east of the car park at Cable Hut Bay.

Little of the hull structure remains to be seen because the wreck, which is scattered on a northerly axis for a distance of some 60 metres, is located on a predominantly rocky bottom in a high wave energy zone. The wreckage is divided into two distinct locations with the forward part of the ship broken and scattered over a shallow reef shelf, and the stern lying in an area of patchy sand in deeper water at the base of the reef.

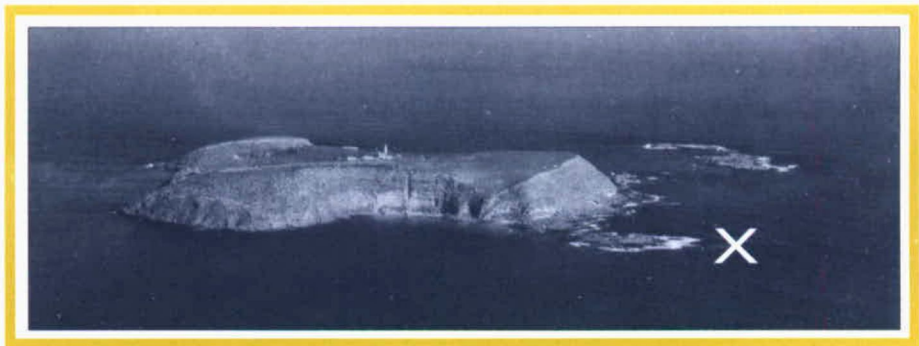
Althorpe Island viewed from the north-east. Cross shows the approximate location of the *Pareora*.

The wreck lies broken and scattered in rocky gullies to a depth of 13 metres, and is situated 75 metres north-west of a large rock, known as The Monument, on the northern extremity of the island. A large proportion of the wreck including a boiler (diameter 3.5 metres), steel frames and hull

plating, as well as the engine, can be found lying in a gully between two reefs. The remains of bow structures and machinery lie in an adjacent gully about 30 metres to the east, and include an anchor, hawse pipes and windlass.

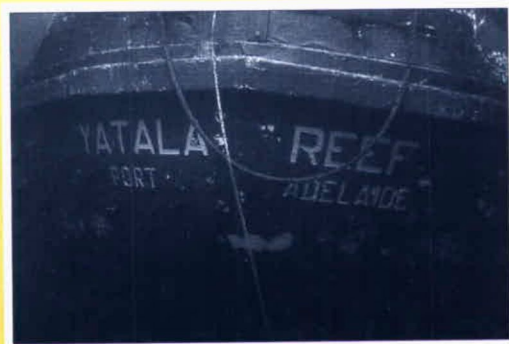
▲ Stern of the *Yatala Reef* shortly after sinking.

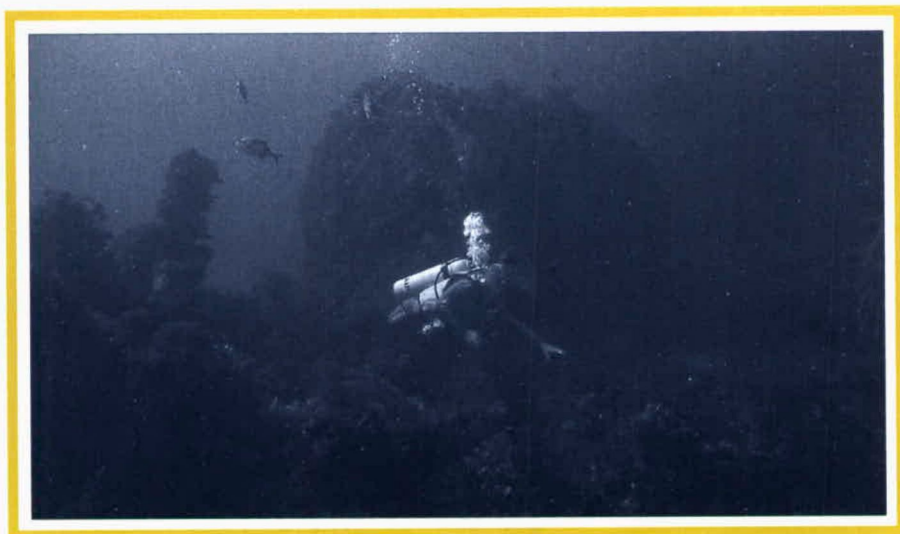
▲ Divers recording the boiler and other remains on the *S.S. Pareora*.
