PORT STANVAC OFFSHORE SANDS INVESTIGATION

Vibrocore Land Based Operations & Core Logs

**Roberta L Rice
Geo-Ocean Horizons Pty Ltd**

30 November 2020

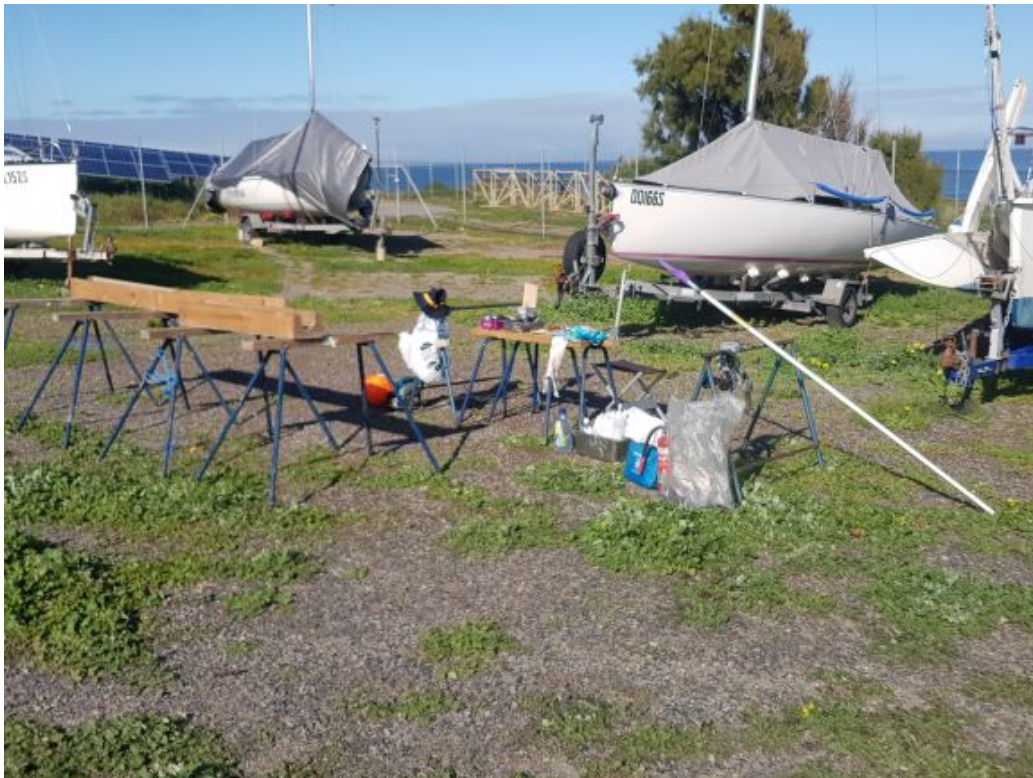
Figure 2a (top): Core Cutting Set-up at O'Sullivan's Beach Boat Storage Facility
Figure 2b (bottom): Core Processing Set-up at O'Sullivan's Beach Boat Storage Facility

GOH supplied the following infrastructure and documentation for the core cutting to processing at the OSBM Boat Storage Area and GOH Facility (Figure 2a):

- ❖ JHA documents for core processing (handling)
- ❖ Appropriate protective clothing for GOH personnel
- ❖ Core cutting area (Figure 2a)
 - core cutting boxes on wooden trestles (3 – 1m length boxes)
 - circular saw for core cutting (Note: supplied by AB for SS01-SS32; GOH for SS34-42)
 - support tools including chisel, hammer & knife for splitting & display
 - appropriate PPE including safety helmet with visor for core cutting personnel (DEW & GOH)
 - ear plugs and ear muffs for core cutting operations
 - safety glasses & protective gloves for core cutting
 - rags, brushes for cleaning of core barrels
 - electrical tape for core caps (colour coded)
 - additional de-contaminated core caps
 - hand wash for COVID19
 - 1st aid kit & fire extinguisher
 - Garbage bags for waste/rubbish.

- h. sterilised end caps were placed back on the barrel ends prior to cutting (tape colour code: green/yellow for TOC & red or blue for BOC)
3. GOH and/or DEW personnel cut the core longitudinally, with a circular saw, using 3 wooden cradles mounted on trestles (Figure 2a):

- a. care was taken to only cut the barrel and not the (internal) core (minimize aluminium fillings on the core, inside)
 - b. the circular saw was battery operated; hence, the associated electrical cable trip hazard was eliminated; battery lasted 1 core/battery; 3 batteries rotated whilst others were charging
