**Client Reference** : Department of Environment and Water (DEW) S.A.

**Date** : 16/10/2020

### SEDIMENT CORING OF PORT STANVAC WATERS BY VIBECORING

#### *A Report for the Department of Environment and Water*

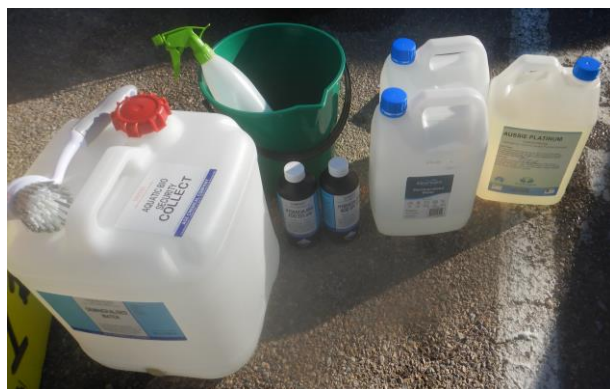
**Figure 5. Sampling core tube cleaning chemicals**

1. Wet with high pressure water @ 1810 PSI (Gerni Classic 125.5)
2. PFAS and Phosphate free detergent wash (Aurora Pty Ltd cleaning products Aussie Platinum commercial detergent) with high pressure Gerni attachment
3. Sponge and brush scrub of outside and inside of tubes
4. High pressure water rinse @1810 PSI
5. Acid spray inside and outside of tubes using 10%HCL solution
6. Sponge and brush scrub of outside and inside of tubes
7. High pressure water rinse @1810 PSI
8. Demineralised water rinse outside and inside tube
9. Cap both ends and cover in pallet wrap plastic sheet until use.

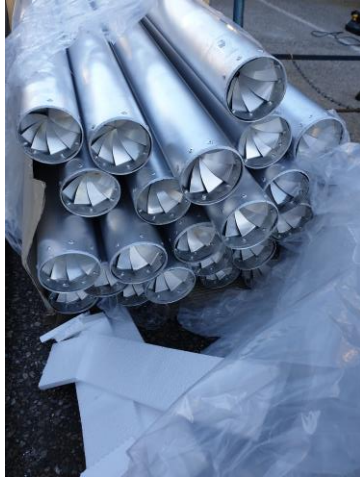
**Figure 7. Core keepers**

Core keepers were OEM made by the manufacturer and installed into the core tubes as per OEM instructions using rivets.

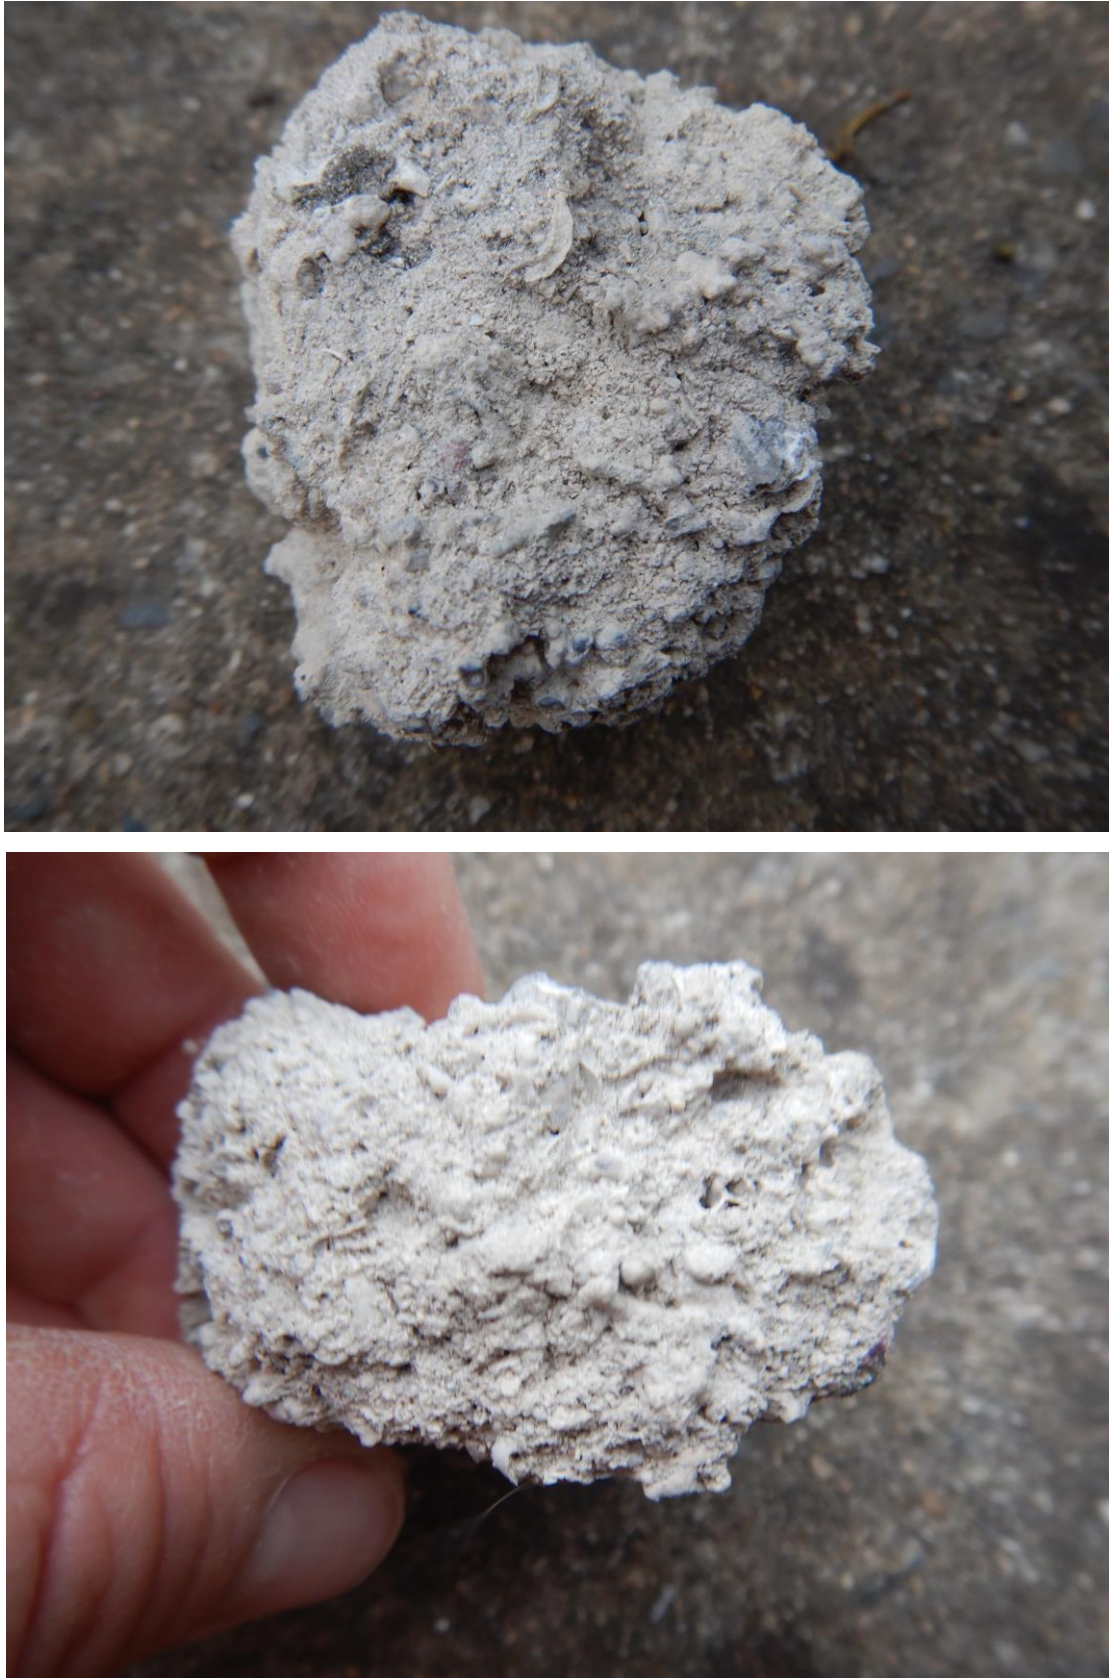
**Figure 8. Calcrete cut through by OEM Vibecore from previous project (not Pt Stanvac area) shows cutting potential of Vibecore unit. (A disc shape until chiselled out of the end of the core).**

Vibecore deployments at Sites: 20, 23 and 33 resulted in rejections where a sediment sample could not be retrieved due to either impenetrable hard bottom, rocks, reef or other impediment. SS36 gave a rejection then a core. Where a rejection occurred, it was repeated. Where two rejections occurred, the site was determined to be a final site rejection. The Vibecore unit has proved that it can cut through segments of calcrete, seagrass, and rhizome mat in previous projects such that some hard reef can be penetrated with the system. A relatively perfect cut disc of calcrete was cut through in one core in a different project which required removal by chisel illustrating the performance of the unit (Figure 7).

In these cases where core rejection was experienced the Vibecore unit was retrieved from the seafloor, the tube dismantled, cleaned and the process was repeated.
