South Australian River Murray Water for the Environment Report 2018-19

Department for
Environment and Water

Each year South Australia prepares an overview of water delivered for the environment along the South Australian River Murray under the Murray-Darling Basin Plan. This report outlines the water volumes and timing of delivery, the sites watered and outcomes achieved for the 2018-19 water year.

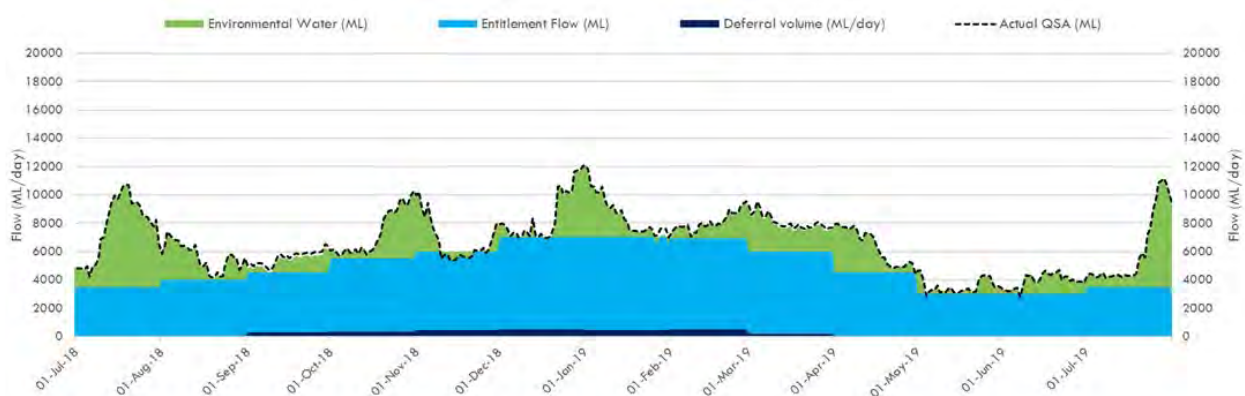
Figure 1: River Murray flows 2018-19

The 2018-19 water year was another dry year, with climate conditions across the Murray-Darling Basin generally warmer and drier than average and system inflows in the driest 7% of years on record (MDBA 2019). As a result, South Australia did not experience any unregulated flow events in 2018-19 and the only water South Australia received above entitlement flow was from environmental water holders (Figure 1).

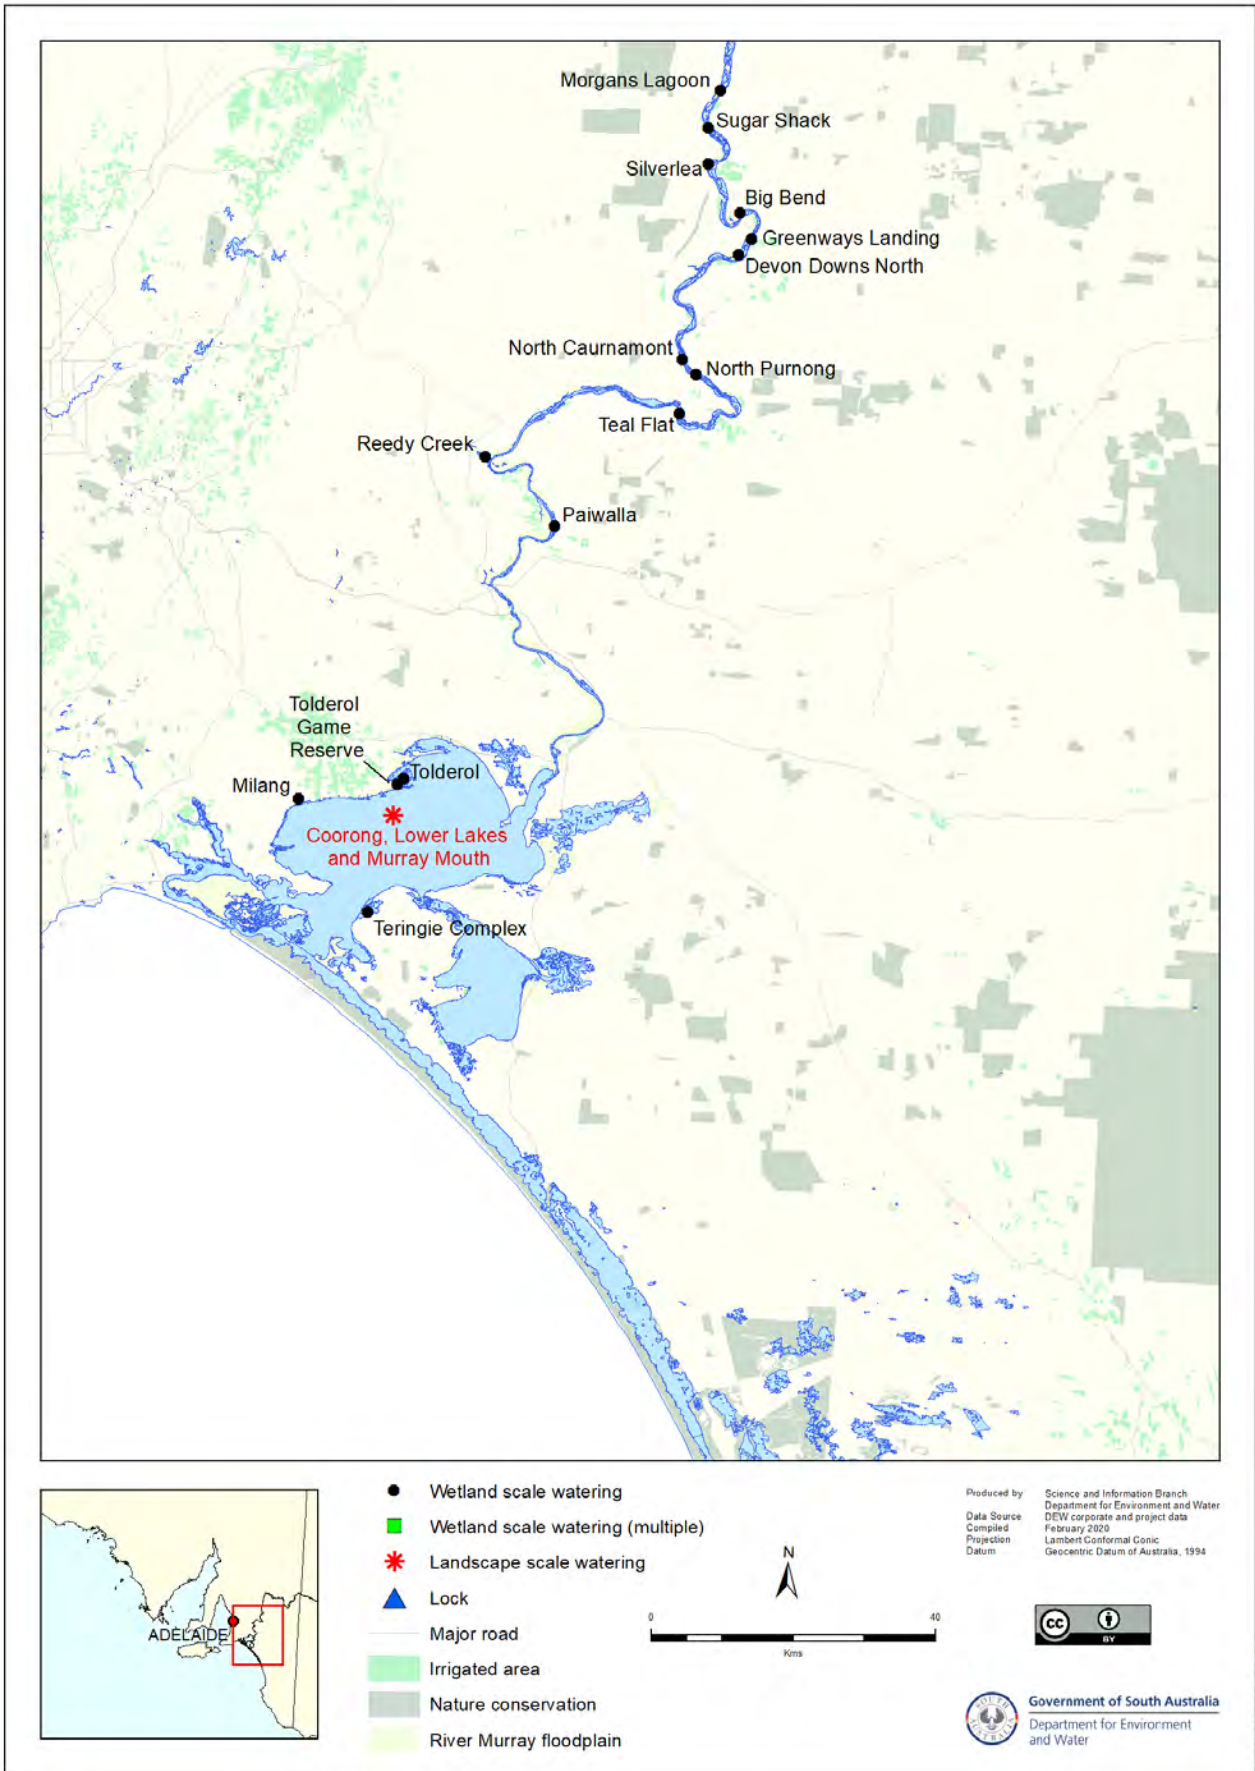
Figure 4: Map 3 - Sites along the River Murray that received water in 2018-19

Locations of sites that received water for the environment are shown in Figures 2, 3 and 4.

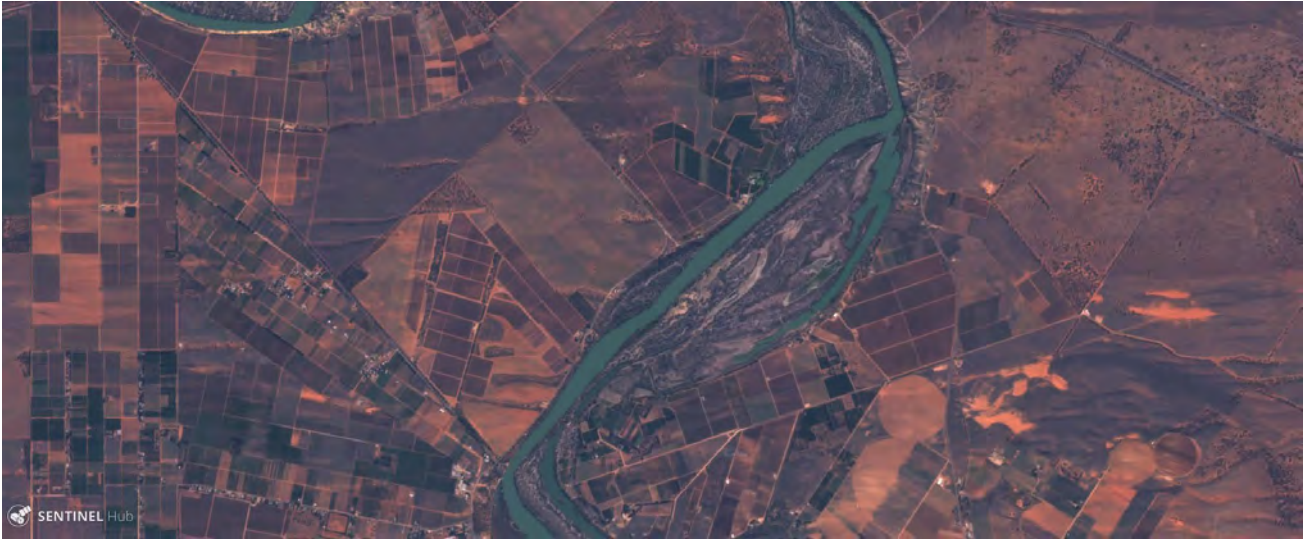
Figure 11: Sentinel images for Big Toolunka during the weir pool raising Source: DEW

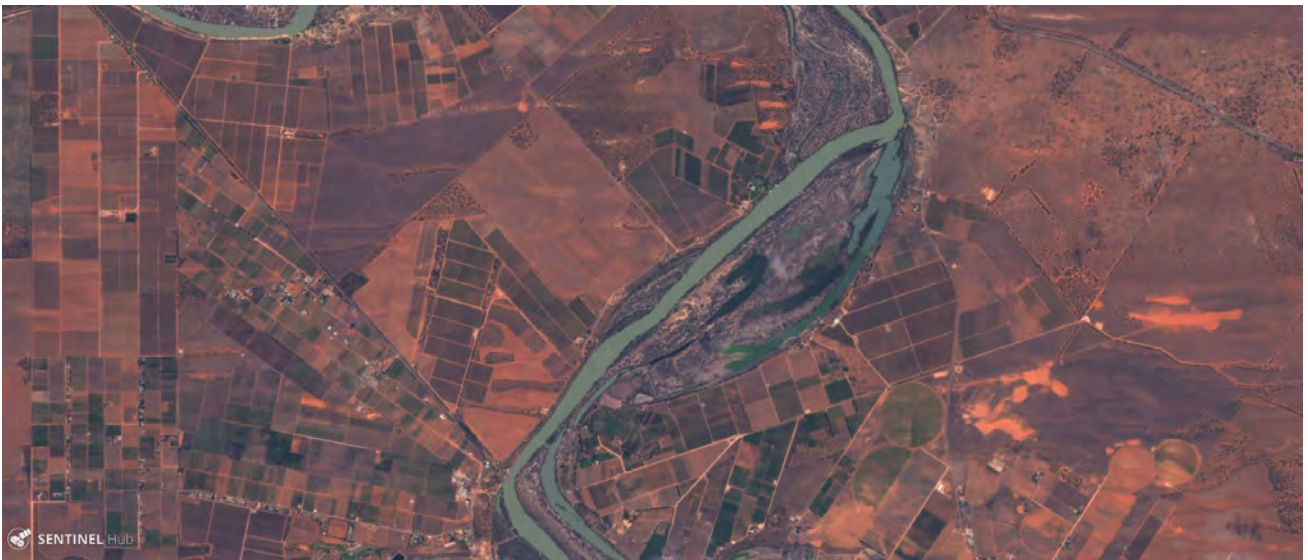
Figure 12: Sentinel image for Big Toolunka at the peak of the weir pool raising Source: DEW

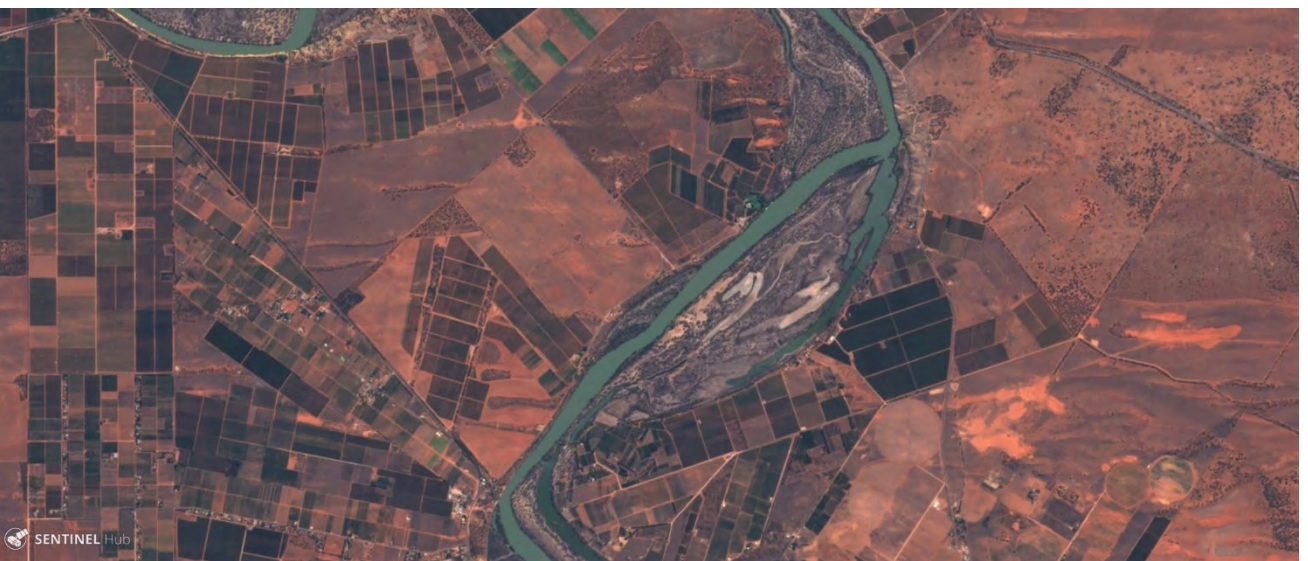
Figure 13: Sentinel image for Big Toolunka post the weir pool raising Source: DEW

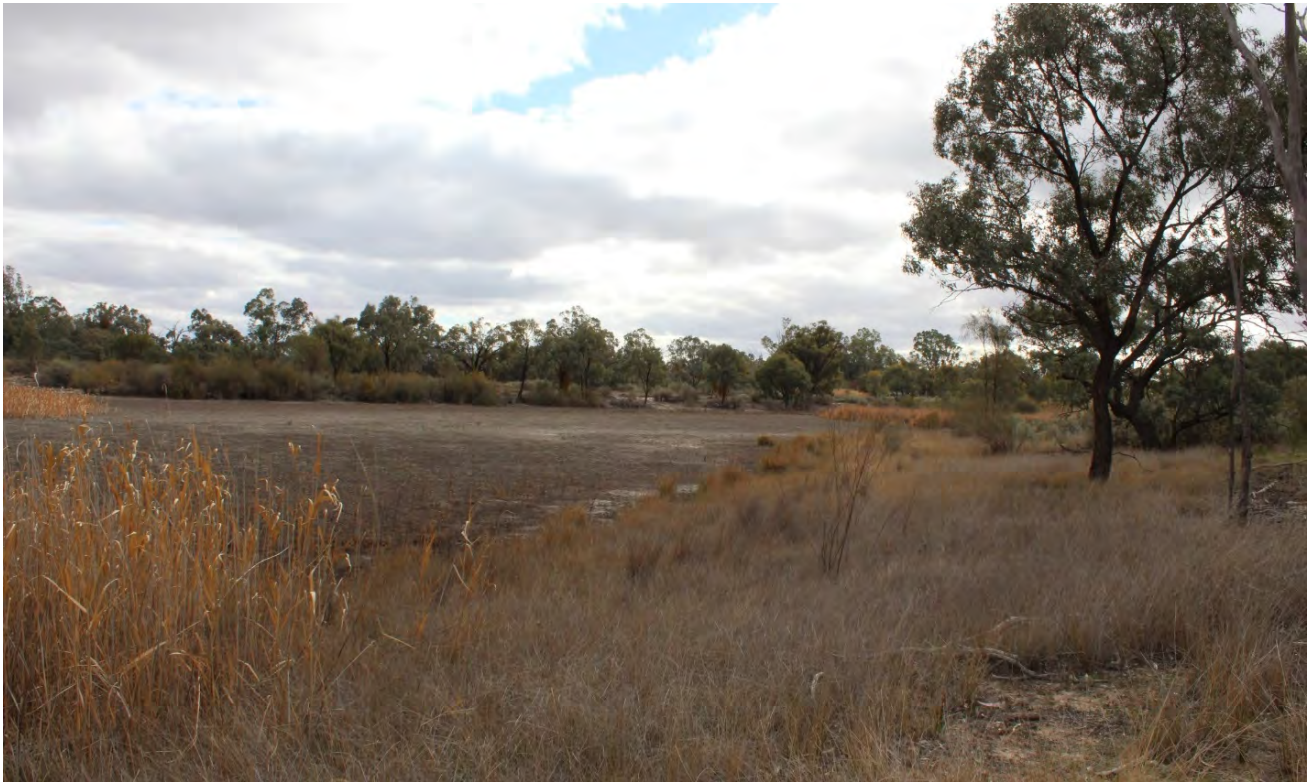
Figure 14: Whirlpool Corner – 18 August 2018 (pre weir pool 5 raising) Source: NR SAMDB

A number of species were observed growing on Whirlpool Corner wetland bed during December 2018 photopoint monitoring (i.e. after drawdown) including nardoo, red water milfoil, joyweed and rosinweed. Flowering black box and emu bush were also observed around the margins of the wetland bed.

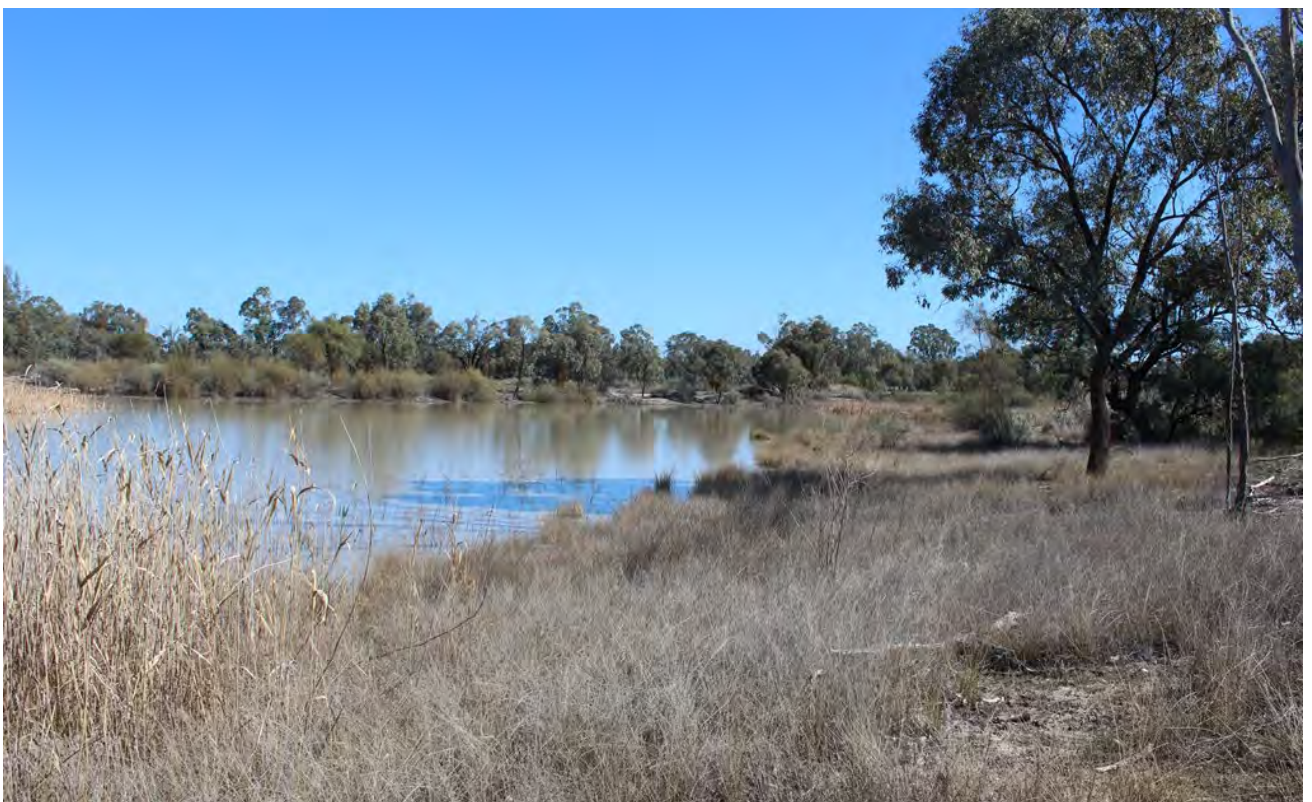
Figure 15: Whirlpool Corner – 13 September 2018 (weir pool 5 at 0.35 m AHD above normal operating level) Source: NR SAMDB

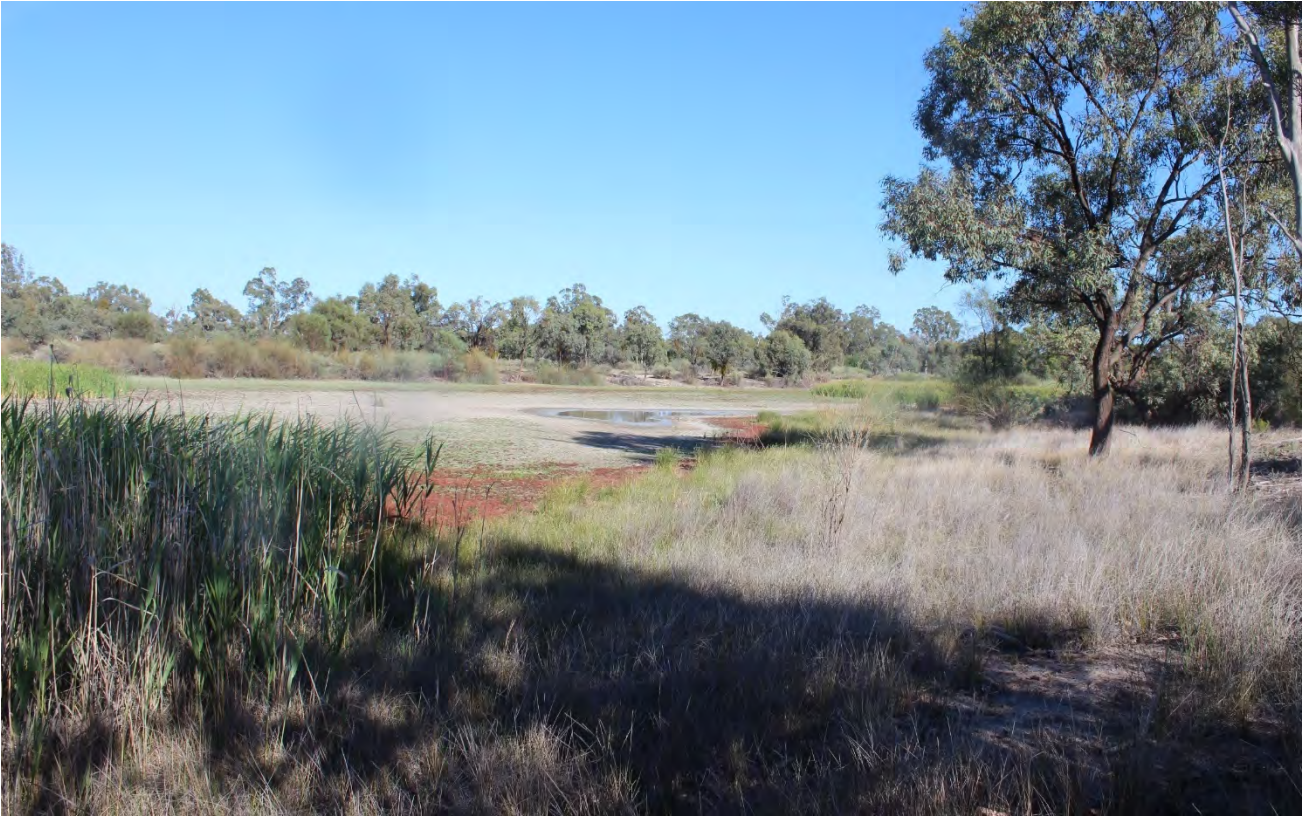
Figure 16: Whirlpool Corner – 18 December 2018 (post weir pool 5 raising) Source: NR SAMDB

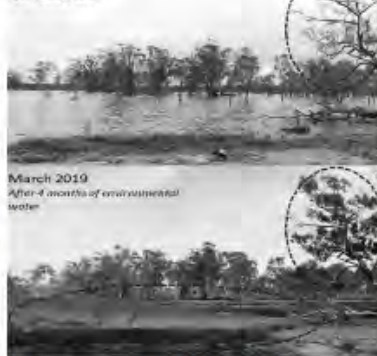
A photo comparison of the Overland Corner Wetland before the delivery of environmental watering and four months following, showing the added water's positive impact.
PHOTO: Supplied
