Nomination form

1. Name	
<b>Name of Place / Object:</b>	Local heritage places and unlisted structures within the Former Hardy's Winery Site, Old Reynella <ul style="list-style-type: none"><li>• Cottage within Reynella Winery (Council Heritage ID 310)</li><li>• Carew Cottage and Attached Former School Room, Sunken Garden and Pine Trees (Heritage ID 5375)</li><li>• Dwelling (Heritage ID 20084)</li><li>• Outbuilding (former Cellar Door) to the winery site on Reynell Road</li><li>• Outbuilding behind and to the south of the former Cellar Door</li><li>• Haselgrove Room</li><li>• Still House</li><li>• Maintenance Shed</li></ul>
<b>Any other or former name(s):</b>	Reynell's Winery, Walter Reynell and Sons, Hardy's Reynella, Accolade Wines
<b>Is the place already on another heritage list?</b>	The following six elements within the Hardy's (former Reynell's) Reynella Winery are state heritage listed <ul style="list-style-type: none"><li>• Pigeon Loft</li><li>• Cave Cellar No.1</li><li>• Reynell's House (now offices)</li><li>• Dairy</li><li>• Shell of the Chateau</li><li>• Boiler Stack</li></ul>

HERITAGE ASSESSMENT – LOCAL HERITAGE PLACES

## Carew Cottage Heritage Assessment

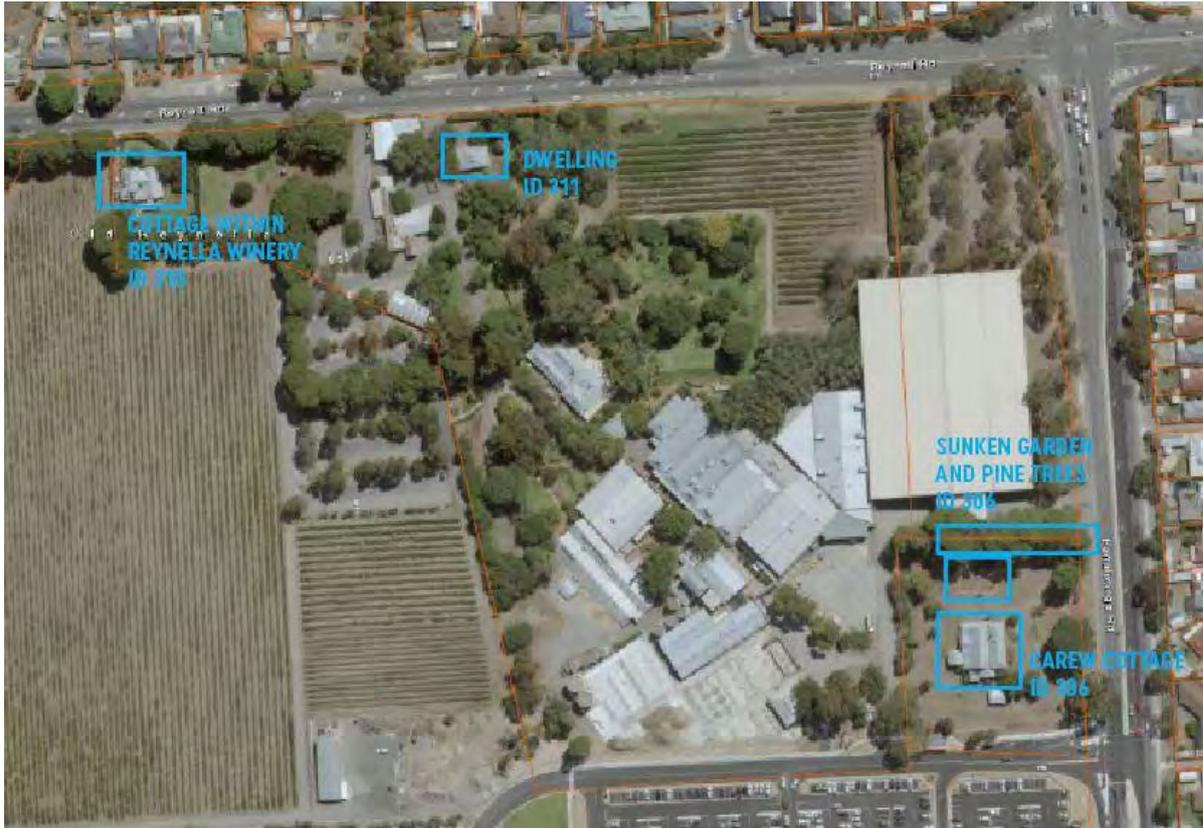
Figure 1: Location of existing Local Heritage Places (GGA over Location SA Map Viewer)

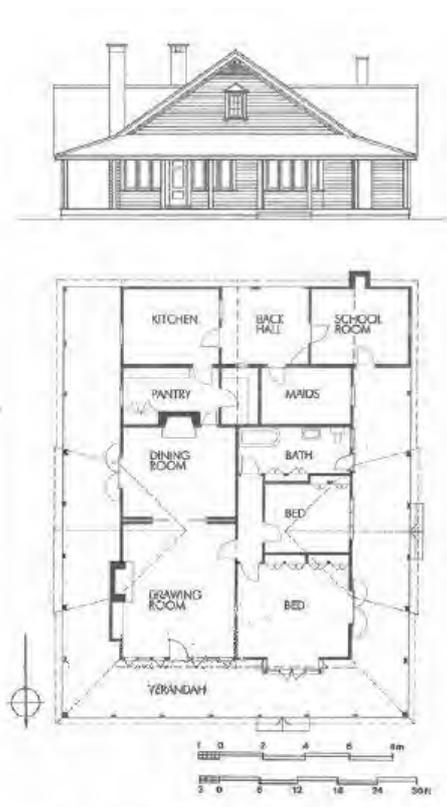
8.188 House for Carew Reynell, Reynella, SA 1910; elevation and floor plan. (Author 1986)

Figure 4: Plans drawn by Robert Riddel for his 1986 thesis on Architect Robin Dods (Robert Riddel,)

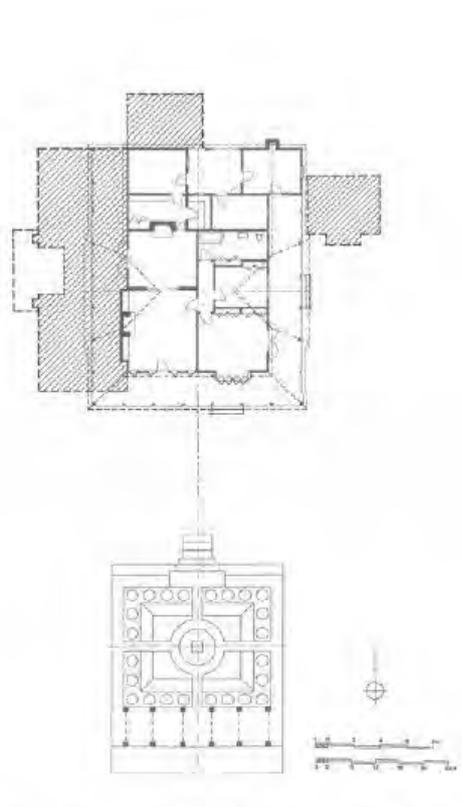
8.189 House for Carew Reynell, Reynella, SA 1910; formal garden with subsequent additions hatched. (Author 1986)

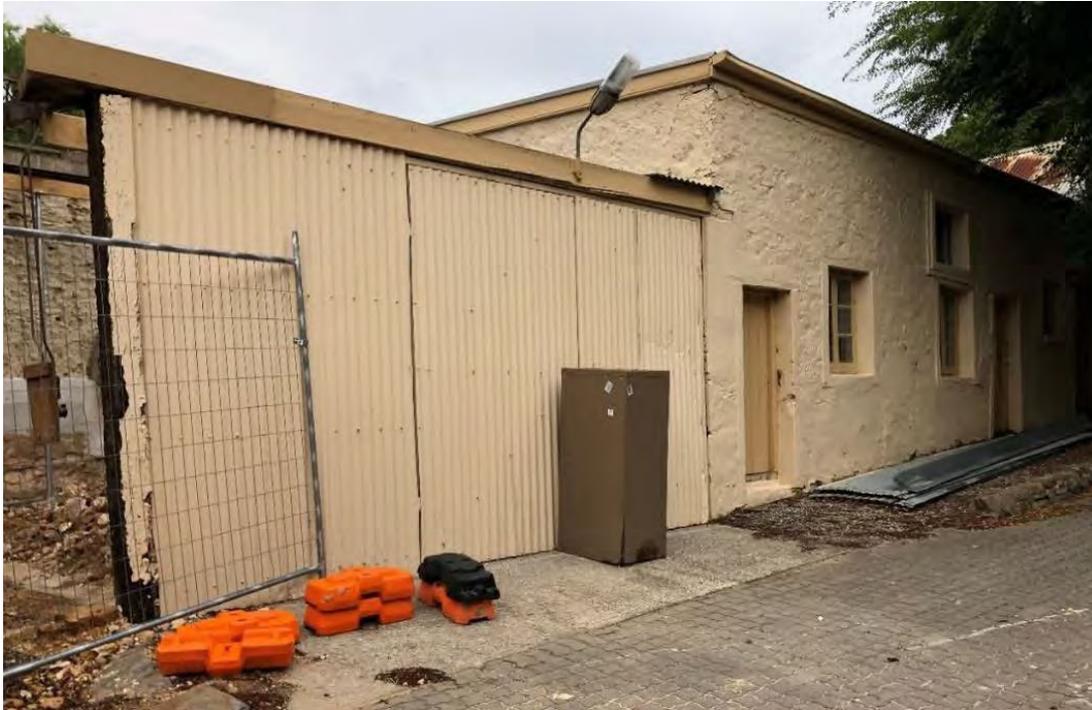
Figure 13: outbuilding with lightweight addition to older masonry section; collapsed wall at left (GGA, February 2021)

It is the opinion of the authors of this report that should a review of the State listed components of the site be conducted, all or part of this outbuilding would potentially be worthy of considering for inclusion in the State listing, as an example of an early farm building that would have supported the development and functionality of the early phases of wine production and farming practices employed in the time of John Reynell. An early photograph held in the State Library of South Australia show this building with a horse drawn wagon in front, and the Noarlunga Heritage Survey asserts that the stables were constructed about 1867, although this is not substantiated.

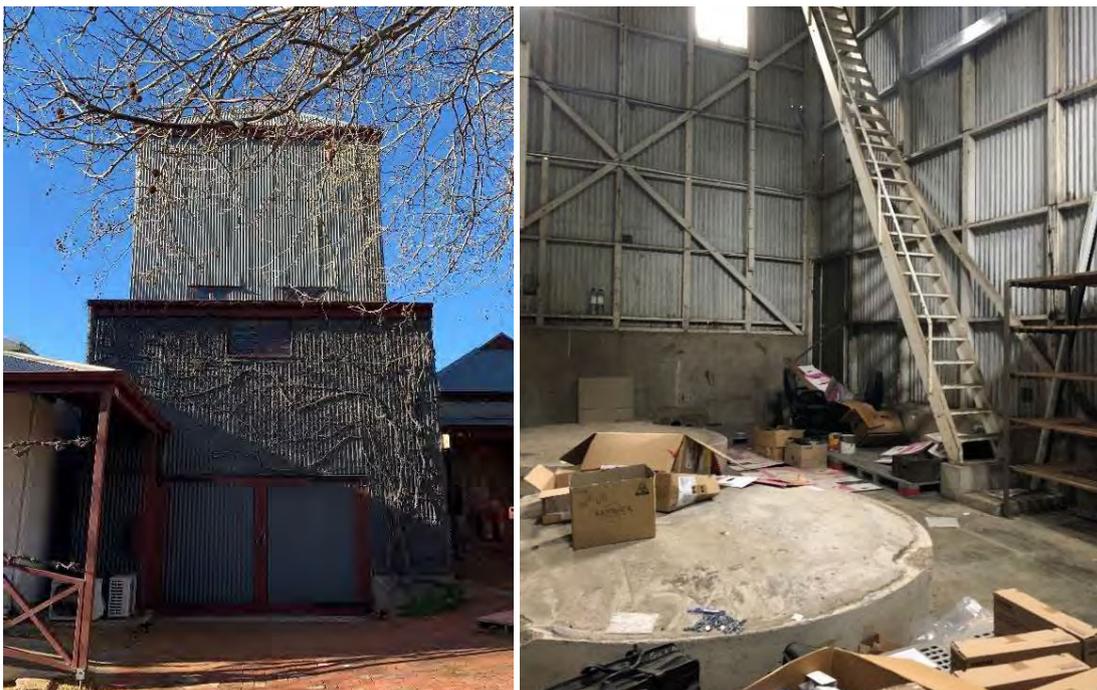
The Still House is a double height structure of timber framing clad in corrugated sheet metal, with large double sliding doors accessing the interior. The interior provides some evidence of the former use of the building, but the stills have been removed, and the building is now used for storage. The Register of State Heritage Items – Item Evaluation Sheet indicates the Still House was built in the 1930s, along with additional storage for fortified wines. It is clearly visible in the 1949 aerial photograph.

Figure 17, 18: Exterior of Still House, and internal view showing concrete bases for stills (GGA, February 2021)

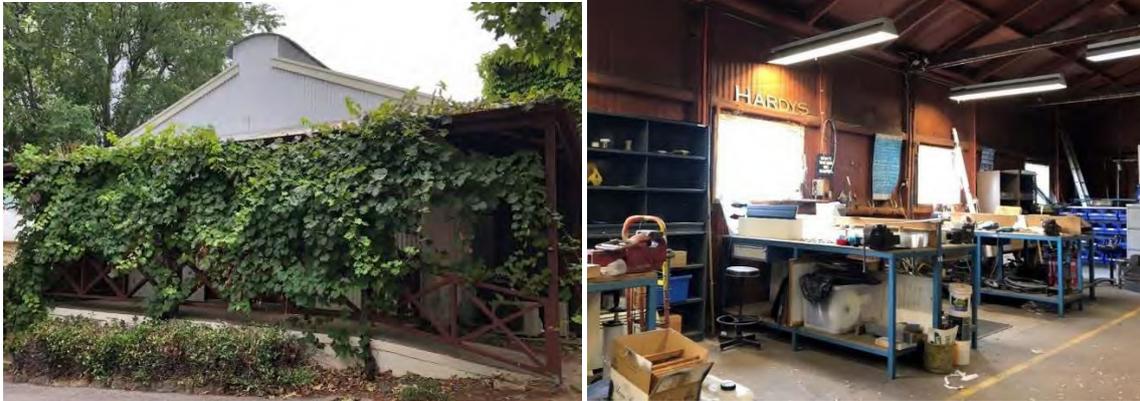
The Maintenance Shed is a utilitarian building with a gable roof form with ventilator running the length of the roof, clad in corrugated sheet metal. The building has been lined internally with a spray applied coating which is known to be a toxic substance, and it is understood the site owners are proposing demolition of the structure.

Figure 19, 20: Exterior and Interior view of Maintenance Shed (GGA, February 2021)

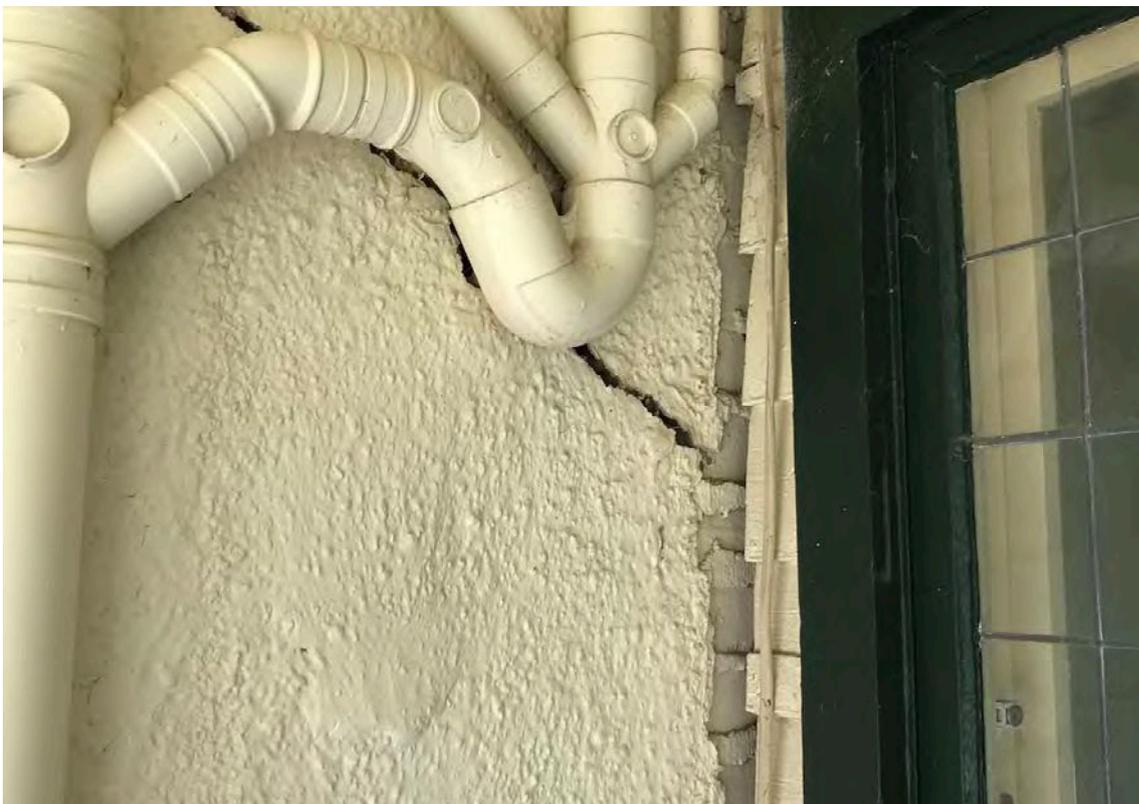
Figure 12: North elevation, indicating unfinished west elevation of two storey wing  
Source: *Hosking Willis, 2020*

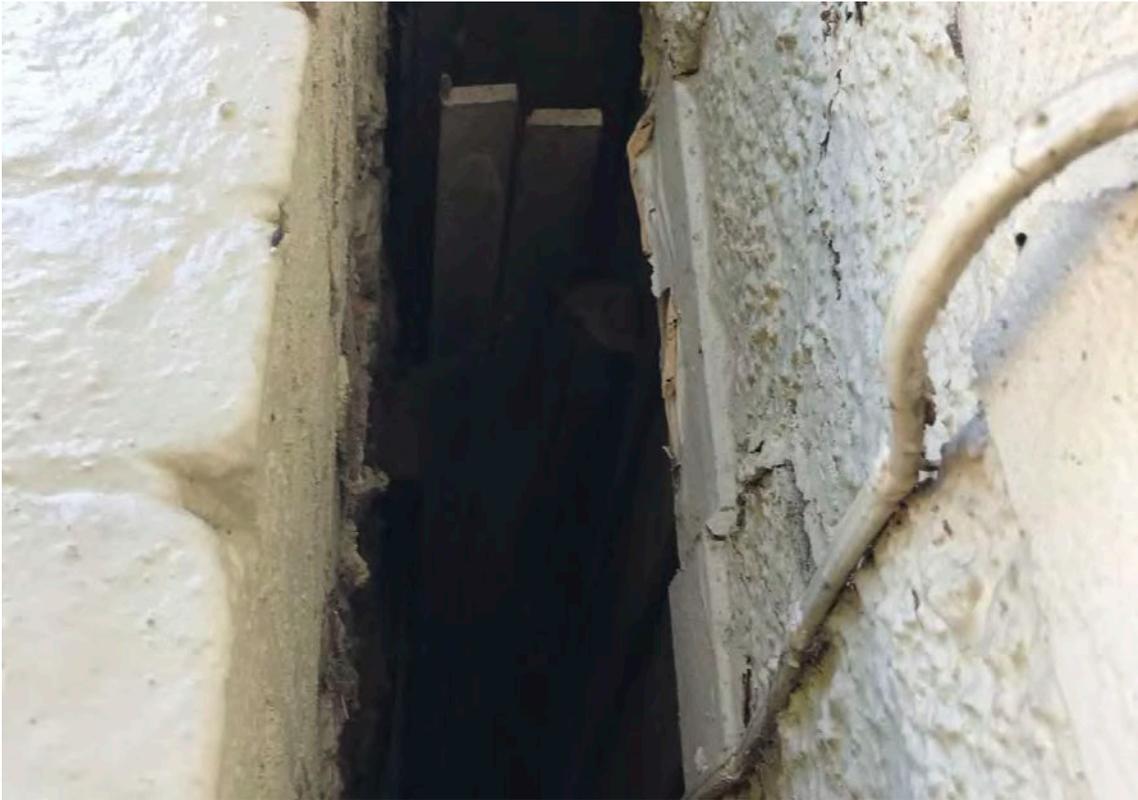
Figure 13: South elevation, junction of timber building and detached stone kitchen wing indicating unfinished north elevation of kitchen

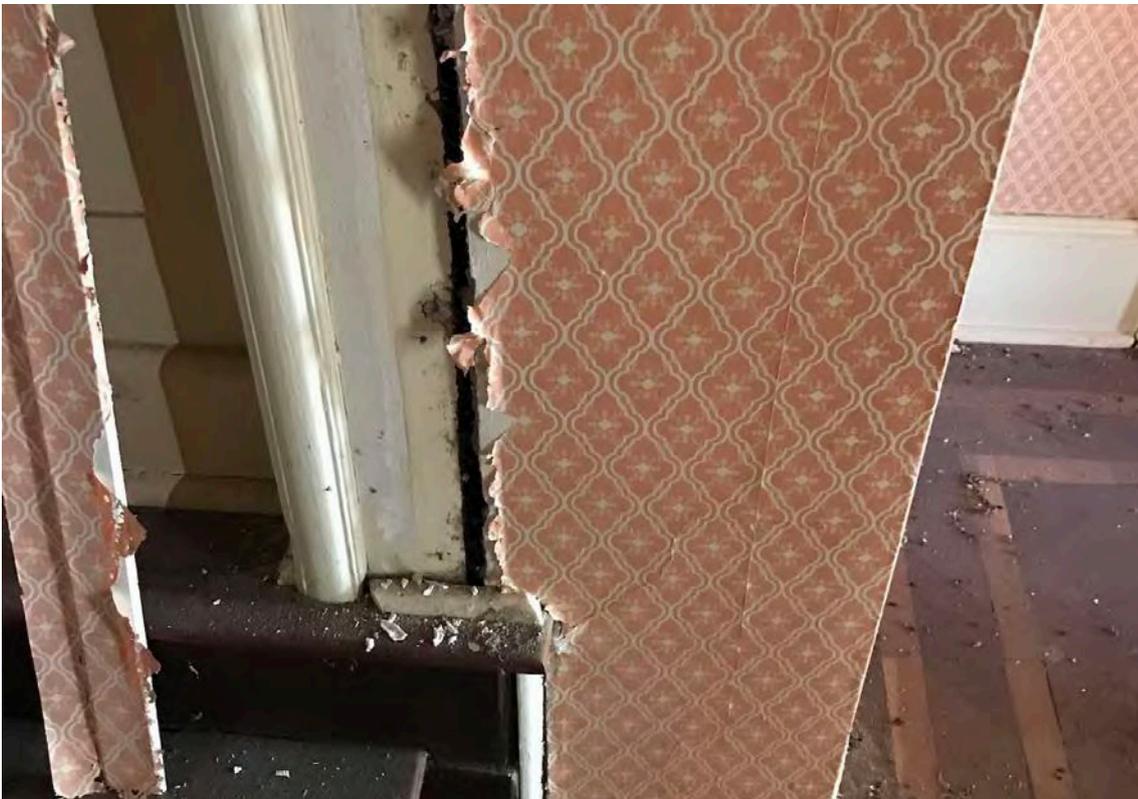
Figure 14: Internal junction of timber dwelling (left) and brick two storey wing (right)

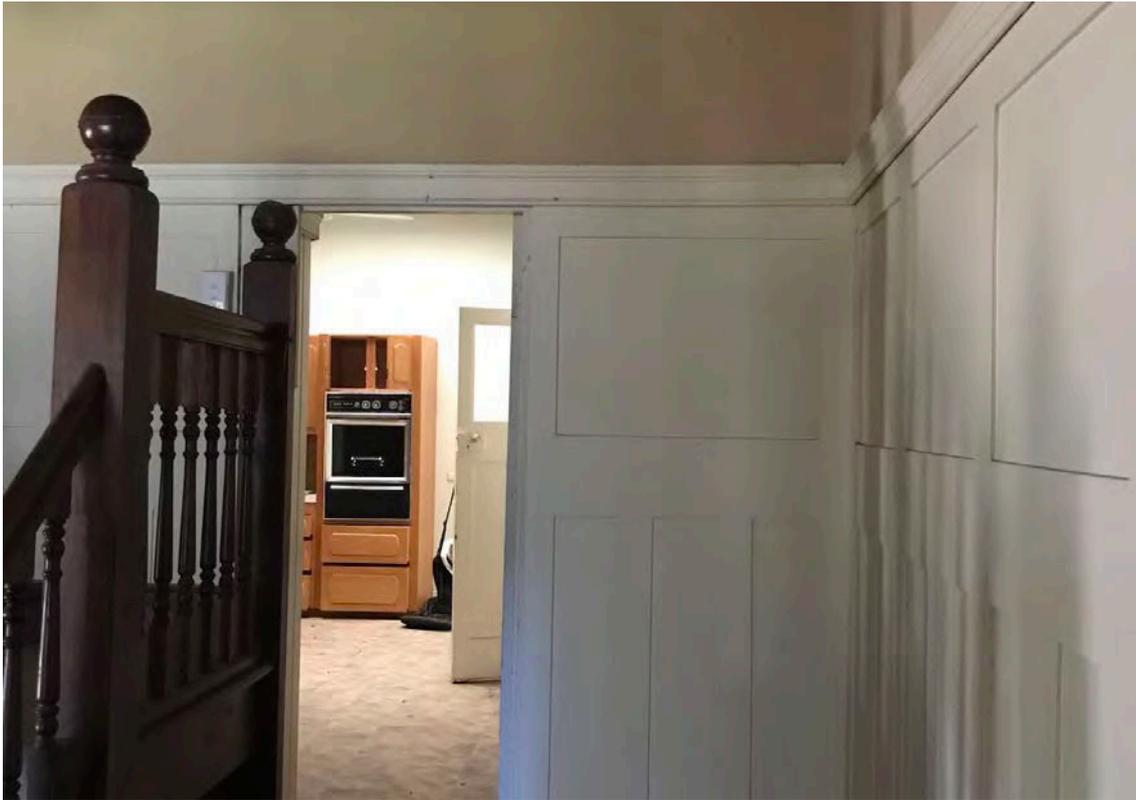
Figure 15: Incongruous fitting of internal stair across kitchen doorway  
Source: *Hosking Willis, 2020*

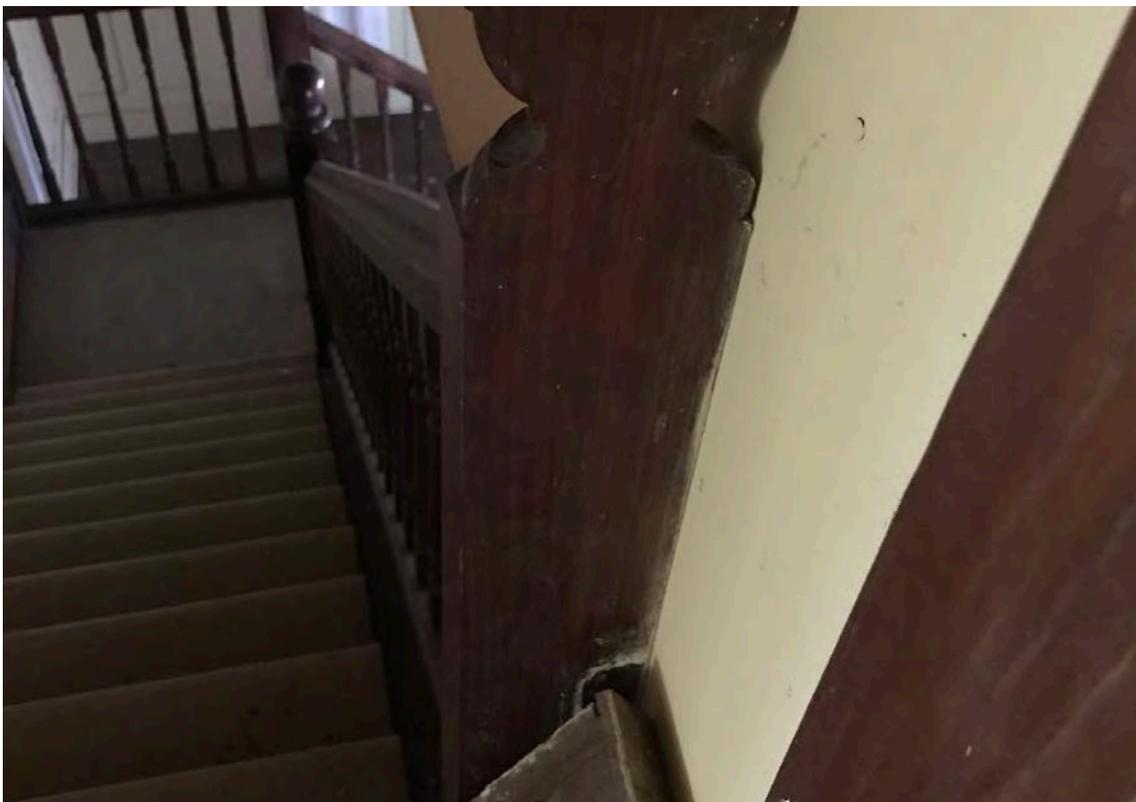
Figure 16: Incongruous fitting of internal stair with half newel post  
Source: *Hosking Willis, 2020*

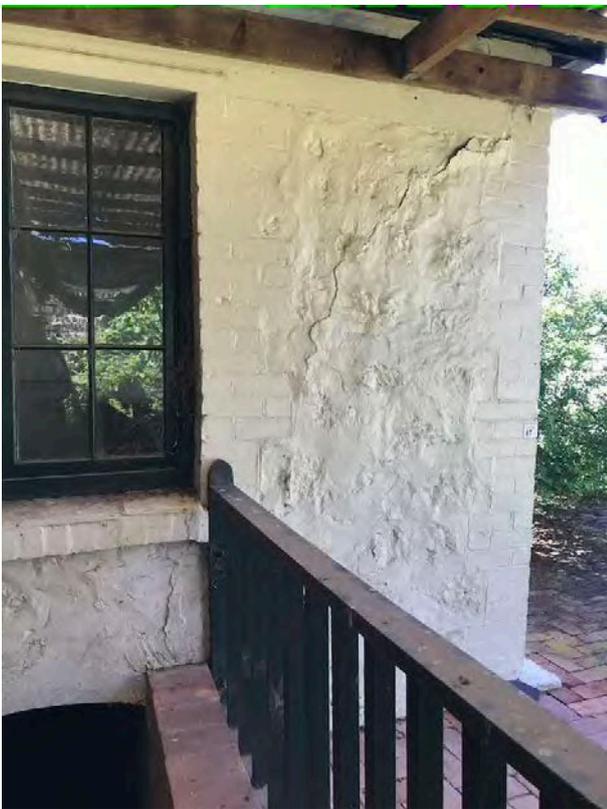
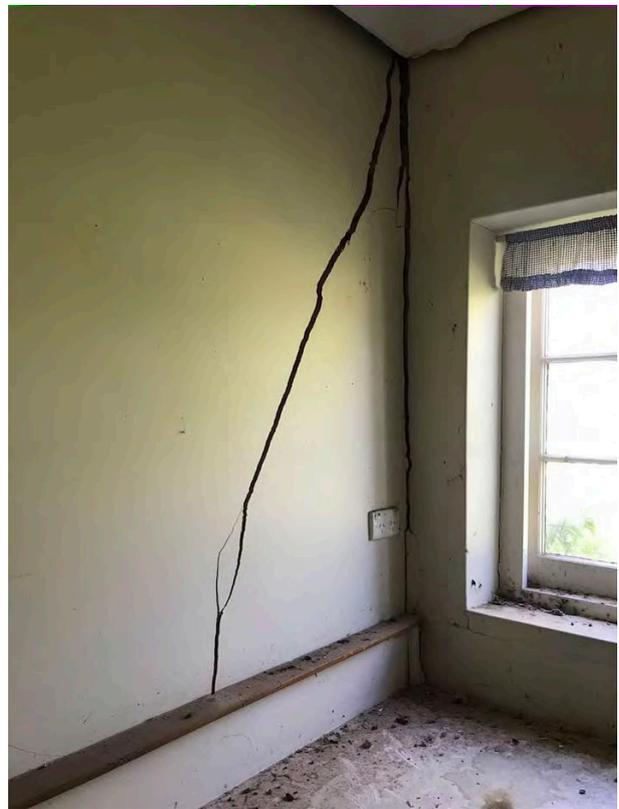
Figure 17: Cracking to masonry walls and interior of (former) kitchen wing

As the following images indicate, the single-storey former kitchen wing and cellar also have extensive structural damage, despite (or as a result of) previous structural works including crack repair and installation of a new deck slab above the cellar area.

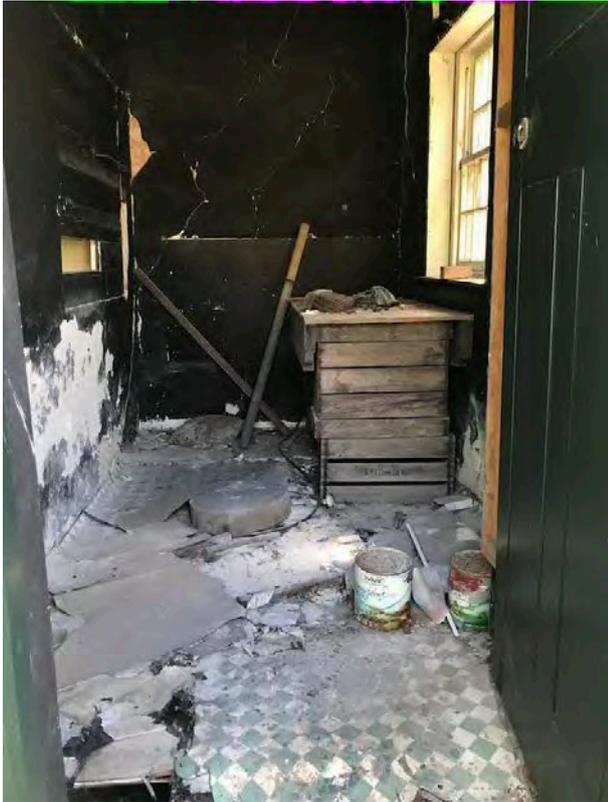
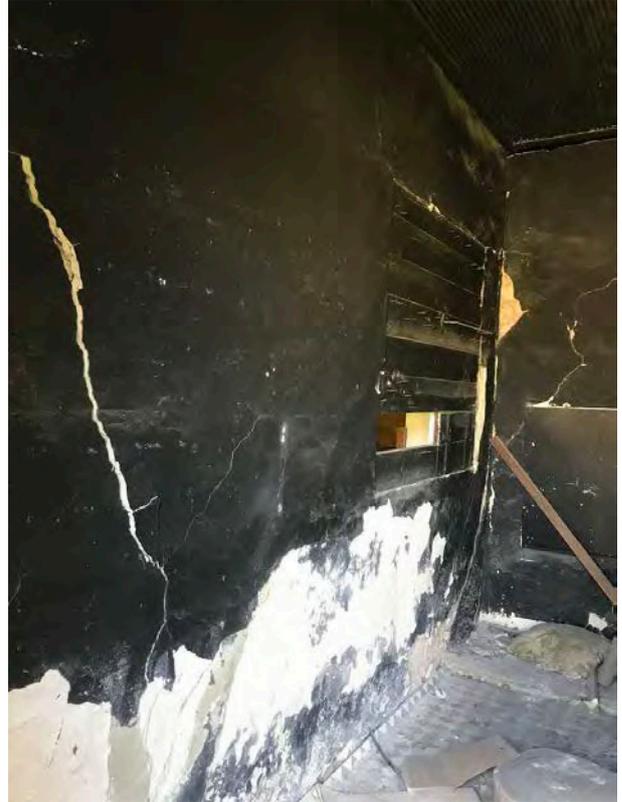
Figure 18: Interior of (former) kitchen wing  
Source: Hosking Willis, 2020

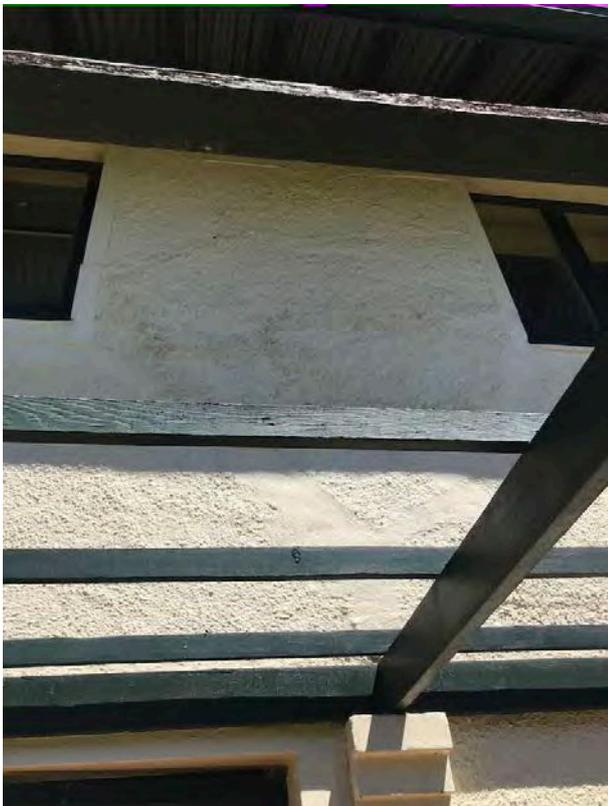
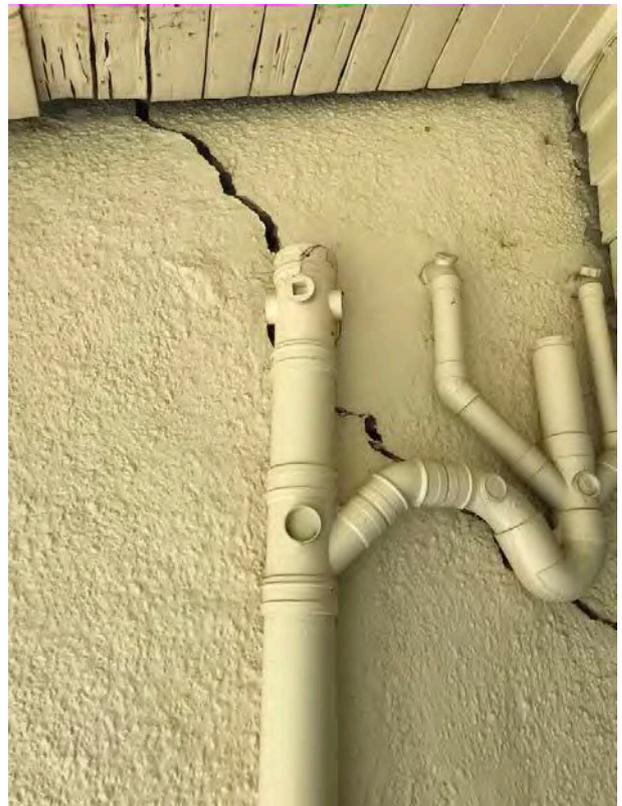
Figure 19: Previous repairs and cracking to masonry walls of double-storey wing  
Source: Hosking Willis, 2020

Further investigation of the building structure was also carried out by John Bowley, a qualified structural engineer with experience in heritage buildings. The investigation confirmed that the two-storey masonry wing is structurally unsound, unsafe and unfit for habitation.

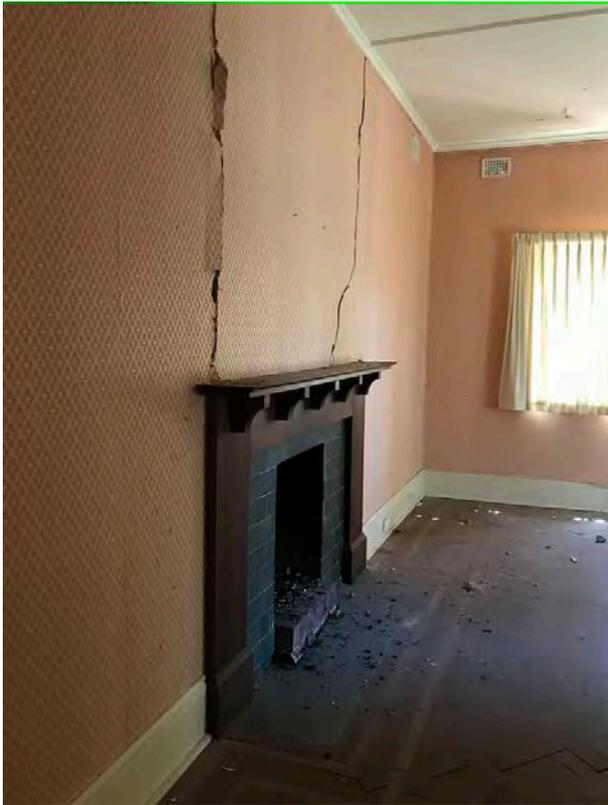
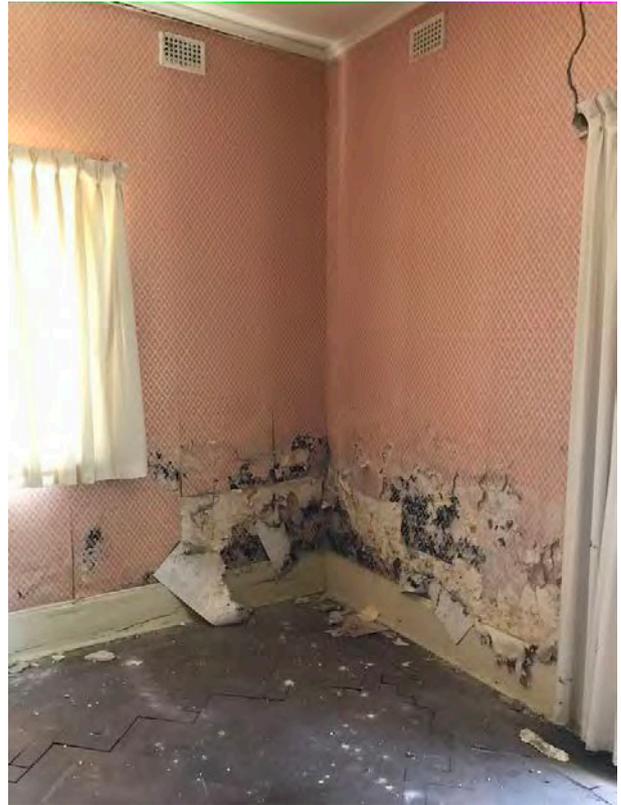
Figure 20: Cracking and damp to masonry walls of double-storey wing. Significant settlement along eastern side of the wing has resulted in major bowing of floor structure

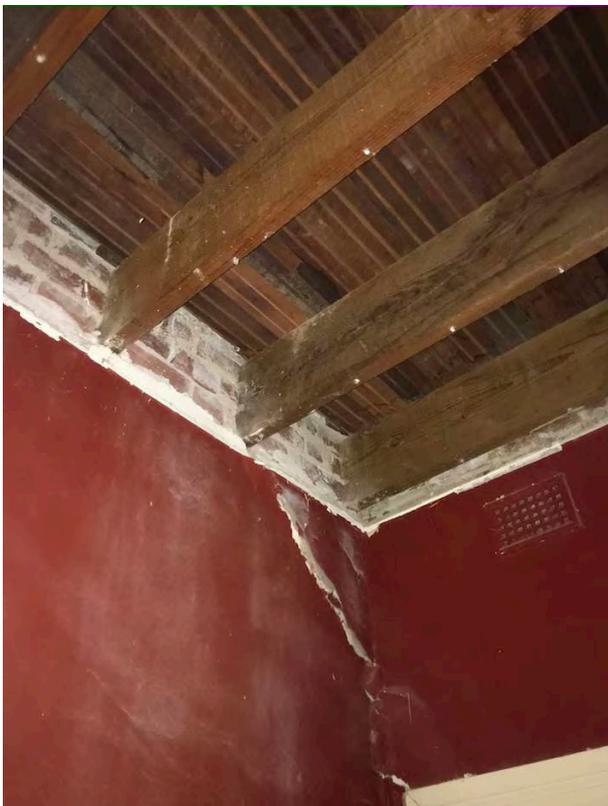
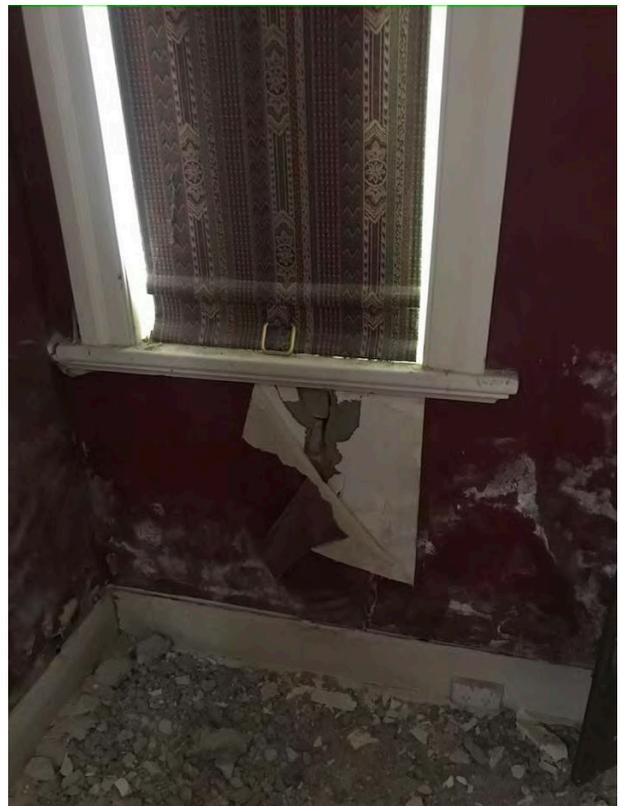
Figure 21: Missing ceilings and cracking and damp to masonry walls of double-storey wing

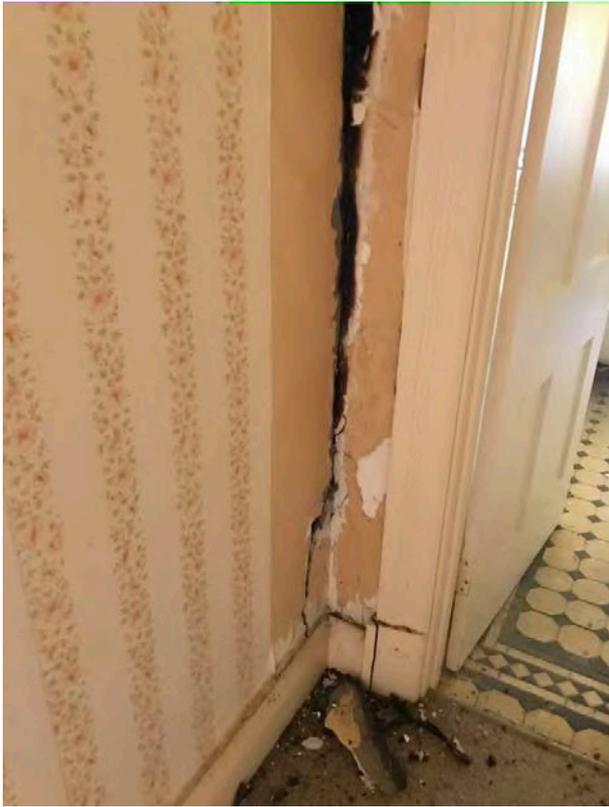
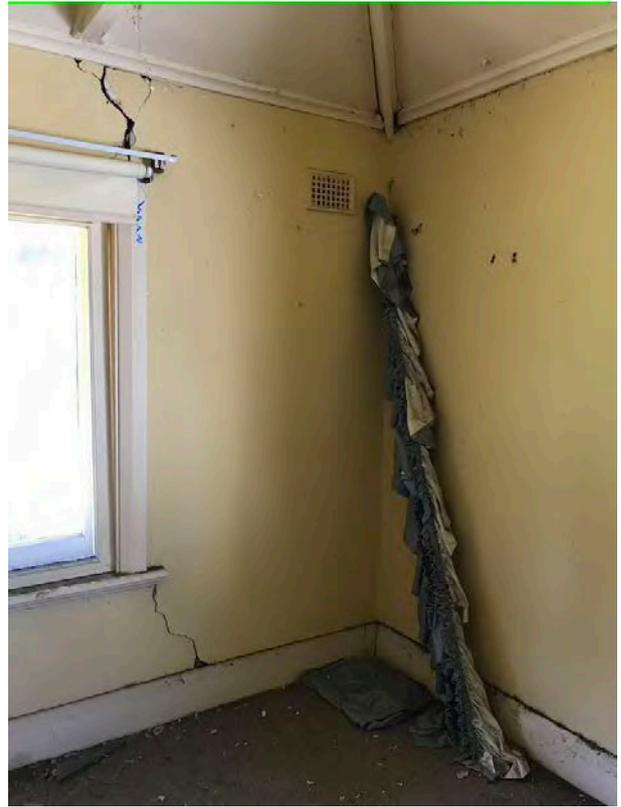
Figure 22: Damage to masonry walls of double-storey wing  
Source: Hosking Willis, 2020

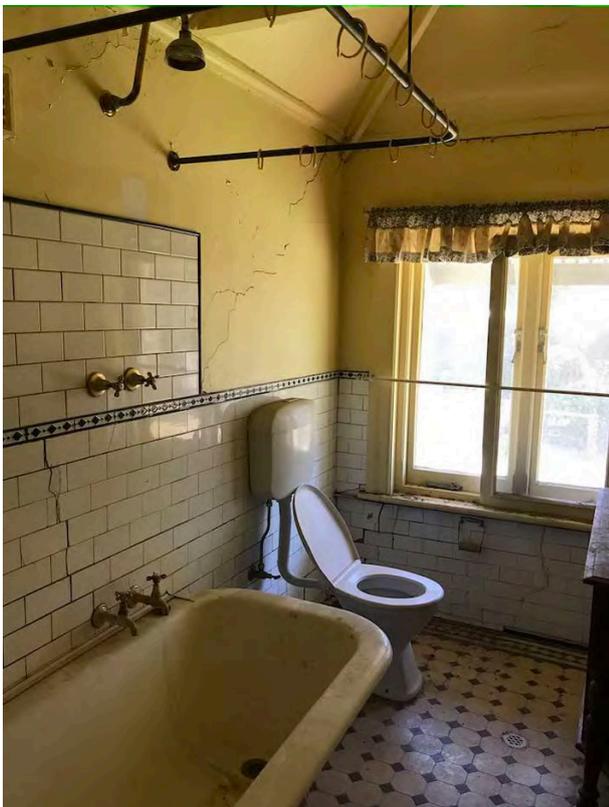
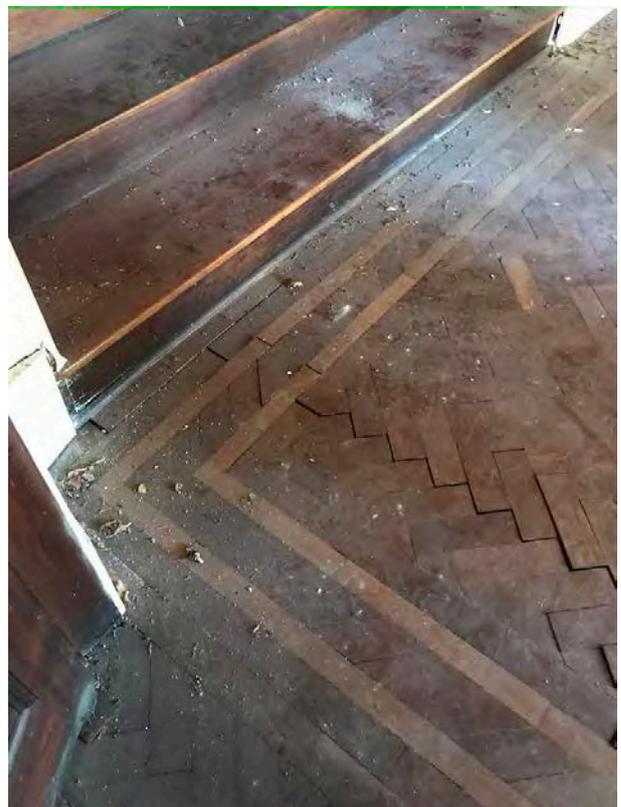
Figure 23: Cracking of masonry and floors of double-storey wing  
Source: Hosking Willis, 2020

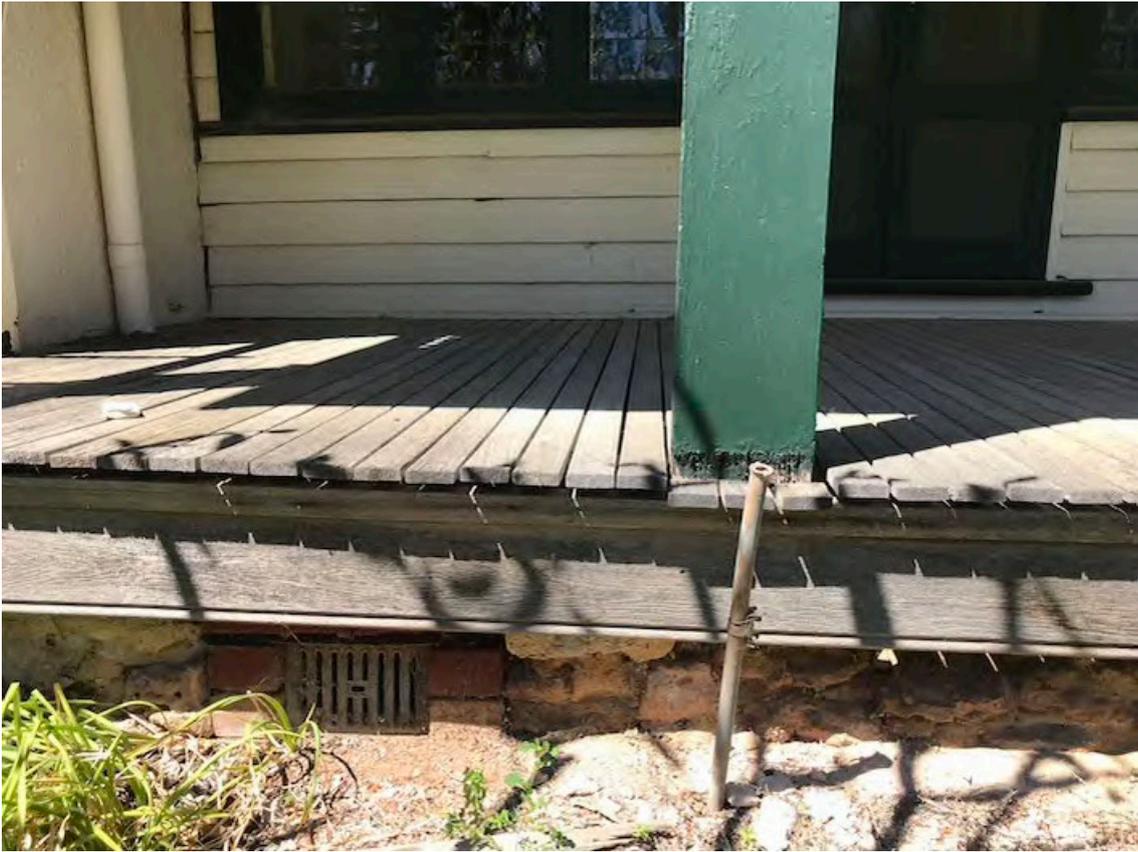
Figure 24: Subfloor masonry walling to verandah of single-storey wing  
Source: Hosking Willis, 2020

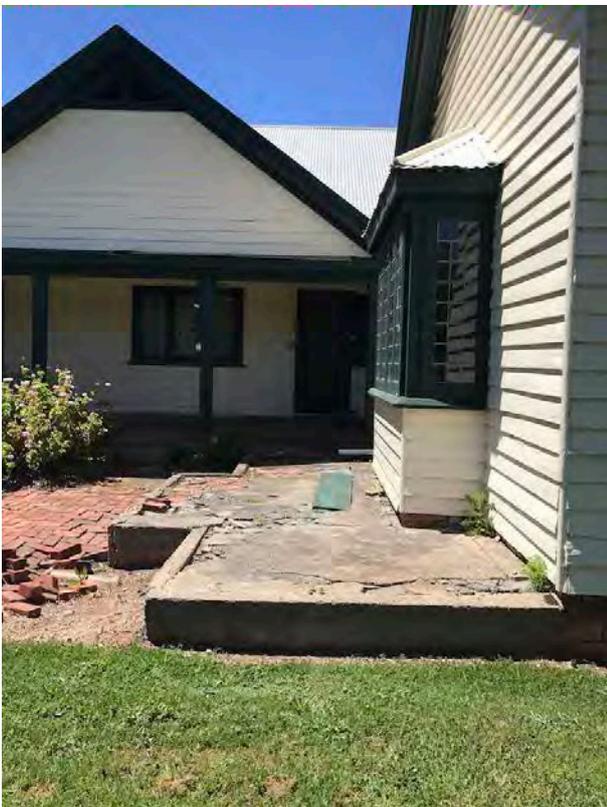
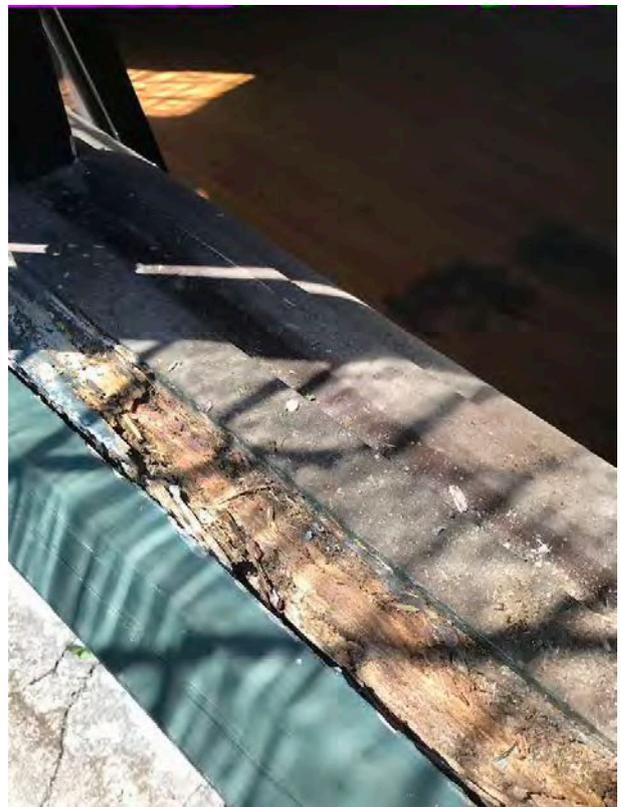
Figure 25: Poor condition of former 'school room'  
Source: Hosking Willis, 2020

While less apparent than the masonry wing, structural issues which may impact the soundness of the timber-framed portion of the cottage and 'school room' include the stability and loss of supporting masonry dwarf walling and timber framing to the sub-floor areas and vermin attack and rot in some timbers, where visible. A full inspection of the sub-floor and ceiling spaces were outside the scope of this report.

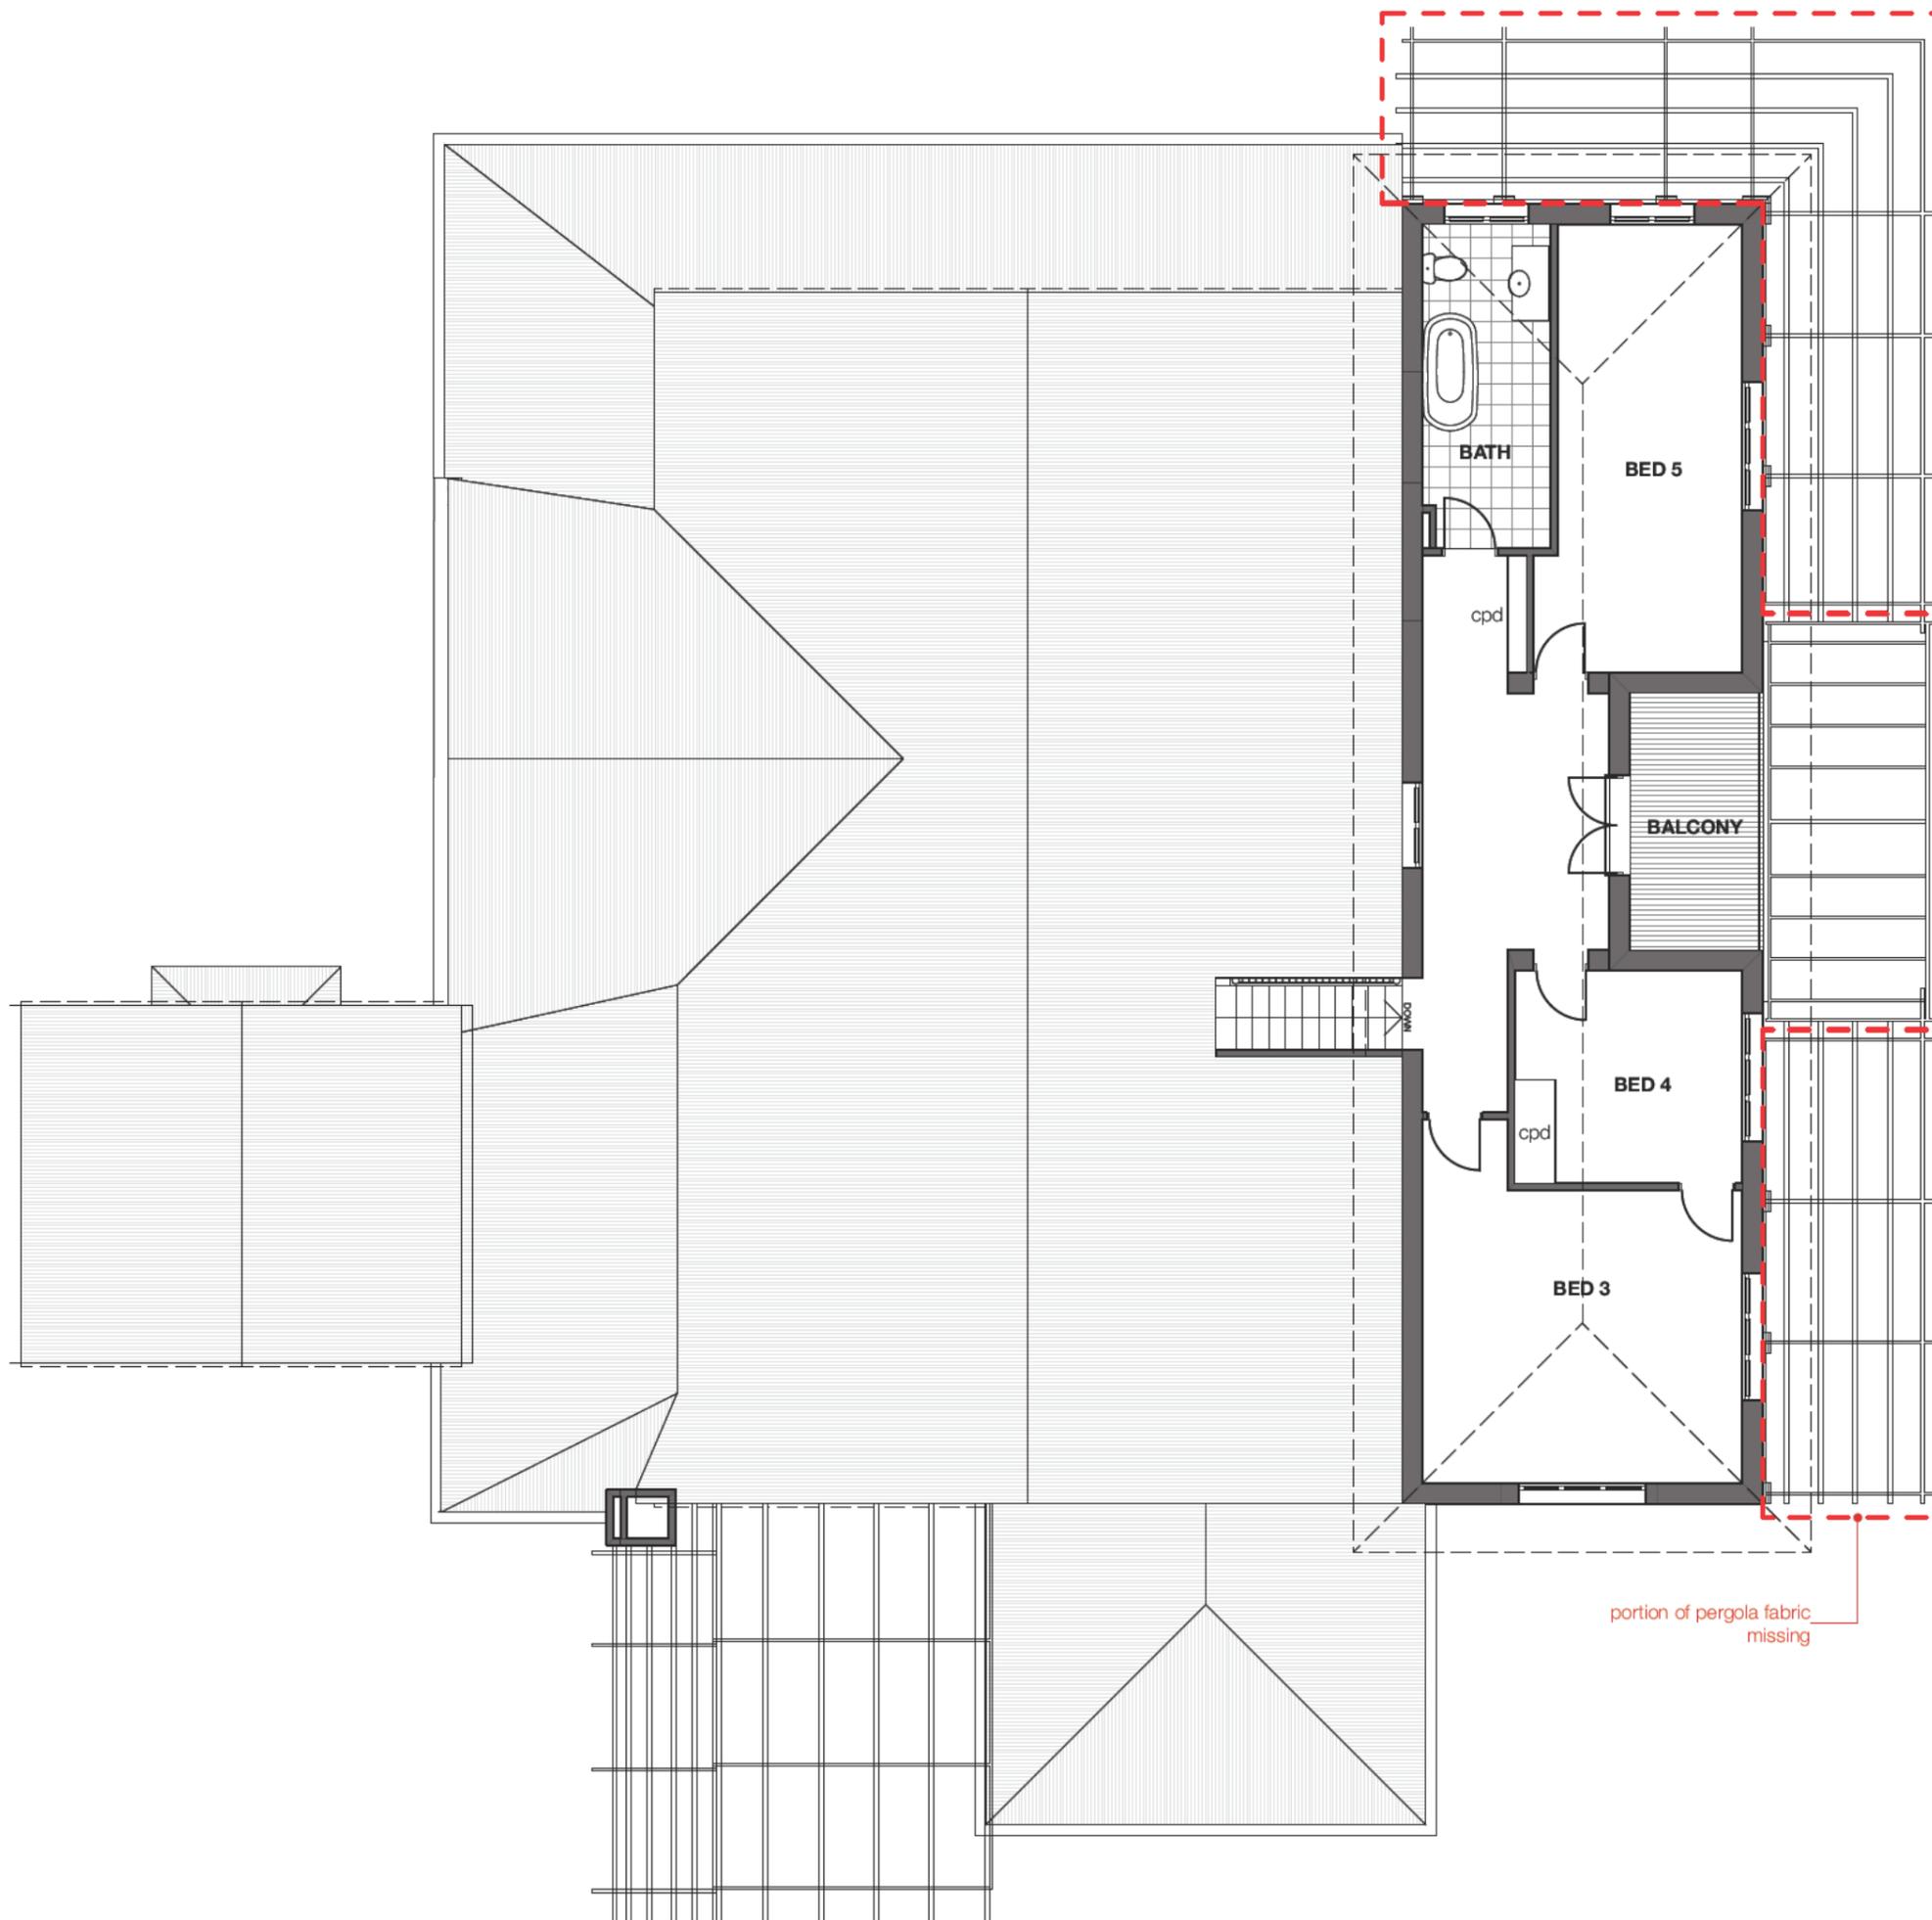
large portion of pergola fabric missing

portion of pergola fabric missing
