Native Vegetation Clearance

Clover Park Scattered Trees Footpath and Track Entrance

Data Report

Clearance under the *Native Vegetation Regulations 2017*

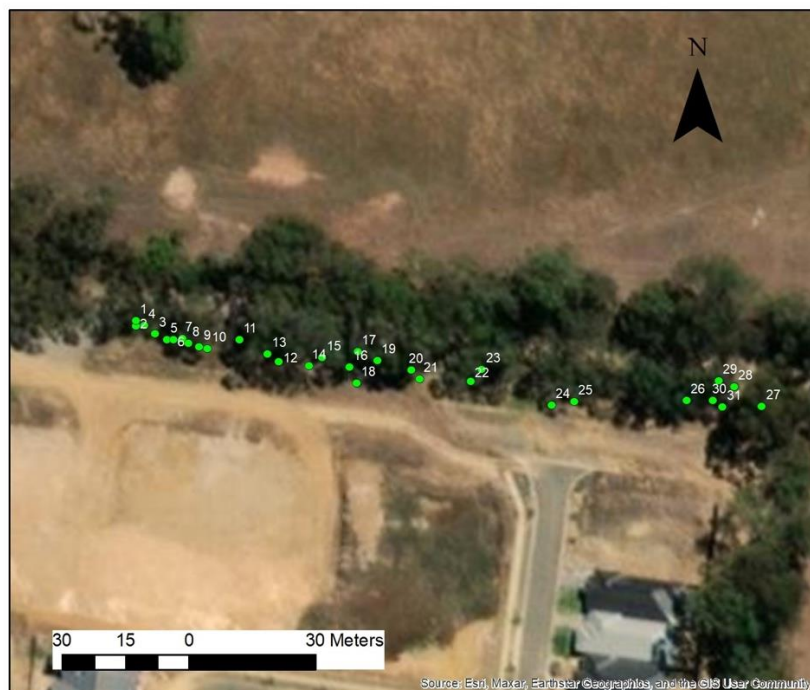
Map of proposed clearance area

Purpose of clearance	Clearance is required to construct a footpath and entry point to a track.
Native Vegetation Regulation	Regulation 12 (35) Residential subdivision
Description of the vegetation under application	River Red Gum woodland growing over exotic grasses
Total proposed clearance - area (ha) and number of trees	30 <i>Eucalyptus camaldulensis</i> var. <i>camaldulensis</i> scattered trees
Level of clearance	Level 3
Overlay (Planning and Design Code)	Native Vegetation / Regulated and Significant Tree

It is proposed to clear 30 native trees to construct a footpath next to Heysen Boulevard at the Clover Park subdivision. A vehicle entrance from Heysen Boulevard to an adjacent track (Martin Road reserve) requires the removal of five trees.

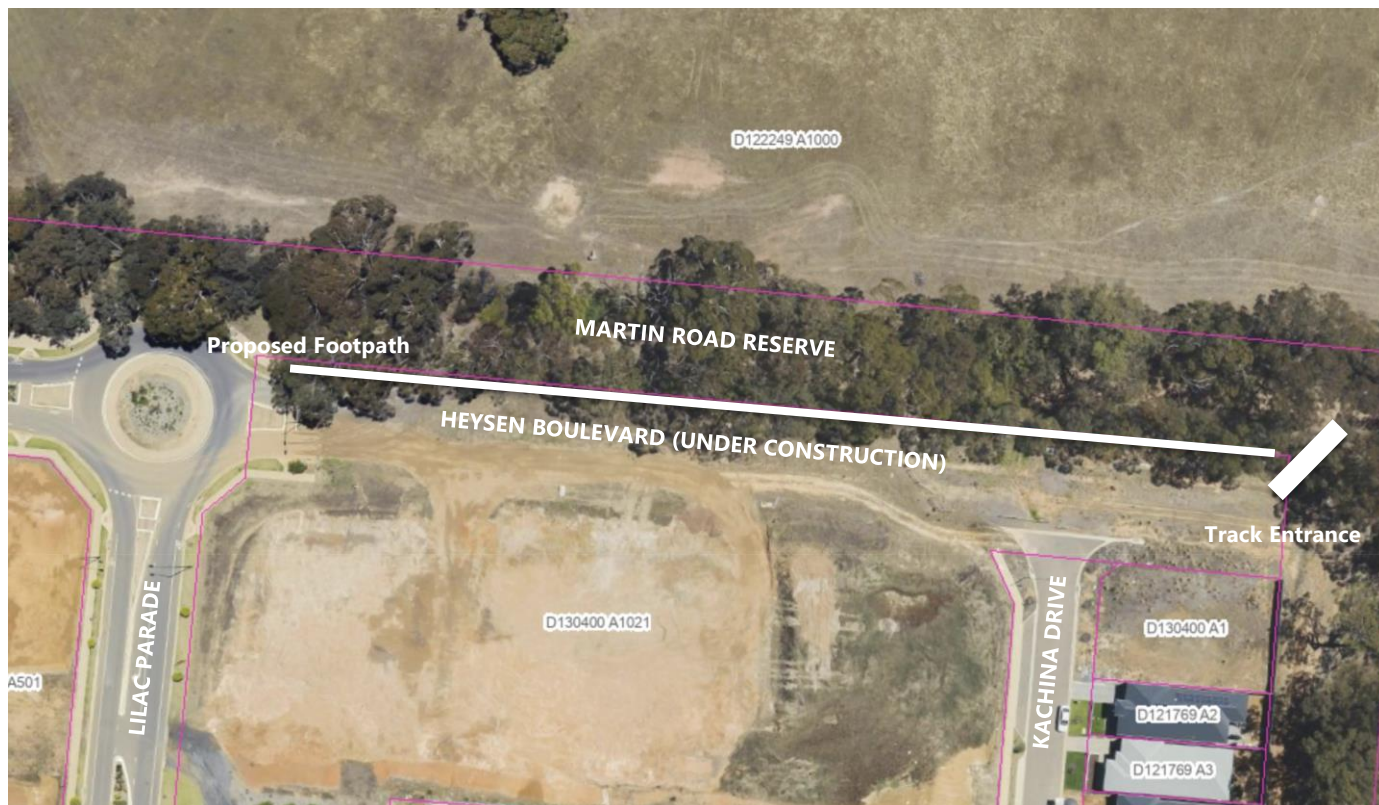
Figure 2. Site Map.

The footpath is to be constructed at the northern edge of land parcel D130400 A1021 adjacent to the Martin Road reserve (Figure 2). The site is zoned Residential Neighbourhood.

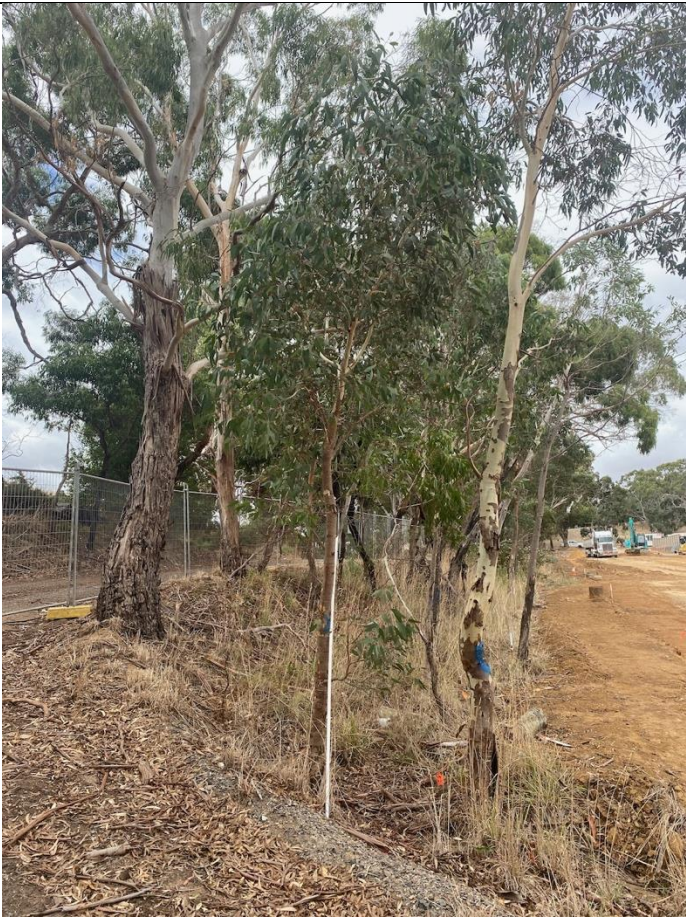
Tree 1

<i>Eucalyptus camaldulensis</i> var. <i>camaldulensis</i>	
Number of trees – 1	
Height (m) – 5 m	
Hollows – 0	
Diameter (cm) – 10	
Canopy dieback (%) – 0%	
Total Biodiversity Score – 0.25	<p>Photo direction: east. Waypoint 9 Photo 6773</p>
<p>The tree is a sapling <i>Eucalyptus camaldulensis</i> without hollows and minimal canopy dieback.</p> <p>The tree potentially provides food resources for food and/or perching habitat for five State-threatened and two species of regional conservation significance (section 4.2).</p>

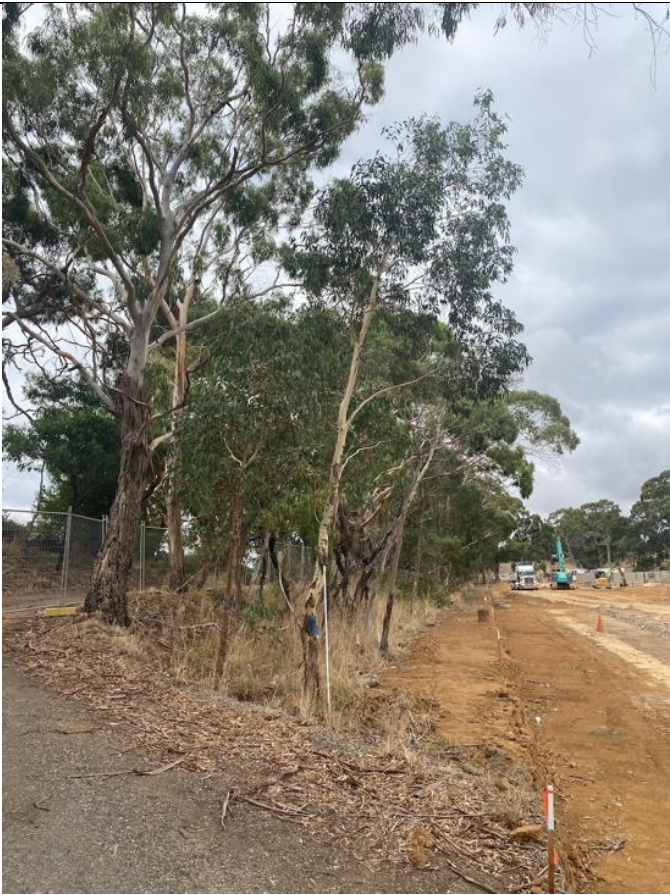
Tree 2

<i>Eucalyptus camaldulensis</i> var. <i>camaldulensis</i>	
Number of trees – 1	
Height (m) – 8 m	
Hollows – 0	
Diameter (cm) – 15	
Canopy dieback (%) – 10%	
Total Biodiversity Score – 0.33	<p>Photo direction: east. Photo 6774 Waypoint 8</p>
<p>The tree is an immature <i>Eucalyptus camaldulensis</i> without hollows and minimal canopy dieback.</p> <p>The tree potentially provides food resources for food and/or perching habitat for five State-threatened and two species of regional conservation significance (section 4.2).</p>

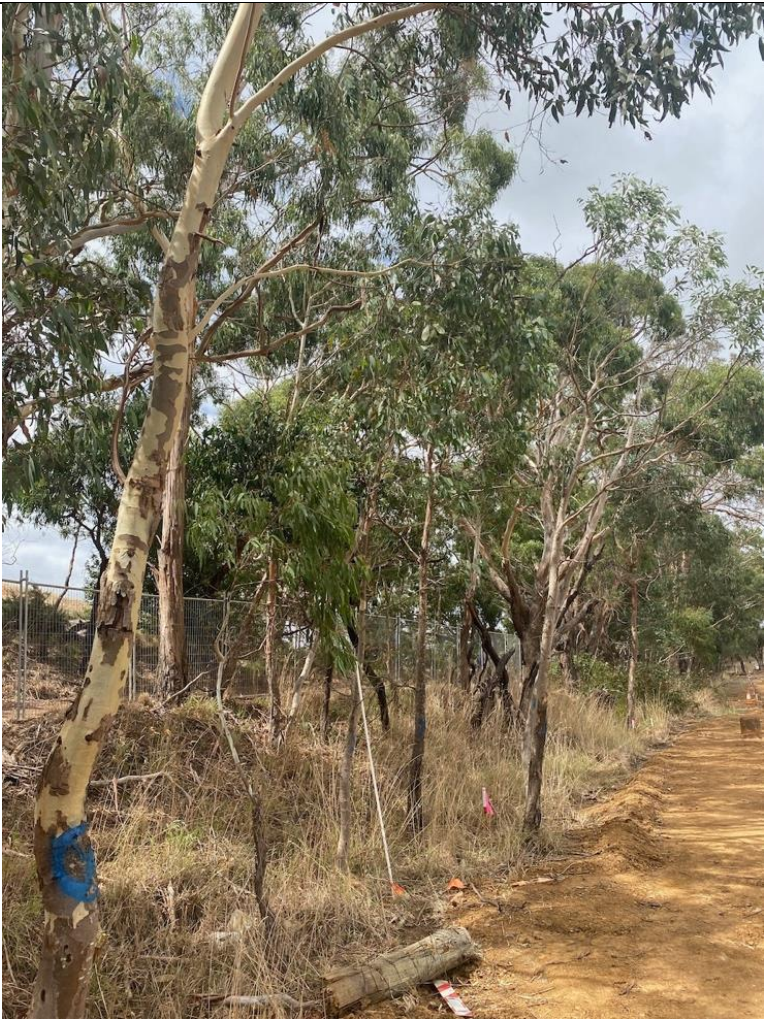
Tree 3

<i>Eucalyptus camaldulensis</i> var. <i>camaldulensis</i>	
Number of trees – 1	
Height (m) – 6 m	
Hollows – 0	
Diameter (cm) – 7	
Canopy dieback (%) – 0%	
Total Biodiversity Score – 0.25	<p>Photo direction: north-east. Photo 6776 Waypoint 11</p>
<p>The tree is an immature <i>Eucalyptus camaldulensis</i> without hollows and minimal canopy dieback.</p> <p>The tree potentially provides food resources for food and/or perching habitat for five State-threatened and two species of regional conservation significance (section 4.2).</p>

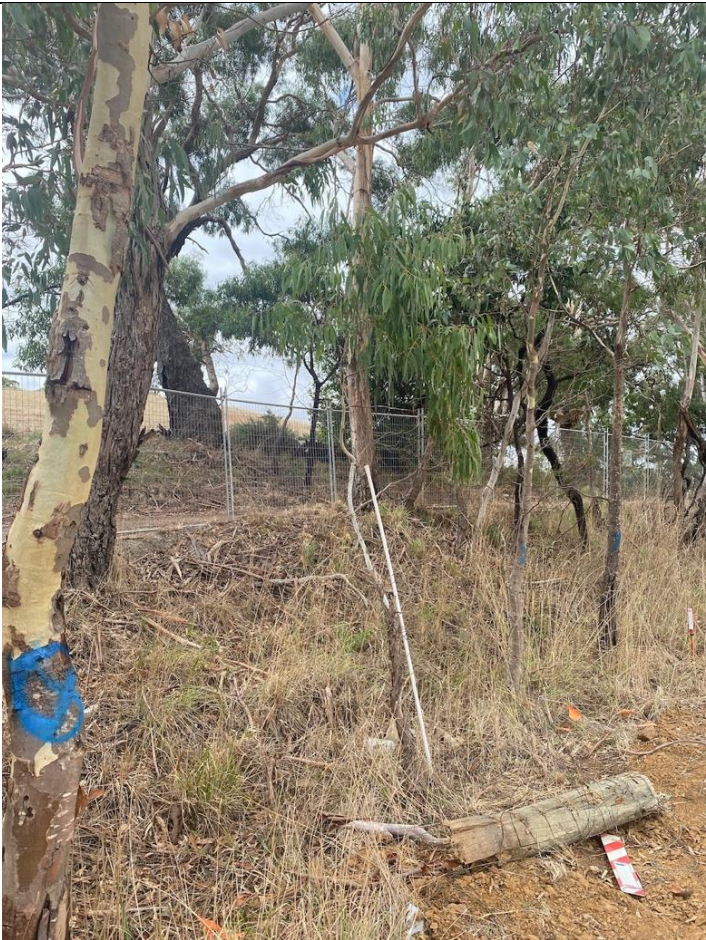
Tree 4

<i>Eucalyptus camaldulensis</i> var. <i>camaldulensis</i>	
Number of trees – 1	
Height (m) – 3.5 m	
Hollows – 0	
Diameter (cm) – 4	
Canopy dieback (%) – 0%	
Total Biodiversity Score – 0.19	<p>Photo direction: north-east. Photo 6775 Waypoint 10</p> <p>The tree is a sapling <i>Eucalyptus camaldulensis</i> without hollows and minimal canopy dieback.</p> <p>The tree potentially provides food resources for food and/or perching habitat for four State-threatened and two species of regional conservation significance (section 4.2).</p>

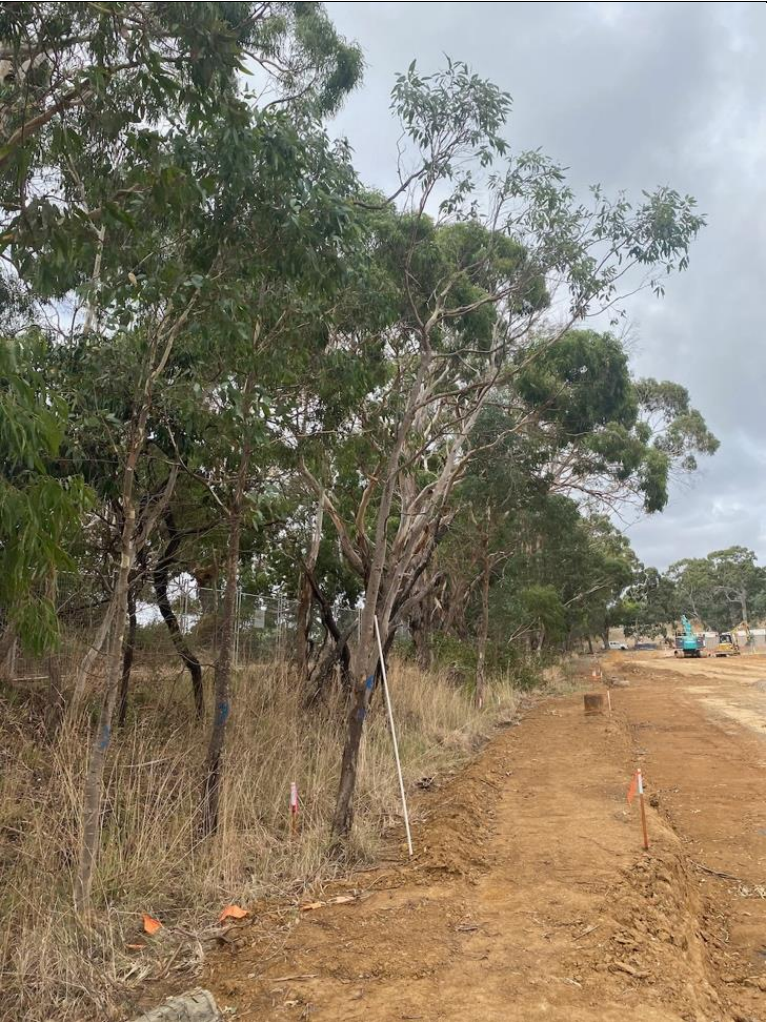
Tree 5

<i>Eucalyptus camaldulensis</i> var. <i>camaldulensis</i>	
Number of trees – 1	
Height (m) – 6 m	
Hollows – 0	
Diameter (cm) – 12	
Canopy dieback (%) – 30%	
Total Biodiversity Score – 0.20	<p>Photo direction: east. Photo 6777 Waypoint 12</p> <p>The young tree has some canopy dieback.</p> <p>The tree potentially provides food resources for food and/or perching habitat for five State-threatened and two species of regional conservation significance (section 4.2).</p>

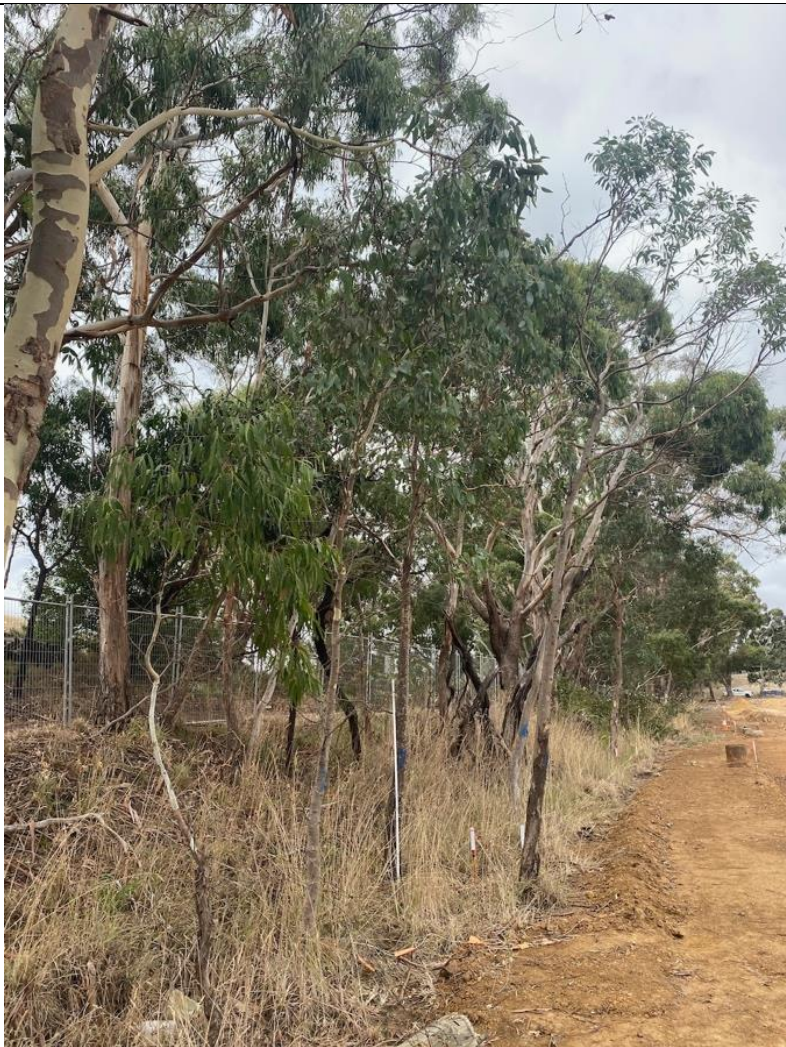
Tree 6

<i>Eucalyptus camaldulensis</i> var. <i>camaldulensis</i>	
Number of trees – 1	
Height (m) – 7 m	
Hollows – 0	
Diameter (cm) – 12	
Canopy dieback (%) – 10%	
Total Biodiversity Score – 0.28	<p>Photo direction: east. Photo 6778 Waypoint 13</p>
<p>The young tree has no hollows and minimal canopy dieback.</p> <p>The tree potentially provides food resources for food and/or perching habitat for five State-threatened and two species of regional conservation significance (section 4.2).</p>

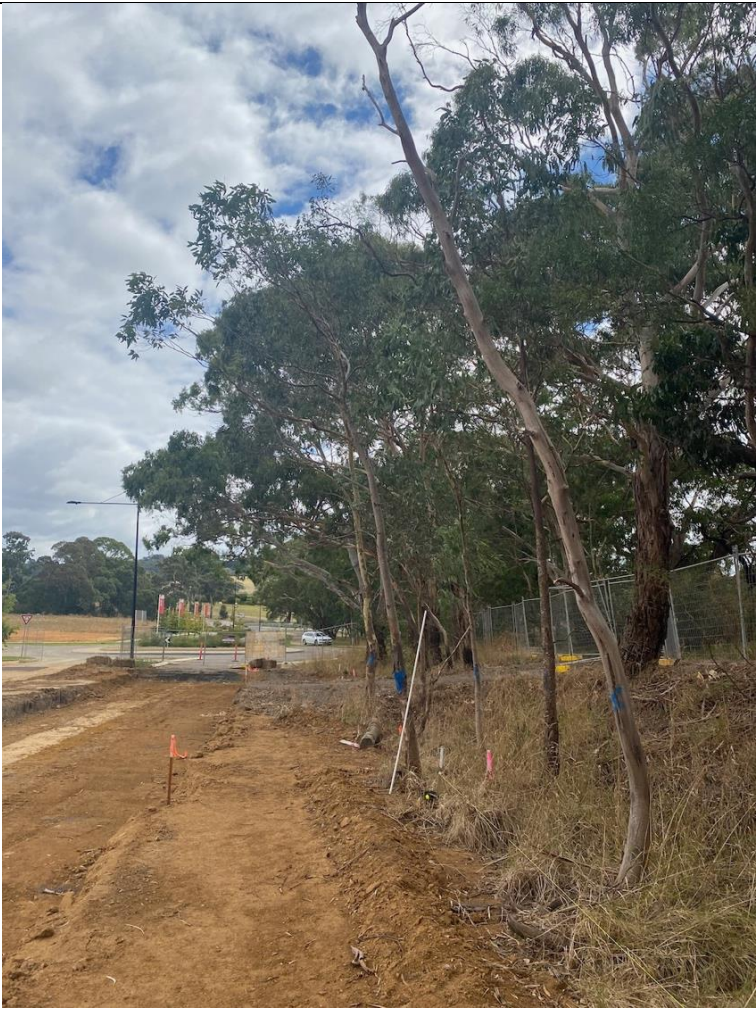
Tree 7

<i>Eucalyptus camaldulensis</i> var. <i>camaldulensis</i>	
Number of trees – 1	
Height (m) – 6 m	
Hollows – 0	
Diameter (cm) – 13	
Canopy dieback (%) – 10%	
Total Biodiversity Score – 0.27	<p>Photo direction: west. Photo 6779, Waypoint 14</p>
<p>The young tree has no hollows and minimal canopy dieback.</p> <p>The tree potentially provides food resources for food and/or perching habitat for five State-threatened and two species of regional conservation significance (section 4.2).</p>

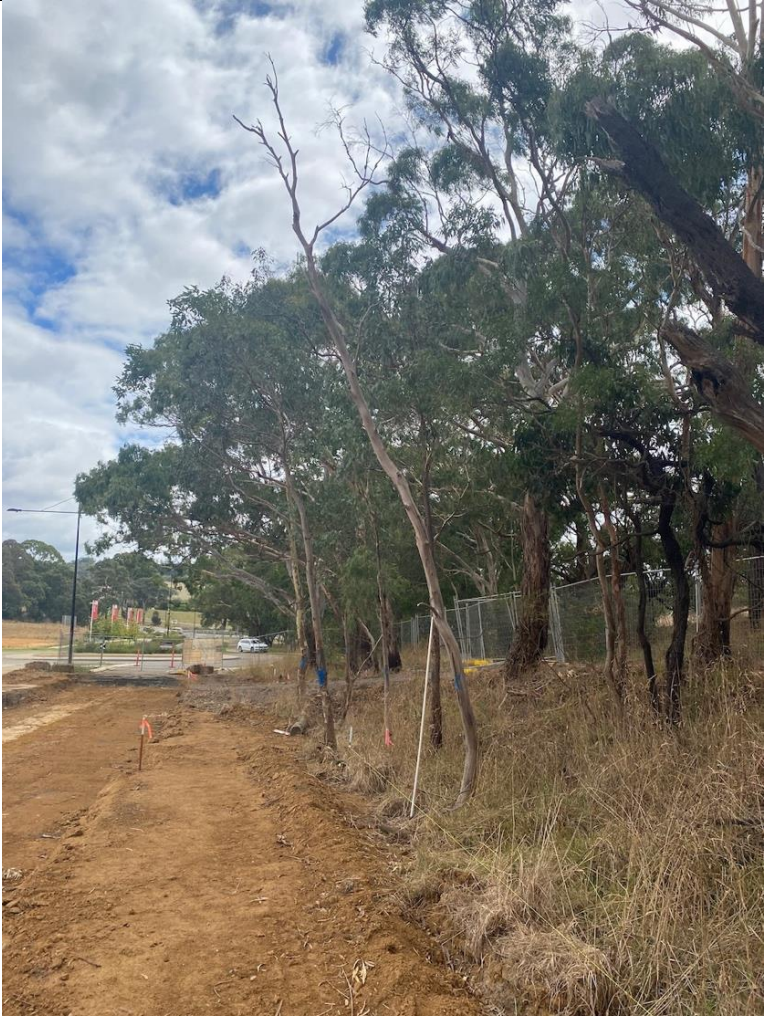
Photo direction: west. Photo 6780, Waypoint 15

Tree 8 - DEAD
<i>Eucalyptus camaldulensis</i> var. <i>camaldulensis</i>
Number of trees – 1

This is a dead young tree. It is included here for completeness.

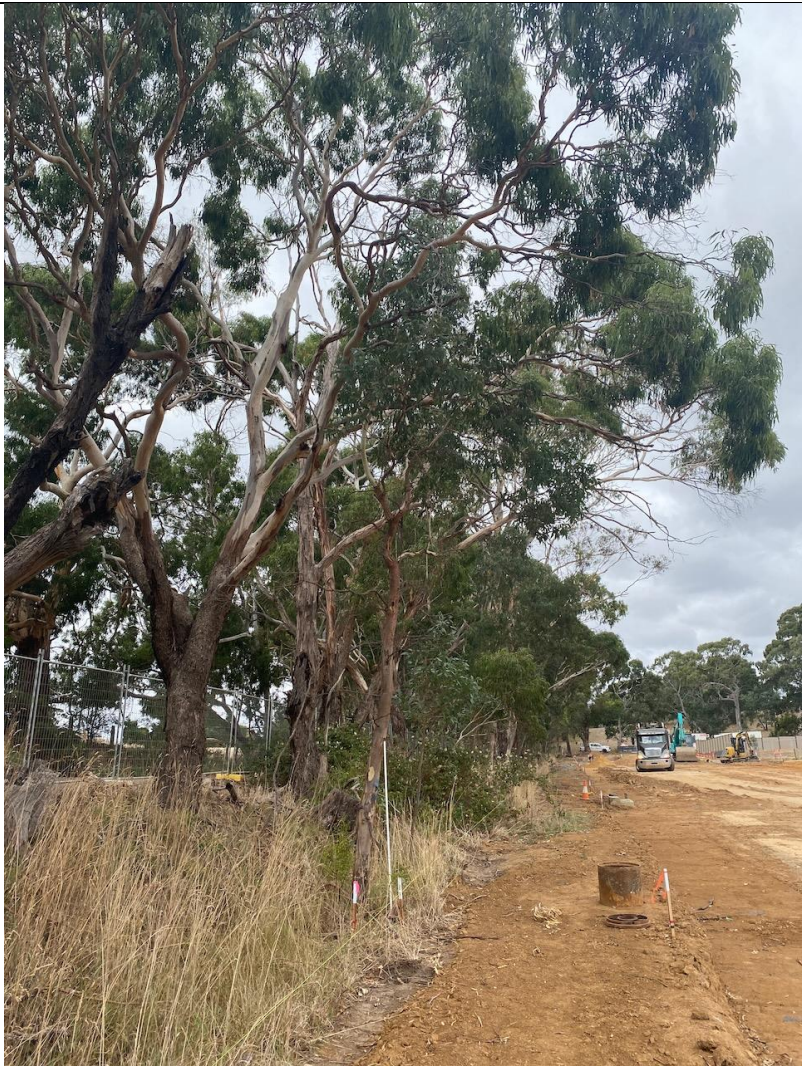
Photo direction: east. Photo 6781, Waypoint 16

Tree 9
<i>Eucalyptus camaldulensis</i> var. <i>camaldulensis</i>
Number of trees – 1
Height (m) – 7 m
Hollows – 0
Diameter (cm) – 15
Canopy dieback (%) – 10%
Total Biodiversity Score – 0.3

The young tree has no hollows and minimal canopy dieback.

The tree potentially provides food resources for food and/or perching habitat for five State-threatened and two species of regional conservation significance (section 4.2).

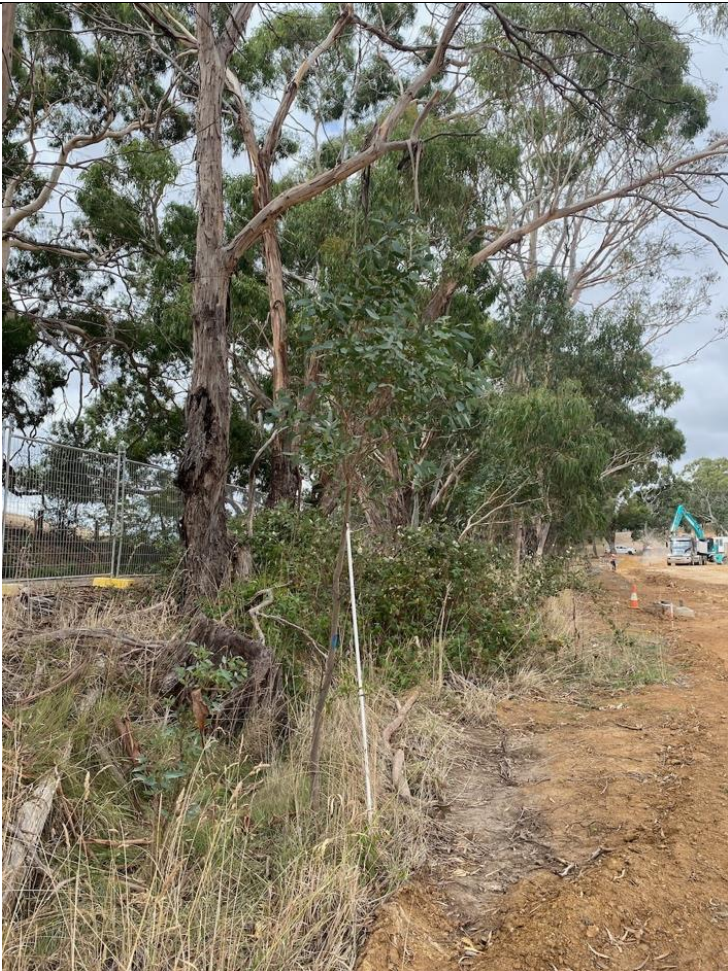
Tree 10

<i>Eucalyptus camaldulensis</i> var. <i>camaldulensis</i>	
Number of trees – 1	
Height (m) – 3.5 m	
Hollows – 0	
Diameter (cm) – 4	
Canopy dieback (%) – 0%	
Total Biodiversity Score – 0.19	<p>Photo direction: east. Photo 6782, Waypoint 17</p> <p>The tree is a sapling <i>Eucalyptus camaldulensis</i> without hollows and minimal canopy dieback.</p> <p>The tree potentially provides food resources for food and/or perching habitat for four State-threatened and two species of regional conservation significance (section 4.2).</p>

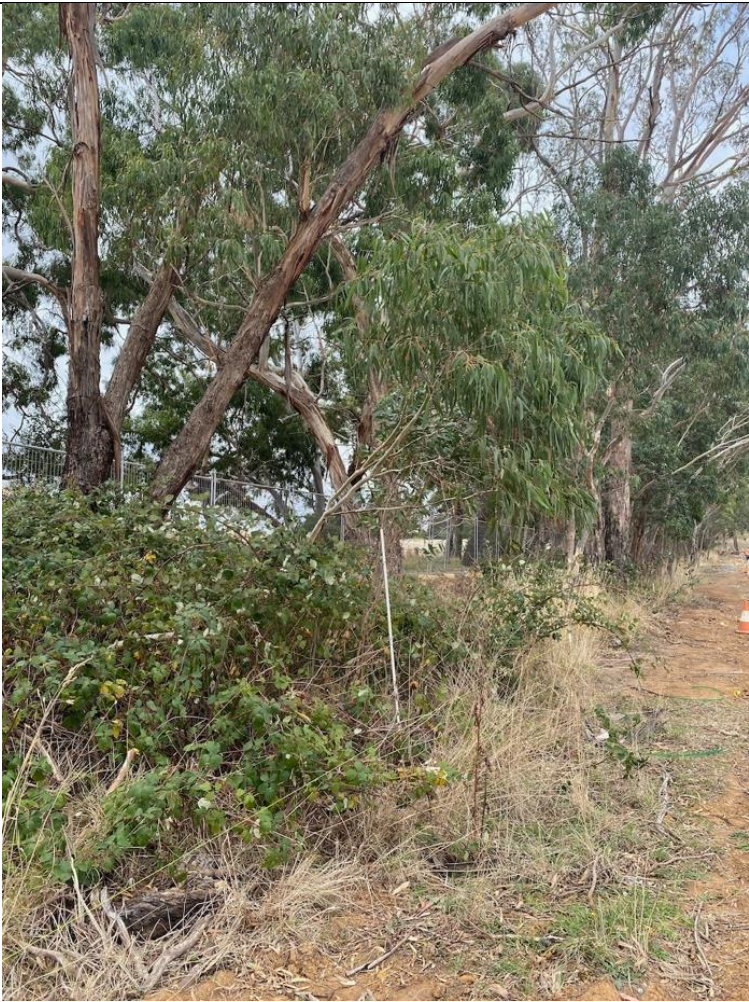
Tree 11

<i>Eucalyptus camaldulensis</i> var. <i>camaldulensis</i>	
Number of trees – 1	
Height (m) – 4 m	
Hollows – 0	
Diameter (cm) – 4	
Canopy dieback (%) – 0%	
Total Biodiversity Score – 0.19	<p>Photo direction: north-east. Photo 6784 Waypoint 18</p>
<p>The tree is an immature <i>Eucalyptus camaldulensis</i> without hollows and minimal canopy dieback.</p> <p>The tree potentially provides food resources for food and/or perching habitat for four State-threatened and two species of regional conservation significance (section 4.2).</p>

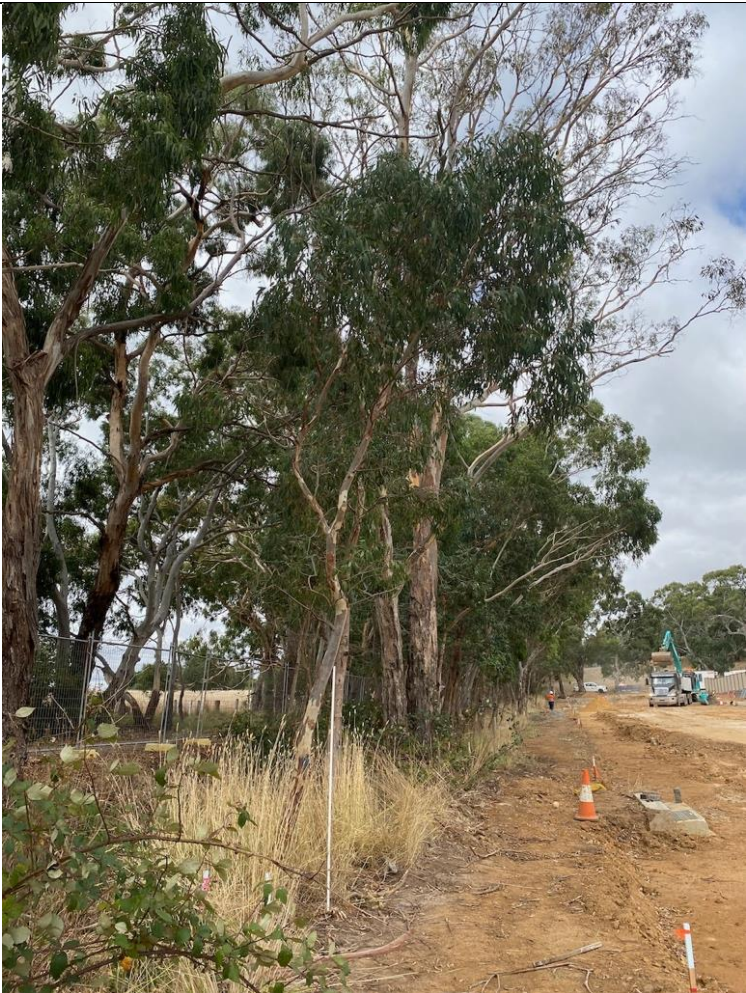
Tree 12

<i>Eucalyptus camaldulensis</i> var. <i>camaldulensis</i>	
Number of trees – 1	
Height (m) – 7 m	
Hollows – 0	
Diameter (cm) – 13	
Canopy dieback (%) – 10%	
Total Biodiversity Score – 0.29	<p>Photo direction: east. Photo 6784 Waypoint 19</p>
<p>The tree is an immature <i>Eucalyptus camaldulensis</i> without hollows and minimal canopy dieback.</p> <p>The tree potentially provides food resources for food and/or perching habitat for five State-threatened and two species of regional conservation significance (section 4.2).</p>

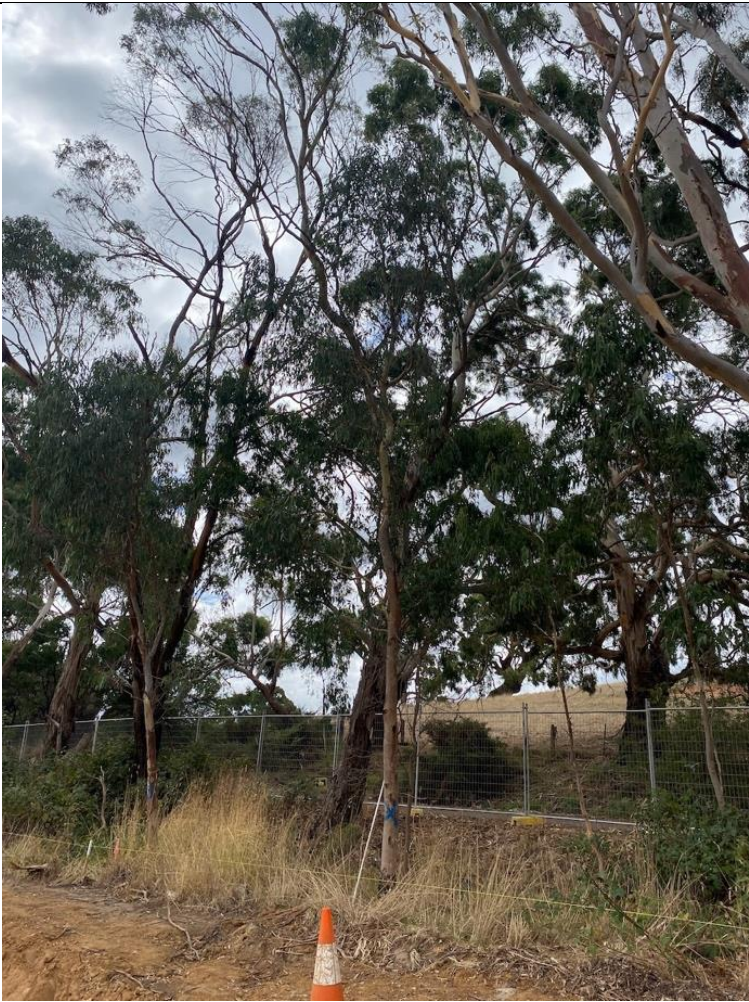
Tree 13

<i>Eucalyptus camaldulensis</i> var. <i>camaldulensis</i>	
Number of trees – 1	
Height (m) – 9 m	
Hollows – 0	
Diameter (cm) – 18	
Canopy dieback (%) – 80%	
Total Biodiversity Score – 0.17	<p>Photo direction: north-west. Photo 6785, Waypoint 20</p> <p>This tree is a young <i>Eucalyptus camaldulensis</i> without hollows and minimal canopy dieback.</p> <p>The tree potentially provides food resources for food and/or perching habitat for five State-threatened and two species of regional conservation significance (section 4.2).</p>

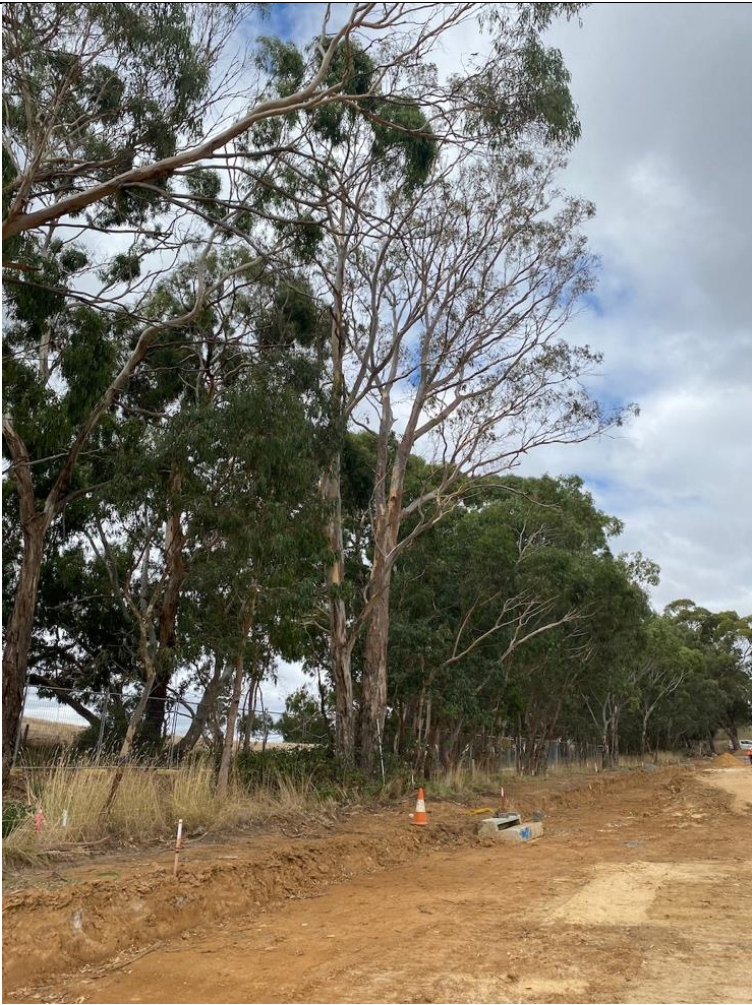
Tree 14

<i>Eucalyptus camaldulensis</i> var. <i>camaldulensis</i>	
Number of trees – 1	
Height (m) – 18 m	
Hollows – 0	
Diameter (cm) – 90, 70	
Canopy dieback (%) – 30%	
Total Biodiversity Score – 3.43	<p>Photo direction: north-east. Photo 6786, Waypoint 21</p>
<p>This young tree is in poor health with a sparse canopy.</p> <p>The tree potentially provides food resources for food and/or perching habitat for five State-threatened and two species of regional conservation significance (section 4.2).</p> <p>This is a Significant Tree.</p>

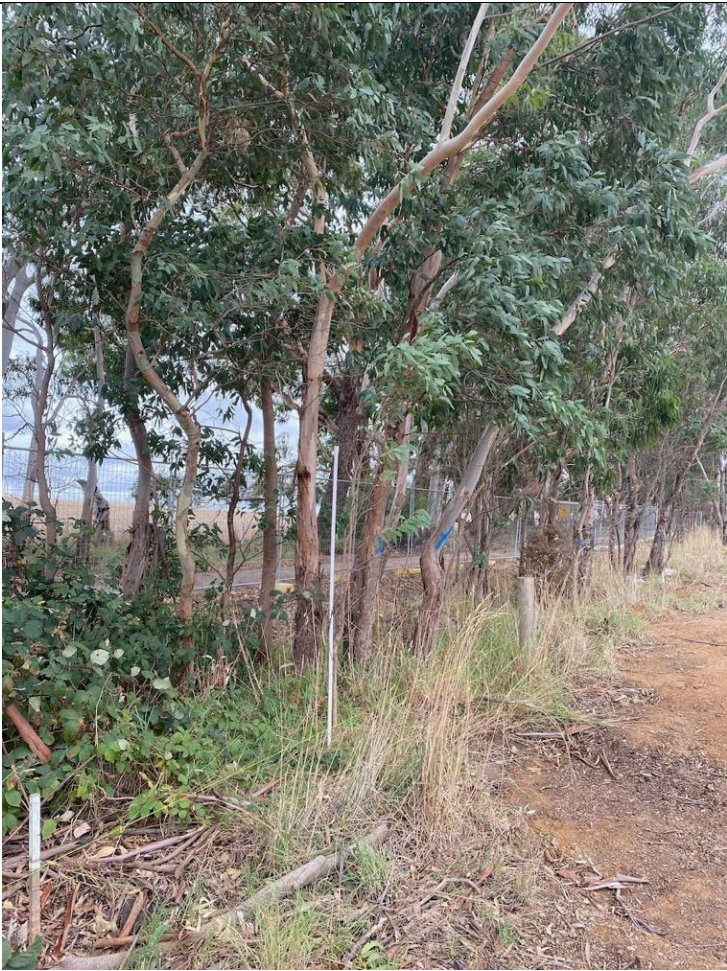
Tree 15

<i>Eucalyptus camaldulensis</i> var. <i>camaldulensis</i>	
Number of trees – 1	
Height (m) – 3 m	
Hollows – 0	
Diameter (cm) – 1	
Canopy dieback (%) – 0%	
Total Biodiversity Score – 0.16	<p>Photo direction: north. Photo 6787, Waypoint 22</p>
<p>This tree is a sapling <i>Eucalyptus camaldulensis</i> without hollows and minimal canopy dieback.</p> <p>The tree potentially provides food resources for food and/or perching habitat for four State-threatened and two species of regional conservation significance (section 4.2).</p>

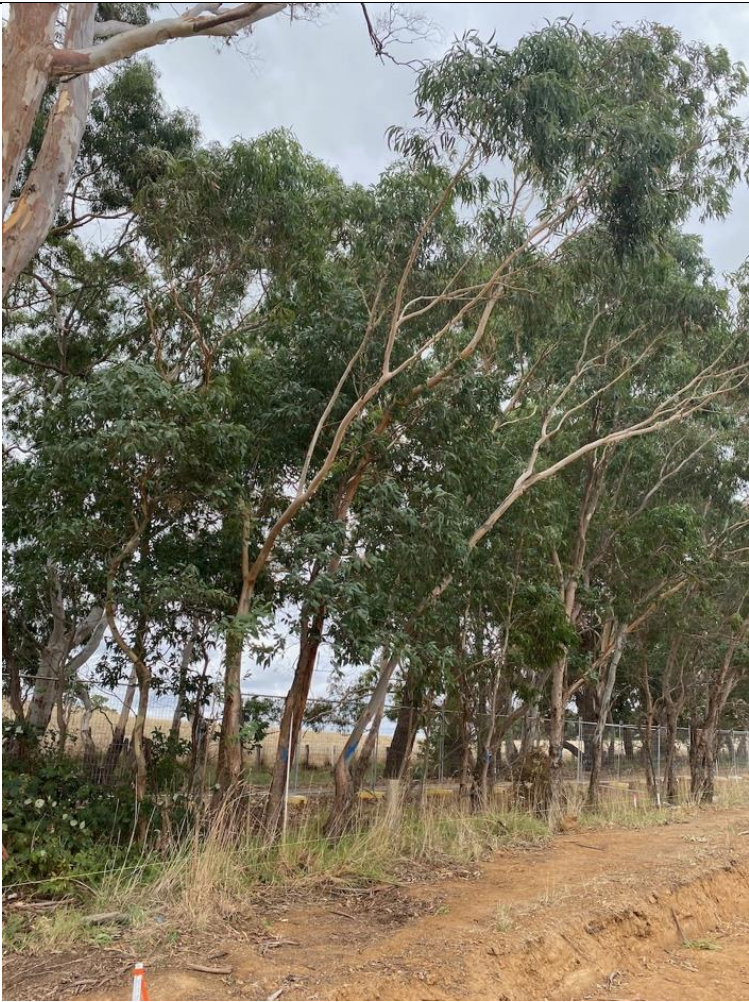
Tree 16

<i>Eucalyptus camaldulensis</i> var. <i>camaldulensis</i>	
Number of trees – 1	
Height (m) – 9 m	
Hollows – 0	
Diameter (cm) – 13	
Canopy dieback (%) – 0%	
Total Biodiversity Score – 0.37	<p>Photo direction: north. Photo 6788, Waypoint 23</p>
<p>The large tree is in good condition with minimal canopy dieback. It has no hollows.</p> <p>The tree potentially provides food resources for food and/or perching habitat for five State-threatened and two species of regional conservation significance (section 4.2).</p>

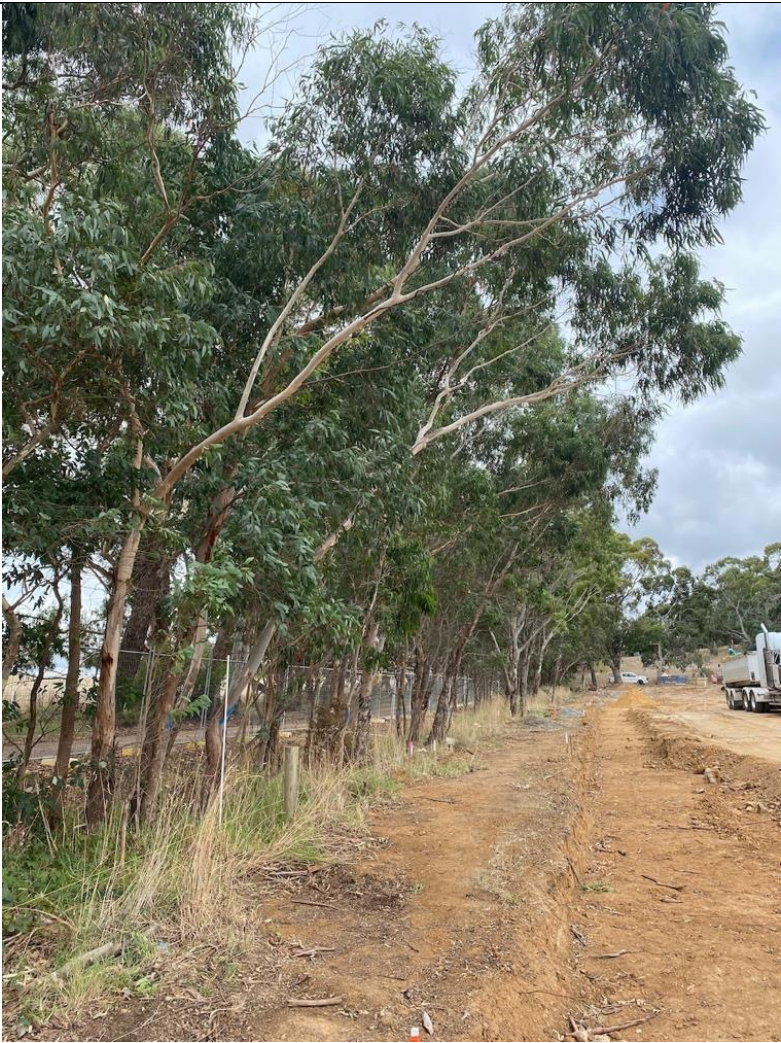
Tree 17

<i>Eucalyptus camaldulensis</i> var. <i>camaldulensis</i>	
Number of trees – 1	
Height (m) – 7 m	
Hollows – 0	
Diameter (cm) – 20	
Canopy dieback (%) – 0%	
Total Biodiversity Score – 0.39	<p>Photo direction: east. Photo 6789, Waypoint 24</p>
<p>This tree is an immature <i>Eucalyptus camaldulensis</i> without hollows and minimal canopy dieback.</p> <p>The tree potentially provides food resources for food and/or perching habitat for five State-threatened and two species of regional conservation significance (section 4.2).</p>

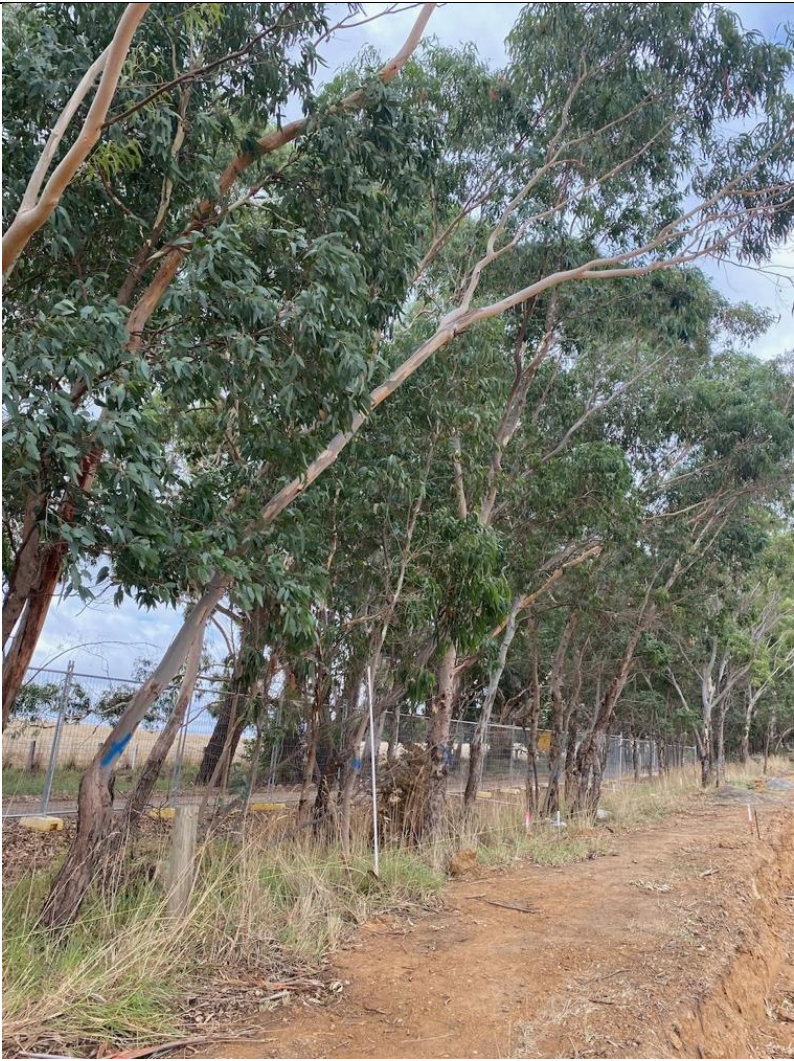
Tree 18

<i>Eucalyptus camaldulensis</i> var. <i>camaldulensis</i>	
Number of trees – 1	
Height (m) – 5 m	
Hollows – 0	
Diameter (cm) – 5	
Canopy dieback (%) – 0%	
Total Biodiversity Score – 0.22	<p>Photo direction: north-east. Photo 6790, Waypoint 25</p>
<p>This tree is an immature <i>Eucalyptus camaldulensis</i> without hollows and minimal canopy dieback.</p> <p>The tree potentially provides food resources for food and/or perching habitat for four State-threatened and two species of regional conservation significance (section 4.2).</p>

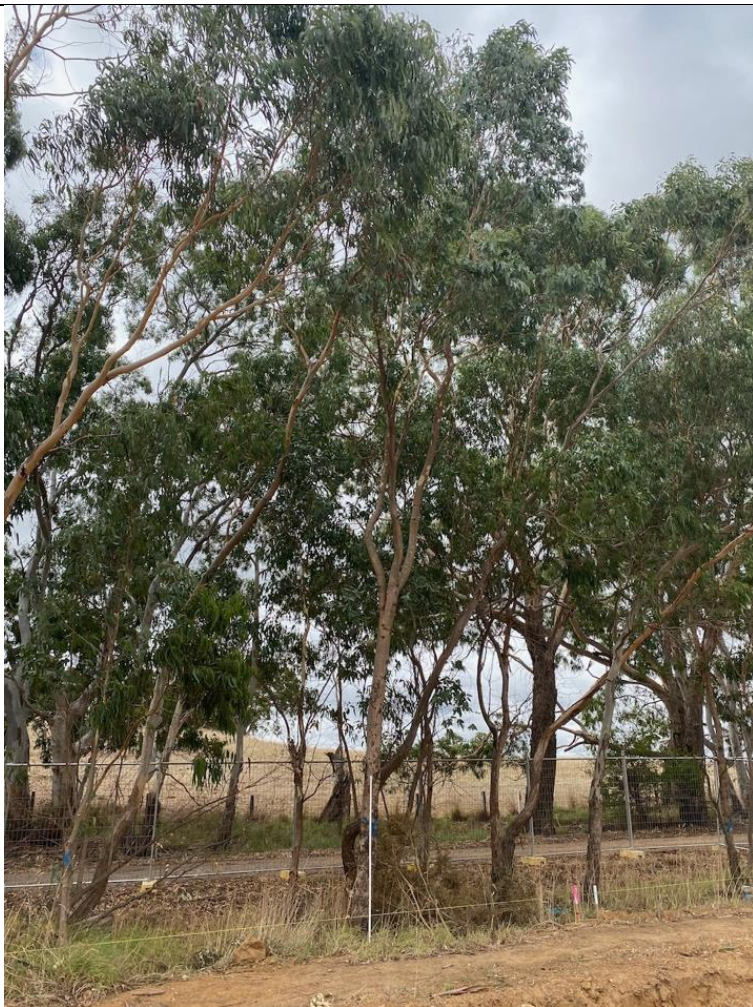
Tree 19

<i>Eucalyptus camaldulensis</i> var. <i>camaldulensis</i>	
Number of trees – 1	
Height (m) – 12 m	
Hollows – 0	
Diameter (cm) – 25	
Canopy dieback (%) – 60%	
Total Biodiversity Score – 0.33	Photo direction: north. Photo 6791, Waypoint 26
This tree is an immature <i>Eucalyptus camaldulensis</i> without hollows and minimal canopy dieback. The tree potentially provides food resources for food and/or perching habitat for five State-threatened and two species of regional conservation significance (section 4.2).

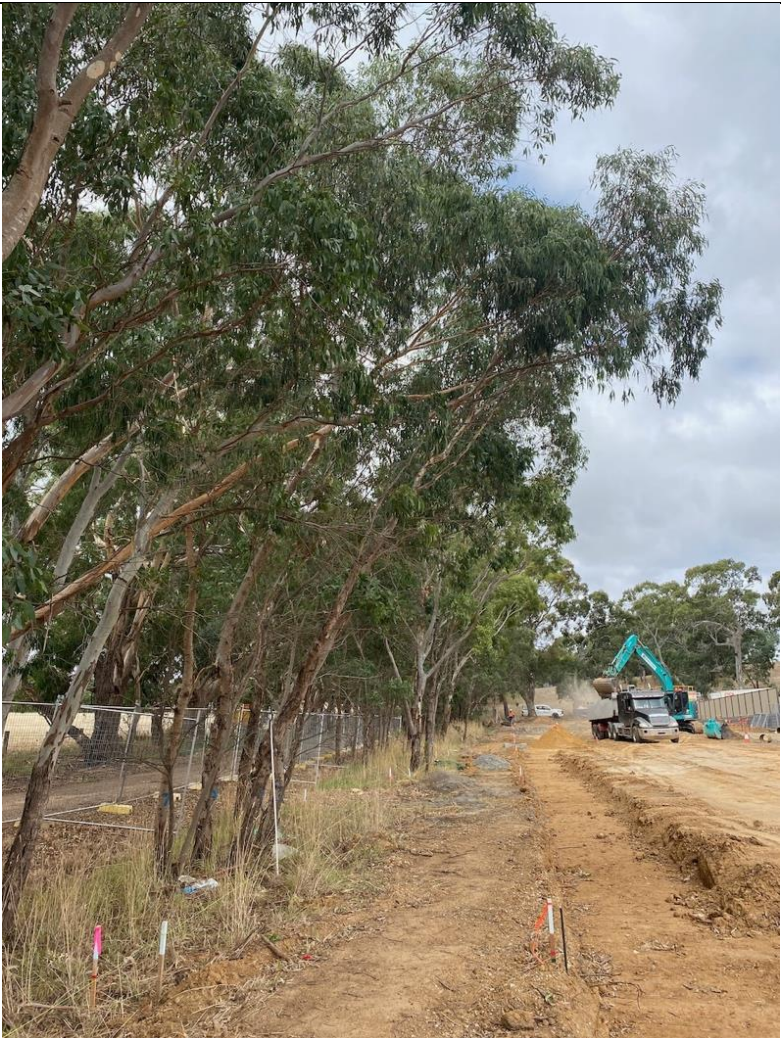
Tree 20

<i>Eucalyptus camaldulensis</i> var. <i>camaldulensis</i>	
Number of trees – 1	
Height (m) – 9 m	
Hollows – 0	
Diameter (cm) – 12	
Canopy dieback (%) – 0%	
Total Biodiversity Score – 0.36	<p>Photo direction: east. Waypoint 6792, Waypoint 27</p>
<p>This tree is an immature <i>Eucalyptus camaldulensis</i> without hollows and minimal canopy dieback.</p> <p>The tree potentially provides food resources for food and/or perching habitat for five State-threatened and two species of regional conservation significance (section 4.2).</p>

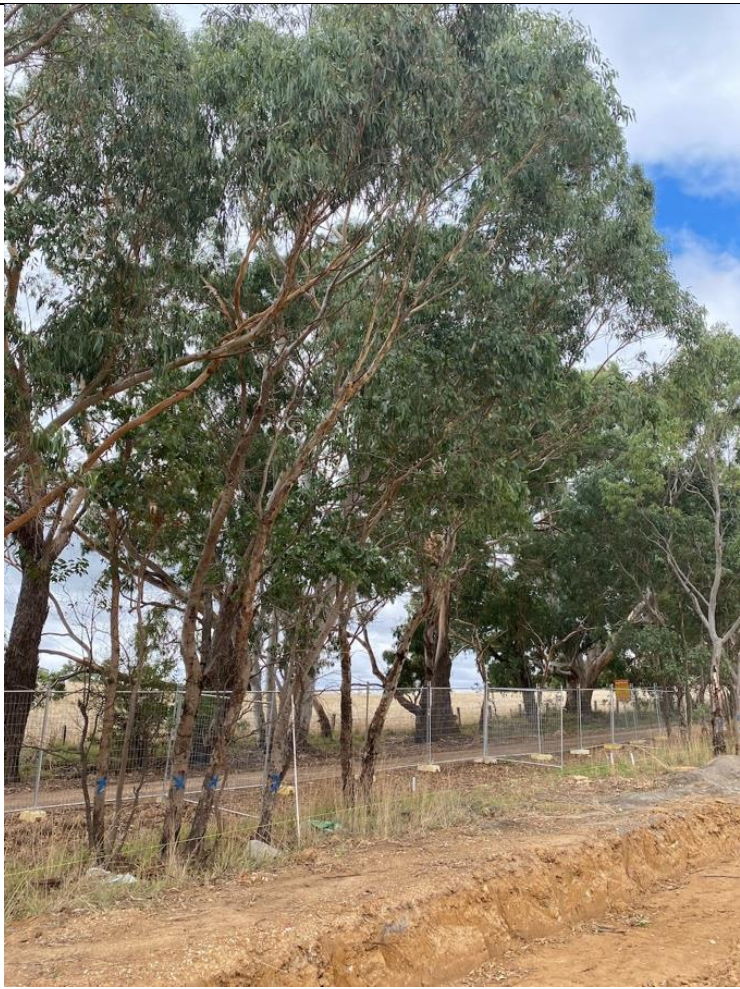
Tree 21

<i>Eucalyptus camaldulensis</i> var. <i>camaldulensis</i>	
Number of trees – 1	
Height (m) – 9	
Hollows – 0	
Diameter (cm) – 13	
Canopy dieback (%) – 0%	
Total Biodiversity Score – 0.37	<p>Photo direction: north-east. Waypoint 6793, Waypoint 28</p> <p>This tree is an immature <i>Eucalyptus camaldulensis</i> without hollows and minimal canopy dieback. The tree potentially provides food resources for food and/or perching habitat for five State-threatened and two species of regional conservation significance (section 4.2).</p>

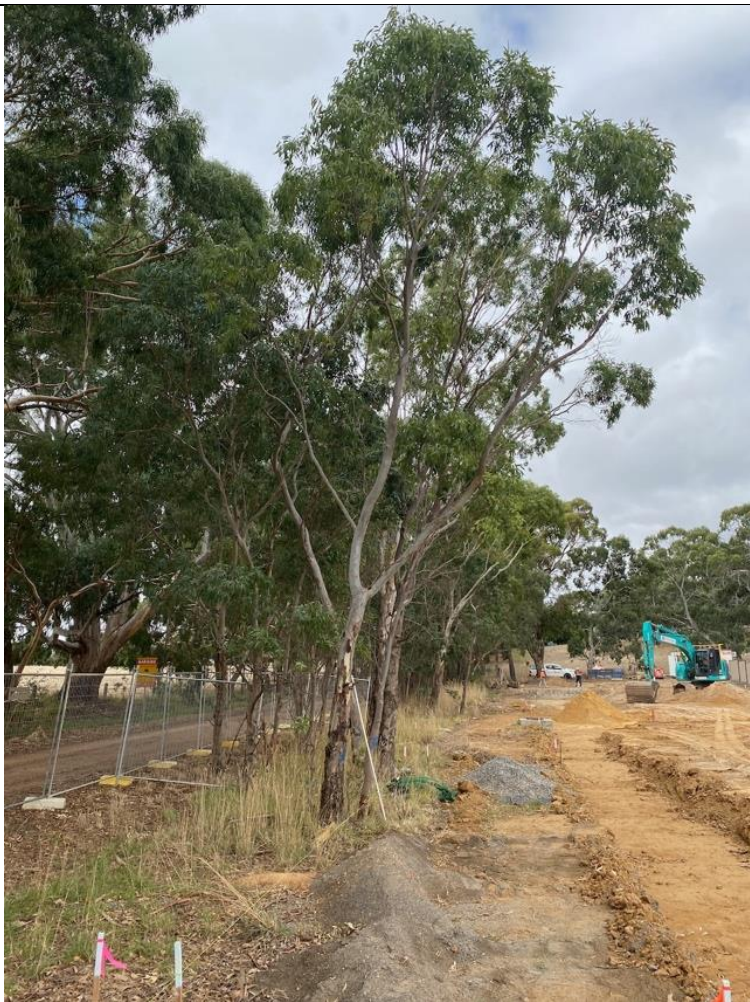
Tree 22

<i>Eucalyptus camaldulensis</i> var. <i>camaldulensis</i>	
Number of trees – 1	
Height (m) – 9	
Hollows – 0	
Diameter (cm) – 25, 80	
Canopy dieback (%) – 0%	
Total Biodiversity Score – 2.18	Photo direction: north. Photo 6794, Waypoint 29
<p>This tree is an immature <i>Eucalyptus camaldulensis</i> without hollows and minimal canopy dieback.</p> <p>The tree potentially provides food resources for food and/or perching habitat for five State-threatened and two species of regional conservation significance (section 4.2).</p> <p>This is a Regulated Tree.</p>

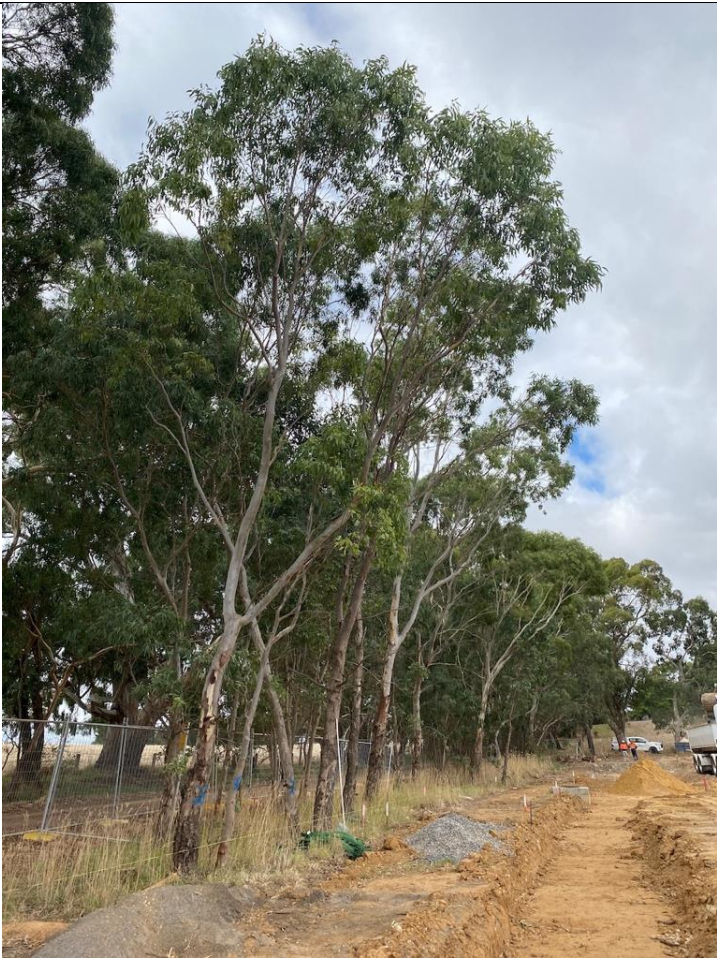
Tree 23

<i>Eucalyptus camaldulensis</i> var. <i>camaldulensis</i>		
Number of trees – 1		
Height (m) –11		
Hollows – 0		
Diameter (cm) – 30, 20		
Canopy dieback (%) – 0%		
Total Biodiversity Score – 0.64	<p>Photo direction: north. Photo 6795, Waypoint 30</p>	
<p>This tree is an immature <i>Eucalyptus camaldulensis</i> without hollows and minimal canopy dieback.</p> <p>The tree potentially provides food resources for food and/or perching habitat for five State-threatened and two species of regional conservation significance (section 4.2).</p> <p>This is a Regulated Tree.</p>
