Native Vegetation Clearance

Clover Park Scattered Trees Footpath and Track Entrance

Data Report

Clearance under the *Native Vegetation Regulations 2017*

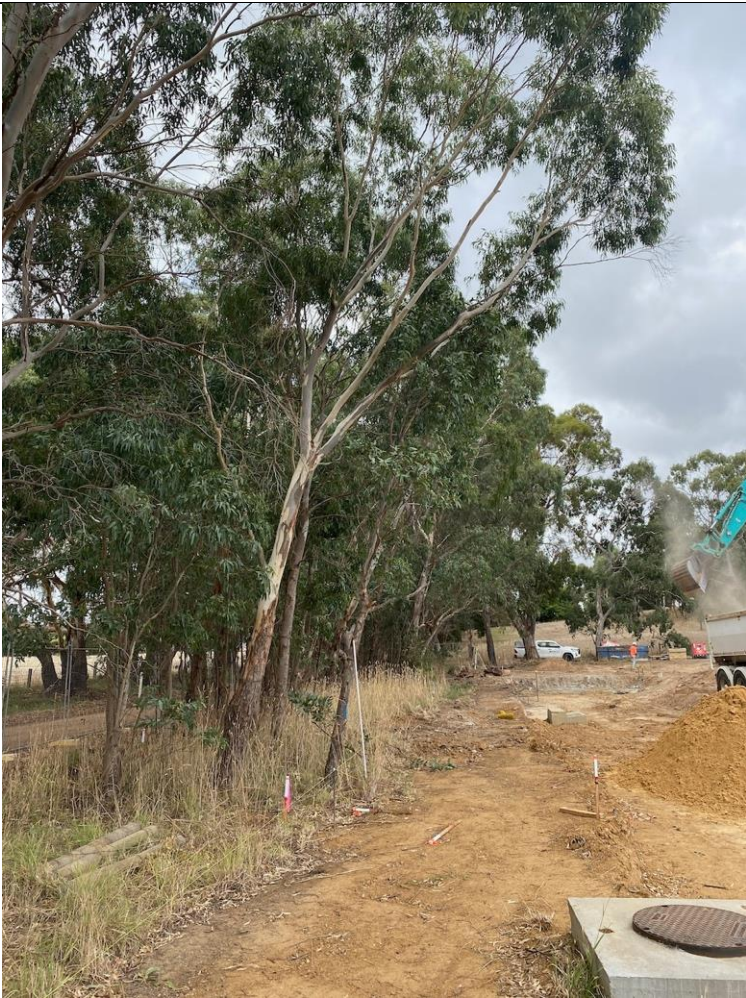
Tree 24

<i>Eucalyptus camaldulensis</i> var. <i>camaldulensis</i>	
Number of trees – 1	
Height (m) – 6.5	
Hollows – 0	
Diameter (cm) – 10	
Canopy dieback (%) – 0%	
Total Biodiversity Score – 0.28	<p>Photo direction: south-east. Photo 6796, Waypoint 31</p> <p>This tree is an immature <i>Eucalyptus camaldulensis</i> without hollows and minimal canopy dieback. The tree potentially provides food resources for food and/or perching habitat for four State-threatened and two species of regional conservation significance (section 4.2).</p>

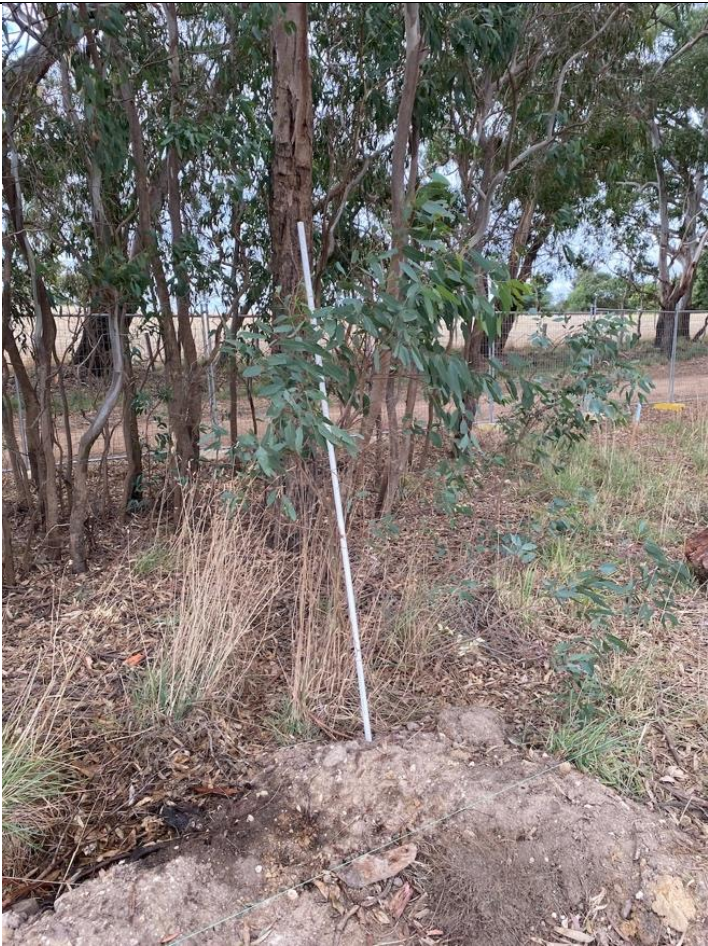
Tree 25

<i>Eucalyptus camaldulensis</i> var. <i>camaldulensis</i>	
Number of trees – 1	
Height (m) – 2	
Hollows – 0	
Diameter (cm) – 2	
Canopy dieback (%) – 0%	
Total Biodiversity Score – 0.15	<p>Photo direction: south-east, Photo 6798, Waypoint 32</p> <p>This tree is a sapling <i>Eucalyptus camaldulensis</i> without hollows and minimal canopy dieback.</p> <p>The tree potentially provides food resources for food and/or perching habitat for four State-threatened and two species of regional conservation significance (section 4.2).</p>

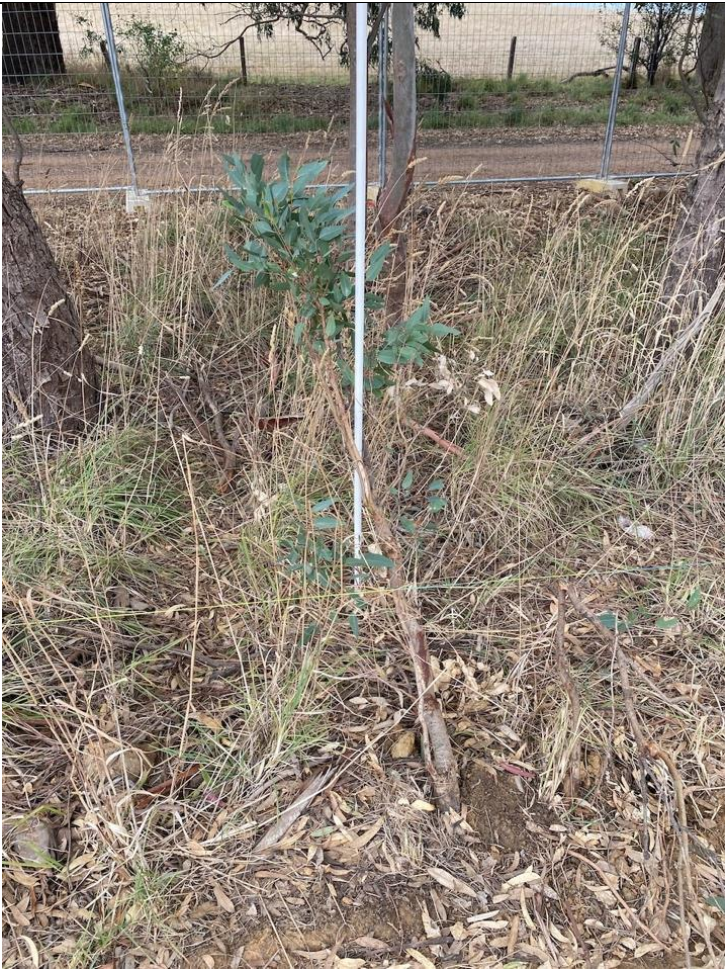
Tree 26

<i>Eucalyptus camaldulensis</i> var. <i>camaldulensis</i>	
Number of trees – 1	
Height (m) – 2 m	
Hollows – 0	
Diameter (cm) – 1	
Canopy dieback (%) – 0%	
Total Biodiversity Score – 0.15	<p>Photo direction: south-east, Photo 6797, Waypoint 33</p>
<p>This tree is a sapling <i>Eucalyptus camaldulensis</i> without hollows and minimal canopy dieback.</p> <p>The tree potentially provides food resources for food and/or perching habitat for four State-threatened and two species of regional conservation significance (section 4.2).</p>

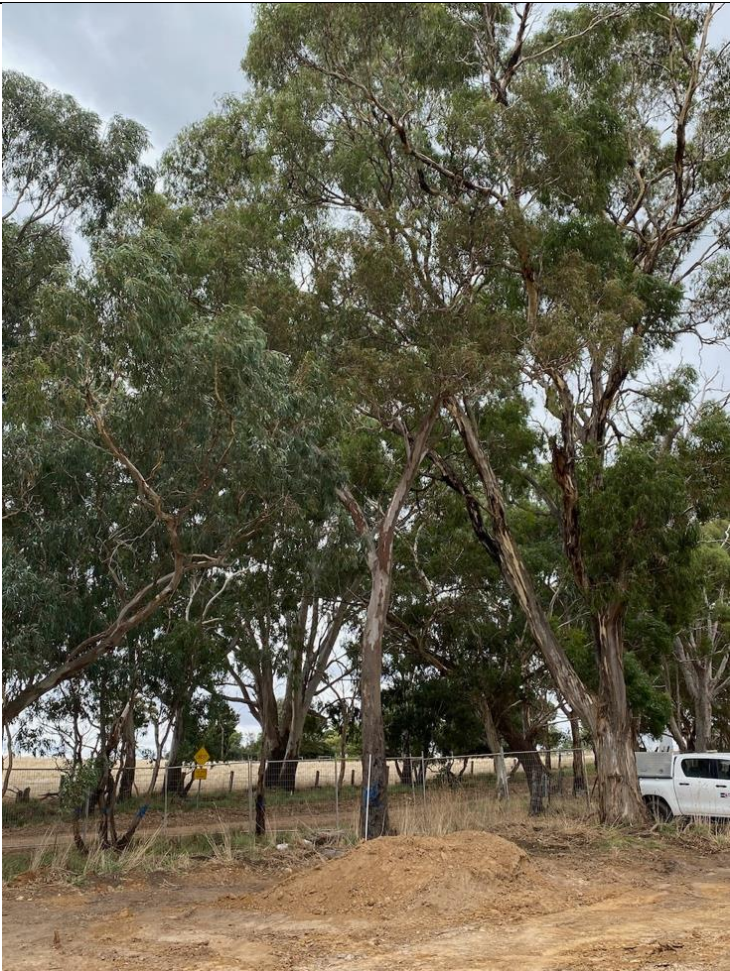
Tree 27

<i>Eucalyptus camaldulensis</i> var. <i>camaldulensis</i>	
Number of trees – 1	
Height (m) – 16 m	
Hollows – 0	
Diameter (cm) – 20	
Canopy dieback (%) – 0%	
Total Biodiversity Score – 0.99	<p>Photo direction: north. Photo 6765 Waypoint 2</p> <p>This tree is an immature <i>Eucalyptus camaldulensis</i> without hollows and minimal canopy dieback.</p> <p>The tree potentially provides food resources for food and/or perching habitat for five State-threatened and two species of regional conservation significance (section 4.2).</p>

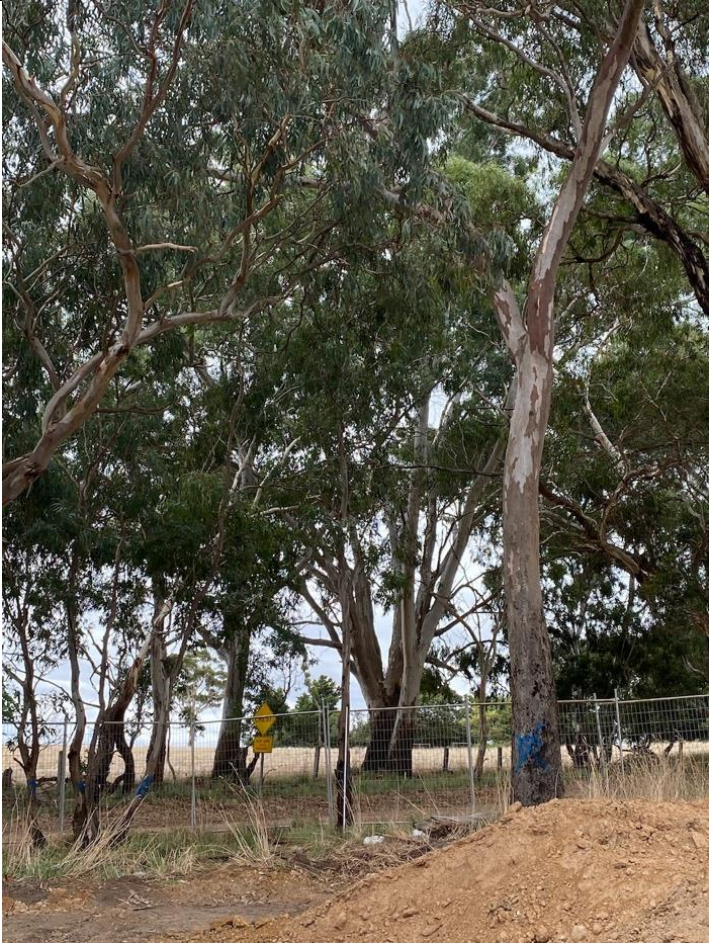
Tree 28

<i>Eucalyptus camaldulensis</i> var. <i>camaldulensis</i>	
Number of trees – 1	
Height (m) – 8 m	
Hollows – 0	
Diameter (cm) – 13	
Canopy dieback (%) – 0%	
Total Biodiversity Score – 0.34	<p>Photo direction: north. Photo 6766. Waypoint 3</p> <p>The tree is a small immature <i>Eucalyptus camaldulensis</i> without hollows and minimal canopy dieback.</p> <p>The tree potentially provides food resources for food and/or perching habitat for five State-threatened and two species of regional conservation significance (section 4.2).</p>

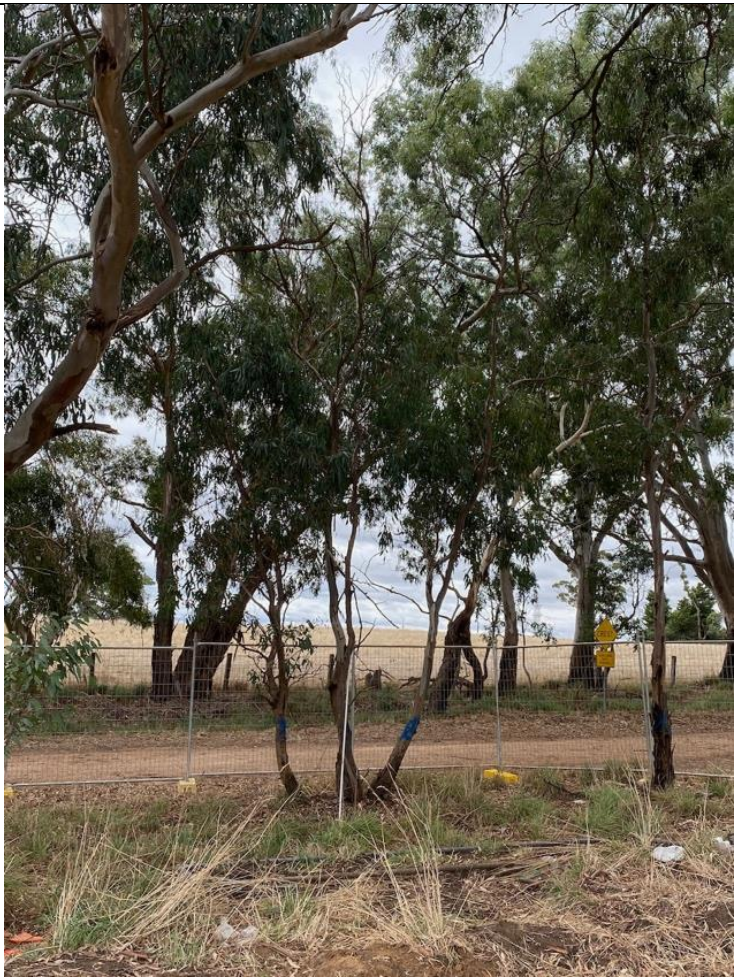
Tree 29

<i>Eucalyptus camaldulensis</i> var. <i>camaldulensis</i>	
Number of trees – 1	
Height (m) – 5 m	
Hollows – 0	
Diameter (cm) – 13	
Canopy dieback (%) – 30%	
Total Biodiversity Score – 0.19	<p>Photo direction: north. Photo 6767, Waypoint 3</p> <p>The tree is an immature <i>Eucalyptus camaldulensis</i> without hollows and minimal canopy dieback.</p> <p>The tree potentially provides food resources for food and/or perching habitat for five State-threatened and two species of regional conservation significance (section 4.2).</p>

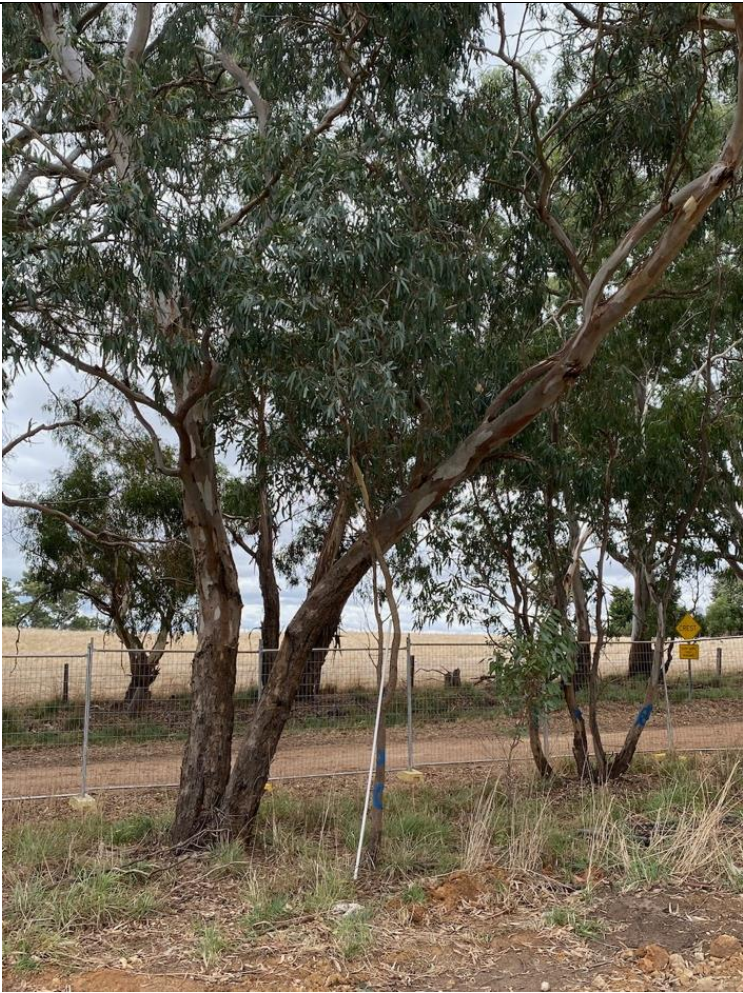
Tree 30

<i>Eucalyptus camaldulensis</i> var. <i>camaldulensis</i>	
Number of trees – 1	
Height (m) – 4 m	
Hollows – 0	
Diameter (cm) – 8	
Canopy dieback (%) – 20	
Total Biodiversity Score – 0.17	<p>Photo direction: north. Photo 6768, Waypoint 5</p> <p>The tree is a sapling <i>Eucalyptus camaldulensis</i> without hollows and minimal canopy dieback.</p> <p>The tree potentially provides food resources for food and/or perching habitat for five State-threatened and two species of regional conservation significance (section 4.2).</p>

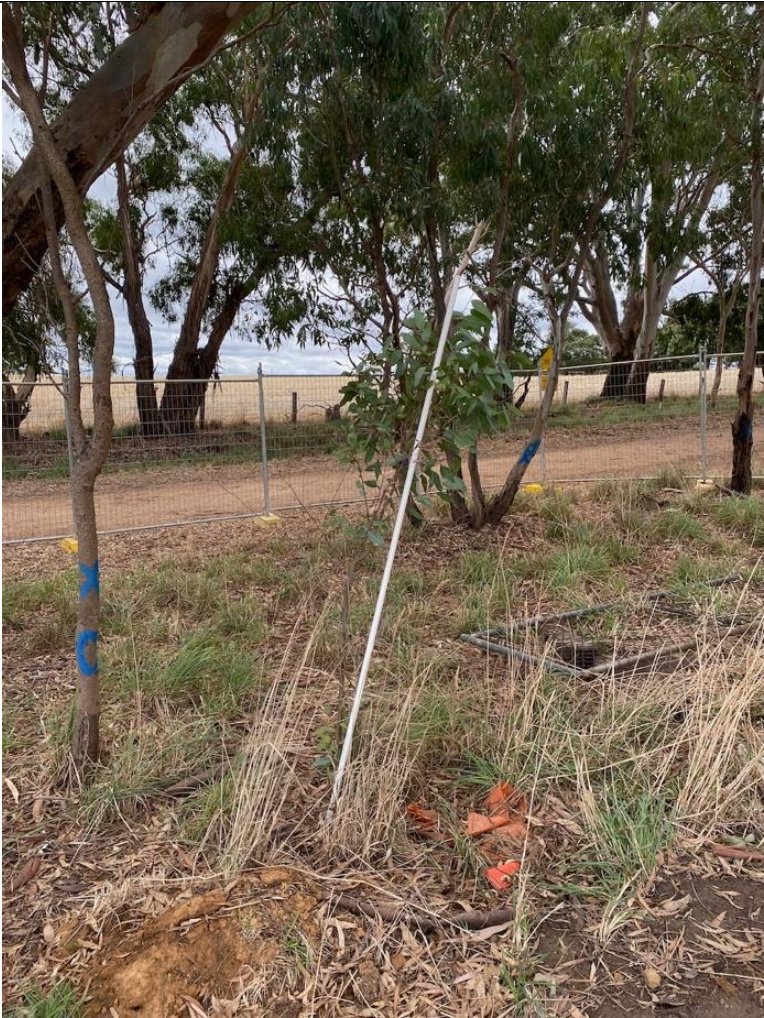
Tree 31

<i>Eucalyptus camaldulensis</i> var. <i>camaldulensis</i>	
Number of trees – 1	
Height (m) – 1.8 m	
Hollows – 0	
Diameter (cm) – 3	
Canopy dieback (%) – 0%	
Total Biodiversity Score – 0.15	<p>Photo direction: north. Photo 6777, Waypoint 6</p> <p>The tree is a sapling <i>Eucalyptus camaldulensis</i> without hollows and minimal canopy dieback.</p> <p>The tree potentially provides food resources for food and/or perching habitat for four State-threatened and two species of regional conservation significance (section 4.2).</p>
