Native Vegetation Clearance

Murray Bridge Growth Infrastructure Upgrade

(ES0423-11)

Data Report – Amendment 1

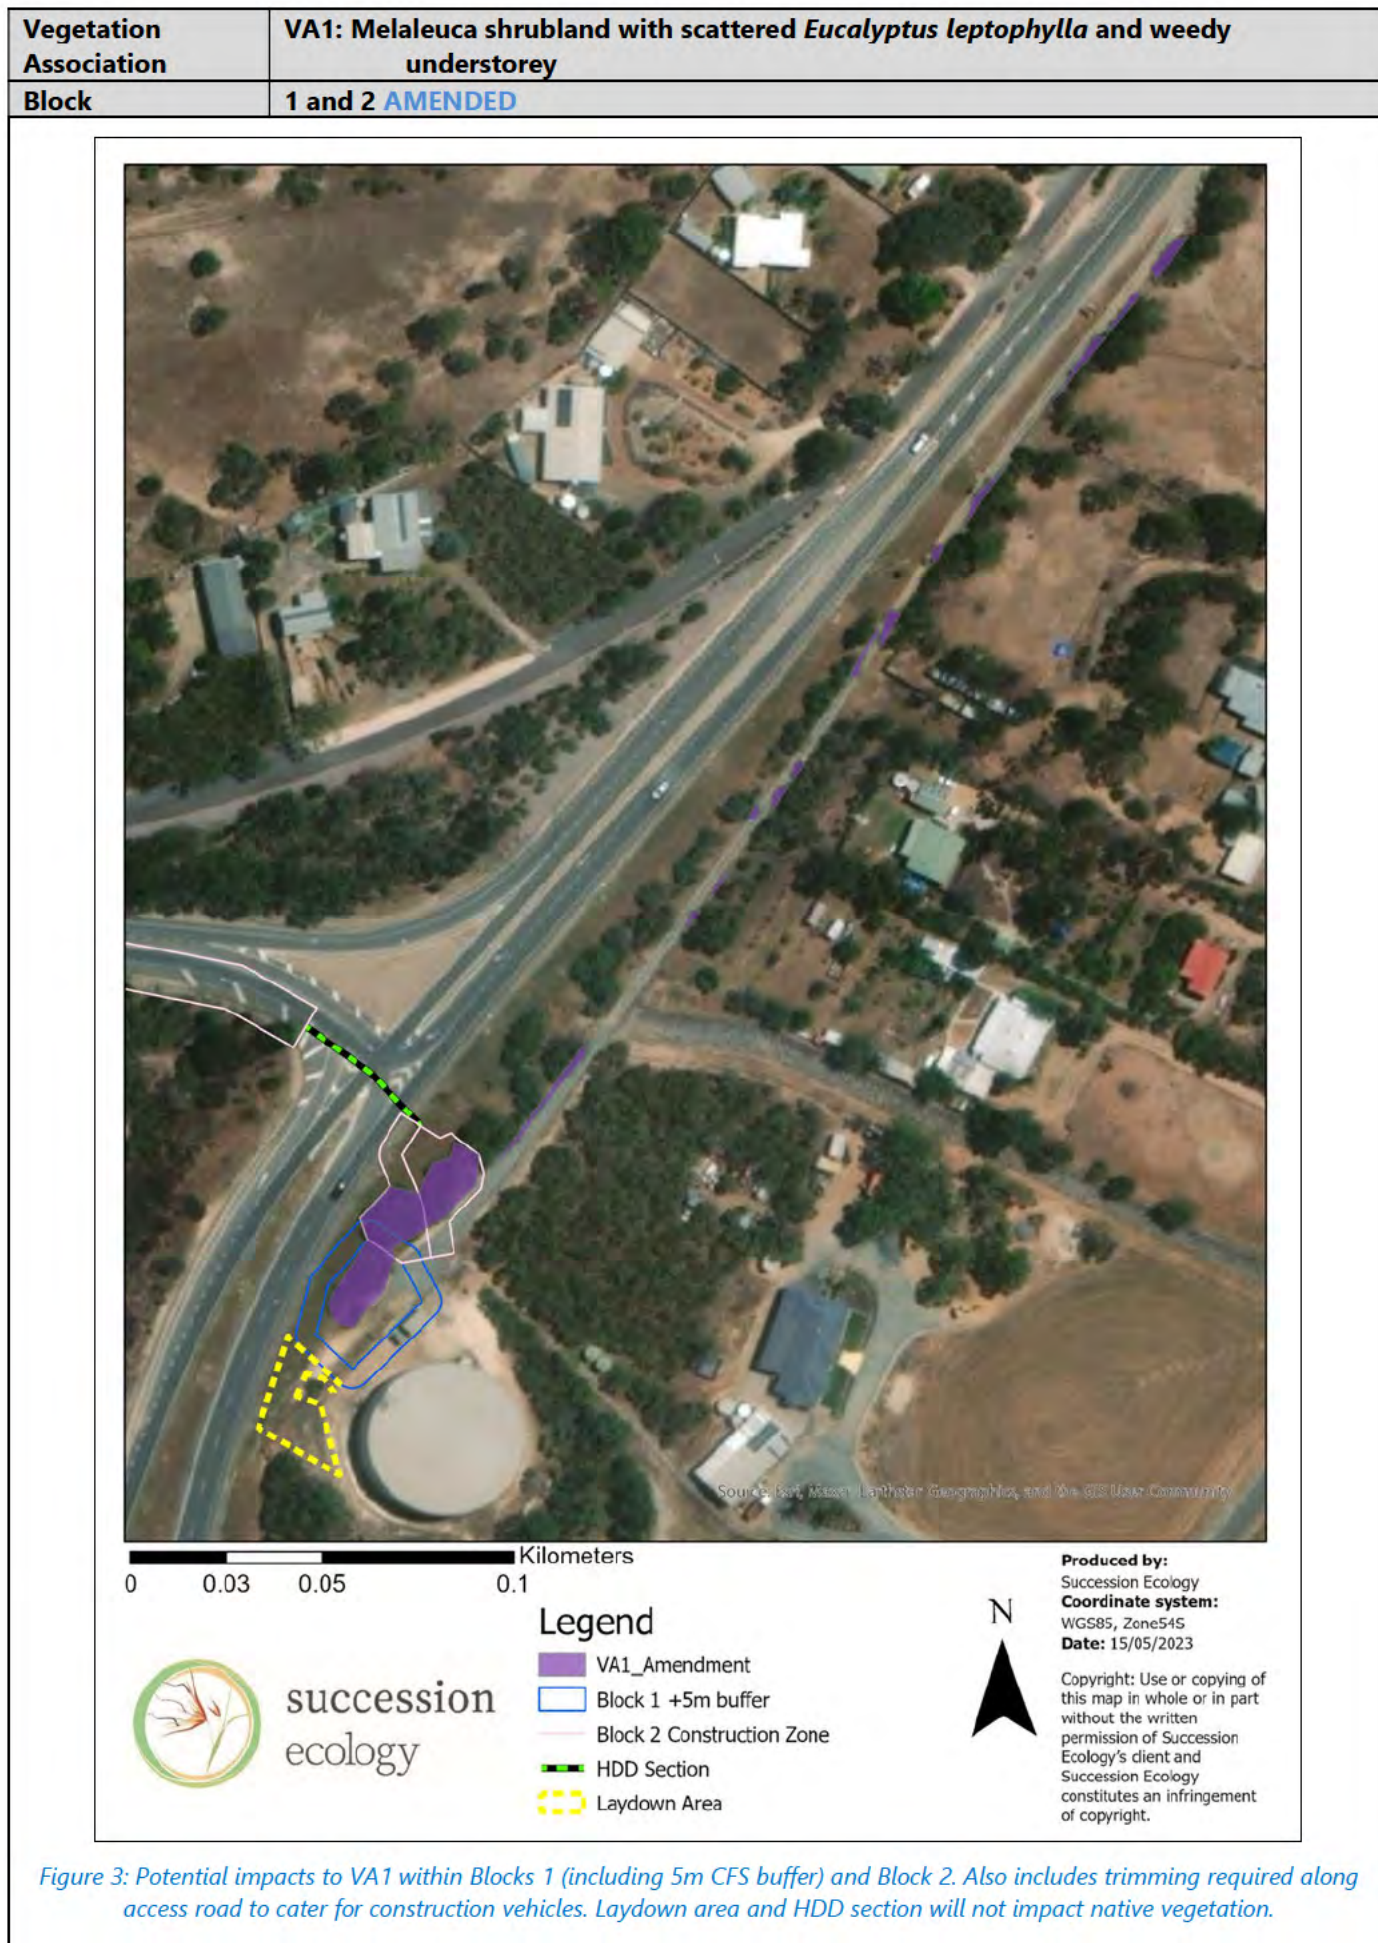
Figure 3: Potential impacts to VA1 within Blocks 1 (including 5m CFS buffer) and Block 2. Also includes trimming required along access road to cater for construction vehicles. Laydown area and HDD section will not impact native vegetation.

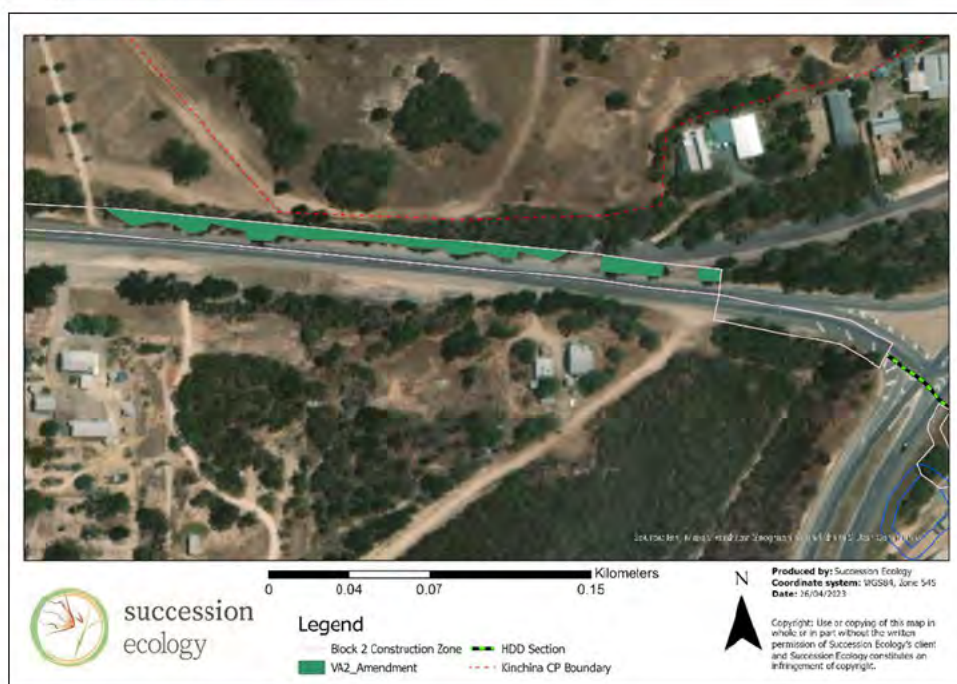
Figure 5: Extent of impacts to VA2 within Block 2 (predominantly pruning). Kinchina CP boundary also shown.

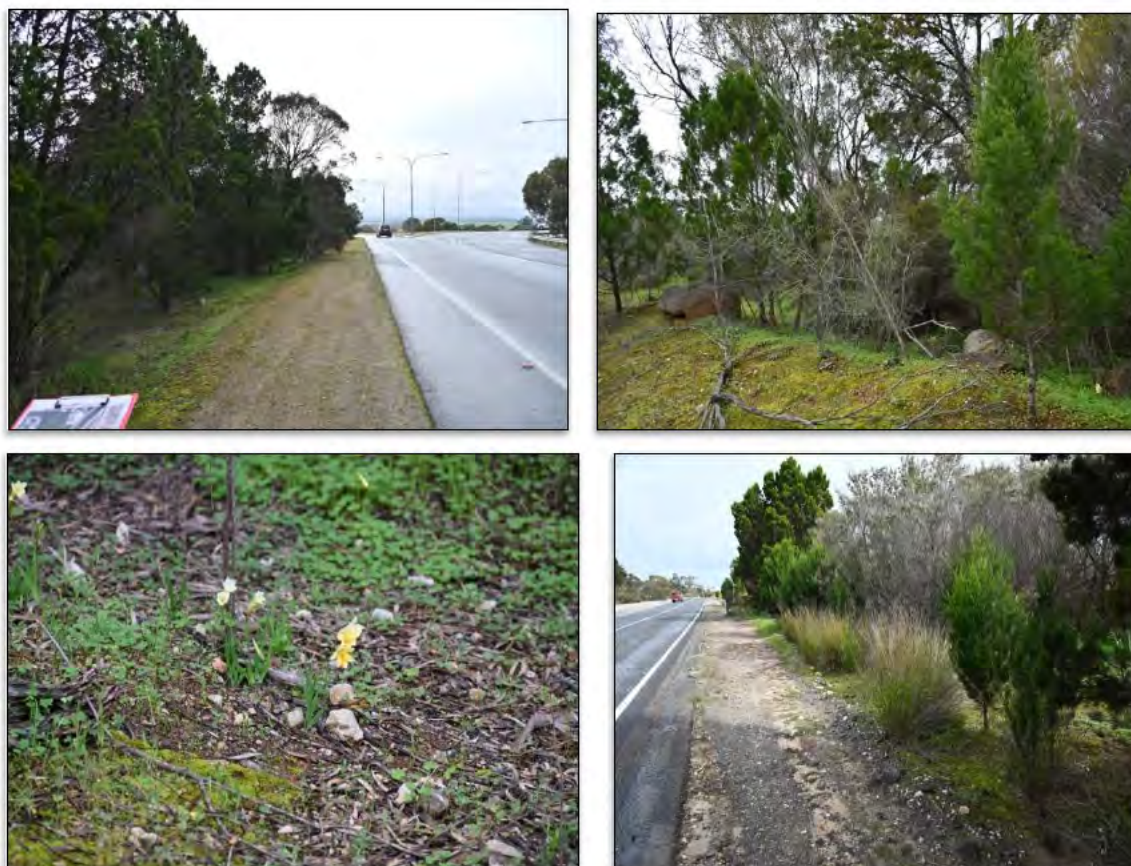
Figure 6: VA2 vegetation association, dominated by *Callitris gracilis* plus *Eucalyptus leptophylla*, open shrub understorey and a mostly weedy groundcover. *Freesia* (pictured bottom left) was prominent amongst the weeds in the groundcover.

Vegetation Association	VA2: <i>Callitris gracilis</i> + <i>Eucalyptus</i> mallee open woodland with open sclerophyll and weedy understorey				
Block	2 AMENDED				
General description	<p>VA2 is in moderate condition dominated by <i>Callitris gracilis</i> in the canopy, with occasional mallee species such as <i>Eucalyptus leptophylla</i> and <i>E. incrassata</i>. The understorey is comprised of an open sclerophyll shrub layer with a mostly weedy groundcover of <i>Oxalis pes-caprae</i> (Soursob) and other weeds such as <i>Freesia</i> sp. It also contains a number of declared weeds such as Gazania (<i>Gazania</i> sp), Bridal Creeper (<i>Asparagus asparagoides</i>), Olive (<i>Olea europaea</i>) and African Boxthorn (<i>Lycium ferocissimum</i>). This association borders the Kinchina Conservation Park for 170m. As such, a loading of 1 has been applied to the scoresheet for VA2. Impacts within this zone are likely to be predominantly pruning, however some full clearance may be required.</p>

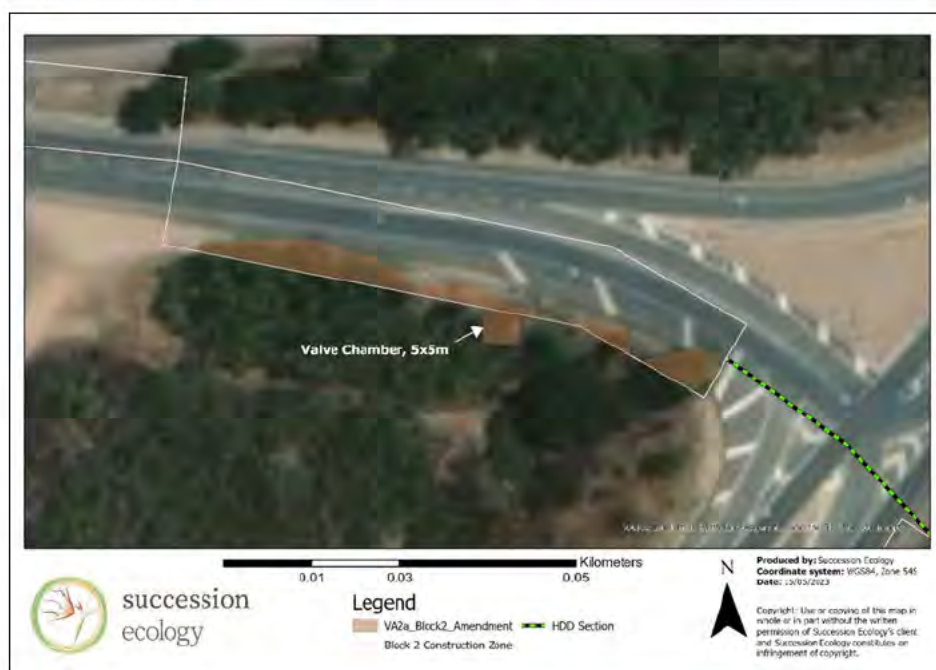
Figure 7: Extent of impacts to VA2a within Block 2 (predominantly pruning), including area for a valve chamber of 5x5m. Note: Horizontal Directional Drilling (HDD) will occur beneath the road pavement.

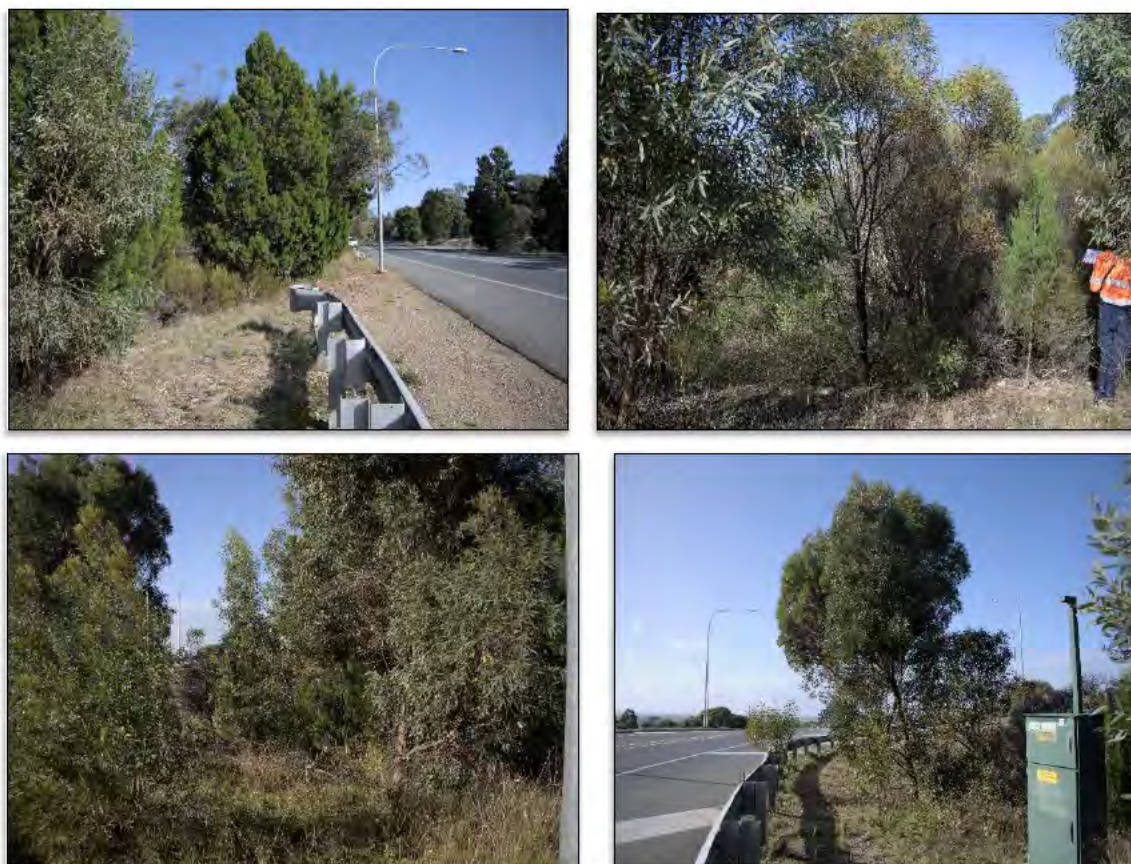
Figure 8: VA2a vegetation association, dominated by *Callitris gracilis* and planted eucalypts, with an open shrub and weedy understorey. Includes declared weeds such as African Boxthorn and *Gazania*.

Vegetation Association	VA2a: <i>Callitris gracilis</i> + planted eucalypt woodland with open sclerophyll and weedy understorey				
Block	2 AMENDED				
General description	VA2a is in poor condition, with the canopy dominated by <i>Callitris gracilis</i> and planted eucalypts of non-SA origin. The understorey is dominated by weed species, with scattered sclerophyll shrub species. It also contains a number of declared weeds such as <i>Gazania</i> (<i>Gazania</i> sp), Bridal Creeper (<i>Asparagus asparagoides</i>) and African Boxthorn (<i>Lycium ferocissimum</i>). Impacts within this zone are likely to be predominantly pruning, however some full clearance may be required within the area delineated for a valve chamber.				
Threatened species or community	<p><u>Search Methods</u></p> <ul style="list-style-type: none"> Protected Matters search – 5km area around the whole project area, to identify threatened species or their habitat, and communities, listed under the <i>EPBC Act 1999</i> NatureMaps search – 5km area around the whole project area, to identify threatened species listed under the <i>NPWS Act 1972</i>, as being recorded within the area since 1995. <p><u>Ecological Communities</u></p> <p>No threatened ecological communities were present within this habitat.</p> <p><u>Threatened Fauna</u></p> <p>The Protected Matters search identified one threatened fauna species: the Malleefowl (<i>Leipoa ocellata</i>; Vulnerable). A NatureMaps search found a further species protected under the <i>EPBC Act 1999</i>; the SA Bassian Thrush (<i>Zoothera lunulata halmaturina</i>; Endangered).</p> <p>The NatureMaps search also identified a further 18 threatened fauna species listed under the <i>NPW Act 1972</i>, three of which are listed as Vulnerable and 15 as Rare. All threatened species identified are listed in section 4.2.2. No threatened fauna were observed within VA2a.</p> <p><u>Threatened Flora</u></p> <p>The Protected Matters search identified six threatened flora species (three Endangered, three Vulnerable). NatureMaps identified a further 13 flora species listed under the <i>NPW Act 1972</i>: (one Endangered, one Vulnerable and 12 Rare). All threatened species identified are listed in section 4.2.2. No threatened flora were observed within VA2a.</p>

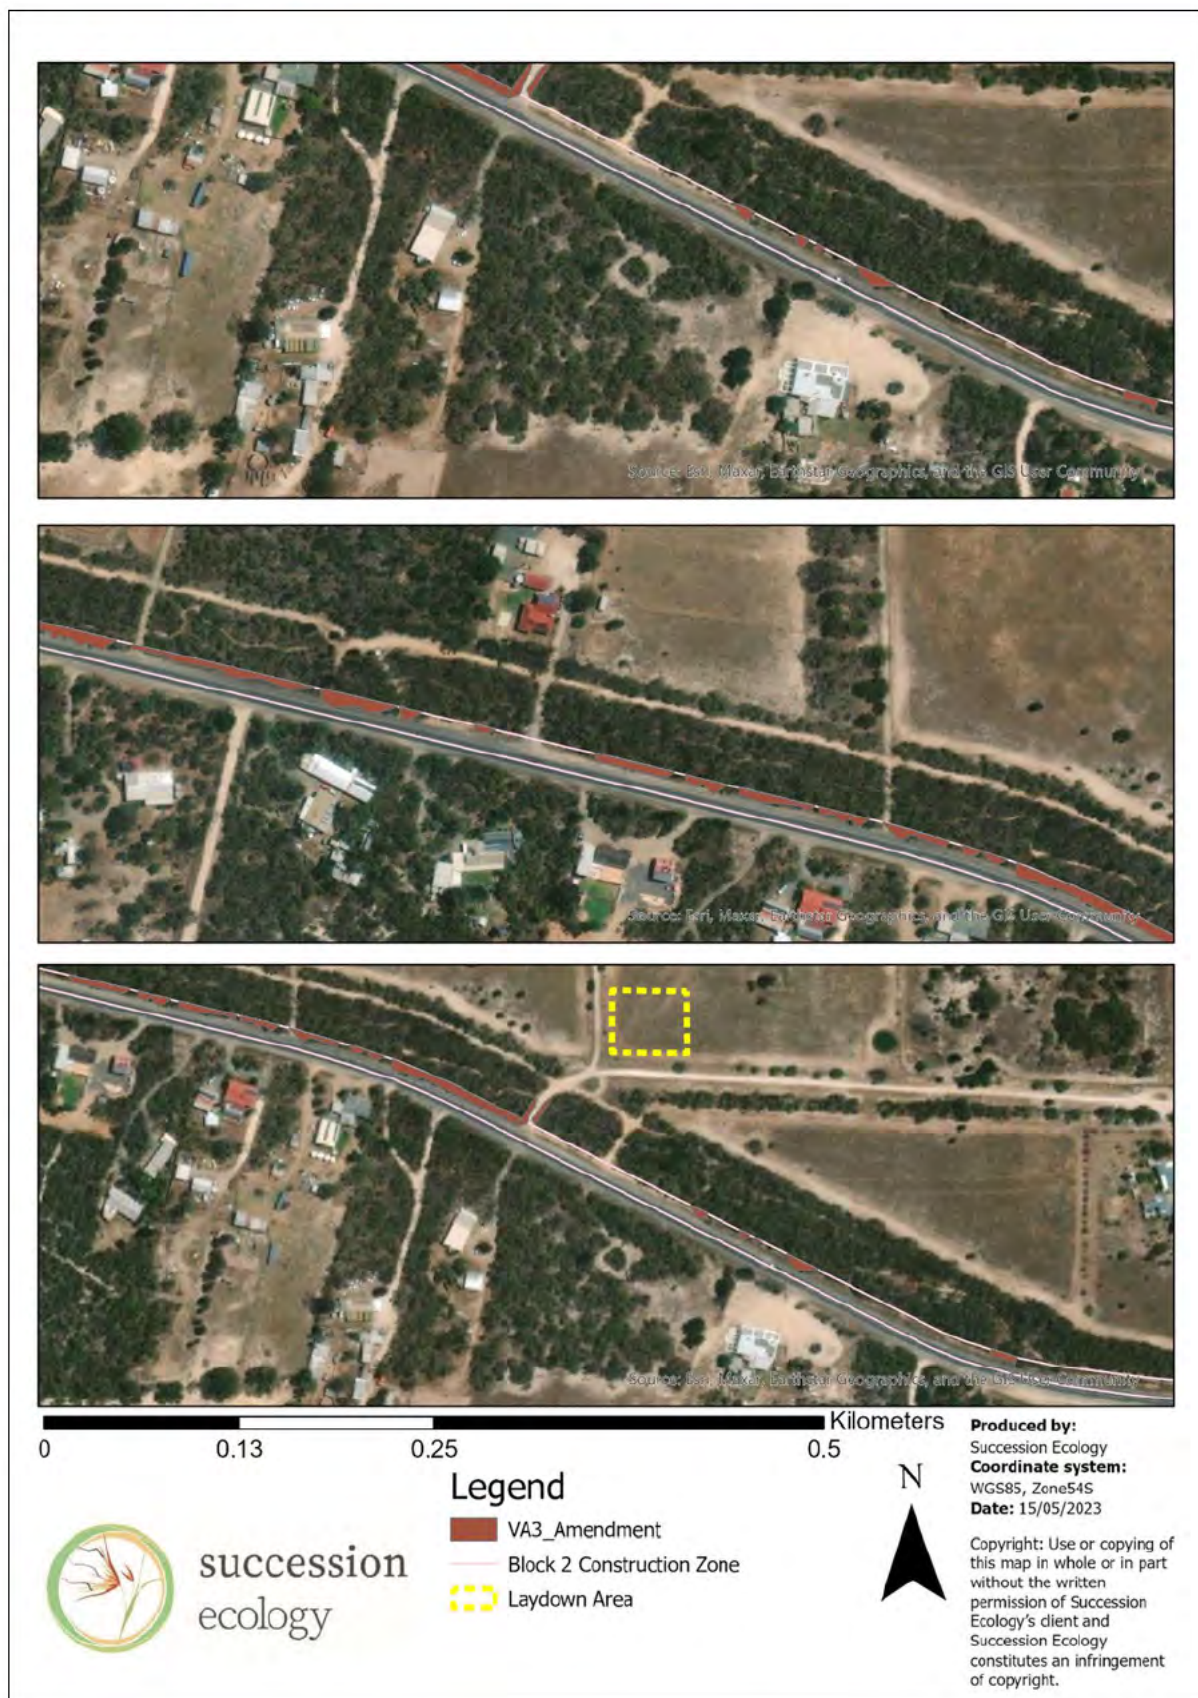
Figure 9: Extent of impacts to VA3 within Block 2 (likely pruning only). VA shown from west to east, top to bottom. Includes trimming required for access track to laydown area.

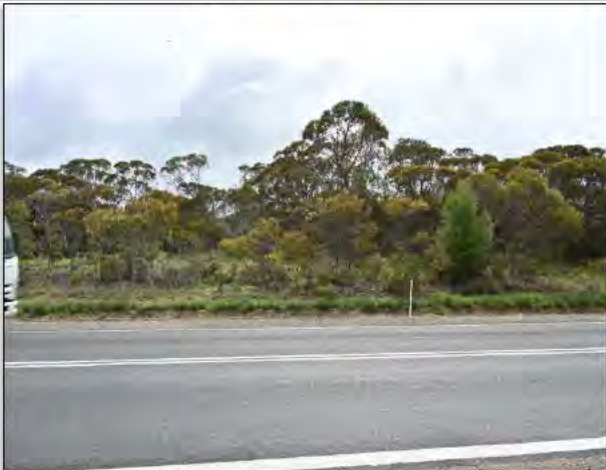
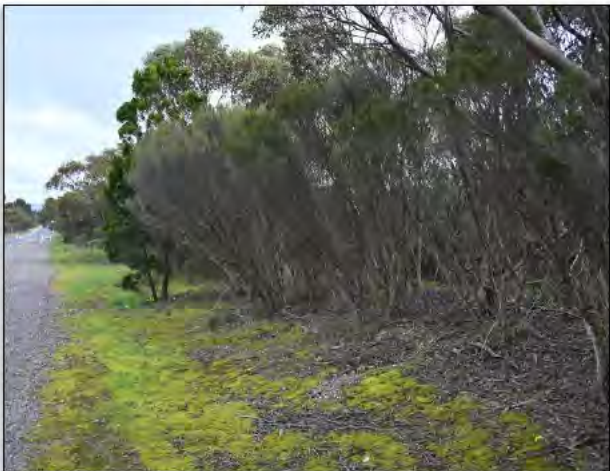
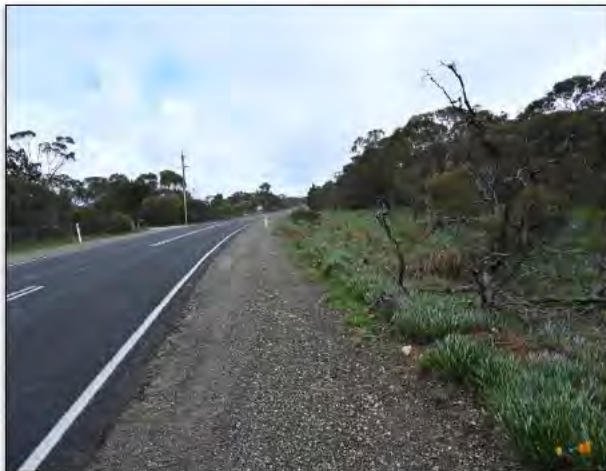
</div>			
<p>Figure 10: VA3 vegetation association, dominated by <i>Eucalyptus incrassata</i>, with an shrub understorey and a mixed native and weedy groundcover.</p>			
General description	<p>VA3 is in moderate condition, dominated by <i>Eucalyptus incrassata</i> and <i>E. phenax</i> in the canopy, with the occasional <i>Callitris gracilis</i>. The understorey is comprised of a sclerophyll shrub layer containing a number of <i>Hibbertia</i> sp, Quandong (<i>Santalum acuminatum</i>) and <i>Melaleuca lanceolata</i>. A number of weed species were present in the understorey, including a number of declared weeds such as <i>Gazania</i> (<i>Gazania</i> sp), Bridal Creeper (<i>Asparagus asparagoides</i>) and Olive (<i>Olea europaea</i>). This vegetation association is contained within a strip of roadside vegetation, 40-50m in width. Impacts within this zone are likely to be predominantly pruning.</p>

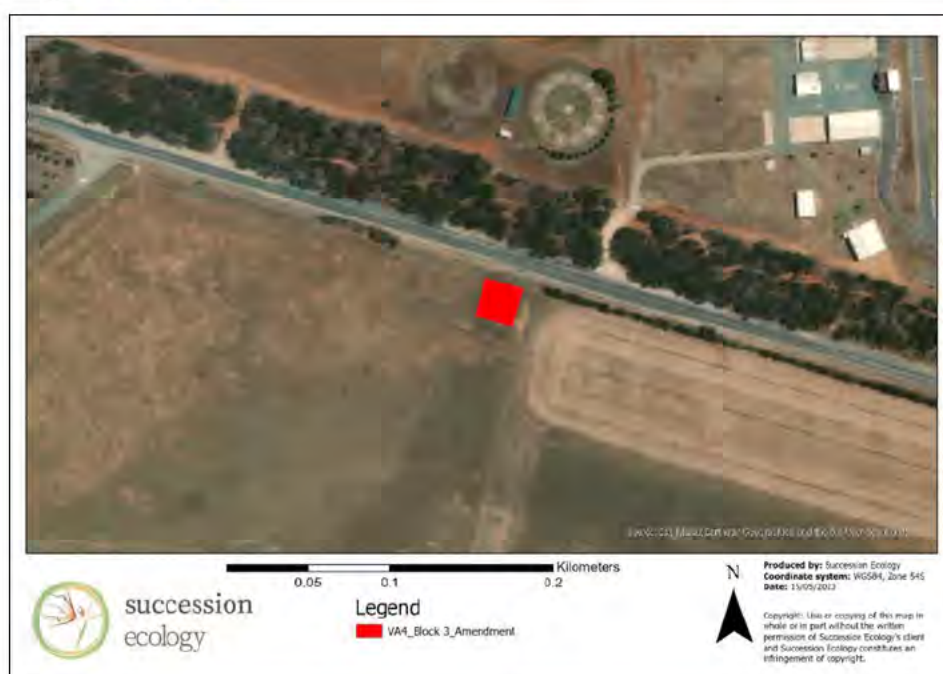
Figure 11: Block 3 within introduced grasslands.

This association is dominated by introduced grasses, pasture species and/or crop species. There are no proposed impacts to native vegetation within Block 3. It should be noted that the land parcel on which Block 3 is located also contains vegetation under a Heritage Agreement (2002/1370). However, the nearest protected vegetation is more than 400m south of the development site.

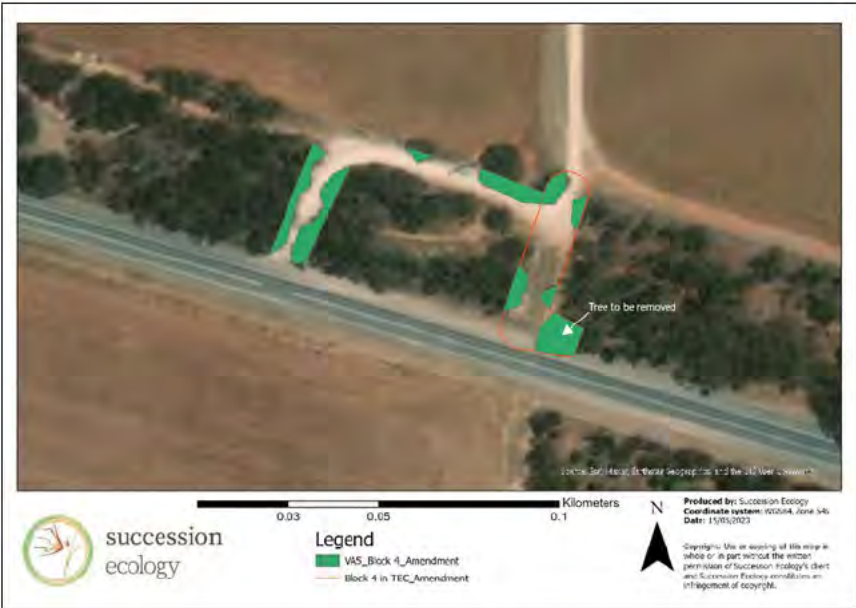
Figure 12: Extent of impacts from pipeline works to VA5 within Block 4. Includes trimming required for access. One tree to be removed, as indicated, the rest likely pruning only.

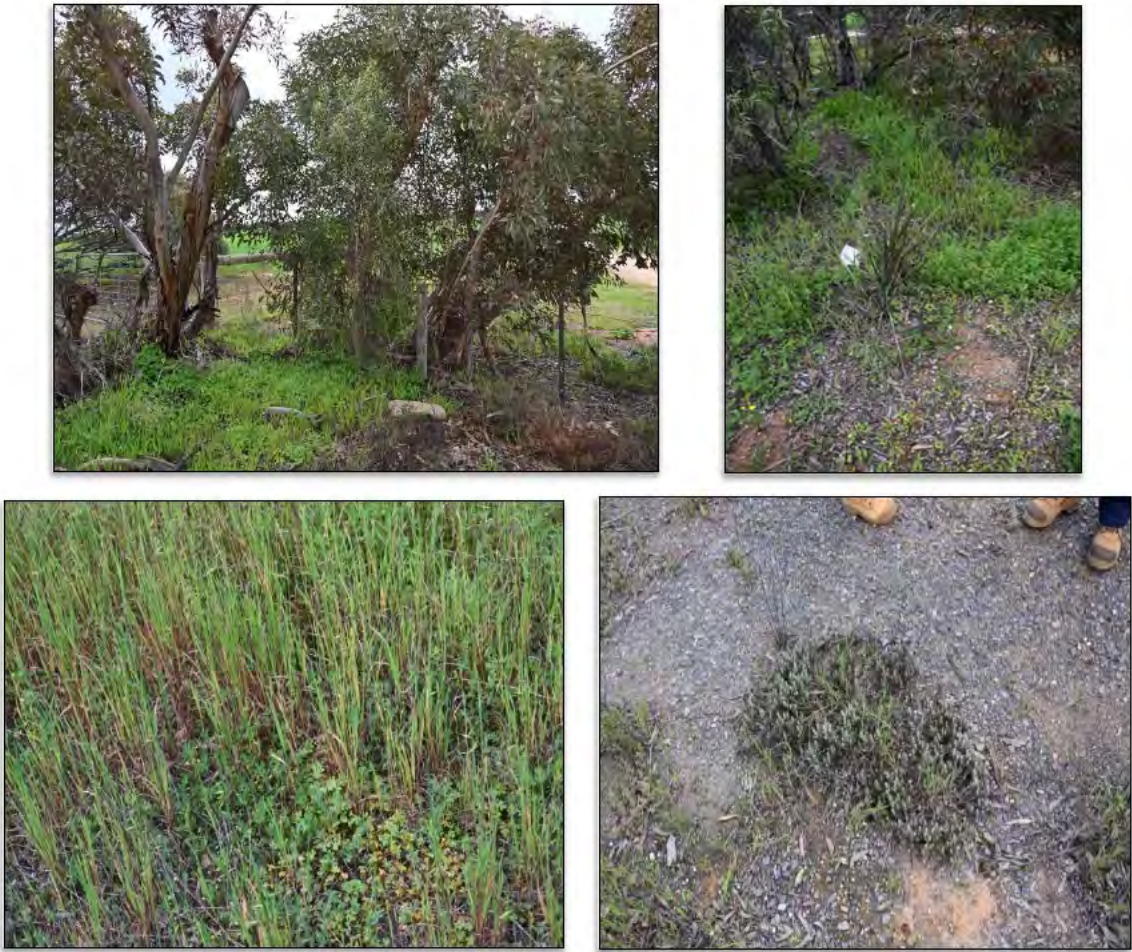
Figure 13: VA5 vegetation association, an open mallee community and very degraded, mostly weedy understorey.

Vegetation Association	VA5: <i>Eucalyptus socialis</i> + <i>E. phenax</i> + <i>E. leptophylla</i> mallee open woodland with open sclerophyll and weedy understorey				
Block	4 AMENDED				
General description	VA5 is located within a roadside section of the identified Mallee Bird Community TEC. Despite being located within a TEC, the section of VA5 within Block 4 is in poor condition, containing an open to very open <i>Eucalyptus leptophylla</i> , <i>E. socialis</i> , <i>E. phenax</i> open mallee woodland, with a sparse native understorey dominated by introduced species. Such introduced species include the declared weed Bridal Creeper (<i>Asparagus asparagoides</i>). The development footprint is within a previously disturbed section of the habitat, which remains predominantly open. It is likely that impacts within this area will include the removal of one tree and the remainder to be pruning only.

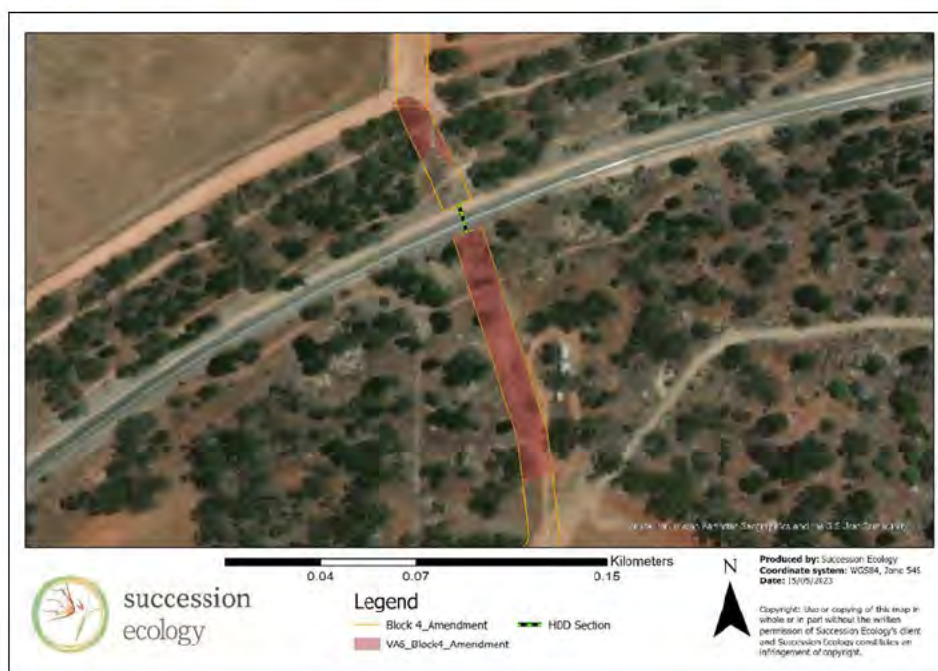
Figure 14: Extent of impacts to VA6 within Block 4. Note: Horizontal Directional Drilling (HDD) is planned under the rail corridor.

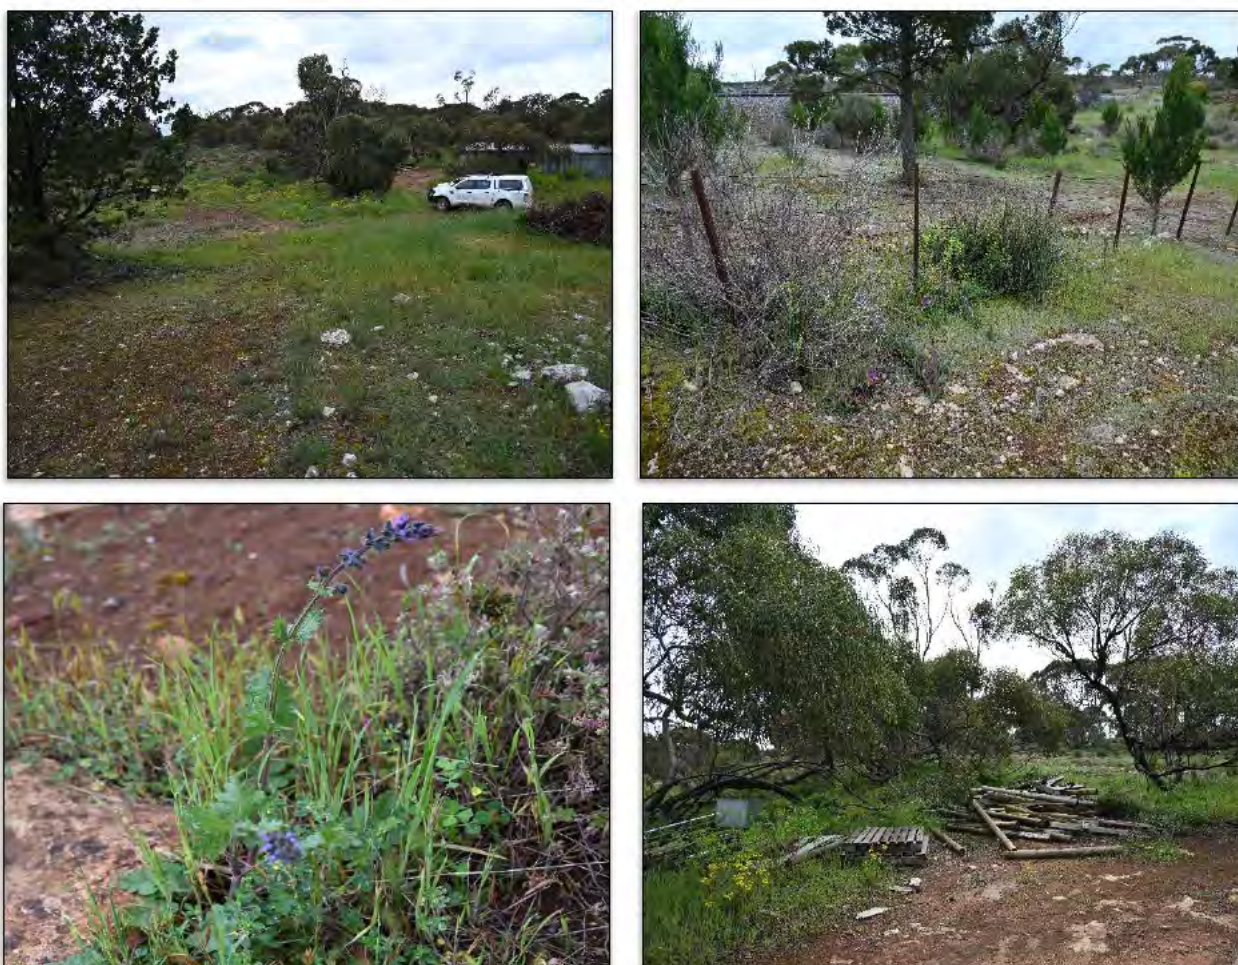
Figure 15: VA6 vegetation association, dominated by mallee eucalypts with *Callitris gracilis* in the canopy and very degraded, mostly weedy understorey.

Vegetation Association	VA6: <i>Eucalyptus socialis</i> + <i>E. phenax</i> + <i>E. porosa</i> mallee open woodland with open sclerophyll and weedy understorey				
Block	4 AMENDED				
General description	VA6 is in moderate to poor condition, containing an open to very open <i>Eucalyptus porosa</i> , <i>E. socialis</i> , <i>E. phenax</i> open mallee woodland, with the occasionally <i>Callitris gracilis</i> . The understorey is dominated by weedy grasses and other weedy groundcovers including the declared weed Bridal Creeper (<i>Asparagus asparagoides</i>) and Horehound (<i>Marrubium vulgare</i>). There is a lot of disturbance within this vegetation association, with infrastructure debris present. Impacts within this VA will include complete removal.				
Threatened species or community	<p><u>Search Methods</u></p> <ul style="list-style-type: none"> Protected Matters search – 5km area around the whole project area, to identify threatened species or their habitat, and communities, listed under the <i>EPBC Act 1999</i> NatureMaps search – 5km area around the whole project area, to identify threatened species listed under the <i>NPWS Act 1972</i>, as being recorded within the area since 1995. <p><u>Ecological Communities</u></p> <p>No Threatened Ecological Communities occur within this association.</p> <p><u>Threatened Fauna</u></p> <p>The Protected Matters search identified one threatened fauna species: the Malleefowl (<i>Leipoa ocellata</i>; Vulnerable). A NatureMaps search found a further species protected under the <i>EPBC Act 1999</i>; the SA Bassian Thrush (<i>Zoothera lunulata halmaturina</i>; Endangered).</p> <p>The NatureMaps search also identified a further 18 threatened fauna species listed under the <i>NPW Act 1972</i>, three of which are listed as Vulnerable and 15 as Rare. All threatened species identified are listed in section 4.2.2. No threatened fauna were observed within VA6.</p> <p><u>Threatened Flora</u></p> <p>The Protected Matters search identified six threatened flora species (three Endangered, three Vulnerable). NatureMaps identified a further 13 flora species listed under the <i>NPW Act 1972</i>: (one Endangered, one Vulnerable and 12 Rare). All threatened species identified are listed in section 4.2.2. No threatened flora were observed within VA6.</p>

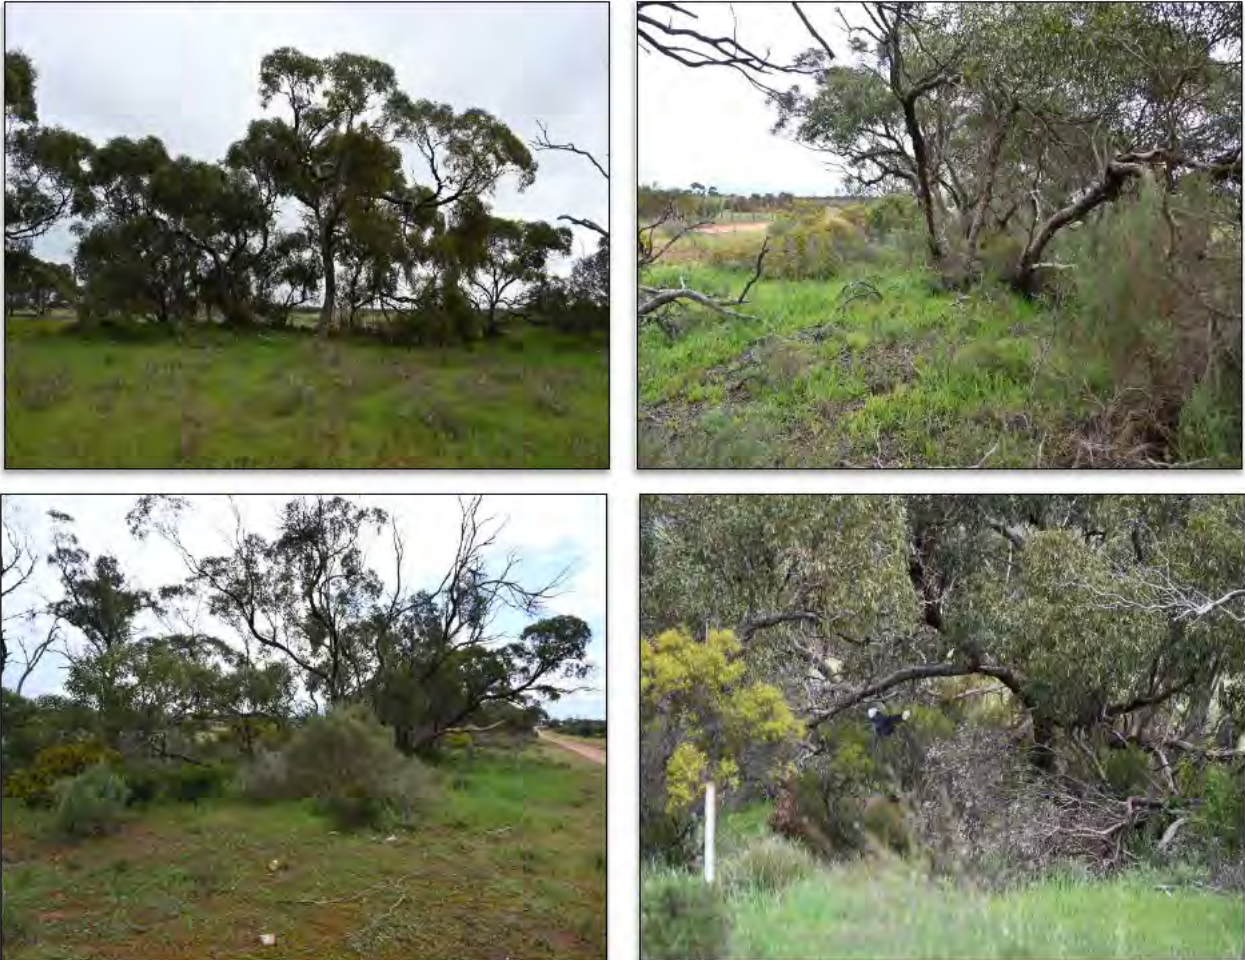
<p>Figure 17: VA7 vegetation association, dominated by <i>Eucalyptus porosa</i> open woodland with sparse sclerophyll understorey, dominated by introduced species. A threatened White-winged Chough was observed at this site.</p>		
General description	<p>VA7 is in moderate to poor condition, containing an open to very open <i>Eucalyptus porosa</i> mallee woodland, with sparse sclerophyll shrubs. The understorey is dominated by weedy grasses and other weedy groundcovers including the declared weed Bridal Creeper (<i>Asparagus asparagoides</i>), Horehound (<i>Marrubium vulgare</i>) and African Boxthorn (<i>Lycium ferocissimum</i>). Despite the degradation of the site, the association provides habitat for the threatened White-winged Chough (<i>Corcorax melanorhamphos</i>), observed flying and perching within the association, and the State listed <i>Acacia rhigiophylla</i>.</p>

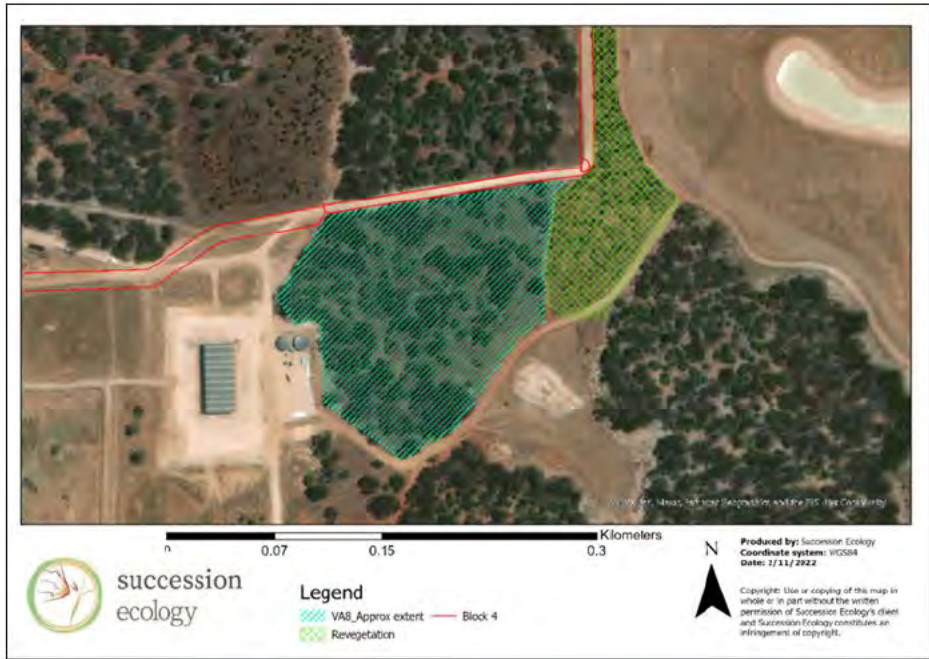
Figure 18: The approximate extent of VA8 (TEC habitat) and the adjacent Block 4 development corridor. Vegetation north of VA8 is inaccessible due to enclosure fencing. Note: the development corridor has been narrowed in this section to ensure the TEC is not impacted.

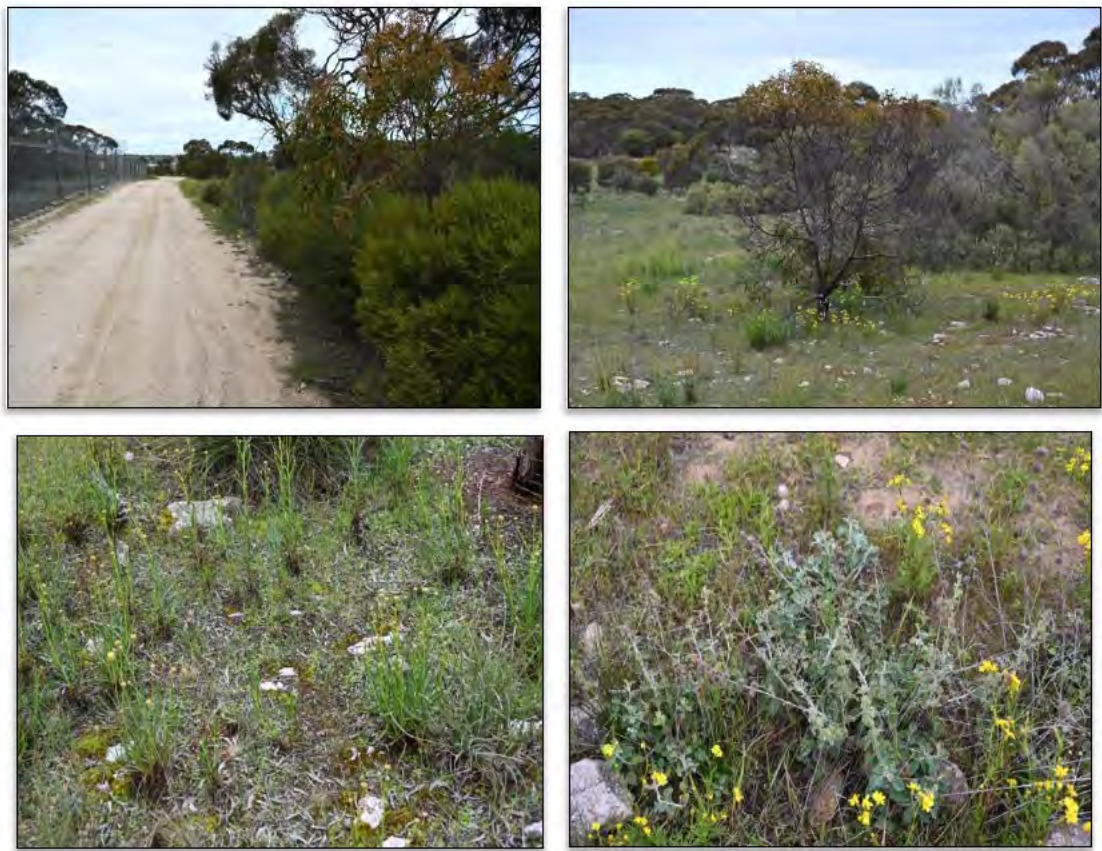
Figure 19: VA8 vegetation association, an open mallee community with an understorey dominated by native grasses and herbs.

Vegetation Association	VA8: <i>Eucalyptus leptophylla</i> + <i>E. rugosa</i> mallee open woodland + open shrubland + grasses				
Block	4				
General description	<p>VA8 is located within a patch of an identified Mallee Bird Community TEC. It is in moderate condition, containing an open to very open <i>Eucalyptus leptophylla</i> and <i>E. rugosa</i> mallee woodland, with an understorey dominated by native grasses and herbs. Introduced species are also present, including the declared weed Bridal Creeper (<i>Asparagus asparagoides</i>) and Horehound (<i>Marrubium vulgare</i>). The development footprint is adjacent to a previously disturbed section of the habitat, which remains predominantly open. To ensure no impacts to the TEC, the construction corridor has been narrowed from 12m to 6m. This will mean modifying construction methodologies to be able to operate within the narrow corridor.</p>

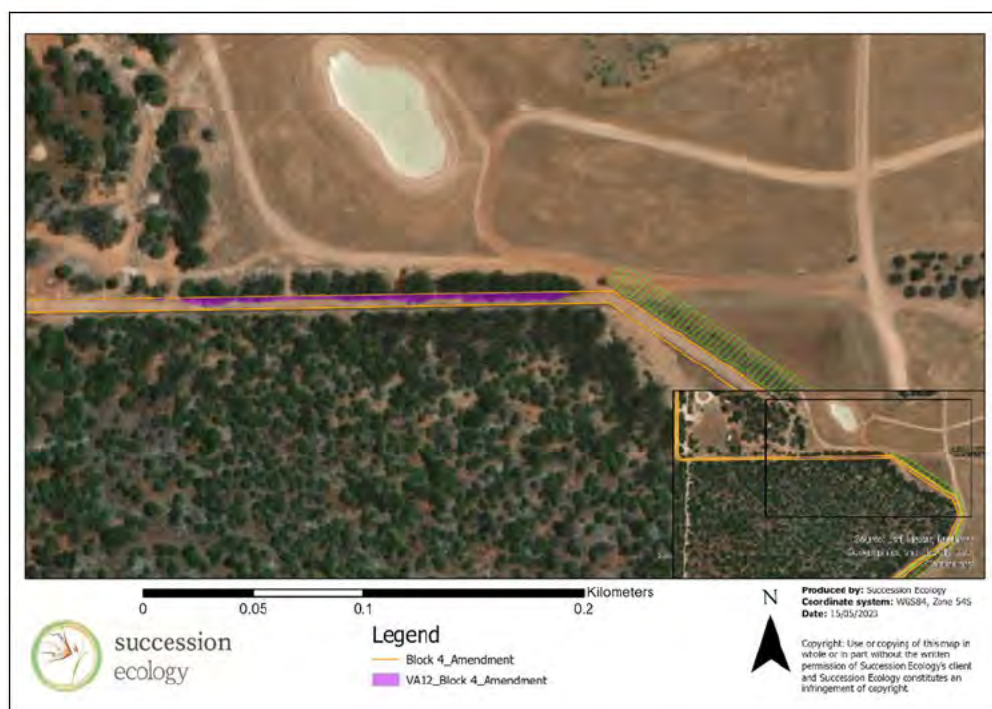
Figure 20: Showing the approximate extent of VA12 and the adjacent Block 4 development corridor. Vegetation south of VA12 is inaccessible. Note: the development corridor has been narrowed in this section to require trimming only.

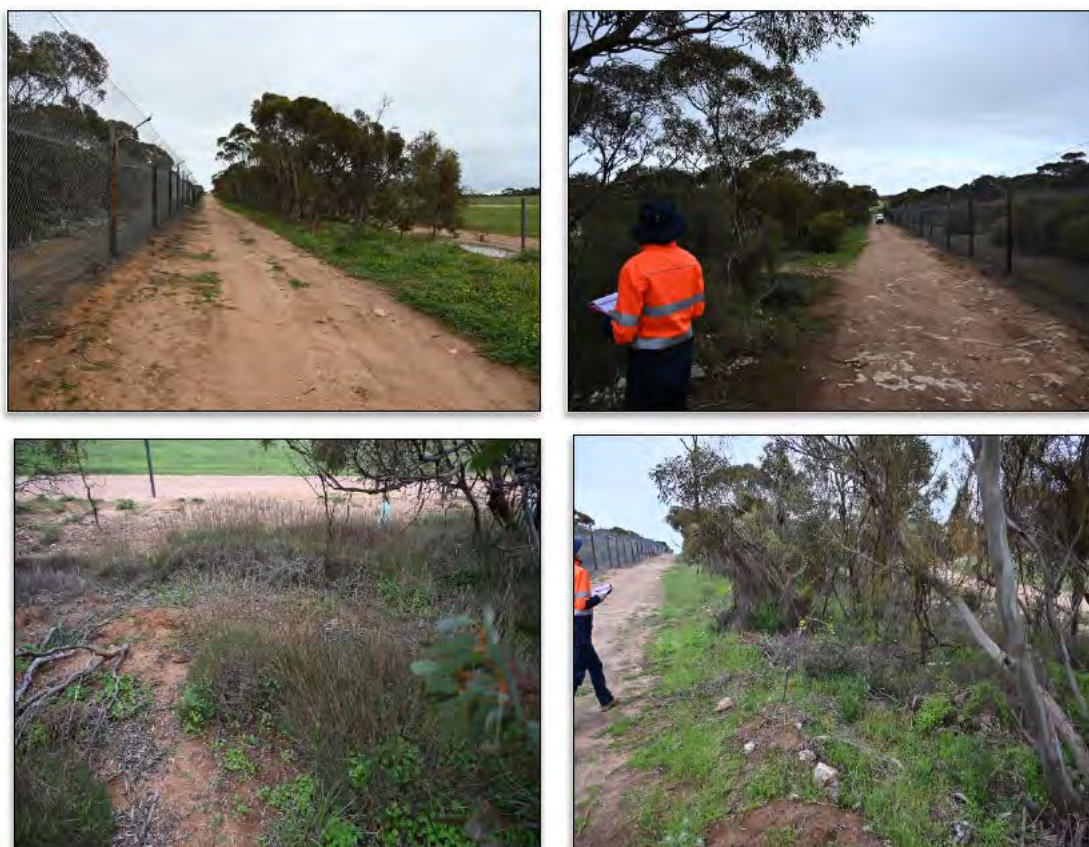
Figure 21: VA12 vegetation association, an open mallee community with an understorey of native grasses, herbs and weeds including the declared weed Bridal Creeper (*Asparagus asparagoides*).

Vegetation Association	VA12: <i>Eucalyptus socialis</i> open woodland + open shrubland + <i>Triodia</i>				
Block	4 AMENDED				
General description	<p>VA12 is located on the very edge of a patch of an identified Mallee Bird Community TEC. It is in moderate condition, containing an open <i>Eucalyptus socialis</i> and <i>E. leptophylla</i> mallee woodland, with an understorey that includes <i>Triodia irritans</i>, and various native chenopod and sclerophyll shrubs. The understorey also contained a substantial cover of introduced species, including the declared weed Bridal Creeper (<i>Asparagus asparagoides</i>) and Soursob (<i>Oxalis pes-caprae</i>) and Medic (<i>Medicago sp.</i>). The development footprint is bound to the south by enclosure fencing. To ensure minimal to the TEC (ie pruning only), the construction corridor has been narrowed from 12m to 6m. This will mean modifying construction methodologies to be able to operate within the narrow corridor.</p>

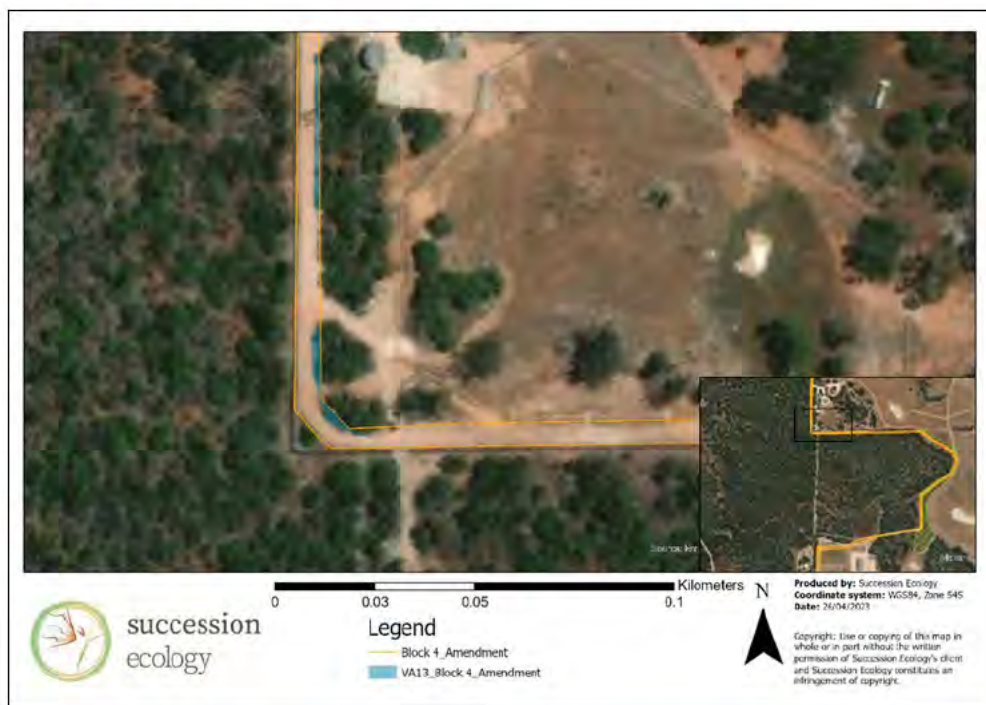
Figure 22: Showing the extent of impacts within VA13 from the 6m development corridor within this section of Block 4. Vegetation to the west of VA13 is inaccessible. Note: the development corridor has been narrowed in this section to require trimming only.

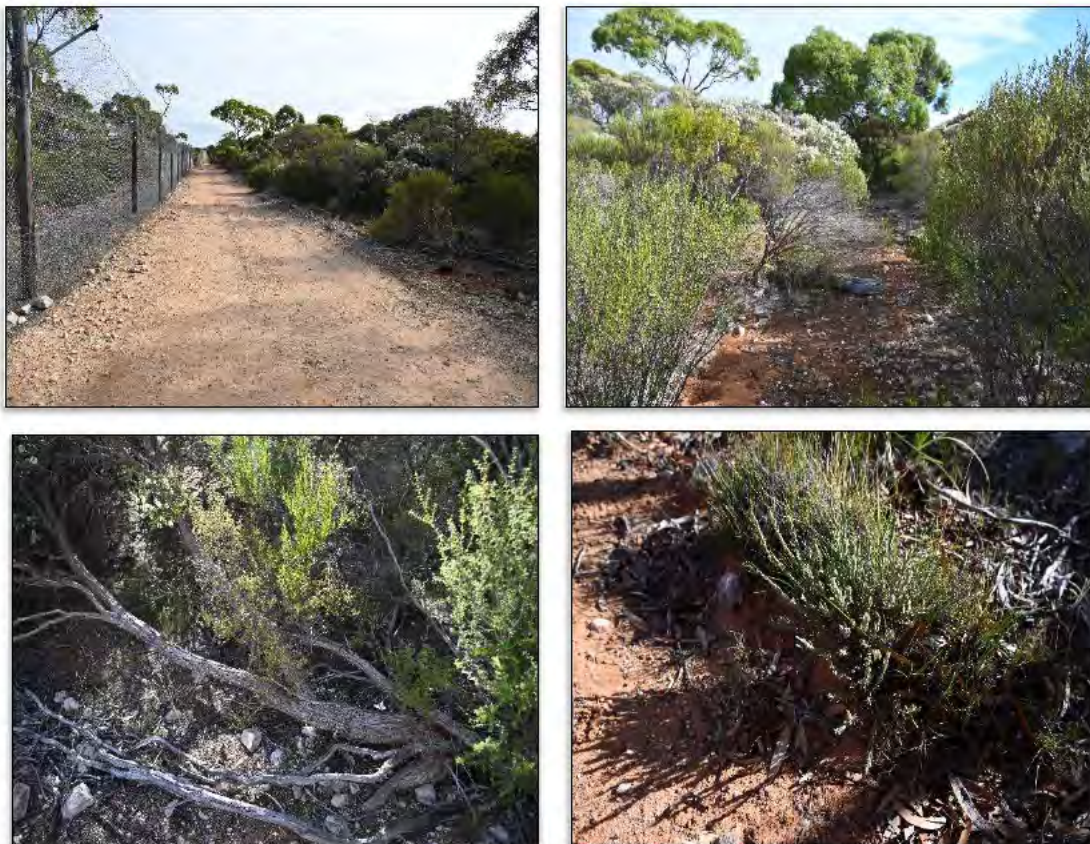
Figure 23: VA13 vegetation association, a mixed mallee community with an understorey of native sclerophyll and chenopod shrubs, with a low cover of weeds.

Vegetation Association	VA13: <i>Eucalyptus leptophylla</i> + <i>E. oleosa</i> mallee woodland + sclerophyll and chenopod shrubland				
Block	4 AMENDED				
General description	<p>VA 13 is located along a council road, on the edge of a patch of an identified Mallee Bird Community TEC. It is in good condition, containing a mixed mallee community of <i>Eucalyptus leptophylla</i>, and <i>E. oleosa</i>, with an understorey which includes a number of sclerophyll and chenopod shrubs, such as <i>Lomandra effusa</i>, <i>Melaleuca acuminata</i> and <i>Lasiopetalum baueri</i>. The understorey also contained few weed species, but did include the declared weed Bridal Creeper (<i>Asparagus asparagoides</i>). The development footprint is bound to the west by enclosure fencing. To ensure minimal to the TEC (ie pruning only), the construction corridor has been narrowed from 12m to 6m. This will mean modifying construction methodologies to be able to operate within the narrow corridor.</p>
