Native Vegetation Clearance

Murray Bridge Growth Infrastructure Upgrade

(ES0423-11)

Data Report – Amendment 1

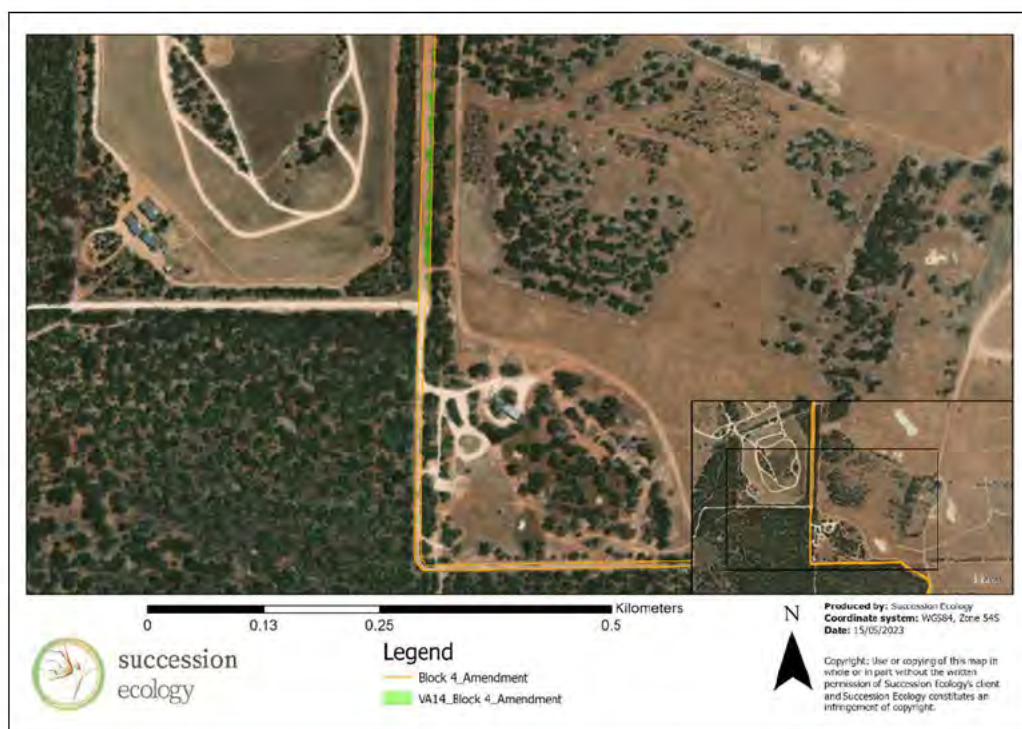
Figure 24: Showing the extent of impacts within VA14 from the 12m development corridor within this section of Block 4. Vegetation to the west of VA14 is inaccessible. This section is to require trimming only.

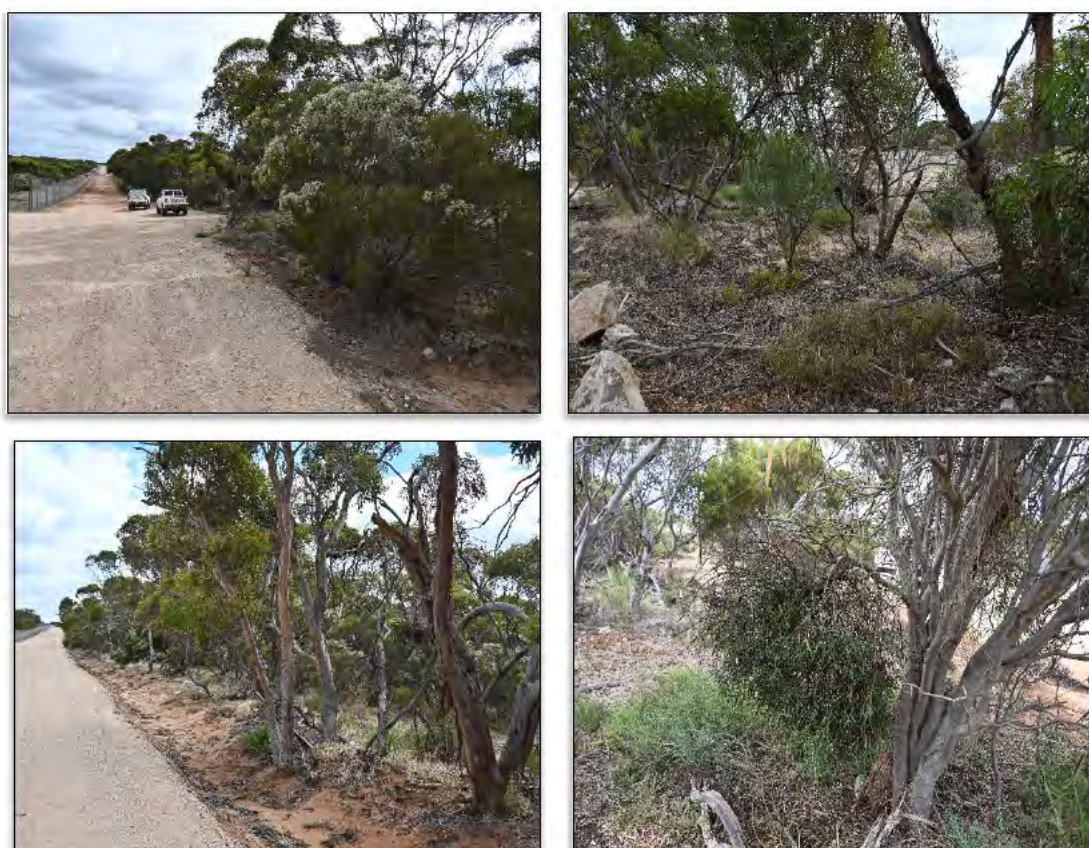
Figure 25: VA14 vegetation association, a mixed mallee community with an understorey of native sclerophyll and chenopod shrubs, with a low to moderate cover of weeds.

Vegetation Association	VA14: <i>Eucalyptus socialis</i> mallee woodland + sclerophyll and chenopod shrubland				
Block	4 AMENDED				
General description	<p>VA 14 is located along a council road, on the edge of a patch of an identified Mallee Bird Community TEC. It is in moderate to good condition, containing a mixed mallee community of <i>Eucalyptus socialis</i>, and <i>E. phenax</i>, with an understorey which includes a number of sclerophyll and chenopod shrubs, such as <i>Correa glabra</i> var. <i>turnbullii</i>, <i>Melaleuca acuminata</i> and <i>Rhagodia candolleana</i>. The understorey also contained a low to moderate cover of weeds, including the declared weed Bridal Creeper (<i>Asparagus asparagoides</i>) and Horehound (<i>Marrubium vulgare</i>). The development footprint is bound to the west by enclosure fencing. The construction corridor will be restricted to 12m, requiring only pruning within this corridor.</p>

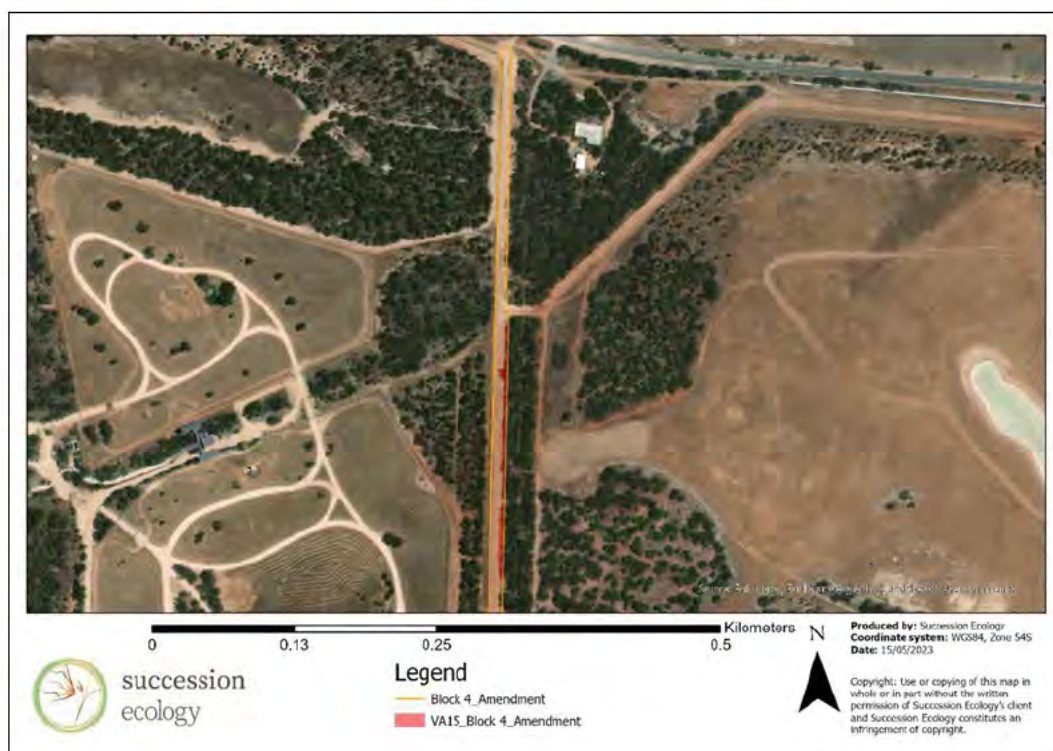
Figure 26: Showing the extent of impacts within VA15. Vegetation to the west of VA15 and at the very north of the Block will not be impacted by the development. Note: the development corridor has been narrowed in this section to require trimming only.

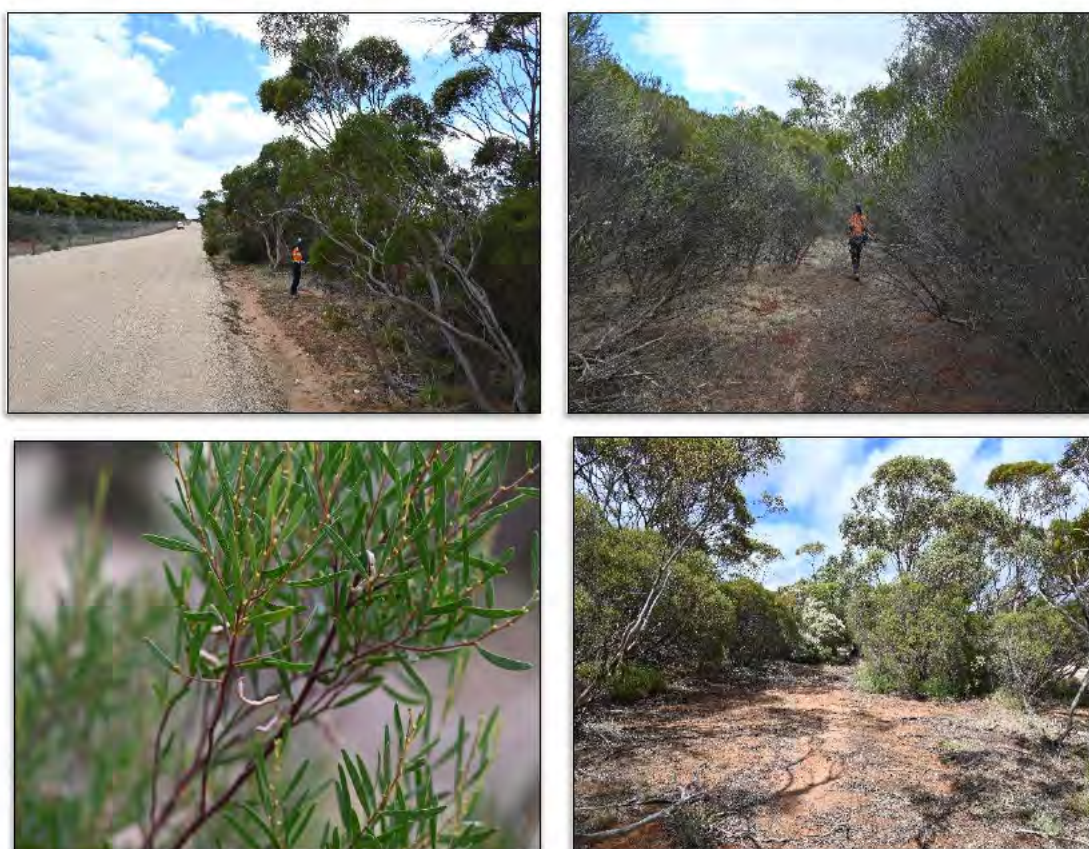
Figure 27: VA15 vegetation association, a mixed mallee community with an understorey of native sclerophyll and chenopod shrubs, with a moderate cover of weeds. It included the state Rare *Acacia montana* (bottom left).

Vegetation Association	VA15: <i>Mixed mallee woodland + sclerophyll and chenopod shrubland</i>				
Block	4 AMENDED				
General description	<p>VA15 is located along a council road, on the edge of a patch of an identified Mallee Bird Community TEC. It is in moderate to good condition, containing a mixed mallee community of <i>Eucalyptus socialis</i>, <i>E. oleosa</i> and <i>E. phenax</i> with an understorey that includes a number of sclerophyll and chenopod shrubs. This included the state Rare <i>Acacia montana</i>. The understorey contained a moderate cover of weeds, including the declared weed Bridal Creeper (<i>Asparagus asparagoides</i>). The development footprint is bound to the west (in the south) and to the east (in the north) by enclosure fencing. The access track widens to the north, where the development will not be impacting adjacent native vegetation.</p>				
Threatened species or community	<p><u>Search Methods</u></p> <ul style="list-style-type: none"> Protected Matters search – 5km area around the whole project area, to identify threatened species or their habitat, and communities, listed under the <i>EPBC Act 1999</i> NatureMaps search – 5km area around the whole project area, to identify threatened species listed under the <i>NPWS Act 1972</i>, as being recorded within the area since 1995. <p><u>Ecological Communities</u></p> <p>One threatened ecological community (TEC) is present within this habitat (the <i>Mallee Bird Community of the Murray Darling Depression Bioregion</i>, condition A). This TEC is discussed further in section 4.2. This TEC will not be impacted by this section of the development.</p> <p><u>Threatened Fauna</u></p> <p>The Protected Matters search identified one threatened fauna species: the Malleefowl (<i>Leipoa ocellata</i>; Vulnerable). A NatureMaps search found a further species protected under the <i>EPBC Act 1999</i>; the SA Bassian Thrush (<i>Zoothera lunulata halmaturina</i>; Endangered).</p> <p>The NatureMaps search also identified a further 18 threatened fauna species listed under the <i>NPW Act 1972</i>, three of which are listed as Vulnerable and 15 as Rare. All threatened species identified are listed in section 4.2.2. No threatened fauna were observed within VA15.</p> <p><u>Threatened Flora</u></p> <p>The Protected Matters search identified six threatened flora species (three Endangered, three Vulnerable). NatureMaps identified a further 13 flora species listed under the <i>NPW Act 1972</i>: (one Endangered, one Vulnerable and 12 Rare). All threatened species identified are listed in section 4.2.2. One threatened flora species was observed within VA15 – <i>Acacia montana</i> (Mallee Wattle).</p>

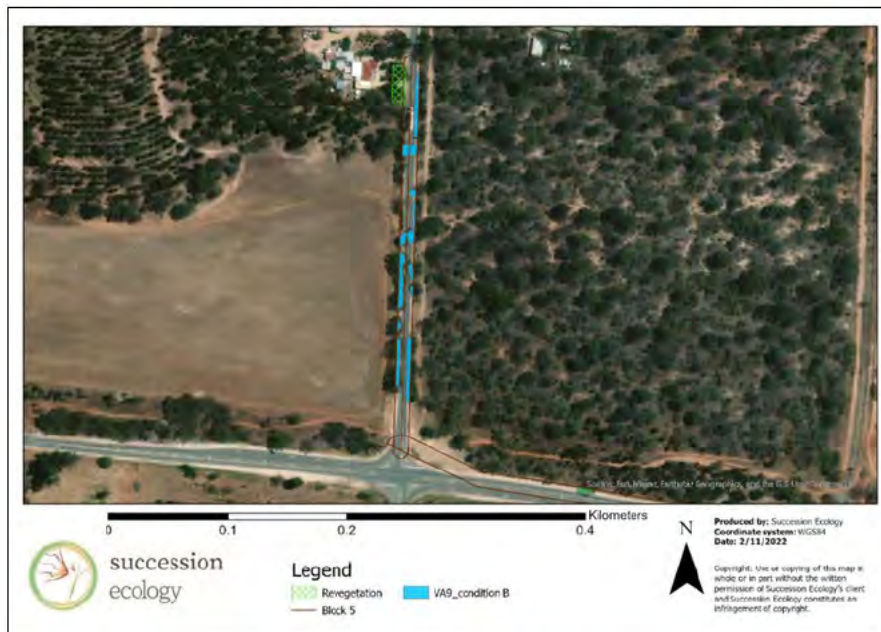
Figure 28: Extent of impacts within VA9 (likely pruning only) from Block 5.

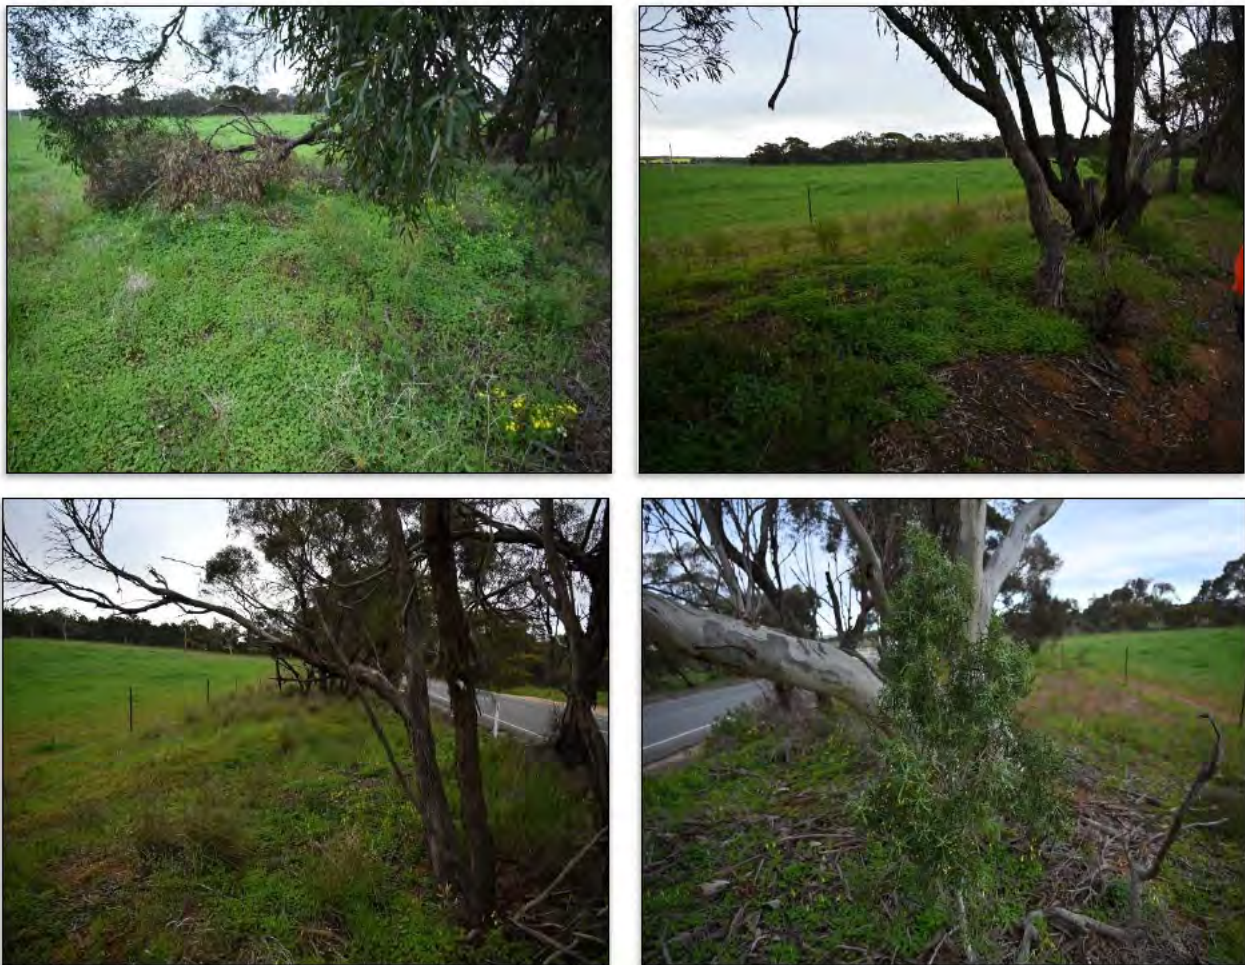
Figure 29: VA9 vegetation association, an open woodland community with a sclerophyll understorey.

Vegetation Association	VA9: <i>Euclayptus leucoxylon</i> + <i>E. porosa</i> open woodland + open shrub + weedy understorey				
Block	5				
General description	VA9 is in poor condition, containing an open <i>Eucalyptus leucoxylon</i> and <i>E. porosa</i> woodland, with an almost entirely weedy understorey. Introduced species include the declared weeds African Boxthorn (<i>Lycium ferocissimum</i>) and Bridal Creeper (<i>Asparagus asparagoides</i> f. <i>asparagoides</i>).				
Threatened species or community	<p><u>Search Methods</u></p> <ul style="list-style-type: none"> Protected Matters search – 5km area around the whole project area, to identify threatened species or their habitat, and communities, listed under the <i>EPBC Act 1999</i> NatureMaps search – 5km area around the whole project area, to identify threatened species listed under the <i>NPWS Act 1972</i>, as being recorded within the area since 1995. <p><u>Ecological Communities</u></p> <p>No Threatened Ecological Communities occur within this association.</p> <p><u>Threatened Fauna</u></p> <p>The Protected Matters search identified one threatened fauna species: the Malleefowl (<i>Leipoa ocellata</i>; Vulnerable). A NatureMaps search found a further species protected under the <i>EPBC Act 1999</i>; the SA Bassian Thrush (<i>Zoothera lunulata halmaturina</i>; Endangered).</p> <p>The NatureMaps search also identified a further 18 threatened fauna species listed under the <i>NPW Act 1972</i>, three of which are listed as Vulnerable and 15 as Rare. All threatened species identified are listed in section 4.2.2. No threatened fauna were observed within VA9.</p> <p><u>Threatened Flora</u></p> <p>The Protected Matters search identified six threatened flora species (three Endangered, three Vulnerable). NatureMaps identified a further 13 flora species listed under the <i>NPW Act 1972</i>: (one Endangered, one Vulnerable and 12 Rare). All threatened species identified are listed in section 4.2.2. No threatened flora were observed within VA9.</p>

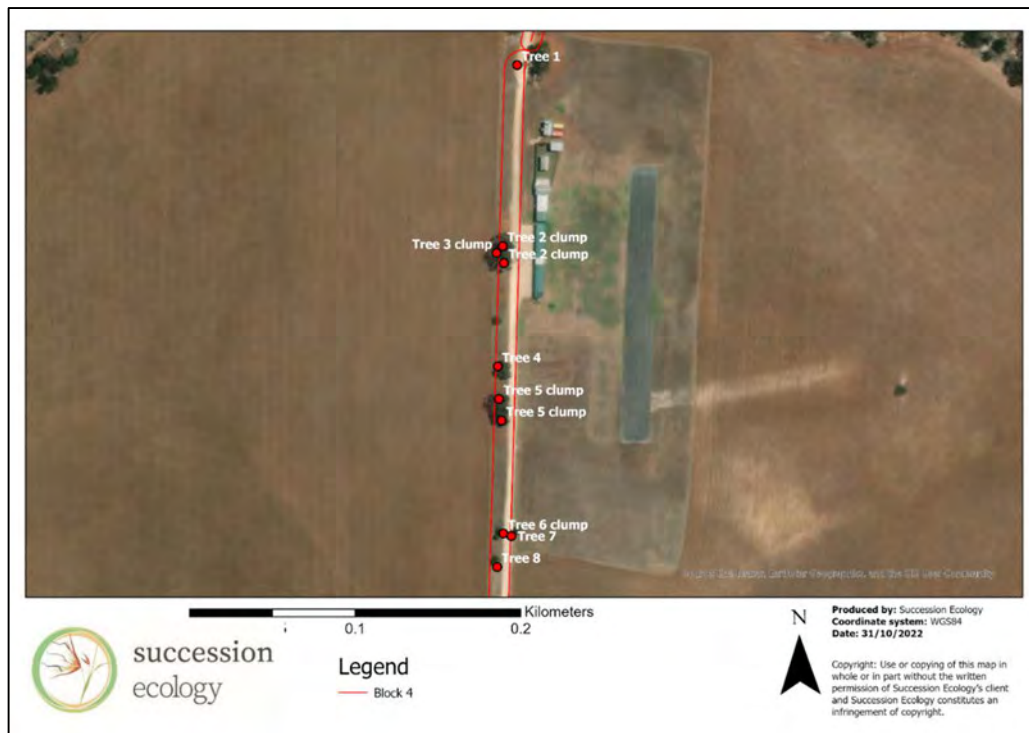
Figure 30: Distribution of scattered trees within Block 4.

The following section presents detailed descriptions of the scattered trees associated with the development envelope. Figure 30 and 31 show the distribution of the scattered trees within Blocks 4 and 5 respectively. Whilst all scattered trees are presented within the scoresheet for some level of clearance, SA Water are confident that they will be able to avoid the complete clearance of trees 1-5 but they may need to clear trees 6-8. Trees 9-11 may require some pruning. Further, the NVC issued an update Scattered Tree Scoresheet on 12th May (dated July 2022). As such, all calculations for all scattered trees have been updated using the updated scoresheet.

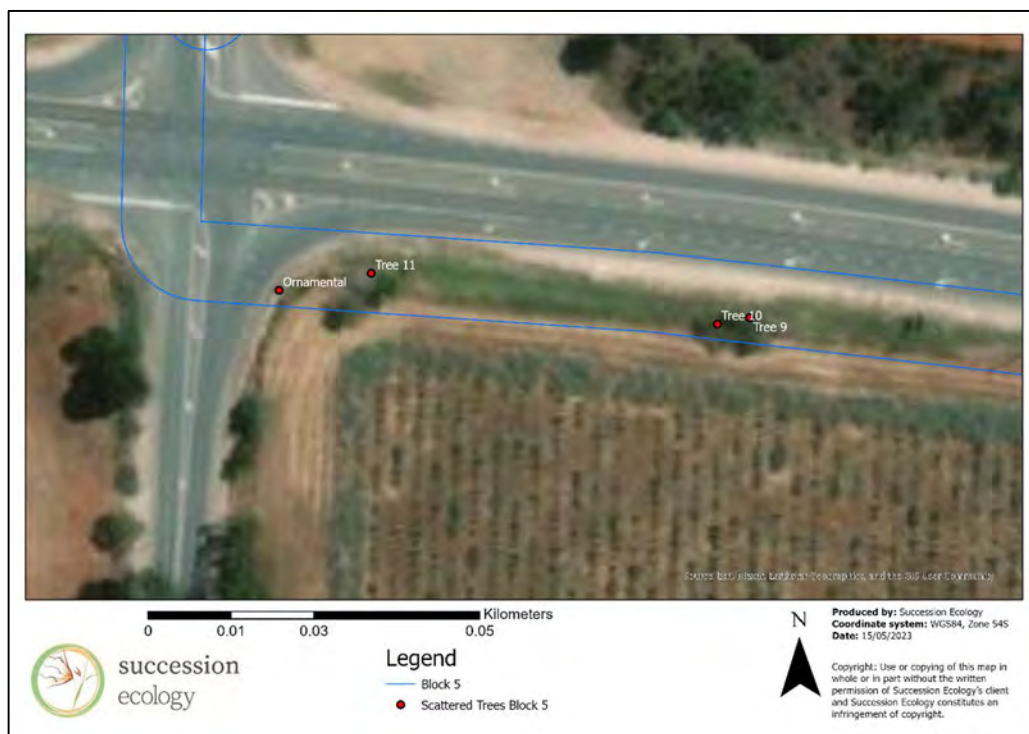
Figure 31: Distribution of scattered trees within the estimated construction zone for Block 5.

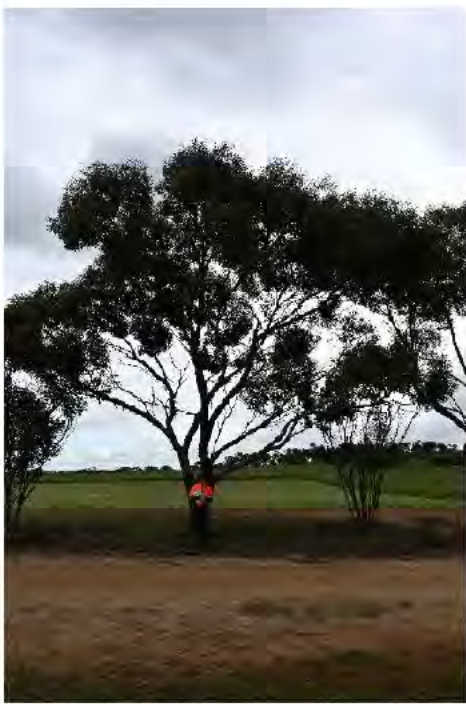
Tree 1 (Block 4)

<i>Eucalyptus porosa</i>	
Number of trees – 1	
Height (m) – 12m	
Hollows – 0	
Diameter (cm) – 34 (2 stems)	
Canopy dieback (%) – 0	
Total Biodiversity Score – 3.58	<p><i>Figure 32: Eucalyptus porosa</i></p>
<p>This tree is in good condition, occurring amongst planted vegetation (including WA species). Would provide habitat for small birds, small reptiles, bats and invertebrates, in the form of shelter, perching/roosting, feeding and nesting. One nest was observed in the tree. No hollows observed.</p> <p>No pruning was evident. SA Water are confident they can avoid impacts to this tree, but it is assessed as having major pruning (ie 50%) in the event that impacts occur.</p> <p>No Threatened ecological communities or species were present at the site.</p>

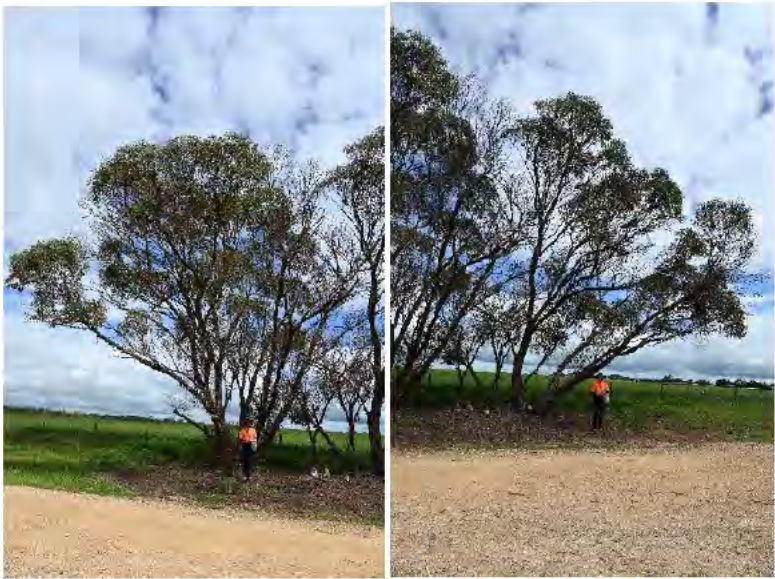
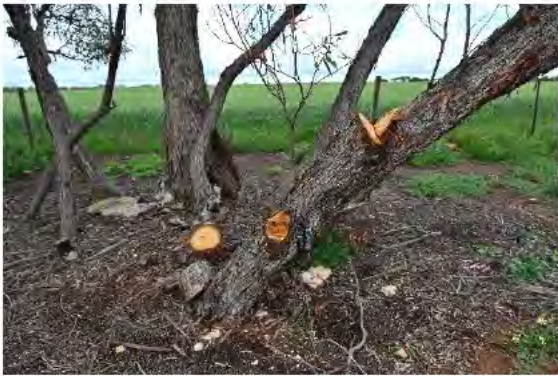
Tree 2 (Block 4)

<i>Eucalyptus porosa</i>	
Number of trees – 2	
Height (m) – 10m	
Hollows – 0	
Diameter (cm) – 37 (5-6 stems)	
Canopy dieback (%) – 35	
Total Biodiversity Score – 4.76

<p><i>Figure 33: Eucalyptus porosa</i></p>
<p>This clump of trees is in moderate-poor condition, with moderate to major pruning observed. Moderate dieback and 5% mistletoe present. Distant from other scattered trees by at least 50m. Would provide habitat for small birds, small reptiles, bats and invertebrates, in the form of shelter, perching/roosting, feeding and nesting.</p> <p>SA Water are confident they can avoid impacts to this tree, but it is assessed as having major pruning (ie 50%) in the event that impacts occur.</p> <p>No Threatened ecological communities or species were present at the site.</p>

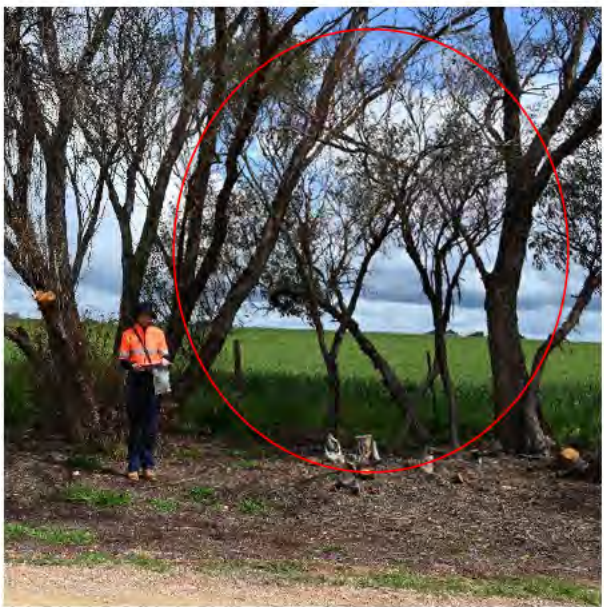
Tree 3 (Block 4)

<i>Eucalyptus porosa</i>	
Number of trees – 2	
Height (m) – 3m	
Hollows – 0	
Diameter (cm) – 15.5 (1-2 stems)	
Canopy dieback (%) – 50	
Total Biodiversity Score – 0.43	<p><i>Figure 34: Eucalyptus porosa (small trees highlighted)</i></p> <p>This clump of trees is located amongst the Tree 2 clump, but is assessed separately as it presents a different age class. It is in poor condition, with some pruning observed and major dieback present. Would provide limited habitat for small birds, small reptiles, bats and invertebrates.</p> <p>SA Water are confident they can avoid impacts to this tree, but it is assessed as having major pruning (ie 50%) in the event that impacts occur.</p> <p>No Threatened ecological communities or species were present at the site.</p>

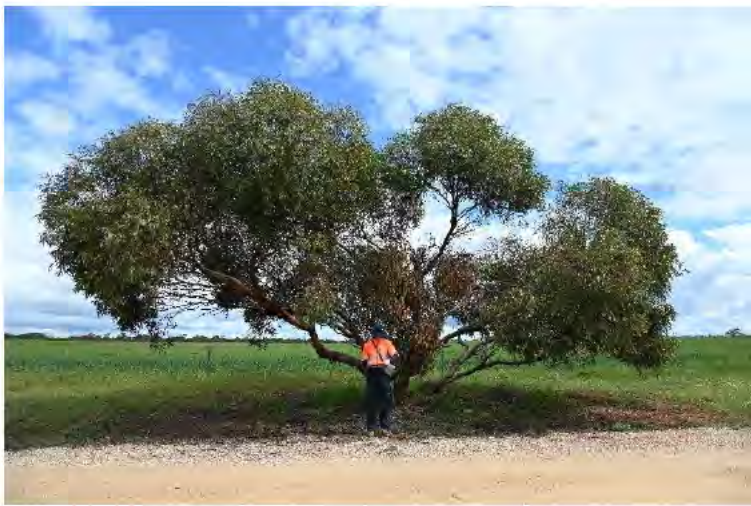
Tree 4 (Block 4)

<i>Eucalyptus porosa</i>	
Number of trees – 1	
Height (m) – 6m	
Hollows – 0	
Diameter (cm) – 25 (4 stems)	
Canopy dieback (%) – 0	
Total Biodiversity Score – 1.19	<p><i>Figure 35: Eucalyptus porosa</i></p> <p>This tree is in moderate condition, within 10m from another scattered tree. Evidence of past pruning is present. Would provide some habitat for small birds, small reptiles, bats and invertebrates.</p> <p>SA Water are confident they can avoid impacts to this tree, but it is assessed as having major pruning (ie 50%) in the event that impacts occur.</p> <p>No Threatened ecological communities or species were present at the site.</p>

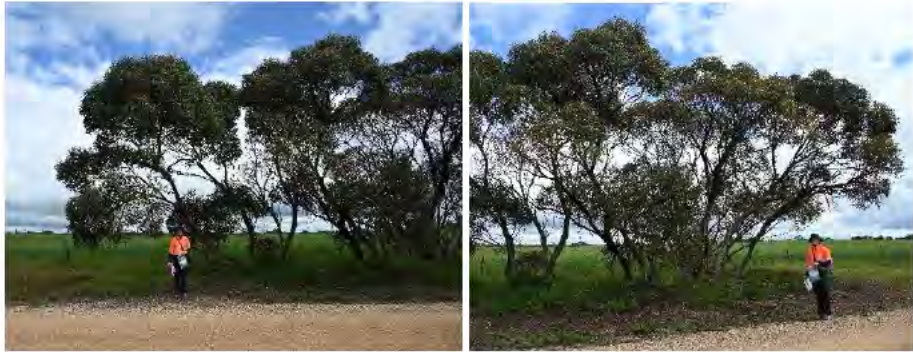
Tree 5 (Block 4)

<i>Eucalyptus porosa</i>	
Number of trees – 4	
Height (m) – 7m	
Hollows – 0	
Diameter (cm) – 21 (5-6 stems)	
Canopy dieback (%) – 0	
Total Biodiversity Score – 5.08	<p><i>Figure 36: Eucalyptus porosa</i></p>
<p>This clump of trees is in moderate condition and would provide habitat for small birds, small reptiles, bats and invertebrates, in the form of shelter, perching/roosting, feeding and nesting. A nest was observed in one of the trees.</p> <p>No pruning was evident, but an African Boxthorn (<i>Lycium ferocissimum</i>) was observed adjacent the clump. SA Water are confident they can avoid impacts to this tree, but it is assessed as having major pruning (ie 50%) in the event that impacts occur.</p> <p>No Threatened ecological communities or species were present at the site.</p>

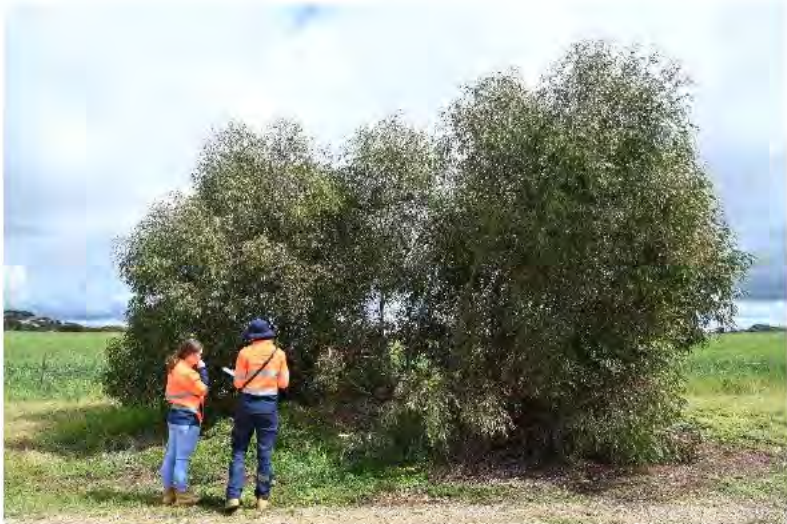
Tree 6 (Block 4)

<i>Eucalyptus porosa</i>	
Number of trees – 3	
Height (m) – 4m	
Hollows – 0	
Diameter (cm) – 9 (coppiced growth form)	
Canopy dieback (%) – 0	
Total Biodiversity Score – 1.16

This clump of trees is in poor condition, having been cut at the stump in the past, and growth being in coppice form. Likely to provide limited habitat to birds and bats, due to the dense nature of the stems. Would provide habitat for lizards and invertebrates.

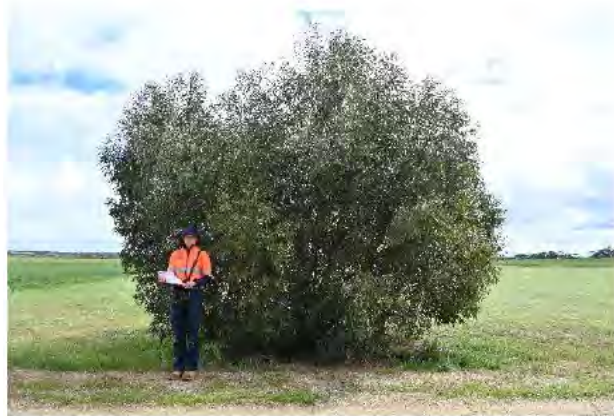
Tree 7 (Block 4)

<i>Eucalyptus porosa</i>	
Number of trees – 1	
Height (m) – 4m	
Hollows – 0	
Diameter (cm) – 12 (coppiced growth form)	
Canopy dieback (%) – 0	
Total Biodiversity Score – 0.42

This tree is in poor condition, having been cut at the stump in the past, and growth being in coppice form. Likely to provide limited habitat to birds and bats, due to the dense nature of the stems. Would provide habitat for lizards and invertebrates.

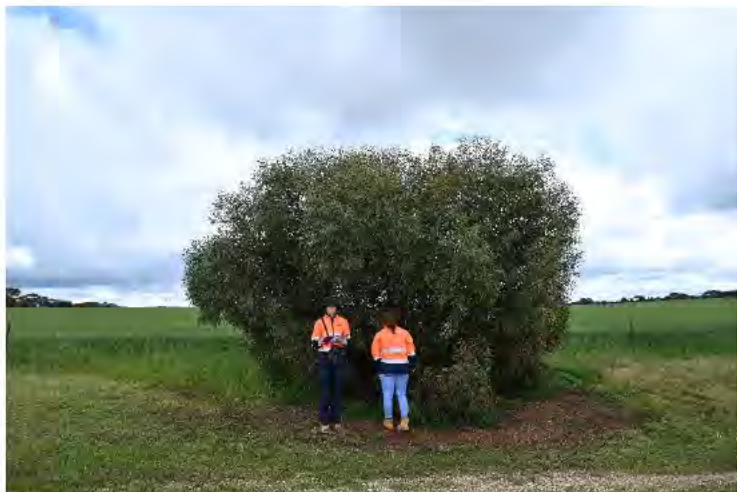
Tree 8 (Block 4)

<i>Eucalyptus porosa</i>	
Number of trees – 1	
Height (m) – 4m	
Hollows – 0	
Diameter (cm) – 8 (coppiced growth form)	
Canopy dieback (%) – 0	
Total Biodiversity Score – 0.38	
<p>This tree is in poor condition, having been cut at the stump in the past, and growth being in coppice form. Likely to provide limited habitat to birds and bats, due to the dense nature of the stems. Would provide habitat for lizards and invertebrates.</p> <p>SA Water predict that works should be clear of the dripline, however it is assessed as being removed in the event that impacts occur.</p> <p>No Threatened ecological communities or species were present at the site.</p>

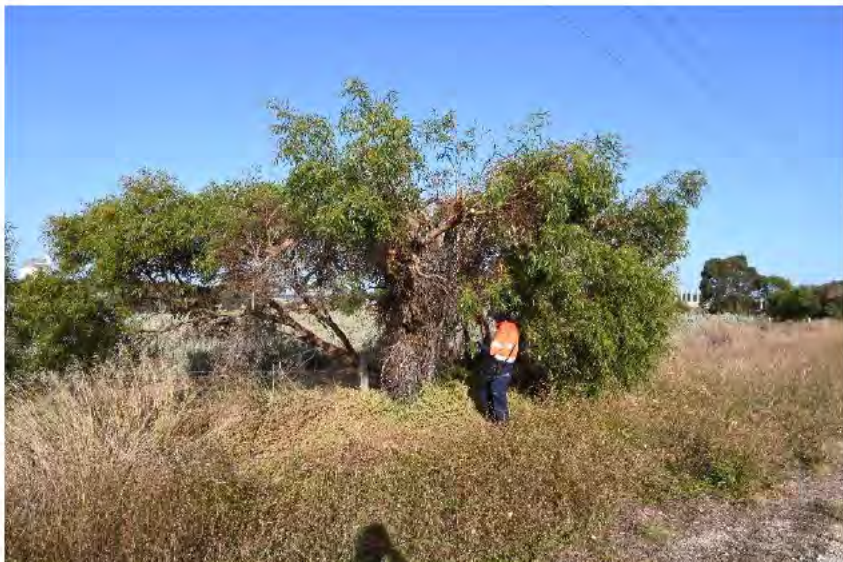
Tree 9 (Block 5)

<i>Eucalyptus porosa</i>	
Number of trees – 1	
Height (m) – 4m (heavily pruned)	
Hollows – 0	
Diameter (cm) – 20	
Canopy dieback (%) – 10	
Total Biodiversity Score – 0.47

This tree is in moderate to poor condition, having been heavily pruned within to canopy for overhead line clearance. Likely to provide some habitat to birds and bats. Would provide habitat for lizards and invertebrates.

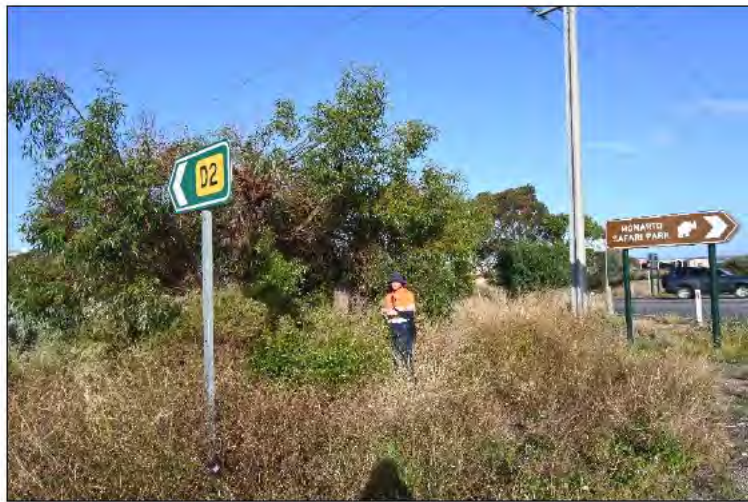
Tree 11 (Block 5)

<i>Eucalyptus porosa</i>	
Number of trees – 1	
Height (m) – 4m (heavily pruned)	
Hollows – 0	
Diameter (cm) – 25	
Canopy dieback (%) – 30	
Total Biodiversity Score – 0.44

This tree is in moderate to poor condition, having been heavily pruned within to canopy for overhead line clearance. Likely to provide some habitat to birds and bats. Would provide habitat for lizards and invertebrates.

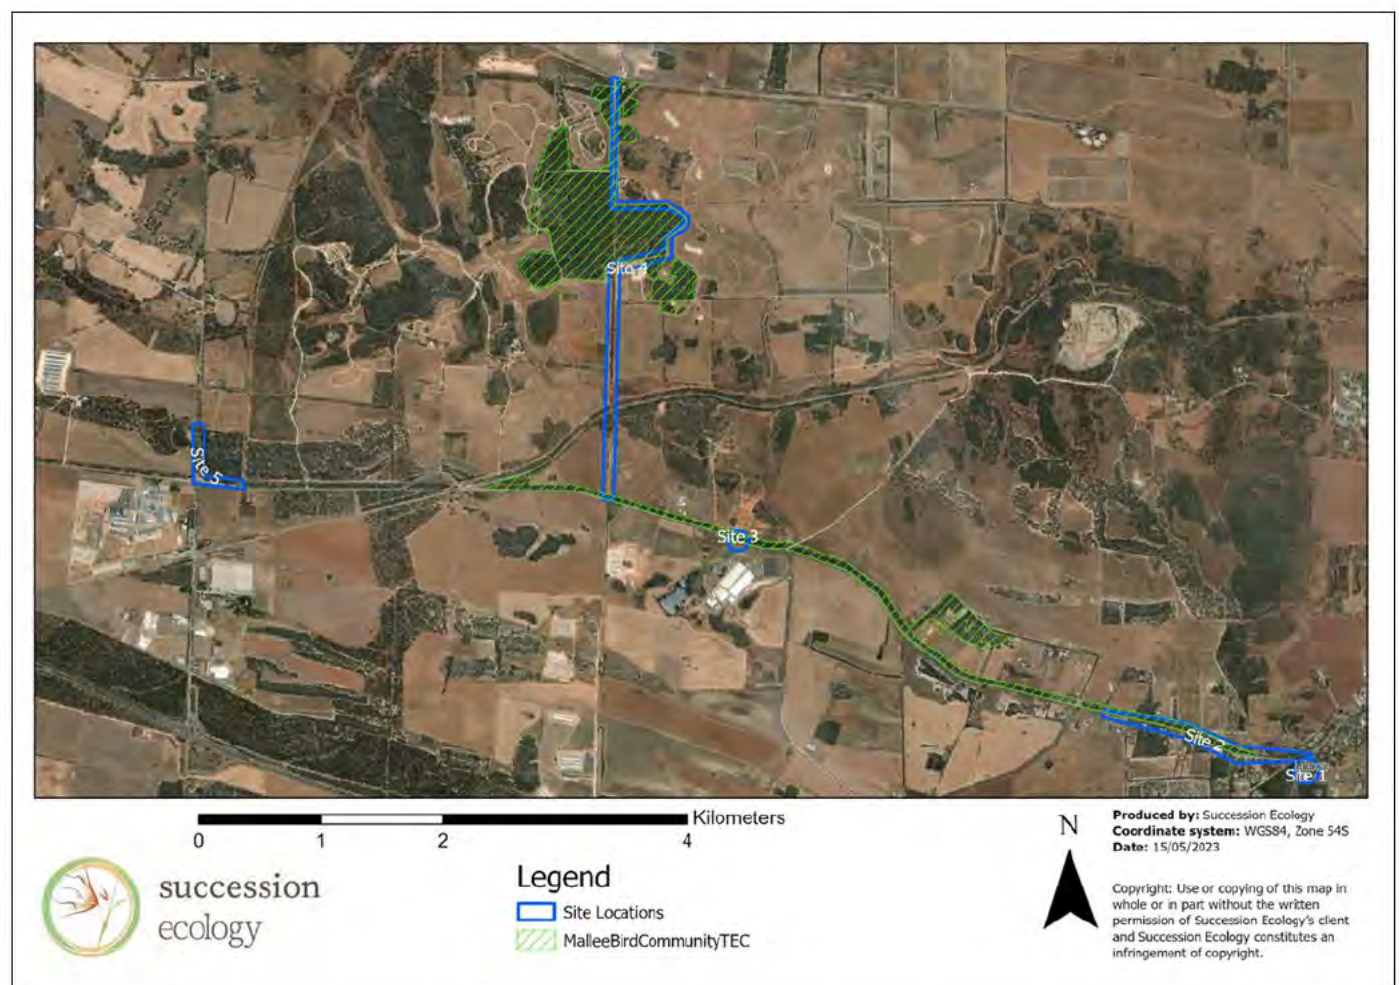
Figure 43: Location of sites (Blocks) in relation to the estimated local distribution of the Mallee Bird Community TEC.

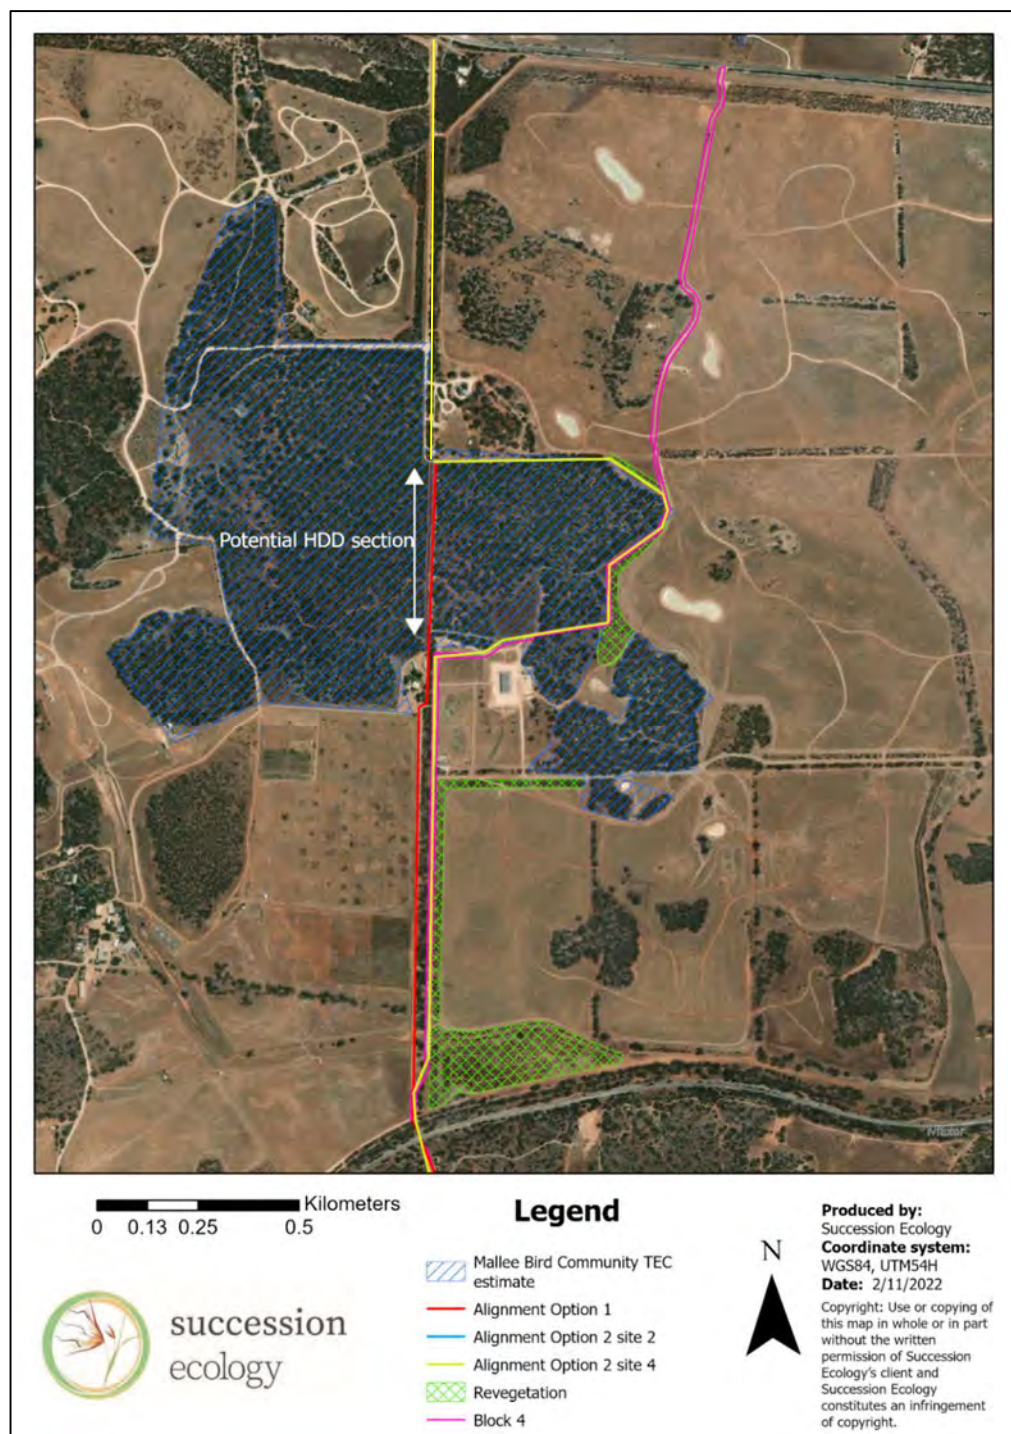
The figure below presents the alignment and construction method options that were investigated for the northern section of Block 4. Options included:

- Alignment Option 1 – following the existing SAW easement, which would have had significant impacts on high quality vegetation within the TEC
- Alignment Option 2 Site 4 – following the outside of the TEC vegetated area, which could avoid most of the TEC vegetation but provided technical difficulties ([Amendment 1 option](#))
- Horizontal Direct Drilling (HDD) – below the area of highest quality vegetation, but this proved cost prohibitive
