Metro Coastline Sand Sampling

Department of Environment and Water

31 March 2022

File	21118.01 R01 031032022
Revision	1
Date issued	31 March 2022
Author(s)	Richard Lewis
Principal review	Joe Pedicini
Quality Check	Tracy Svingos

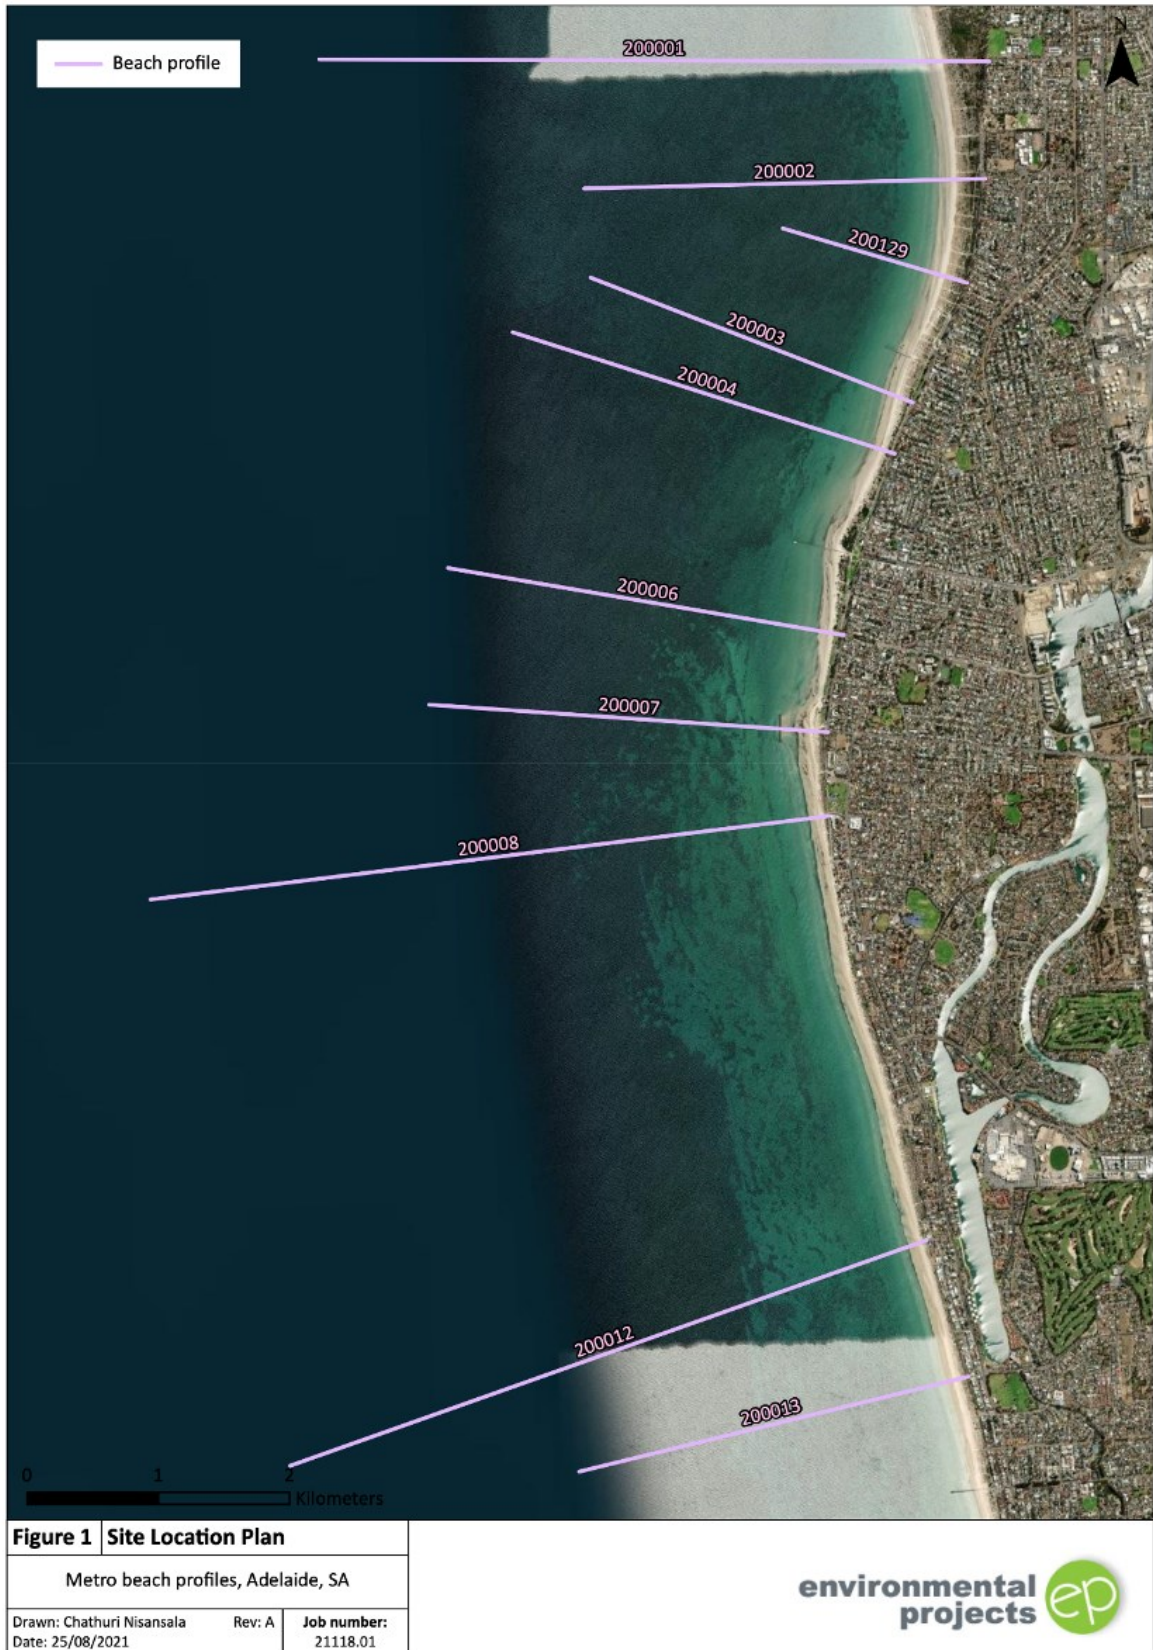
Figure 1-1: Site location plan

This report provides preliminary assessment of ten locations between North Haven and Grange (the Site). A site location plan is provided in Figure 1-1.

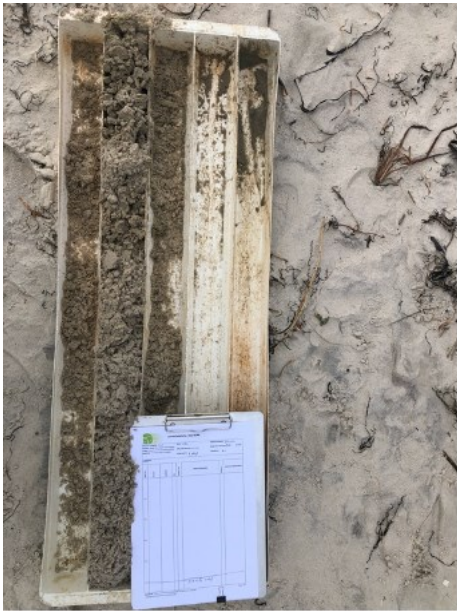
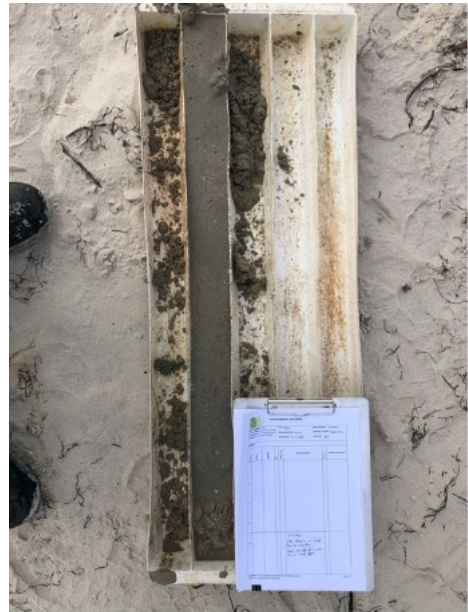
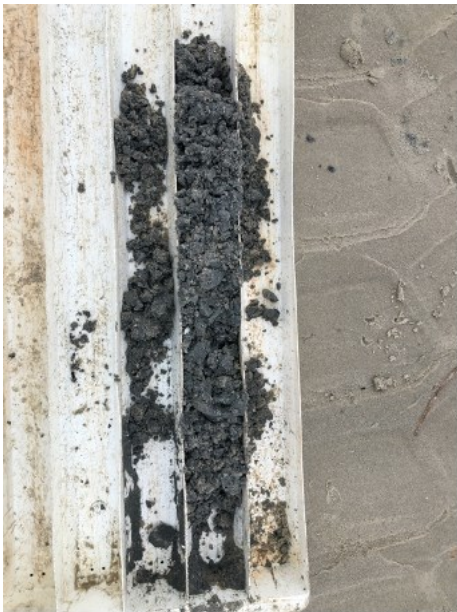
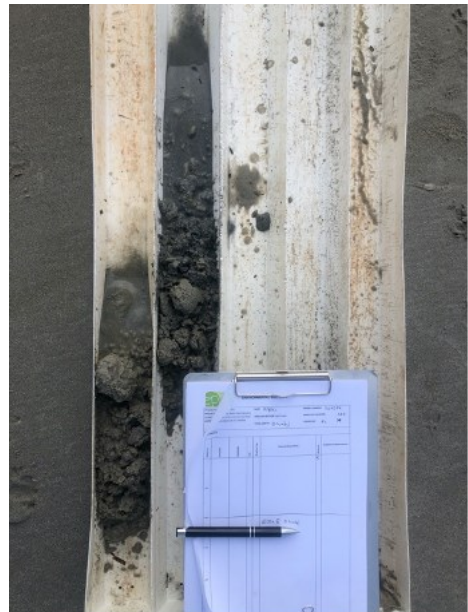
Figure 3-1: Profile 200004 (Toe of dune, HWM, MSL, saturated zone)

Sampling locations in the dry zone of the beach profile (toe of the dune) primarily consisted of a fine to medium grained sand, of a cream or grey/cream colour, with some vegetation, shell grit and shells.

HWM locations were generally logged as fine to coarse grained sand, of a cream to grey colour with shell grit, and some small shells. Sample holes were drilled to between 0.6 m BGL and 1 m BGL, with the exception of SB38, which was drilled to 0.45 m BGL as it was located in a saturated water channel.

Mean sea level (MSL) locations were drilled to between 0.4 m BGL and 0.75 m BGL, at which point the hole would collapse due to water saturation. Sand was recorded as fine to coarse grained, cream to pale grey and grey, with coarse shell grit and some shells. Traces of black inclusion (consistent with vegetation) were noted at a number of locations.

Saturated zone samples were drilled to a maximum depth of 0.4 m BGL in nominally 0.5 m of water. Sand was generally recorded as fine to medium grained with some coarse grained, cream to pale grey and grey (sometimes mottled) in colour with shell grit, some whole shells and trace vegetation.

- 200004: SB09, SB10, SB22 and SB31 (see Figure 3-1)
- 200008: SB04, SB05, SB39 and SB40 (see Figure 3-2)
- 200012: SB03, SB36, SB37 and SB38 (see Figure 3-3).

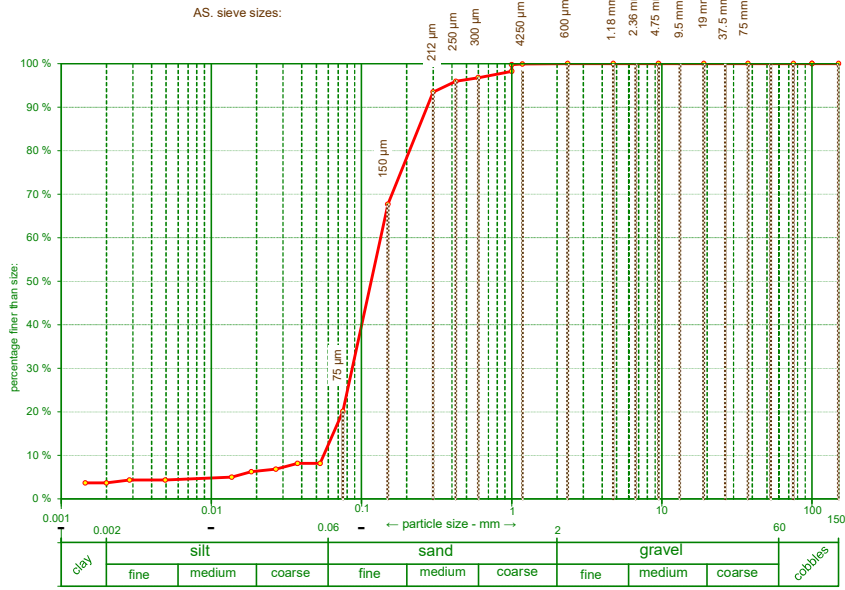
287867-1

Sieve Analysis		Hydrometer Analysis	
Sieve Size mm	% Passing	Particle Size μm	% Passing
100	100.0	53.1	8.2
100	100.0	37.5	8.2
75	100.0	26.9	6.9
37.5	100.0	18.5	6.3
19	100.0	13.7	5.0
9.5	100.0	4.9	4.3
4.75	100.0	2.9	4.3
2.36	100.0	2.0	3.7
1.18	99.9	1.4	3.7
600 μm	99.8		
425 μm	98.3		
300 μm	96.8		
250 μm	95.9		
212 μm	93.5		
150 μm	67.7		
75 μm	20.1

d50 122.11μm

The median d50 results ranged between 122.11 µm (SB99) and 345.7 µm (SB38) and are presented in Table 3-3.

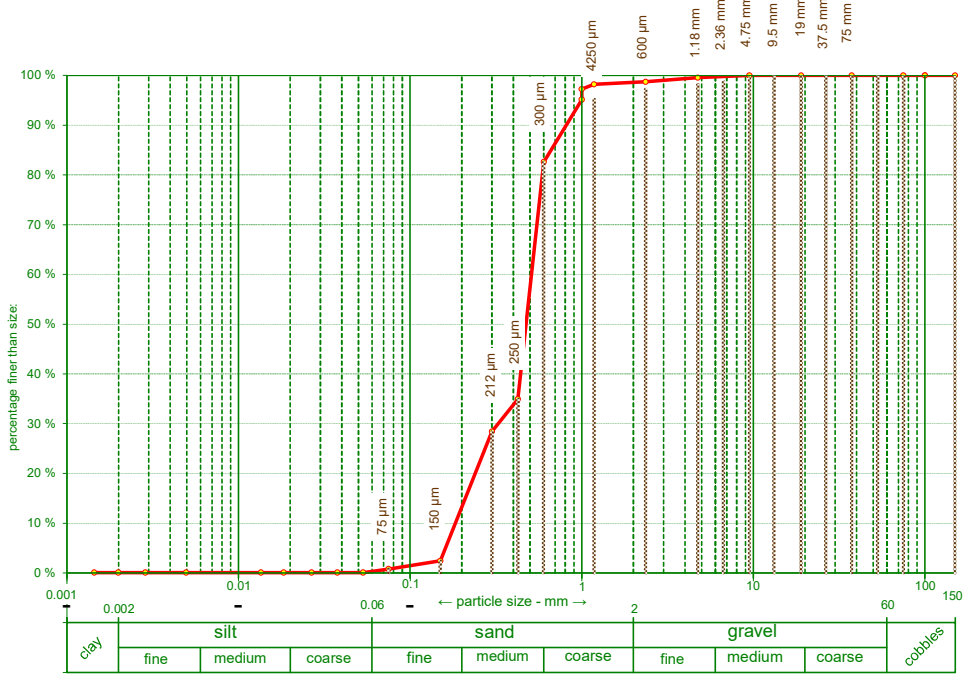
287867-3

Sieve Analysis		Hydrometer Analysis	
Sieve Size	% Passing	Particle Size	% Passing
mm		µm	
100	100.0	53.2	0.1
100	100.0	37.6	0.1
75	100.0	26.7	0.1
37.5	100.0	18.3	0.1
19	100.0	13.5	0.1
9.5	100.0	5.0	0.1
4.75	99.5	2.9	0.1
2.36	98.7	2.0	0.1
1.18	98.2	1.4	0.1
600 µm	97.2		
425 µm	95.2		
300 µm	82.6		
250 µm	34.9		
212 µm	28.4		
150 µm	2.4		
75 µm	0.8

d50 265.83
