# Sheeted catchments meet future water need

**Location:** Wharminda

**Issue:** A reliable water source, independent of mains water, to supply farming business.

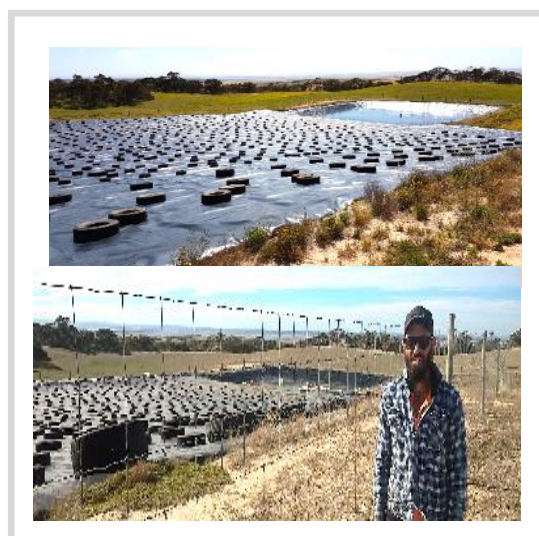
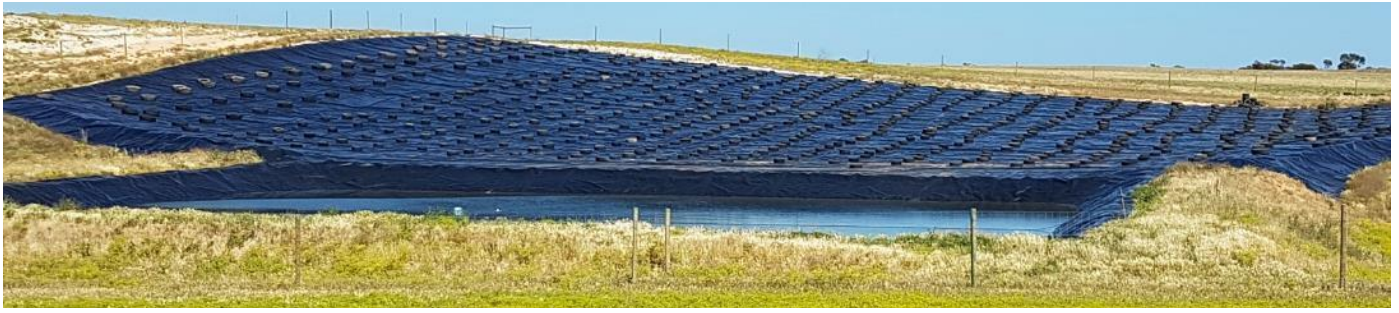
The sheeted catchment was installed in January 2016 on a sandy rise on the highest point on the property. Heavy duty plastic was welded together and held in place with earth banks around the edge and tires to prevent wind blowing under the plastic. Runoff was captured in a plastic lined dam at the bottom of the slope and stored for future use. A solar pump is used to move the water to two 240,942 litre and one 227,304 litre feeder tanks and several 22,730 litre tanks placed at strategic sites around the properties.
