Onkaparinga, Clarendon Oval, Riffle 1

Comparison March 2012 and 2013

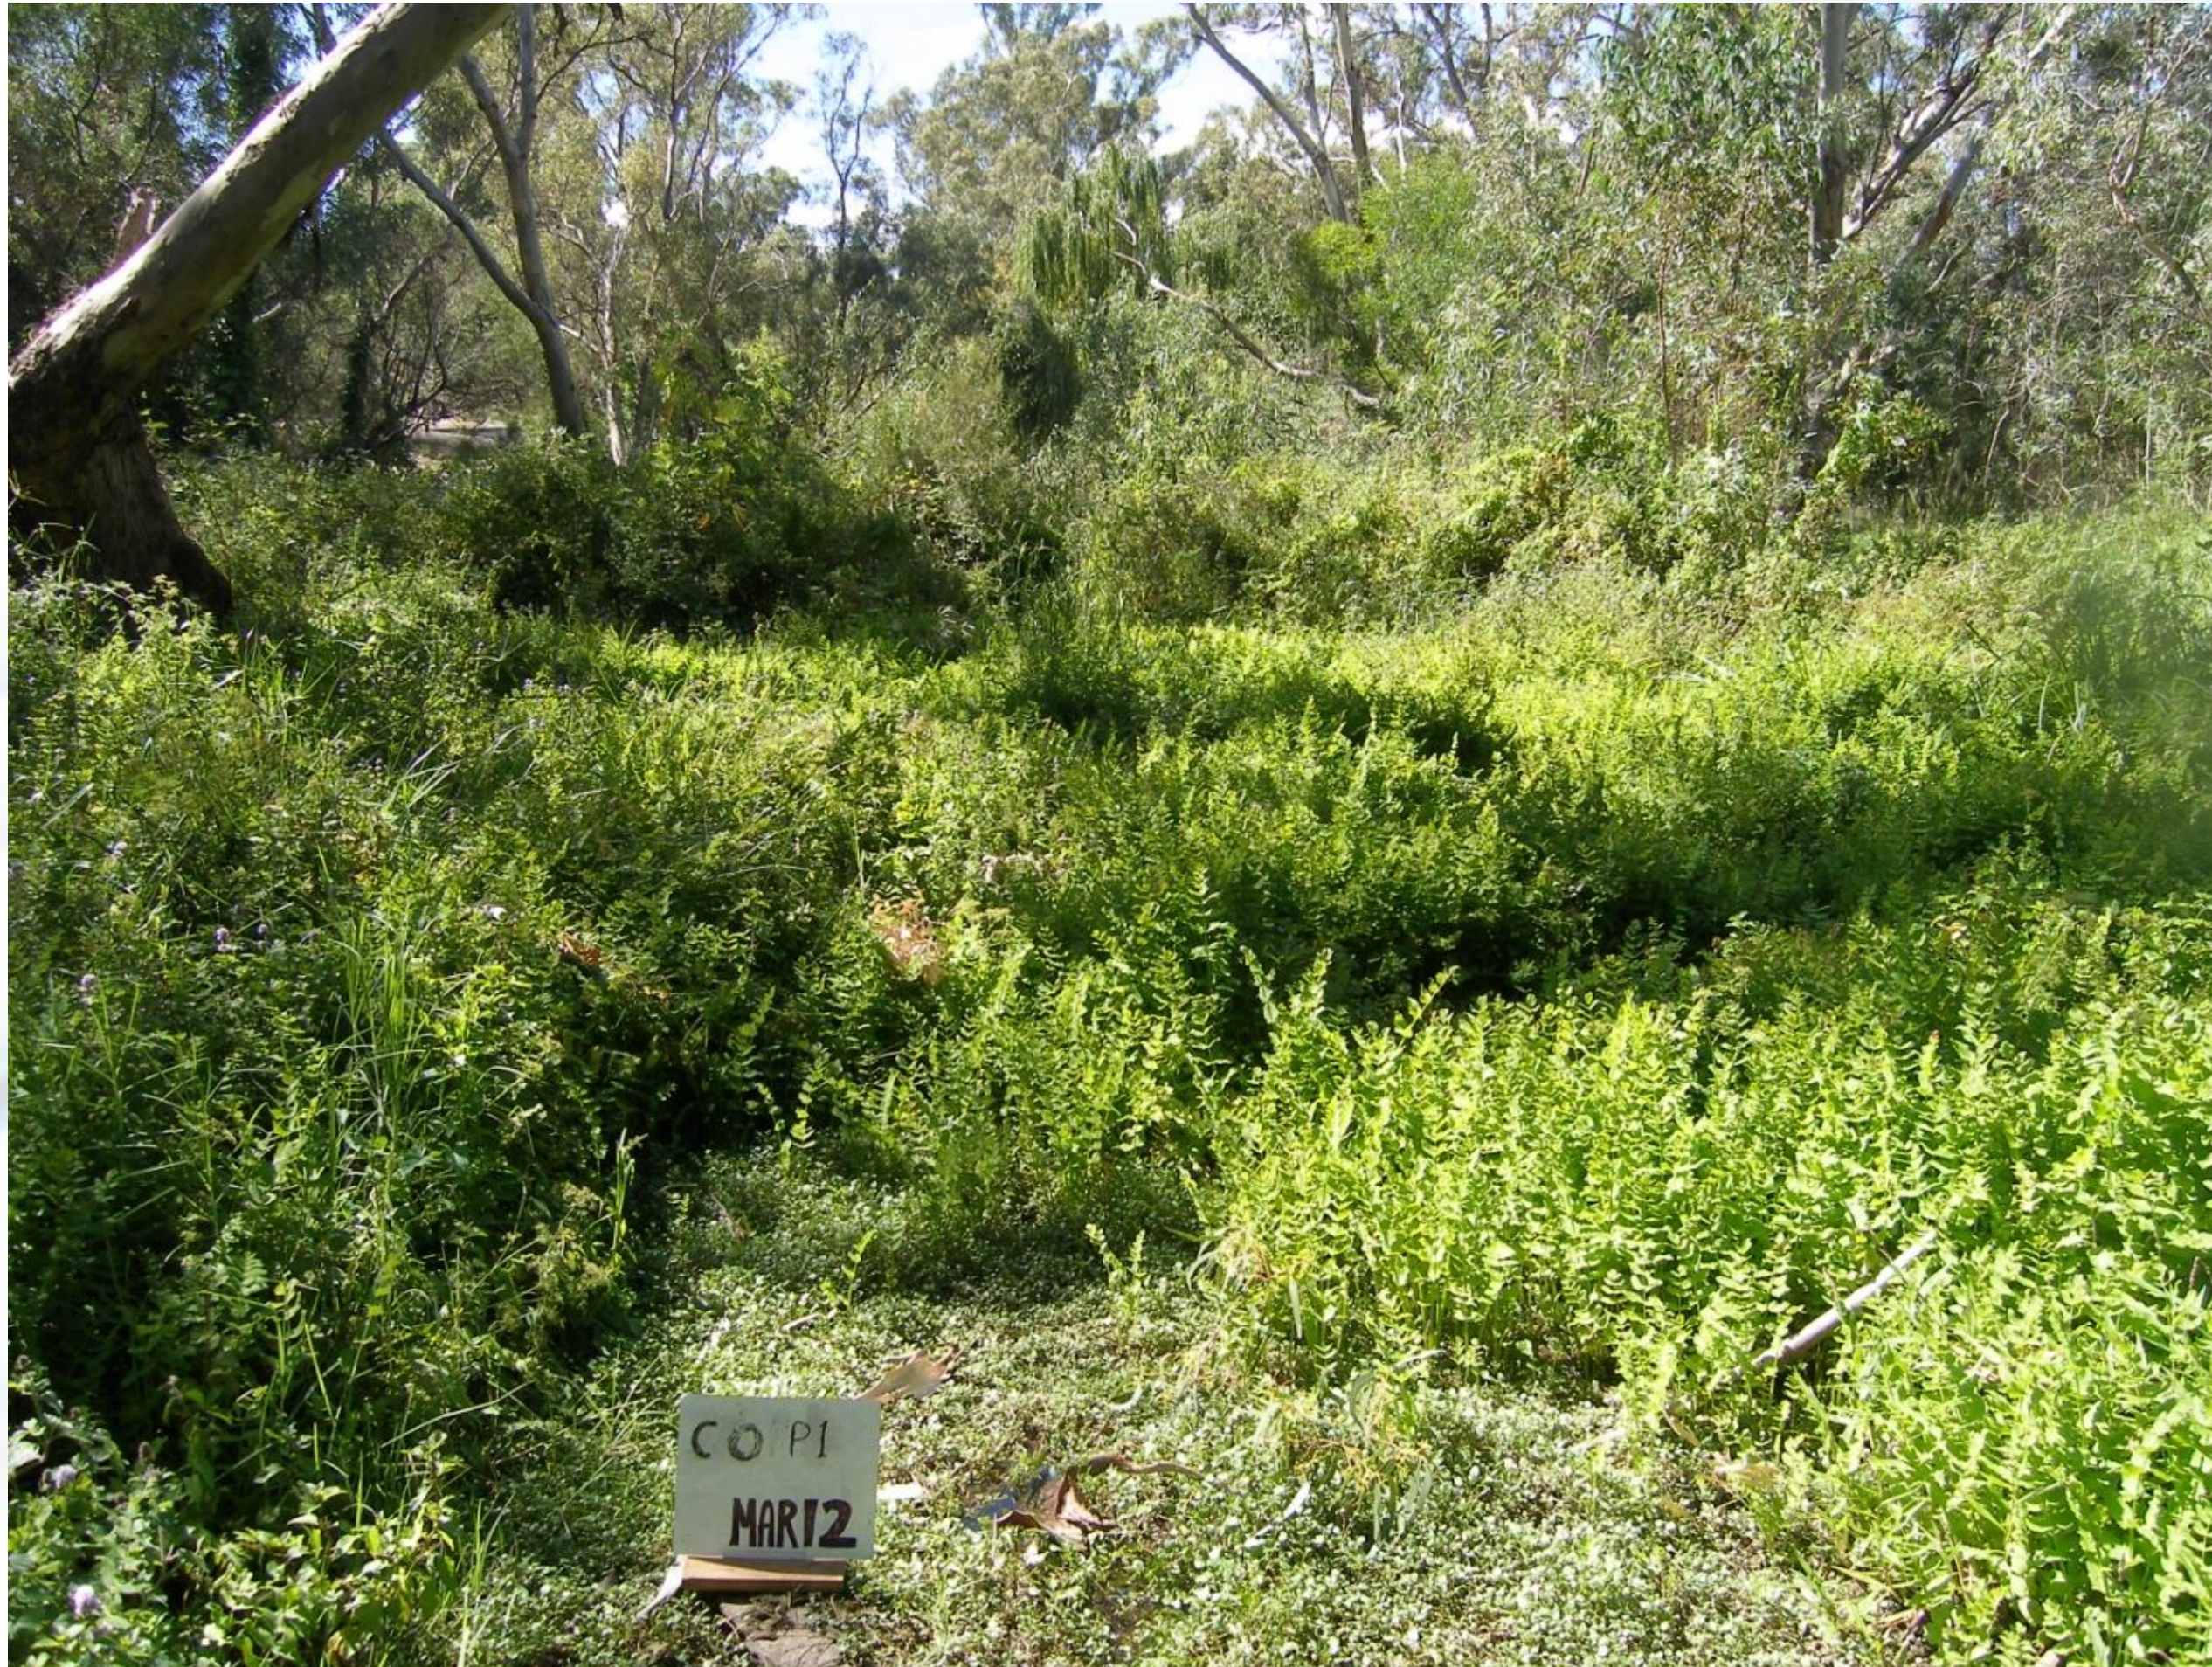
20 March 2012, channel choked with water parsnip, slight water trickles through vegetation

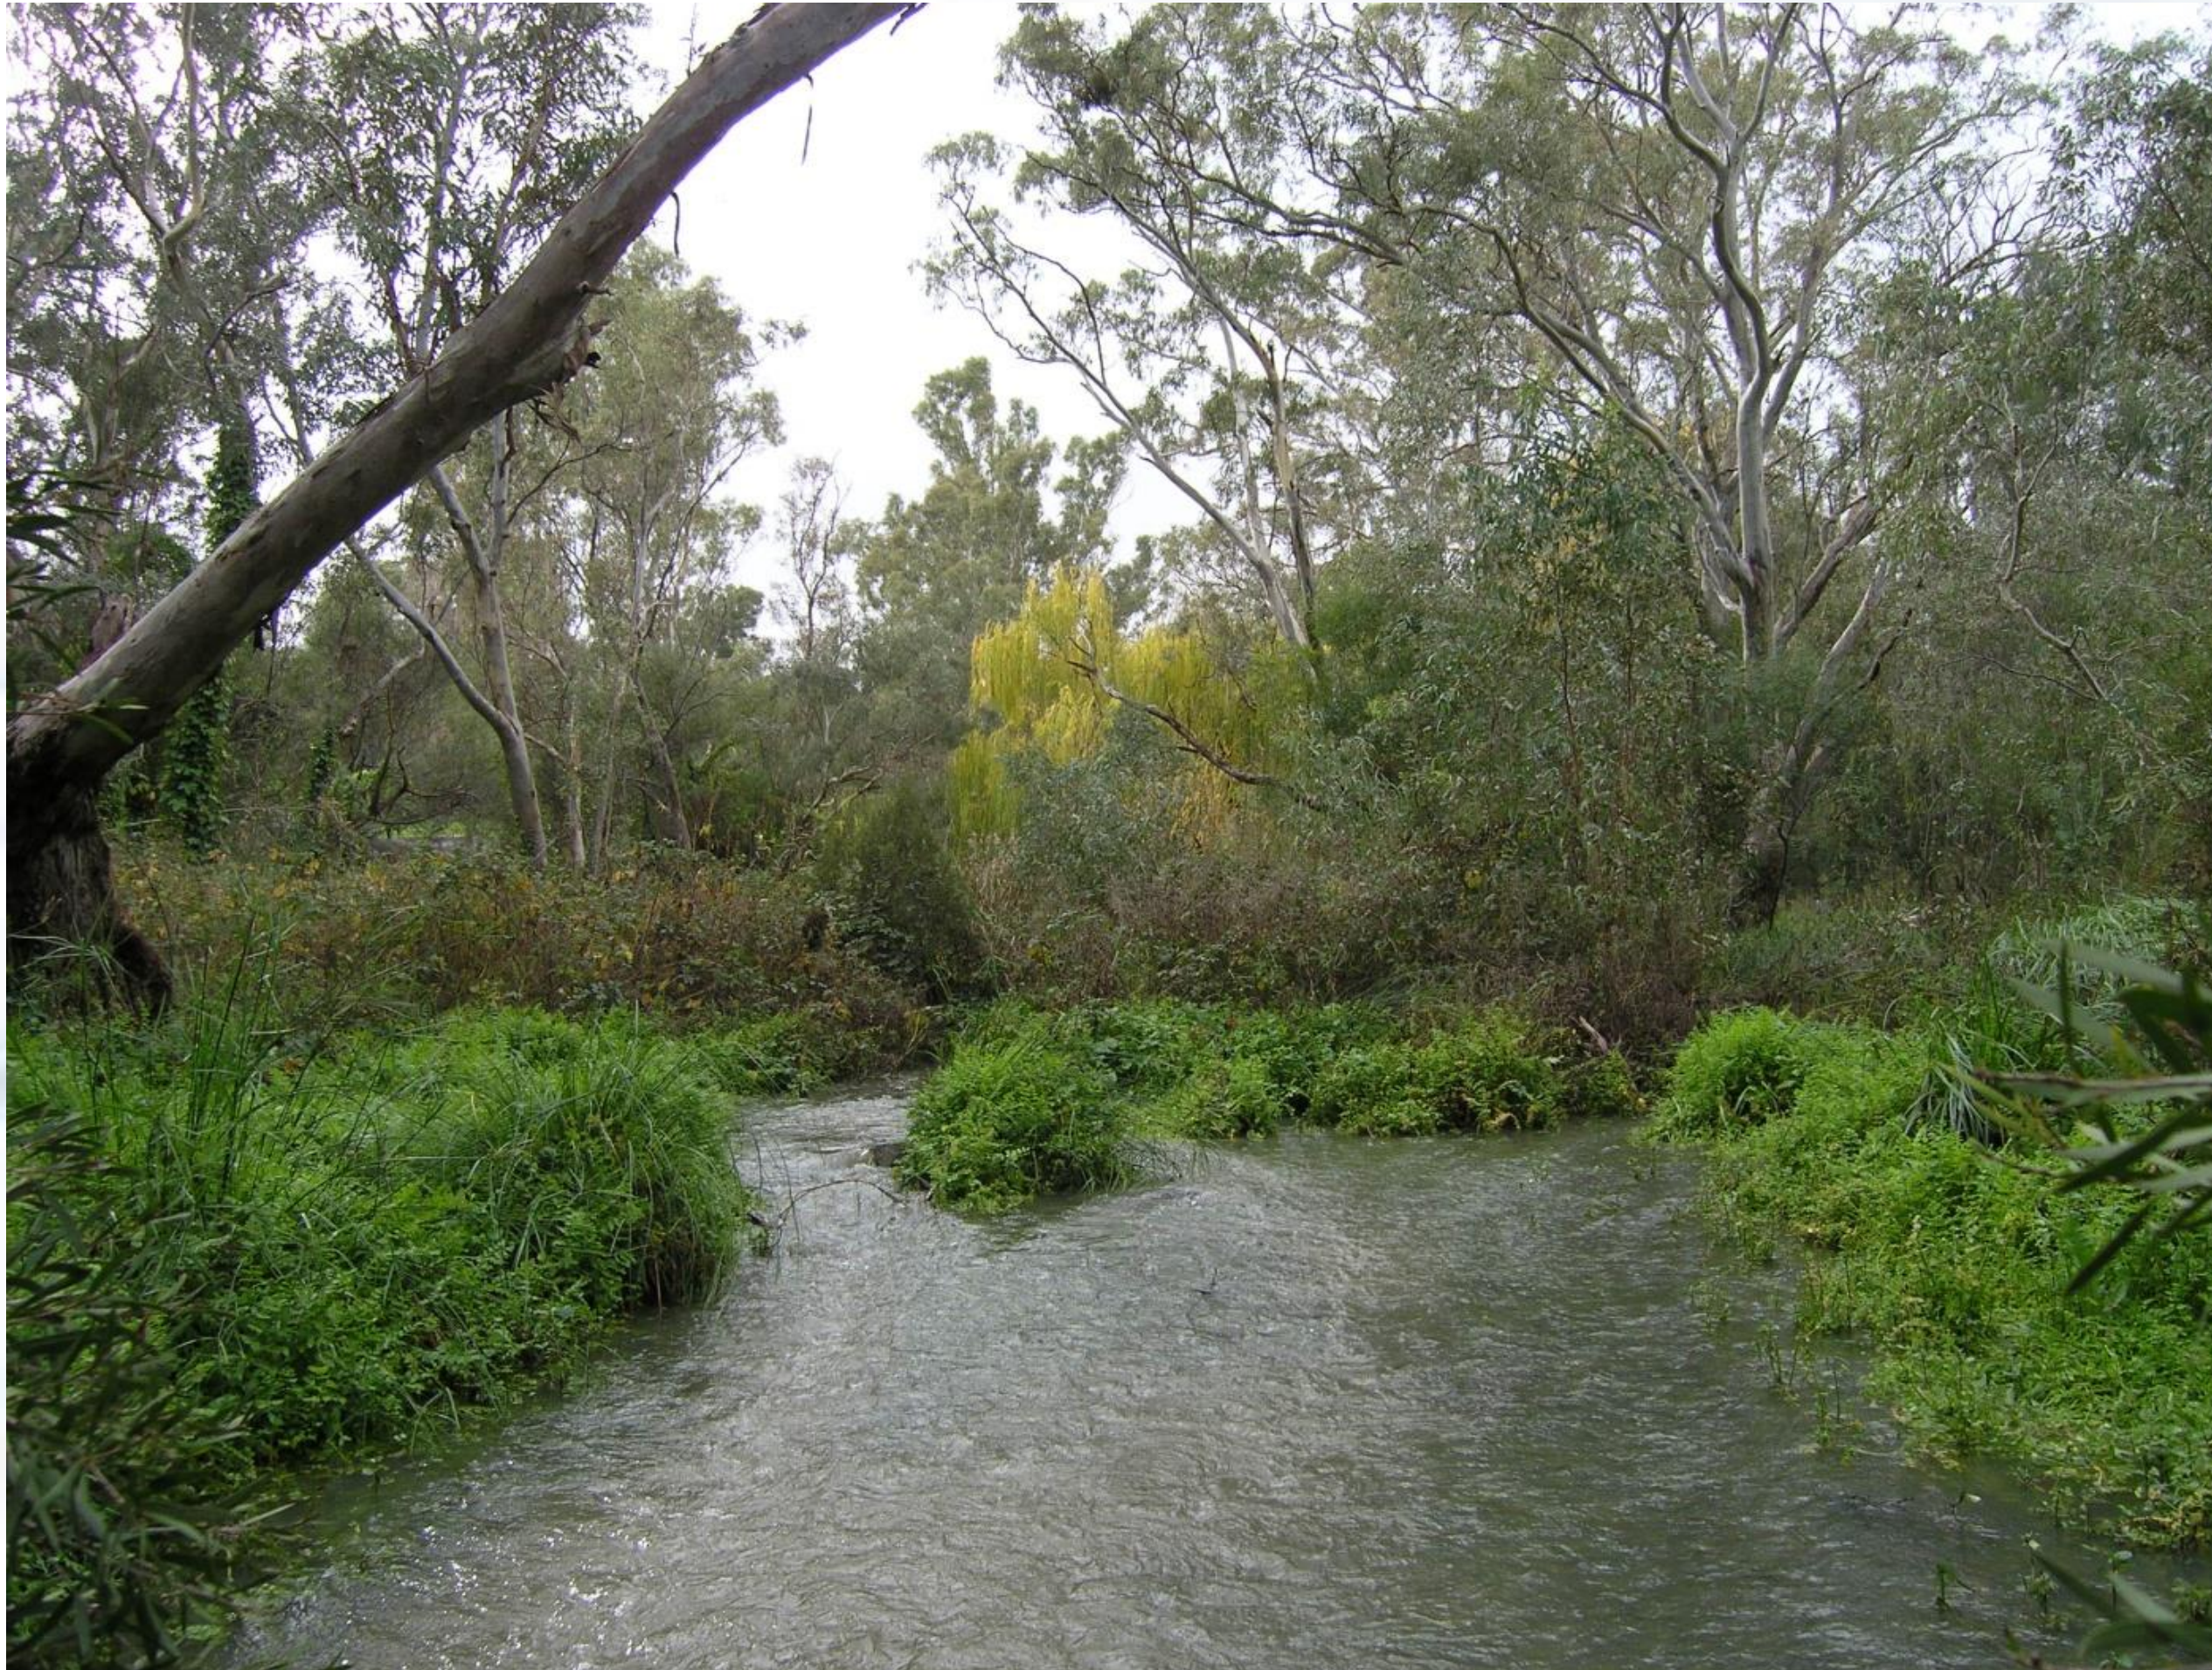
Onkaparinga, Clarendon Oval, Riffle 1

5 June 2012, channel opening up laterally at primary riffle site, length of riffle constrained by chocking vegetation, water parsnip present still, quite strong flow

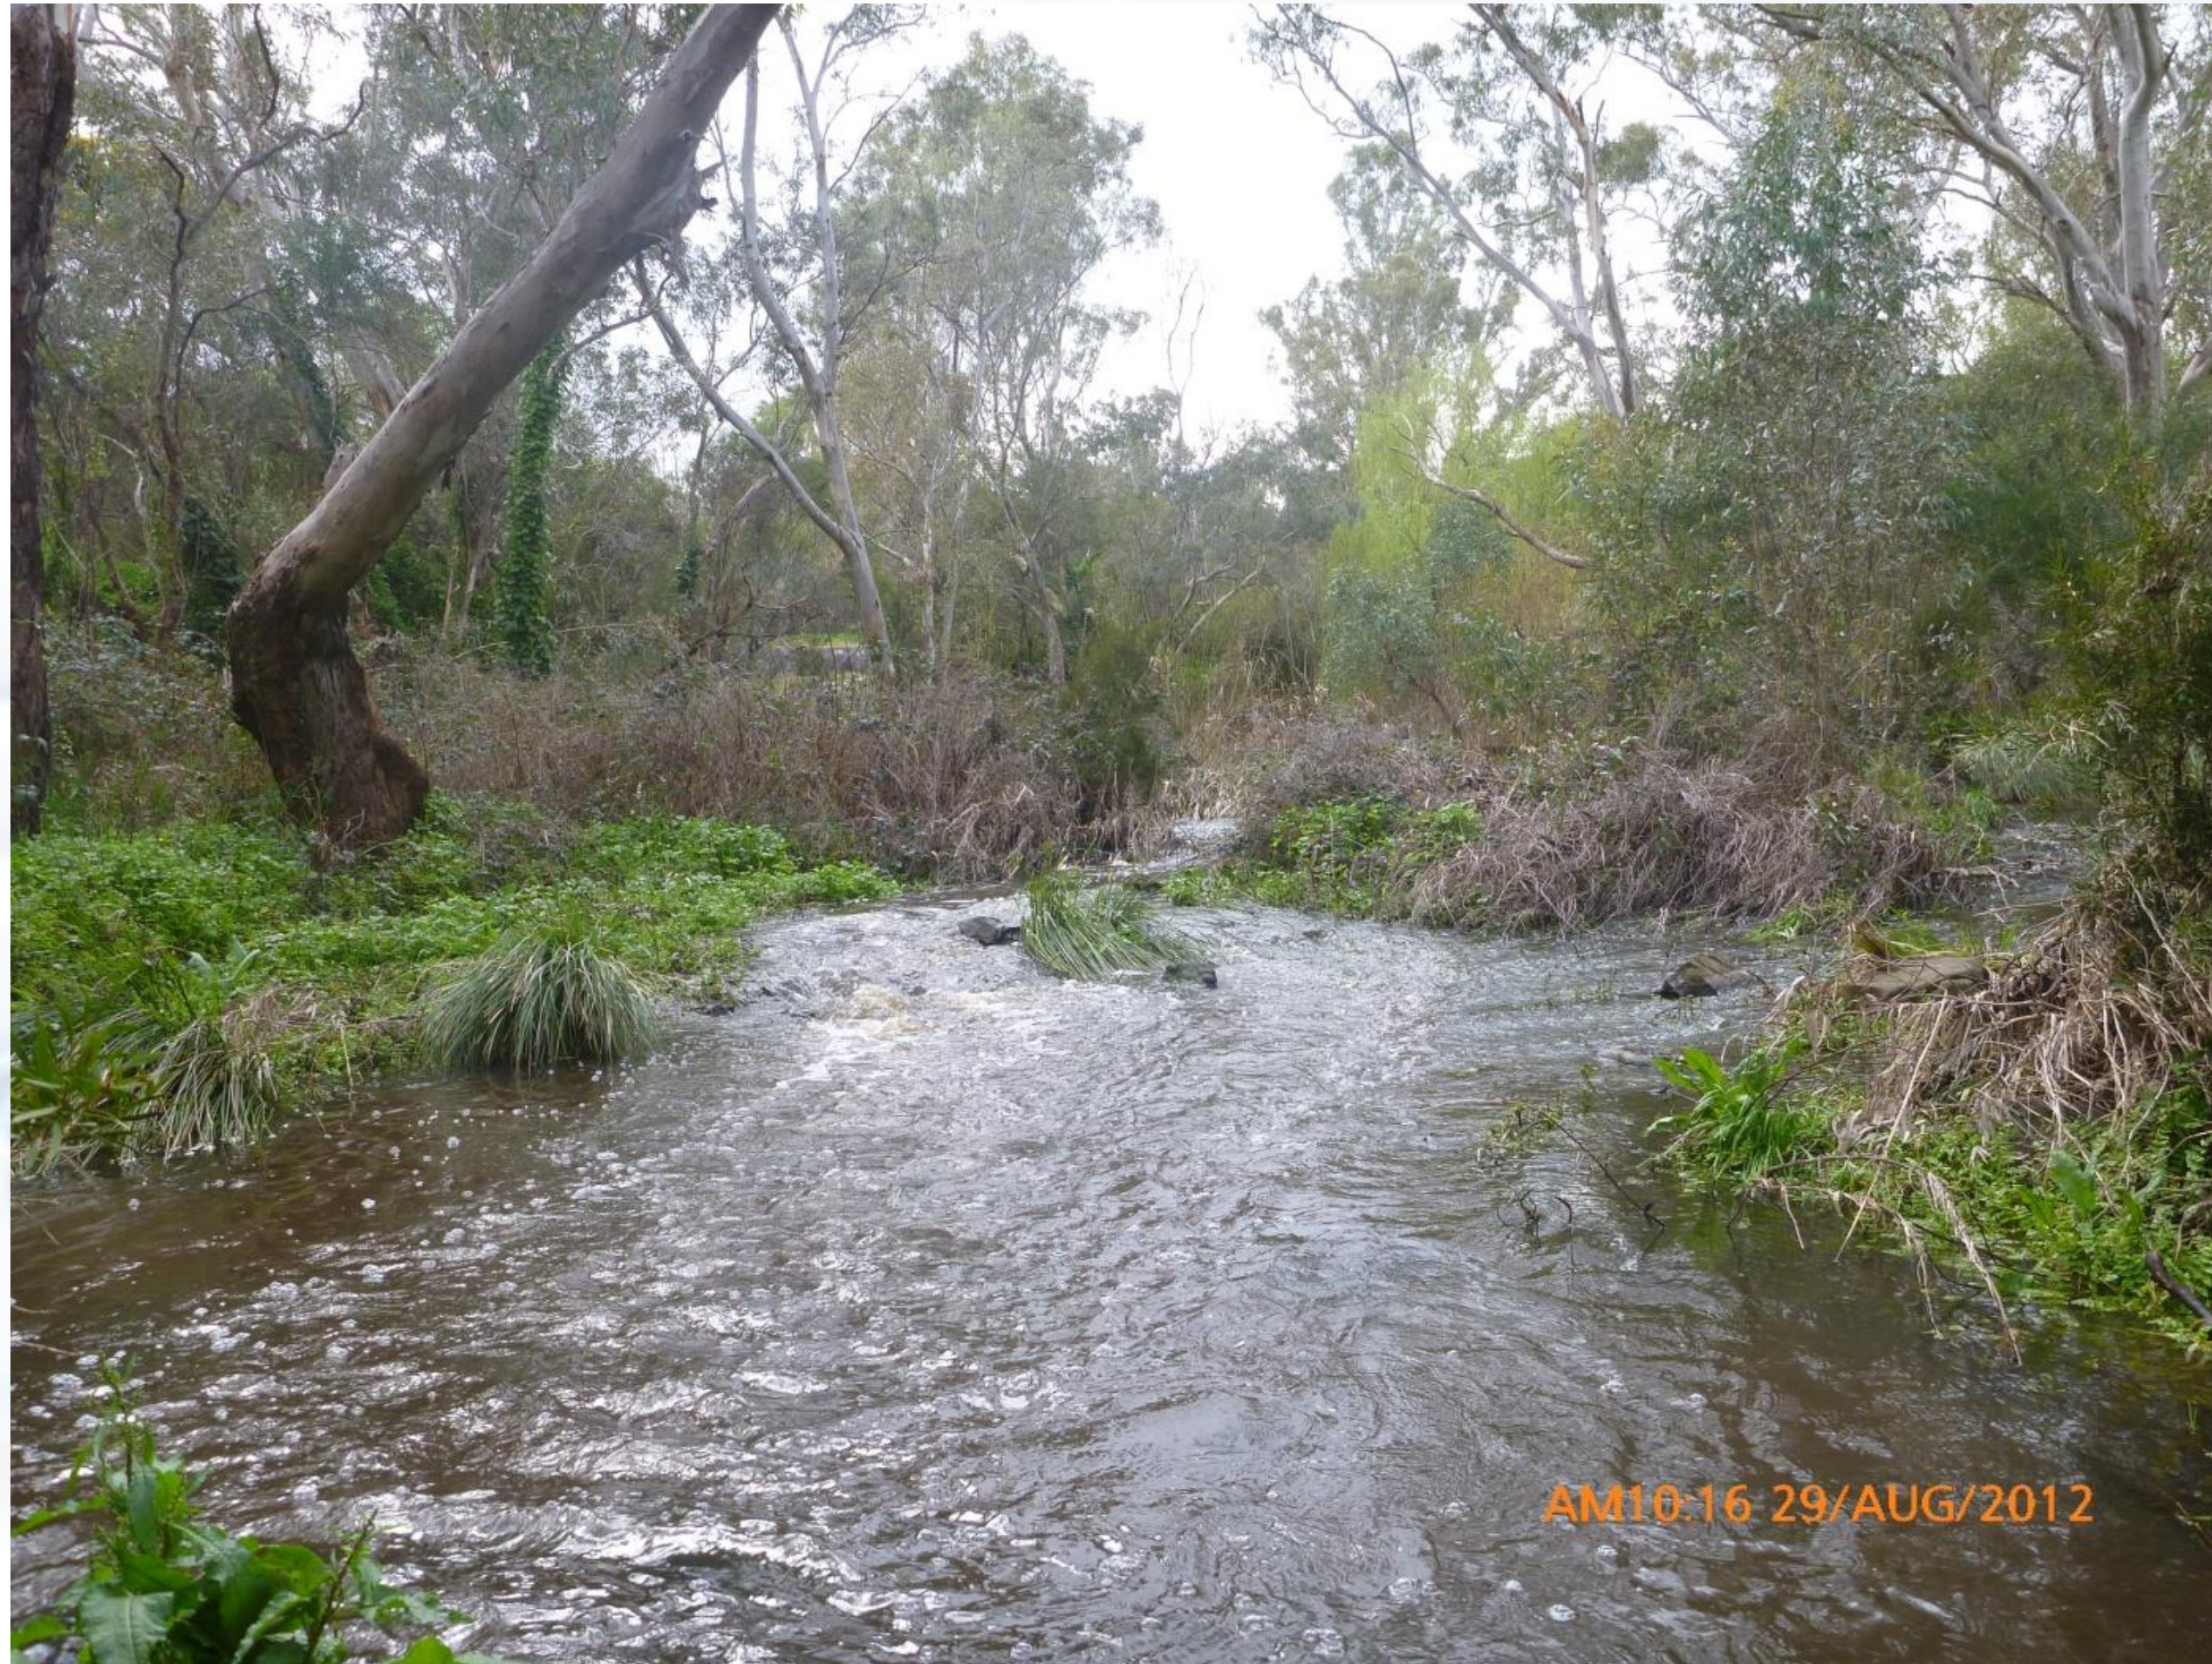
Onkaparinga, Clarendon Oval, Riffle 1

29 August 2012, some removal of vegetation within middle of channel, riffle appears to be lengthening, quite strong flow

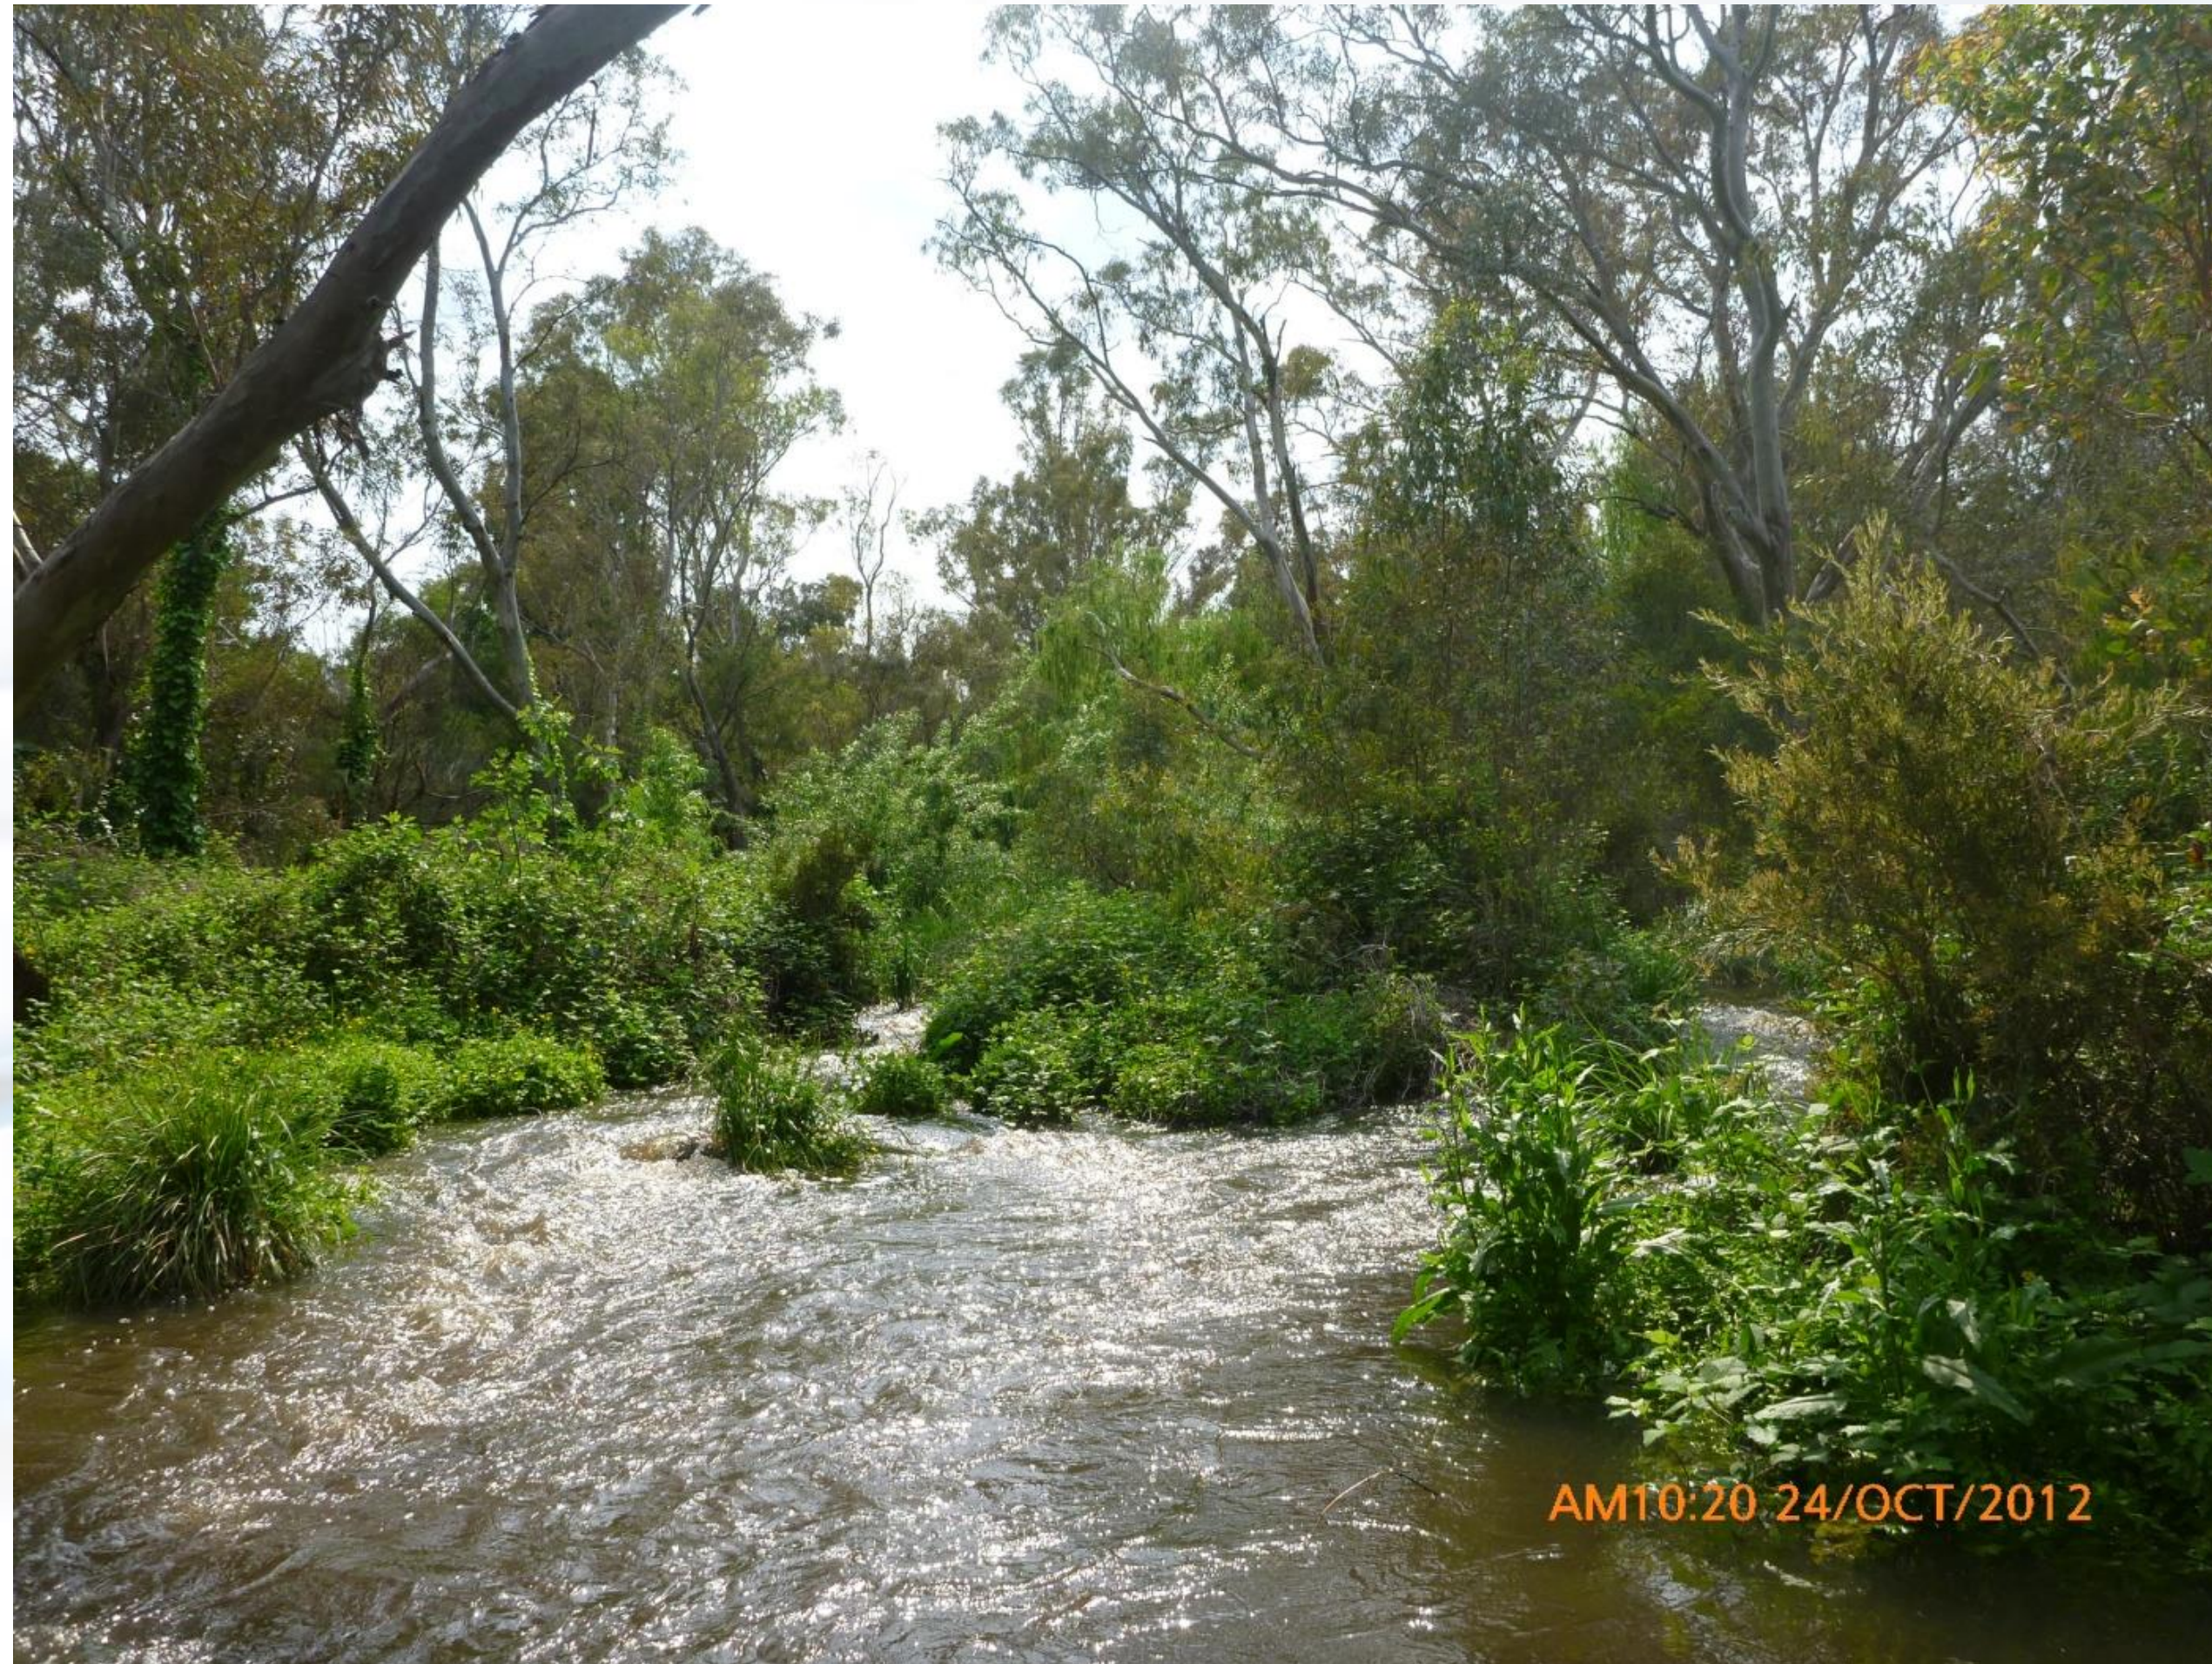
Onkaparinga, Clarendon Oval, Riffle 1

24 October 2012, in channel vegetation making a come back with onset of warmer weather, quite strong flow still

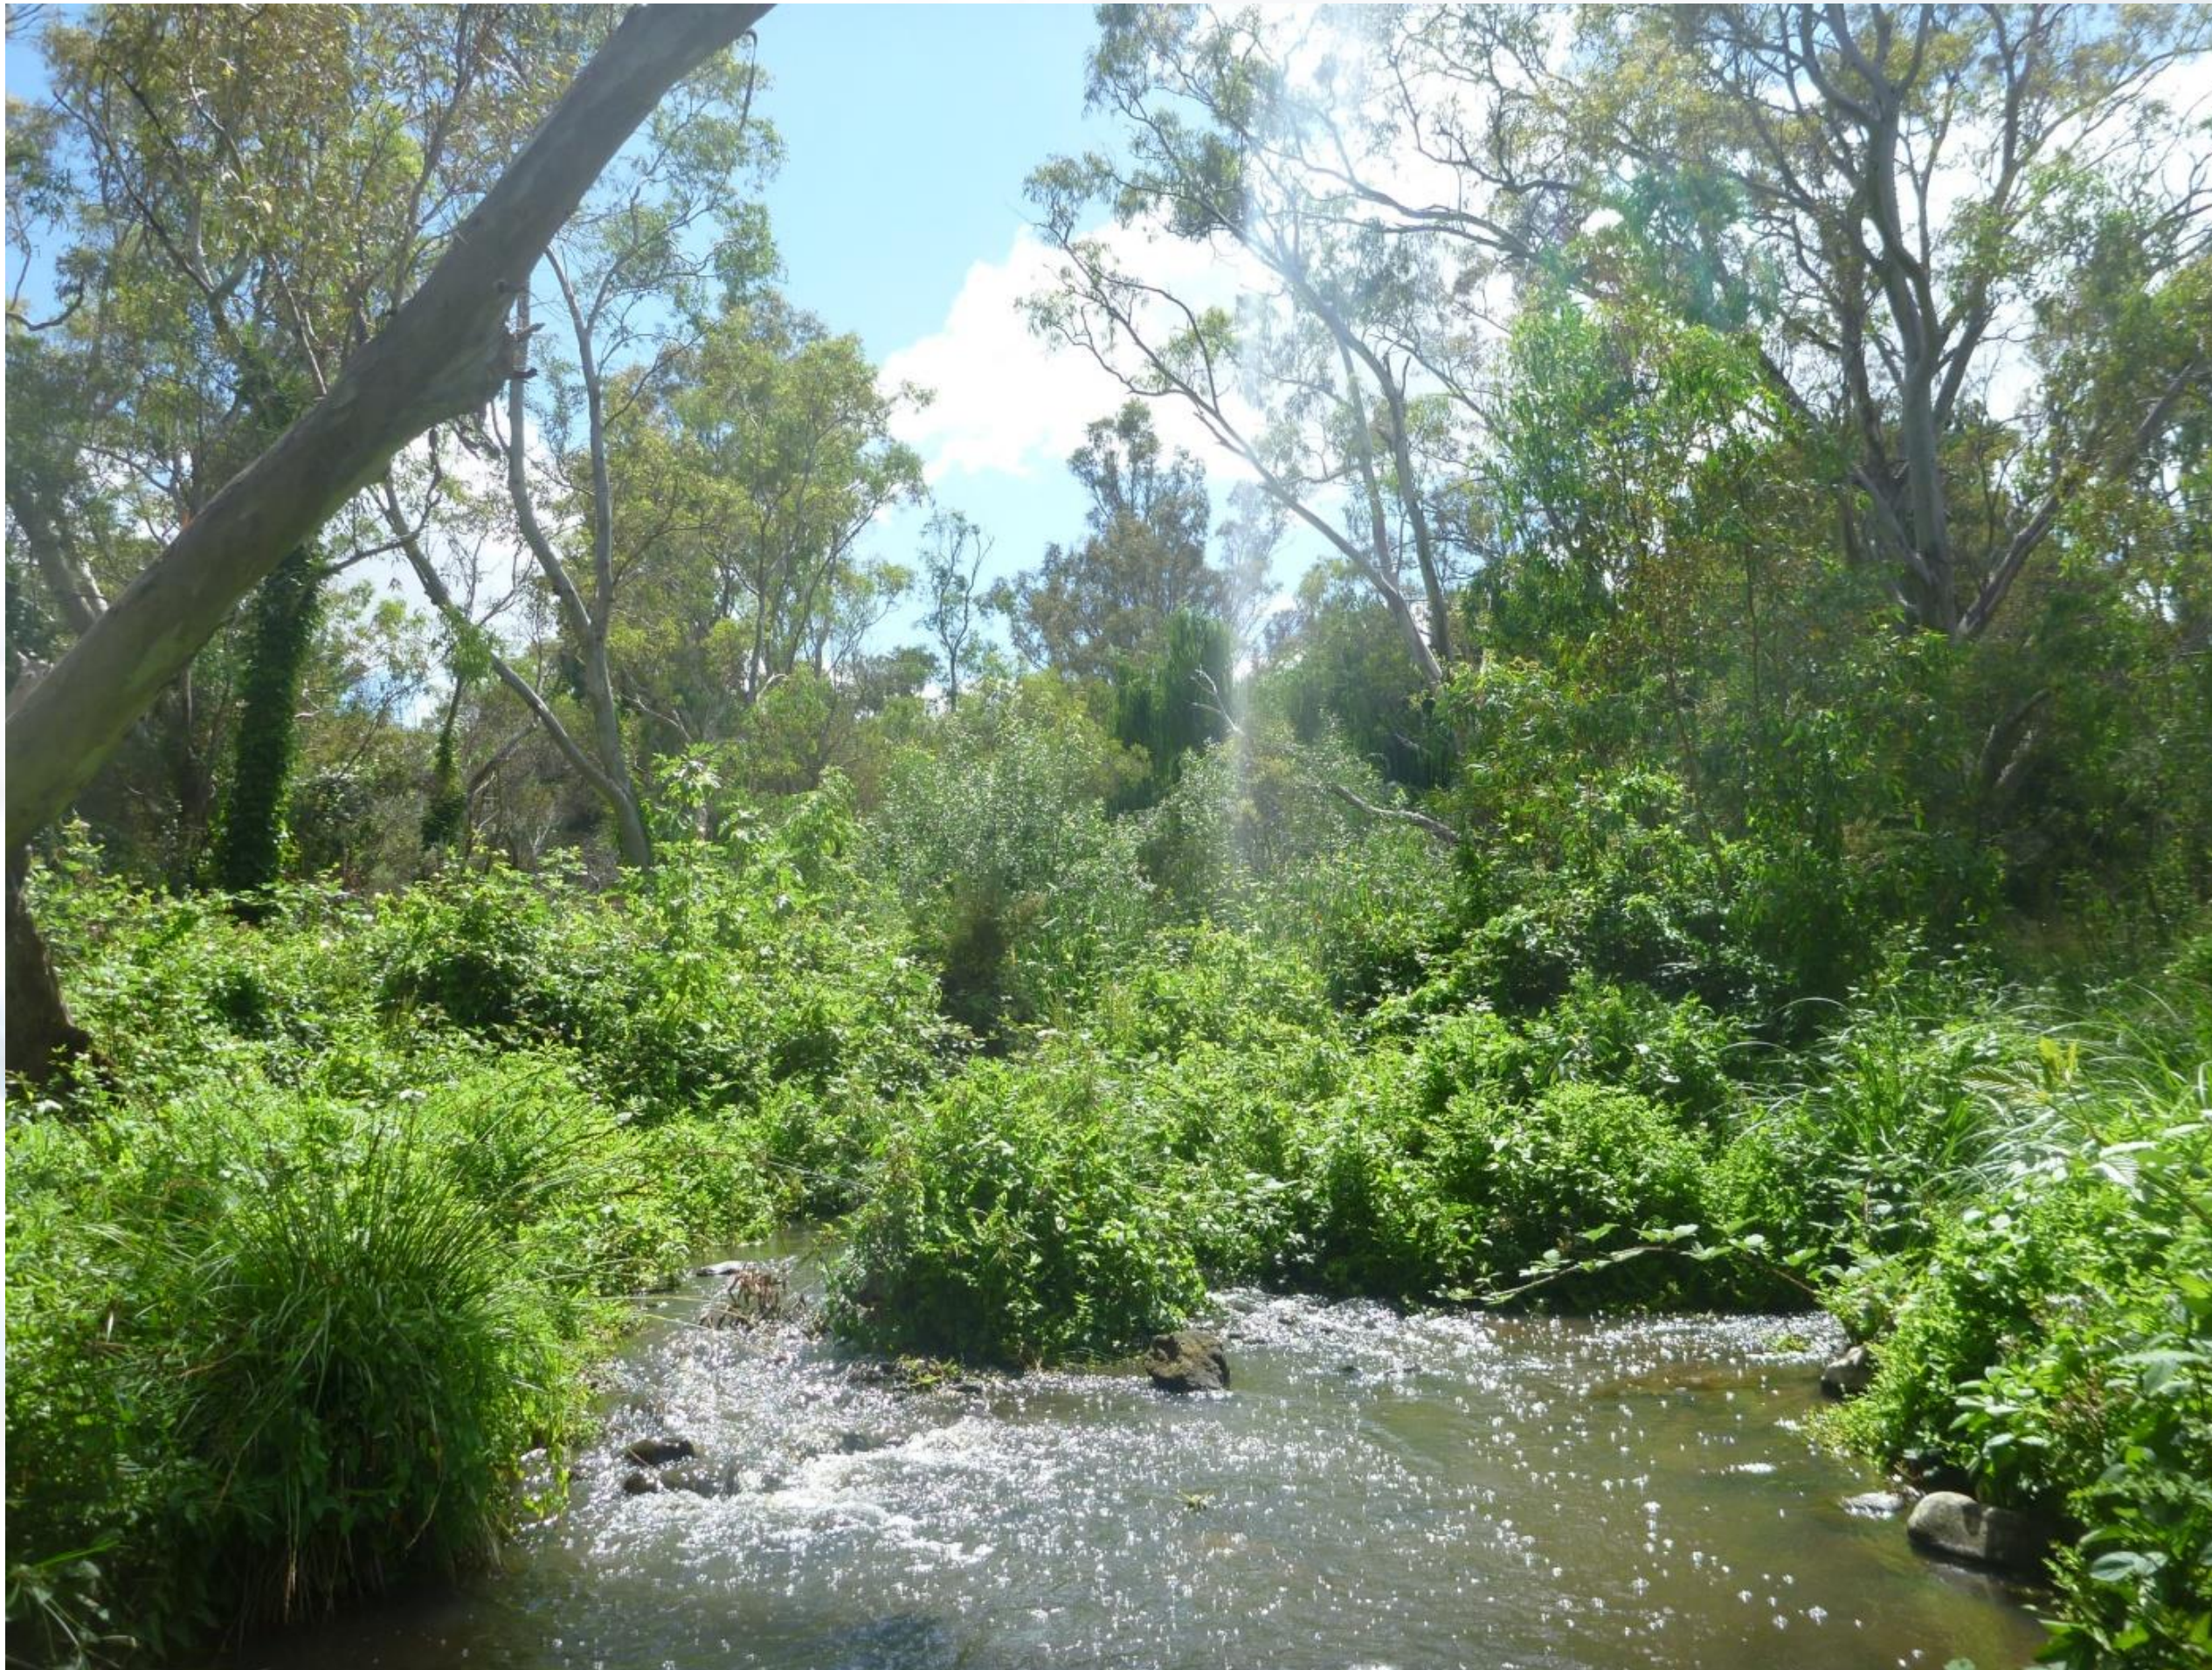
Onkaparinga, Clarendon Oval, Riffle 1

17 December 2012, in channel vegetation continuing to grow and encroach more on the channel with warmer weather, flow has slowed, riffle habitat still present, hard stony substrates observable

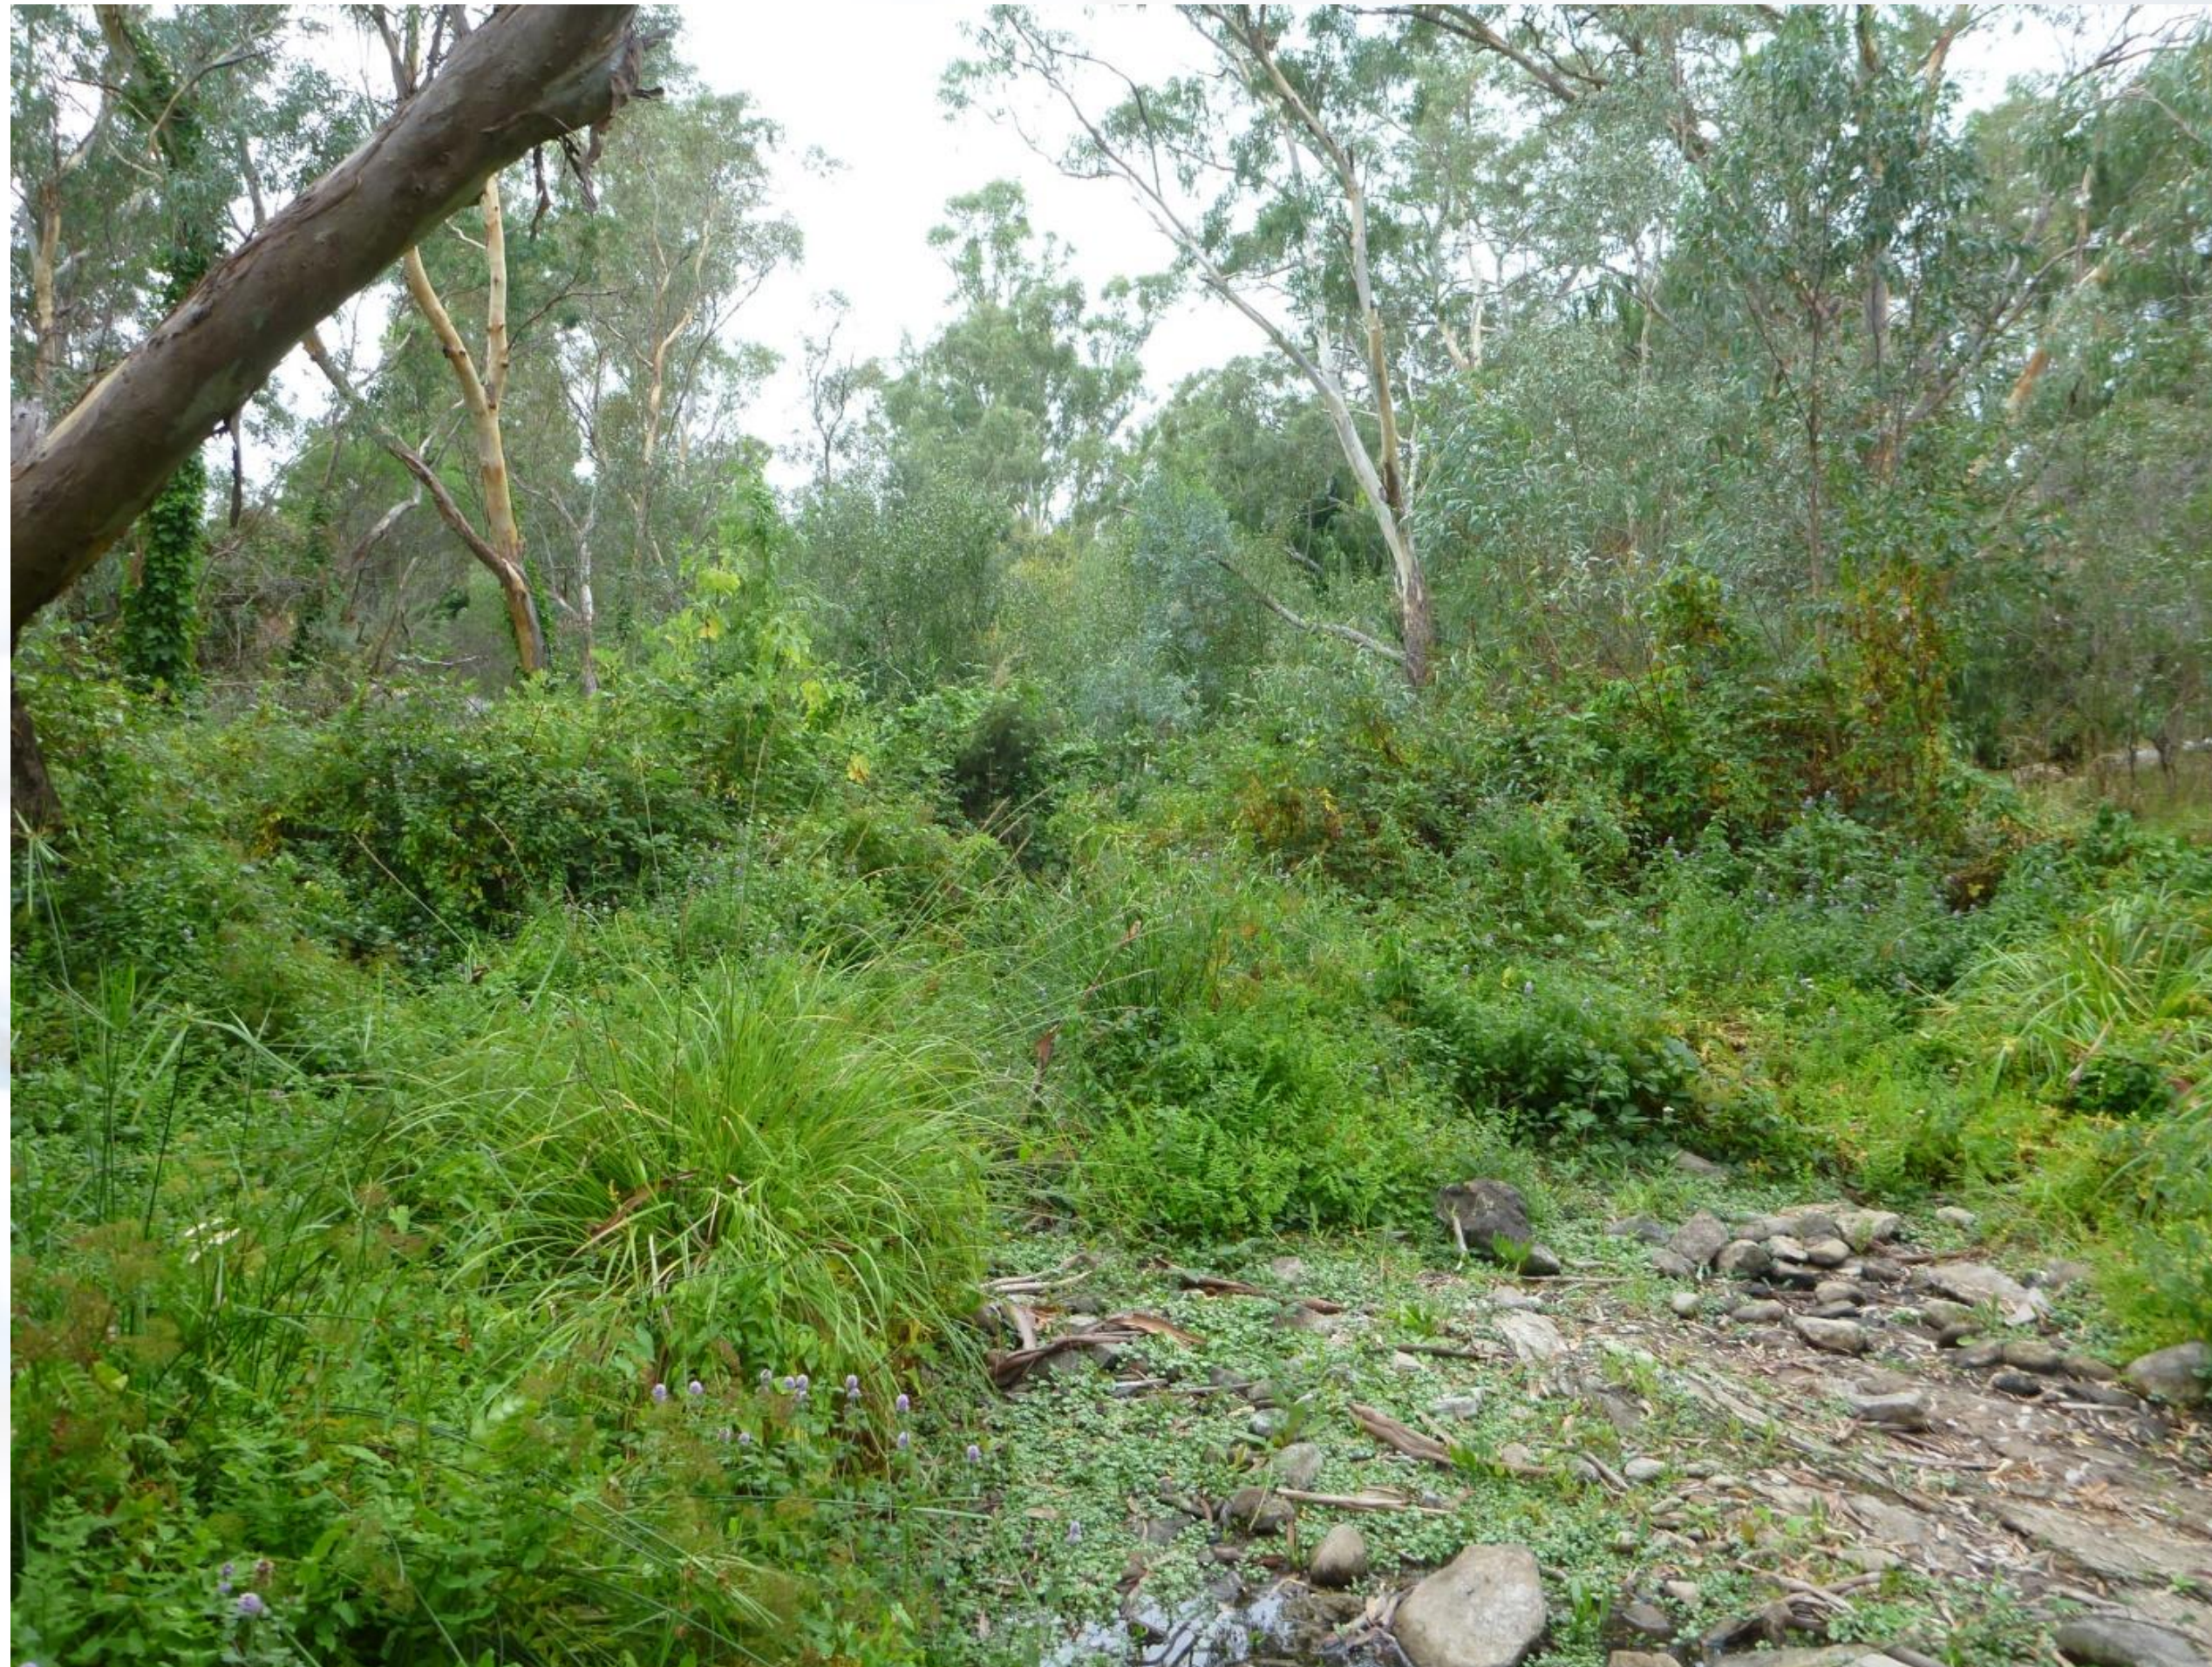
Onkaparinga, Clarendon Oval, Riffle 1

25 March 2013, channel less choked with vegetation than in 2012, water parsnip not as dominant as same time last year, slight water trickles through vegetation and rocks, exposed rocky substrate available for immediate colonisation of riffle bugs with onset of flows
