Onkaparinga, Clarendon Oval, Riffle 1

Comparison March 2012 and 2013

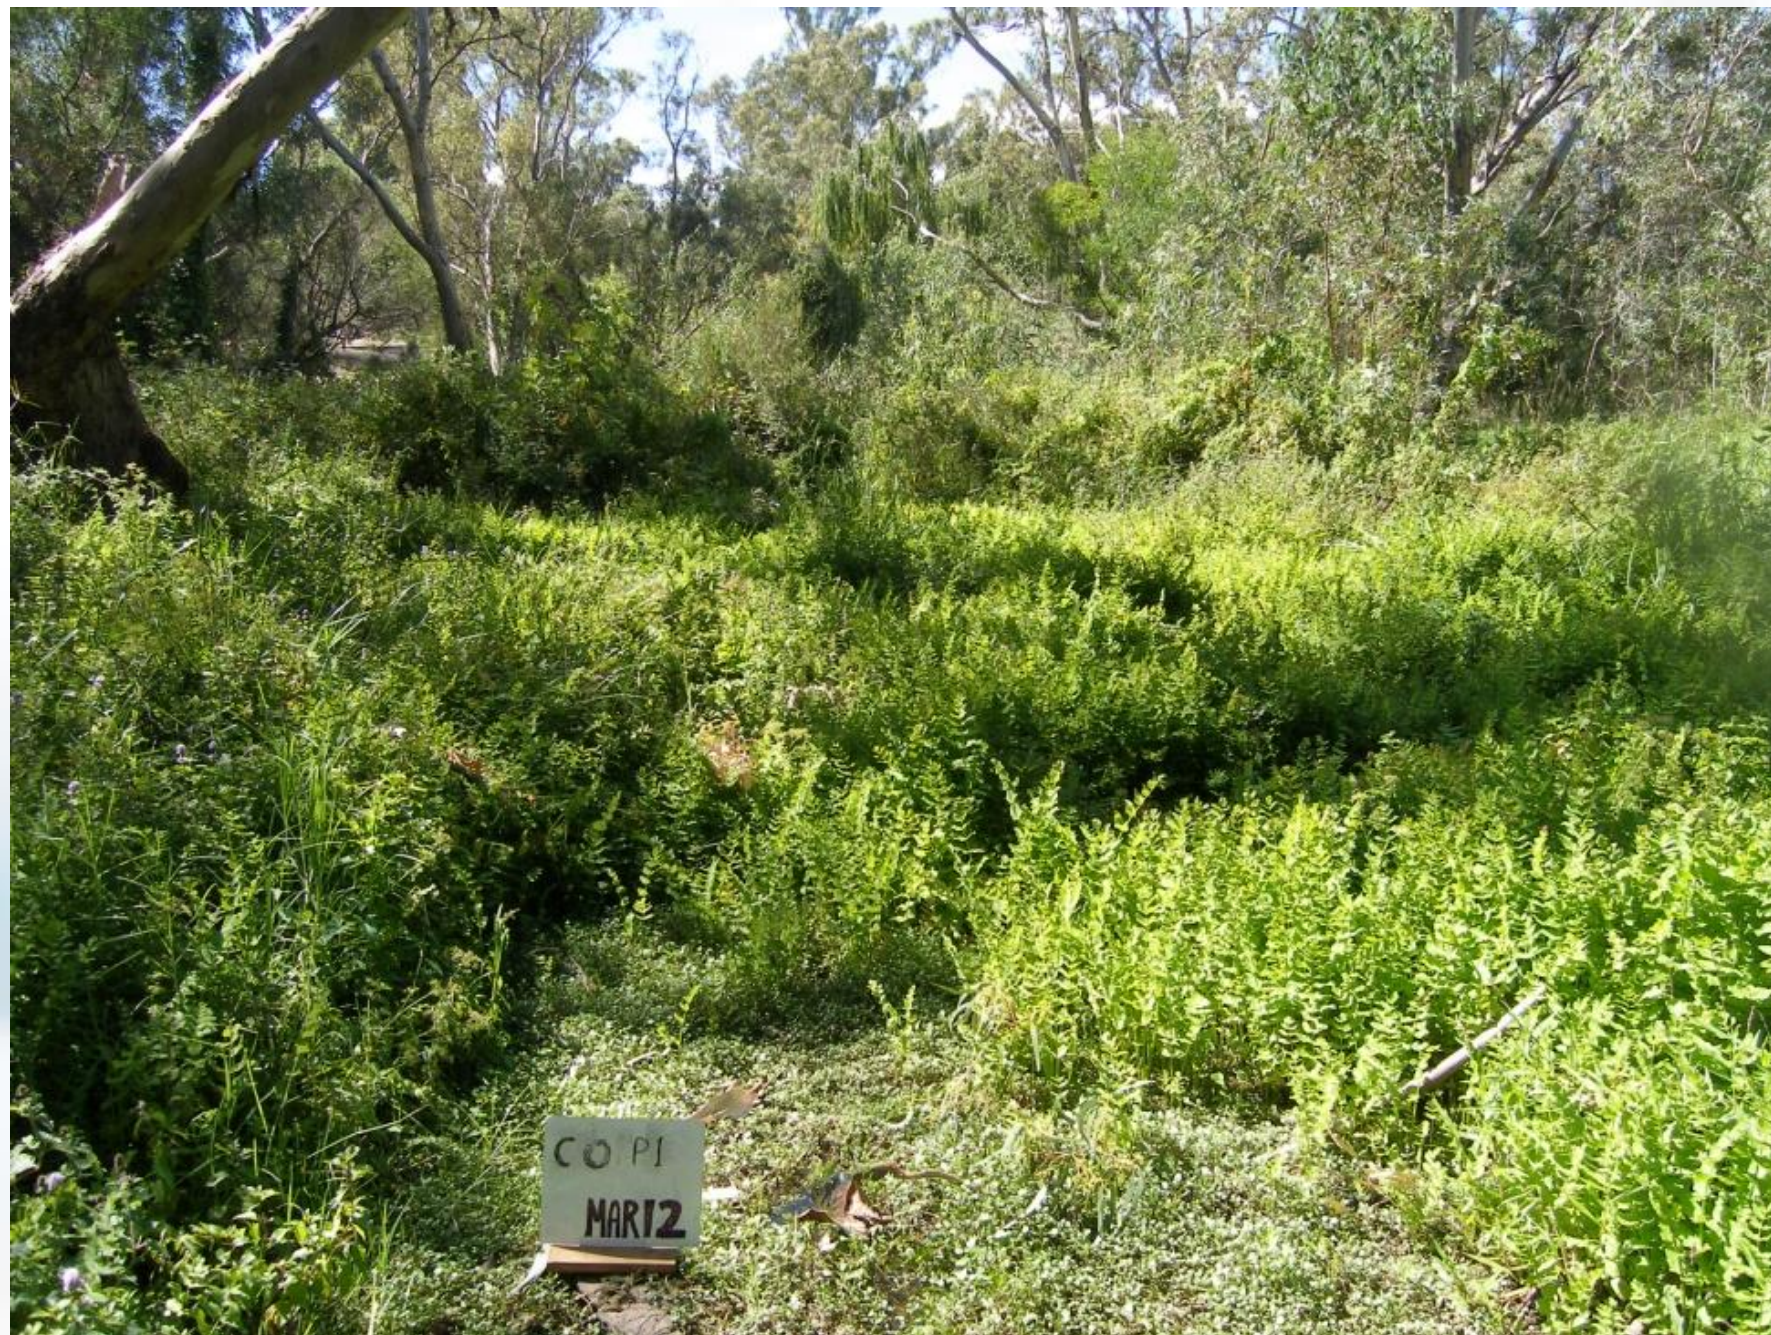
Onkaparinga, Clarendon Oval, Riffle 1

20 March 2012, channel choked with water parsnip, slight water trickles through vegetation

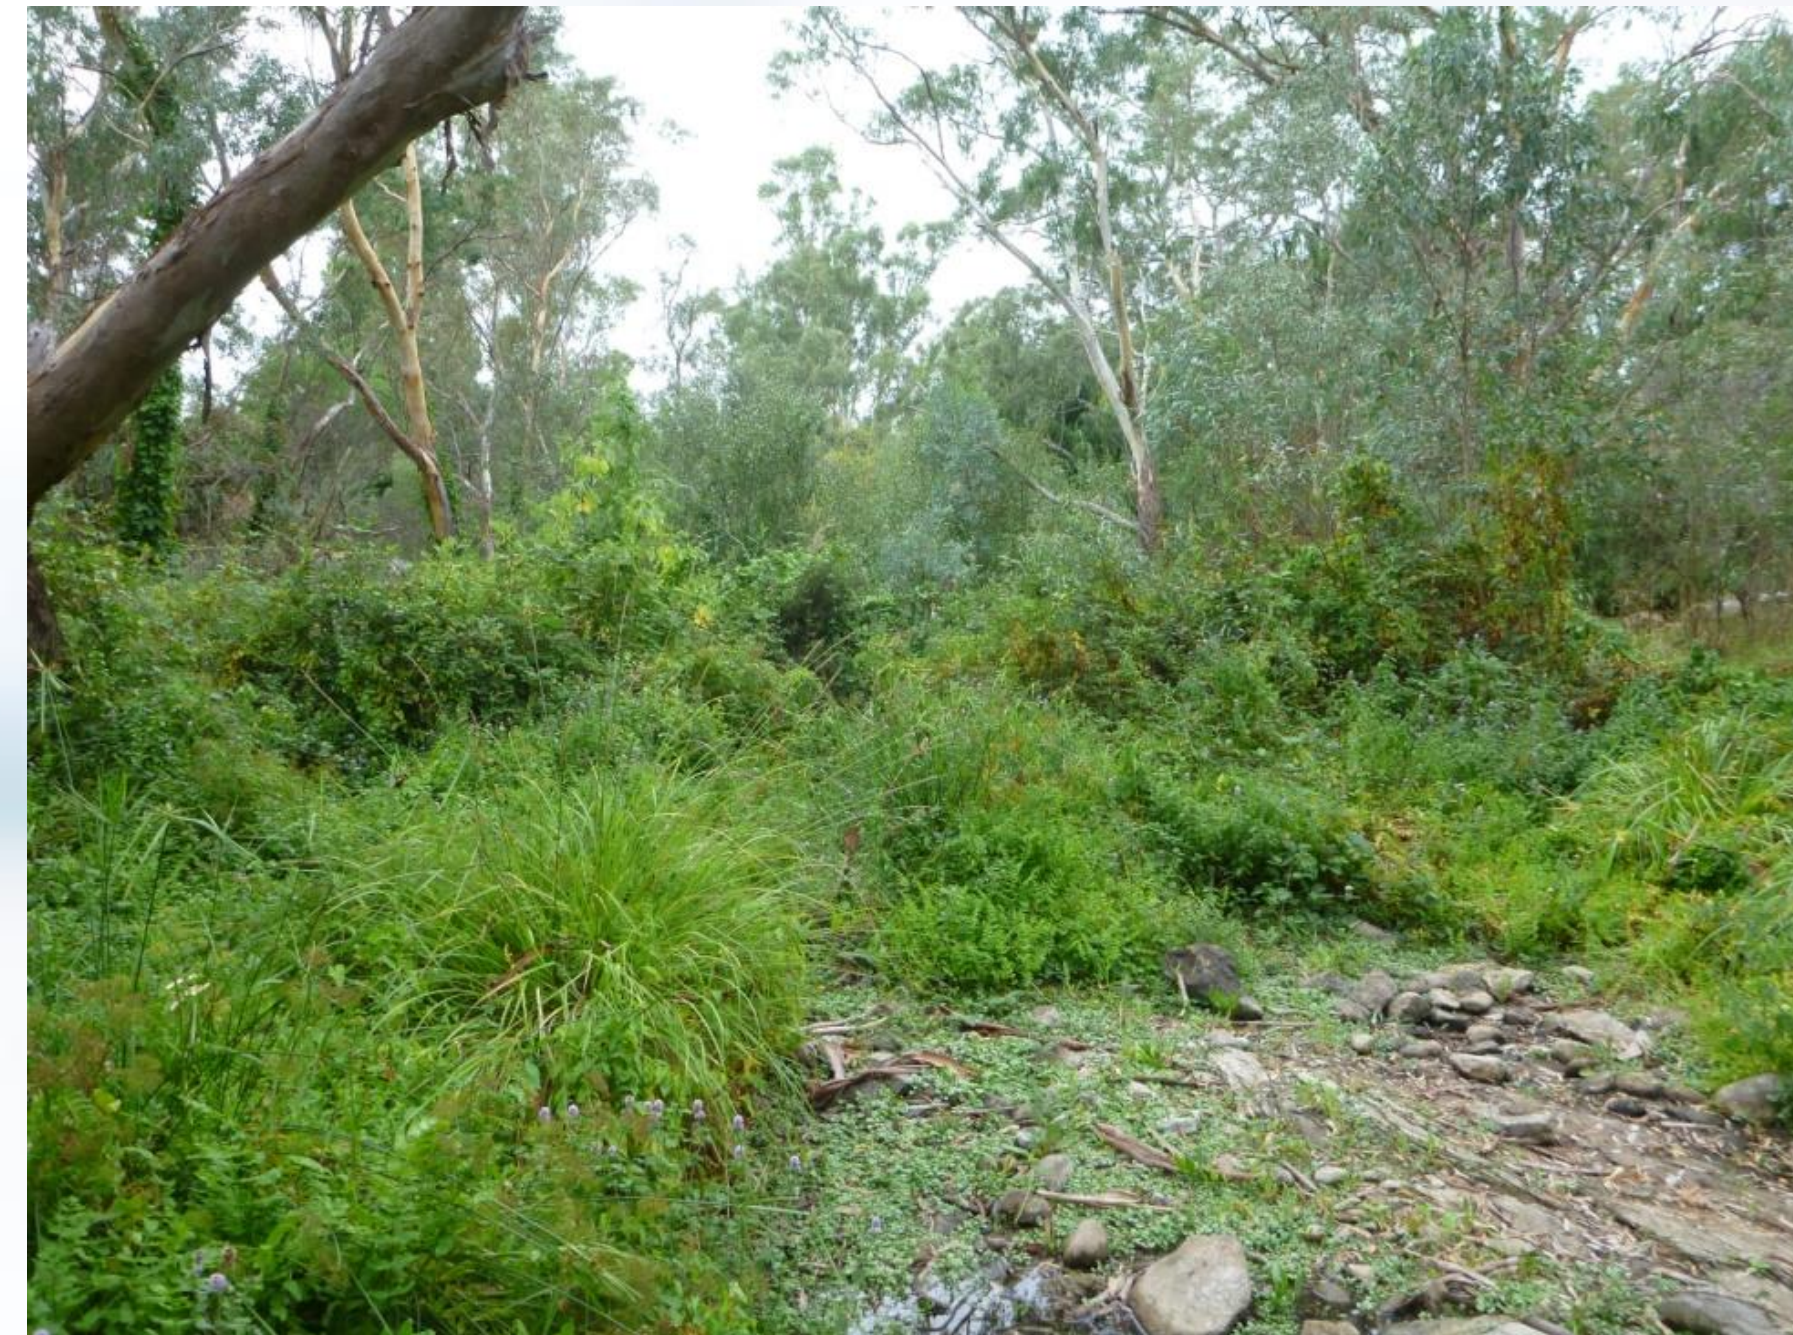
Onkaparinga, Clarendon Oval, Riffle 1

25 March 2013, channel less choked with vegetation, water parsnip not as dominant as same time last year, slight water trickles through vegetation and rocks, exposed rocky substrate available for immediate colonisation of riffle bugs with onset of flows

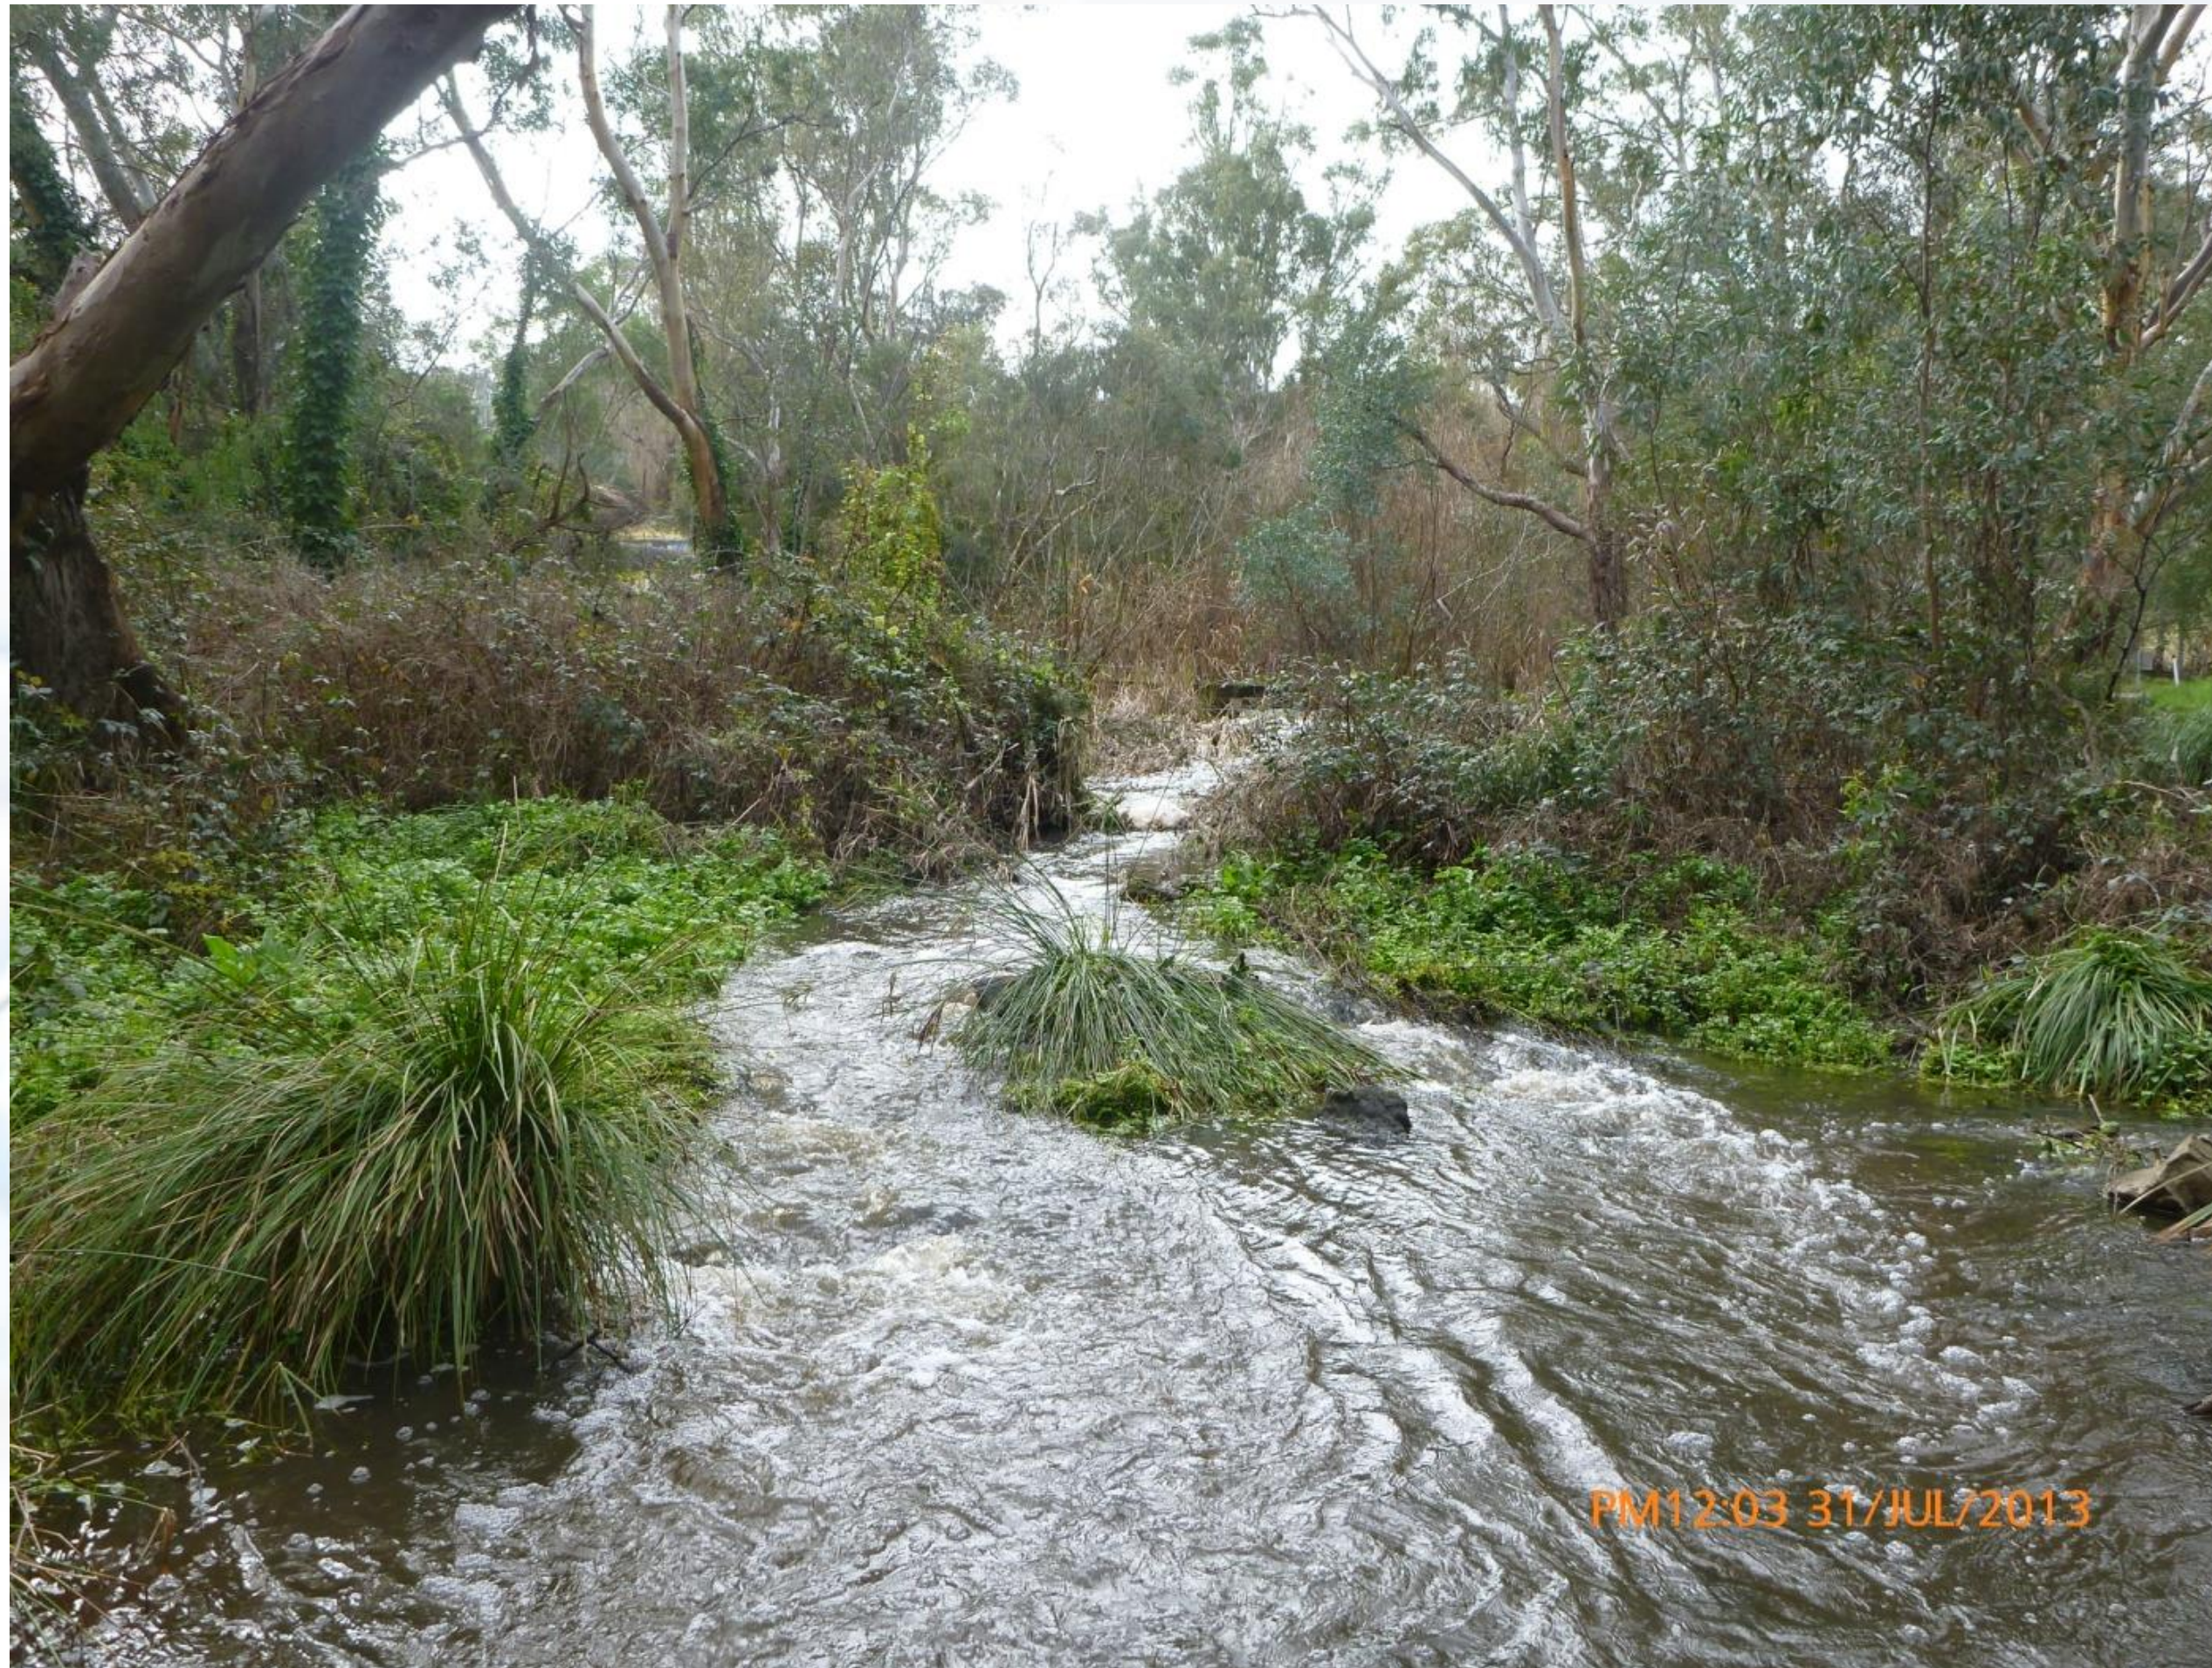
Onkaparinga, Clarendon Oval, Riffle 1

31 July 2013, bottom half of quite lengthy riffle is more stony and supportive of a mature riffle macroinvertebrate community, the new upper half exposed by the flow resembles the bottom half at the beginning of onset of flows in mid 2012, though flow still strong the lateral spread of the water and the reduced resistance of plant matter has this riffle being more like a riffle than a run habitat

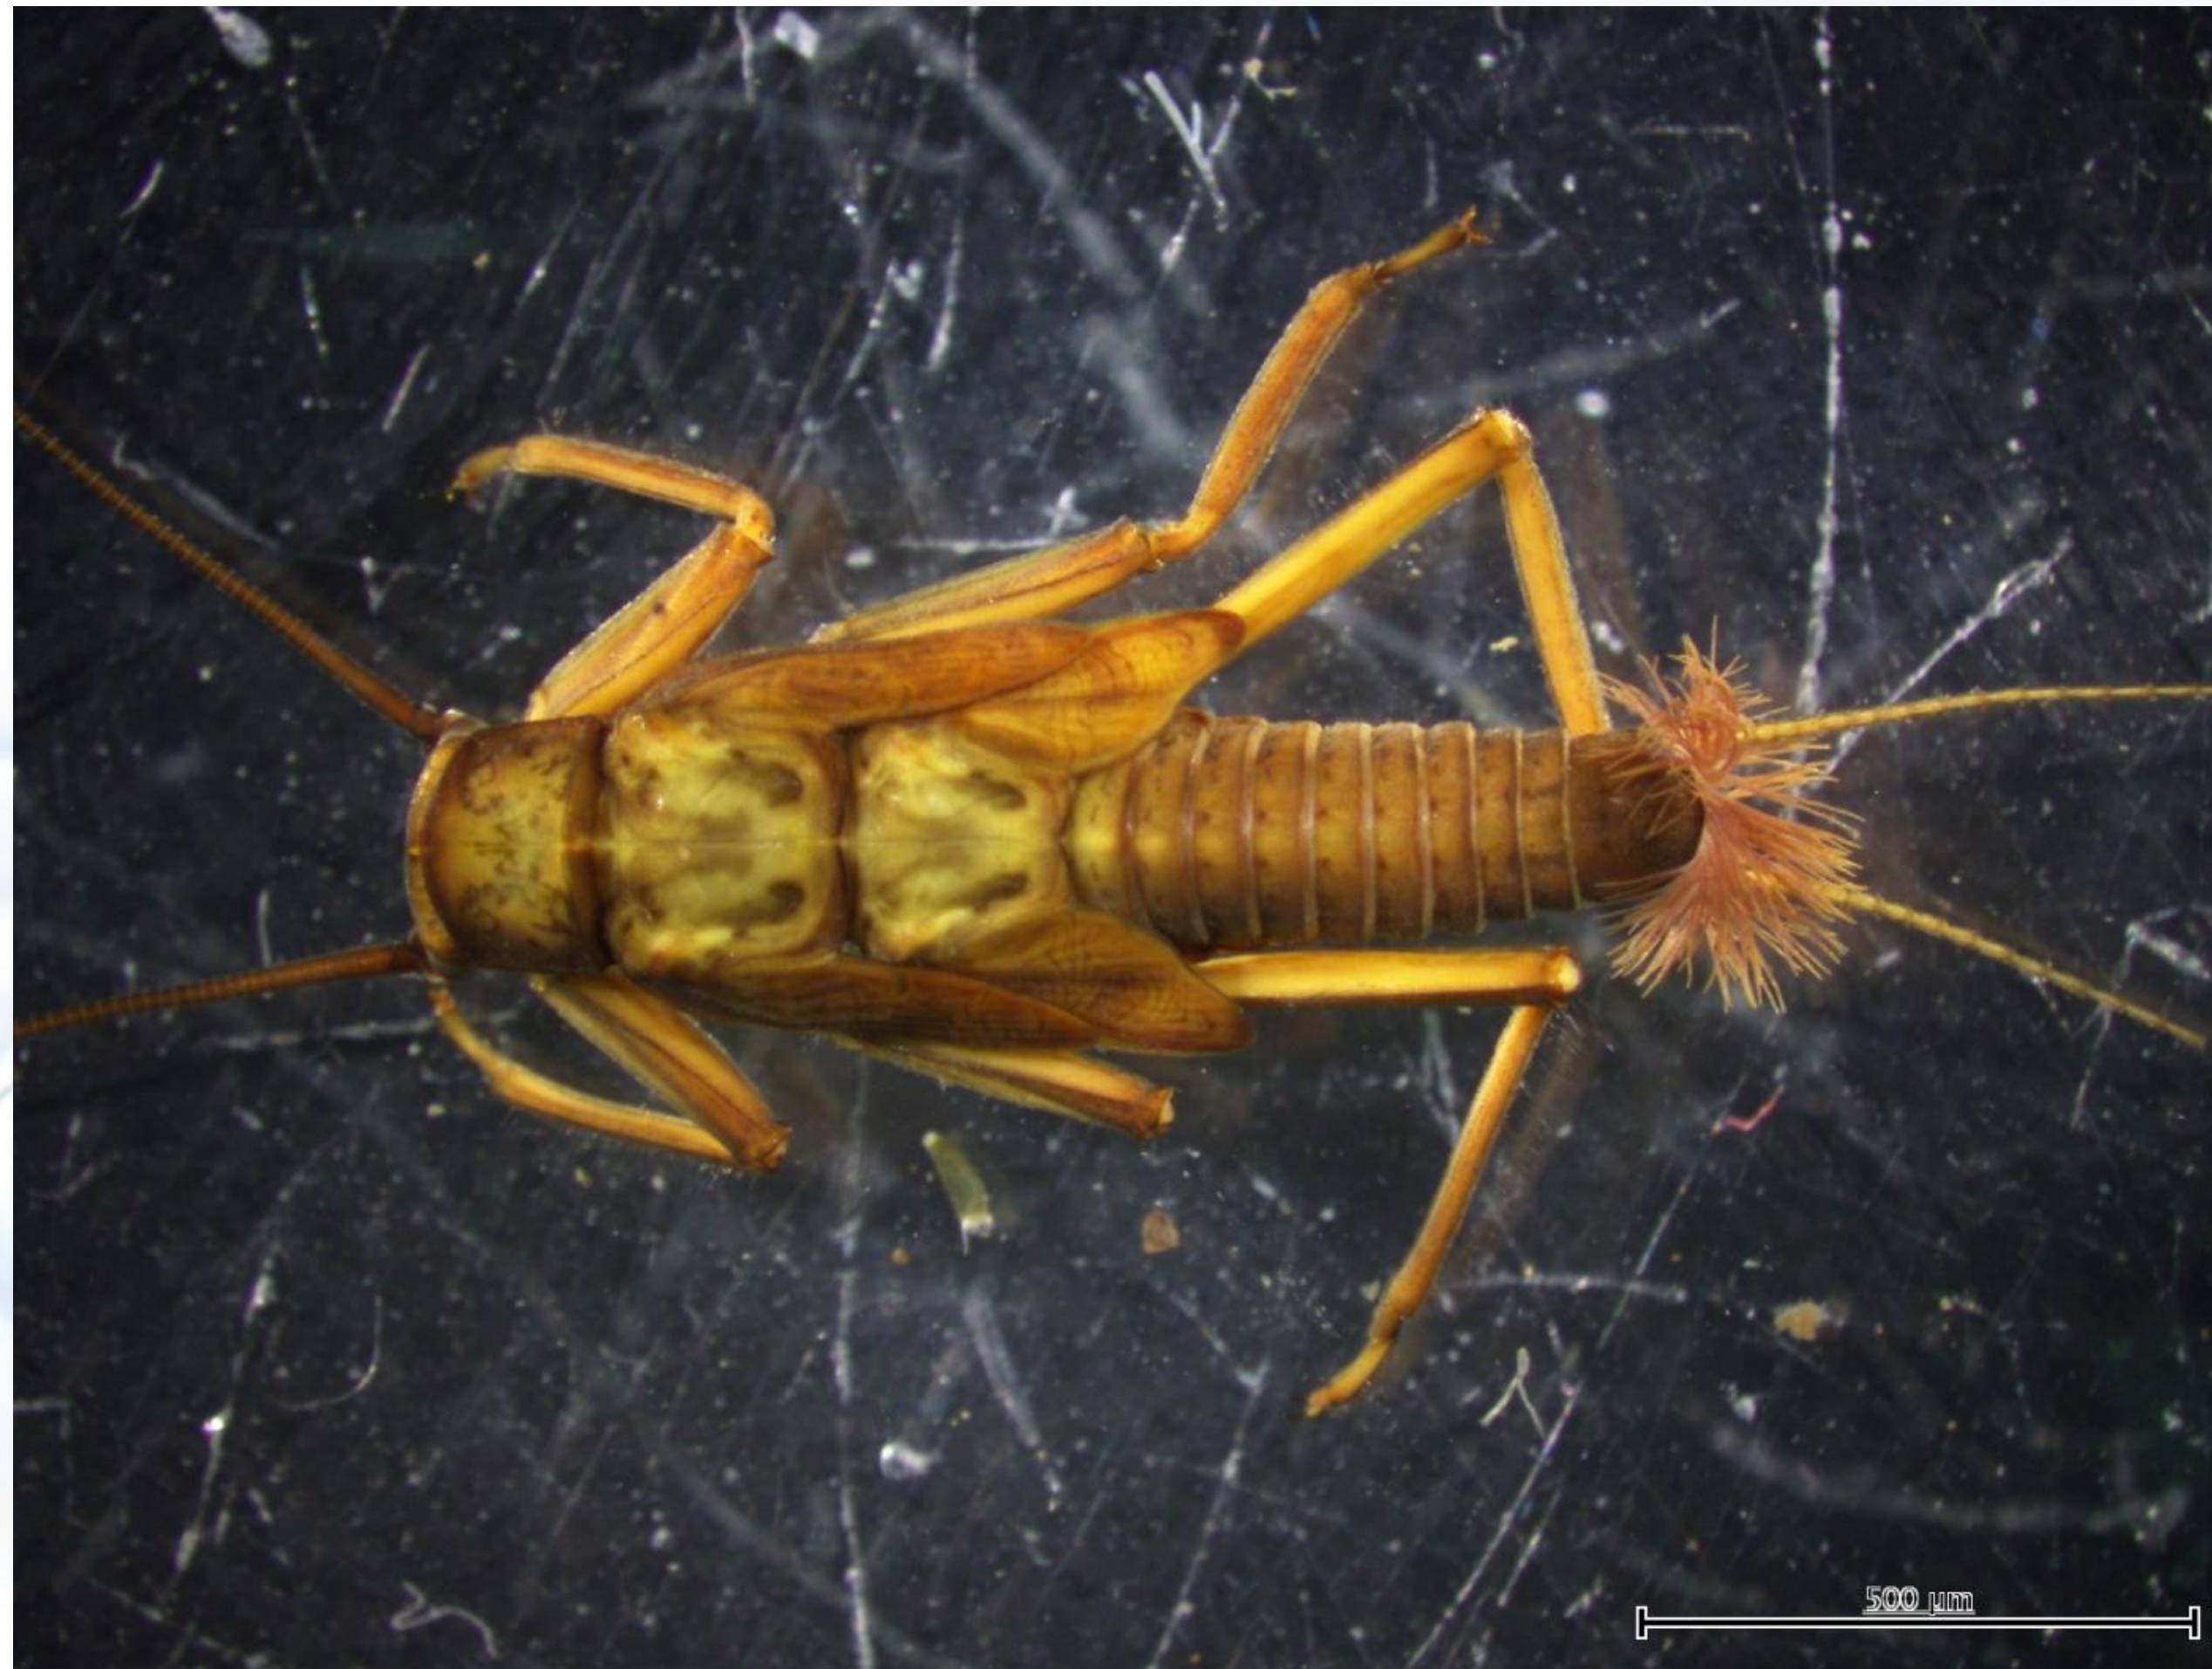
Each of the replicates that fell in the bottom stony end of the riffle supported mature Stoneflies (*Illiesoperla mayii*), 3 to 4 for each replicate. Photo from Replicate 3, 31/7/13
