# Murraylands and Riverland Landscape Board

## Martin Bend Monitoring Summary

### 2021-22

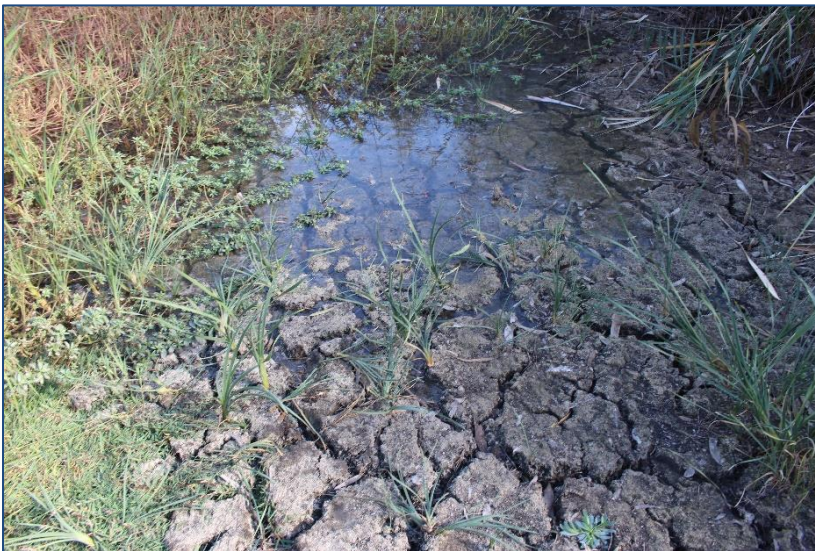
**Figure 4.** Martins Bend refilling, water filtering through mud cracks and understorey vegetation.

Over 14 months, the permanent lagoon successfully dried. In May 2021, the regulator was re-opened, initiating the refill phase of the hydrological cycle. During the dry phase, the wetland bed consolidated, and a dense covering of the native slender knotweed (*Persicaria decipiens*) covered the basin. Once water returned to the basin, this vegetation decomposed, revealing beautiful water clarity thanks to the exclusion of common carp (*Cyprinus carpio*) and consolidation of the wetland bed.

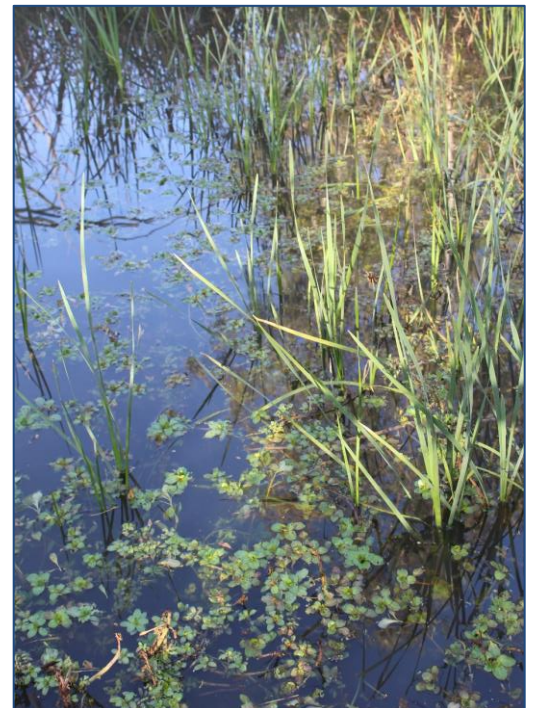
**Figure 5.** Martins Bend, clear water and submerged vegetation response

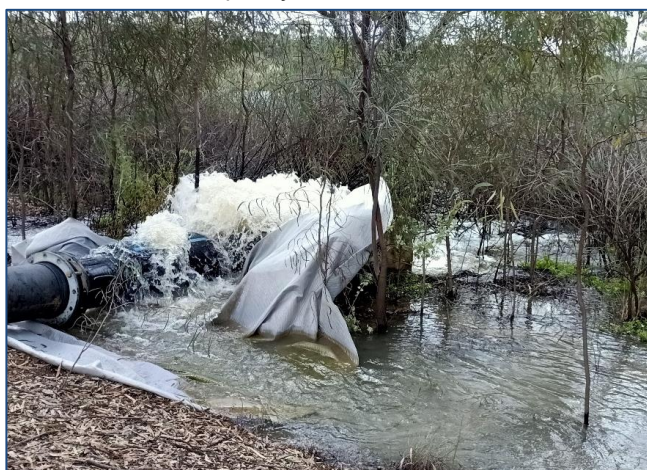
**Figure 6.** Pump outflow into temporary basin (T1)

Because Martin Bend has multiple wetland types, it receives water from numerous sources. Primarily, the permanent lagoon receives water from Class 9 Wetland Consumptive Pool. The 3 temporary basins connect naturally to the river when experiencing high flows. However, in between high flow events, delivery of environmental water to these basins using a portable pump allows for more frequent inundation. Pumping environmental water allows these basins to receive enough water to support the vegetation communities beyond the reach of the permanent lagoon, building the resilience by improving and maintaining health of the ecological communities. Pumping also allows for the exclusion of large fish (carp) from these basins resulting in excellent water quality, which creates favourable conditions for native flora and fauna.

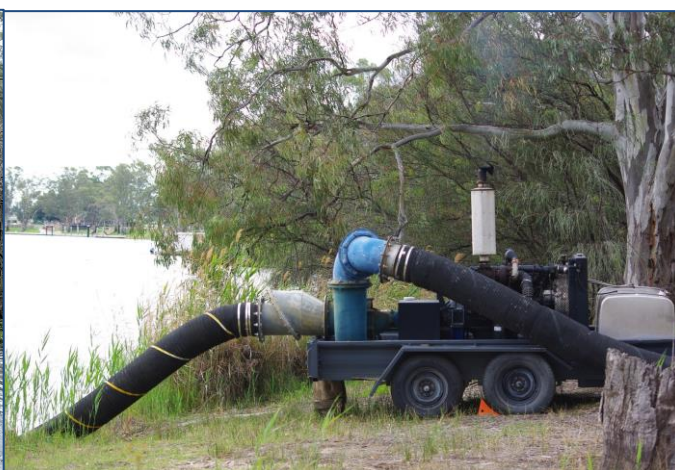
**Figure 7.** Pump and intake from river channel

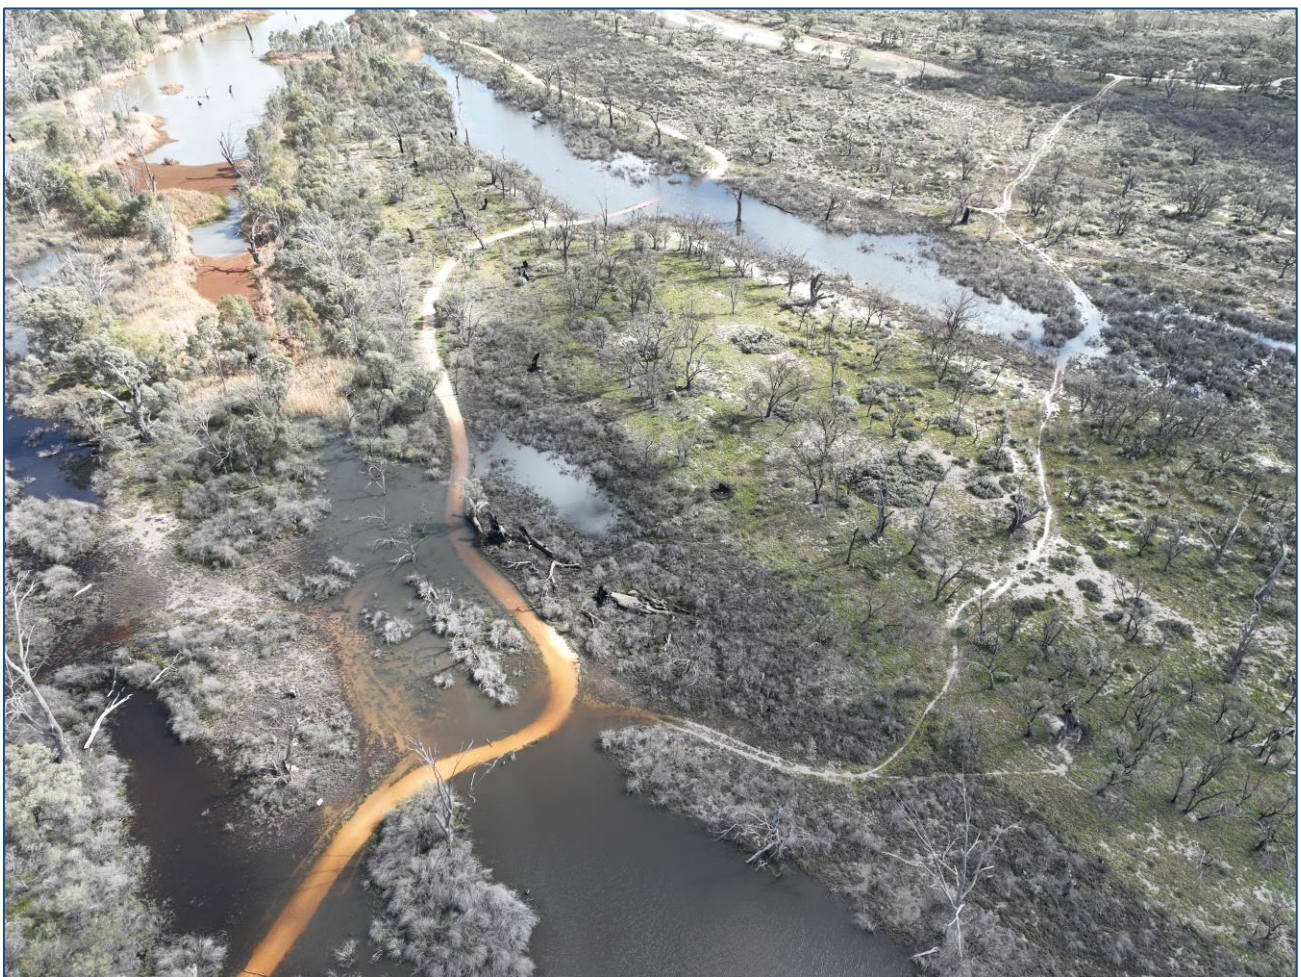
**Figure 9.** Martin Bend floodplain inundation over walking trail during unregulated flows in August 2022

Since July 2021, the South Australian River Murray has been experiencing unregulated flows. Flows at the SA border (QSA) most recently peaked at ~ 54,000 ML/day. At Martin Bend, these flows are inundating the wider floodplain, increasing the extent of the permanent lagoon, and beginning to fill temporary basin 1 (T1). Much of the walking trail is inundated, pictured below. A secondary inlet is now flowing, connecting to the permanent lagoon, allowing it to act as a flow through system. This will allow for nutrient and salt exchange into the main river channel, and allow for fish access. The high flows overtopped the fish screens at the permanent lagoon, the screens were opened at this time, large bodied natives and carp will be able to move through the system freely.
