# Monitoring Mallee Seeps

Project 1569C for the

South Australian Murray-Darling Basin  
Natural Resources Management Board

Progress Report July-Dec 2017

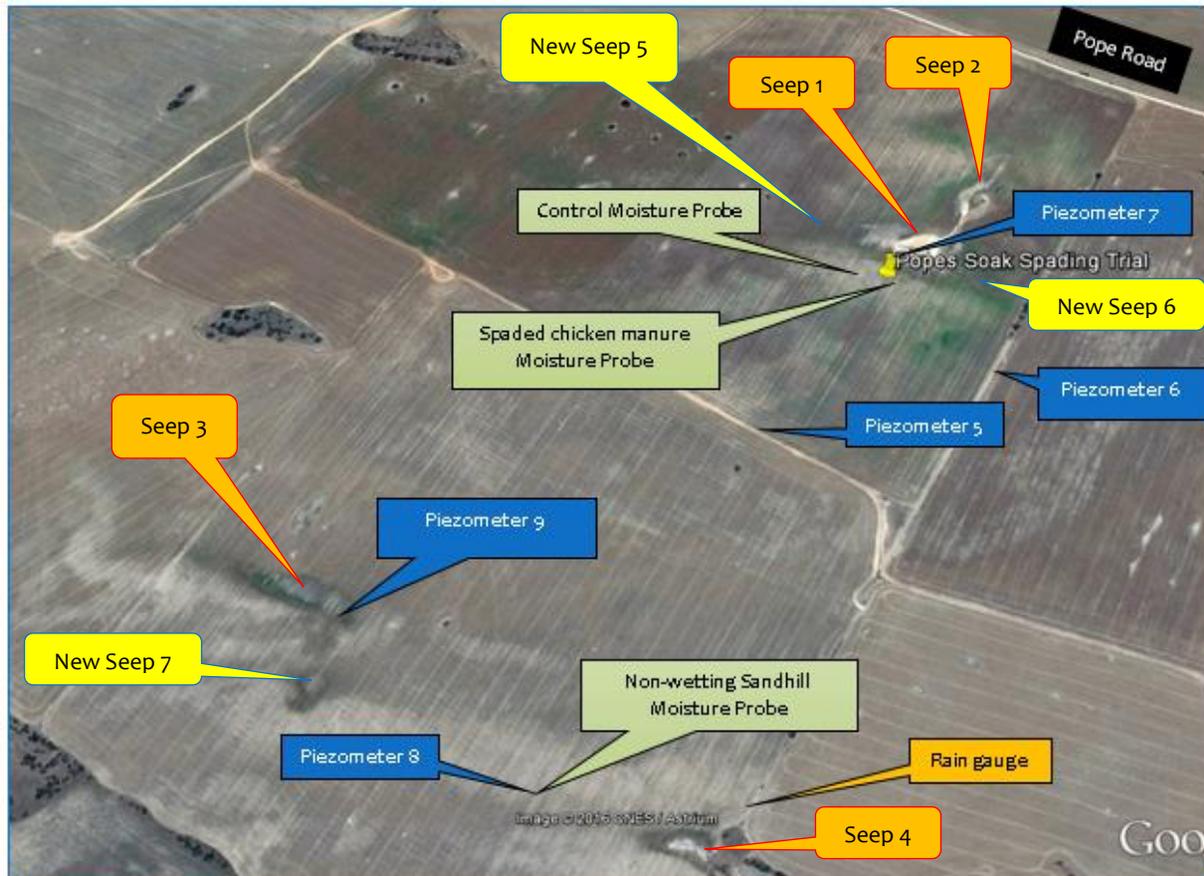
Figure 1. Martin soak site with monitoring equipment approx. locations

The Martin property, south west of Karoonda, has 2 main areas of monitoring (see Figure 1). There is the southern paddock in the upper catchment area, directly feeding into 2 soaks, as well as the lower catchment area surrounding a major salt scald and seep area. A network of strategically placed piezometers and moisture probes have been placed throughout to monitoring moisture levels, ground water flows within the landscape as well as the impacts of seasonal factors, farming systems influences and spading treatments.

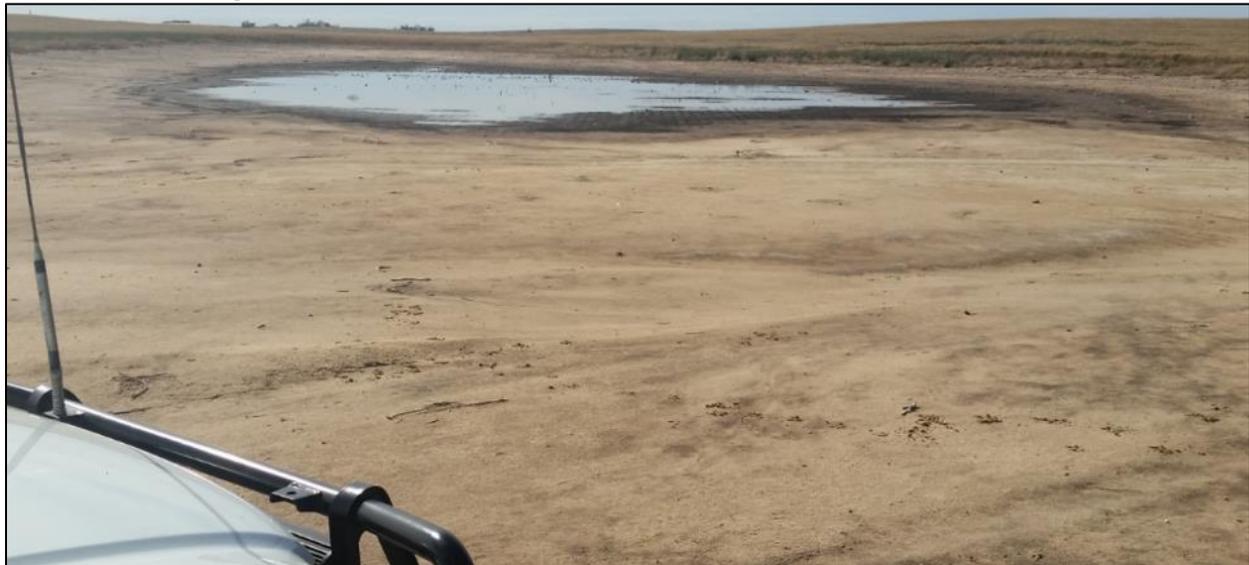
Photo 3. declining surface water in Seep 5 (Dec 2017).

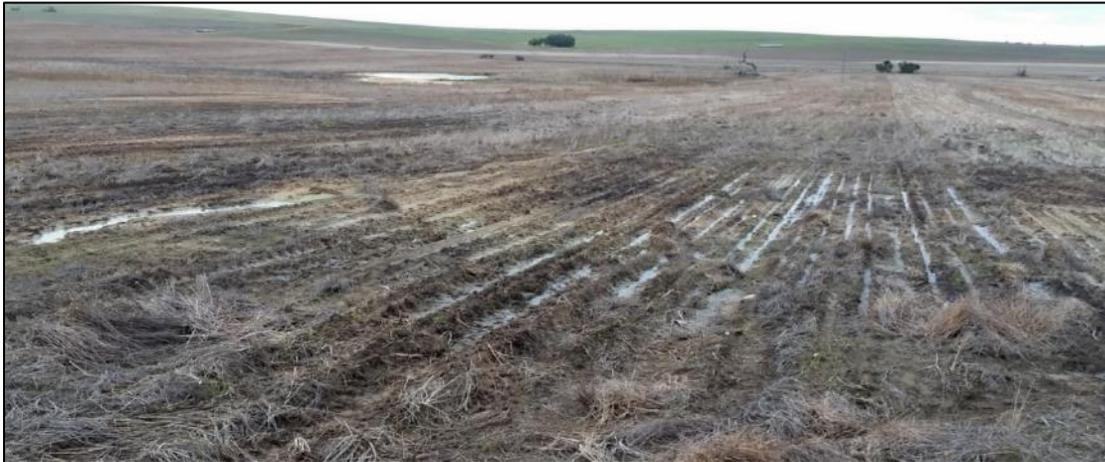
**Photo 4. Saturated topsoil at developing New Seep 6 area after seeding**

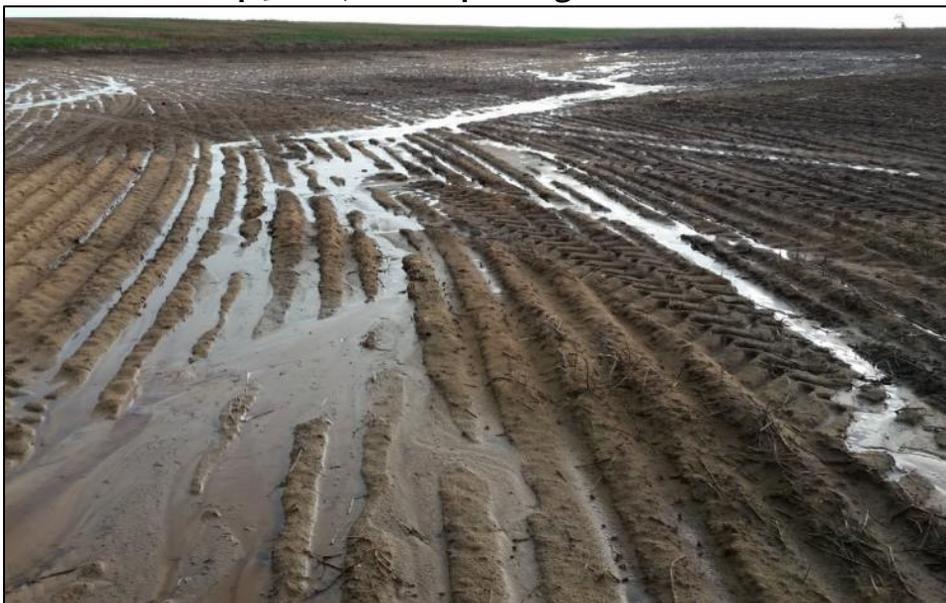
**Photo 6. New seep 5 area, with expanding saturated zone sown to crop, west of main seep**

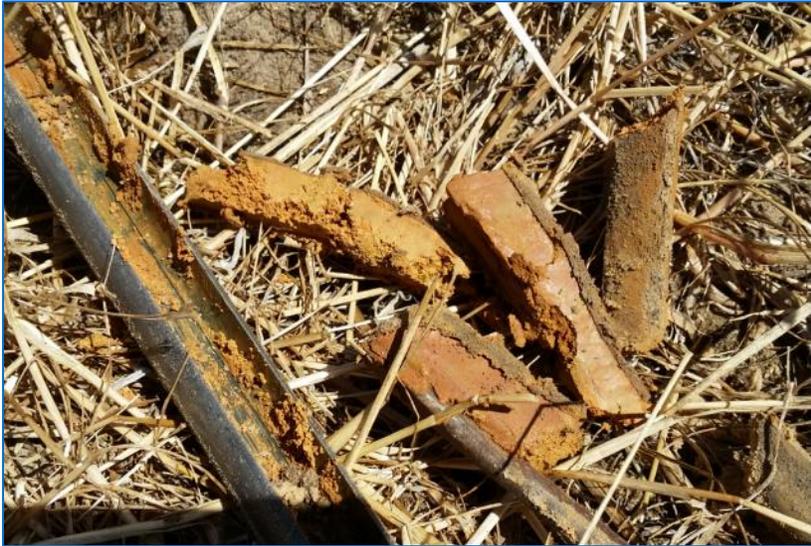
**Photo 10. Saturated clay in developing seep areas at 70cm, in Dec 2017**

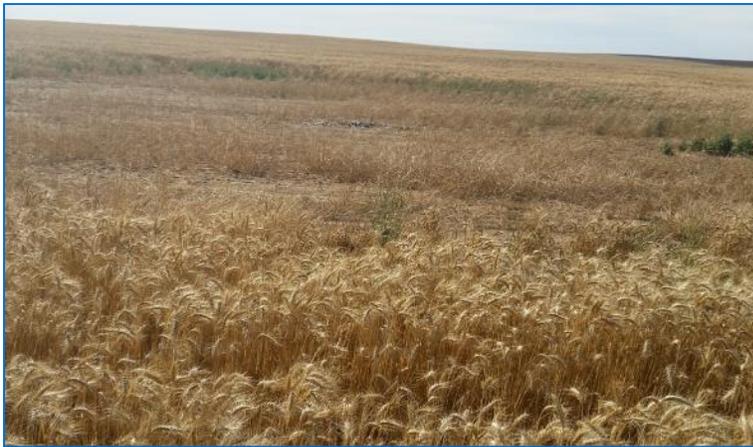
**Photo 13. Developing seep areas in midslope below sandy rise**

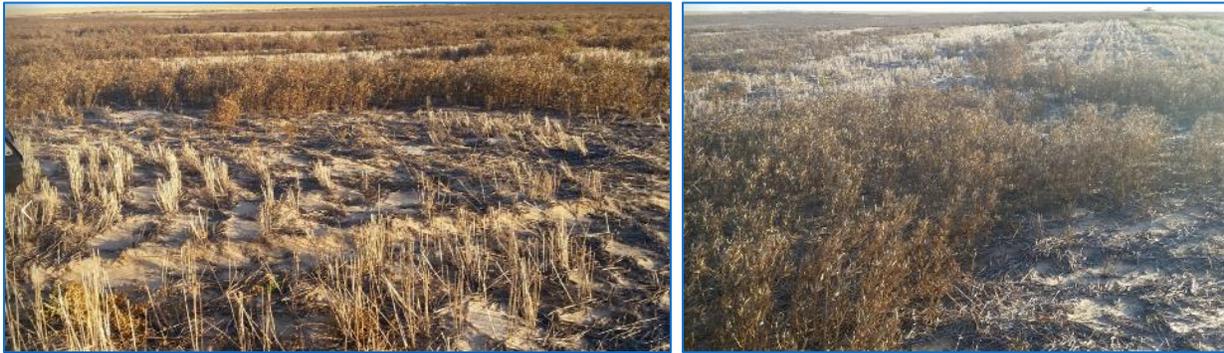
The spading of chicken manure to improve the crop production and water use of the sand above the seep area was unable to measure useful yield data in the 2017 season, as it was sown to lupins which suffered considerable mouse damage and patch crop growth across the various treatments. In previous years this treatment has clearly lead to high yields and gross margins, as well as increased root zone water retention and moisture use, when compared against the control treatment. It is a recommended management technique, but presently under-utilised due to high upfront costs, the poor accessibility of spading machines, as well as the extra effort required by busy farmers to successfully implement this relatively new technology. This may change in the future. Ameliorating the deep non-wetting sands to retain more water and increase productivity is a very attractive option, as farmers don't have to take out valuable cropping land or change management programs to work around trees or lucerne patches. There are still some practical issues that need to be overcome to see a greater uptake of this technique.

**Photo 14. Patchy lupin growth at original spading trial area due to mouse damage, Dec 2017**

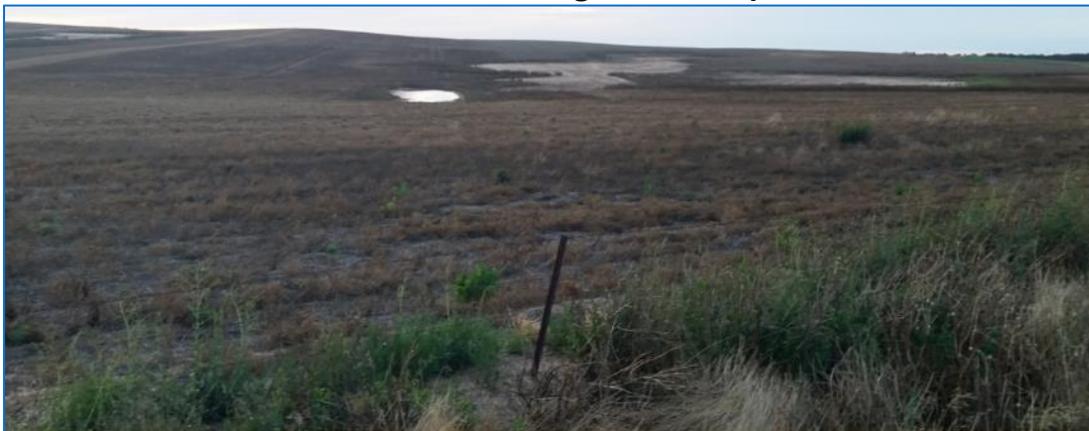
Photo 16. Bare scald and lake areas forming in western paddocks

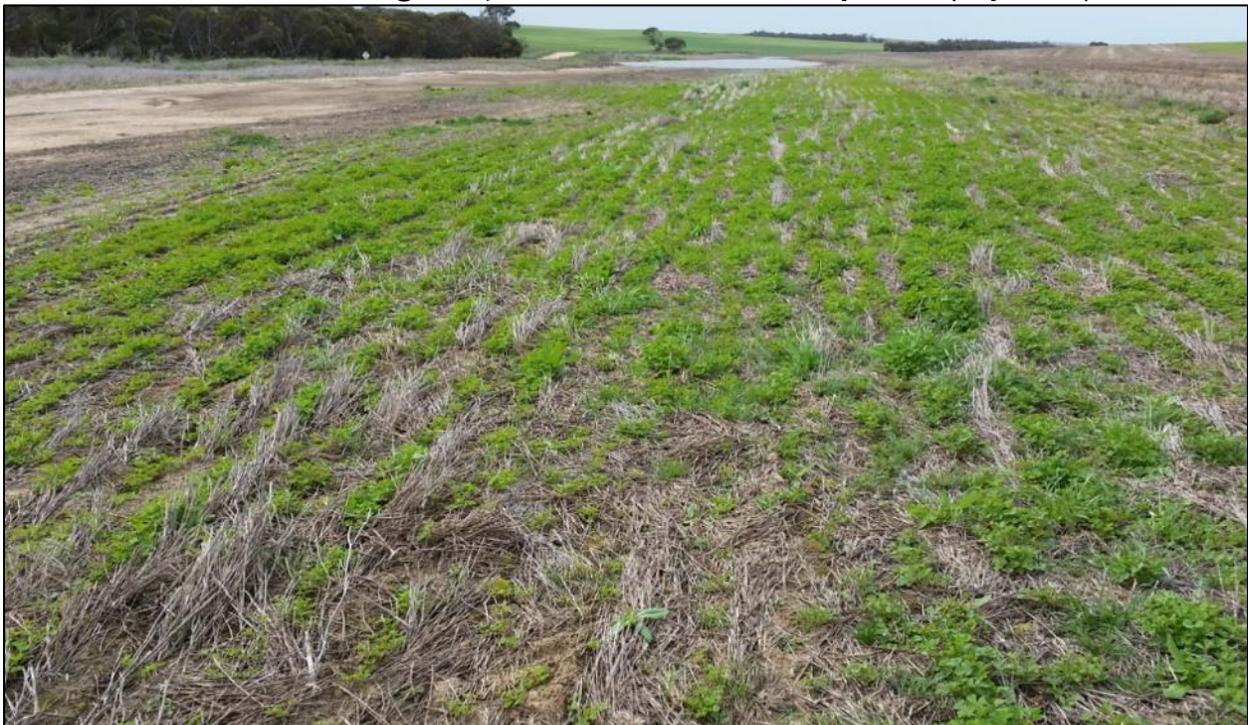
Messina was sown with the farmers air seeder across the scalded and often waterlogged areas beneath the lucerne zone, to test whether this new pasture would provide cover and reduce the ongoing degradation of these areas. As shown in Photos 20 and 21, it established well in the ground just above the scalded bare areas, but was unsuccessful in areas already bare. It would appear that this may be due to the high surface salinity of these areas, rather than water logging. Small raised areas with some organic matter within the scald areas often saw some germination and growth. Consideration should be given to ridging or roughing up these areas to assist in this pasture establishment.

**Photo 21. Messina establishing well just above the scalded seep areas (Sept 2017)**

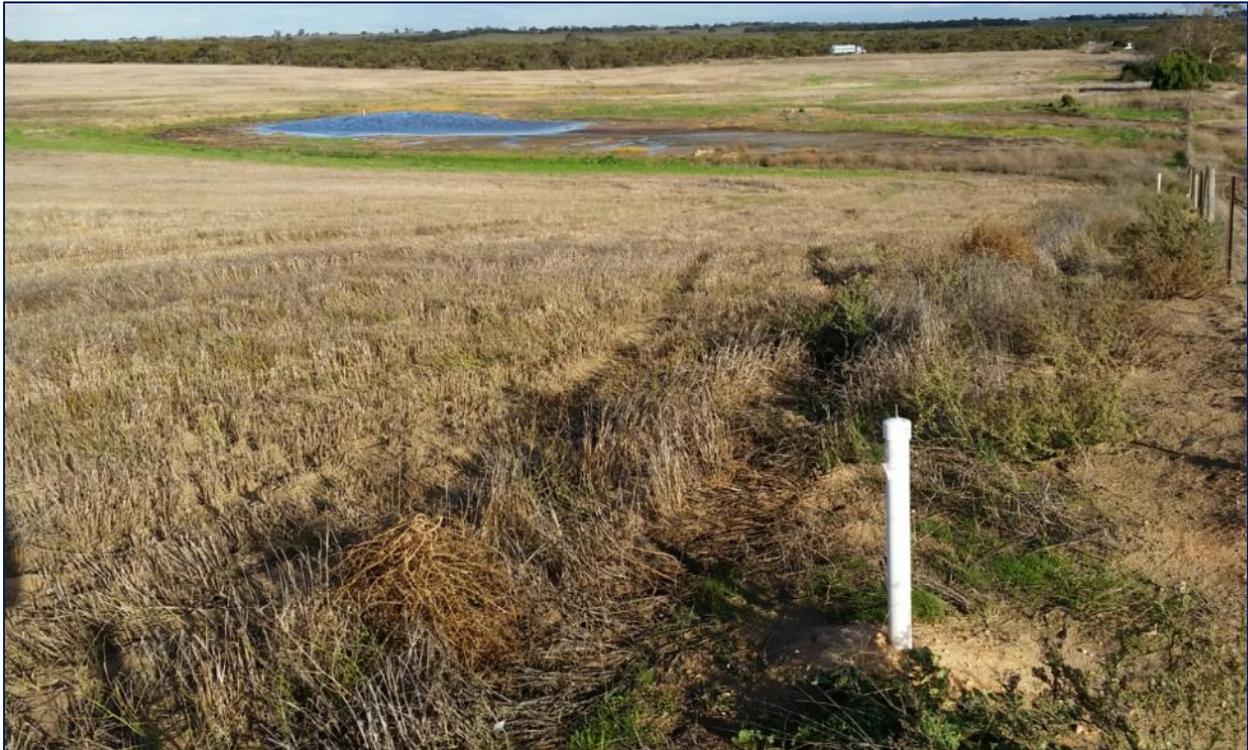
This monitoring site consists of a main seep area that is either filled with water or a bare scald below non-wetting sandhills to the north and south. The area has been expanding rapidly since its formation after 2010, most recently with scalded overflow areas and saturated cropping areas that are being overcome by ryegrass competition. The immediate site has 3 piezometers, a soil moisture probe and a rain gauge which continues to build our understanding of the soil/water/crop dynamics and their interactions in seeps formation. This area is rapidly expanding and needs to have remedial action taken immediately to halt further degradation.

**Photo 23. Main seep area, piezometers at top sand, midslope and at the edge of the seep**

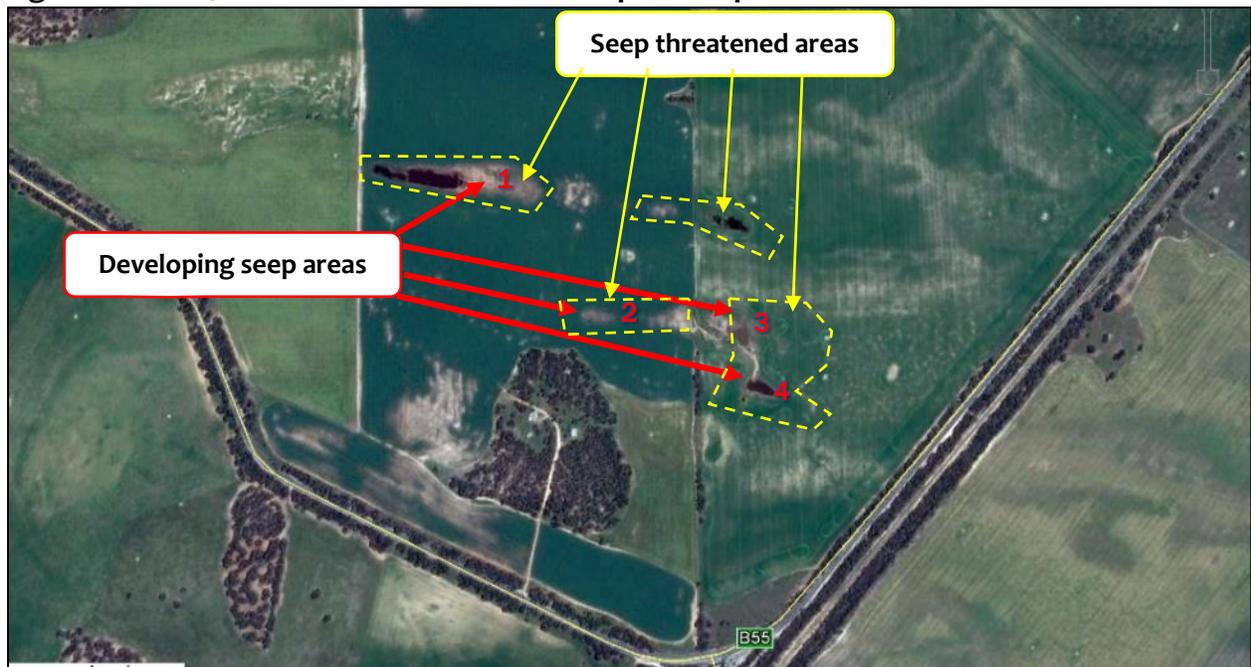
Figure 22. Rose/Thomas wider catchment seep development

Figure 22 shows large productive areas within this catchment that are currently threatened with seep degradation if no remedial action is taken. It is currently recommended that trees should be planted strategically along fence lines to intercept some of the lateral flow to lower areas. It is also advised that strips of lucerne be sown for hay production along the mid-slopes above the developing seep areas to assist in deep water use and stop the spread of seep areas. Scalded bare areas would also benefit by reducing evaporation and surface salt accumulation by establishing salt and waterlogging tolerant pastures such as puccinellia, tall wheat grass and Messina.

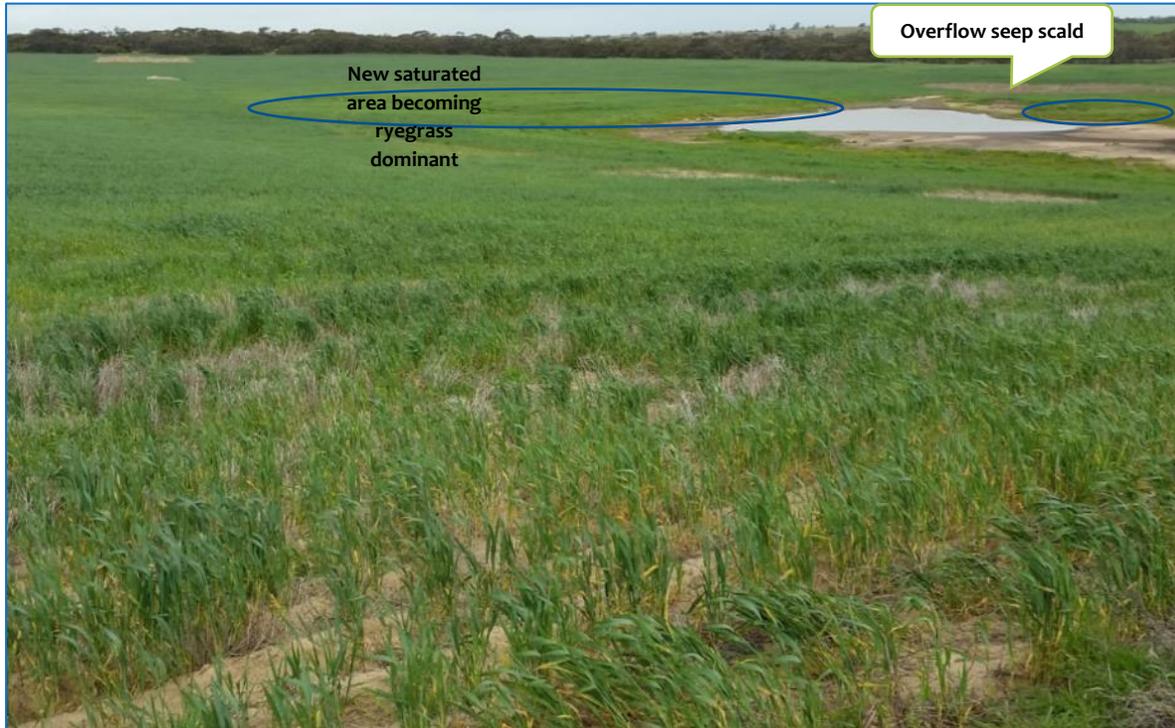
Photo 24. View from top of sandhill showing expanding areas around main seep

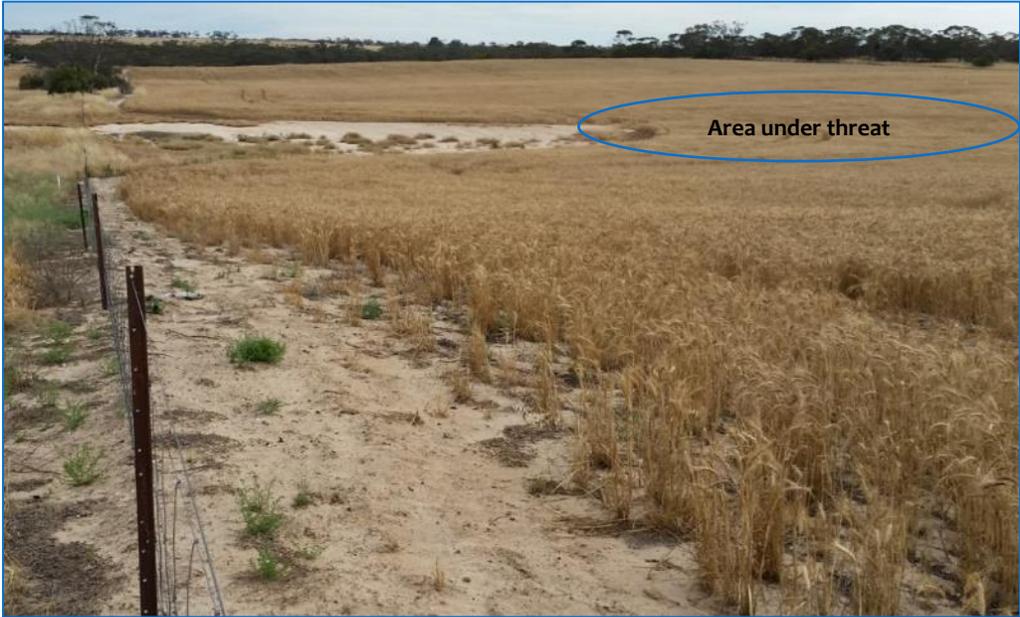
**Photo 27. View of eastern seep area showing area under seeps threat**

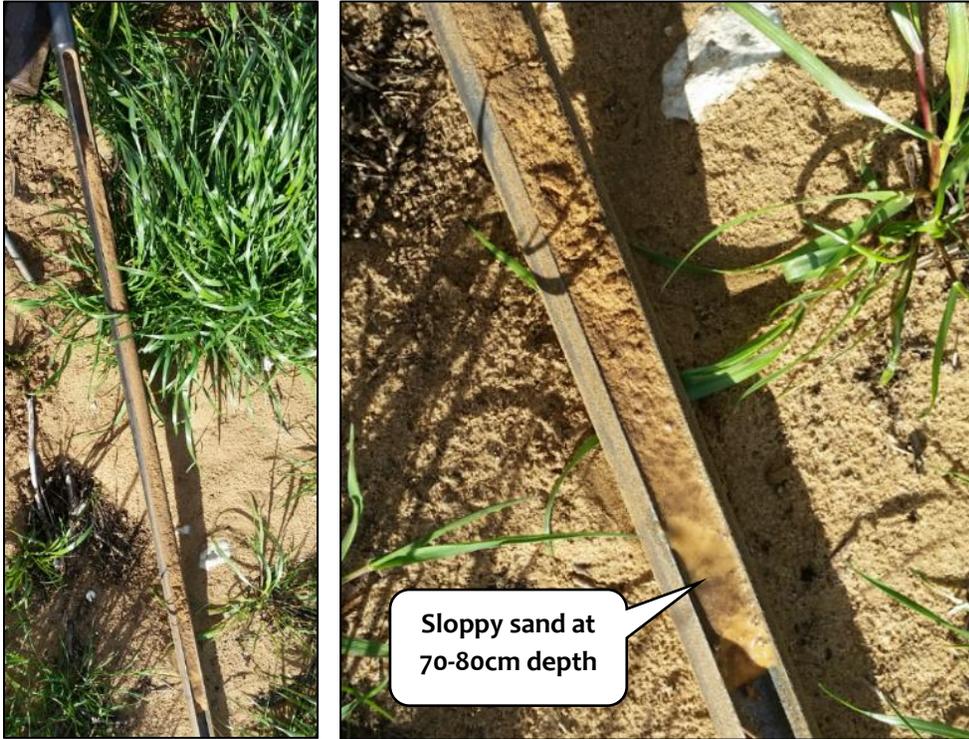
**Photo 31. Saturated sand below ryegrass areas near Seep 2**

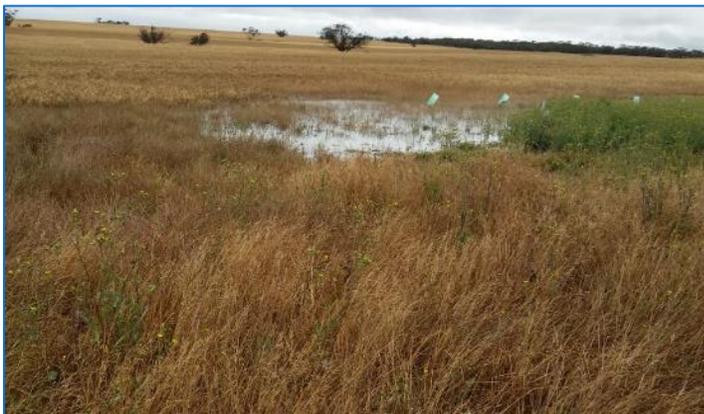
**Photo 33. Ponding at the base of Seep 1a, Nov 2017**

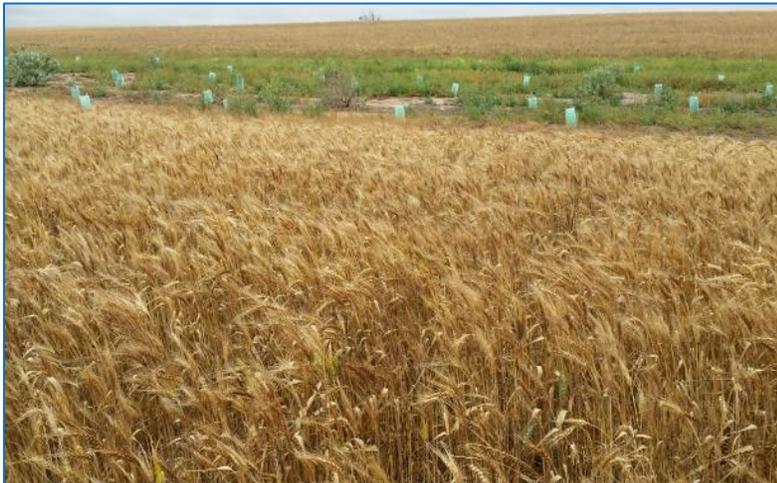
**Photo 34. Excellent wheat yield near Seep 1a, utilizing excess moisture in dry season**

Photos 34 and 35 illustrate the progression of productive ground into land degradation. Initially the extra fresh subsoil water can provide a huge advantage to the growth of a wheat crop, particularly in a dryer season. However, as the soil becomes saturated for longer, the soil becomes too wet for wheat, and the ryegrass dominates. However, this is still at a stage when the productive potential of the soil could be maintained and restored, provided steps are taken to use up the excess moisture flow into these areas.

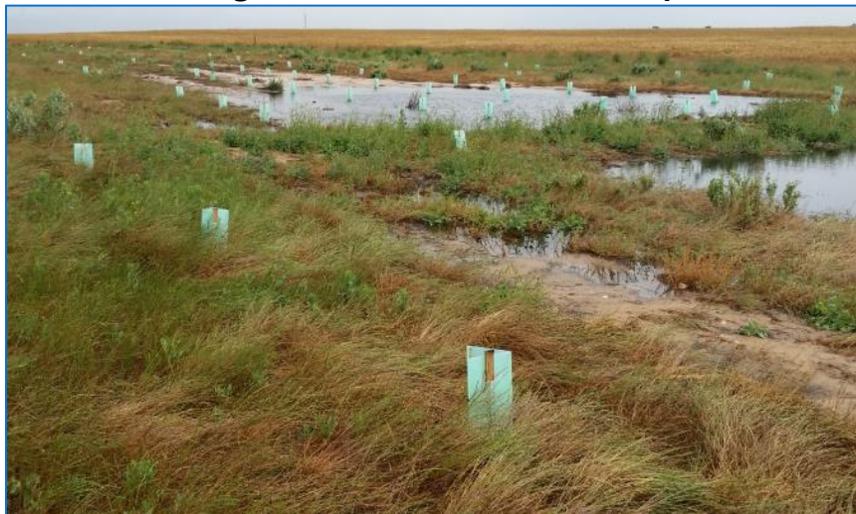
**Photo 37. Ponding still evident in Nov 2017 in Seep 2 saltbush area fresh**

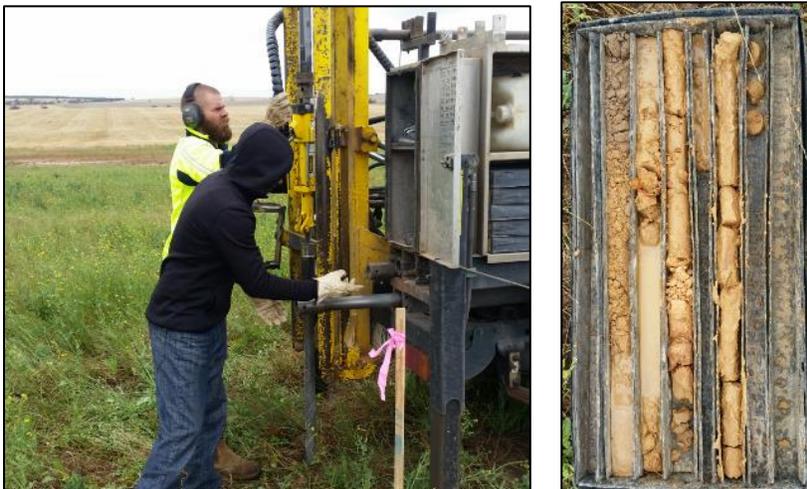
Piezometer 20 is placed below the tree line near the top edge of the seep area (see Photo 54). Photo 51 shows the soil profile of the drill hole which was found to a very sloppy clay at approximately 60cm depth, indicating the top of the water table, as evident in Photos 51-52.

**Photo 51. Drilling Piezometer between tree line and seep area, showing soil profile**

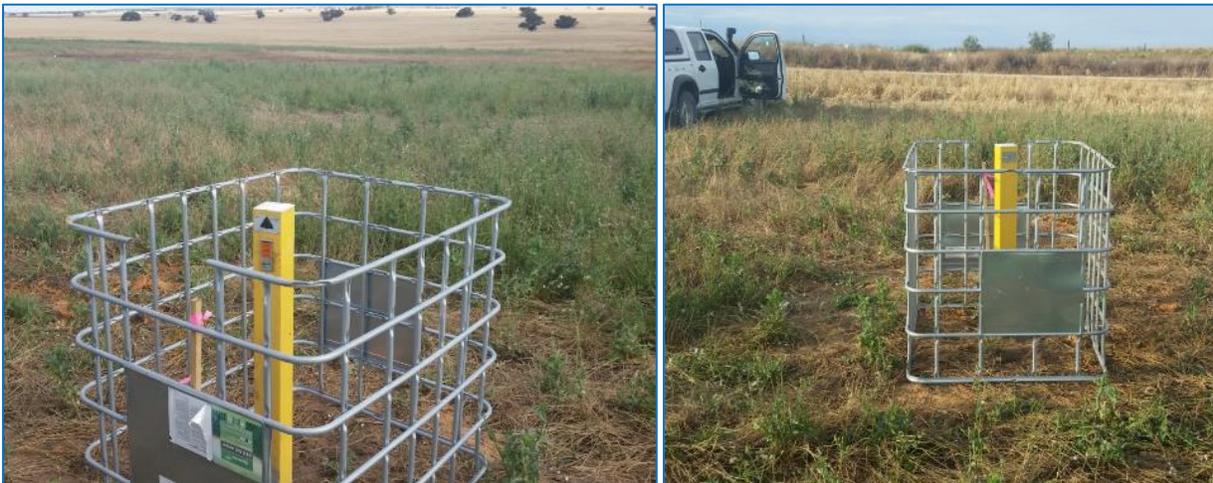
Photo 54. Piezometer 20 on northern side of Seep area 3, below the tree line

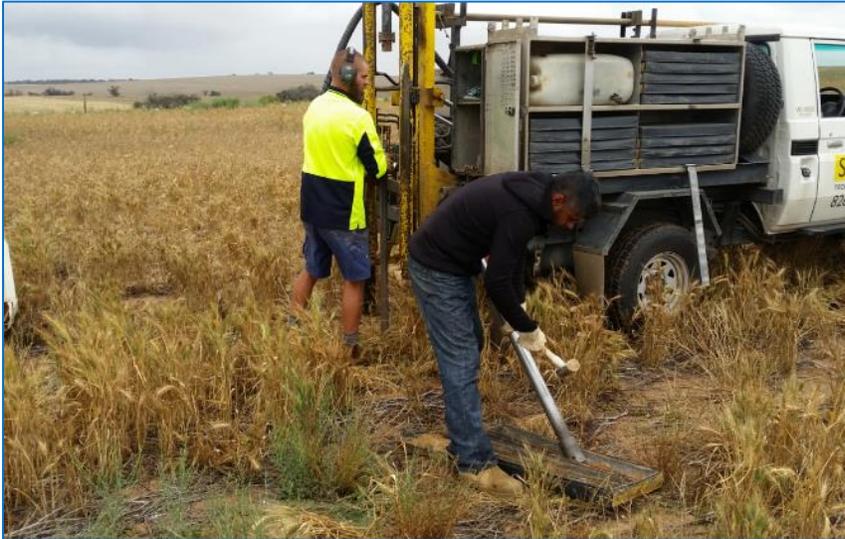
Photo 55. Site of unsuccessful piezometer drill where no water table found to 7m.

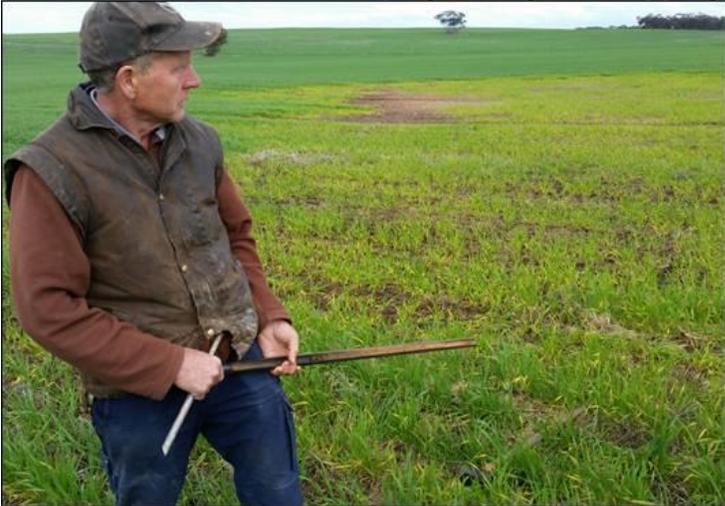
The major development in 2017 was the large areas of saturated soils appearing and affecting crop growth, resulting from the well above average rainfall in 2016, as clearly evidenced in Photos 60-64. The new areas under immediate threat are as high as 10-20ha.

**Photo 60. Kevin Bond surveying damage to cropping land resulting from wet 2016 season**

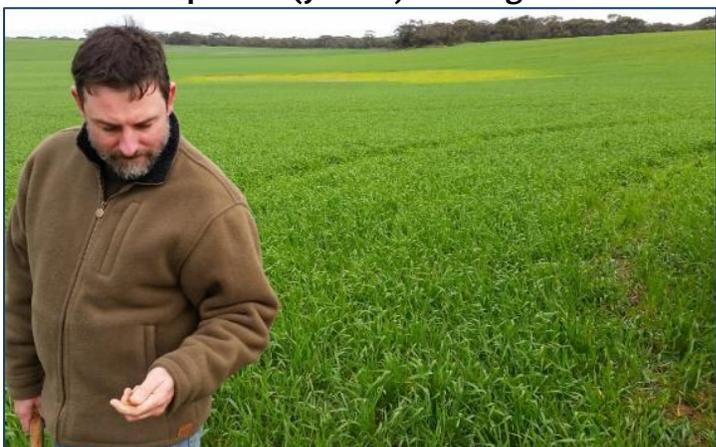
**Photo 62. Seep areas (yellow) forming at base of sandy rises**

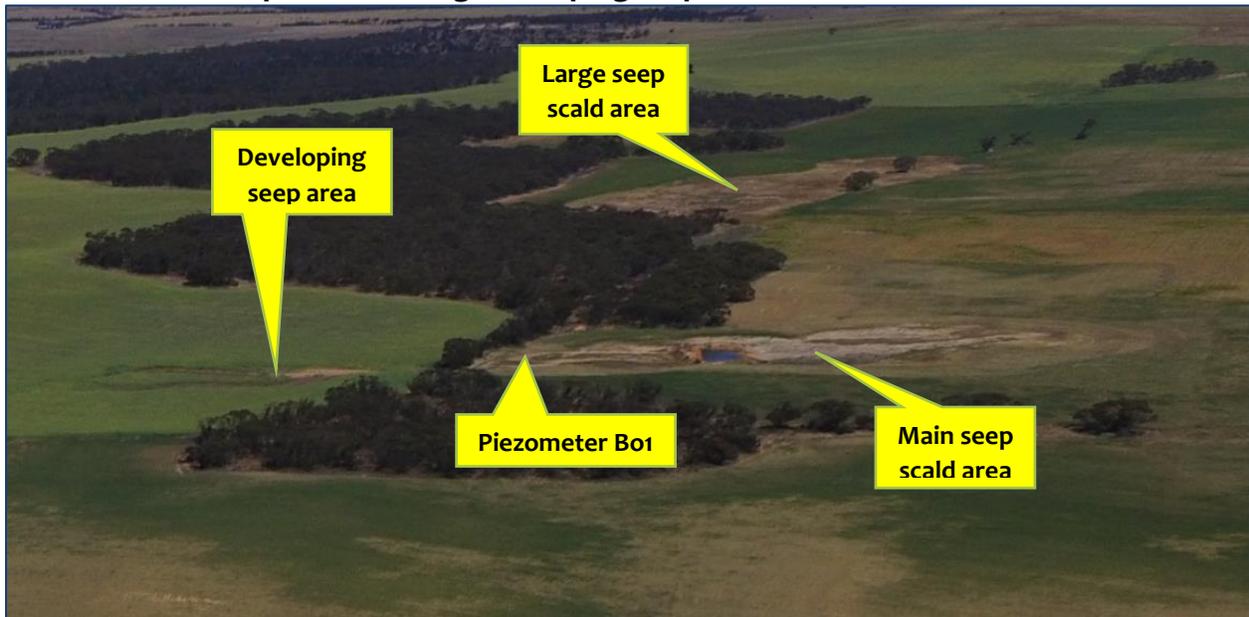
**Photo 66. Main seep area showing developing seep below**

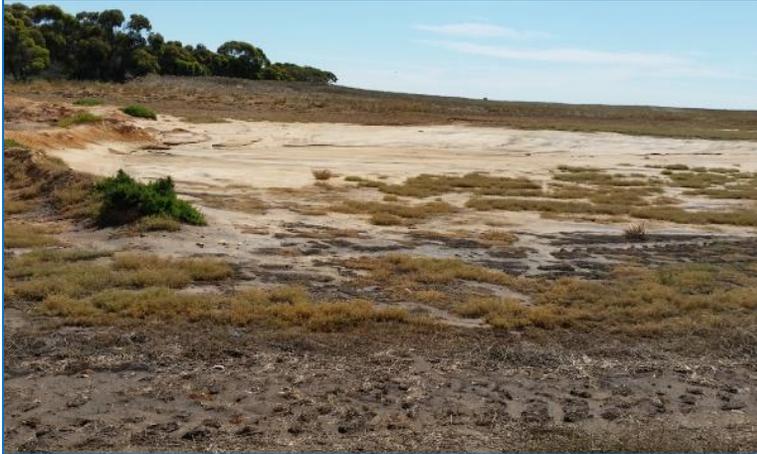
**Photo 70. Main seep scald area**

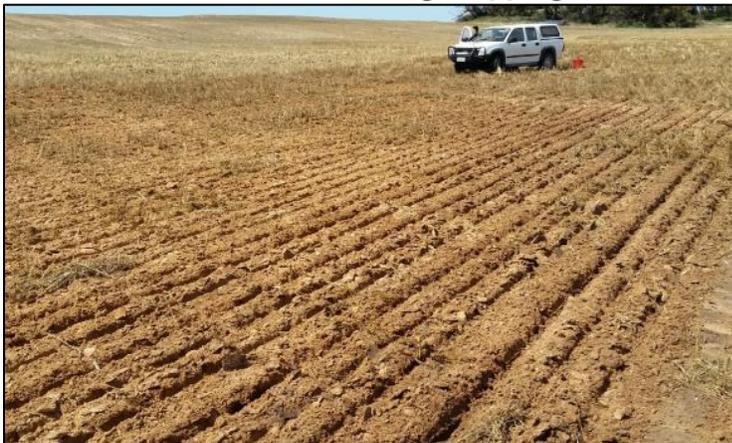
**Photo 71. Area saturated during cropping season sown to millet after harvest**

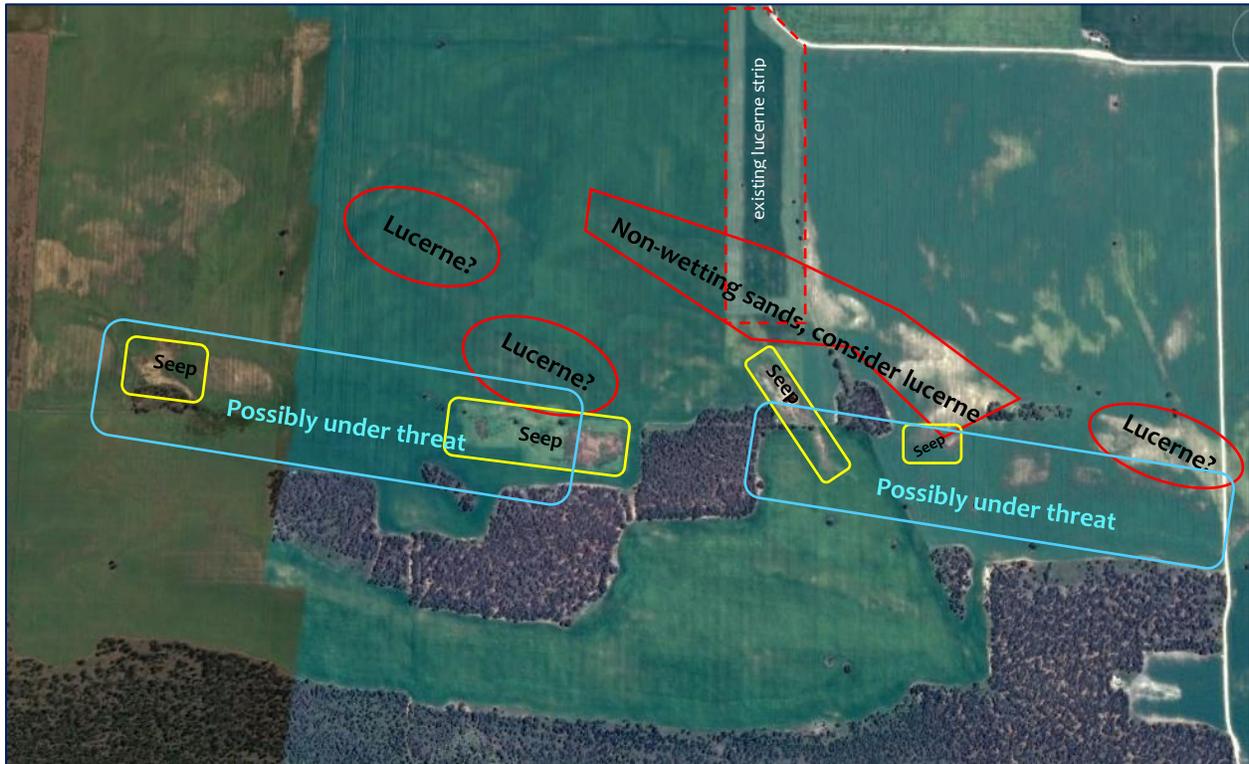
Figure 32. Seep site showing possible lucerne strips and areas needing protection

The key message for this farm and those in similar situations is that unless strategic action is taken, the seep areas will continue to grow, become scalded, saline and unproductive.
