Baroota Creek
Tree condition surveys
December 2022 - October 2025

FINAL REPORT
Produced by Todd Wallace
Riverwater Life Pty Ltd
December 2025

Report produced by Riverwater Life Pty Ltd for the Northern and Yorke Landscape Board

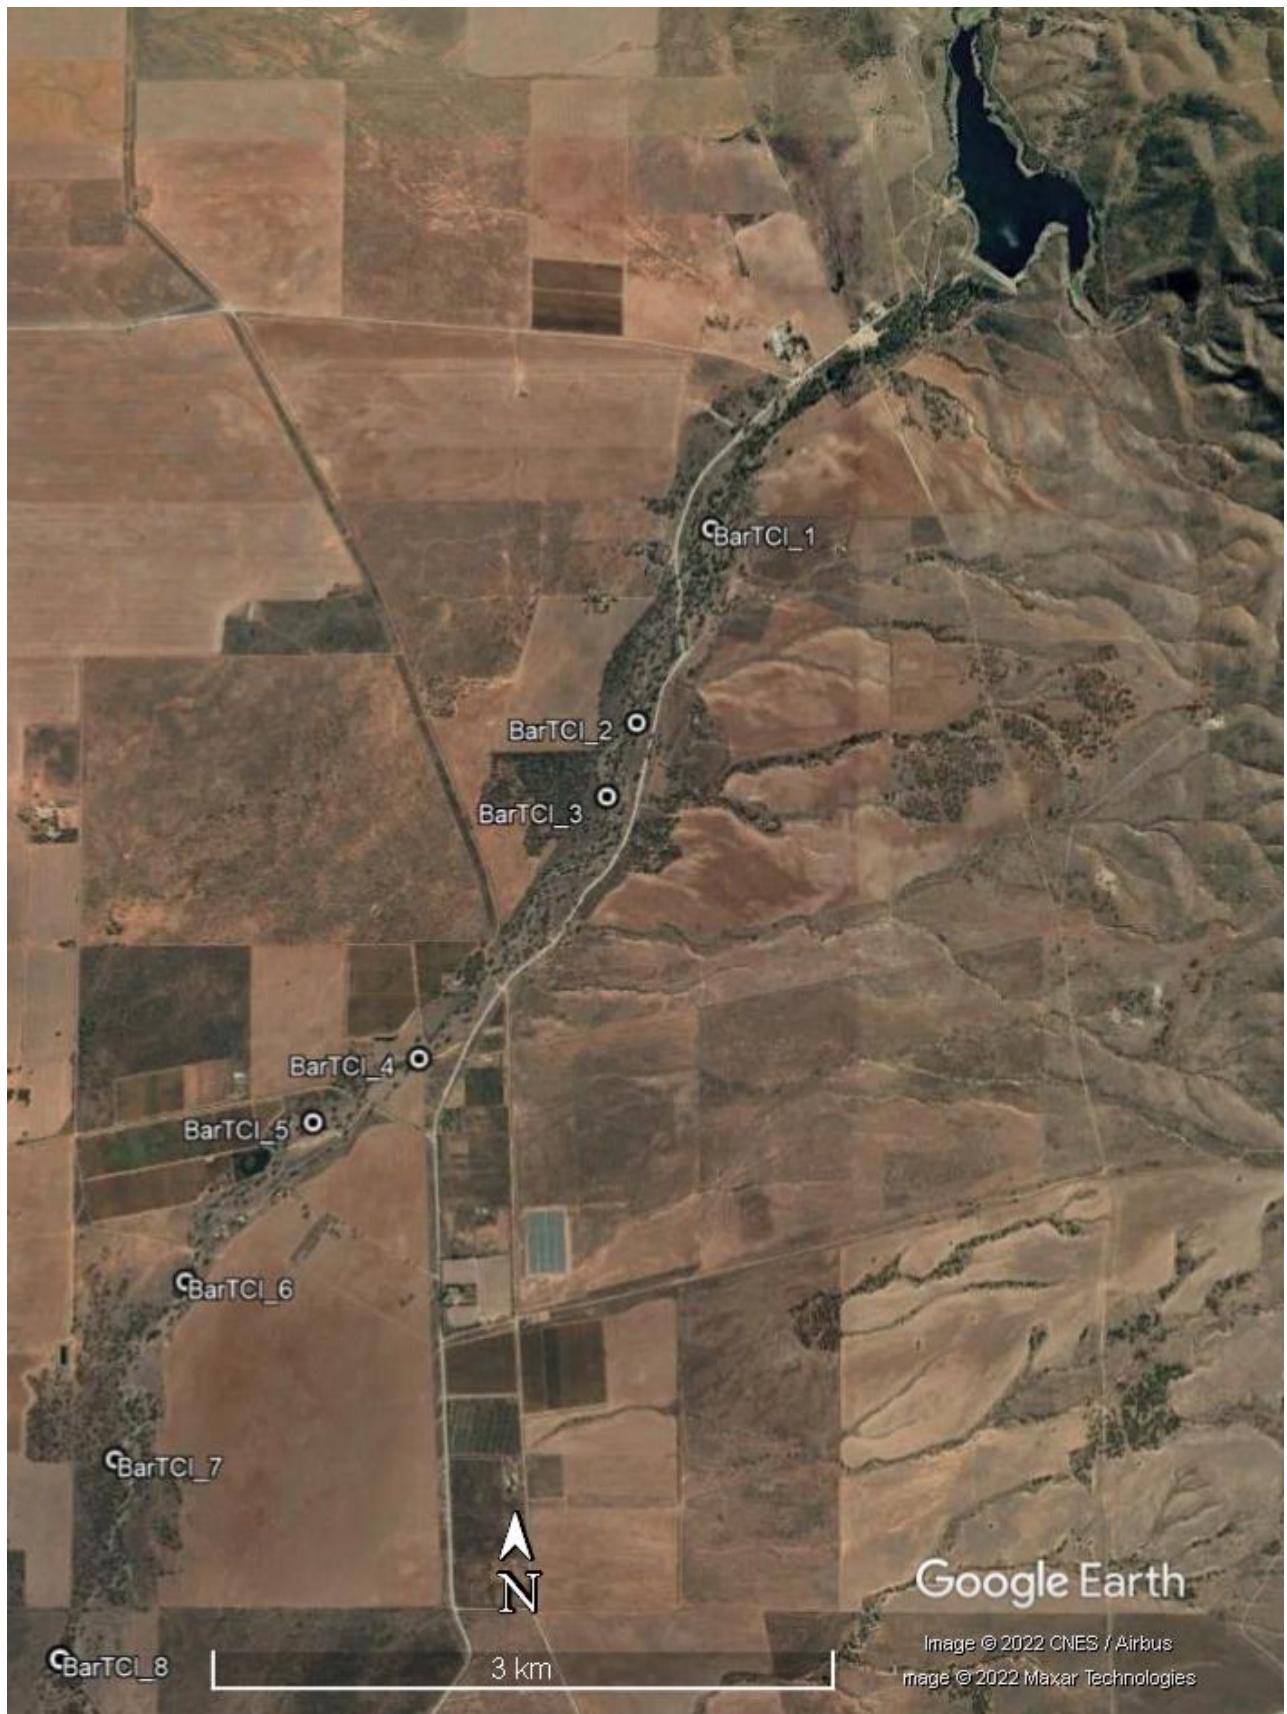
Figure 1: Locations of tree condition transects along Baroota Creek downstream of Baroota Reservoir

It is preferable that monitoring for multiple attributes (e.g. tree condition, groundwater, soil condition, understory vegetation) are co-located so as to maximise the interpretation of data and trajectory of condition. For this project, assessment sites that are being used for geophysics (soil condition) and tree physiology monitoring currently being undertaken by the Flinders University (Banks and Shanafield 2022) were retained to maximise the management utility of collected data. Site locations are presented in Table 1 and Figure 1. The eight assessment areas (Table 1) were established as transects (not spatially constrained).

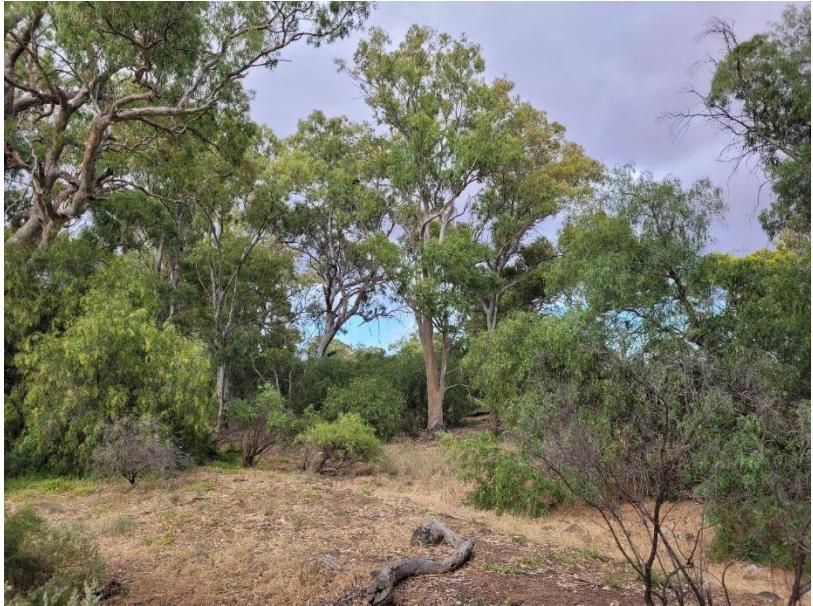
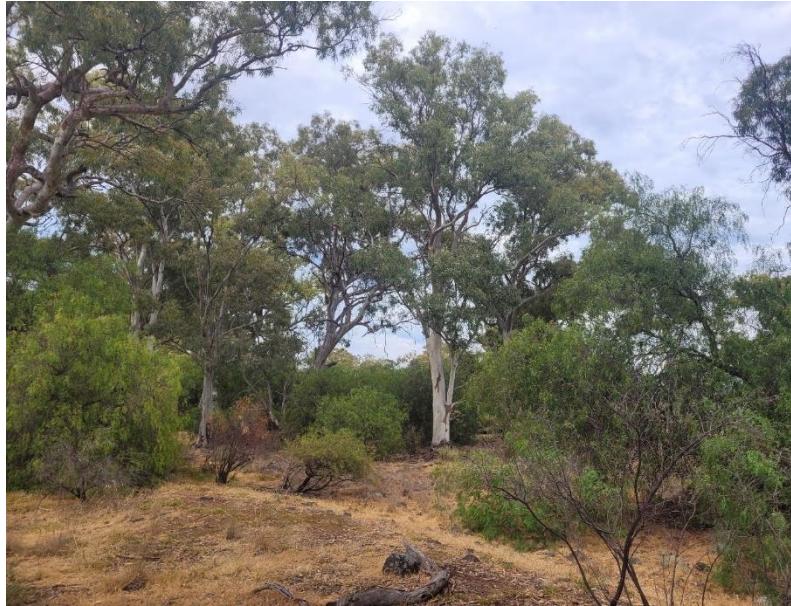
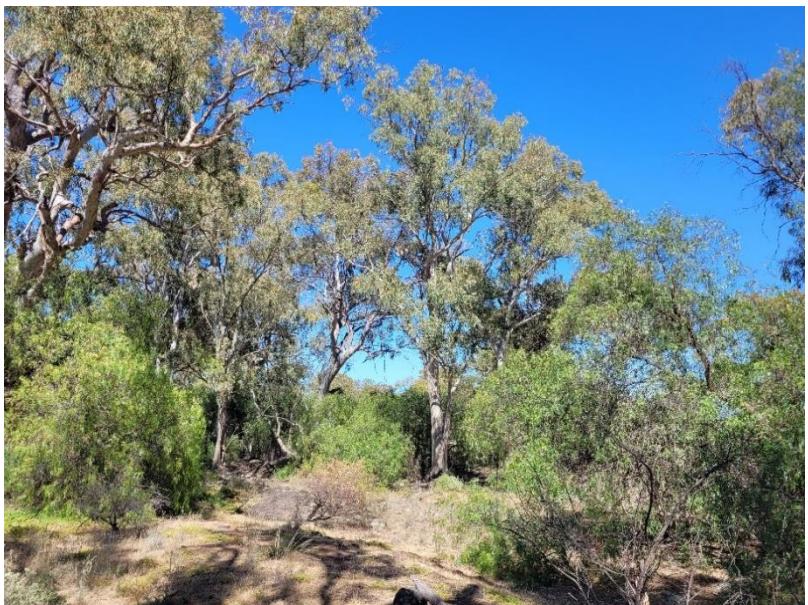
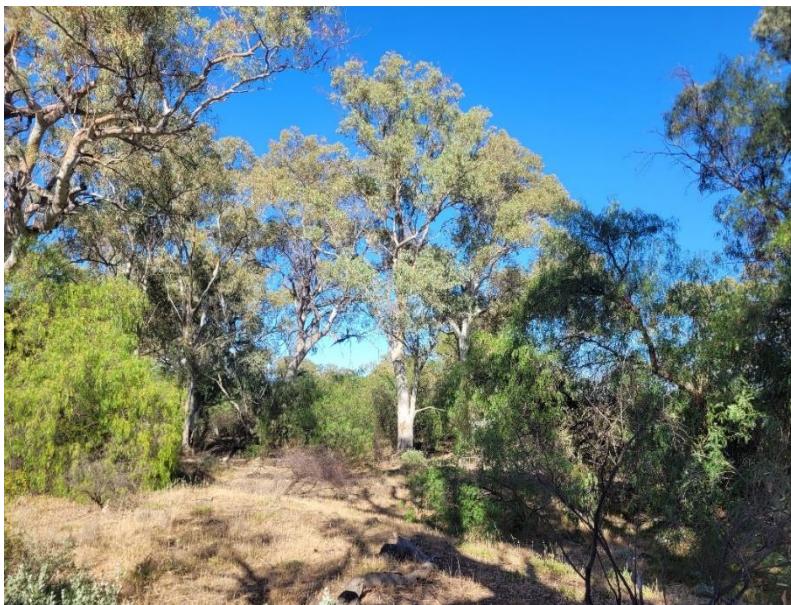
Figure 6: Ground based photo-point of BarTCI_1. Top left panel December 2022, Top right panel November 2023, Bottom left panel November 2024, Bottom right panel October 2025.

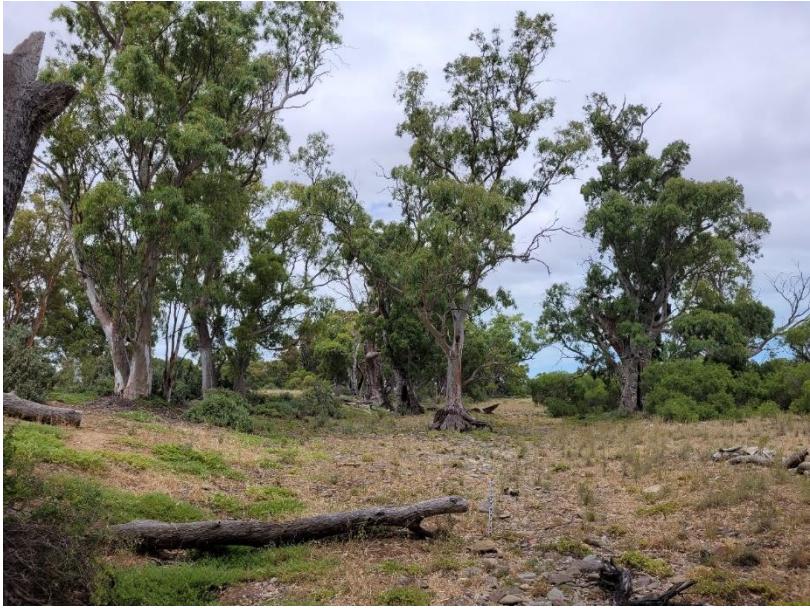
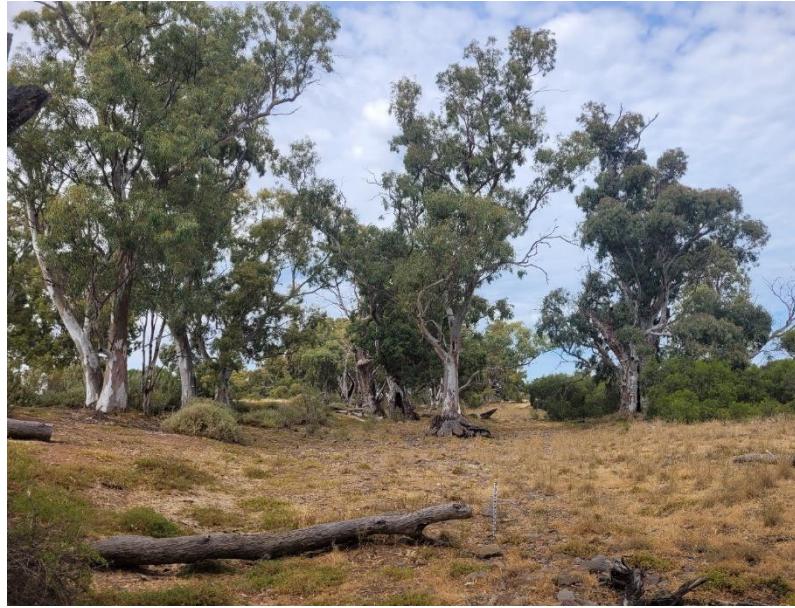
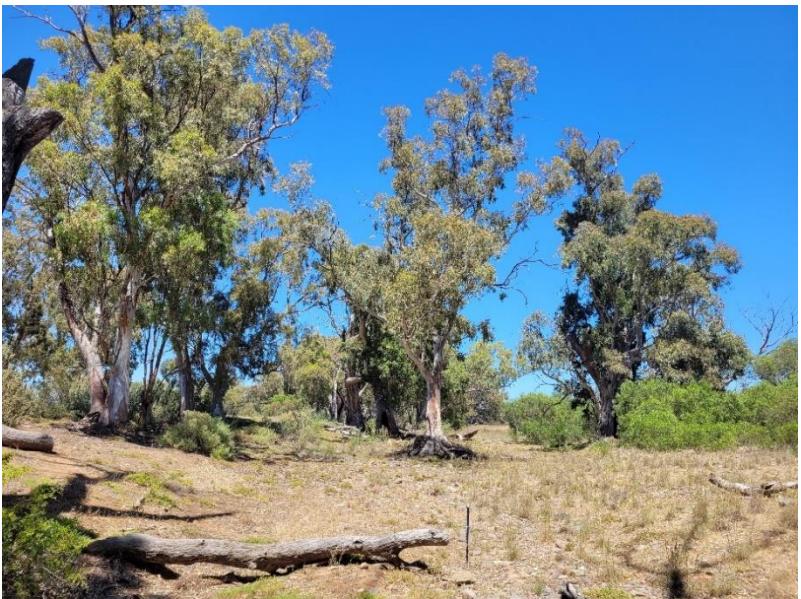
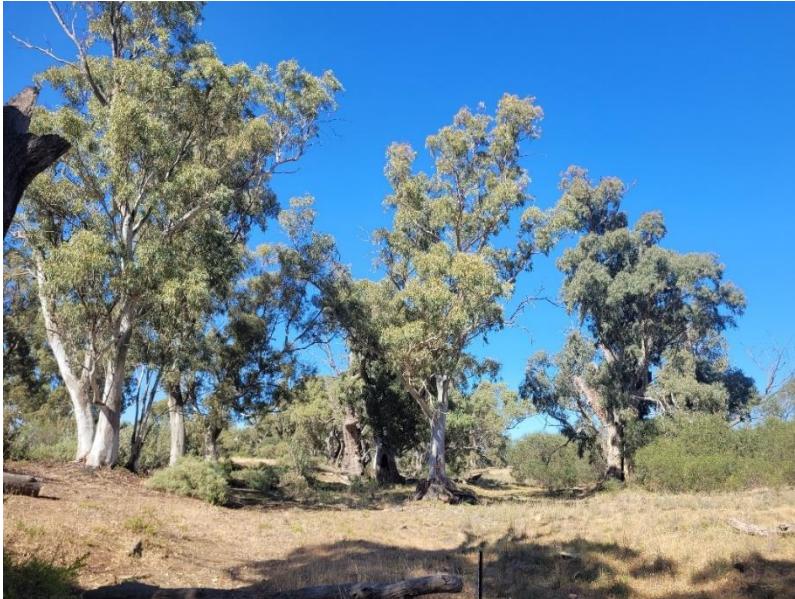
Figure 7: Ground based photo-point of BarTCI_2. Top left panel December 2022, Top right panel November 2023, Bottom left panel November 2024, Bottom right panel October 2025.||

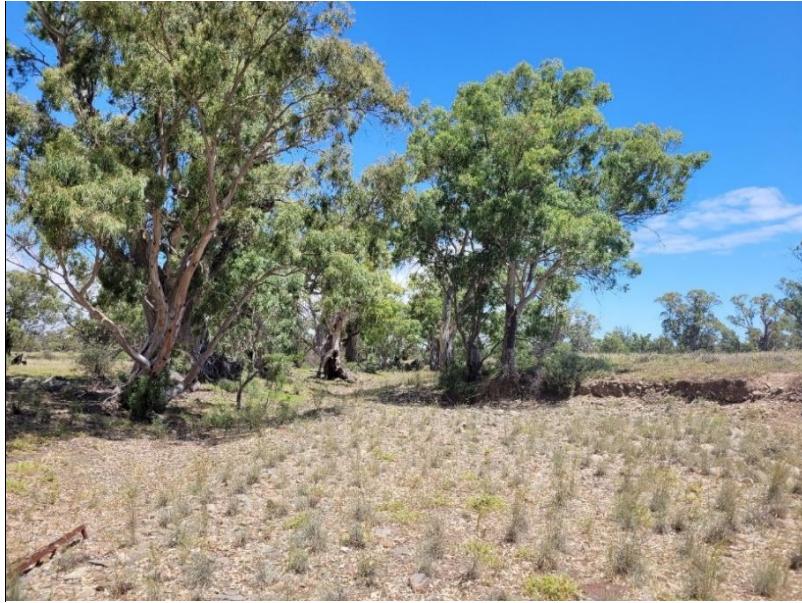
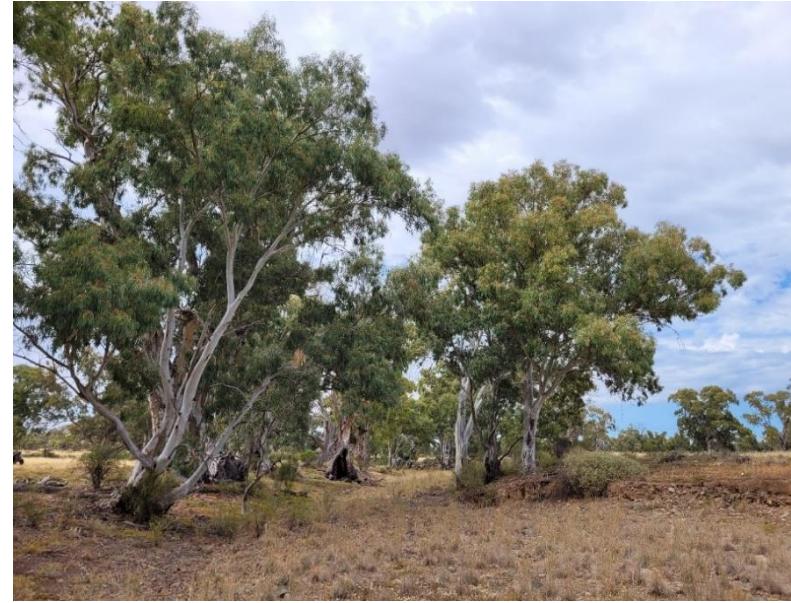
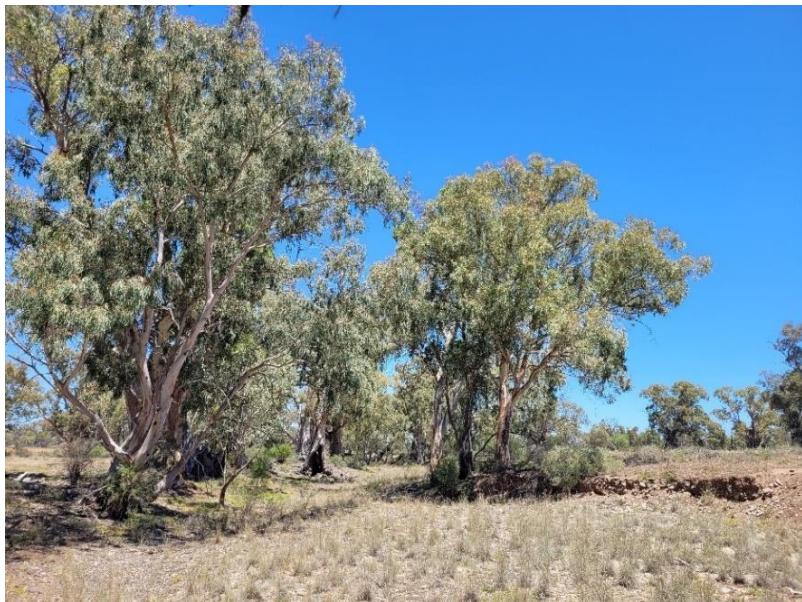
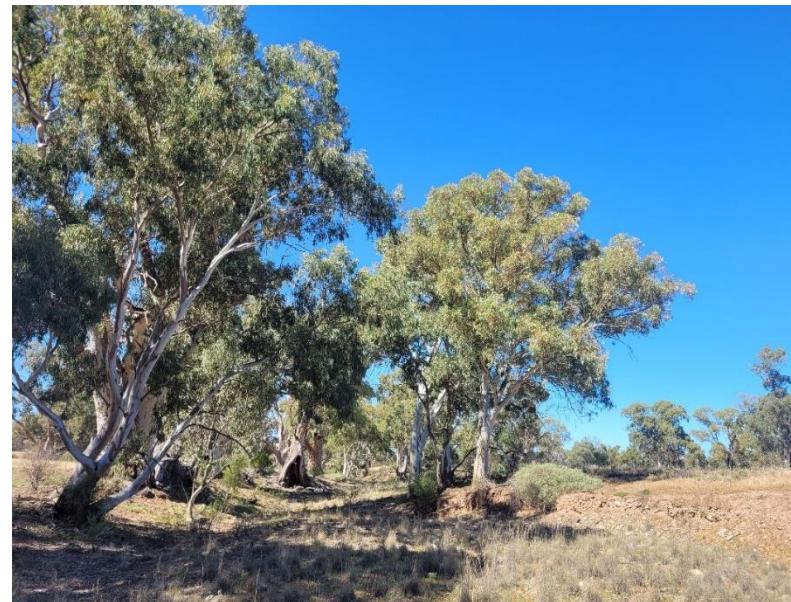
In transect 4 (BarTCI_4), one tree became defoliated between the December 2022 and November 2023 surveys. In transect 3, (BarTCI_3), one tree became defoliated between the November 2023 and November 2024 surveys. In both cases, the trees were rated as ‘very poor’ condition in the preceding survey. In October 2025, one tree that had been in poor condition in all preceding surveys became defoliated.

Figure 8: Ground based photo-point of BarTCI_3. Top left panel December 2022, Top right panel November 2023, Bottom left panel November 2024, Bottom right panel October 2025.

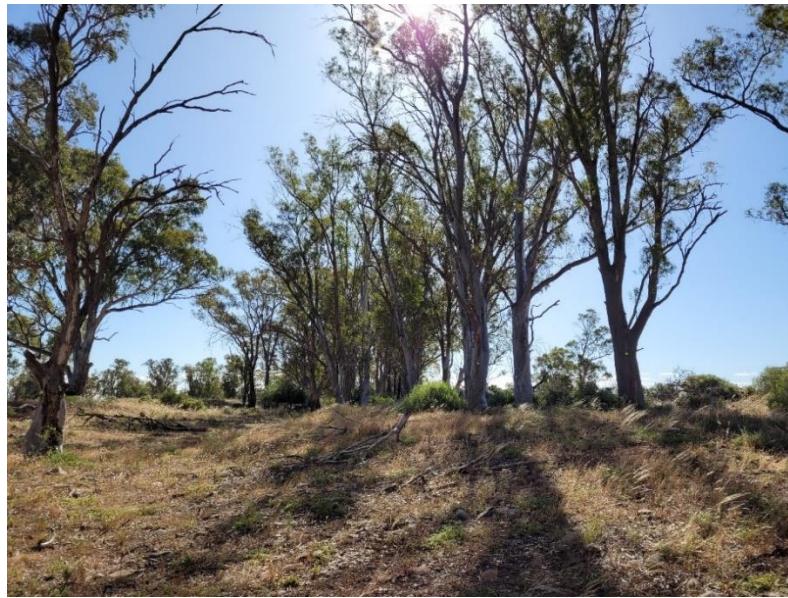
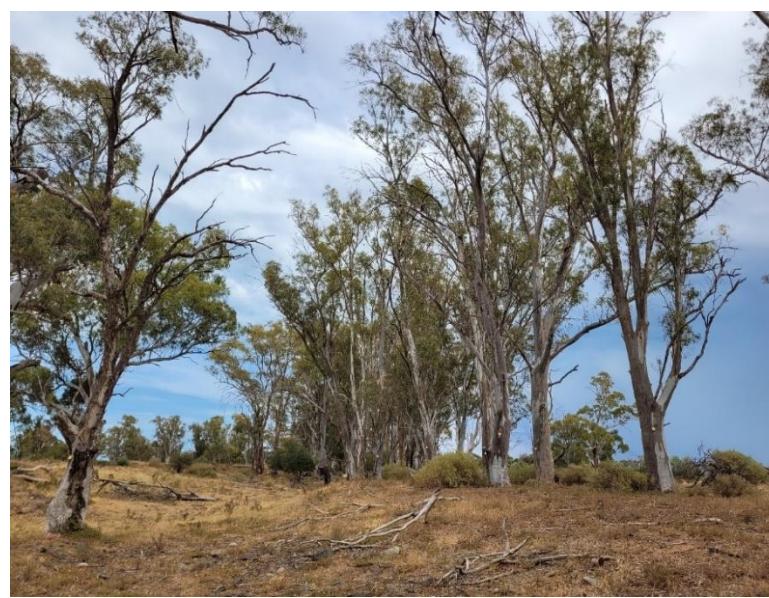
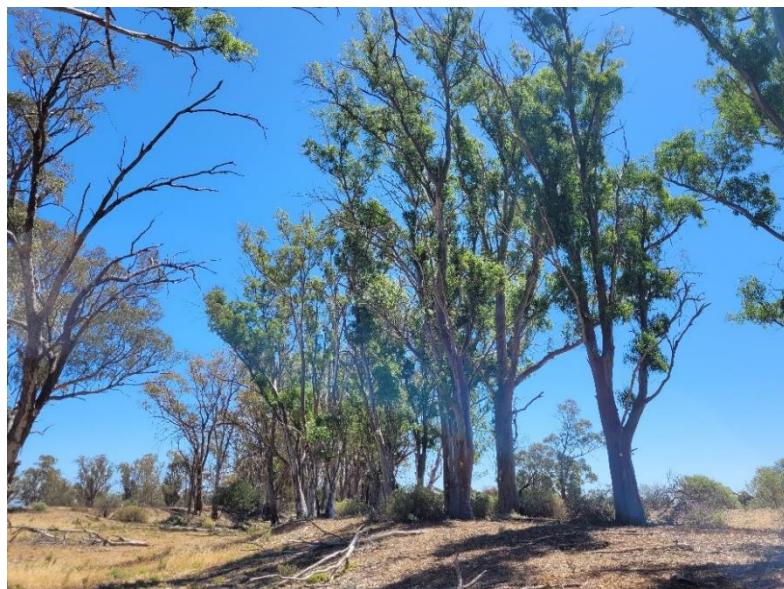
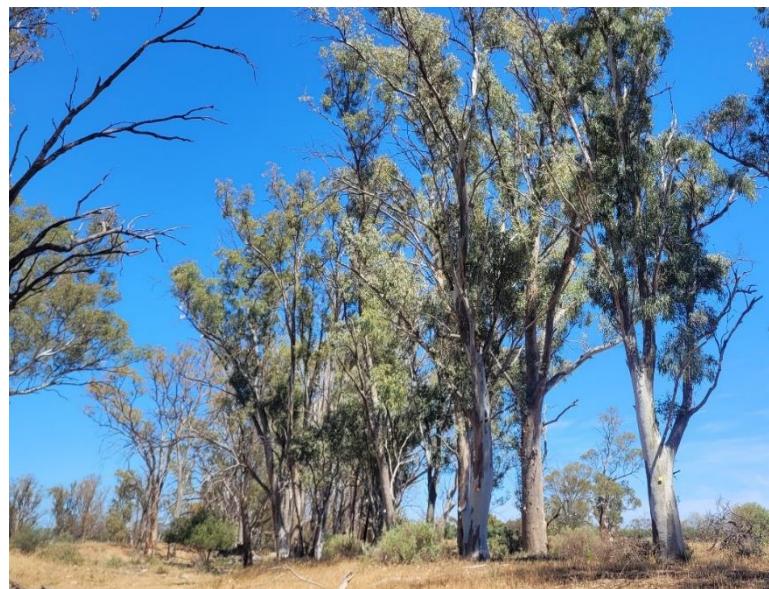
Figure 9: Ground based photo-point of BarTCI_4. Top left panel December 2022, Top right panel November 2023, Bottom left panel November 2024, Bottom right panel October 2025.

In November 2023, condition at transect 4 (BarTCI_4) had been approaching a critical tipping point. An environmental flow was delivered at the start of September 2024 which reached this location. Between the November 2023 and November 2024 surveys, condition improved substantially with some improvement continuing through to October 2025. However, the crown of these trees is dominated by recent epicormic growth (Figure 14), and their habitat value is compromised as a result. One tree was lost (became completely defoliated) between November 2024 and October 2025. In the October 2025 survey, one tree received the lowest possible field score. It is anticipated that in the absence of a substantial flow event, this tree will be recorded as defoliated in the 2026 survey.

Based on the partial recovery observed at transect 4, combined with the gradual improvement in condition at transects 1-3, the recent loss of trees, and the ongoing presence of trees with TCI scores ≤ 8 , it is recommended that pending water availability, planning for delivery of additional environmental water releases commence as soon as practicable. This will support the ongoing recovery of trees that have previously responded to improved soil water potential (as indicated by the high prevalence of epicormic growth), and (iii) increase the likelihood of recovery and achieving the Environmental Target.

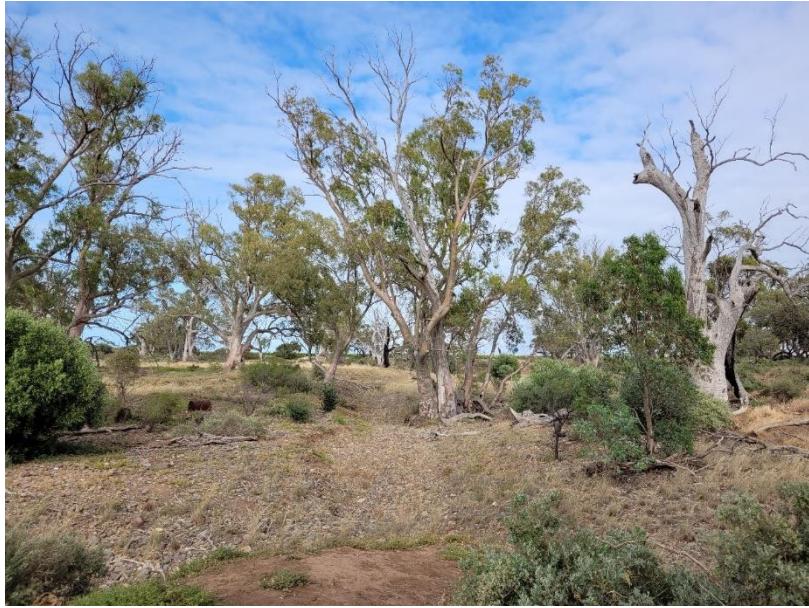
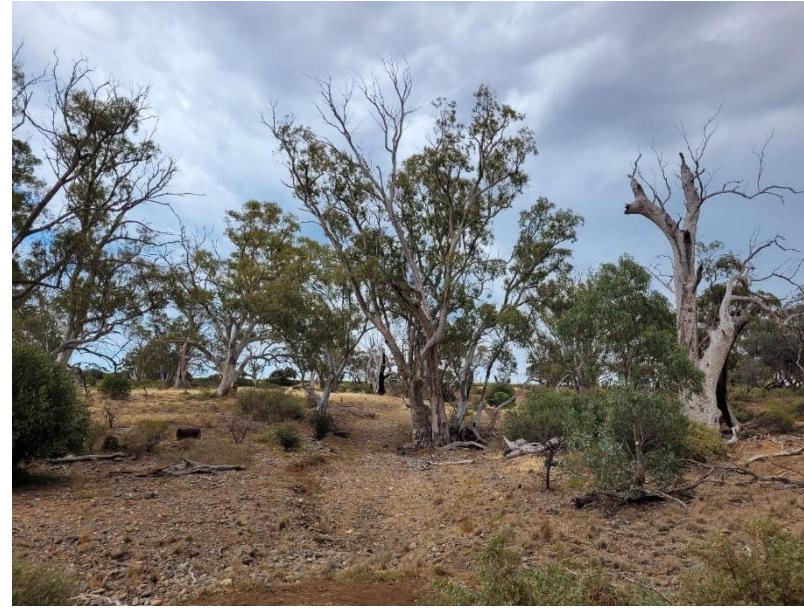
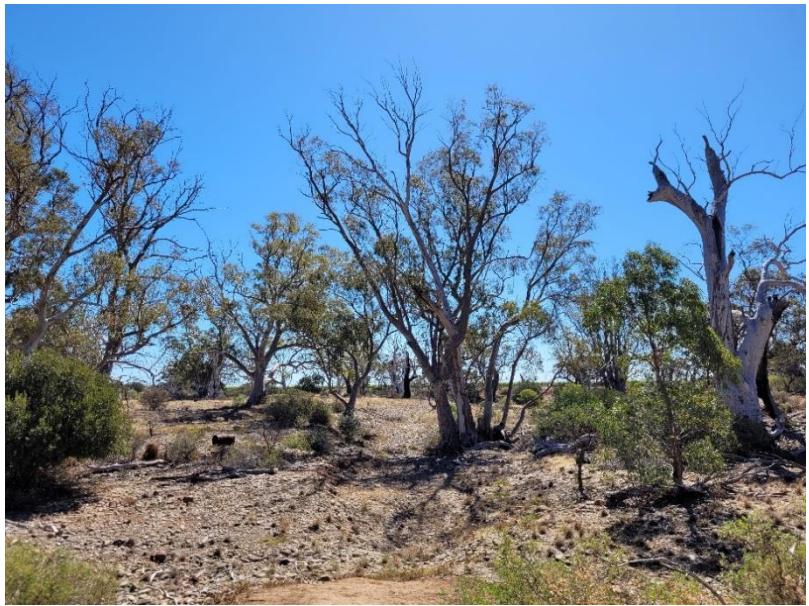
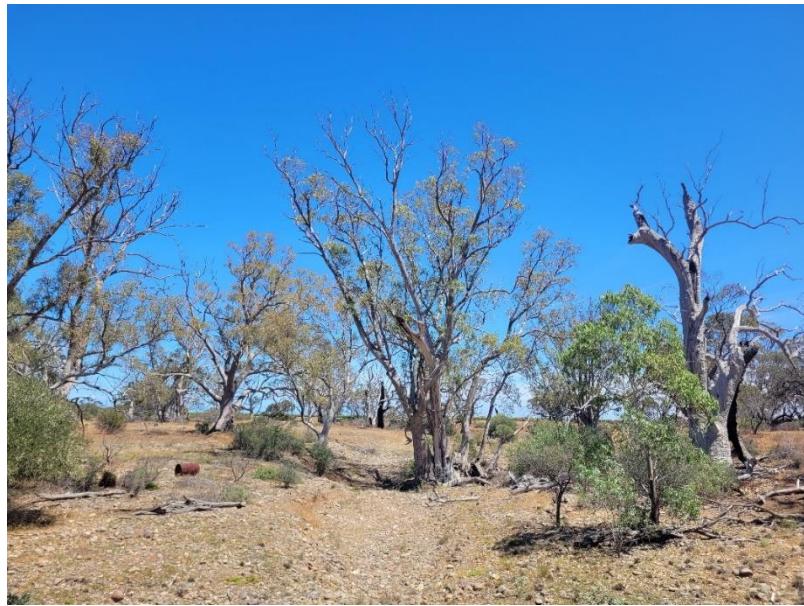
Figure 10: Ground based photo-point of BarTCI_5. Top left panel December 2022, Top right panel November 2023, Bottom left panel November 2024, Bottom right panel October 2025.

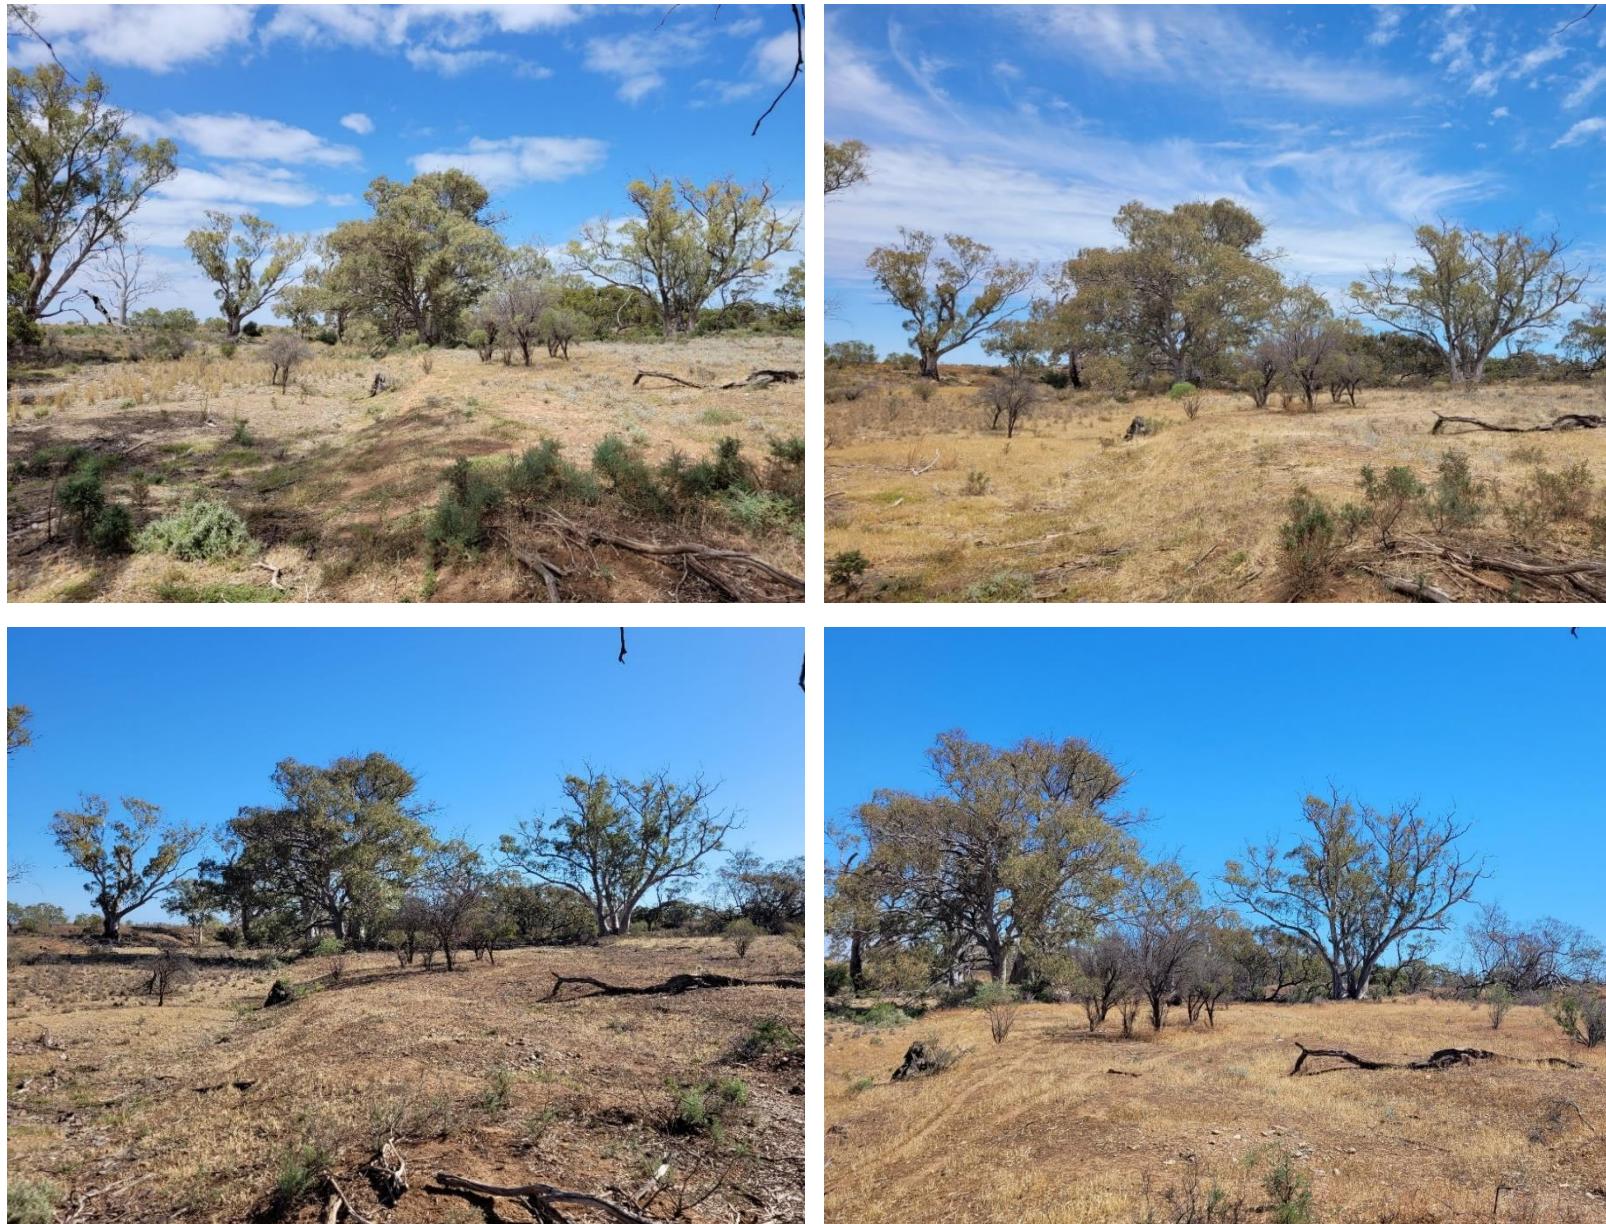
Figure 11: Ground based photo-point of BarTCI_6. Top left panel December 2022, Top right panel November 2023, Bottom left panel November 2024, Bottom right panel October 2025.

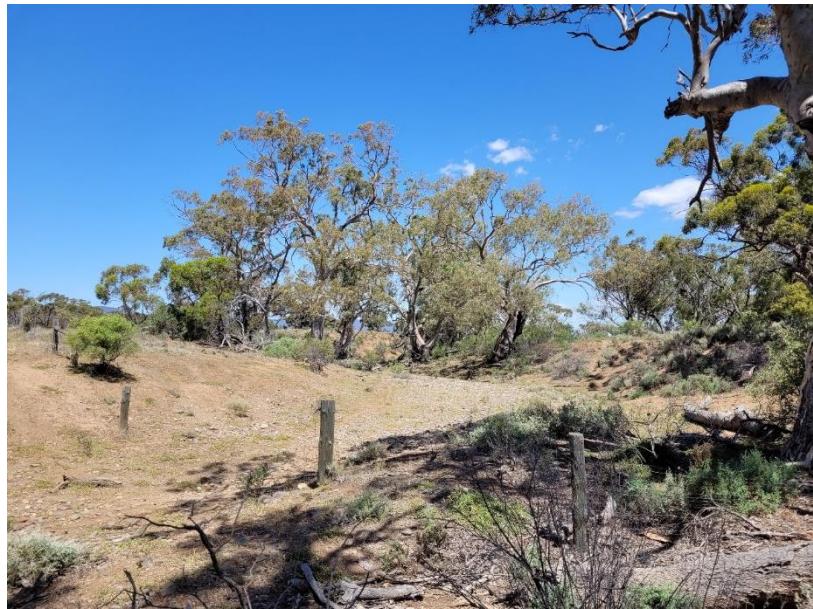
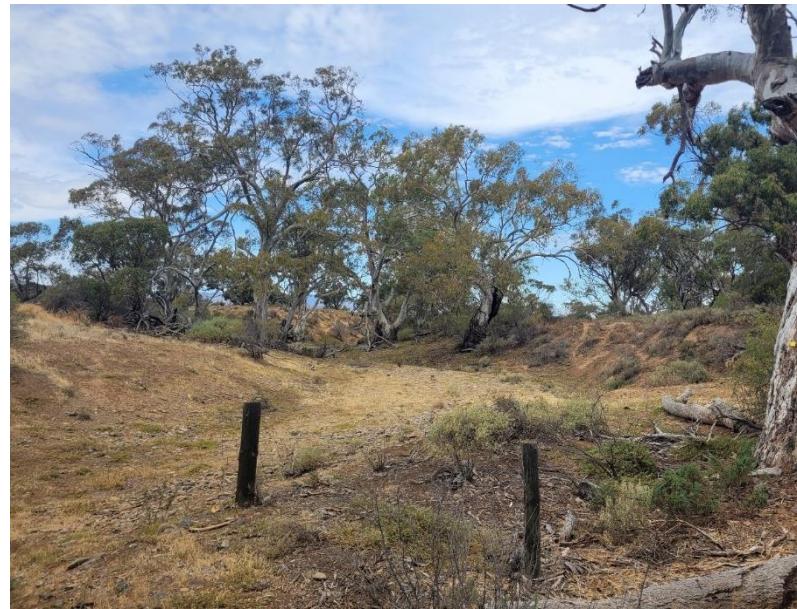
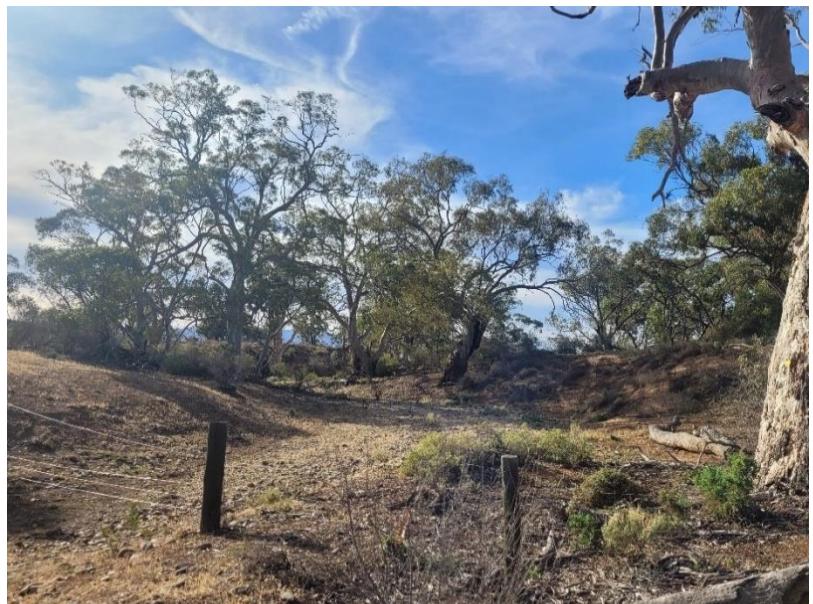
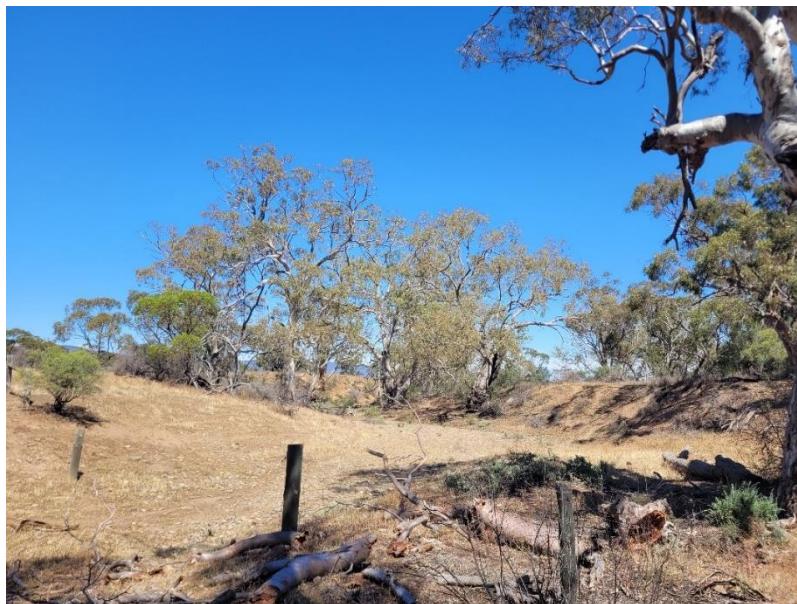
Figure 12: Ground based photo-point of BarTCI_7. Top left panel December 2022, Top right panel November 2023, Bottom left panel November 2024, Bottom right panel October 2025.

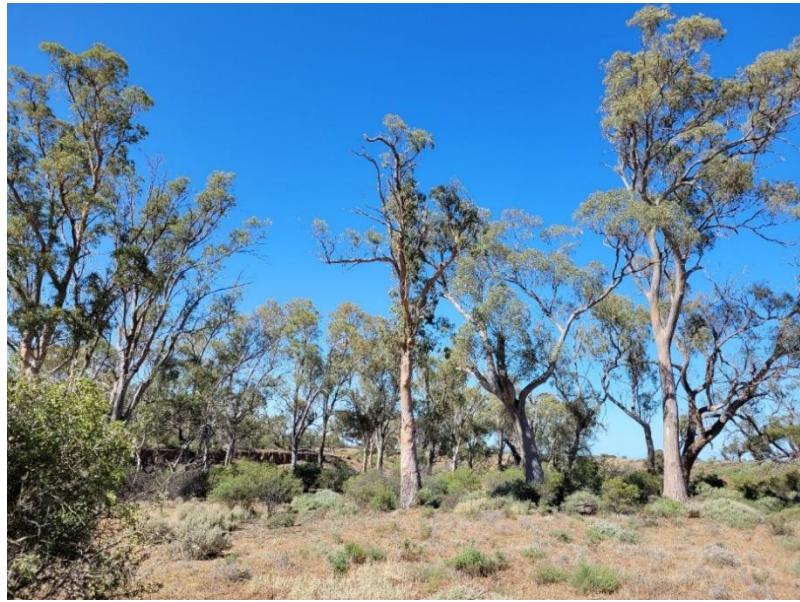
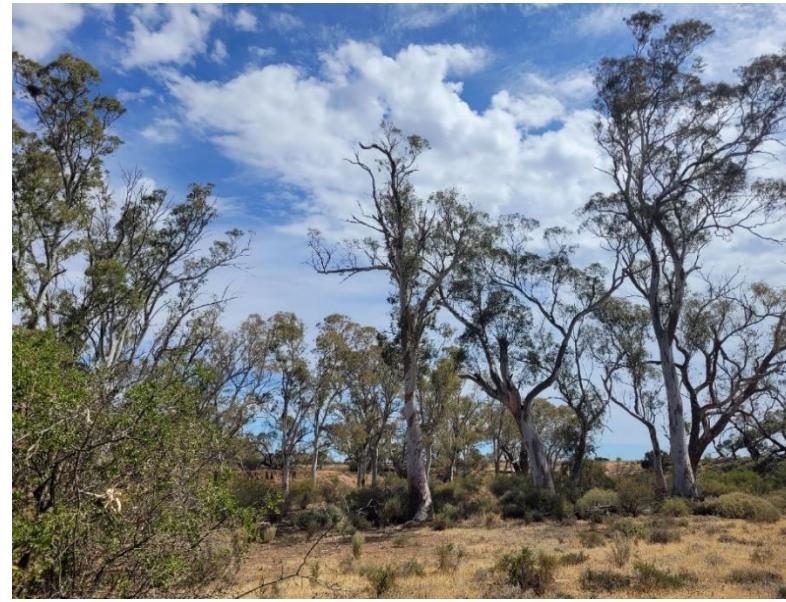
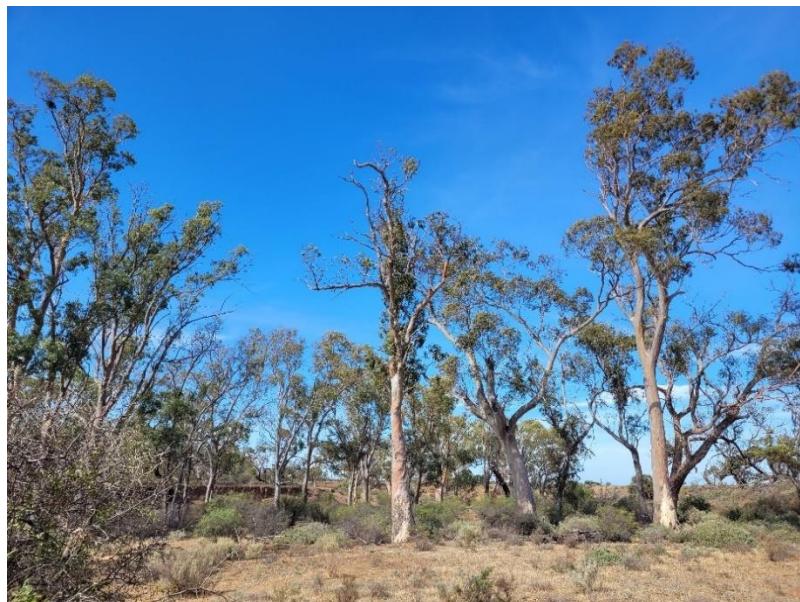
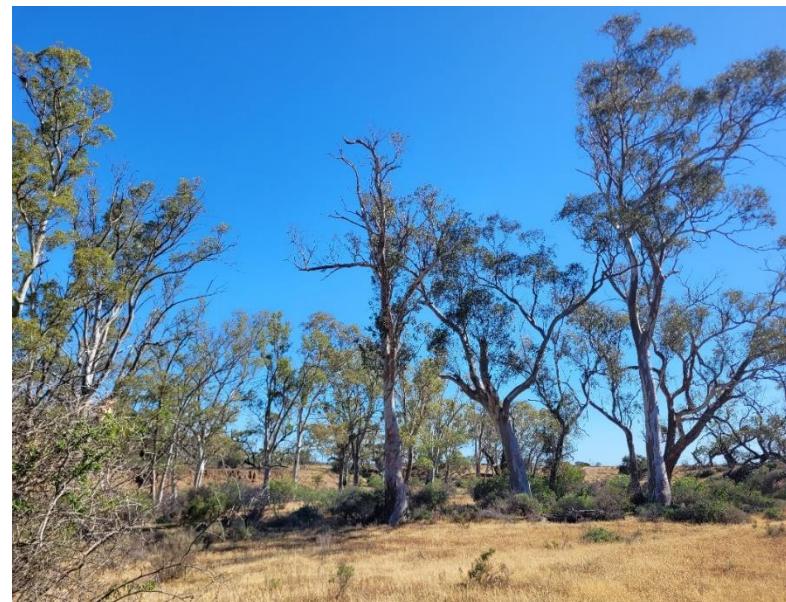
Figure 13: Ground based photo-point of BarTCI_8. Top left panel December 2022, Top right panel November 2023, Bottom left panel November 2024, Bottom right panel October 2025.

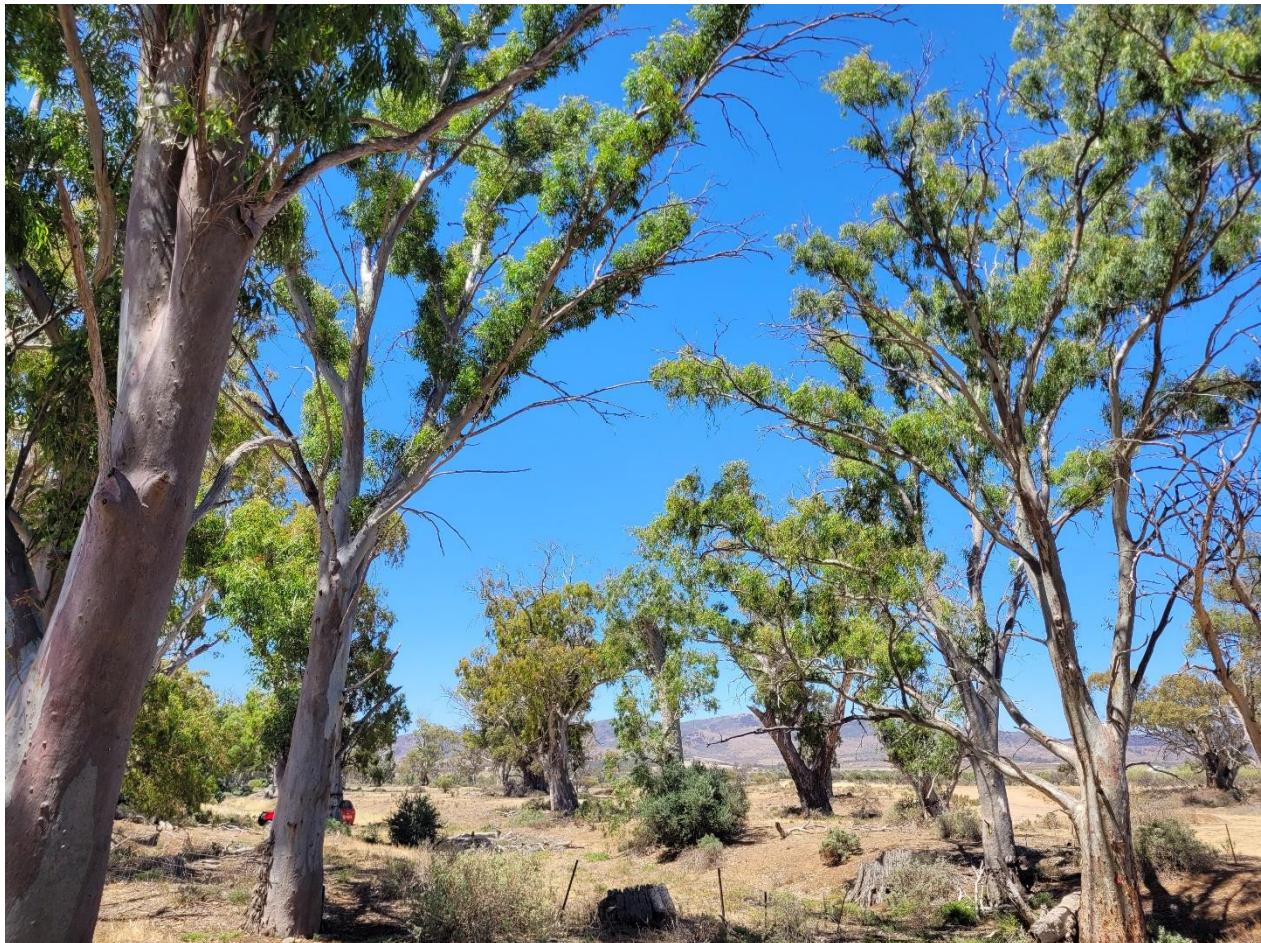
Of the 240 trees comprising the 8 transects, 116 (53% of) viable trees were characterised by the presence of epicormic growth. This is considered an indicator of partial recovery from preceding water stress and reflects the progressive improvements in condition scores observed at most transects. The high prevalence of epicormic growth is considered a strong indicator that either high seasonal rainfall, an unregulated release (spill), or delivery of an environmental water release from Baroota Reservoir will be required to support a continuation of condition recovery and subsequent achievement of the Ecological Objective.

Figure 14. Tree crown at transect 4 (BarTCI_4) dominated by epicormic growth in November 2024.
