# River red gum response to Beetaloo environmental water release

A trial environmental water release from Beetaloo Reservoir along Crystal Brook Creek in late 2021 has led to monitoring to assess the impact on river red gum health.

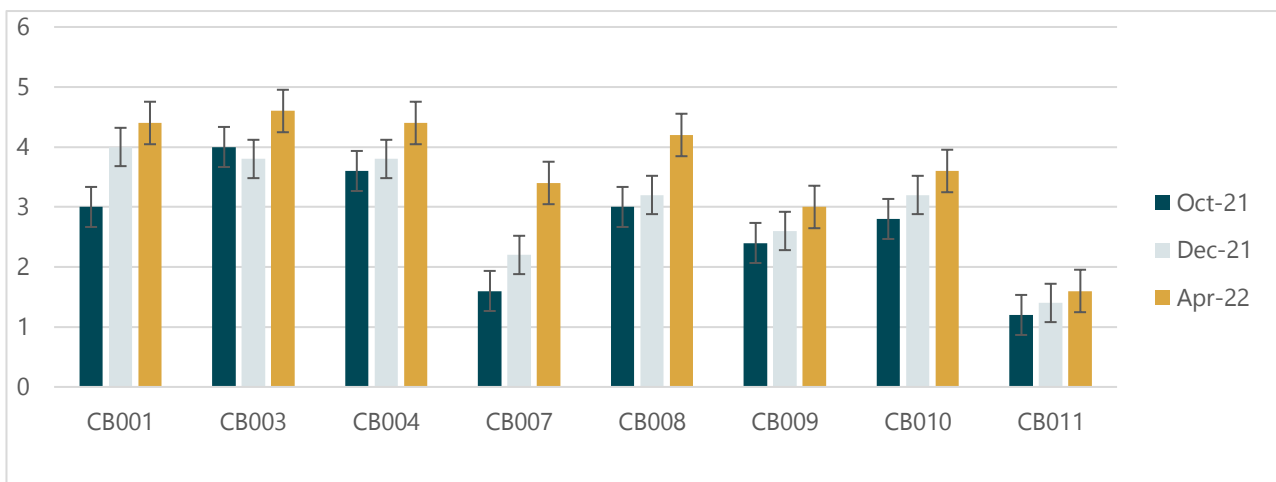
Figure 1: River red gum condition scores by site, showing consistent improvement over the survey period. Improvements at non-watered sites (CB003, CB009-11) likely due to large rainfall events.

The results showed a measurable improvement from October 2021 to April 2022 in the trees' condition at both watered (CB001, CB004, CB007, CB008) and non-watered sites (CB003, CB009-11), with improvements in the non-watered sites likely due to large rainfall events in November 2021 and January 2022 (*Figure 1*). Over the three surveys there was a clear and consistent trend of improving canopy condition.

It is also interesting to note that improvements in tree condition (*Figure 1*) within the watered sites appear to increase with time following the water release, compared to the non-watered sites which didn't show the same level of improvement.

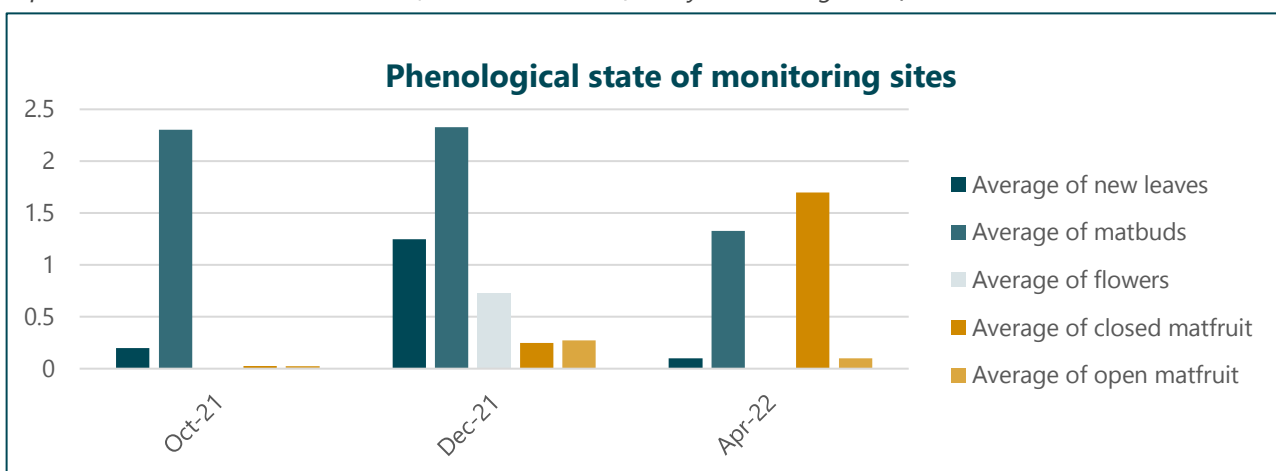
Figure 2: Plant features (phenology) showing mature buds dominant in October to December 2021, new leaves and flowering evident in December 2021 and closed mature fruit with seeds developing in April 2022.

Monitoring of plant features in October 2021, showed that the trees were displaying normal flowering activity, with mature buds the most obvious feature, as expected for river red gums in spring. In the December 2021 survey, there was a significant increase in new leaves and an observed increase in flowers and fruit as per the normal flowering season, which indicates that the trees were healthy enough to reproduce. Finally, the April 2022 survey showed that the trees successfully completed their reproductive cycle and recorded a further strong increase in seed-containing mature fruit (*Figure 2*), which is a promising sign for the next generation of trees.
