# Surface Water Technical Advice Memo

**Technical Memo:** Barossa -Monitoring of Permanent Pools

Approved:	Jason VanLaarhoven, Manager Surface Water	Distributed to:	Jennifer Munro Planning Officer, Northern and Yorke Landscape Board
Date:	11/09/2025	Date:	11/09/2025
<b>Document Reference:</b>	<b>DEW SWTAM 2025-09-11</b>

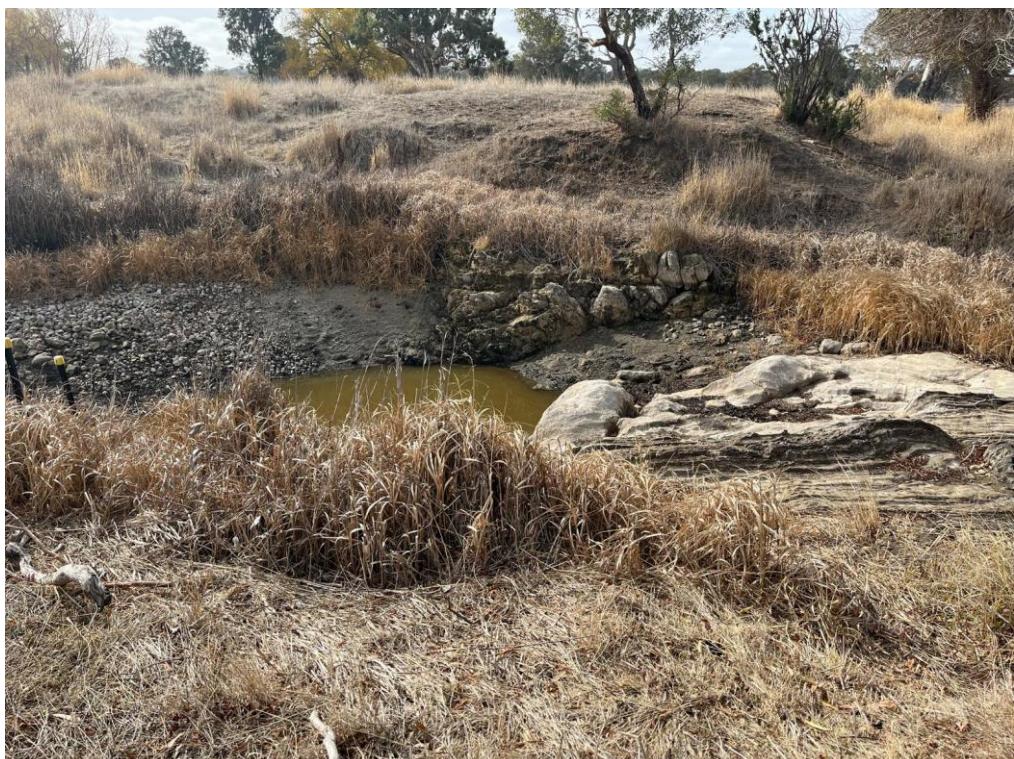
Photo 19. Site 12- May 2025

- Based on observations on 28/05/2025 (Photo 19) the pool was stagnant and discoloured, indicating disconnection from groundwater (In contrast, a groundwater-connected pool would appear as in Photo 24).

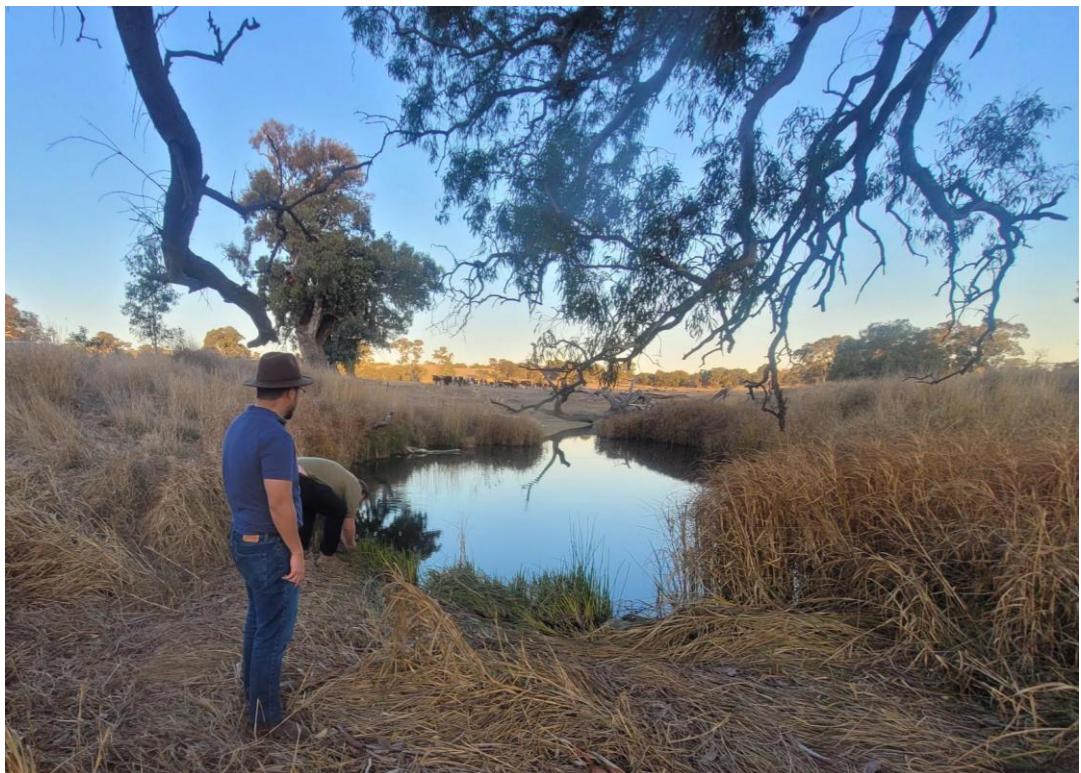
Photo 20. Site 13- May 2024

- Site 13 (Figure 21) is downstream of Site 12 and it represents a better groundwater connective pool compared with other pools in Flaxman Valley. It displayed a minimal pool depth variation throughout the year until November 2024. Similar to the rest of the pools the pool depth gradually declined during the low rainfall period between November 2024 and March 2025, but maintained a pool depth around 0.6 m.
- This demonstrates the **pool's high groundwater connectivity throughout the whole monitoring period**.
