Environmental and Cultural Flows Project | River Red Gum Condition

Water Releases Supporting Red Gum Resilience along Crystal Brook Creek

Monitoring data reveal iconic river red gums along Crystal Brook Creek are responding well to Beetaloo Reservoir environmental flows.

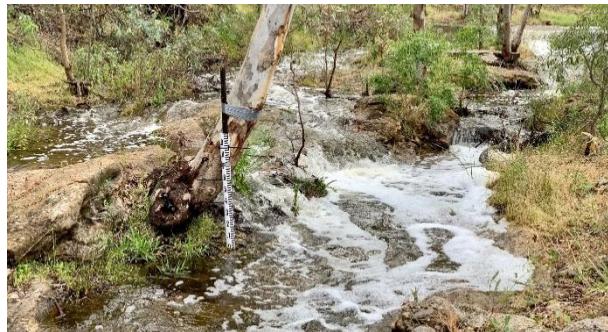
Crystal Brook Creek flowing from the e-flow trial in 2021. Credit: Amy Tutunkoff.

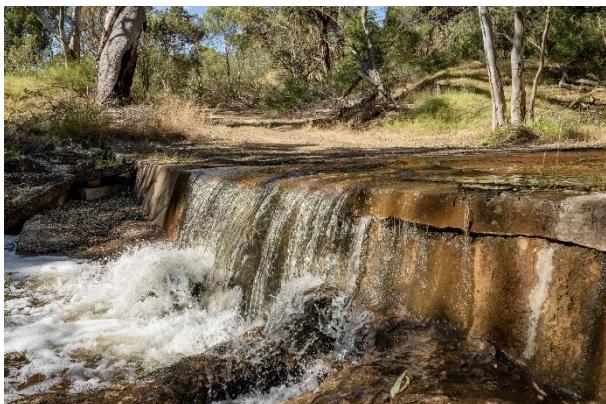
Crystal Brook Creek flowing at Bowman Park after the e-flow trial in 2021. Credit: Mark Zed.

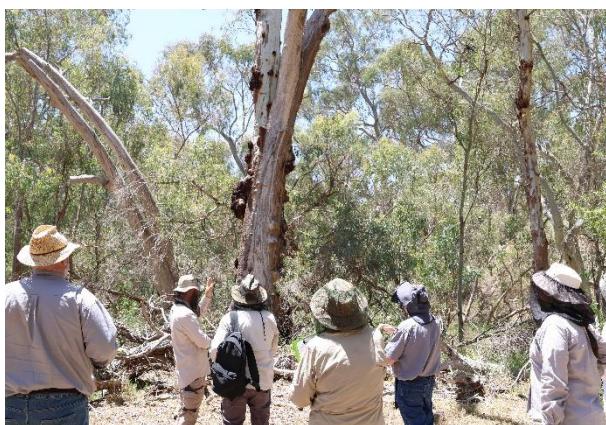
Tree health monitoring with Nukunu Wapma Thura Aboriginal Corporation in 2024.

The monitoring protocols being used have been developed with the guidance of Dr Todd Wallace. Seven transects have been established along Crystal Brook Creek. During monitoring 30 trees per transect are visually inspected to determine the crown extent and crown density of the canopy. Trunk diameter is also measured, and the trees are checked for epicormic growth (new growth along branches) and signs of obvious damage and stress (e.g., bark fissuring – cracks and grooves in the bark).

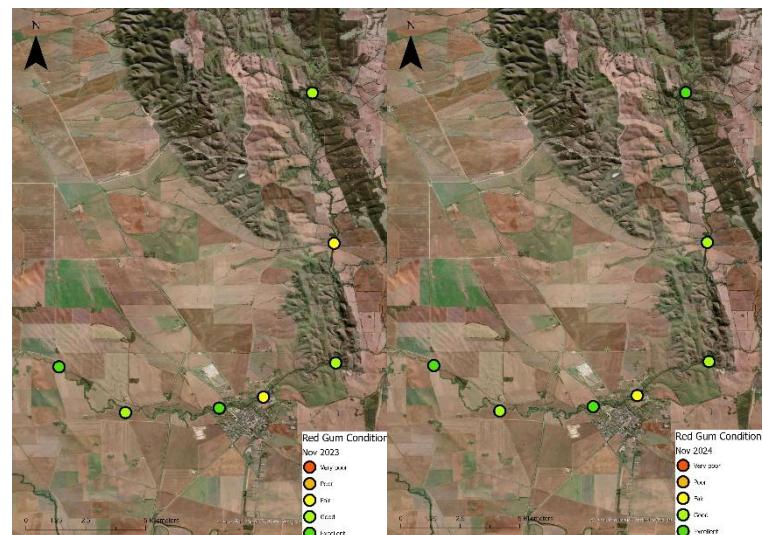
Figure 1. Changes in red gum condition at seven transects along Crystal Brook Creek between 2023 (left) and 2024 (right).

There was substantial improvement in river red gum condition at several sites between the 2023 and 2024 monitoring. In 2023, only one transect had 100% of trees meeting environmental targets. In 2024, this increased to three transects having 100% of trees meeting these targets.

Red gums across four transects were classified in 'excellent' condition in 2024, compared to only one in 2023 (Figure 1).

No trees were lost between 2023 and 2024, and only a single transect (Transect 4) remains at the highest priority level for environmental water delivery. Over half of monitored trees showed epicormic growth, a promising sign of partial recovery from previous water stress.
